# DOWNTON TANNERY, DOWNTON WILTSHIRE

BUILDING RECORDING AND  
INDUSTRIAL ARCHAEOLOGICAL RECORDING

# DOWNTON TANNERY

## BUILDING RECORDING AND INDUSTRIAL ARCHAEOLOGICAL RECORDING

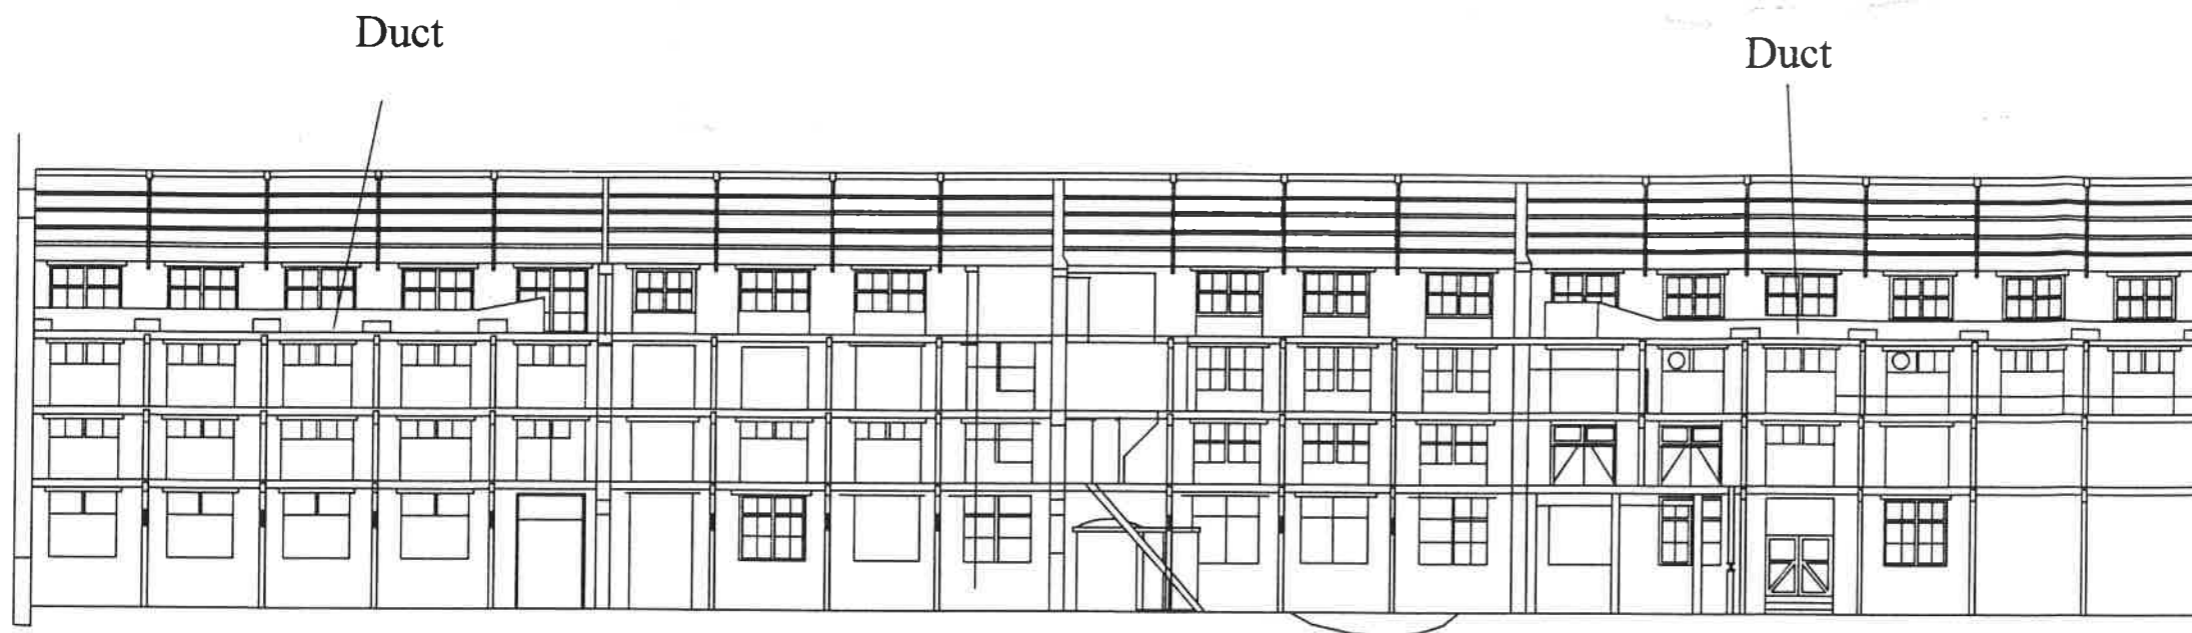
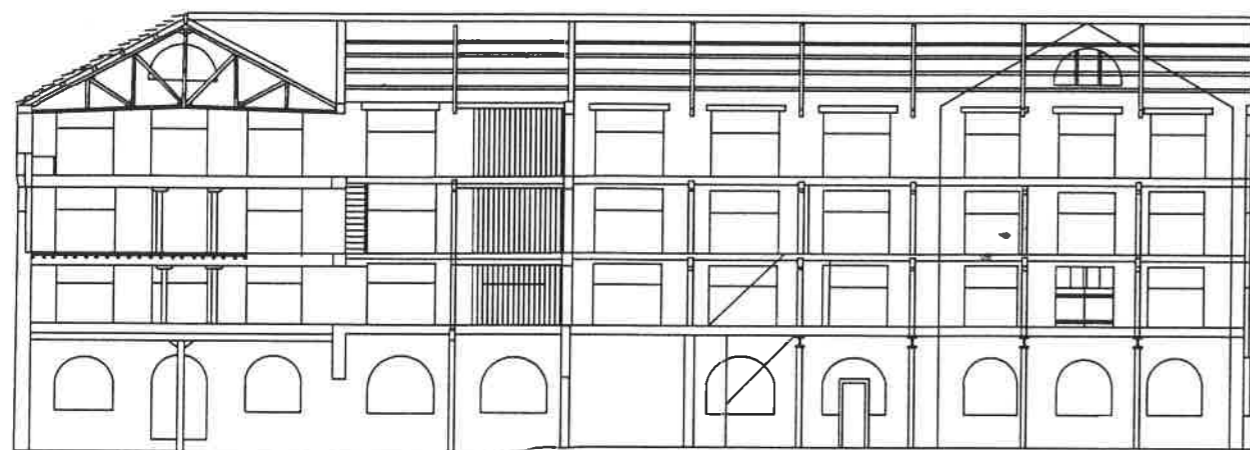
Drawing No.	Figure 7
Scale at A3	1:250

Section Through Block 2 Looking North East

Section Through Block 1 Looking South East

**Internal Sectional  
Elevation**

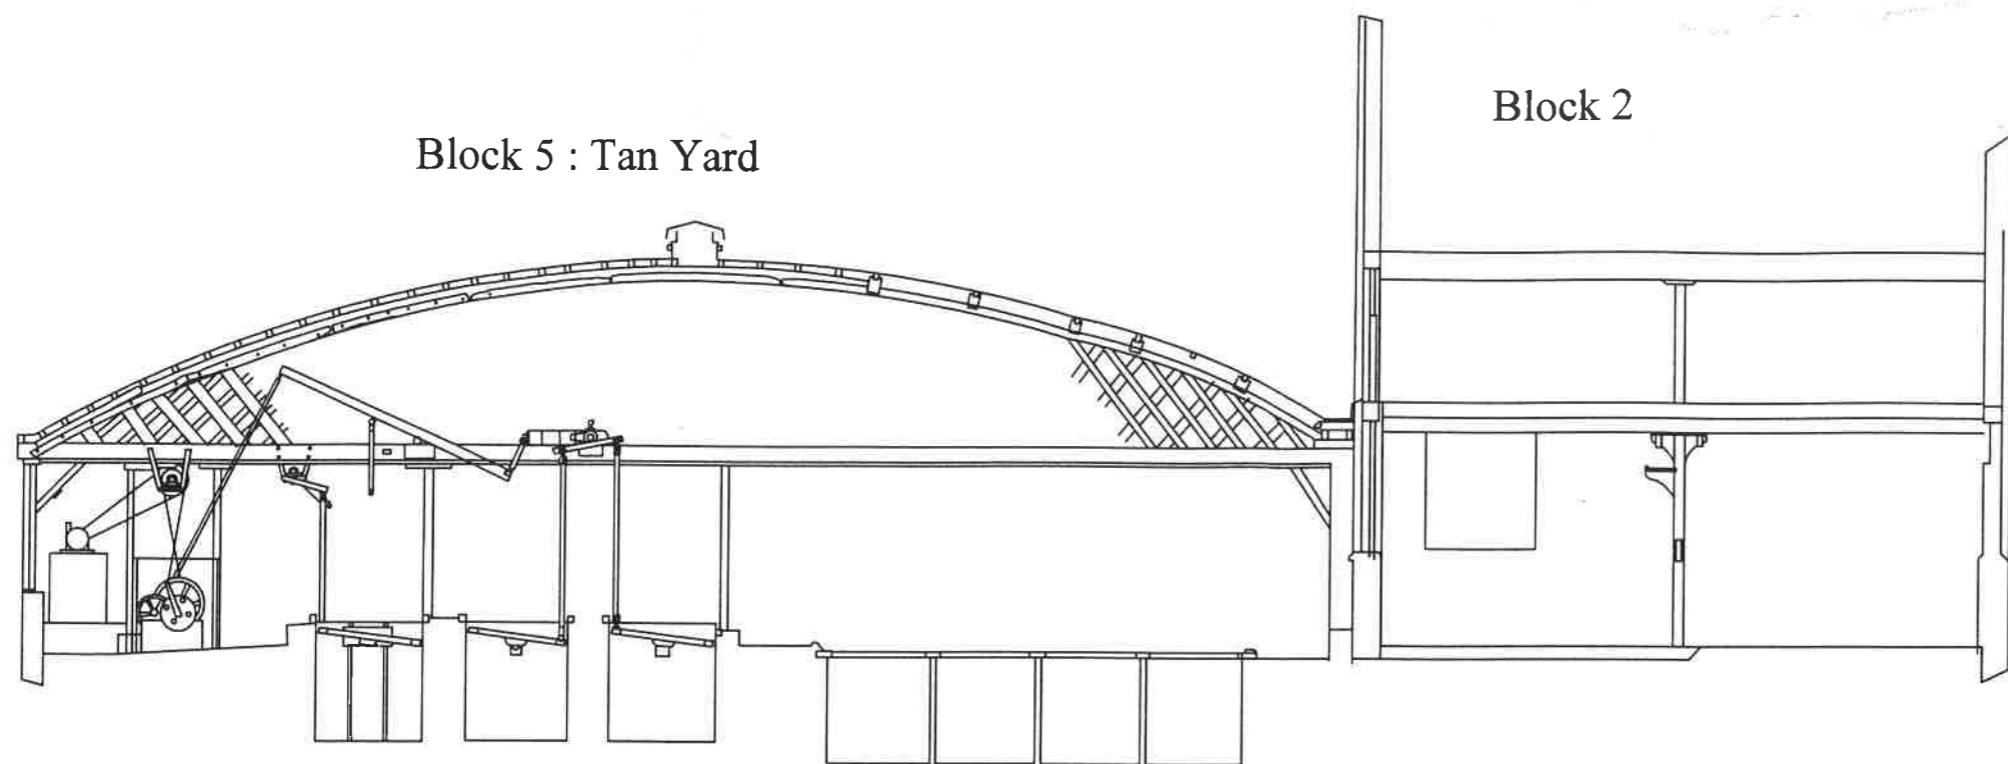
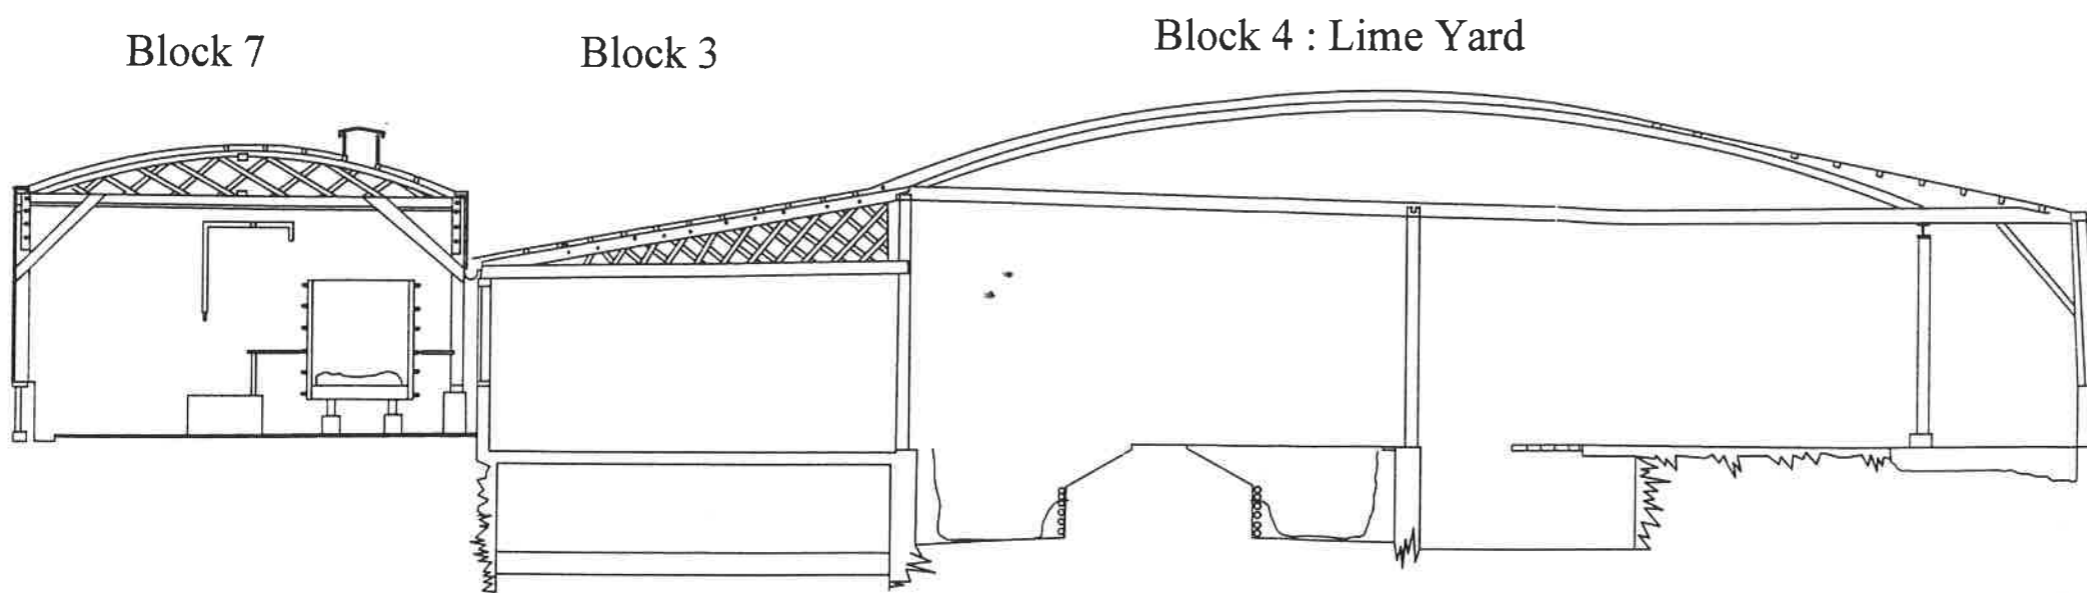
Drawing No.	Figure 8
Scale at A3	1:250

Section A - A Looking North

### Sections Through Tannery

- 3.5.4 The two rows of pits were divided by a central walkway and their profile was a mirror image of each other (see Fig.8). Each pit was c.3.5 m long by 1.5 m wide by 1.65 m deep at its deepest point. It had a sloped face adjacent to the walkway on which hides could be laid to drain which was continued by a vertical face to which was attached 6 pipes. Hot air or water would have been pumped through the pipes to warm the lime solution and thus accelerate the liming process. The base of the pits sloped gently away from the pipes and the opposite face of the pit was vertical. A feature of interest within each pit were two sets of chains, c.1 m apart from each other, set into each end face of the pit with 2 bars between them. These would have been used to regularly haul the hides out of the lime solution. The walls of the pits appeared to be constructed of brick although they had a thick, white lime encrustation. Many of the pits were covered by thick planks. There were five more pits adjoining to the south of the main rows of pits which also had sloped faces, pipes and chains.

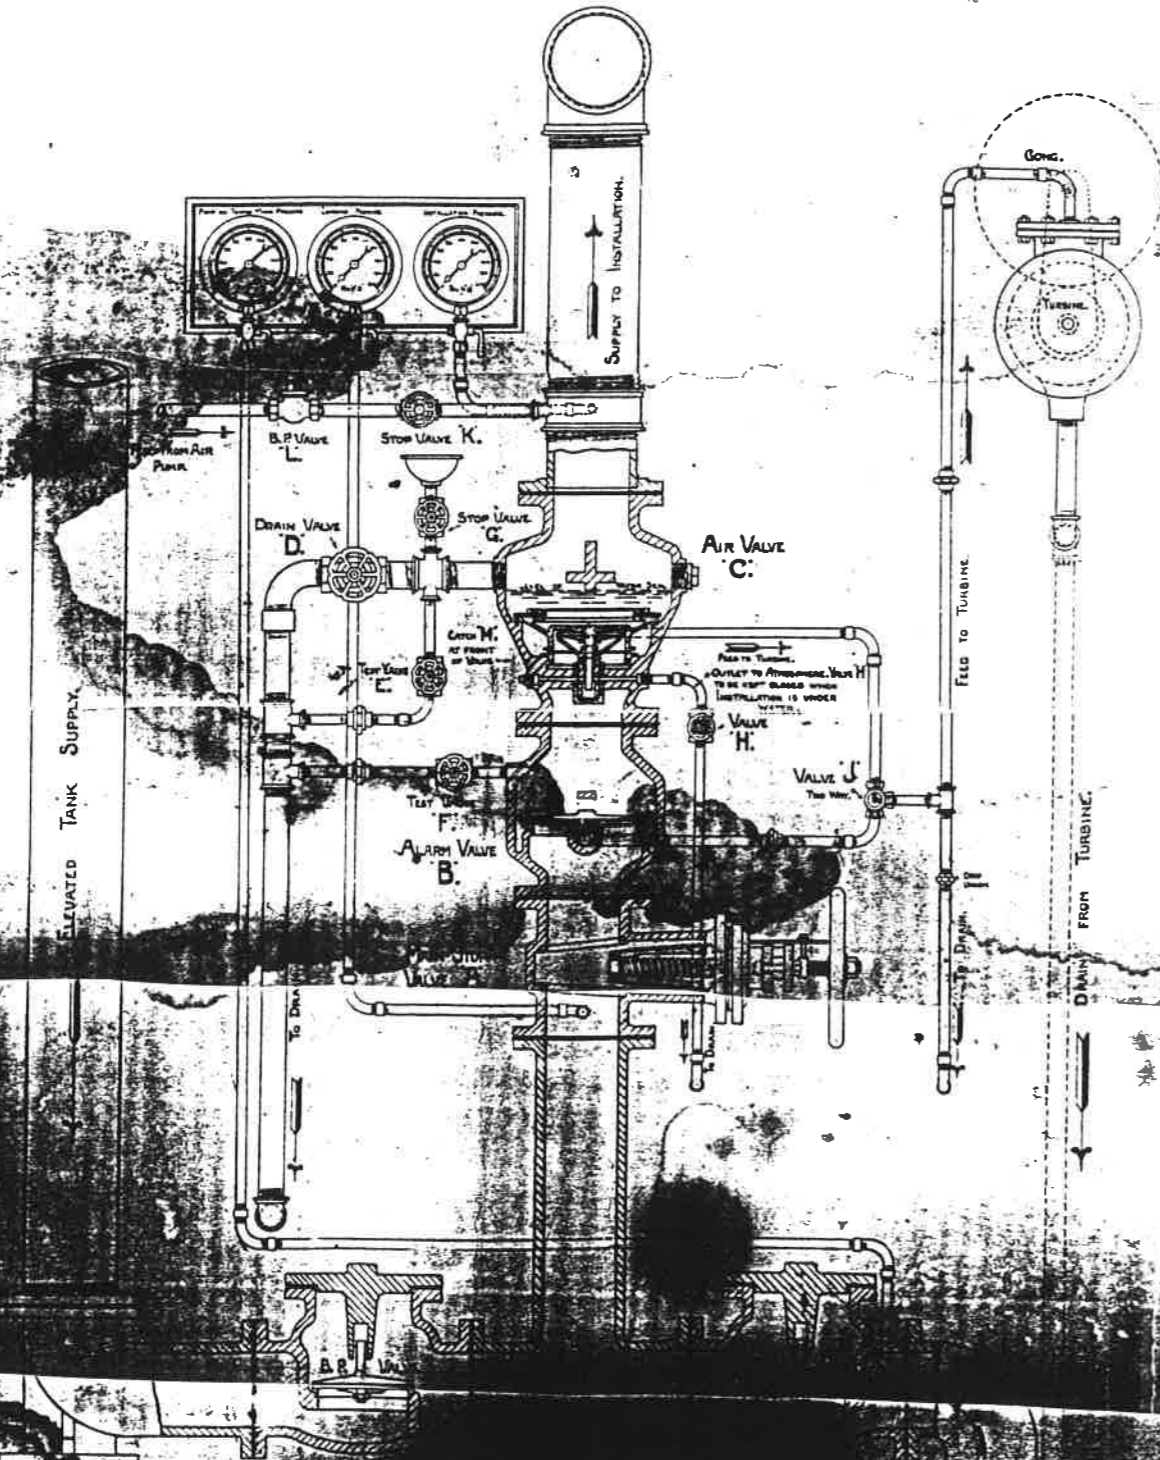
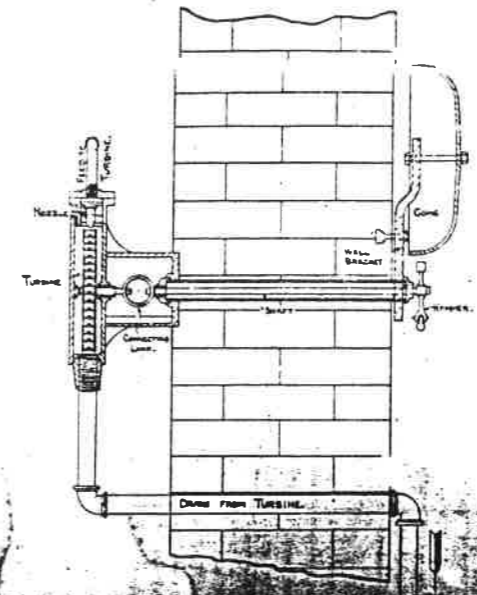
# ARRANGEMENT OF HOFFMANN'S ALTERNATE SPRINKLER VALVES

- GENERAL INSTRUCTIONS**
- TO CONVERT INSTALLATION FROM WET TO DRY SYSTEM -
1. SHUT MAIN STOP VALVE A
  2. OPEN DRAIN VALVE D AND ALL DRAIN VALVES CONNECTED TO INSTALLATION. (THEN CLOSE AIR VALVE C)

Figure 11: Sprinkler system at Downton Tannery (dated 20 Feb 1919)

- 3.7.1 At the southern corner of the tan yard was a small adjoining brick structure labelled on the 1943 plan as *Compressor Room*. Although the room was dominated by a large (9 m long) riveted, cylindrical compressor tank the feature of greatest interest was the system of valves and mechanics of the tannery's sprinkler system. The sprinkler system extended throughout the covered yard as well as on each floor of the main building and the operation of the system is detailed in a badly damaged framed illustration which was recovered from the room (Fig. 11). The illustration is titled *Arrangement of Hoffman's Alternative Sprinkler Valves for Wet and Dry Pipe Installations* and includes instructions for operating the system. The illustration is dated 20<sup>th</sup> February 1919, the year that it is believed the tan yard was covered over, strongly suggesting that the existing sprinkler system is primary to the tan yard.

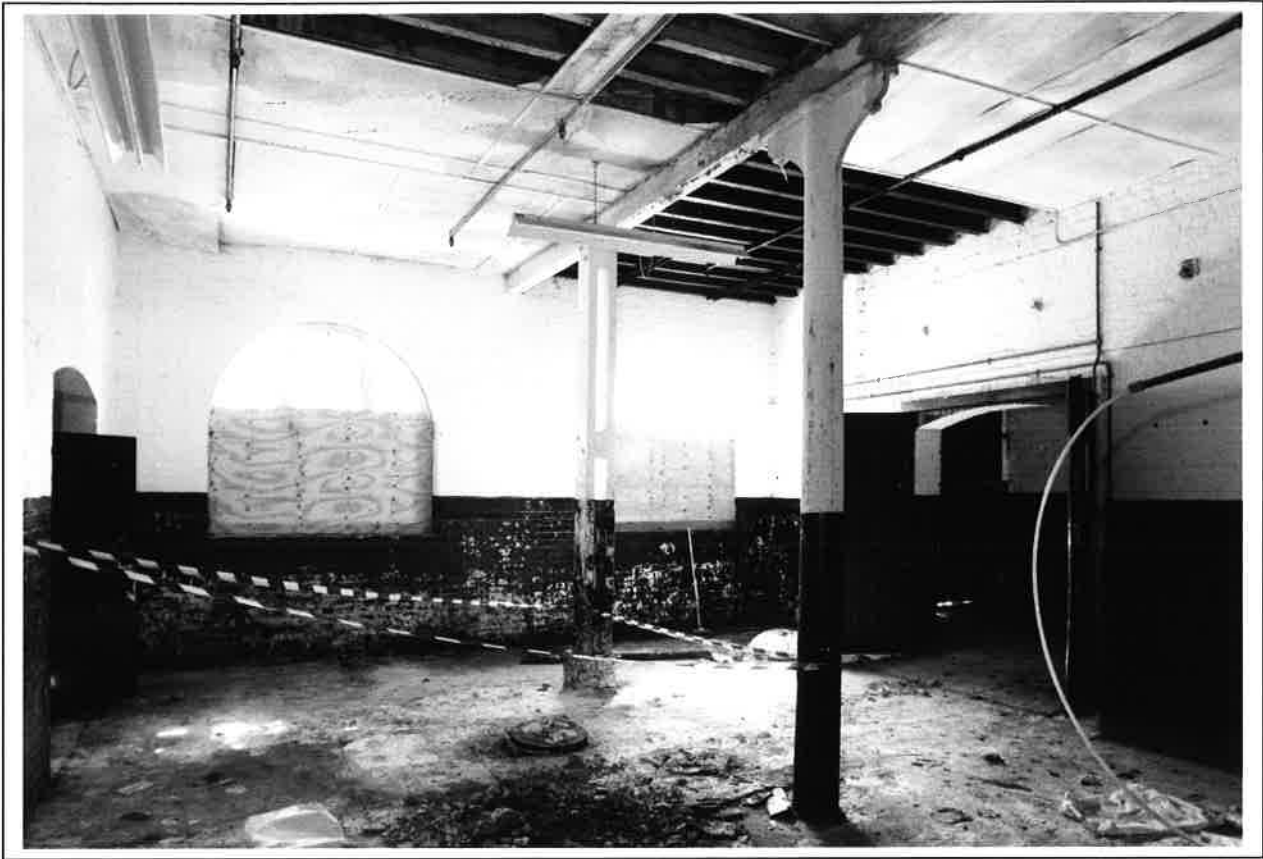
Plate 6: Interior of G22 (Ground floor Block 2) with line shafting brackets on columns

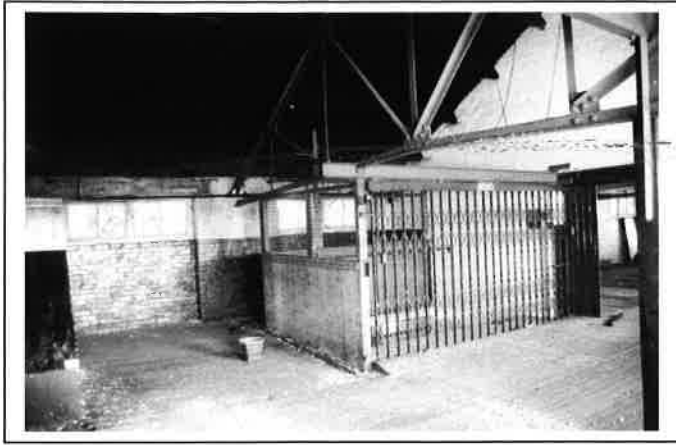
Plate 17: Lift at third floor level

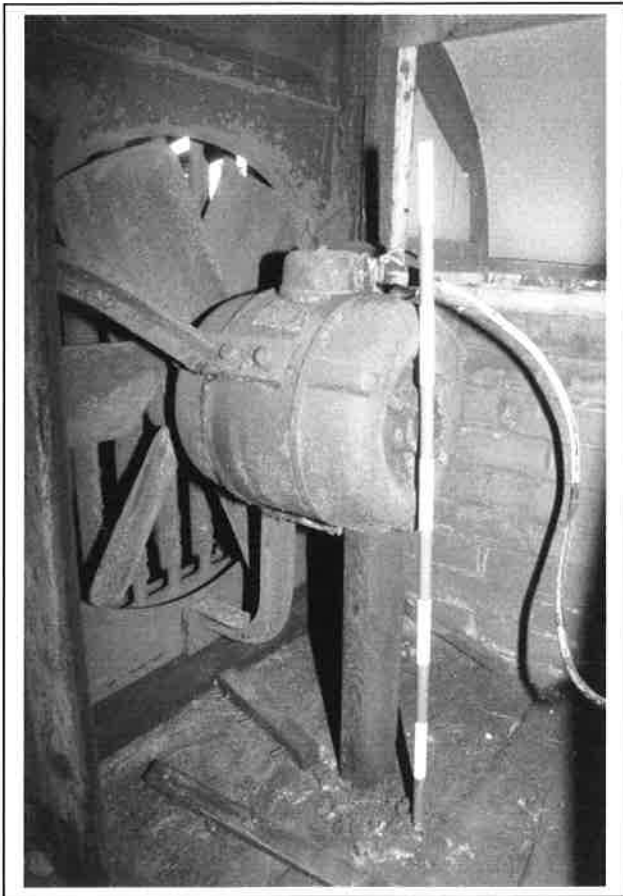
Plate 19: fan at end of duct at third floor level

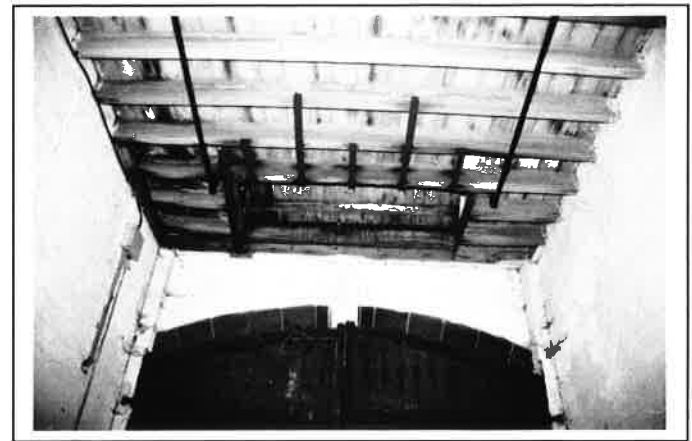
Plate 20: trapdoors over main entrance from south

- 3.2.8 The **ground floor** plan of Block 1 (Fig. 3) was divided by a N-S cross passage to the tan yard (Block 5) with load-bearing brick walls to either side and two trap doors in the floor above (Pl.20). The area to the west of this passage was divided into offices by light-weight and glazed partitions and there was an apparently primary staircase at the south-east corner of this area. The arrangement of offices was broadly similar to that shown on the 1943 plan but the offices had been extended eastwards into a former store area.

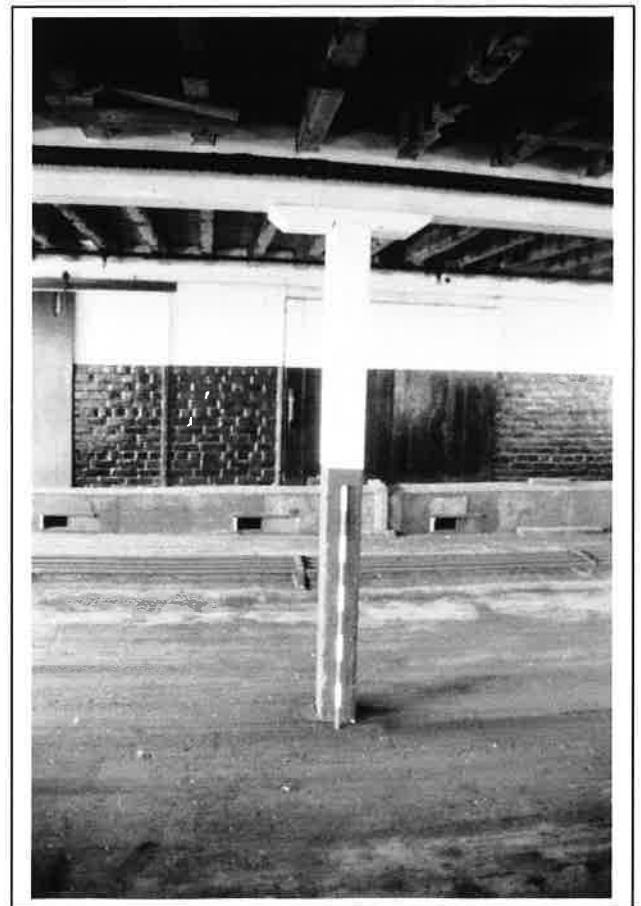
Plate 23: Power shaft and gearing at N end of tan yard

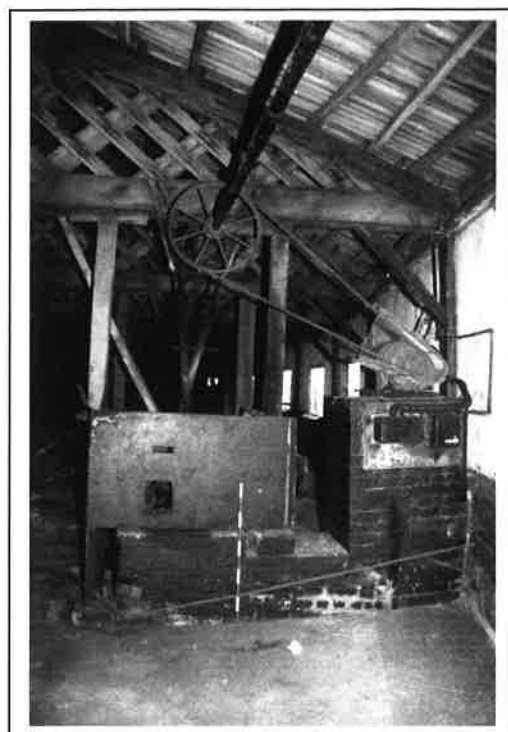
Plate 24: Shaft and gearing within tan yard

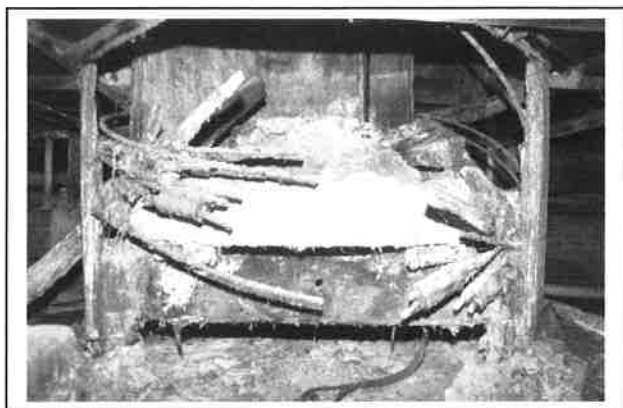
Plate 25: Broken base of vat in Block 7

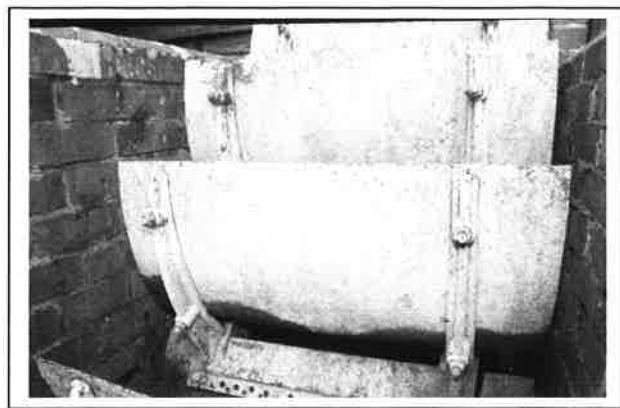
Plate 26: blades of waterwheel

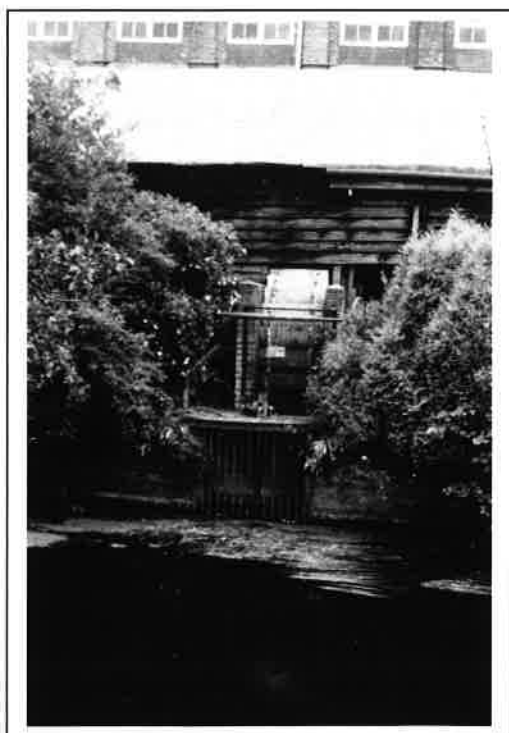
Plate 27: Waterwheel at west side of tan yard

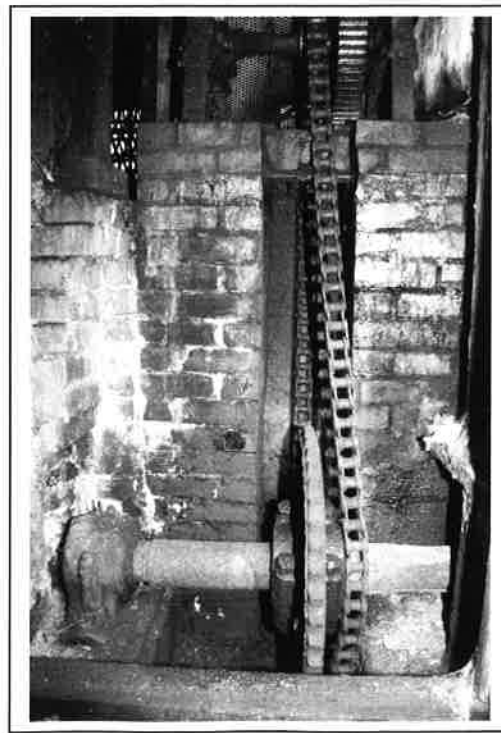
Plate 28: gearing adjacent to water wheel

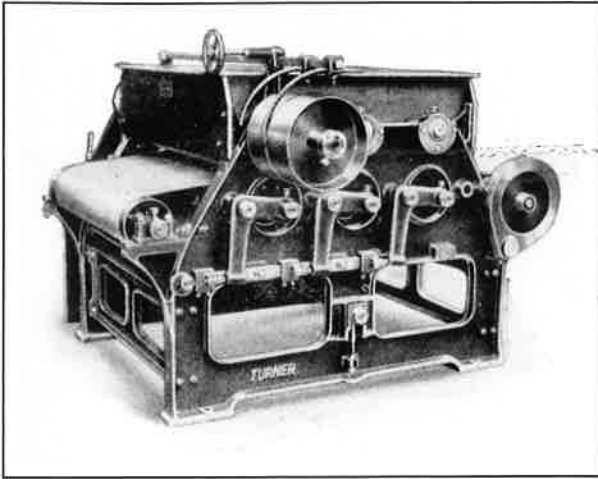
Plate 29: Sole leather polishing machine

- 3.3.12 **G21** had three cast iron columns with line shafting brackets and the 1943 plan shows that at that date it was a *Machine Room* with several electrically-powered machines (*Turner 149, Turner 280 and fixed head setter*). Turner is clearly the make of machine rather than a specific type of machine and illustrations of several other Turner machines are included at the end of this report as Plates 29 to 33.

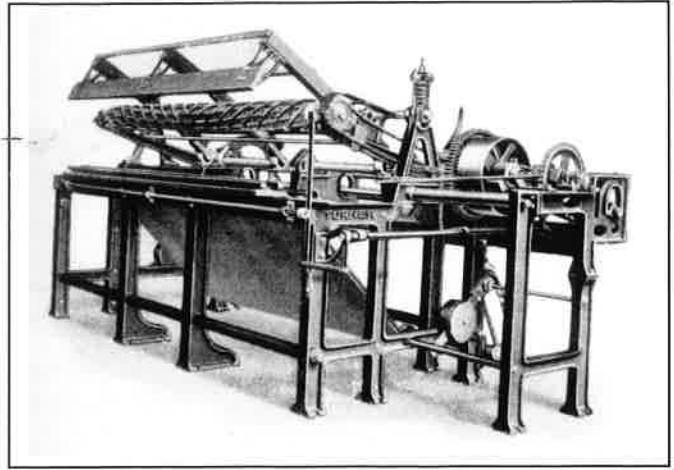
Plate 30: unhairing machine

which pulled the hide through and over blades which removed the hair. There is known to have been an unhairing machine at Downton and an illustration of an unhairing machine from this period (not necessarily the same as that at Downton) is included as Plate 30.

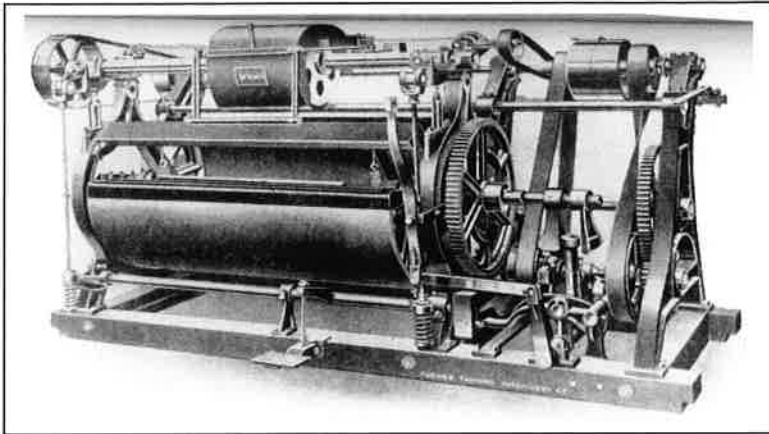
Plate 31: Setting out machine

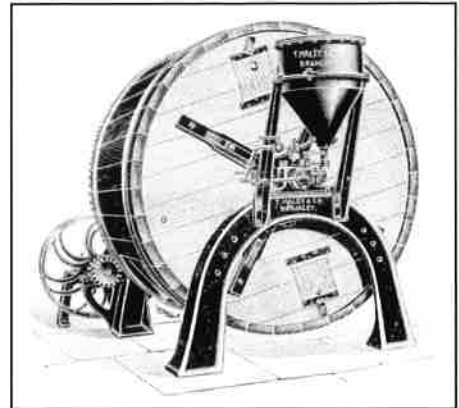
Plate 32: Leather-stuffing drum

- 2.3.12 **9). Dressing** the leather was the final element of the process. There were a wide variety of dressing processes employed in different tanneries but they included polishing, fluffing, dyeing, buffing, printing, embossing and waterproofing the leather. Many of these processes were mechanised and illustrations of some typical machines are included at the rear of this report as Plates 29 and 32. For example leather was stuffed into large rotating drums containing either dye or heavy grease.

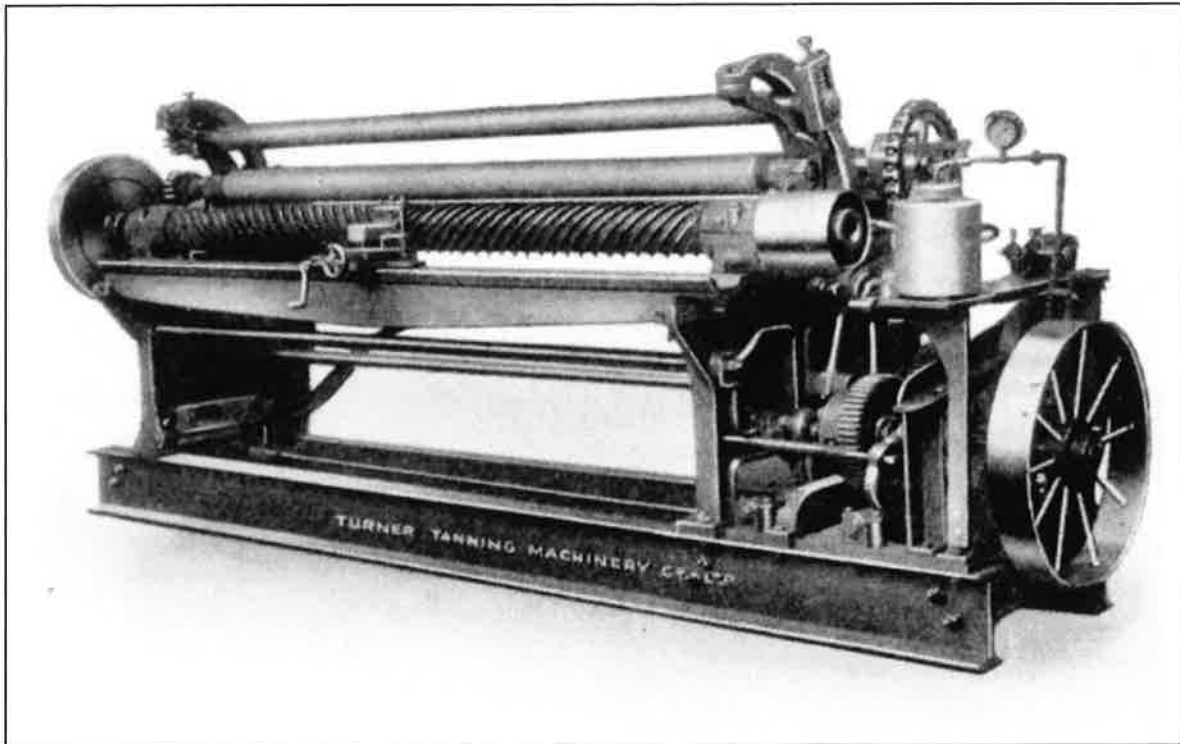
Plate 33: Fleshing machine

- 2.3.7 **4). Fleshing** (removal of flesh) was another process which had traditionally been undertaken by hand but was mechanised in the early 20<sup>th</sup> century with fleshing machines similar in principal to unhairing machines. There is known to have been a fleshing machine at Downton and an illustration of a fleshing machine from this period (not necessarily the same as that at Downton) is included as Plate 33.
