# Chapter 3 The Later Development of the Site from c 1600 to the Present Day

## SITE 29: THE ORACLE WORKHOUSE

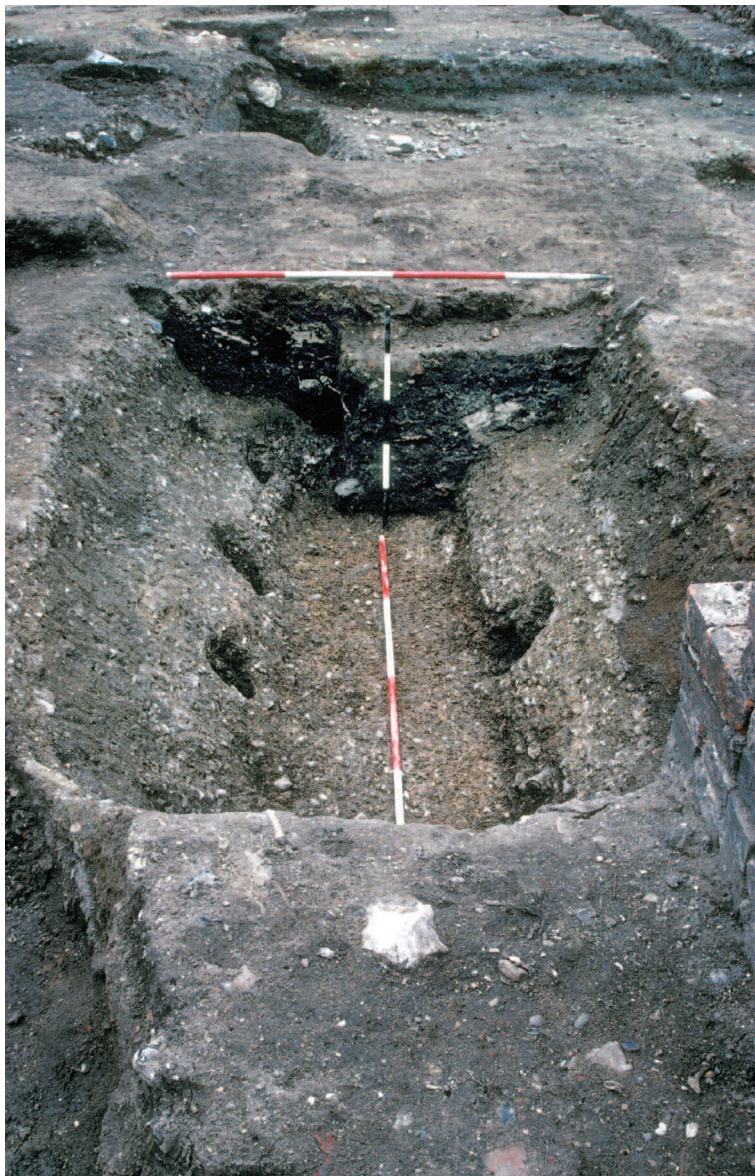
*Plate 3.5 Site 29 the Oracle:  
view looking SE of the saw  
pits (Project Phase 7)*

Two adjacent pits (4326 and 4410), probably saw-pits (Plate 3.5), show that the area that had first been used as a builder's yard in the 16th century (see Chapter 2 Project Phase 7) was probably used again in this way during the construction of the workhouse in 1627 and 1628. The primary courtyard surfaces 3755=3743, 4207 and 4621 sloped gently down to the south and consisted of rubble fragments and small stone cobbles. They survived only in patches, some of which had slumped into the softer infills of the

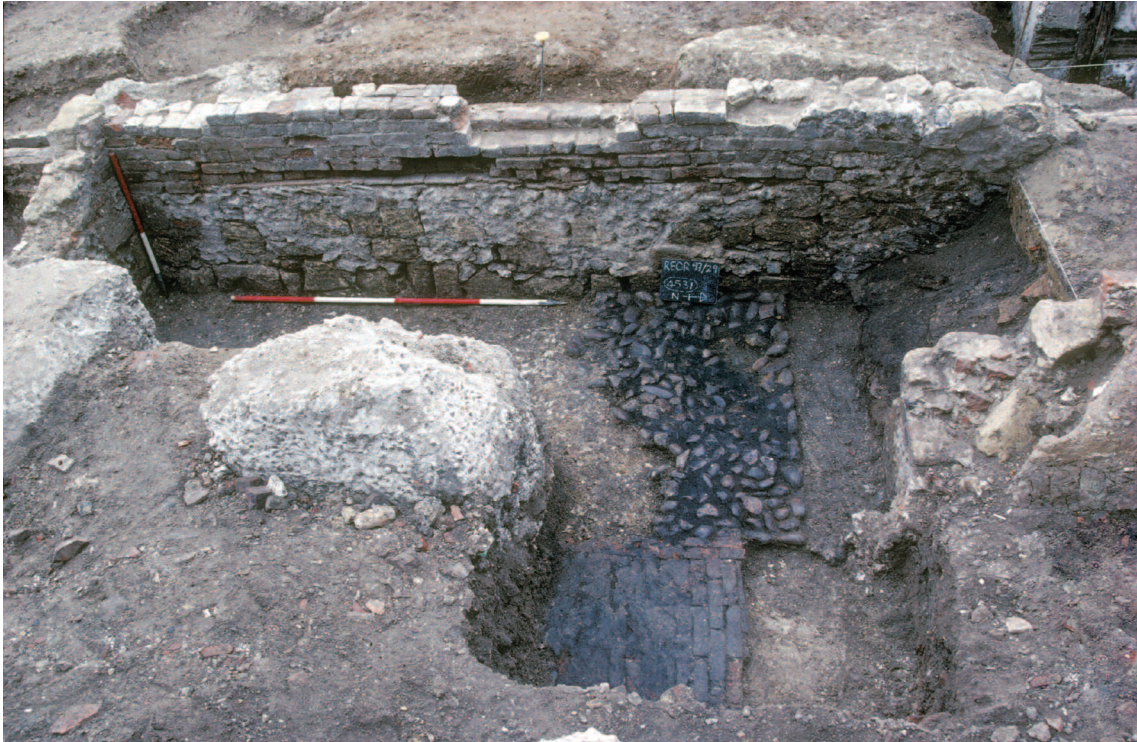
*Plate 3.6 Site 29: view looking NW of cellar 4575 in the east range of the workhouse (Project Phase 7)*

western wall of the east range was represented by robber trench 3951 and/or 4103 in the south-east corner of the site. The west part of a cellar (4575) was found in the southern half of the courtyard, on the east side, some 8 m north of the Holy Brook (Plate 3.6). It was built within a large pit 4973 which measured 5.2 m (N-S) by 3.2 m+ (E-W). The lower element of the walls was constructed from re-used masonry, some of which seems to have come from Reading Abbey (see Preston, Chapter 8). The upper elements of the walls were constructed of brick, and were keyed into a brick-built drain, 3852, which ran

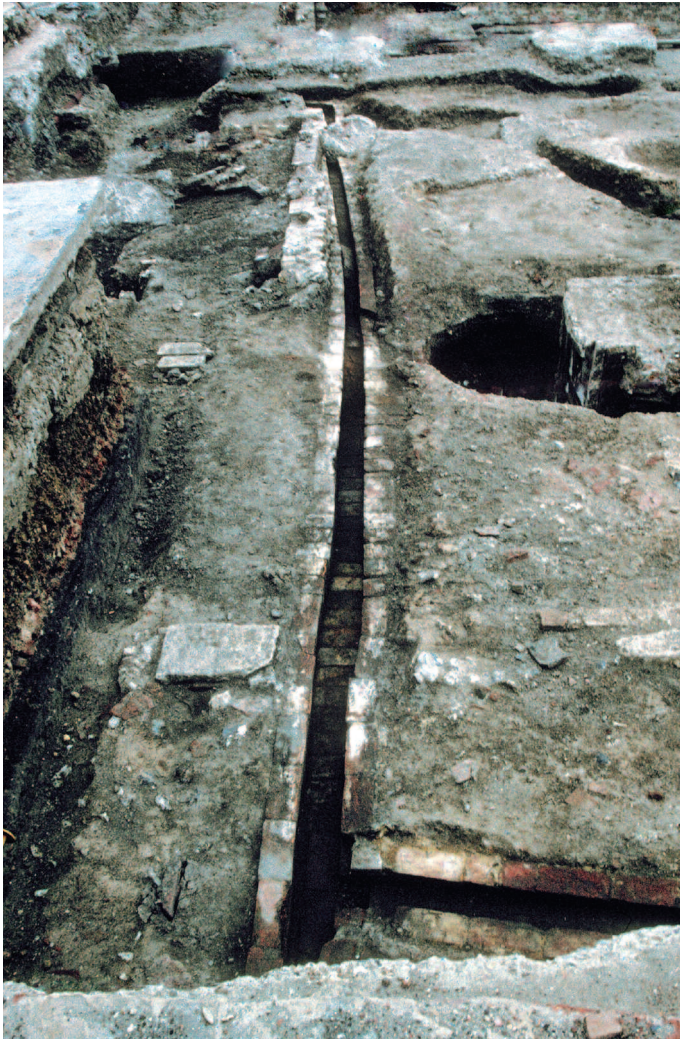
*Plate 3.7 Site 29 the Oracle: view looking SE along drain 3852 (Project Phase 7)*

towards the Holy Brook (Plate 3.7). Access via a set of steps (that did not survive) was provided from the north end. The cellar floor consisted of large well-laid cobbles, 4604, around a brick hearth setting, 4605, in the northern half of the room. The hearth and to some extent the surrounding floor was overlain by charcoal-rich occupation deposits 4790 and 4510, although there were no finds. It is unclear whether this hearth was purely for heat, or whether it had some function in a production process.

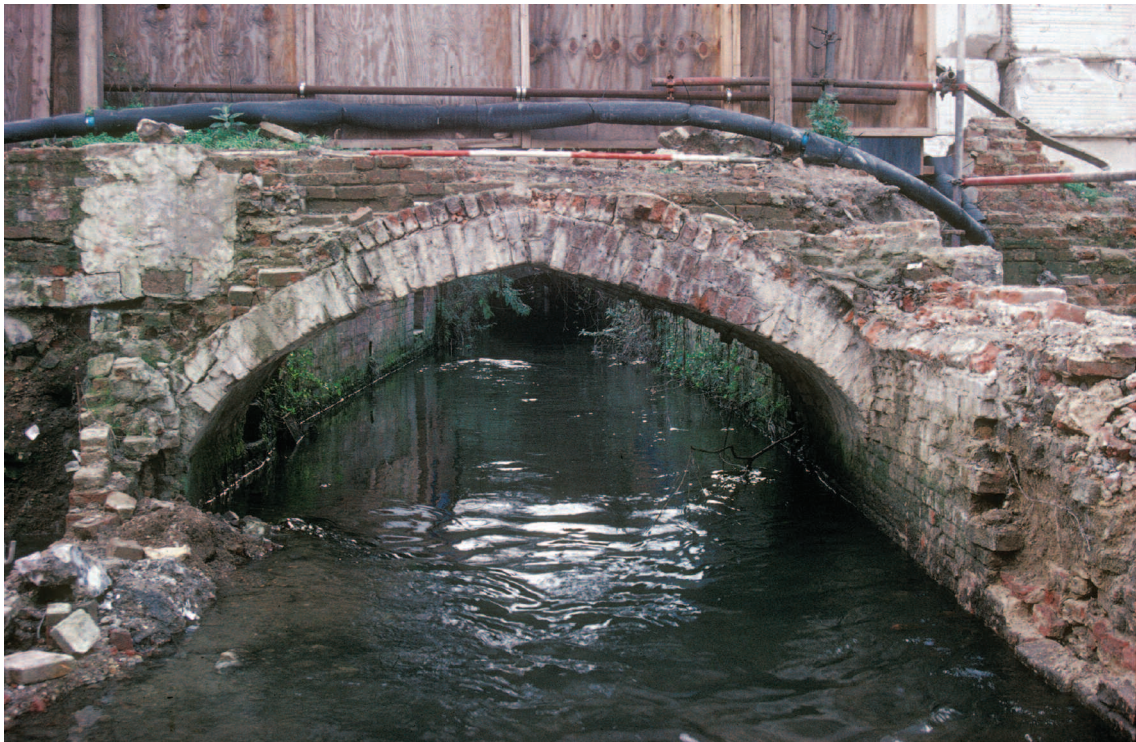
*Plate 3.8 Site 29 the Oracle: view looking SW at original brick bridge 6015 which carried the western range of the workhouse over the Holy Brook (Project Phase 7)*

Bridge 6015 (Plate 3.8), of four-centred arch design, was 2.4 m wide and constructed entirely of non-vousoired brick. It had a centre span of 3.30 m between the two east-west orientated brick walls with flint foundations that acted as abutments on either side of the Holy Brook. The apex of the arch sat 1.2 m above the uppermost level of the flint foundations. Until its demolition to make way for the shopping centre this was the oldest surviving bridge in Reading and the only surviving element of the Oracle Workhouse from which the shopping centre took its name.

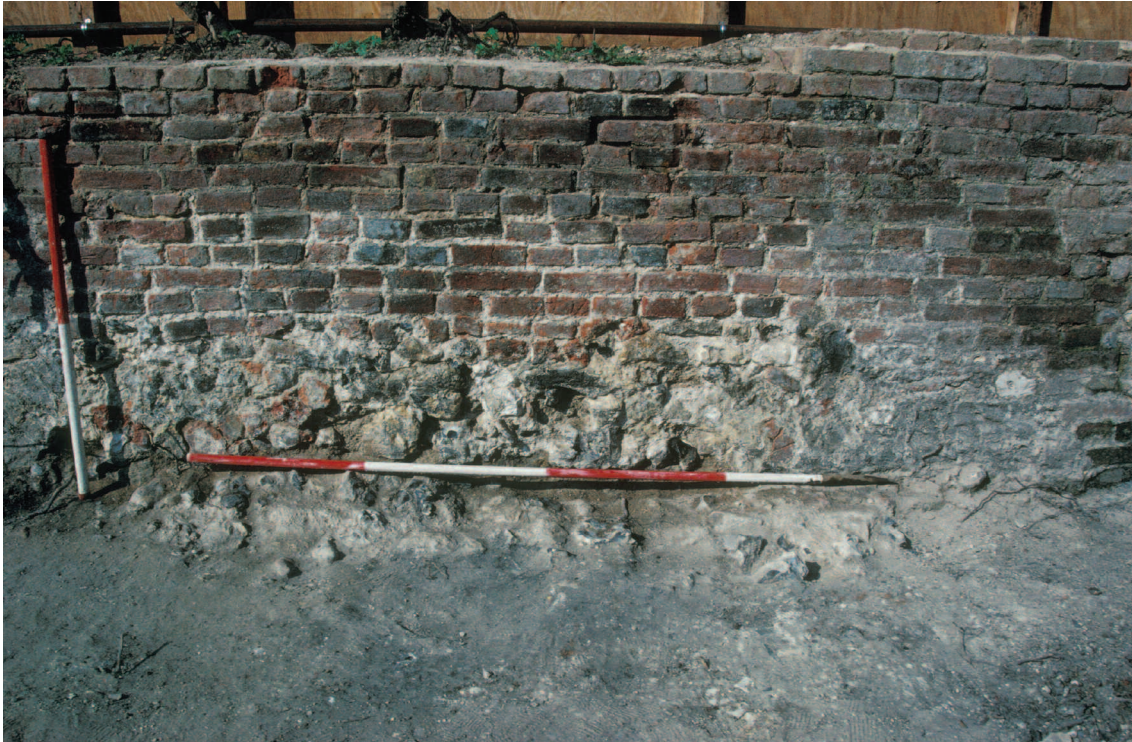
Plate 3.9 Site 29: view looking SW at the west wall (3967) of the west range of the workhouse (Project Phase 7)

The western wall of the west range, and its foundation, were revealed. This wall (3967) was 0.40 m wide and was constructed of brick laid in a random bond. To the south it was founded upon the remains of the 16th-century sandstone building that had previously occupied the site (see Chapter 2, Project Phase 6, above); however to the north of this it sat upon a contemporary foundation of reused bricks, tiles, flint, chalk and limestone (4181) (Plate 3.9). The eastern wall and the majority of the internal occupation levels of the west range had been removed when the floor levels for almost the entire range were lowered to provide a new basement in the mid 19th century (see below). The later basement did not extend to the full northern limits of the west range, and it was in this location that a comprehensive sequence of construction, repair, re-use and finally disuse of the interior of

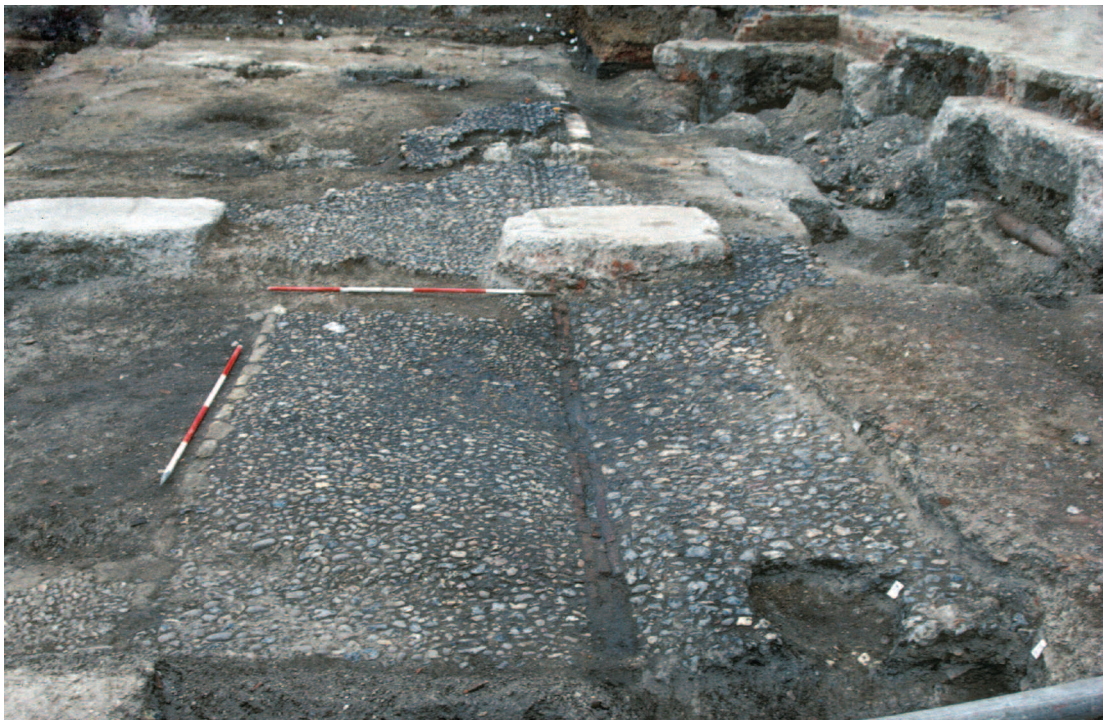
*Plate 3.10 Site 29 the Oracle: view looking NW along the main NW-SE pathway of the Oracle Courtyard (Group 3846) (Project Phase 8)*

(4145=3879, 3.9 m wide and over 13 m long; Plate 3.10). At its south end, it joined an east-west path (4161 and 4267) that ran parallel, and adjacent to, the open Holy Brook. A third, narrower path (4129, 1.82 m wide) joined 4145 just north of its junction with path 4161/4267, and ran in a north-westerly direction. Its line was picked up again around 20 m to the north-west (4160), and it continued out of the excavated area towards the location of the entrance gateway. Path 4160 was joined by a further cobbled path (3964, 1.9 m wide) which ran in a south-westerly direction for over 3 m (its make-up layer ran for a further 3.5 m). These remains suggest that the complete pattern of pathways would have formed a square of wide paths around the outside of the courtyard, enclosing narrower paths forming a 'X' shape inside.

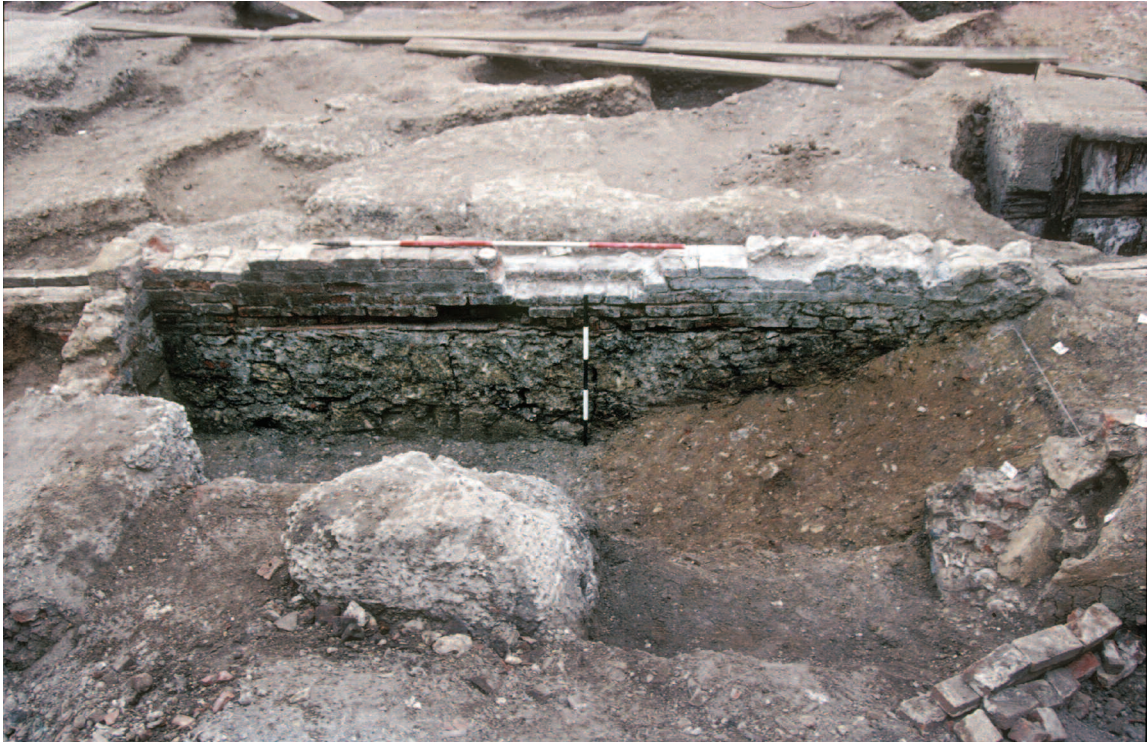
*Plate 3.11 Site 29 the Oracle: view looking SW showing the back-filling in the cellar in the east range of the workhouse (Project Phase 8)*

The 17th-century cellar towards the south end of the east range (4575) and its hearth went out of use, and the cellar was backfilled (Plate 3.11). The initial dumps of sand and brickearth-rich mortar suggest they were the product of demolition activity, probably within the Oracle, and they included broken medieval tiles and post-medieval brick with occasional metal fittings such as hinges and metal straps. Later infilling included material indicative of more domestic activity, such as pottery, animal bones, shell, clay pipes (including locally-made examples, see Higgins, Chapter 9, below), pins and two fragments from an attractive maiolica tile (Plate 3.12). Some of these finds probably derived from the

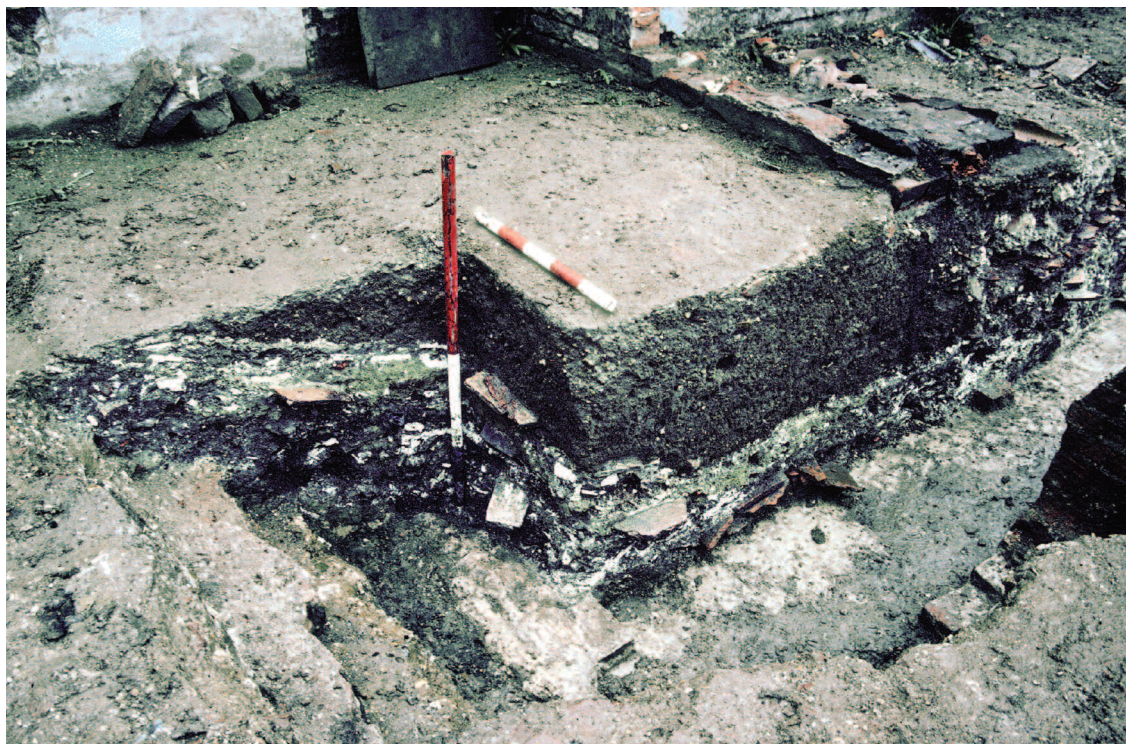
Plate 3.14 Site 29 the Oracle: view looking E showing material dumped into the cellar (3967) in the west range of the workhouse (Project Phase 8)

This sub-phase saw major remodelling of the north end of the western range. Echoing changes seen in the east range, the brick-built cellar described in the previous phase in the west range went out of use. Its brick walls were almost totally dismantled, and the resulting hole infilled with material derived from demolition activity (Plate 3.14). The fills contained significantly fewer finds than the backfilled cellar in

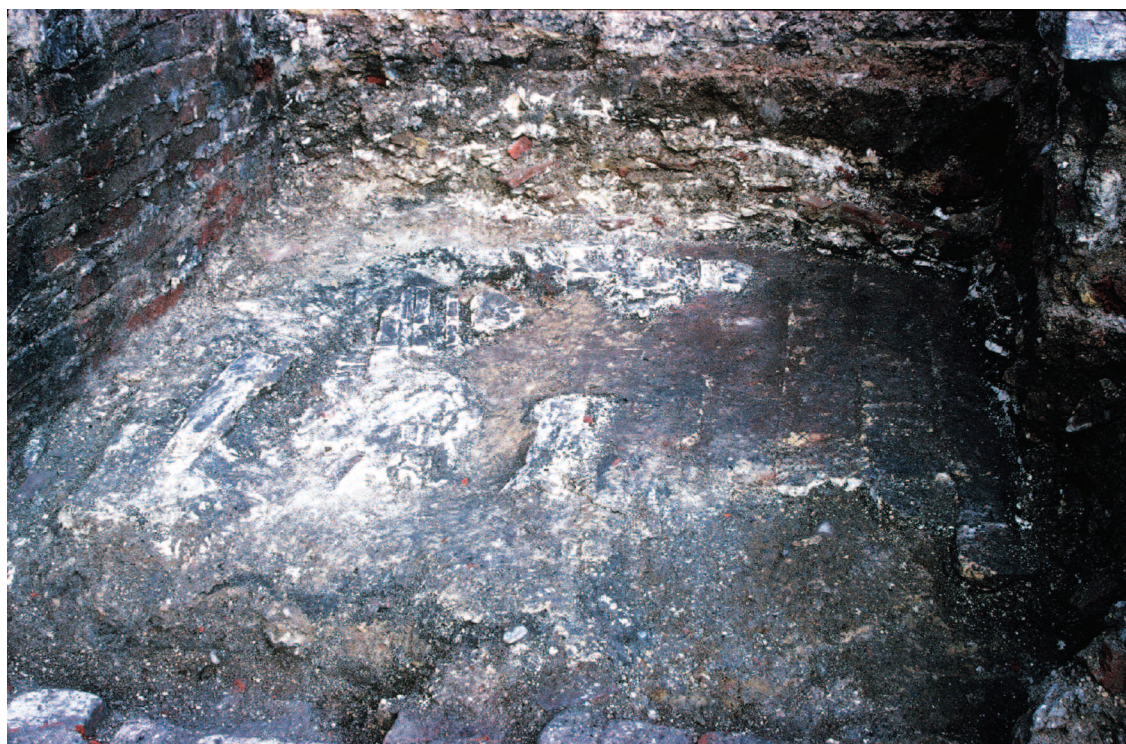
Plate 3.15 Site 29 the Oracle: view looking NW at a detail of demolished or collapsed workhouse wall and ceiling plaster showing the impressions of laths in the untruncated northern part of the west range (Project Phase 8)

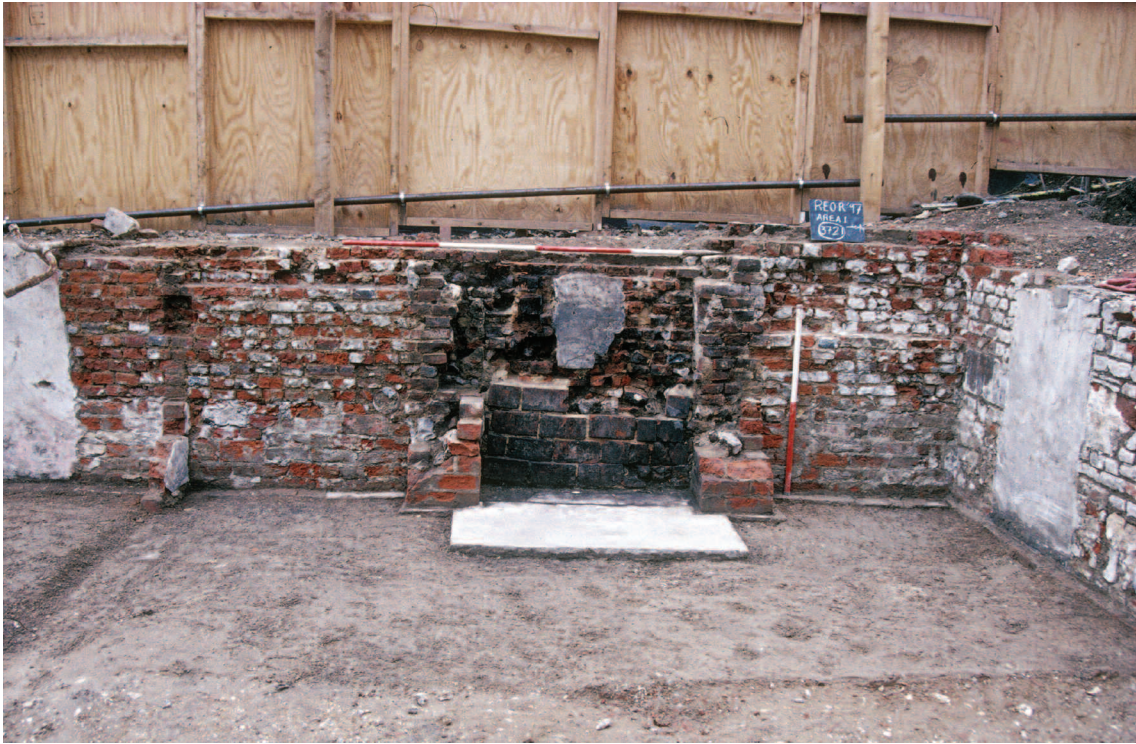
*Plate 3.16 Site 29 the Oracle: fire places: (above) view looking SW at the western fireplace 3721 and (below) looking NE at the eastern fireplace 3775 (Project Phase 10)*

the new basement for buildings that ran down the west side of the site in the south-west quadrant. Construction of this basement removed all the floor levels associated with the use of the west range of the workhouse, except in the location of its extreme northern end (see above). The new building, with additional rooms to the east of its northern end, one of which had a basement, was L-shaped and extended into the area of the former workhouse courtyard. At a later date, probably in the 20th century, further buildings were added extending the area covered by basements southwards, that is, adjacent to the original basement. A stepped access was built into the basements at the southern end of these additions. The new structures were built in brick with the walls on concrete foundations; an element of reused undiagnostic architectural stone was also present, which may have come from the Oracle Gateway. The two northernmost basement rooms retained their brick-built fireplaces (Plate 3.16).

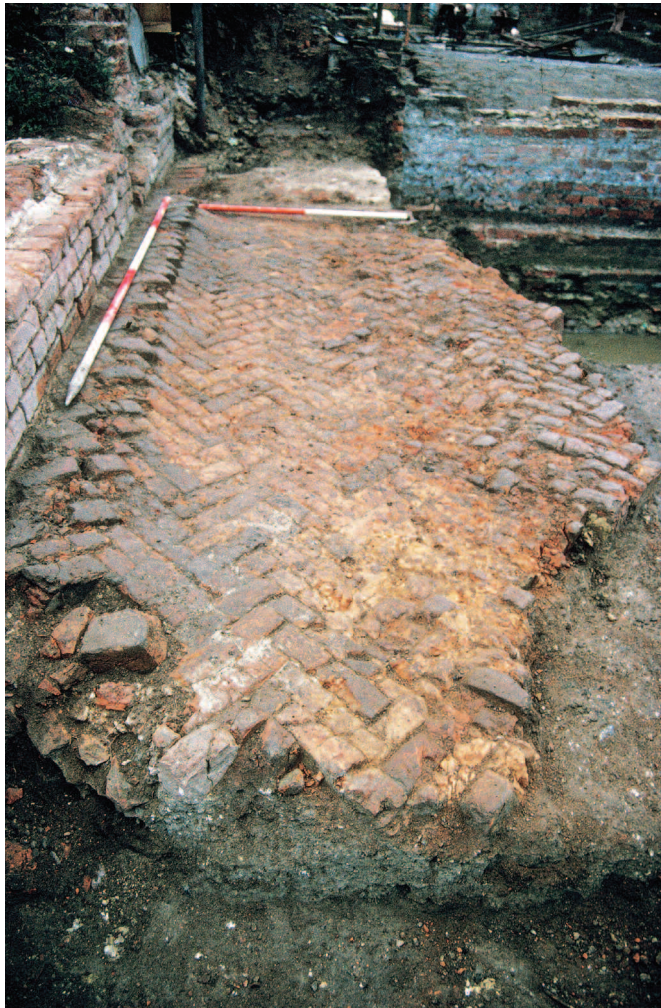
*Plate 3.17 Site 29 the Oracle: view looking NW of herringbone brick floor 3812 (Project Phase 10)*

The far western corner of the south range of the Oracle was also maintained and it is likely that the latest brick herringbone flooring (3812; Plate 3.17) inside this part of the building served as the floor until it was demolished in the mid 20th century. The brick culverts covering the Holy Brook and Minster Mill Stream were recorded. The south-east quadrant did not have basements in the initial or later redevelopment, although foundations for the structures built there comprised large and deep square concrete bases, which removed the archaeology from all the previous phases. The culvert enabled the building north of the Holy Brook to be extended southwards over the watercourse to meet the building in the south-west corner. To the west of this, the bridge that had been constructed in 1628 was retained to provide access over the stream.

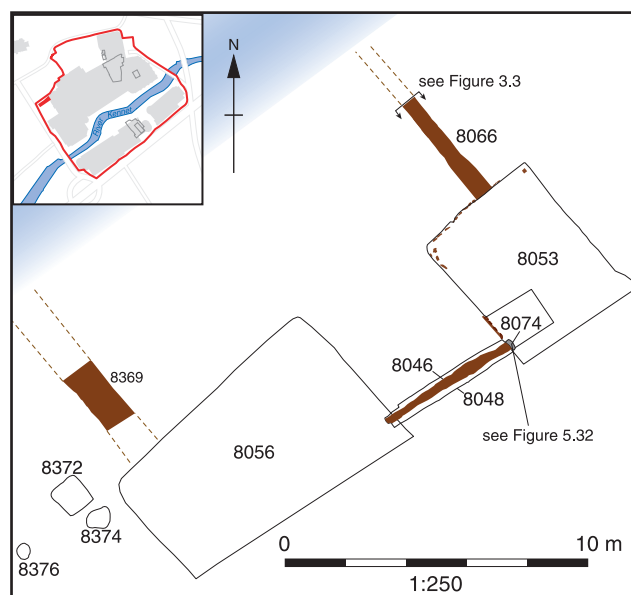
Fig. 3.2 Site 28 Test Pit 78: plan of features related to the dyehouse (Project Phase 7)

The remains (Fig. 3.2) consisted of two roughly square pits positioned 4.5 m apart and cut into a series of alluvial deposits below. The western pit (8056) was of unrecorded depth and the eastern pit (8053) was at least 1.5 m deep; its sides were vertical for the first 0.55 m from the top and then sloped inwards at an angle of about 50°. The pits were linked by a channel (8048) containing a hollowed-out oak timber 0.3-0.45 m wide (8046). This channel sloped slightly from pit 8056 into pit 8053, being 0.08 m lower at the eastern end which was covered with a sheet of perforated lead (8074, Fig. 5.32 No. 5) suggesting that liquid was filtered on its way into pit 8053. Timber channel 8046 and beam 8288 were

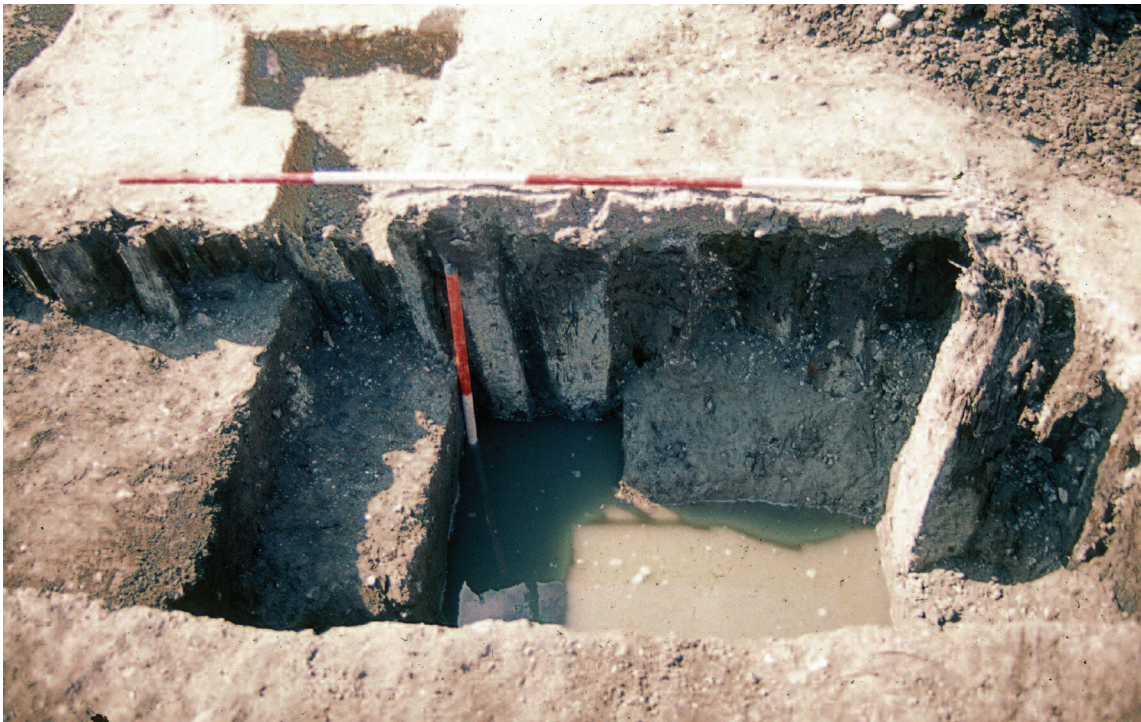
Plate 3.18 Site 78: view looking SE showing the construction detail of the eastern dyeing vat pit 8053 (Project Phase 7)

The eastern pit (8053) was lined with a timber revetment (8052) comprising vertical planks measuring 0.15 m wide x 0.04 m thick x 1.1 m long (Plate 3.18). They were positioned flush with the vertical section of the pit but went through the lower angled part and into the underlying deposits so that the lower part of the pit was not lined. It is likely that the pit would have held a large vessel to contain the liquid and that only the upper part of the pit needed to be protected and lined. Two silty clay fills were deliberately packed around the timbers to keep them in place (8076, 8078) and in each of the two visible corners was a pair of more substantial posts. The function of these posts is not clear but they are most likely to have supported the vessel in the pit. The structure of the pit at Reading is highly reminiscent of Structure 791 at Beverley where a wooden vat was set into a pit in the ground and fed by a wooden pipe. Around the top part of the square pit at Beverley was wooden shuttering, similar to that identified here, and posts to support the vat (Evans and Tomlinson 1992, 29-30). This pit may have been used for cooling liquid, with the coolness of the surrounding earth helping to bring the temperature down (Evans and Tomlinson 1992, 284).

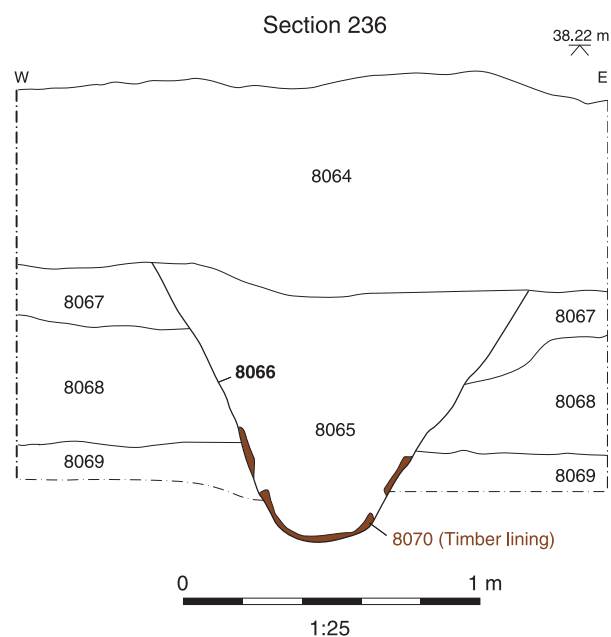
Fig. 3.3 Site 28 Test Pit 78: SE facing section 236, showing timber-lined drainage channel 8066

The liquid from pit 8054 appeared to have drained out through a north-south orientated linear channel adjoining the northern side of pit 8053 (8066). This was lined with thin planks (Fig. 3.3) and at the junction between the channel and the pit, the timber planks of 8053 had gaps between them suggesting that this may have been some kind of sluice gate controlling the outflow of liquid. This channel could have fed back into the Minster Mill Stream which was positioned approximately 5-10 m to the north (the precise location at this time is unknown).

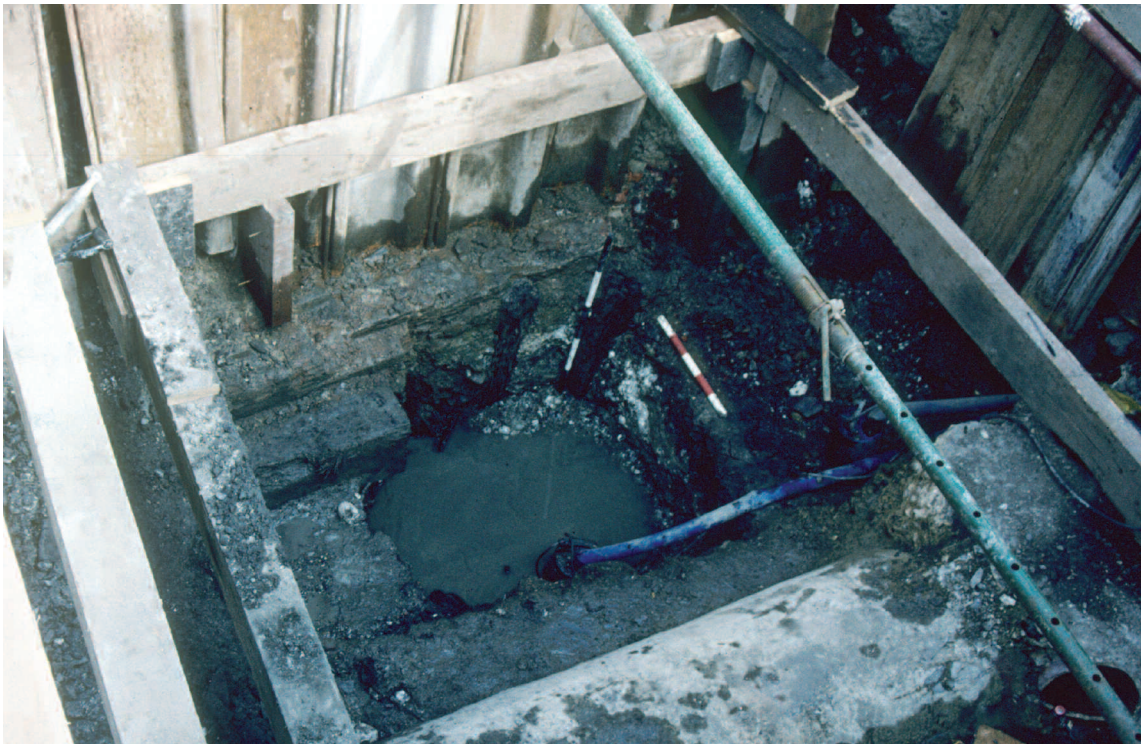
Plate 3.19 Site 150 Minster Mill: view looking NE of the wooden platform in Test Pit 135 (Project Phase 7)

3.19) measuring 3.25 m wide, observed for 3 m of its length. It had been constructed upon a series of deposits that had been dumped into and around the edges of the channel in order to raise and stabilise the ground surface prior to construction. The frame comprised 8 horizontal timbers of which four were north of, and four south of, a modern sewer that bisected them. Two longitudinal timbers formed the external limits of the structure, within which the transverse timbers were jointed to form a rectilinear lattice work (as at St Giles Mill, see Site 300 Fig. 3.11, below). The timbers were all rectangular in section and joined together with nails through mortise and tenon joints, the tenon on the transverse timber and the mortise on the longitudinal timber.

Dendrochronological dates were provided by two timbers within the structure: post-1595 (timber 8293), and late summer 1611 (timber 8288). These, in combination with the late 16th-century date of the underlying deposit 8300 (site sub-phase 15006a), suggest an early 17th-century date for the construction of the frame. From the form and position of this structure it is possible that it supported a planked deck to form a tailrace, or alternatively that it was put in place to limit damage from erosion within the tailrace channel immediately downstream of the mill.

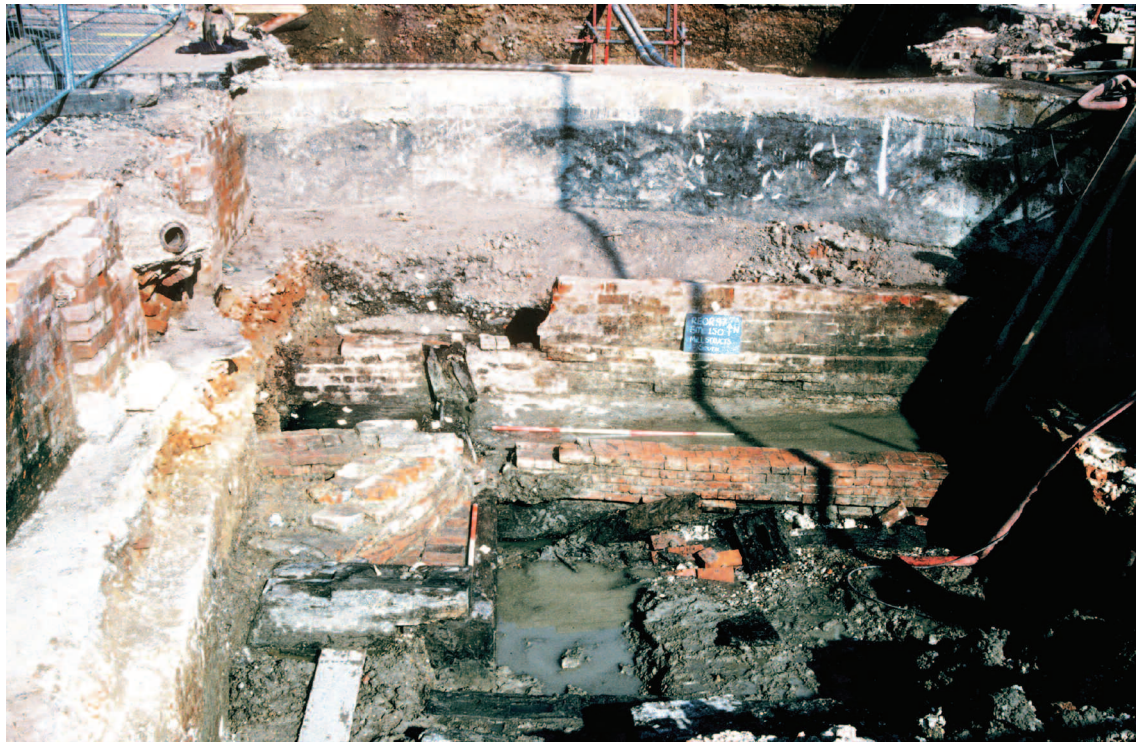
*Plate 3.20 Site 150 Minster Mill: a general view looking N of the 18th-century remains (Project Phase 8)*

Project Phase 8 revealed a series of significant structures on site 150 that were part of the early 18th-century Minster Mill (Fig. 3.5). The excavated remains comprised a headrace and sluice leading into the wheelpit of the mill (Plates 3.20 and 3.21).

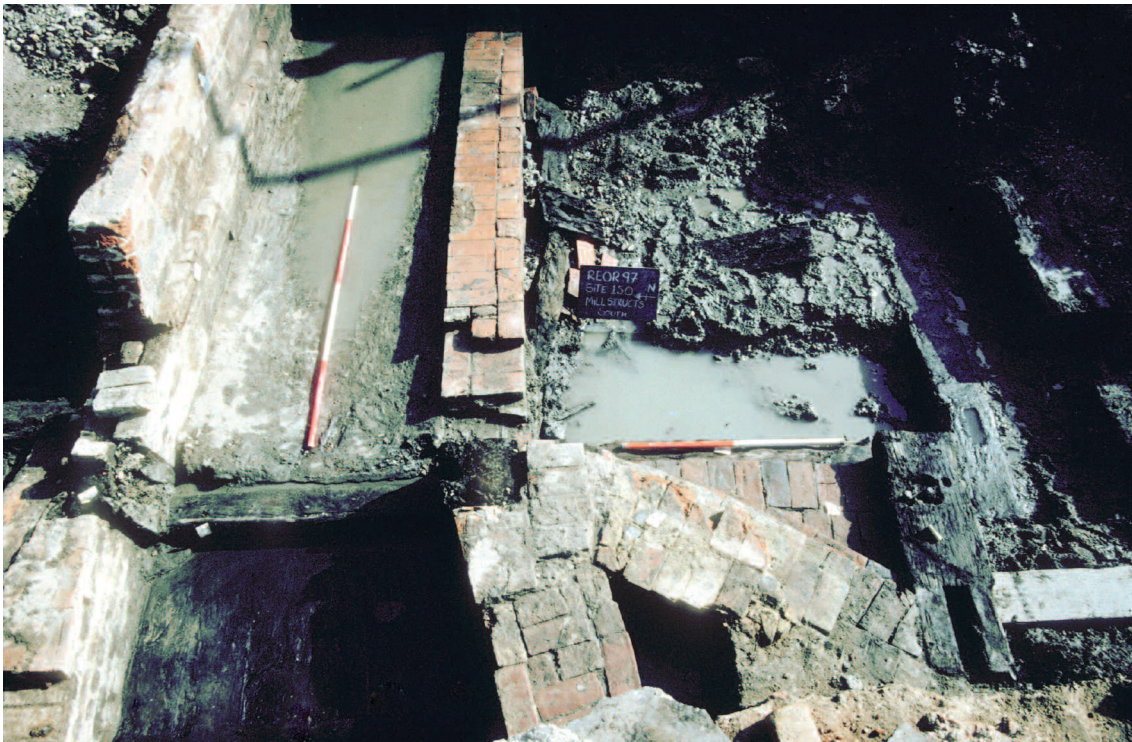
Plate 3.21 Site 150 Minster Mill: view looking E showing detail of the 18th-century penstock (Project Phase 8)

Immediately to the west of the wheelpit lay the headrace and sluice gate which controlled the flow of water into it. This consisted of two upright posts (10014 and 10015) and a layer of five horizontal E-W planks (10024-10028) laid directly on the clay foundations 10036. The posts were angled and contained central recesses in their inner faces (for boards not present), and are most likely to have been the guides for the sluice gate itself. Behind the sluice gate lay the planked headrace floor measuring 1.5 m long and tapering in width to 1 m wide at the sluice gate; this was covered at its eastern end by a long beam (10039) connected to the sluice gate posts via mortise and tenon joints. This form of water delivery to the wheelpit is known as a penstock and sluice.

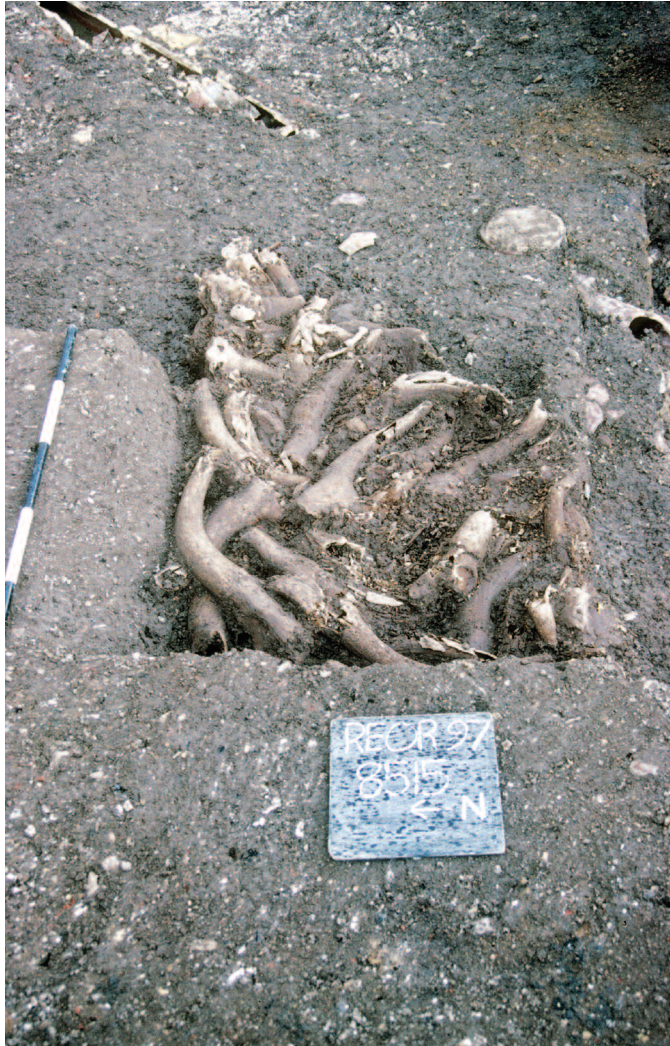
*Plate 3.22 Site 12 the Yield Hall: view looking E showing a deposit of horncores (Project Phase 7)*

In the central part of site 12 between Building 7410 and the Yield Hall, in an area of land apparently otherwise undeveloped, a series of pits were cut and filled with refuse. These pits were not drawn on site and most were unexcavated, but one which was investigated (8513) contained a densely packed deposit of horn cores (8515; Plate 3.22)

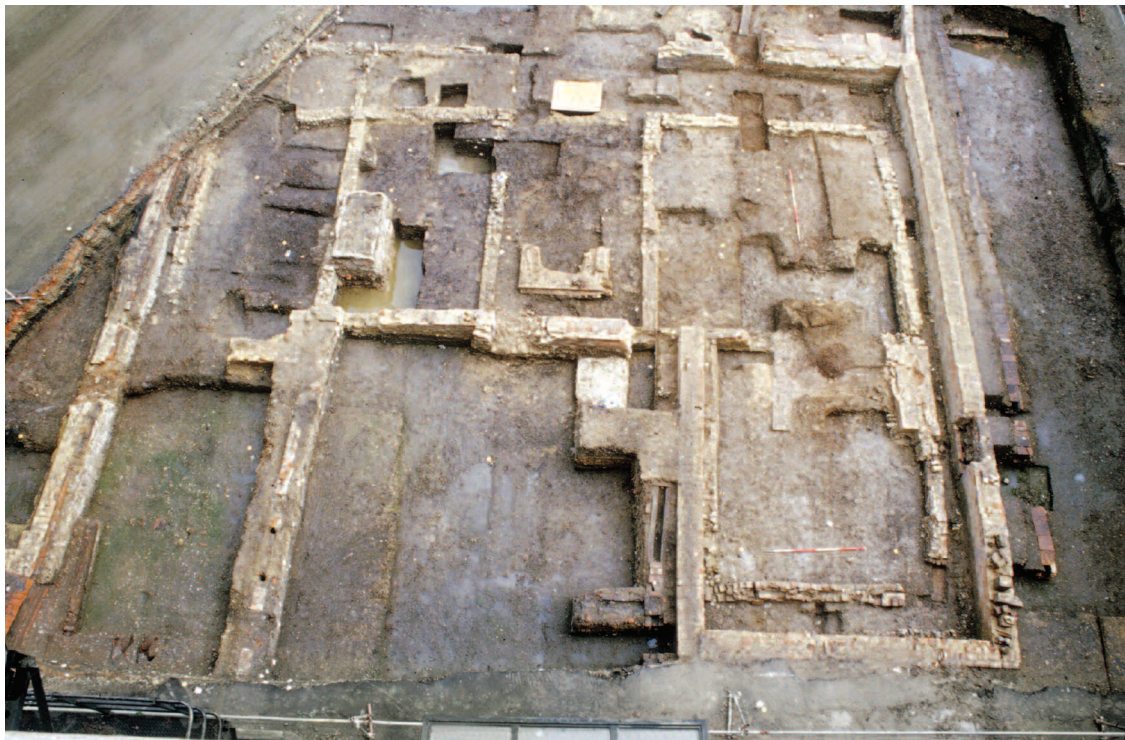
*Plate 3.23 Site 12: the Yield Hall, view looking SE showing the addition of Room 5 (Project Phase 7)*

During this phase, the Yield Hall was extended into an L-shaped building with the addition of a fifth room along the northern side of Room 4 (Fig. 3.6; Plate 3.23). The walls (517, 705 and 774) were built upon the dumped deposits (see above) and were constructed entirely using coursed brick (Plate 3.24) with the exception of a single piece of architectural stone of 12th-century date salvaged from Reading Abbey (Preston, Chapter 8). Although the bricks were laid in an inconsistent pattern, the use of brick

An entrance into the Yield Hall was possibly provided by a doorway at the western end of the northern wall of Room 5 (see Plate 3.23). This may have coincided with blocking of doorway 2812 (with 2811) at the western end of the corridor which was not directly dated but must have occurred before the wing was demolished and rebuilt in the early 18th century (phase 1210 below).

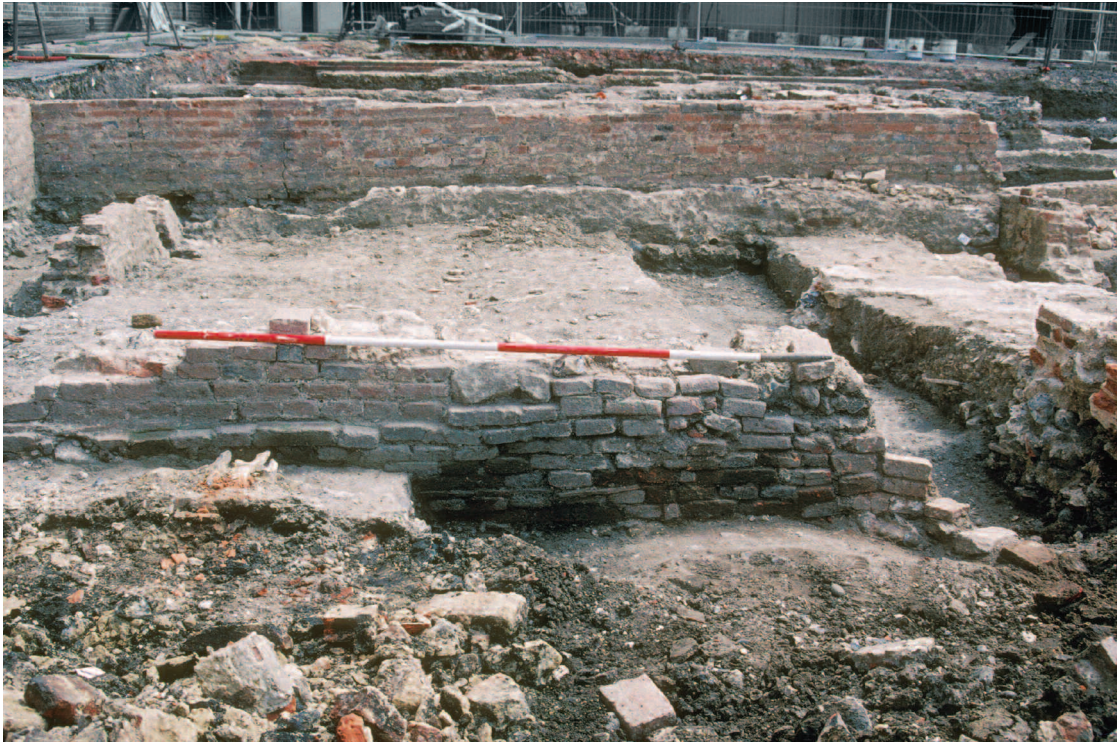
Plate 3.24 Site 12: the Yield Hall view looking NE of brick wall 705 forming west wall of Room 5 (Project Phase 7)

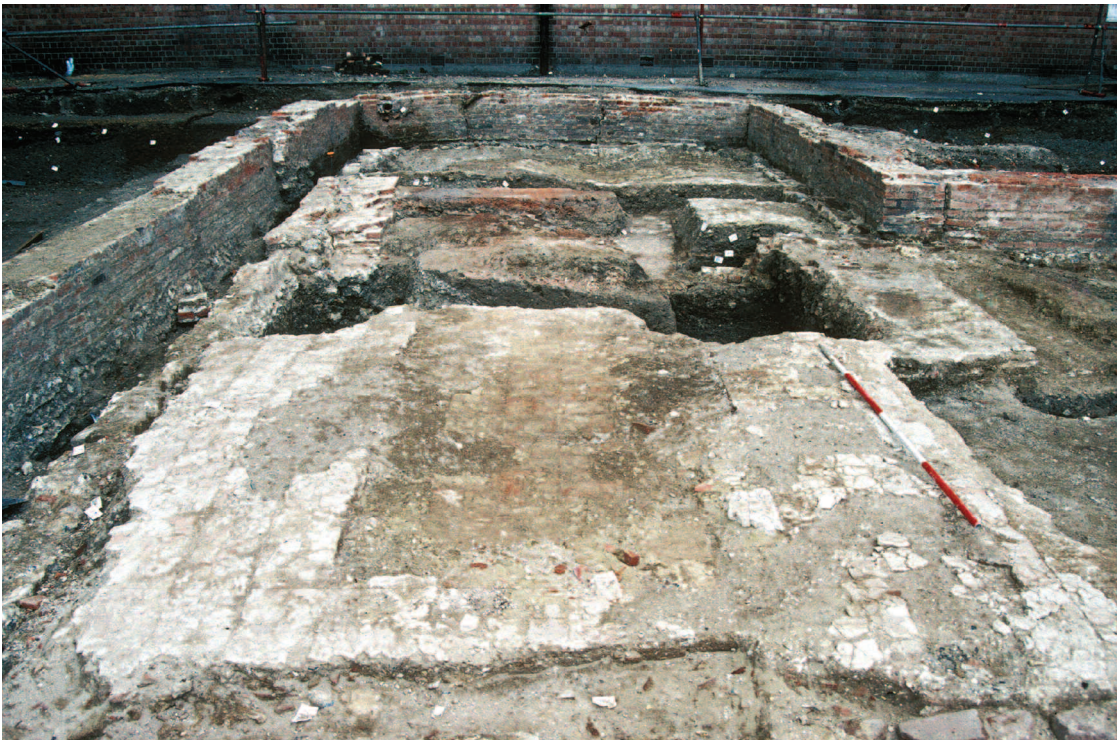
Plate 3.25 Site 12: the Yield Hall, view looking NW showing mortar bedding layer with the impressions of ceramic tiles or bricks for floor 716 in Room 4 (Project Phase 7)

Inside Room 5, the floor was surfaced with tile or brick (the mortar bedding 794 survived) probably at the same time as a similar floor was laid in Room 4 to the south of wall 715 before the insertion of a fireplace and subsequent floors (Plate 3.25). Interestingly, not all the rooms were given tiled floors at this time; a brick floor surface (955) was laid in Room 2 in the early part of the 17th century

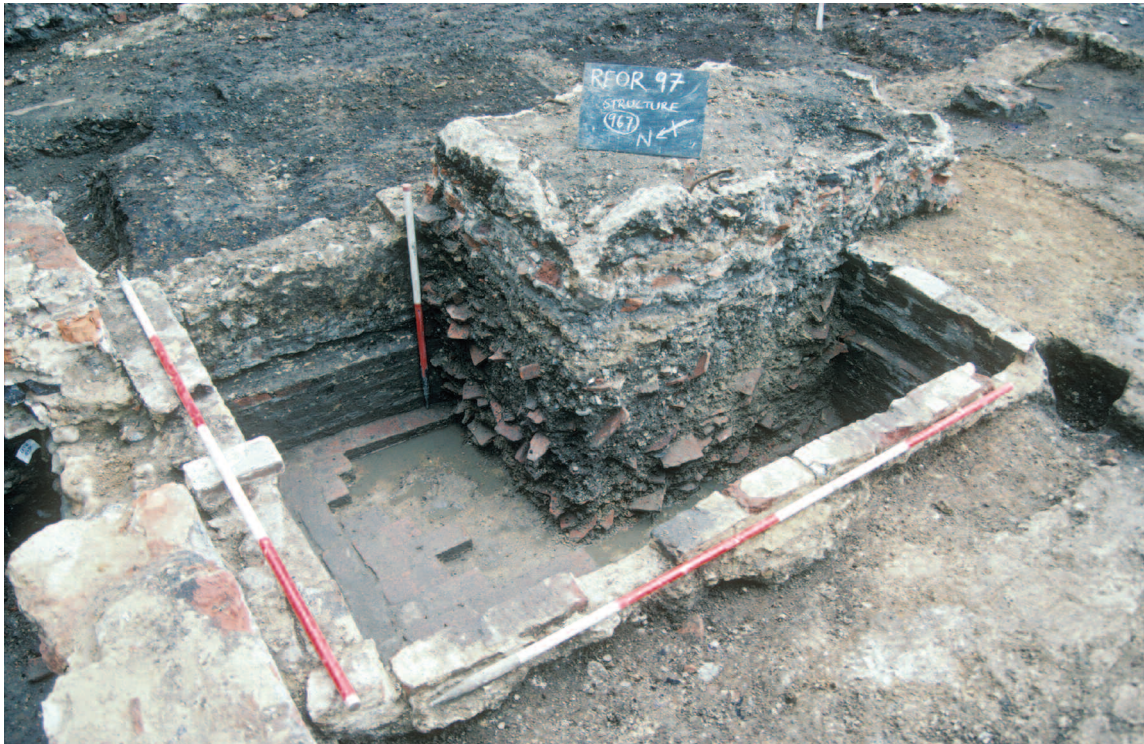
Plate 3.26 Site 12: the Yield Hall (above) view looking NE showing cellar 967 with a later brick reflooring, and (below) with original flooring of reused ceramic rooftiles (Project Phase 7)

(1610+) but there is no evidence that the floor surfaces in Rooms 1 and 3 were changed. At the same time as the brick floor was laid in Room 2, a half cellar (967) was installed in the north-eastern corner of the room. This cut through the foundation deposit 709, forming a cellar 0.7 m deep, with a floor constructed from roof tiles laid in a random pattern. Plate 3.26(i) shows the cellar with a later floor; Plate 3.26(ii) is a detail of the original cellar floor, revealed at a later stage of excavation. In the south-east corner of the cellar and embedded in the floor up to rim height was a complete ceramic vessel measuring 0.32 m diameter x 0.51 m deep. It had been broken and stapled together before being deposited with a weight inside it and capped with brick fragments. A large number of early wine bottles were found in this cellar (see GL 19-35, Chapter 9; for illustrated examples see Chapter 5 and Plate 3.27). These date to the late 17th or early 18th century, and both the type of bottle and the period during which the cellar was used predate the general practice of the ageing of wine (Willmott, Chapter 9) making it unlikely that wine was stored for long periods of time in the cellar.

can be compared with this survey. At some point after 1770, the wine cellar in Room 2 was filled in with rubble and decayed timbers from its structure (see Plate 3.26), and a new floor (707) was laid throughout the room. A staircase is shown on the Terrier in the area where the cellar had previously been. The evidence of the Terrier suggests that the original wall between Rooms 2 and 3 was partially dismantled, and a new wall installed, to form a long, narrow room across the north side of the building. The new wall can be equated with a partition wall (542) identified in the excavations in the north part of the former Room 2. There was a distinct step up of 0.17 m at this point. A division in brick floor surface 707 indicates that a partition may have existed in the southern half of the room along the same alignment at some point, although apparently not when the Terrier survey was undertaken.
