# Chapter 3 The Later Development of the Site from c 1600 to the Present Day

## SITE 29: THE ORACLE WORKHOUSE

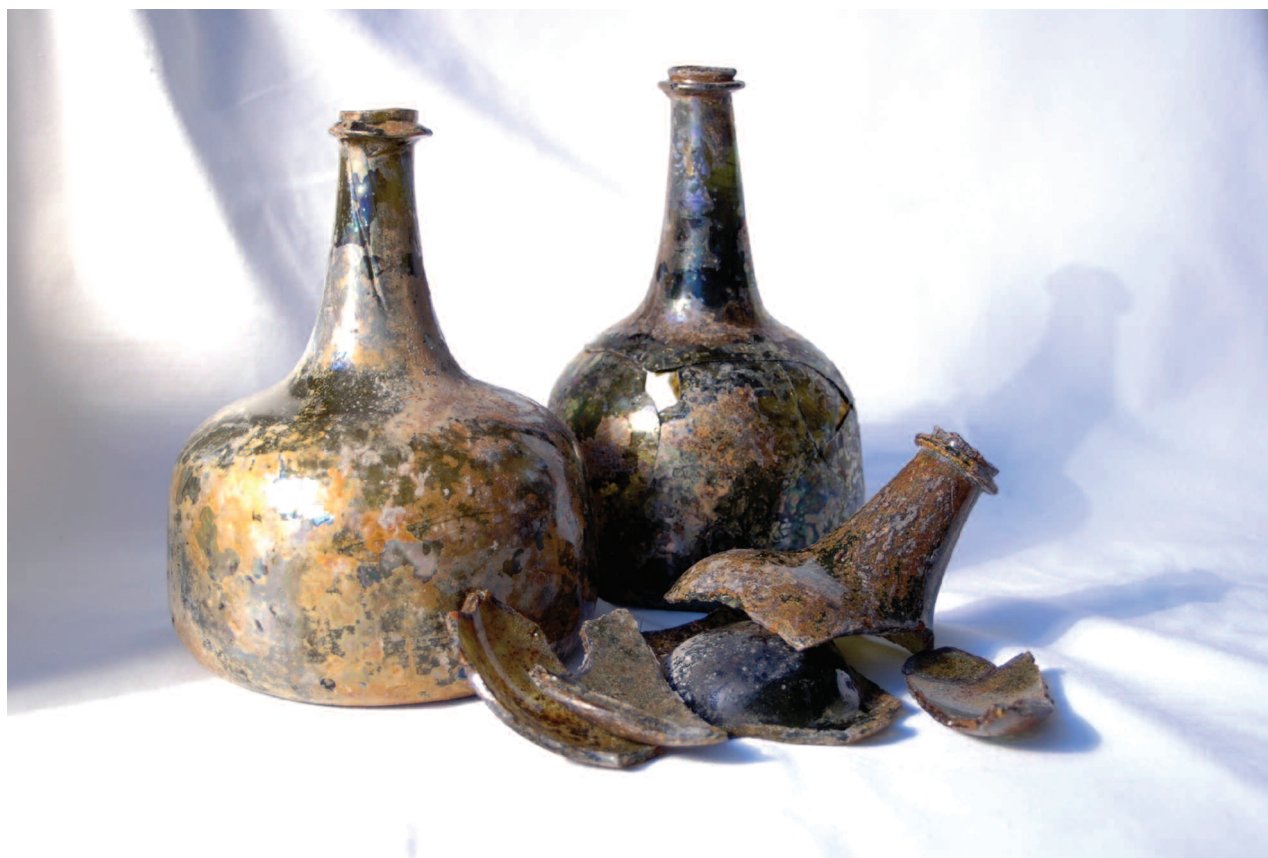
Plate 3.27 Site 12: the Yield Hall, some of the bottles from cellar 967 (Project Phase 7)

(1610+) but there is no evidence that the floor surfaces in Rooms 1 and 3 were changed. At the same time as the brick floor was laid in Room 2, a half cellar (967) was installed in the north-eastern corner of the room. This cut through the foundation deposit 709, forming a cellar 0.7 m deep, with a floor constructed from roof tiles laid in a random pattern. Plate 3.26(i) shows the cellar with a later floor; Plate 3.26(ii) is a detail of the original cellar floor, revealed at a later stage of excavation. In the south-east corner of the cellar and embedded in the floor up to rim height was a complete ceramic vessel measuring 0.32 m diameter x 0.51 m deep. It had been broken and stapled together before being deposited with a weight inside it and capped with brick fragments. A large number of early wine bottles were found in this cellar (see GL 19-35, Chapter 9; for illustrated examples see Chapter 5 and Plate 3.27). These date to the late 17th or early 18th century, and both the type of bottle and the period during which the cellar was used predate the general practice of the ageing of wine (Willmott, Chapter 9) making it unlikely that wine was stored for long periods of time in the cellar.

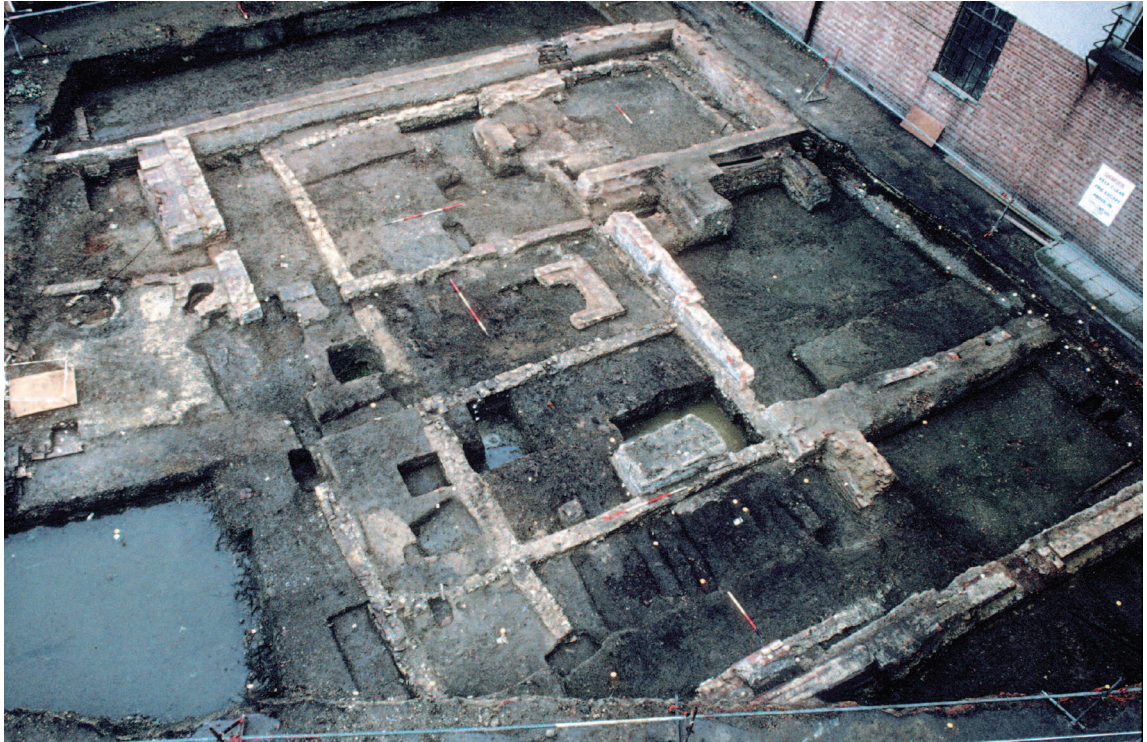
*Plate 3.28 Site 12: the Yield Hall, general view looking W (Project Phase 8)*

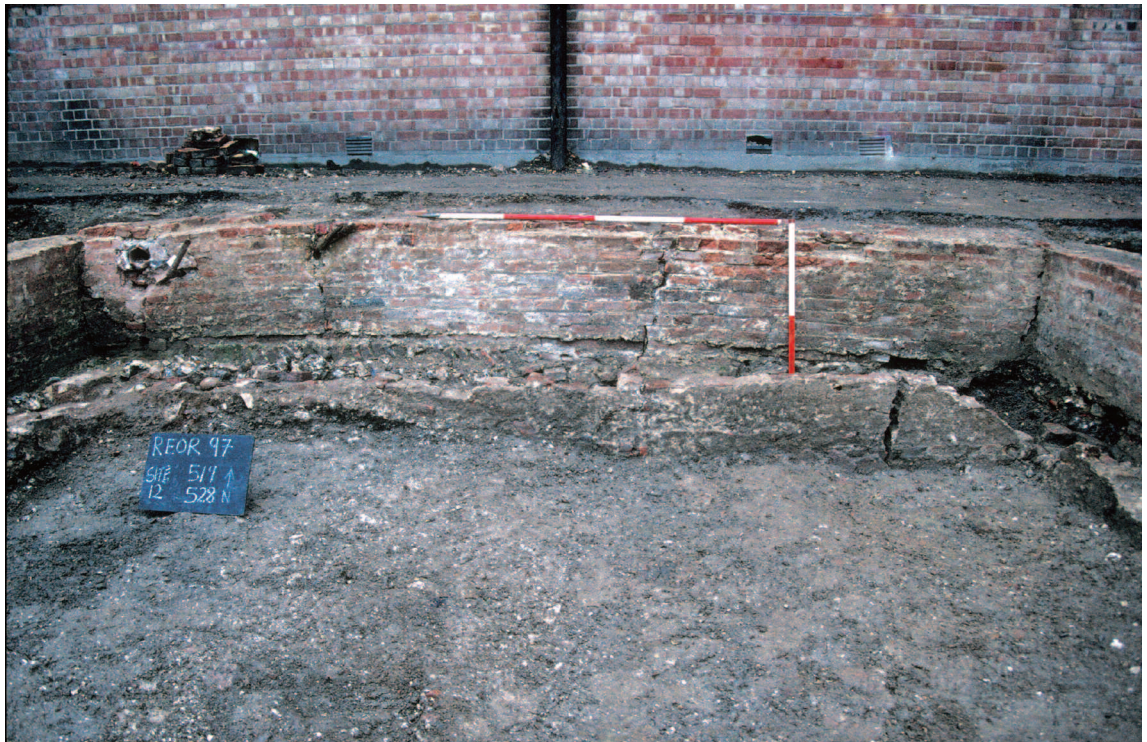
*Plate 3.29 Site 12: the Yield Hall: view looking NW showing the problems of subsidence affecting two phases of walls (Project Phase 8)*

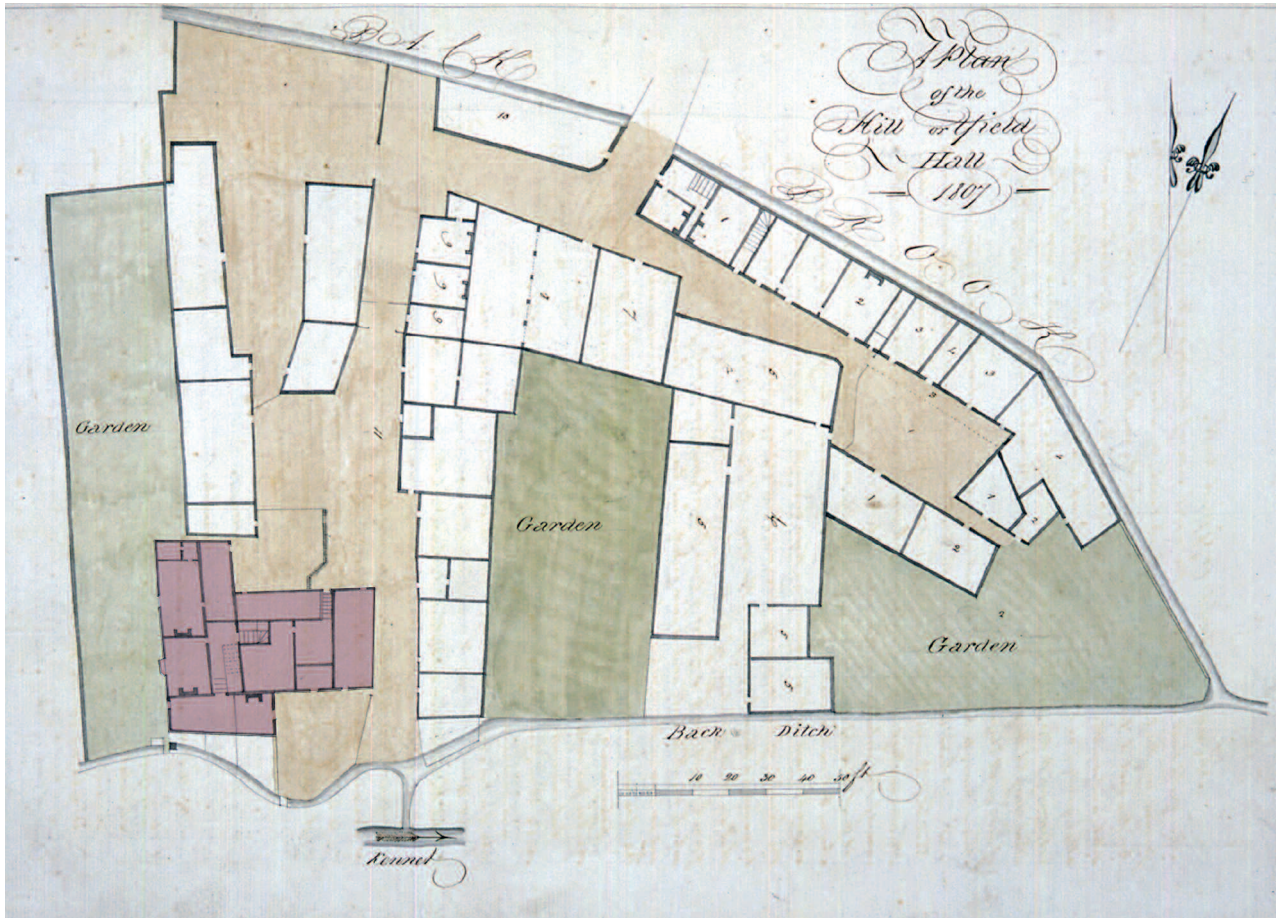
Plate 3.30 Plan of The Yield Hall in a Reading Corporation Terrier of 1807

can be compared with this survey. At some point after 1770, the wine cellar in Room 2 was filled in with rubble and decayed timbers from its structure (see Plate 3.26), and a new floor (707) was laid throughout the room. A staircase is shown on the Terrier in the area where the cellar had previously been. The evidence of the Terrier suggests that the original wall between Rooms 2 and 3 was partially dismantled, and a new wall installed, to form a long, narrow room across the north side of the building. The new wall can be equated with a partition wall (542) identified in the excavations in the north part of the former Room 2. There was a distinct step up of 0.17 m at this point. A division in brick floor surface 707 indicates that a partition may have existed in the southern half of the room along the same alignment at some point, although apparently not when the Terrier survey was undertaken.

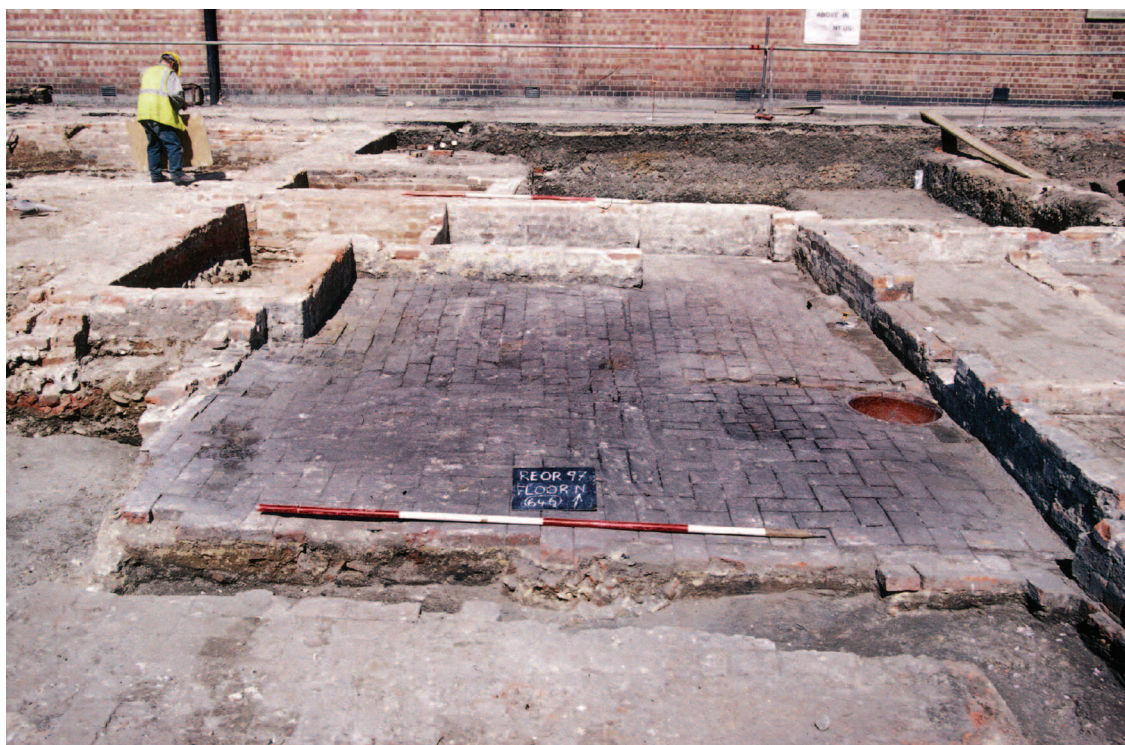
Plate 3.31 Site 12: the Yield Hall, view looking NW showing a ceramic vessel set into surface 646 (Project Phase 10)

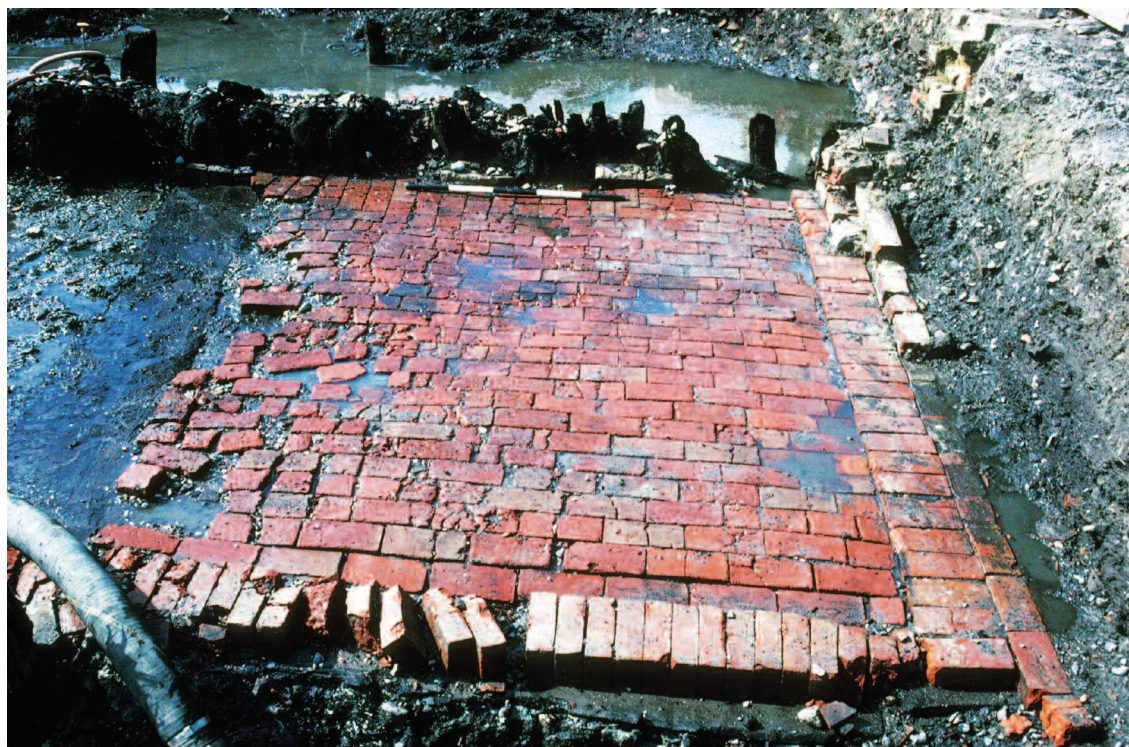
Plate 3.33 Site 101: the Back Brook, view looking NW showing the well-built brick surface 7122 constructed on the southern bank of the Back Brook (Project Phase 7); the Back Brook and its substantial revetment can be seen in the background

During the late 17th century (site subphase 10107a), this wooden floor surface was replaced by one of brick (7122: Fig. 3.8 and Plate 3.33). This was laid directly on top of the series of wooden planks of phase 10106 and against the revetment, with some evidence for plaster/pitch waterproofing against the revetment. It contained no dating material but may have been late 17th-century on the basis of the style of bricks used. No metallised external surface was associated with the floor but plank 7270 remained *in situ* along the western side of the floor suggesting access was still from this direction. Neither Speed nor Roque shows any structures on the south bank of the Back Brook during the 17th and 18th centuries, and the purpose of this platform remains unclear.

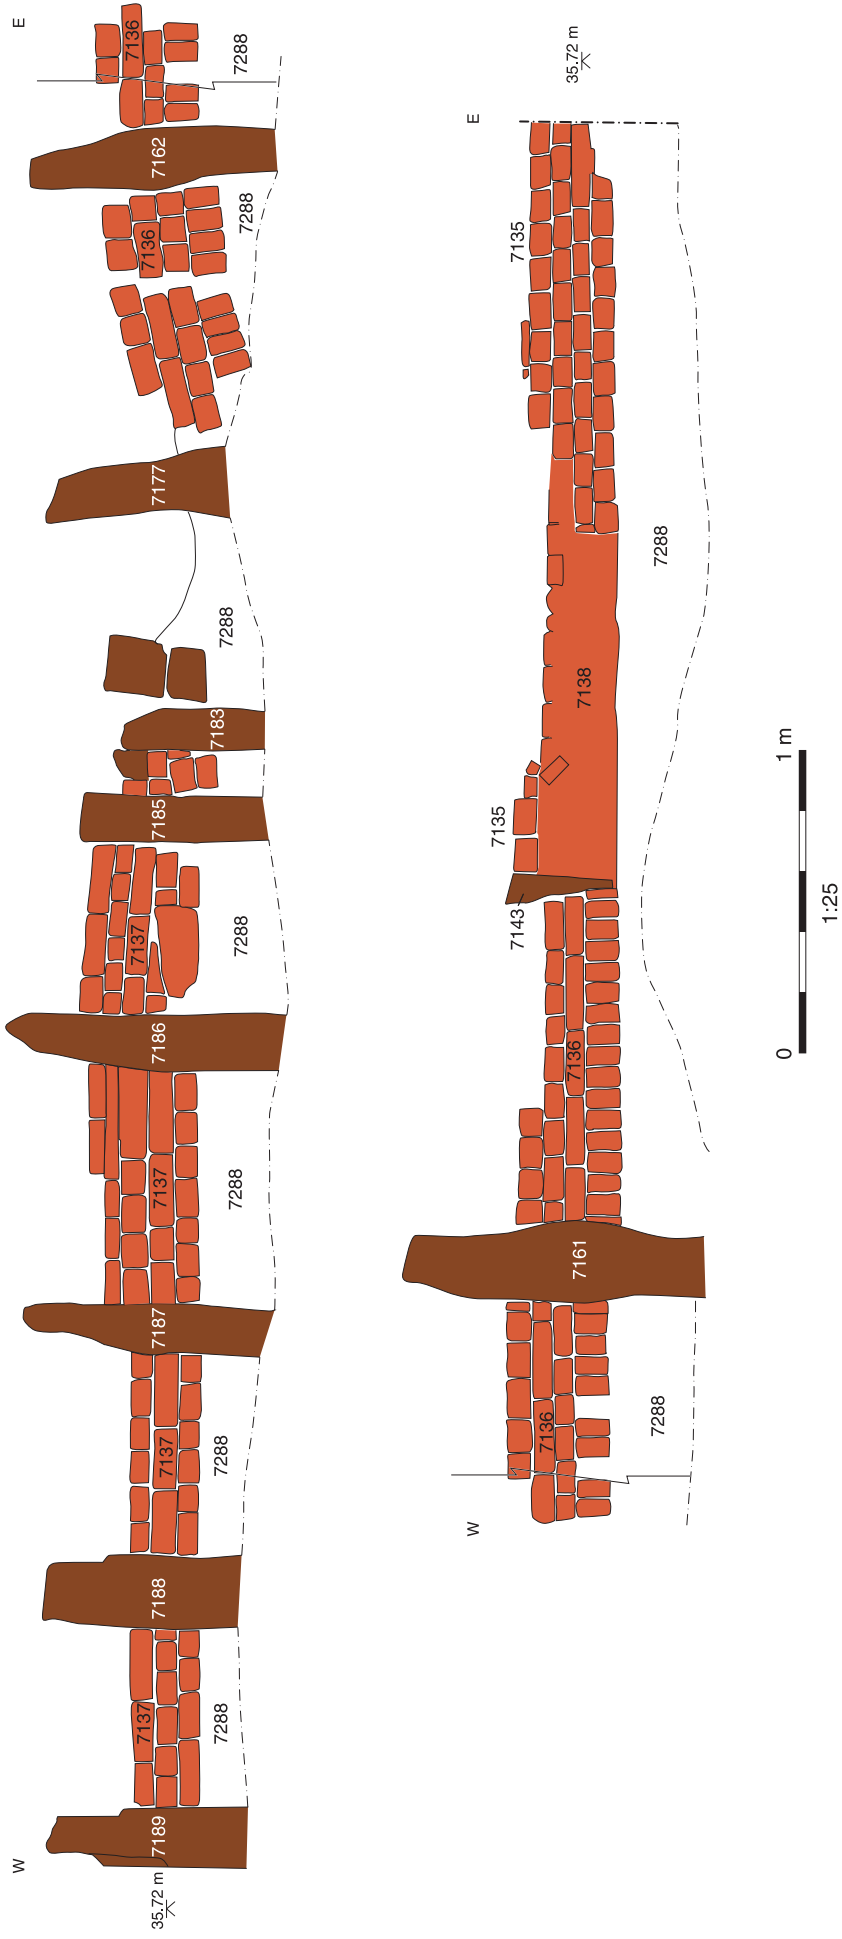
Fig. 3.10 Site 101: Section 305 along the north bank of the Back Brook showing the ongoing brick reinforcement of the timber revetment (Project Phases 7 and 8)

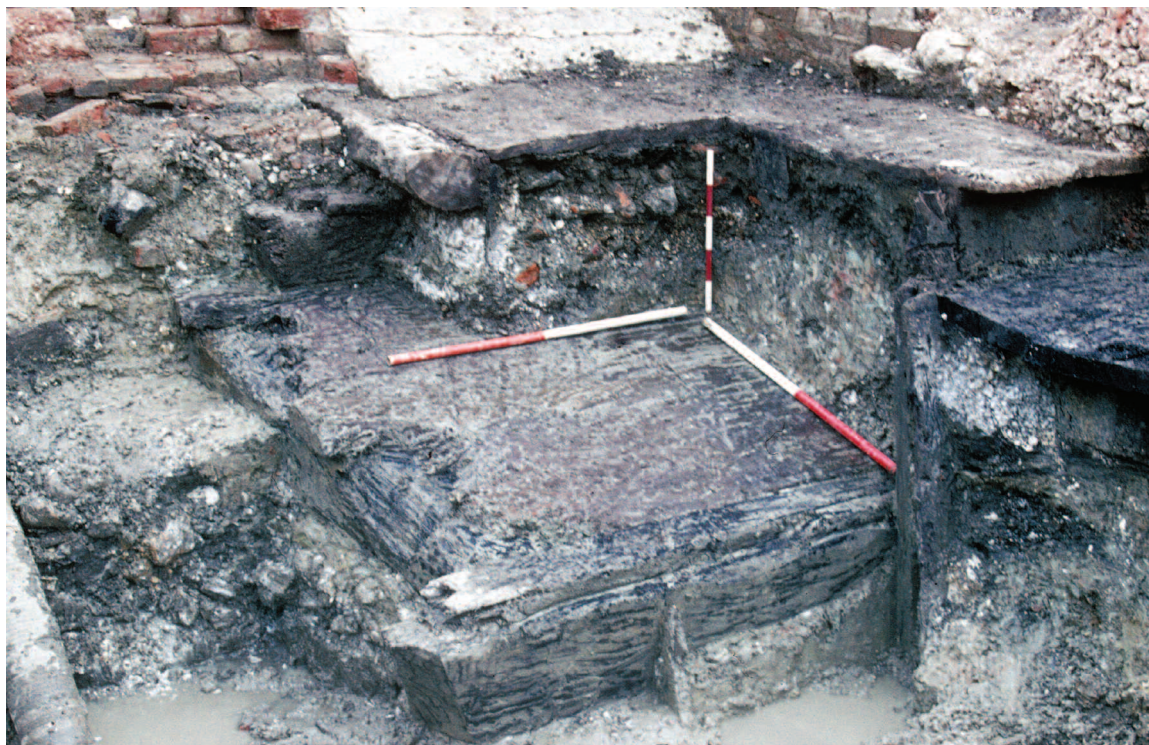
Plate 3.34 Site 300 St Giles Mill: view looking SE showing the exposed 17th-century elm plank deck of the head race (13713) (Project Phase 7)

constructed on the previously laid 14th-century chalk rubble foundation deposit (site subphase 3002a). This deck was angled up relatively steeply towards its upstream end. The upstream end of the frame was jointed to transverse ground beam 13706 which in turn was jointed at its northern end to 13705, a 0.4 m-square horizontal longitudinal ground beam, which was orientated east-west and ran out of the eastern site limits towards site 300. The timber deck is considered to represent the head race (its incline raised the height of the water prior to its fall on to the waterwheel), and the ground beams are part of a large Hurst Frame. None of these timbers yielded a tree-ring date.

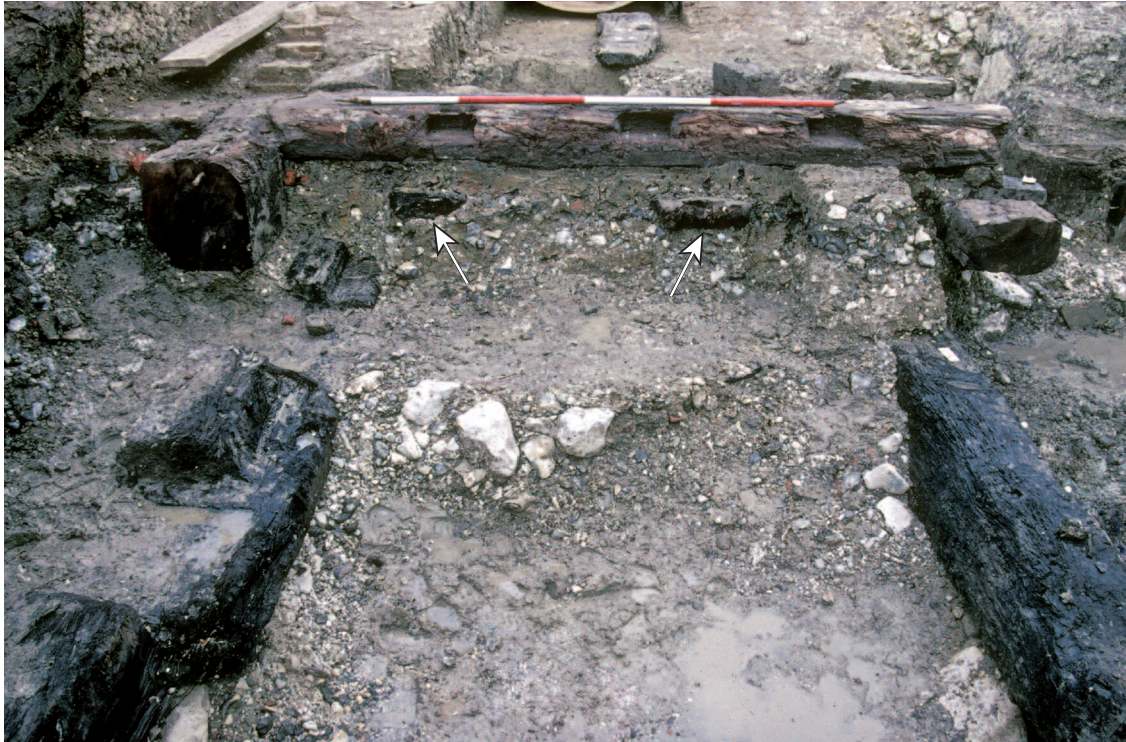
Plate 3.35 Site 300 St Giles Mill: view looking NW showing ground beams 13467, 12057, 13476 overlying the early 14th-century mill timbers (Project Phase 7)

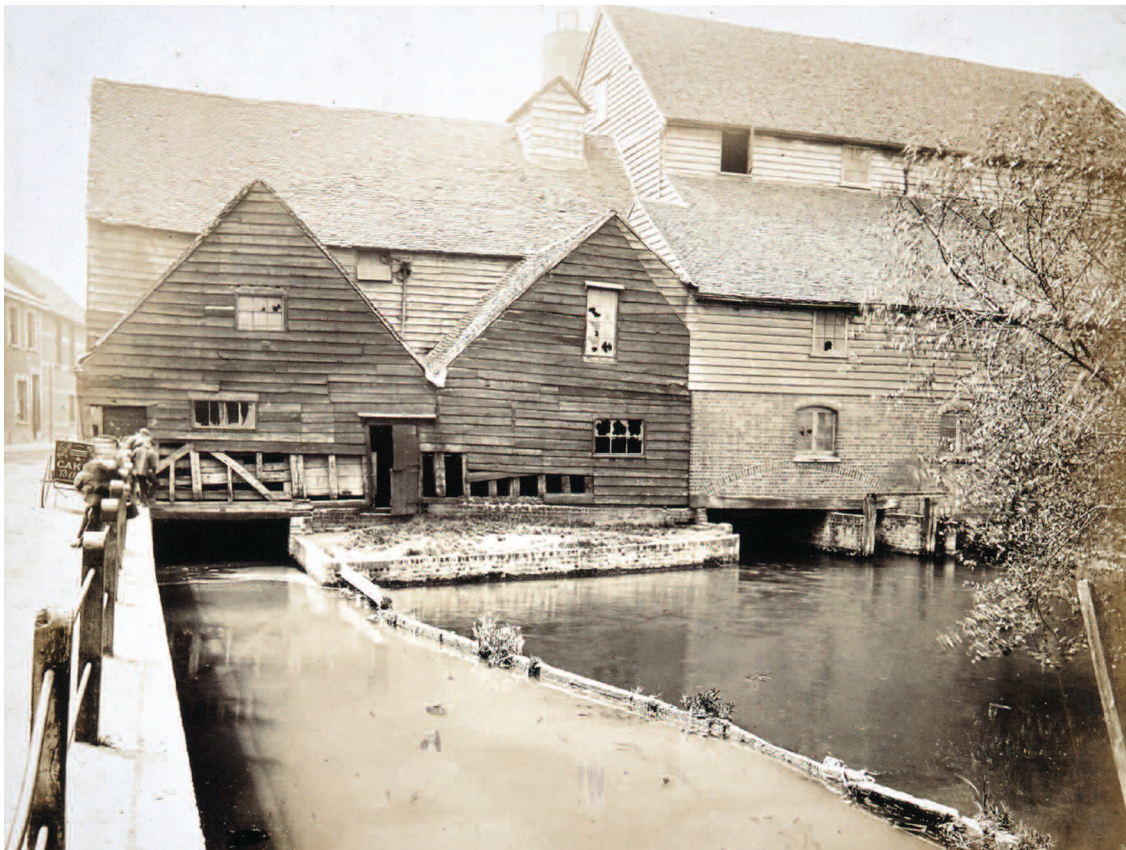
Plate 3.36 Site 300 St Giles Mill: photograph looking SW of the east elevation of the mill taken c 1900; on the left is the 17th-century mill, with the more substantial buildings of the 18th-century rebuild to the right (Project Phase 7)

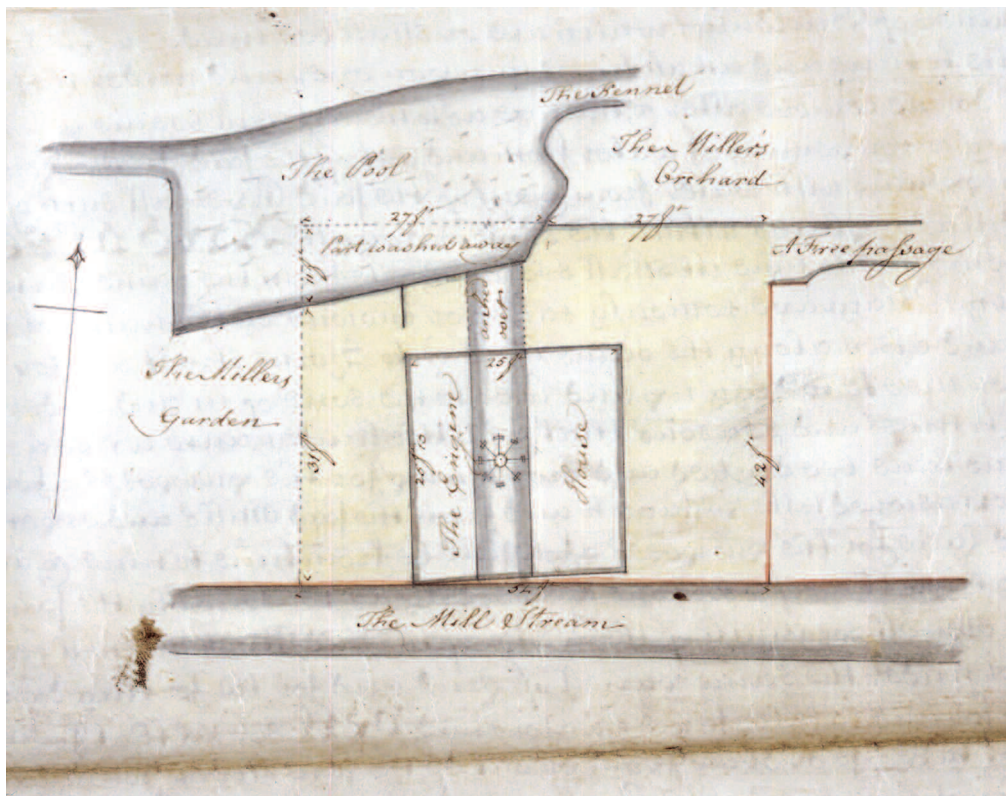
Plate 3.38 Plan of the property and building layout of the water pumping mill shown on a lease of 1697

Two test pits (268 and 293) were located to investigate the water pumping mill constructed at the end of the 17th century. The location of this building can be seen on the Goad Insurance map of 1895 (Plate 1.8), upstream of St Giles Mill in the area labelled Water Works Dept. The building in question is the square one, labelled 'Store'. The archaeological investigations here revealed the remains of a timber structure comprising a plank deck upon a lattice-work horizontal frame of ground beams supported on timber piles. This structure was orientated north-south, at right-angles to Mill Water and leading in the direction of a more northerly braid of the Kennet. Although no timbers yielded tree-ring dates this structure is considered to be the remains of the race for a water pumping mill, constructed according to documentary references in the period AD 1694-6 (Plate 3.38). Photographs taken towards the end of the 19th century show a building orientated north-south in the position of these remains (Plate 3.39). The structure is entirely clad in timber weather-board, an appearance that is very similar to the 17th-century elements of St Giles Mill. A sluice gate opening protected by a grill can be seen, positioned at water level, and central to the gable end that faces Mill Water. This would have taken water through the building, and indicates the entrance to the head race which the excavated timber remains represent.

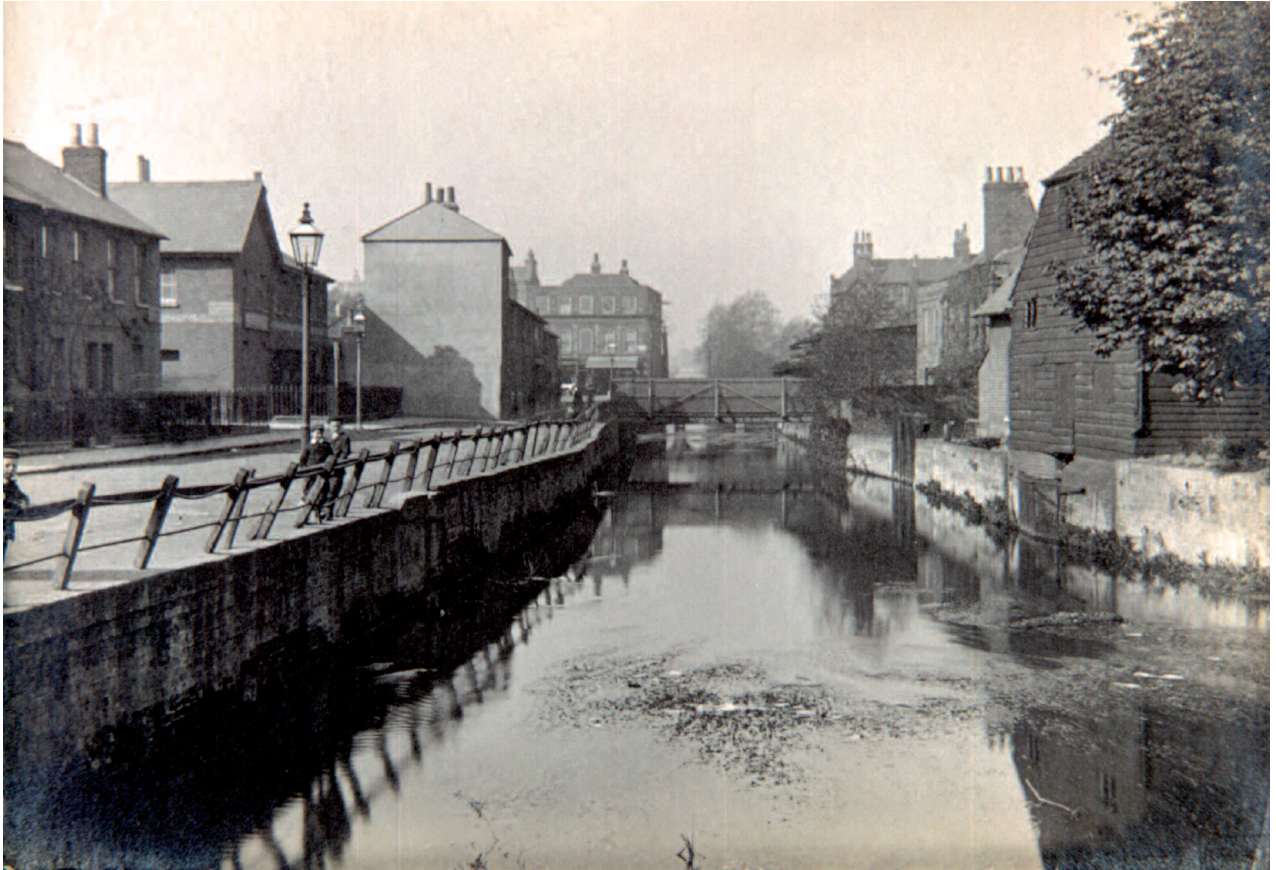
Plate 3.39 Photograph looking NW along Mill Lane showing the water pumping mill towards the centre of the photograph, immediately behind the tree, view c 1900

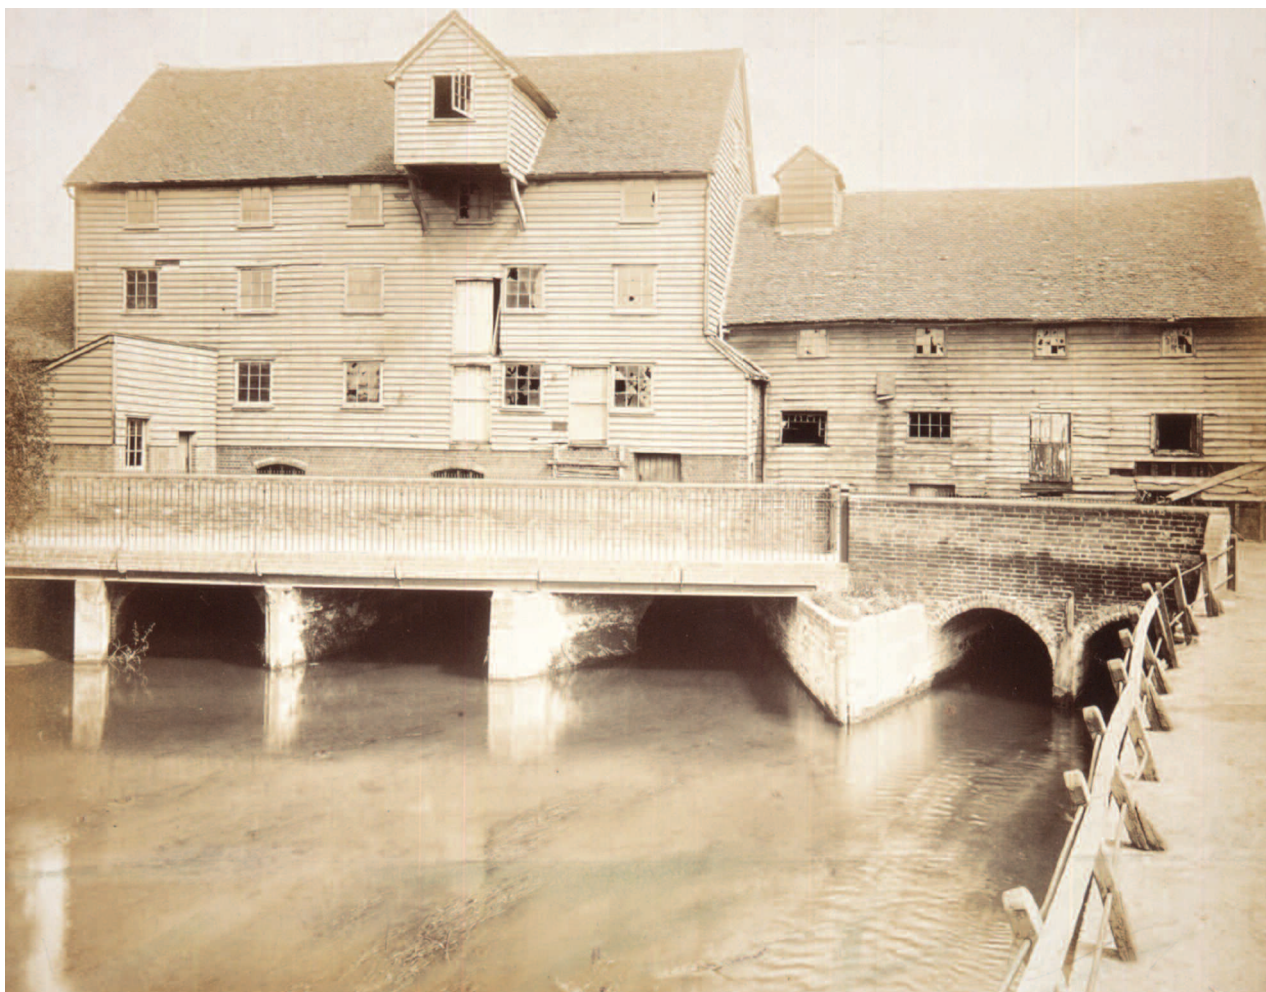
*Plate 3.40 Site 300 St Giles Mill, photograph looking NE of the south-west elevation of the mill taken around 1900; the larger buildings added in the 18th century are on the left, with the smaller 17th-century buildings on the right*

boarding for the remaining three storeys (Plate 3.40). The mill races that had been at the northern end of the former mill were rebuilt to house two new mill races. The new mill building extended northwards over the line of the former mill bypass channel, which was remodelled and became three mill races. The main retaining walls to these races, and the walls dividing them, were constructed in brick, but still as in previous periods these were constructed upon large timber ground beam and post foundations. The mill races ran through and under the mill building, with all the waterwheels housed within the mill structure itself; thus ended the era of the external water wheel at St Giles Mill (Fig. 3.11).

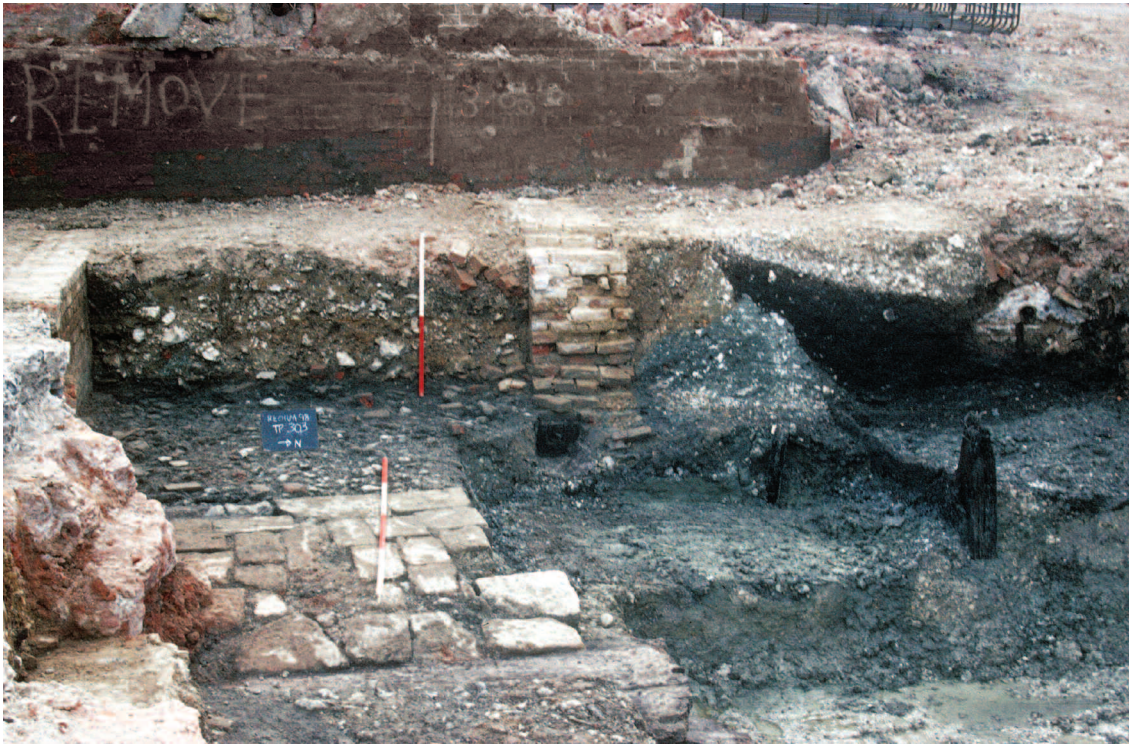
Plate 3.41 Site 300 St Giles Mill: view looking SW showing a section through the central mill channel and retaining wall upstream from the mill (Project Phase 9)

along each side of the trench-base upon a water-proofing deposit of clay (Plate 3.41). These longitudinal beams formed the foundations for the brick revetment walls. The walls were 0.4 m wide and survived to a maximum height of 0.70 m. Gravel deposits formed the channel floors. The two channels led from Mill Water and delivered water to the head races, which commenced below the west-facing elevation of the mill.

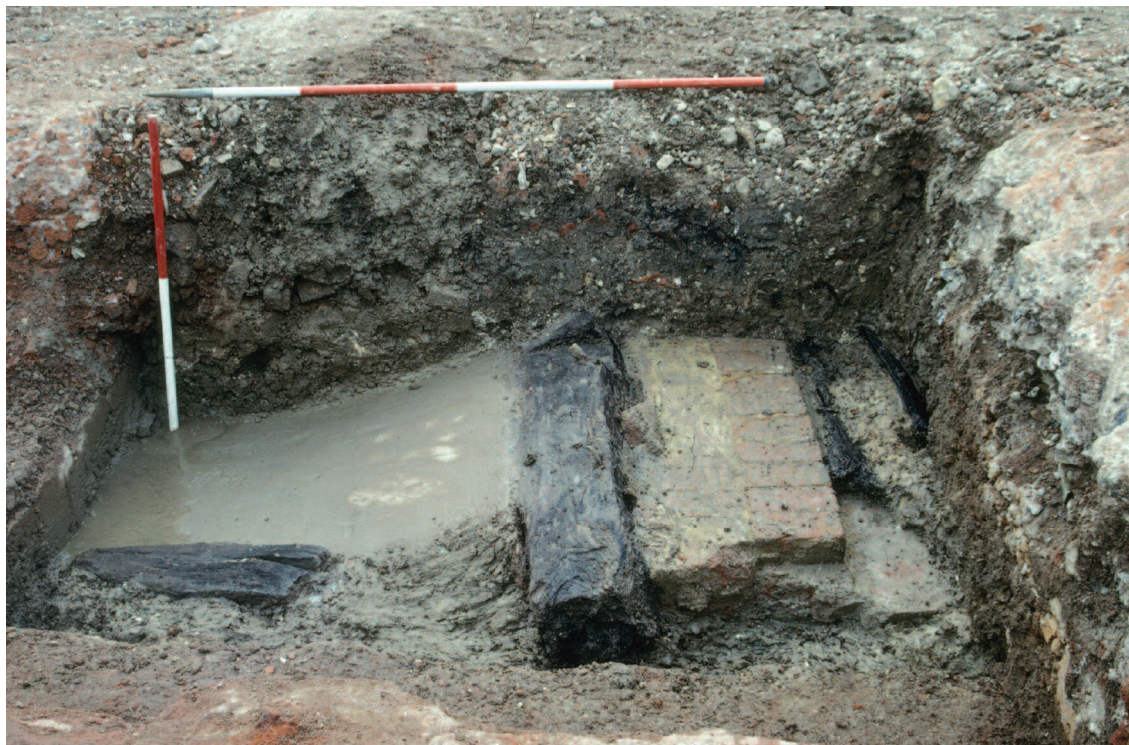
Plate 3.42 Site 300 St Giles Mill: view looking SE showing the curved floor of the wheel race in the northern channel (Project Phase 9)

In TP 380, which was located over the northern mill races, the partial remains of the downstream end of a head race, and significantly the curved floor of a wheel race, were found (Plate 3.42). Timber remains that indicated the position of a probable sluice/control gate separated these two elements. This was the only wheel race to be located and represents the clearest direct evidence for the position of one of the waterwheels within the new mill. It strongly suggests that all the waterwheels were located to the west of the limits of site 300 and to the east of site 303, therefore within the area that was not excavated.

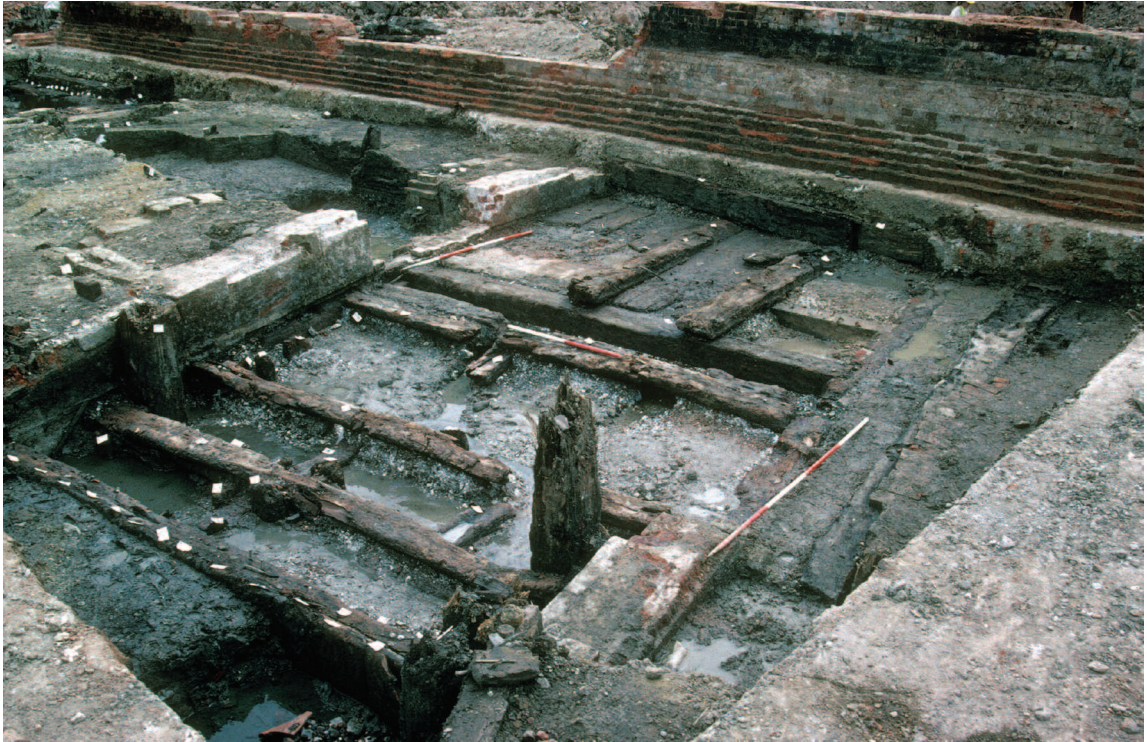
*Plate 3.43 Site 300 St Giles Mill: view looking SW of the timber lattice framework for the races in the northern channel (Project Phase 9)*

Further east on site 300 the full width of this channel was revealed; it was separated into three adjacent races. The races had been constructed within a construction trench, within which a timber latticework frame was constructed from oak, elm and beech (Plate 3.43). The frame was made from longitudinal beams which were again set into a deliberately laid layer of clay. A series of transverse beams were jointed into these using nailed half-lap joints. These beams were fixed into position by vertical posts to which they had been nailed. The beams were then overlain by two further longitudinal beams, which formed the foundations to the partition walls and divided the channel into three separate races. The spaces between these partition beams were planked over using tangentially split elm boards that were nailed to the underlying beams to form the floors to the three races. Only the partial remains to two of these floors survived, Group 13267. The three races were of different sizes: the northern race was 0.91 m wide, the central race was 0.74 m wide, and the southern race 1.54 m wide. The outermost retaining walls to this channel were

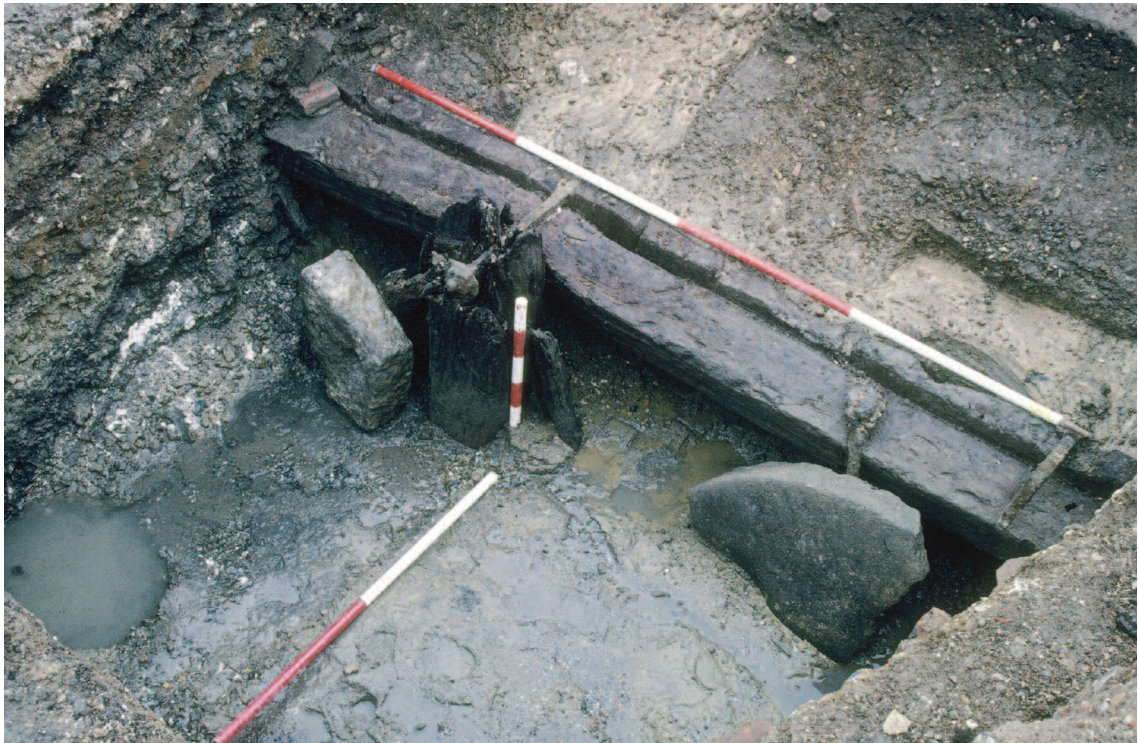
*Plate 3.44 Site 300 St Giles Mill: view looking NW showing the mill tail revetment structure as seen in Test Pit 362 (Project Phase 9)*

picked up in TP 362; it was constructed from horizontal planks lain on-edge retained by posts and tied into the bank with iron bolts (Plate 3.44).

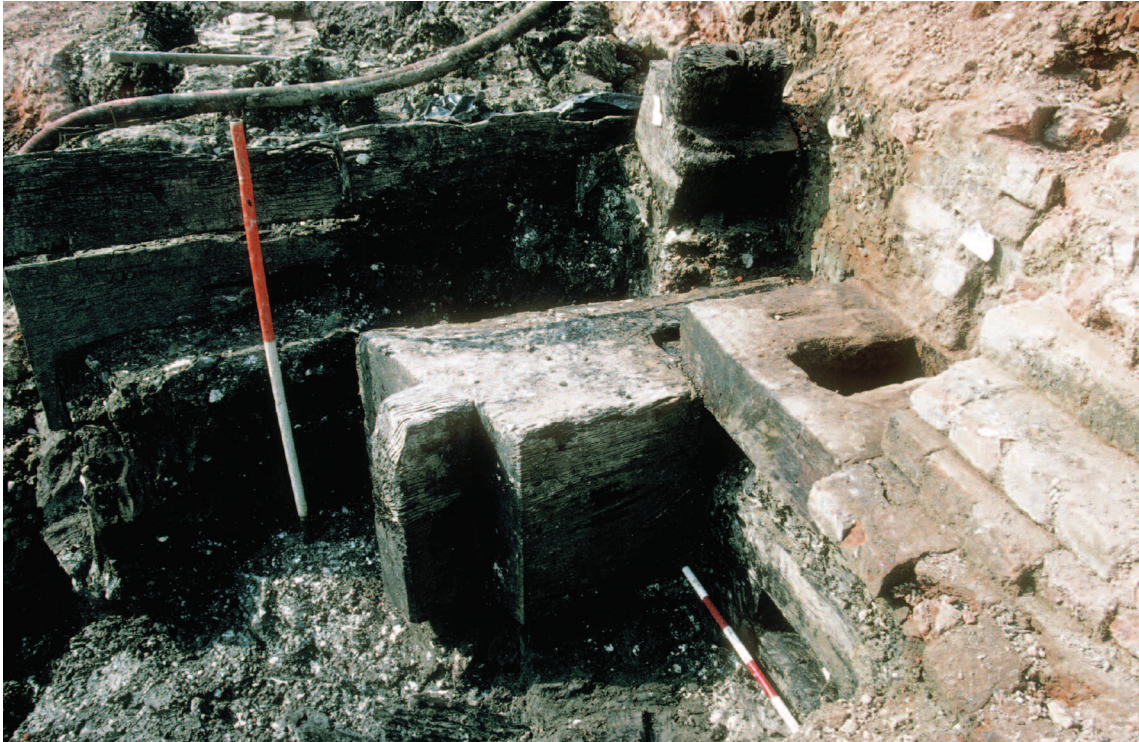
Plate 3.46 Site 300 St Giles Mill: view looking N showing the vacant mortice for one of the posts for the Hurst frame (Project Phase 9)

A small element of the Hurst Frame was revealed at the eastern end of the site (Plate 3.46). Together with similar elements at the western end of site 300, this suggests that the wheel race for this central channel was located in the unexcavated and heavily truncated area between sites 300 and 303.

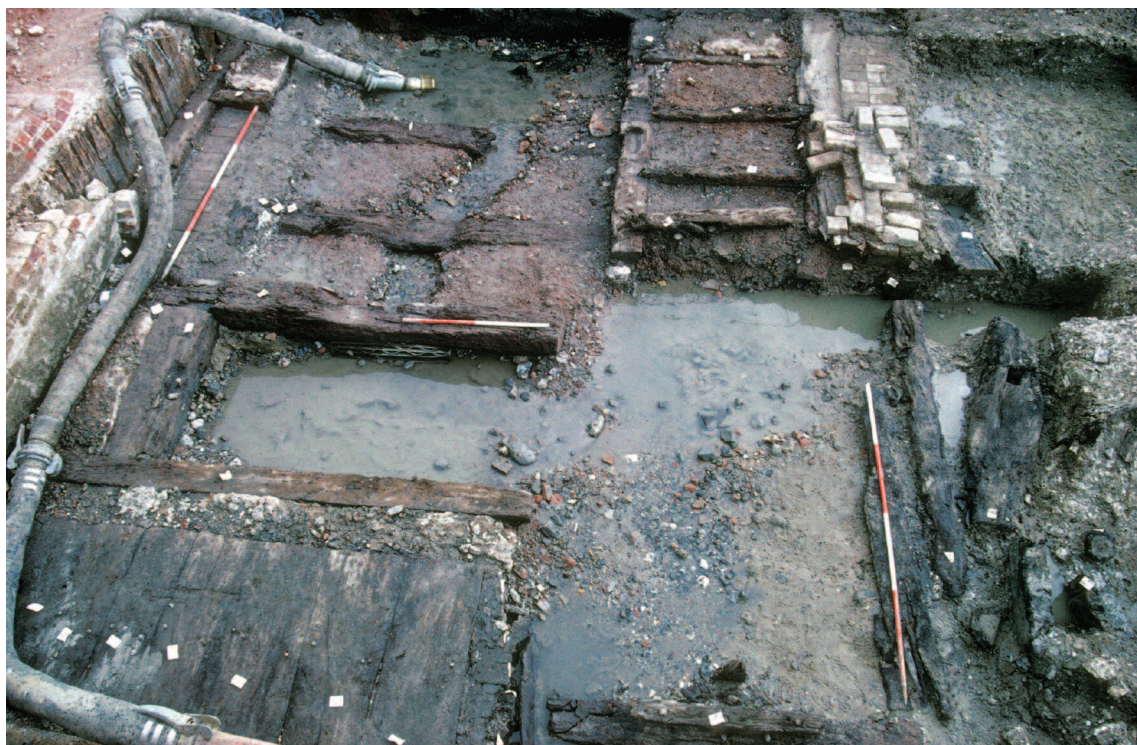
Plate 3.47 Site 300 St Giles Mill view looking SW showing the southern race (Project Phase 9)

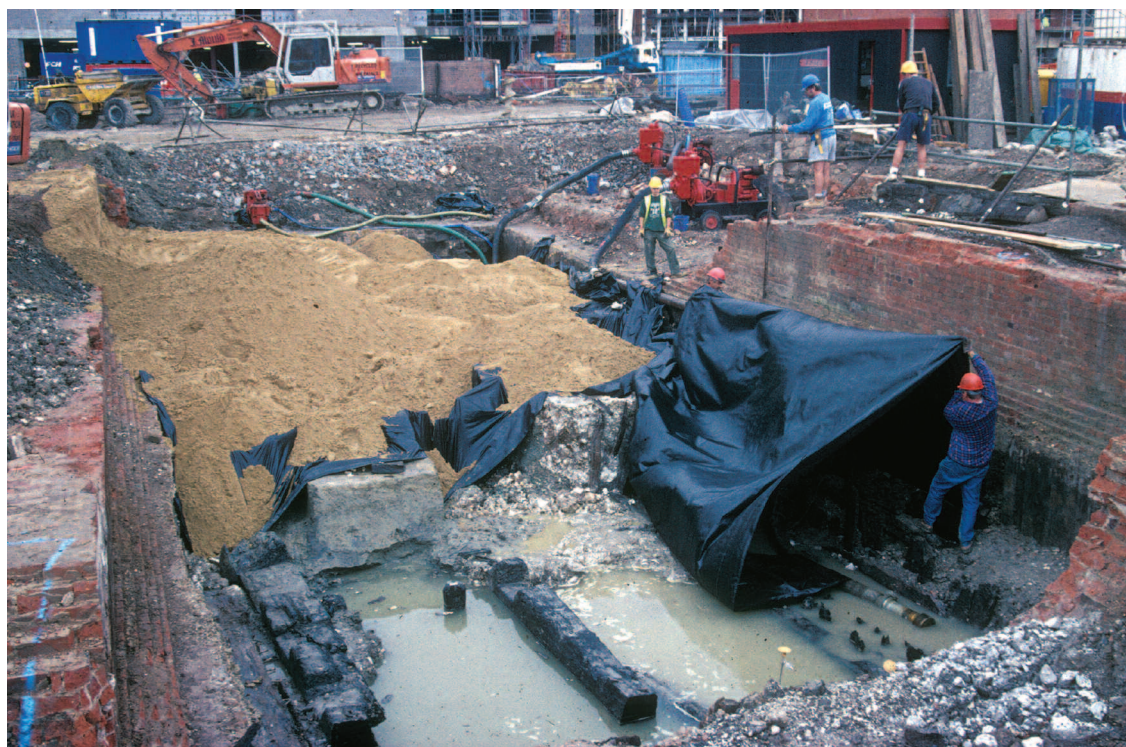
Plate 3.51 Site 300 view looking N, the remaining unexcavated mill timbers of St Giles Mill are preserved in situ

tered from previous phases of activity they were removed. This exercise was achieved not by the wholesale removal of the timbers but by the careful and labour intensive process of sawing off the timbers to the exact dimensions needed for the foundation trench. The trench sides were then lined with vertical timber planking, probably pine, which acted not only to shore up the deep faces of the trench but also as shuttering to receive the poured concrete foundation. It is as a direct consequence of this construction technique for the foundations that so much of the archaeological evidence of the former mill structures remained. It is an object lesson in preservation *in situ* (Plate 3.51).
