# St Giles in the Fields Camden London

Archaeological Watching Brief

**Document Type:** Watching Brief

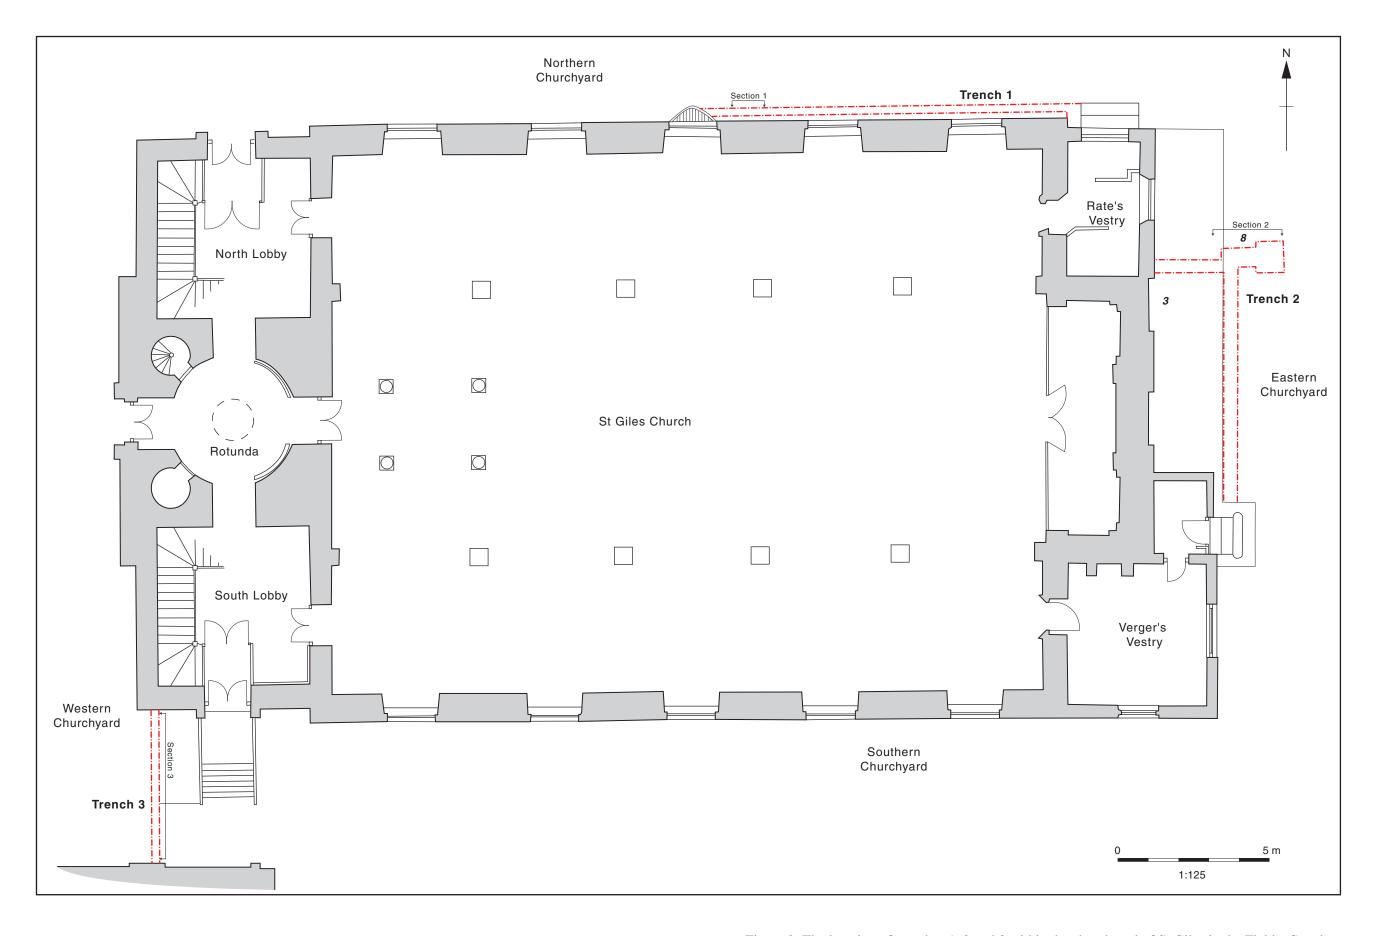
Figure 2: The location of trenches 1, 2 and 3 within the churchyard of St Giles in the Fields, Camden

- 3.2.1. An archaeologist observed the hand excavation of three pipe trenches within the northern, eastern and western churchyards. The location of the trenches in relation to the present church is shown in Figure 2.
- 3.2.2. All archaeological features were planned at a scale of 1:100 and where excavated their sections drawn at scales of 1:10.
- 3.2.3. All excavated features were photographed using colour slide and black and white print film. A general photographic record of the work was made in black and white and colour. Recording followed procedures detailed in the *OA Fieldwork Manual* (ed D Wilkinson, 1992).

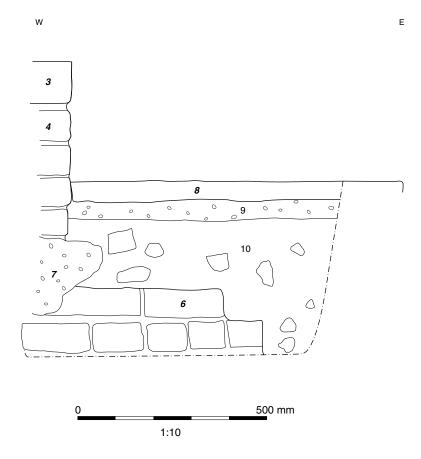
# Trench 2 Section 2

Figure 3: South-facing elevation showing walls 4 and 6

- 4.1.2. In the eastern churchyard, Trench 2 cut through an area paved with York stone slabs. The earliest structure revealed within the trench was a short 0.55 m section of brick and mortar wall located at the northernmost extent of Trench 2 (Figure 3). The wall was orientated eastwest, but appeared to turn to the north approximately 2.7 m to the east of the present church wall. The wall was composed of a double thickness of pinkish-orange unfrogged bricks (22 mm x 10 mm x 7 mm) bonded by a soft crumbly yellow-grey mortar. The finish was rough. Two courses of the brickwork were revealed, the uppermost being 0.28 m below the level of the present-day ground surface. The full depth of the structure is unknown. To the west, wall 6 extended beneath structure 4, clearly pre-dating it. It is difficult to interpret the function of wall 6, but it is quite probable that it may be a remnant of one of the earlier postmedieval church buildings known to predate the present church.

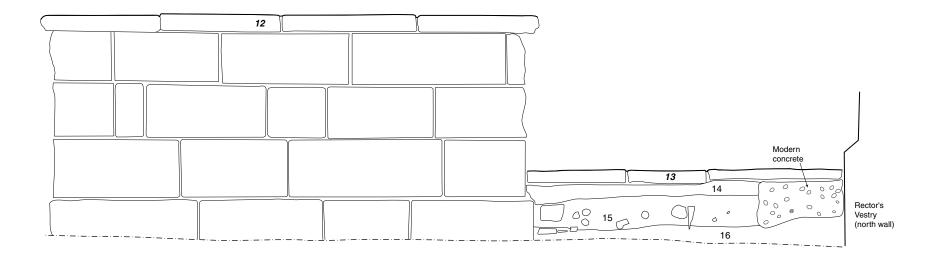
Trench 3 Section 3

Figure 4: West-facing section through Trench 3 showing staircase 12

- 4.1.6. Trench 3 was flush against the northern wall of the external stairs leading to the south lobby of the church from the western churchyard and Rector's Vestry. The trench revealed an additional course of the stonework of staircase 12, but the foundations or footings were not exposed at this depth. The well dressed stone blocks were bonded with crumbly white-grey mortar, and neatly pointed, in keeping with stonework above.
