Chapter 10

Techniques of underground quarrying:

3. Support of the roof and spoil management

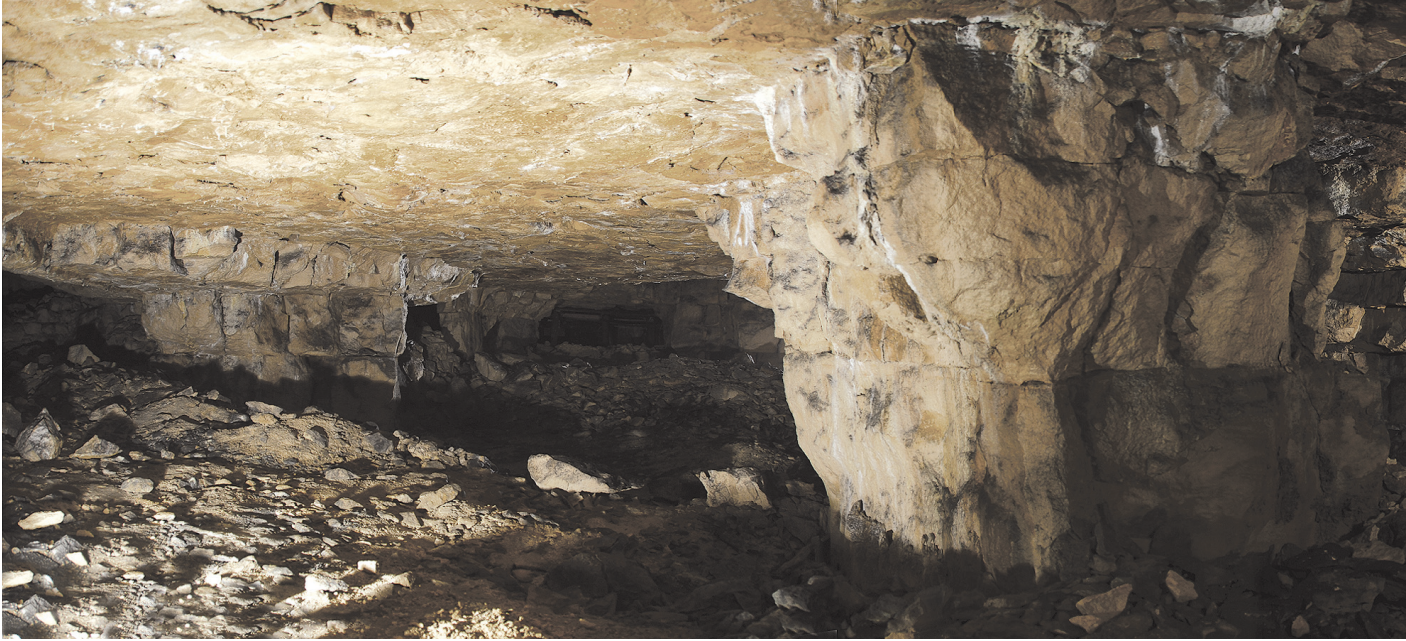
Fig. 10.2 Apophygate pillars within Central Byfield (Quarry 505). The pillar on the left is severely degraded

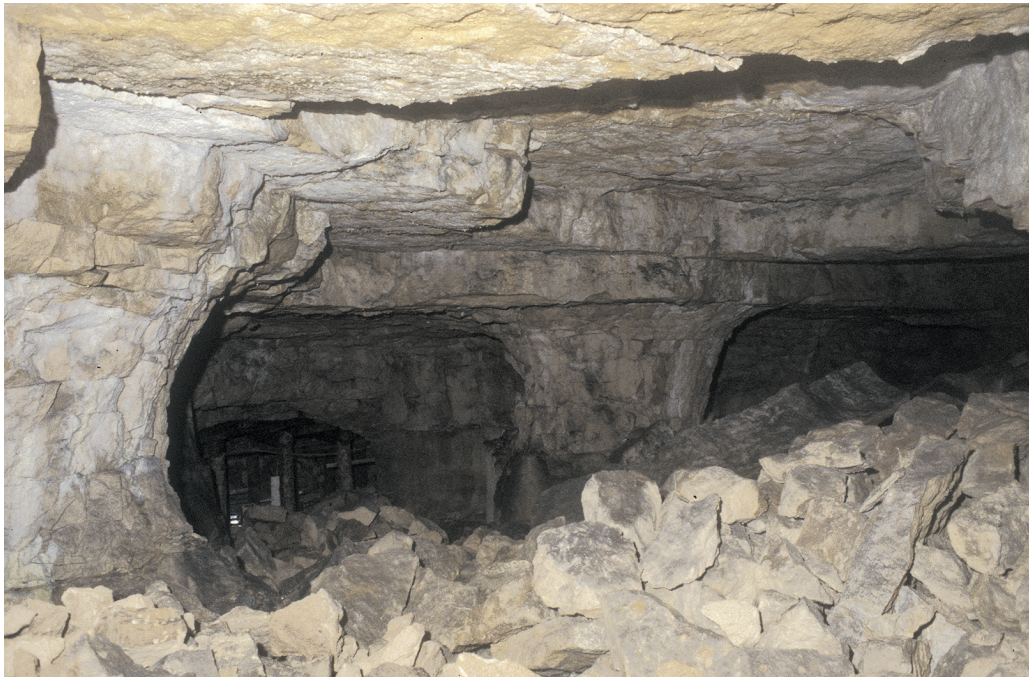
Fig. 10.3 Apophygate pillar in East Firs close to The Brow cartway in Quarry 2339. This is an example outside Allen's quarrying area

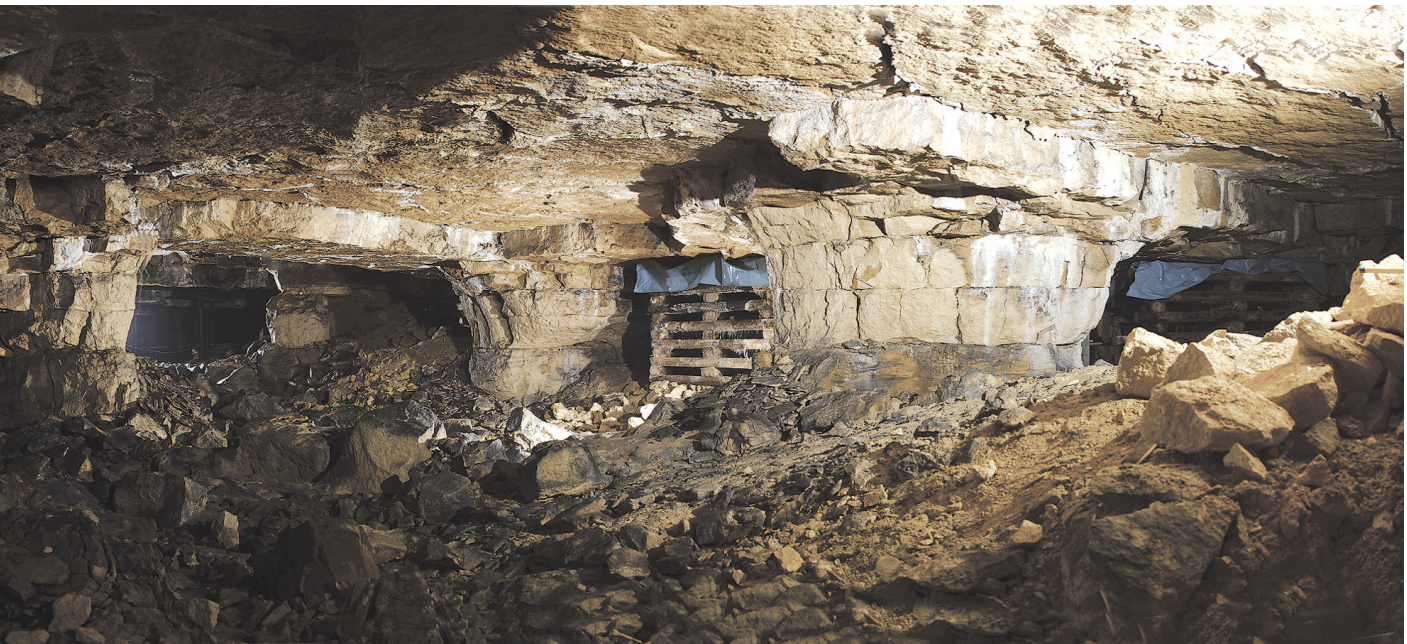
Section 40
Pillar 32

Fig. 10.4 Section of the top of an apophygate pillar including a small chamfered jad

It is a highly distinctive pillar form with a slightly hourglass shape with a top resembling the *apophyge* or 'curving-out' seen on classical columns (Fig. 10.4). The shape was intended to increase the bearing area under the roof and was formed by hacking out the three or four picking beds from around the pillar just below the roof level. Between the top outer edge of the apophygate pillar the roof was flat, following a bedding plane. The beds below the picking bed appear to have had joint faces predominating, with a characteristic narrow lip or collar at the intersection below. The pillars could be

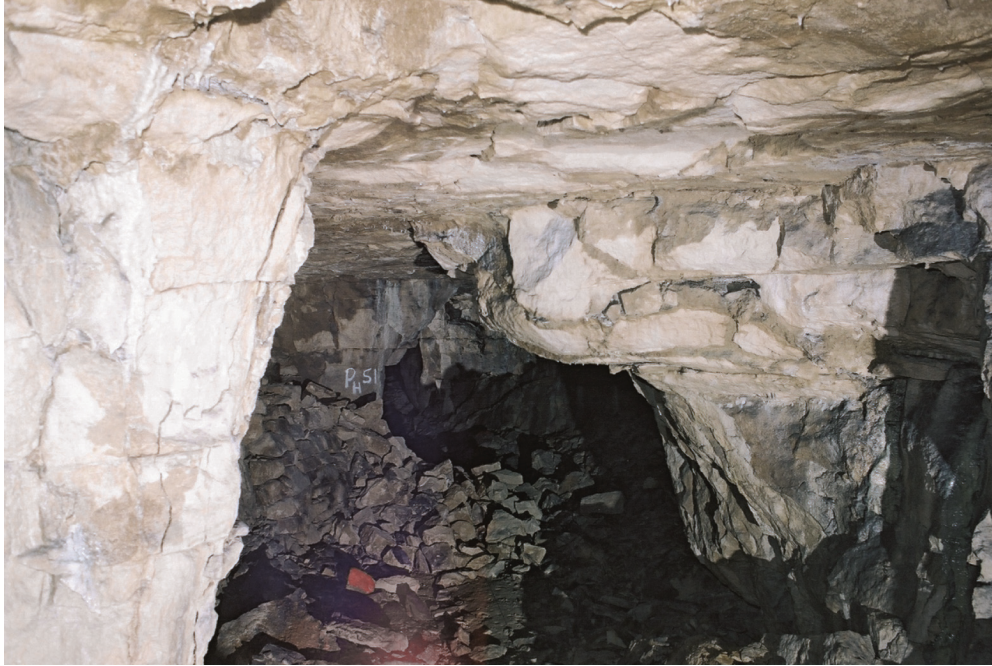
Fig. 10.6 Corbelled pillar in Byfield

Corbelled pillars usually occupied very limited areas as an outer ring to apophygate pillars, though their earliest introduction was in the E4 stub Quarry 2347, where the corbels projecting at the top of the pillar were more substantial than was usual later (Fig. 10.6). In Byfield Quarry 505 a transitional form of pillar with both apophygate and corbelled style developed (Fig. 10.7). The wider use of corbelled pillars may have resulted from the general intro-

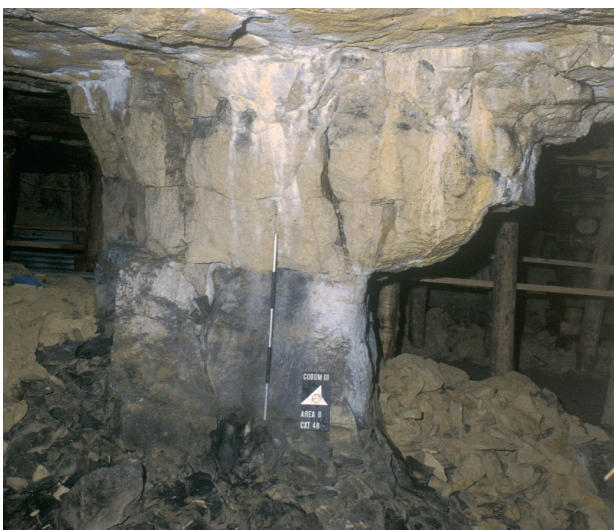
Fig. 10.7 Transitional form of apophygate and corbelled pillar in Central Byfield (Quarry 505)

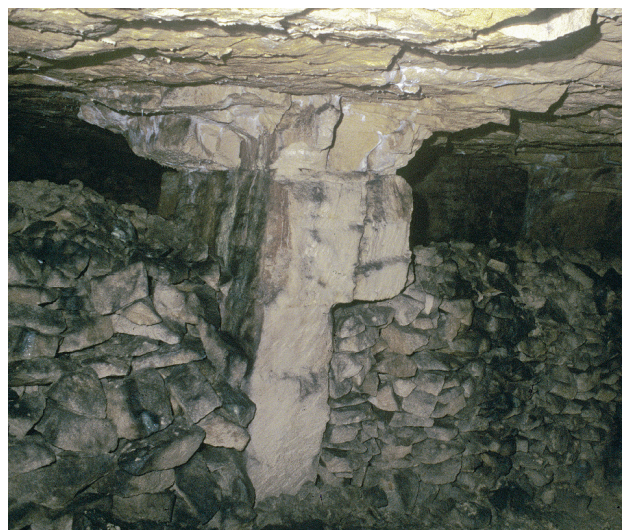
Fig. 10.8 Corbelled pillar just west of Firs Shaft, with inadequate support in the core width below

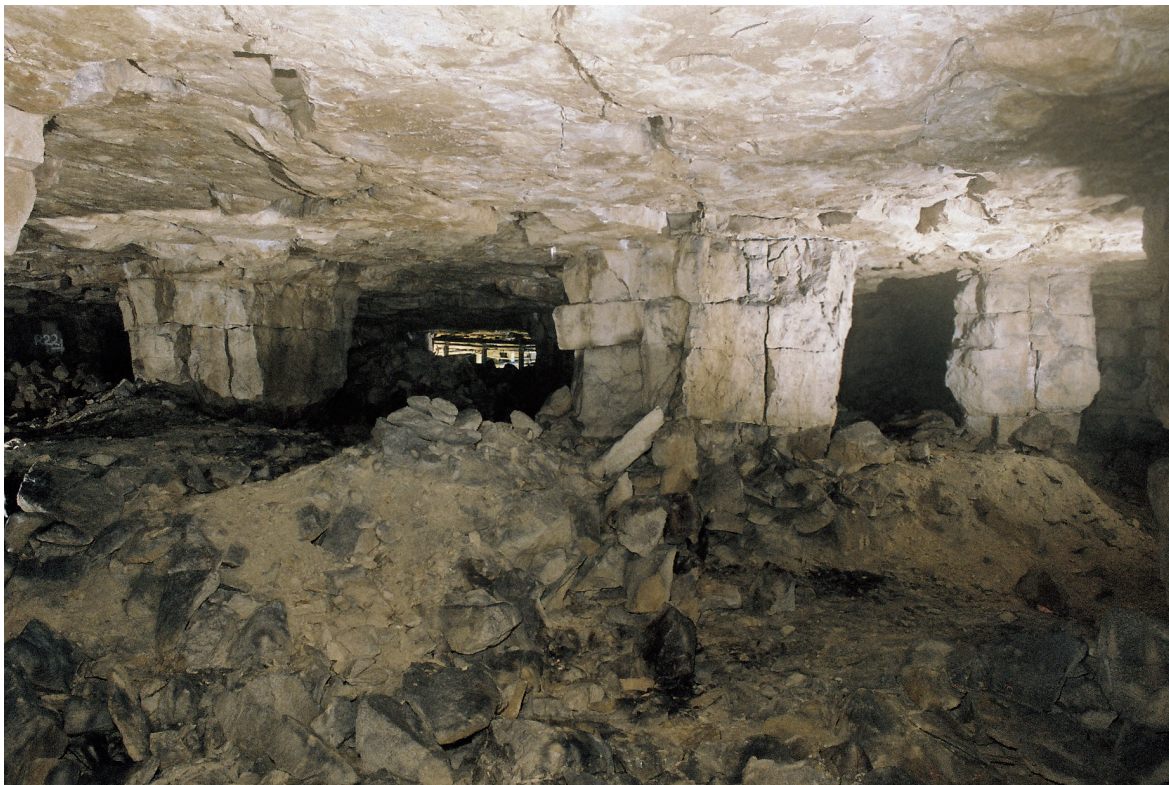
Fig. 10.9 *Direct pillars in Central Firs (Quarry 2340)*

Direct pillars were the most common type found in later workings (Phases IV-VI), and proved the best type structurally (Fig. 10.9). Ideally they had vertical sides with either a joint face or a carefully vertically broken side with bed end faces in line from floor to roof. Many cases, however departed from this ideal and overly narrow or other irregular forms were common (Fig. 10.10). The introduction of the direct pillar, alongside corbelled pillars, appears to have coincided with the common use of horizontal jad slots with near-parallel faces and usually, as with corbelled pillars, the abandonment of the full-height opening-out of the picking bed. With the almost simultaneous systematic use of wedge-and-chip method for the breaking of sedimentary beds and for the removal of blocks from the pillar faces. Fairly regular shaped direct forms could usually be achieved and the later introduction of saws allowed for very regular forms, as was observed in the latest worked areas of the quarries in the later 19th and early 20th centuries.

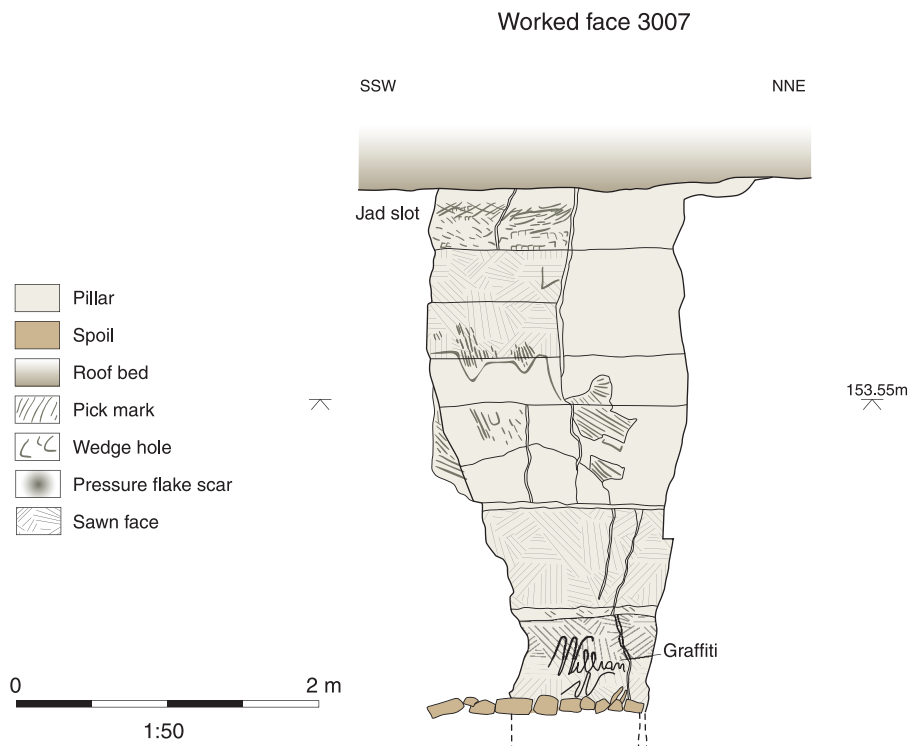
Fig. 10.10 Section of worked face 3007, an irregular form of direct pillar with narrow core, showing picked and wedge and chip broken surfaces

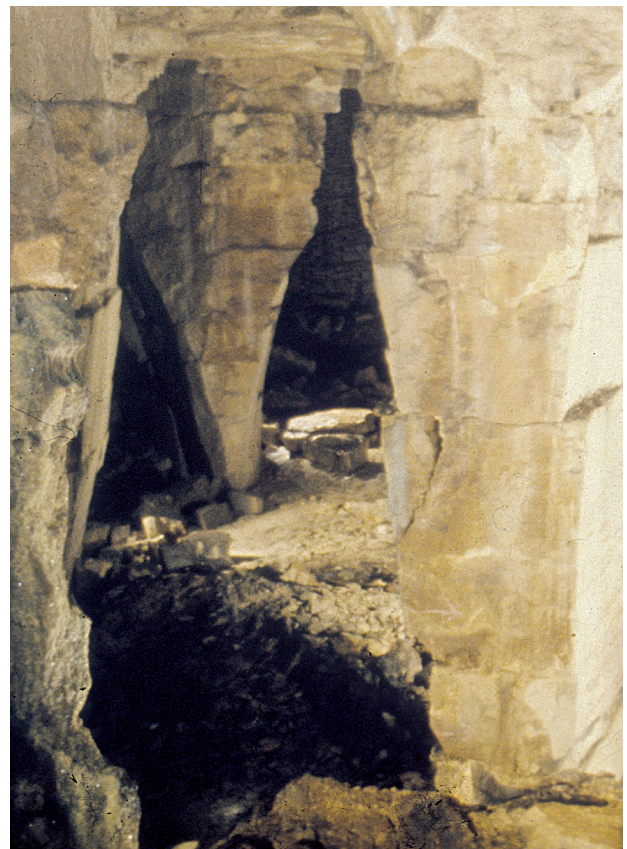
Fig. 10.11 Tapered sawn pillars in north Central Firs (Quarry 2215)

like taper so regular and frequent that they must have been deliberate, but were clearly misconceived, as they placed the load on a very small area (Fig. 10.11). Saws were also frequently used for scavenging, cutting into otherwise regular pillars to remove the best thick bed just above or below the spoil-dump level. Many pillars appear to have been severely cut away just below the spoil to a highly dangerous degree which, subsequently hidden, was hard to detect. Particularly bad examples were found in the southern part of East Firs where nearby apophygate pillars also led to instability. Joints produced some of the greatest irregularities, including pillars with major open joints running through them. A pillar in the Grand Canyon in Firs, for example, from one angle appeared twinned, but was regular from the other.

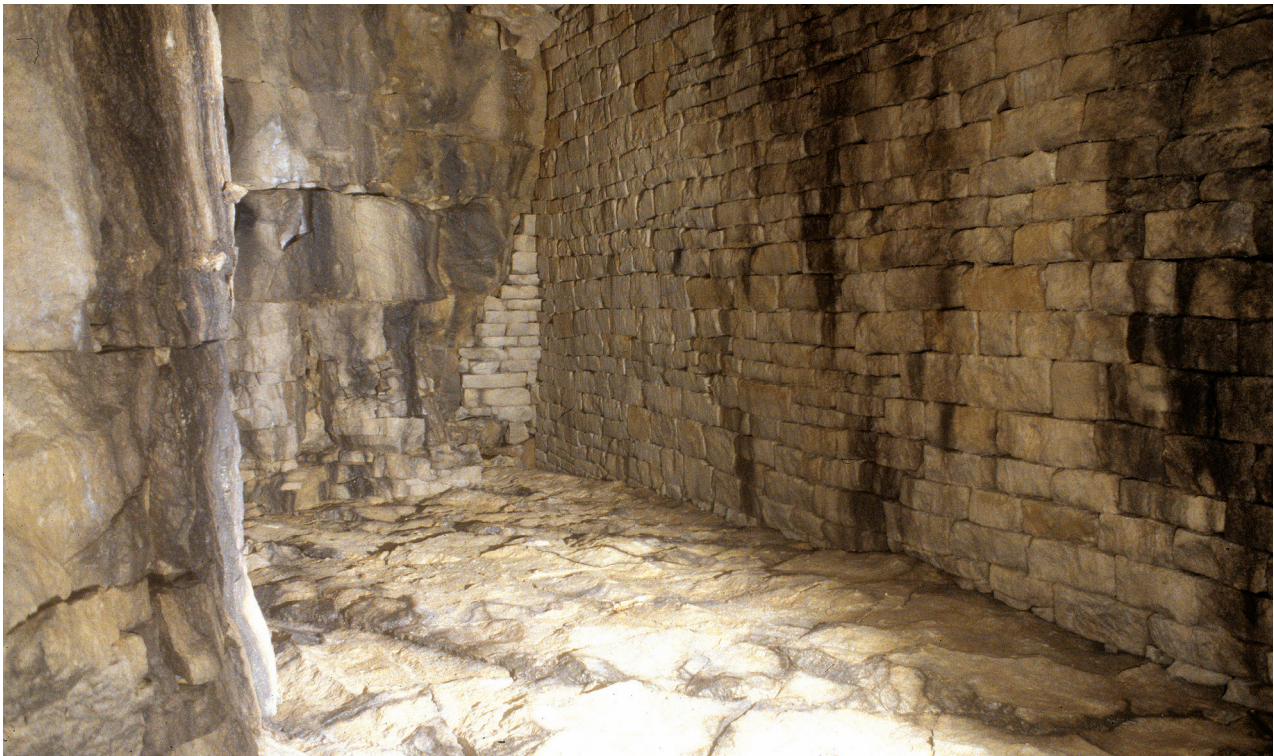
Fig. 10.12 Substantial rubble and blocks used to construct the wall near the Hadley Arms under the south side of North Road

to separate areas of quarrying, possibly for boundary purposes or to direct air-flows, and many small packs were built to provide local support where roof stones had slipped or slumped. In one instance in north Central Firs a pack had removed the arch effect and an adjacent keystone block slipped as a result, remaining hanging above the floor. One of the most major coursed-rubble and block packs or walls was built near the Hadley Arms Public House, running below the south side of the North Road. It was in an area noted by Hawkins (1994) as having a roof thickness of less than four metres and sometimes below three, and where a very substantial fall appears already to have taken place. This filled the space between pillars to a height of about 5 m and was chocked under the roof by small stones (Fig. 10.12).

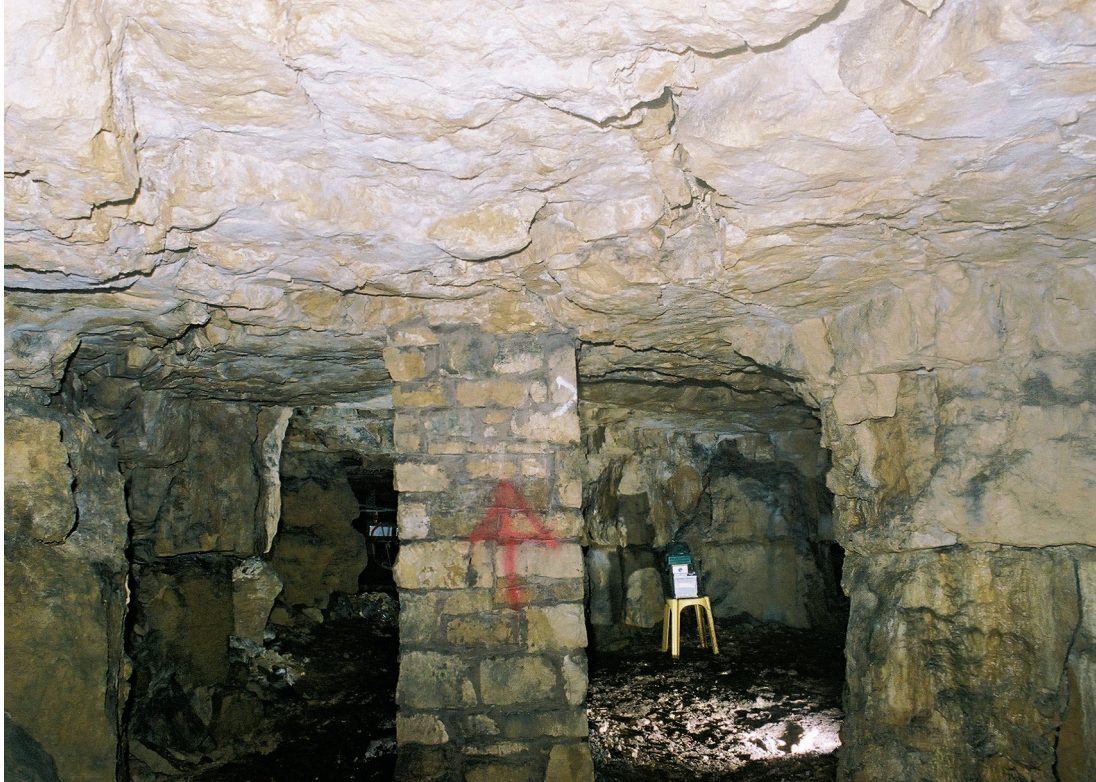
Fig. 10.13 Rubble stone mortared packs under a municipal drain running across the surface overhead in West Byfield

particularly insubstantial way-marking cairn. Substantial packs were built between pillars at Stonehouse Lane Quarry (2219), probably to retain surface quarry spoil in position while a line of mortared-stone packs were built to support the length of a drain in the mid 1920s in West Byfield (Fig. 10.13).

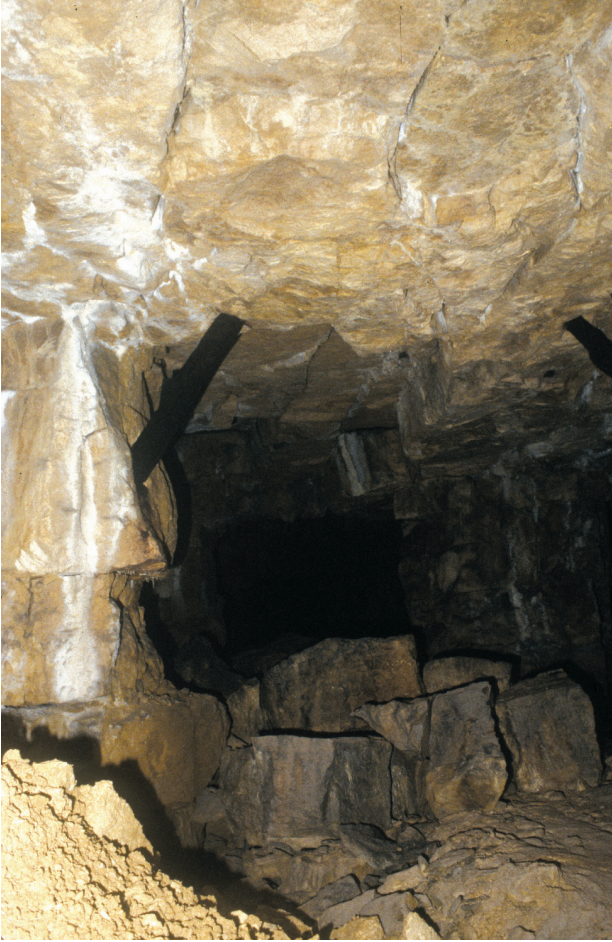
Fig. 10.14 Fallen blocks in Byfield (Quarry 509)

Roof collapses occurred throughout the Combe Down Quarries. They could involve the falling of an individual block (Fig. 10.14), such as that noted in Quarry 509. More serious collapse due to roof bed separation was noted (Fig. 10.15) above the cartway in Quarry 2211, where one or more of the sedimentary beds of stone just above the roof level had separated from the bed above, but remained *in situ* at roof level. Some collapses were contemporary with the quarrying periods but could also represent post-quarrying episodes. Partial collapses were sometimes held at roof level by the construction of stone packs, stone chocks or timber sprags, and could also be alleviated naturally by the proximity of roof supporting pillars or hinged on adjacent roof blocks.

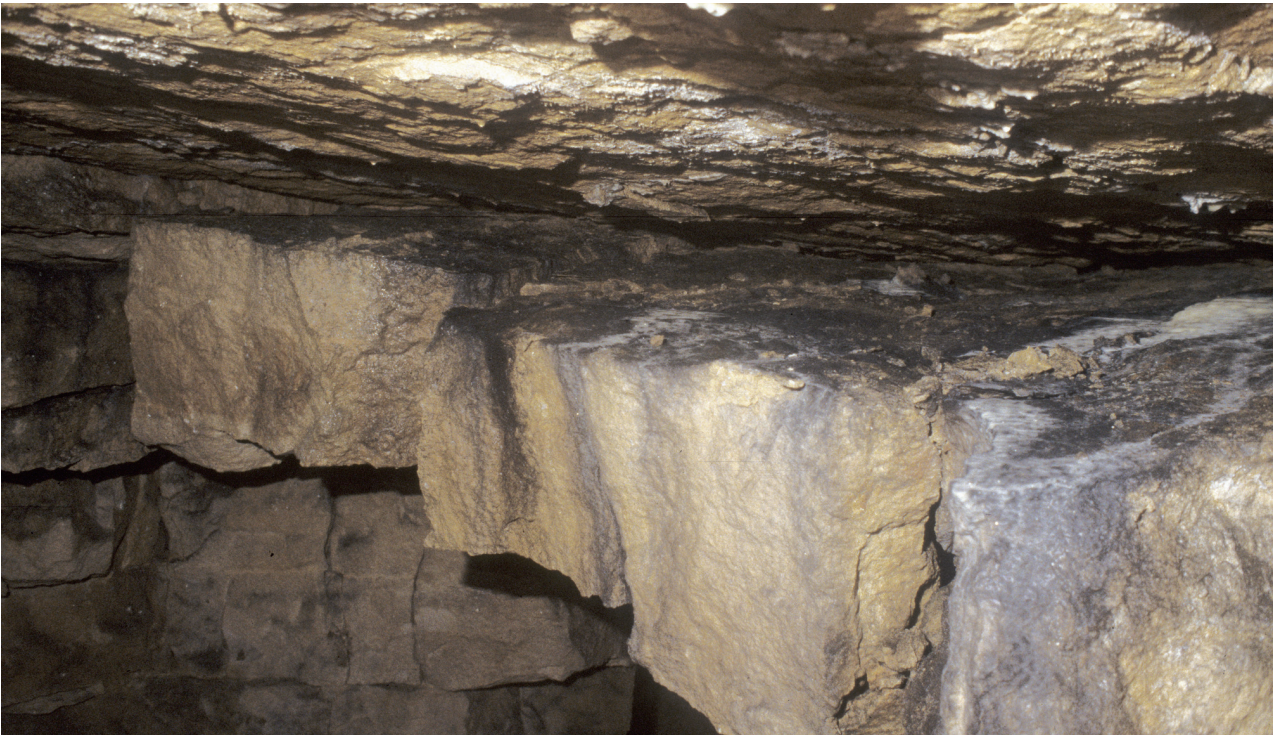
Fig. 10.15 Delaminating roof bed in Central Firs (Quarry 2211)

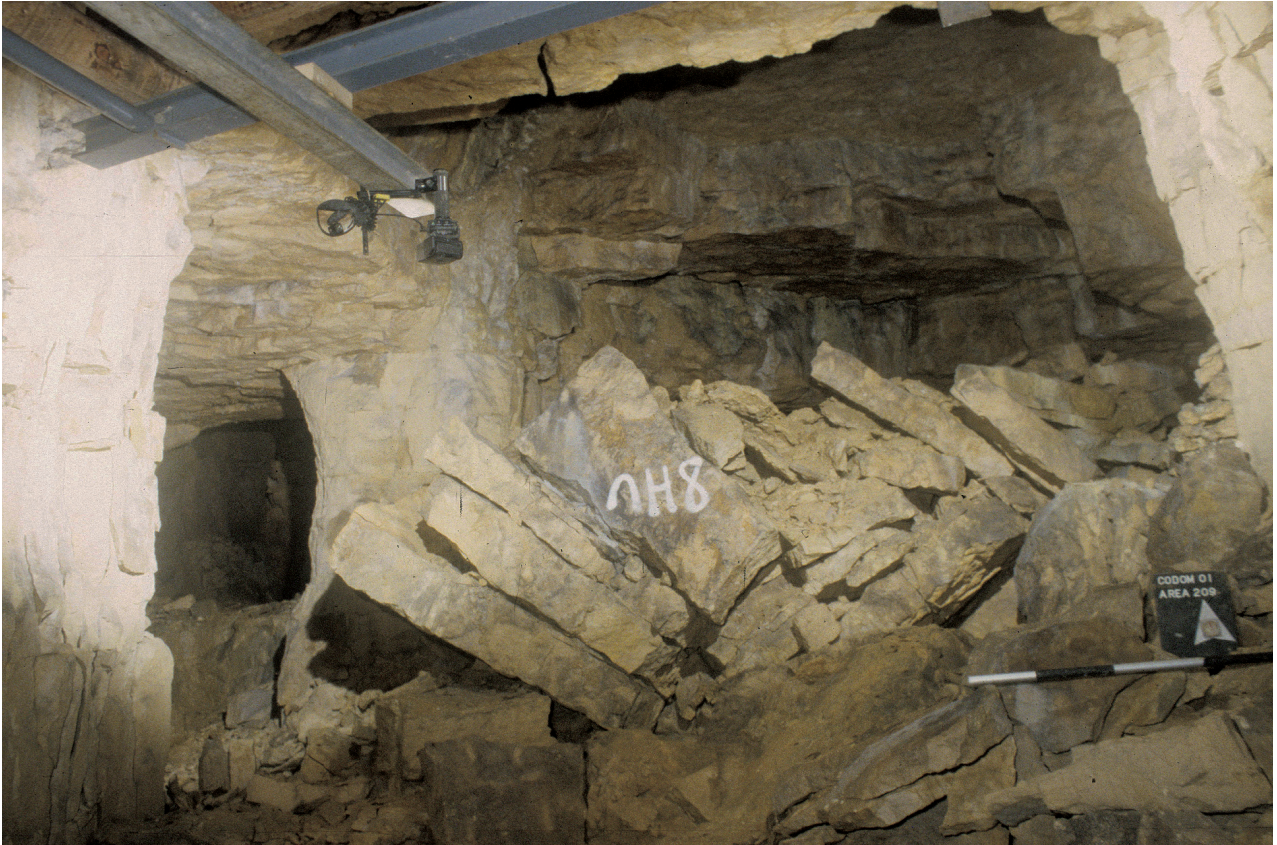
Fig. 10.16 Collapse of Twinhoe Beds in East Firs

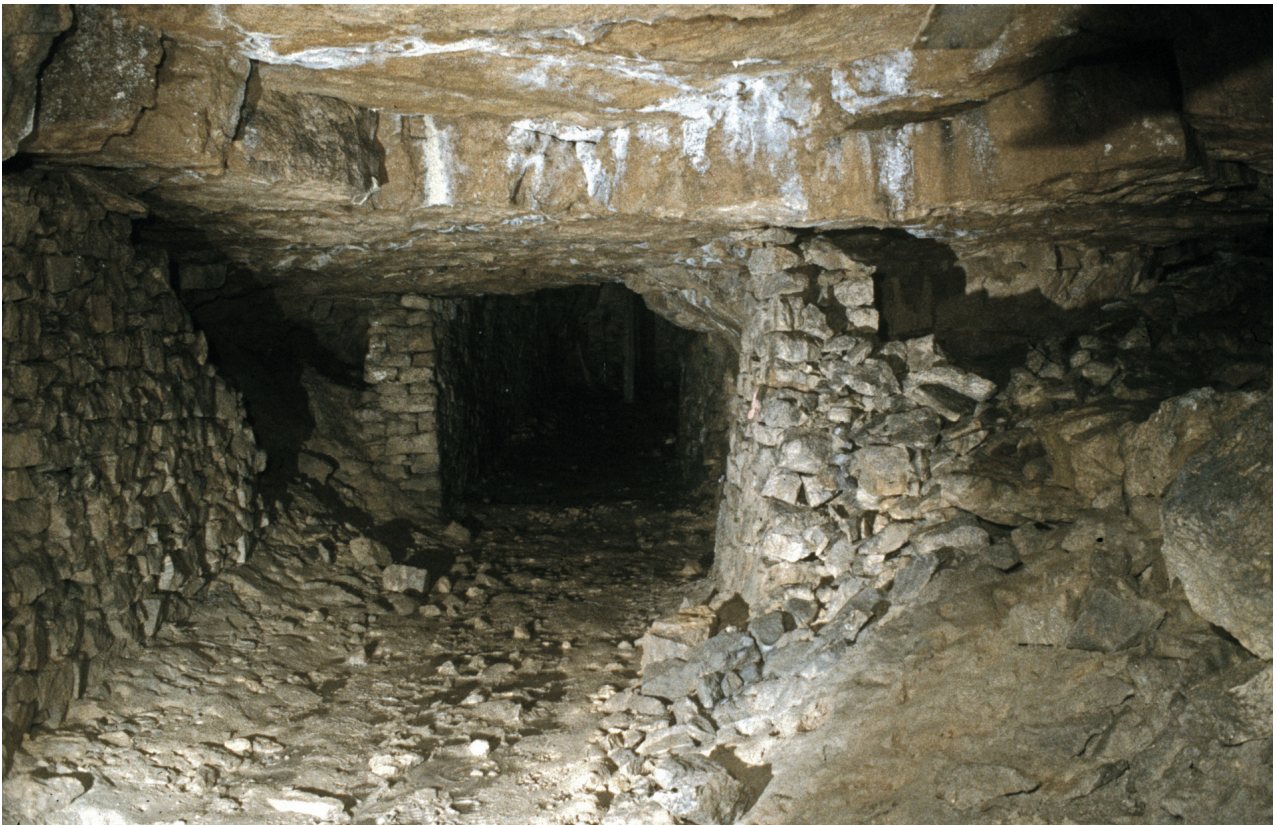
Fig. 10.17 Support pack in Central Firs

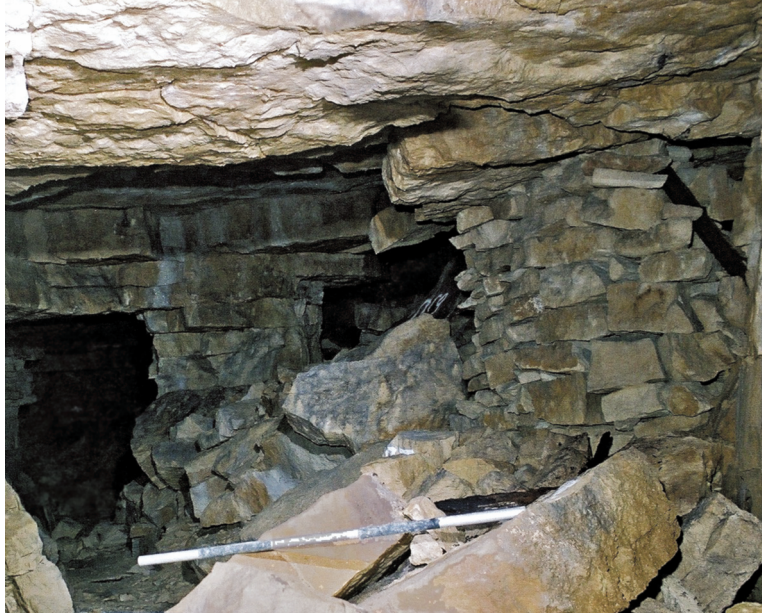
Fig. 10.18 Pack built on top of fallen blocks in Central Firs (Quarry 2200)

On the floor of the cartway in Quarry 2217 there was evidence for both contemporary and post-quarrying roof collapse. This was a main transport route for the movement of stone products to the surface quarry north of North Road. Flanking stone packs show that the roof required consolidation during the period of quarrying and post-quarrying collapse was noted at the southern end of the cartway (Fig. 10.18). Some 10 m to the north between packs there was evidence that collapsed

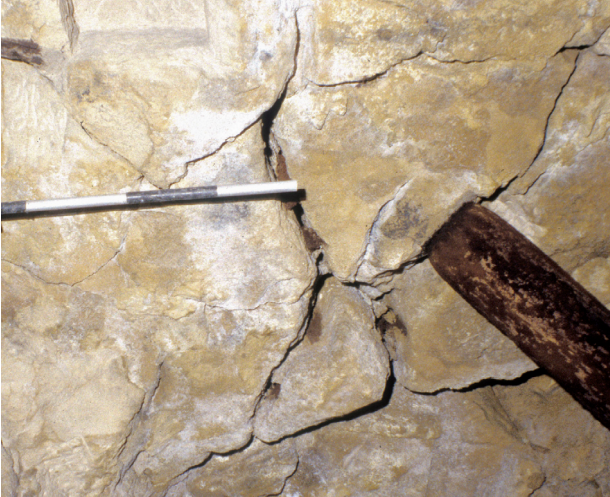
Fig. 10.21 *Wooden wedges or cleats inserted to tighten roof blocks*

Wooden wedges or cleats, often made from softwood, were also used to support the roof-beds and were placed in the cracks between the separating roof blocks so that they would provide some support and help to tighten them where the roof had weakened. They may have provided an early warning of any movement in or of the roof beds, with wedges subsequently falling to the quarry floor. The occurrence was rare in the Firs and Byfield quarries – excepting James Riddle’s 20th-century quarry (518) – but common at Shaft Road quarries 2373, 2377 and 2382 and at Foxhill, suggesting it was generally a later practice (Fig. 10.21). In many instances the individual blocks were generally keyed together, but where they had got slightly parted or sounded ‘hollow’ and had separated from the sedimentary bed above the insertion of the wedge or wedges prevented any of

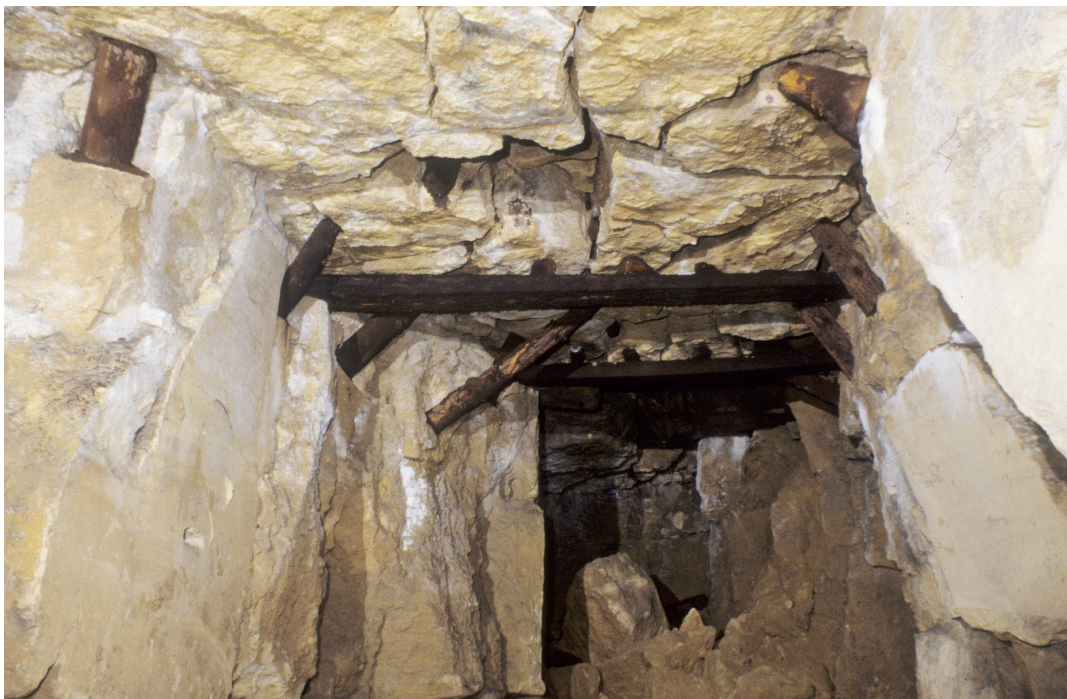
Fig. 10.22 *Horizontal timber used for roof support under Shaft Road.*

The placement of horizontal timbers was a slightly more common practice by the end of the 19th century and examples of their use were seen in all the outlying quarries. Timbers were used to support roof beds by wedging them between two pillars or placing them in horizontally cut recesses. Timbers were also used as supporting beams across the entire width of a quarried breach or Long Room or positioned where there was a roof gull and from where smaller rubble and materials that had migrated or that had been washed from the upper geological beds may have fallen. The timbers in these situations were often used in conjunction with other smaller cross timbers. A particularly long example was found at Shaft Road, where it spanned the whole of the room width just under the roof (Fig. 10.22).

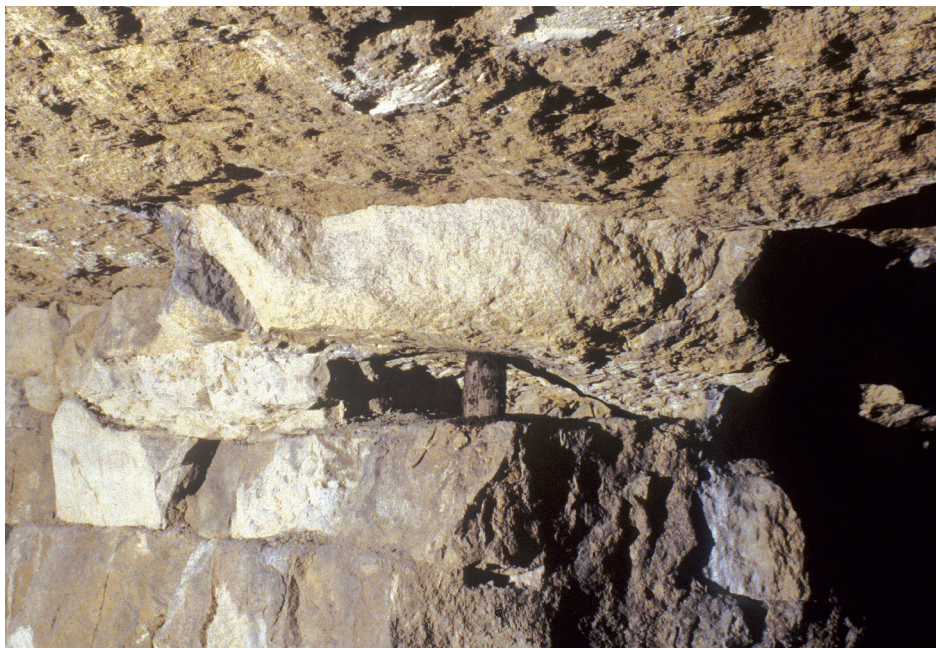
Fig. 10.23 Vertical prop placed on a pack

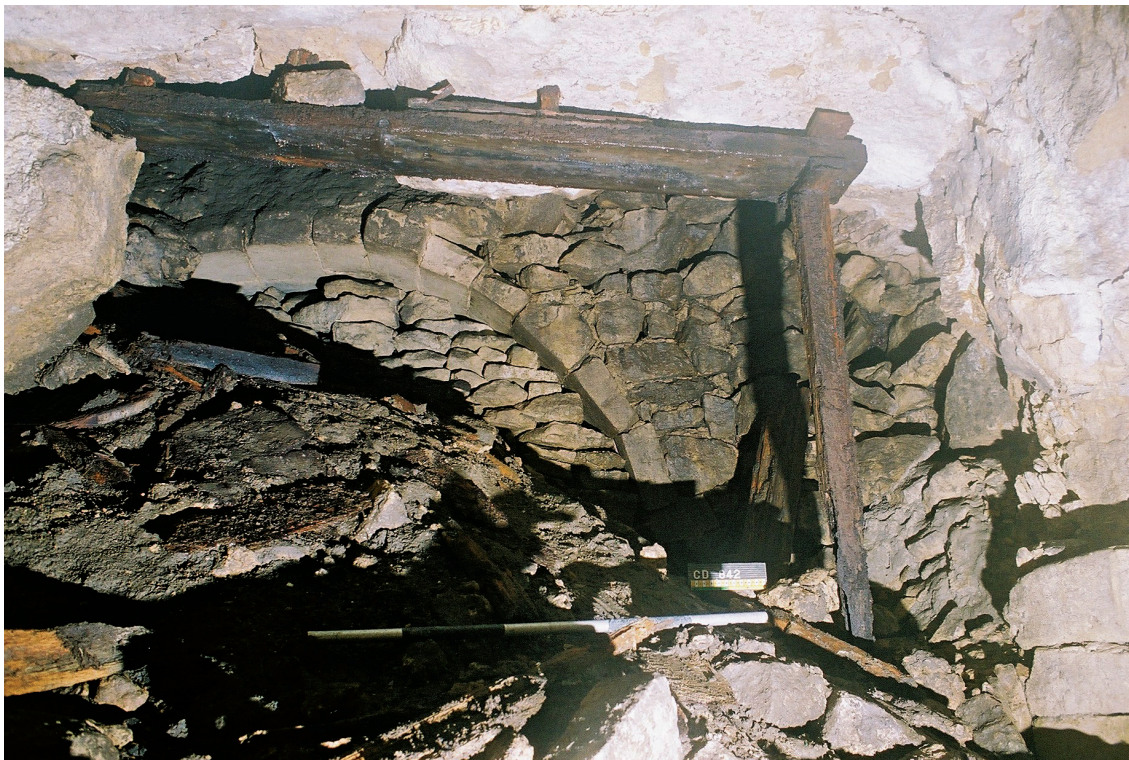
Fig. 10.24 Stone arch at a West Byfield entry (Quarry 505) with sawn voussoirs

Three other stone arches were also constructed in the southern part of the (Byfield) Jones Quarry at Ralph Allen Yard. where three converging cartways emerge. Because of the use of sawn blocks to create the interlocking voussoirs, they are thought to have been constructed at the same time in the 19th century when the much older cartways were still in use for extracting stone to the surface, but an earlier date is not impossible. All three largely remain buried by post-quarrying surface-derived debris. One arch has been preserved behind a layer of sand, prior to concrete consolidation (Fig 10.24).

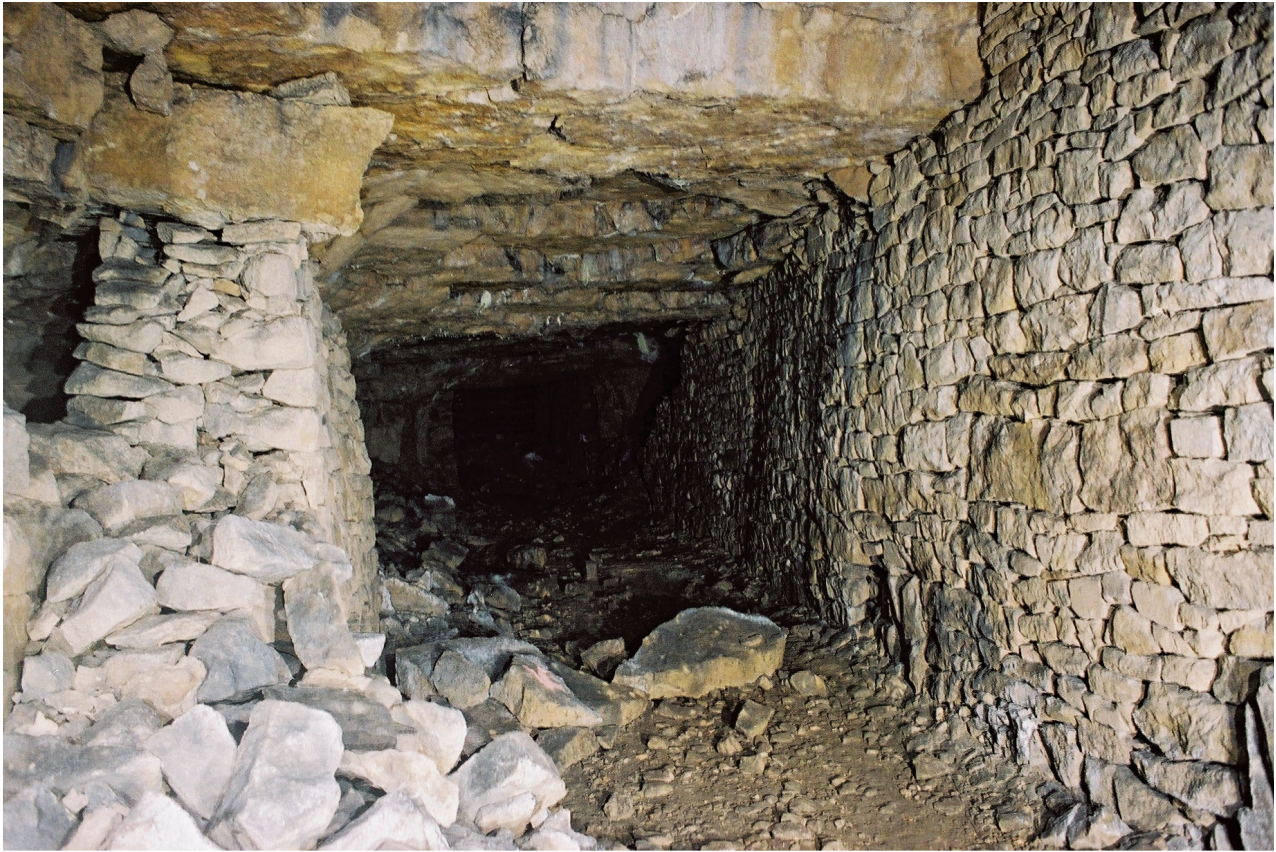
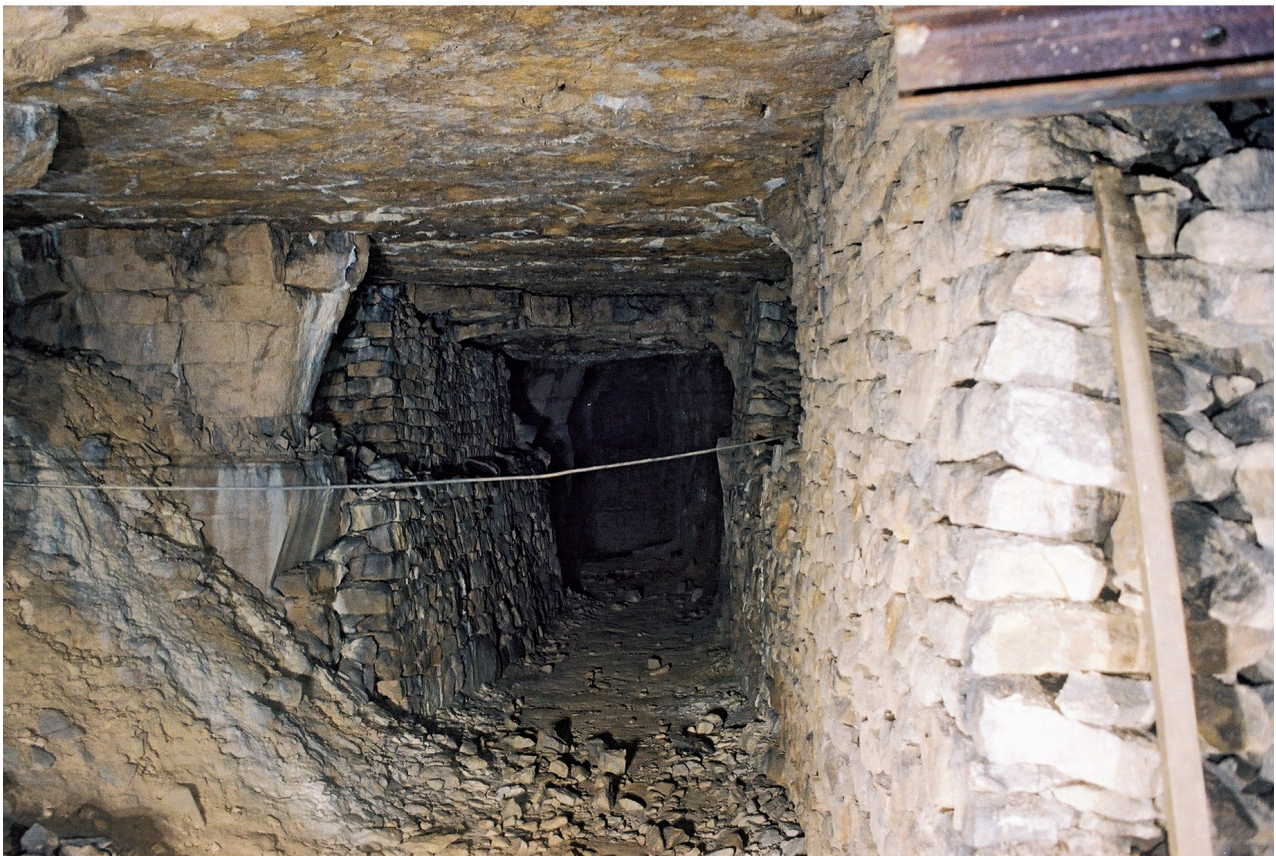
Fig. 10.27 Flanking roof support packs in the first section of Allen's west cartway from Sheeps House Quarry

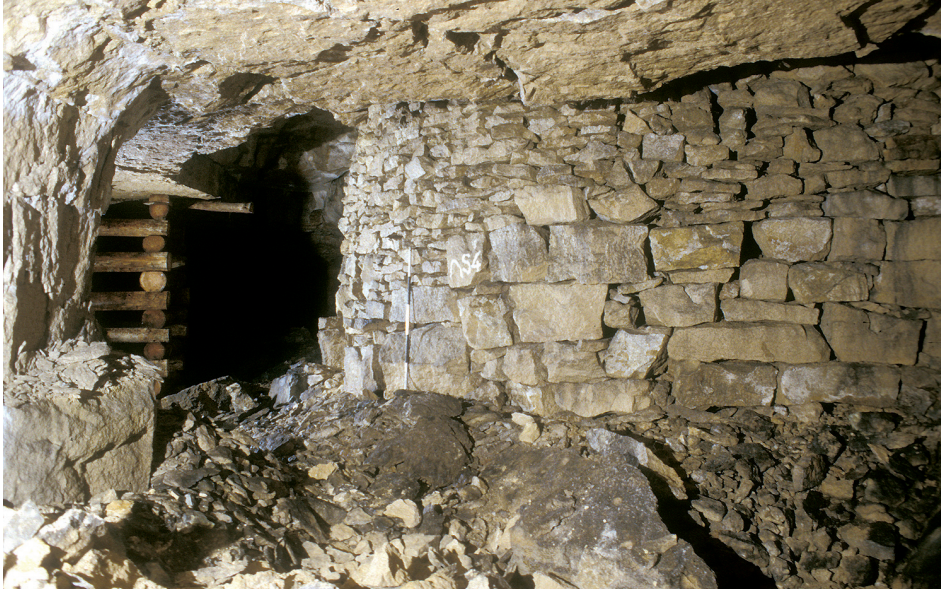
Fig. 10.29 Bathite blocks used to support roof under the rear of the Hadley Arms

An unusual use of materials within the same Quarry (2211) was a stone pack located to the south-west of the Hadley Arms, constructed to consolidate and retain the backfilled surface-derived materials in one of the former extraction shafts. It also provided a room underneath the Public House for entertainment in the 1980s (Hadley Arms landlord pers. comm.). The lower courses utilised stone from the quarry whereas the upper courses used discarded 'Bathite' blocks, a faced concrete block made by Tarmac at Mount Pleasant Quarry in the 1970s (Fig. 10.29).

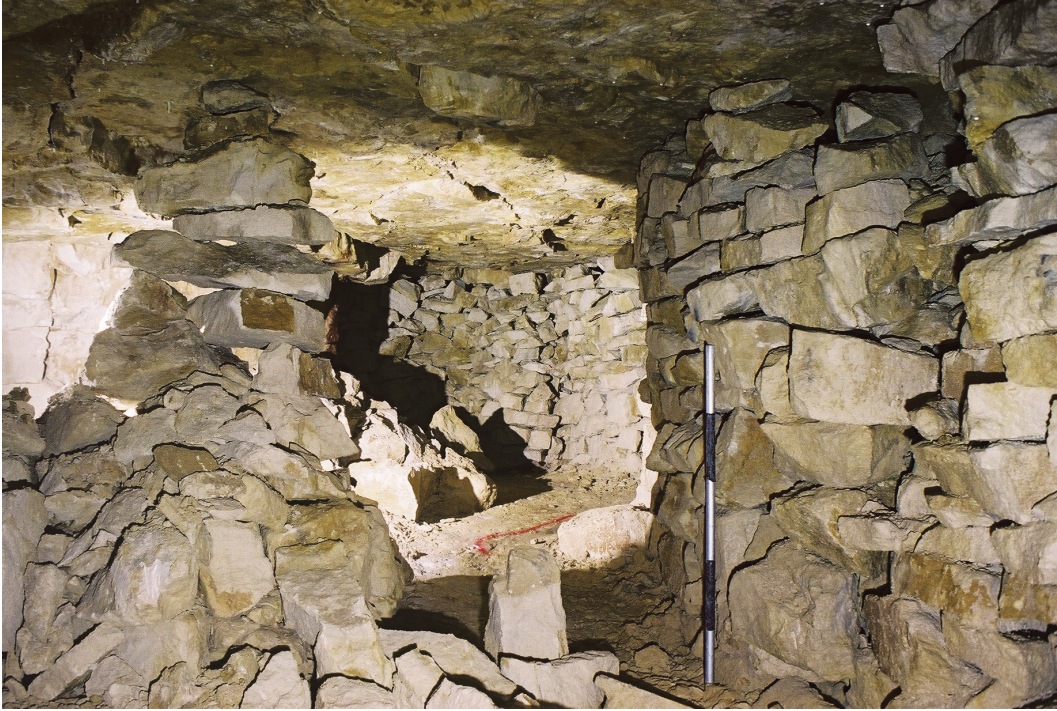
Fig. 10.30 Conical pack in East Firs (Quarry 2364)

Small stone packs within the open areas of the rooms between the pillars were occasionally built, with perhaps a dozen examples found. Most were square or rectangular in plan but two examples were conical in structure. One located in Firs Quarry (2203) was constructed next to two other stone pack roof supports (Fig. 10.30). It was built to a height of 2.30 m and supported an area of roof that (unusually) had been previously supported by vertical timber props, which had failed. The other, located in Byfield Quarry (514), was noted previously by David Pollard during his 1994 survey (Pollard, 1994, 86).

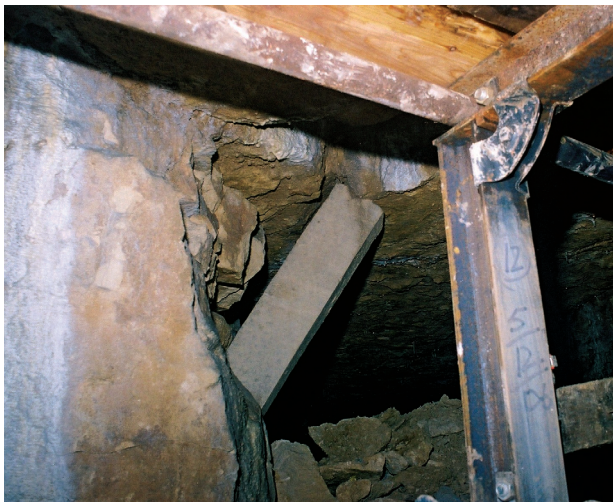
Fig. 10.31 Sawn stone used as a sprag in West Firs (Quarry 2342)

Another type of chock was a variant of the sprag, with the insertion of an individual block placed at an angle or near-vertically. Two examples of this type of support have been seen within the Firs quarry complex. That from Quarry 2342 was a sawn stone support measuring 850 mm x 200 mm x 113 mm in blockstone, which had been sprung from a pillar face into the roof. A sawn block in Quarry 2211 was placed on the southern side of the cartway to support a failing roof block (Fig. 10.31).

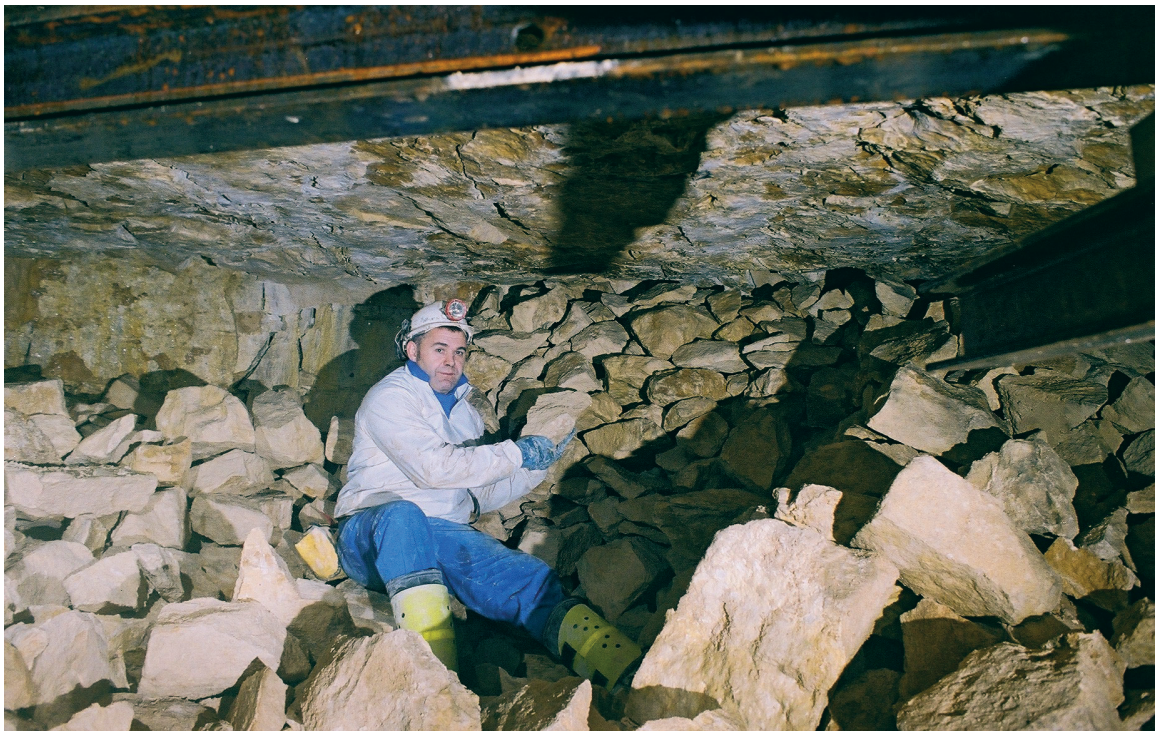
Fig. 10.32 Miner seated in original position demonstrating waste-stowing to roof level

a few tens of centimetres from the roof, partly by 'shooting' it over the end of the barrow, after which rubble was thrown-up by hand to the roof level (Fig. 10.32). This dumping continued so as not to intrude on the open, worked-out areas to maintain handling space before its eventual abandonment.

Examples of suitable planks were found, but not *in situ*. Subsequent dumping from this or other quarry and secondary dumping often reduced this height to around 1.4-1.6 m, the likely but uncomfortable height needed for barrowing with a bent back, and in some areas dumping was done up to roof level. Figure 10.32 shows a modern miner seated in an surviving original position demonstrating how material would have been handed up and stowed at the back to roof level.
