Chapter 10

Techniques of underground quarrying:

3. Support of the roof and spoil management

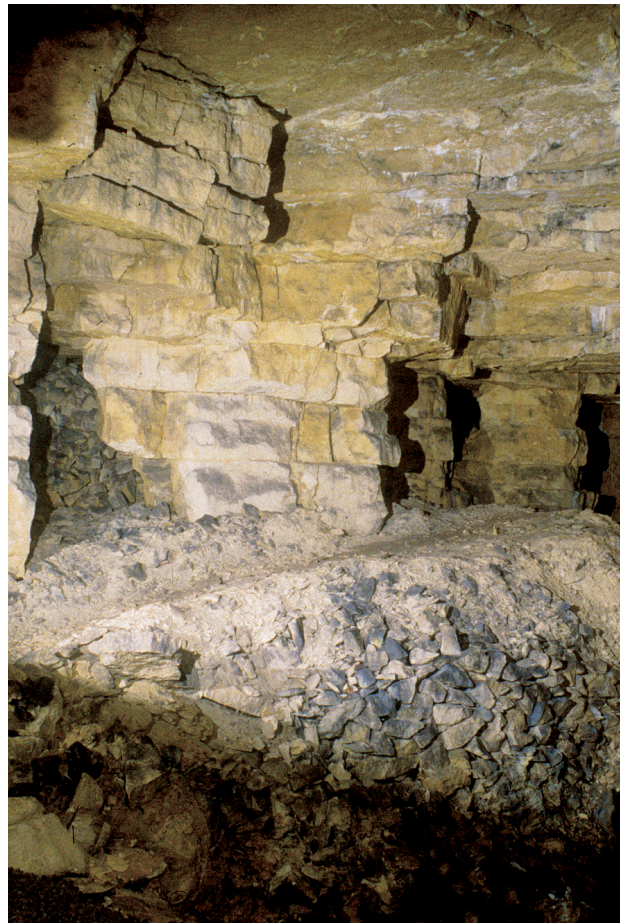
Fig. 10.33 Inclined barrow-way

Either the barrow-way was developed on top of an existing bank or, especially in high workings where space allowed, a single barrow-way, inclined as necessary, was developed out of the working area at grades typically between 1:4 and 1:6 (Fig. 10.33). To achieve this spoil was dumped over the front of the barrow to form a tongue ahead, with coarse lumps thrown to the side. Fines seemed to have been selected to form the surface for the wheel to run easily.

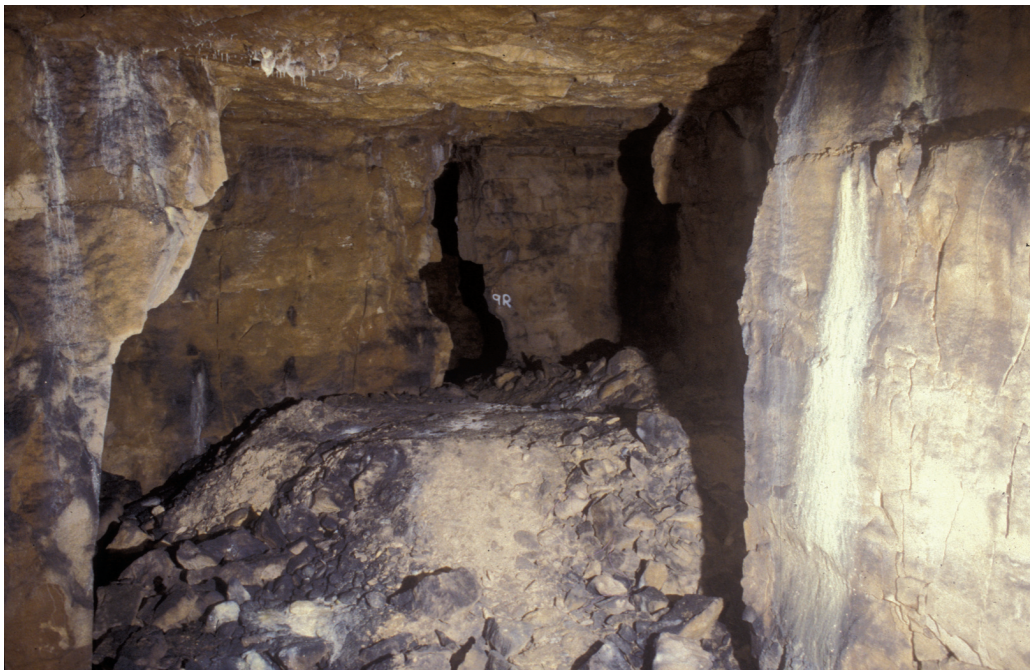
Fig. 10.34 Lobate tipping in Central Firs south of the Grand Canyon (Quarry Area 2209)

Lobate dumps were often found in either wide areas or in a long linear sequence of rooms. In other cases the tipping took place on a wide front, across rooms, with a distributary system of barrow-ways (see Chapter 12, Case Study 9). These were developed similarly to the above but along the 'dumping-margin' a series of ever-widening arcuate fronts were developed, with the barrow-loads clearly having been run around the near circular front tipping over the edge, until the margins of the area were reached. A highly developed sequence of this type was found south of the Grand Canyon (Fig. 10.34). It may be more suited to dumps where there was a high proportion of fine material, allowing a good surface over the whole of the dump.
