# Church of St. Nicholas, East Challow, Oxfordshire

Archaeological Watching Brief Report

OXFORD ARCHAEOLOGICAL UNIT

August 1995

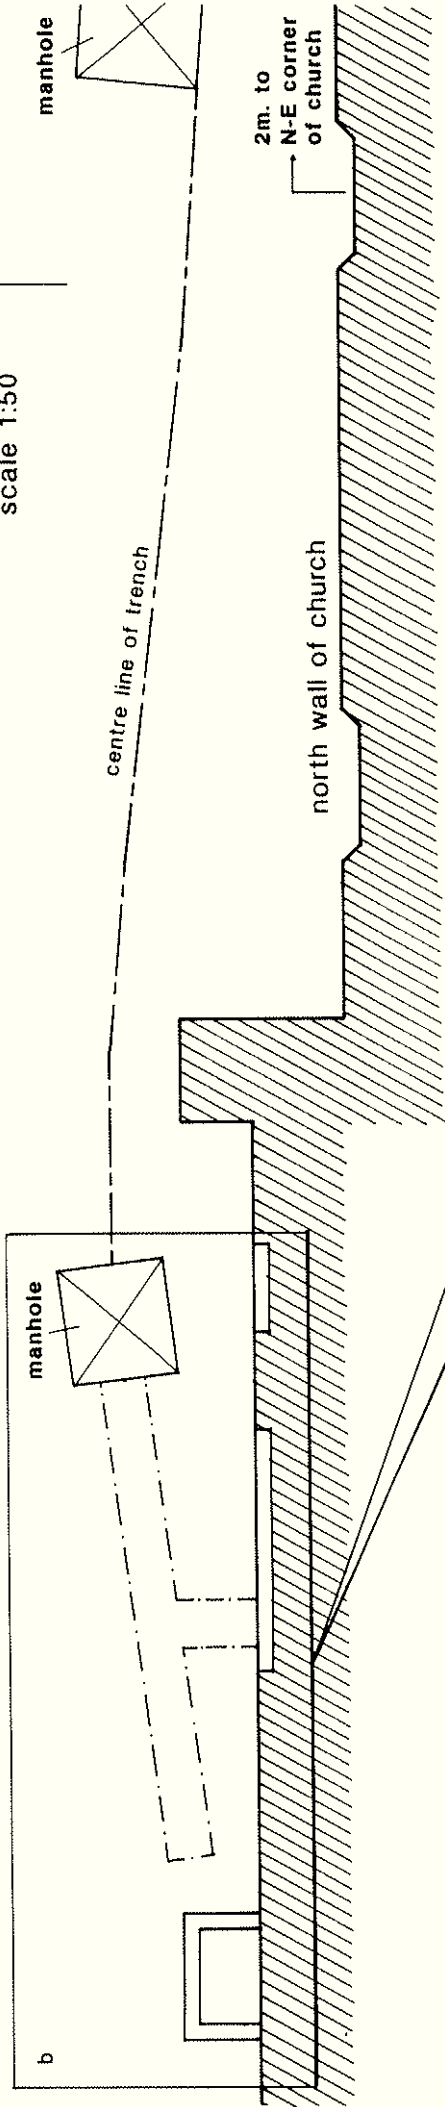
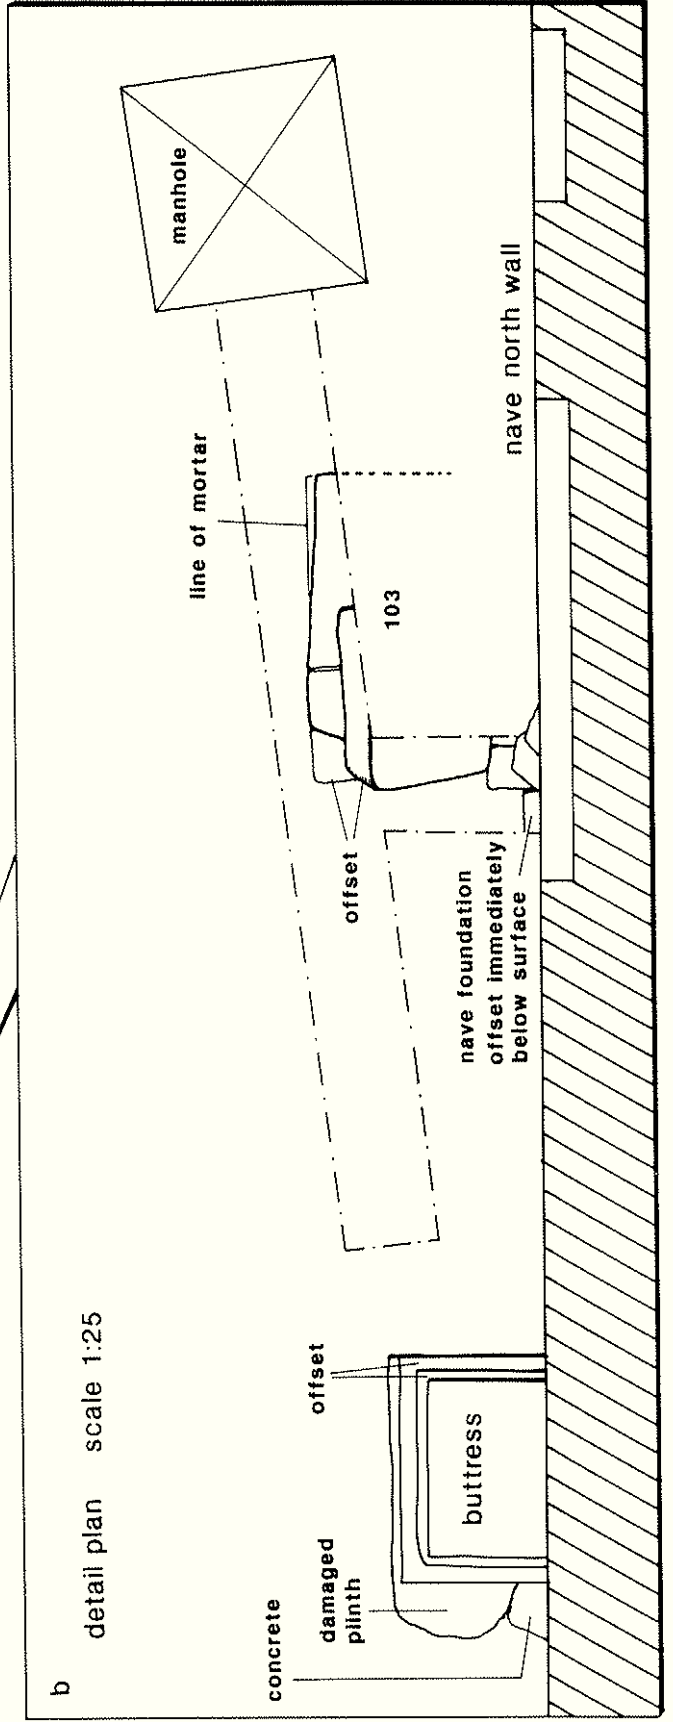
detail plan scale 1:25

scale 1:50

trench location plan

## **RESULTS (Fig. 2)**

Structure 103 comprised coursed large rough-dressed limestone slabs bonded with a sandy, pea gritty mortar. Six courses were visible (the structure continued beyond the depth of excavation), while an additional course is probably represented by a single stone which was just visible through the turf and which was bonded in to the nave N wall. The masonry had suffered obvious truncation in the past, with some stones broken and missing. It was clear, however, that the straight line across the N of the masonry was the original face. A skim of soft mortar on this face may have resulted from stone decay, but it could also have been the remains of a mortar render.

The structure was 1.03 m long (E-W) and extended for 0.74 m from the nave N wall. There was one 0.12 m offset between the second and third courses down, and a further 0.06 m offset between the first and second courses. Neither offset was chamfered. The masonry appeared to be bonded in with the foundations of the nave N wall. These had a narrow offset (0.05 m) immediately below the turf.

Masonry structure 103 represents the buried remains of a buttress to the N wall of the
