# The Talbot Hotel Oundle Northants.

**Historic Building Recording  
And Archaeological Monitoring**

## **The Talbot Hotel, Oundle, Northamptonshire**

*Historic Building Recording and Archaeological Monitoring*

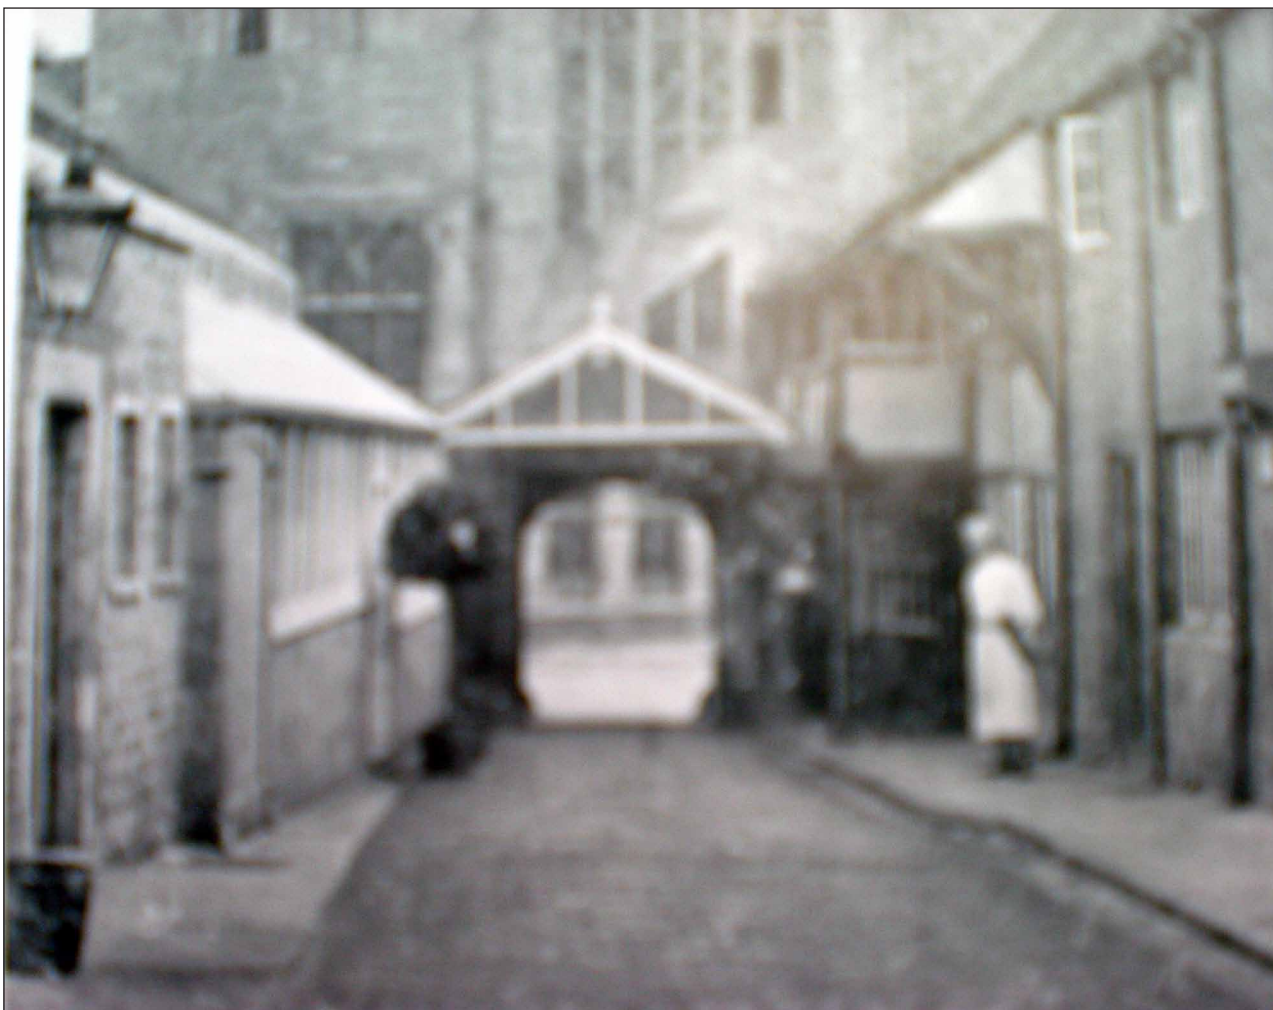
Figure 13: Photograph of the courtyard of the Talbot Hotel with "Icehouse" on left, undated (from client)

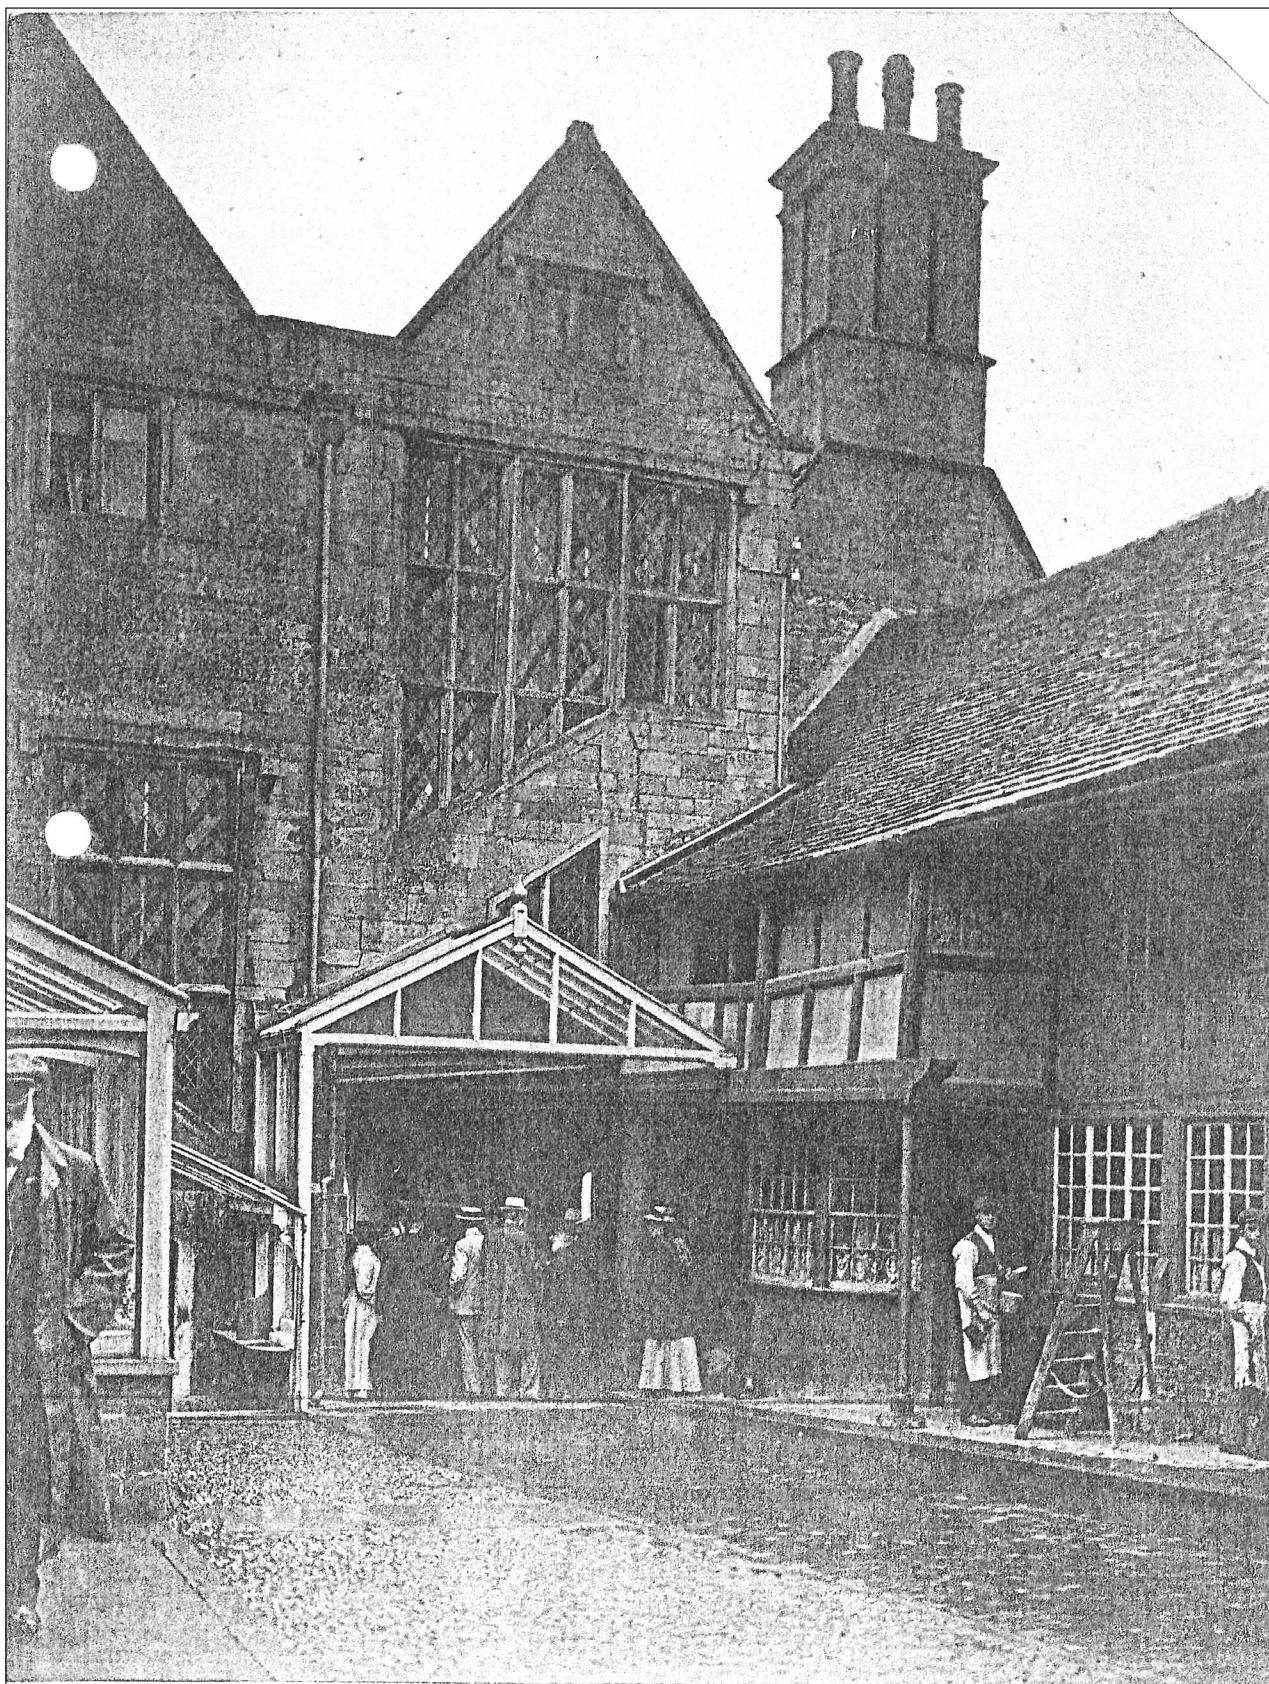
Figure 14: Undated photograph of courtyard showing “shelter” inside archway and corner of a conservatory building (left), prior to construction of 1917 “icehouse” (NMR OP.01832)

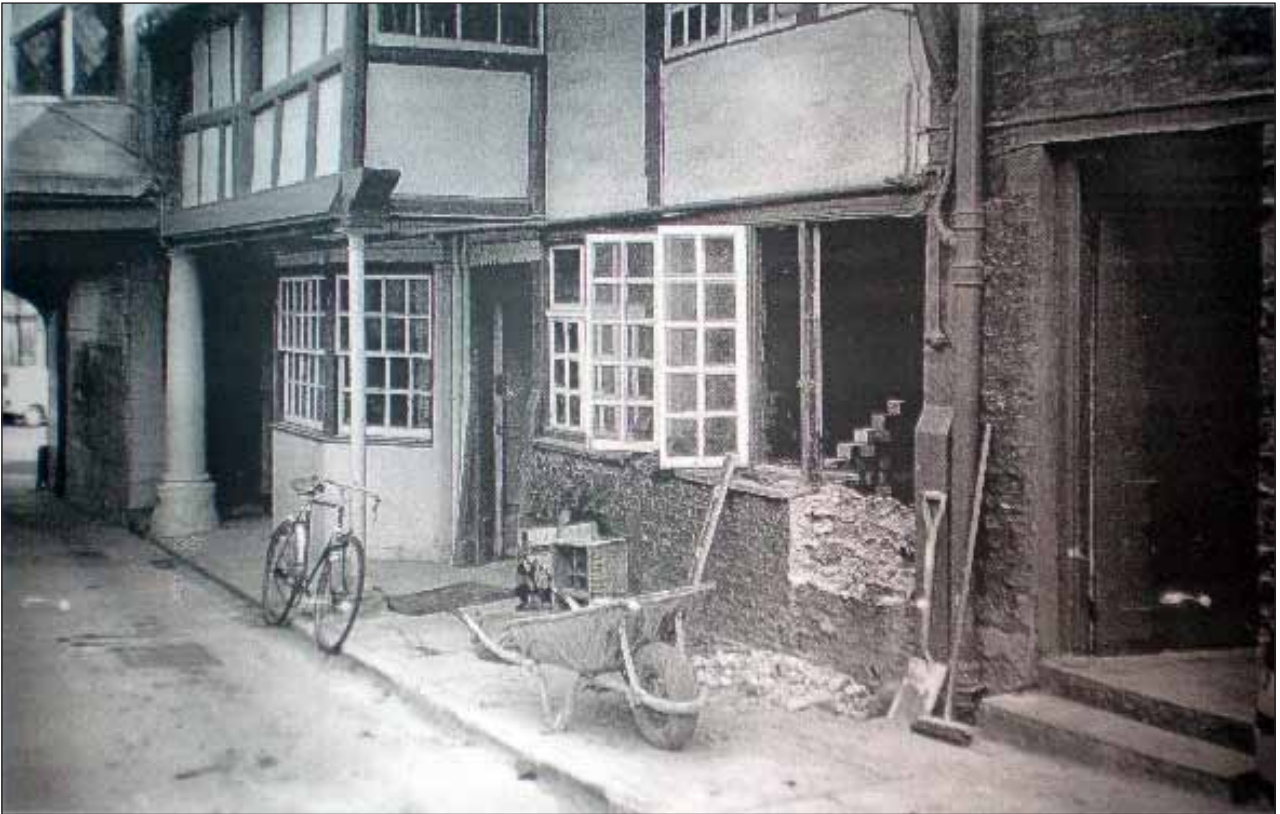
Figure 17: Photograph of building alterations taking place, 1966 (from J. Irving)

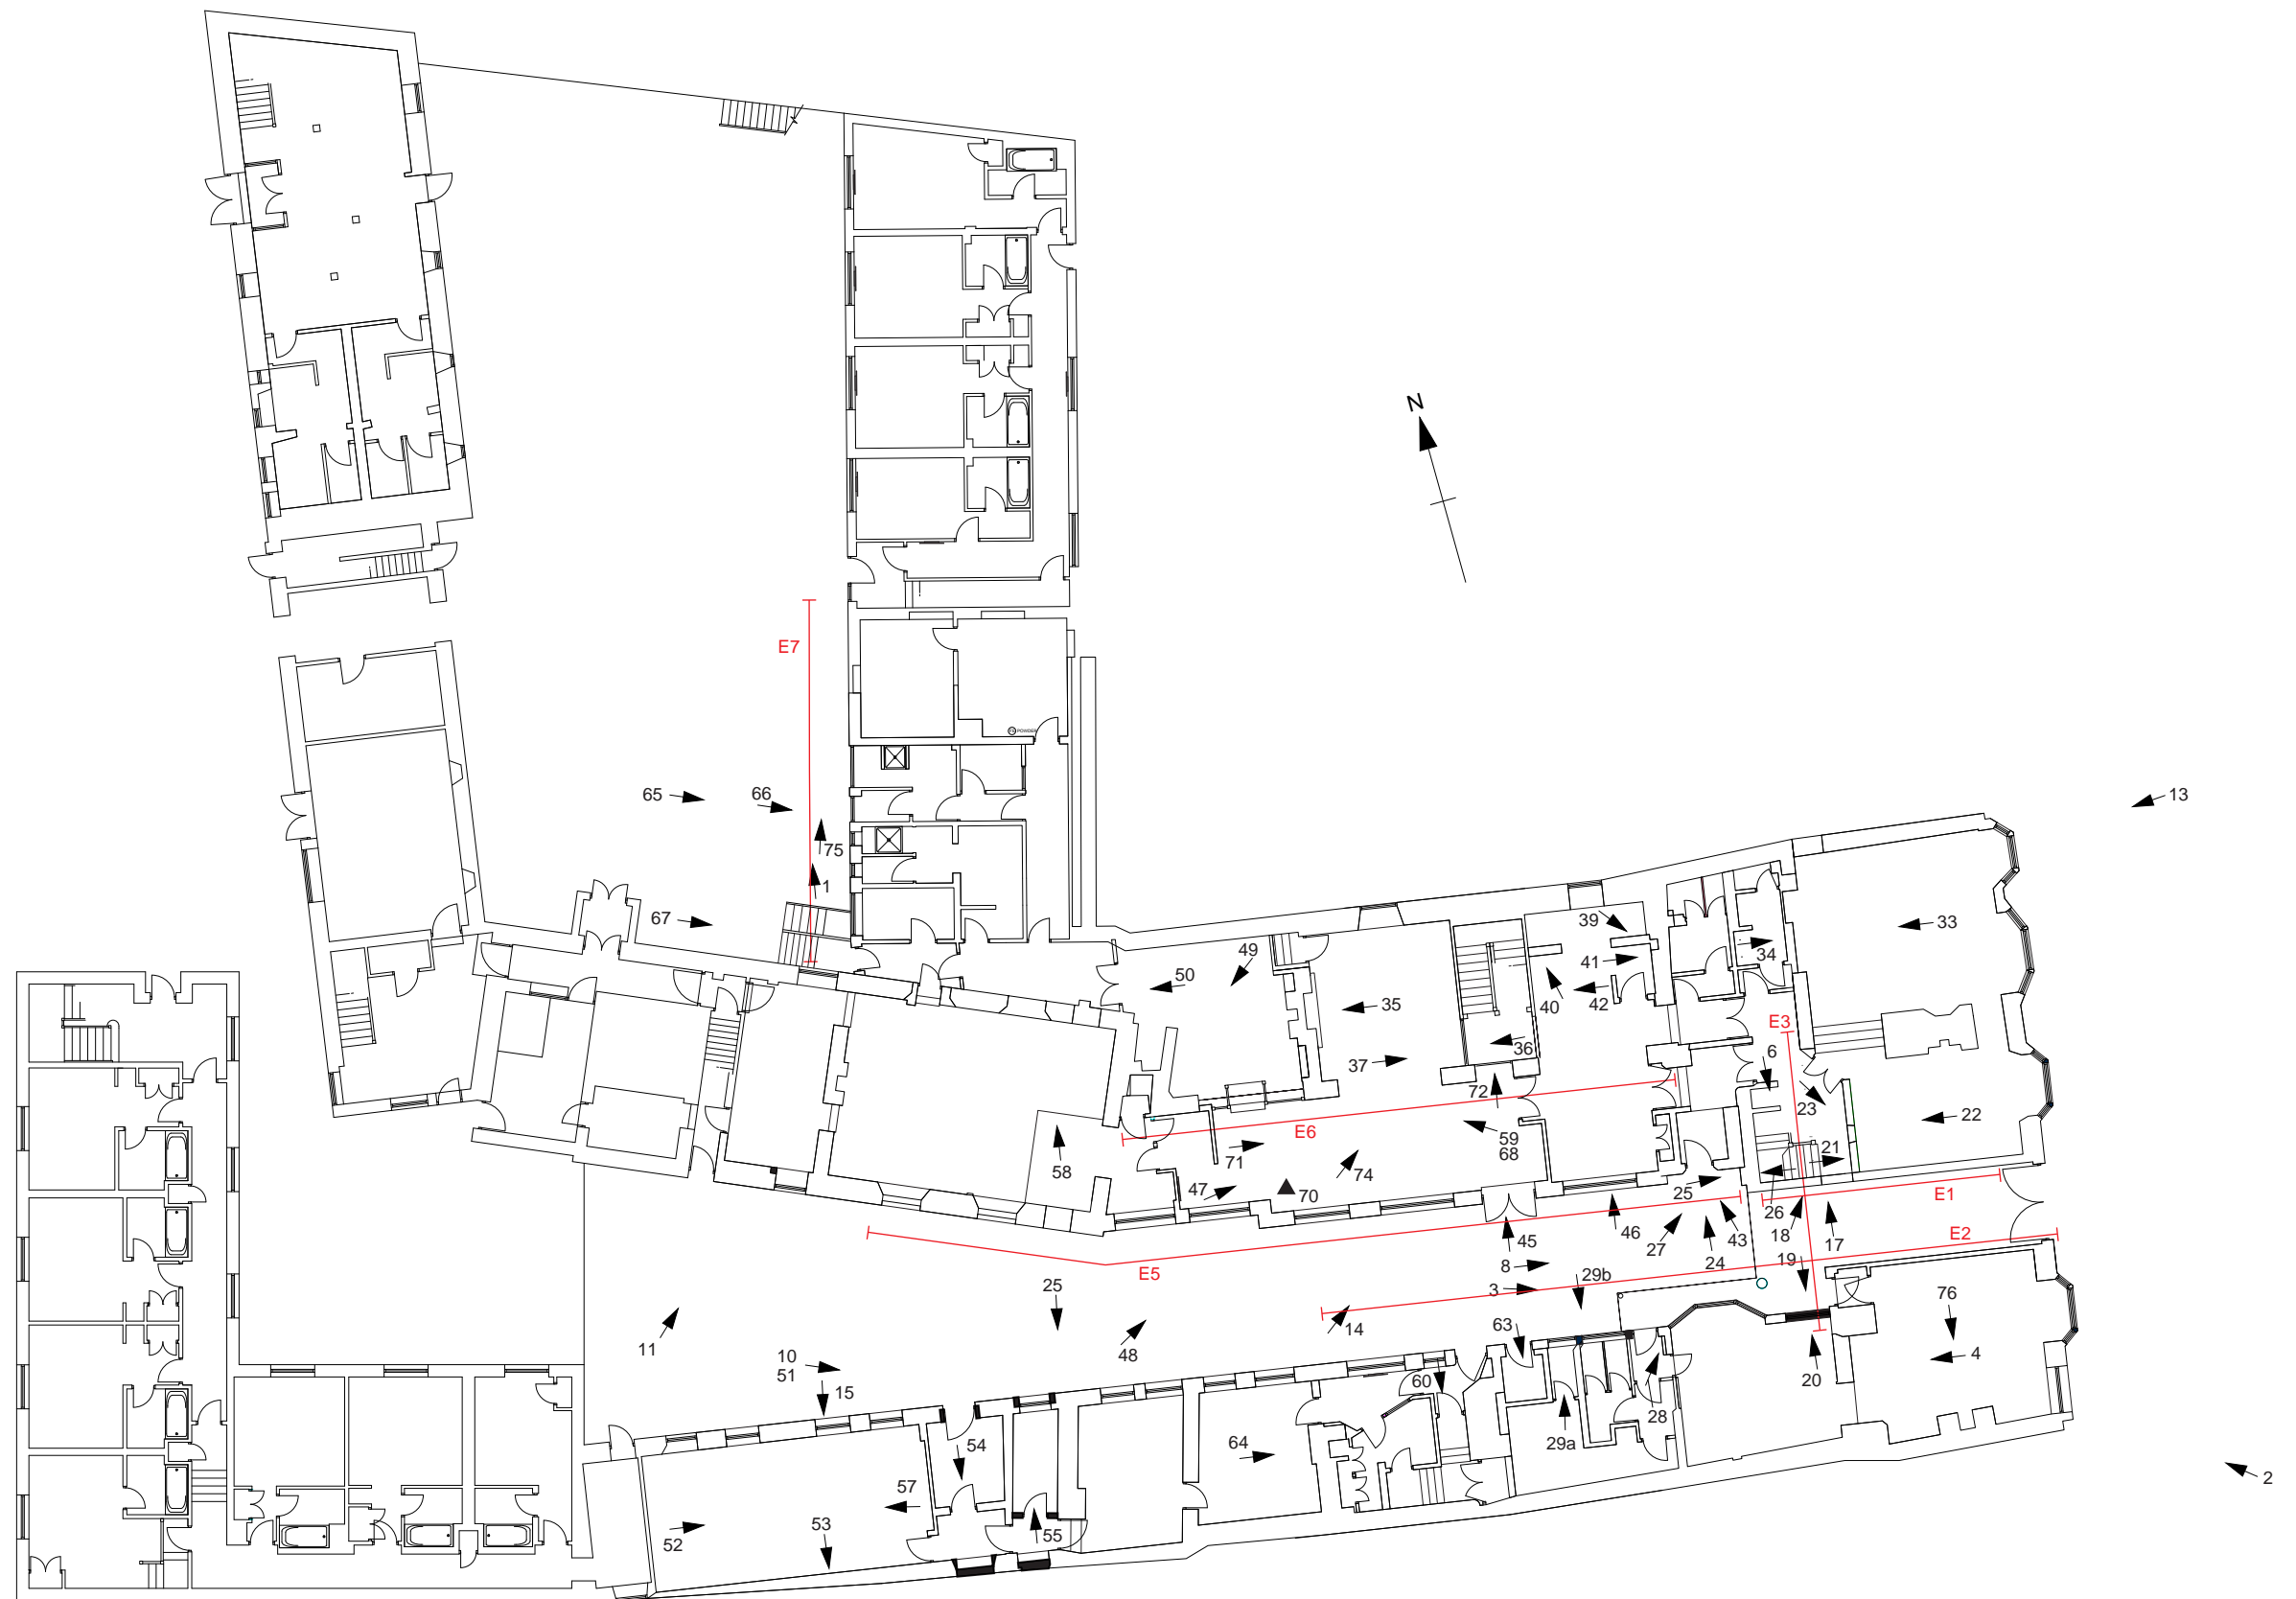
Figure 19a: Ground floor plan showing locations of plates and elevations (from data supplied by client)

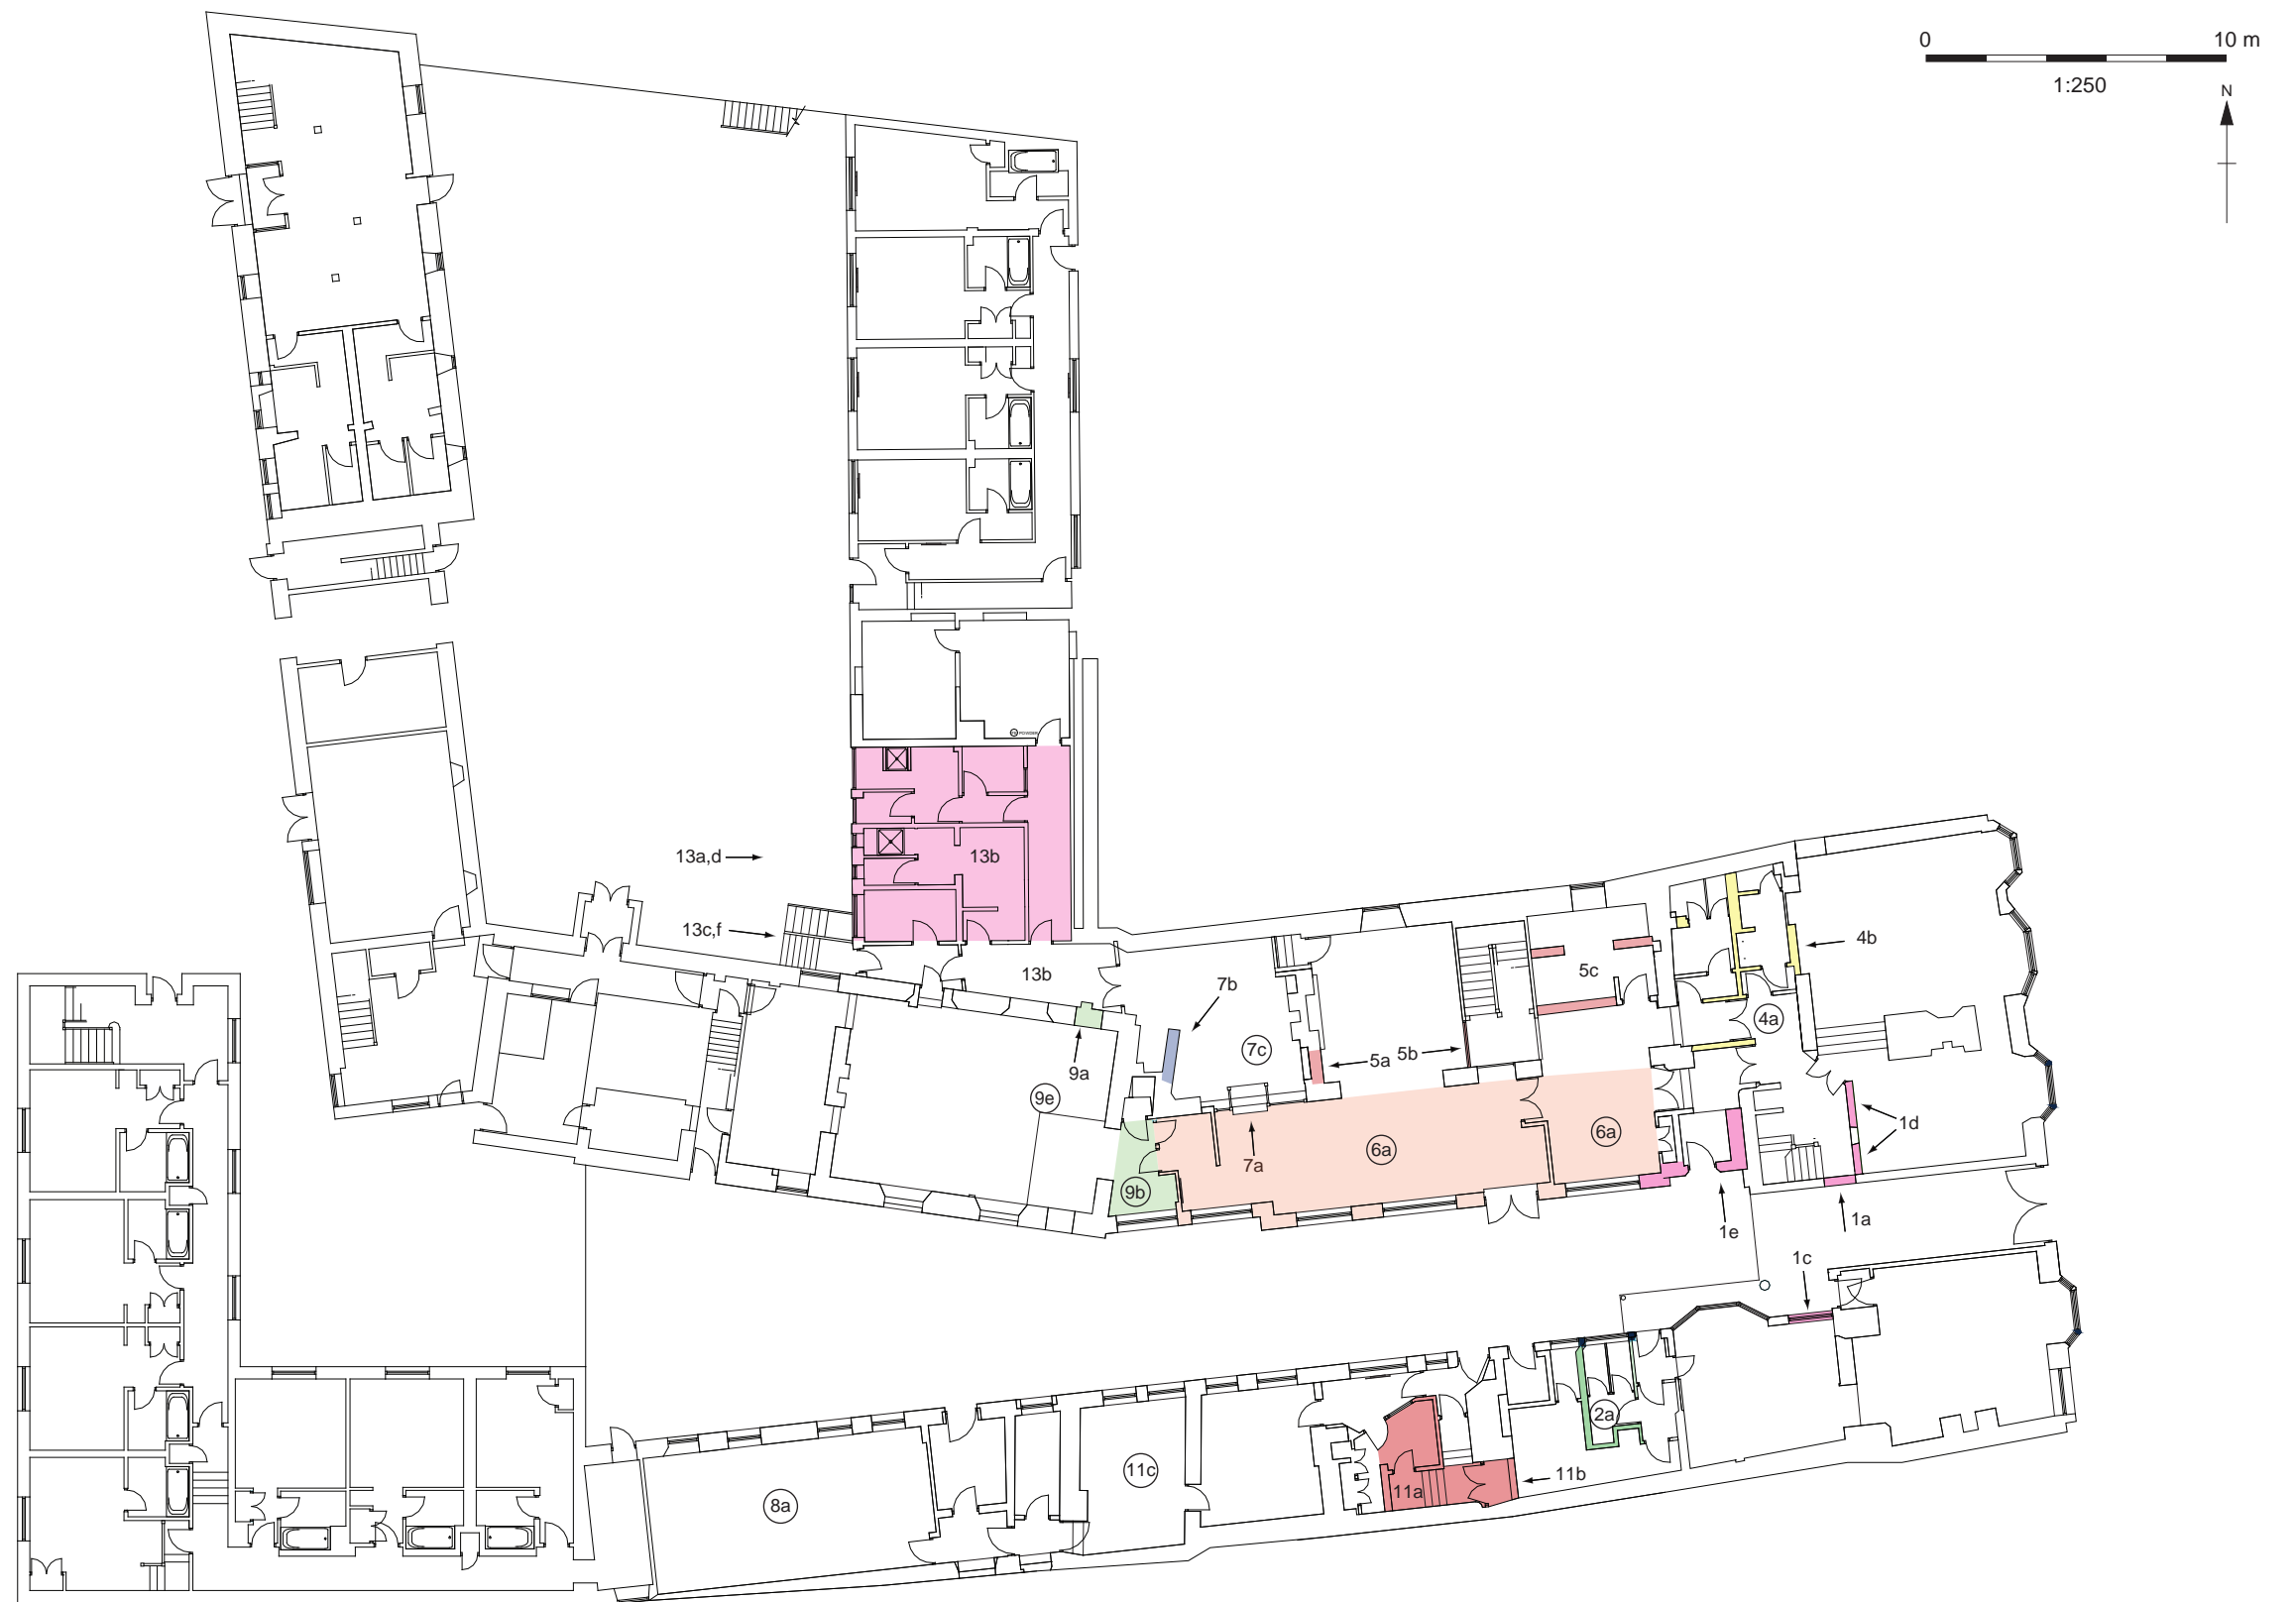
Figure 21a: Ground floor plan of the Talbot Hotel with location of areas recorded prior to proposed alterations (from data supplied by client)

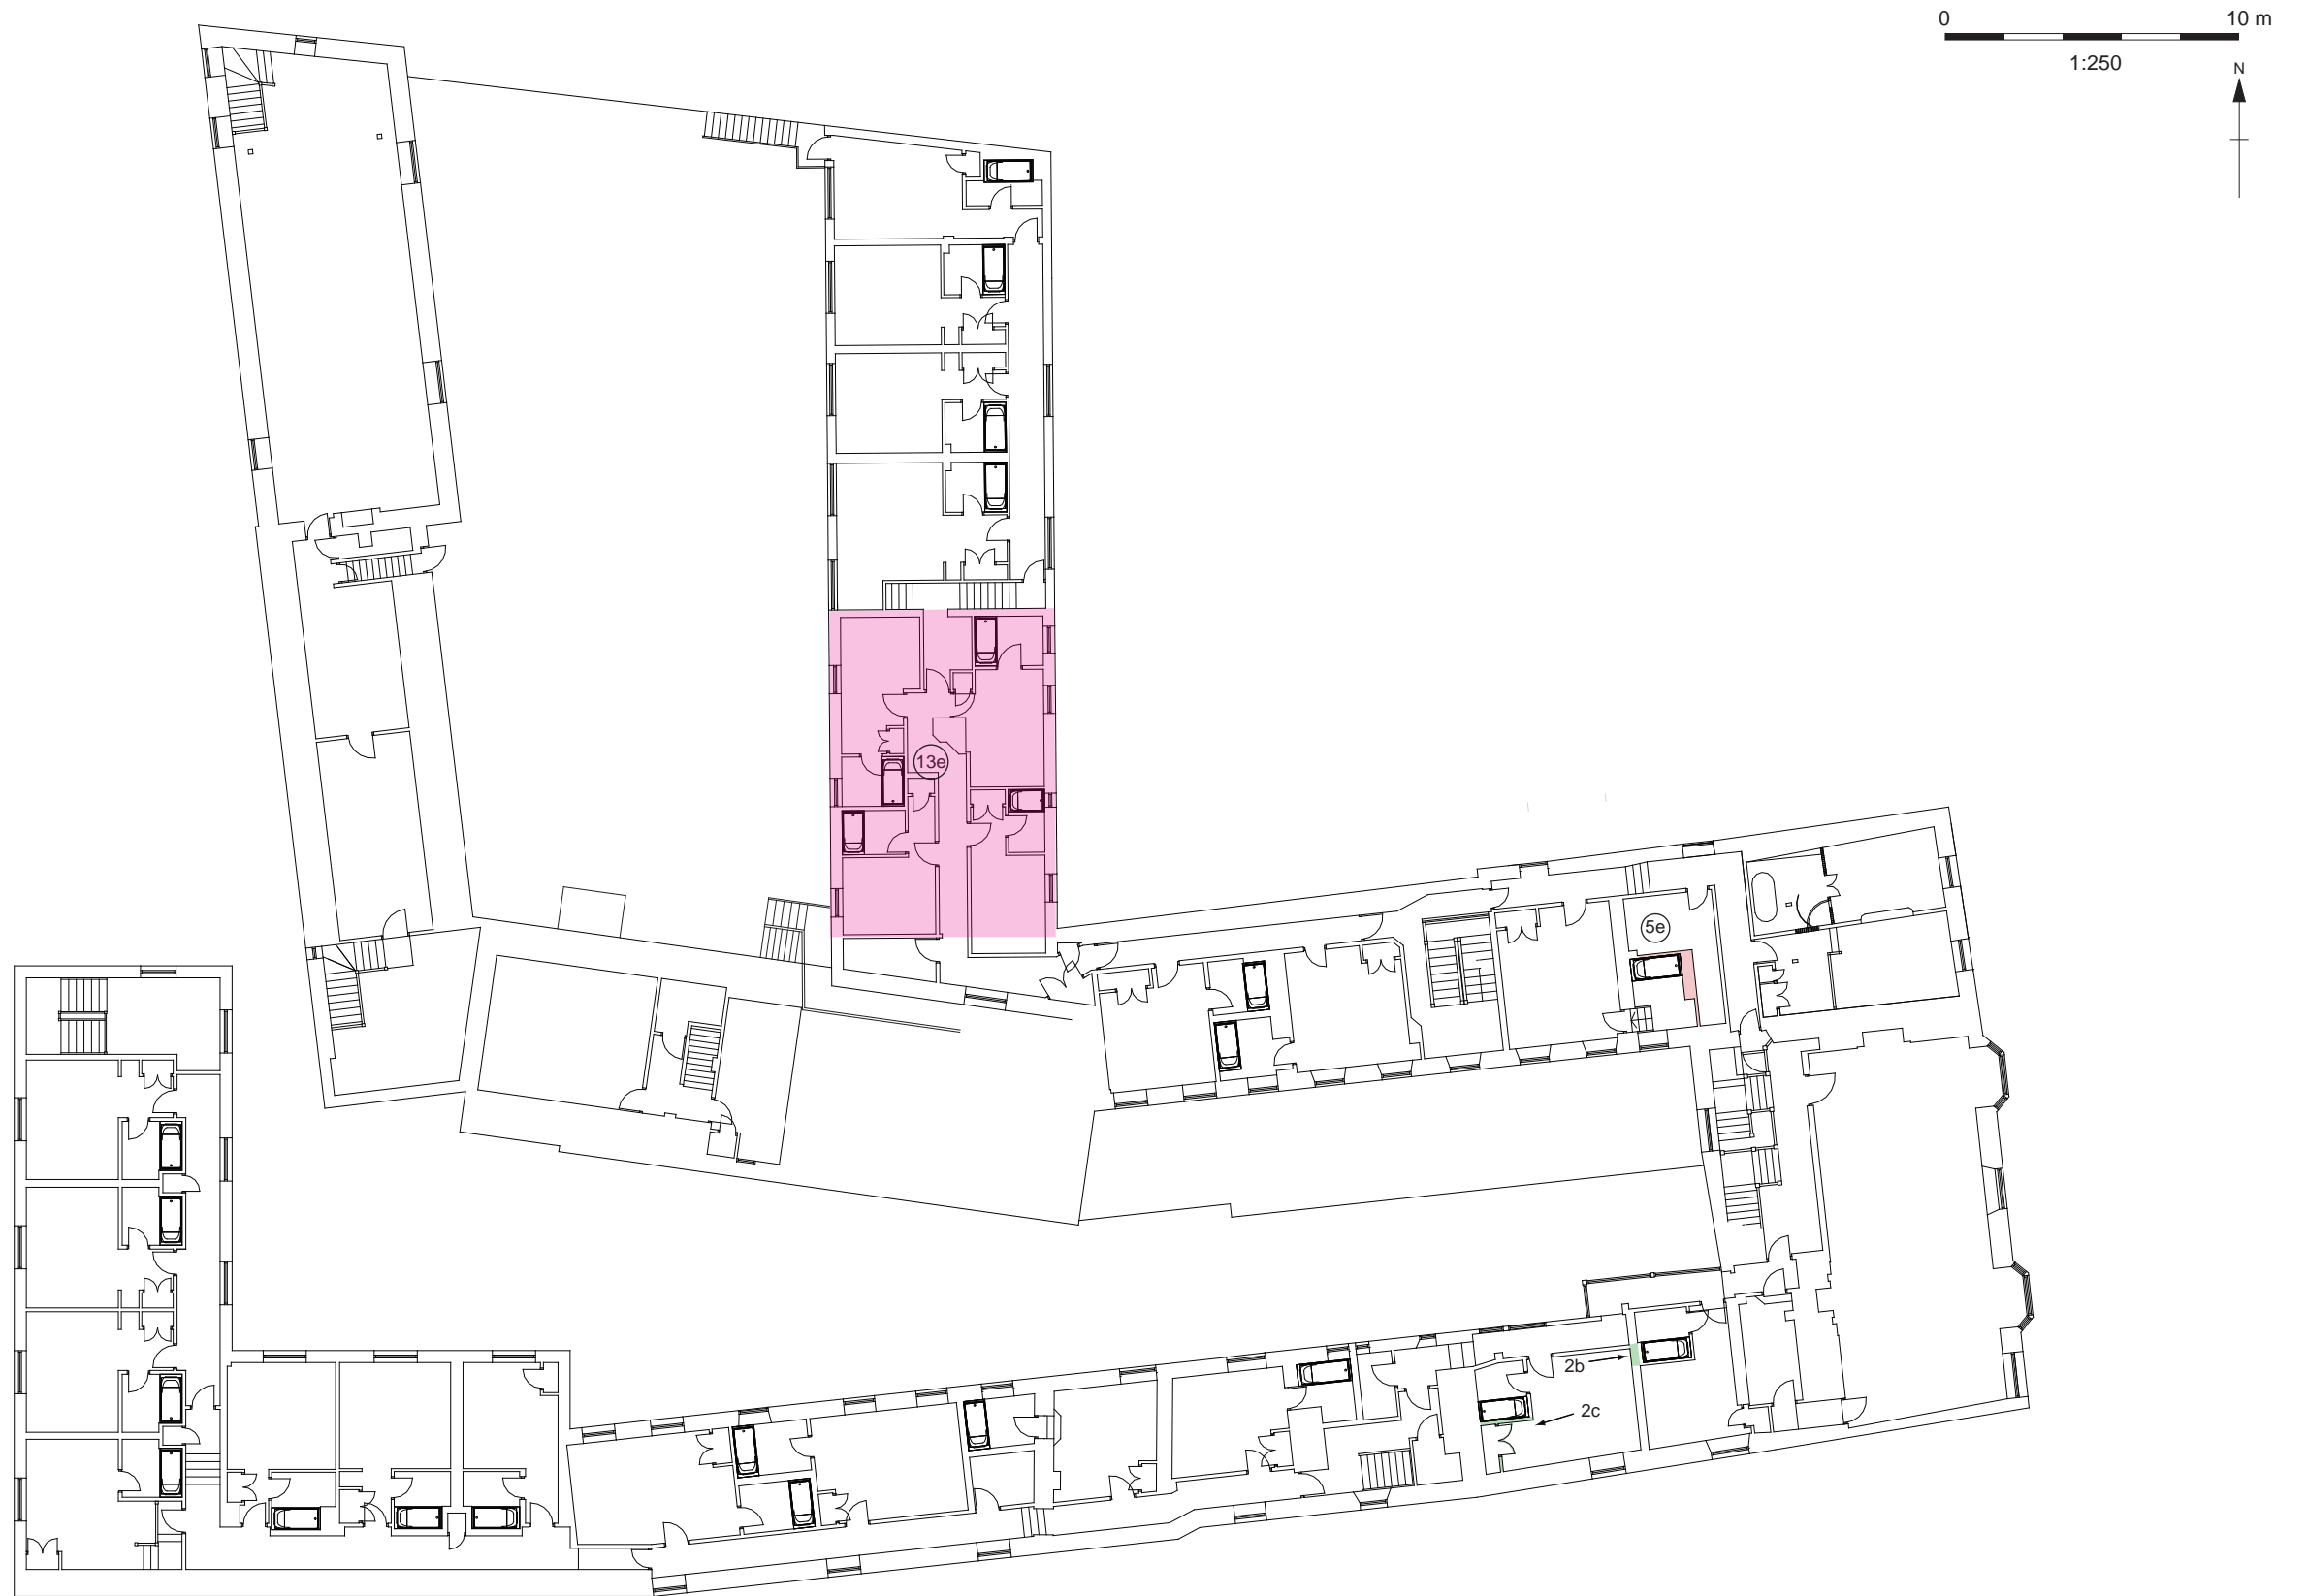
Figure 21b: First floor plan of the Talbot Hotel with location of areas recorded prior to proposed alterations (from data supplied by client)

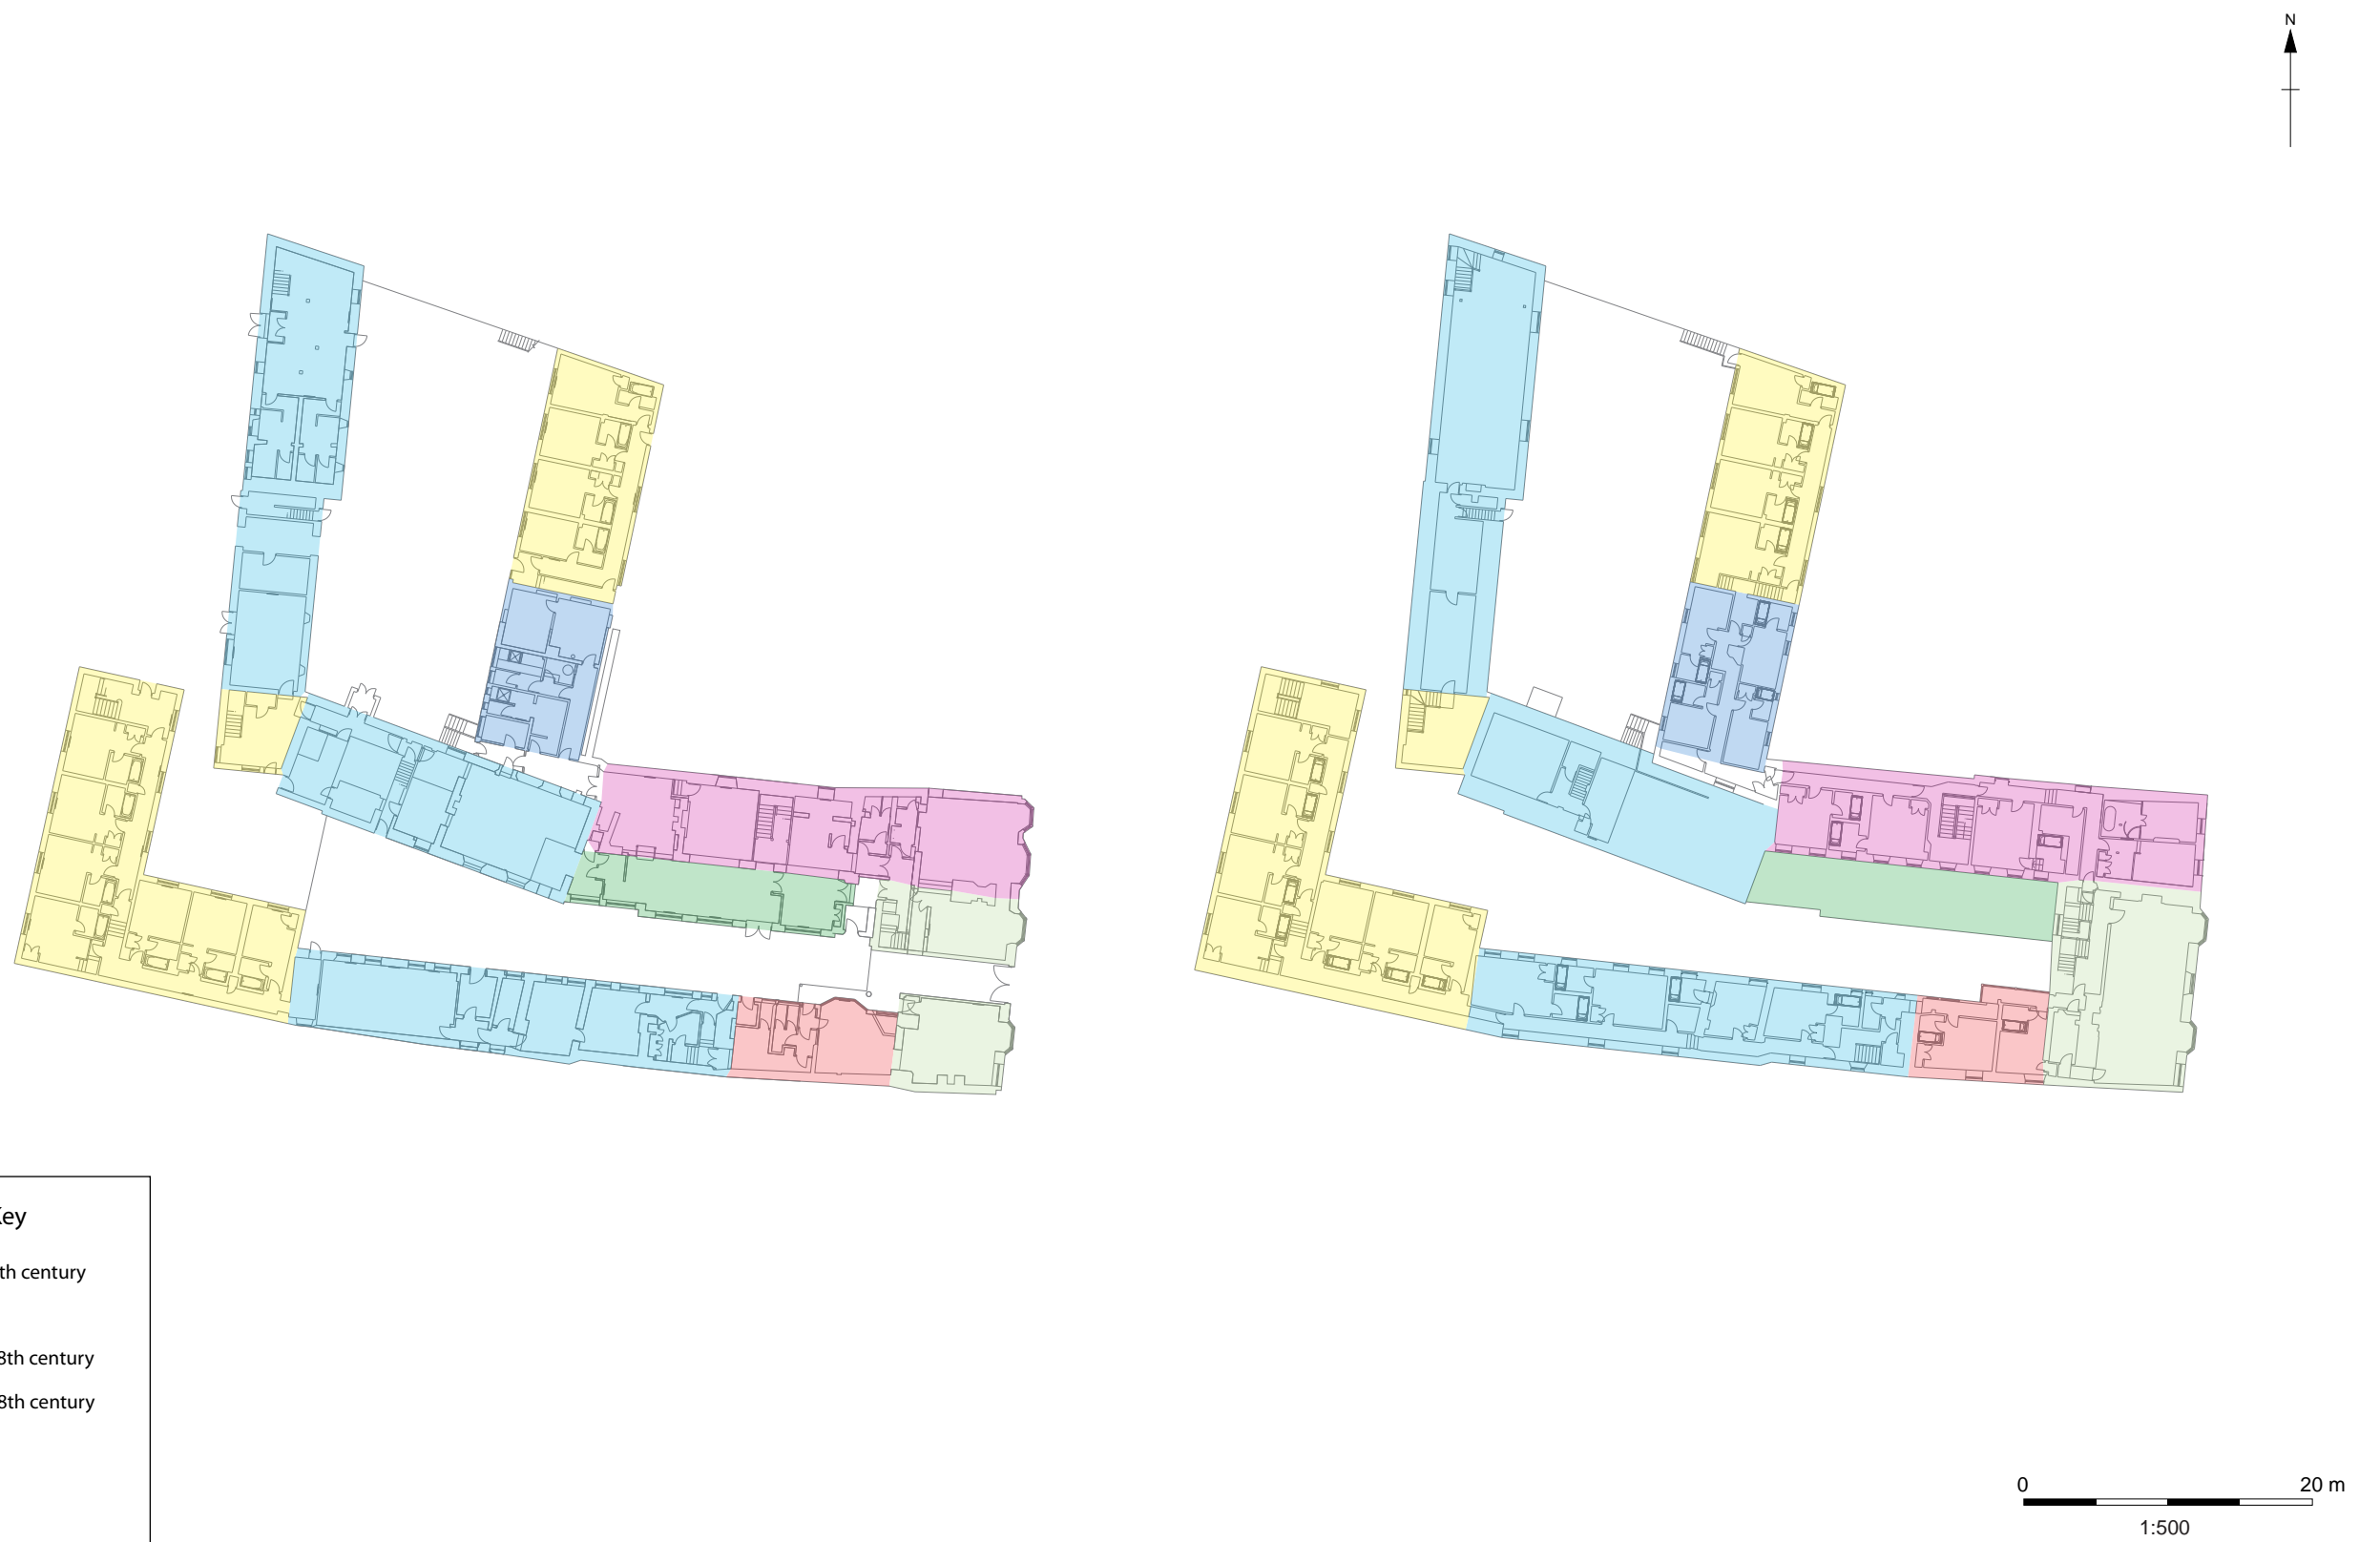
Figure 22: Ground and first floor plans of the Talbot Hotel with suggested phasing (data supplied by client)
