# The Talbot Hotel Oundle Northants.

**Historic Building Recording  
And Archaeological Monitoring**

## **The Talbot Hotel, Oundle, Northamptonshire**

*Historic Building Recording and Archaeological Monitoring*

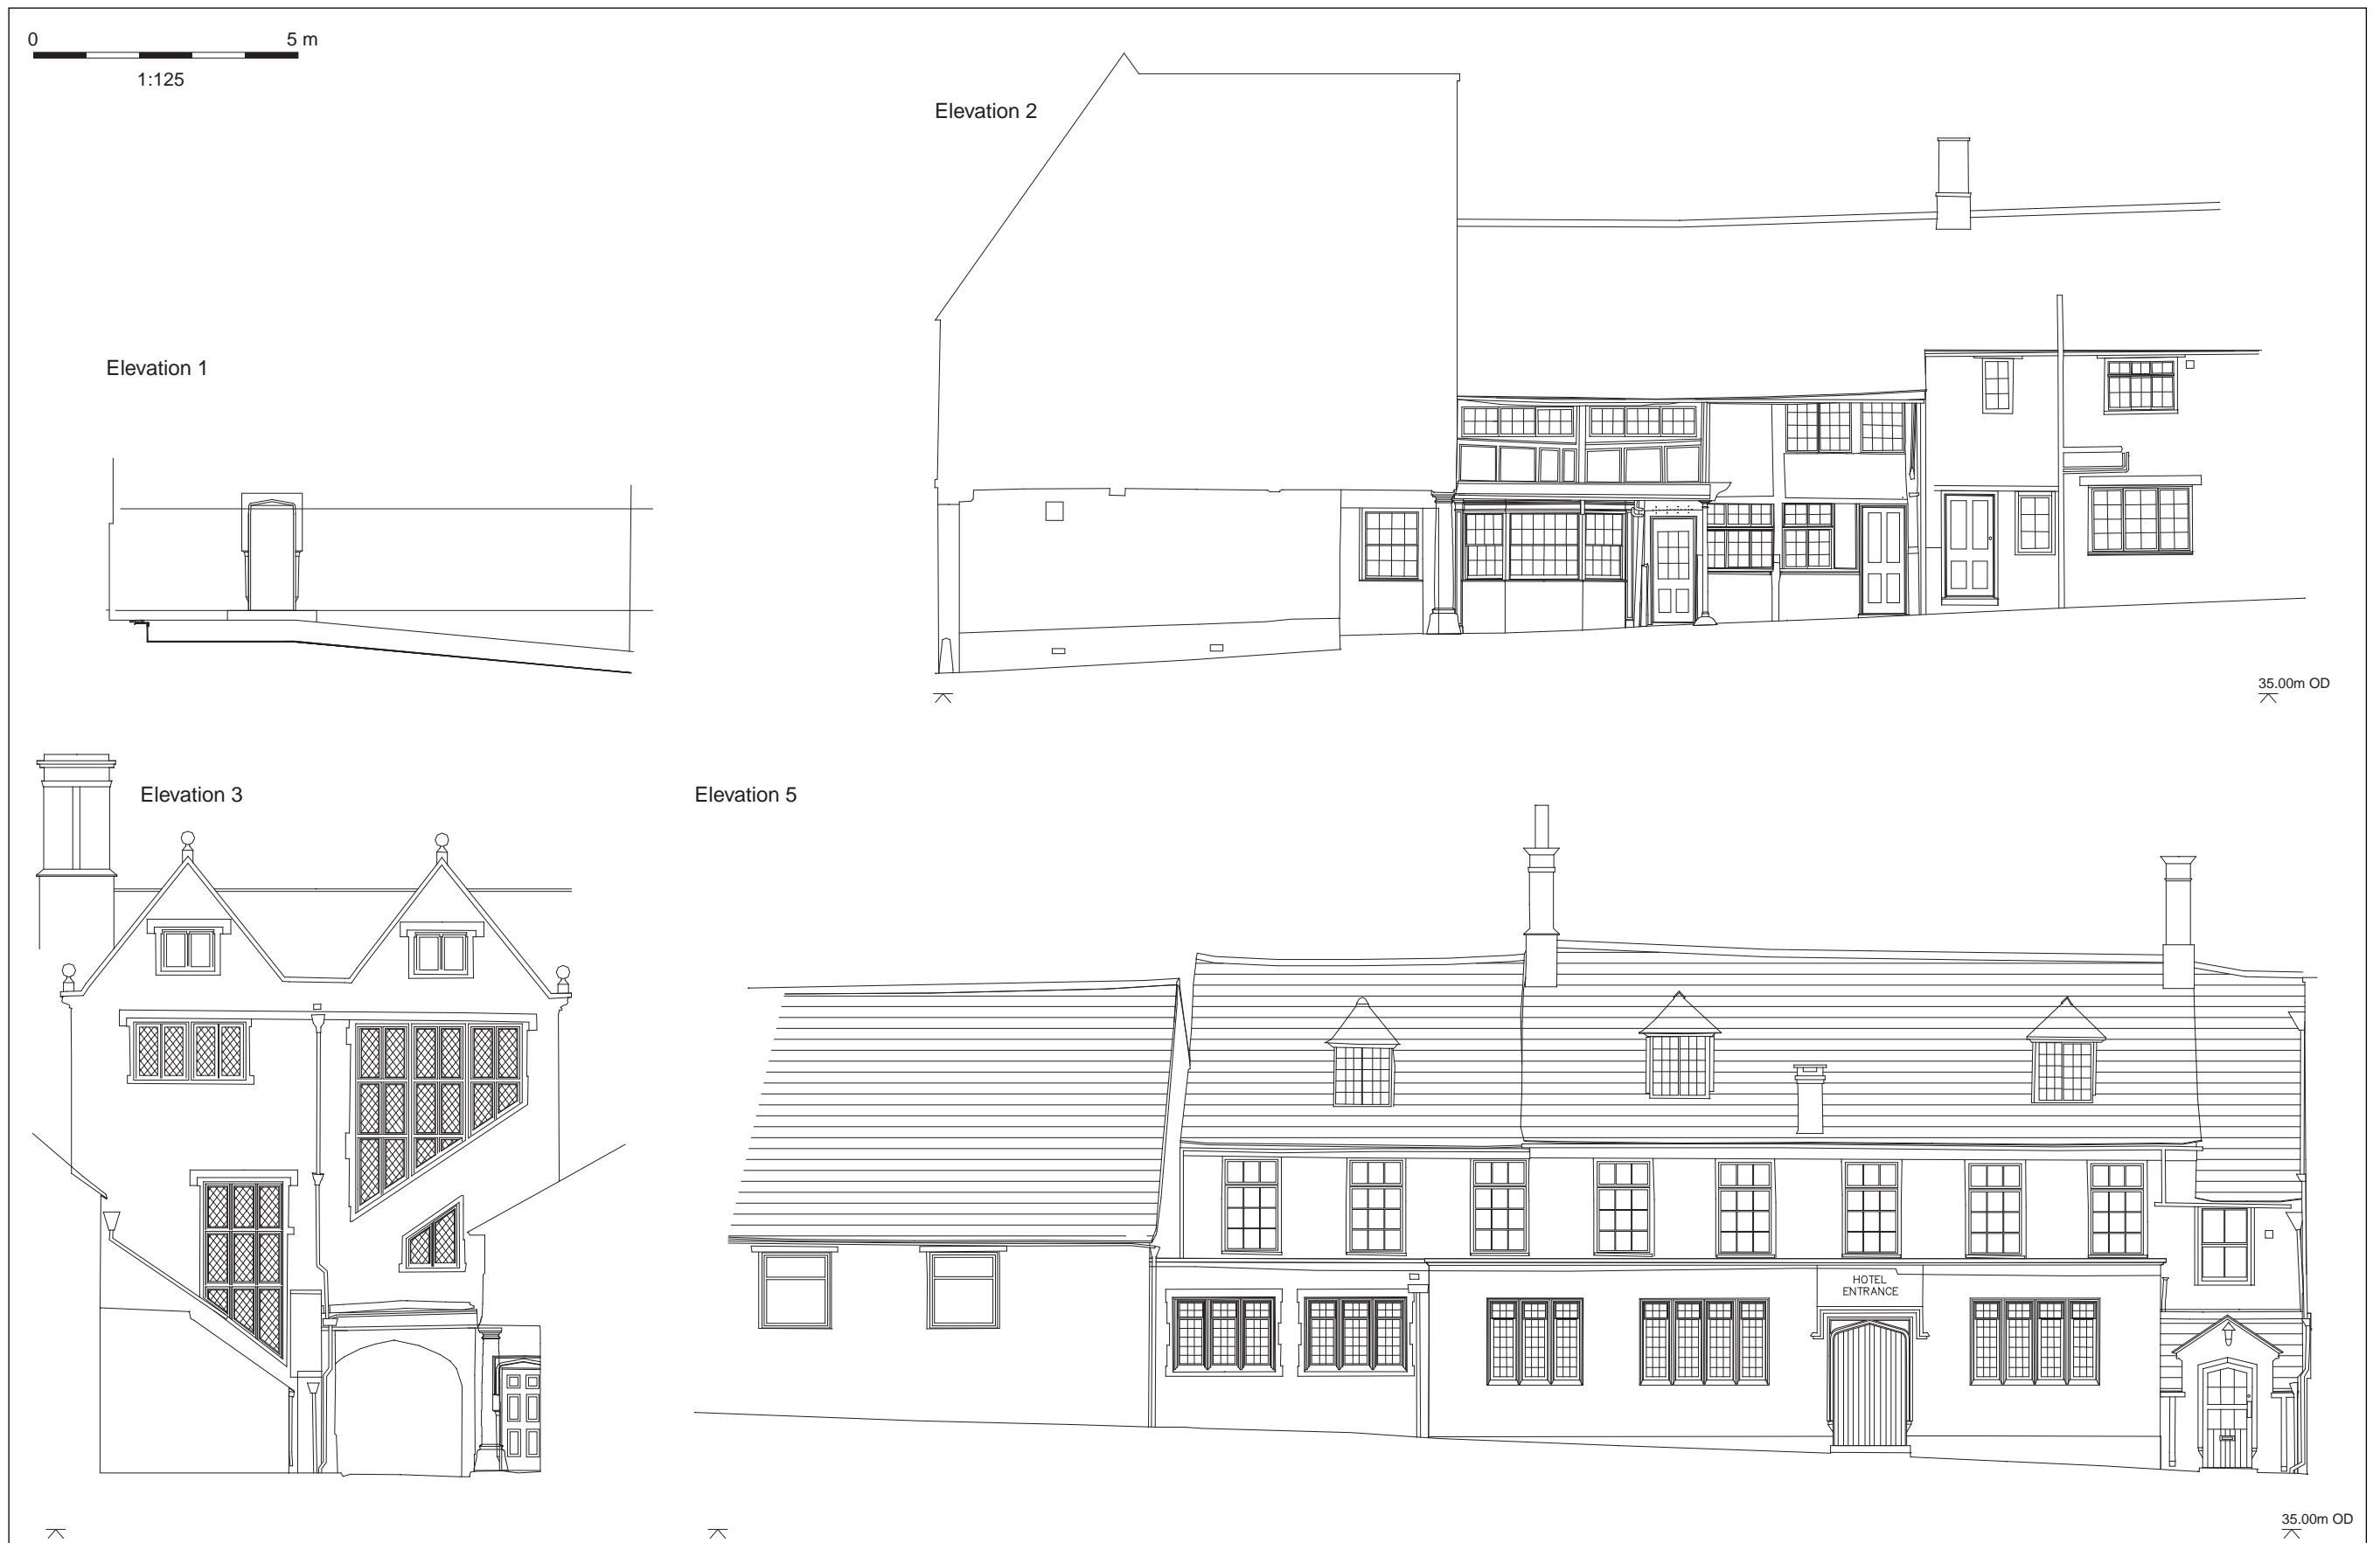
Figure 23: Elevations 1, 2, 3 and 5 (from data supplied by client)

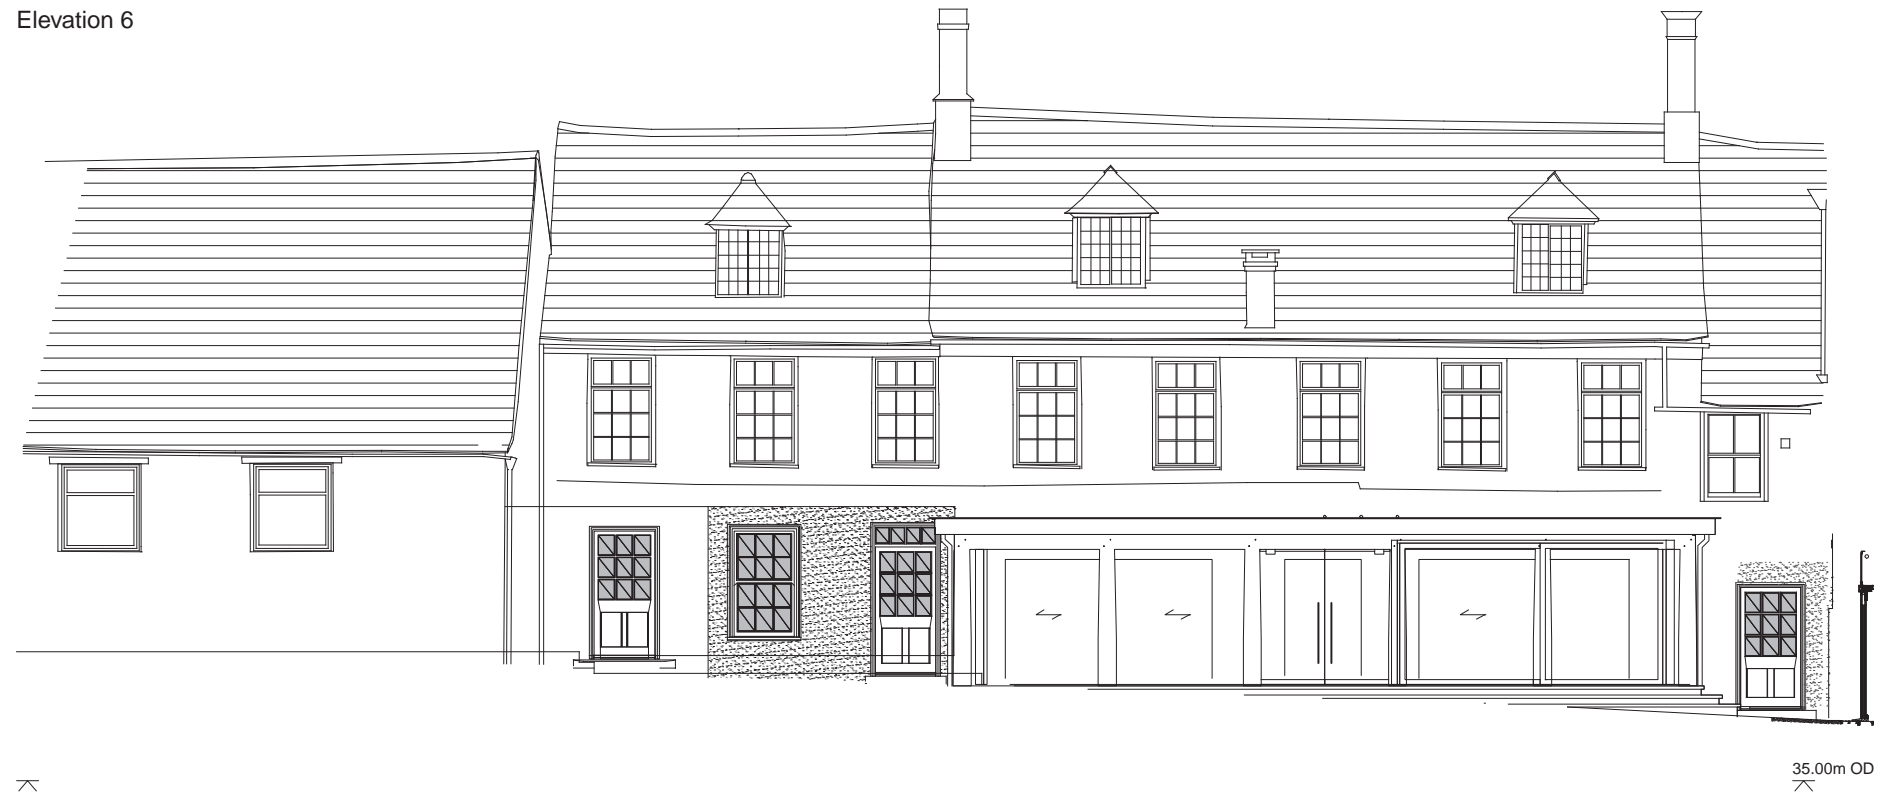
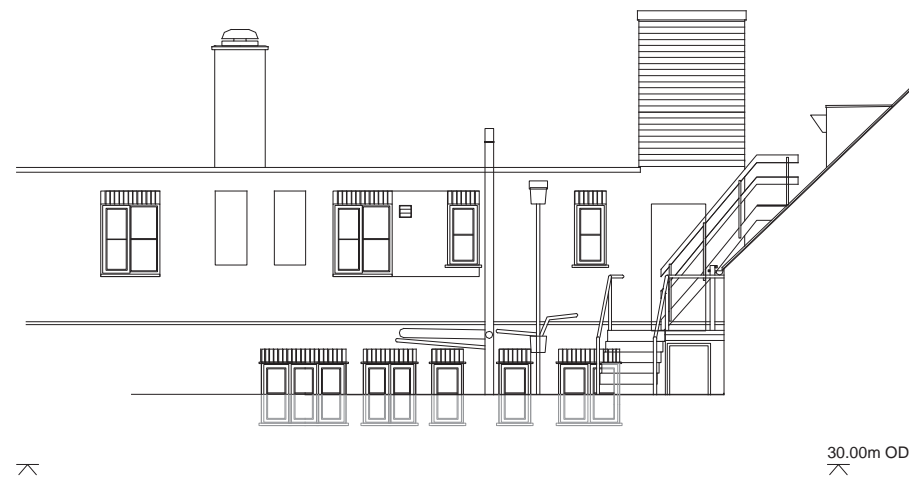
Figure 25: Elevations 6 and 7 (from data supplied by client)

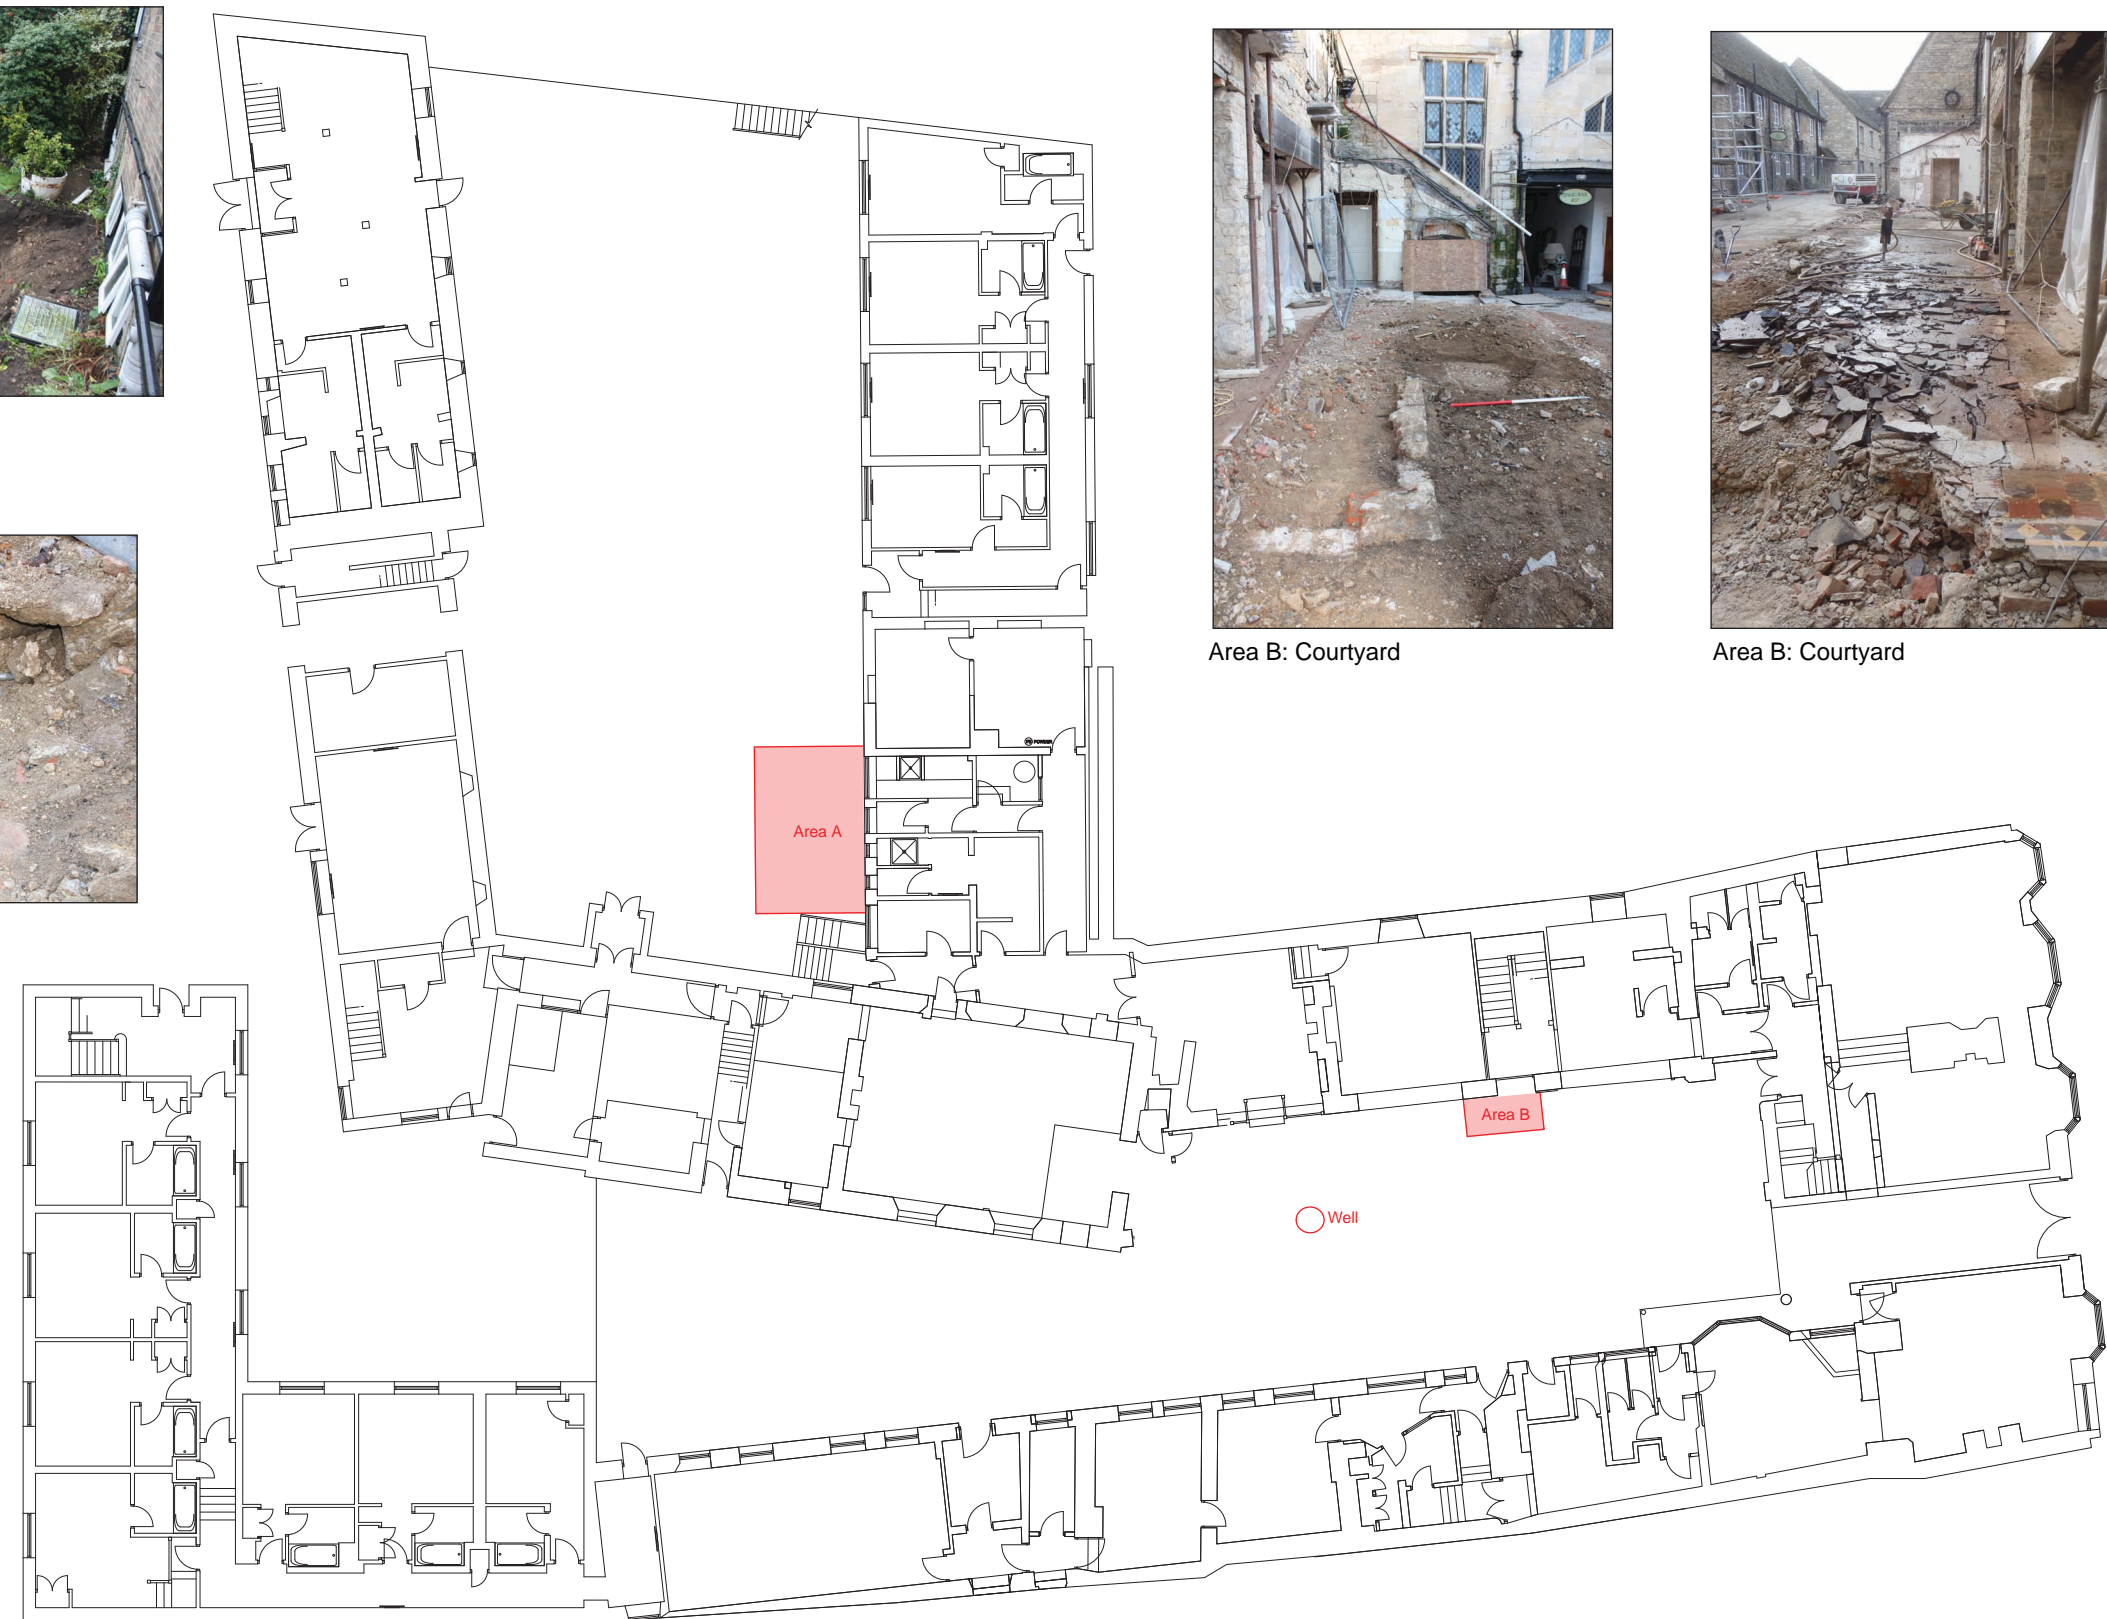
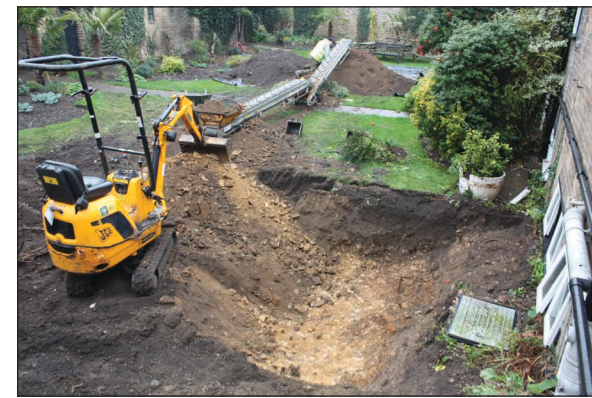
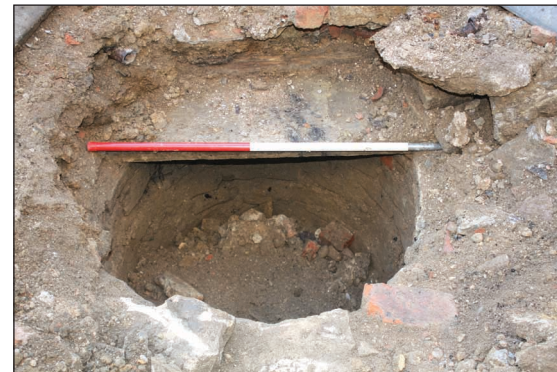
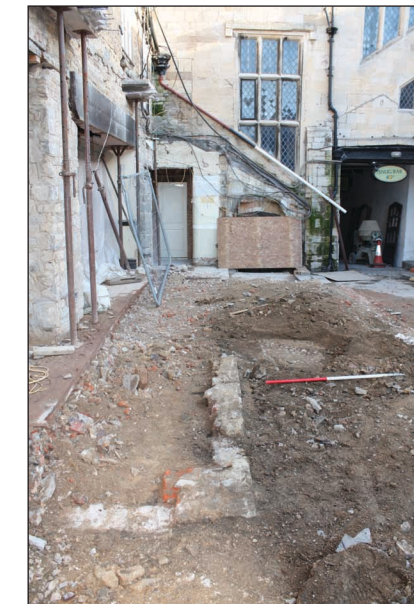
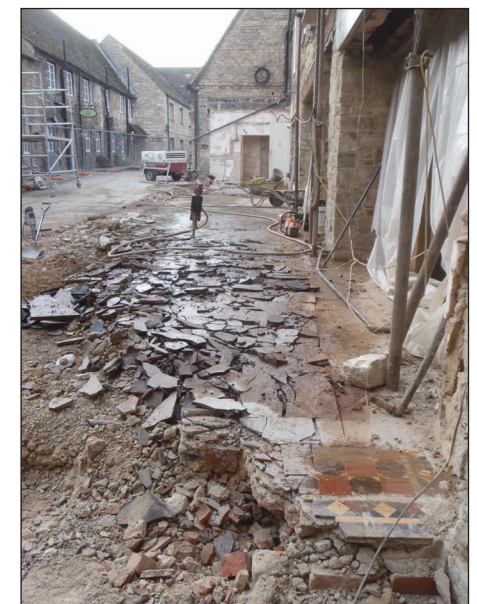
Area A: Rear of hotel

Area A: Well

Area B: Courtyard

Figure 26: Location of areas of archaeological monitoring

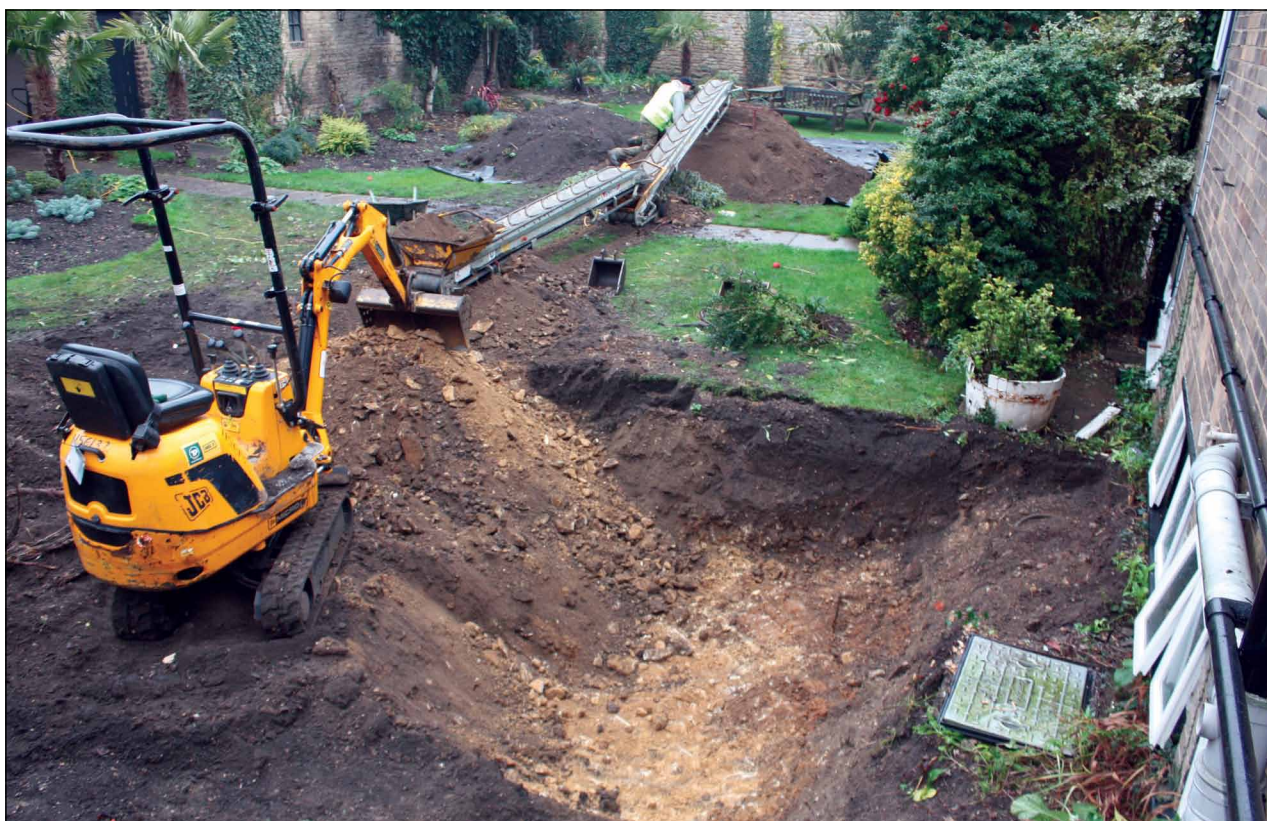
Plate 1: Ground reduction at the rear of the hotel

3.3.1 The area at the rear of the hotel was excavated using a mini-digger with toothless bucket, the spoil was moved and stored within the garden area with the use of a conveyor belt (Plate 1).

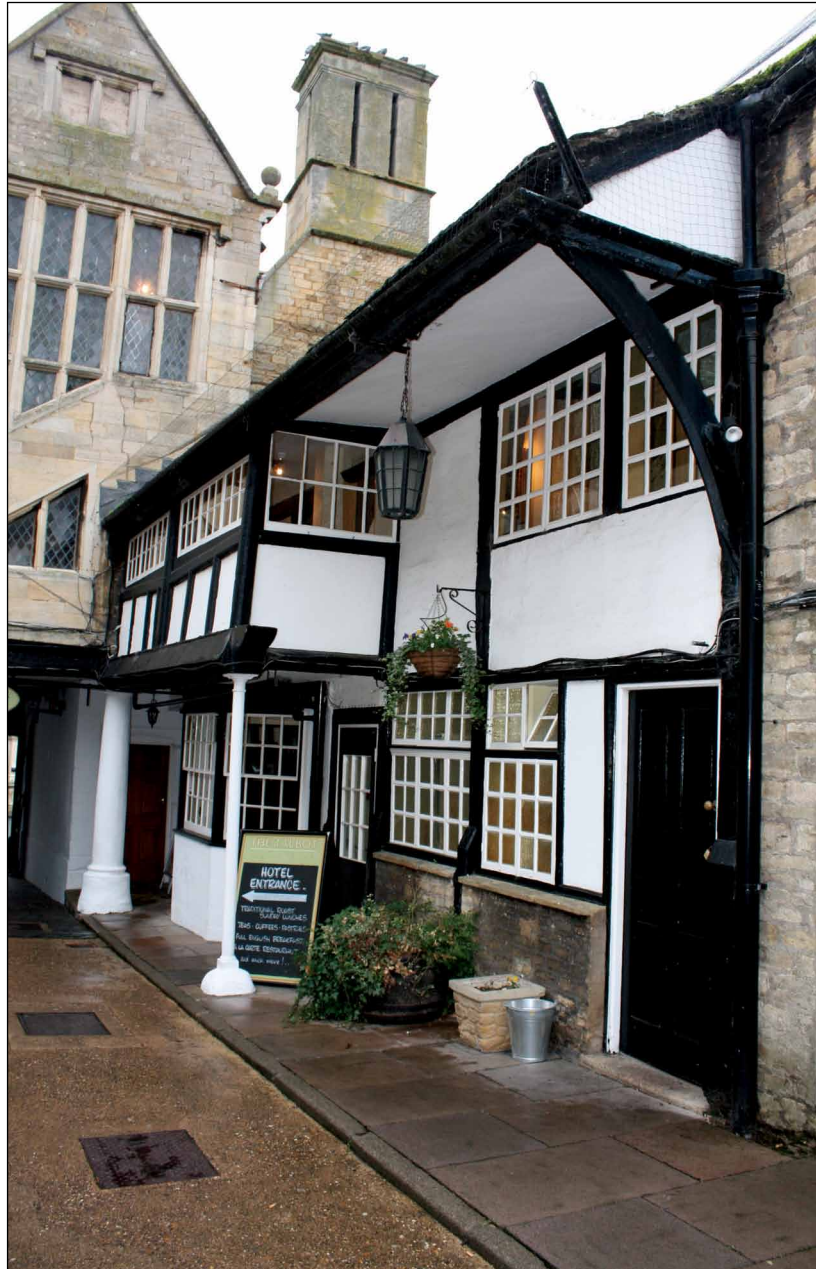
Plate 3: Timber-Framed building on southern wing (from courtyard)

- 5.2.1 This element of the hotel is located just inside of the entrance arch on the left (with New Street behind), on the southern range (Plate 3).
- 5.2.2 This part of the range stands out from the rest of the southern wing and surrounding buildings in the courtyard as it is the only obvious timber-framed structure, the rest are constructed from stone. A report by Dr Gee from the Royal Commission for Historical Monuments (RCHM) in 1963 described this part as the earliest element of the present site. Although this phase of investigation did not allow for a full survey and phasing of the buildings, a brief inspection was made which supports the description and

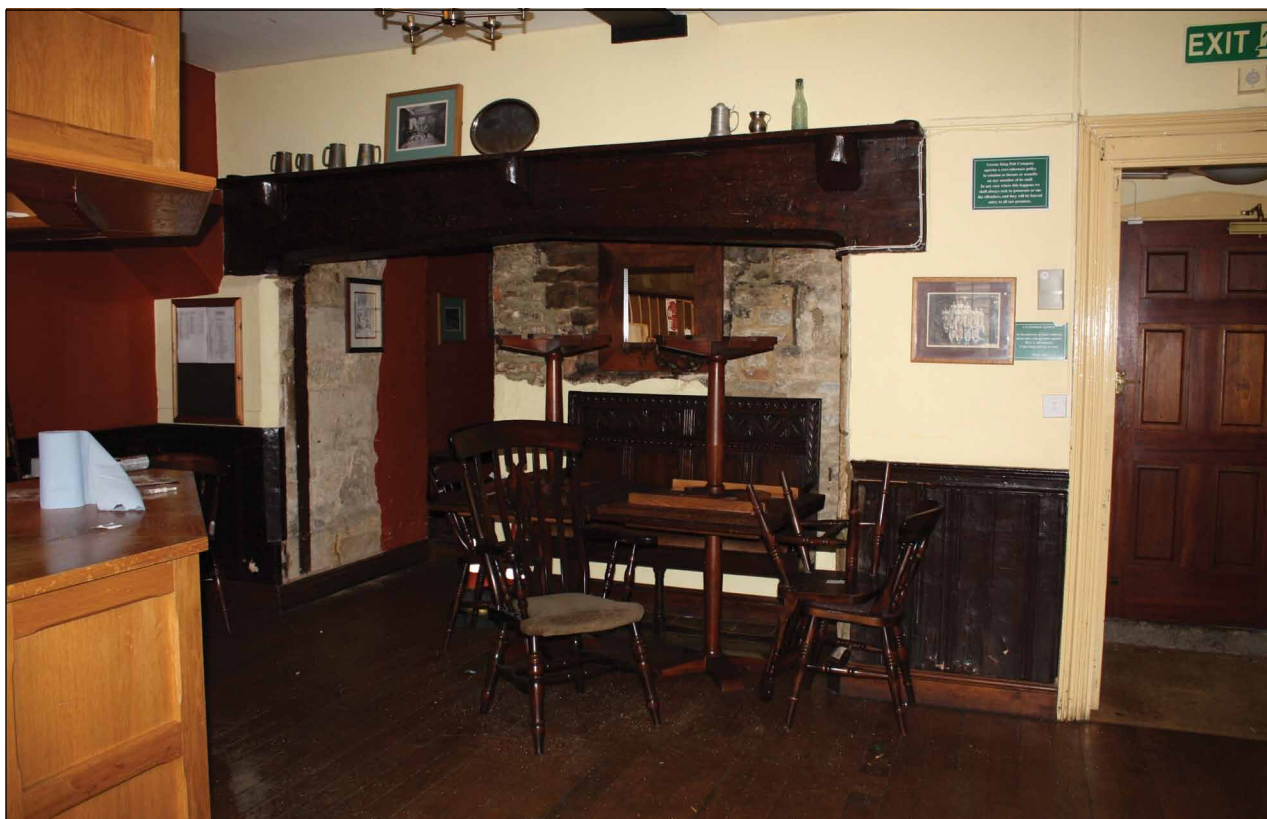
Plate 4: Large bressumer, viewed from front bar

“The timber-framed range continues forward into the main range and joins it at the level of the timber wall on the inner side of the main staircase. The head of the bar on the ground floor and near the inner end of the timber-framed range, is the bressumer of a great open fireplace with stopped chamfered reveals, perhaps the sixteenth century fireplace.” (Plate 4).

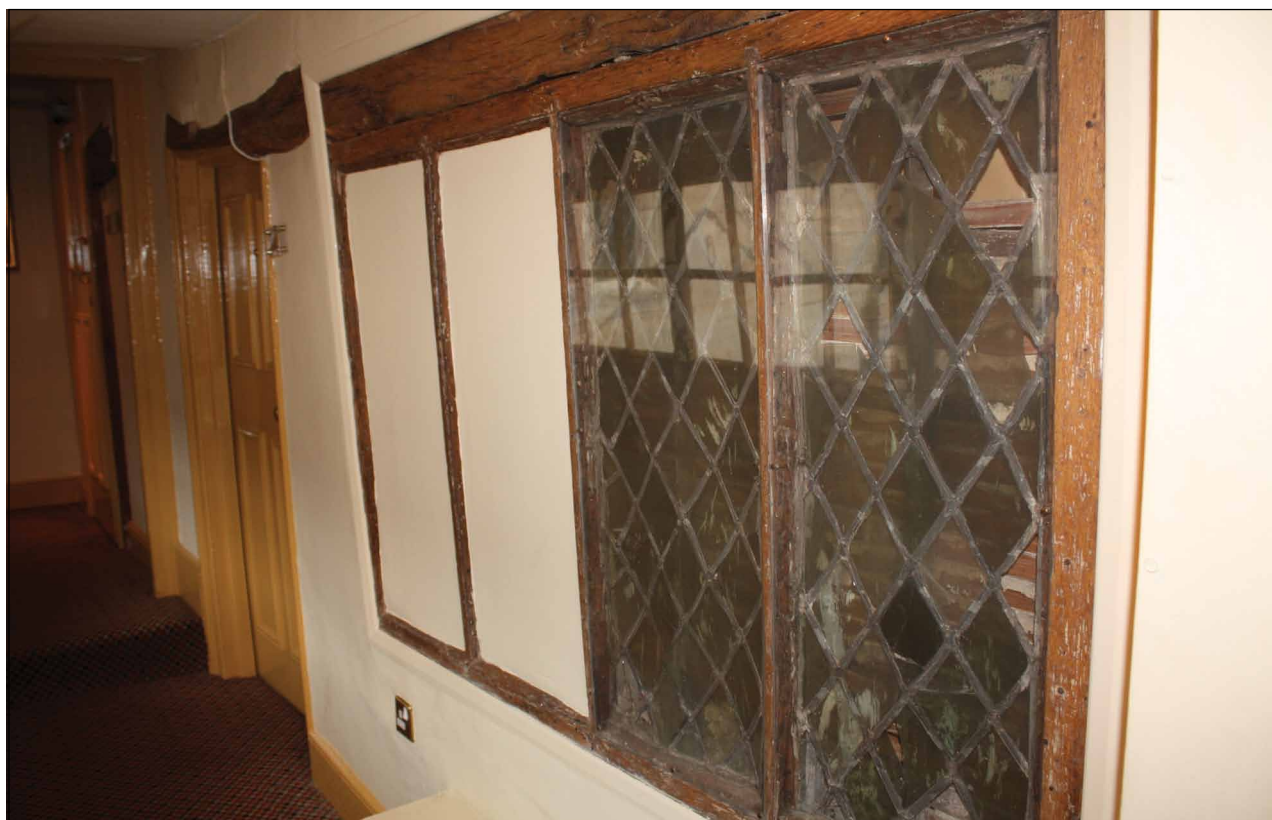
Plate 5: Window within the timber-framed range

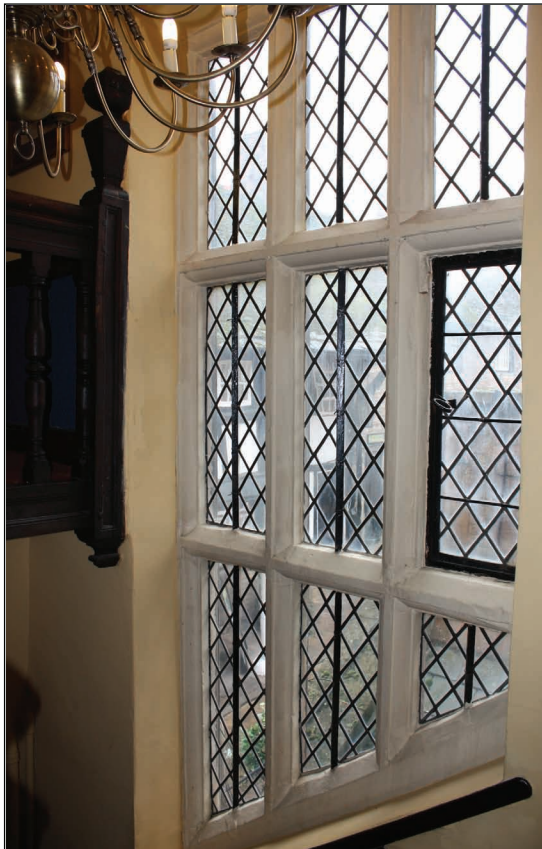
Plate 7: Detail of window, as viewed from staircase

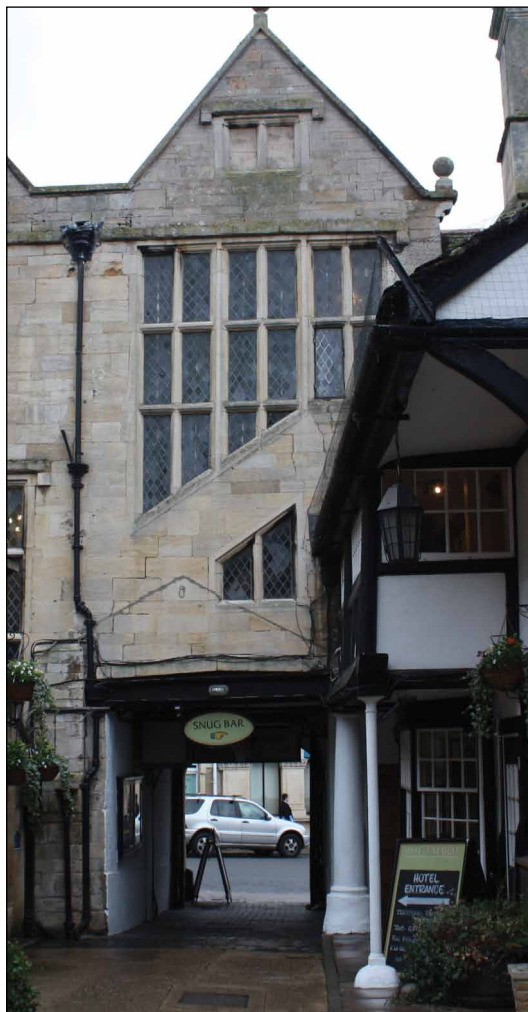
Plate 8: Window, from courtyard

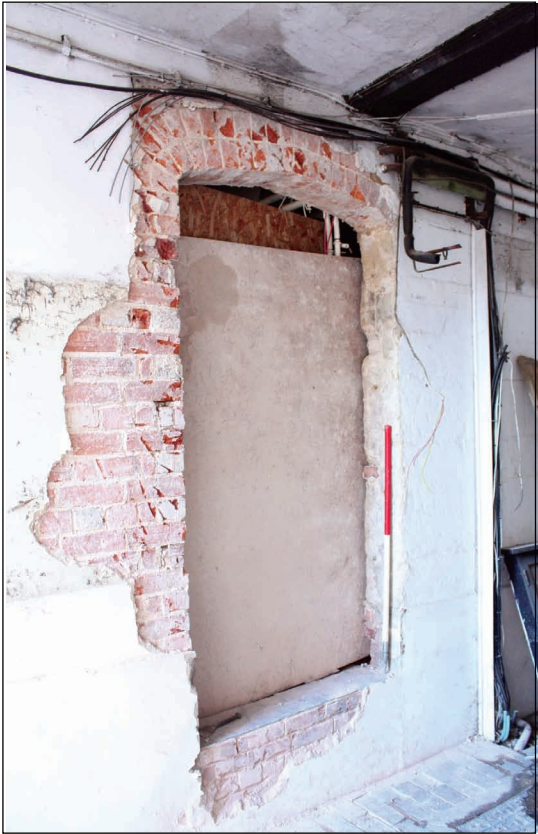
Plate 17: Position of bricked-up former entrance

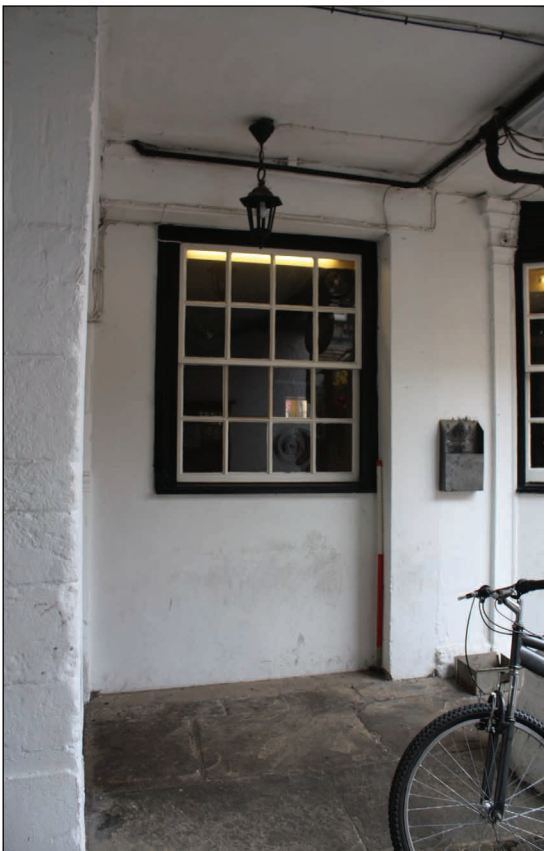
Plate 18: Re-opened former entrance

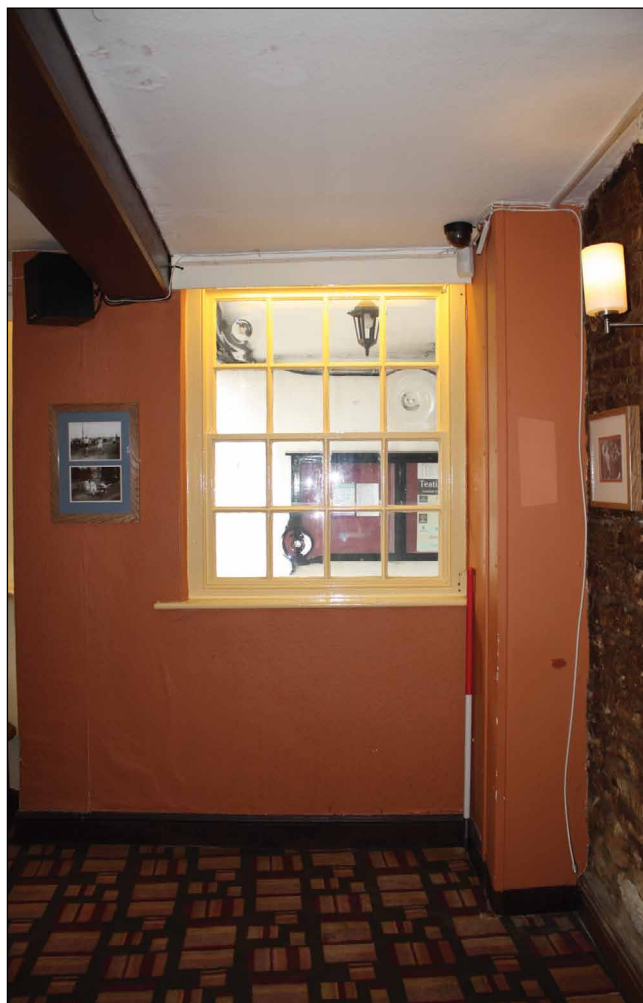
Plate 19: Former doorway with window inserted

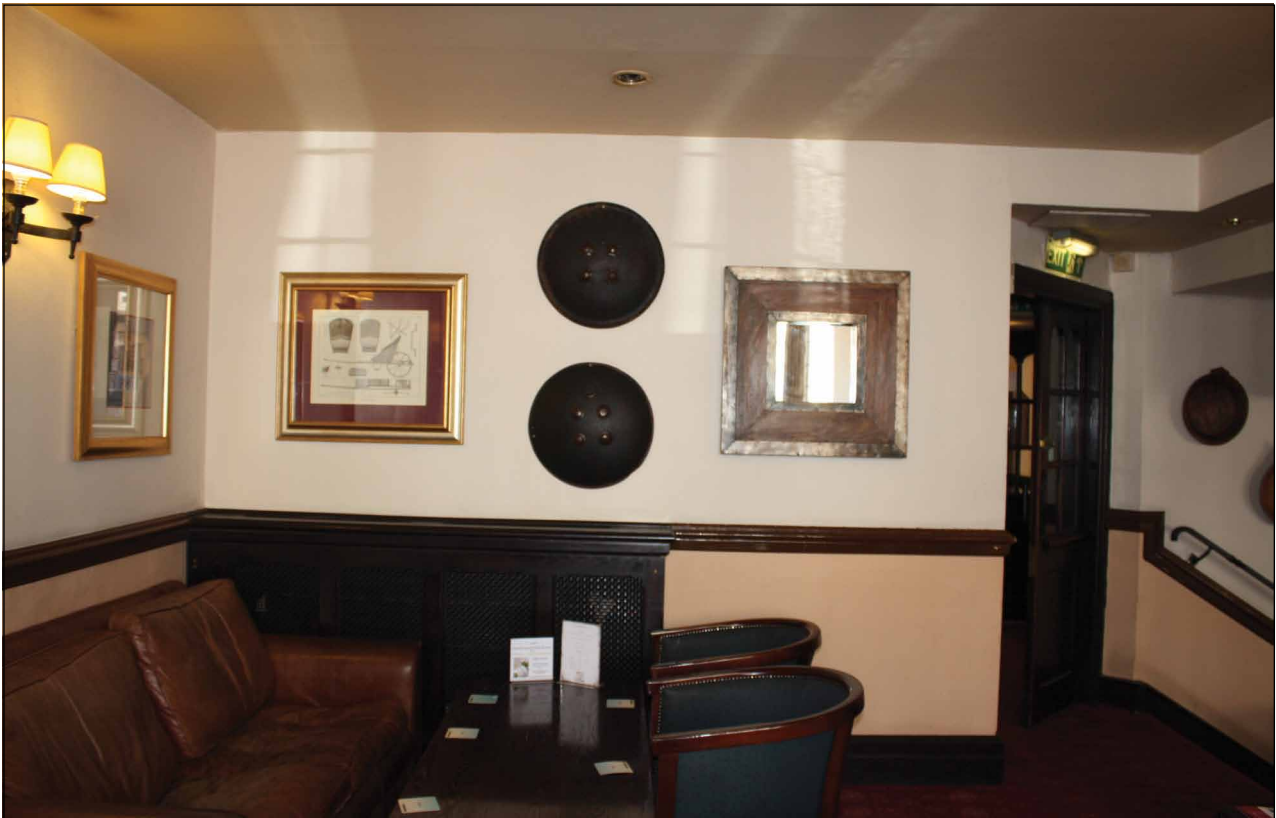
Plate 21: Location of former opening at foot of staircase

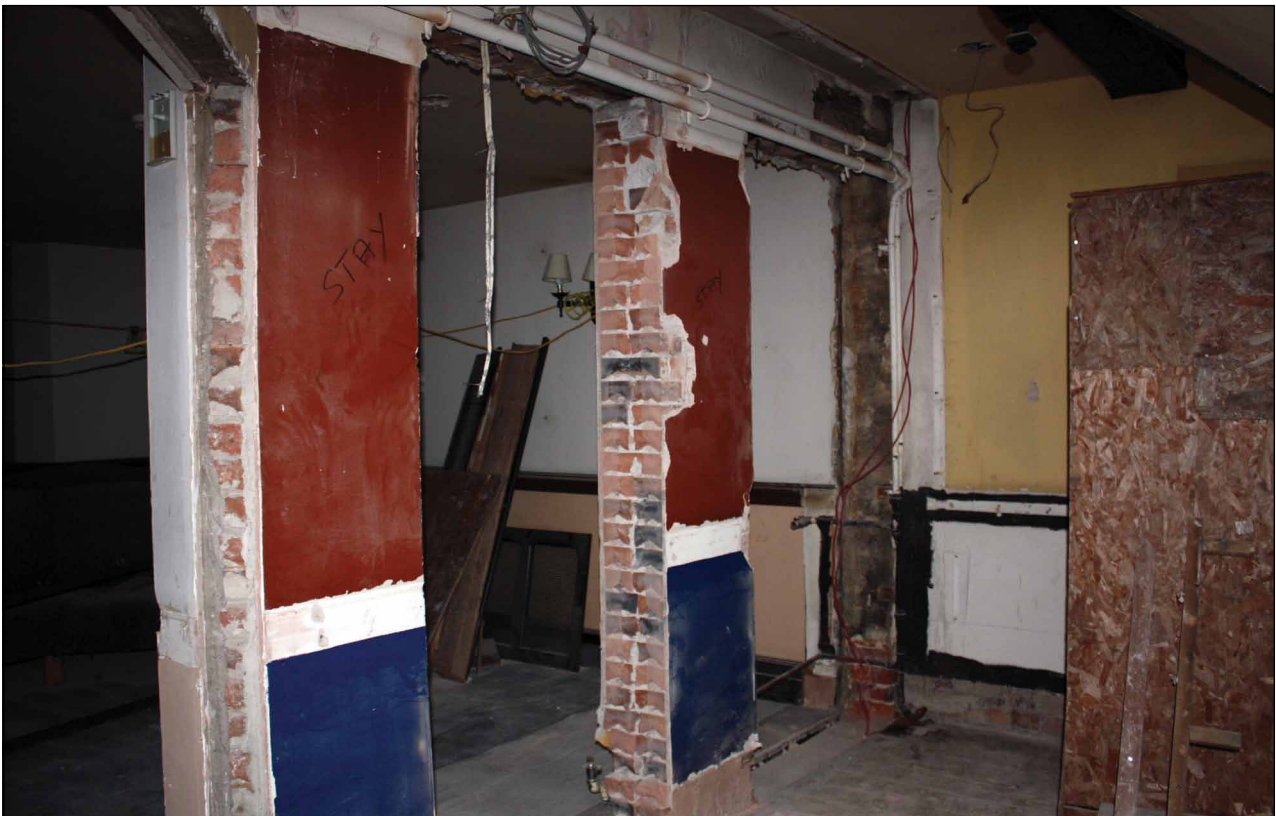
Plate 22: Location of former opening as viewed from bar

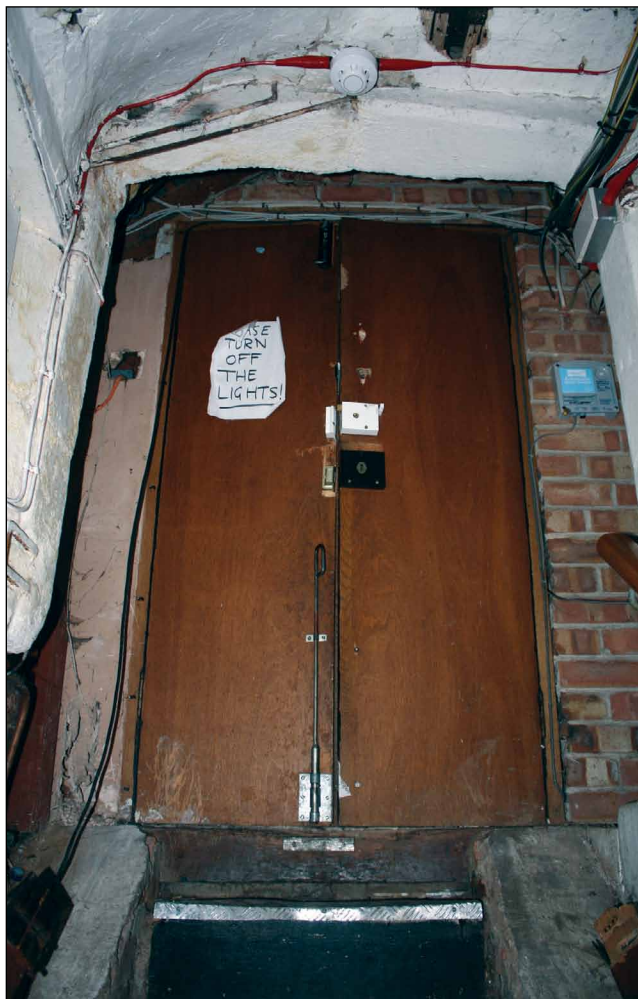
Plate 25: Detail of stone arch over access to cellar

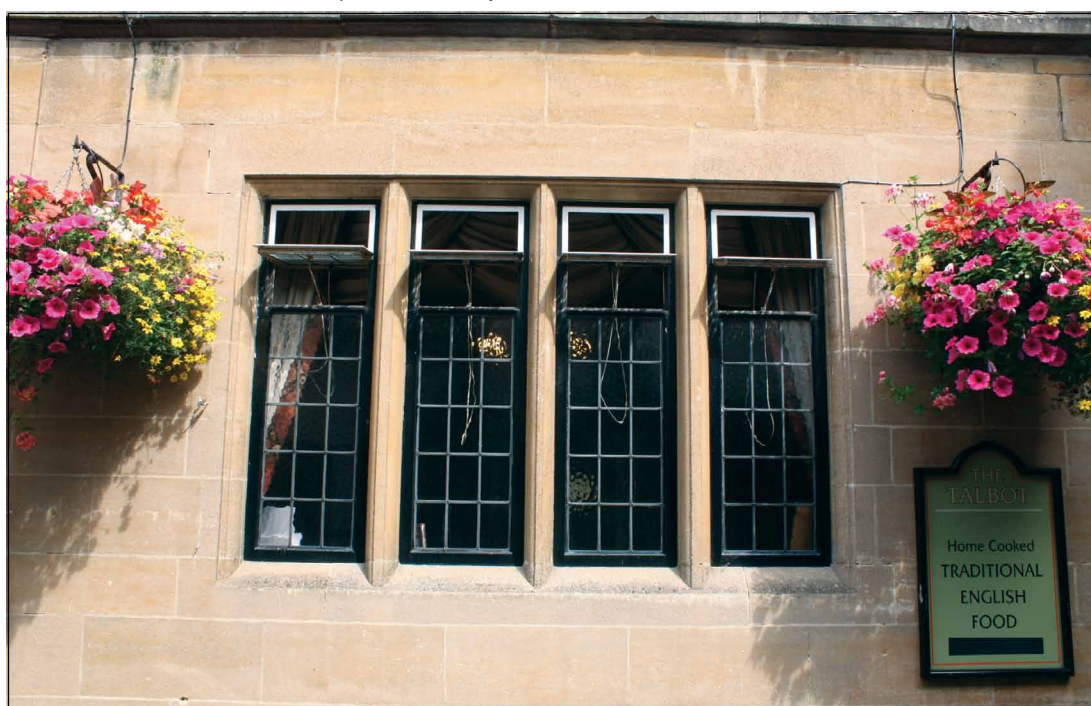
Plate 46: Detail of window in 1949 extension

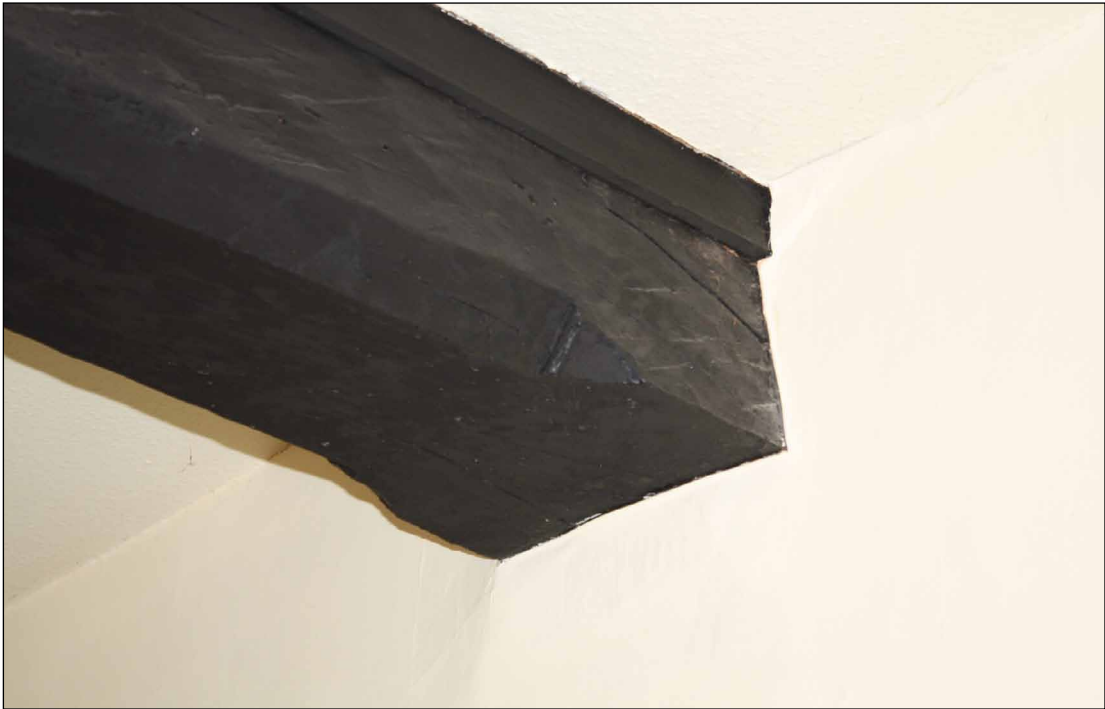
Plate 53: Detail of stop-chamfered beam in Tabret Room

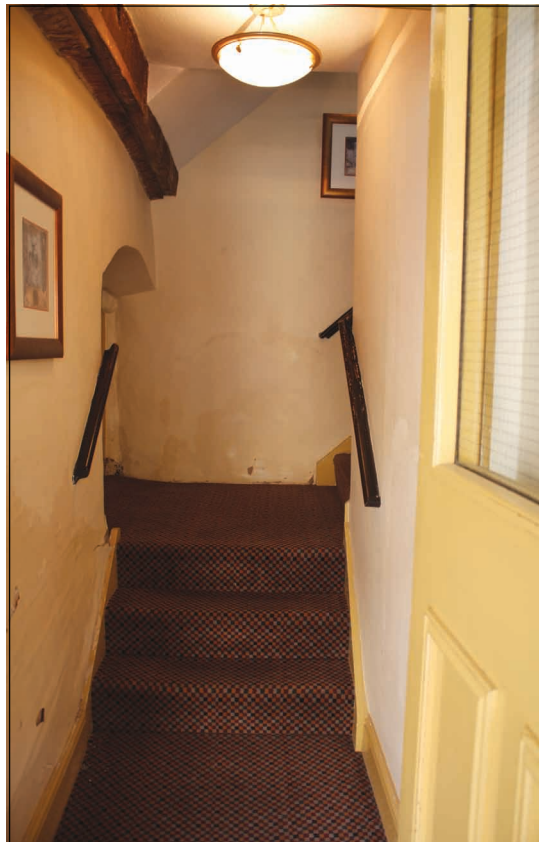
Plate 60: Stairs within Building 11

- 6.9.3 The staircase to be removed was of a simple timber construction and covered with carpet. It was in two parts (unlike the former one shown on the 1965 plan). On entering Building 11 from the external doorway, a small flight of three steps gave access to the bottom of the main staircase to the right (Plate 60).

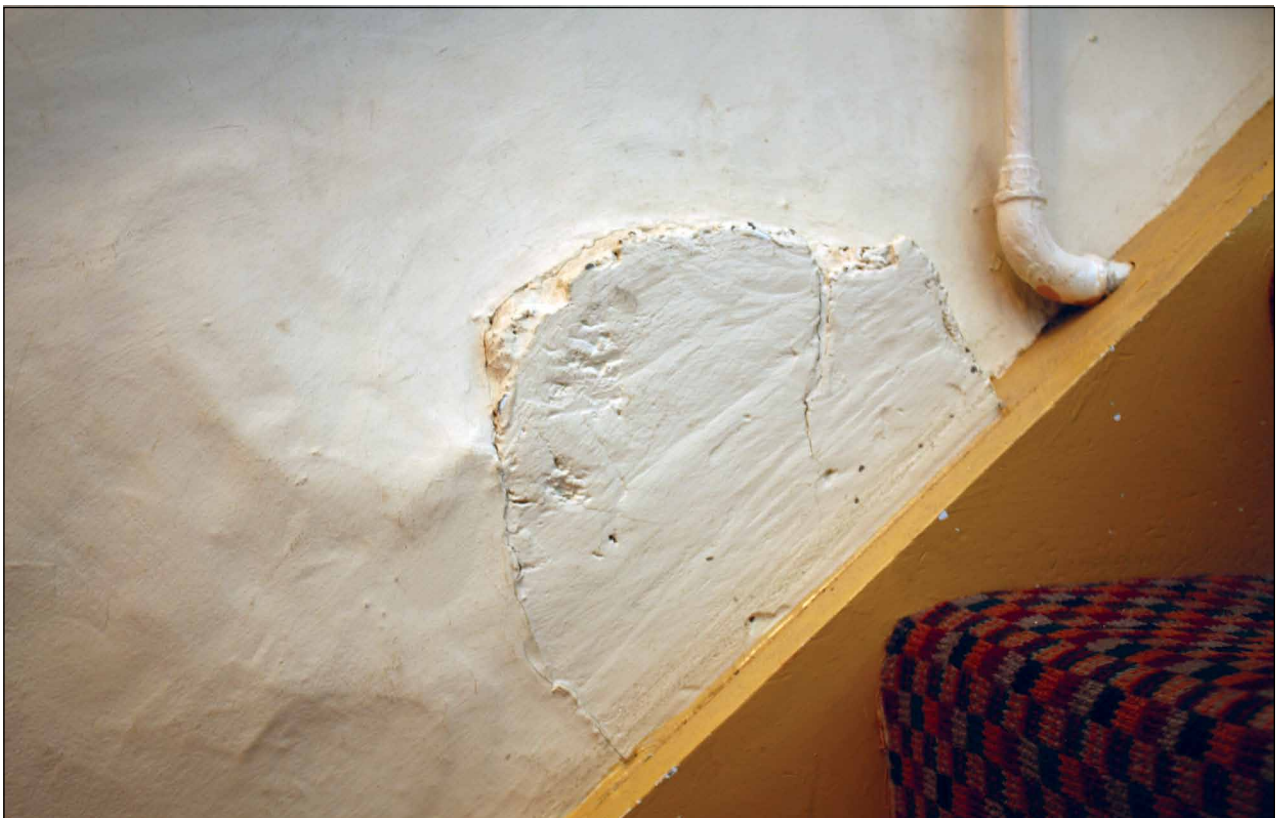
Plate 62: Remnants of sawn timber adjacent to stairs, Building 11
