# The Talbot Hotel Oundle Northants.

**Historic Building Recording  
And Archaeological Monitoring**

## **The Talbot Hotel, Oundle, Northamptonshire**

*Historic Building Recording and Archaeological Monitoring*

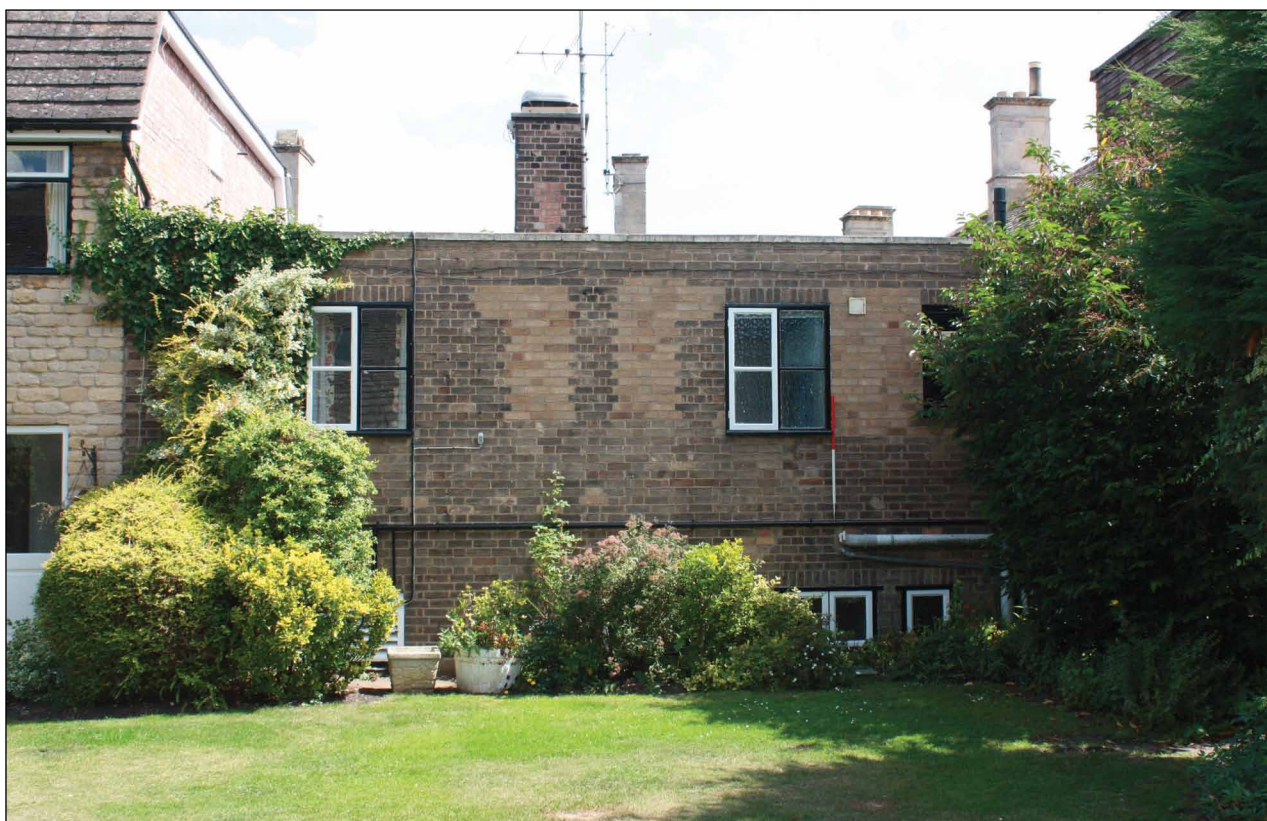
Plate 65: West-facing elevation of 1930's former plant room

- 6.10.10 This alteration presumably refers to the first floor windows as those at ground floor level are to be removed to allow for new access doors. The current first floor fenestration arrangement is shown on Plates 65 and 66 and represented in the client's architect's elevation drawing (Figure 25, Elevation 7). The windows are thought to date to the 1970s when Building 13 was converted into accommodation from a plant room. This alteration would require the insertion of windows which respect the arrangements of rooms created internally.
- 6.10.11 The windows on this elevation are thought to be contemporary, comprising wooden one or two-part casements set within wooden frames with plain or dimpled-effect glass and painted black and white.

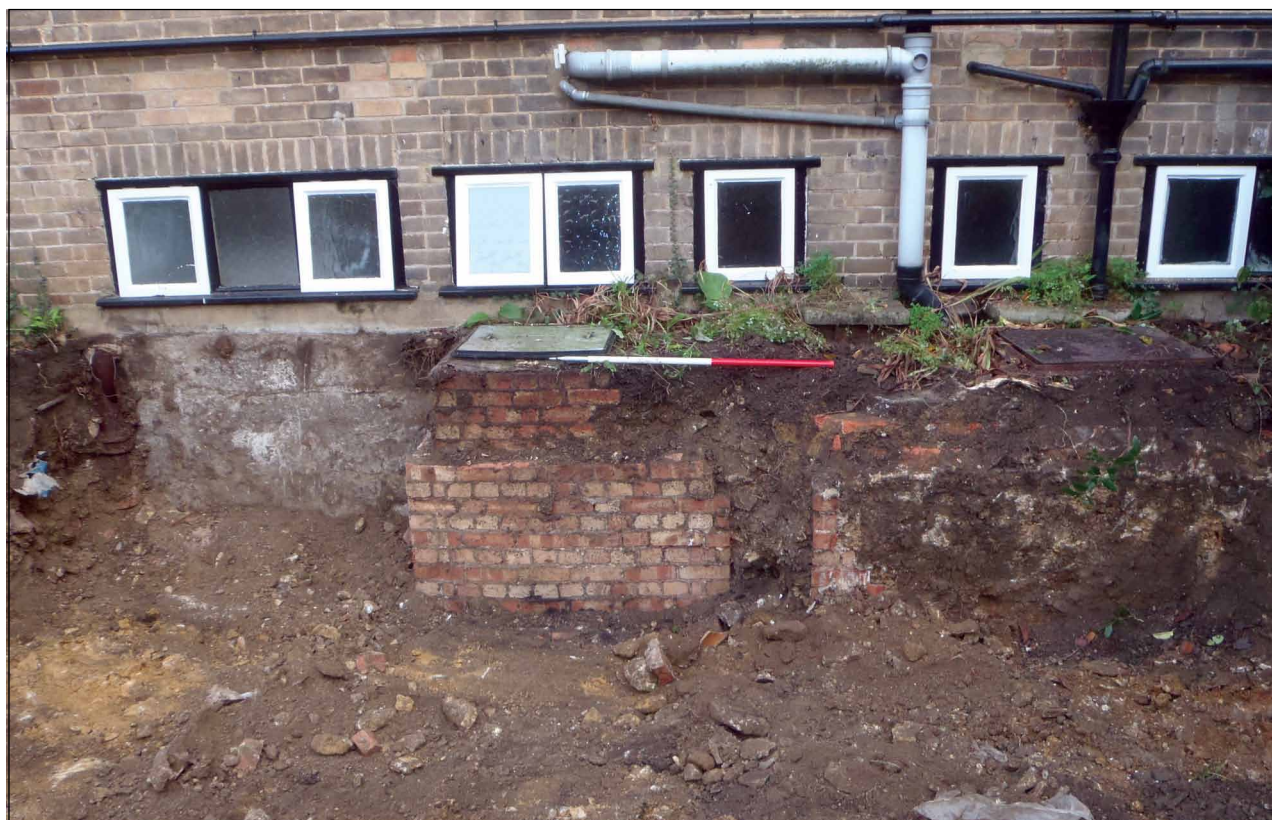
Plate 66: West-facing elevation of 1930's former plant room during ground reduction works

- 6.10.3 The ground level has been significantly reduced for the construction of this building and the proposed alterations will involve removing more of the ground in front of this elevation to allow for a sloped access. During the watching brief phase of investigations outside of the building in November 2011, more of the elevation including rendered foundations and brick-built drainage covers were exposed (Plate 66).

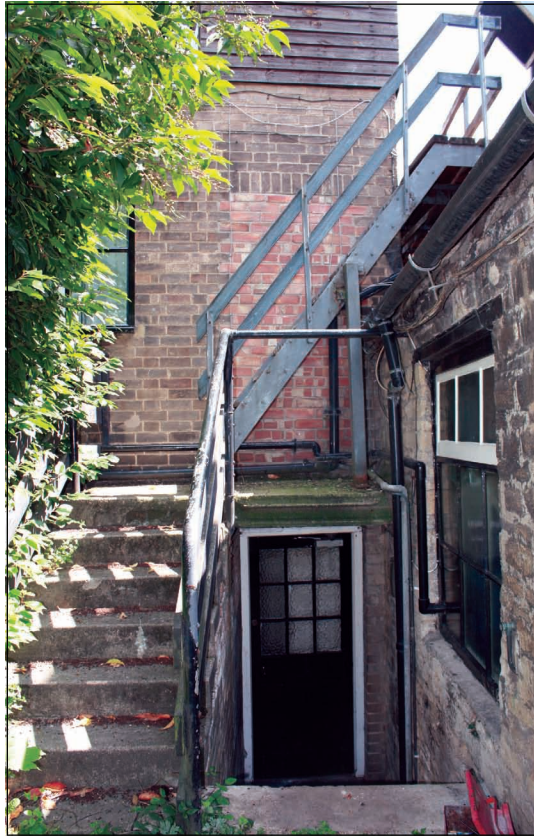
Plate 67: Fire escape and stone stairs

- 6.10.12 The current fire escape comprises two sections; stone steps which presumably previously allowed first floor access from outside (possibly as an earlier fire escape) and an additional flight of galvanised steel steps which lead up to a suspended walkway area connecting the roofs of Buildings 9 and 13 (Plate 67 and Figure 25, Elevation 7).
- 6.10.13 During the return visit in November 2011, the fire escape was being removed.

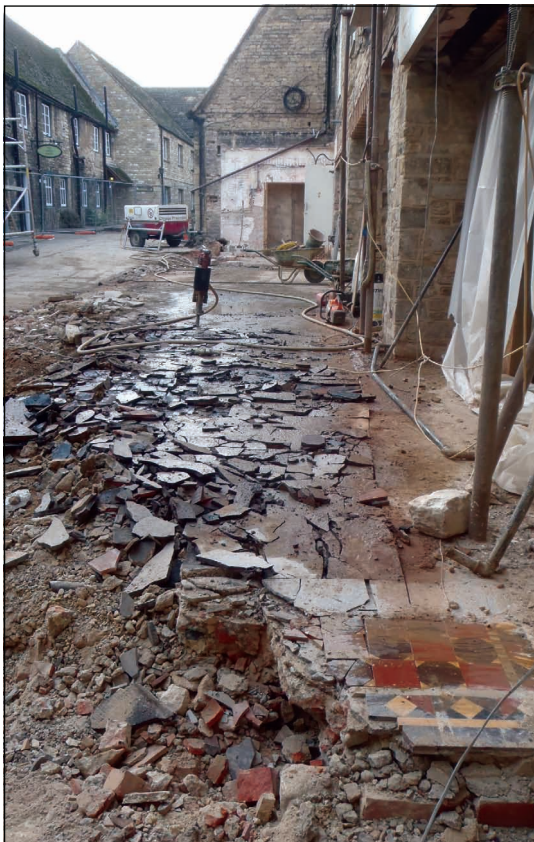
Plate 68: Exposed floor tiles within footprint of former extension, exposed during building works

- 7.1.2 The remnants of a decorative tiled floor were noted within the location of the single storey extension. This was revealed during the removal of the concrete floor which had until demolition covered the floor of the restaurant area (Plate 68). The tiles were comprised terracotta, yellow and black colours and created an octagonal pattern with diamond borders (Plate 69). These tiles are likely to have formed the original floor covering of the 1949 extension (entrance and residents lounge), later concealed with concrete – perhaps during the later 20th century when the restaurant was created.

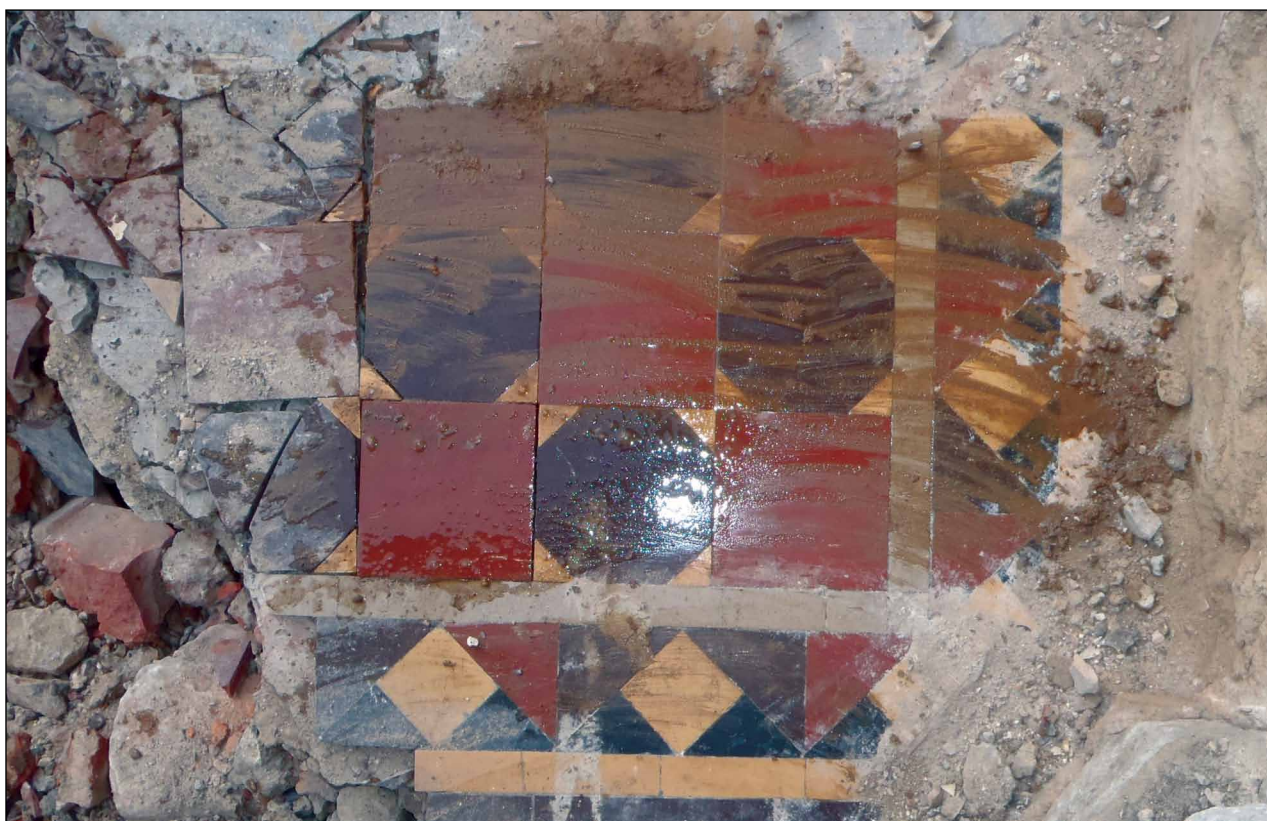
Plate 69: Detail of exposed tiles

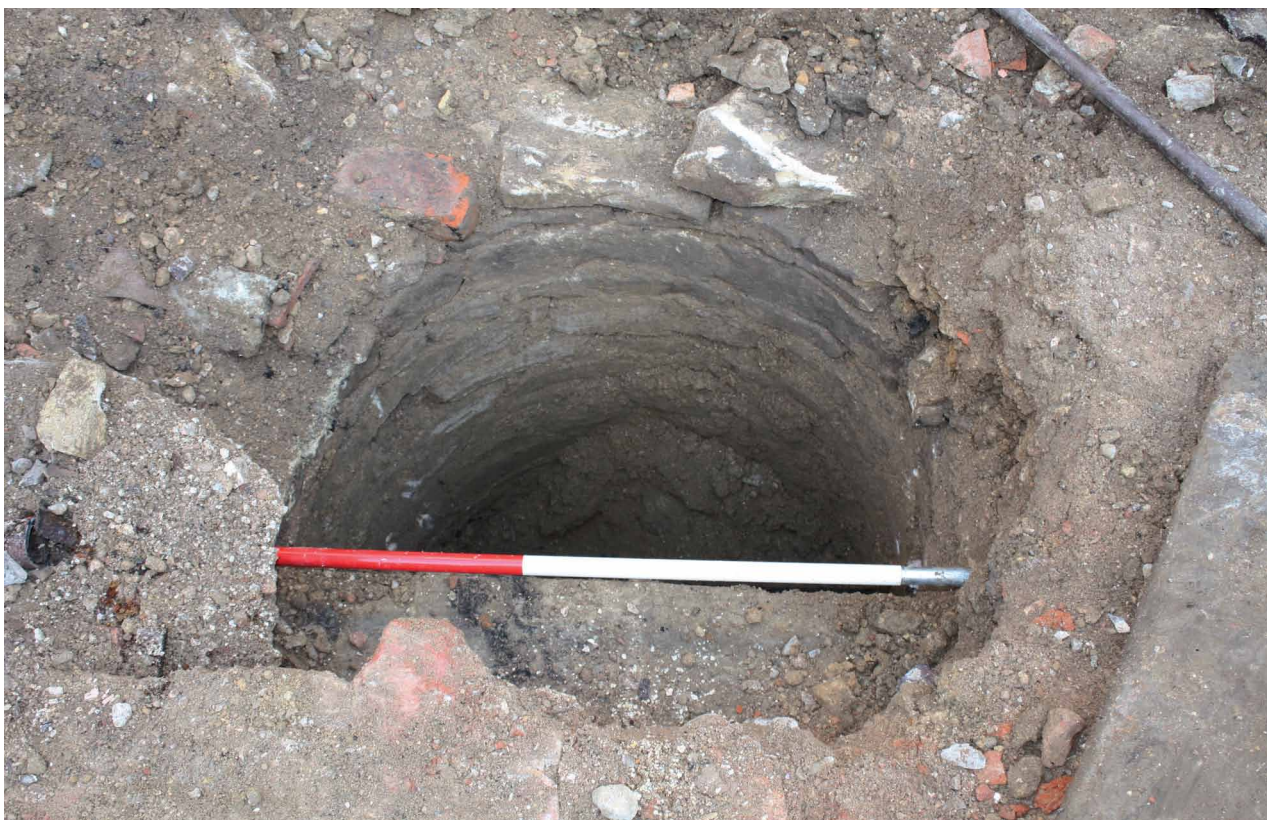
Plate 70: Well exposed during groundworks in courtyard

- 7.1.3 A stone-lined well was encountered by the ground workers (Plate 70). It had been covered over with large slabs of stone and was not under threat from development it was decided to leave *in-situ* and cover back over. The well measured approximately 1 metre in diameter and despite the use of a mechanical excavator, only 2 metres of its rubble backfill could be removed. No dating evidence was retrieved, however, the well does not appear on any of the historic maps consulted.

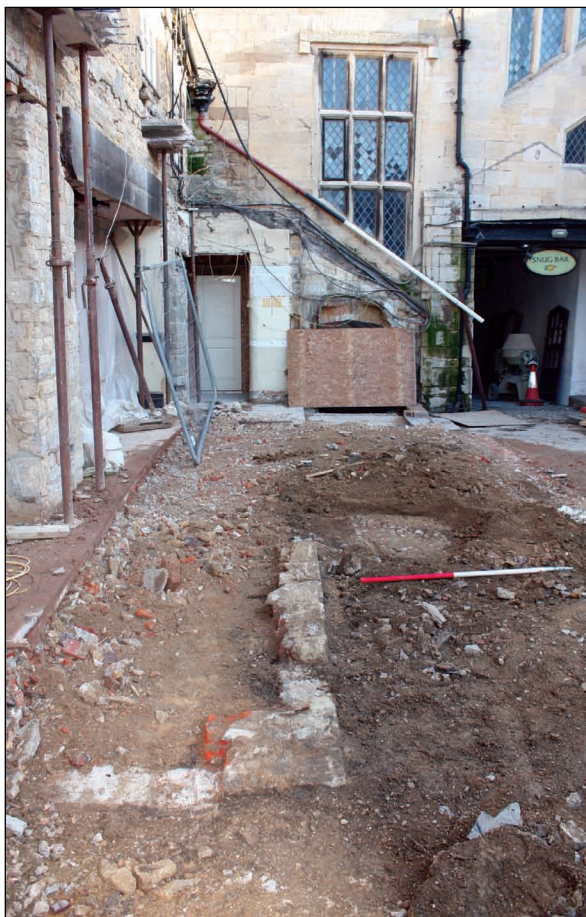
Plate 71: Foundations and cobbled surface in courtyard exposed during external alterations

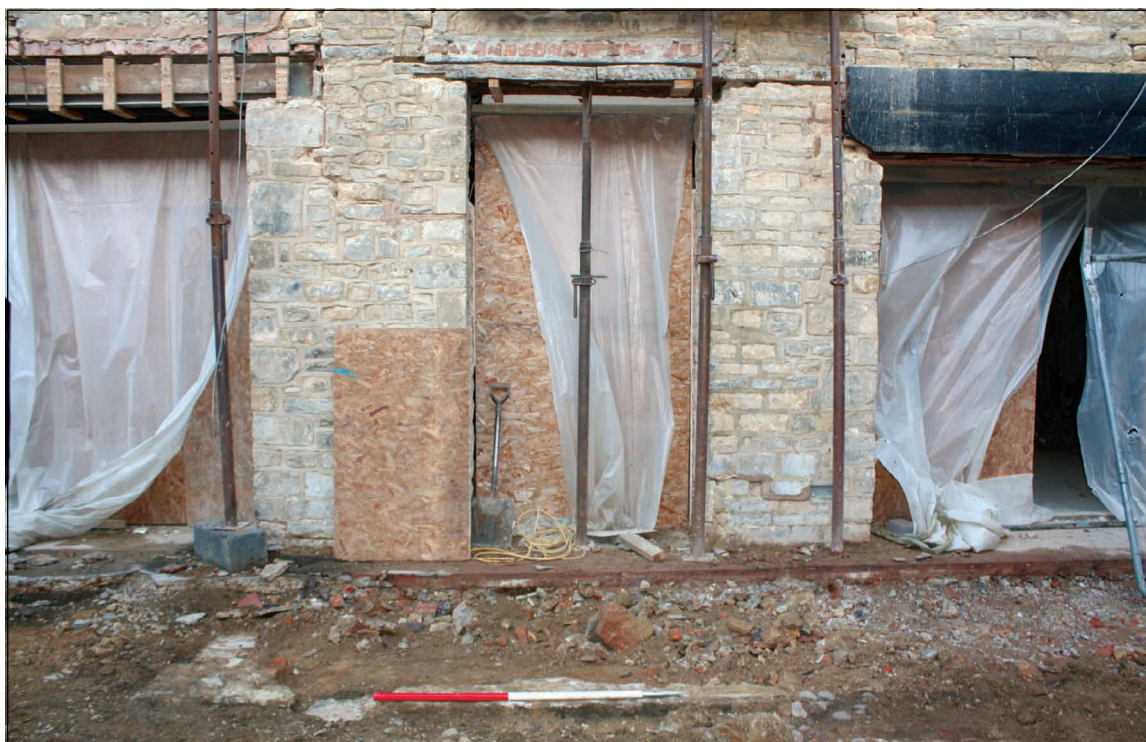
Plate 72: Detail of foundations and former doorway of Building 5

- 7.1.4 A small area of surviving stone wall foundations was exposed following the removal of the concrete and tiled floor beneath the 1949 single storey extension. The foundations measured 1.2m by 3m and were located in front of an exposed doorway on the south-facing elevation of the north courtyard range (Plate 71) (Figure 26). These foundations may have been for a small porch or sheltered area in front of the doorway as shown exposed in Plate 72. This is likely to be the same doorway as is shown on a photograph of the courtyard taken in the late 19th/early 20th century (Figure 18) which would have provided an entrance to this building range prior to the addition of the 1949 extension.

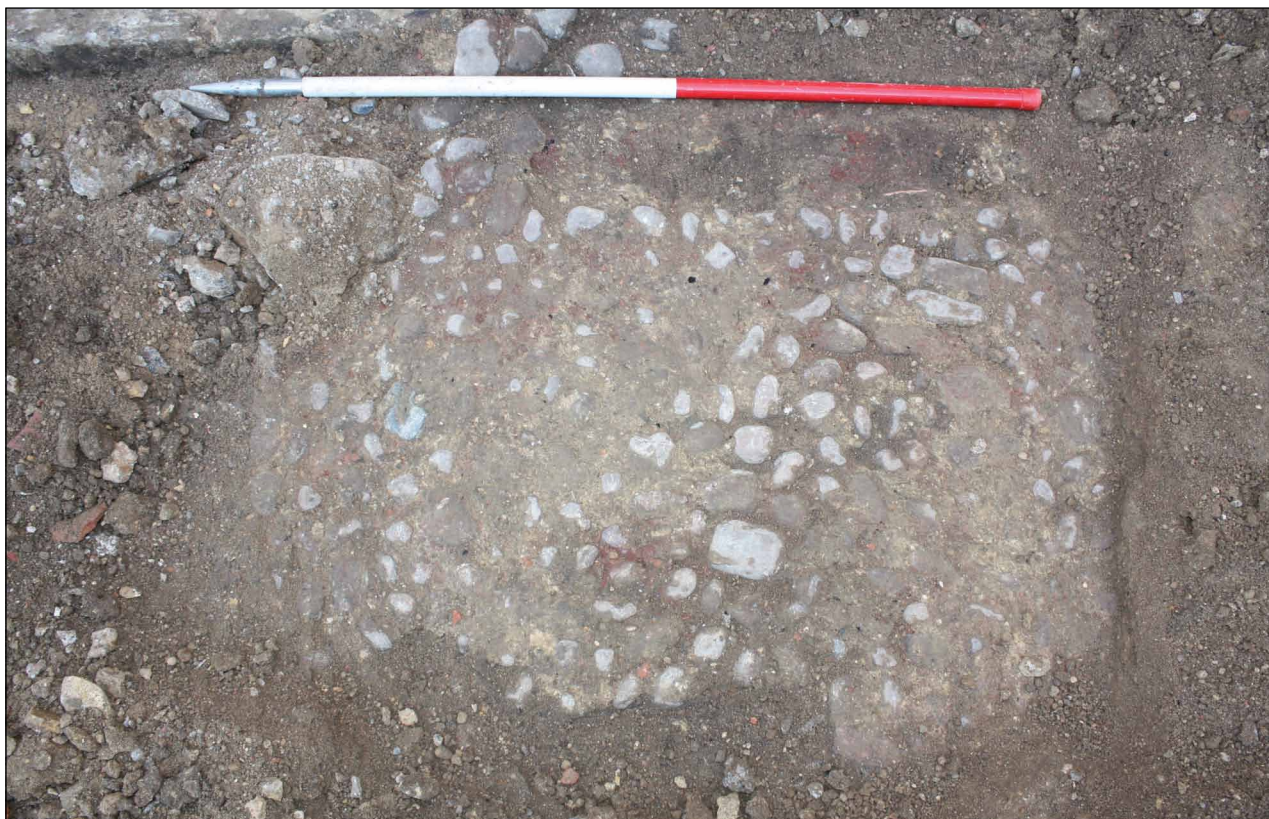
Plate 73: Detail of cobbled surface

- 7.1.5 A small area of cobbled surface was also exposed following the removal of the concrete and tiled floor beneath the 1949 single storey extension (Plate 73). Located at the same level as the foundations, and only present in a small exposed area, this may have been the remnants of a path leading to the doorway as noted above or perhaps the remains of an early courtyard surface. A small amount of investigation revealed that these small rounded pebble stones were pressed into a firm, sandy surface below and were extremely compacted. Although no dating evidence was recovered during cleaning or the removal of a small area of stones, this surface will not be removed as part of the alterations and will remain protected *in-situ*. Plate 74 shows how the cobbled surface, foundation stones and location of earlier doorway relate to each other.

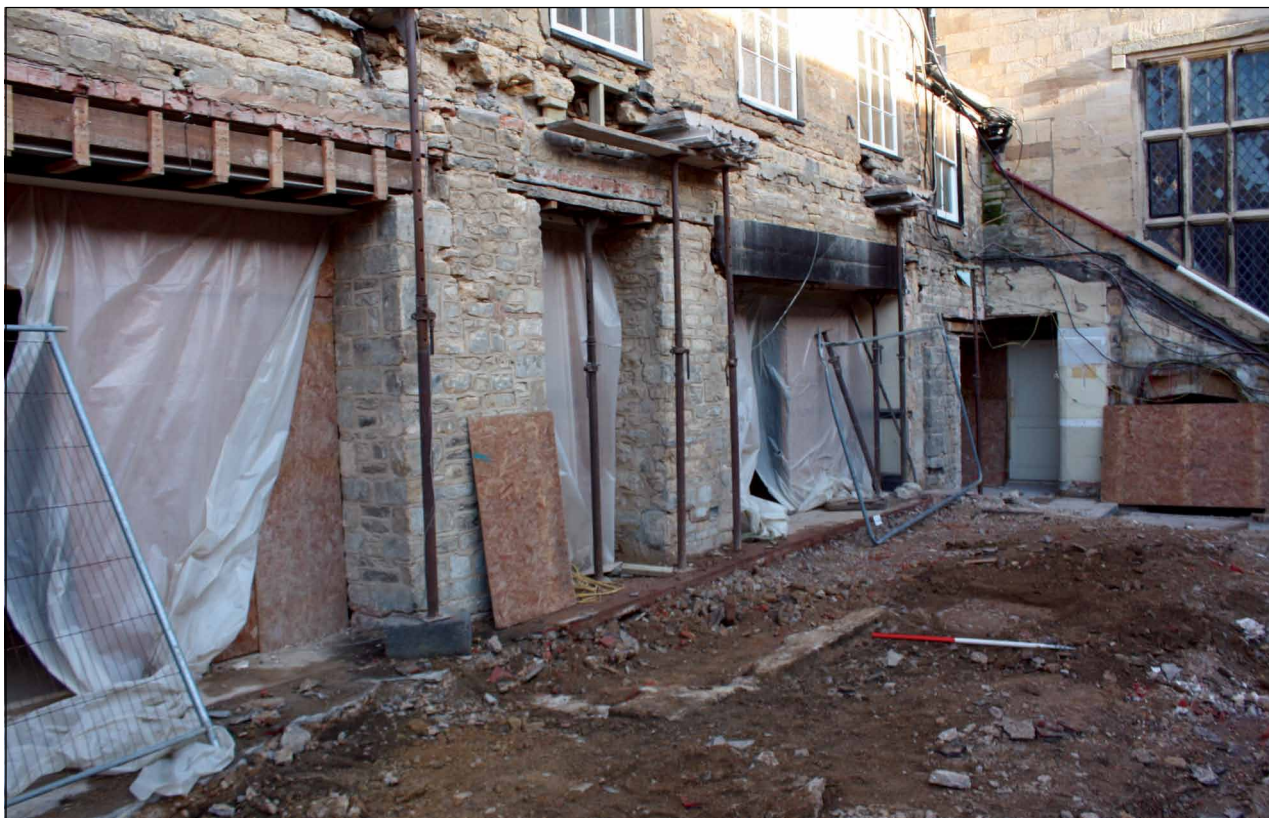
Plate 74: Façade of Building 5 and remains exposed during groundworks in courtyard, from south-west

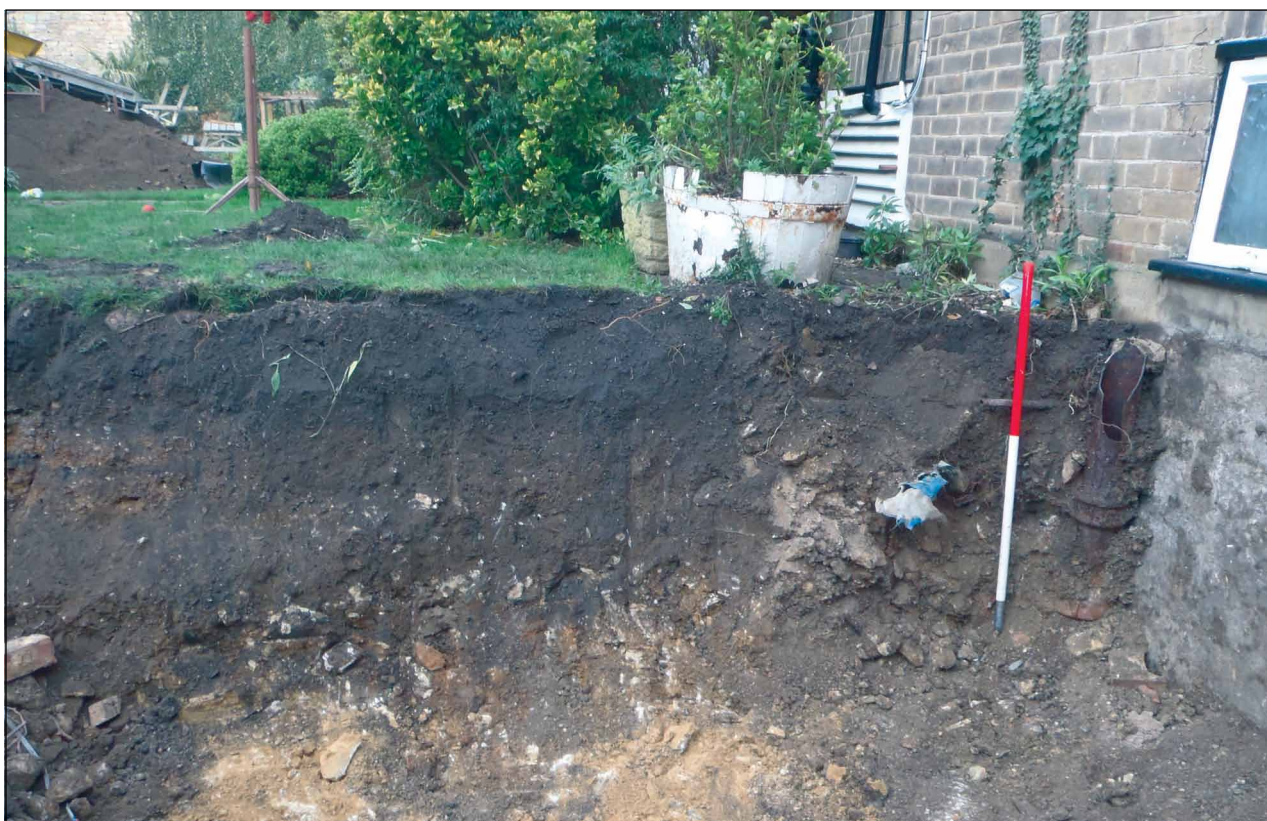
Plate 75: South-facing section exposed during ground reduction at rear of hotel

- 7.2.1 Monitoring of the ground reduction in the rear hotel gardens did not expose any significant archaeological remains.
- 7.2.2 An area measuring approximately 4.5m by 2.75m was removed under constant observation using a mini digger. Spoil was removed and stored on site with the use of a conveyor (Plate 1). All spoil was scanned using a metal detector.
- 7.2.3 Up to 0.80m of topsoil and subsoil was removed to a point where natural sands and gravels were exposed (Plate 75).
- 7.2.4 There is no available cartographic evidence to suggest there were buildings on this site after 1725 and all maps consulted show this part of the hotel as garden with trees (Figure 8).

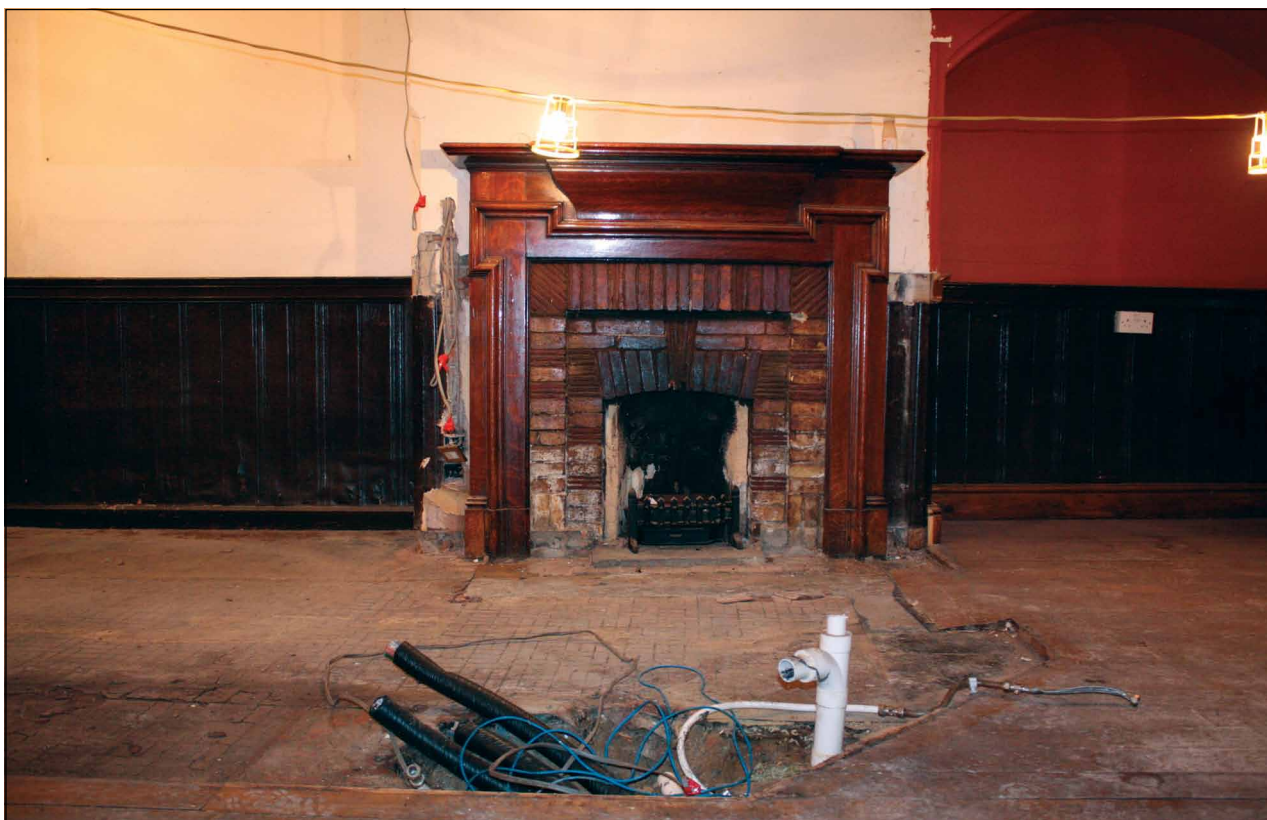
Plate 76: An exposed fireplace in the "snug" bar

- 7.3.1 Although not part of the required monitoring, a fireplace was exposed within the former “snug” bar of Building 1 which was worthy of an additional note. The fireplace was previously concealed behind late 20th century bar fixtures and fittings. Constructed using decorative brick and tile with a carved wooden surround this fireplace is thought to be late 19th/early 20th century in date (Plate 76).
