Stables and Office Blocks, Ditherington Flax Mill, Shrewsbury, Shropshire

Archaeological Building Investigation

Oxford Archaeology North

March 2015

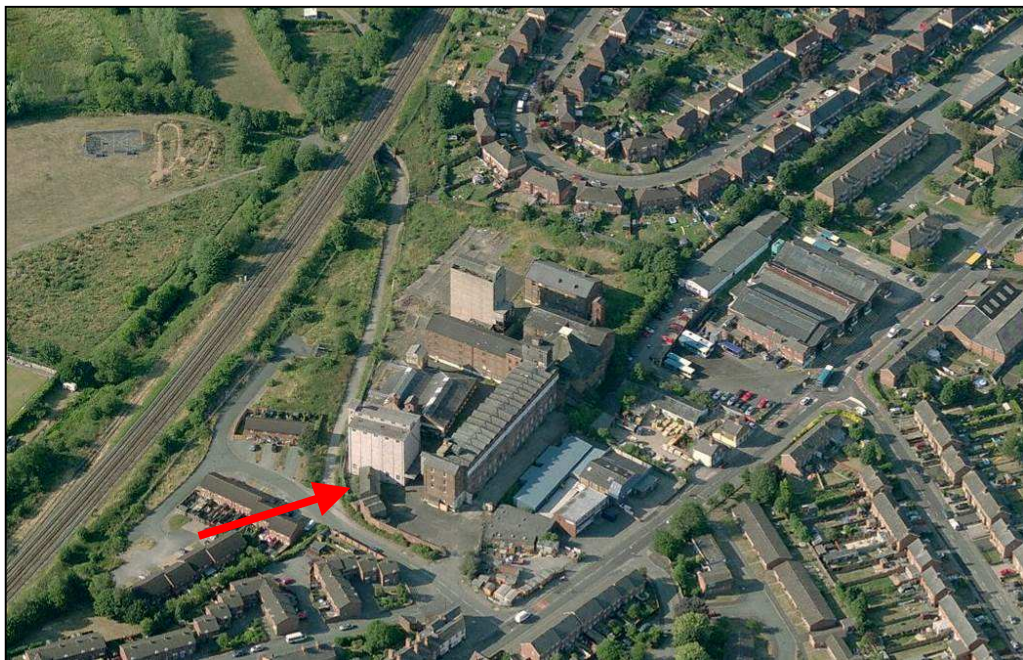
Plate 1: Recent aerial view of the site, with arrow marking the Office and Stables

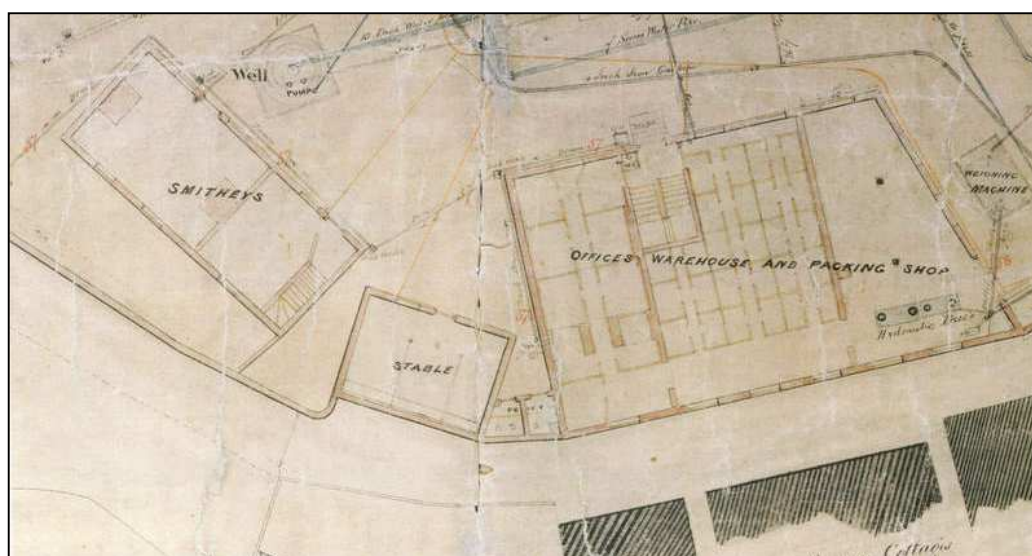
Plate 1: Extract of plan of Ditherington Flax Mill, dated 1855

- 2.1.8 Internally, the building was divided into two unequal rooms by a brick cross-wall (Fig 2), housing fireplaces to both face on both floors (Images F013 and F014). The 1855 plan, however, clearly depicts a fireplace on only the northern side of the wall, with an additional fireplace being placed against the northern gable within the original construction (Plate 1). The southern fireplace was probably inserted during the conversion of the upper floor into offices in the late nineteenth century, allowing a fireplace to be inserted into both offices. An internal straight stair and lobby shown within the southern room on the plan of 1855 (Plate 1) appears to have been removed at this time. An extant ceramic tile floor in the southern room (Image F057), revealed below a later concrete floor, respects the chimney breast, suggesting that it was a contemporary or later feature. It seals the brick foundation structure for the former staircase (Image F059), indicating that it represents a secondary floor surface. The floor retains several narrow timber-filled channels set a short distance from the west wall, and each approximately 4' in length (Image F057), possibly representing the footings for a bench.

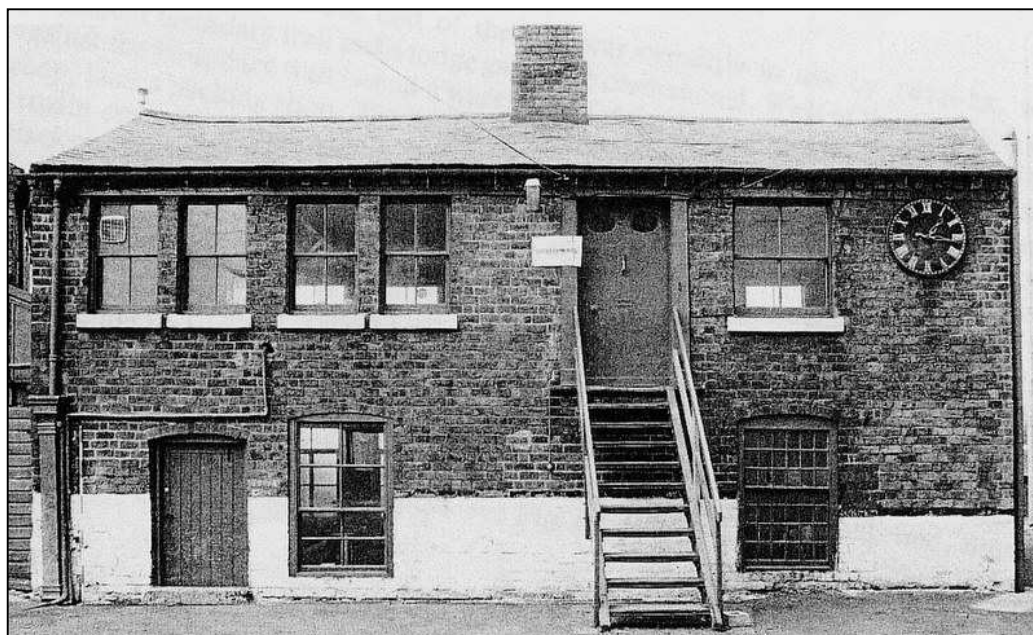
Plate 2: Mid-twentieth-century photograph of Building F

- 2.1.4 At first-floor level, a panelled door to the north of the internal cross wall has projecting moulded timber architrave and rolled sandstone threshold, with the straight external timber stair shown in the historic photograph (Plate 2) having been removed and is currently stored on site. The door itself appears to have been inserted, with brick rebuilding around its jambs, and dark mortar and cracking of the brickwork around all the first-floor windows suggest that they too were inserted during the conversion of the upper floor into offices. The windows have flush lintels and projecting chamfered sandstone sills, and retain four-light vertical sash timber frames behind the external boarding. In the southern room, they are arranged as two pairs within each bay, with a single wider window in the north room, placed above that at ground-floor level. Circular timber casing to a socket through the wall face adjacent to this window housed a clock (Plate 2), also dating to the creation of offices at first-floor level.

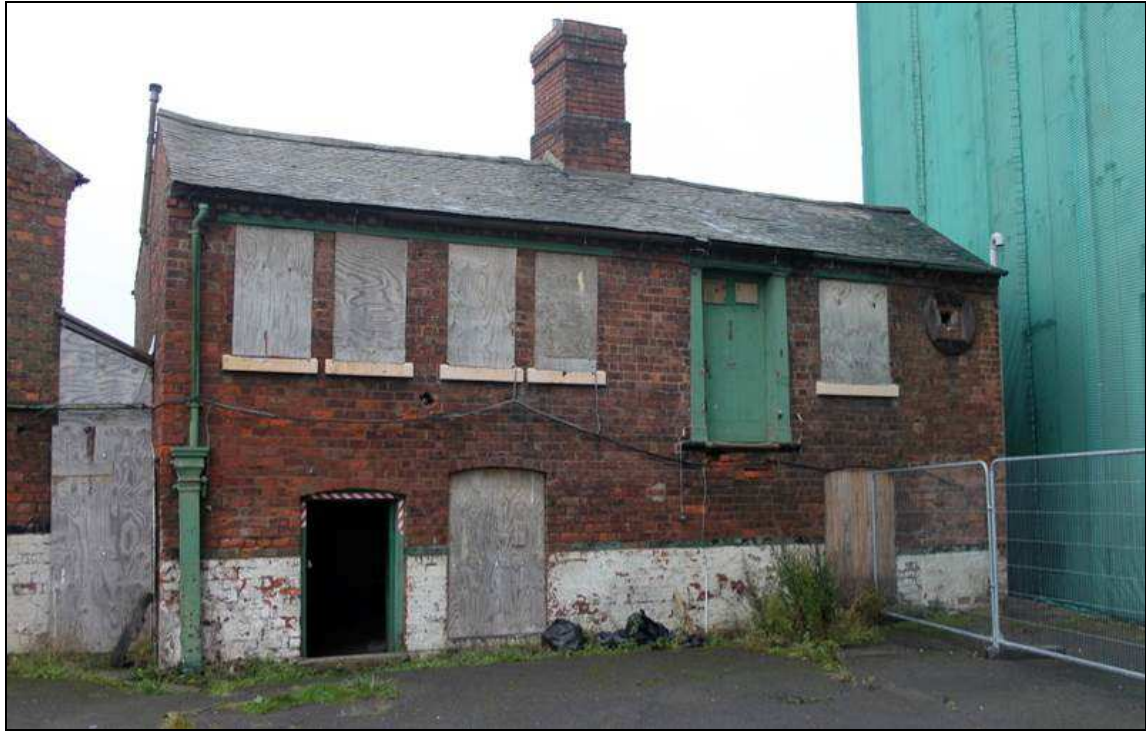
Image F001: Feature F/01

- 2.1.2 The extant structure comprises a two-storey building with a Welsh slate roof and a brick chimney on the ridge, in what is presently the centre of the building (Image F001), set above a brick cross wall housing fireplaces within either face (Fig 1). It is of hand-made brick construction in a mixture of Flemish Bond and Monk Bond; a variant of Flemish Bond, but with two stretchers between each header (Images F001 and F003). The rebuilt north wall was exclusively in Flemish Bond, and appears to have re-used brick from the original wall.

- 2.1.3 The front, eastern façade, has a doorway towards its southern end, with a shallow segmental brick arch, and is flanked on its northern side by a tall widow of similar proportions to the doorway (Image F001), and latterly boarded over following the removal of the frame. A similar window towards the northern end of the extant elevation has a blocked doorway on its northern side, shown on a plan of the building from 1855 (Plate 1), and probably having been blocked during the rebuilding of the northern end of the building, again re-using brick from the original structure. An historic photograph of the structure, taken after the construction of the adjacent South Silo (Plate 2), not only shows the blocked doorway, but also the sash windows within the latterly blocked window apertures. That at the northern end of the elevation retained a 42-light, three-over-four row sash window, probably representing the original fenestration of the building, with that to the south having a larger-paned eight-light vertical sash.

F/70	056		External	Metal pipe projecting through south wall F/01 above blocked door F/67.	Neutral
F/71	001		External	Blocked doorway at north end of east wall F/01.	Very High
F/72	057		Ground floor	Ceramic tile floor below concrete floor F/32 in south room.	Moderate
F/73	057		Ground floor	Three timber rails set within ceramic floor F/72 in south room.	Moderate
F/74	058		External	Timber stair providing access to first floor. Stair removed and currently stored on site.	Moderate
F75	059		Ground floor	Fragmentary brick-built foundation for the original internal stair.	Moderate

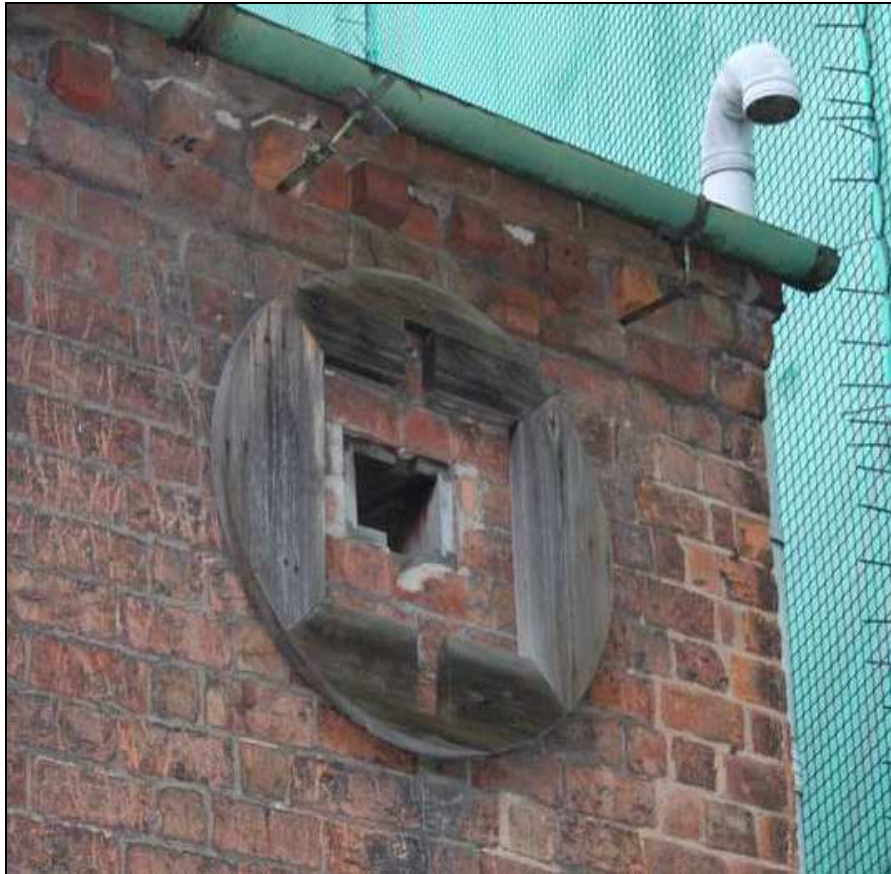
Image F009: Features F/10, F/11, and F/12

F/09	008	F1	External	Rectangular-section cast-iron downpipe.	High
F/10	009	F2	External	Cylindrical downpipe and octagonal-section hopper, east and west walls.	High
F/11	009		External	Cast-iron gutter and brackets above west wall.	High
F/12	009		External	Replacement plastic gutter to east elevation and downpipe on west wall.	Neutral
F/13	010		External	Tapering brick chimney stack.	High
F/14	011		External	Single gas flue pipe of modern date inserted into the chimney stack.	Neutral
F/15	012	F2	External	Vent at first-floor level projecting through south wall.	Neutral
F/16	012	F2	External	Blocked segmental window to first floor in south elevation.	High
F/17	012	F2	External	Two metal/plastic-lined vents at eaves level in south gable.	Neutral
F/18	013	F1	Ground floor	Internal cross-wall.	Very High
F/19	013	F1	Ground floor	Fireplace against southern face of F/18.	High
F/20	014	F1	Ground floor	Fireplace against northern face of F/18.	High

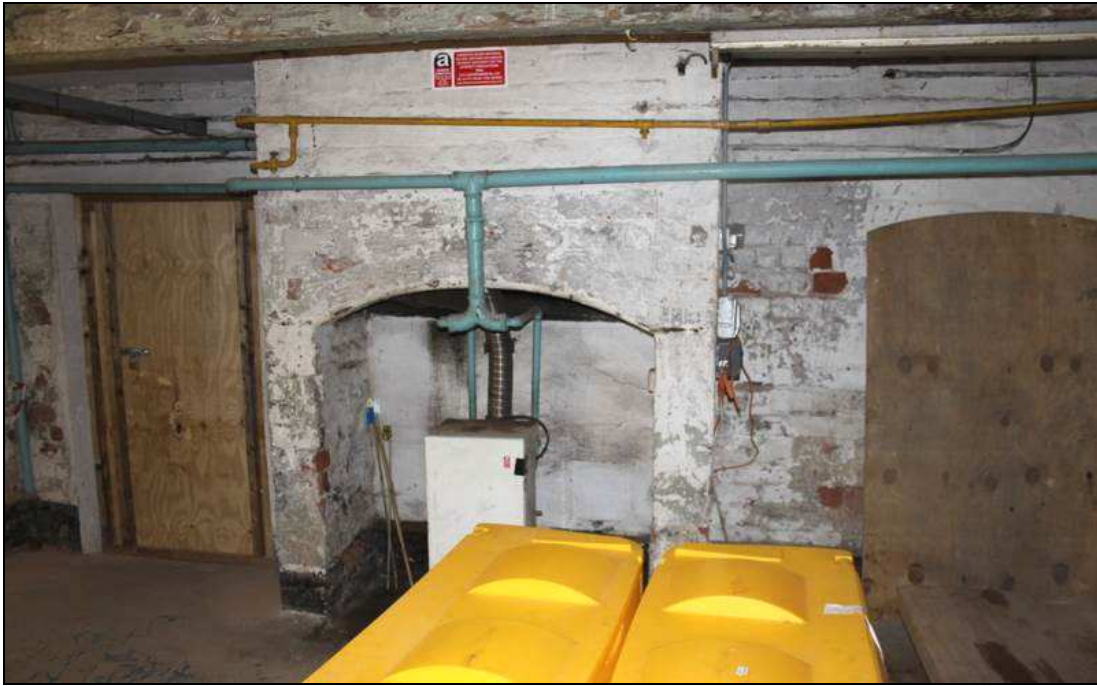
Image F013: Features F/18 and F/19

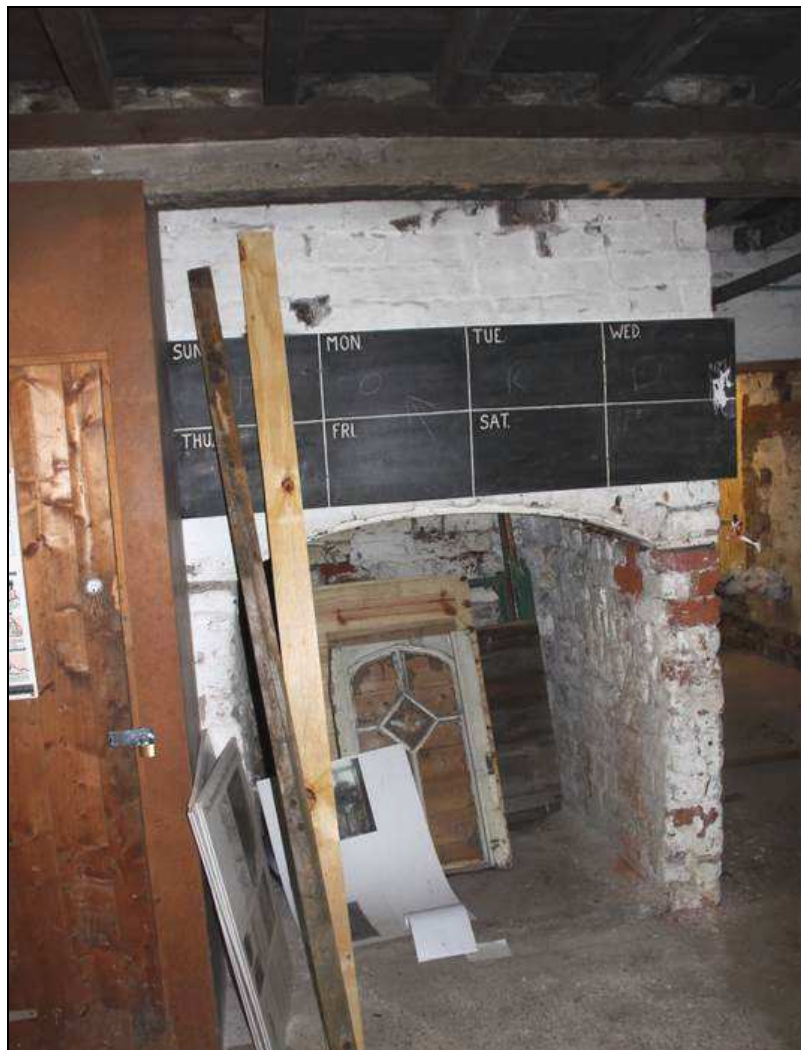
Image F014: Features F/20 and F/32

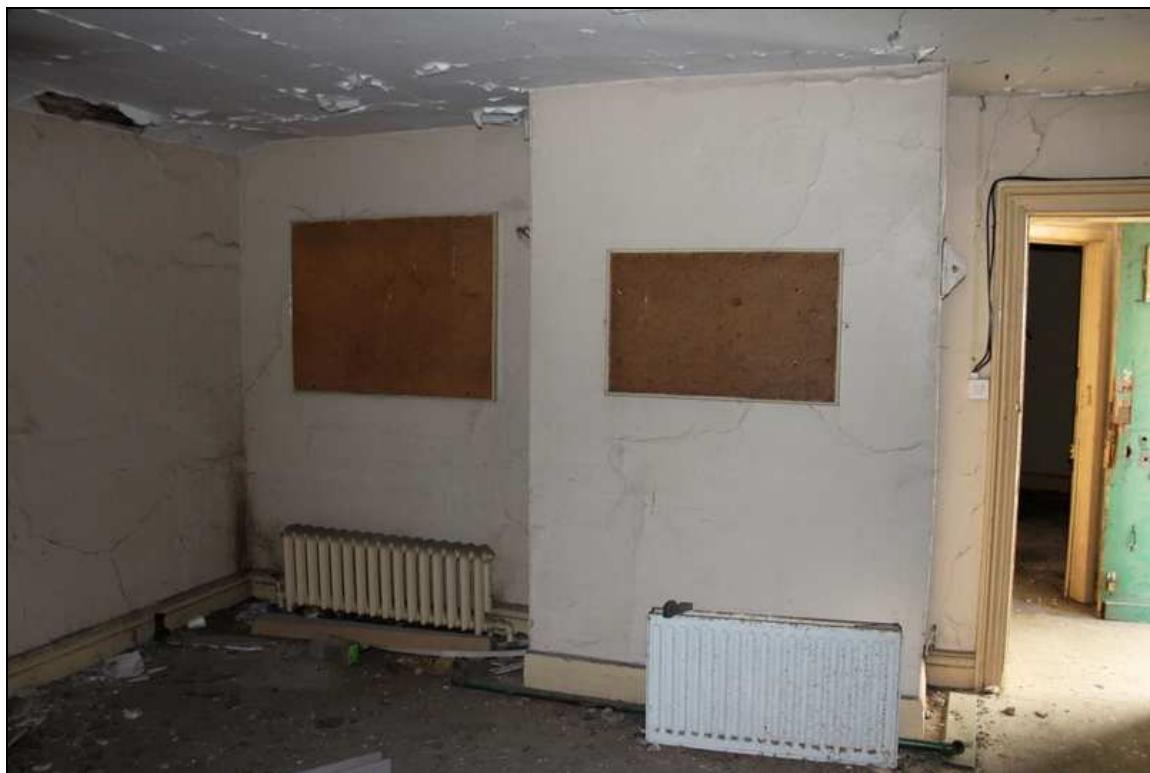
Image F025: Features F/36 and 58

F/58	025	F2	First floor	Pair of cork notice boards on F/36 in south office.	Moderate
F/59	047	F2	First floor	Timber towel rail in south office.	Neutral
F/60	048		Roof space	Timber king post roof trusses with timber pegged joints.	Very High
F/61	049		Roof space	Narrow timber ridge boards.	Very High
F/62	050		Roof space	Butt-ended single purlin to each pitch.	Very High
F/63	050		Roof space	Square-section timber rafters.	Very High
F/64	051		Roof space	Lath and plaster undersealing of roof.	High
F/65	052	F2	First floor	timber plank partition forming first-floor entrance vestibule.	High
F/66	053		First floor	Removed door knocker from F/04.	Moderate
F/67	054/056	F1	External	Blocked door in south wall, F/01.	Very High
F/68	054/055		External	Roof line and white paint scar of late-nineteenth century lean-to against south wall F/01.	High
F/69	055	F1	External	Sockets for timber framing associated with lean to at south end of west wall F/01.	Neutral
