St Andrew's Church Kingham Oxfordshire

Archaeological Watching Brief Report

St Andrew's Church, Kingham, Oxfordshire

ARCHAEOLOGICAL WATCHING BRIEF REPORT

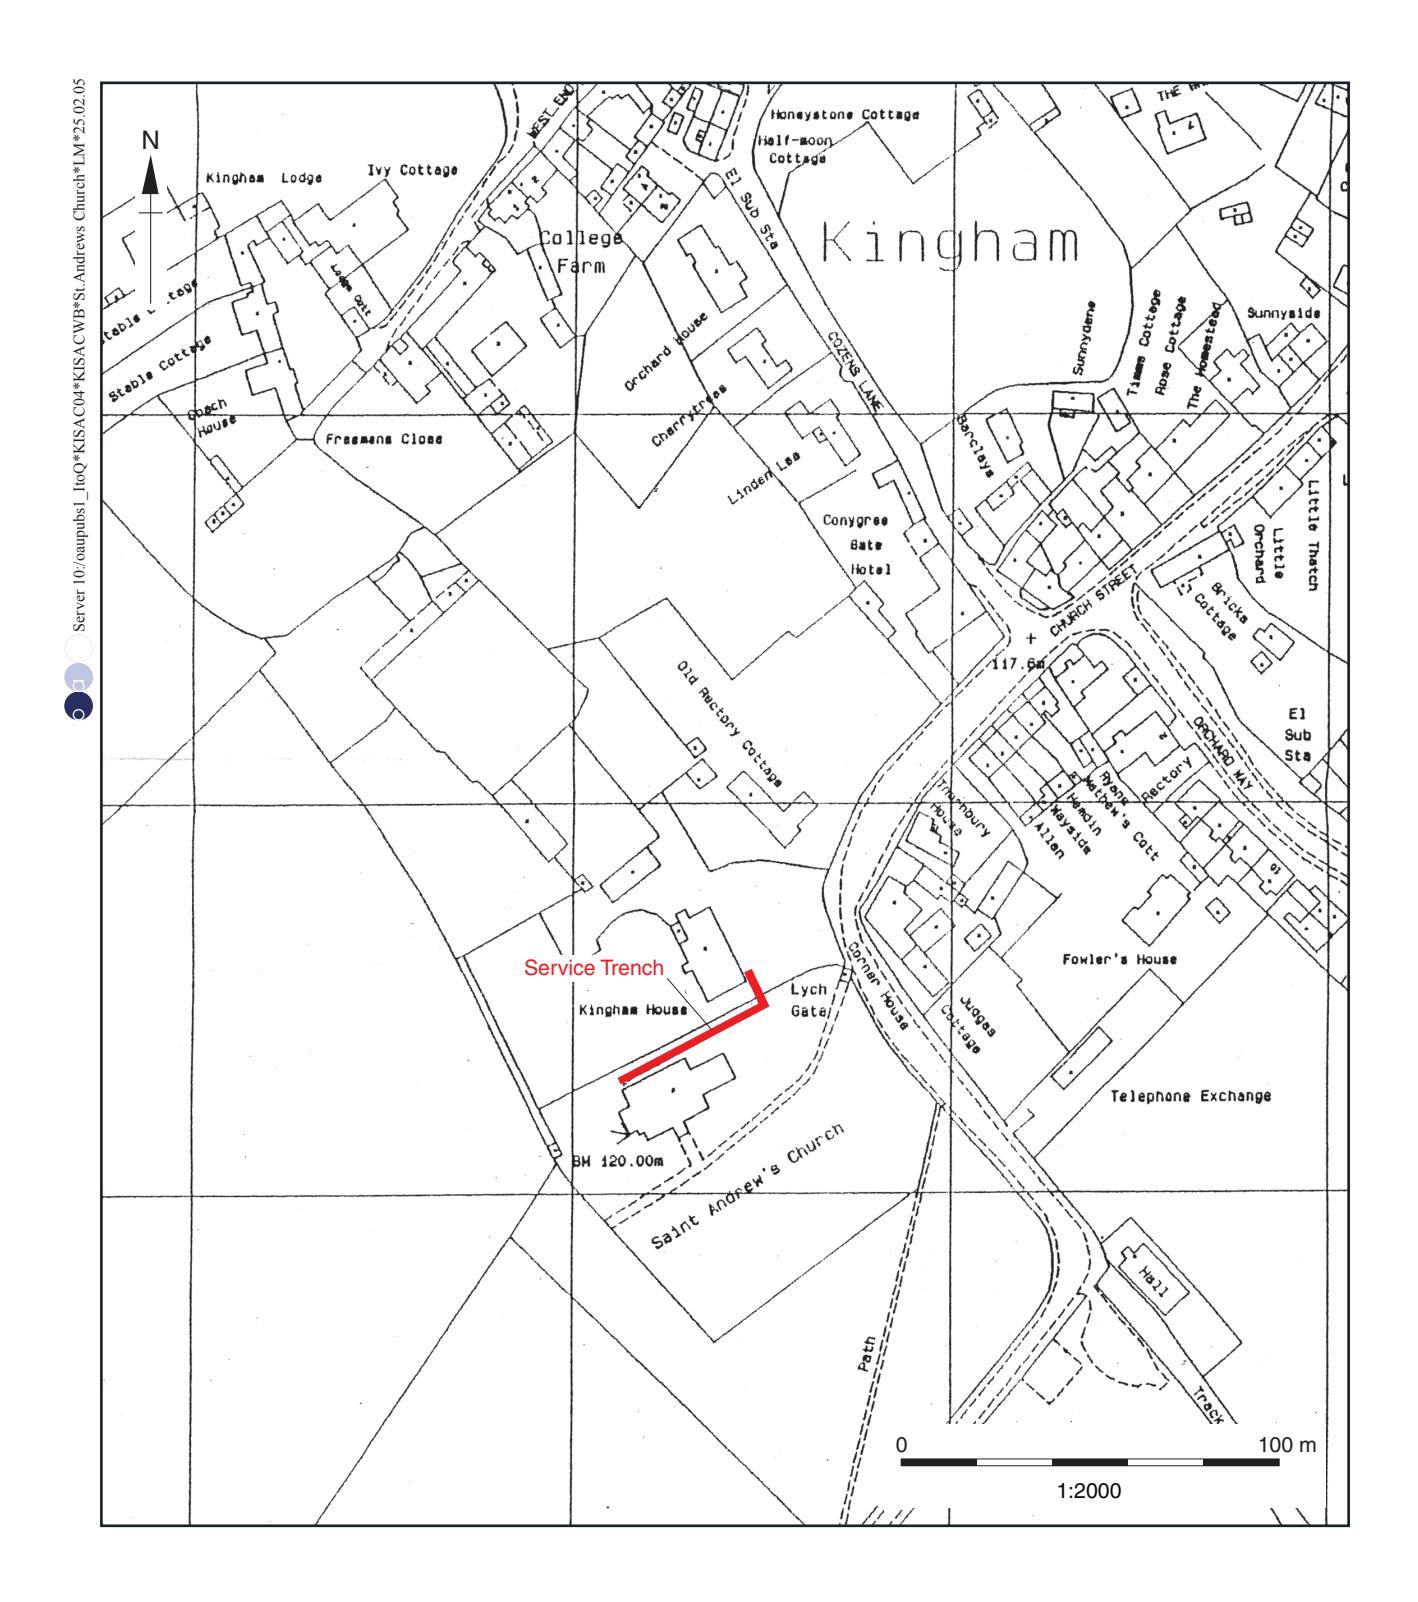
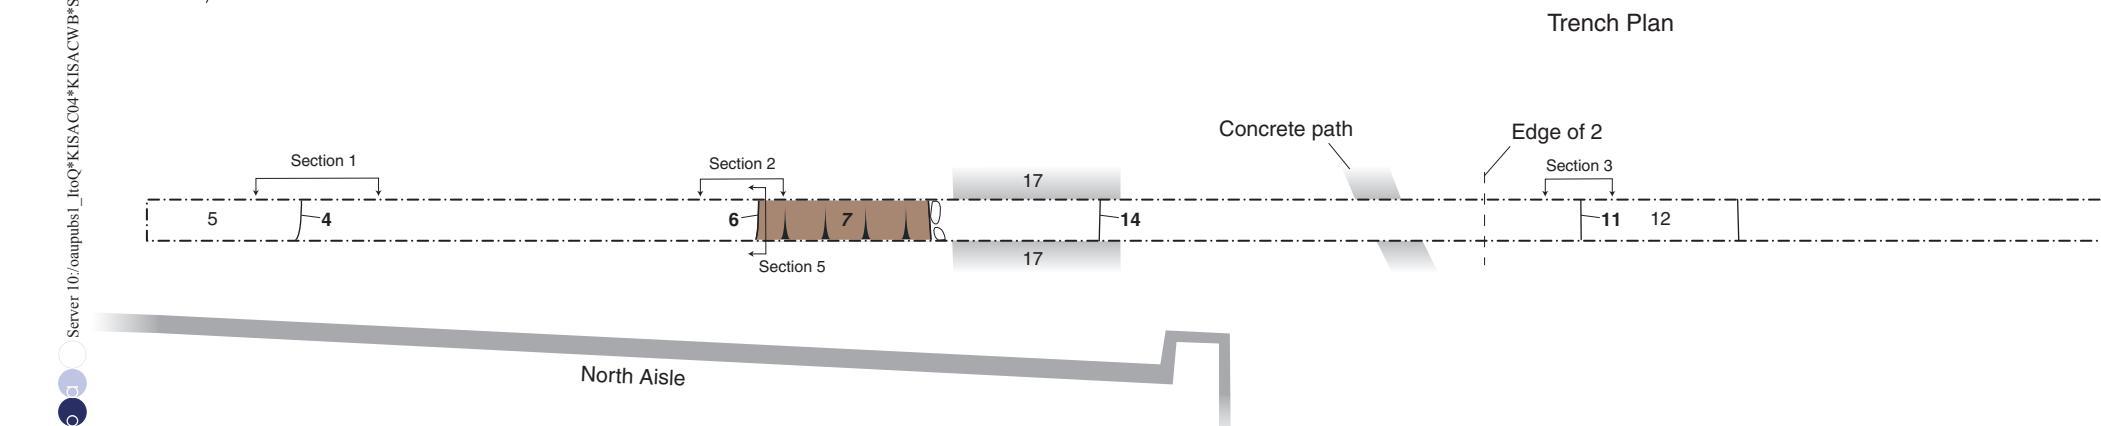
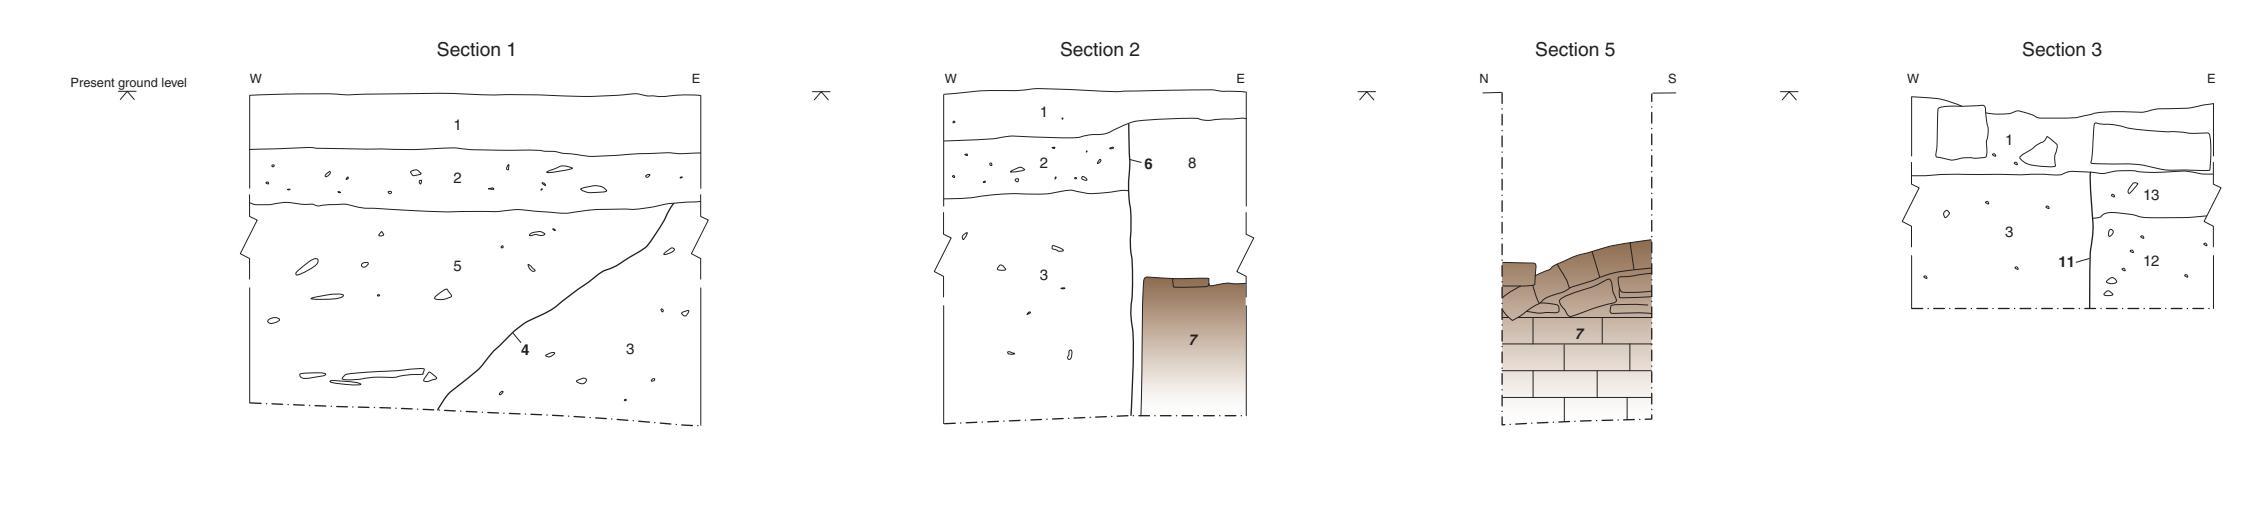
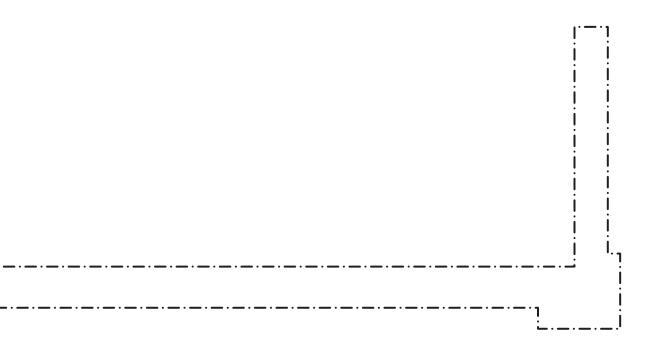
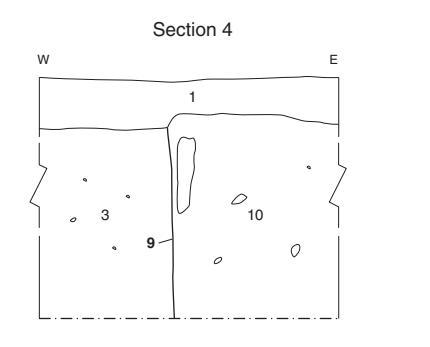
Figure 3: Service trench and sections

- 3.1.1 The service trench was 37.6 m east to west across the graveyard and turned 3 m northwards from the eastern end. It was 0.5 m wide and was 1 m in depth for the first 8 m and then was excavated to 0.8 m from the east end of the vault 15. The trench cut into a cultivated grave yard soil of light reddish brown silty sand (3). This layer had been cut by a number of features. These consisted of a charnel pit (4), which was partly exposed with a steep sloping side, but its base was below impact level. It measured 3 m x 0.5 m x 1.1 m and was filled with a dark brown silty sand loam (5) containing a lot of charnel. This had been sealed by a 0.2 m thick spread of 19th century building construction debris from the north aisle, which consisted of loose light reddish brown silty sand (2) with a lot of mortar and stone fragments and was observed for 17.5 m along the trench.

- 3.1.2 To the west of this two graves were observed in the trench. These were grave 9, which was partly exposed in trench with vertical sides, but base below impact. It measured 1.6 m x 0.5 m x 0.6 m and was filled by a light reddish brown silty sand (10) with patches of gravel. The second grave 11 was also partly exposed in the trench. It measured 2.1 m x 0.5 m x 0.5 m and contained two fills. The first a light yellowish brown silty sand (12), which was overlain by a dark grey brown (13) old disturbed topsoil. In this and the overlying graveyard topsoil (1) the fragments of a headstone and foot stone on a broken ledger stone. The foot stone was inscribed W B 1826 and the inscription of the headstone fragments read: *Sacred to died 6th May 1808 Aged Her loss will*. In neither grave was the burial exposed.

- 3.1.3 The 19th century building construction debris layer (2) had been cut by construction pits of two vaults 6 and 14. Pit 6 was partly exposed and measured 2.2 m x 0.5 m x 1.1 m with vertical sides, but its base was below impact. Exposed in this was a

rectangular brick lined vault (7) with a single skin barrel top and was built of bricks with a mortar bond. Overlying this was a loose dark reddish brown silty sand (8) filling in the pit. Directly to the east of this was a second pit 14, which measured 2.2 m x 0.9 m x 1.5 m and contained a 'coffin' shaped brick lined vault (15), of which only six courses of brick work was exposed with a mortar and stone cap, possibly supported on a wooden frame now rotted away. The remains of a lead coffin lining was visible, but not disturbed. Filling the grave over this vault was a light reddish brown silty sand loam (16). Overlying this was a 0.2 m thick concrete base (17) with two courses of limestone fragments. This was a monument base to the burial, which had been levelled off below the level of the graveyard. Sealing all these features was a 0.2 m thick very dark grey brown silty sand (1) cultivated graveyard topsoil.
