Gainsborough Building Bath

Archaeological Evaluation Report

The Proposed Gainsborough Thermal Spa Hotel, Beau Street, Bath

ARCHAEOLOGICAL EVALUATION REPORT

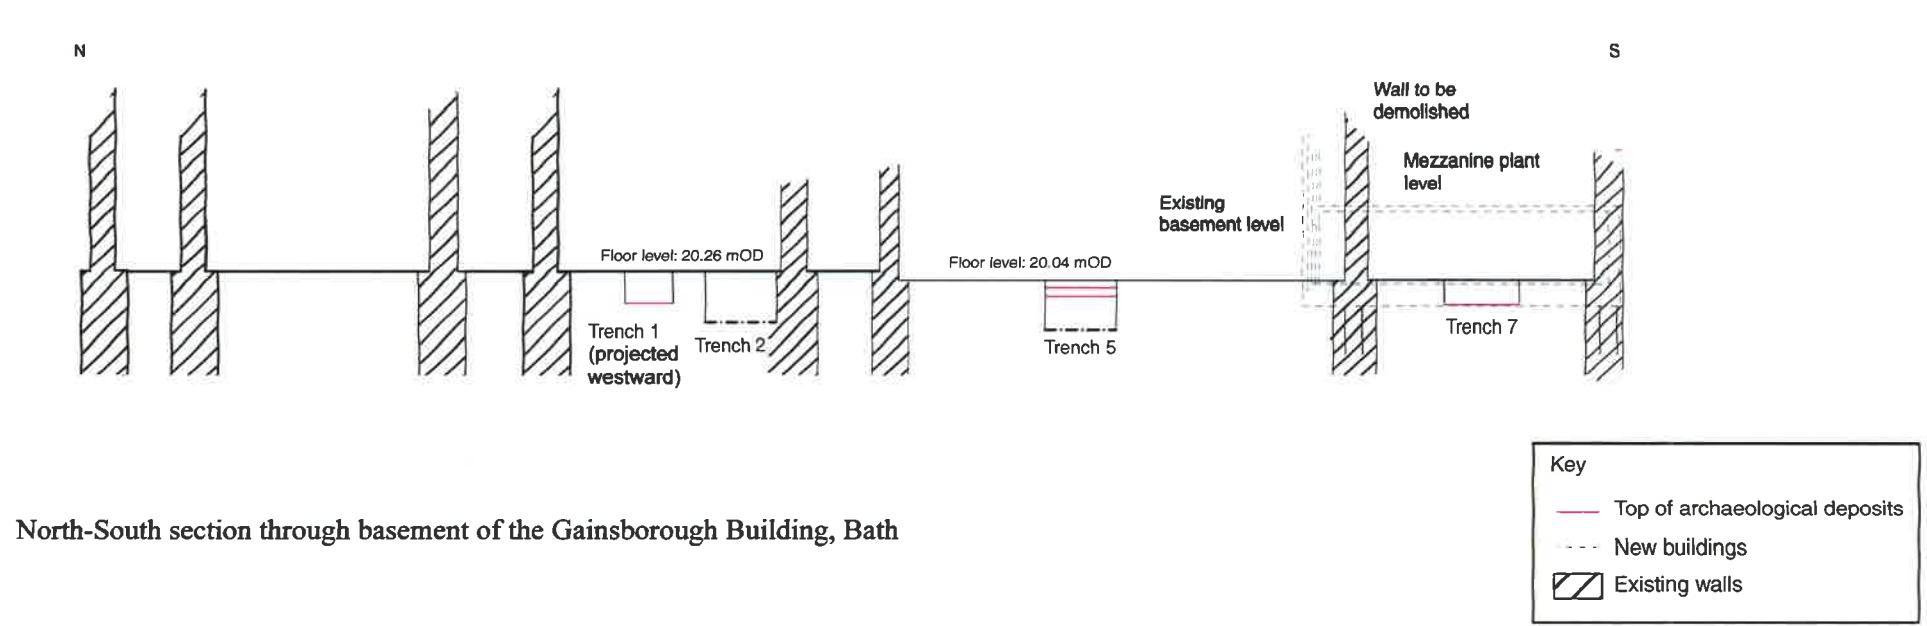
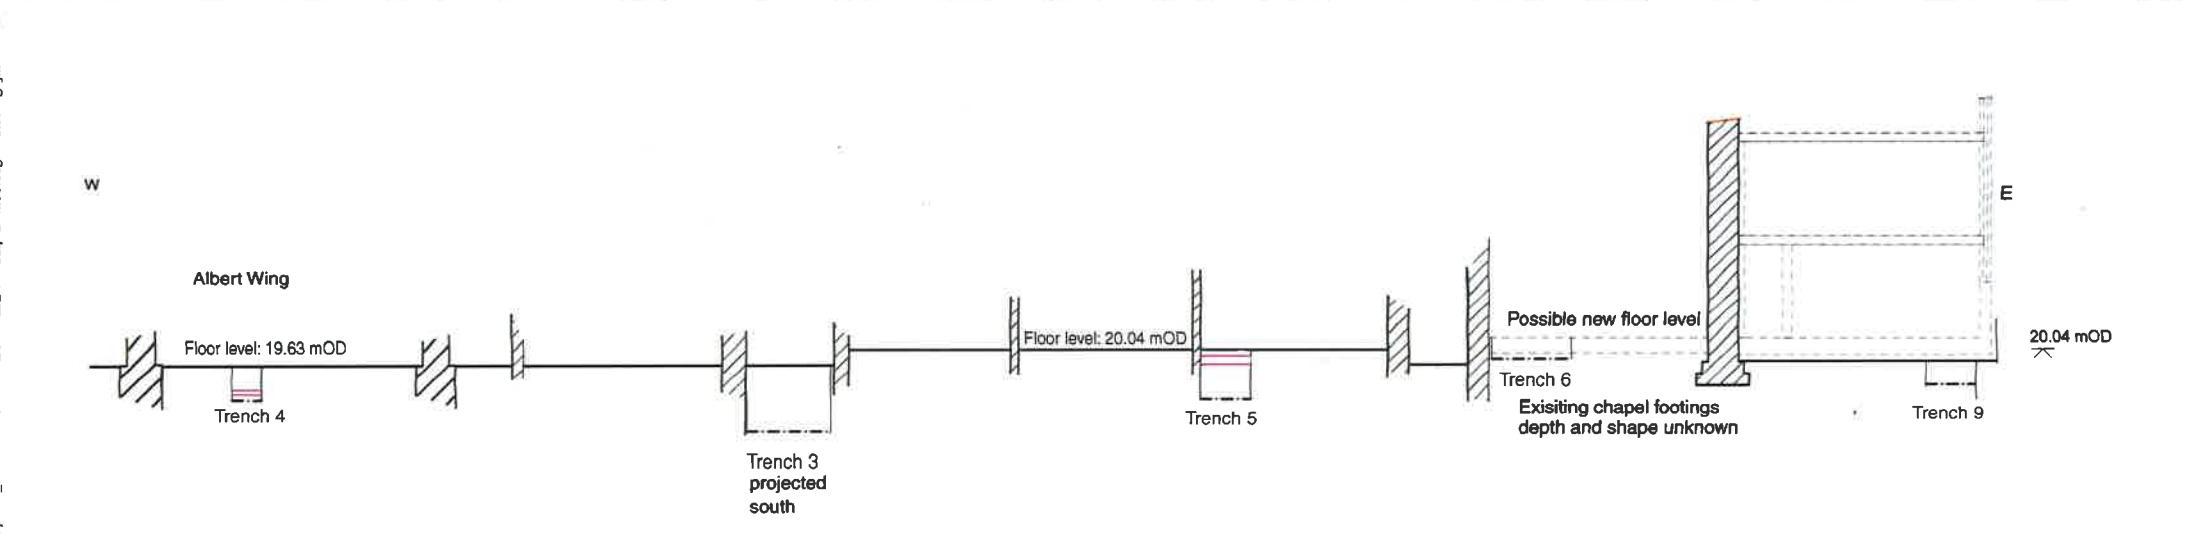
West-East section through basement of the Gainsborough Building, Bath

Figure 7: Sample cross sections showing archaeological deposits and proposed foundation design and potential impacts

8.1.1 The new build along the southern side of the site requires the insertion of new foundations in the form of concrete piles (Fig. 6 and 7). To reduce impact to a very low level, it is intended to insert these through the current masonry footings which form the north and south walls of the existing range (Fig. 6). On the assumption that no archaeological deposits remain under the base of the footings, this will have no effect on the archaeological layers and structures. Investigations are planned to confirm the depth of the footings and the lack of archaeological deposits under them.

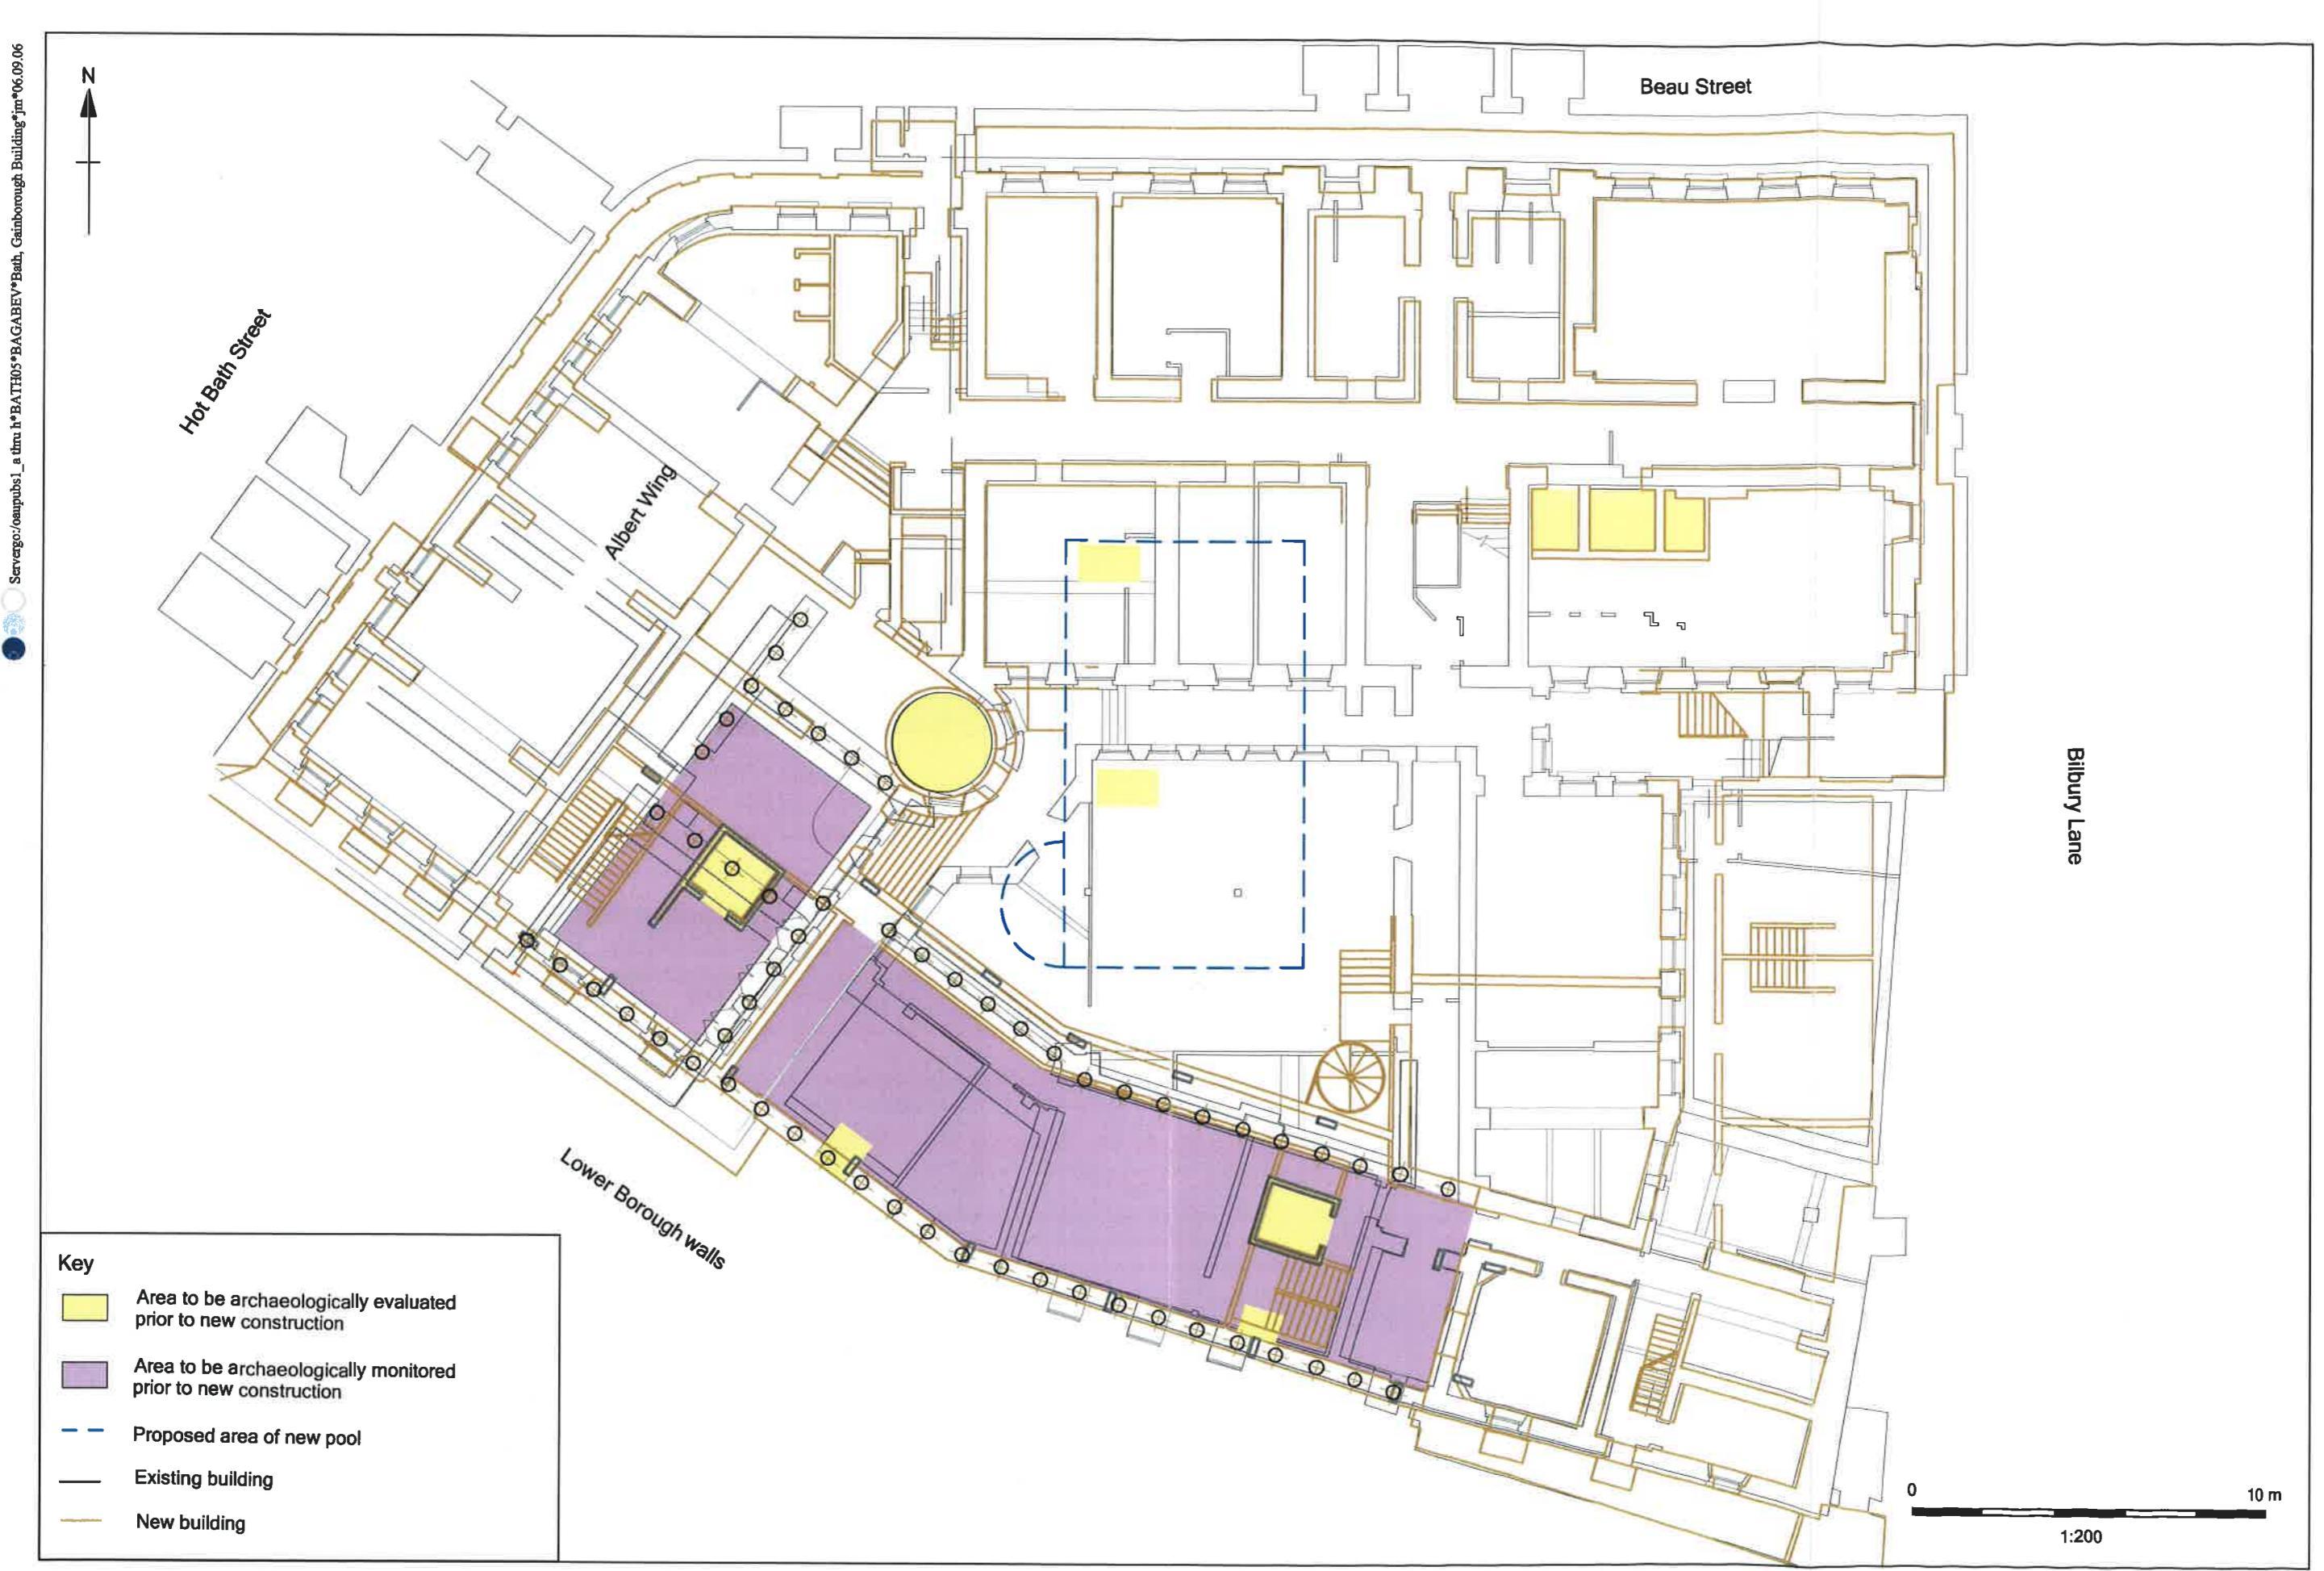
Figure 8: Proposed piling plan and areas where further evaluation and excavation may be required

- 8.2.3 Two baths are to be built in the existing building, requiring excavation below the basement floors (Figs. 6 and 8).
- 8.2.4 One of these will be a circular bath in the apse-ended room where Trench 3 was excavated (Figs. 6 and 8). The results from that trench showed that at least 1.15 m below the basement floor was devoid of deposits later than 1864 in that part of the room (the result of antiquarian excavation). It is likely that the trench is typical of this end of the room and that a bath could be inserted to this depth (or possibly even more) without causing damage to archaeological deposits.

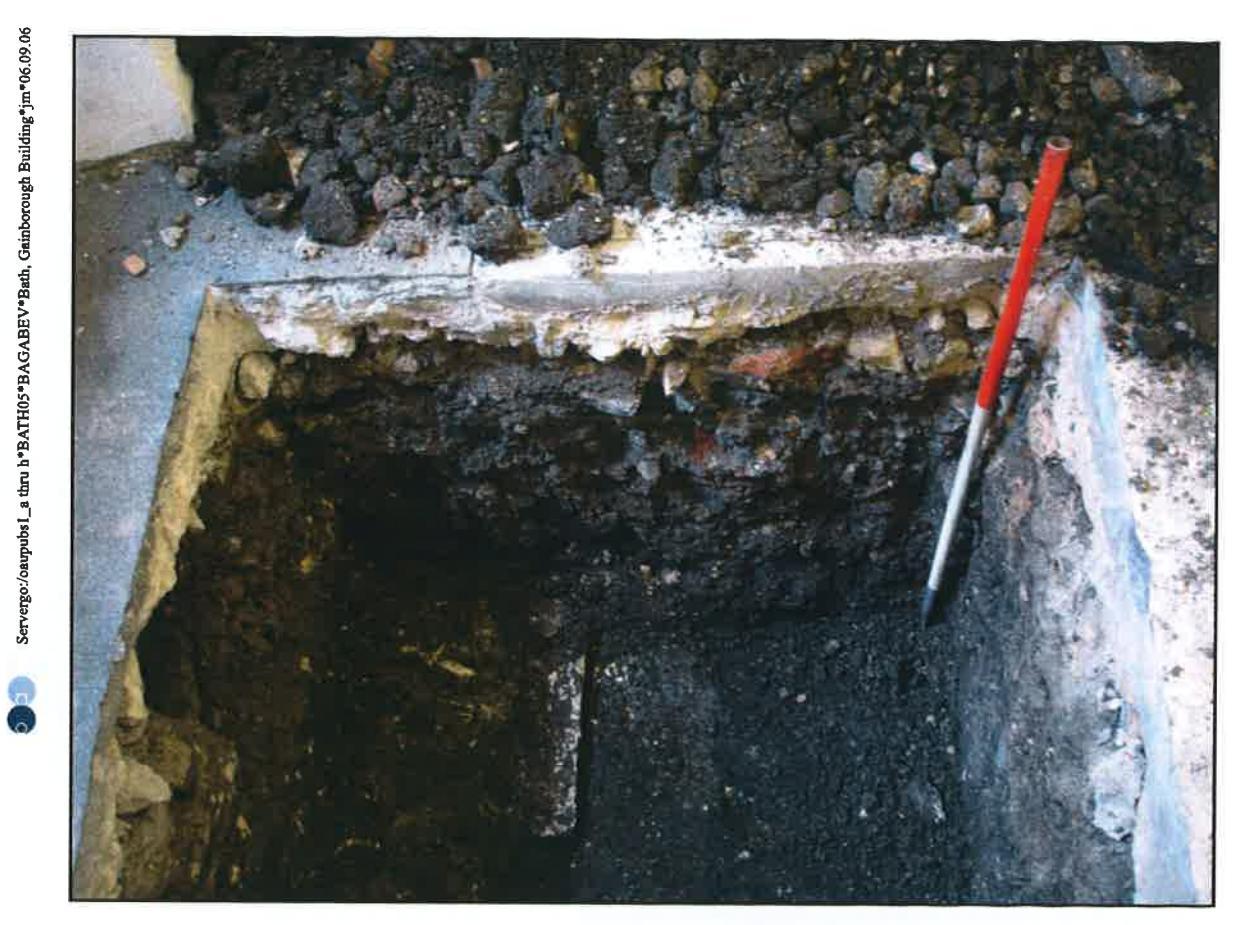
Plate 1. Trench 2 looking west, showing depth of post-1825 deposits

- 7.2.1 In this area the 19th century make-up layers abutting the footings of the existing building wall continued to a depth of over 1.33 m. No earlier deposits were recorded, and the area appears to have been dug away during or before the construction of the 1825 block (Fig. 3 and Pl. 1).
- 7.2.2 It is hard to imagine this being done for no good reason in the era of hand digging (a hand forged spade blade and socket with broken wooden shaft was found in the back fill). It may be that cellars of the earlier buildings here were filled in after construction was completed. That the deep excavation was not common to the whole 1825 building is shown by the survival of Roman remains in Trench 1 nearby to the east.

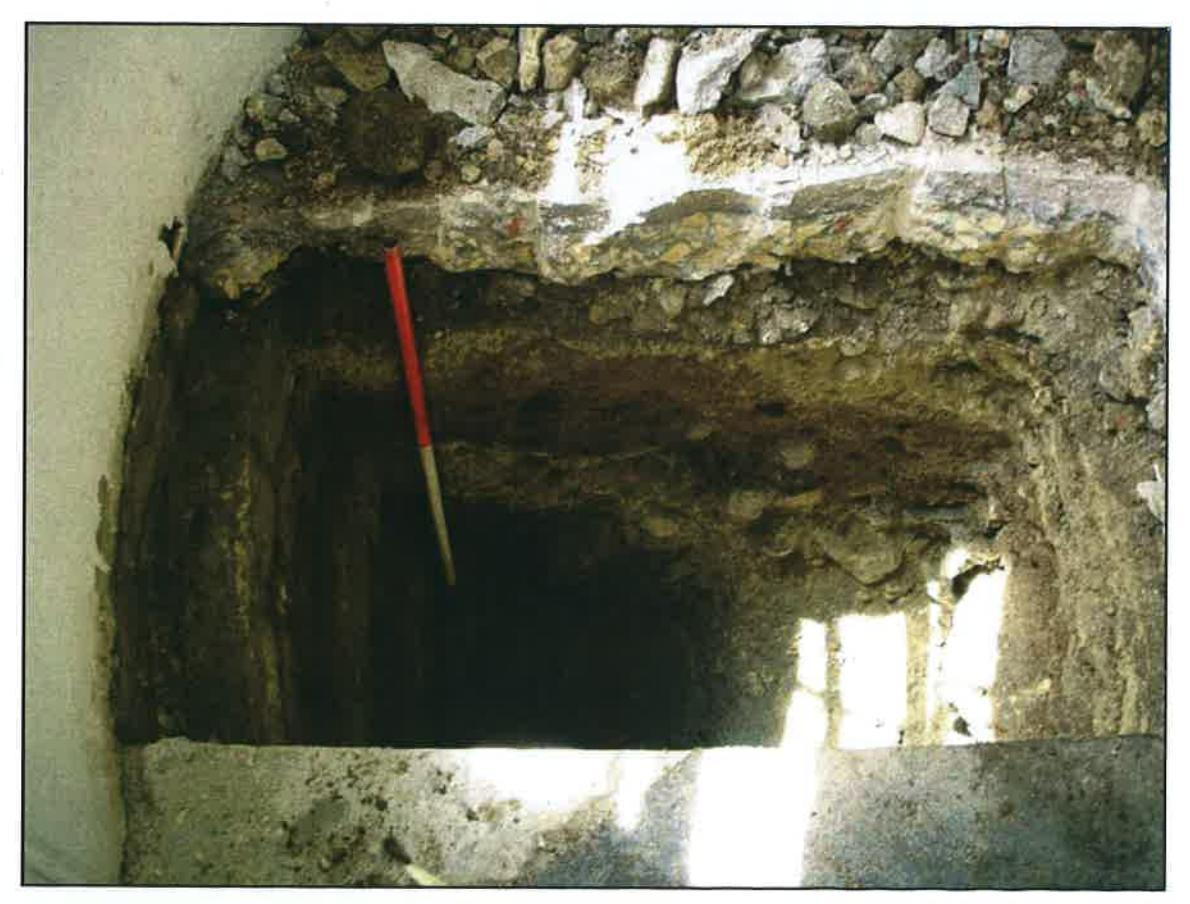
Plate 2. Trench 3 looking south-west. The curve of the bow window wall is evident on the left. All the fill shown is post-1864.

- 5.3.1 This trench was 1.4 m in length by 0.8 m wide and located adjacent to the apsidal wall at the southern end of a room in the central western part of the building (Figs. 2 and 3 and Pl. 2).
- 5.3.2 The trench was excavated to a depth of 1.15 m below floor level (floor at 19.61 m OD), where (305) a layer of moderately loose rubble mixed with lenses of topsoil and mortar and frequent charcoal was recorded. This also contained 19th century

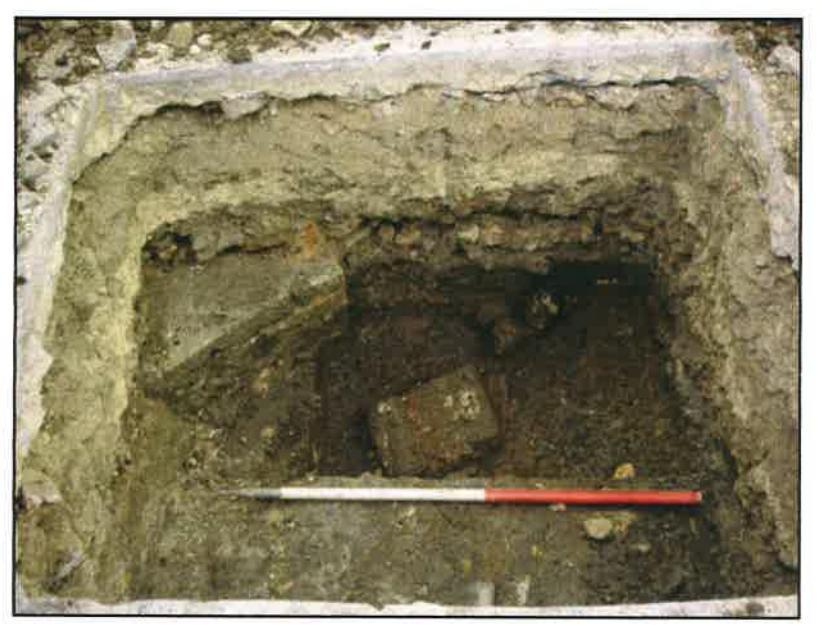
Plate 3. Trench 4 looking east. Post 1864 backfill has been removed showing the Roman buttress in the top left corner.

- 7.4.1 This trench revealed part of an RB stub wall, or buttress, the top of which was 0.65 m below floor level (Fig. 3 and Pl. 3). This wall was abutted by over 0.37 m in depth of later Roman stratigraphy, sampled to a depth of 1.05 m below floor level, the bottom of which was not found. There was also a straight-edged cut, of unknown purpose through the RB deposits, which appeared to be of Later Roman or post-Roman date? (see finds). In the area around the wall an irregular cut had been excavated through these deposits in the 19th century. This appeared to be an exploration dug by Irvine in the 1860s when he planned part of the Roman bath house building, including this butt end of wall.

7.4.3 This trench confirms that the archaeological remains that Irvine recorded in the 1860s will survive under the floors of the Albert wing, where not removed or damaged by later alterations. It also showed that the remains are slightly east of the position shown on Fig. 2, which was arrived at by "best fitting" the 19th century plans to the modern survey.

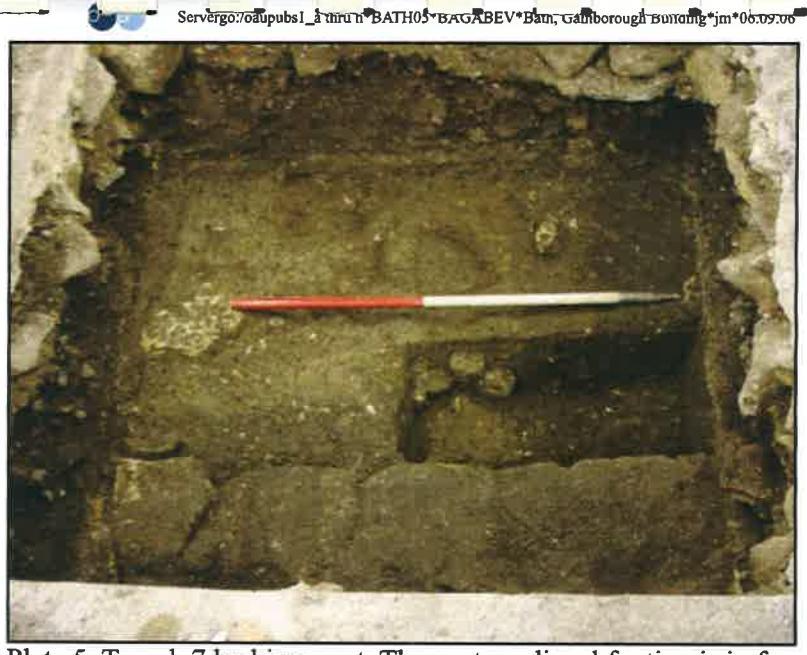
Plate 5. Trench 7 looking west. The post-medieval footing is in front and the Roman or post-Roman surface behind

- 5.7.3 On the southern side of the trench this deposit had been cut by a vertically sided feature [706], with a straight southern edge on a roughly east west alignment. The upper fill (707) was a soft, dark brown, compacted soil with frequent charcoal flecks, and occasional bone, pot (of medieval date but with one residual RB sherd), and one piece of slag. This deposit was excavated to a depth of 0.22 m but the base was not found.

- 5.7.5 A layer of dark brown, loamy soil, (705), with occasional medieval and RB pottery overlay the truncated wall. Layer (704), a hard white mortar 0.01 m thick with large black inclusions then overlaid this. Then there was a make-up layer, (703), of soil with frequent grey mortar 0.6 m deep. This was overlain by a further make-up layer of cinders and rubble, (702), 0.25m deep, and then a loose rubble make-up of large Bath stone blocks 0.17 m deep (701). The overlying concrete floor (700) was 0.15 m thick.

- 7.7.2 The "Roman or post-Roman horizon" is broadly part of the sequence seen in Trenches 5 and 8. The post-medieval footings may well be part of the foundations of the second Bave's house, erected around 1720.

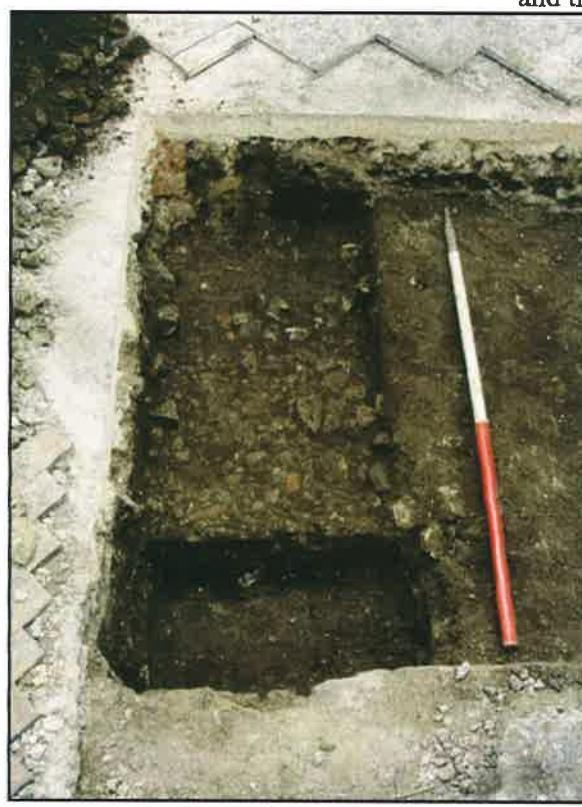
Plate 4. Trench 5 looking south showing the probably 13th century hardened surface.
