WALVERDEN WATER FLOOD ALLEVIATION SCHEME, NELSON, PENDLE, LANCASHIRE

Archaeological Watching Brief

Oxford Archaeology North

February 2006

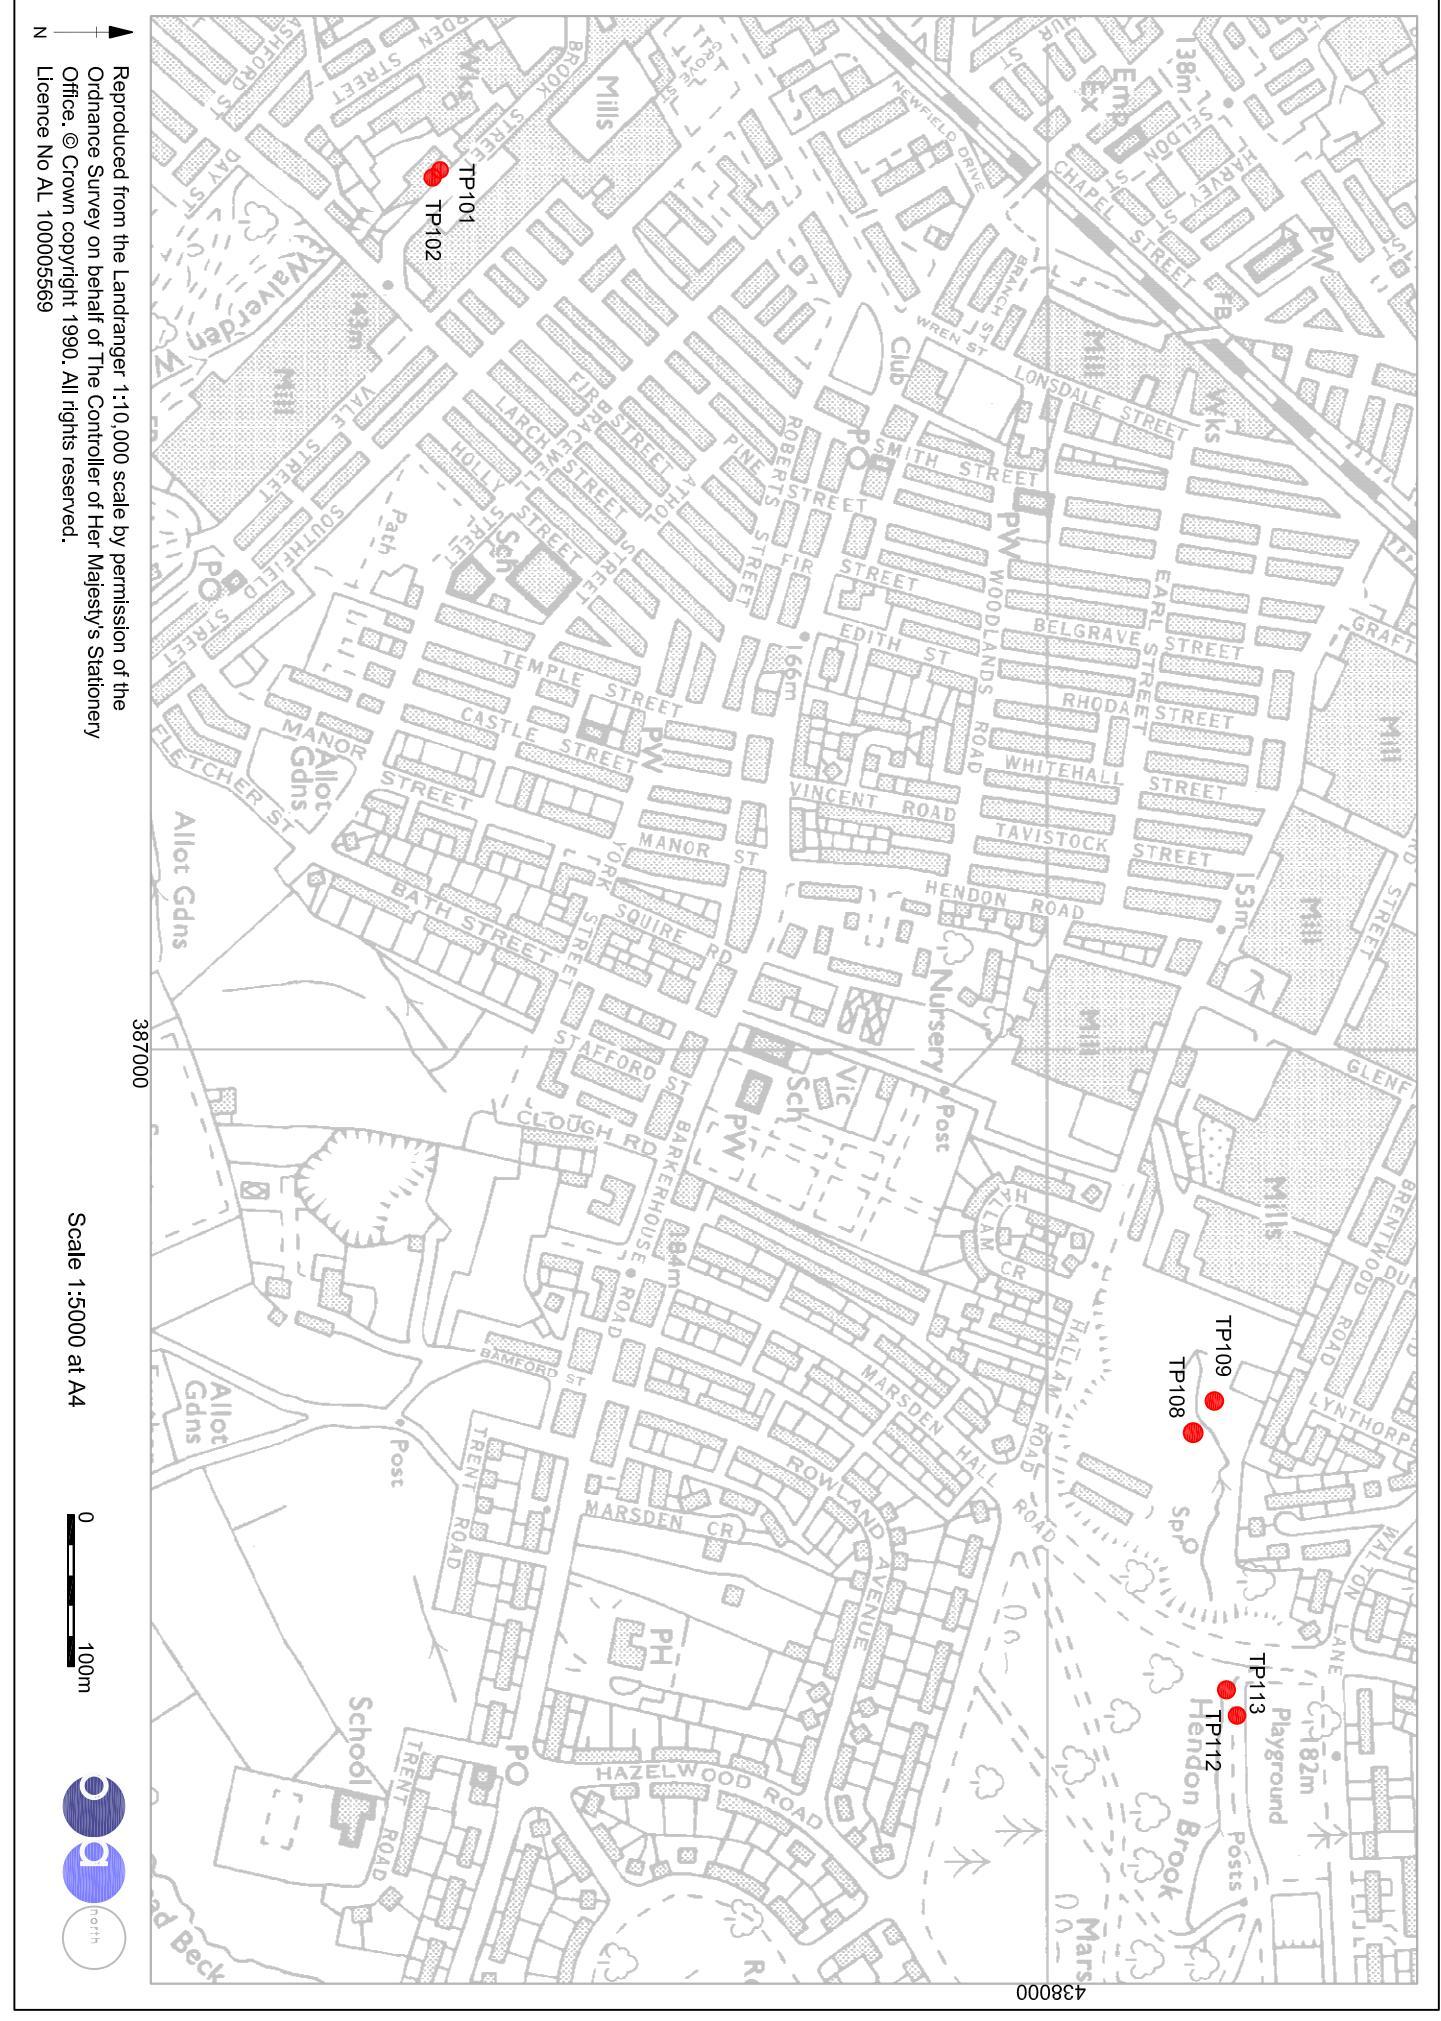
Figure 2: Test Pit location plan

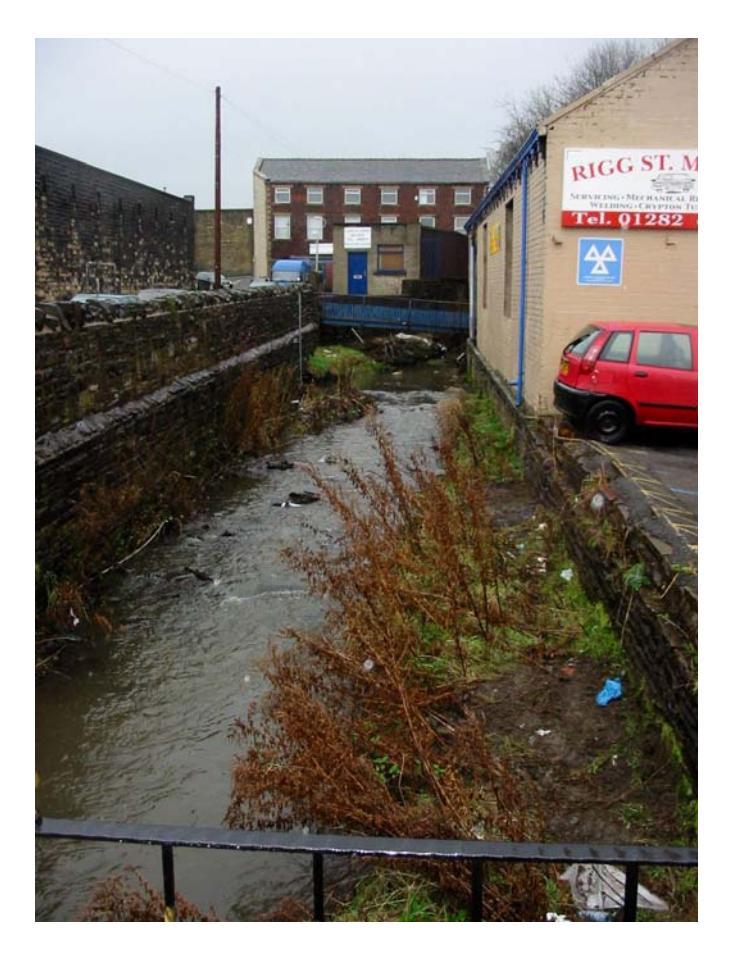
Plate 1: The Brook Street Culvert facing south, location of TP101 and TP102

- 4.1.1 *Introduction:* both of the Brook Street test pits, TP 101 and TP 102, were hand-excavated into an overgrown area which had developed within, the culvert against, the south-western face of a north-west/south-east aligned brick-built wall. This feature formed the north-eastern wall of the culvert and bounded, the south-western edge of a small carpark (Fig 2; Plate 1). The brick construction of this wall contrasted with the taller, stone-built wall on the opposite side of the culvert, which ran along the edge of Brook Street, and it is possible that this brick wall replaced an original stone-built culvert wall. Both test pits were located close together to the north of Brook Street's intersection with Chapel House Road and to the south of the Primrose Mill footbridge.

- 5.1.1 The concrete foundations contacted by the test pits excavated within the Brook Street Culvert are unlikely to be original features of what would appear to be an early twentieth century culvert: the material is of the wrong type (brick and concrete rather than stone) and, more importantly, the original foundations of the culvert wall should lie beneath the base of the culvert, much deeper than those that were exposed during the watching brief. The identification of the culvert as early twentieth century in this area relates mainly to the lack of the streambed cobbling which is so characteristic of the nineteenth century culvert in the Leeds Road area. This may suggest that areas of the culvert, particularly its walls, have already been affected by later developments. It is possible that only the south-western side of the culvert, along which Brook Street runs, was provided with a wall and, at the time of construction, there was less need for such a structure on the less-heavily used north-eastern side of the culvert. Given the circumstances, it is likely that change to the culvert profile caused by the insertion of this later brick wall was influential in the build-up of deposits in this area. However, there is also a good chance that the original base of the culvert survives intact beneath the more recent concrete footing.

that prior to any destructive works at these locations, a targeted programme of photographic recording should be undertaken, supported, where appropriate, by basic (ie, without recording individual stones) measured plans and sections of the culvert itself.

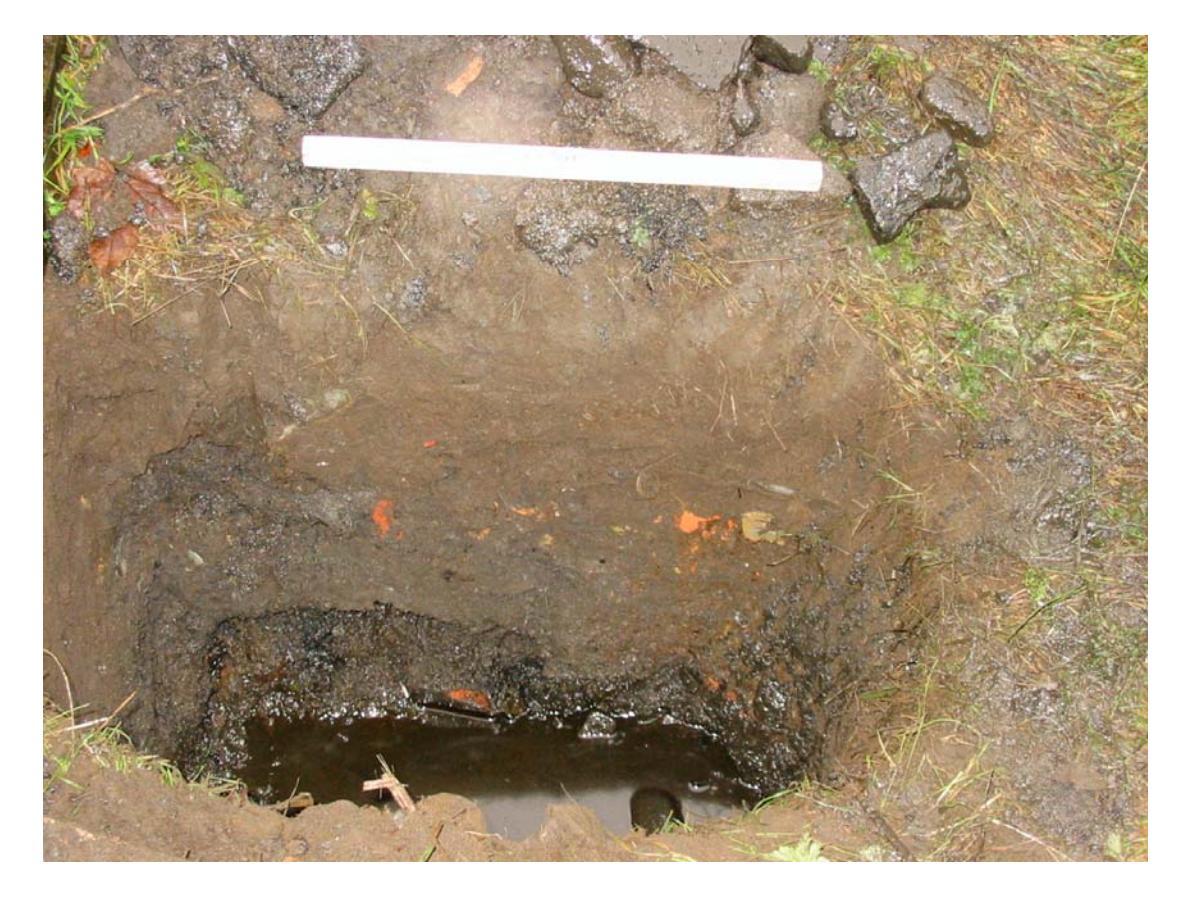
Plate 2: South-west-facing section of TP102

- 4.1.3 **Test Pit 102:** TP 102 was excavated just to the south-east of, and on the same alignment as TP 101. TP 102 measured 0.75m x 0.5m, and was excavated to a maximum depth of 0.7m. The exposed stratigraphy comprised a mid-brown sandy-clay soil with 10% inclusions of small-to-medium sub-rounded stones and broken brick, contaminated with waste oil (Plate 2). As in TP 101, the concrete base of the adjoining brick wall was revealed at 0.7m depth, precluding further excavation. No archaeological features were revealed and no artefacts were found.

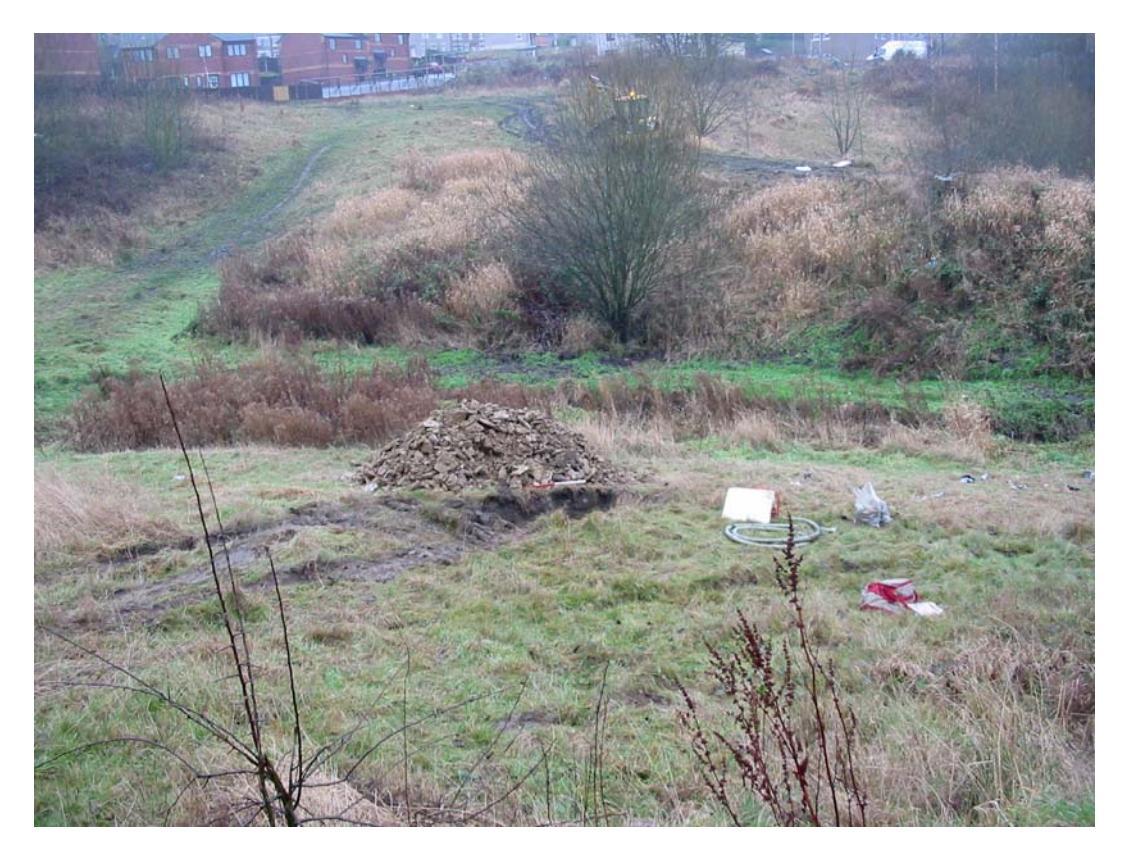
Plate 3: Glenfield Park facing south, location of TP108 and TP109, TP109 in foreground

- 4.2.1 *Introduction:* the Hendon Brook runs overland through Glenfield Park for approximately 150m on an east/west alignment, before dipping below the modern ground surface within the western part of the park. The test pits in this area, TP 108 and TP 109, were both excavated by a mechanical excavator using a toothed bucket on steeply rising ground either side of the banks of the Hendon Brook (Plate 3).

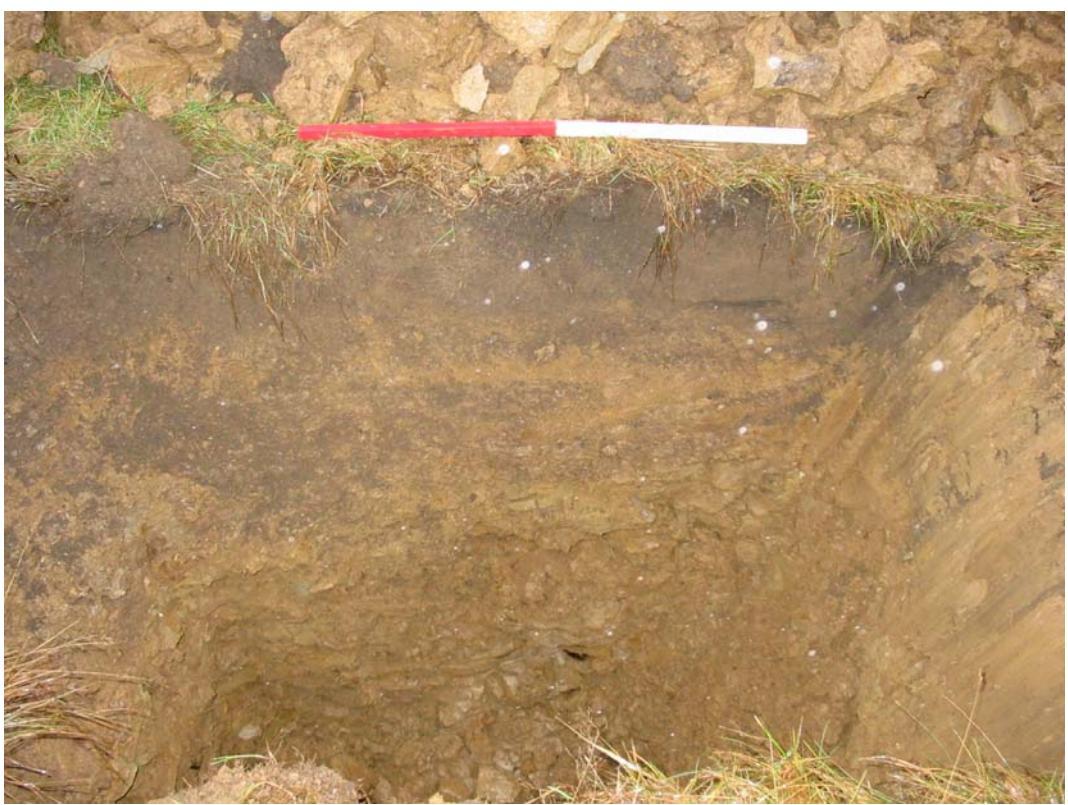
Plate 4: North-facing section of TP109

4.2.3 *Test Pit 109:* TP109 was excavated to the north of the brook on a north-west/south-east alignment and measured 0.85m x 0.5m with a maximum depth of 0.75m. The section revealed a 0.5m deep mid-brown topsoil of friable sandy-clay over a subsoil of orange-brown firm clay with 10% inclusions of small sub-angular stones. No archaeological features were revealed.

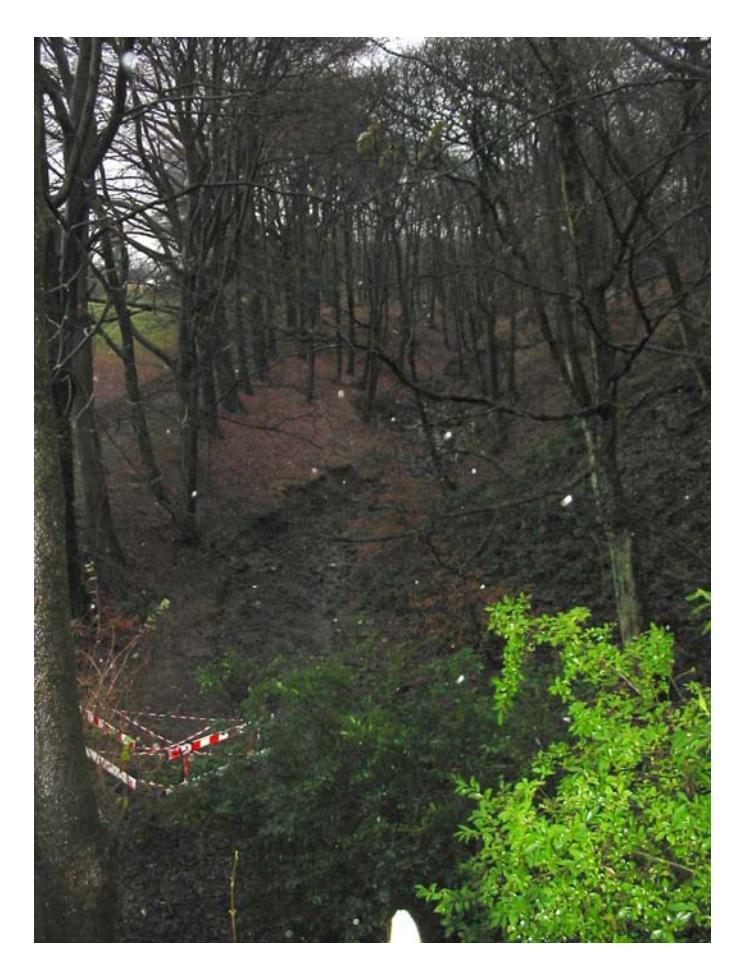
Plate 5: Marsden Park, location of TP112 and TP113

- 4.3.1 *Introduction:* the Hendon Brook runs for approximately 150m across Marsden Park on a rough east/west alignment. Test Pits 112 and 113 were excavated into steeply-rising wooded ground by a mechanical excavator using a 0.8m wide toothless ditching bucket (Plate 5).

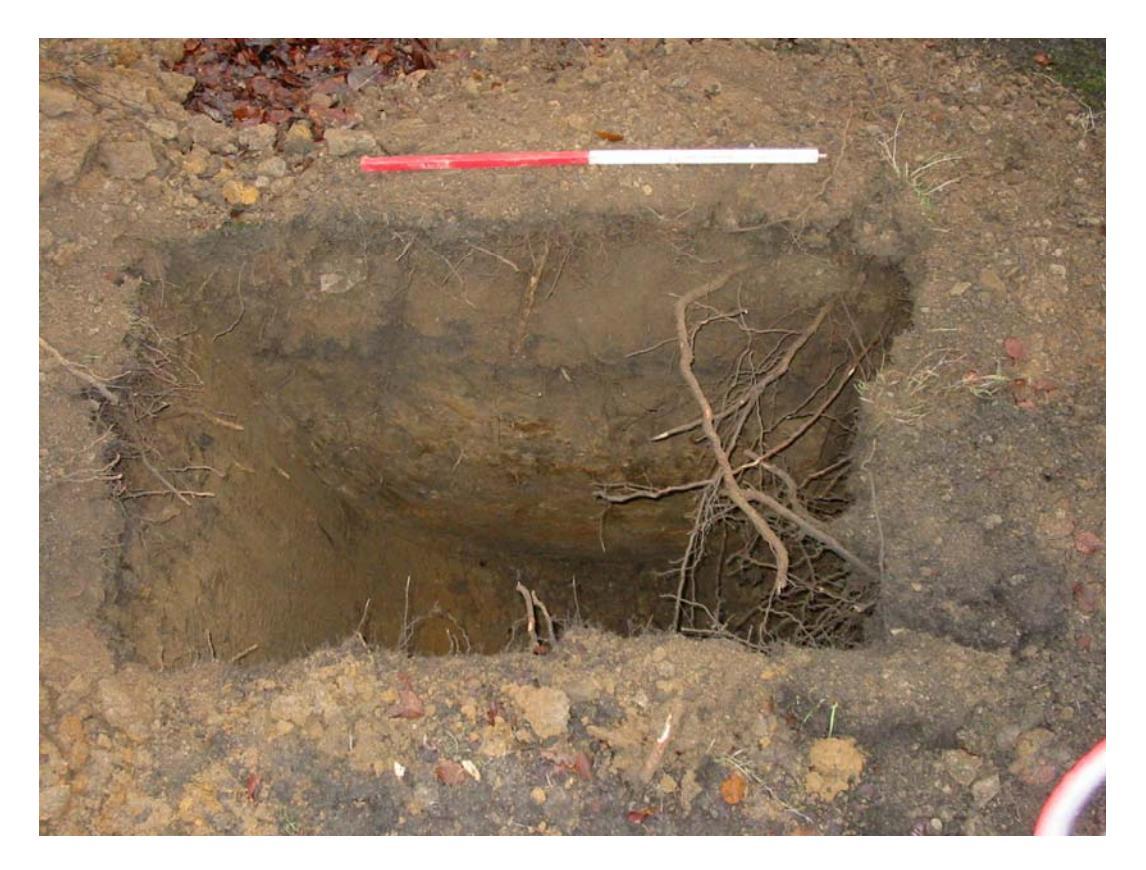
Plate 6: South-west-facing section of TP113

- 4.3.3 **Test Pit 113:** TP113 was on a north-west/south-east alignment 20m west of Test Pit 112, measured 1.5m x 1m and was dug to a maximum depth of 2m. The section revealed a blackish-brown friable loamy soil 0.05m in depth. Below this topsoil was a layer of firm yellowish-brown sandy-clay with the occasional small sub-rounded stone. The millstone grit bedrock was exposed at a depth of 2m and no archaeological features were encountered.
