# Former W H Shaw Pallet Works Archaeological Watching Brief and Strip, Map and Record Report

**Client: Interserve Construction Ltd**

Issue No: 2 OA Reference No: L2098/2020-2021 NGR: SE 00155 07284

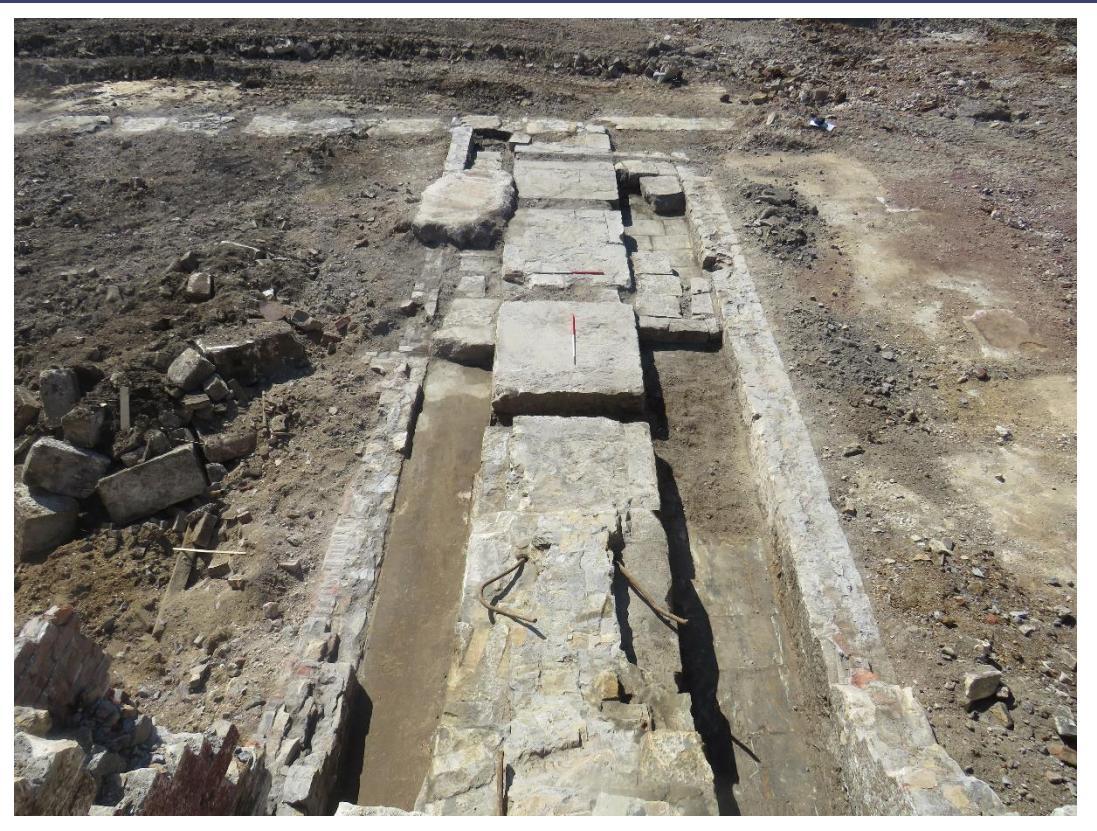
Plate 7: Foundation of the engine house looking west, following excavation (with 2 x 1m scales)

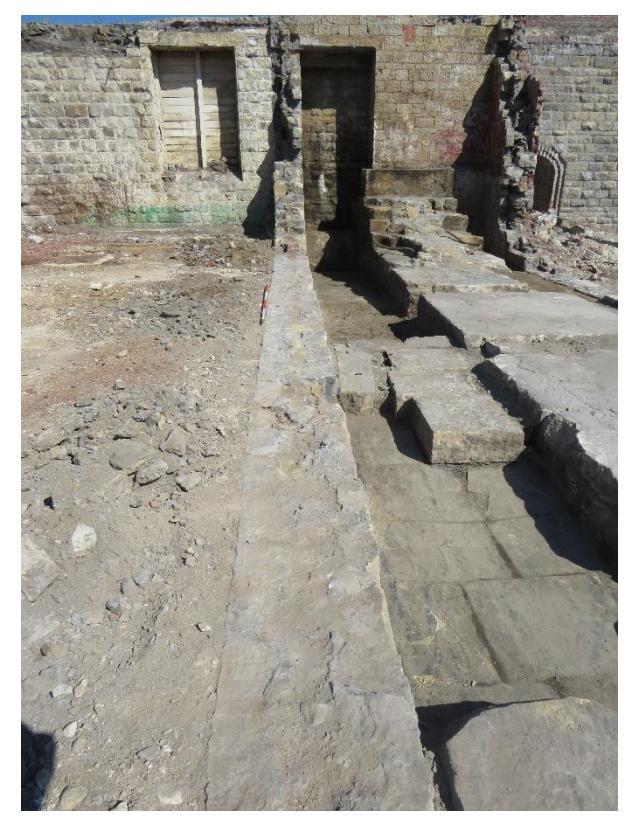
Plate 8: Wall 100, facing east (with 1m scale)

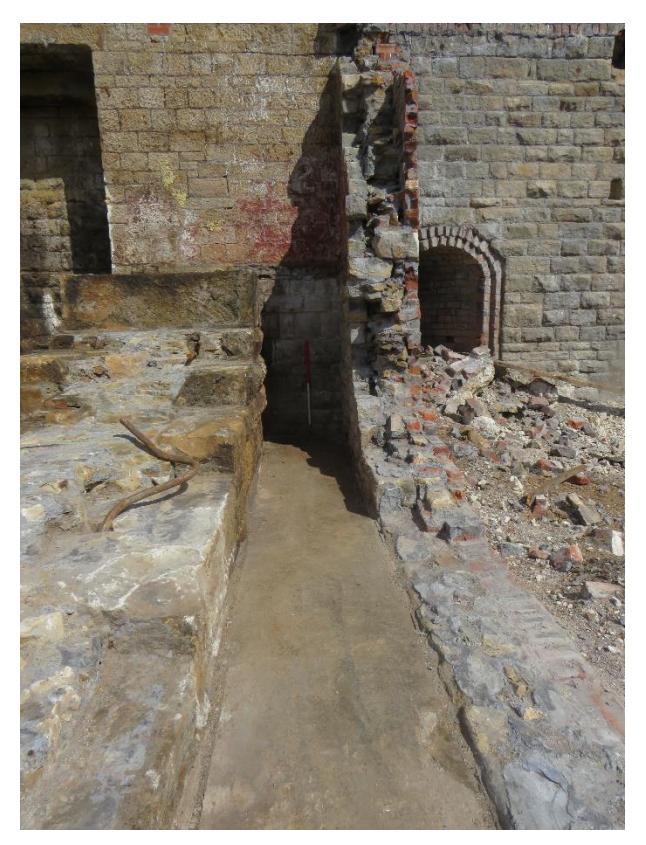
3.4.2 At 16.1m in length, the southern wall (**101**) extended slightly further to the west, but its construction was otherwise identical to wall **100**. It typically survived to a height of only 0.3m, but again, to the east, it was preserved as a fragmentary stub, 3m in height, where it joined the retaining wall (Plate 9).

Plate 9: Wall **101** (right) facing east, with engine beds (left) and floor **108** (centre)

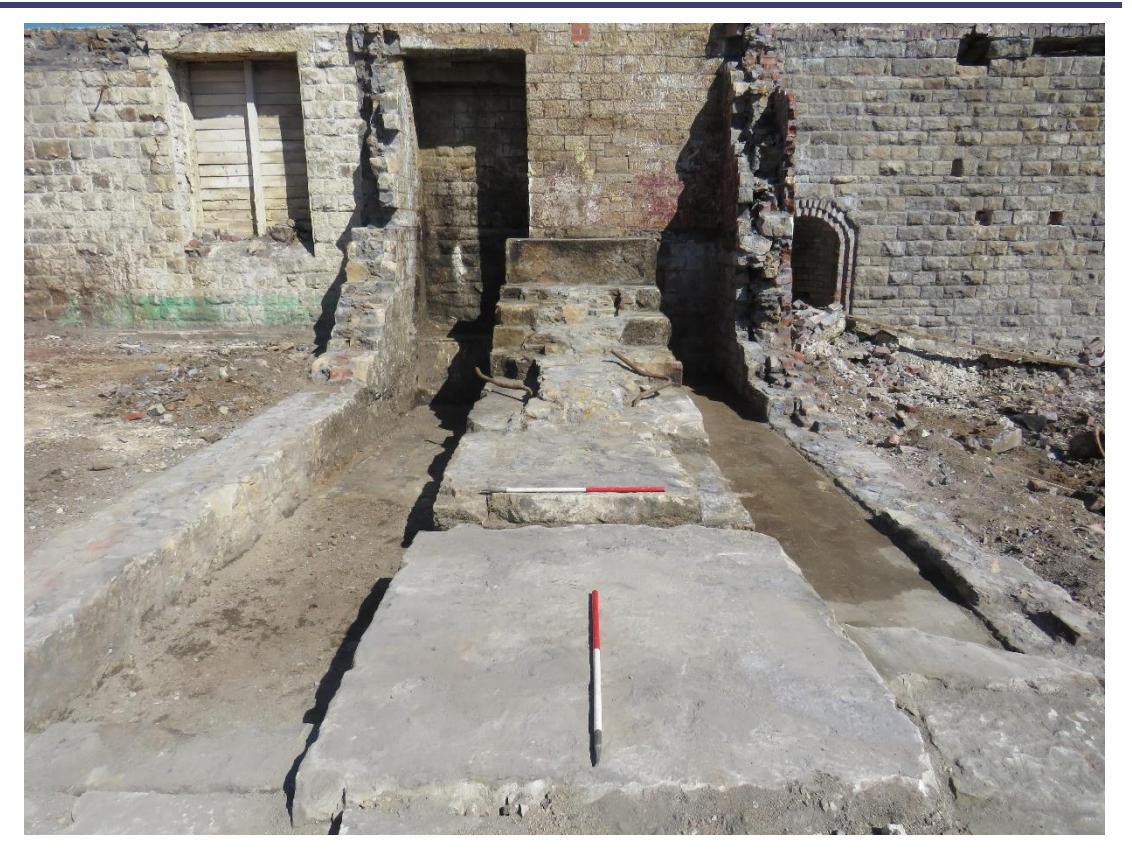
3.4.3 Between walls **100** and **101**, and sharing their alignment, lay several raised platforms, 2m in width and divided by a series of narrow voids 0.5m across. The largest platform (**102**) was to the east, measured 6m long and was constructed with a series of rectangular sandstone blocks defining its northern, southern and western sides (Plate 10). Between these blocks, a rubble core, bonded with a compacted lime mortar, comprised the remainder of the platform, which typically stood to a height of 0.58m but survived to over 1.5m at the eastern end, where it abutted the retaining wall. To the west, a pair of circular-sectioned iron bars protruded vertically from the sides of the rubble core (Plate 9), but had been bent over horizontally during demolition.

Plate 10: Engine beds 102 (background) and 103 (with 2 x 1m scales)

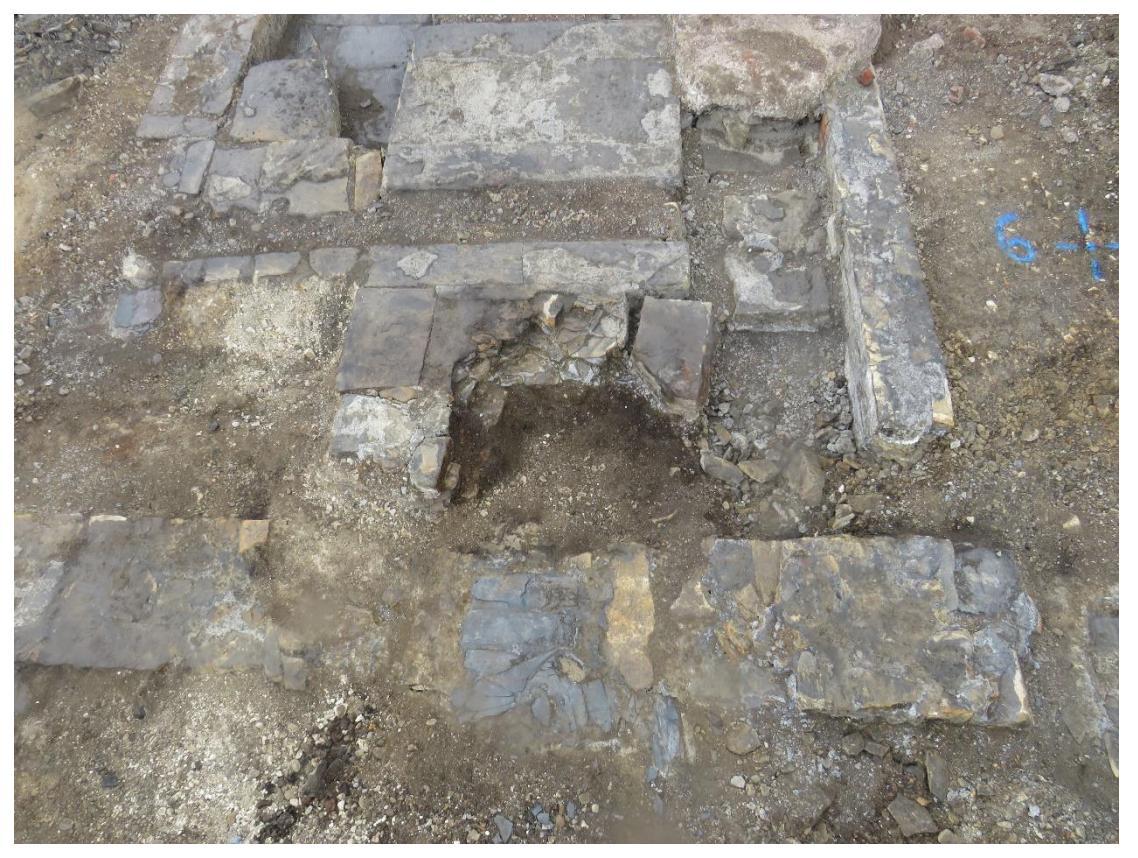
- 3.4.4 Platform **103** was to the west of platform **102**. This was smaller and square, 2.1m long, but of a similar construction. However, it had been reduced to just 0.47m in height and did not feature the same iron-bar protrusions (Plate 10).
- 3.4.5 A third platform (**104**), with a length of 2.5m, lay to the west and survived to a height of 0.38m, with a smaller fourth platform (**105**) beyond, that was 1.8m long and stood to a height of just 0.34m. To the west again, there was evidence to suggest there had been a fifth platform (**106**) of similar dimensions to the last, but its south-western corner had been removed, leaving the feature in a fragmentary condition (Plate 11).

Plate 11: The remains of platform **106**, with the northern end of wall **112** (bottom) and wall **109** (top left)

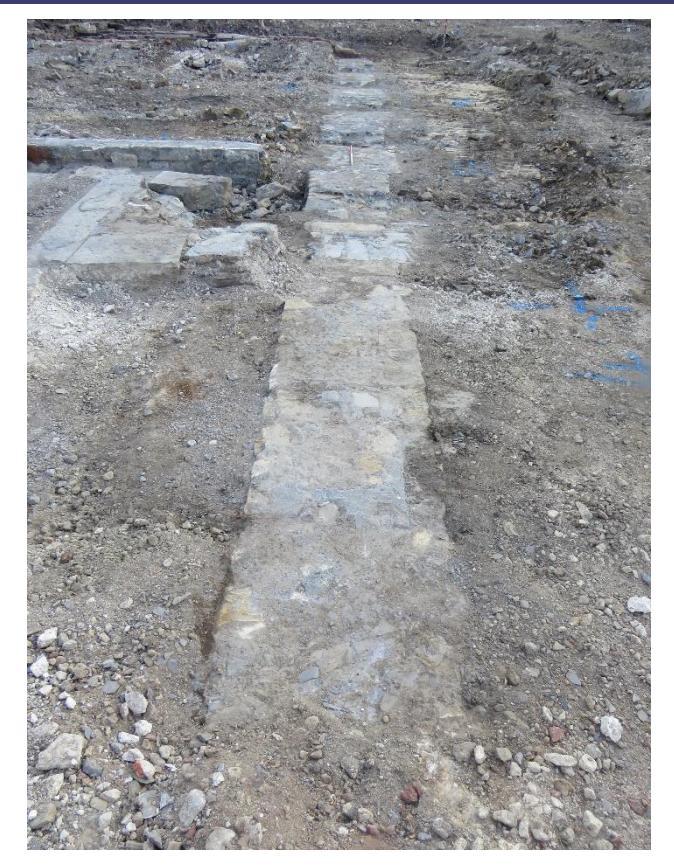
3.4.6 The remnants of this platform appeared to abut the western wall of the structure (**112**). This was a north/south-aligned wall of sandstone rubble, 0.8m wide, that extended for a length of 20.4m, continuing well beyond the southern wall of the present structure (Plate 12).

Plate 12: Wall 112, facing south

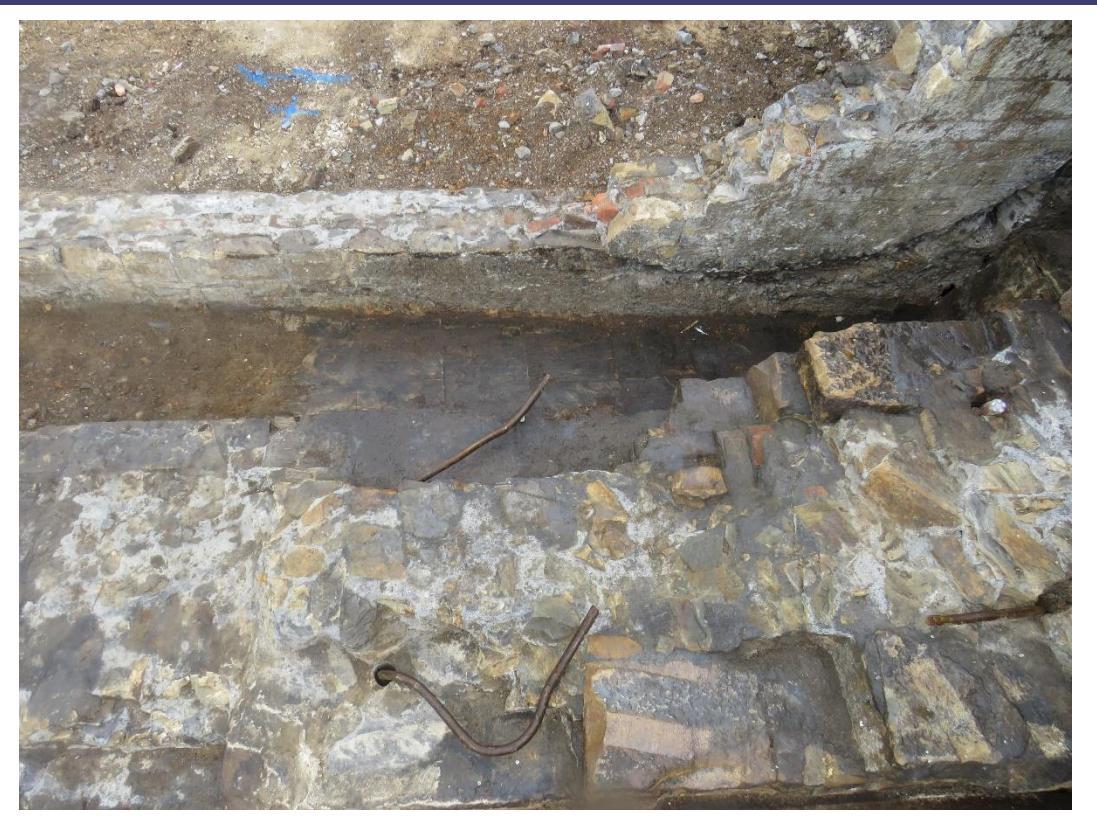
3.4.7 Between wall **100** and the raised platforms (**102-106**) lay a channel, 1.3m wide, that extended nearly the full length of the structure from east to west. Although lost from the central portion, the base was covered with rectangular flagstones (**107**) that bore evidence of soot staining (Plate 13). Towards the western end, some of these stones had been raised as a small platform, but it was unclear if this represented a later alteration, as their appearance perhaps suggested that these were secondary (Plate 14). At the western end of floor **107**, a short section of single-skinned sandstone wall (**109**), 1.6m long and 0.2m wide, extended in plan south from the projected continuation of wall **100** to intersect with platform **106** (Plate 11).

Plate 13: northern channel, showing flagstone floor **107** at the eastern end, facing north

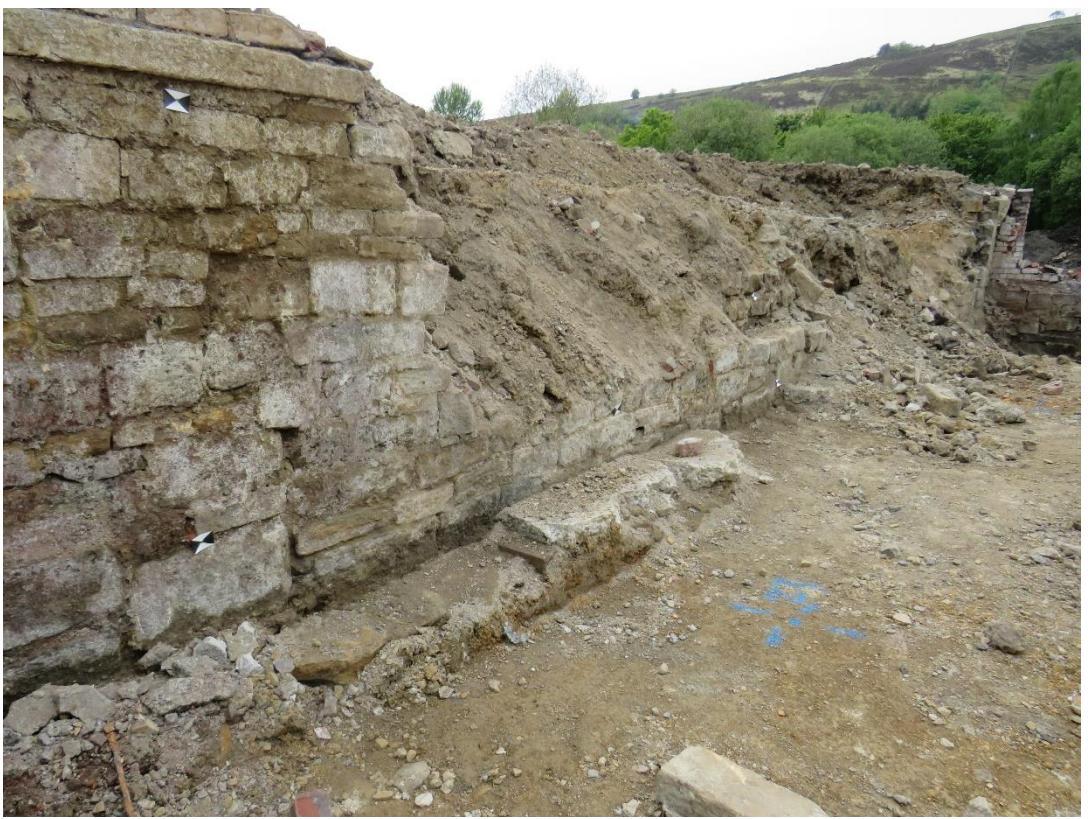
Plate 30: North-east-facing elevation of the south-western wall, facing south-west, with a window lintel (left) and the remnants of a floor (centre)

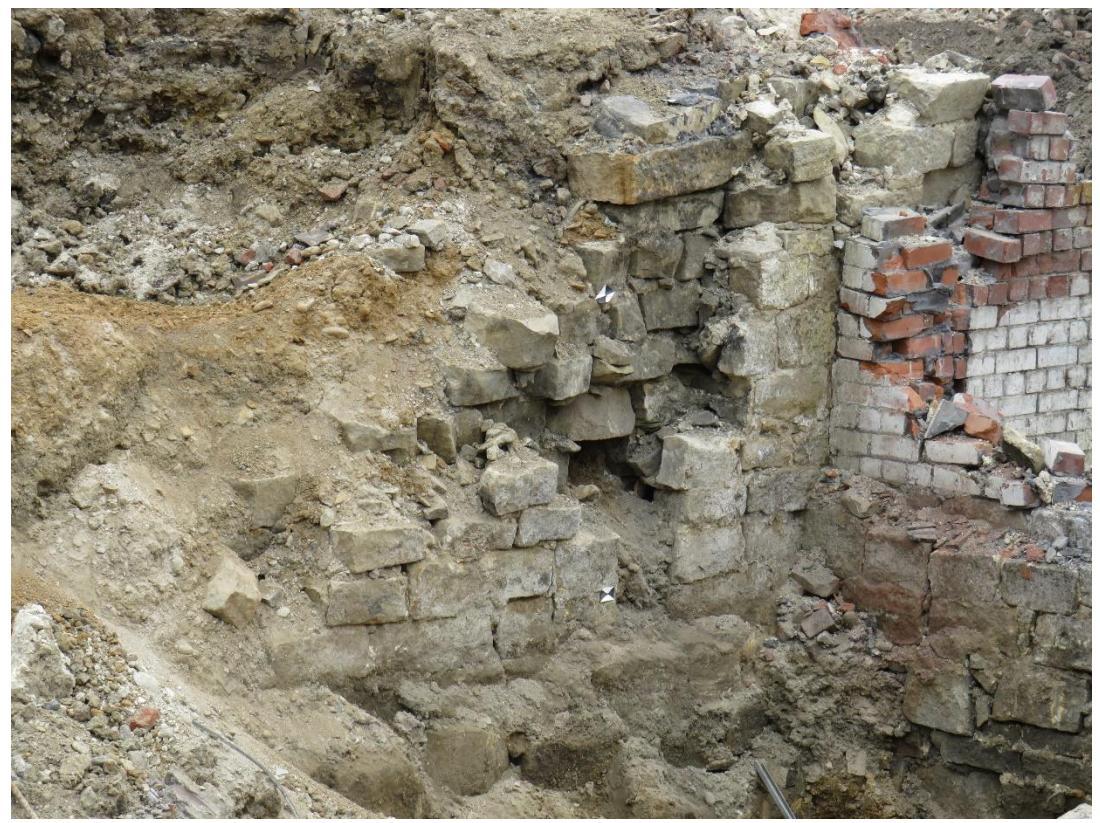
3.4.20 At its south-western end, wall **300** turned once again at a right-angle back towards wall **303** for an additional 7.4m, preserving at its north-eastern end another horizontal sill with evidence on this example of blocking in machine-made red brick (Plate 30). Much of the remainder of this south-western length of wall **300** survived to a height of no more than six courses, but towards it centre the lower three courses stepped forward as a low plinth. The north-western end of the wall survived in poor condition, but where it adjoined wall **303**, it was just possible to see that it had continued on to the north-west, beyond the line of **303** (Plate 31).

Plate 31: The north-western end of the south-western part of wall **300**, with the continuation of wall **300** beyond wall **303** (right)

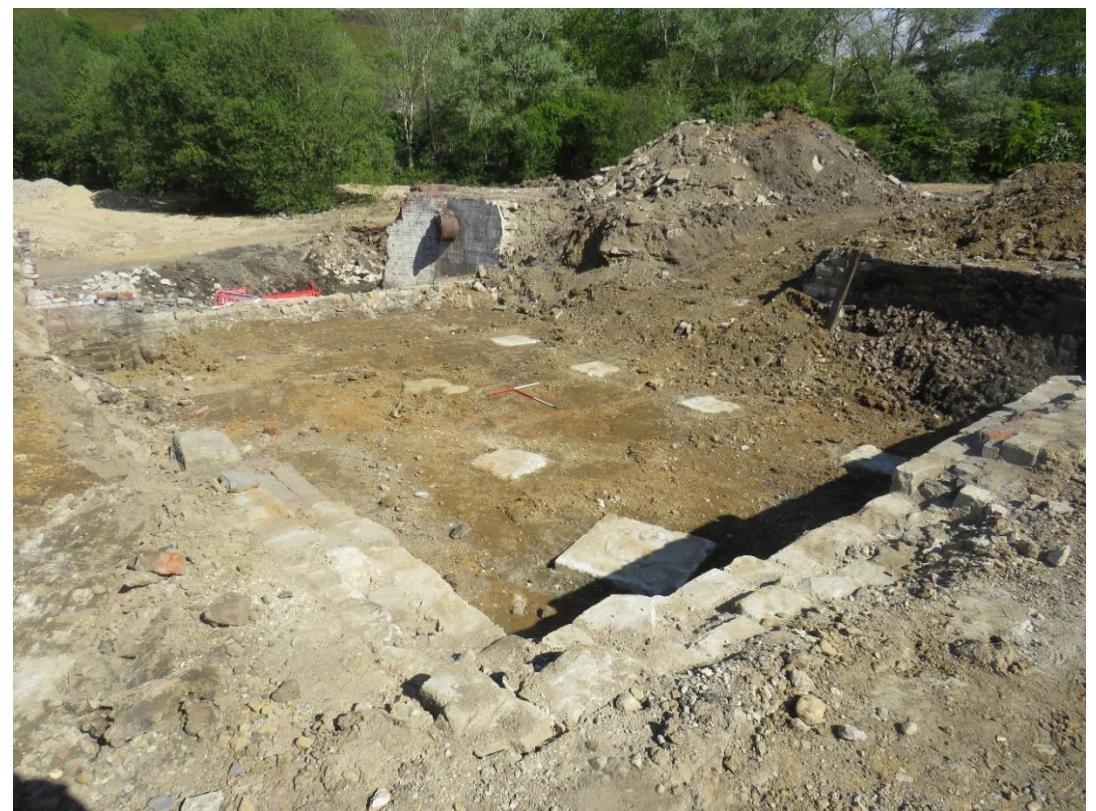
3.4.21 Clearance of the building's interior revealed a row of four concrete post-pads (**301**), extending along the north-eastern side of the building (Plate 32). The pads measured between 0.75m and 0.8m square and had been laid directly upon the natural sand. Only the south-eastern two pads survived of what must have been a corresponding second row along the opposing side of the building, the most easterly of which, at 1.2m square, was the largest and had been rotated at 45° to the remaining pads.

Plate 32: View of Wrigley Mill, facing north-west (with 2 x 1m scales), with post-pads (**301**) (centre)

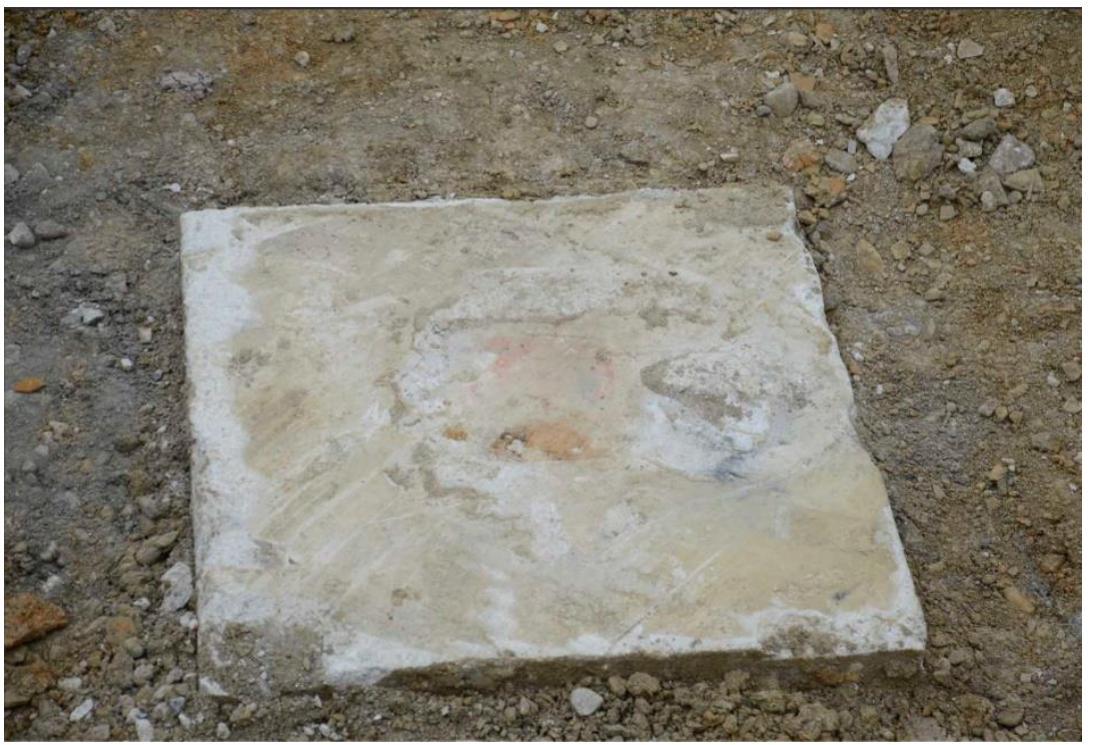
3.4.22 At least one of the post-pads retained the impression of having borne the weight of a square-section post (Plate 33). The height of the pads and the identification of the undisturbed natural sands and gravels beneath them determined that the approximate floor level had stood 1.8m above the apparent floor level to the west of wall **303**. Very little of the original floor to the east of wall **303** survived, consisting of just a small area of concrete abutting the south-western wall, and another section lying against the centre of the south-eastern wall (Plate 30).

Plate 33: Impression of a post on a post-pad

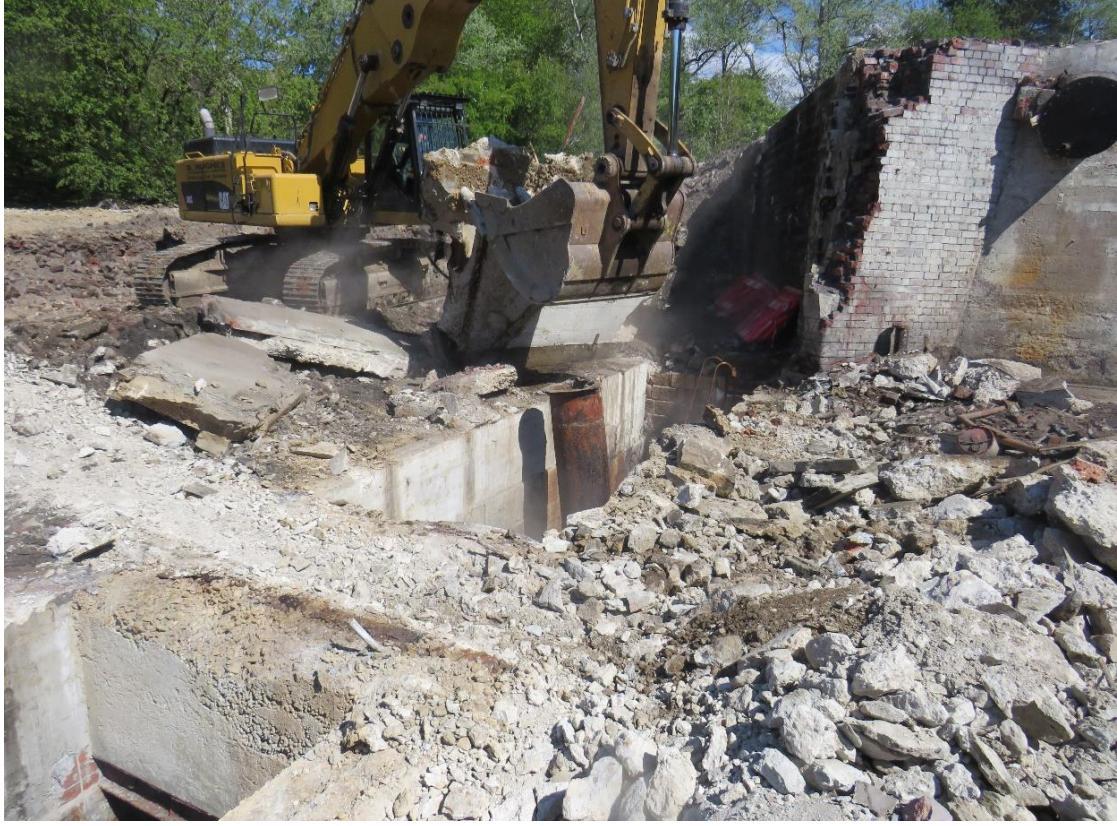
Plate 34: The subterranean chamber, during the removal of the concrete slab, facing north

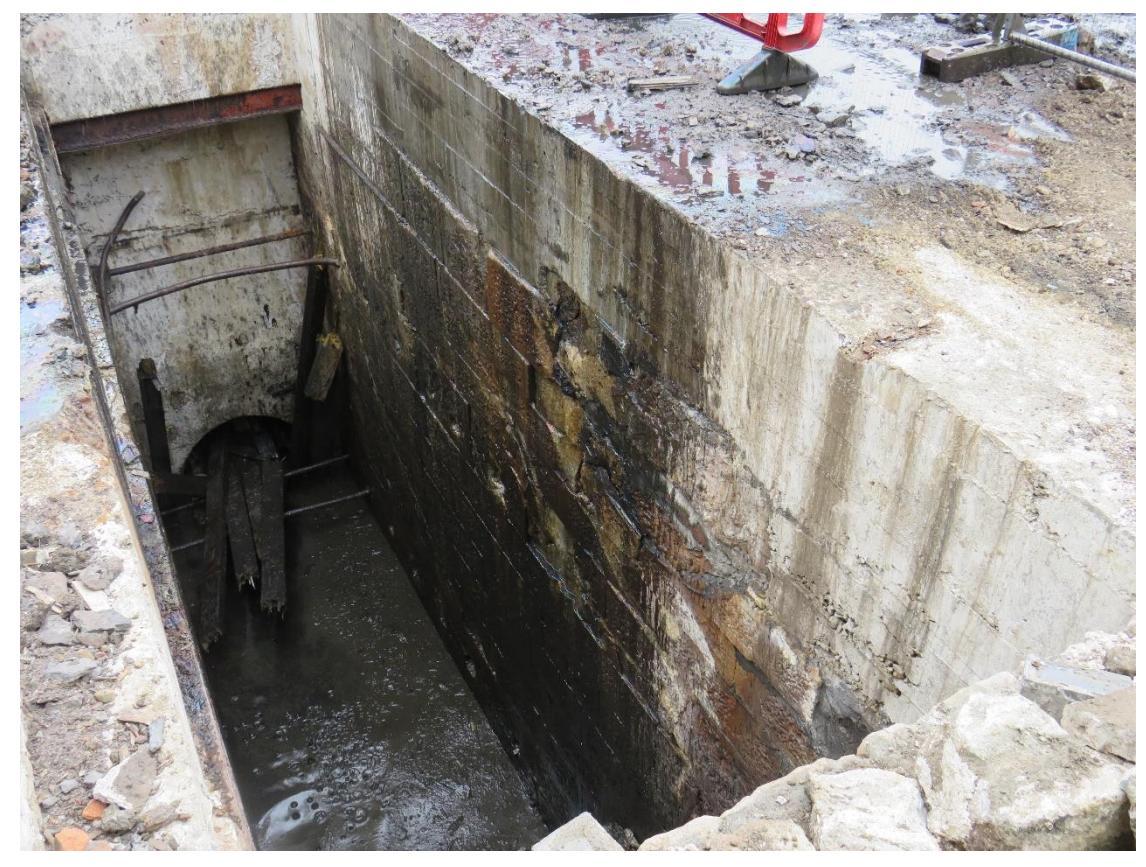
3.4.23 **Area 3: Wrigley's Mill, Waterwheel Pit**: to the west of wall **303**, the removal of the concrete floor slab had been temporarily suspended after the identification of a subterranean chamber of apparently two levels, in excess of 4m deep (Fig 6; Plate 34), and with a steel ladder bolted to its south-western end. The subsequent removal of the floor slab from across the remainder of this feature revealed the chamber to be an elongated pit, 12.3m in length, 2.9m wide and 6m deep (Plate 35).

Plate 35: The waterwheel pit, facing south

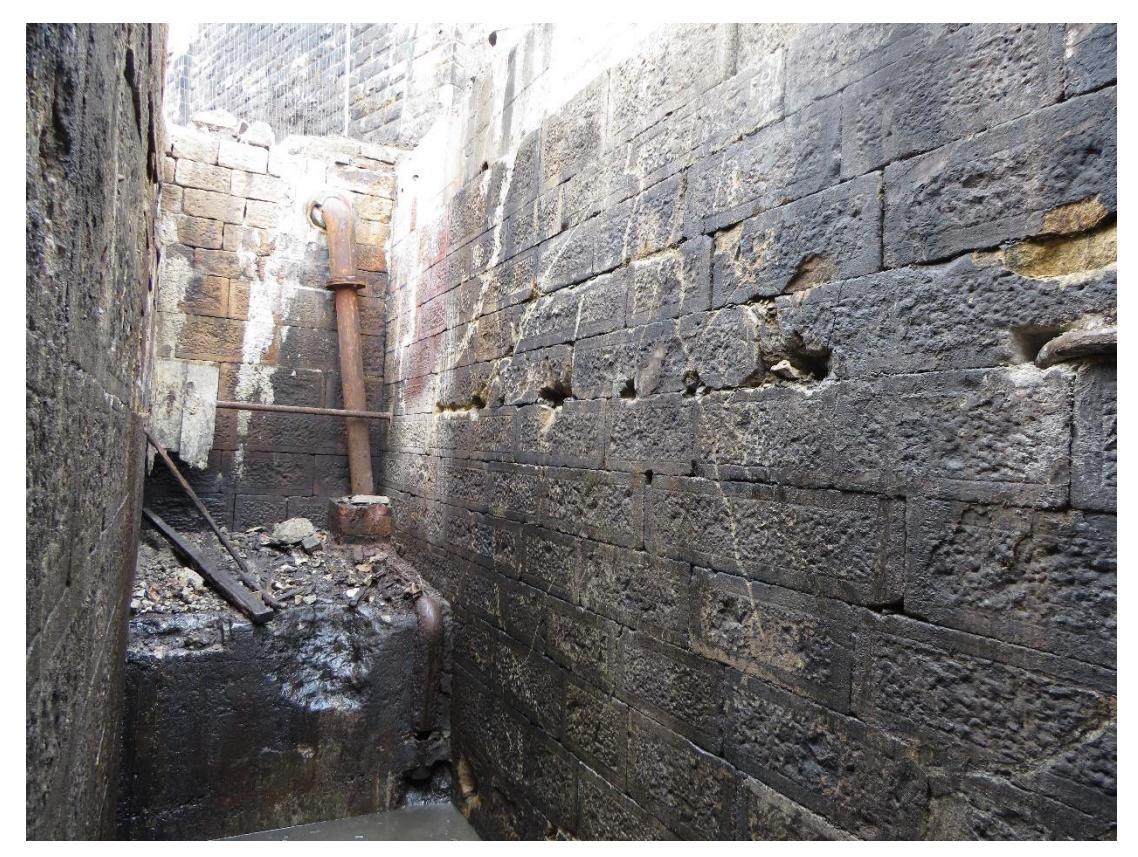
Plate 36: Interior view of the wheel pit, facing north-east

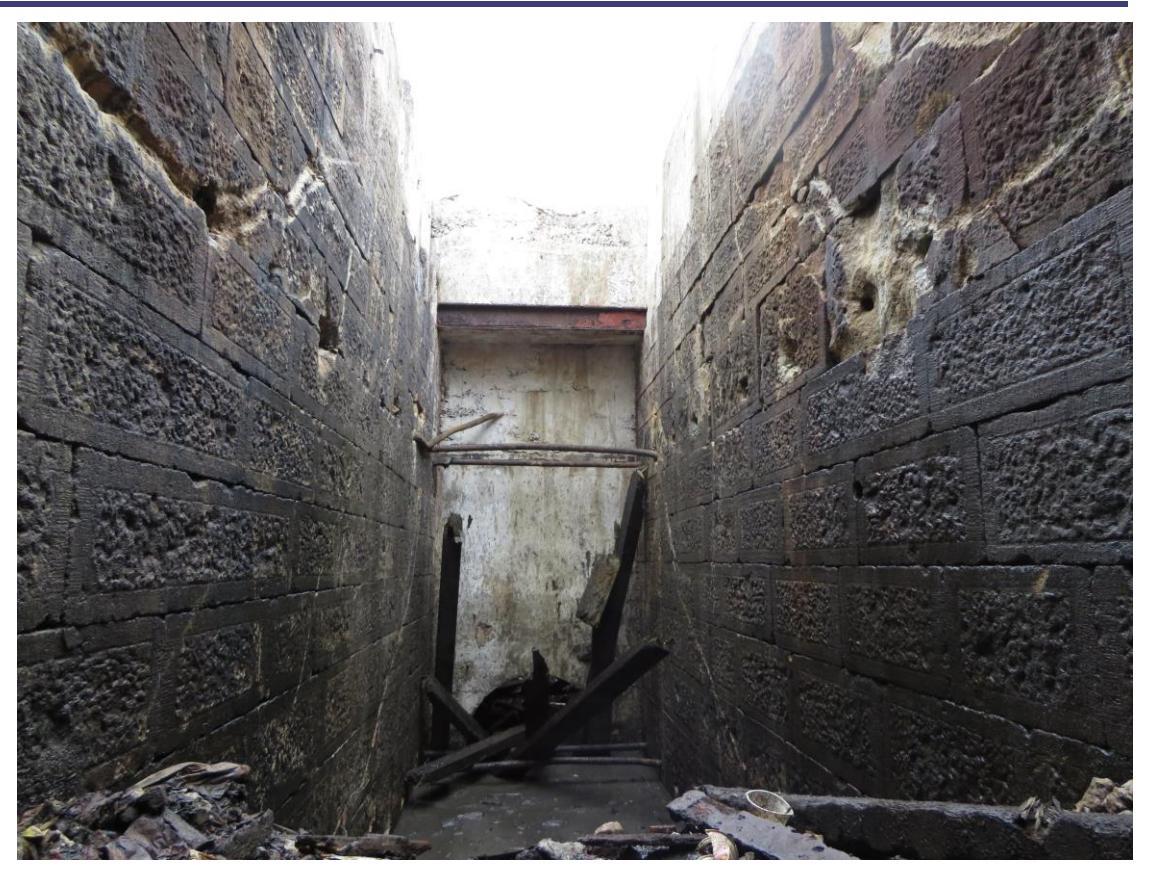
3.4.24 This pit was defined on each of its longer sides by retaining walls, comprising 13 visible courses of substantial elongated rectangular blockwork (**305**), tooled to a rusticated finish, with drafted margins and bonded with lime mortar (Plate 36). Evidently the uppermost courses of the longer walls had been replaced with cast-in-place shuttered concrete to bring it up to the height of the base of the concrete slab, and a concrete bridge had been installed across the south-western end of the pit, mounted upon lateral steel joists. Beneath this bridge, a modern concrete sluice had been installed to control the flow of water passing though the channel (Plate 37).

Plate 37: The wheel pit, facing south-west, with the modern concrete sluice

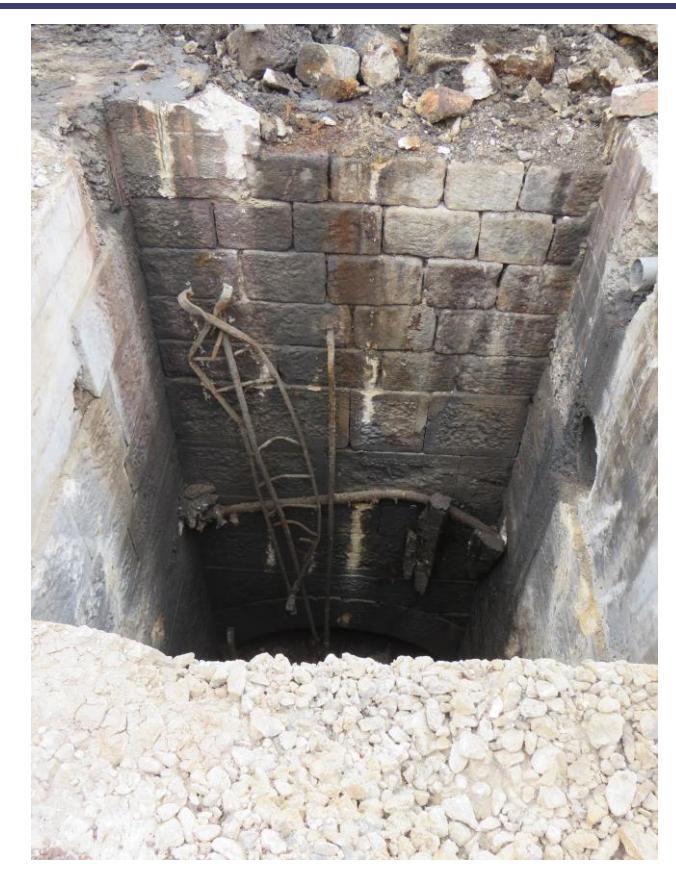
3.4.25 The lower portions of the shorter sides of the pit were constructed using the same tooled and drafted masonry blockwork seen in the longer sides, but in both instances rectangular blocks, similar in form to those used in the construction of walls **300** and **303**, formed the upper five courses (Plate 38). In addition, the south-western wall of the wheel pit incorporated a semi-circular arch at its base, formed in voussoirs of various widths (Plate 39). At the opposing end, a raised concrete platform had been latterly inserted into the base of the pit, spanning its full width and extending for a length of approximately 1m to the south (Plate 36). An iron pipe protruded vertically from the eastern corner of this platform, before returning via a flanged U-bend to the north-east.

Plate 38: Coursed sandstone blocks at the south-western end of the wheel pit

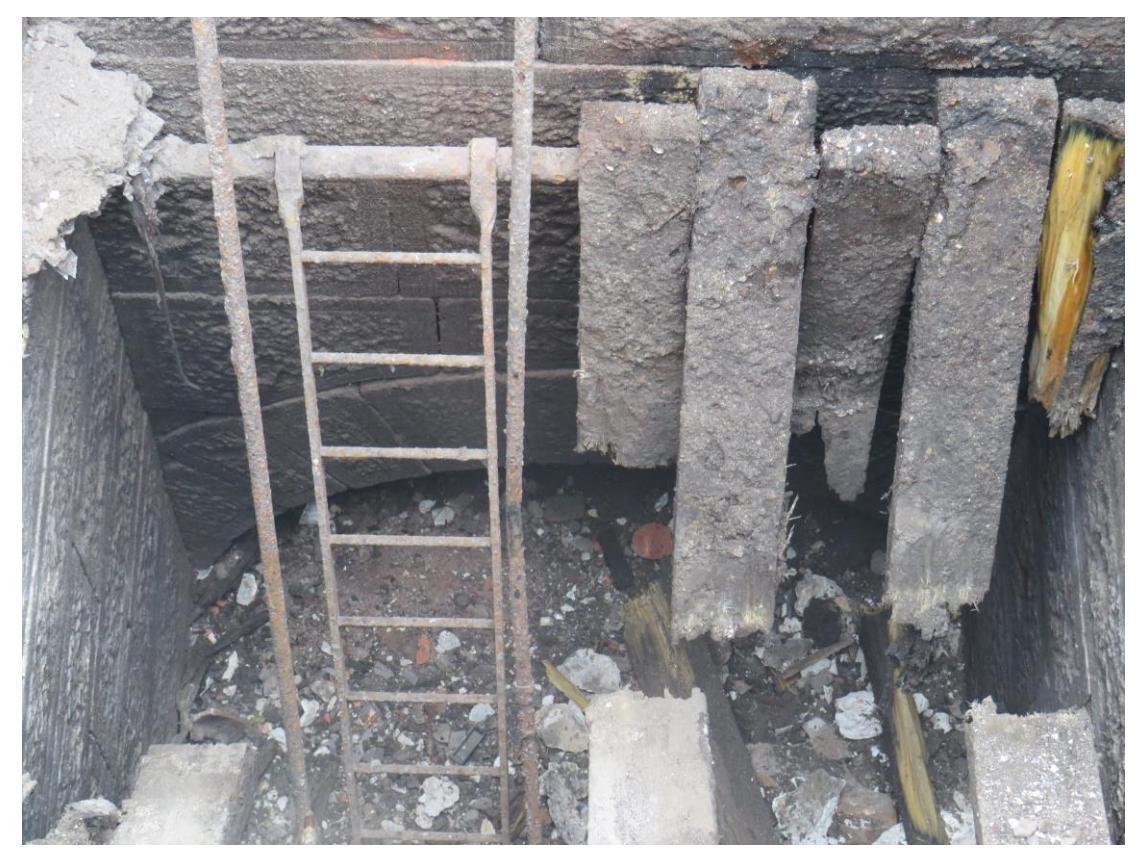
Plate 39: Semi-circular arch at the south-western end of the wheel pit

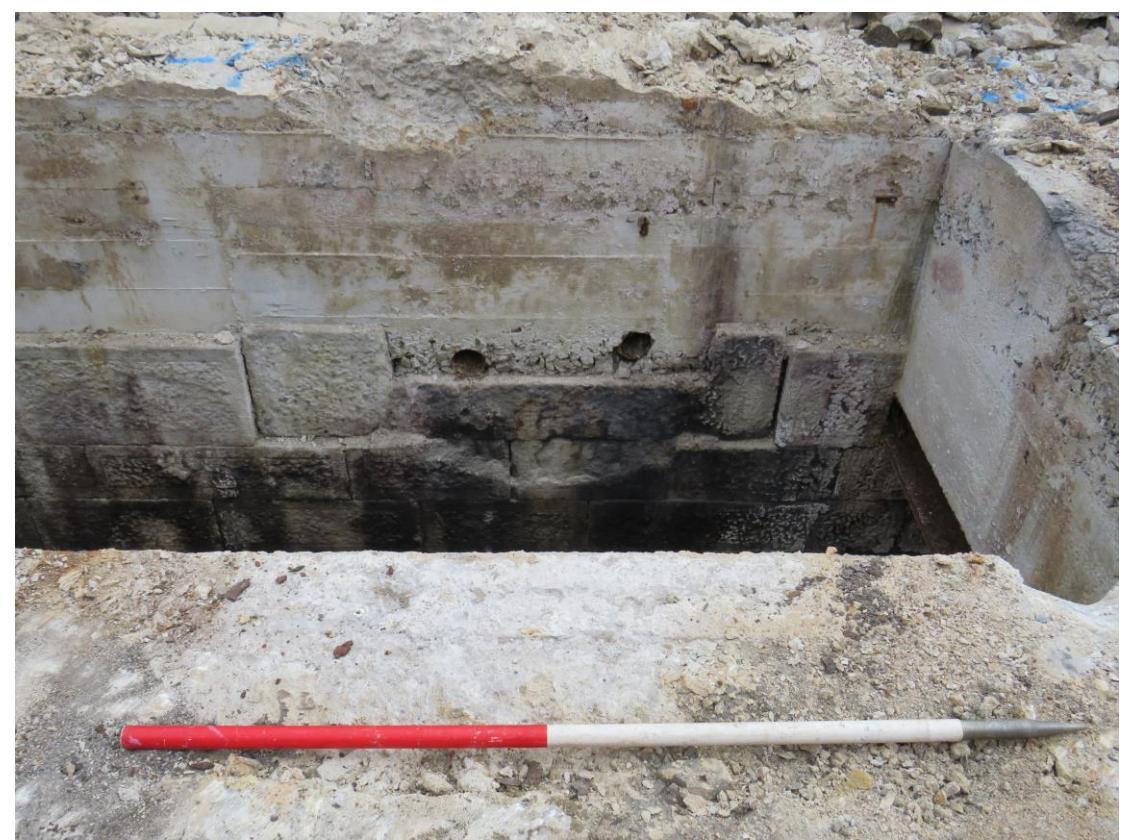
3.4.26 There were several features of historic interest identified on the longer sides. Towards the centre of the south-eastern side, an elongated block with a wide channel cut into its upper face was noted immediately below the base of the shuttered concrete, with another of identical appearance recorded on the opposing face (Plate 40). The profile of a semi-circular depression was seen beneath the former, presumably to accommodate some form of bearing. The position and character of these features almost certainly identifies them as the axle-mounting points for a waterwheel, although the concrete above prevented inspection of the mounts in any detail.

Plate 40: Recess for the waterwheel bearing below the axle-mounting point, facing southeast (with 1m scale)

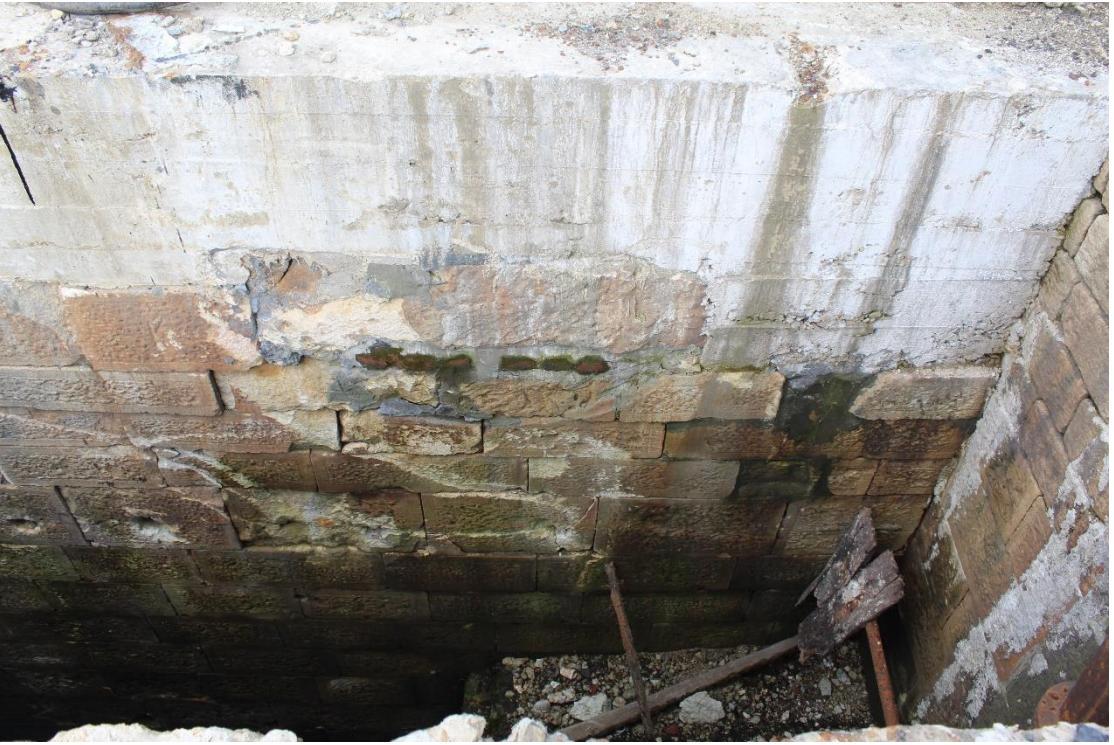
3.4.27 Perhaps due to the limitations of access, no wear marks associated with the likely circumference of the wheel were detected on either face of the wheel pit. Near the north-eastern end of the north-western wall, however, there was the tell-tale circular wear pattern of what may have been a smaller spur wheel (Plate 41).

Plate 41: Recess for possible spur gear on the north-western wall

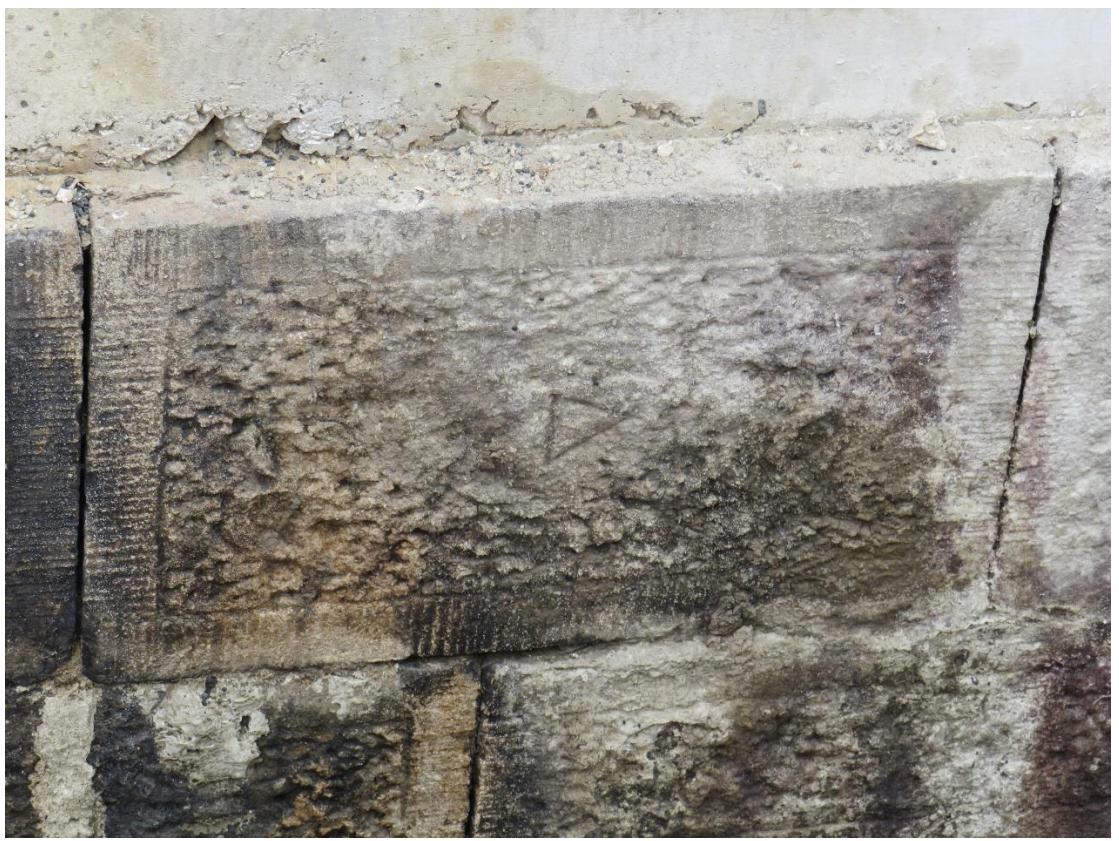
3.4.28 In addition, at the north-eastern end of the south-eastern wall, the first five blocks of the uppermost course exhibited an enigmatic triangular symbol cut into their centres (Plate 42; Fig 8) reminiscent of a mason's mark. Again, limited access prevented any certainty of interpretation, but their position on a level with the centre of the wheel and apparent absence from the remainder of the elevation suggests that they may have been used as assembly marks, perhaps for levelling the axle during construction.

Plate 42: Possible assembly mark, indicating the centre line of the waterwheel

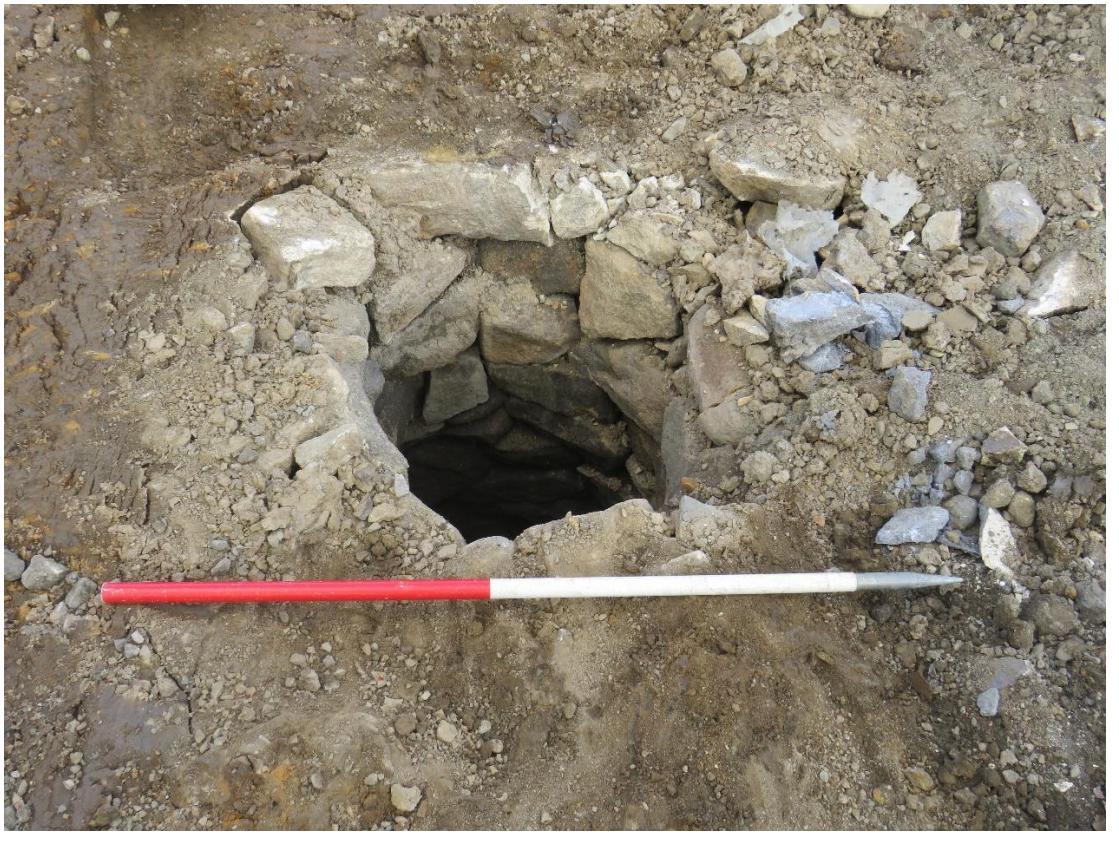
Plate 43: Drystone-lined well **302**, located to the south of the wheel pit (with 1m scale)

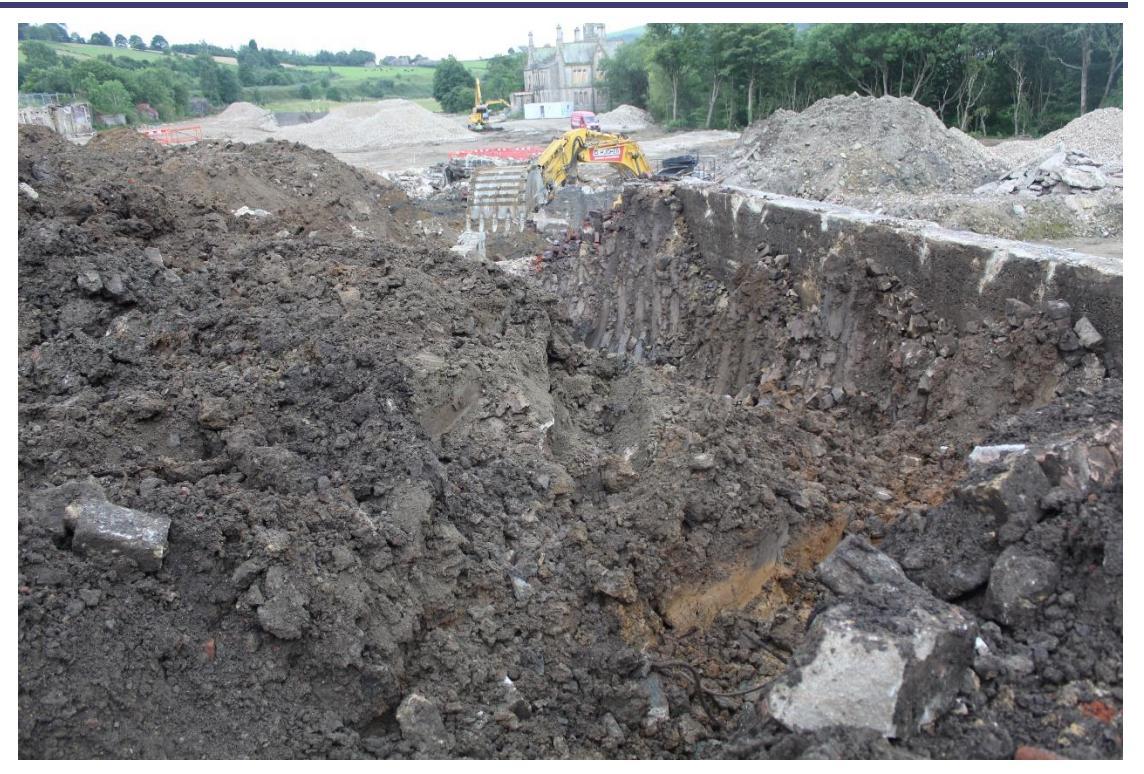
Plate 44: The demolition of the retaining wall and removal of pipework entering the waterwheel pit, from the north-west, facing south

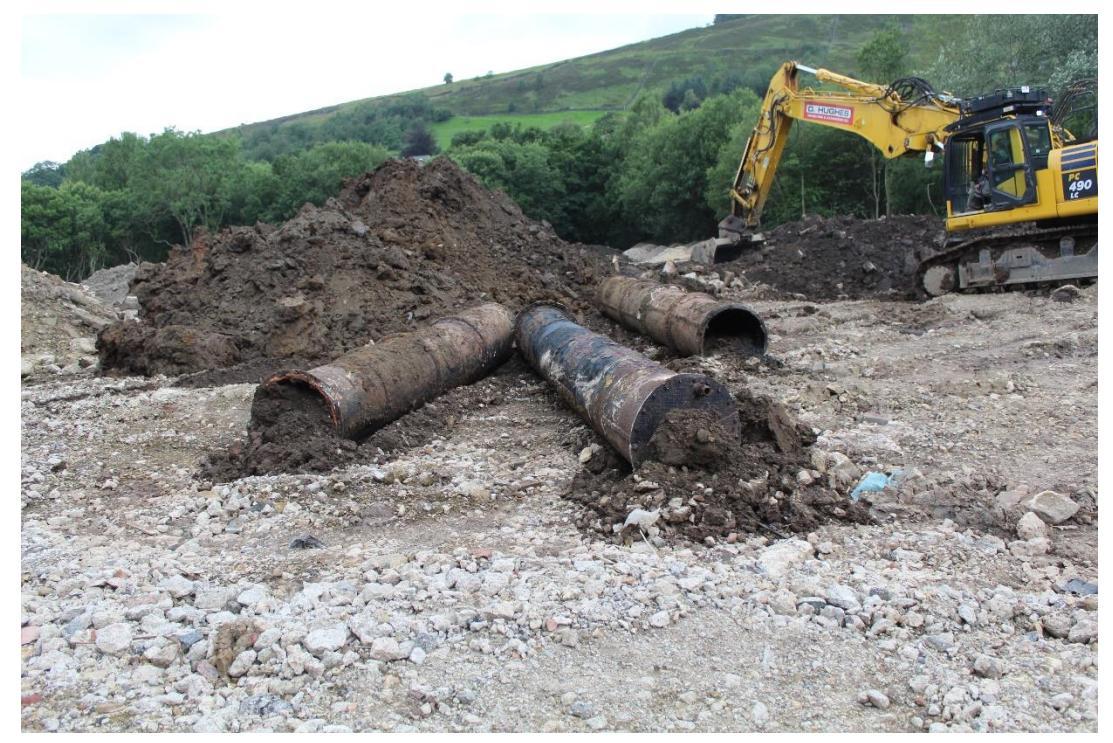
Plate 45: The removed pipework associated with the demolition of the retaining wall
