# Former W H Shaw Pallet Works Archaeological Watching Brief and Strip, Map and Record Report

**Client: Interserve Construction Ltd**

Issue No: 2 OA Reference No: L2098/2020-2021 NGR: SE 00155 07284

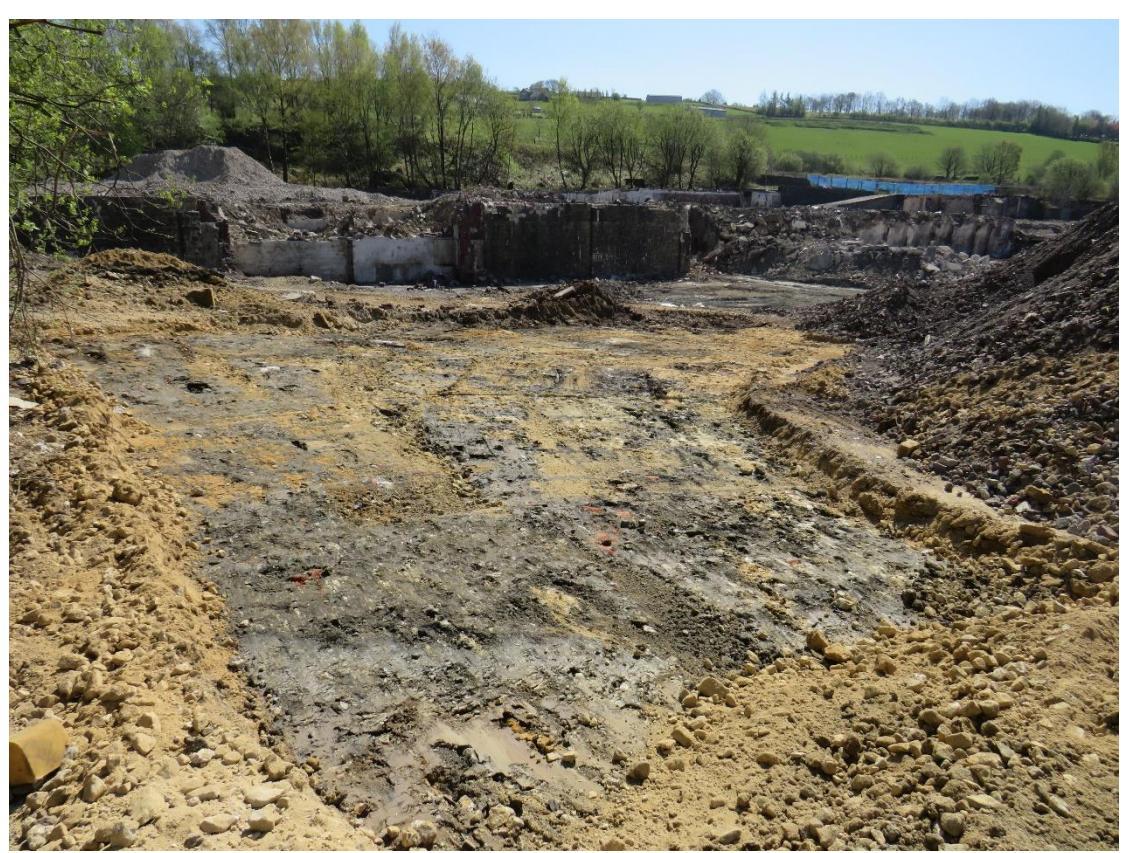
this area and the remainder of the building appears to have been destroyed by later activity (Plate 46).

Plate 46: The reduction in levels across the western part of Wrigley Mill revealed no trace of the earlier mill

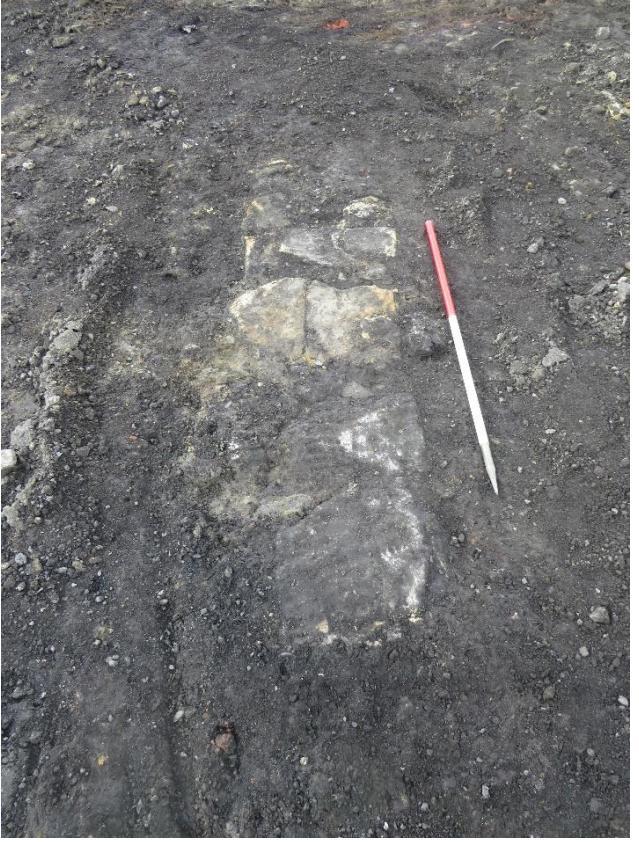
Plate 47: Wall **307**, facing south (with 1m scale)

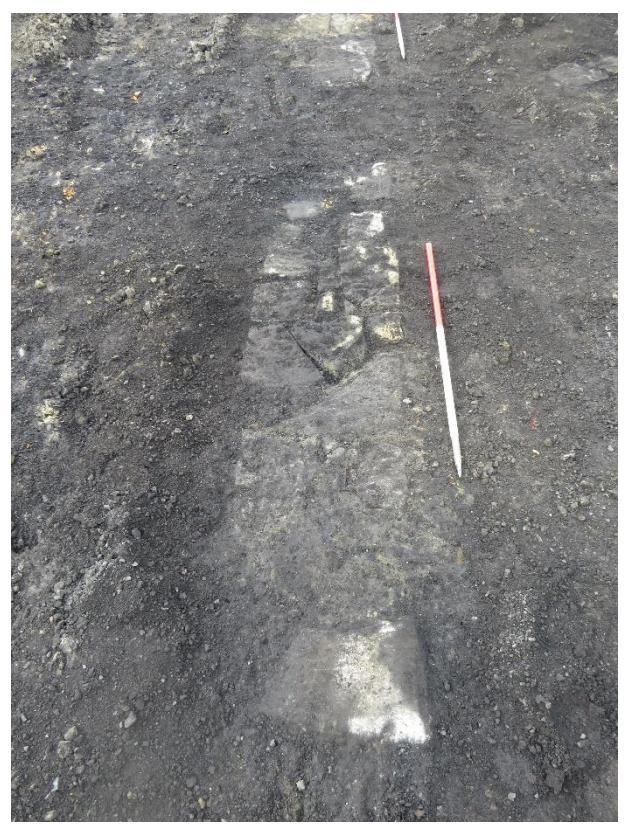
Plate 48: Wall **306**, facing south (with 1m scale)

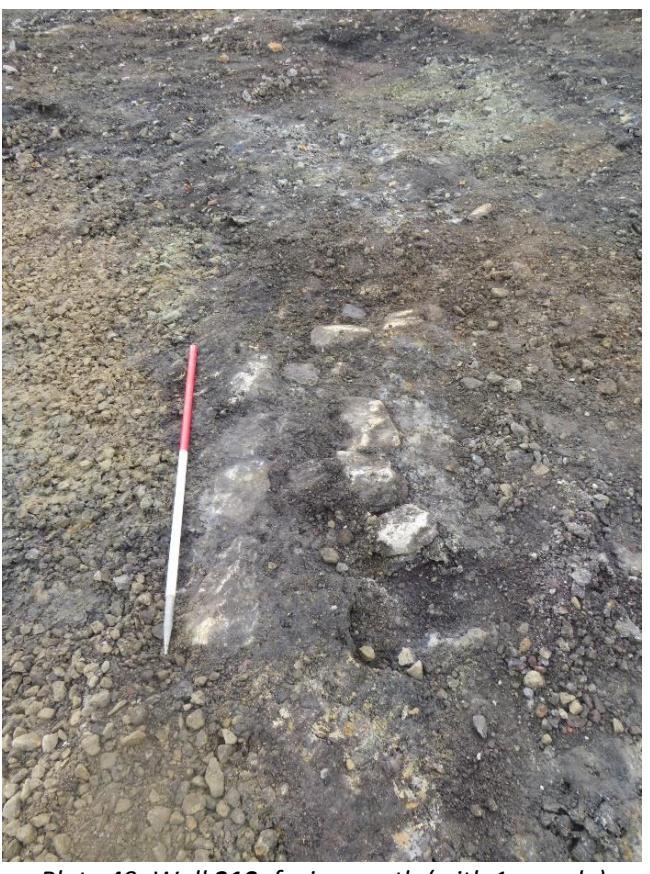
3.4.34 Approximately 2m to the south-east of these, there were two further fragments of masonry (**309** and **310**), both sharing the same alignment, approximate width and sandstone construction. The smaller section (**310**; Plates 49) to the south-west was 1.6m long and was double skinned, with a rubble infill, while wall **309** (Plate 50) to the north was 1.7m long and incorporated a T-junction at its northern end. The wall was primarily constructed of rubble, but the northern end was formed of roughly squared sandstone blocks, similar to those used in wall **300** (*Sections 3.4.19-20*) and arranged in pairs. The western arm, however, was just a single block wide and its position suggests it may have formed the return of an internal partition.

Plate 49: Wall **310**, facing south (with 1m scale)

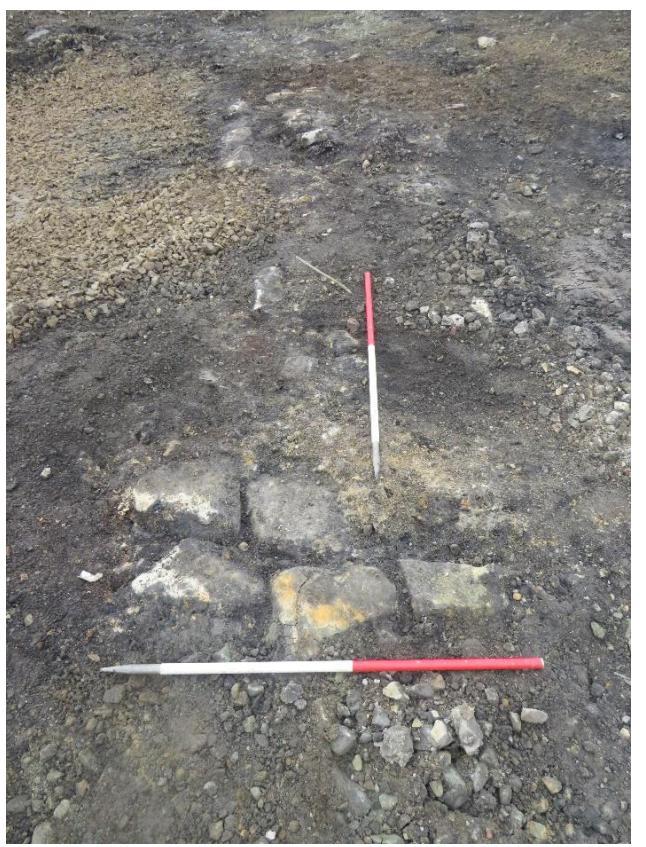
Plate 50: Wall junction 309, facing south-west (with 1m scale)

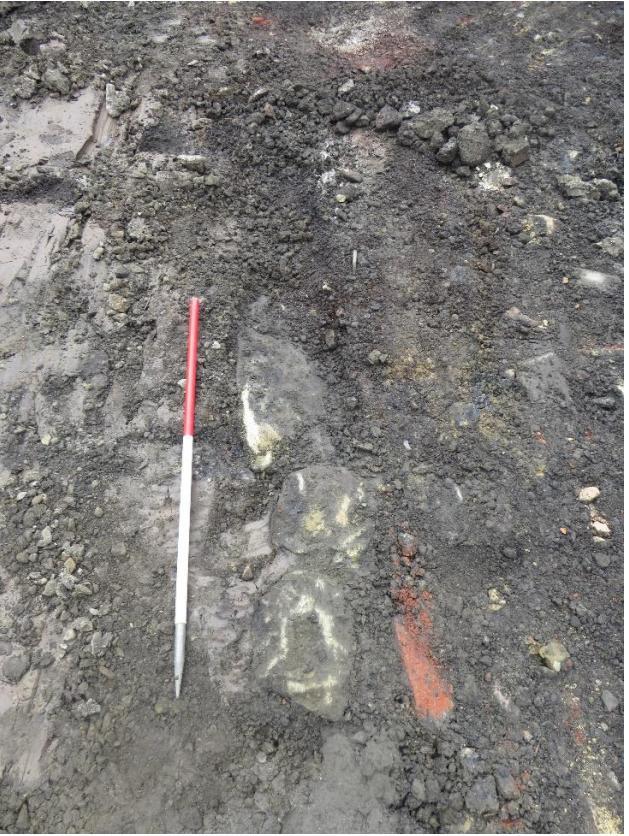
3.4.35 To the east of walls **309** and **310** were two other sections (**311** and **312**) of what had probably once formed a single length of sandstone wall. Wall **311** (Plate 51) lay to the north, where it extended as a single course of sandstone rubble 0.4m wide in a southerly direction for a length of 1.4m. Wall **312** lay 2m to the south of this, where it continued south for a further 2.5m as a double-skinned rubble-built sandstone wall, 0.6m wide (Plate 52). The ground immediately to the west of this wall, and south-east of walls **309** and **310**, had been infilled with large stone chippings, covering a rectangular area 6m long and 3m wide.

Plate 51: Wall **311,** facing south (with 1m scale)

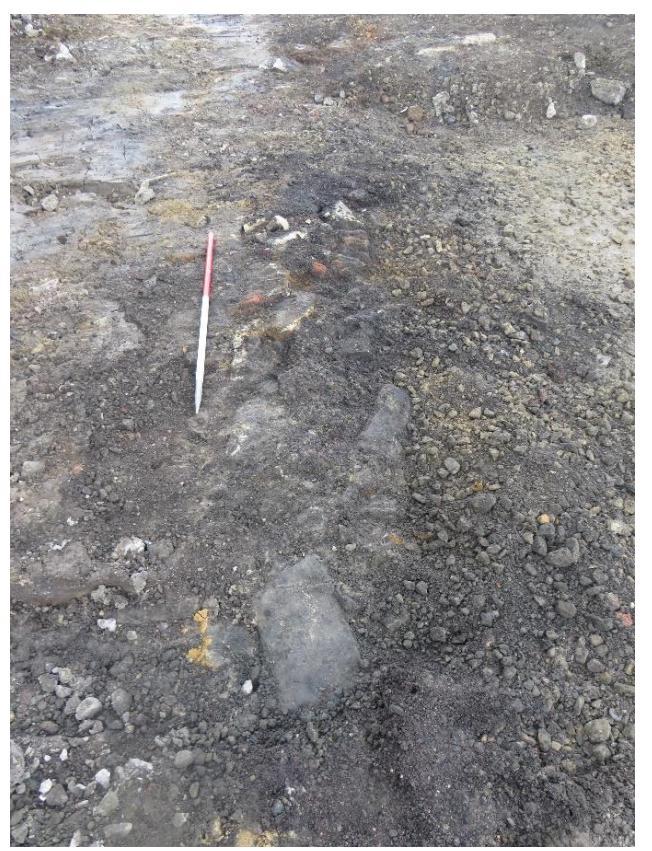
Plate 52: Wall **312**, facing south (with 1m scale)

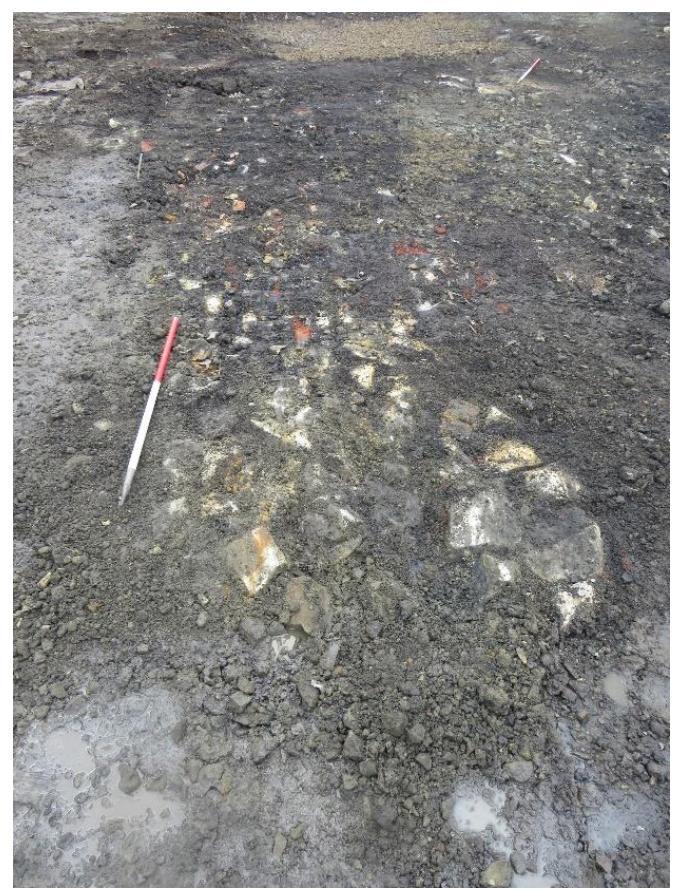
3.4.36 North of wall **311** was a possible compacted floor (**314**; Plate 53). The area, which measured 3m from north to south and 1.5m from east-west, was composed of a series of fragmentary sandstone blocks or flags set within a dark brown sandy matrix.

Plate 53: Area of cobbles **314**, facing south (with 1m scale)

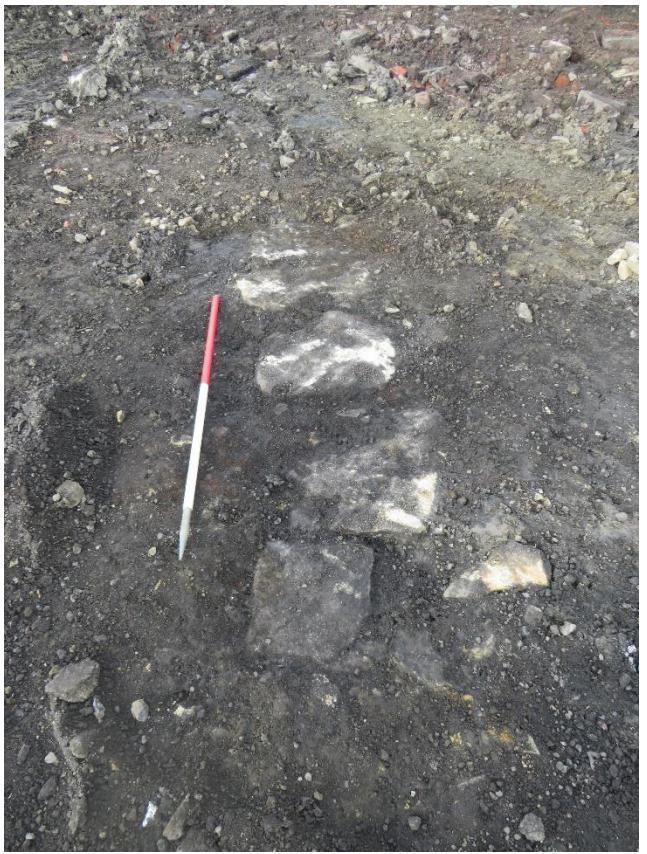
3.4.37 An additional section of wall was revealed to the north-west of walls **306** and **307**, 2m in length and 0.6m wide (**308**; Plate 54). This fragment was just a single course thick and its alignment was different from the other walls, appearing to be slightly north of east-west.

Plate 54: Wall 308, facing west (with 1m scale)

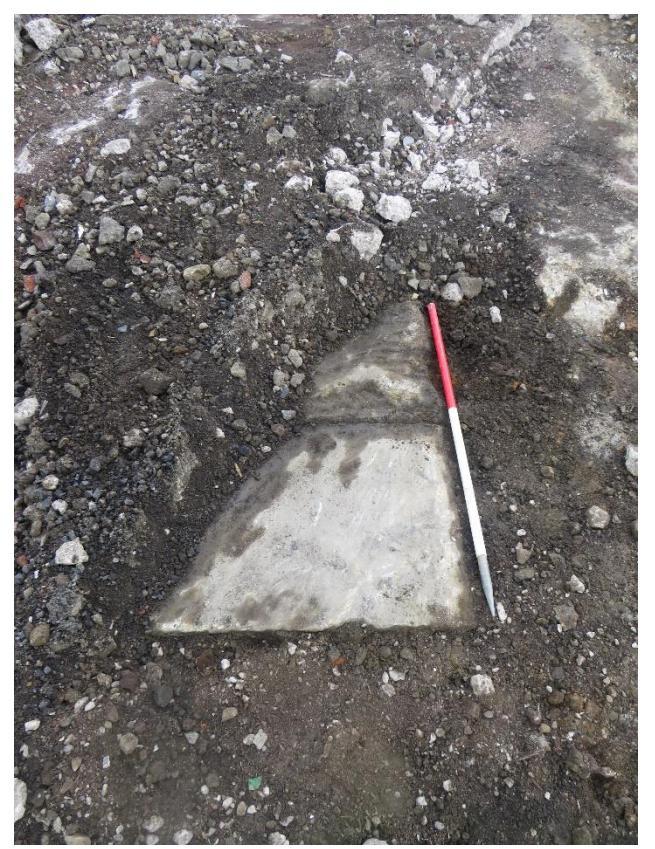
3.4.38 A pair of flagstones were identified at the southern limits of the excavation area on a similar alignment to wall **308** (Plate 55). The flags were 100mm thick, had a smooth upper face and had a visible extent of 1.5 x 0.8m, extending beyond the limit of excavation.

Plate 55: Stone flags **313**, facing west (with 1m scale)

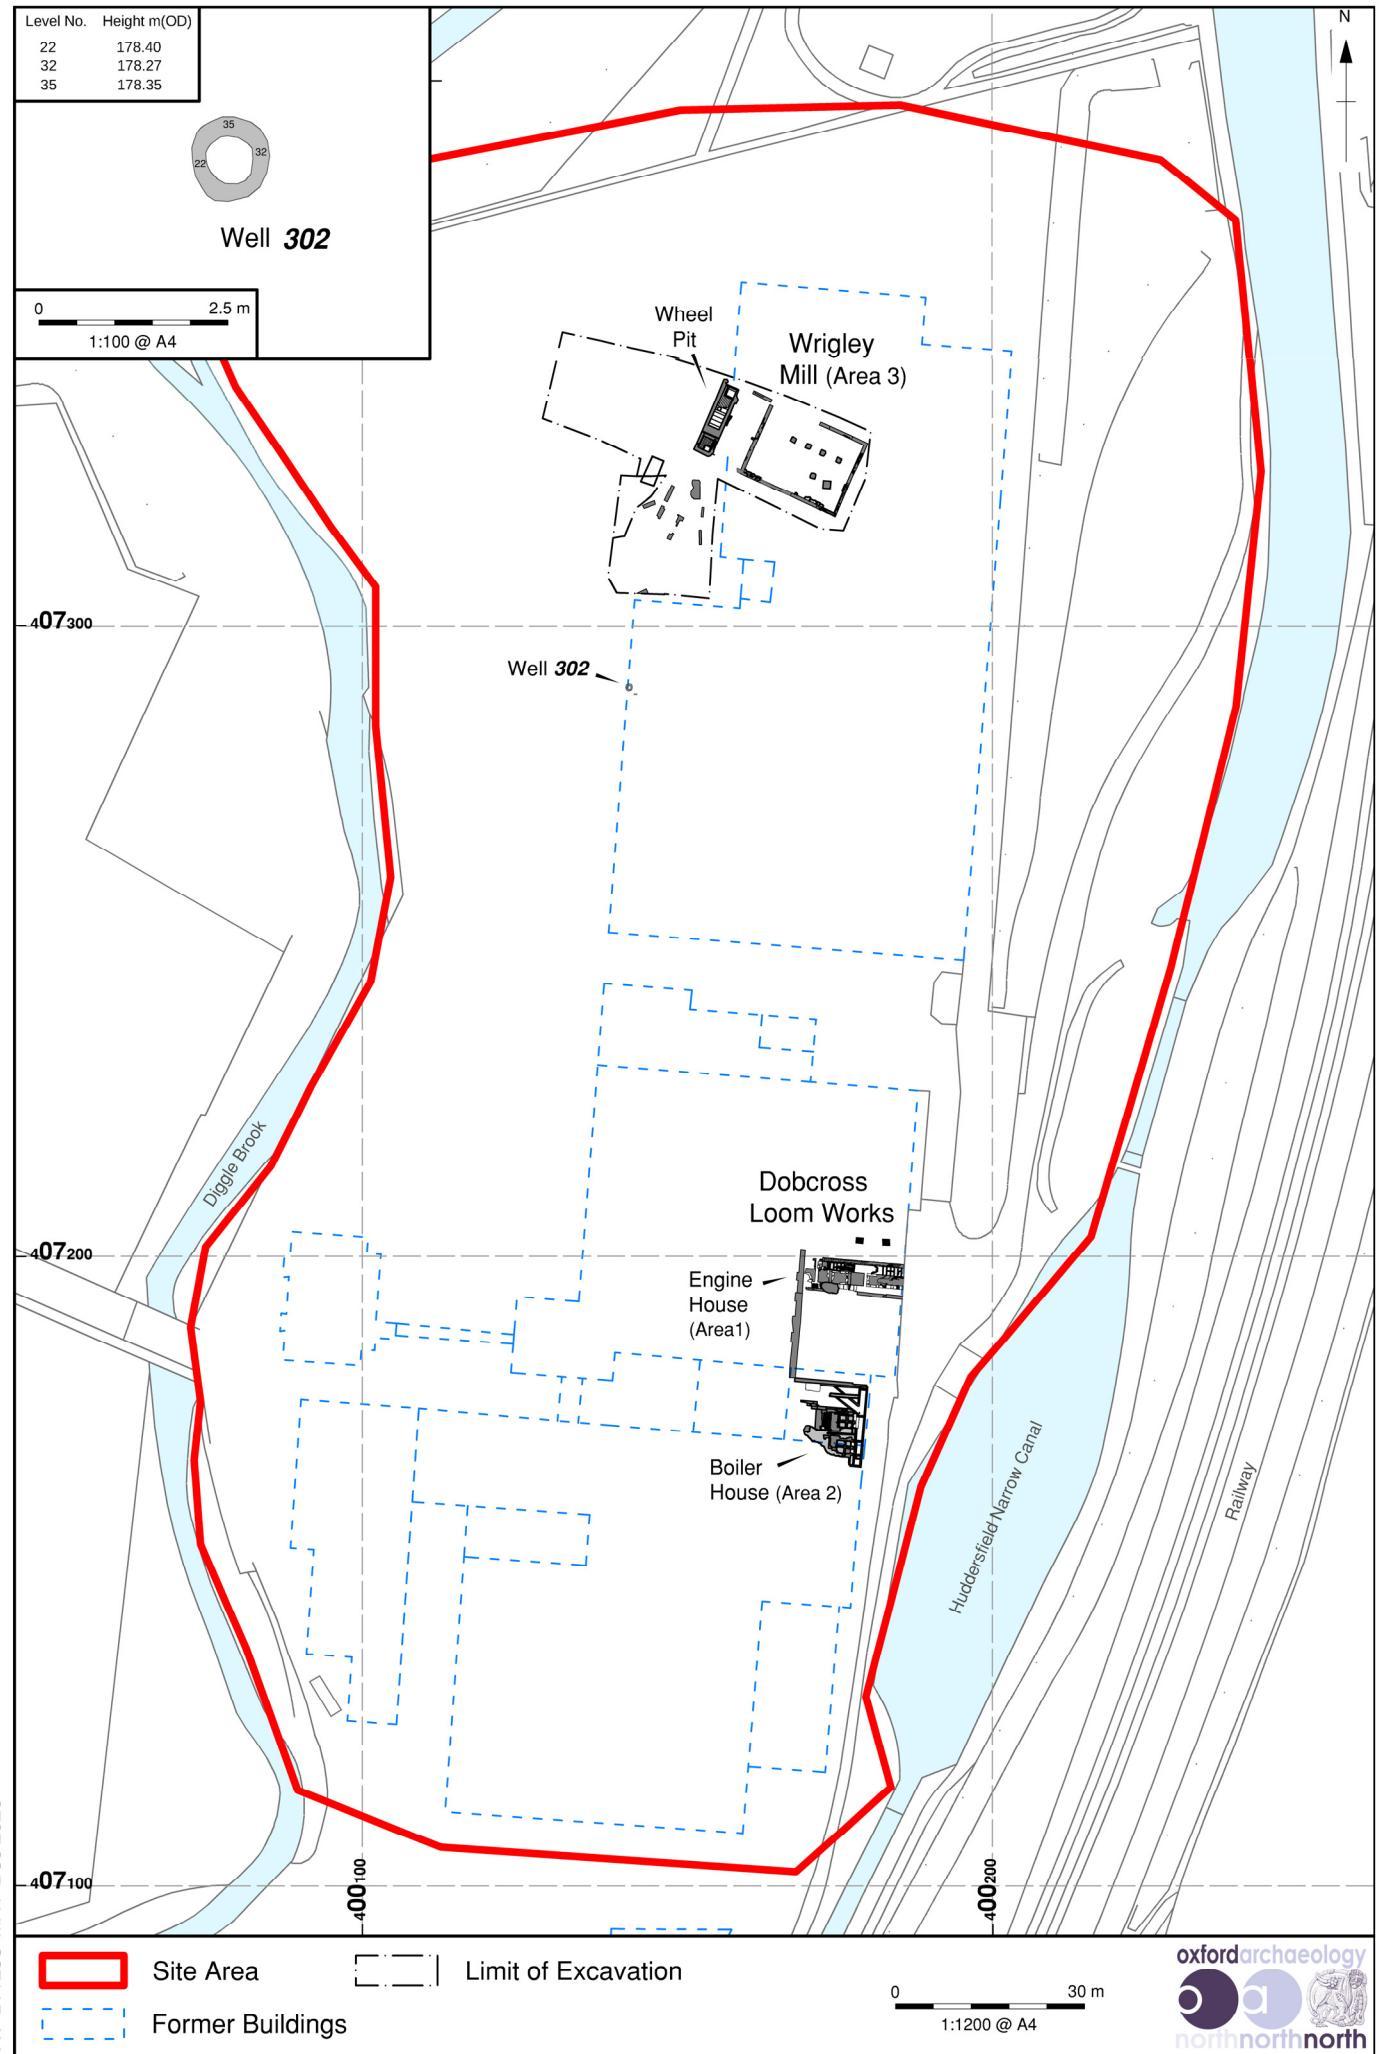
Figure 2: Plan of features found by strip, map and record process

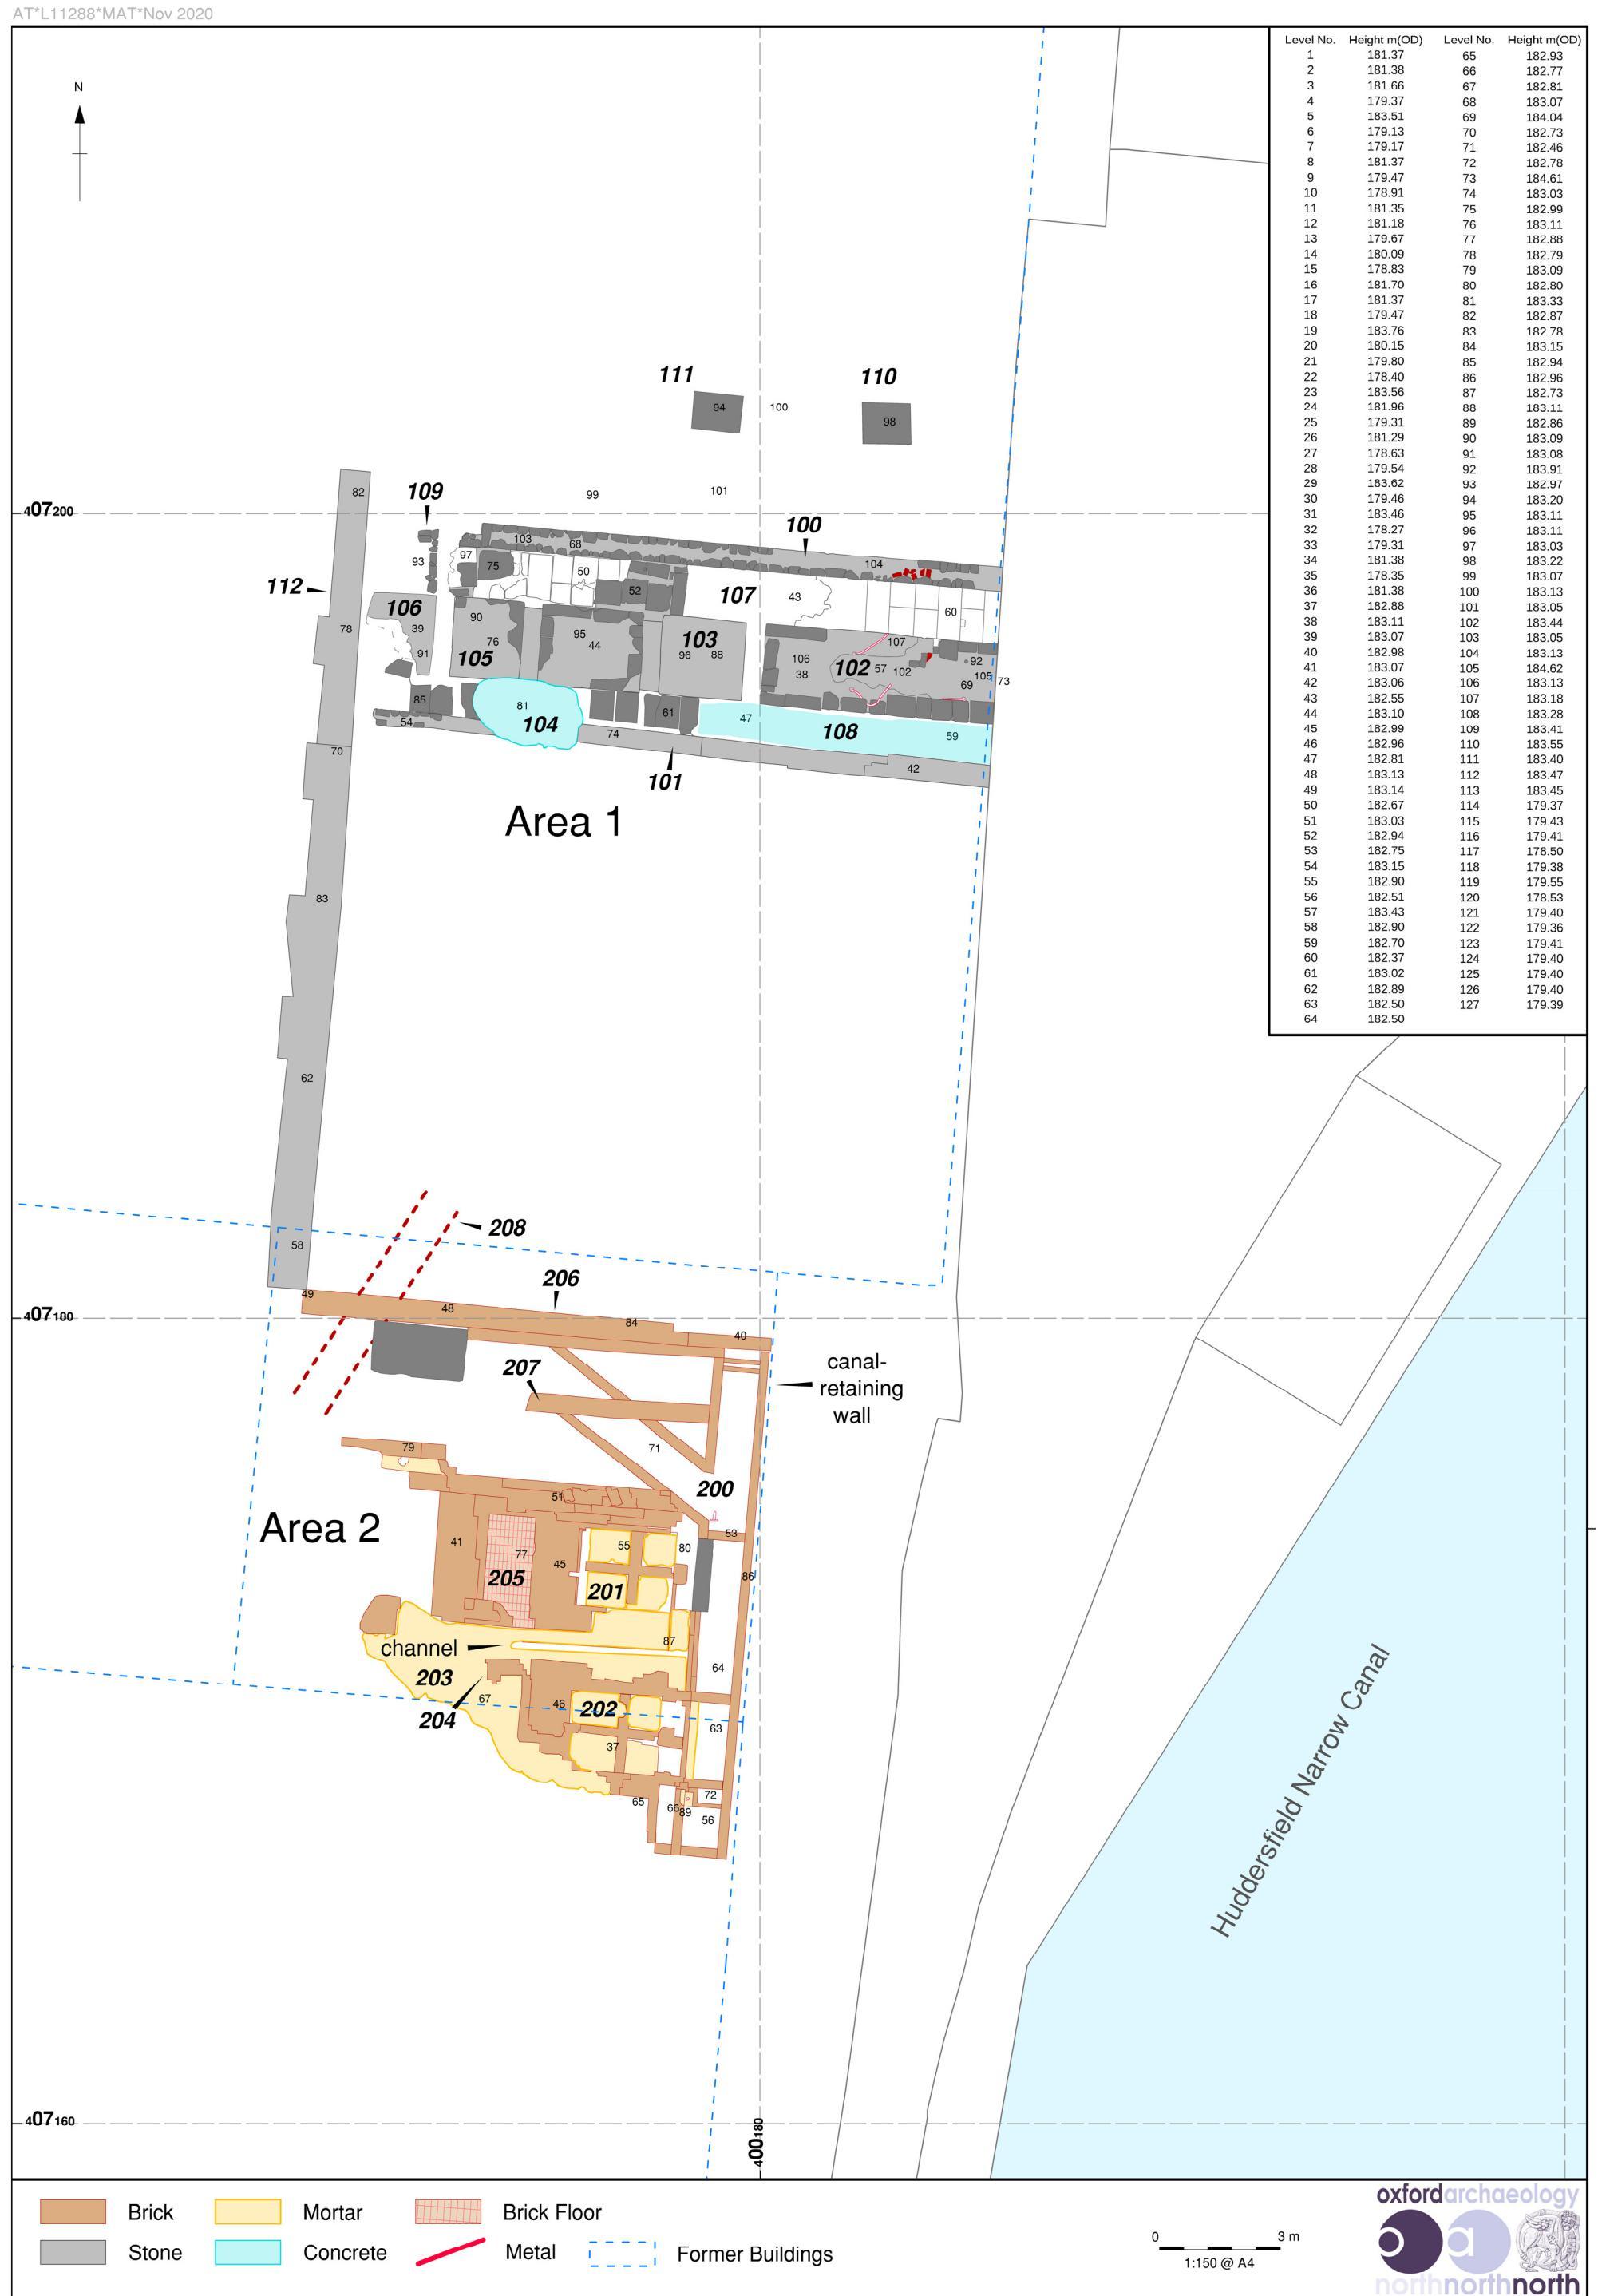
Figure 5: The remains exposed during the strip, map and record of Dobcross Loom Works, Areas 1 and 2

3.4.11 **Area 2: Boiler House**: wall **206** abutted the southern end of wall **112** (Fig 5). This foundation was exposed in plan and was 0.6m thick, constructed of red brick bonded with a lime mortar. Wall **206** then extended on a perpendicular alignment to the east for a distance of 11.5m before abutting the canal-retaining wall at right-angles. At its eastern end, an elongated channel or flue (**200**), 1m wide and 0.36m deep, extended from the southern face of wall **206** along the base of the retaining wall for a length of 12.4m (Plate 17). A smooth render had been applied to the base of the channel and a substantial cast-iron pipe, partially encased in concrete, ran along its western edge. The channel had been interrupted at several points along its length by a series of low red-brick cross-walls, although it was not apparent if these were a later insertion.

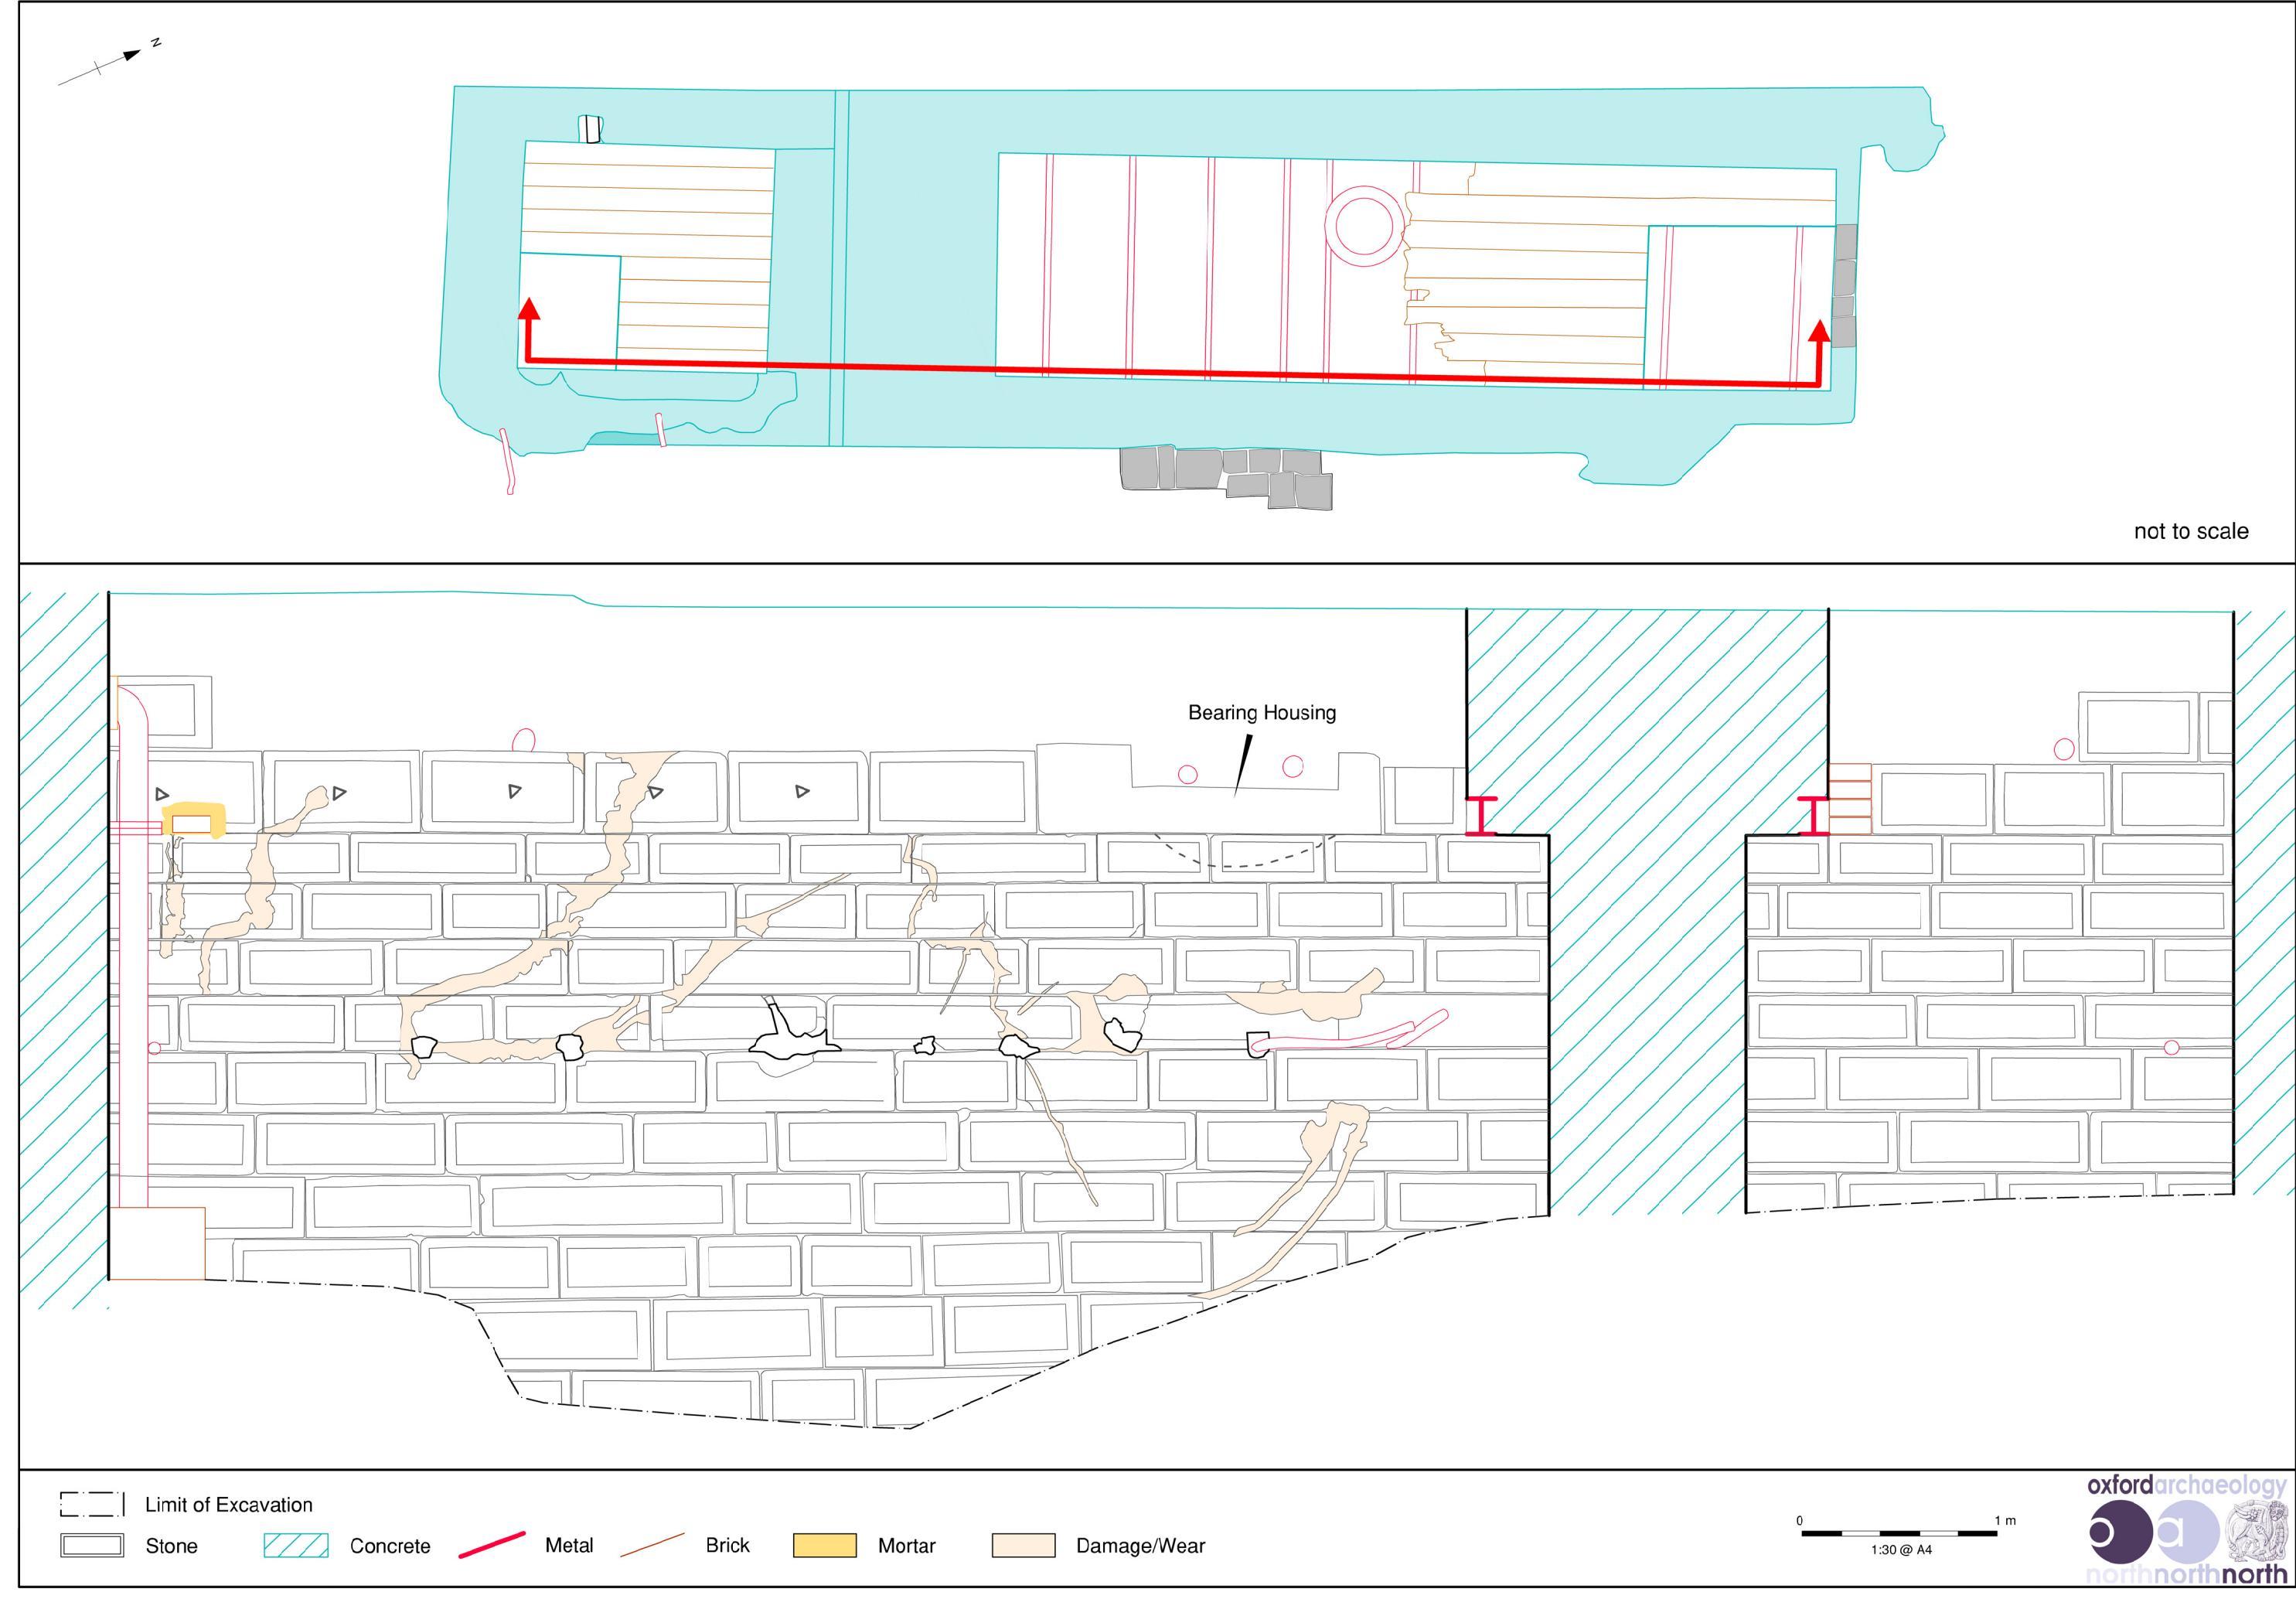
Figure 8: North-west-facing elevation of wheel pit, Area 3
