National Graphene Institute, Booth Street East, Manchester

Archaeological Excavation

Oxford Archaeology North June 2013

University of Manchester

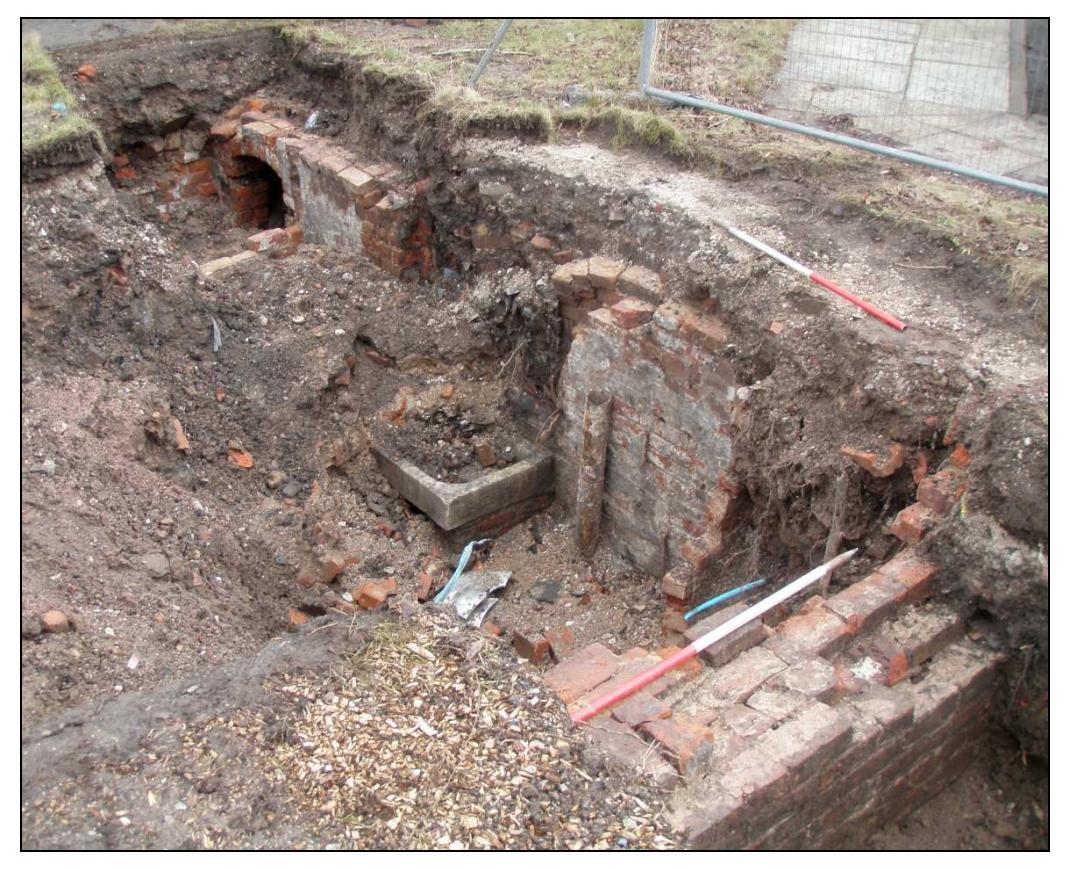
3.2.1 Trench 4 measured approximately 8.63 x 4.20m, and was excavated to a maximum depth of 2.36m (Plate 6). It was aligned broadly north-east/south-west across the south-eastern corner of the site, and was targeted on the footprint of a row of three double-depth workers' houses that were built between 1831 and 1845 (Fig 3).

Plate 6: General view across Trench 4, looking east, showing wall 406 in the foreground

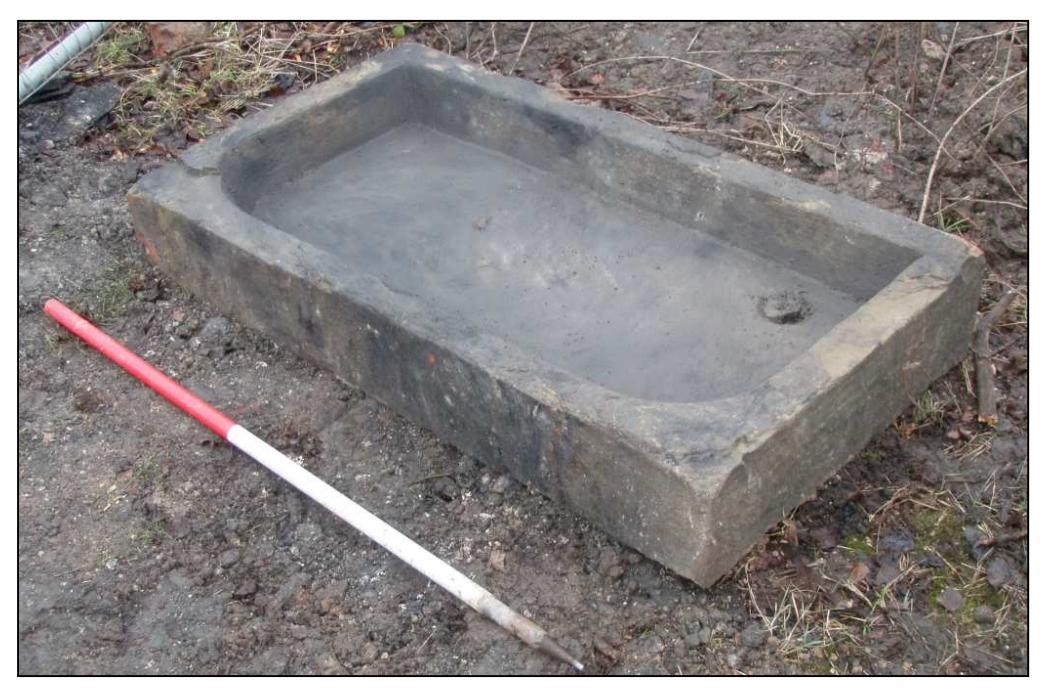
- 3.2.4 The cellar in the end house, represented by walls *402*, *405* and *406*, was 3.55m (11ft 7in) wide, and retained a stone-flagged floor at a depth of 2.36m below ground level. A 1.24m wide cellar window was visible within wall *402*, presumably the front of the house, below which was a 1.1 x 0.66m stone sink, set on a brick platform. The sink was of a 'gamekeeper' type, and was 0.25m deep with a lead lined hole in one corner, presumably intended for a plug (Plate 7).

Plate 7: The stone sink following removal

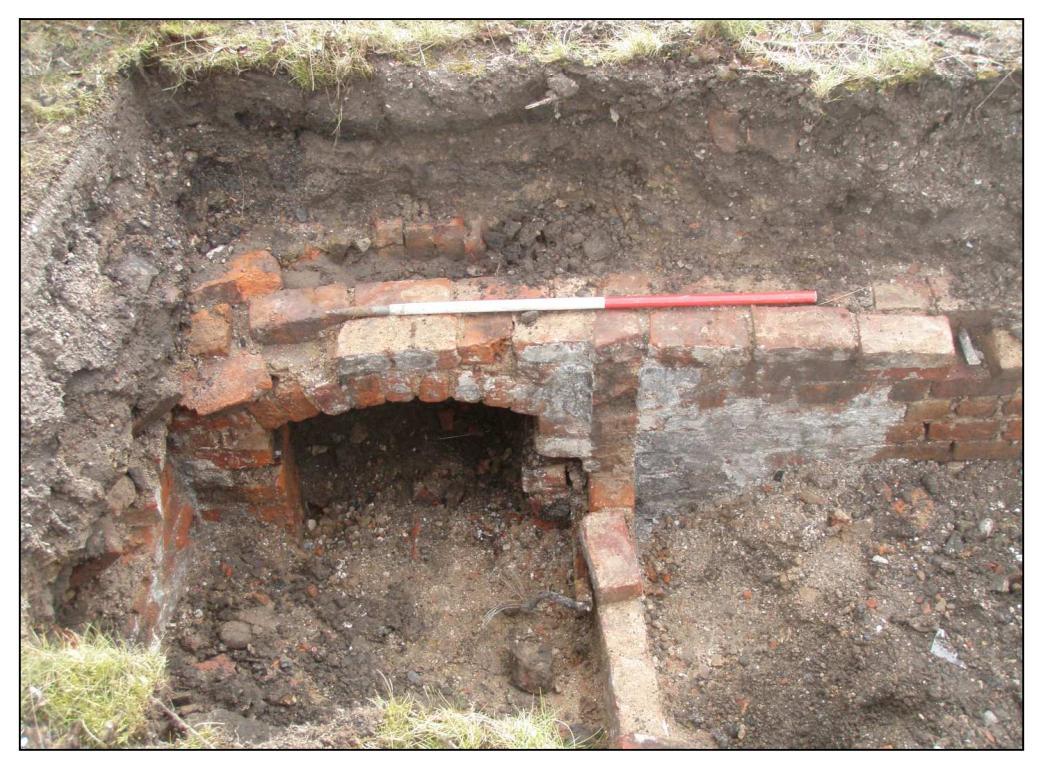
- 3.2.6 Excavation of the north-eastern part of the trenches exposed a 1.24m wide passageway between walls 403 and 404, leading from a brick-built arch in wall 402 (Plate 8). The arch was 0.69m wide, and probably afforded access via steps from Clifford Street to the cellar adjacent to the excavated example. A similar passage was exposed within the excavated cellar, bounded by walls 405 and 406. This continued beyond the edge of the trench, and thus an access arch was not encountered. An electric cable had been installed against the south-western wall (404) of the passage at the north-eastern end of the trench. A similar cable was also identified in the passage between walls 405 and 406.

Plate 8: Arch through wall 402, looking south-east

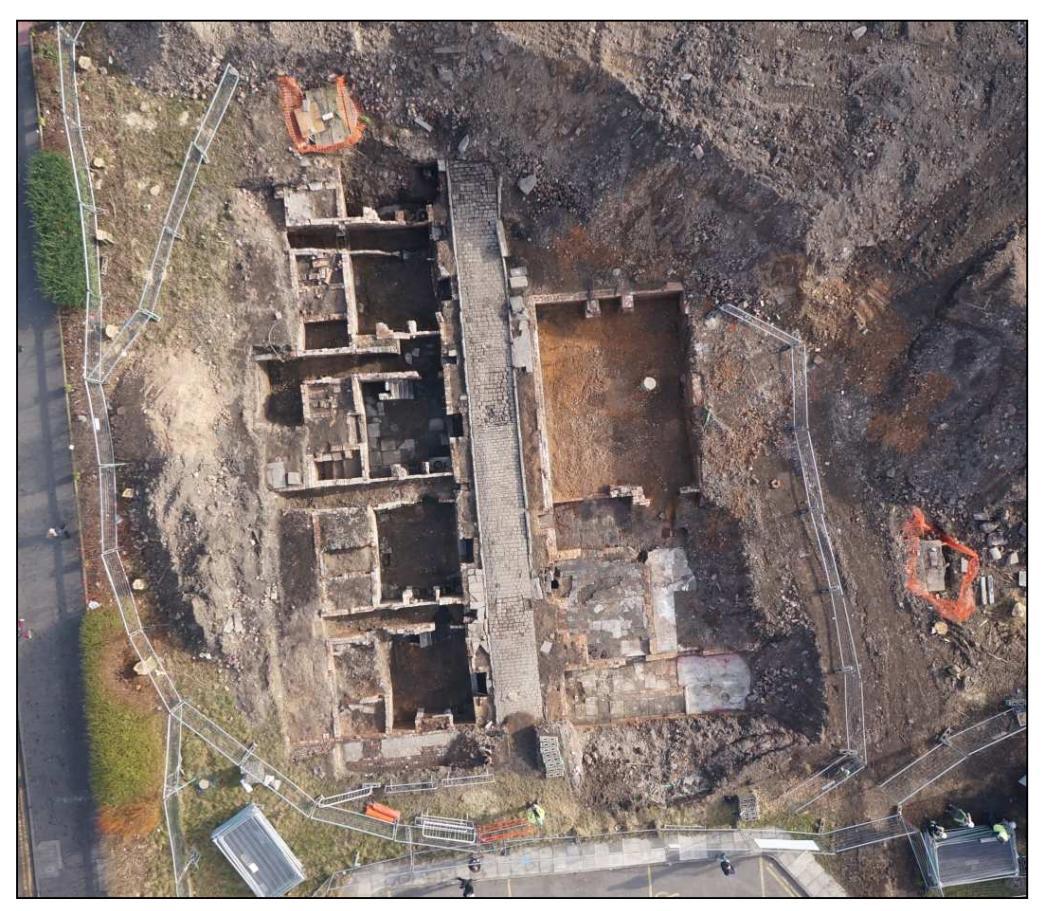
3.3.1 Following on from the results obtained from the initial evaluation trenches, a larger, irregularly shaped trench measuring approximately 26 x 20m was subject to more detailed excavation (Fig 4). The trench was divided conveniently into two principal components by the former Lawson Street, which lay north-east/south-west across the excavation area (Plate 9). The remains of the cellars beneath the Lawson Street properties were exposed to the north of Lawson Street, and the foundations of the Albert Club / Turkish baths to the south. The remains of the club / baths were split into five distinct areas of cellarage, designated C1 to C5. The cellars beneath the Lawson Street houses were designated H1 to H5, with cross passages designated G1 to G4 (Fig 4).

Plate 9: High-level view of the excavated remains

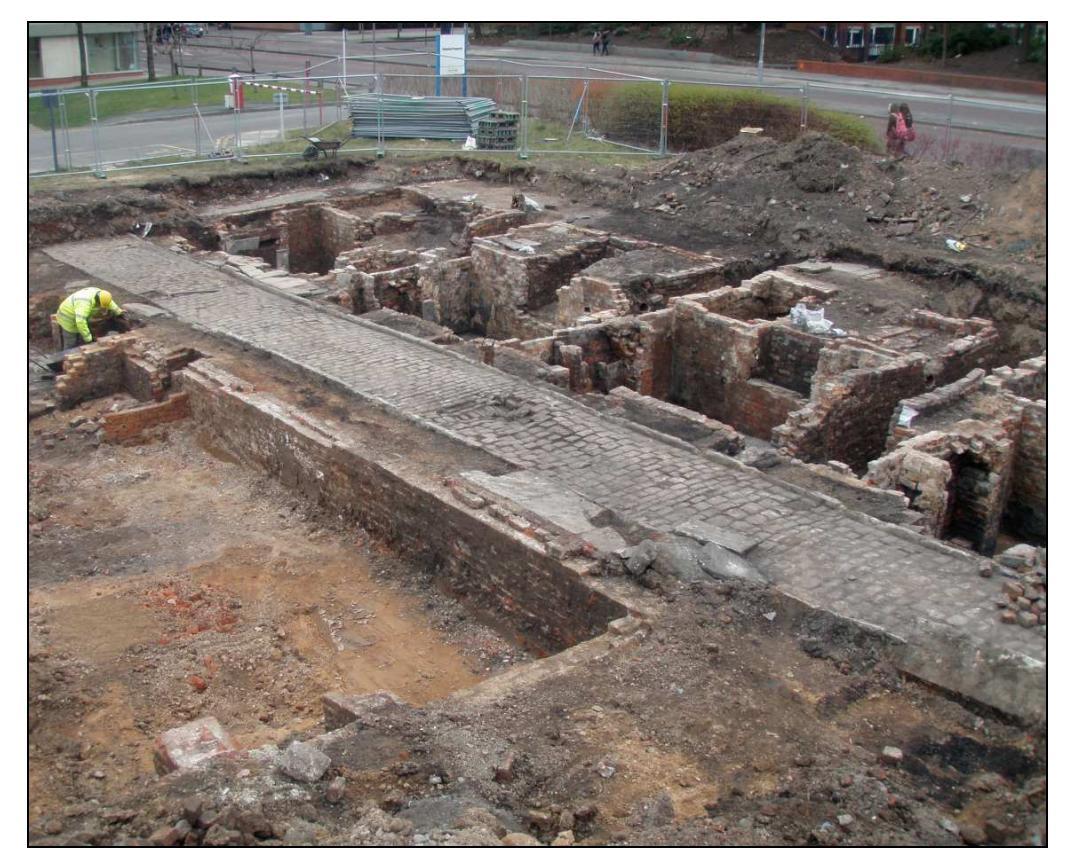
3.3.2 The surface of Lawson Street was buried beneath a mixture of loamy topsoil and mixed rubble. The insertion of a large, circular, pre-cast concrete manhole immediately to the east of the excavated area had removed any archaeological remains to the east, whilst excavation to the south-west was precluded by the route of live fibre optic communications cables. This entire footprint of the cellar for the Albert Club was thus not exposed, whilst excavation of the south-western corner of the trench was limited due to further fragments of asbestos chrysotile sheeting and possible asbestos insulation material resulting from refurbishment of the hospital carried out during the 1930s. 3.3.3 *Lawson Street:* a 24m long section of the former Lawson Street was uncovered within the excavated area (Plate 10). This was 2m wide, and comprised tightly laid sandstone sets of varying sizes, with an average of 230 x 120 x 100mm. The surface incorporated a slight camber, with kerbs formed from stone flags of varying sizes placed on edge along both sides.

Plate 10: General view looking west across Lawson Street

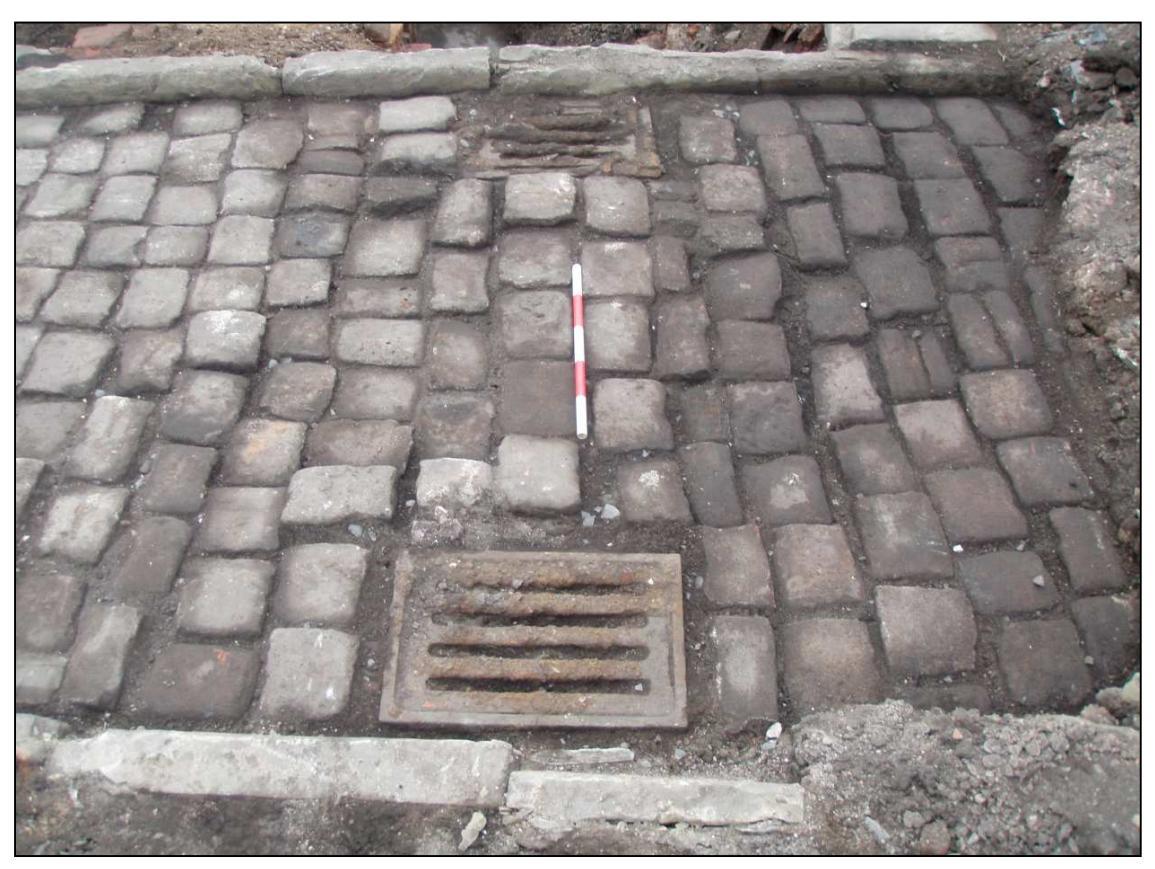
- 3.3.4 Cast-iron drain grids, each measuring 500 x 340mm, were set into the road surface. Two grids were exposed on each side of the street, each retaining a three-bar iron grate (Plate 11).
- 3.3.5 A modern intrusion revealed towards the south-western end of the exposed section of the street had resulted in the removal of some of the stone sets, and the resultant gaps had been infilled with concrete. Further damage to the street surface was noted in the north-eastern part of the excavated area, where some localised subsidence had occurred. This was restricted to an area covering approximately $2 \ge 1.2m$, and had resulted in the slumping of the road surface to a depth of *c* 200mm (Plate 12). It seems likely that this subsidence may have derived from the collapse of the original sewer pipe running below Lawson Street.

Plate 11: Drain covers set into Lawson Street

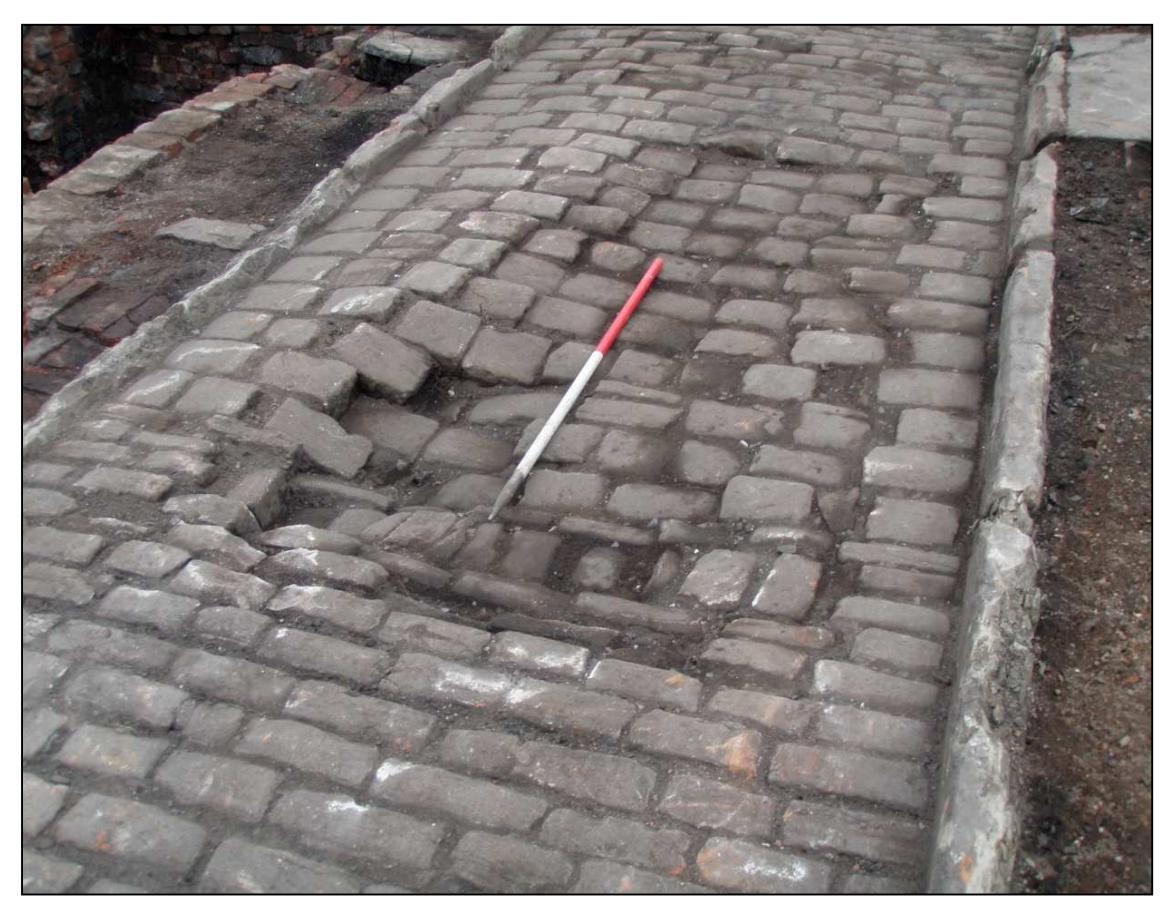
Plate 12: Localised collapse in the road surface, looking north

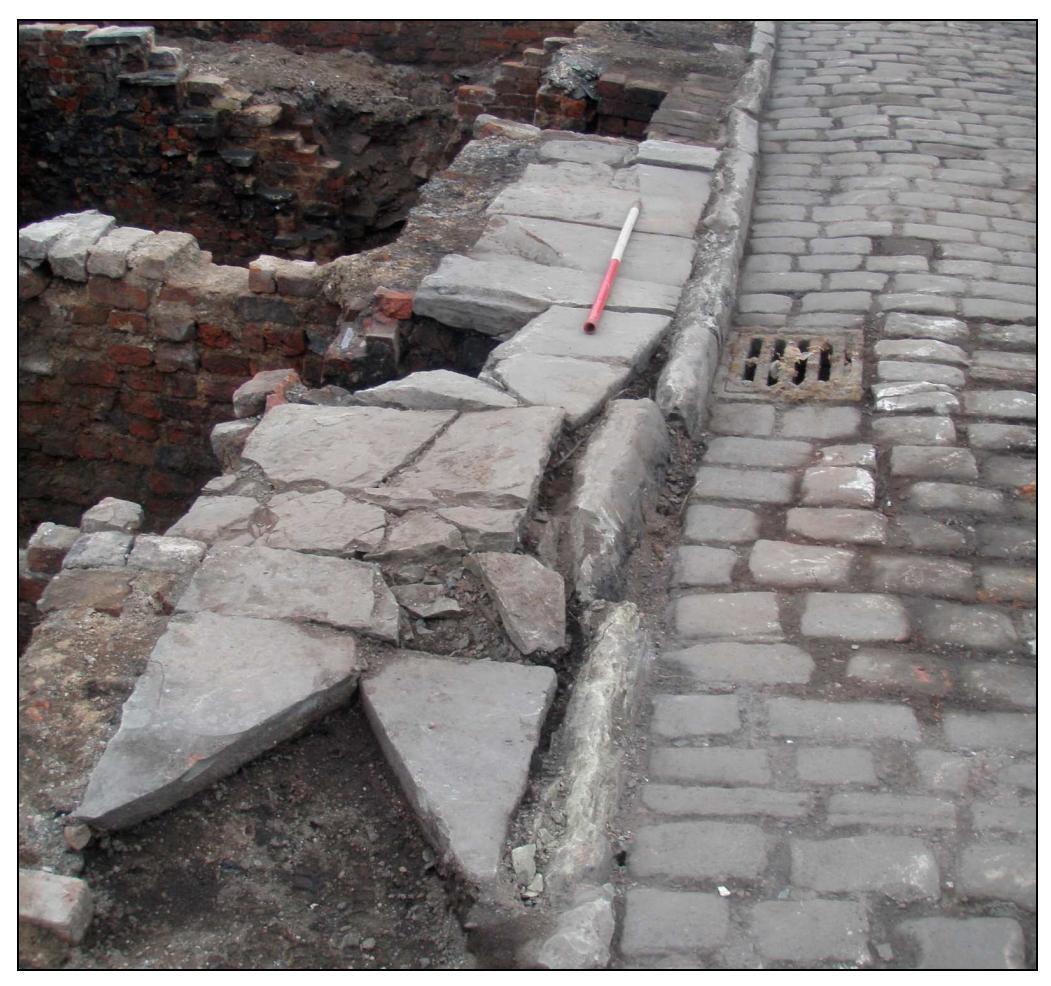
3.3.6 The fragmentary remains of a narrow, stone-flagged pavement survived *in-situ* in places along the side of Lawson Street (Plate 13). These included a 4.6m long section adjacent to the northern corner of the Albert Club (Cellar C1) on the southern side of the street, and a 3.7m long section on the northern side between Cellars H4 and H5. Both sections of pavement were 420mm wide.

Plate 13: Section of pavement surviving along the northern side of Lawson Street

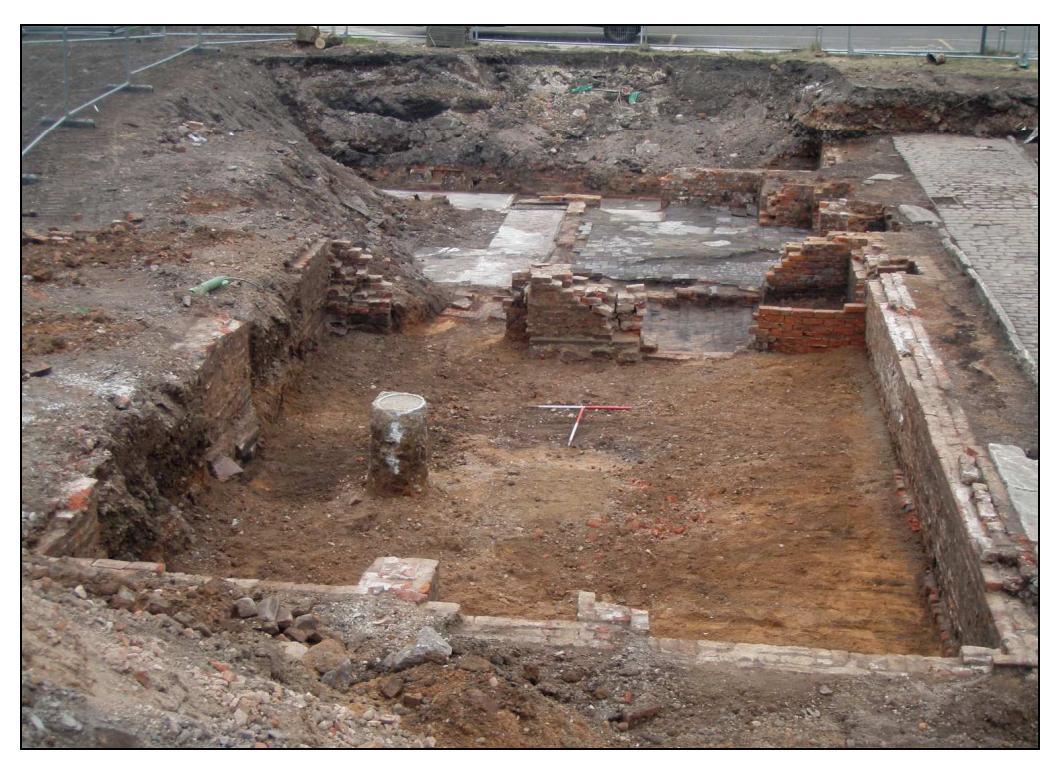
- 3.3.7 *Cellars to the south of Lawson Street:* excavation along the southern side of Lawson Street exposed the remains of the Albert Club / Turkish baths, and comprised five basement structures (Cellars C1 C5). The largest of these (Cellar C1) occupied the north-eastern part of the nineteenth-century building, and measured 8.42 x 6.25m (Plate 14).
- 3.3.8 The main outer wall, situated adjacent and parallel to Lawson Street, was three brick courses wide, with a foundation that was offset by another 50mm, and survived to a height of 13 courses. The fabric of this wall comprised hand-made bricks bonded with a lime-based mortar, indicative of a nineteenth-century construction date. The wall was aligned north-east/south-west, from the east corner of the cellar for 6.23m then returned to the south-east (Fig 4).

Plate 14: The excavated remains of Cellar C1, looking south-west

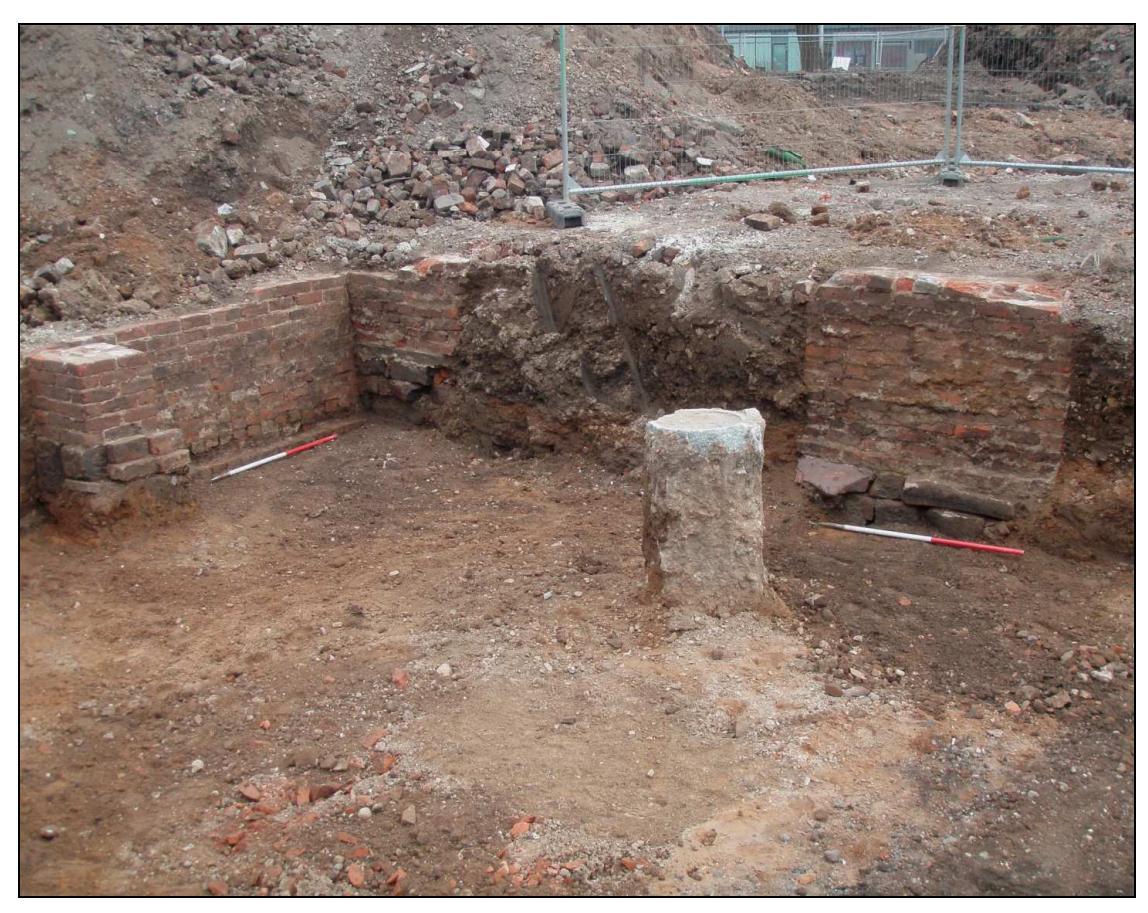
- 3.3.10 This walling continued to the north-west from the south-eastern corner of the south-western wall for 0.71m, then had a 1.32m gap for a doorway that afforded access between Cellars C1 and C5 (Fig 4). This then continued for another 1.34m, terminating at a 0.9m wide gap forming an entrance into Cellar C2. Beyond this gap was a single brick course wide wall, with a 40mm splayed foundation, which the original north-western wall. Butted against the interior of the north-eastern wall were two roughly square brick structures (Plate 16). These were placed 0.86m apart, the north-western structure was 0.6m square, and that to the south-east measured 0.62 x 0.55m. These structures comprised hand-made bricks bonded in a lime-based mortar, and had been placed on reused sandstone masonry fragments as a foundation, similar to the south-eastern and south-western walls of Cellar C1. Although they resembled a hearth, there was no indication for the fabric to have been subject to any high temperatures.

Plate 15: The north-eastern corner of Cellar C1, showing the stone foundations

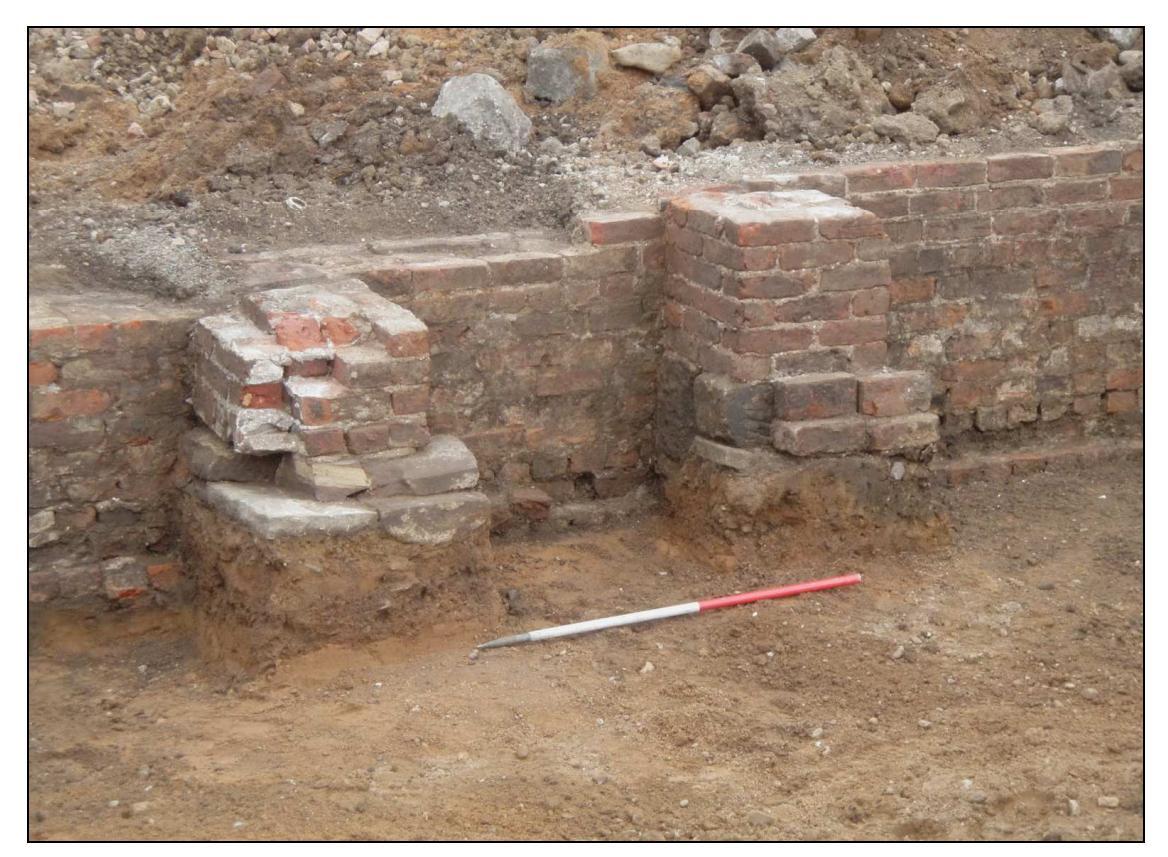
Plate 16: Brick structures abutting the north-eastern wall in Cellar C1

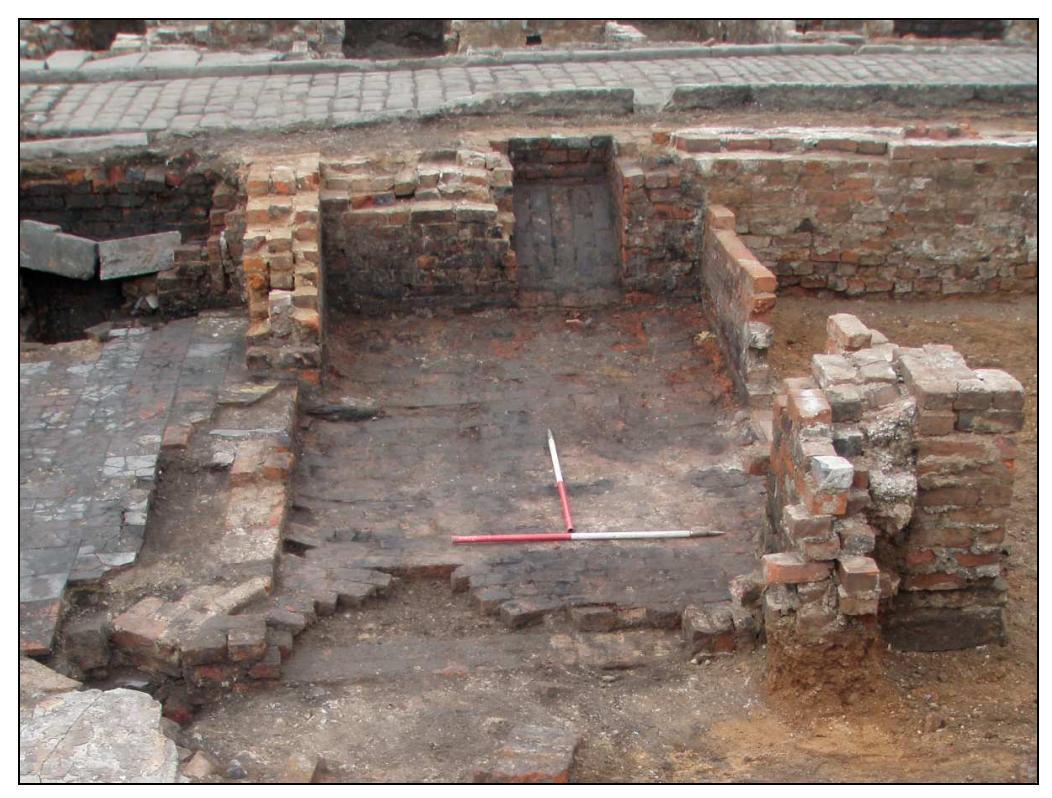
Plate 17: General view across Cellar C2, looking north-west

- 3.3.14 Cellar C2 incorporated a brick floor that sloped slightly downwards to the south-east (Plate 17). Built into the north-west wall was a 0.7 x 0.64m alcove with a brick-built chute leading from Lawson Street (Plate 18). This feature appeared to have been inserted into the north-western wall of the building, and had almost certainly been intended as a mechanism of delivering coal into the basement, suggesting that this cellar may have been used for storing coal required in the furnace room for the Turkish bath. The interpretation of this feature having been a late addition is supported by its absence from the detailed Ordnance Survey map of 1849.

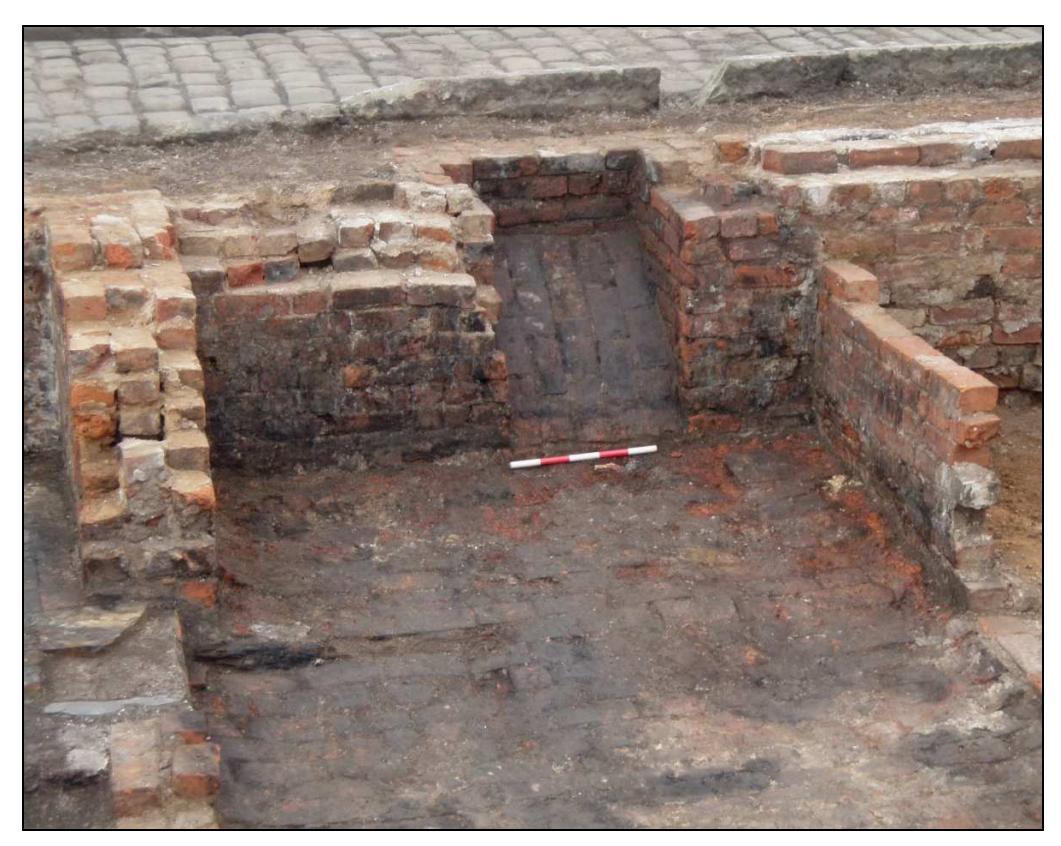
Plate 18: The coal chute in Cellar C2, looking north-west

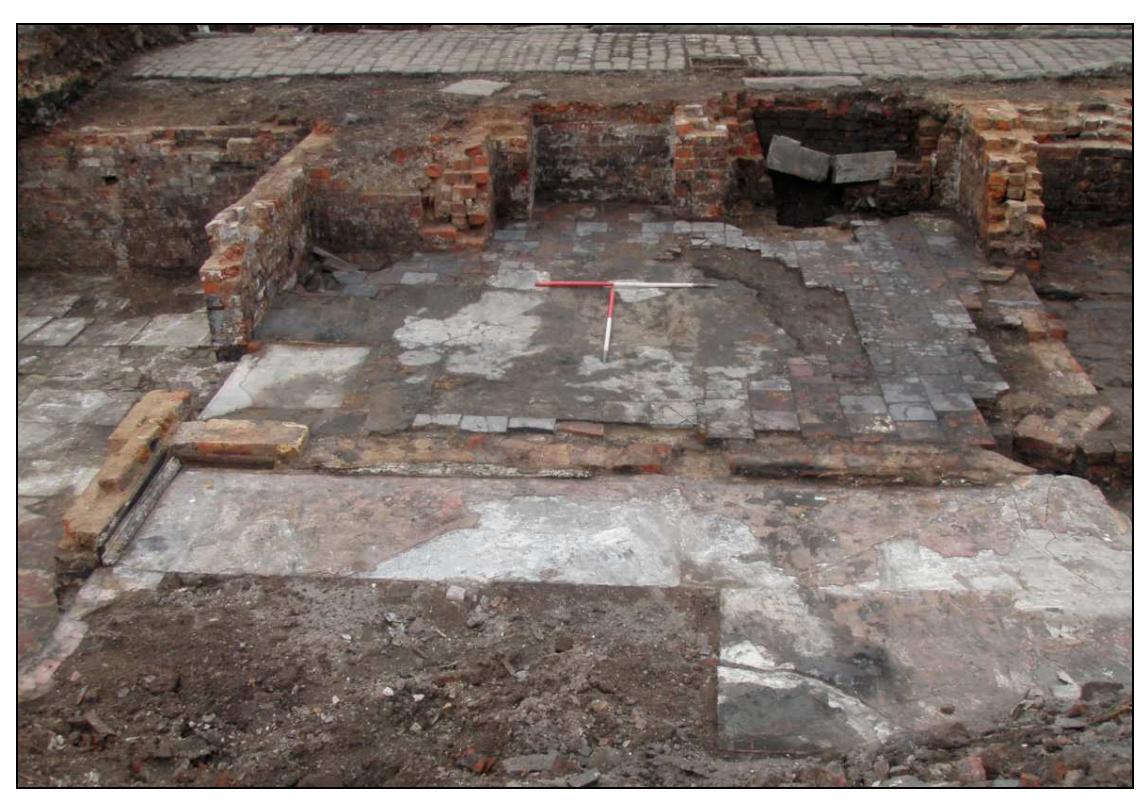
- 3.3.15 Cellar C3 measured 4.6 x 4.0m, and lay between Cellar C2 and C4, with Cellar C5 to the south-east (Fig 4). Access into Cellar C3 was afforded via Cellar C4, which was at a slightly lower level, was afforded via a 0.92m wide doorway in the south-western part of the cellar (Plate 19). This doorway was marked by a 0.45m high stone-capped step. At the top of the step was a 0.9 x 0.7m slab of concrete, presumably representing a twentieth-century repair.

Plate 19: General view across Cellar C3, looking north-west

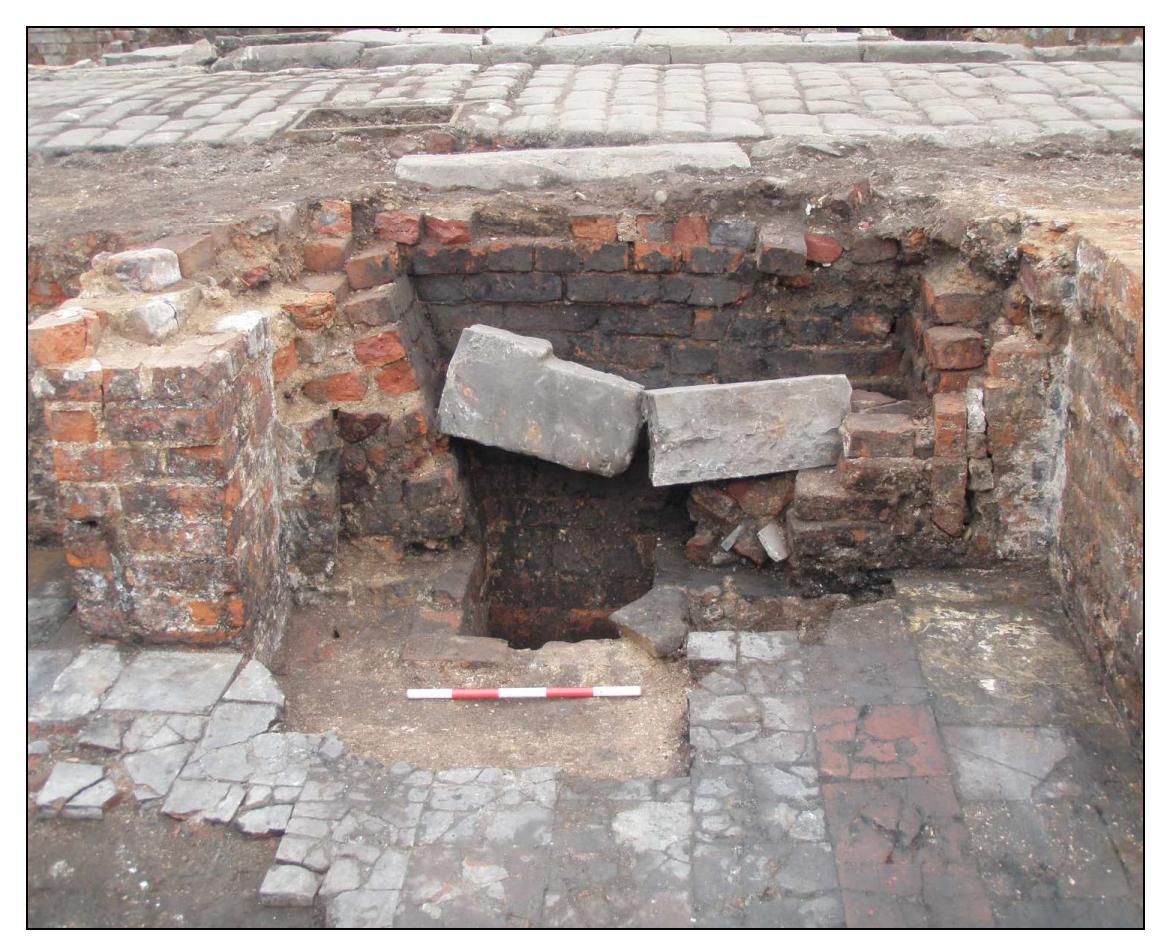
- 3.3.17 Set into the north-west wall was a 1.7m wide and 0.91m deep alcove, with a 0.6 x 0.5m brick drain at its base (Plate 20). Excavation revealed that the drain led vertically to a stone-capped and brick-lined drain that ran south-eastwards beneath the floor of the cellar. The floor of the cellar comprised dark grey, square 'quarry' type tiles with several patches of repair in concrete, representing twentieth-century repairs.

Plate 20: The alcove set into the north-west wall of Cellar C3, looking north-west

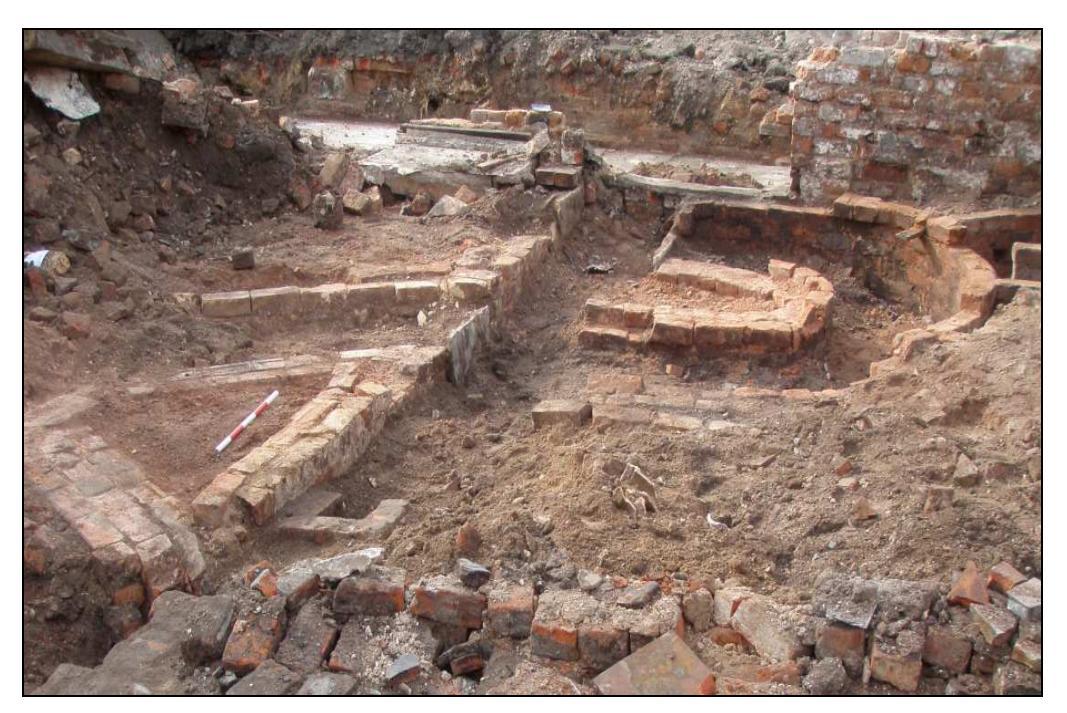
- 3.3.21 A 0.9m wide and 0.34m deep brick channel, which terminated in a slight step up of brick at its north-eastern end, was excavated in the northern part of Cellar C4, and continued beneath the floor of Cellar C5. The southern end of this channel had been destroyed by twentieth-century activity, although it may have connected originally with other elements of the flue system. The channel was lined with firebricks, an infilled with ash, adding weight to an interpretation of it having formed part of the flue system. The continuation of this structure into Cellar C5 suggests that this may have been a stokehole for the heating system.

Plate 21: General view across the under-floor heating system, looking south

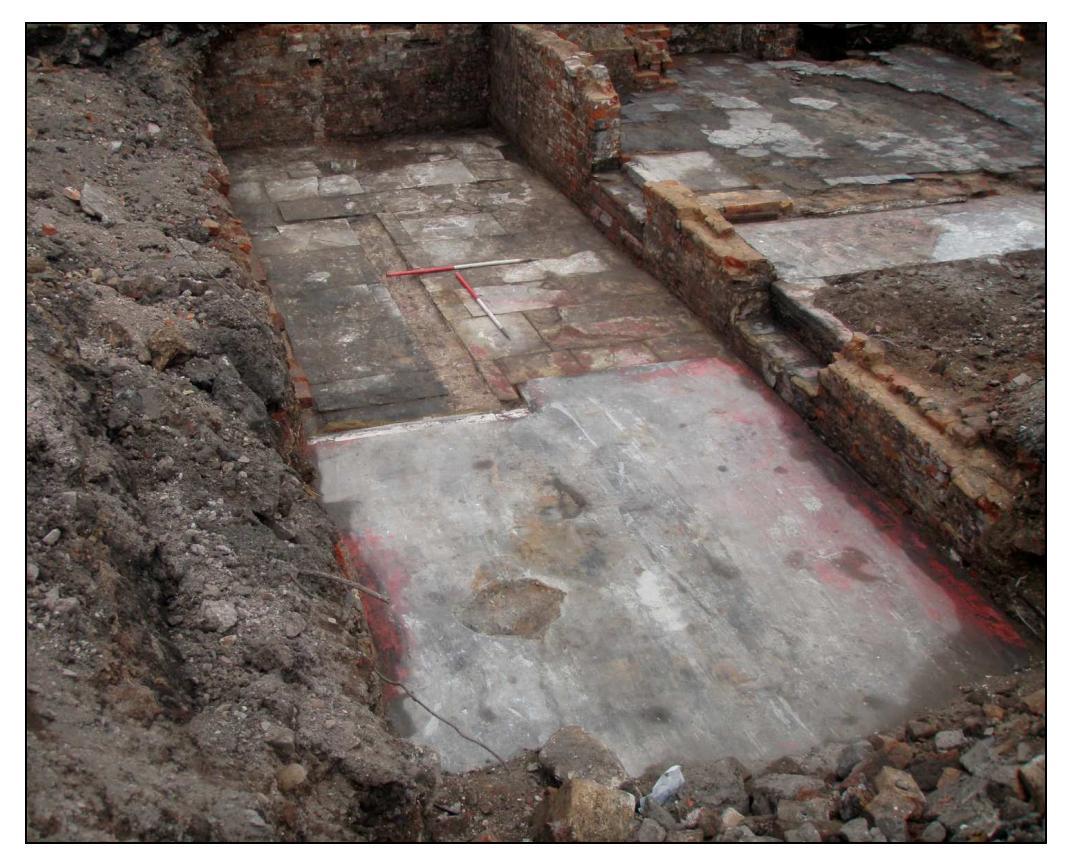
3.3.22 Cellar C4 lay to the south-west of Cellars C3 and C5 (Fig 4). Due to the presence of fibre optic communications cables to the south-west, only half of the room was excavated. The room also continued further to the north-east than the edge of the excavation trench, but work was halted in this area due to the presence of asbestos derived from hospital refurbishment during the 1930s. The excavated portion of the room was 2.7m wide (Plate 22).

Plate 22: General view across Cellar C4, looking south-west

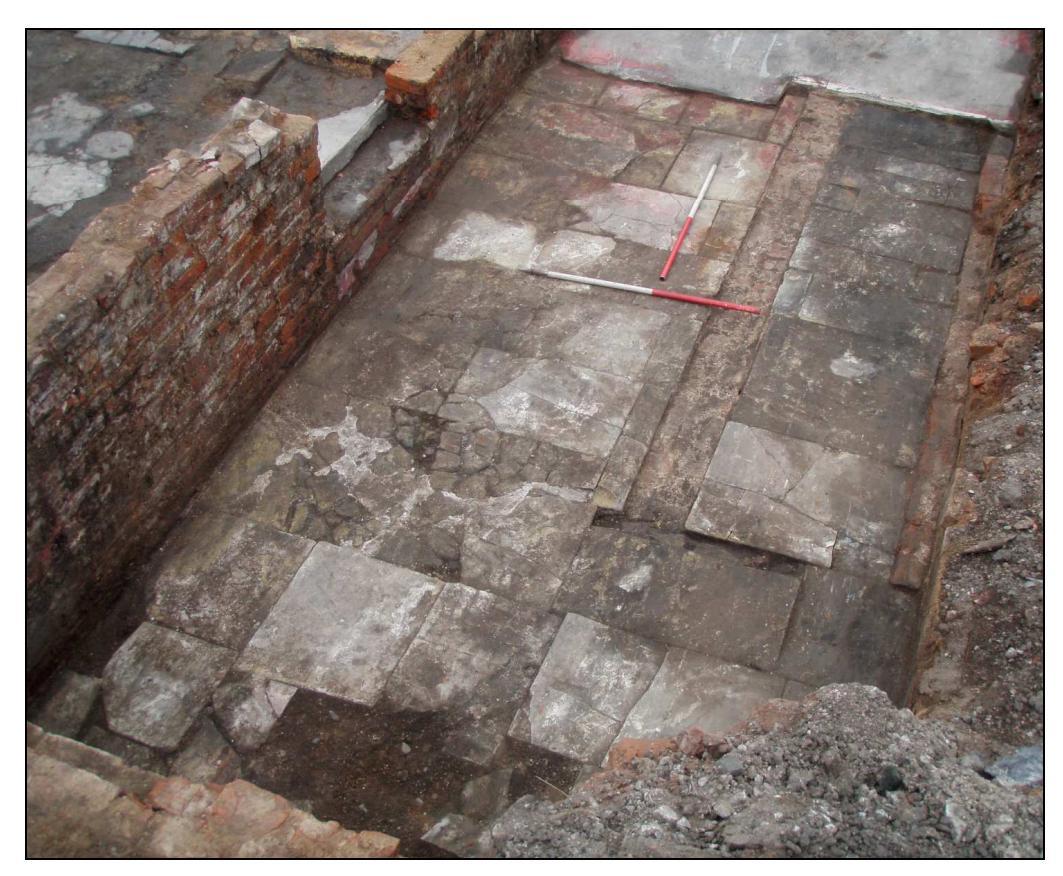
- 3.3.24 The south-western wall of the cellar, adjacent to Lawson Street, was three courses wide, and comprised hand-made bricks bonded with a lime-based mortar. It is likely that this step is due to the floors in Cellars C2, C3 and C5 being raised to accommodate the under-floor heating system, and that this room represents the original floor surface of the club and earlier villa. The north-western part of the room retained flagstones, almost certainly original, whilst the floor to the south-east comprised a concrete slab. A single row of bricks was embedded in the floor, lying parallel to the partition wall. This may have been the foundation course for an insubstantial partition, which formed a 3.48m long and 0.77m wide internal corridor.

Plate 23: The flagstone floor in Cellar C4, looking south-east

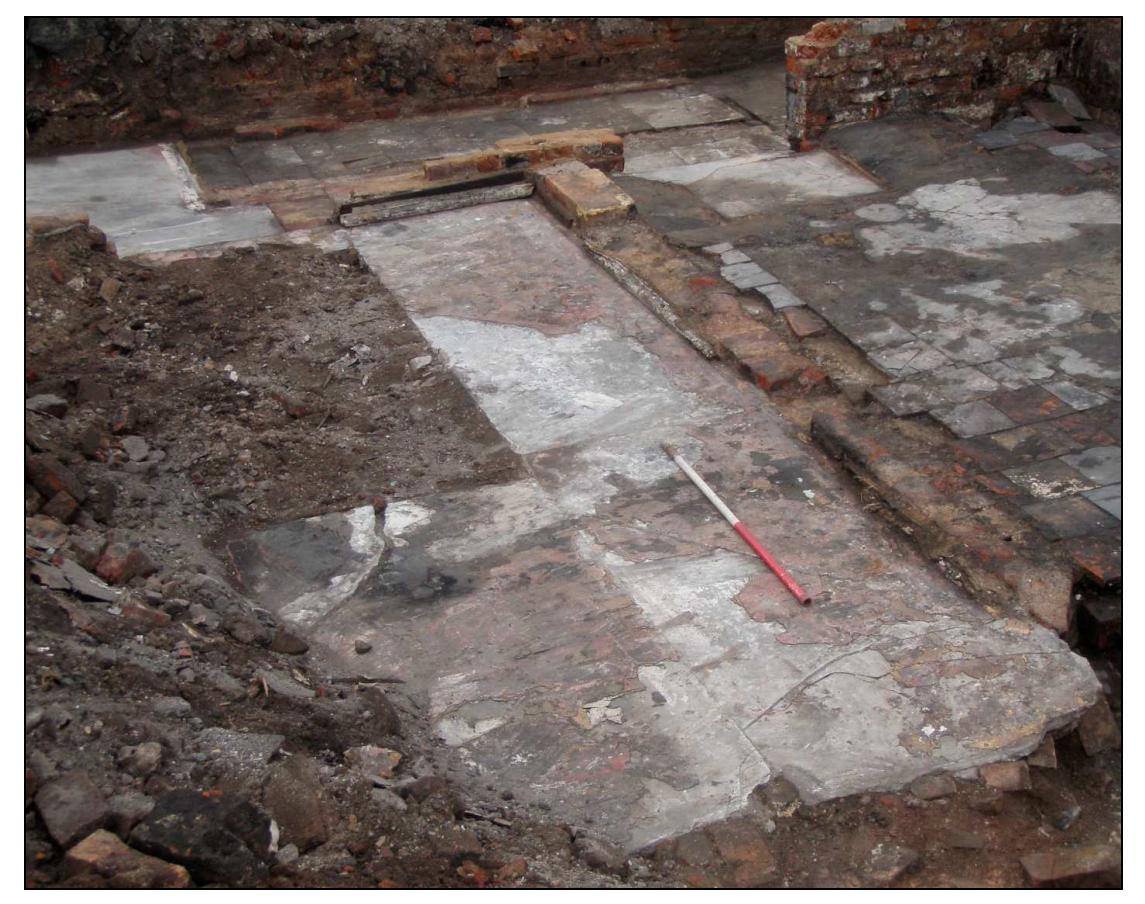
- 3.3.26 Room C5 lay to the south-east of Cellars C2 and C3, and was excavated only partially due to the presence of asbestos (Plate 25). The surviving fabric of the room had clearly been remodelled during the twentieth century, although elements of the under-floor heating for the Turkish baths lay beneath the concrete floor (*Section 3.3.21 above*).

Plate 25: Cellar C5, looking south-west
- 3.3.27 *Cellars to the north of Lawson Street:* excavation to the north of Lawson Street revealed a row of five cellars beneath single-depth workers' houses with cross passages between them (Plate 26). During excavation the houses were designated H1 to H5, and the cross passages as G1 to G4 (Fig 4). House H1 corresponds to N° 10 Lawson Street, H2 to N° 8, H3 to N° 6, H4 to N° 4, and H5 to N° 2 Lawson Street.

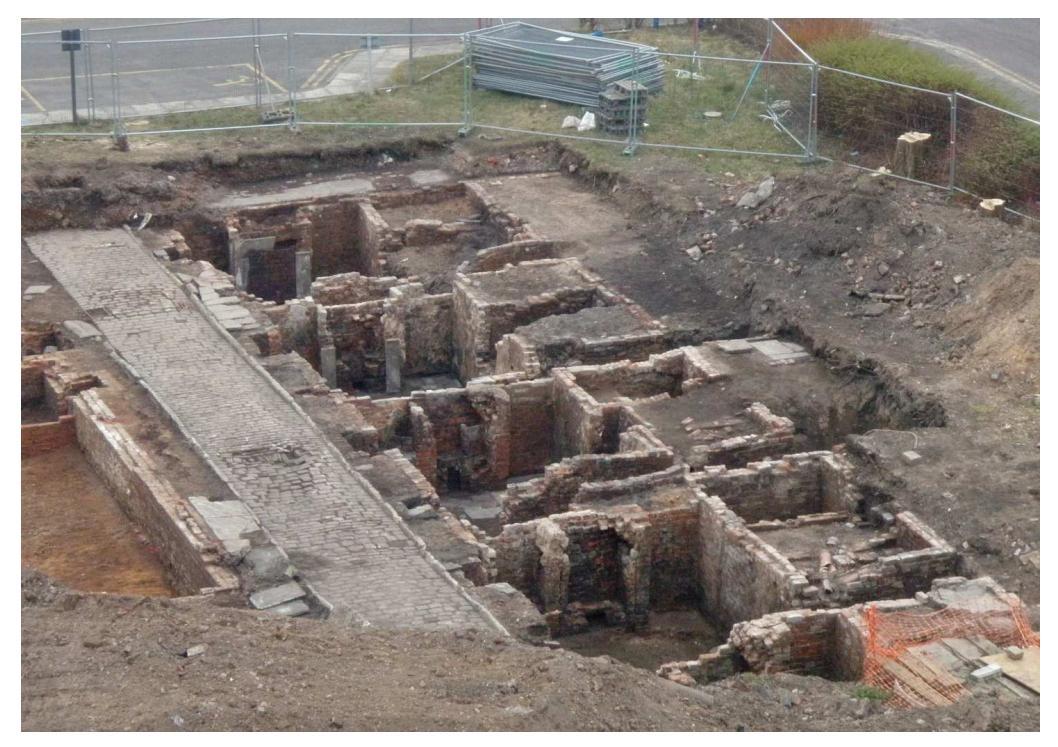
- 3.3.28 All the houses followed a similar pattern of layout and construction, although each retained physical evidence for slight differences and alterations. The floor plan of each property measured approximately 6.2 x 4.5m, and was split into a full-width main room at the front 3.6m of the building, and two small cellars to the rear, each measuring 1.5 x 1.8m, separated by a small open yard, measuring 1.25 by 1.8m (Fig 4). Nearly all of the component walls were two courses wide, and comprised hand-made bricks bonded with lime-based mortar.

Plate 26: General view looking south-west across the excavated cellars and Lawson Street
