National Graphene Institute, Booth Street East, Manchester

Archaeological Excavation

Oxford Archaeology North June 2013

University of Manchester

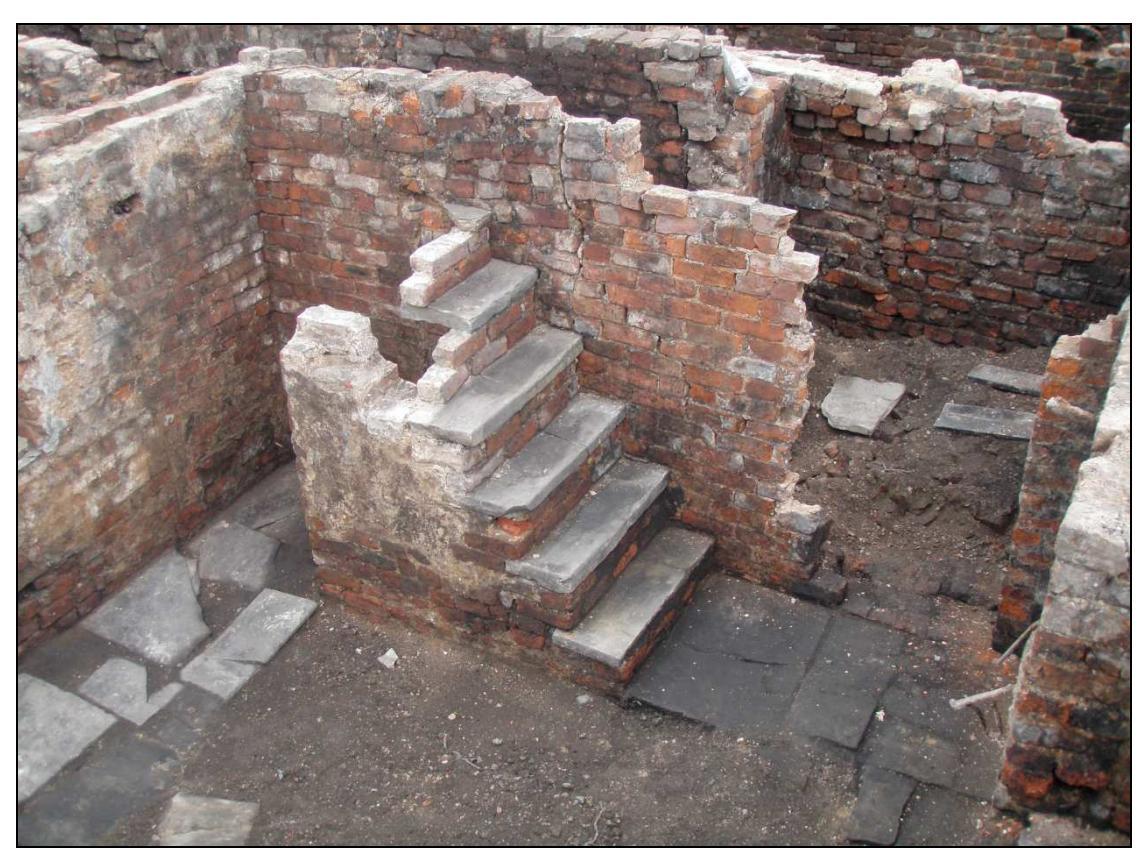
- 3.3.29 All of the cellars had a private entrance into the main front room from a cross passage to the north-east, and an entrance into the south-western rear room from the cross passage to the south-west. This meant that the rear south-western room of each cellar was only accessible by the adjacent property. Each seemed to originally have had access through the rear wall of the main cellar into the small rear yard, and from there into the small north-east cellar room. Only cellar H3 retained clear physical evidence for access from the south-western rear room into the yard.
- 3.3.30 The main cellar rooms all had a cellar light window at the front, along the side of Lawson Street. All the cellars had an internal stair against the north-eastern wall, composed of brick with six stone slab treads (Plate 27), and a large fireplace set into the south-western wall (Plate 28).

Plate 27: The remains of the stair in Cellar H3

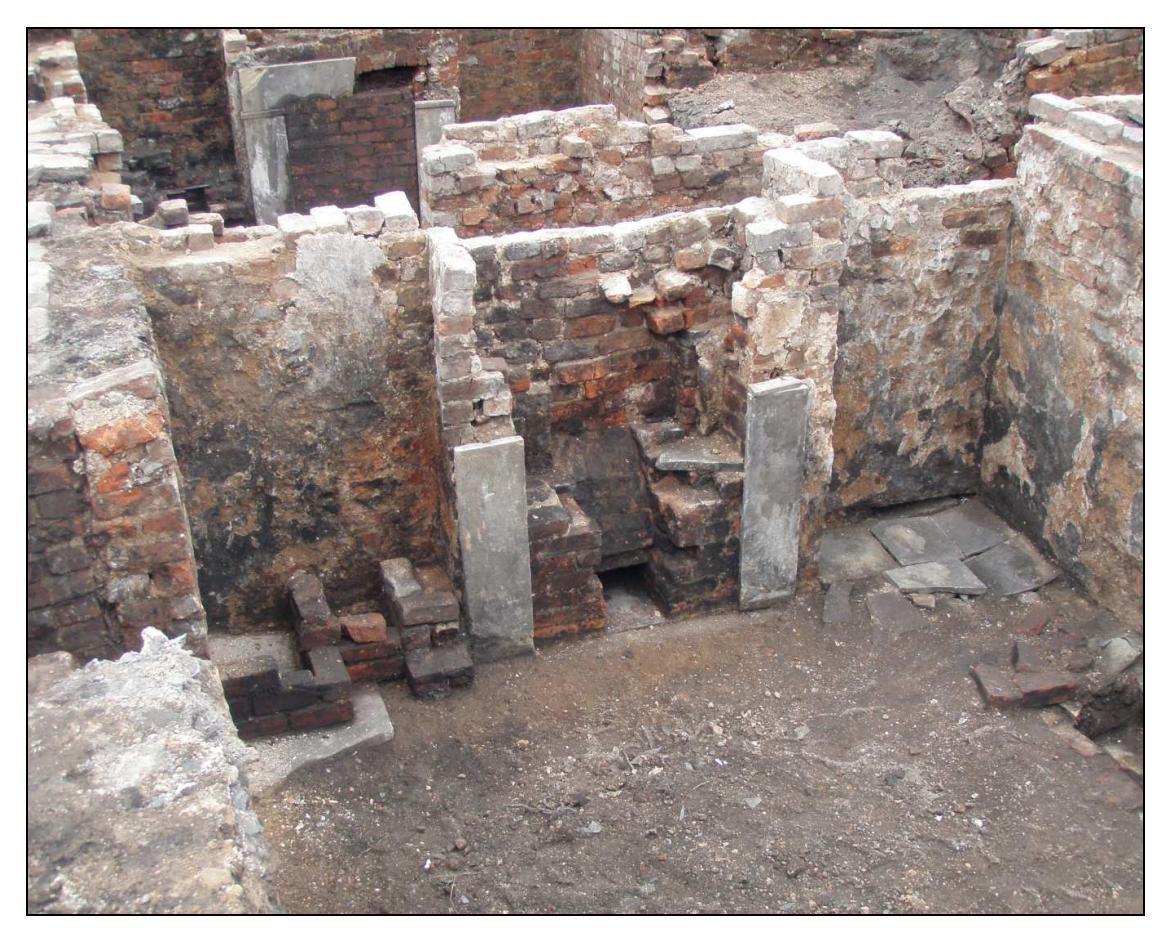
Plate 28: The remains of the fireplace in Cellar H4

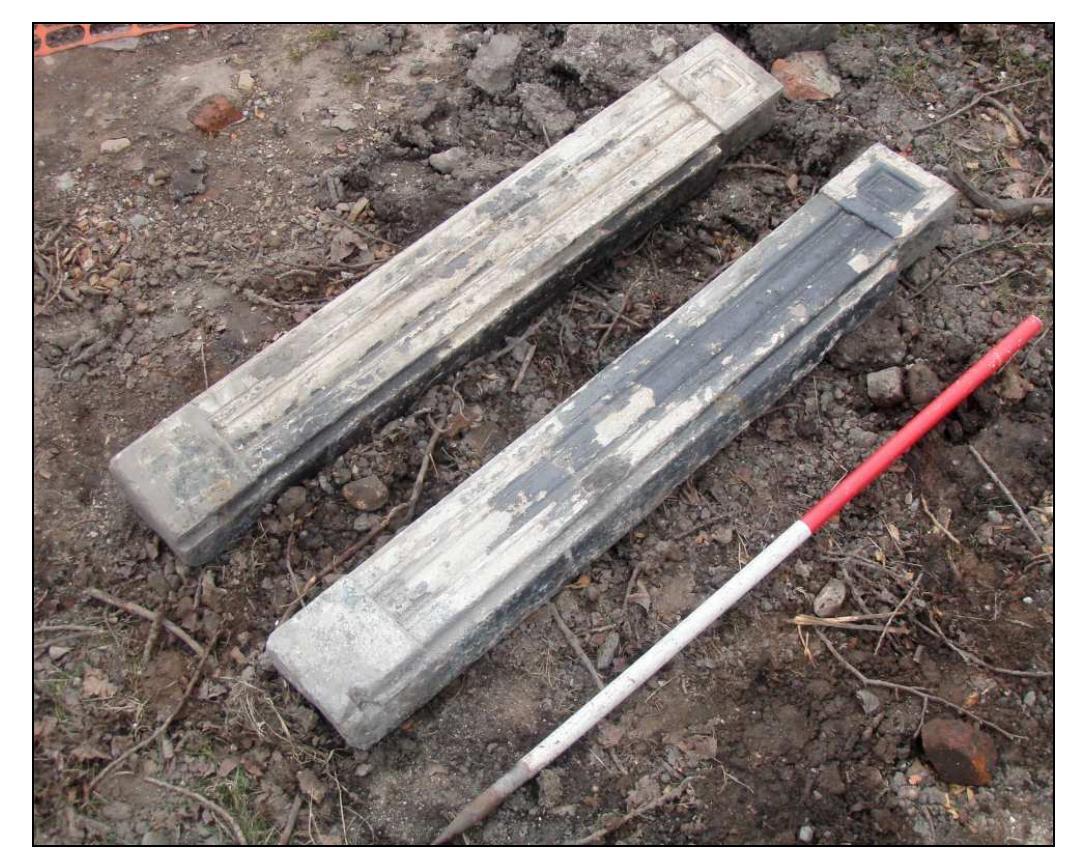
- 3.3.32 Within each cellar were found identical pieces of architectural masonry measuring 1.1 x 0.25 x 0.2m (Plate 29). Theses had a square motif carved into the top and a flat panel at the bottom with vertical fluting between them and chamfers cut into the rear edges. Two were found per cellar with most broken but two intact, and it was felt that these also flanked the fireplaces.

Plate 29: Worked stone fire surround

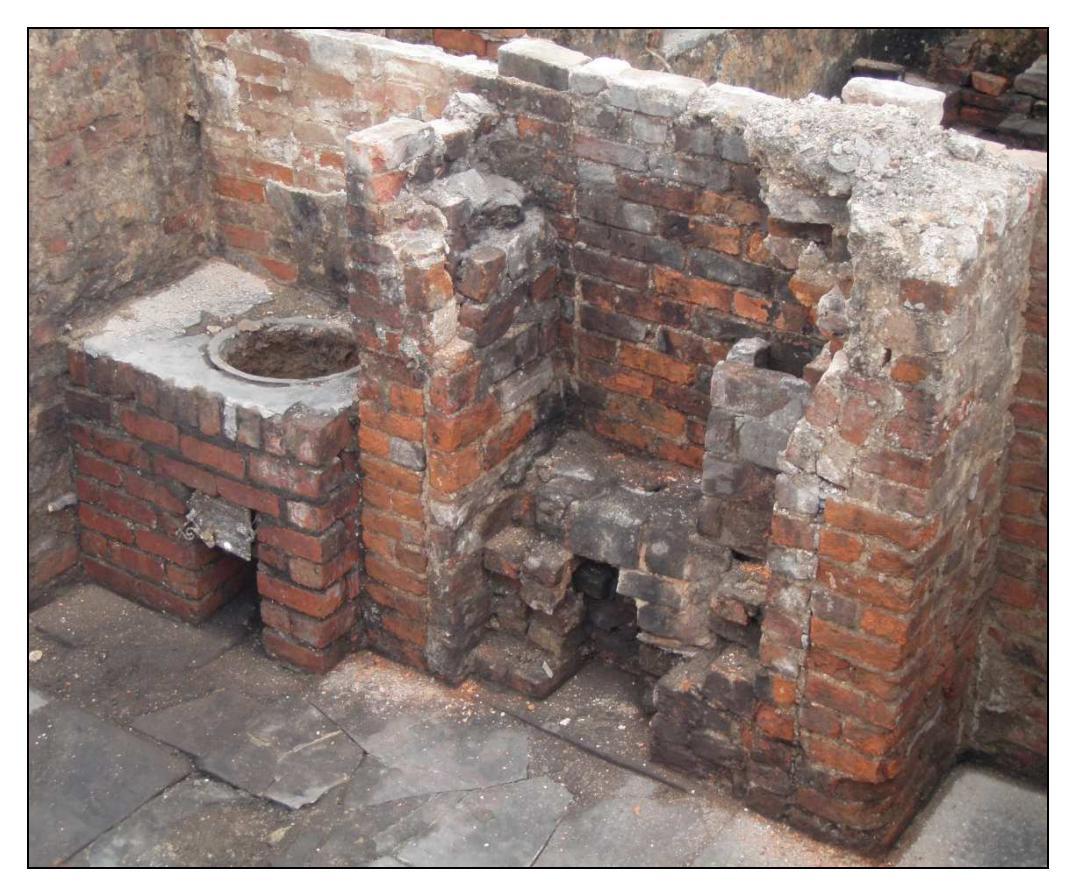
3.3.33 Each of the cellars contained the remains of a 'set-pot' boiler in the southern corner, situated between the fireplace and the front wall. These had been built with machine-pressed bricks and hard, dark grey mortar, indicative of later nineteenth-century construction (Plate 30). They each measured an average of 0.95m wide by 0.5m deep by 0.68m high, and had a hinged metal grill at the front to allow the fire inside to be fuelled and ash to be raked out. Each had a deep cast-iron vessel set into the top surface, and the surface was skimmed with cement. Most of the boilers were very fragmentary, but the most intact showed that the vessel was ringed with a firebrick 'screen' around its back and sides with an open front. The boilers had flues which vented either into the fireplace chimney of out through the wall into the cross passage.

Plate 30: 'Set-pot' boiler in Cellar H3

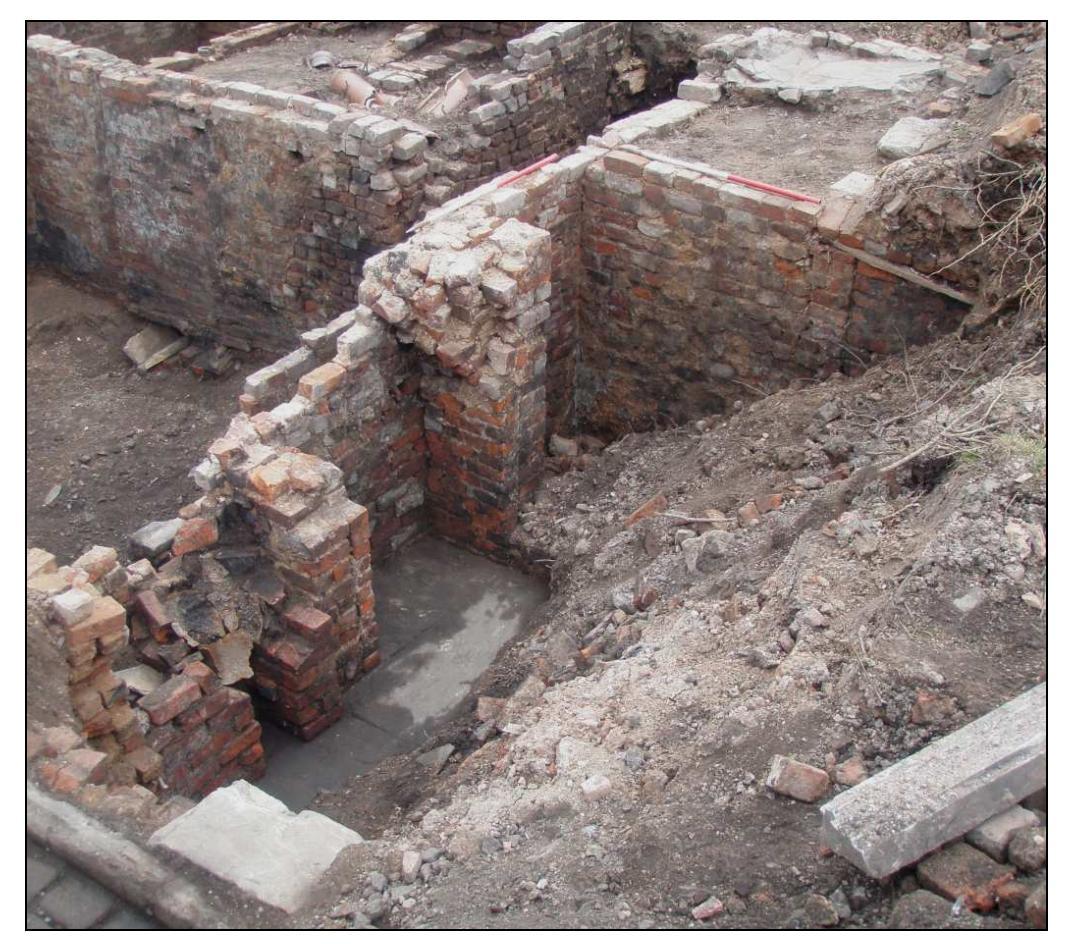
3.3.37 *Cellar H1:* the property at the north-eastern end of the excavated row (Cellar H1) had been partly destroyed by the insertion of a large, circular pre-cast concrete manhole. The surviving remains of the cellar to this house comprised a 3.5m long front room and a 1.9m long rear room (Plate 31).

Plate 31: The excavated remains of Cellar H1

- 3.3.40 The fireplace set into the south-western wall of the front room was 1.6m wide and 0.48m deep, with an internal width of 0.92m (Plate 31), and retained the foundations of a brick-built housing for a range. The boiler in the southern corner survived very well, with just part of the front damaged and the grate removed (Plate 33). Part of the cast-iron vessel remained intact, with the base of the firebrick screen still *in-situ* around the rear and sides. The flue for this boiler seemingly existed the room via the south-western wall.

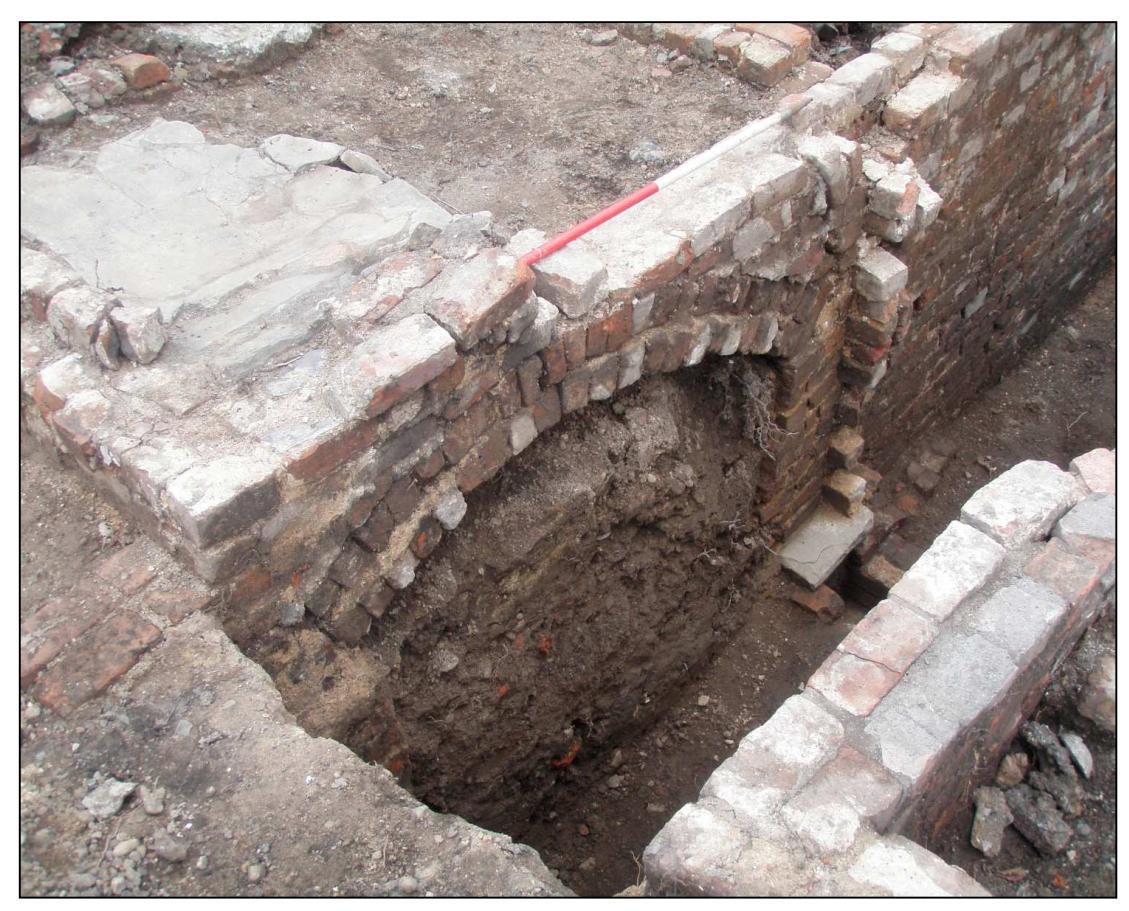
- 3.3.38 The surviving rear room of Cellar H1 was not excavated fully for logistical and health and safety considerations, although it retained the remains of a concrete and flagstone floor at ground level, laid onto a mixed clayey gravel. Elements of a brick-built partition between the south-eastern rear room and the small yard were identified along the north-western edge of the excavated trench. An entrance into the yard at cellar level was also observed. This had been blocked with machine-made brick and hard grey cement, and had a wooden beam above it, presumably surviving from the original doorway. The south-western rear cellar was accessed through a 1.6m wide and 1.2m high brick archway from passage G1 (Plate 32).

Plate 32: Arched entrance to the rear yard from the passage G1

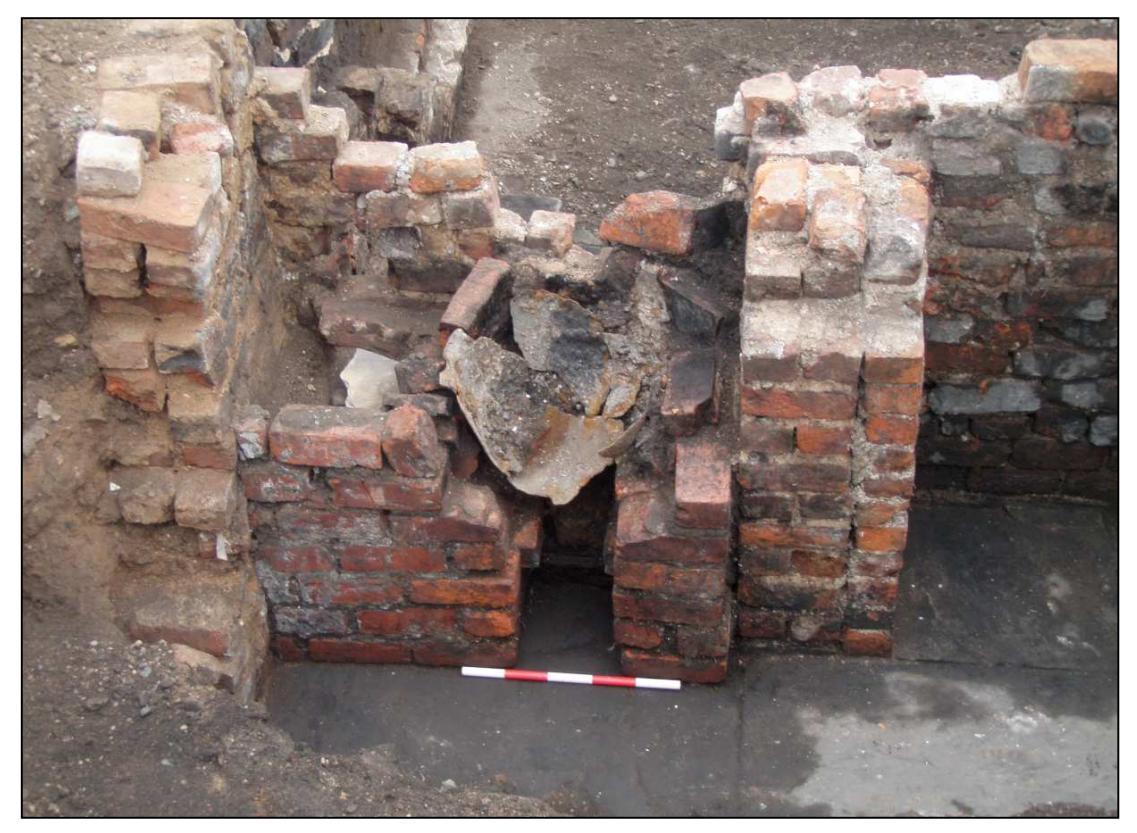
- 3.3.39 The floor of the front cellar room retained elements of a flagstone floor, which was exposed at a depth of 1.8m below the modern ground surface. Part of the south-western wall of this room, between the fireplace and the wall adjacent and parallel to Lawson Street, had been reduced in width to a single course of bricks, a modification that was presumably necessitated by the installation of the 'set-pot' boiler in the southern corner of the room during the later nineteenth century (Plate 33).

Plate 33: The remains of the boiler in the southern corner of Cellar H1

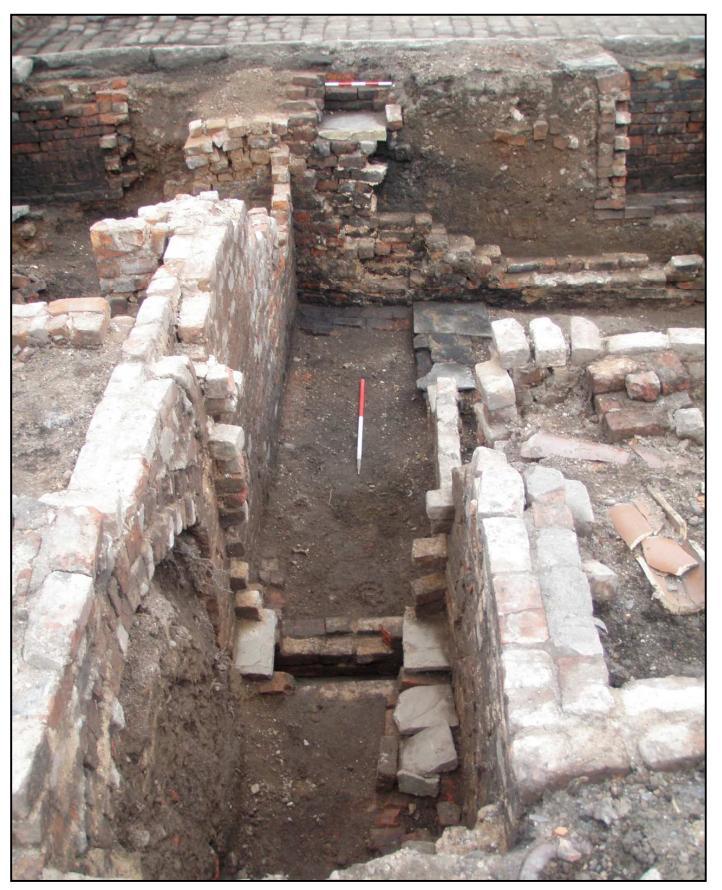
- 3.3.43 Passage G1 was aligned north-west/south-east between Cellars H1 and H2 (Fig 4), and was 1.06m wide (Plate 34). The south-eastern end terminated at a brick wall, adjacent and parallel to Lawson Street, which incorporated a cellar window light that measured 0.48 x 0.46m and retained a stone cill.

Plate 34: Passage G1, looking south-east

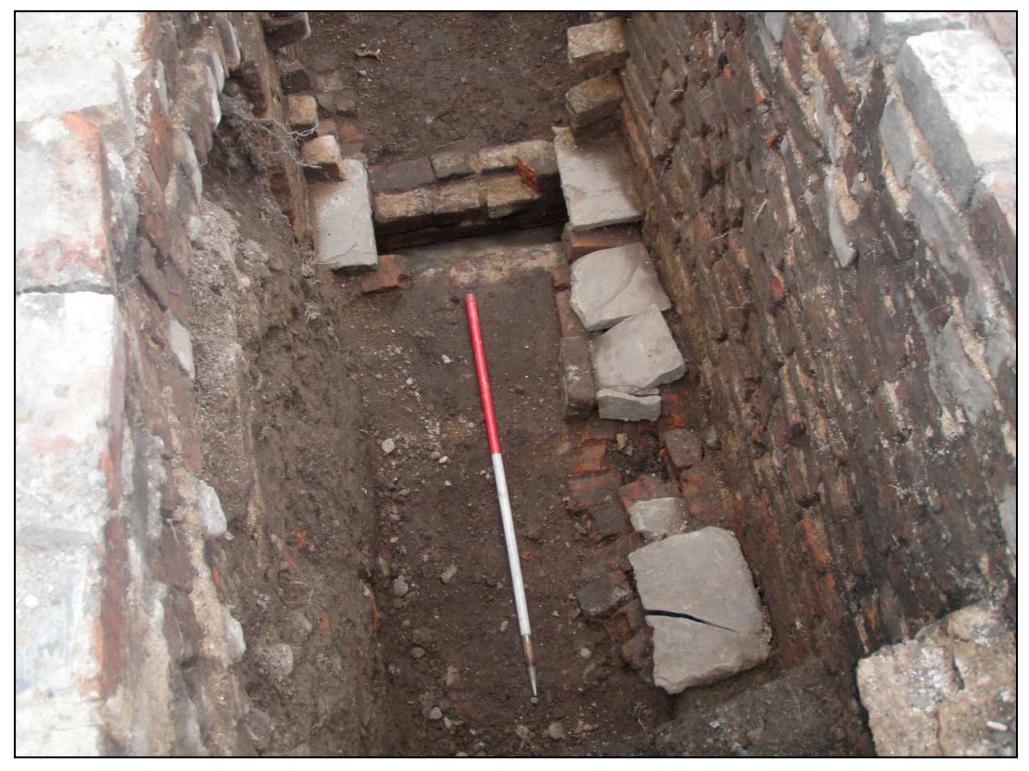
- 3.3.44 There was no physical evidence for a wall at the north-western end of the passage, although this may have been removed by the insertion of a sewer pipe after that passage had been infilled with clayey sand and gravel. No floor surface survived in the passage.
- 3.3.45 The drain beneath the passage ran from out from the north-eastern wall of Cellar H2, serving a late privy, and turned north-west along the passage beyond the houses, to link in with the rear sewer for the Booth Street East houses. In line with the internal dividing walls of the two houses was a stone-capped brick drain running north-east/south-west across the passage, and then turning north-west along the north-eastern wall of Cellar H2. It was 0.6m wide and 0.35m deep (Plate 35).

Plate 35: Stone-capped drain in passage G1, looking south-east

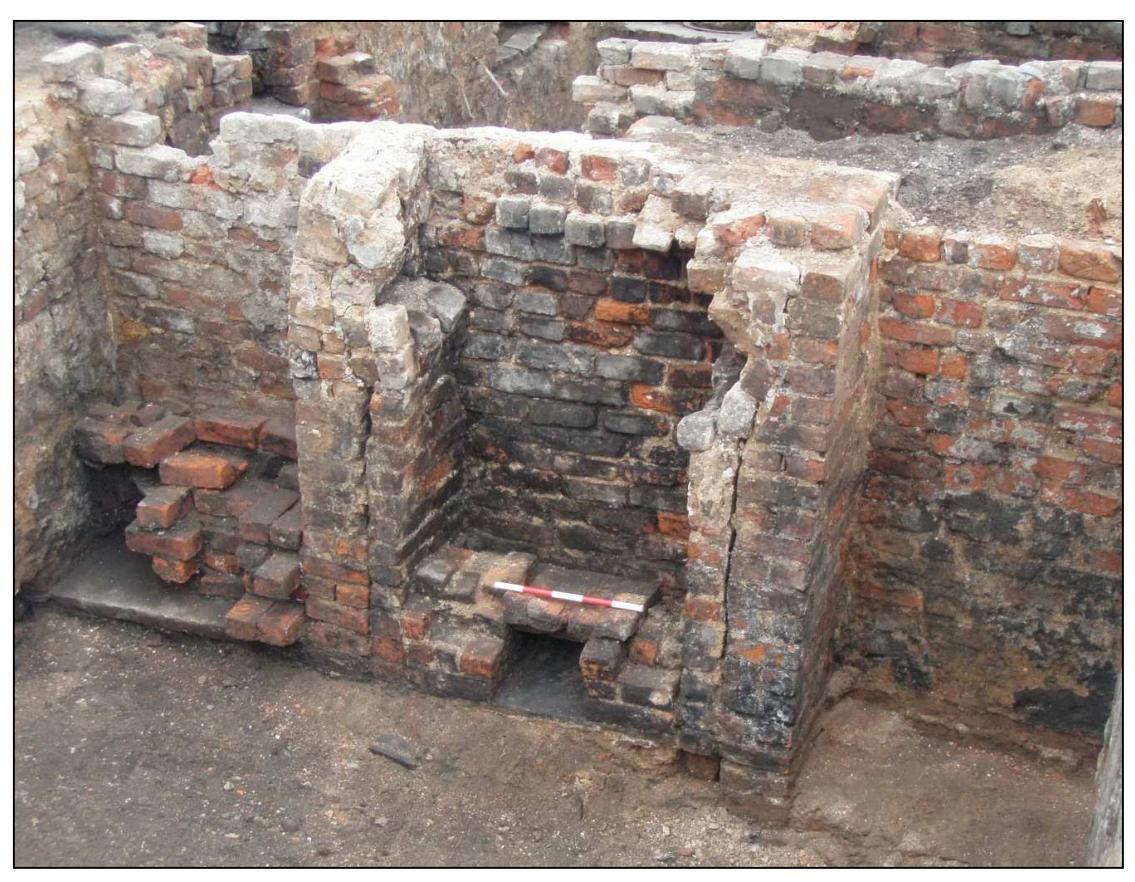
- 3.3.49 The position of the fireplace mirrored that in Cellar H1. It was 1.66m wide and 0.5m deep, with an internal width of 0.9m. The base of the range had survived showing a 0.3m wide central void for raking out ash (Plate 37). The 'set-pot' boiler was placed immediately to the south-east of the fireplace. This had been damaged during demolition, but sufficient fabric survived to demonstrate that it was of a similar construction to those identified in the other excavated cellars (Plate 37).

Plate 37: The fireplace in the front room of Cellar H2

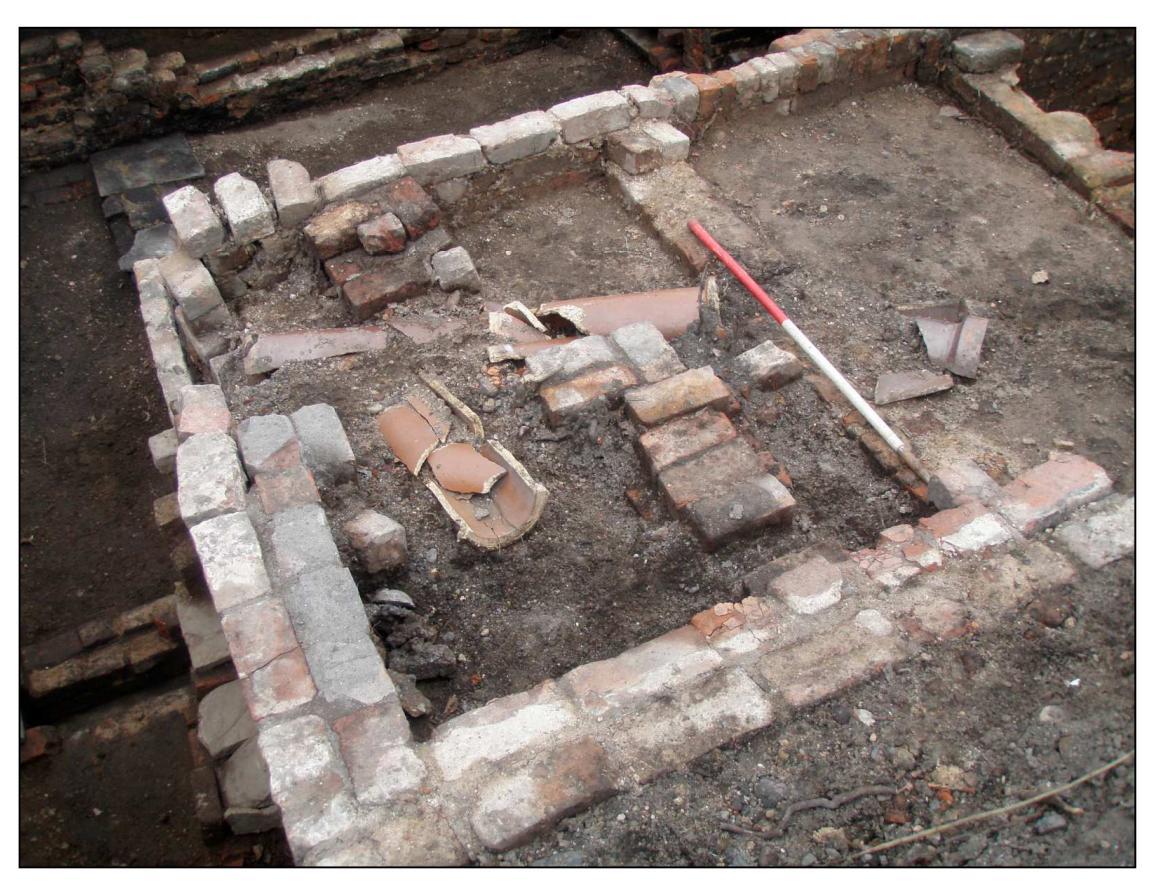
Plate 38: The foundations of the privy added to the rear of Cellar H2

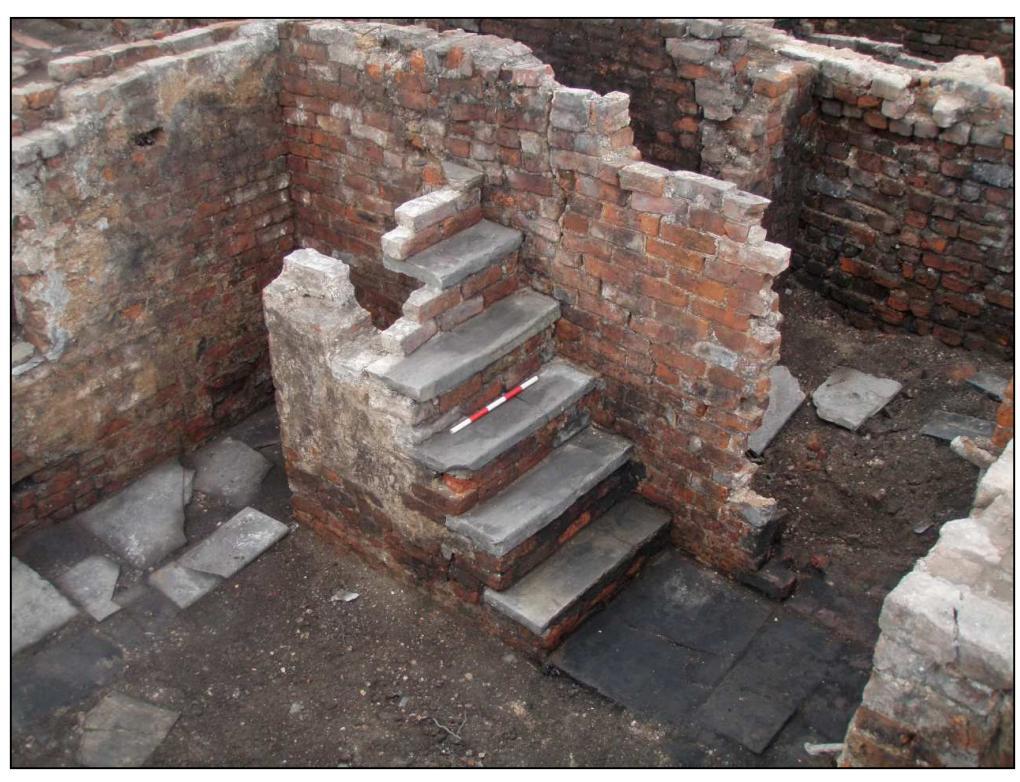
- 3.3.56 The stairs appeared to have been rebuilt at some point as a construction break was clearly visible in the fabric of the wall at a point coinciding with the two ends of the stairs. At the base of the stairs, and in front of the doorway, within the lower backfill were broken pieces of chrysotile sheeting. This is likely to have surrounded the edges of the hatch at the top of the stairs, and possibly the entrance to the passage as well, and been used as a simple form of fire prevention during the later period of the cellar's use.

Plate 43: Stairs in Cellar H3, looking north

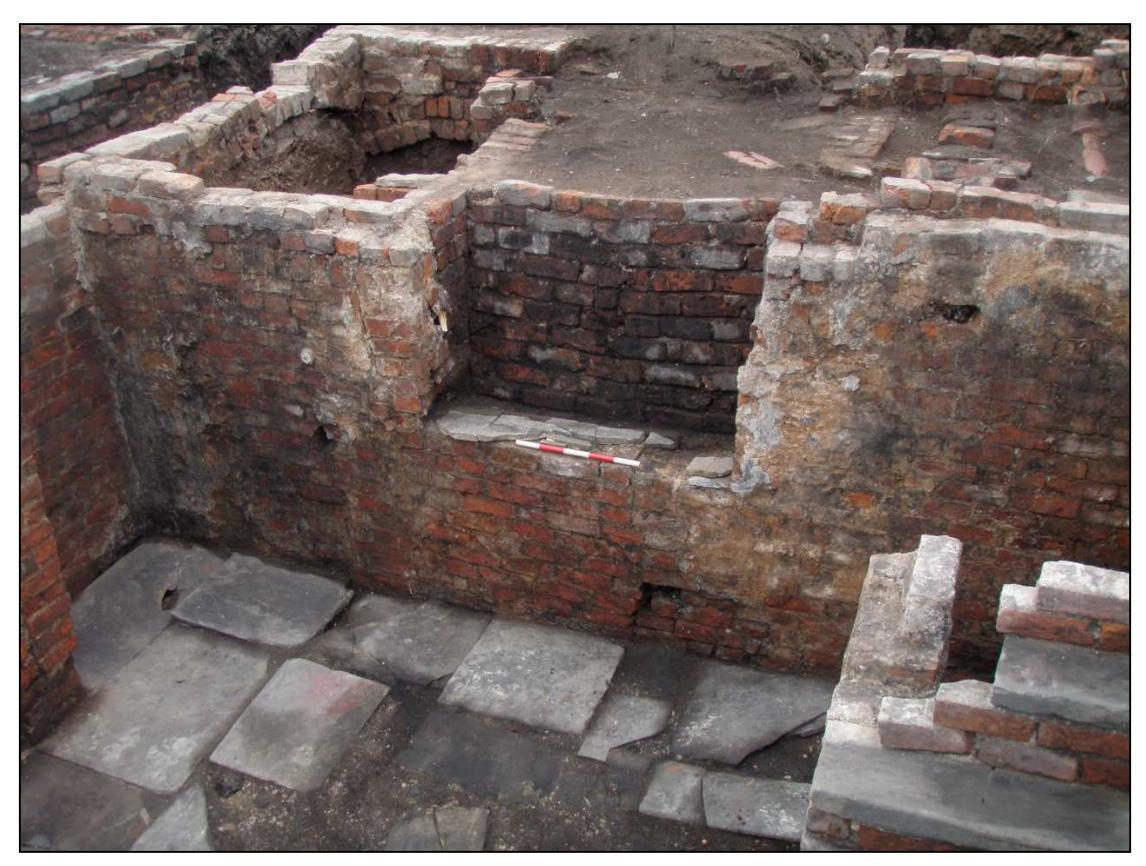
- 3.3.60 This room also had the most intact flagstone floor, with only part of the centre missing. The rear rooms and yard had again been infilled with clayey sand and gravel and the entrance from the front room into the rear yard turned into a second window light, which measured 1.26 x 0.63m with a brick sill 0.5m above the floor level (Plate 45).

Plate 45: Cellar light window in Cellar H3, looking north-west

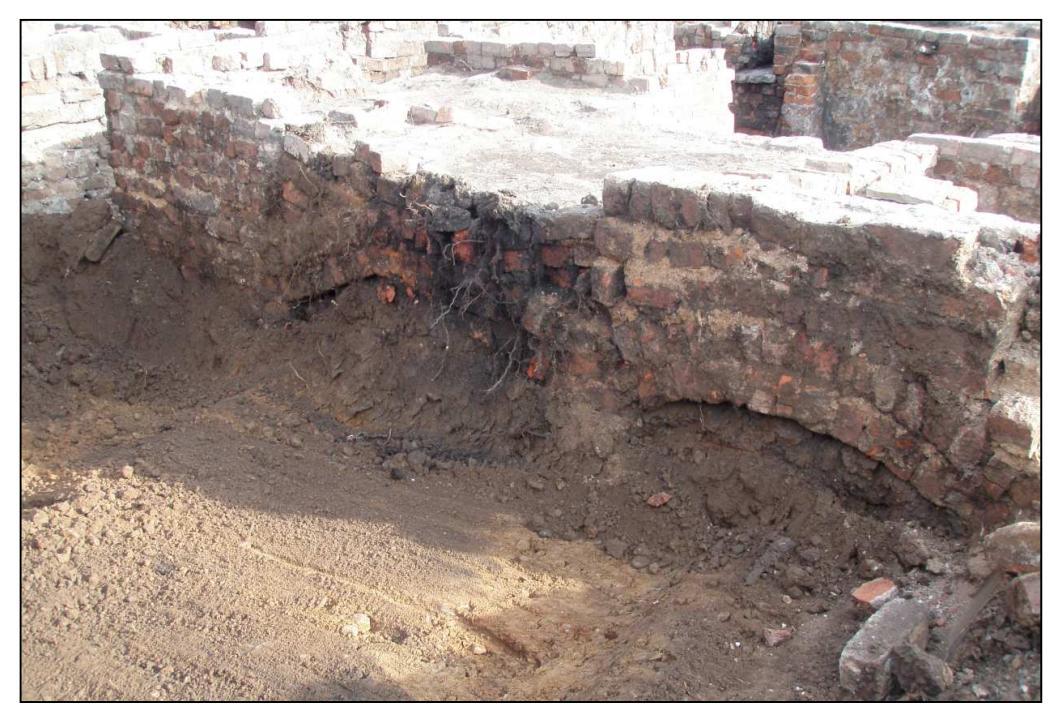
3.3.62 The rear room was also filled in with clayey sand and gravel and brick fragments, and had a flagstone floor laid above it at ground-floor level. The main north-western rear wall of the south-west and north-east rear rooms and the rear yard was much coarser in build than the rest of the walls, and abutted at both ends. It may have been rebuilt at some point, and was clearly always below ground as its outer surface was very rough. A fifth brick archway was observed running through the centre of the rear wall of the building, immediately to the north-east of the arch leading into the south-western outshut (Plate 47). This was also unblocked, running out from the rear yard, but had no evidence of any structures beyond it, and so its intended function remains uncertain.

Plate 47: Arches at the rear of Cellar H3, looking east

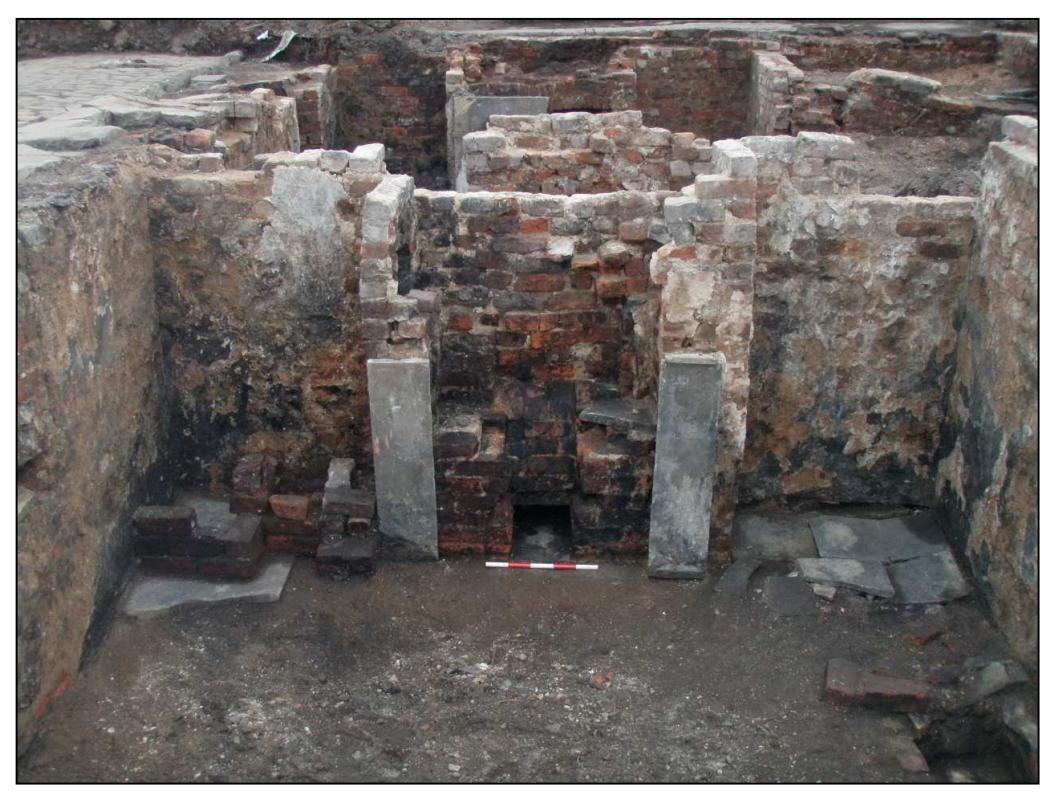
Plate 50: Fireplace and boiler in Cellar H4, looking south-west

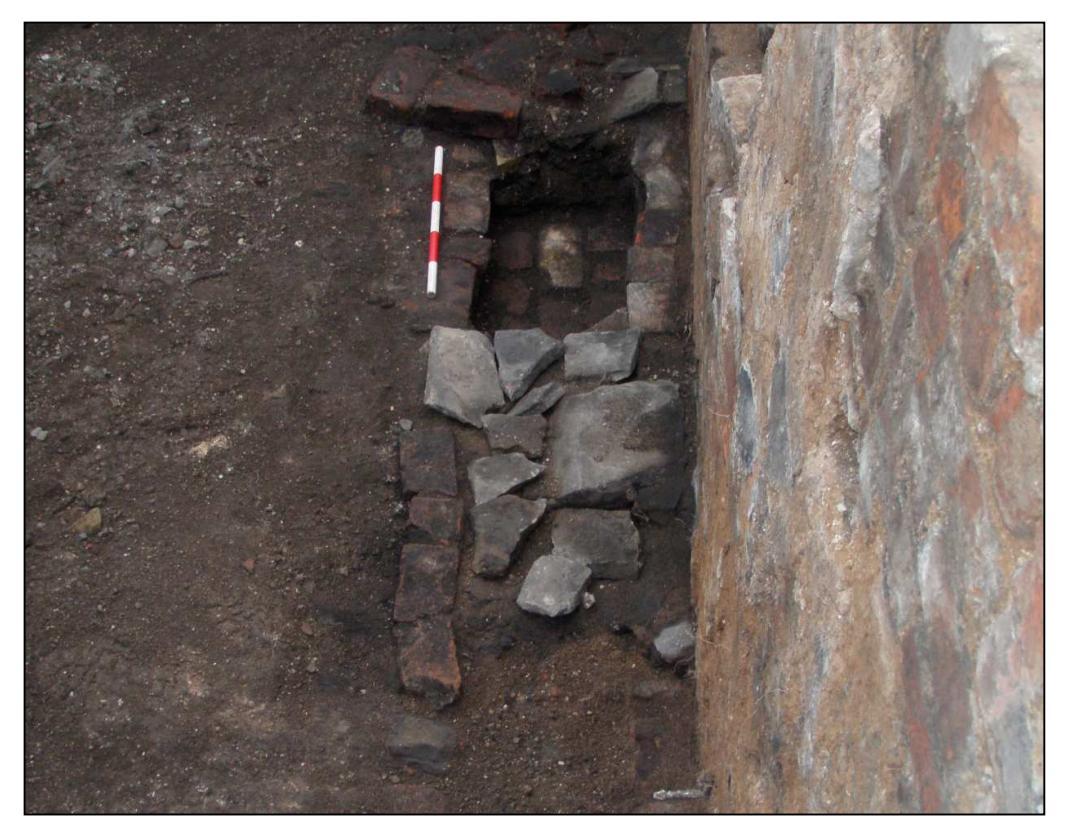
Plate 51: Drain below the floor in Cellar H4, looking south-west

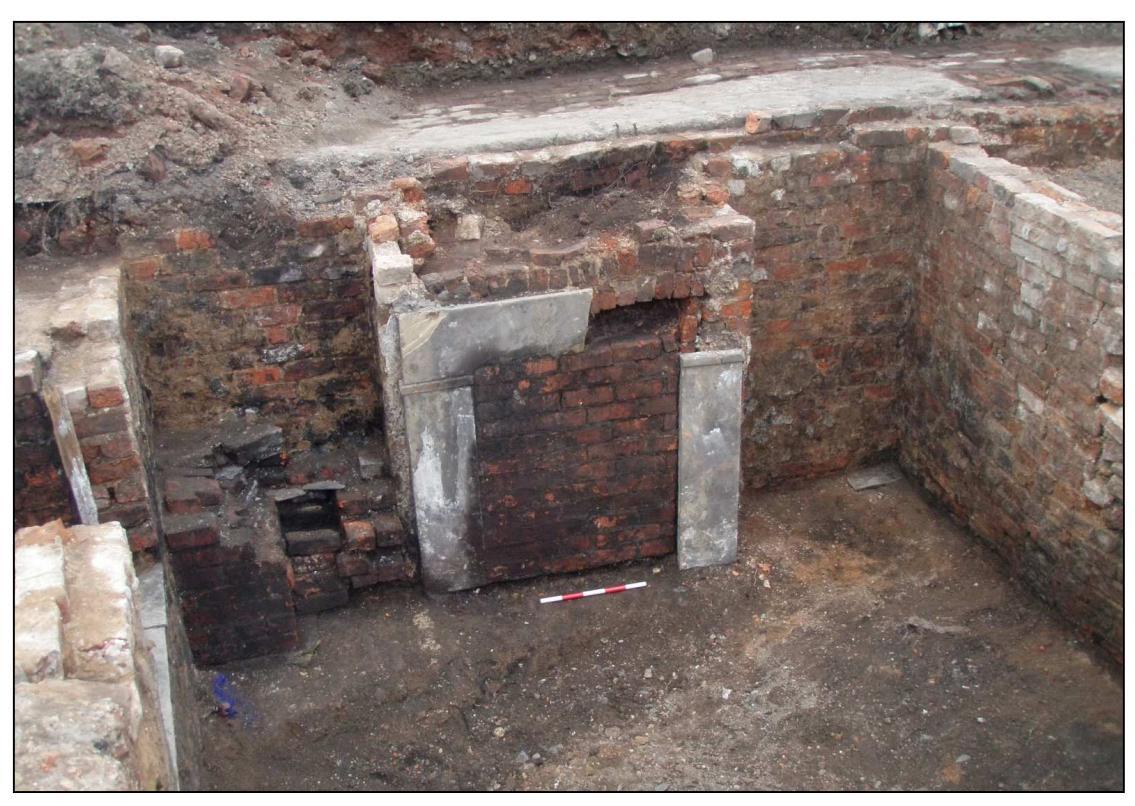
Plate 55: Fireplace and boiler in Cellar H5, looking south-west

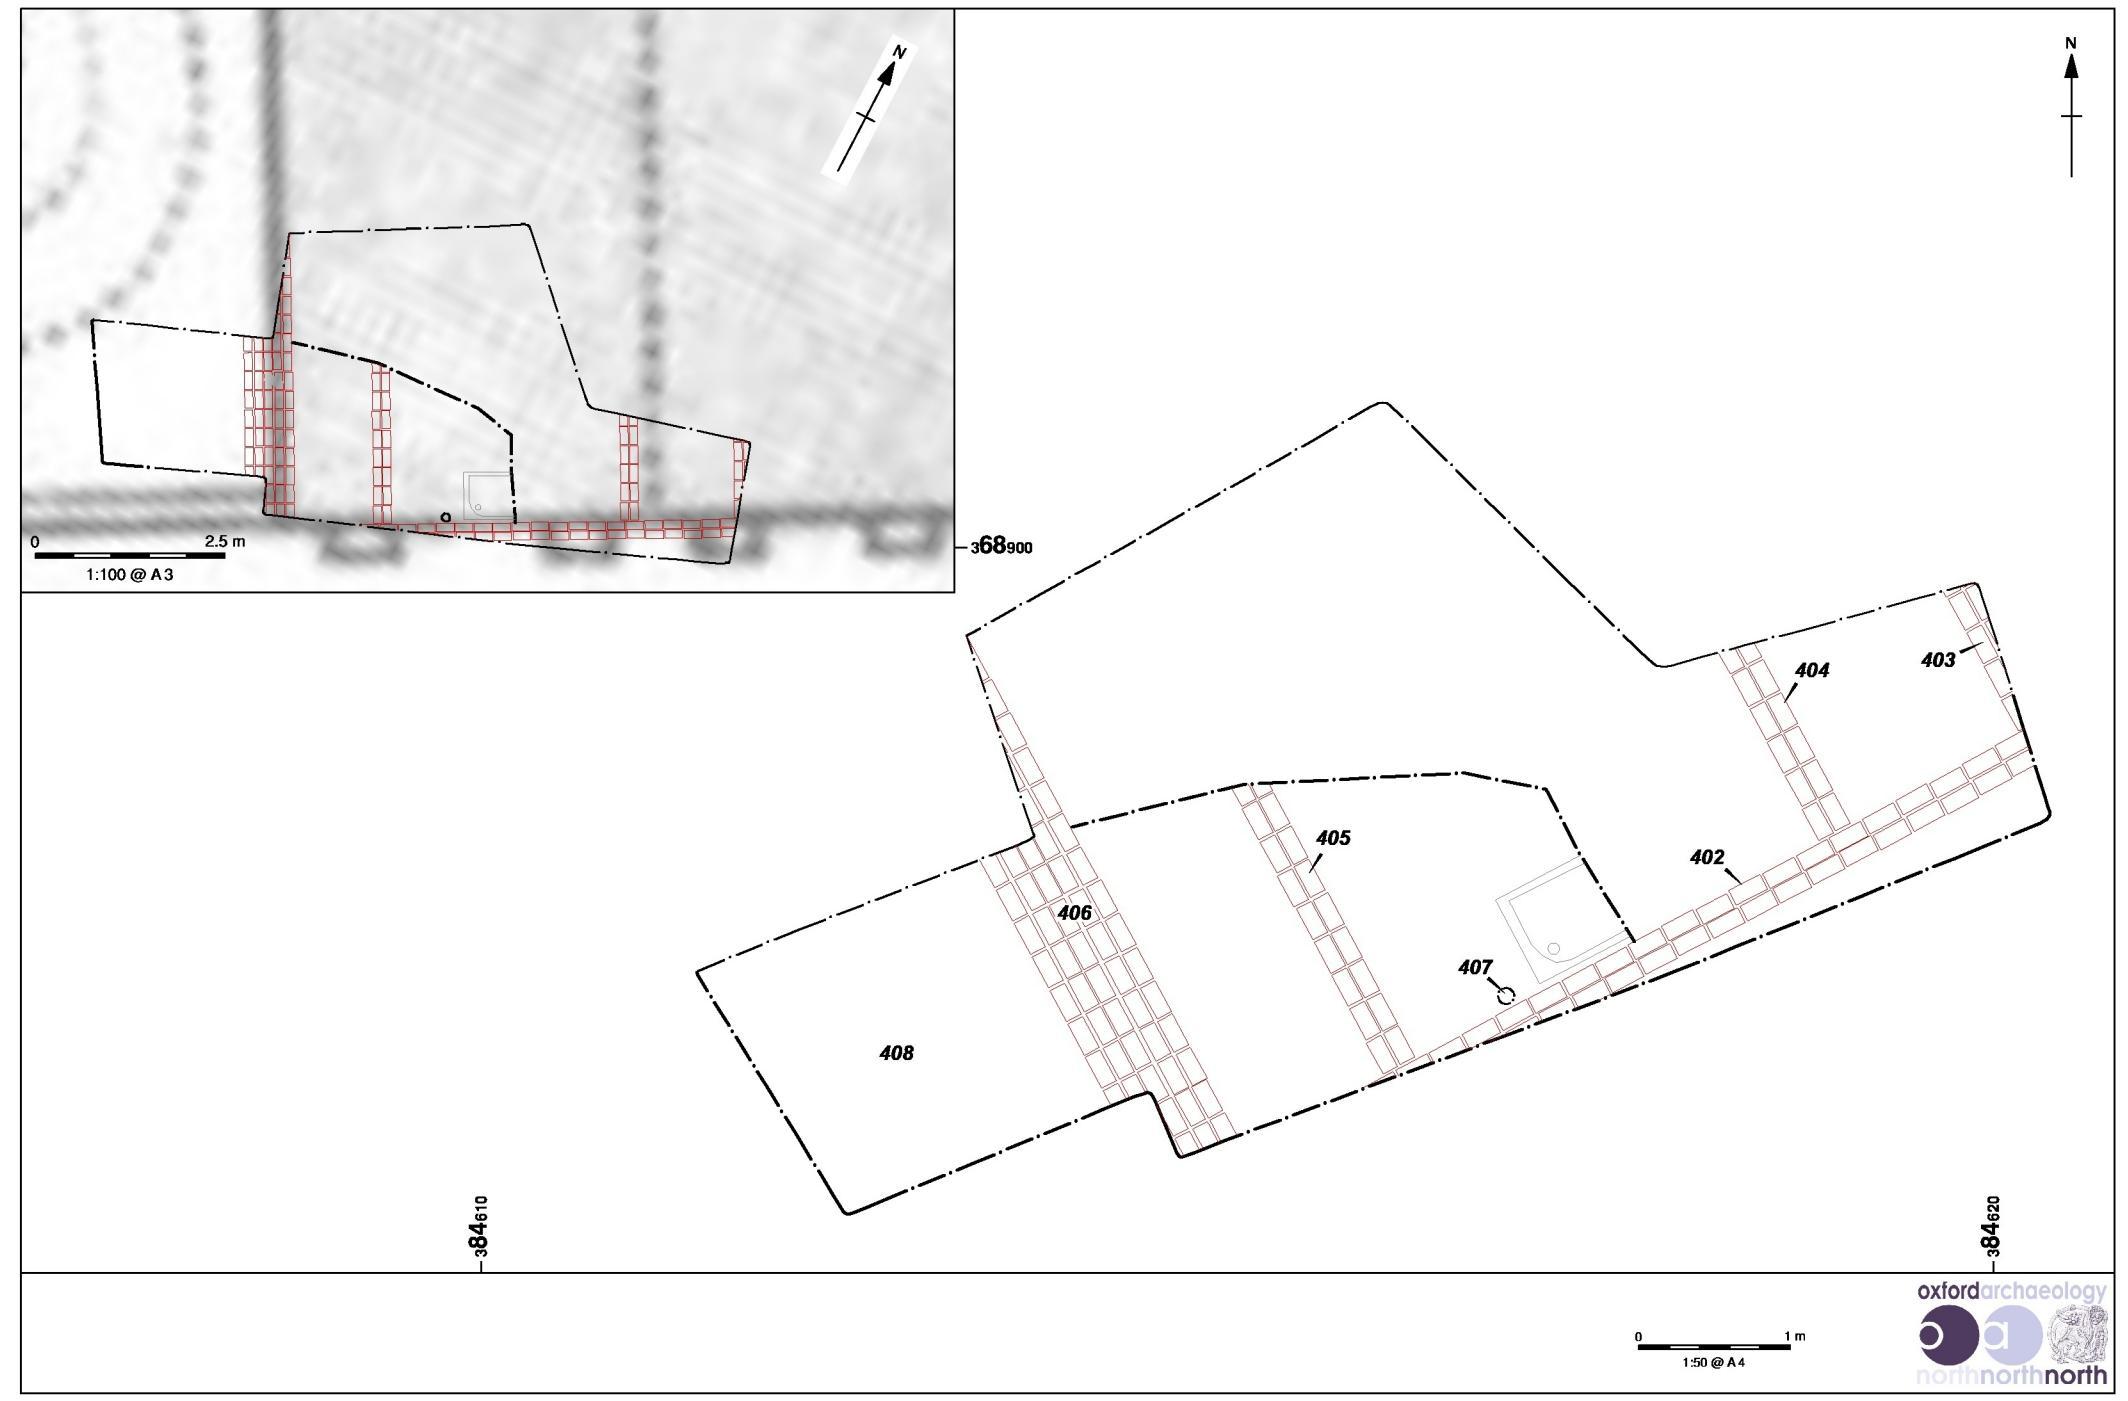
Figure 3: Plan of Trench 4, superimposed on the Ordnance Survey 5':1 mile map of 1851
