TRENCHERFIELD MILL N° 1, POTTERY ROAD, WIGAN,

Archaeological Evaluation

Oxford Archaeology North

March 2006

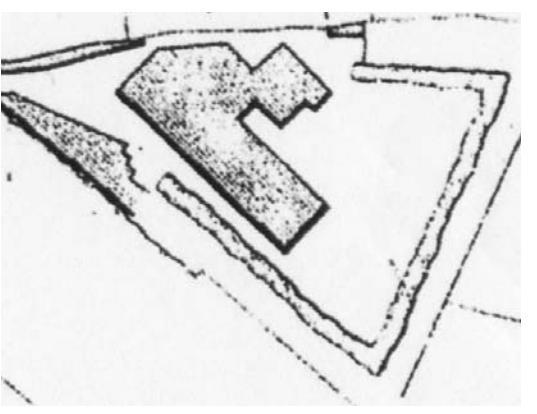
Extract from Mather's Plan, 1827

Map of the Town of Wigan, published in 1827. This shows the mill to have been situated on the edge of the town, surrounded by fields, and comprising a long building running approximately north-west/south-east with a large, irregular projection to its eastern elevation. The main building is shown on Mather's map to have measured some 62m by 16m (203ft by 52ft), representing a huge mill for its period, although the precise accuracy of Mather's survey should be viewed cautiously. The map also shows a narrow, three-sided reservoir alongside the south-west, south-east and north-east elevations of the mill, which presumably furnished a supply of water required by the mill's steam-power plant.

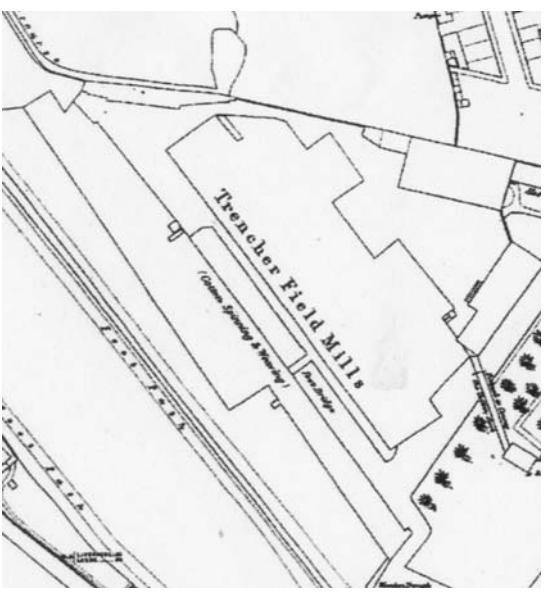
Extract from the Ordnance Survey map of 1847

- 3.1.14 The Ordnance Survey 5': 1 mile map of the area, surveyed in 1847 (Fig 3), shows Trencherfield N° 1 Mill to have been expanded further. The main block

- of the mill is shown to have been some 99m long (325ft), with large projections against the north-eastfacing elevation, and ancillary buildings have been added to the eastern part of the site. The northern arm of the three-sided reservoir had also been in-filled by this date, although the other elements evidently remained in use. The map also indicates that William Woods had expanded his textile-manufacturing site at Trencherfield with the addition of a second mill, placed immediately to the south-west of the existing factory (Fig 3).

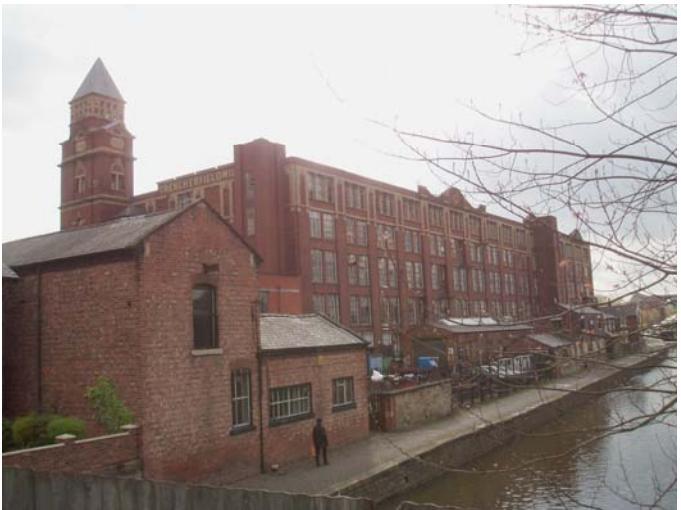
South-west-facing elevation of Trencherfield Mill Nº 3

3.1.18 *Trencherfield Mill N^o 3:* the construction of the mill in 1907 retained several characteristics common to the last generation of Lancashire spinning mills. The first of these was the use of steel framing and concrete floors supported by

triple brick-arch a fireproof system. The second characteristic of this later mill was the of a use large compound horizontal steam engine housed in an engine house located at a right angle to the mill and powering a rope race. Trencherfield Mill is recorded as having 100,000 mule and ring spindles by 1910 (UMAU 2005).

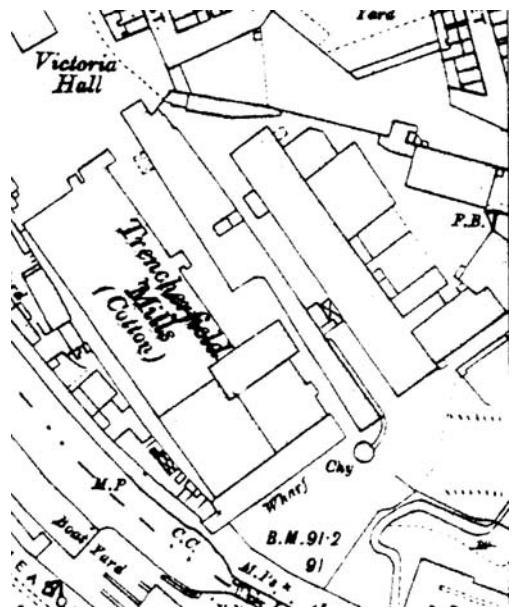
Extract from the Ordnance Survey map of 1908, the final cartographic depiction of Mill N° 1

3.1.19 Shortly after Trencherfield Mill N° 3 had been completed, the N° 1 was demolished. The exact date of this event is uncertain, although based on the

available cartographic evidence, it would appear to have been between 1908 and 1929. In June 1914, the company changed its name to the Trencherfield Spinning Company Ltd, which it continued to trade under until taken over by Courtaulds in the mid-20th century. Courtaulds announced the closure of the mill in 1968, with the loss of 350 jobs (Wigan Observer, 10th May 1968). Nº 2 Mill remained extant until after 1969, although the original engine had been removed and the former engine house was in use as an oil store (Cook 1969, 1).

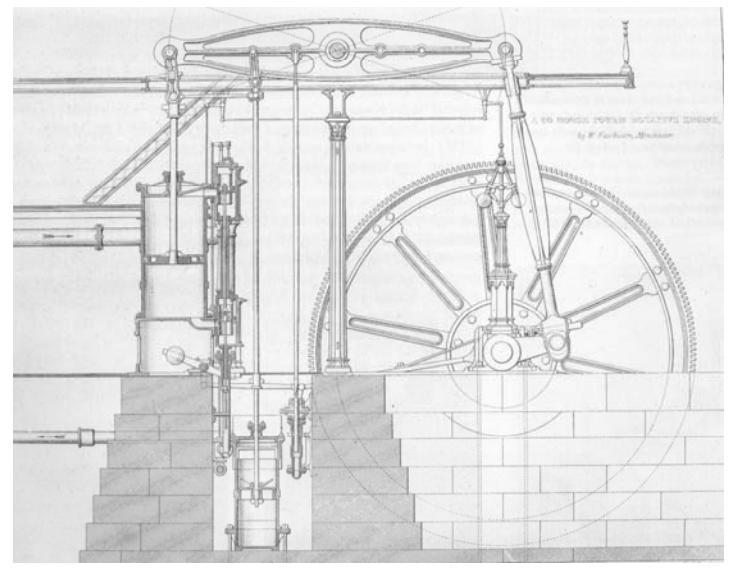
5.2.3 The most significant remains of this initial phase were represented by the large ashlar blocks exposed within Trench 2, within the north-western part of the mill. These undoubtedly represented the foundations for a large steam engine, whilst the size and configuration of the component ashlar blocks and iron restraining rods suggested that it had probably been a single-cylinder condensing beam engine. Documentary sources have indicated that Trencherfield Mill N° 1 was powered by an engine of 70hp (PP (HC) 1834 (167) XX, A1), which was a very powerful model for its date. This may be illustrated by comparison with engines that powered cotton mills in Preston

during the same period, as noted by Tulket. Writing in 1821. Tulket mentioned 12 factories in Preston, and listed the power ratings of their engines. These ranged from 7hp to 40hp, with an average power of just under 20hp (Whittle 1821), considerably less than installed that in Trencherfield Mill Nº

1 just two years later. A single-cylinder beam engine typical of the period (Bourne 1872)

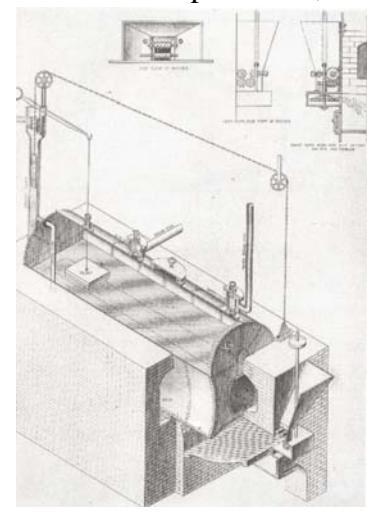
- 5.3.3 The position of the boilers, economiser and possible chimney lay beyond the footprint of the original mill, and the extension shown on the map of 1837, but
 - were incorporated within the additions to the mill shown on the Ordnance Survey map of 1847. Despite a growing tendency for detached boiler houses from the mid-19th century, the continued use of internal boilers appears to have been common. The increased use of detached boiler houses was resultant upon the introduction and widespread adoption of the Lancashire boiler from 1844 (Williams with Farnie 1992, 86). However, the foundations exposed within Trench 5 may be identified as the remains of wagon-type boilers with some confidence. In particular, the dimensions of the exposed boilers were too small for the Lancashire-type, which typically measured 9.1m long (*ibid*).

A wagon boiler (Bourne 1872)

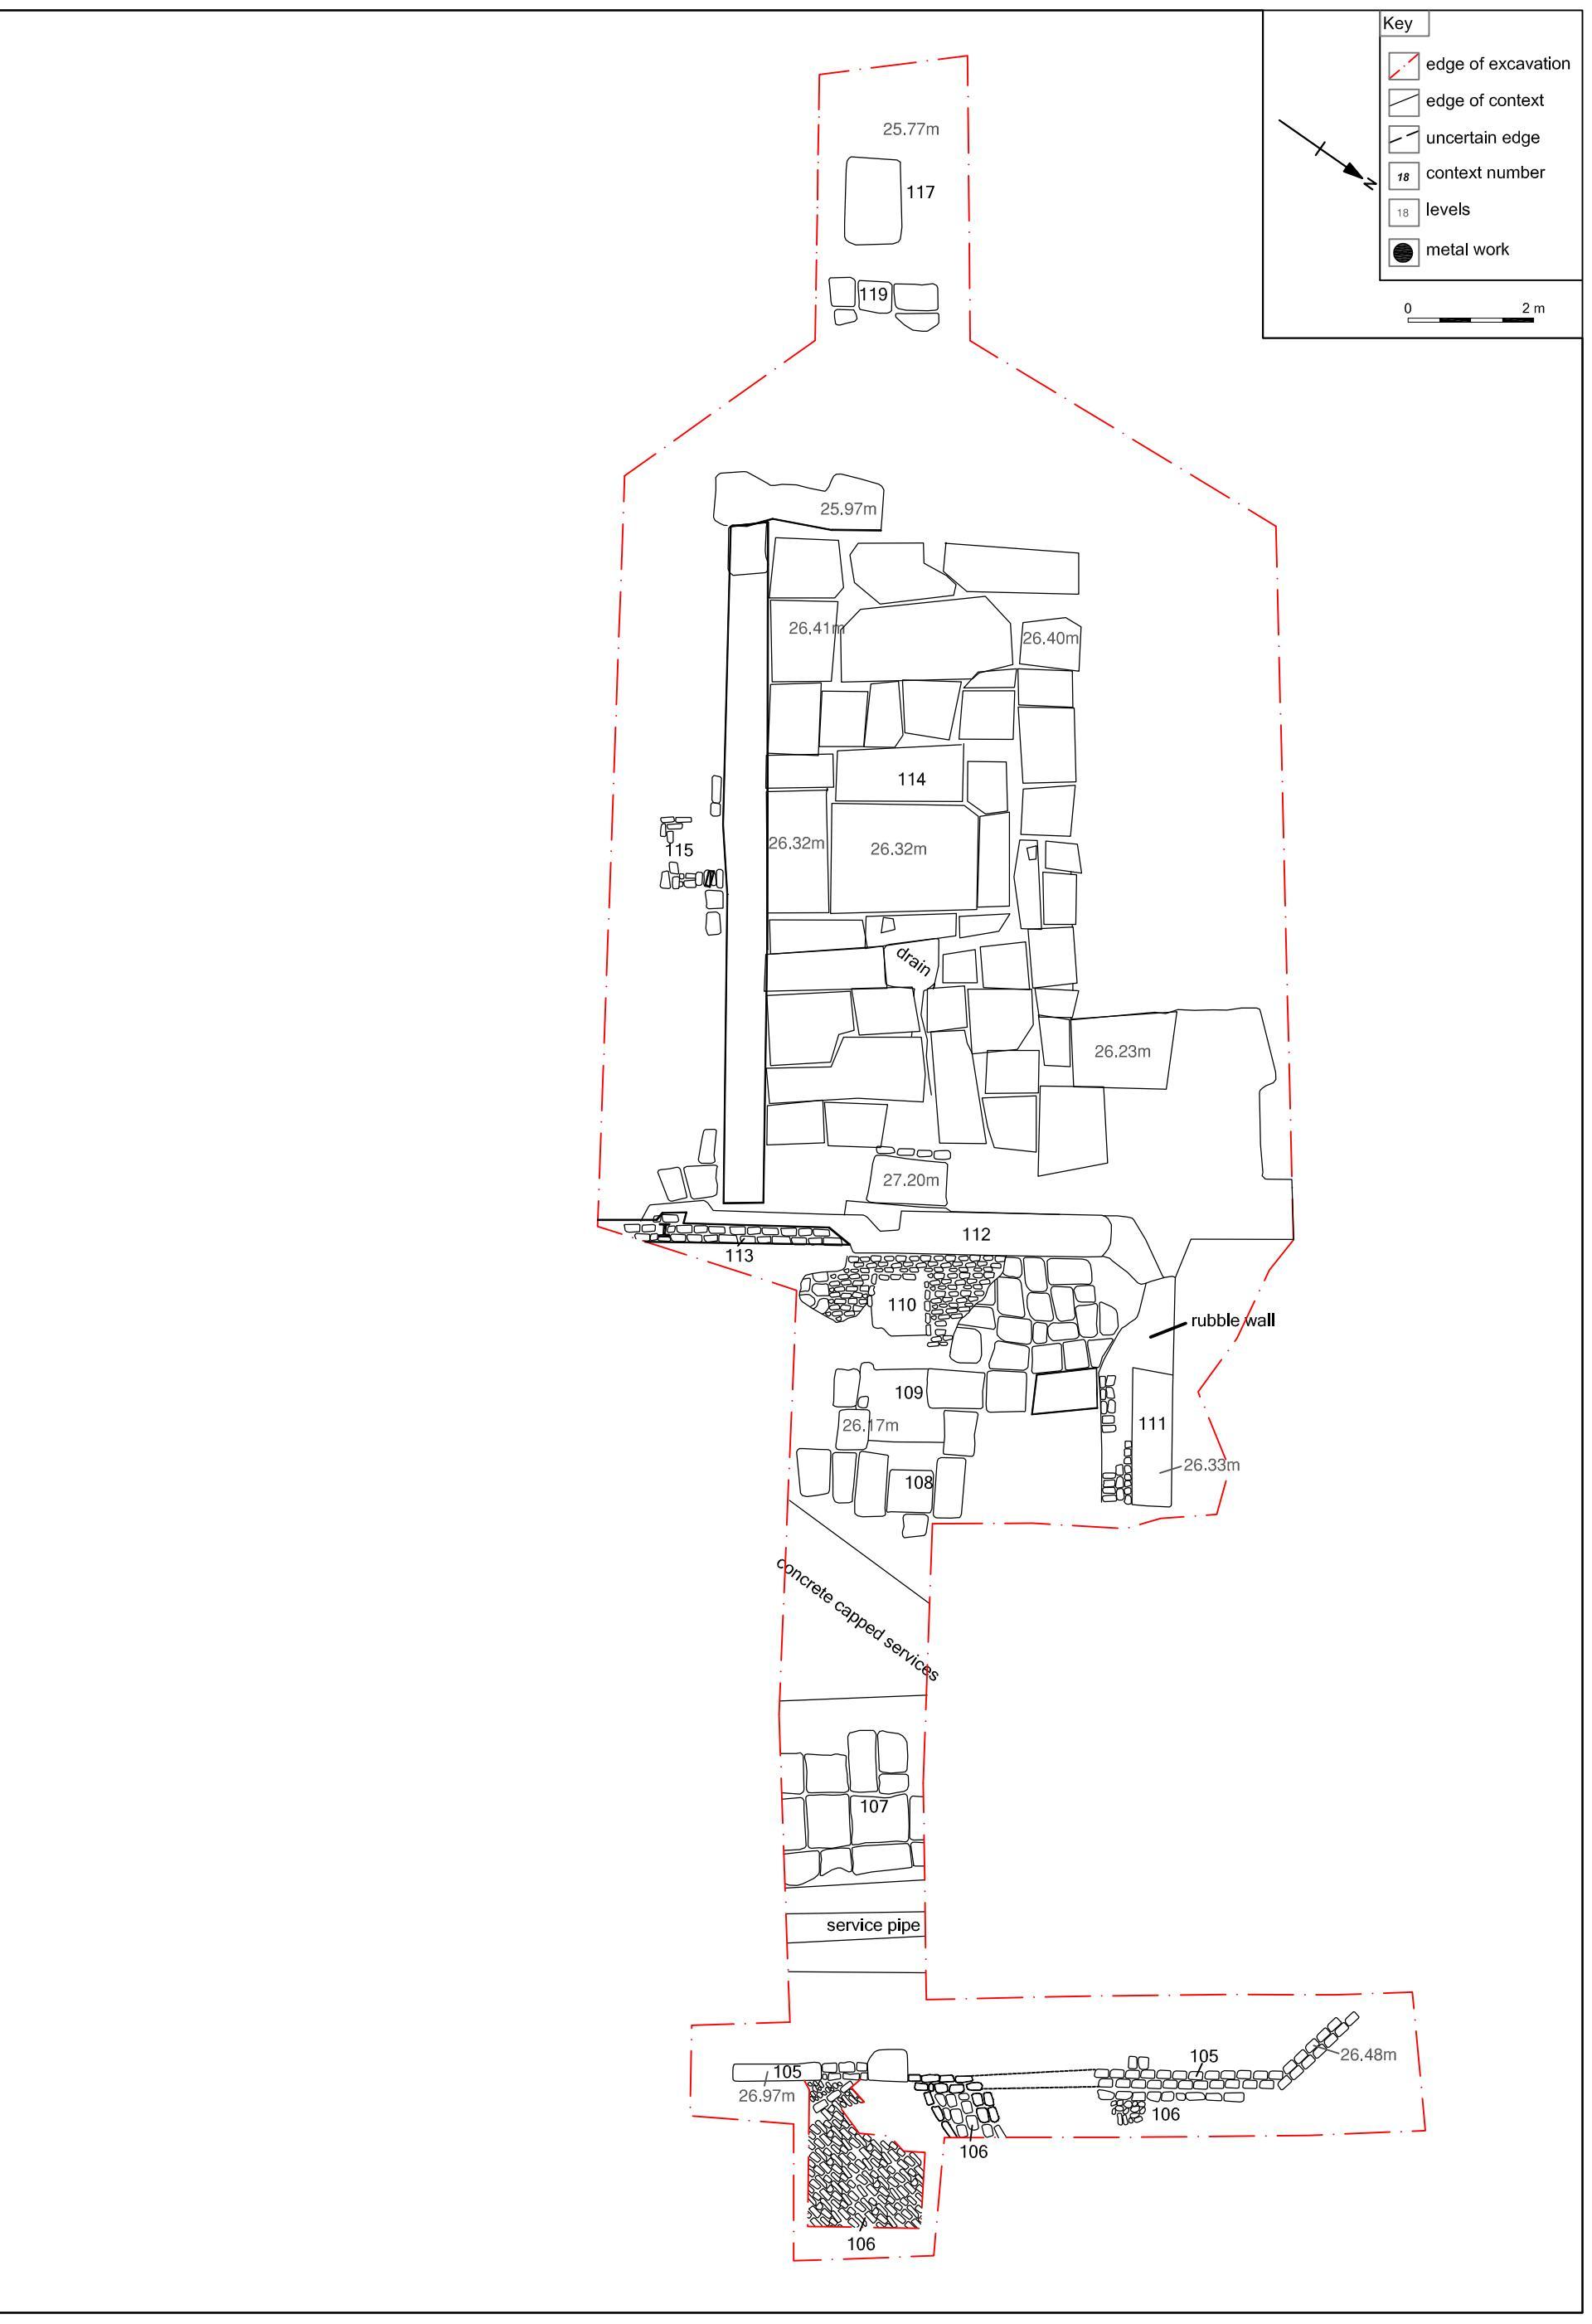
Figure 4: Detailed plan of Trench 2

- 4.2.8 Natural grey clay was exposed at a depth of 0.85m below the modern road surface, which bordered the south-western edge of the trench. This was overlain by a spread of stone ashlar blocks that collectively formed a substantial base for a large steam engine (Plate 3). Other structures observed included a culvert that ran beneath the stone foundation, a wide load-bearing wall that probably formed the external wall of the engine room, external walls of the mill, internal flagged floors, and the remains of an external cobbled yard. On the basis of these structures, the trench was enlarged to maximise the recovery of information pertaining to the former steam-power plant (Fig 4).

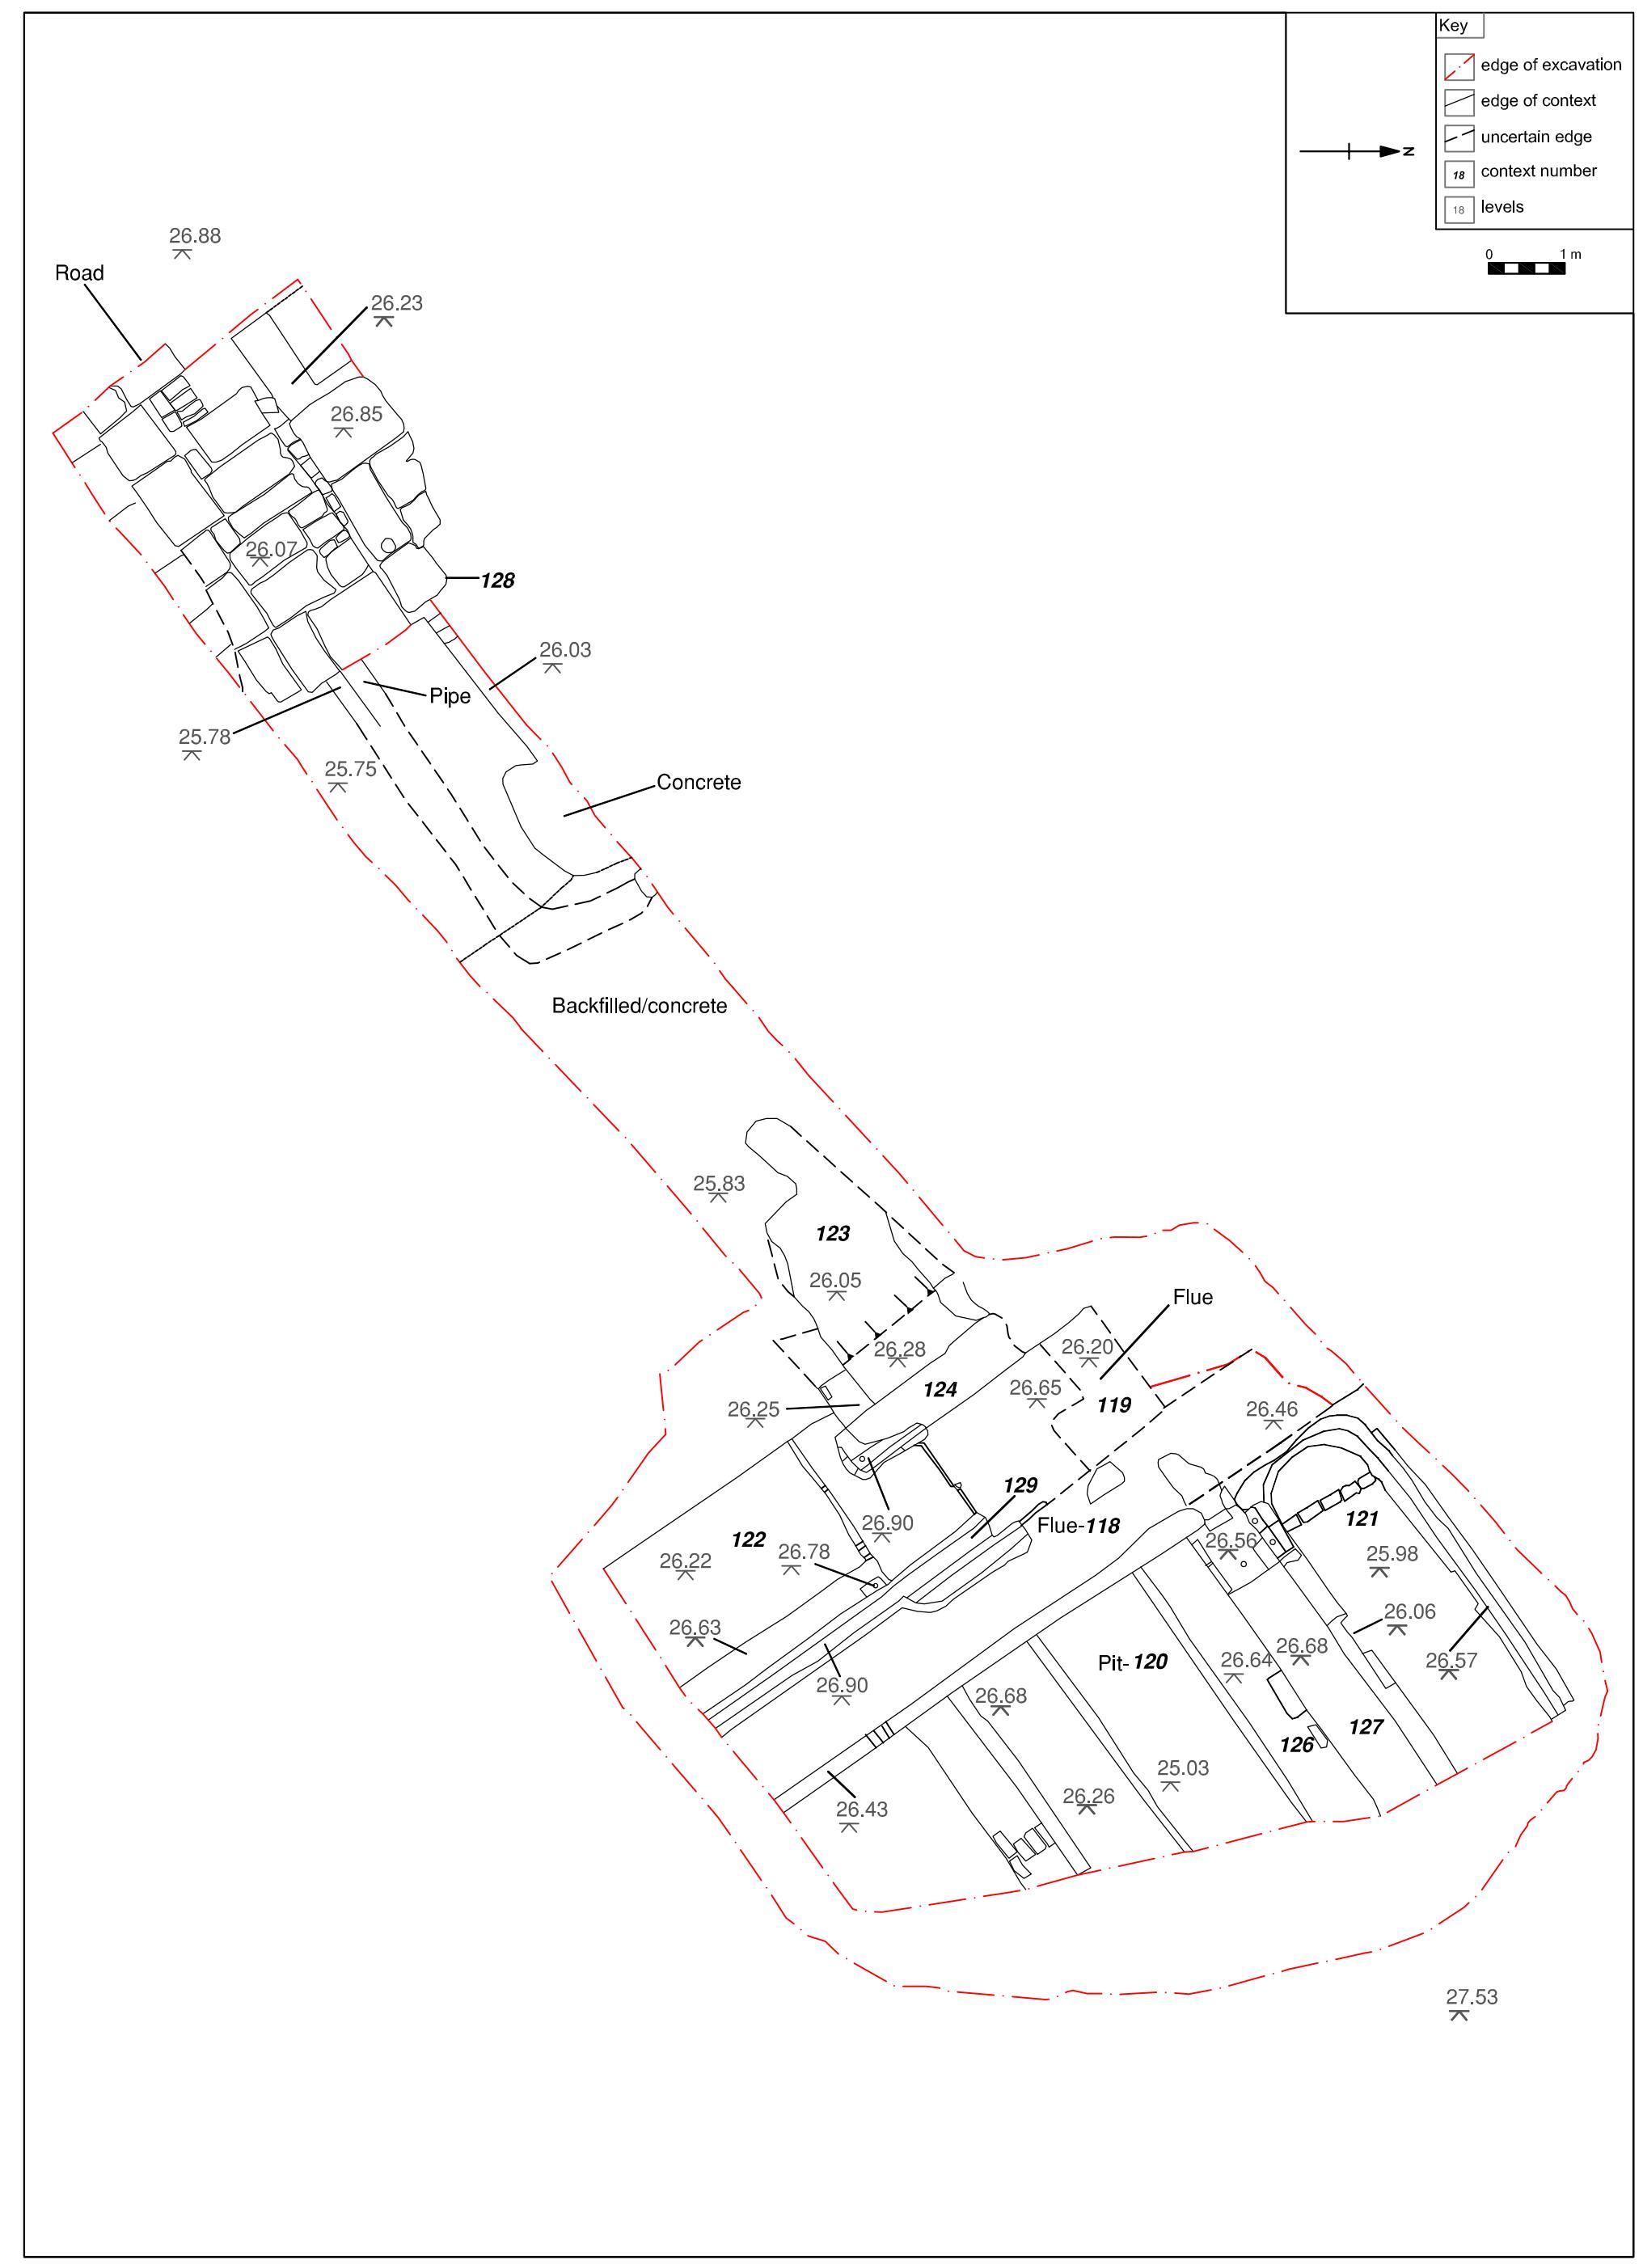
Figure 5: Detailed plan of Trench 5

- 5.3.1 Analysis of available maps for the site has indicated that the south-eastern part of Trencherfield Mill N° 1 was expanded between 1827 and 1837, with further additions being completed prior to 1847. Surviving remains identified during the evaluation that may be ascribed to this period included elements of steampower plant additional to the original infrastructure. These included the well-preserved remains of a bank of boilers, a probable economiser, and the foundations for a possible second engine, which were all identified within Trench 5.

- 5.3.2 The substantial nature of structure *128*, exposed within the south-western end of Trench 5, is consistent with that used as a foundation for a steam engine, especially the ashlar component. However, only a small proportion of the structure was exposed and, as no iron restraining rods characteristic of a foundation for an engine were present, it precise function cannot be ascribed with confidence. The brick component may have represented the original south-eastern external wall of the mill, prior to the extension shown on the map of 1837. The position of structure *128* lay just within the footprint of the original mill, as shown on Mather's map of 1827, although this part of the building had been subject to considerable remodelling before 1847. However, notwithstanding the destruction of any physical link between structure *128* and the boilers exposed within the north-eastern part of the trench, it is tempting to suggest that all these remains were of a contemporary date.

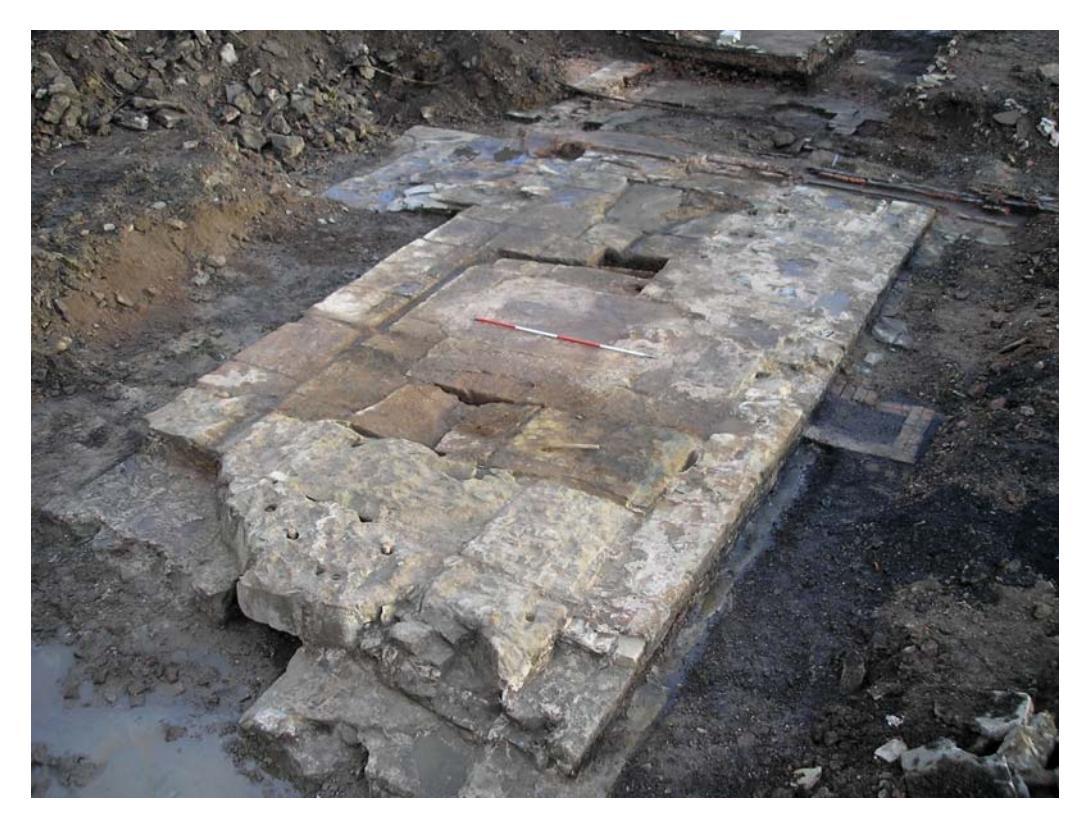
- 4.2.9 The stone foundation (114) was essentially rectangular in plan, aligned northeast/south-west, with an L-shaped projection along its north-western corner (Plate 4), giving overall dimensions of 10.5m by 9.1m. It comprised 24 closely-spaced rectangular- and square-shaped sandstone ashlar blocks, which survived to a height of three courses (0.85m). Many of the blocks contained evenly-spaced holes, some of which housed circular and threaded restraining rods that protruded above the block surface. The rods were largely concentrated along the western edge of foundation 114, although several isolated rods were observed throughout the surface. It would seem that the concentration of holed blocks along the western edge of the surface was intended to support the engine cylinder. Overall, the foundation is likely to have provided the foundation for a compound beam engine, which would have provided the higher power ratings needed for spinning and its allied preparatory processes (Dickinson 2002).

Plate 3: View of machine foundation 114 in Trench 2, looking north

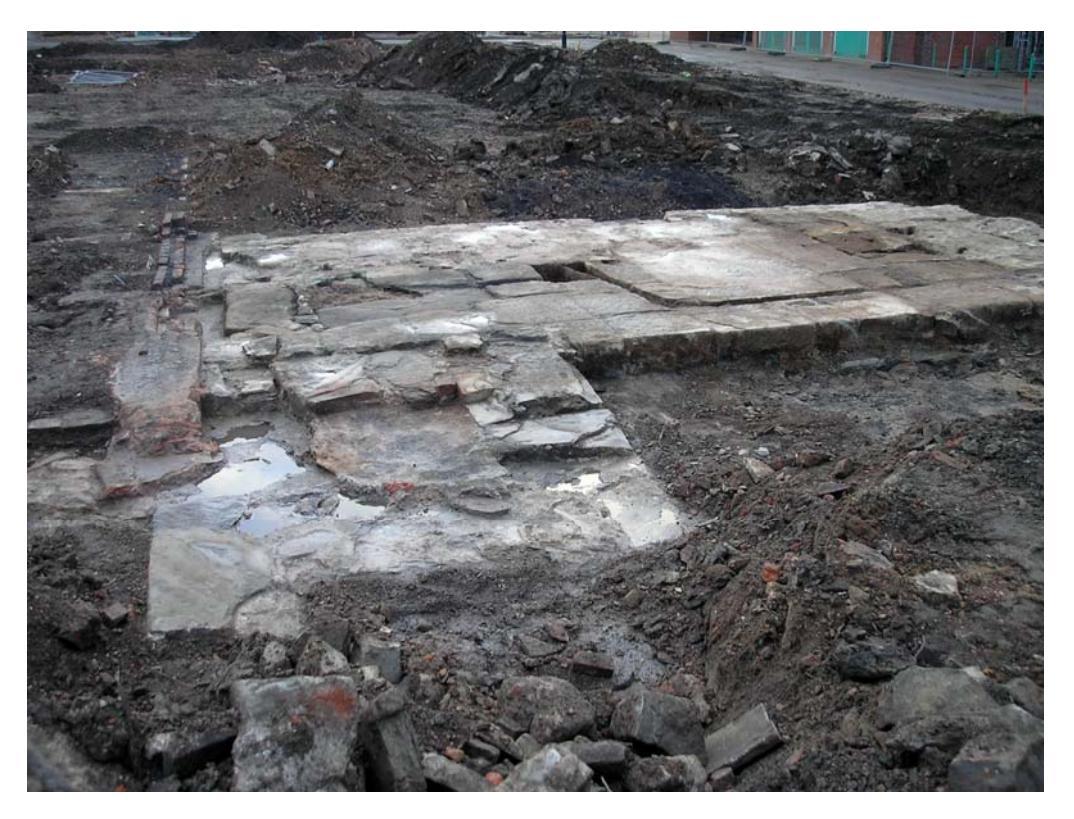
Plate 4: View of machine foundation 114 in Trench 2, looking east

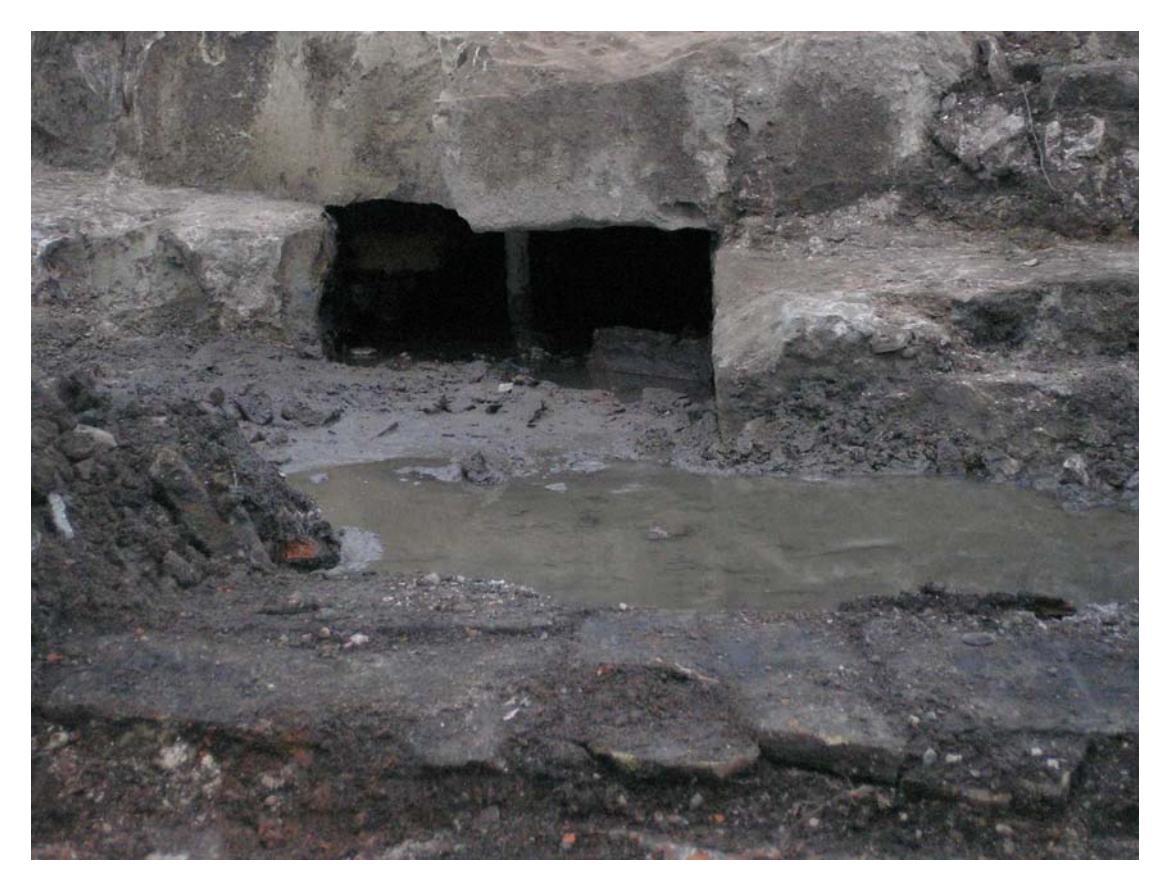
order to detect the water flow and exposed natural grey clay that retained surface water pooled at the same level below the foundation (Plate 5). This suggests the culvert may have functioned as a feed channel from a reservoir providing the constant water source required by the engine for condensing purposes. Evidence for this was identified by a wide valve (Plate 6) that passed through a block at the culvert entrance, into the water below, and the remains of an iron shutter across the entrance that possibly controlled the amount of water passing beneath the foundation. Further evidence of water carriage associated with the engine was represented by a drainage channel hollowed within the upper surface of the blocks along the western part of the foundation. The channel extended north for a distance of 2.5m then returned sharply east for 1.3m and terminated into an iron man-hole (110), which led into the culvert below.

Plate 5: Surface water pooled at the southern edge of foundation 114 in Trench 2

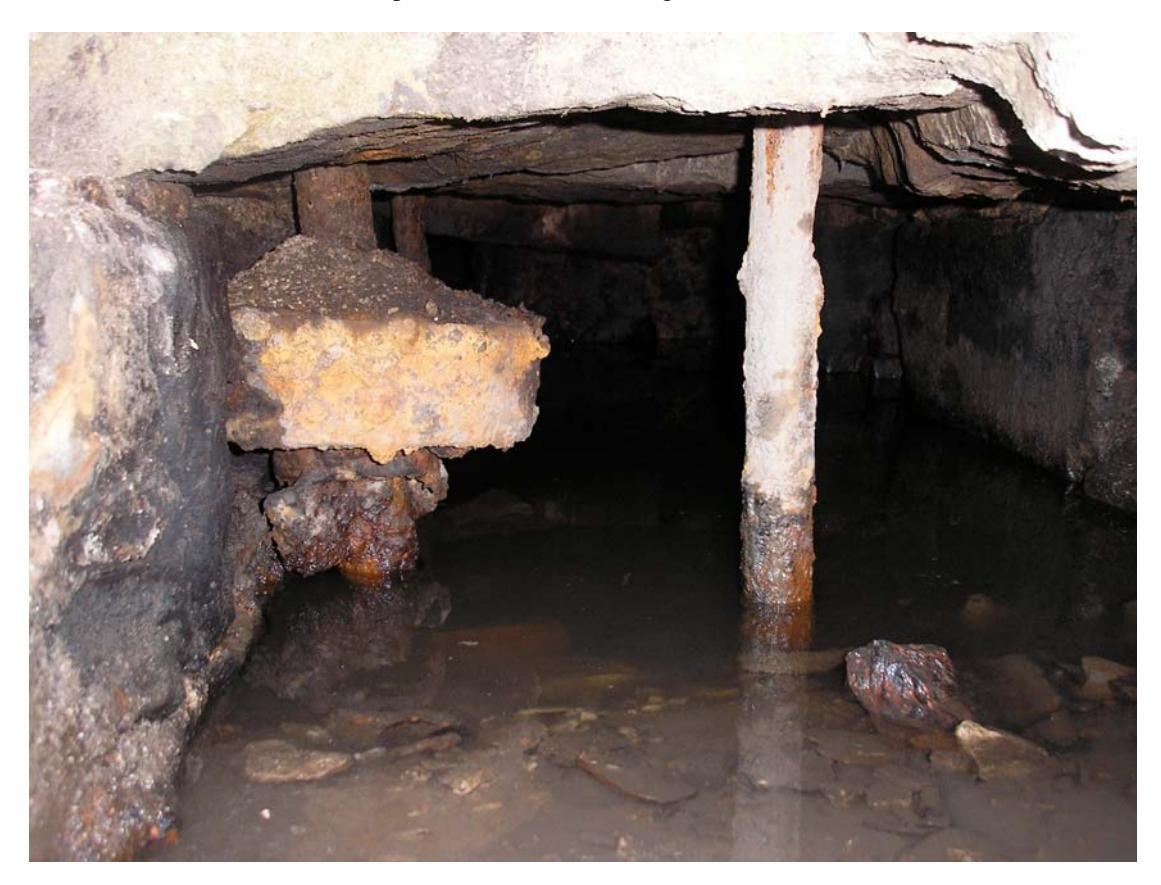
- 4.2.10 Located beneath the blocks was a north-east/south-west-aligned culvert (*109*), lined with stone, which extended below the central part of foundation *114* toward the northern part of the trench. At the time of the evaluation, the culvert was immersed under water, and it was not clear where the source of water derived. Although no pipe or structure was observed, the water appeared to run from the direction of the canal beneath N^o 3 Mill, to the immediate south of the trench. A sondage was excavated across the culvert entrance in

Plate 6: The culvert beneath foundation blocks 114, showing the metal rods used to restrain the engine

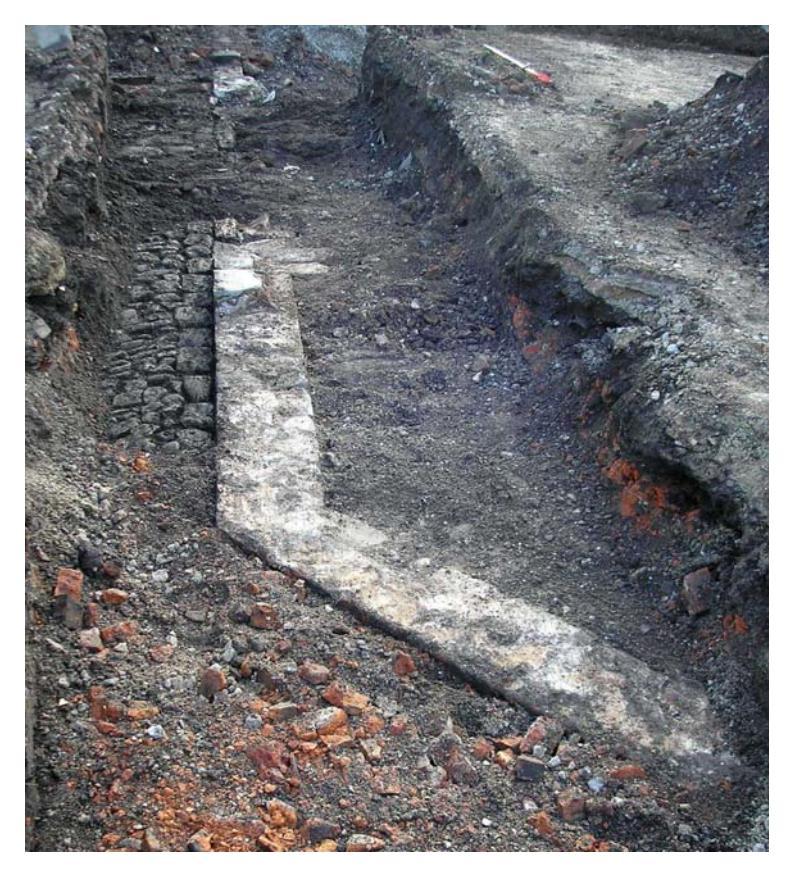
- 4.2.13 Part of the mill's north-eastern external wall (105) was exposed within the northern part of the trench. The wall was aligned east/west, angling at a corner return to the south for a distance of 1.45m (Plate 7). It comprised hand-made bricks, married with sand and lime mortar, which survived to three courses in height (0.17m), and a width of 0.45m. The upper surface of the angled section was lined with roughly-cut stone, adhered to the underlying brick with compacted brown sand/cement mortar. A possible threshold (Plate 8) was observed within the centre of the wall, comprising two cut stone blocks set 1m apart, bridged by a single skin wide section of the wall. The northern edge of the threshold was bordered by tightly-packed and worn cobbles, seemingly representing a yard surface (106). This surface is likely to have been associated with the initial phase of the mill, as shown on Mather's map of 1827.

Plate 7: North external mill wall 105, looking east

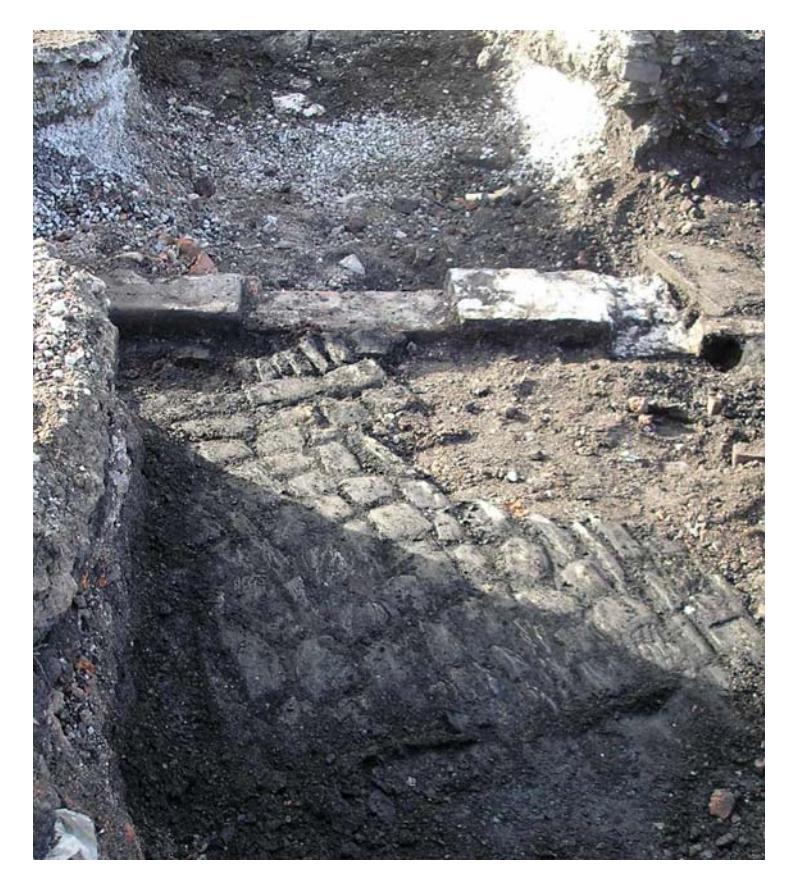
Plate 8: Threshold through wall 105 in Trench 2, looking south

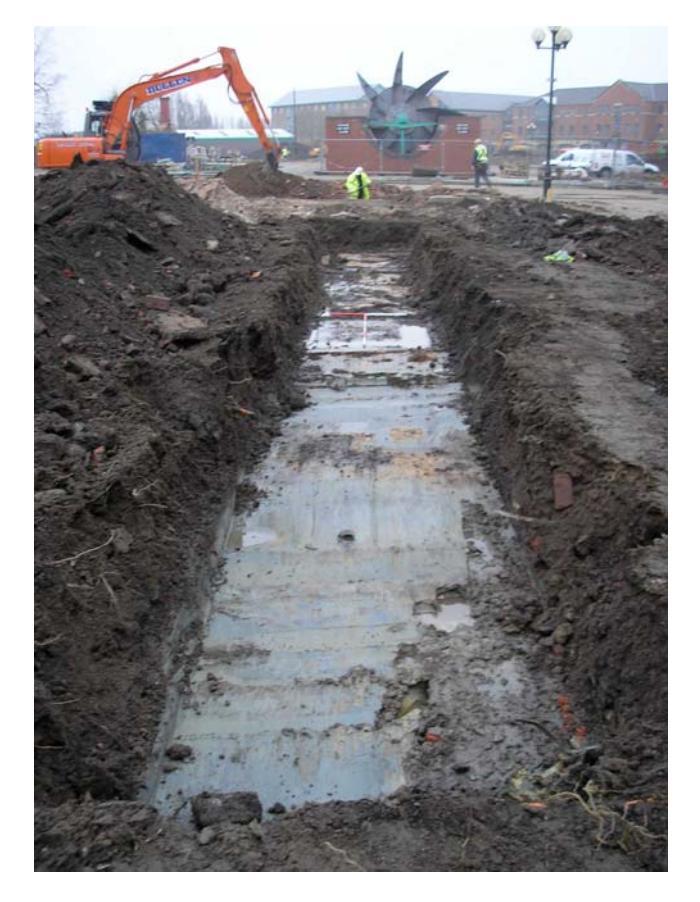
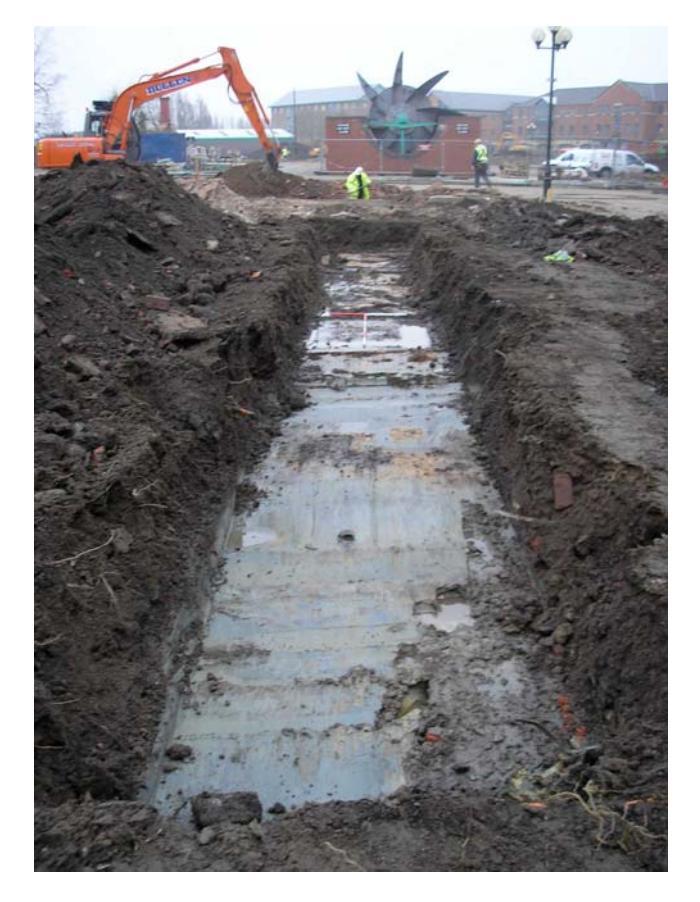
- 4.2.17 The deposits in the trench comprised mid- to dark brown silty-sand, which measured up to 0.80m in thickness, sealing natural clay. The sand contained 60% building debris, comprising crushed brick, plaster and concrete with occasional patches of clinker. No archaeological features were observed.

Plate 9: View of Trench 3, looking east

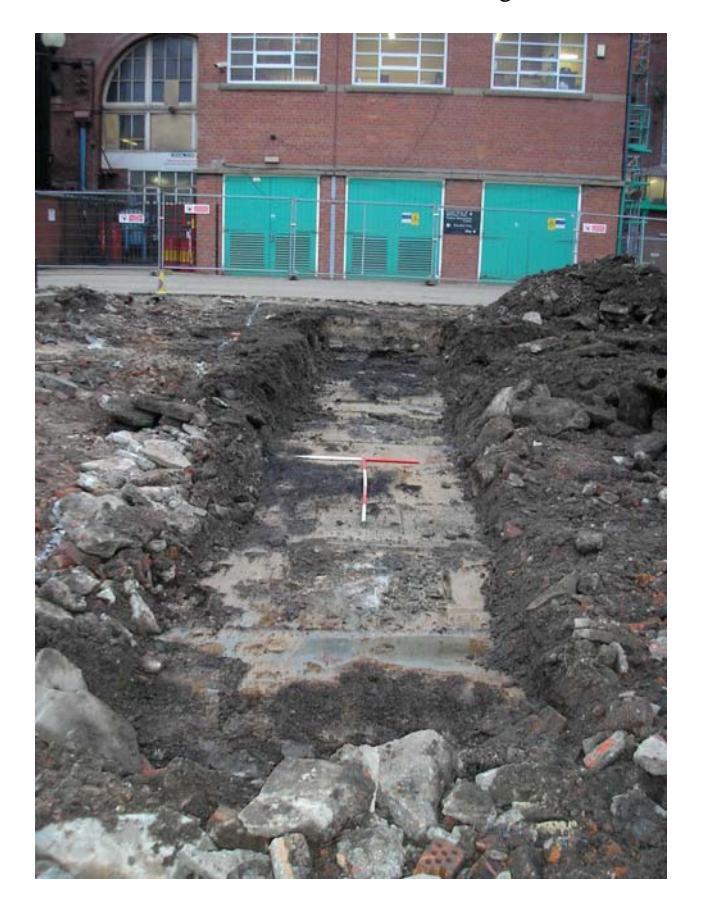
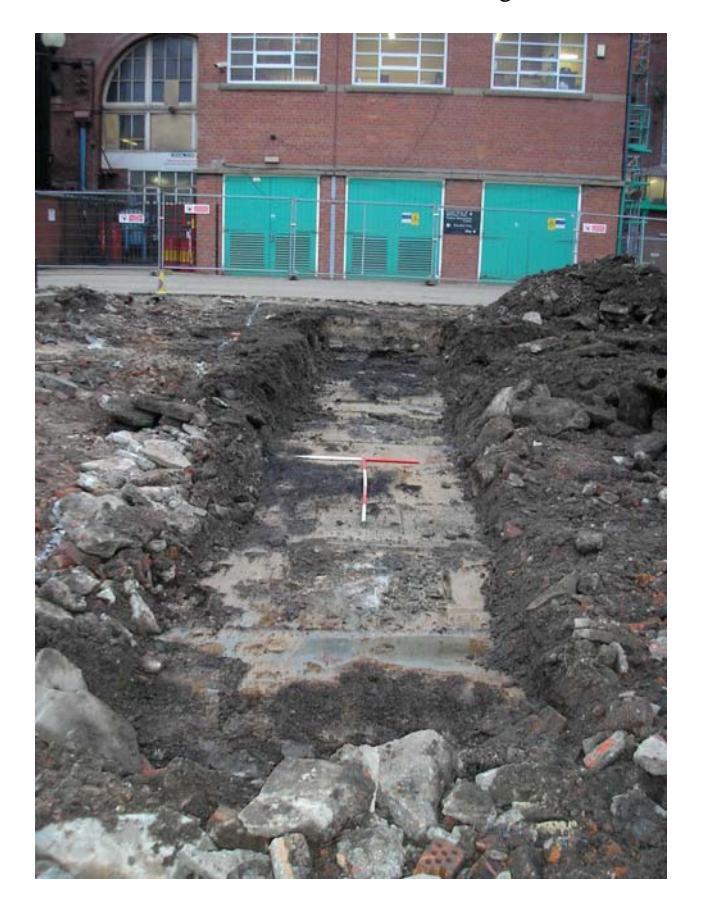
- 4.2.18 *Trench 4:* the trench was excavated with similar intention to that of Trench 3, and, additionally, to trace the mill's southern external wall. The trench was aligned north-east/south-west, measuring 13m long and 2m wide, and was excavated to a maximum depth of 0.66m onto natural grey clay (Plate 10). It would seem that the construction of a canteen facility in the last century had eradicated the foundations of the mill within this area of the site.

- 4.2.19 The deposits in the trench were similar to the type of demolition material observed within Trench 3, although several modern interventions were observed across all parts of the trench, including a reinforced-concrete platform. This appeared to have been associated with a system of modern drainage.

Plate 10: View of Trench 4, looking south

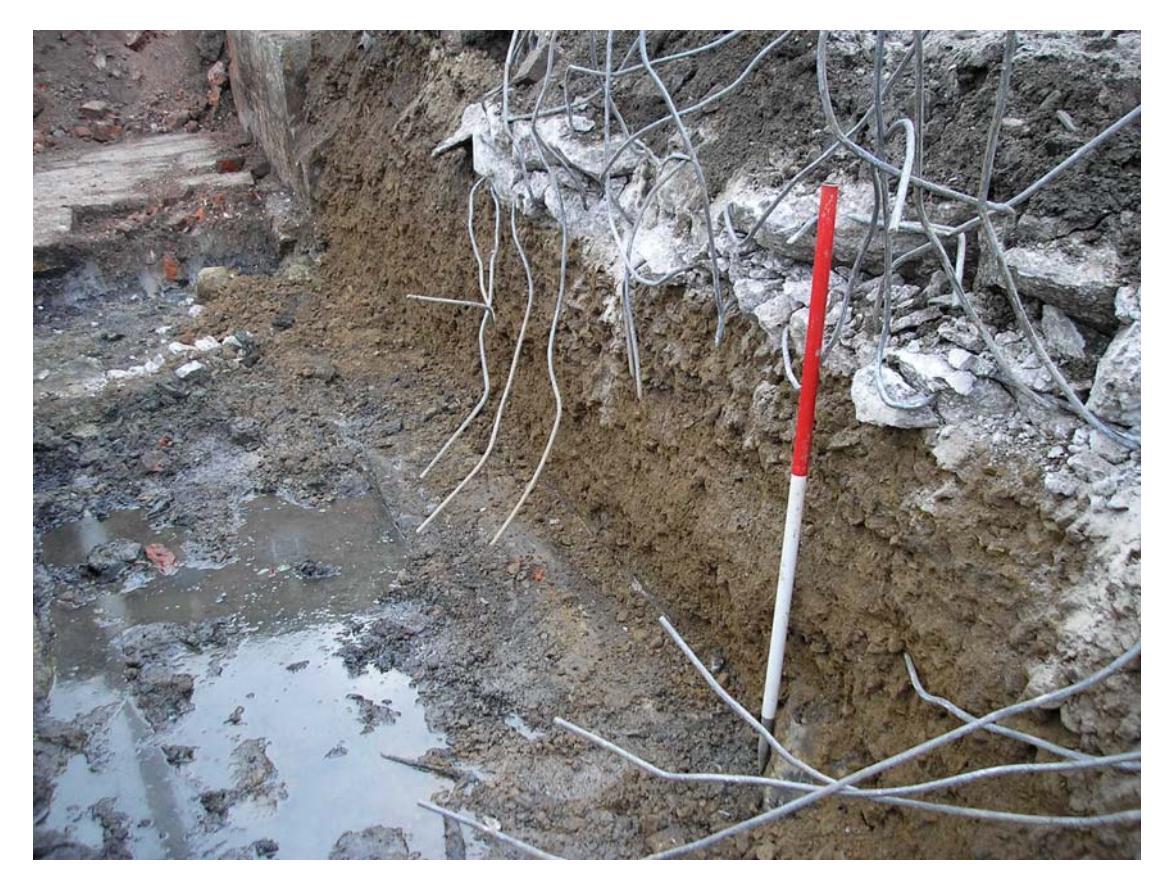
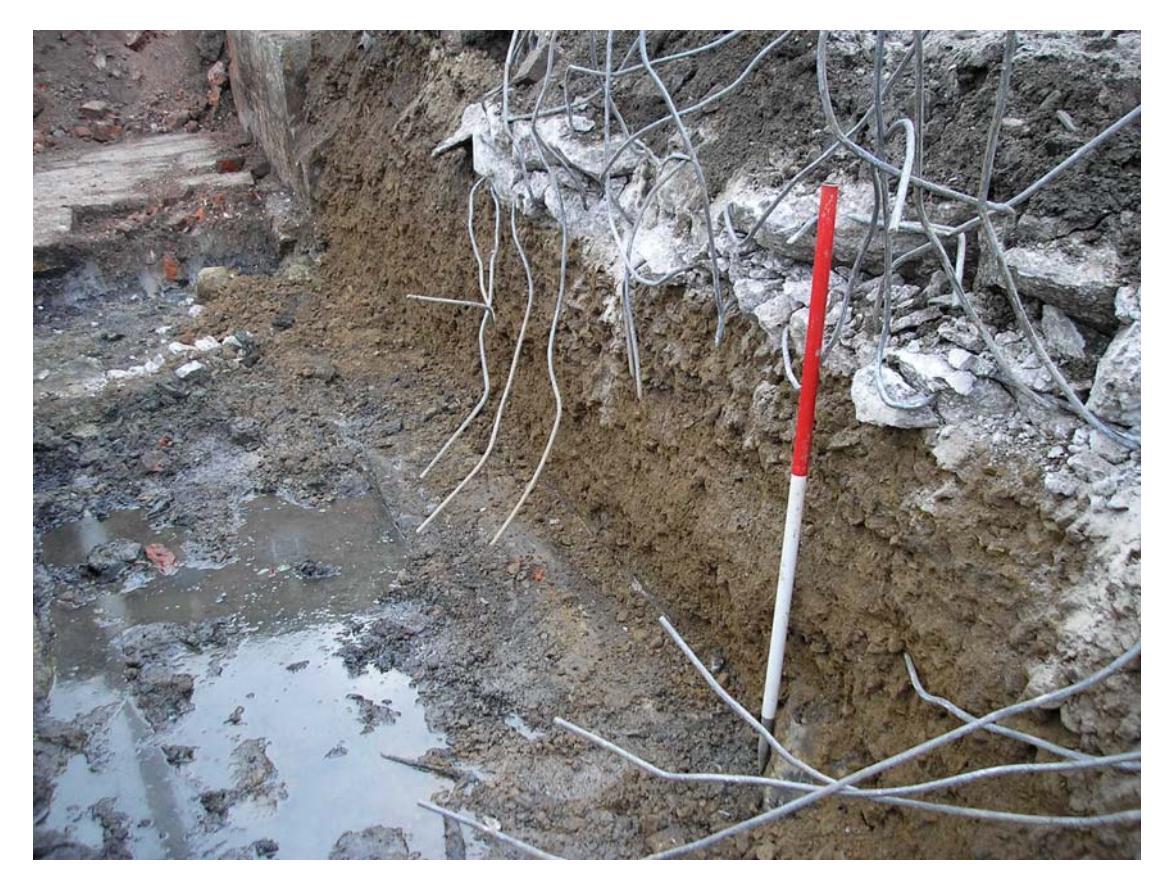
- 4.2.22 The central part of the trench was dominated by the installation of steel reinforced-concrete (130) laid above aggregate bedding associated with a toilet block of a 20th century date, positioned east/west across the trench for a distance of 7m. This had been cut into natural grey-yellow clay, and seemingly destroyed any structures that possibly linked the archaeology at either end of the trench, except for traces of a stone foundation associated with room (128) along the southern edge of the trench, and a north/south aligned 0.42m diameter cast iron pipe (Plate 11) observed immediately below the aggregate.

- 4.2.23 The pipe ran from the direction of the Leeds and Liverpool Canal beneath Trencherfield Mill N° 3 Mill, and continued north in the direction of the excavated boiler room. It seems possible that this pipe was intended to provide the supply of water for the steam-power plant. Interestingly, a pipe of identical dimensions and depth was noted to lie beneath the engine room floor within N° 3 Mill, running along the same alignment, and connected with the canal.

Plate 11: Pipe immersed under water running below engine room 128
