TRENCHERFIELD MILL N° 1, POTTERY ROAD, WIGAN,

Archaeological Evaluation

Oxford Archaeology North

March 2006

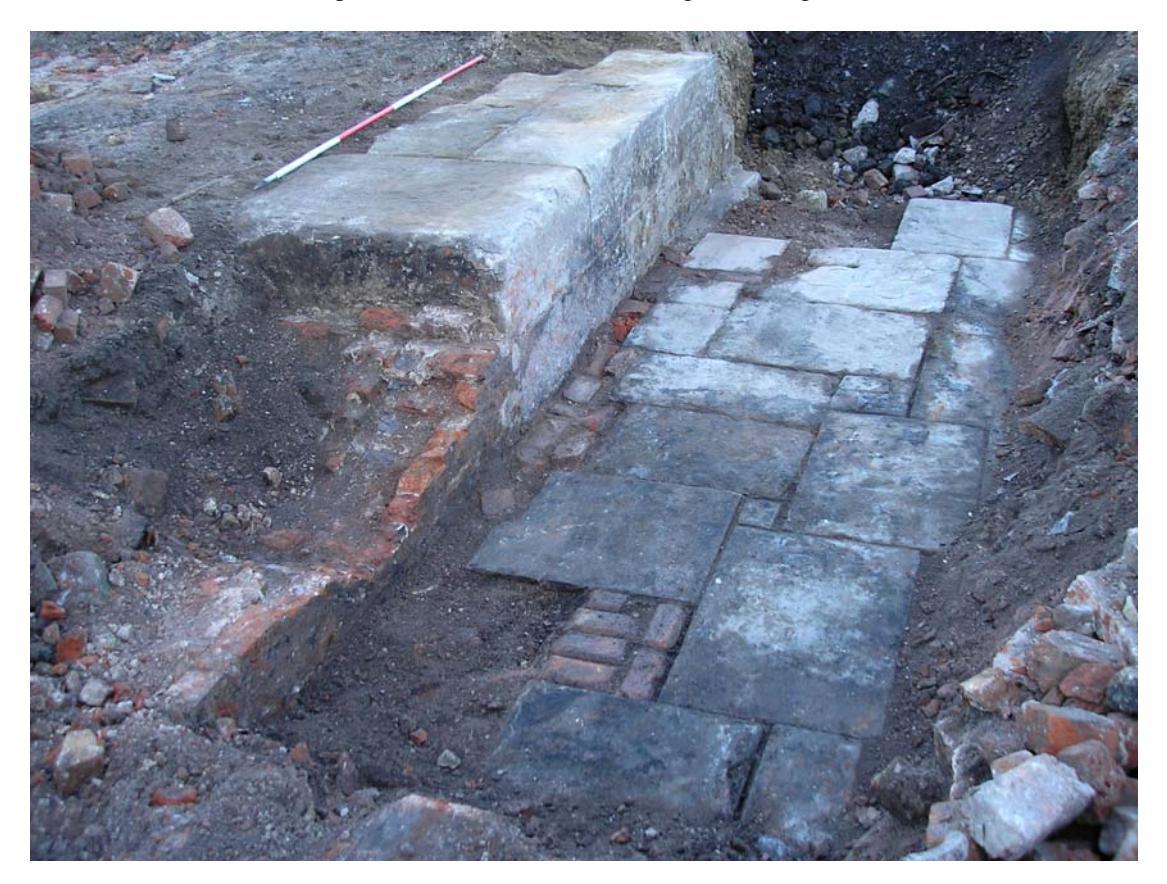
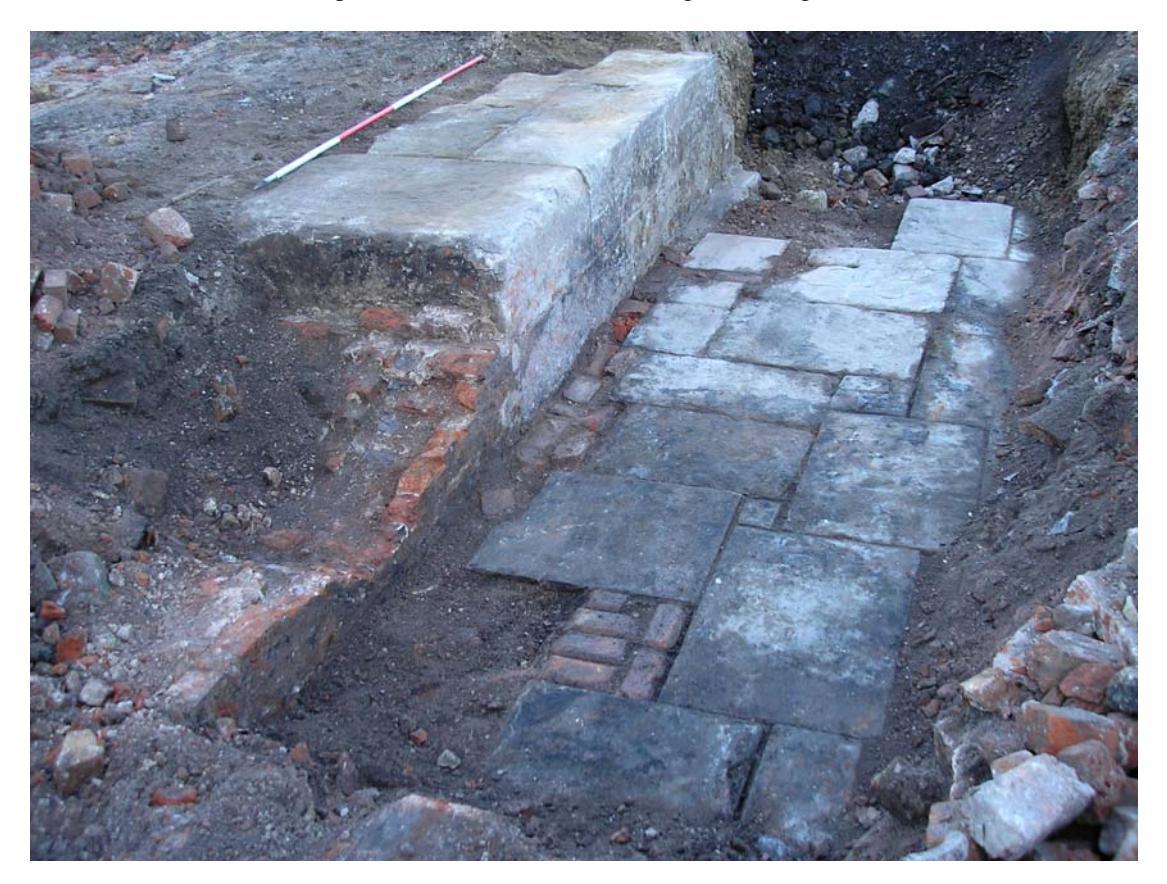
- 5.3.2 The substantial nature of structure *128*, exposed within the south-western end of Trench 5, is consistent with that used as a foundation for a steam engine, especially the ashlar component. However, only a small proportion of the structure was exposed and, as no iron restraining rods characteristic of a foundation for an engine were present, it precise function cannot be ascribed with confidence. The brick component may have represented the original south-eastern external wall of the mill, prior to the extension shown on the map of 1837. The position of structure *128* lay just within the footprint of the original mill, as shown on Mather's map of 1827, although this part of the building had been subject to considerable remodelling before 1847. However, notwithstanding the destruction of any physical link between structure *128* and the boilers exposed within the north-eastern part of the trench, it is tempting to suggest that all these remains were of a contemporary date.

Plate 12: Engine room 128, looking north

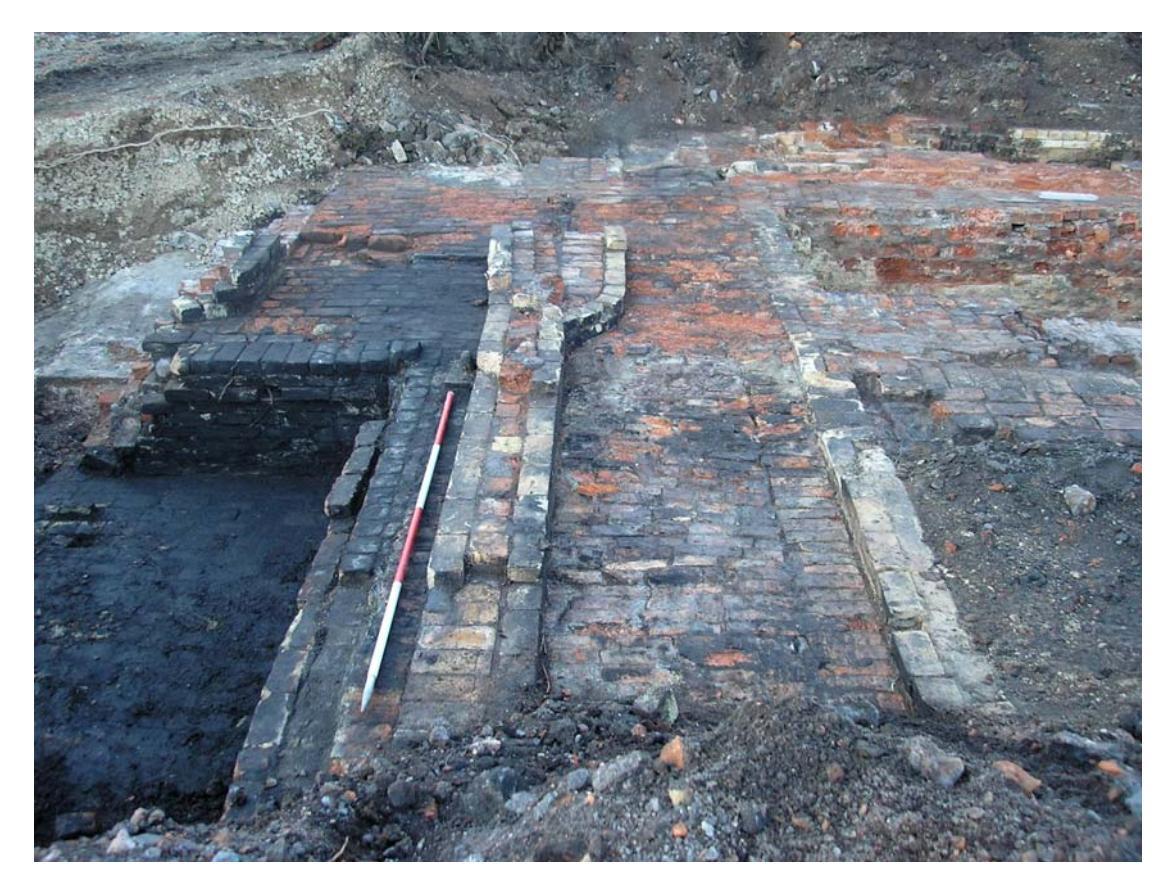
Plate 13: View of boiler room, looking west

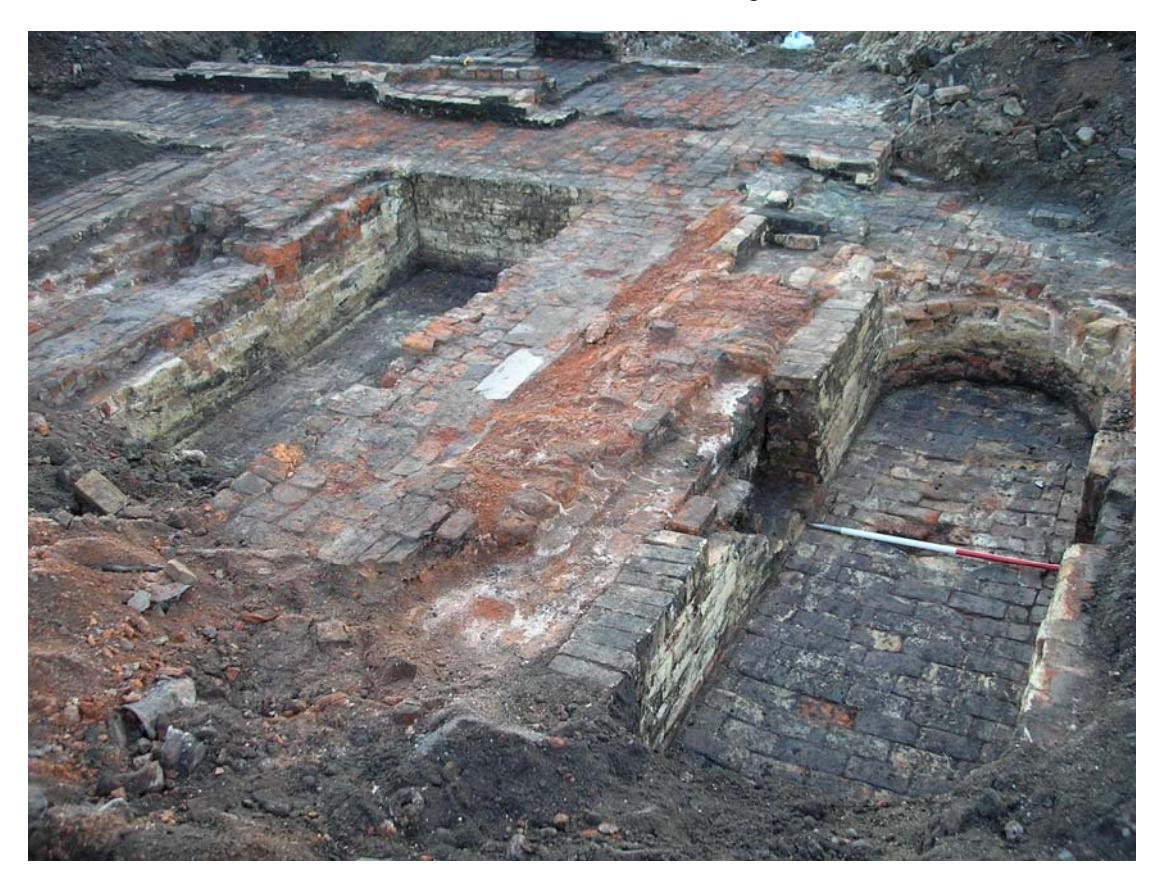
Plate 14: Pits 120 and 121, looking south-west

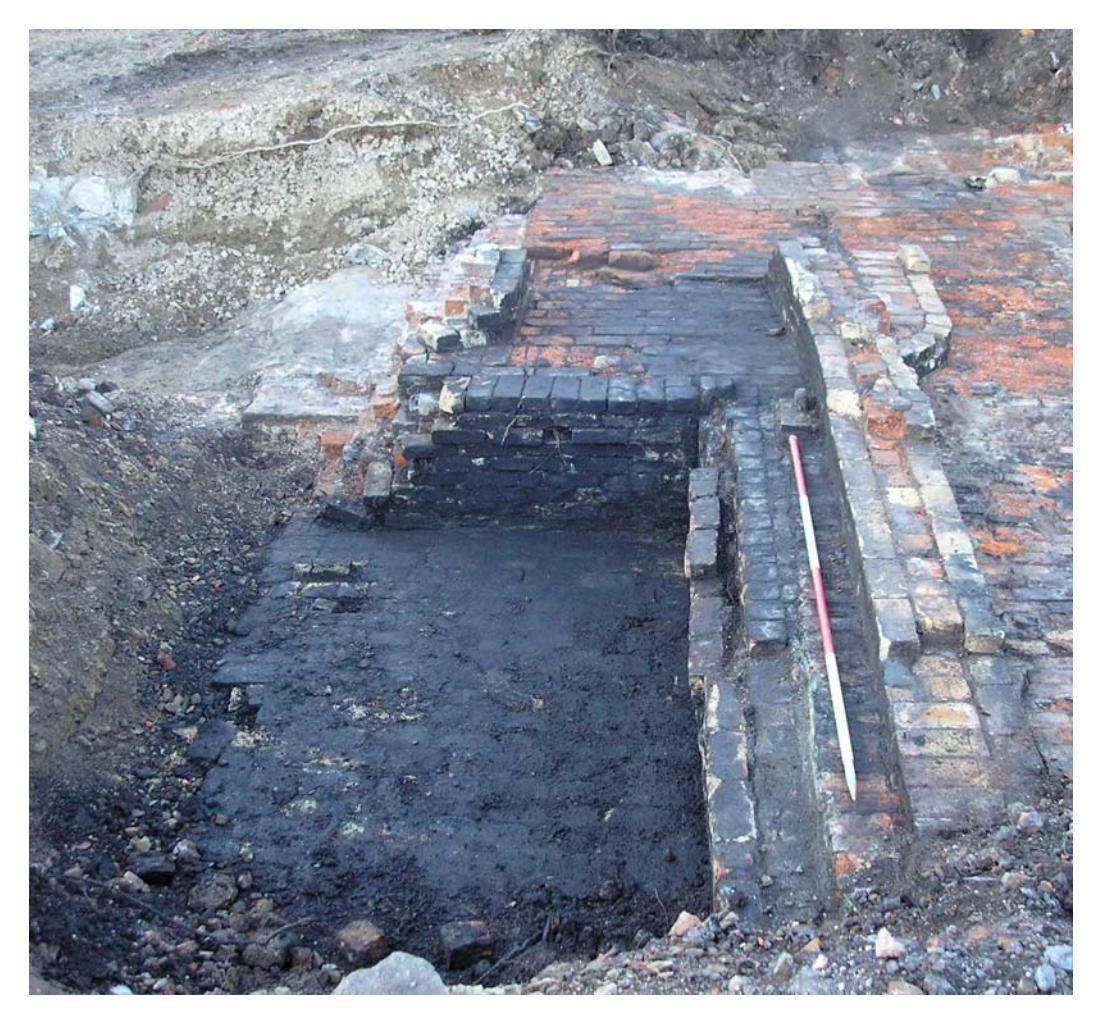
5.3.4 The identification of an economiser is of interest, particularly as it was seemingly of a contemporary date to the boilers. This device, also known as a feed water heater, was patented by William Green in 1845, and comprised a series of vertical tubes connected together in rows by manifolds situated at the top and bottom of the pipes. The various rows of pipes were coupled together

Plate 15: Economiser pit 122, looking west

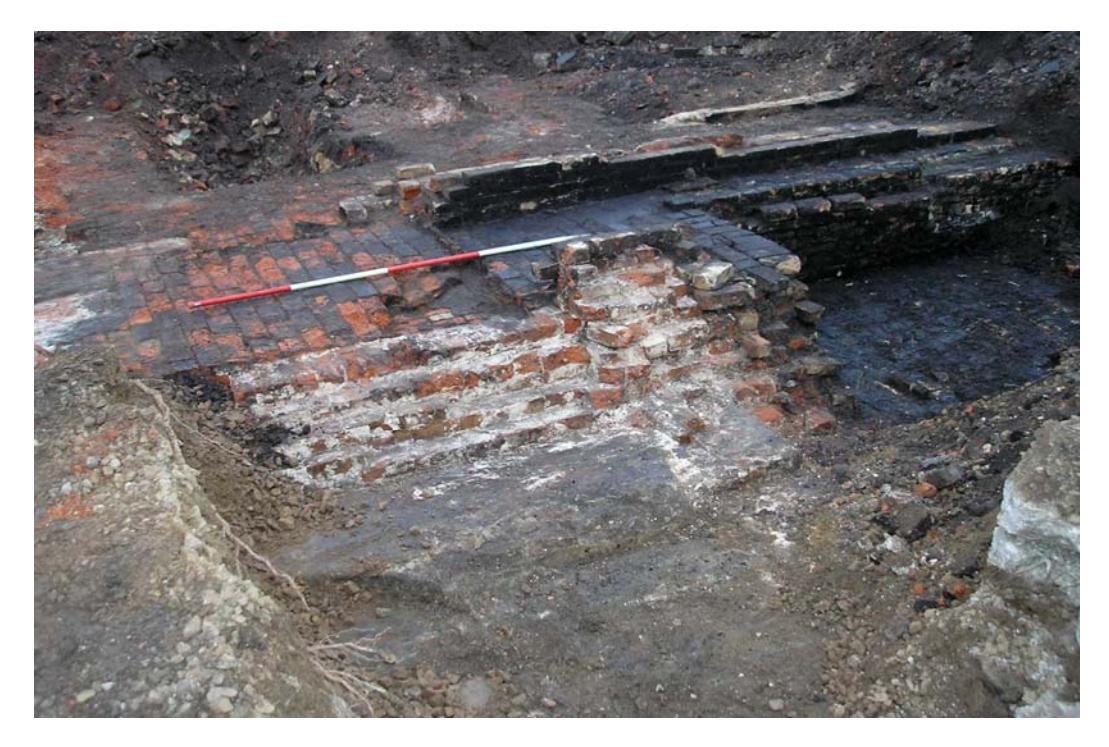
- 4.2.30 *Chimney:* wall *124* was built directly above a sandstone base (*123*) that possibly represented the foundation of a chimney (Plate 16). The sandstone foundation extended 4m south from wall *124*, and comprised a contoured split-level construction that contained several semi-circular cuts and hollows

Plate 16: Remains of the south external wall (*124*) of the boiler room and stone foundation of a possible chimney (*123*), looking north
