Clapham Park Regeneration Lambeth

Historic Building Recording

October 2007

Client: Clapham Park Homes

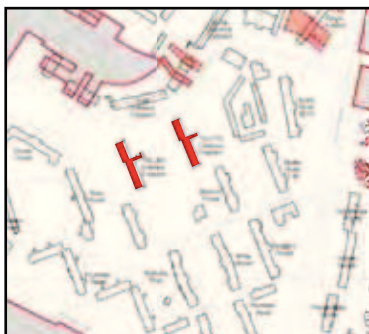
3: CLARENCE CRESCENT (NO.S 158-178 AND NO.S 180-200)

The buildings shows the influence of the Brutalist style with angular geometries and exposed concrete. Although the overall design of this building is different to that of 140-154 Clarence Crescent there are many similar stylistic features such as the window types, the horizontal bands indicating floor heights, the types of railings and brightly coloured front doors.

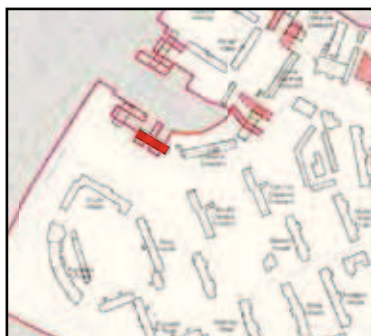
4: CLARENCE CRESCENT (No. 1-6)

This a terrace of six houses beneath a gabled roof. Each house is two storied and essentially of brick construction although the fronts (south-facing) comprise large areas of glazing and white painted panels. Each property is divided from its neighbour by a brick pier and each has a small front garden. The front doors are each recessed slightly within the building to create a covered porch.

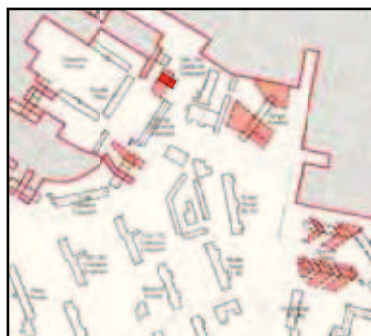
7: CLARENCE CRESCENT (No. 58-60)

This small block comprises three properties and it is currently being refurbished so it was largely covered with scaffolding when the recording was undertaken. It shares many constructional similarities with other buildings along Clarence Crescent including brick piers between the dwellings, large areas of glazing with painted panels between, recessed front doors, raised ridges along the gable ends and emphasised kneelers at the base of these ridges.

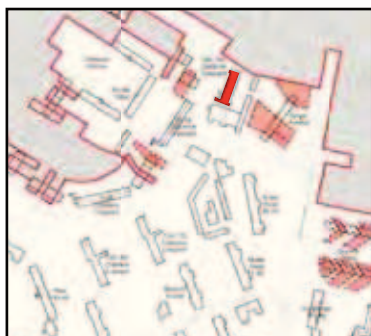
10: CLARENCE CRESCENT (No. 140-154)

No. 140 to 154 Clarence Crescent is a four storey concrete-framed structure clad in brick and concrete block. It is a long rectangular plan building with a flat roof and a plant room projecting above the roof line. No flats have been inspected internally but it appears that each flat is located over two floors. The horizontal emphasis of the building is increased by each of the floors and roof being articulated in the elevations with visible bands of concrete. It is also emphasised by rows of balconies at second floor on the rear (east) elevation and by an access gallery on the west elevation, also at second floor. It is balanced somewhat on the west front by distinctive alternating panels of slightly projecting concrete block and single-pane, horizontally hung casements. The cross-sectional profile of the building is stepped so that the second floor balconies are on top of (rather than cantilevered over) the ground and first floor. There is also a row of detached garages to the rear of the main block and beyond the gardens.

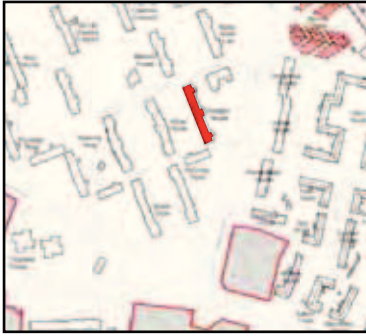
11: RODGERS HOUSE

Rogers House is located along Kings Avenue and is very similar to Muller Road (35-74) which also faces onto this road. It is a six-storey brick building with a flat roof and parapet and the linear, rectangular plan is only broken by three projections to the front (NE) which house the staircases and lifts. These projections have white painted fronts and small porch roofs over the entrances. The sides of these entrances are decorated with honeycomb brick sides. The windows are metal framed with small and large casements but not of the 'stepped transom' type found in other blocks. The rear elevation shows the same distinction in the brickwork found in Muller Road (35-74) in that this elevation (other than the parapet) is of light yellow brick in contrast to the dark brown in each of the other faces. This elevation has vertical bands of concrete balconies which project from the main face of the building at a slight angle. They incorporate frosted-glass panels to allow through more light onto the balconies.

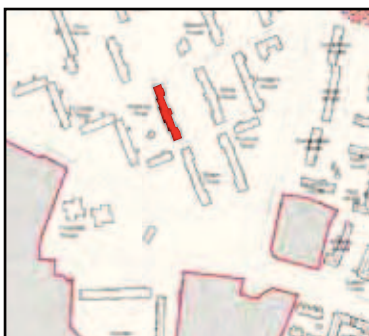
13: MOBERLEY ROAD (No. 1-41)

No. 1-41 Moberley Road is an attractive building which forms part of the planned complex laid out in the 1950s of broadly similar relatively low-rise blocks. It relates particularly to the adjacent, very similar White House and the two Bowie Close blocks with which it forms a large open, rectangular court. The building has a relatively long rectangular plan but the block-type appearance is broken up by three vertical stairwells and circulation blocks which project slightly beyond the footprint of the building. The vertical emphasis of these elements is further enhanced by them projecting above the roof line and by the two side projections incorporating vertical piers of windows and light-blue tiled panels in their main face. At the base of these two flanking projections (in the north-east elevation) are entrances to the building sheltered by cantilevered concrete porch roofs which curve gently upwards. The central entrance is also sheltered by a concrete roof but this is not curved and is supported to either side by concrete piers.

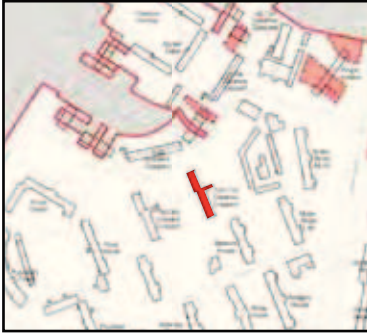
19: PLUMMER ROAD (No. 60-101)

This block is stylistically quite different to the other buildings being laid out in the early 1950s at Clapham Park and appears quite unusual for its date in this country. The building is mentioned in *The Buildings of England London 2: South* (Cherry and Pevsner) and their design is described as 'Swedish-influenced New Towns style'. It is a relatively long rectangular plan terrace of two-storey houses set at a sharp angle to Kings Road. This angle may have been to mirror the footprint of the Muller Road block (and the other contemporary blocks) on the opposite site of Helby Road. The terrace has a single-pitch roof with visible rafters overhanging on the east (higher) side of the building. It is constructed with ochre coloured bricks and each property is provided with relatively generous front and back gardens. The overall appearance of the elevations is plain, with a minimum of decoration and the extent of the glazing is less than on most of the other buildings at Clapham Park from this period. The building appears to have suffered subsidence or other structural faults because there are now a number of visible cracks on the external walls.

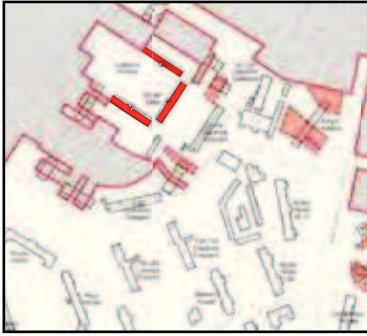
21: MORTON CLOSE

Morton Close comprises three similar three-storey ranges laid out around a green which faces onto Clarence Avenue. Access to the blocks is from Clarence Avenue and is via a horseshoe-shaped road between each block and the green. Each block is of brown brick construction and has a relatively conservative design with similarities to blocks laid out in the 1930s both in Clapham park and elsewhere. The blocks each have rectangular plans, flat roofs and a central projecting stairwell (with tall window to emphasise its vertical nature. This stair block also projects above the roof line to further emphasise its distinctiveness and at its base it is supported by pilotis.

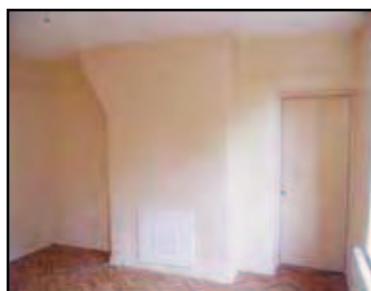
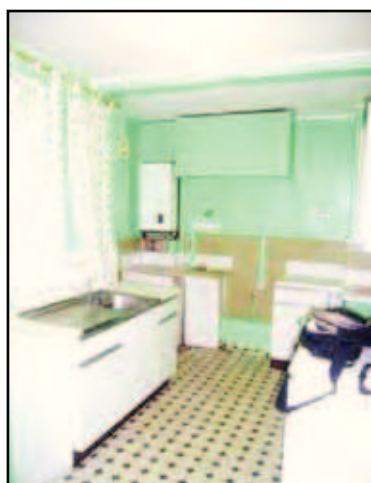
67: INTERIOR OF 14 RIGG HOUSE

Rigg House was almost certainly constructed in the 1930s when a large part of Clapham Park East was laid out (see Gazetteer Entry No. 59 for general description). The interior of one of the flats (No. 14 Rigg House) was accessed as part of the current project and was recorded photographically and descriptively. It shows many similarities with a flat also investigated in the contemporary Whiteley House (see No. 70).

The flat is comparatively spacious with three bedrooms (one of which would originally have been a dining room), a living room, a kitchen, a bathroom and a separate WC. The flat is located towards a corner of the overall building and the plan is broadly T-shaped. In the main body of the flat are the two main reception rooms together with the two smaller bedrooms at one end while in the smaller 'branch' at right angles to the main body, are the WC, the entrance hall, the bathroom and kitchen. The kitchen is relatively small, reflecting the fact that when the building was originally constructed it would have been assumed that any house or flat would have had a dining room separate to the kitchen. The bathroom and separate WC are either side of the entrance hall. The fittings within the WC, bathroom and kitchen are all modern replacements.

Similarly to the exterior of Rigg House the features and fittings within the flat are clearly detailed to appear older than they are and in this they are quite different to the post-war blocks also recorded. The flat has sash windows (6 over 6 and 4 over 4) with wide mullions similar to those found on buildings from the Queen Anne or early Georgian periods. The primary 4-panel doors largely and the joinery (timber sills, simple architraves, plain low skirtings) also all give the flat a 'traditional' feel and the superficial appearance of being much older than it actually is. The fireplaces (within the two main rooms) had been removed prior to the current works. There is a picture rail in the living room and there are curved edges to chimney breasts and window jambs. Although access to the flat is via a gallery to the rear it does not have an individual balcony as many of the post-war flats do.

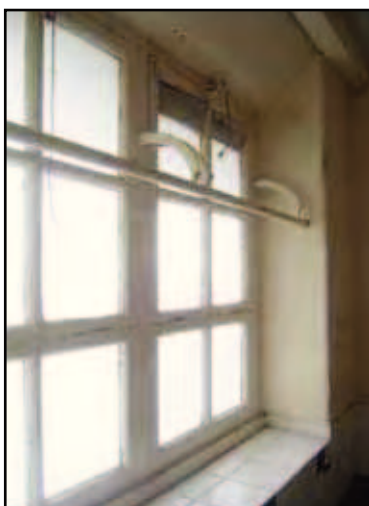
70: INTERIOR OF NO. 7 WHITELEY HOUSE

Whiteley House was almost certainly constructed in the 1930s as part of the initial establishment of Clapham Park East (see Gazetteer entry No. 65 for general description). The interior of one of the flats (No. 7) was investigated in the current works as a typical example of the flats from this period of Clapham Park's history.

The layout of the flat is relatively compact with the entrance opening into a central hall to which all the other rooms are directly linked. To either side of the entrance are the bathroom and separate WC (the same arrangement to that in the contemporary Rigg House - see No.67). Off the central hall is a kitchen, a relatively large living room, and two smaller rooms which are now bedrooms but one of which may originally have been a dining room.
