ST. JAMES' CHURCH, STOCKS IN BOWLAND

Interim Historical Study

Document Title: ST JAMES' CHURCH, STOCKS IN BOWLAND, LANCASHIRE

Document Type: Interim Historical Report

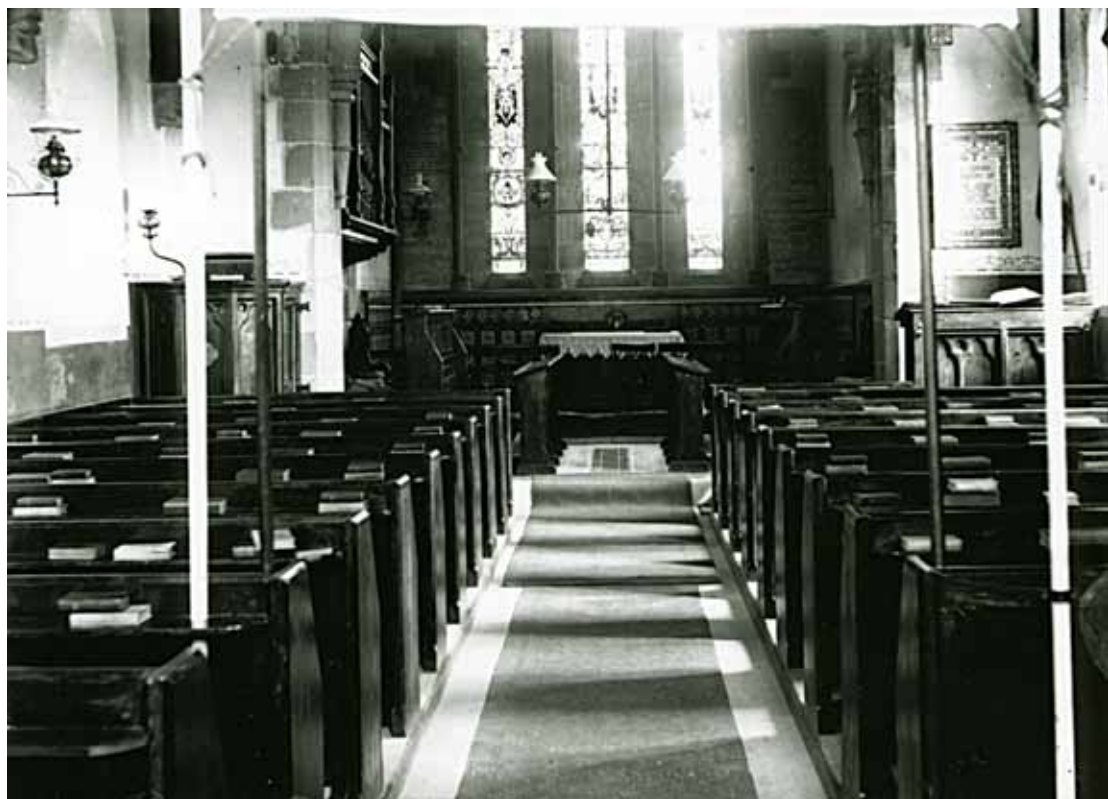
Plate 4: The church interior, which shows a Laycock and Bannister piped organ to the front left

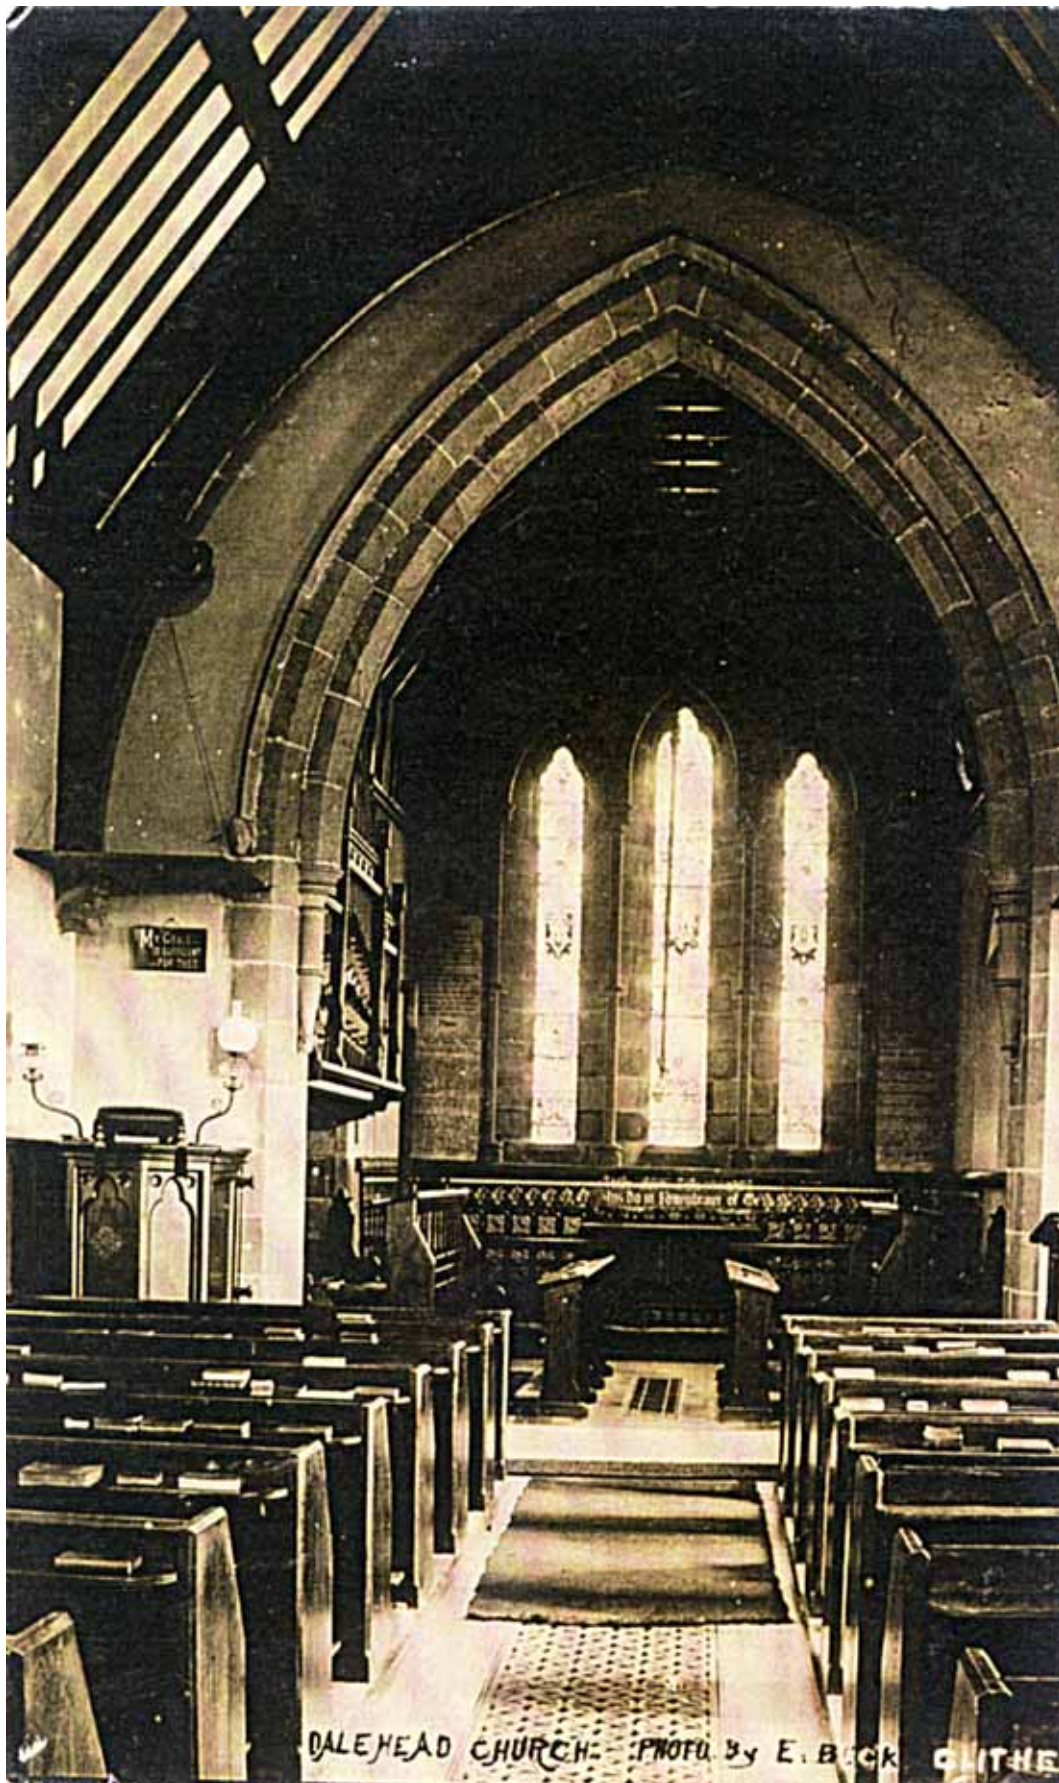
Plate 5: The church interior with decorated floor tiles evident in the choir
