Park Way, Newbury Phase 2 Evaluation

Archaeological Evaluation Report

November 2008

Document Title: Park Way, Newbury. Phase 2 Archaeological Evaluation

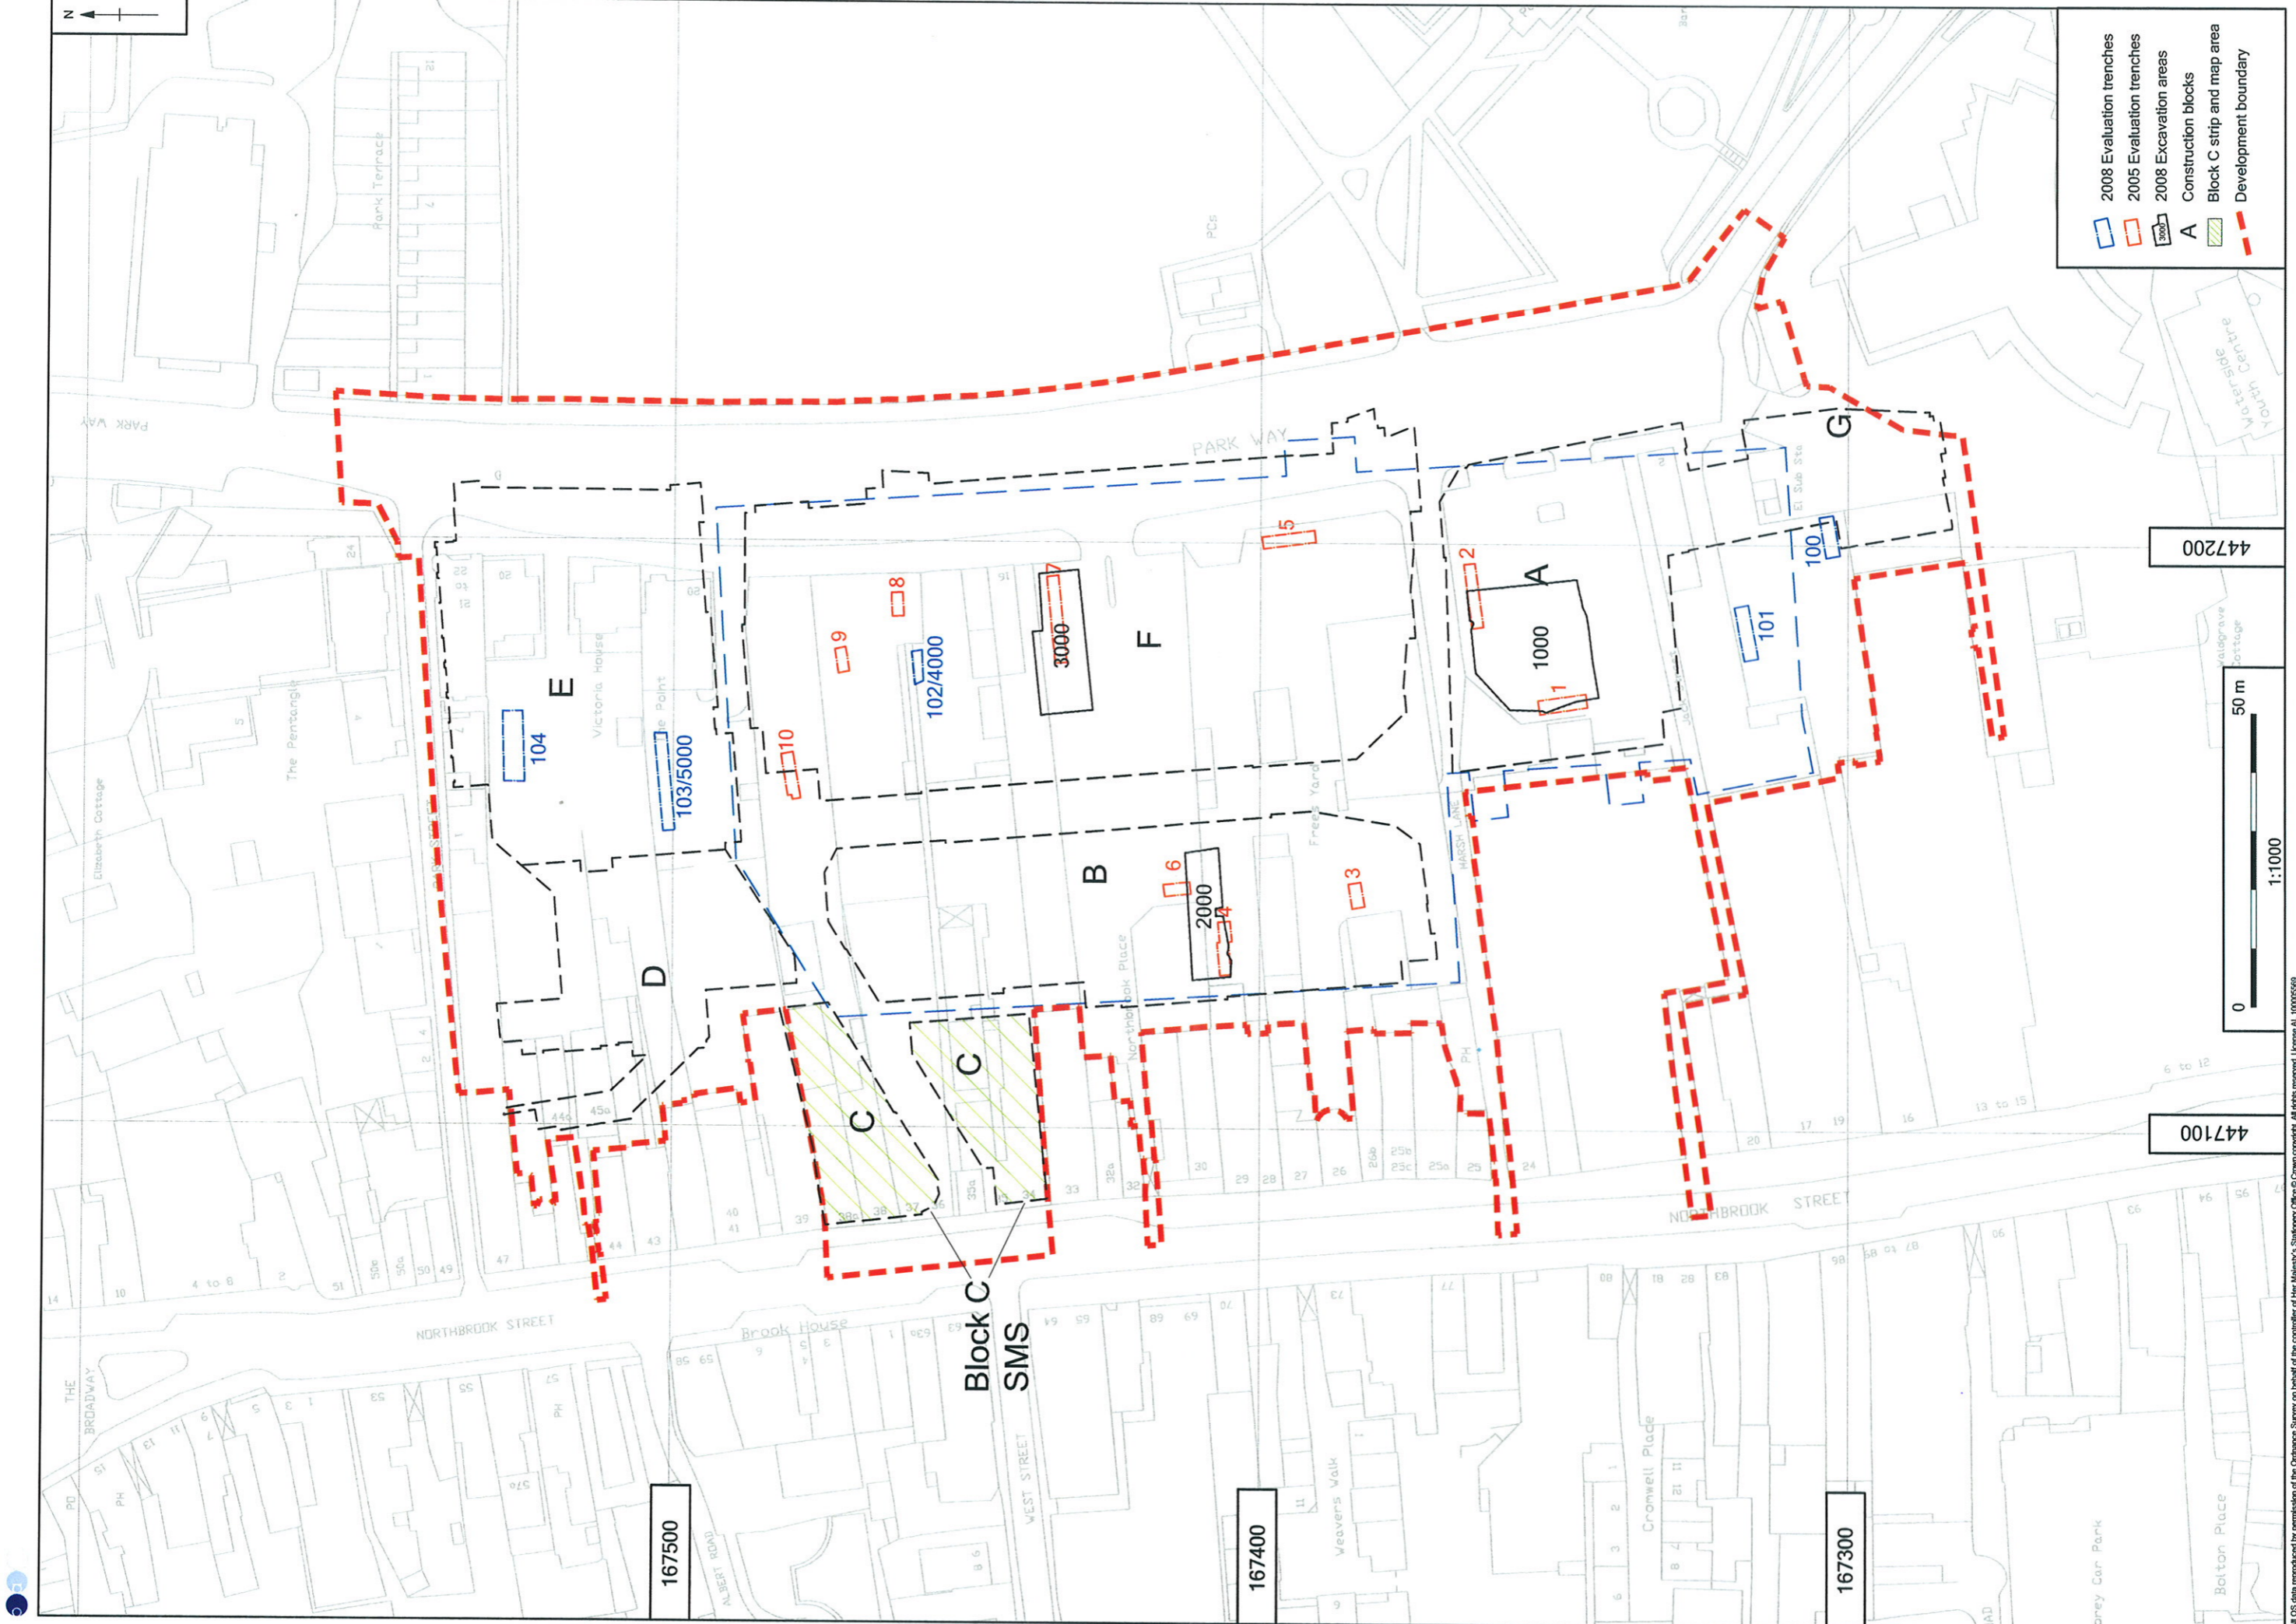
Figure 2: Trench locations

3.1.1 Five evaluation trenches were originally intended (Fig. 2, Trenches 100-104) although access arrangements could not be established for the northernmost (Trench 104) prior to the compulsory purchase order and the start of the construction work. This area was also required from the outset of the construction programme for site accommodation and parking making it unavailable for trench investigation. Due to these limitations it was agreed between all parties that this area would remain substantially undisturbed until a later date when limited investigation could be undertaken to reflect the level of impact that the development would have here.

4.2.1 The four excavated evaluation trenches (100-103) were positioned within enclosed parking areas to the rear of buildings fronting Northbrook Street. Surface conditions were good due to the hard surfaces surrounding each trench although Trenches 102 and 103 were excavated during prolonged wet spells. The excavated depth of these trenches, proximity of the excavated depth to the water table and the limited drainage possibilities led to these becoming flooded and it was not possible to work in these for several weeks.

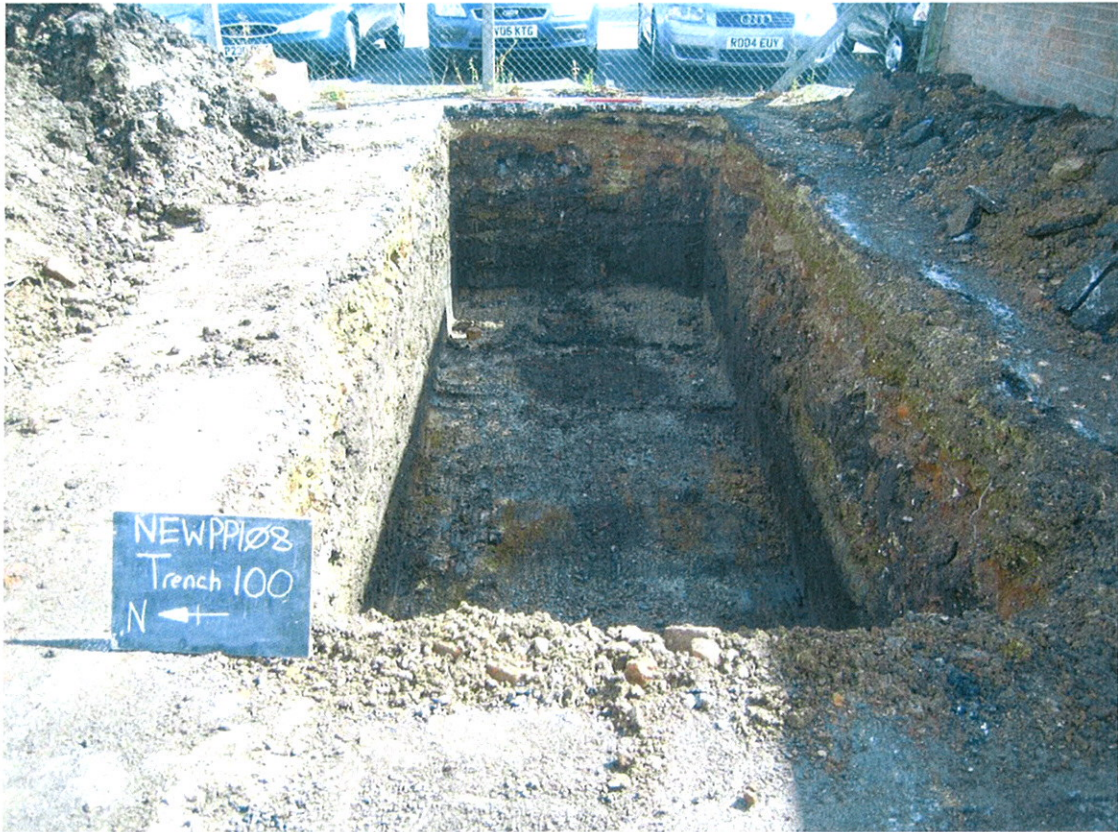
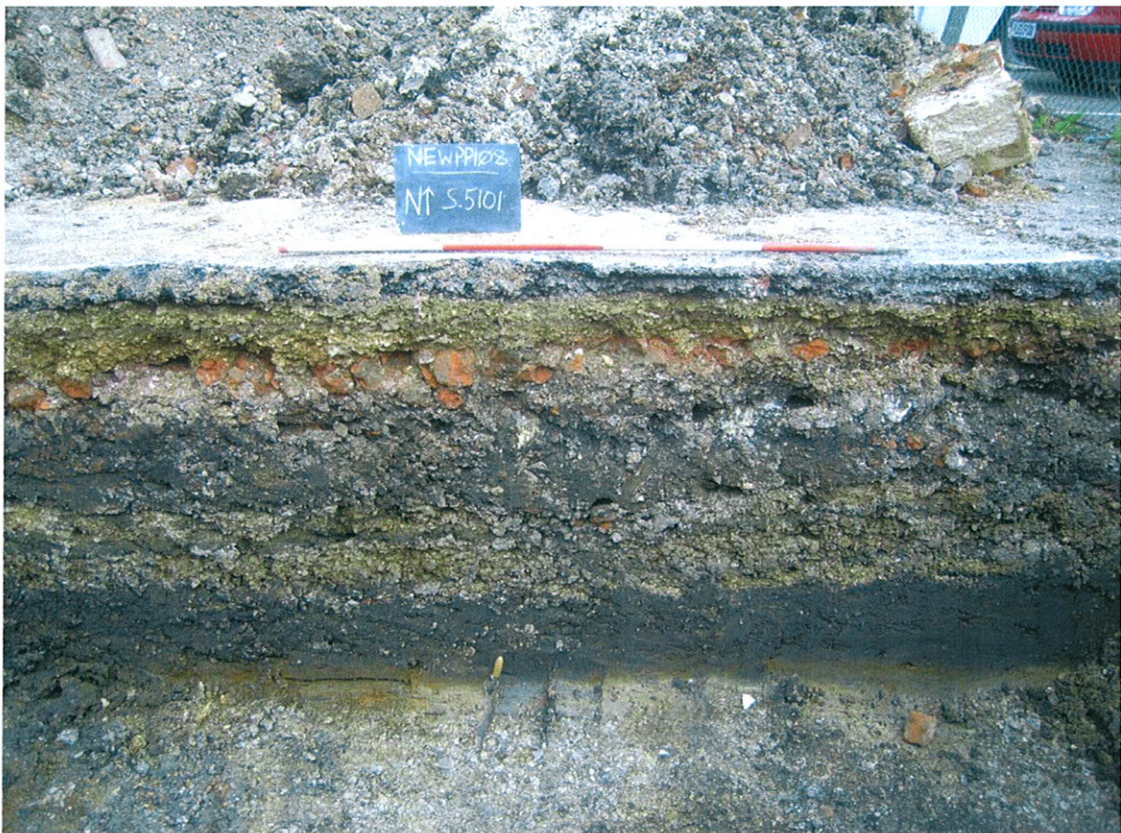
Plate 1: Trench 100

4.3.1 Trench 100 (Plate 1) was located within the southern limit of the development boundary and to the immediate north of the Woolworth Garden Centre.

4.3.2 Natural gravel (5100) was encountered at a depth of 1.75 m below ground level (74.22 m aOD) and was overlain by a sterile grey alluvial clay (5116) throughout the trench to a depth of 0.21 m. Processed samples from this deposit produced negative results for the presence of small flint artefacts despite the dryer conditions indicated by the lack of peat deposits suggesting that this may have been a favourable habitat.

4.3.3 Three circular pits were identified within the trench cut through the surface of the clay horizon (5116) and into the underlying gravel. Two of these (5102 and 5104) had approximate diameters of 1.15 m and were between 0.25 m and 0.35 m deep. Pit 5107 was smaller with a diameter of 0.5 m and 0.1 m deep. However, the upper limit of each feature had been removed by machine excavation to reveal the surface of the gravel so these were originally up to 0.2 m deeper. Each pit had a rounded profile and was infilled with a similar dark grey brown sandy silt deposit with mixed gravel inclusions. A total of 3 small body sherds of pottery in the Newbury B type fabric were recovered from the pit fills (5103 and 5105). Although these lacked diagnostic traits, this fabric has a date range of late 11th to mid 13th century.

4.3.4 A 0.25 m thick layer of grey slightly sandy silt and clay (5115) sealed the fills of each pit. This layer possibly represents a reworked or disturbed soil horizon that originated from the natural sediment sequence. The stiff grey clay is comparable to deposits recorded within some of the excavation areas towards the base of the peat sequence. Genuine thick peat deposits were absent from this area of the development and this deposit occupies the level above the gravel that this would otherwise be expected. A small pottery fragment of the same Newbury type fabric was recovered from this deposit with a sherd of flint and sand tempered peg tile. The presence of the peg tile indicates a date within the later part of the pottery date range.

4.3.5 A 0.4 m thick sequence of made ground gravel deposits (5114) sealed the lower clayey soil horizon and probably represents the deliberate raising of this area. This was capped by a 0.1 m thick deposit comprising a mixed brown sand, silt and gravel (5113) that may represent the surface or 'occupation horizon'. A mixed cultivation soil (5112) sealed the 'surface'. Despite a general lack of artefact inclusions this deposit almost certainly represents the late post-medieval garden soil with crushed brick and gravel deposits (5111 and 5110) sealing this as the foundation layers for the existing tarmac car park surface (5101).

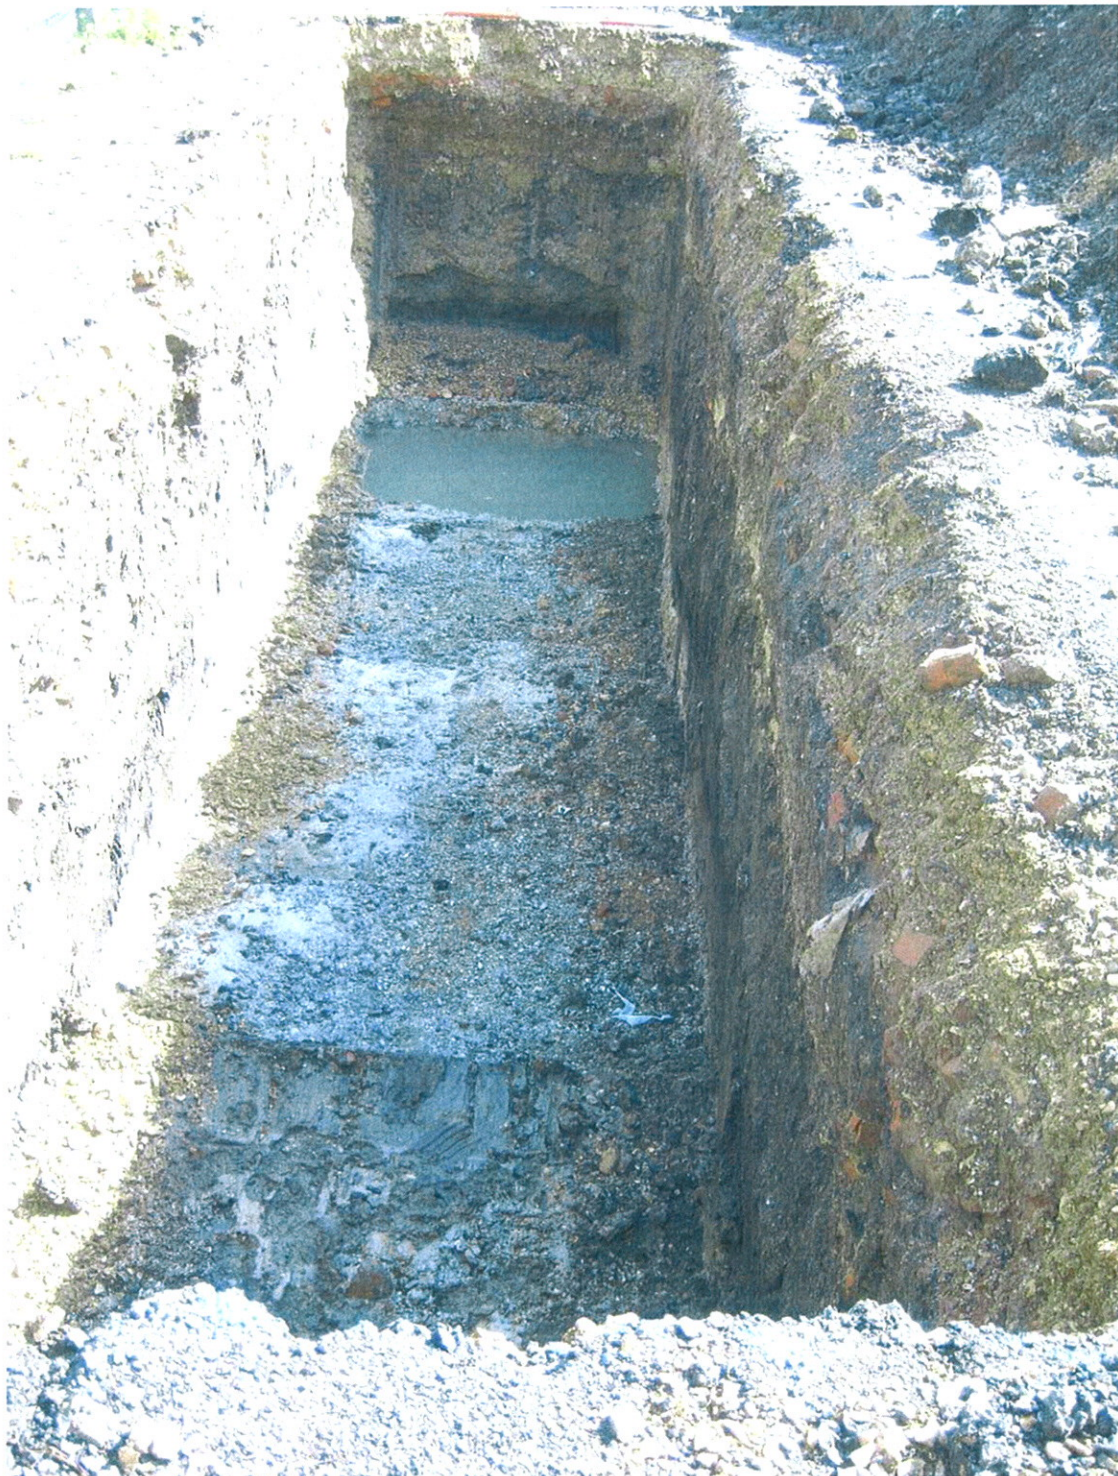
Plate 2: Trench 101

4.4.1 Trench 101 (Plates 2 and 3) was located approximately 16 m to the northwest of Trench 100, also within the Woolworth parking area.

4.4.2 Natural gravel (5201) was encountered at a depth of 2.10 m below ground level (73.58 m aOD) and was overlain by a sterile white/light grey alluvial clay (5203) throughout the trench to a thickness of 0.15 m. The pale clay graded into a more consistent light grey alluvial clay (5204) which, in turn, graded into an organic clay/peat deposit (5205). This had a maximum thickness of 0.20 m and represents the sole peat deposit encountered within the southern part of the development area (Trenches 100 and 101). As with the samples taken from the equivalent deposit(s) within Trench 100, the samples from this trench also produced negative results for the presence of flint artefacts.

4.4.3 A mixed grey clayey garden soil (5206) with a maximum thickness of 0.58 m sealed the peat deposit although its clayey appearance probably reflects that this originated as part of the lower sediment sequence. This soil is comparable to 5115 within Trench 100 and also produced a single non-diagnostic sherd of Newbury B type fabric.

4.4.5 Overlying the infilled well and the surface of the cultivation soil 5206 was a clay and gravel levelling layer or made ground (5207/5218). The clayey inorganic appearance of this deposit suggests that it was not cultivated as a garden soil although this was not present across the entire extent of the trench so it may represent only a localised raising or levelling of the ground. This was overlain by a thick accumulation of

garden soil (5221 and 5209) that had a Victorian brick drain (5222) constructed within it.

4.4.6 Modern gravel and brick rubble levelling deposits (5210, 5211 and 5212) sealed the soil sequence forming the foundation for the existing tarmac parking surface (5202).

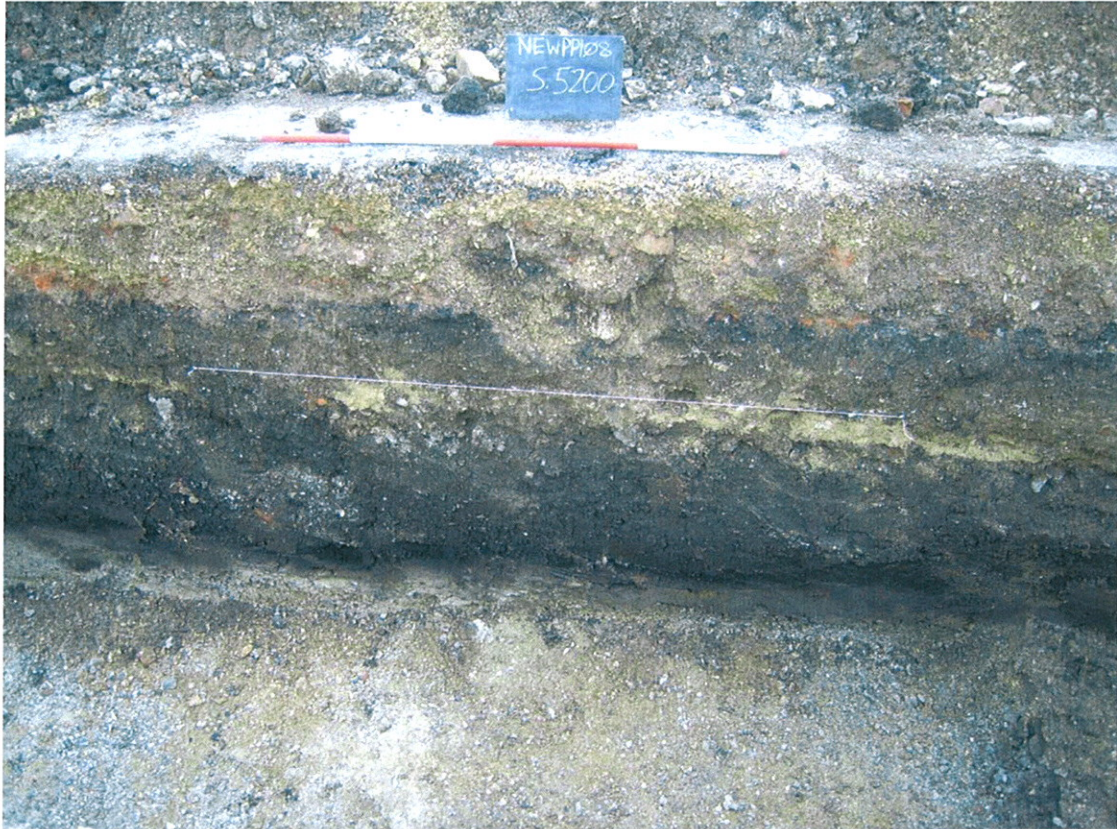
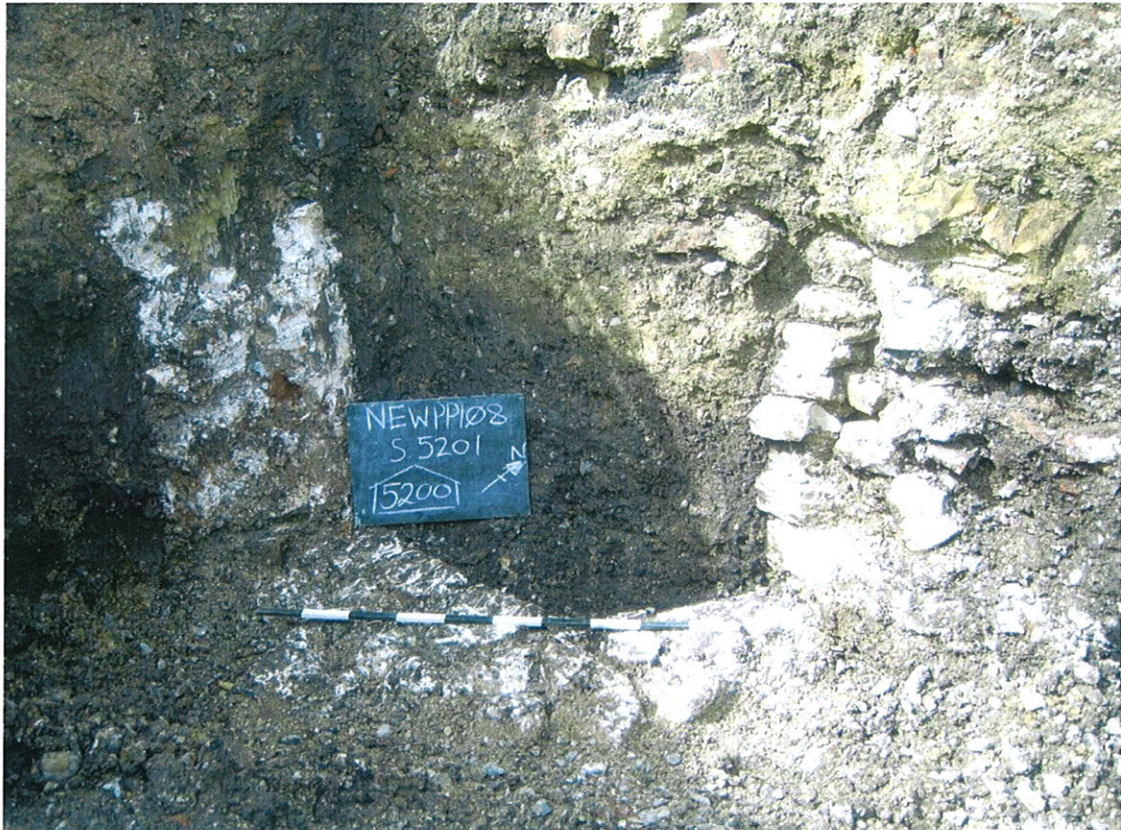
Plate 3: Trench 101, section and well 5200

4.4.4 Cut into the surface of soil horizon 5206 was a well (5200). This was neatly constructed in an octagonal form with faced chalk blocks and chalk packing pieces (5200) set within a circular construction cut (5213). Due to the high water table the construction pit was only cut to a total depth of 1.1 m below the surface of 5206 just penetrating the gravel below the clay and peat levels. The backfill (5214) of the construction cut comprised rubble and some tile. The interior of the well was infilled with a sequence of three deposits variously comprising grey silt clay and brown clay backfills (5215, 5216 and 5217) from which two very small 17th century sherds of pottery were recovered. The top of the well structure was capped by a stiff yellow brown clay deposit, the purpose of which is not entirely clear.

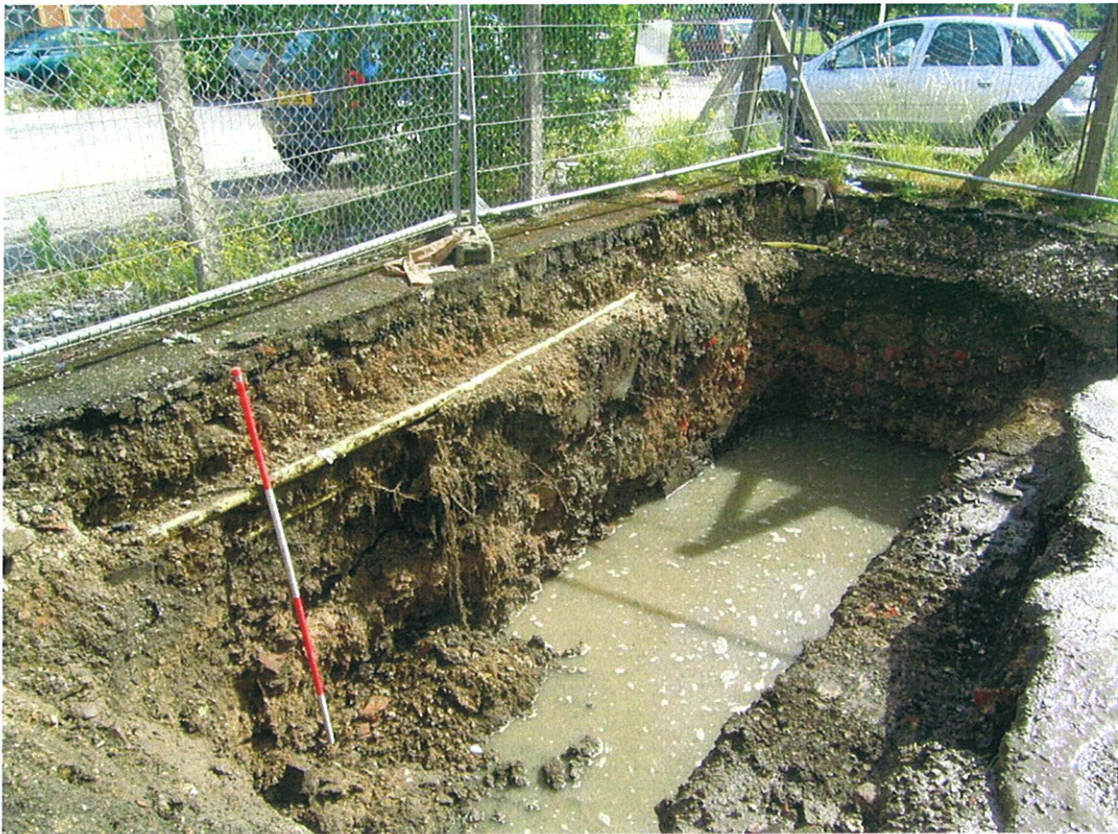
Plate 4: Trench 102 (4000)

4.5.1 Trench 102 (also referred to as Area 4000) (Plate 4) was located to the north side of a historical small property fronting on to Park Way. The trench was machine excavated during poor weather conditions and abandoned after only a trial pit measuring *c* 5 m by 2 m and 1.75 m deep had been excavated.

4.5.2 Natural deposits, including the sediment sequences that were recorded as deep units close by within this area of the development, were not encountered within this trench. The trial pit was excavated to a total depth of 1.75 m below ground level through various deposits of loose made ground. Due to the poor cohesion of the deposits, these continually collapsed into the trench resulting in its abandonment. A section of the made ground deposits was rapidly recorded.

4.5.3 The earliest deposit revealed was a sand and gravel layer (4006) approximately 0.1 m thick. This was sealed by a thick layer of very mixed made ground (4004) principally comprising stone rubble, brick, tile, glass, pottery and animal bone waste. The artefacts had a date range from the 17th to early 19th century although the majority of the assemblage appears to date from the late 18th century. This was sealed by successive sandy soil and rubble deposits (4002 and 4003). The upper levels of the sequence were represented by the modern graded stone rubble foundation (4001) and a 0.2 m thick concrete surface (4000).

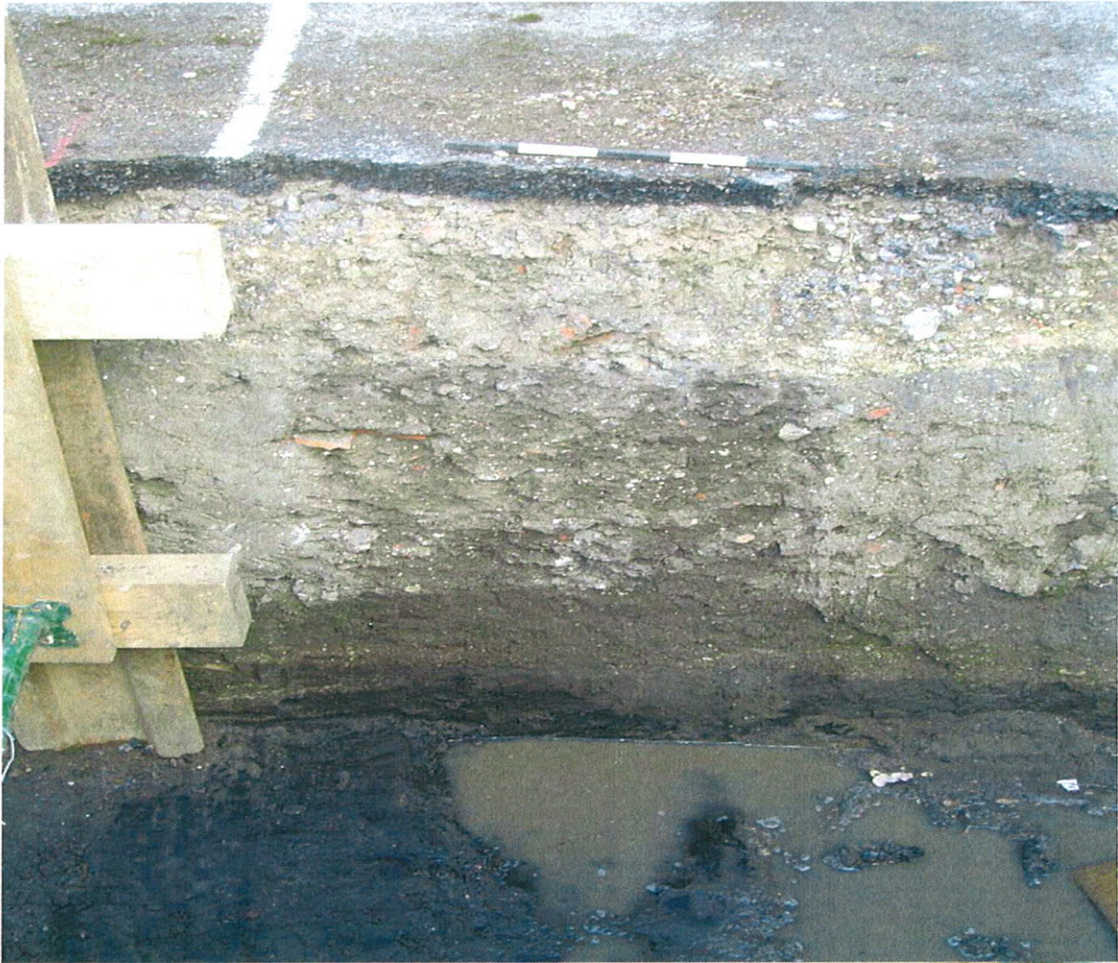
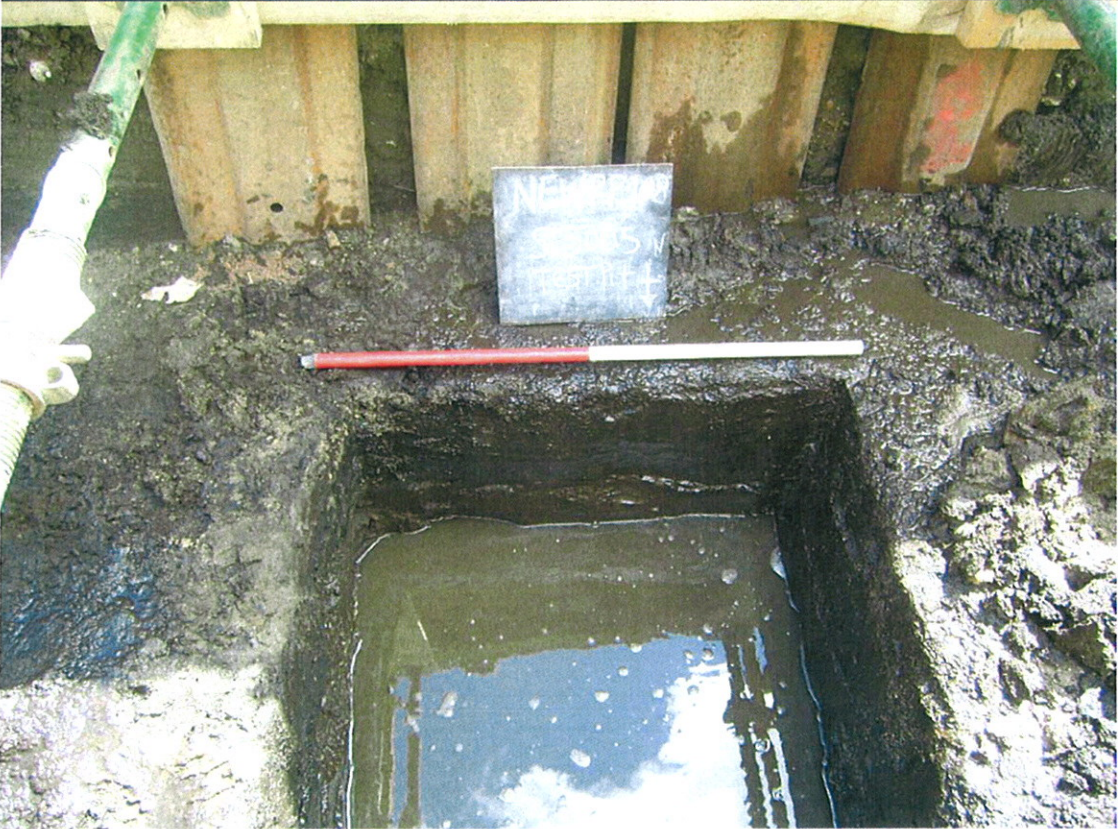
Plate 5: Trench 103 (5000)

4.6.1 Trench 103 (also referred to as Area 5000) (Plate 5) was located to the rear (west) of a modern office block fronting on to Park Way. The trench was machine excavated to the surface level of the peat deposits that were encountered at *c* 1.7 to 2.0 m below the modern ground level. Due to the depth of the trench, the wet conditions and the high water table, this trench flooded shortly after machine excavation of the overlying deposits and it was not possible to access this for several weeks.

4.6.2 A 1 m x 1 m test pit was excavated through the peat and sediment sequence in the base of the trial pit within its western end. This encountered natural gravel (5016/5017) at a depth of 2.74 m below the modern ground level (72.74 m aOD). This was overlain by a sequence of two major peat bodies (5015 and 5007), 0.80 m and 0.65 m thick respectively, although both contained distinctions within them that could represent surface horizons. Samples recovered from the top of the gravel and the base of the peat did not produce any evidence for Mesolithic artefacts.

- 4.6.3 The surface of the peat deposits was overlain by a relatively thin layer of mixed silt and gravel (5006). This extended throughout the trench and appears to be comparable to similar deposits recorded within the excavation areas also sealing the peat and reflecting the primary land reclamation of this low-lying area in the late 11th and 12th centuries. However, no dating material was present within this deposit although this may substantially reflect the fact that it was removed almost entirely by machine during the initial excavation of the trench.

- 4.6.4 The relationship between layer 5006 and the cut features recorded in this trench is not totally clear. Two linear ditches (5000 and 5010) that were aligned north to south and a small pit (5008) were recorded in this trench. The pit was clearly cut through layer 5006 whilst the relationship between the ditches and the layer was less clear. No conclusive dating evidence was present from any of these features although peg tile fragments with a general 12th century or later date were recovered from the ditches. Each ditch also produced small, but well preserved, animal bone assemblages. In addition, the fills of ditch 5010 produced scrap off-cuts of leather and a small fragment of a wooden comb showing excellent waterlogged preservation. This is comparable to that encountered within the excavation Area 3000.

- 4.6.5 A 0.2 m thick layer of dark grey brown silty clay with gravel inclusions (5005) overlay the medieval gravel deposit (5006) and sealed the fills of the cut features. This seems most likely to be a cultivation soil although no artefacts were present to date this deposit. This was, in turn, overlain by another cultivation soil (5004) that was 0.72 m thick representing a prolonged accumulation. This had a more humic appearance to that of the underlying horizon. Although no artefacts were recovered from this deposit a post-medieval date seems most likely.

- 4.6.6 A brick rubble layer (5003) and the current tarmac surface (5002) completed the sequence.
