**Land Adjacent to Cooper's Gate,
East of Southam Road, Banbury,
Oxfordshire**

Archaeological Watching Brief Report

Oxford Archaeological Unit

December 1996

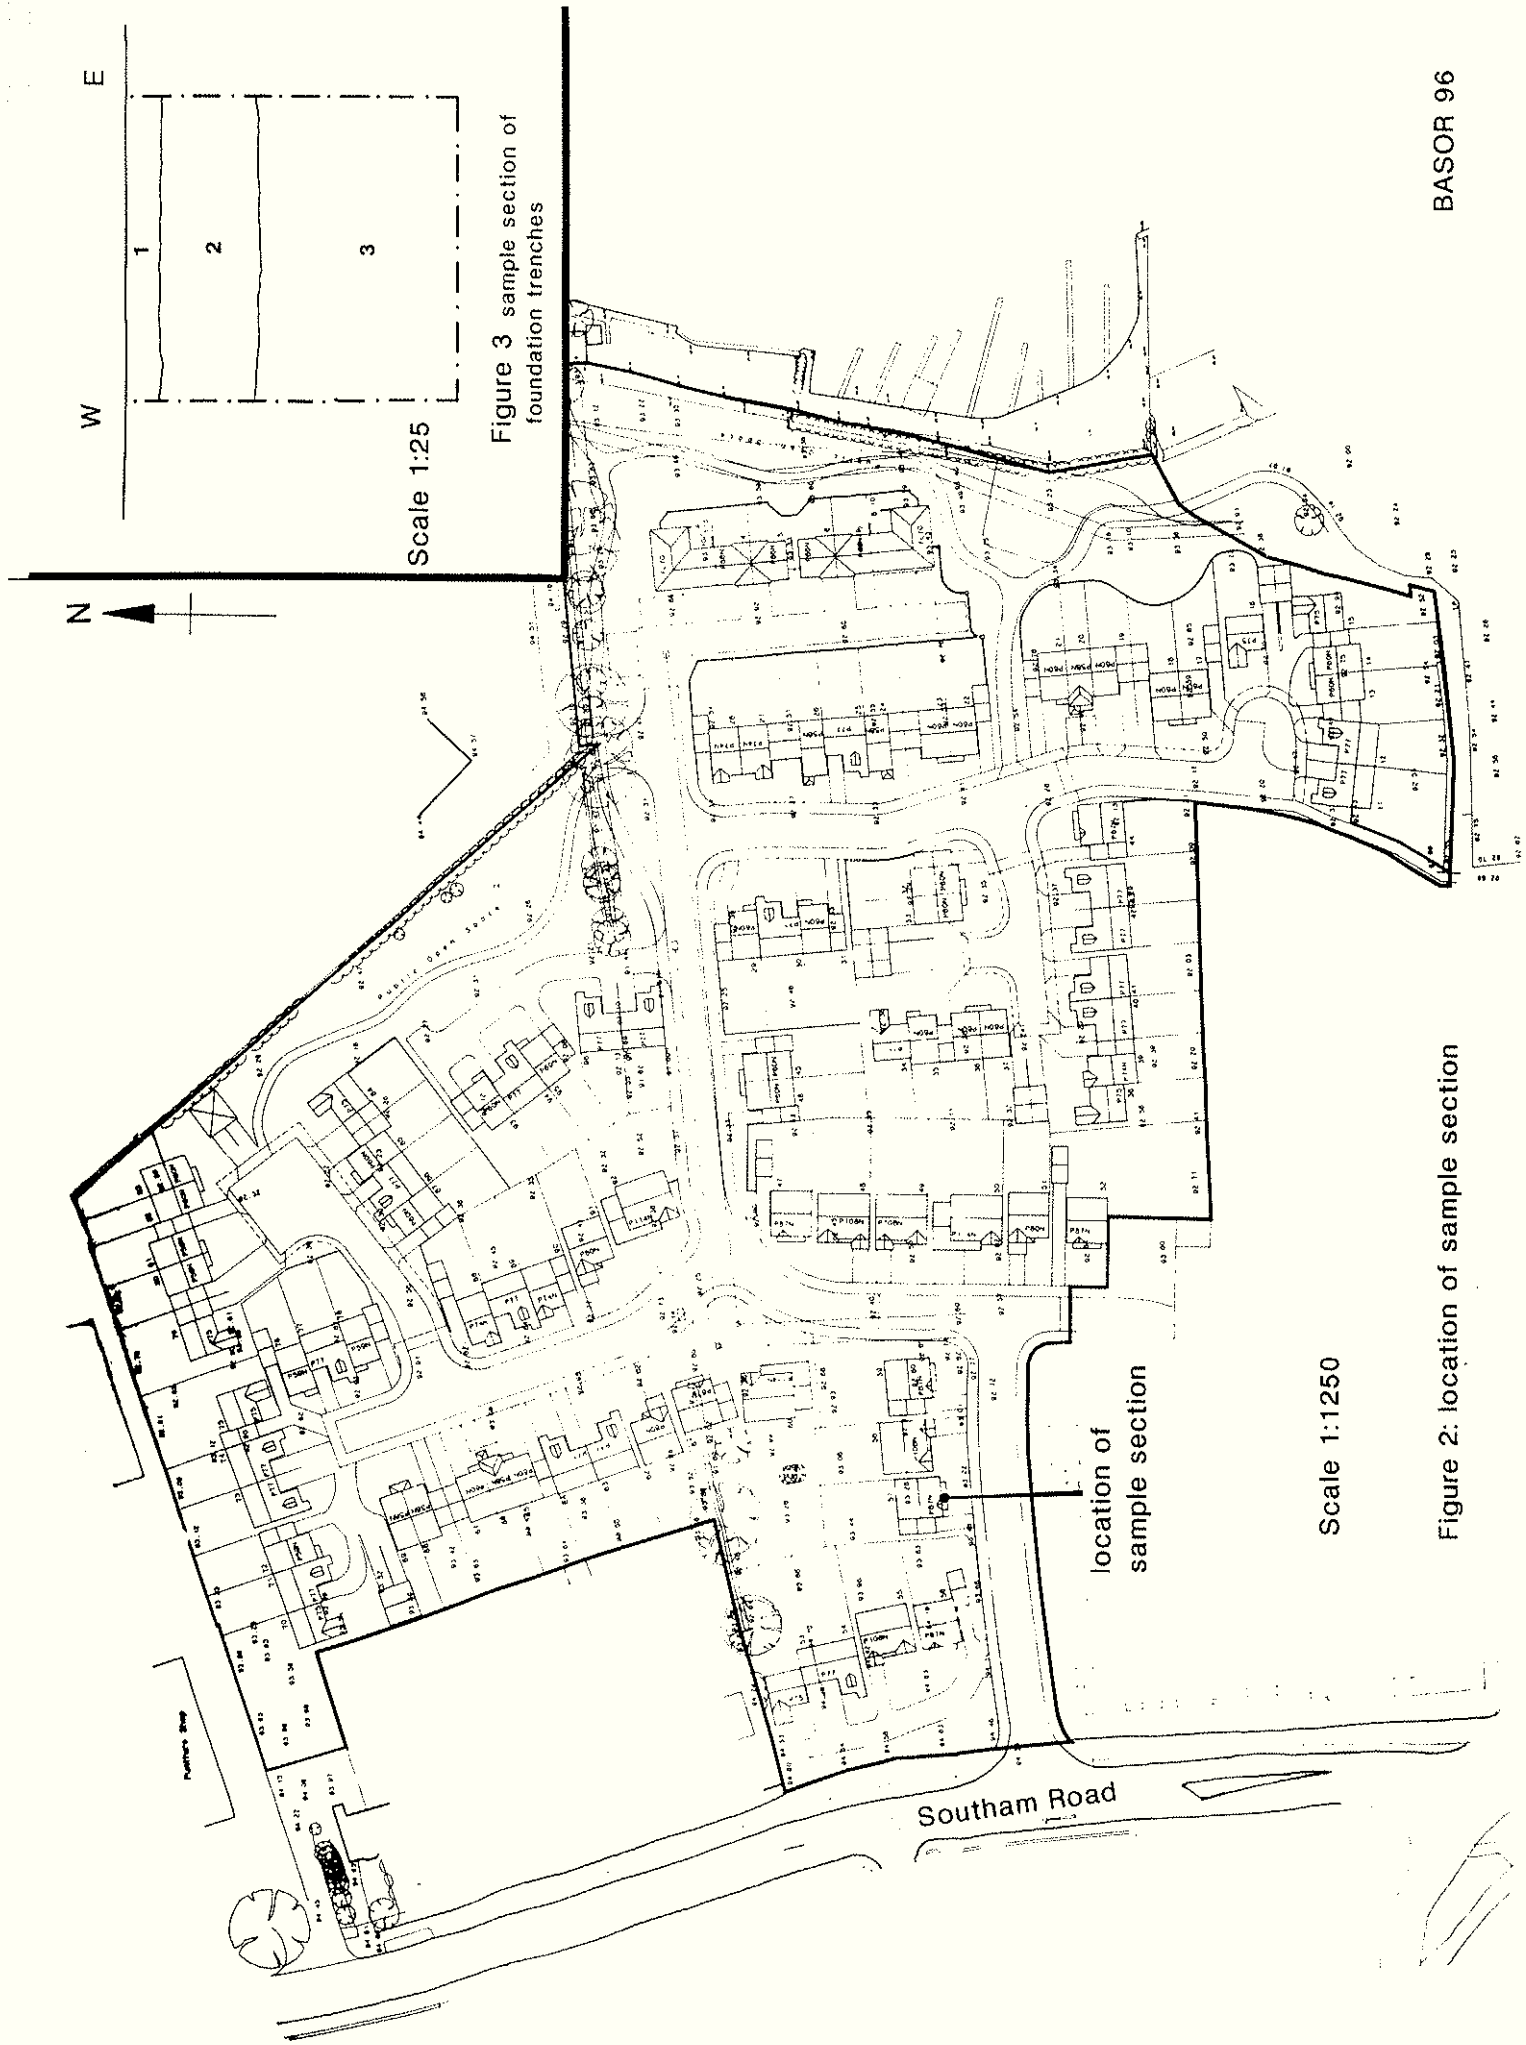
Figure 2: location of sample section

location of
sample section

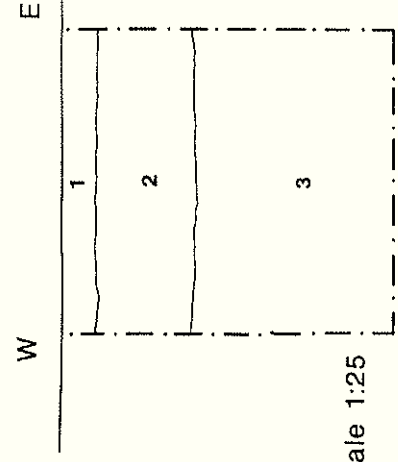
Figure 3 sample section of
foundation trenches

Except where localised disturbance was encountered, foundation trench sections revealed a consistent profile. This was recorded formally at the western end of the site; the sequence of deposits to the east was seen to be similar and therefore, in the complete absence of any archaeological features, was not recorded in detail there. The earliest deposit revealed in the foundation trenches was a layer (3) of light brown sandy clay which was 0.8 m+ thick. This layer was interpreted as the natural clay. At the western end of the site and in places elsewhere this deposit was no more than 0.40 m below the machine stripped surface of the site. Above layer 3, and observed consistently across the site, was a layer of mid-dark grey-brown sandy loam (2). This layer contained occasional modern brick and flower pot fragments, but no earlier artefacts. The layer was generally 0.3 m thick. Layer 2 was sealed by the remnant of a layer of modern topsoil (1), which contained substantial quantities of brick, glass and flower pot fragments. None of these finds were retained. The water table was reached at a depth of 0.5 m in many of the foundation trenches, and ground conditions throughout much of the course of the Watching Brief were damp underfoot. At the level of the topsoil on the northern side of the site were the foundations of several greenhouses relating to the nursery. Against

Context	Type	Depth	Comments
1	Layer	0.1 m	Topsoil and building site debris
2	Layer	0.3 m	General mixed soil horizon
3	Layer	0.8 m+	Natural clay
