# **Aldsworth Manor, Aldsworth Manor, Aldsworth, Gloucestershire**

## **Archaeological Watching Brief Report**

**November 2022**

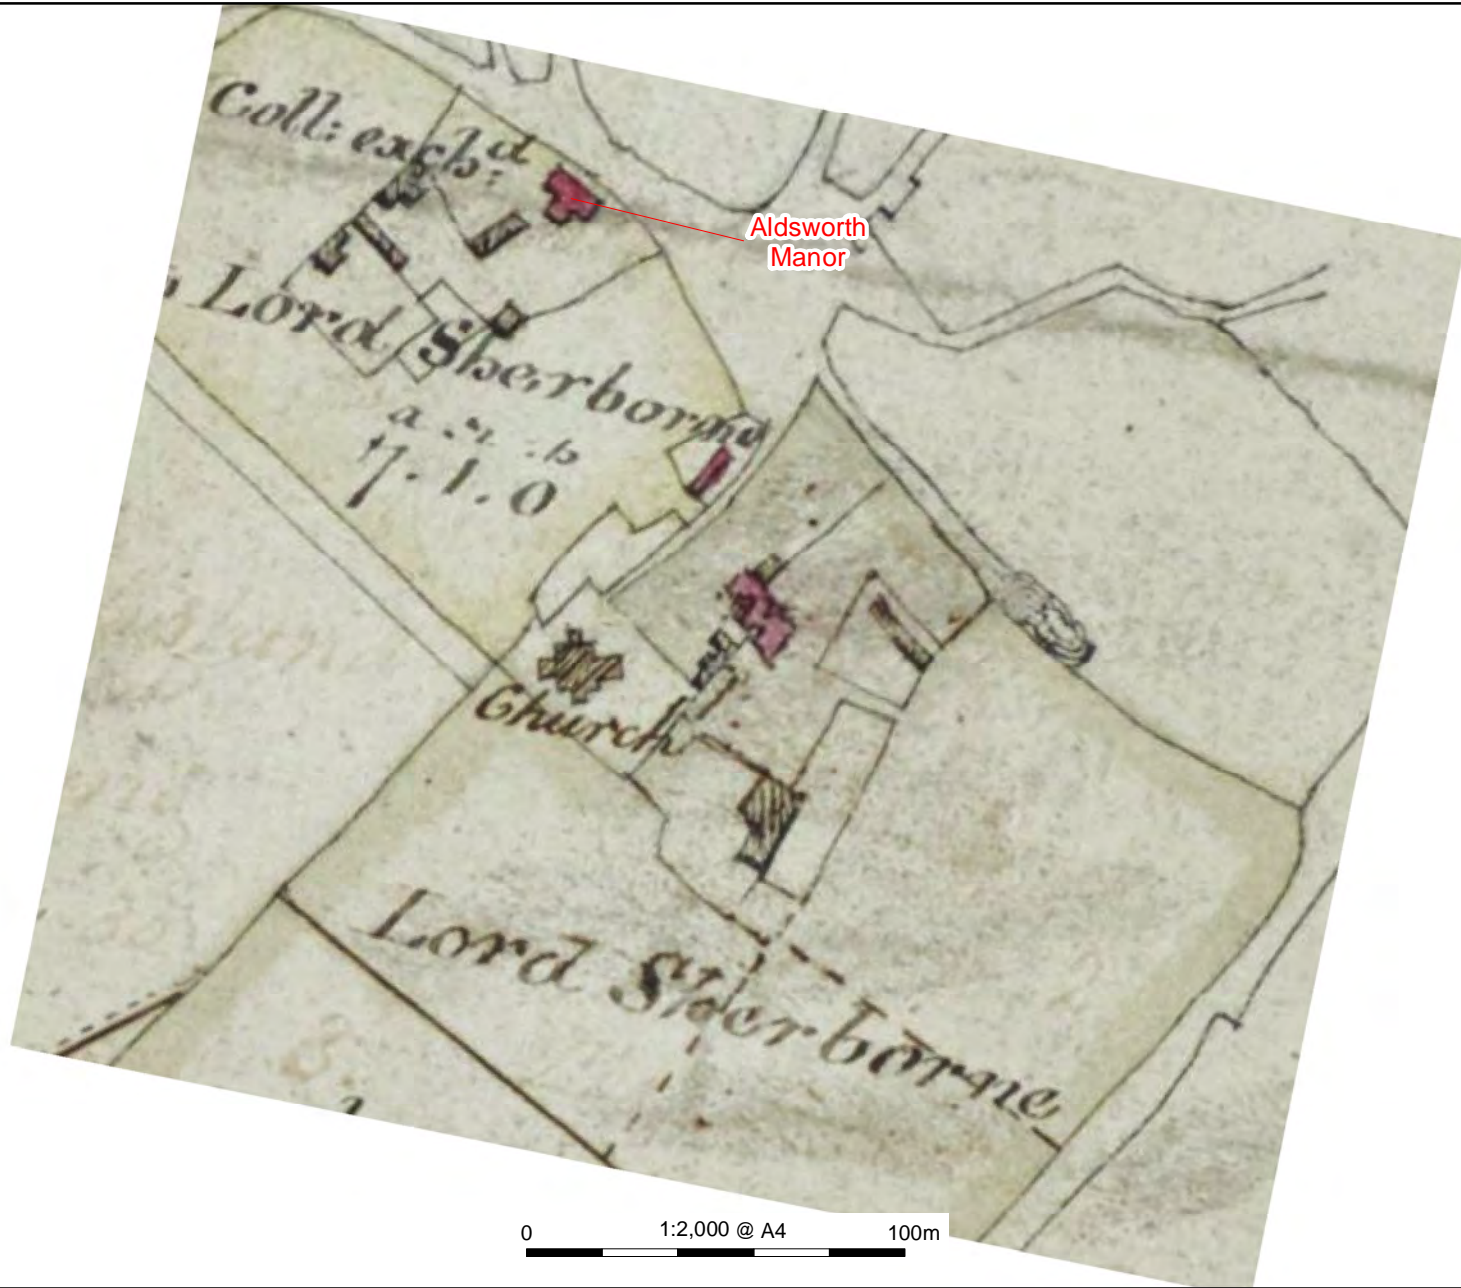
Figure 3: 1799 Enclosure Map, Christ Church Archives

- 2.3.1 The Aldsworth Enclosure Map dating to 1799 shows a building on the site of Aldsworth Manor that is difficult to make out but appears to be L-shaped in plan (figure 3). This may be an error in the map but may also represent structures built onto the current house that no longer exist. To the rear of the building on the west side is a structure that may be what is now the north garage on the terrace over the house.

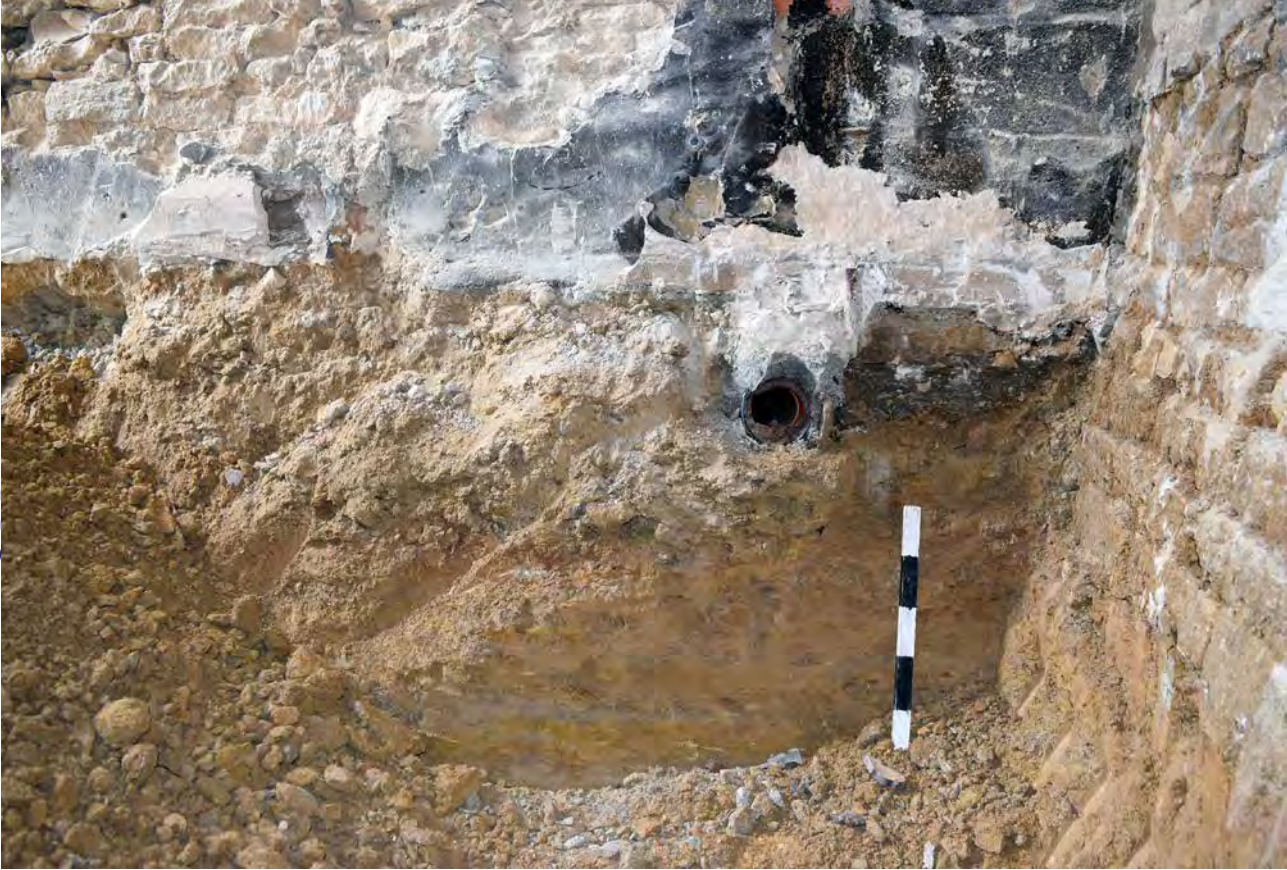
Plate 1: Section 1

3.3.4 Section 1 is located in the south-west part of the room and contains a 20<sup>th</sup> century wall with a concrete foundation. The foundation is truncated by a modern construction cut for water pipe. The wall abuts the primary wall of the staircase and the foundation overlies natural the geology of light yellow clay (plates 1 and 7).

Section 1						
General description					View	SW
Section devoid of archaeology. Contained one modern construction cut for pipe which truncates modern foundation. Consists of wall and foundation overlying natural geology of light and dark yellow clay.					Width (m)	3.50
					Avg. depth (m)	0.55
Context No.	Type	Width (m)	Depth (m)	Description	Finds	Date
1	Structure	3.50	-	South-west exterior wall of back hall	-	20 <sup>th</sup> c
2	Fill	0.25	0.15	Dark grey concrete- fill of construction cut	-	20 <sup>th</sup> c
3	Structure	0.12	0.13	Pipe	-	20 <sup>th</sup> c
4	Cut	0.25	0.28	Construction cut for pipe	-	20 <sup>th</sup> c
5	Layer	> 3.50	0.13	Dark grey concrete- foundation part	-	20 <sup>th</sup> c
6	Layer	> 3.50	0.12	Light grey concrete- foundation part	-	20 <sup>th</sup> c
7	Layer	> 3.50	0.11	Dark grey concrete with pebbles poor sorted- foundation part	-	20 <sup>th</sup> c
8	Layer	> 3.50	0.12	fine grained sediment soft, dark greyish yellow, sandy clay- levelling layer	-	20 <sup>th</sup> c

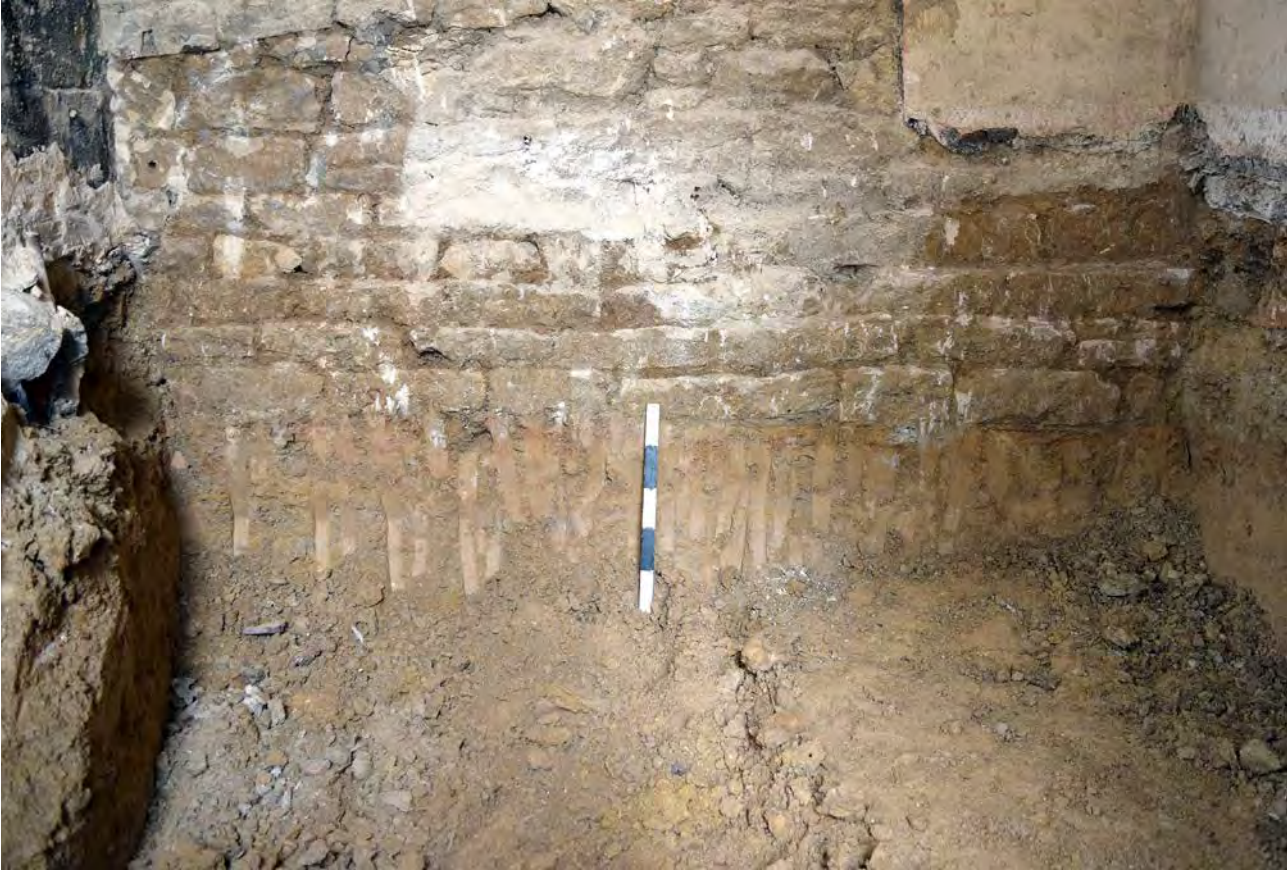
Plate 2: Section 2

3.3.6 Section 2 is exposed in the north-west part of the back hall and is located under the south-east wall of the staircase. This profile consists of the 19<sup>th</sup>-century wall of the staircase and its foundation, made of 4 rows of rough hewn stones. This foundation is the deepest among all of the walls of the room, i.e., at a depth of 0.55 m below the ground level. Additionally, the foundation base extends from the wall line at 0.30 m and its top is level with the wall line. The foundation overlies the natural geology of dark yellow clay (plates 2, 7, and 8).

Section 2						
General description					View	NW
Section devoid of archaeology. Consists of wall and foundation overlying natural geology of dark-yellow clay.					Width (m)	2.50
					Avg. depth (m)	0.55
Context No.	Type	Width (m)	Depth (m)	Description	Finds	Date
11	Structure	2.50	-	Nort- west primary wall of back hall	-	19 <sup>th</sup> c
12	Structure	2.50	0.55	Hewn stones- foundation	-	19 <sup>th</sup> c
10	Layer	> 2.50	> 0.35	fine grained sediment firm, dark yellow, sandy clay-natural	-	-

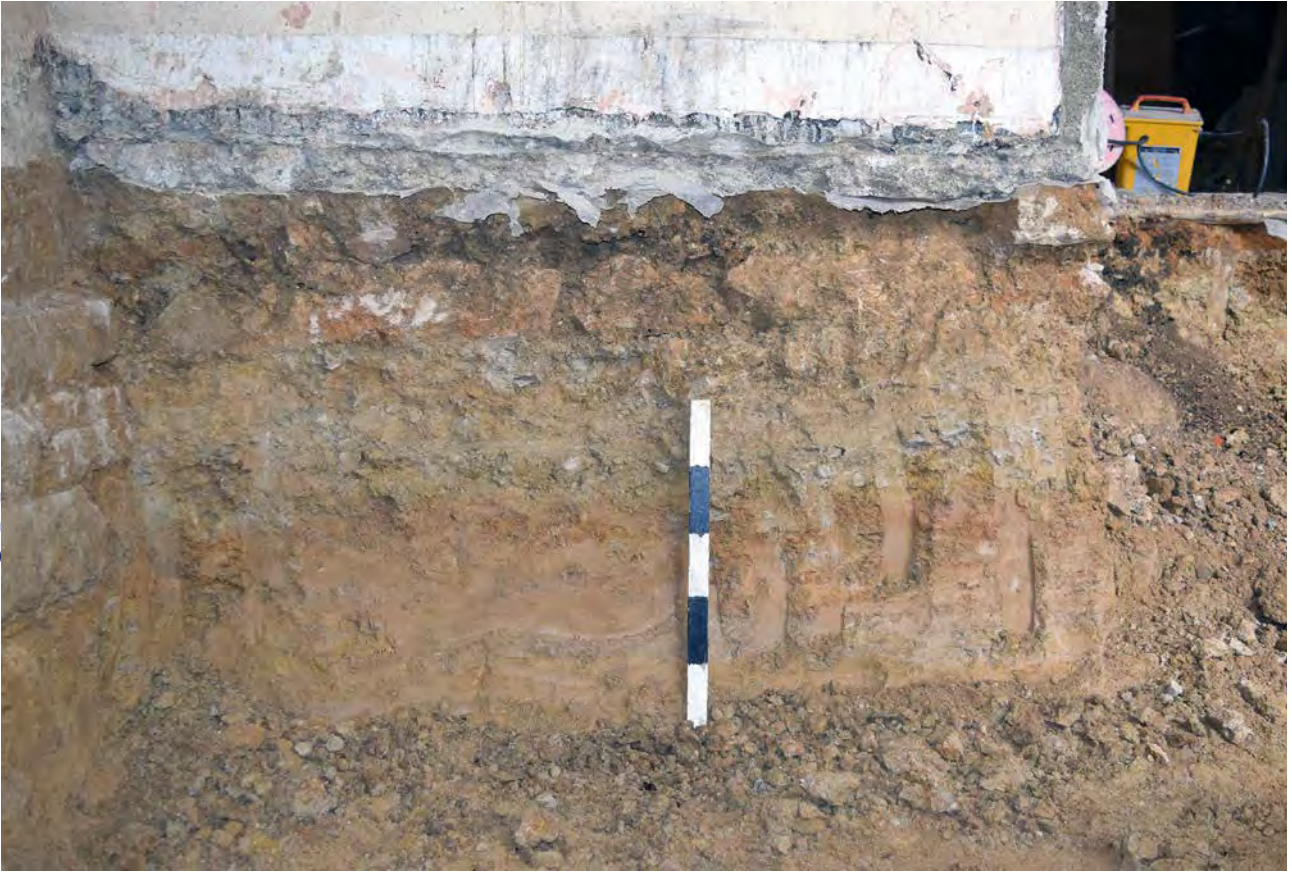
Plate 3: Section 3

3.3.8 Sections 3 and 4 are located in the north-east part of the room, under the same primary wall from the 17<sup>th</sup> century, but on two different sides: south-west and south-east. The foundation here is constructed of a single row of rough stones, 0.25 m thick. It is based on the natural layer of light yellow clay (plates 3, 4, and 8).

Section 3						
General description					View	NE
Section devoid of archaeology. Consists of wall and foundation overlying natural geology of light and dark yellow clay.					Width (m)	1.50
					Avg. depth (m)	0.50
Context No.	Type	Width (m)	Depth (m)	Description	Finds	Date
13	Structure	1.50	-	Nort- east primary wall of back hall	-	17 <sup>th</sup> c
14	Structure	1.50	0.25	Rough stones- foundation	-	17 <sup>th</sup> c
9	Layer	> 1.50	0.25	fine grained sediment soft, light yellow, sandy clay-natural	-	-
10	Layer	> 1.50	> 0.40	fine grained sediment firm, dark yellow, sandy clay-natural	-	-

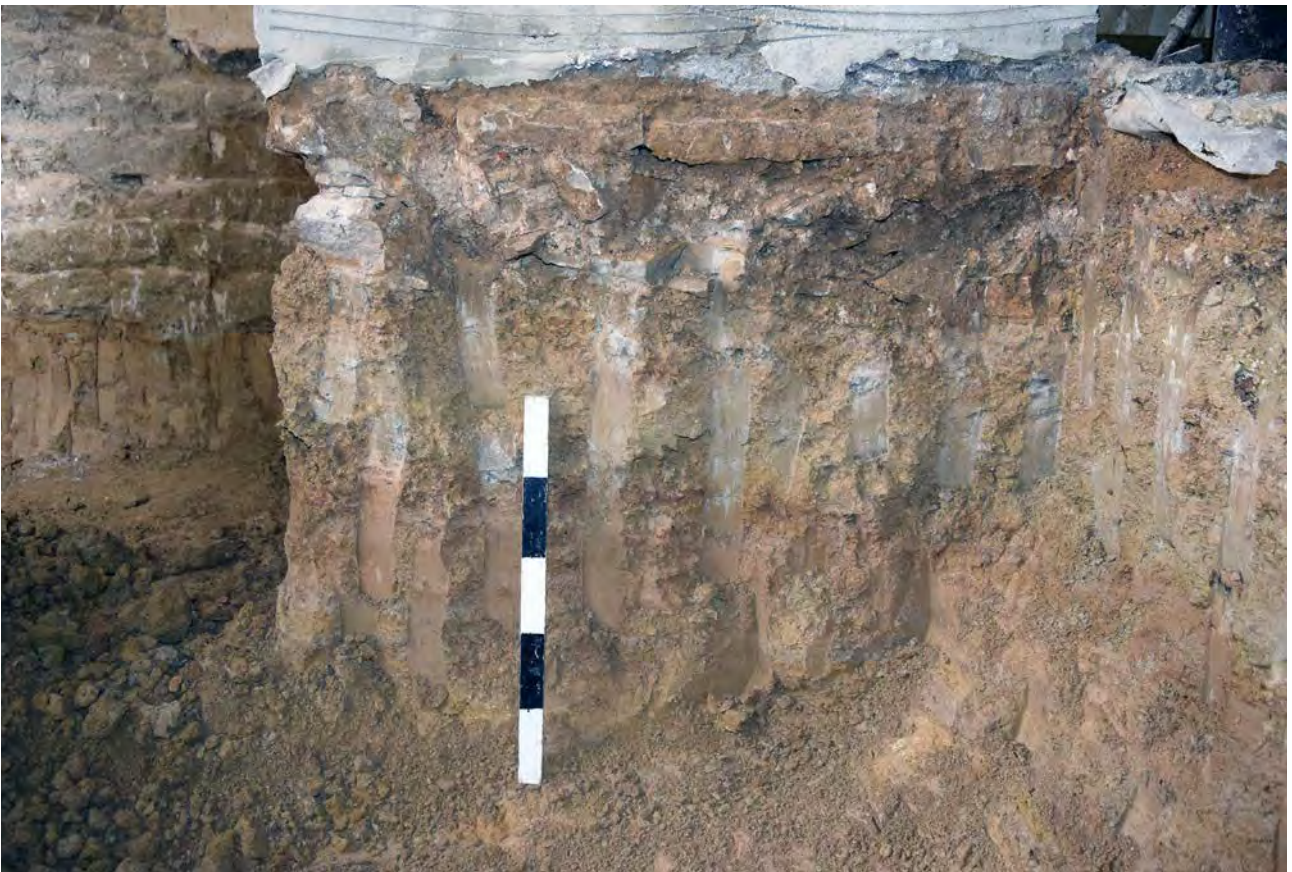
Plate 4: Section 4

Section 4						
General description					View	NW
Section devoid of archaeology. Consists of wall and foundation overlying natural geology of light and dark yellow clay.					Width (m)	1.00
					Avg. depth (m)	0.50
Context No.	Type	Width (m)	Depth (m)	Description	Finds	Date
13	Structure	1.00		Nort- east primary wall of back hall, NW view	-	17 <sup>th</sup> c
14	Structure	1.00	0.25	Rough stones- foundation	-	17 <sup>th</sup> c
9	Layer	> 1.00	0.25	fine grained sediment soft, light yellow, sandy clay-natural	-	-
10	Layer	> 1.00	> 0.40	fine grained sediment firm, dark yellow, sandy clay-natural	-	-

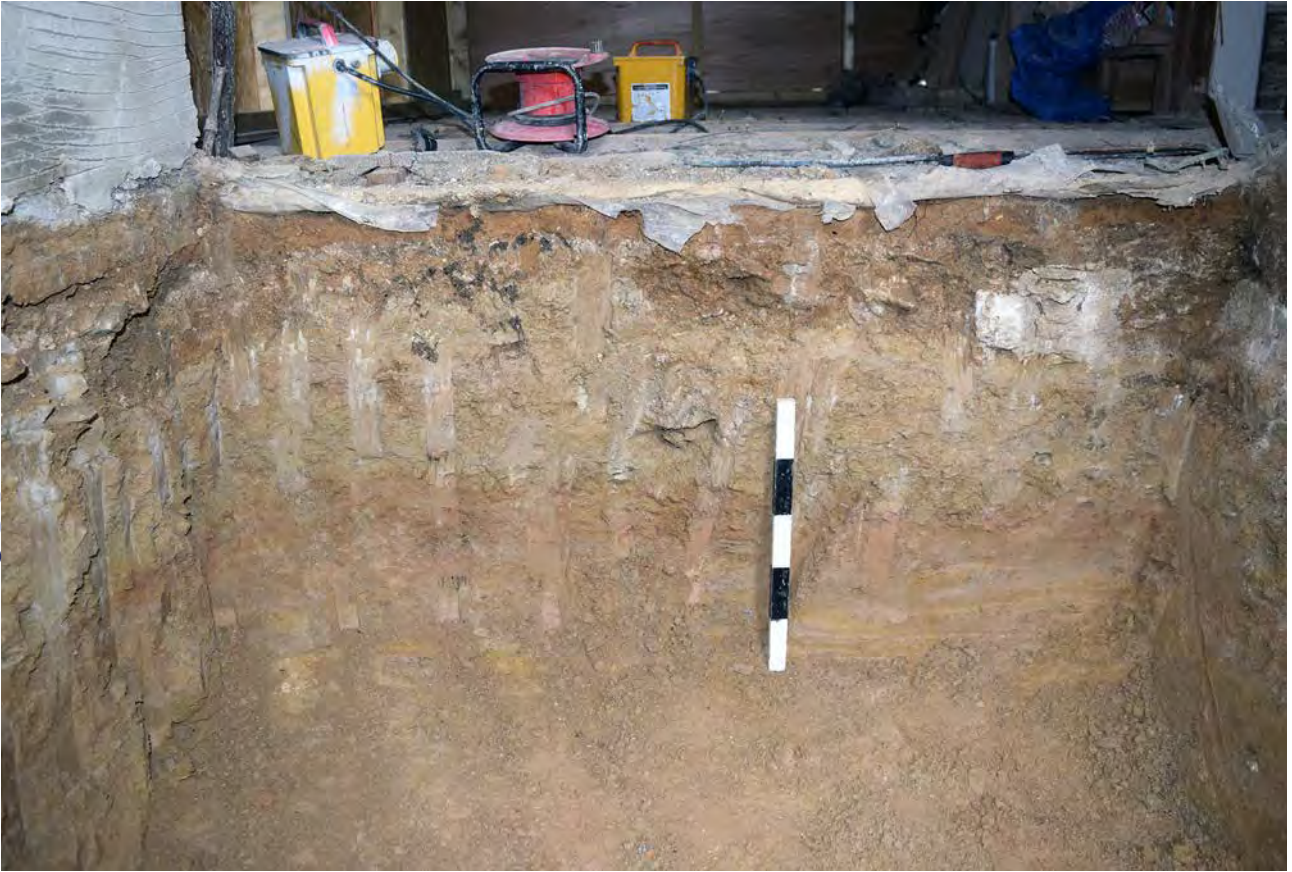
Plate 5: Section 5

3.3.10 Section 5 is at the entrance to the reception hall. No foundations have been found here. This section consists only of a concrete floor layer from the 20<sup>th</sup> century, which is placed on two levelling layers. These layers in turn cover the natural layer of light yellow clay (plates 5, 8 and 9).

Section 5						
General description					View	NE
Section devoid of archaeology. Consists of concrete floor and leveling layers overlying natural geology of light and dark yellow clay.					Width (m)	1.50
					Avg. depth (m)	0.50
Context No.	Type	Width (m)	Depth (m)	Description	Finds	Date
15	Surface	> 1.50	0.03	Concrete floor	-	20 <sup>th</sup> c
16	Layer	> 1.50	0.05	fine grained sediment soft, dark yellow, sandy clay with pebbles poor sorted-levelling layer under concrete	-	20 <sup>th</sup> c
17	Layer	> 1.50	0.17	fine graine sediment firm, dark yellow, sandy clay with stones poor sorted-levelling layer	-	20 <sup>th</sup> c
9	Layer	> 1.50	0.25	fine grained sediment soft, light yellow, sandy clay-natural	-	-
10	Layer	> 1.50	> 0.40	fine grained sediment firm, dark yellow, sandy clay-natural	-	-

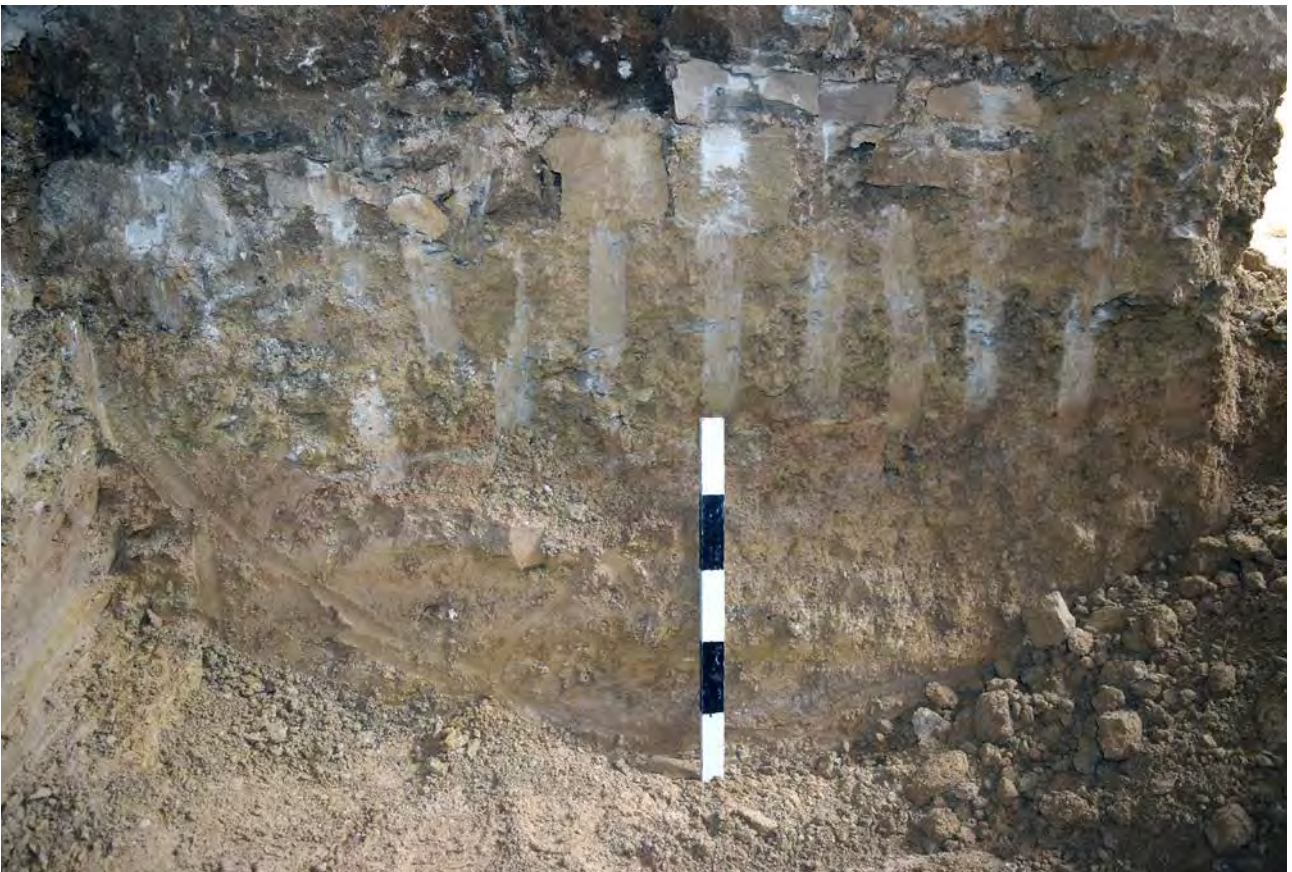
Plate 6: Section 6

3.3.12 Section 6, similarly to sections 4 and 5, is located in the northeast part of the back hall, under the primary wall from the 17<sup>th</sup> century. Below it there is one row of hewn stones 0.22 m thick - the foundation. The stones rest on the natural geology of light yellow clay (plates 6 and 9).

Section 6						
General description					View	SE
Section devoid of archaeology. Consists of wall and foundation overlying natural geology of light and dark yellow clay.					Width (m)	1.30
					Avg. depth (m)	0.50
Context No.	Type	Width (m)	Depth (m)	Description	Finds	Date
13	Structure	1.30		Nort- east primary wall of back hall, SE view	-	17 <sup>th</sup> c
18	Structure	1.30	0.22	Hewn stones- foundation	-	17 <sup>th</sup> c
9	Layer	> 1.30	0.25	fine grained sediment soft, light yellow, sandy clay-natural	-	-
10	Layer	> 1.30	> 0.43	fine grained sediment firm, dark yellow, sandy clay-natural	-	-
