The Turl Bar Turl Street Oxford

**Historic Buildings Investigation
and Recording**

Client Name: Lincoln College
Document Title: The Turl Bar, The Mitre Hotel, Oxford

Document Type: Historic Building Recording and Investigation
Issue Number: 1

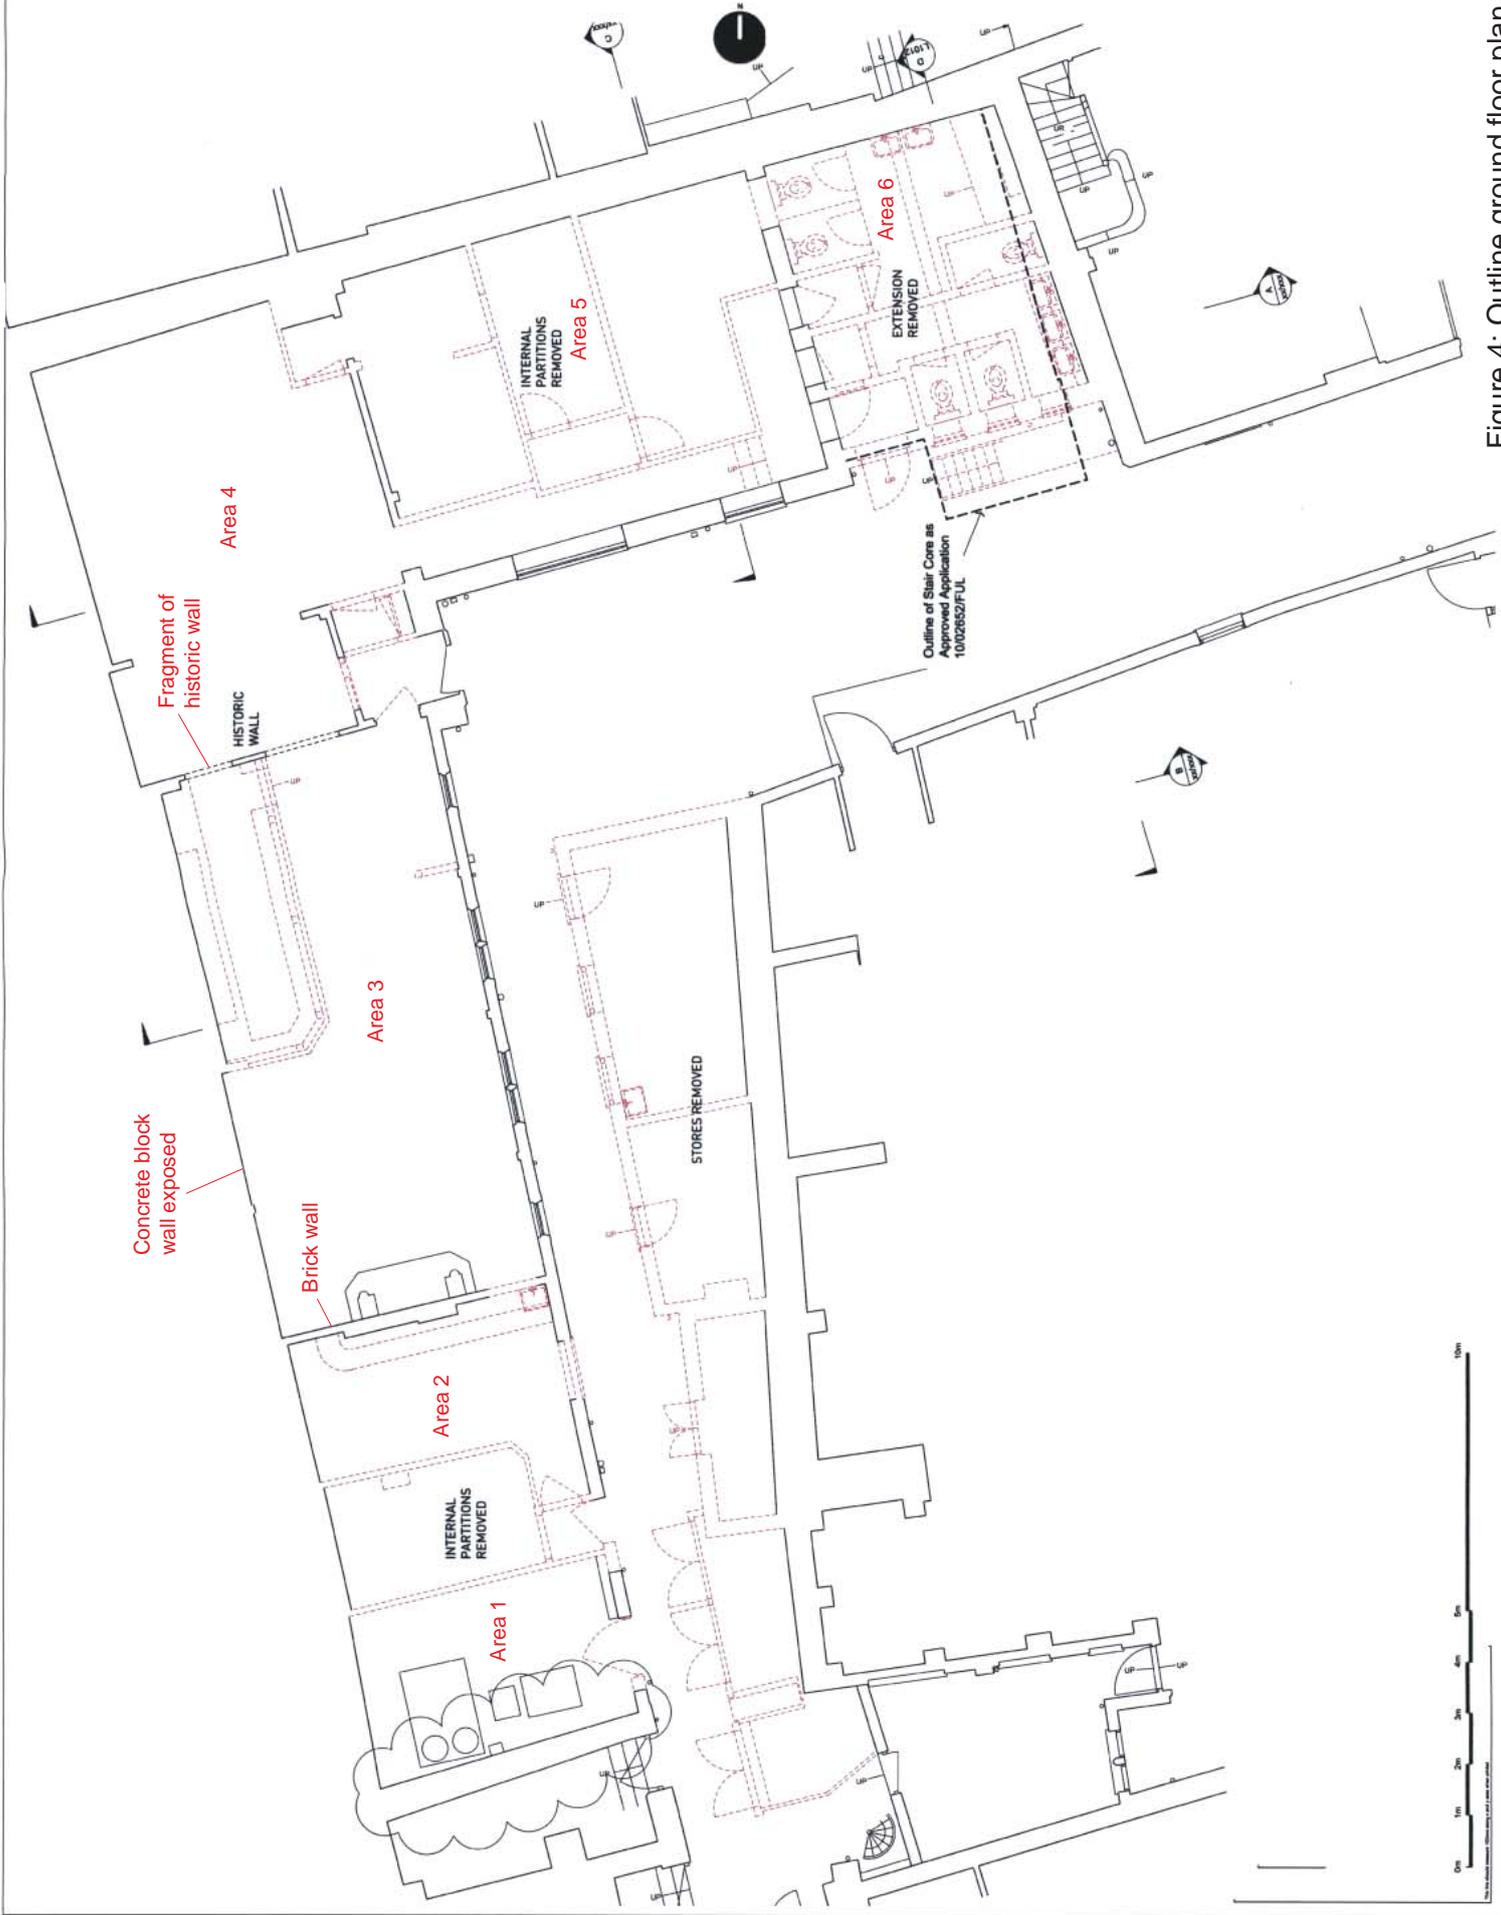
Figure 4: Outline ground floor plan of the Turf Bar

- 3.3.1 The ground floor of the main areas recorded divide into 6 rooms or areas.
- 3.3.2 **Area 1** (G18 in previous OA rep) is towards the southern end of the Turl Bar's west range and it is a room with a rough character and does not appear to have been much used in recent years (Pl.6). The north wall is of painted brick while the other walls are rendered. There are various exposed pipes, the frame from a storage rack and visible ceiling joists. Against the south wall there is a boiler.

This room inventory is taken from OA's 2009 assessment report on the wider Mitre Hotel complex. Refer to Figure 4 for ground floor room numbers

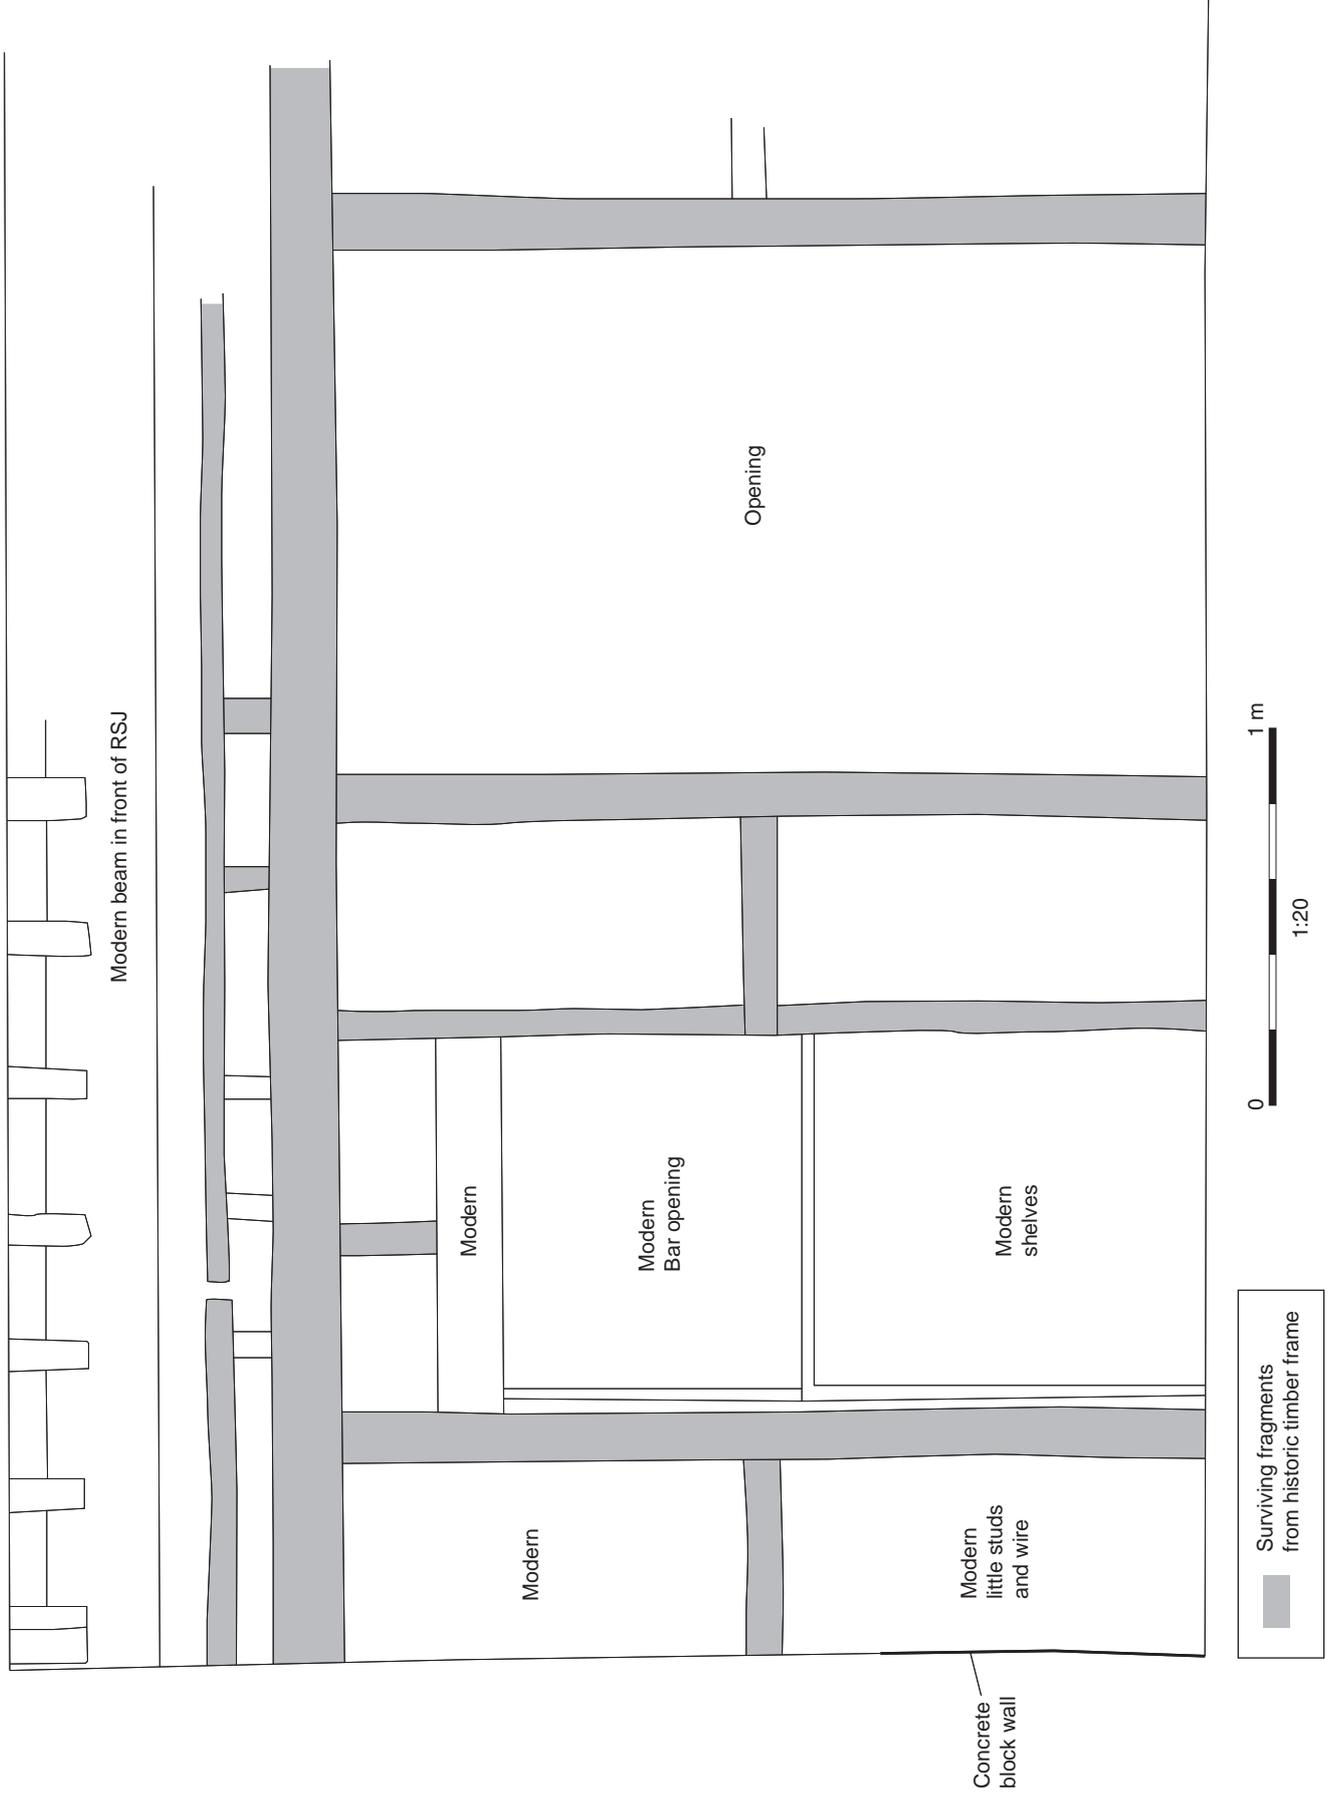
Figure 5: South Elevation of Historic Section of Wall

- 3.3.12 The frame comprises four studs, a main horizontal rail extending over the posts and two smaller mid height rails. Each of these members are old timbers and it appears that they form a surviving in-situ fragment from an historic timber framed wall rather than being an entirely rebuilt 20th-century wall re-using old timbers. The alignment of the wall is slightly different to that of the current 20th-century building and structurally the two are separate; an RSJ spans the building just above the older frame. The render is all modern and fixed onto wire mesh; no historic plaster survives. The condition/survival of the frame is poor with many areas cut to allow modern pipes/ducts to pass. The main studs are relatively slender (c.11 cm squ) and would have been part of a partition or wall frame rather than principal structural members.

- 3.3.13 *Interpretation:* Although the frame was partly obscured by the mesh it was possible to gain a reasonable understanding and the current work and strengthened the suggestion made in the 2009 assessment that the framing is probably of 17th or 18th-century date. The frame was carefully examined after the partial removal of modern plaster to determine whether it was an intact fragment of historic wall or a modern construction reusing old timbers and as stated above the evidence pointed towards it being a partially surviving historic relic. The framing is not of high quality work but it is jointed rather than nailed.

- 3.3.14 As detailed above in the historical background it is reported that the 1926 works incorporated a timber-framed relic of one of the original stable walls so presumably this frame is that structure (See Fig 5 and Plates 9-16). It is reported that the stables burnt down in 1726 so it may well be that wall post-dates that event.

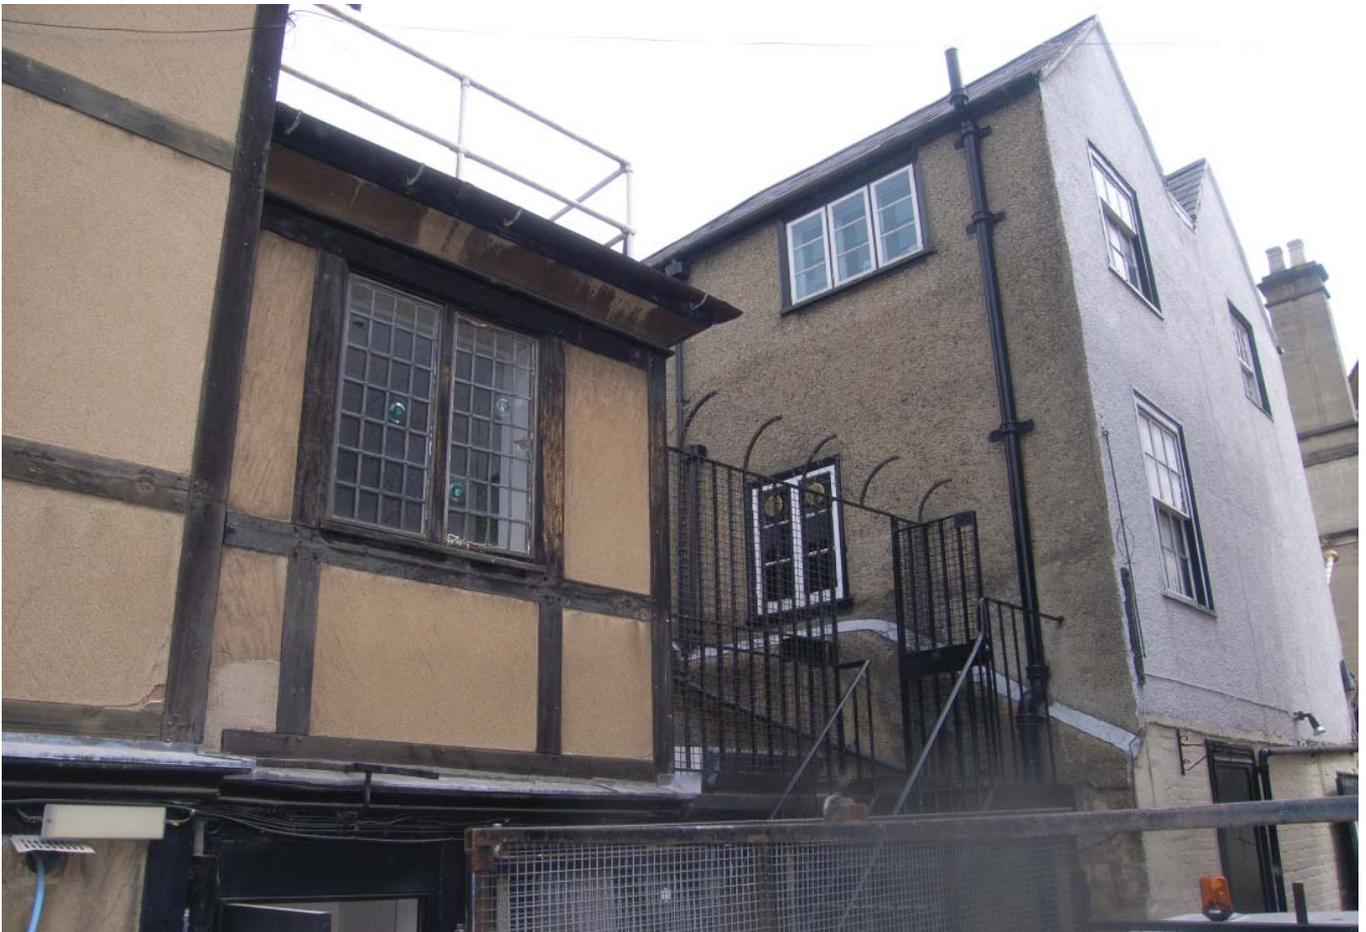
Plate 4: Eastern end of north range

- 3.3.7 **Area 6** is at the eastern end of the north range and houses the public WC's for the Turl Bar. This area is being removed in the current works to allow the construction of a new staircase (Pl.4).

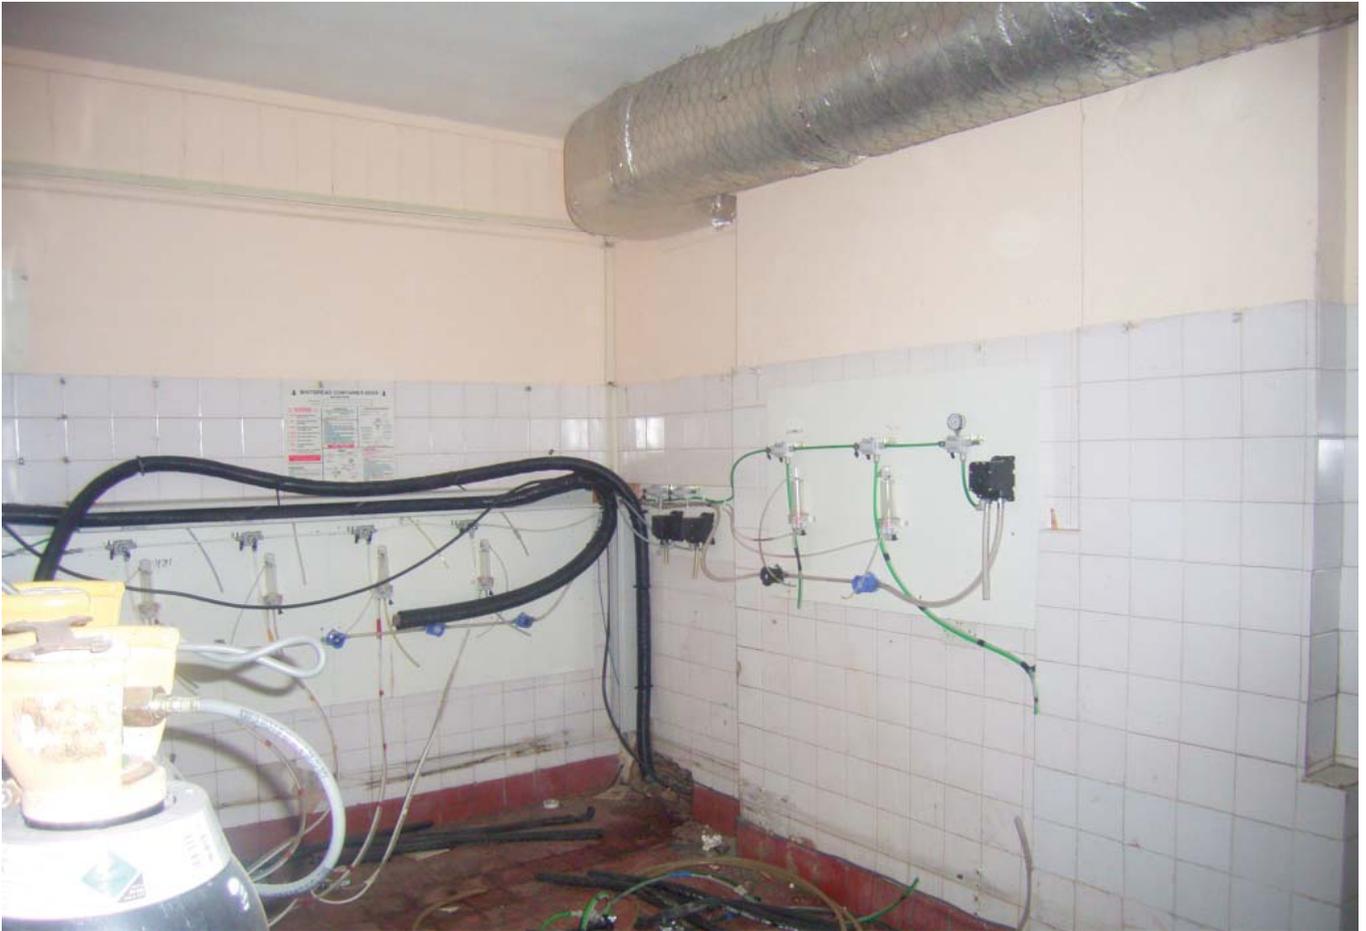
Plate 7: Area 2

- 3.3.3 **Area 2** (G17 in previous OA rep) includes two rooms accessible via a small lobby adjacent to the door in the east wall. These rooms appear to have remained in use until the recent closure of the bar (Pl.7). The larger room is to the east and it has tiled walls together with tubes and fittings which appear to be from former beer kegs. The smaller room has plastered ceilings and walls and it has light plant probably related to the kegs in the adjacent room.

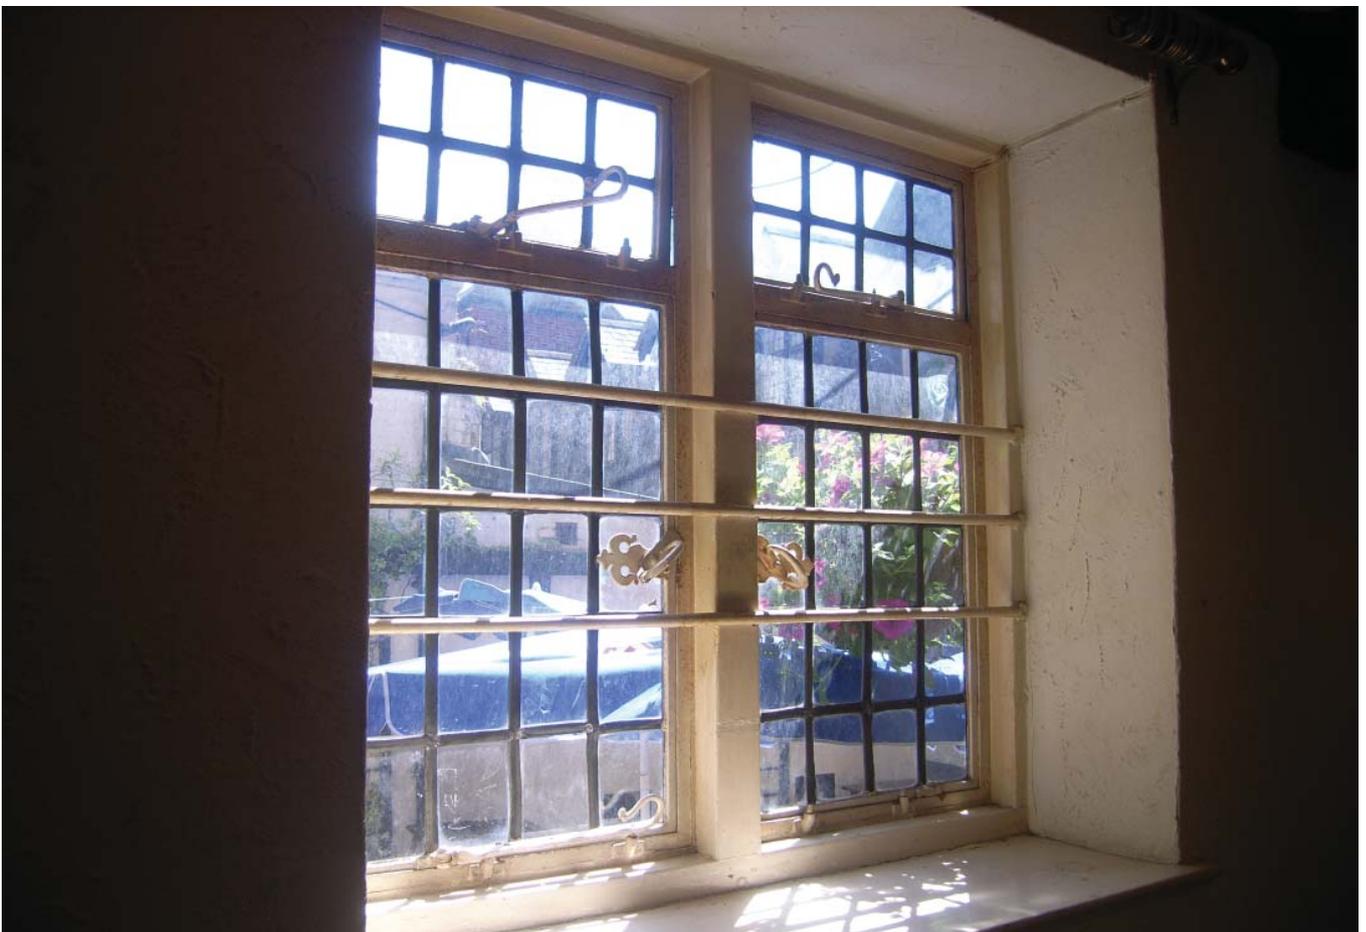
Plate 8: Window latches in North Range

- 3.2.3 The north block is clearly an imitation of historical timber-framing with pegged square framing and straight braces. The original fittings throughout the block are in an Arts and Crafts style being of good quality and with reference to historical examples these include the windows which have iron casements with leaded panes; some with bulls eyes, swan neck stays and shaped turnbuckle catches and the doors of three vertical panels with furniture consisting of upright iron handles and latches.

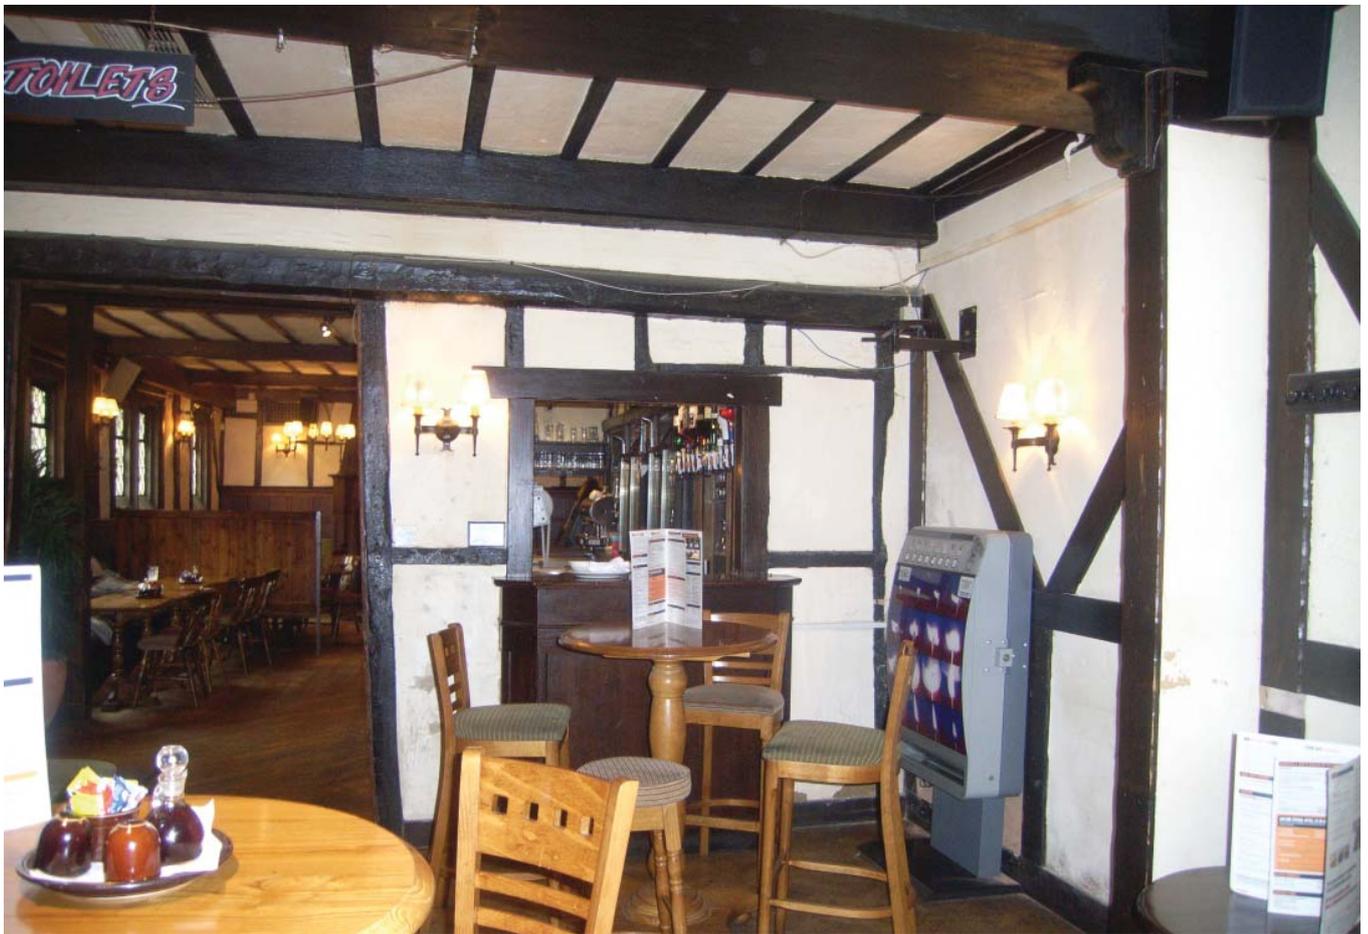
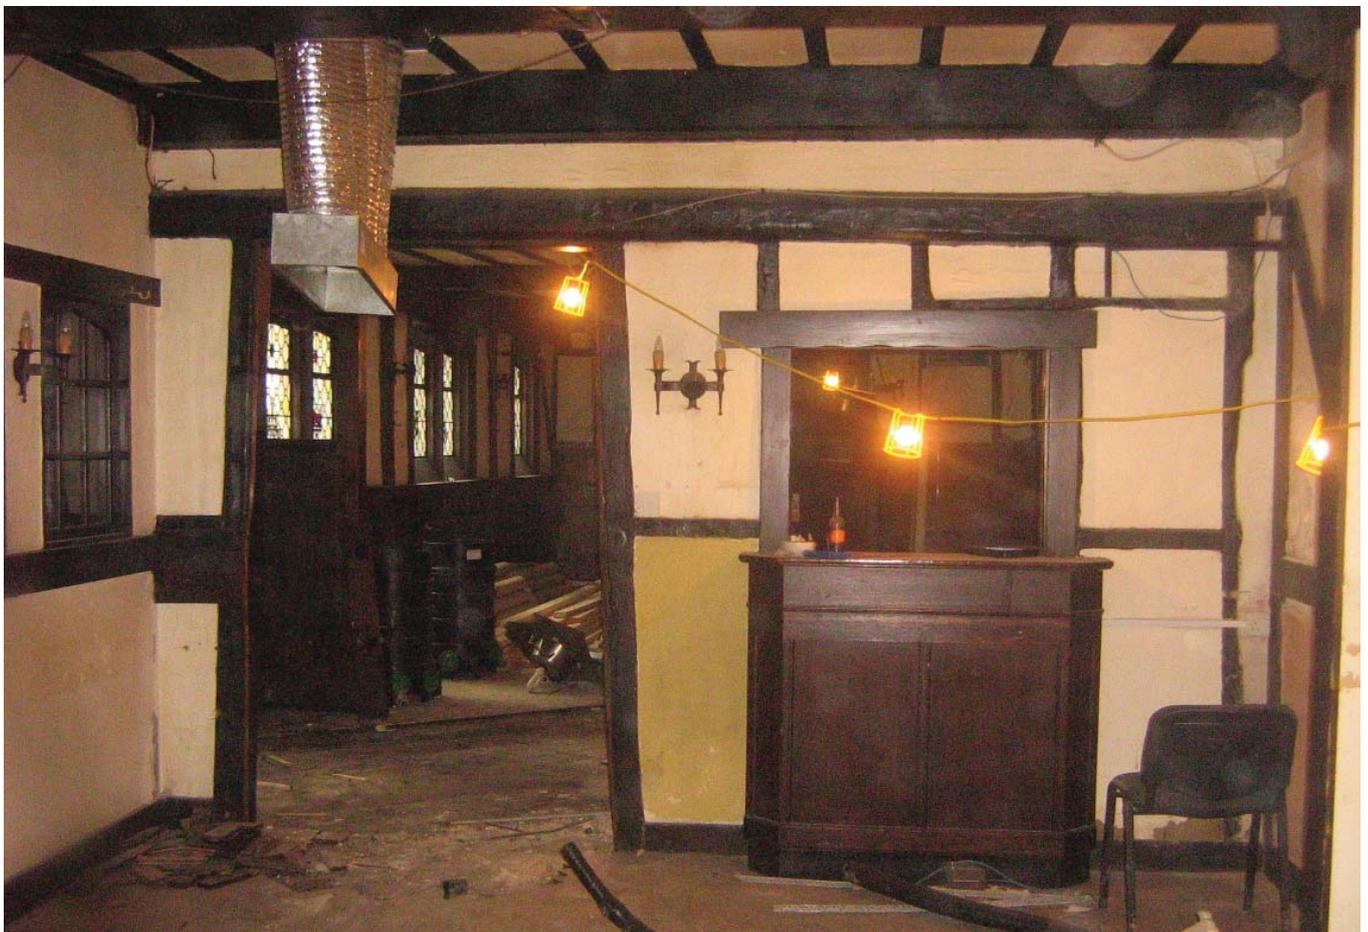
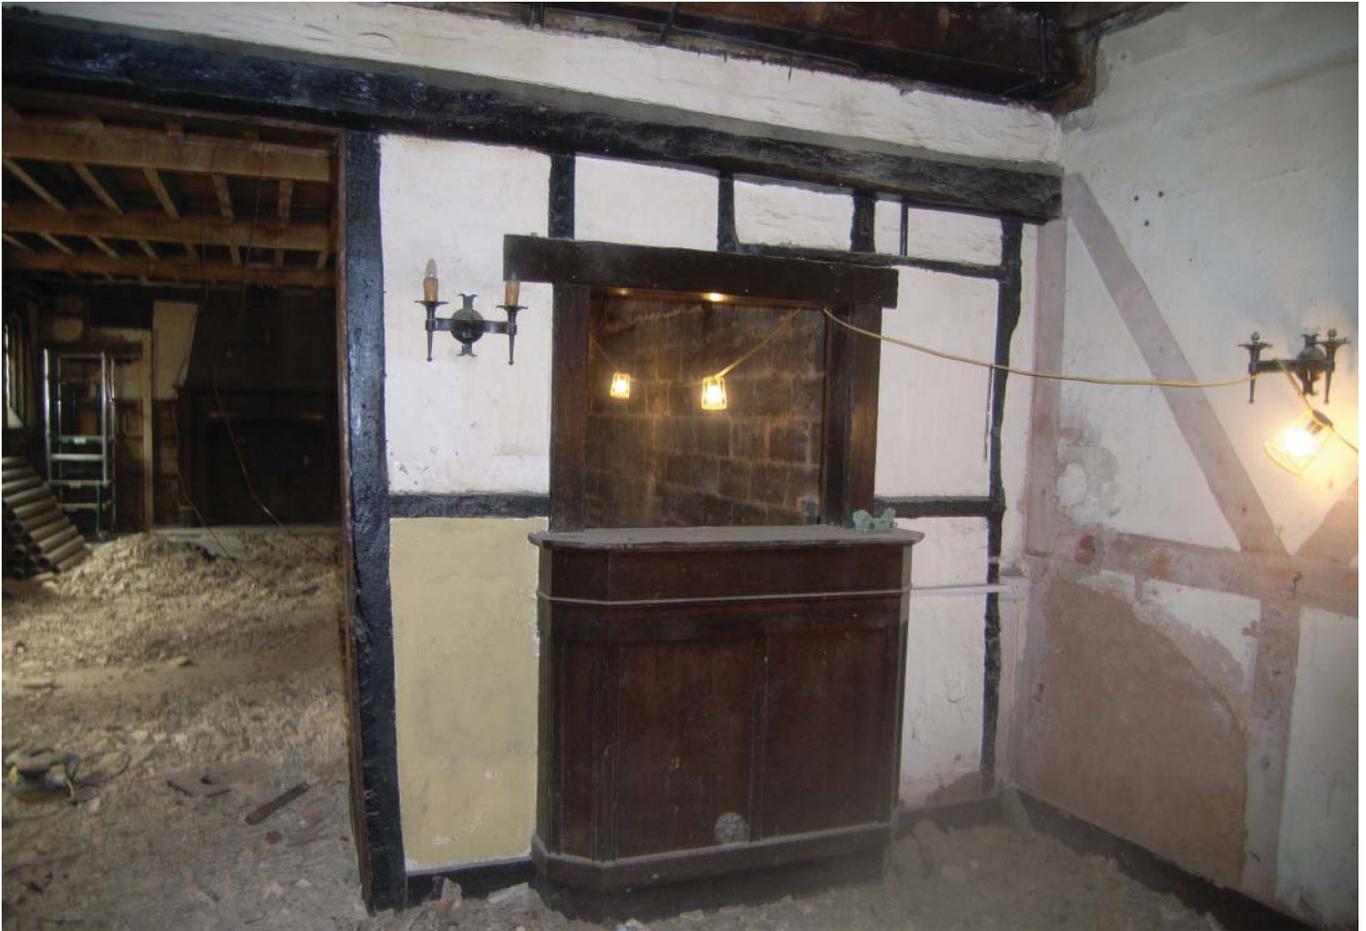
- 3.3.10 *Description:* The partition is orientated east to west and is located towards the northern end of the Turl Bar's southern range, adjacent to the main entrance into the building. It has been incorporated into a small modern bar servery with a hatch opening between the northern and southern rooms (Areas 3 and 4).

Plate 9: Interior looking south showing fragment of historic wall (taken in 2009)

Plate 10: Interior looking south at start of current work

Plate 11: Fragment of historic wall

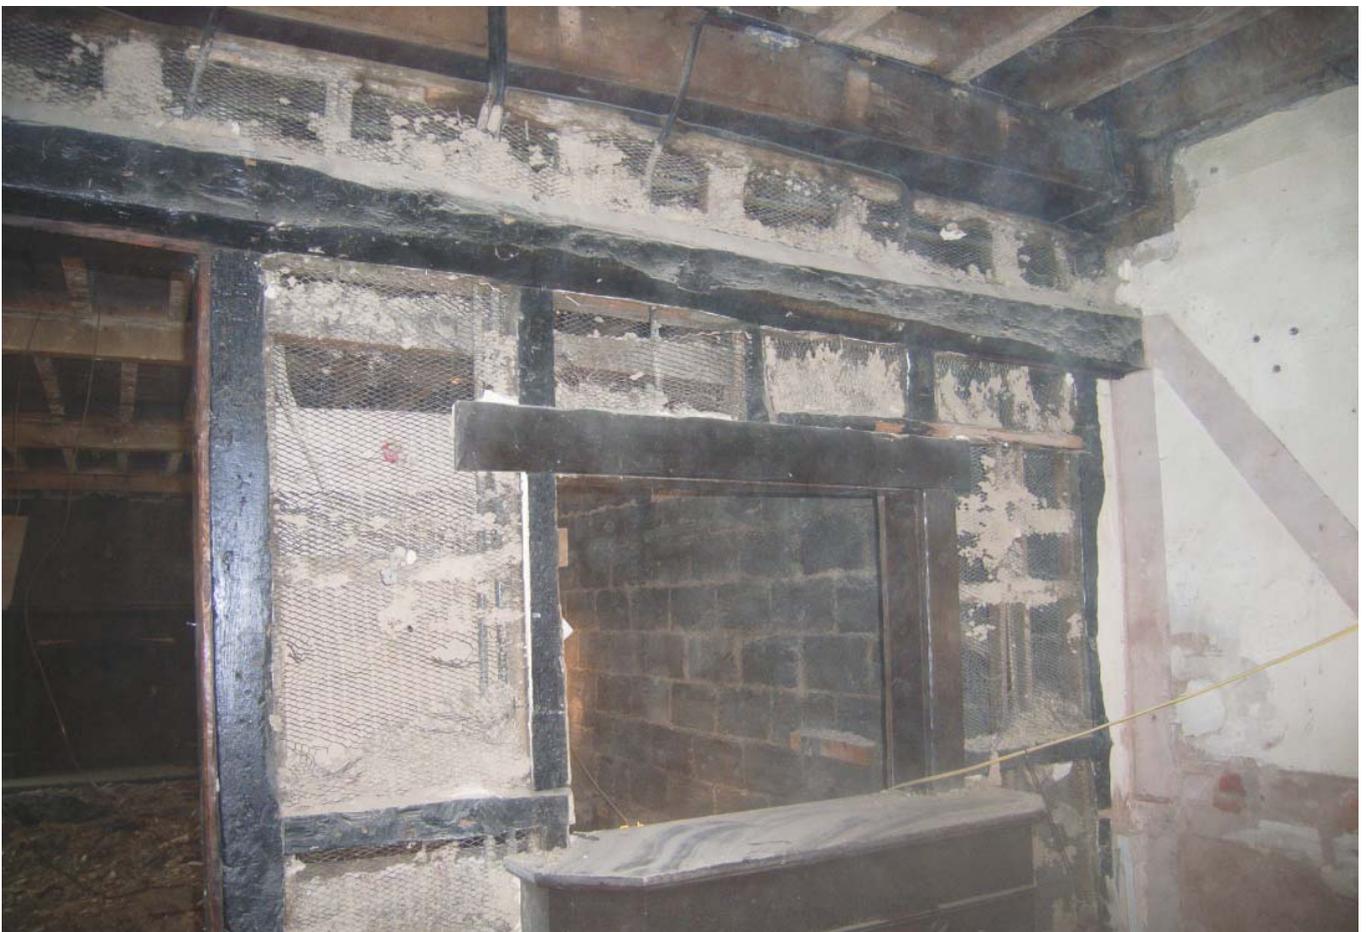
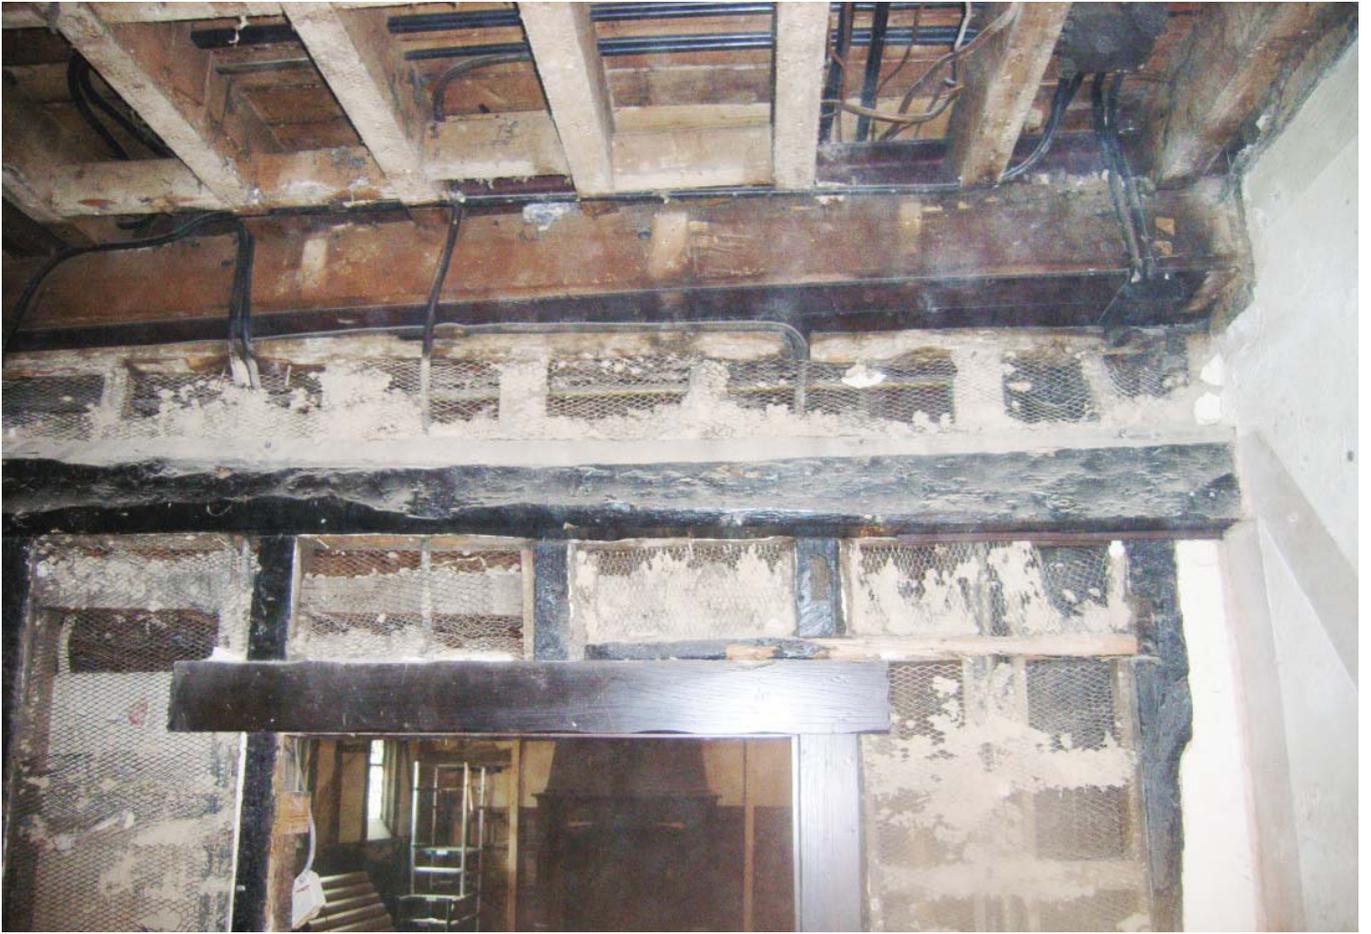
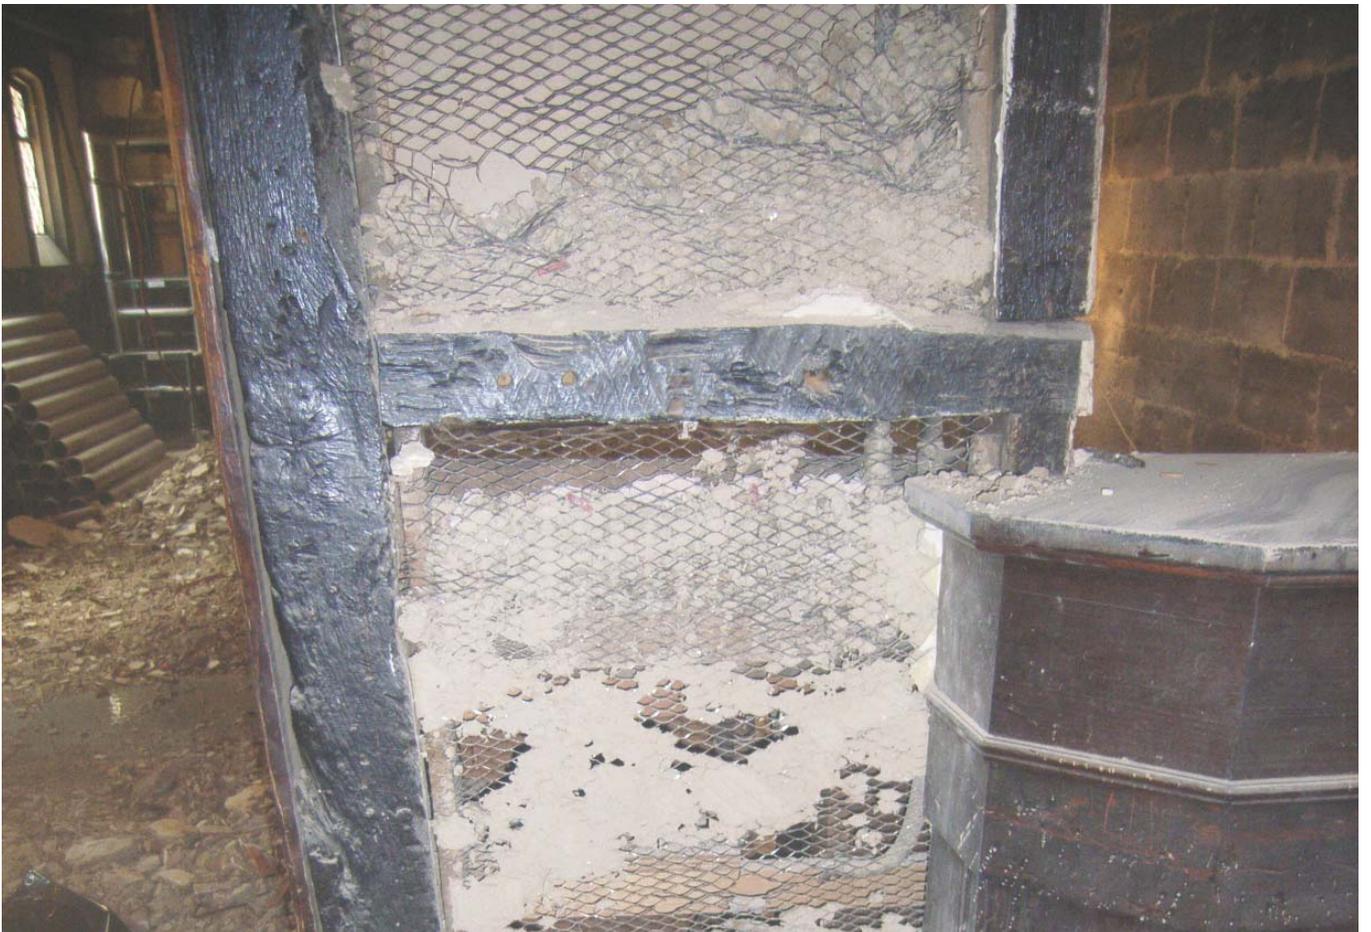
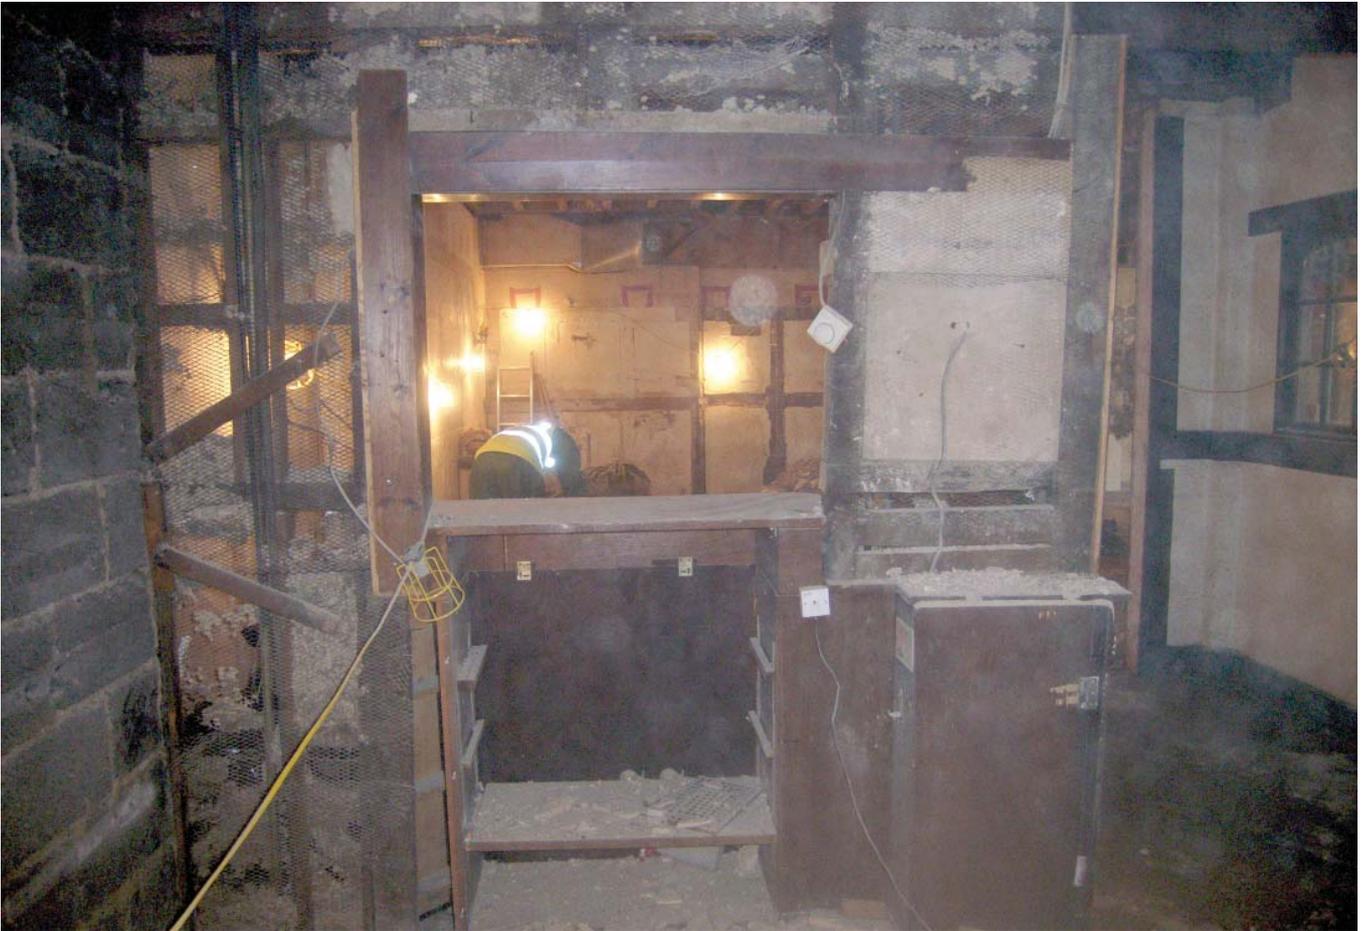
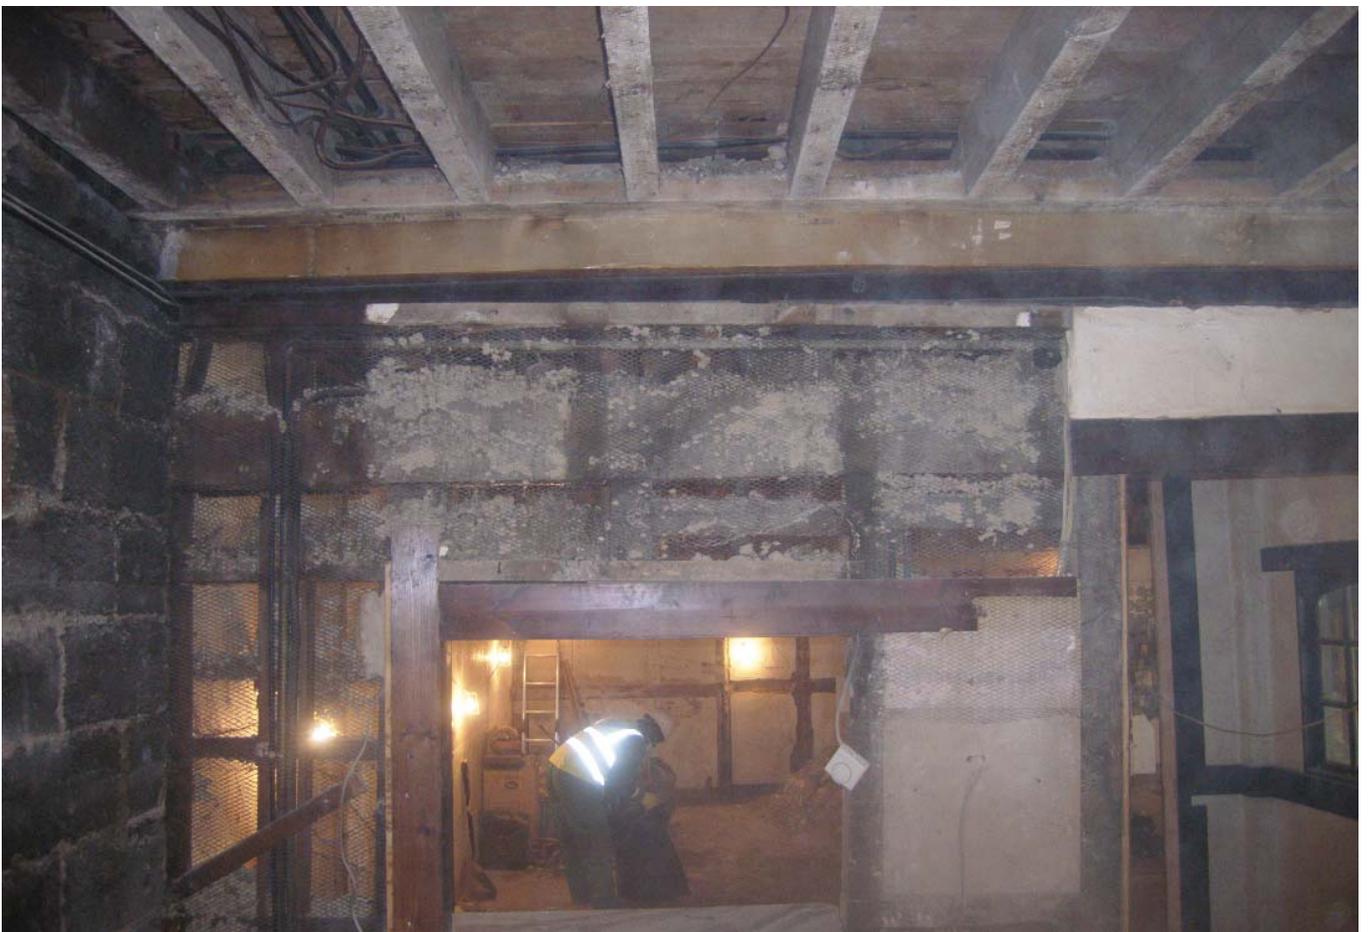
Plate 12: North side of historic frame after partial clearance of 20th-century plaster

Plate 13: North side of frame

Plate 14: Detail of frame

Plate 15: South side of frame

Plate 16: South side of frame
