The Turl Bar Turl Street Oxford

**Historic Buildings Investigation
and Recording**

Client Name: Lincoln College
Document Title: The Turl Bar, The Mitre Hotel, Oxford

Document Type: Historic Building Recording and Investigation
Issue Number: 1

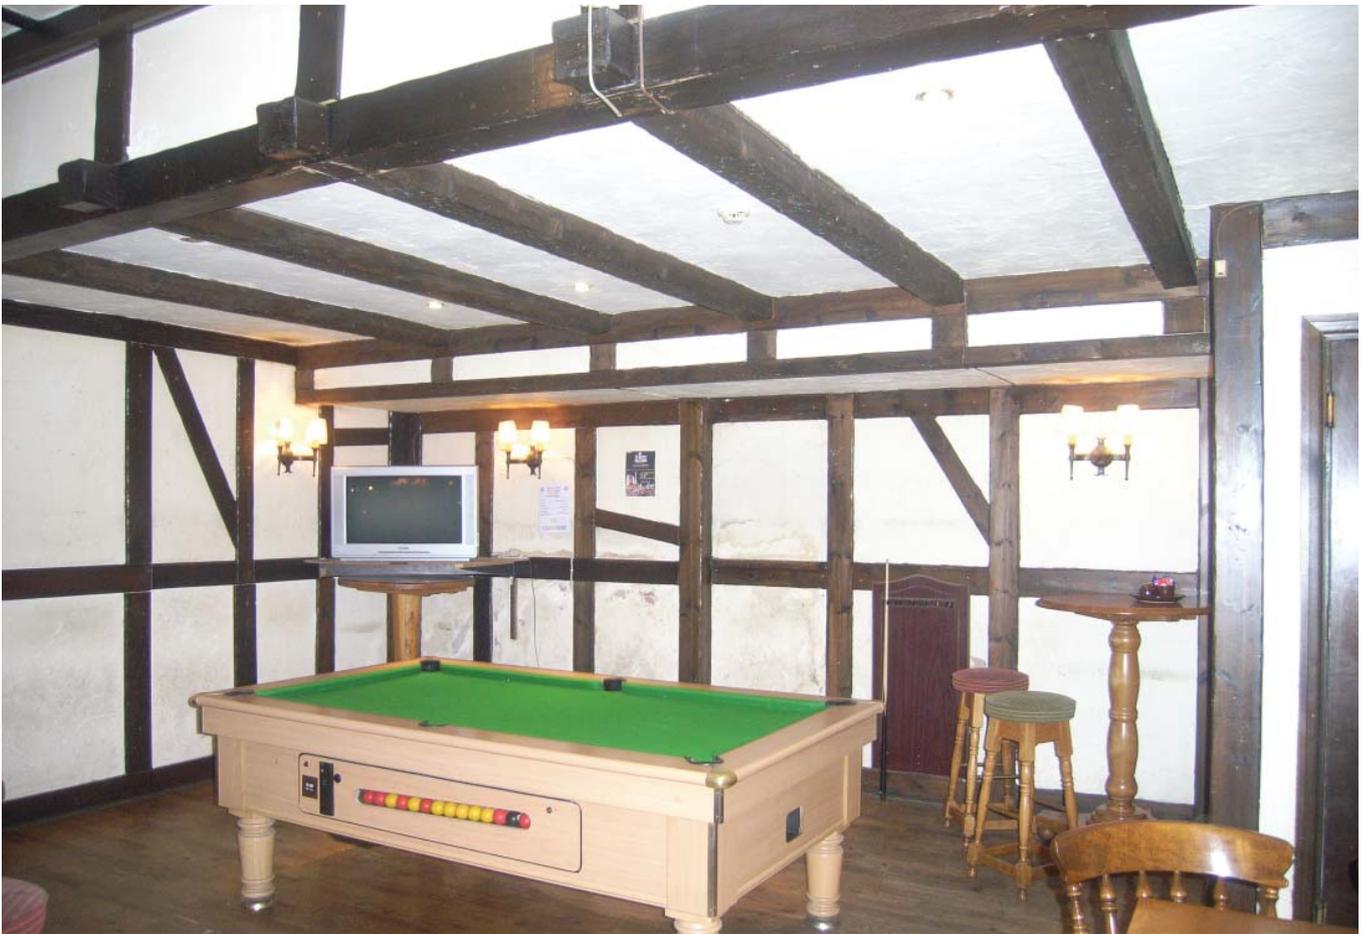
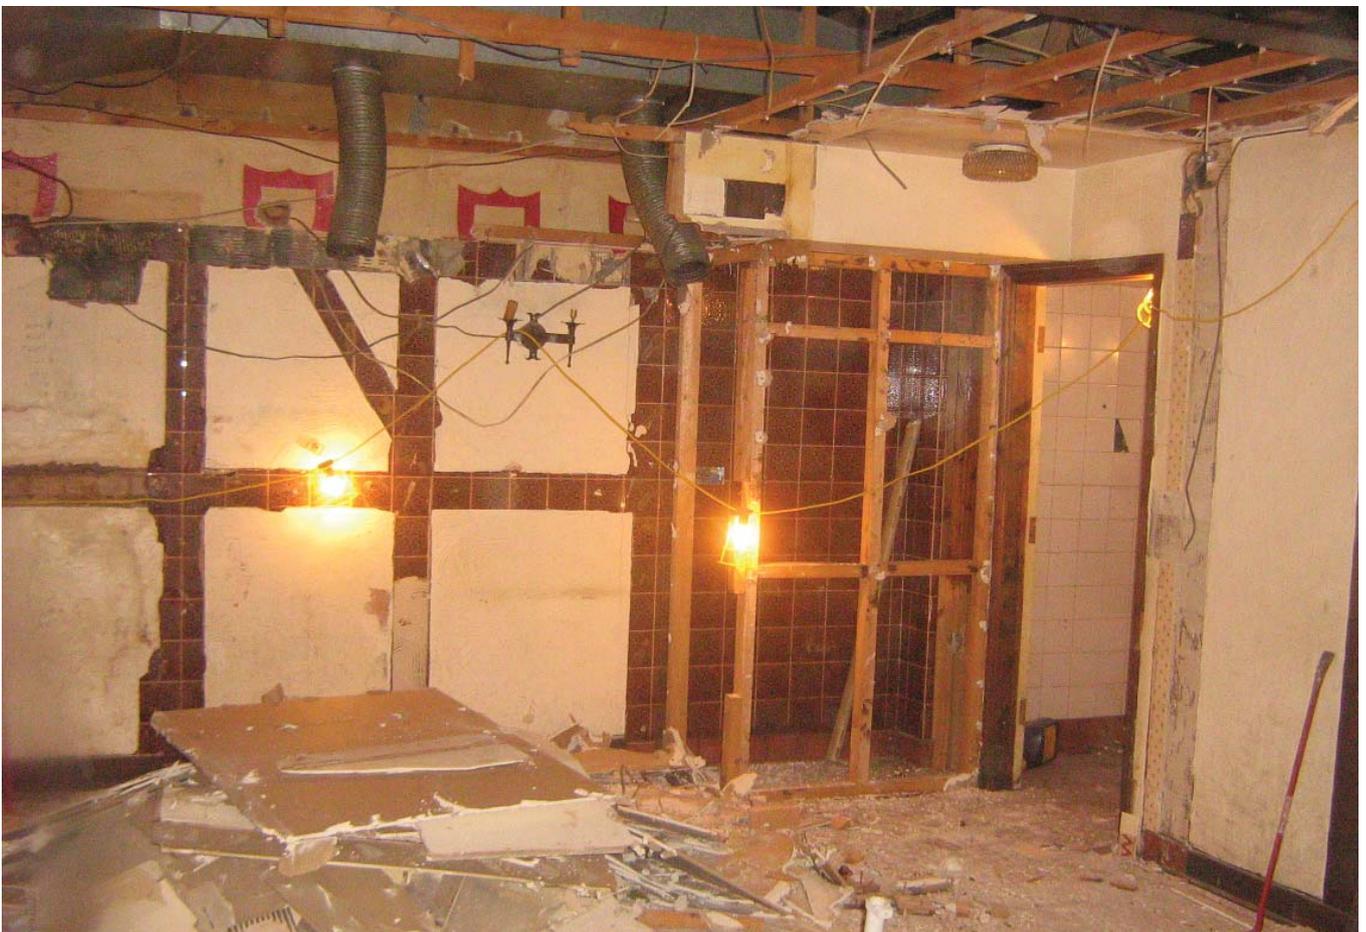
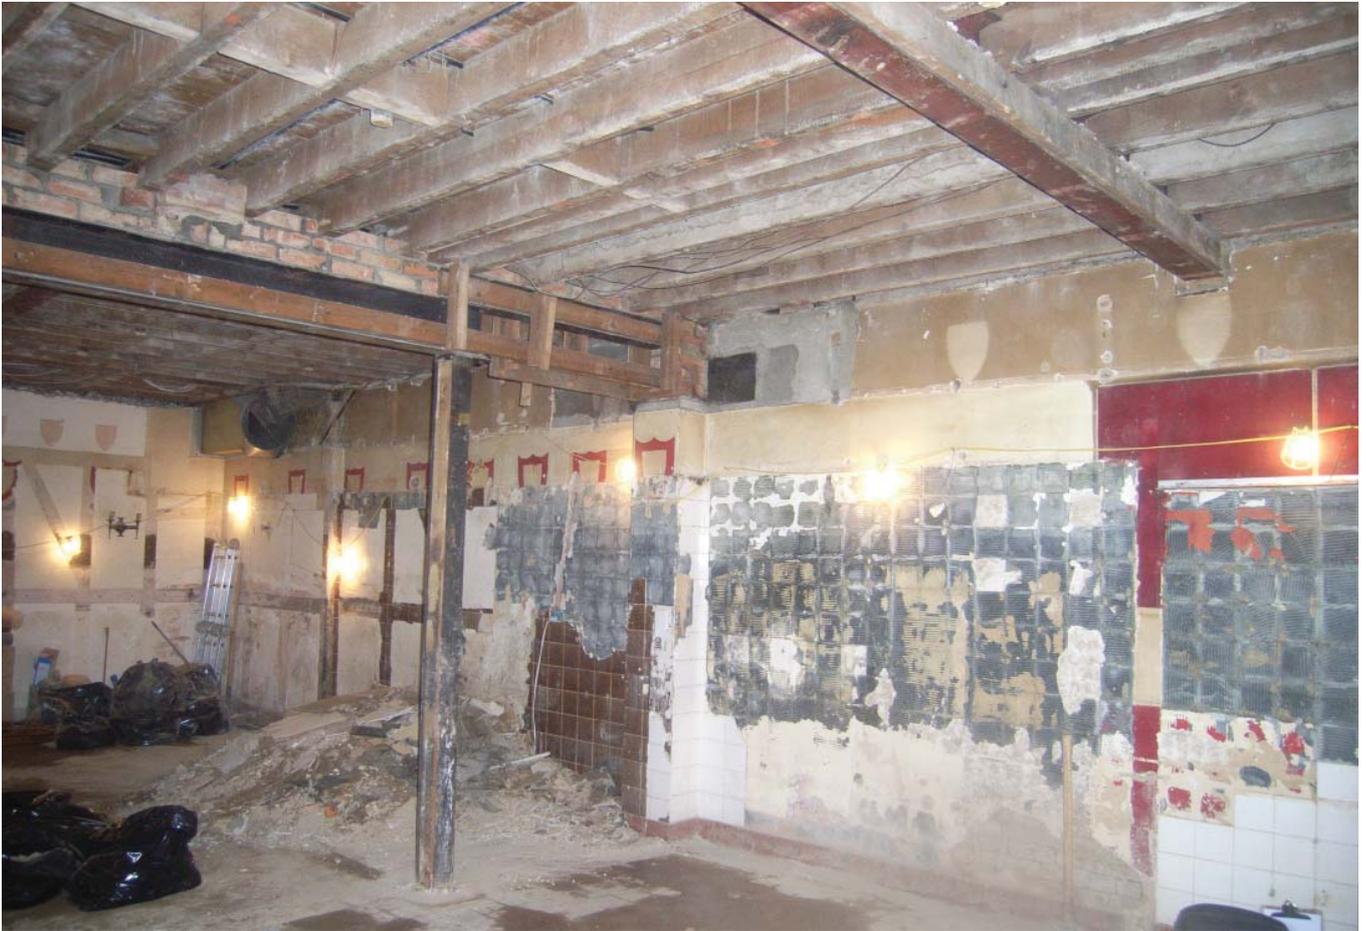
- 3.3.5 **Area 4** (north half of G15 in previous OA rep) is at the junction between the northern and western ranges of the building and it houses the second main bar area. This area also has mock timber framed cladding on the walls but this has been removed in the current work and it is interesting to note that beneath the cladding in the north wall are older wall tiles (Pl.18-19). The tiles are 20th century in date, possibly mid 20th-century, but it shows that this area must previously have been a kitchen or similar service room prior to the addition of the timber cladding. At the south-eastern corner of this area is an entrance lobby with modern timber-frame partitioning.

Plate 17: Area 4 (taken in 2009)

Plate 18: Area 4 during current work

Plate 19: Area 4 and 5 after removal of partition

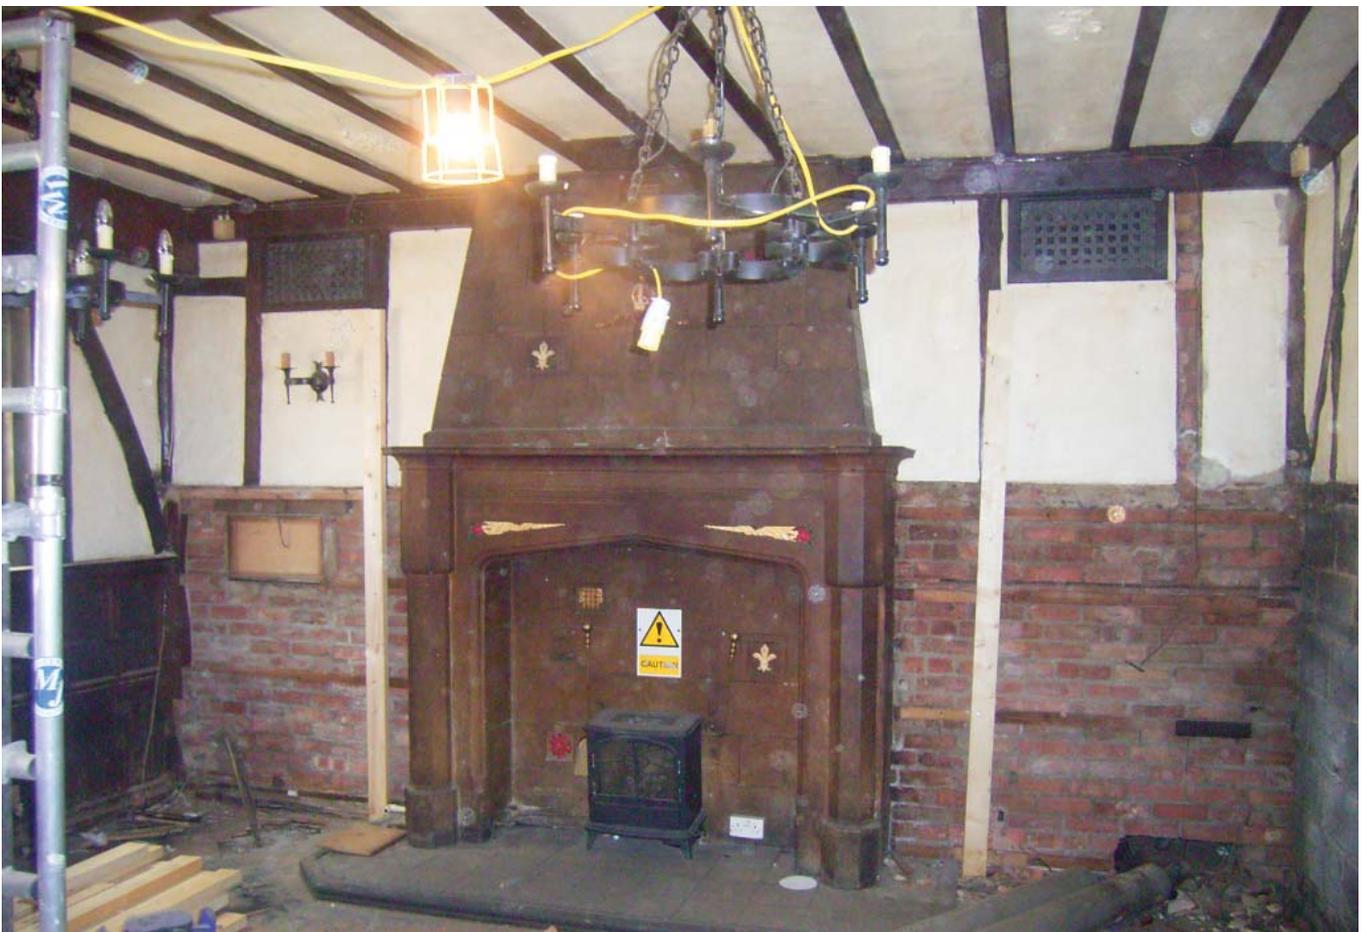
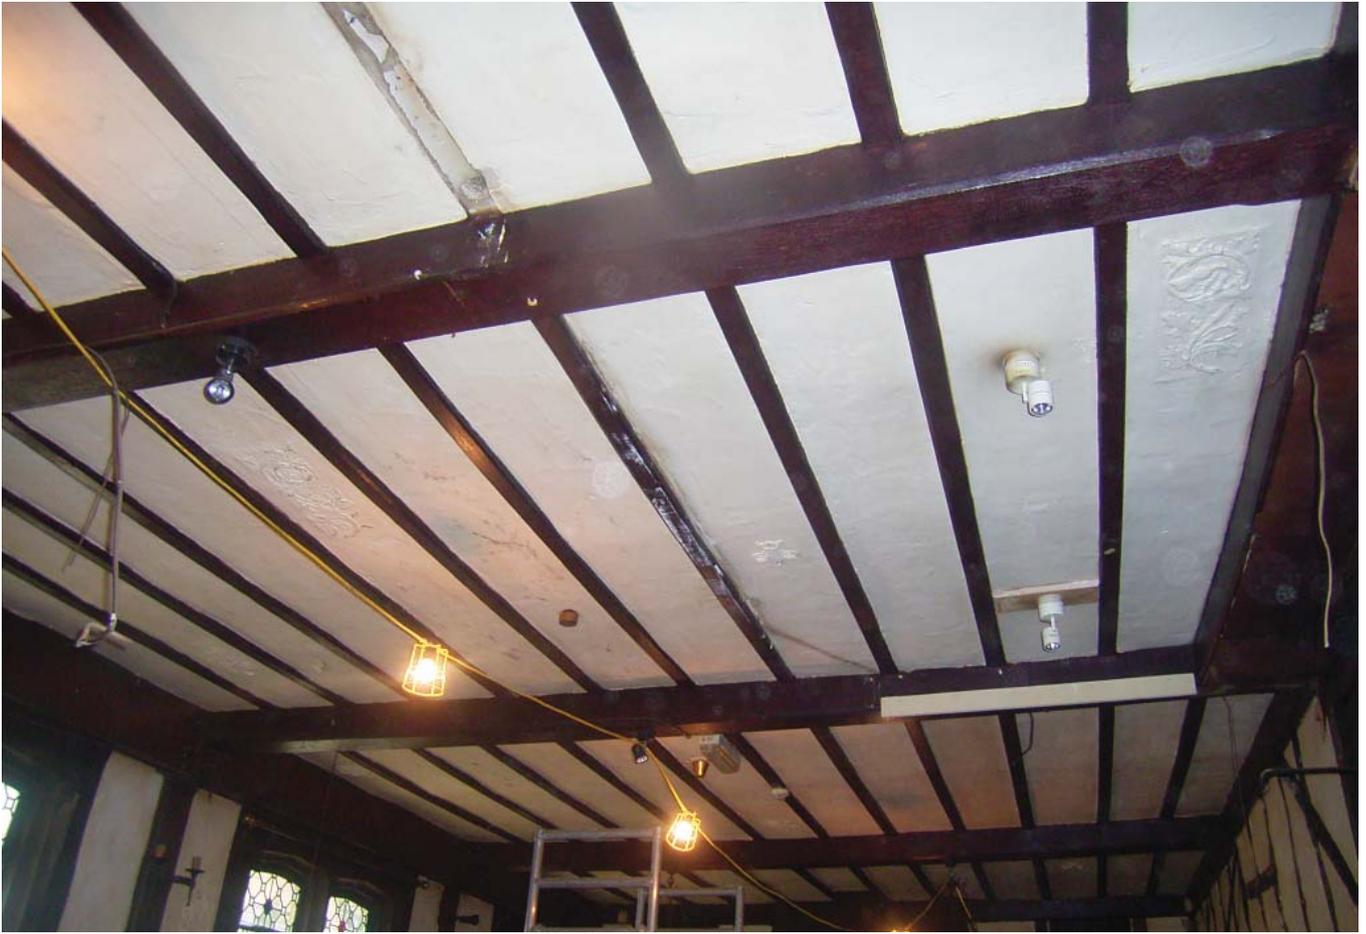
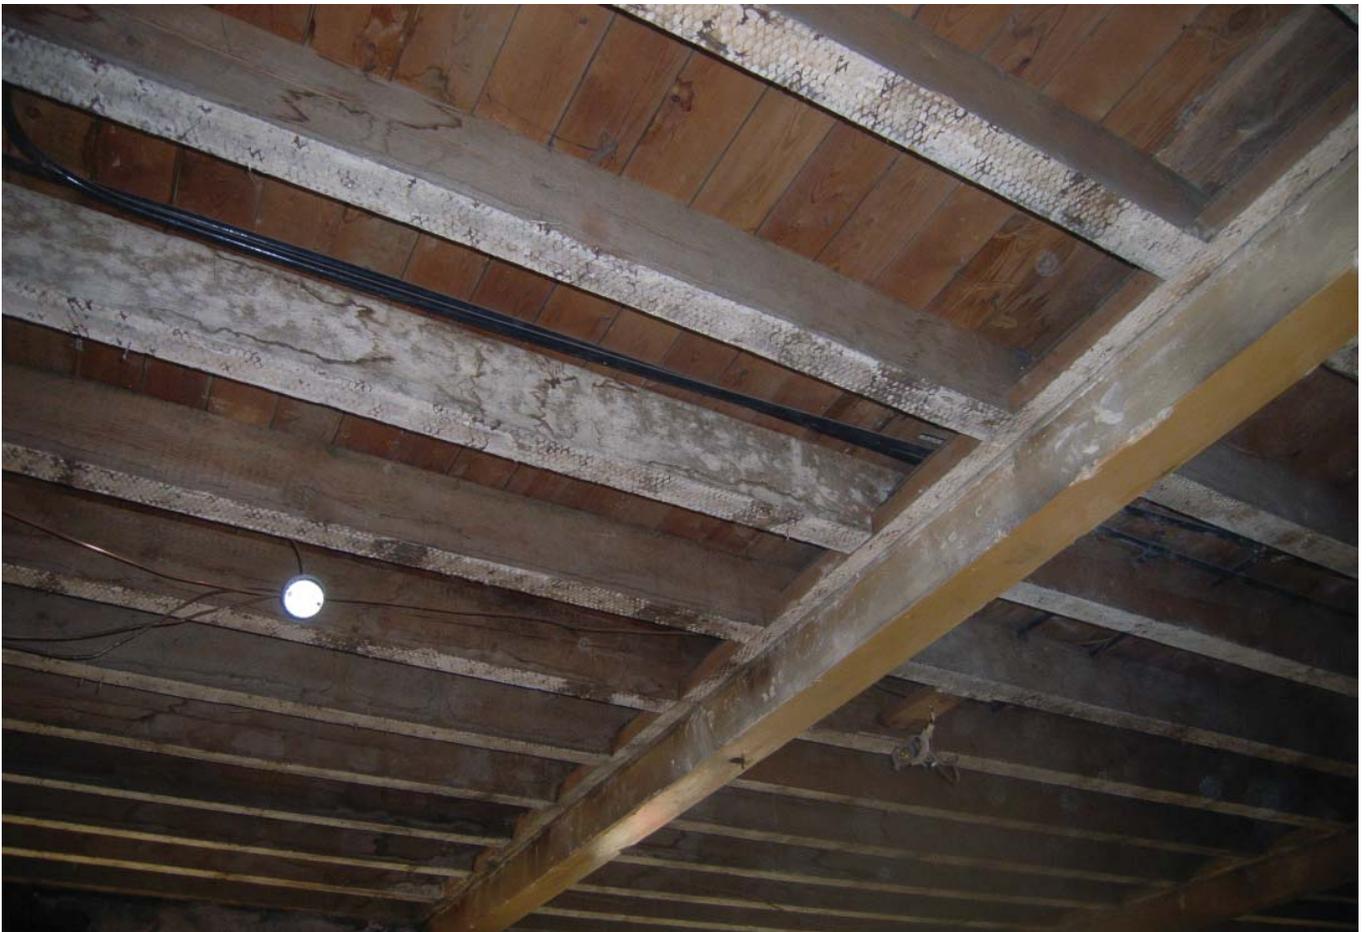
- 3.3.4 **Area 3** (south half of G15 in previous OA rep) is a large single room housing one of the two main bars and at its northern end is the fragment of surviving historic wall (detailed further below). The walls were clad in timber-frame cladding but these have been removed in the current project to reveal concrete block to the west wall and modern brickwork to the south wall. At the centre of the south wall is a Tudor style 1920s stone fireplace (Pl.20). Prior to the current work the ceiling comprised visible dark joists with plaster between and this has been recently removed to confirm that the floor is entirely 20th century. It comprises tall joists and the plaster was secured by chicken wire (Pl.21-22). The area has attractive arts and crafts style windows with iron-framed side-hung opening casements with leaded panes.

Plate 20: Fireplace at south end of Area 3

Plate 21: Ceiling in Area 3 prior to works

Plate 22: Ceiling in Area 3 after soft strip

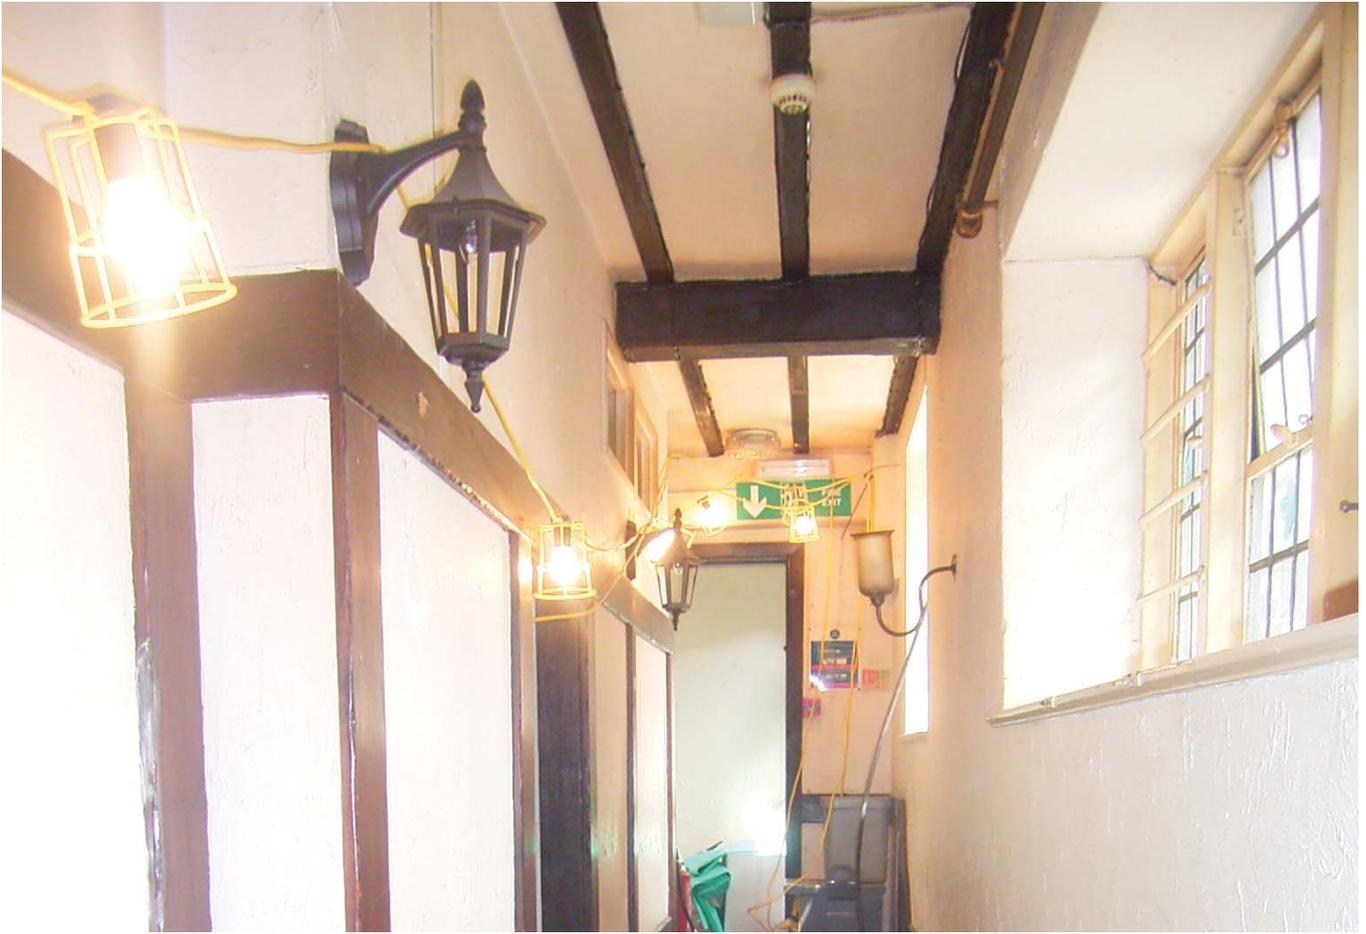
Plate 23: Corridor in north range

- 3.3.6 **Area 5** (G16 in previous OA rep) comprises a series of service rooms with tiled partition walls and a public corridor along the southern edge with timber frame cladding (Pl.23). These rooms would all have been kitchens and storage areas. OA's 2009 report states that the kitchen was a recent insertion and that it replaced a former bar/servery area.
