Valentines Park Ilford

London Borough
of Redbridge

**Historic Building Recording and
Archaeological Watching Brief**

April 2009

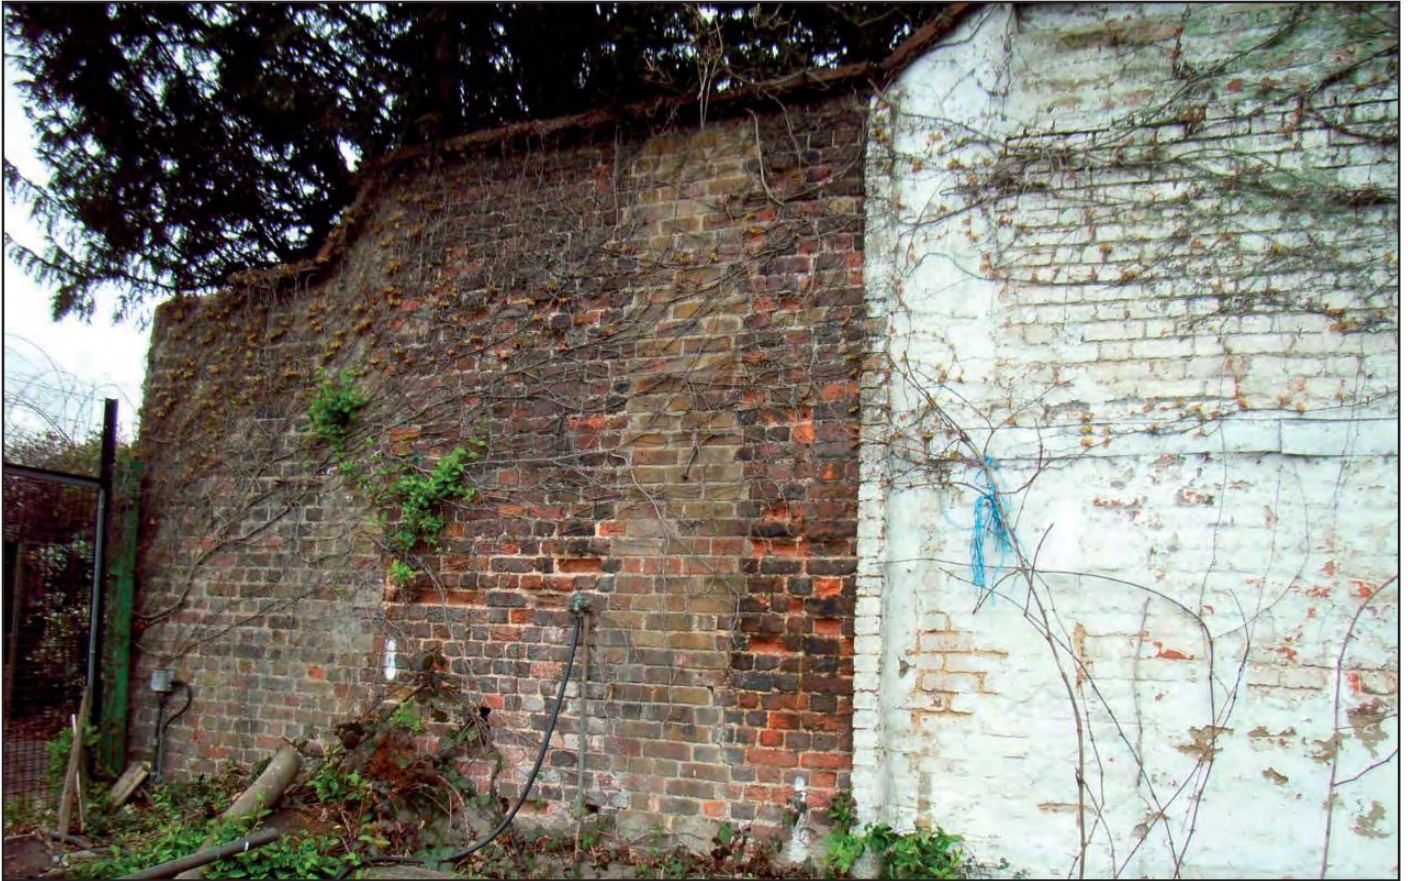
Plate 5: Pier of rebuilt brick towards centre of Wall 1 (Flue 1)

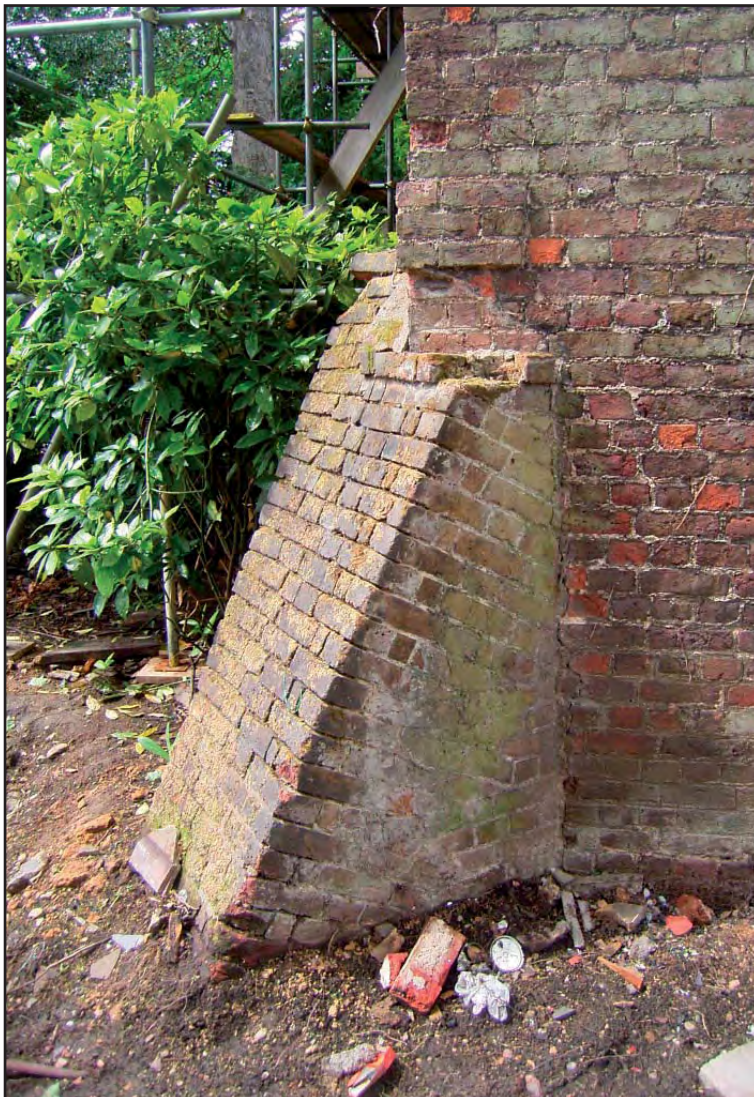
Plate 12: Later 19th-century buttress at south corner of Dovecote

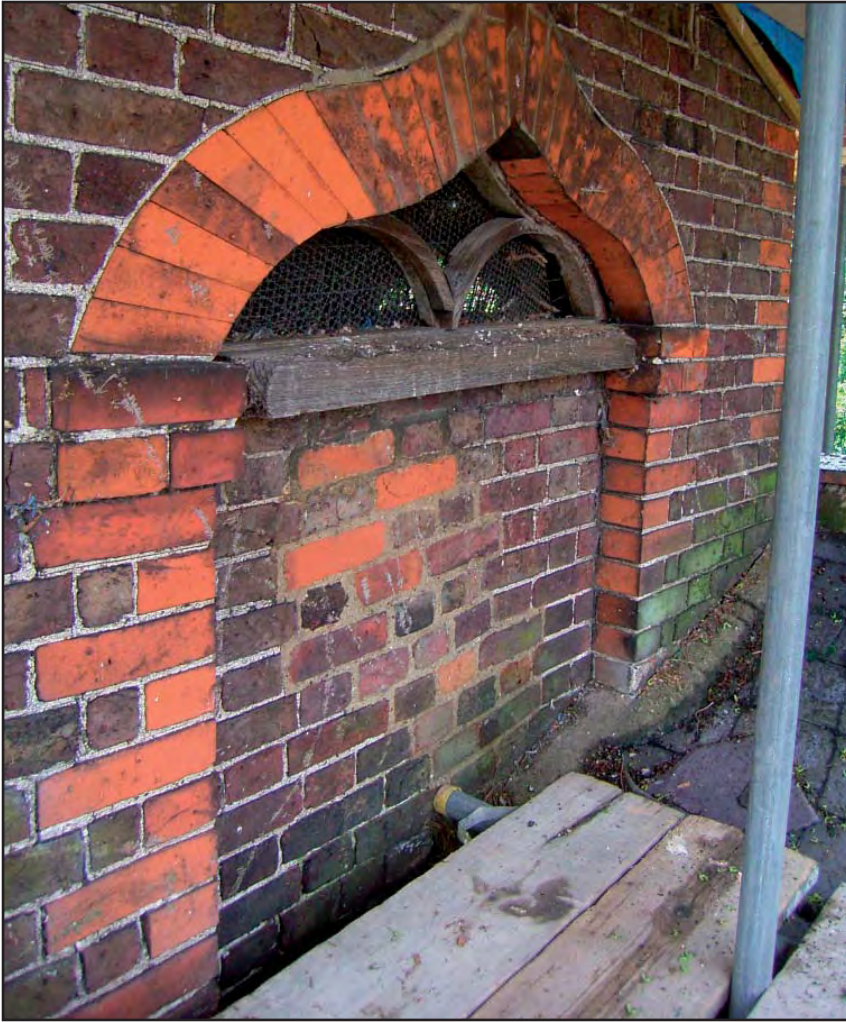
Plate 15: 1st floor blind window in Dovecote with 1864 inscribed on brick

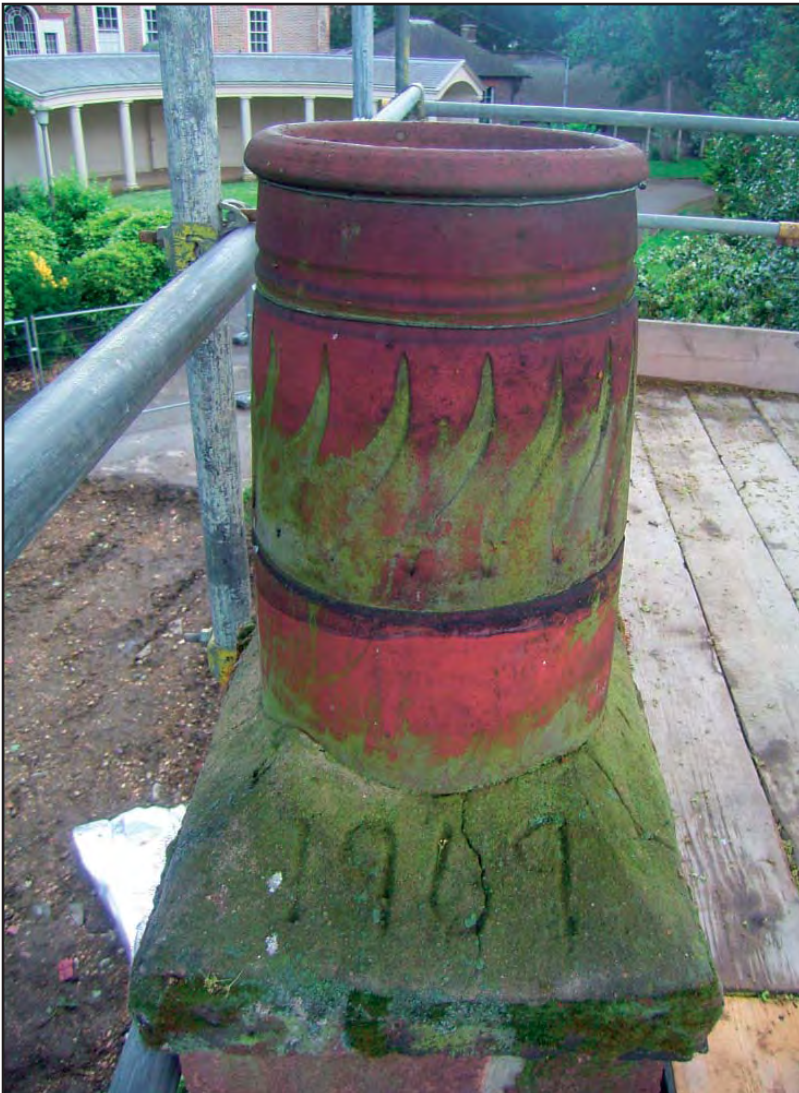
Plate 18: Chimney of Dovecote with 1909 inscribed at base

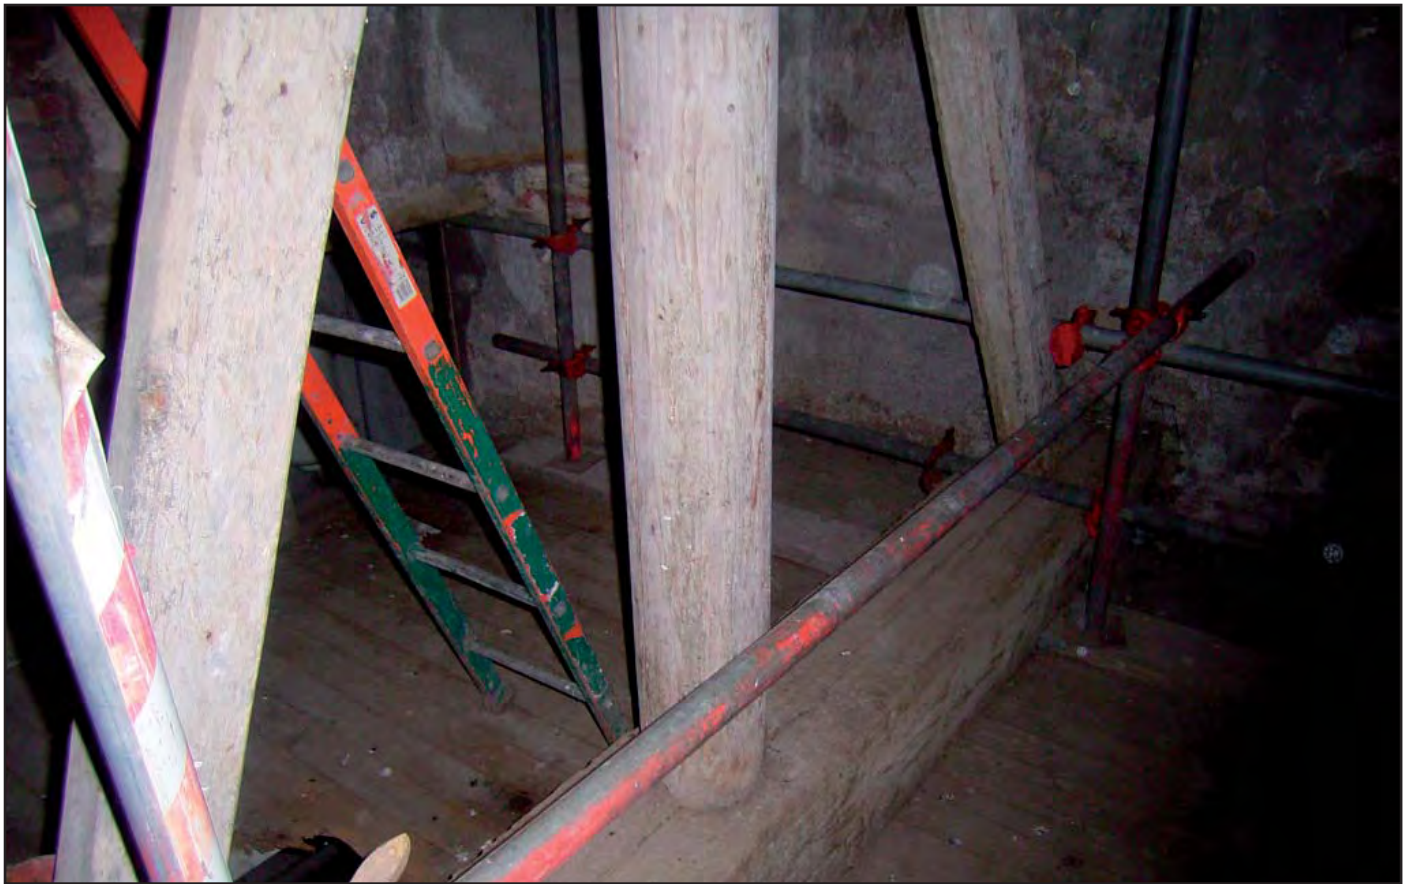
Plate 27: Bearer across floor in Dovecote supporting central post

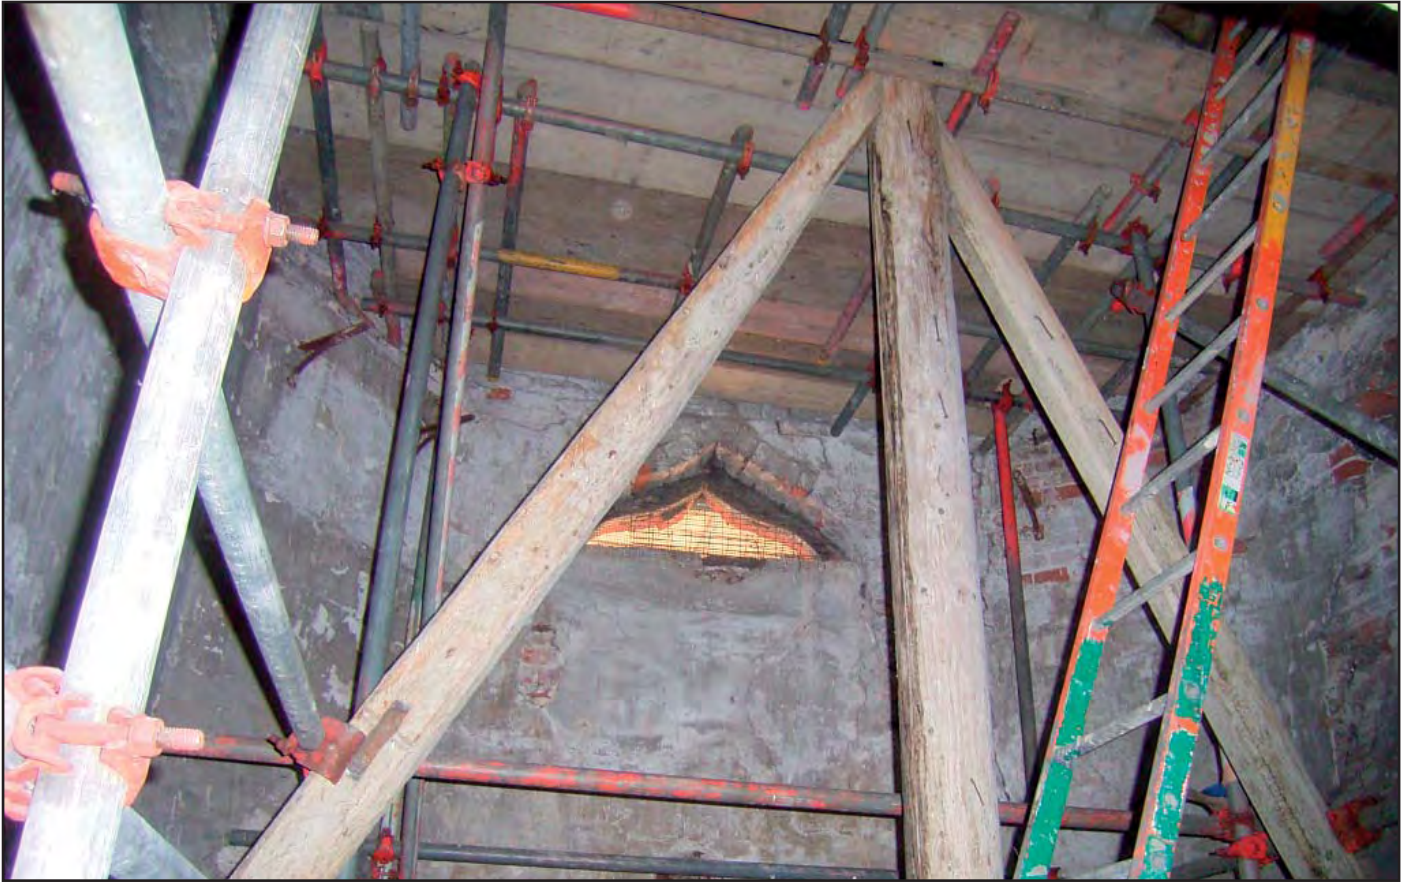
Plate 31: General view in Dovecote

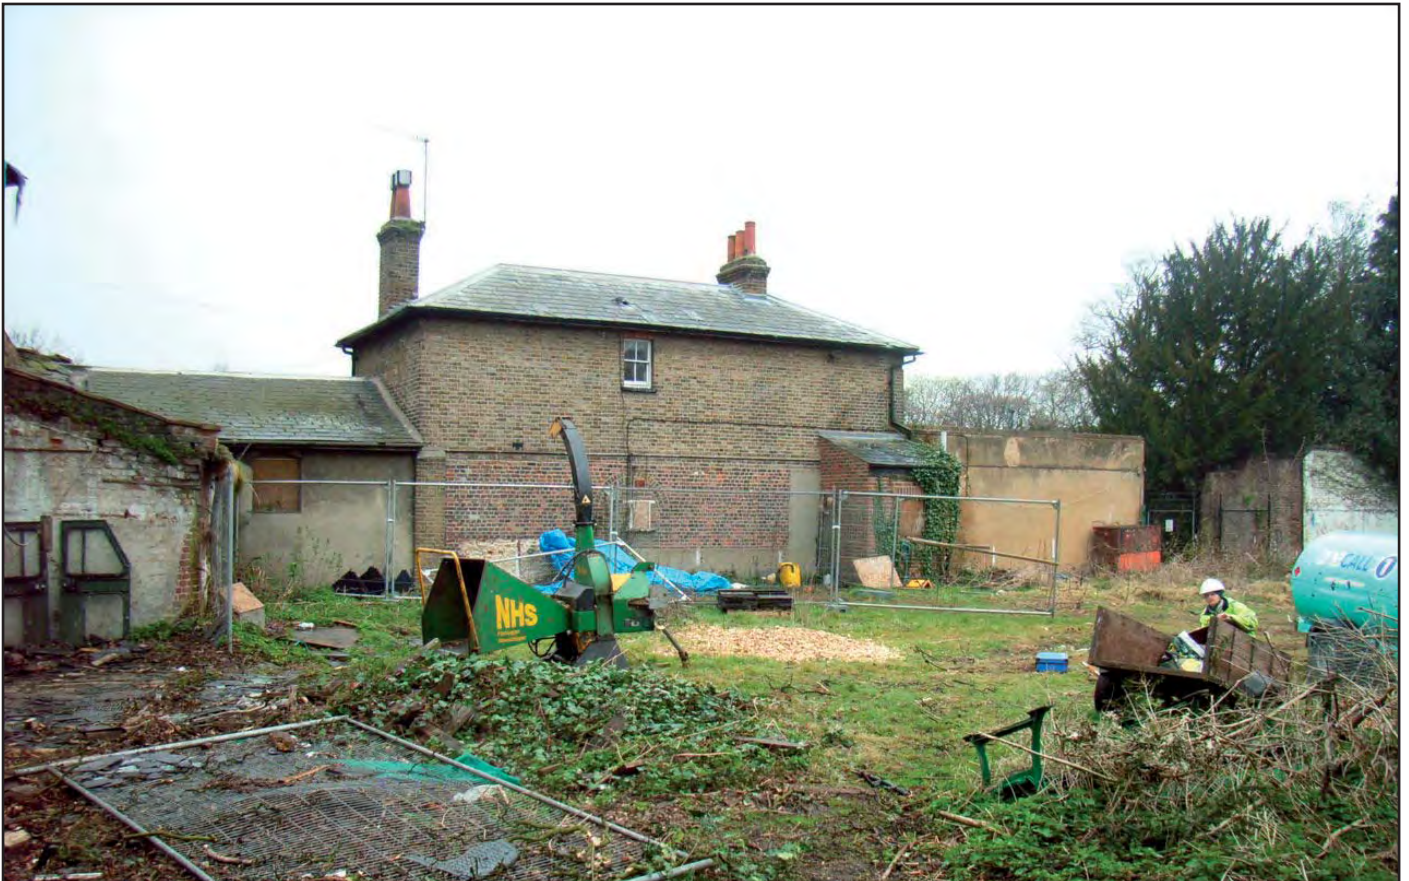
Plate 32: General view towards cottage before start of works

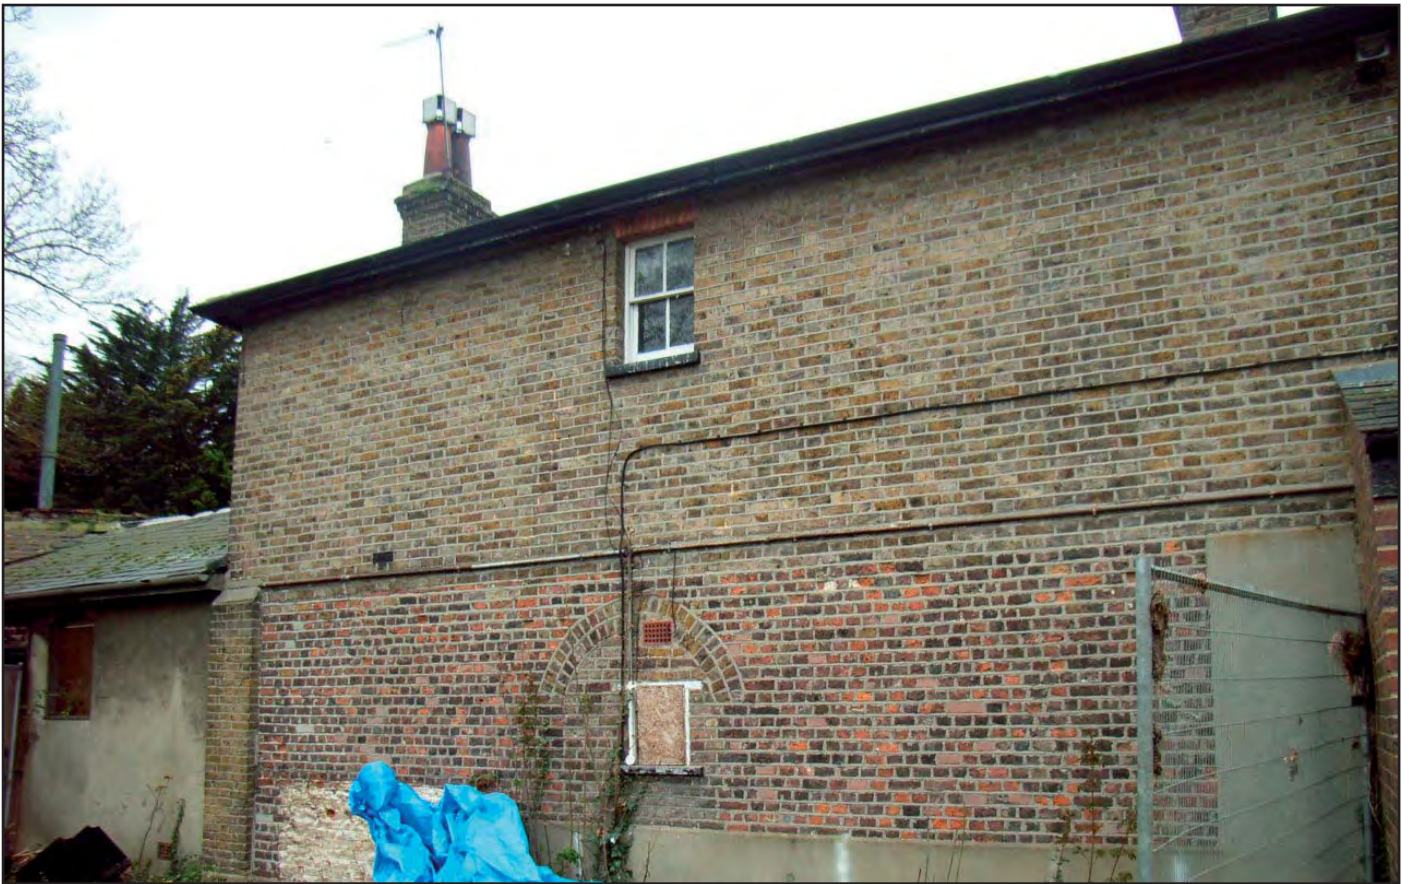
Plate 33: SE wall of Cottage showing 18th-century brick below 19th-century

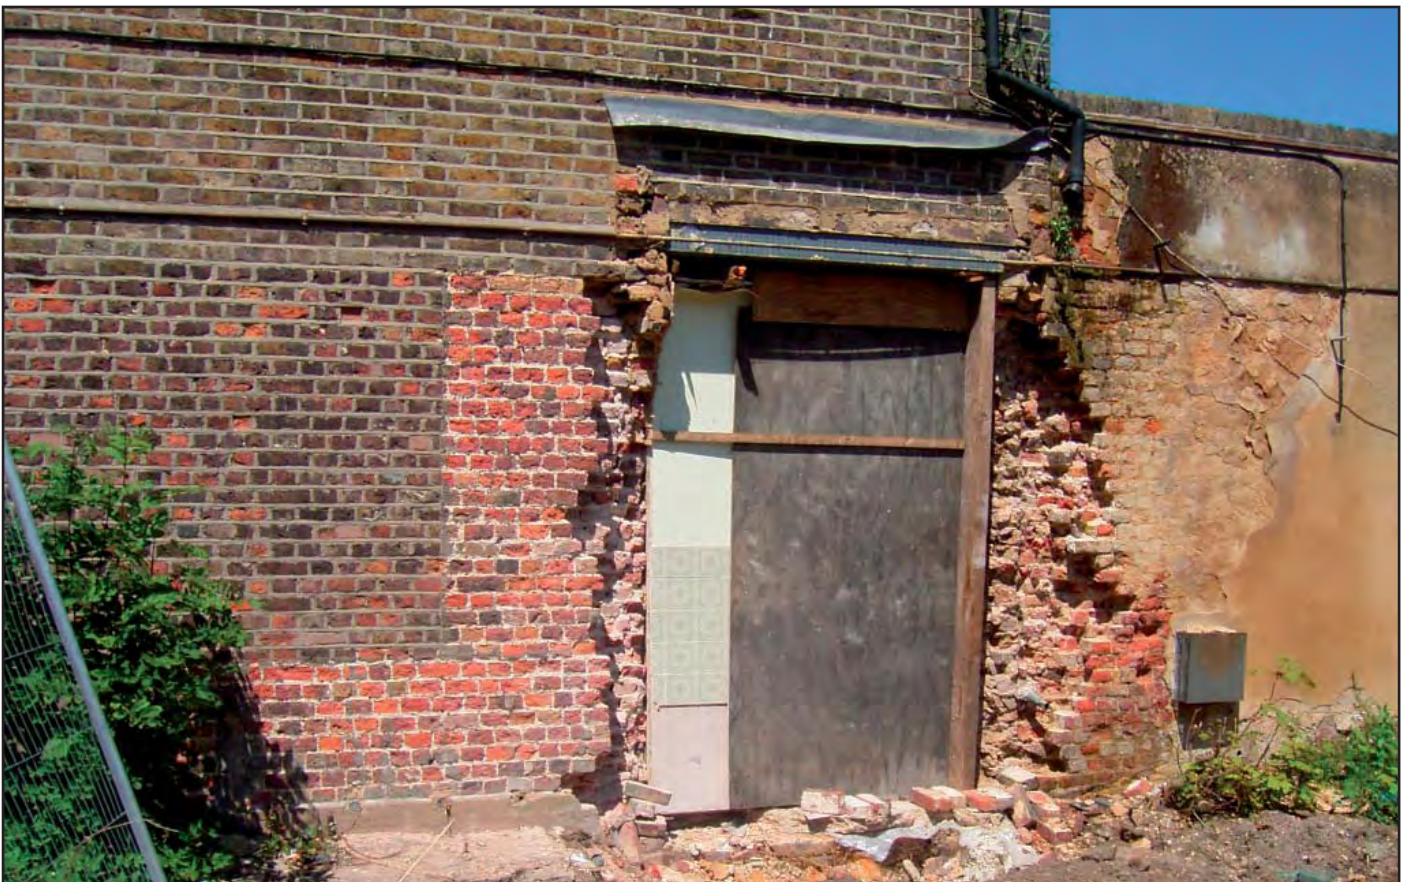
Plate 34: SE wall of Cottage after removal of WC lean-to

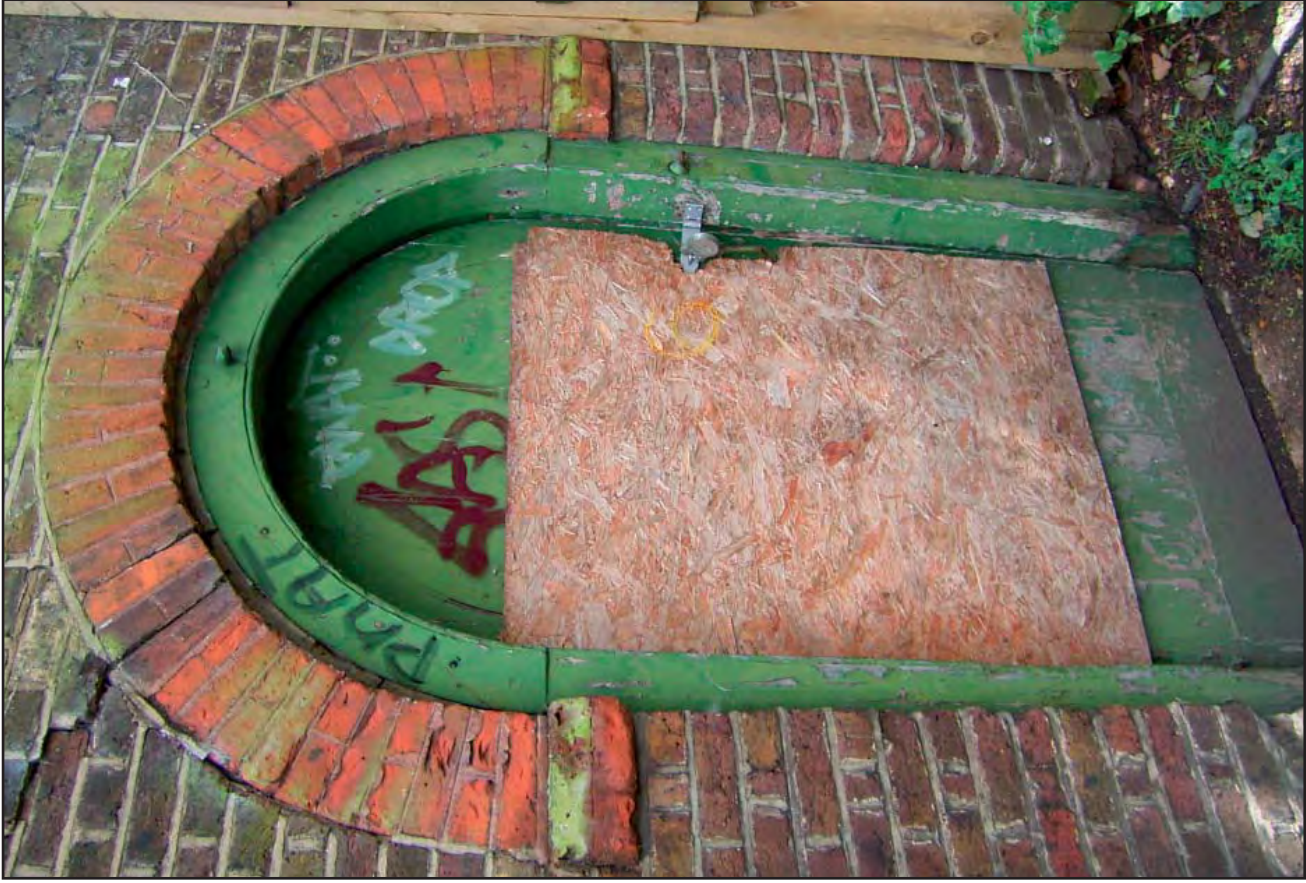
Plate 35: Door in late 19th-century screen wall

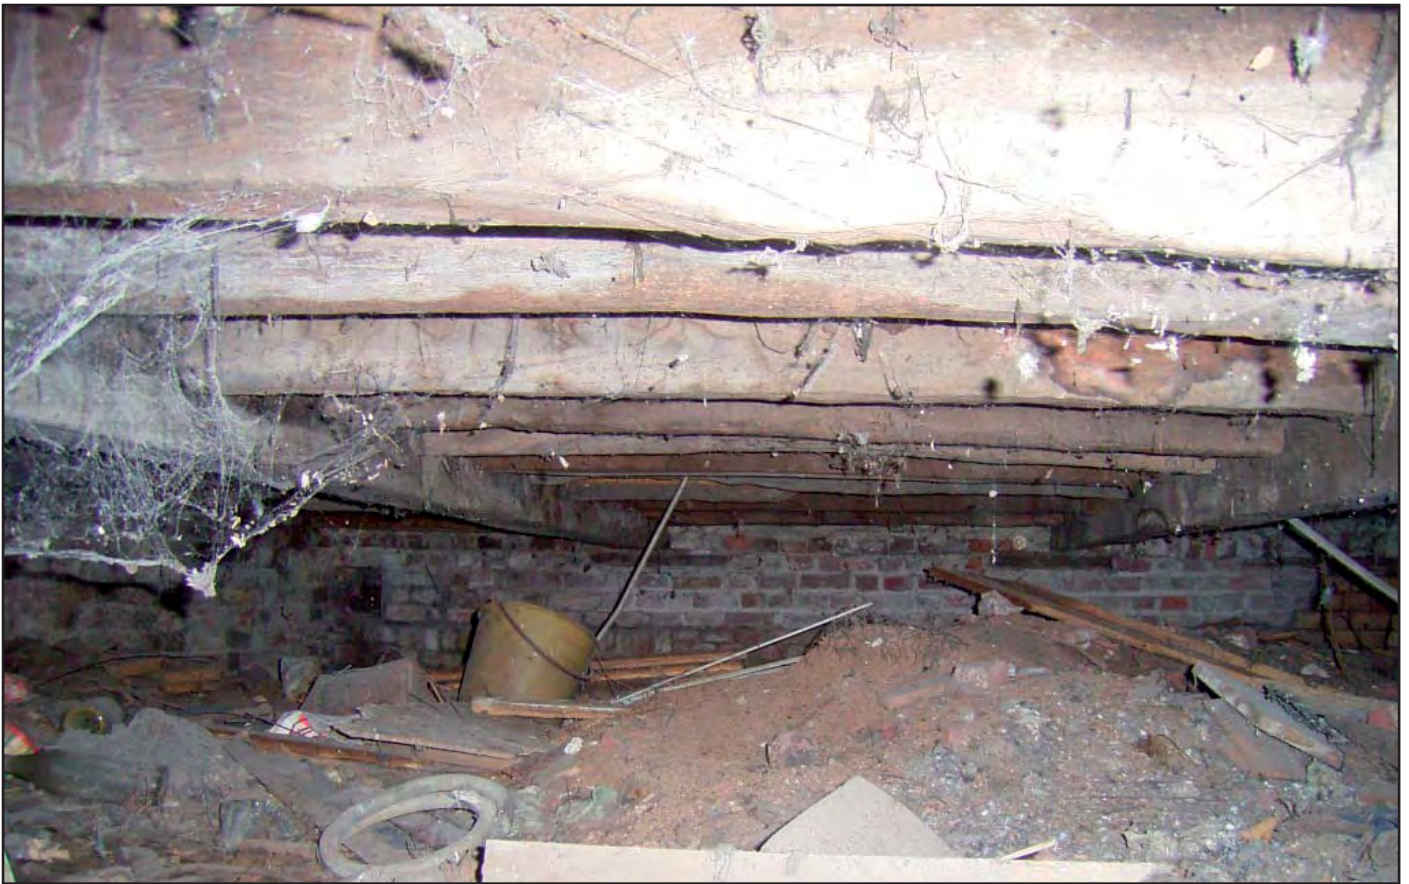
Plate 37: View under Granary

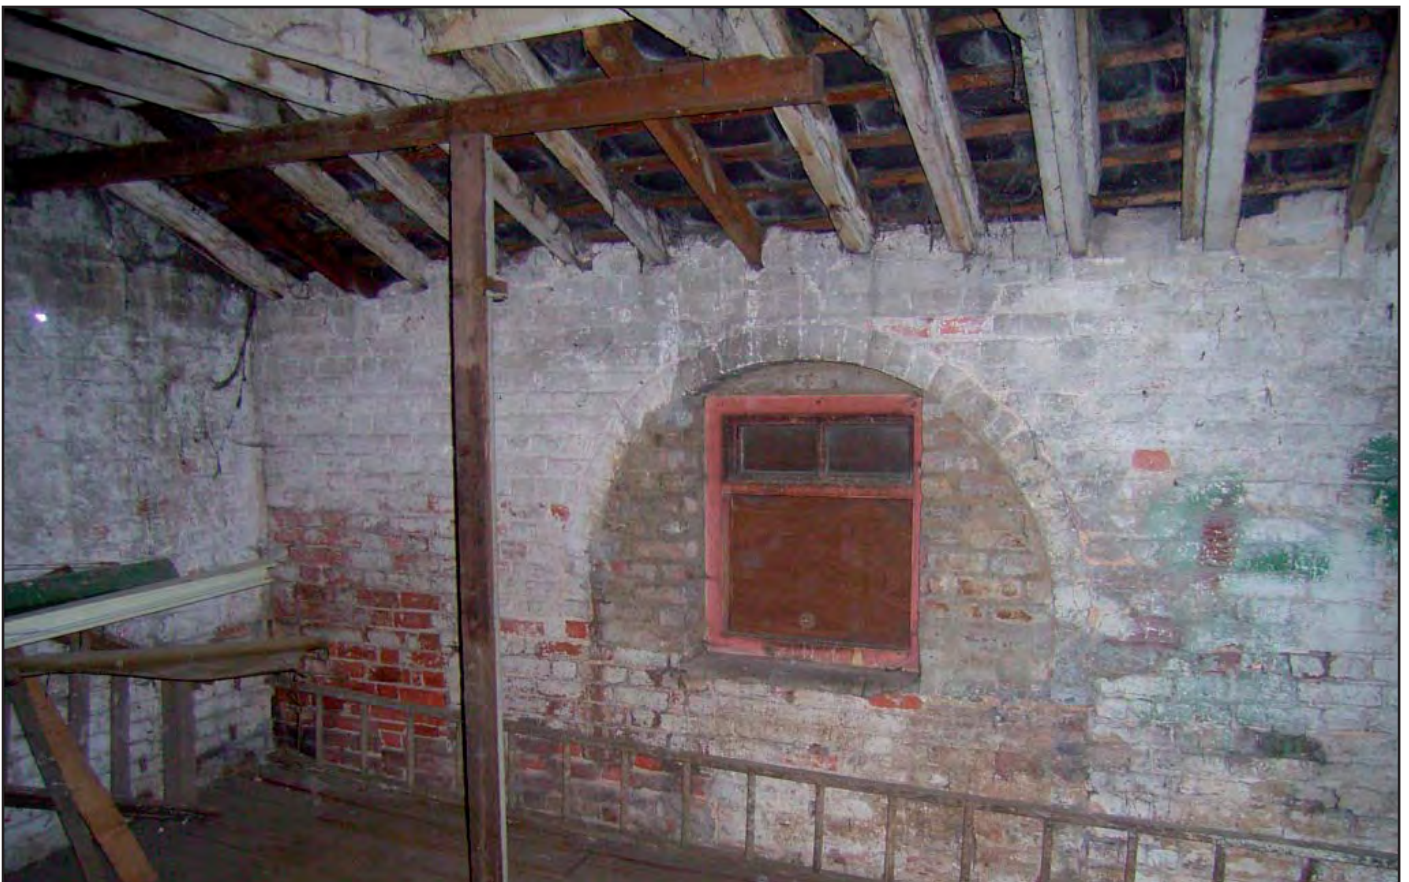
Plate 38: SE wall in Granary

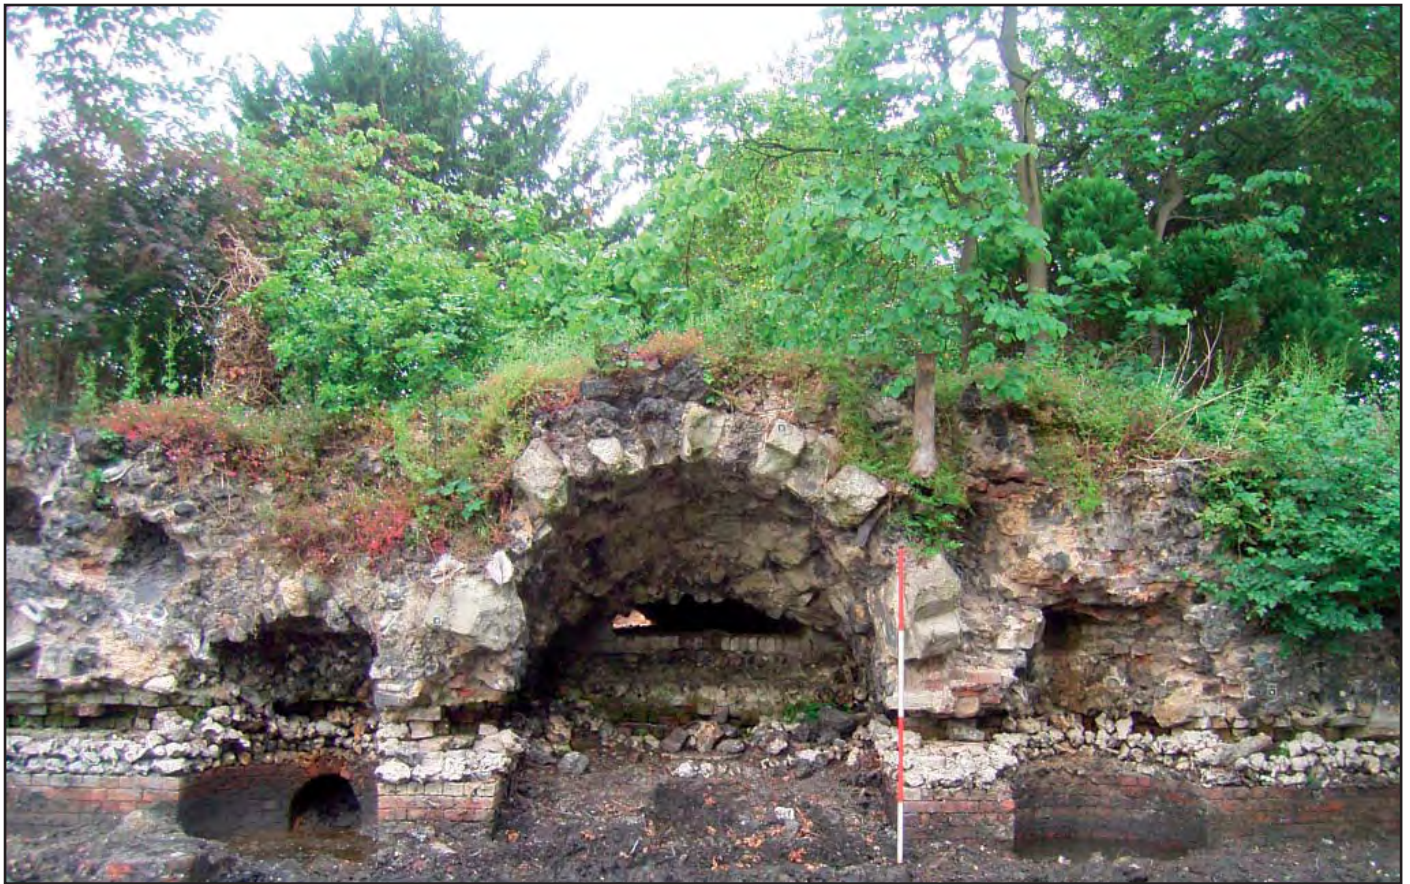
Plate 43: North Grotto

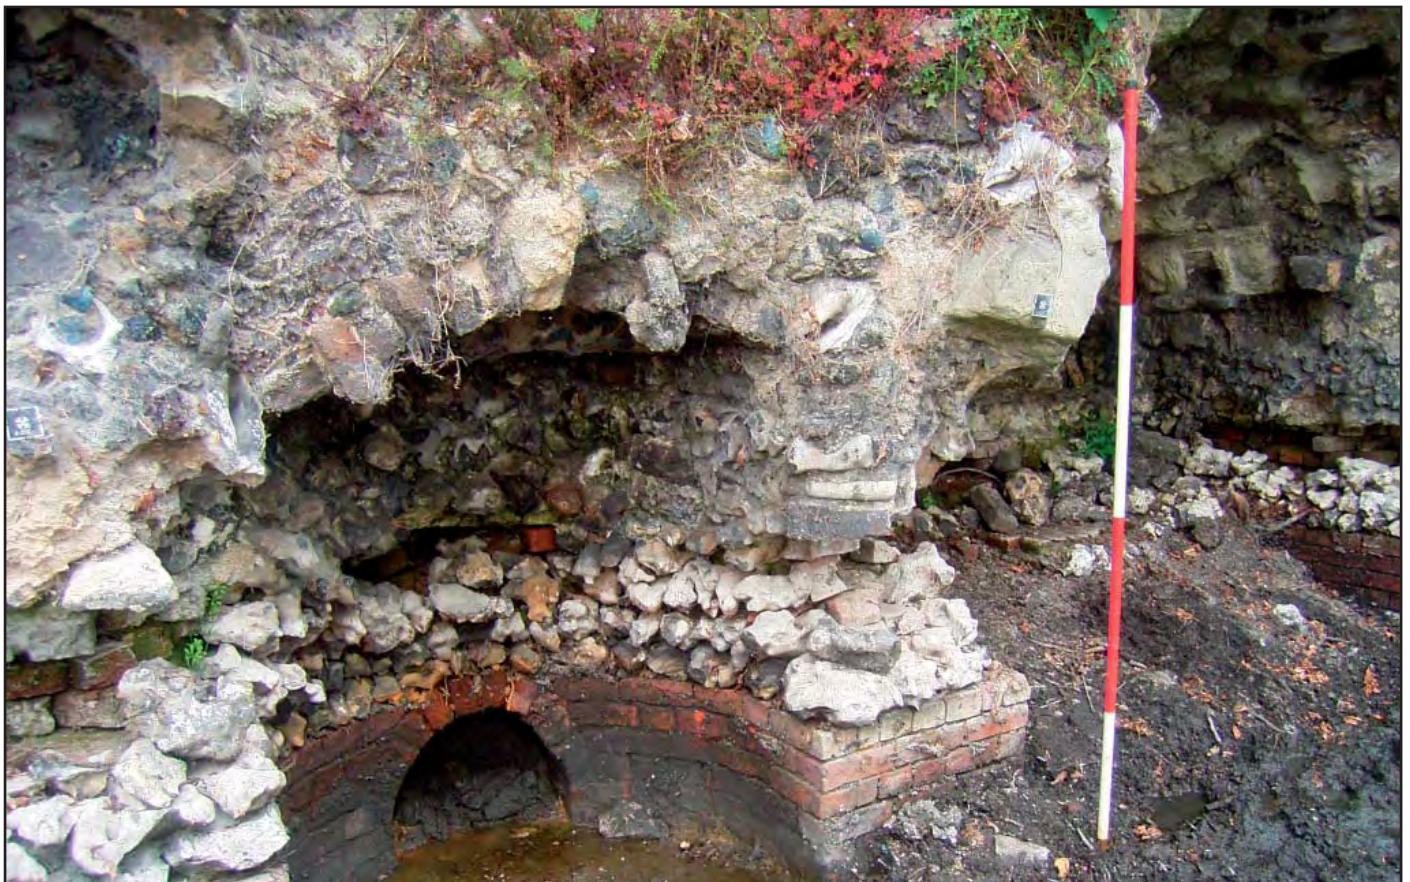
Plate 44: Detail of North Grotto

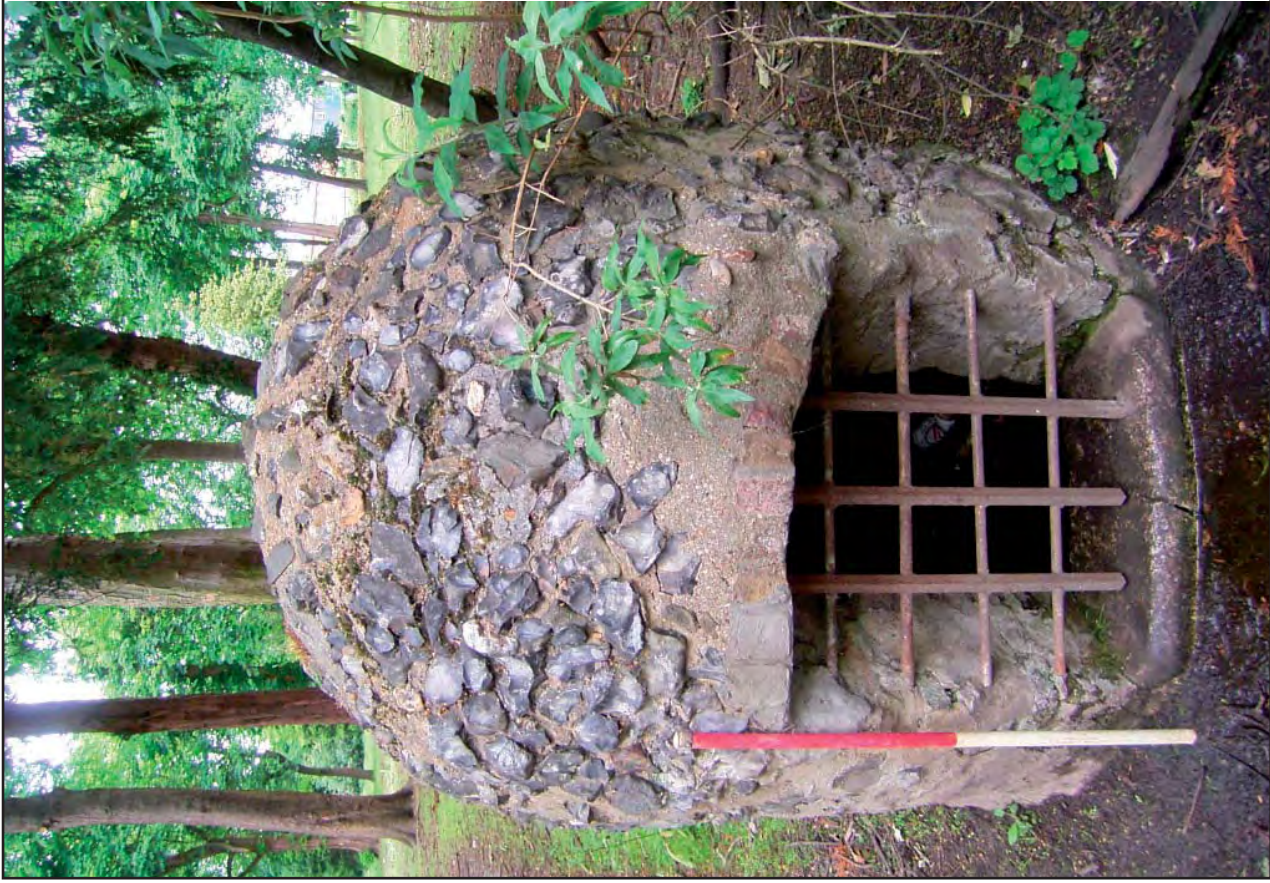
- 5.9.1 This is a small domed structure approximately 1.8 metres high which forms an ornamental cap to a spring which feeds the Wishing Well and Fish Pond (Plate 45).

Plate 45: Jacob's Well

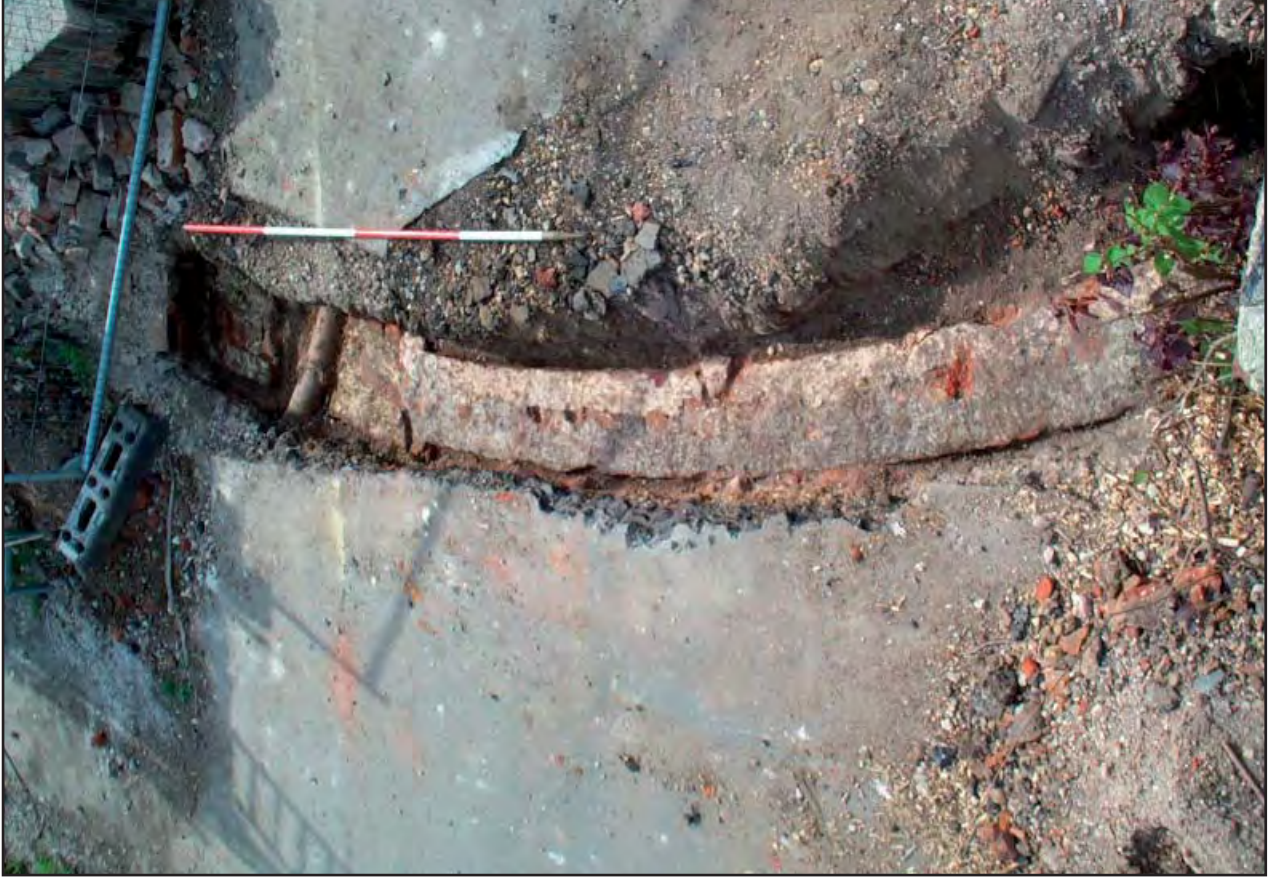
- 5.3.15 During the watching brief it was discovered that the eastern corner, where wall 4 would have joined Wall 6, was originally curved (Plate 46). This is different from the corner between Walls 1 and 6 which was shown to have been at right angles (Plate 47). This is detailed further below.
- 5.3.16 Within the Kitchen Garden are a number of small brick wall footings denoting previous structures. These have been recorded in the current recording (detailed below in section 6) and OA's evaluation in 2002 demonstrated that this area had been subject to extensive disturbance from the construction of green/hot house structures as well as from its later use as a nursery.

Plate 46: Footings from curved NE end of Wall 4 exposed during works

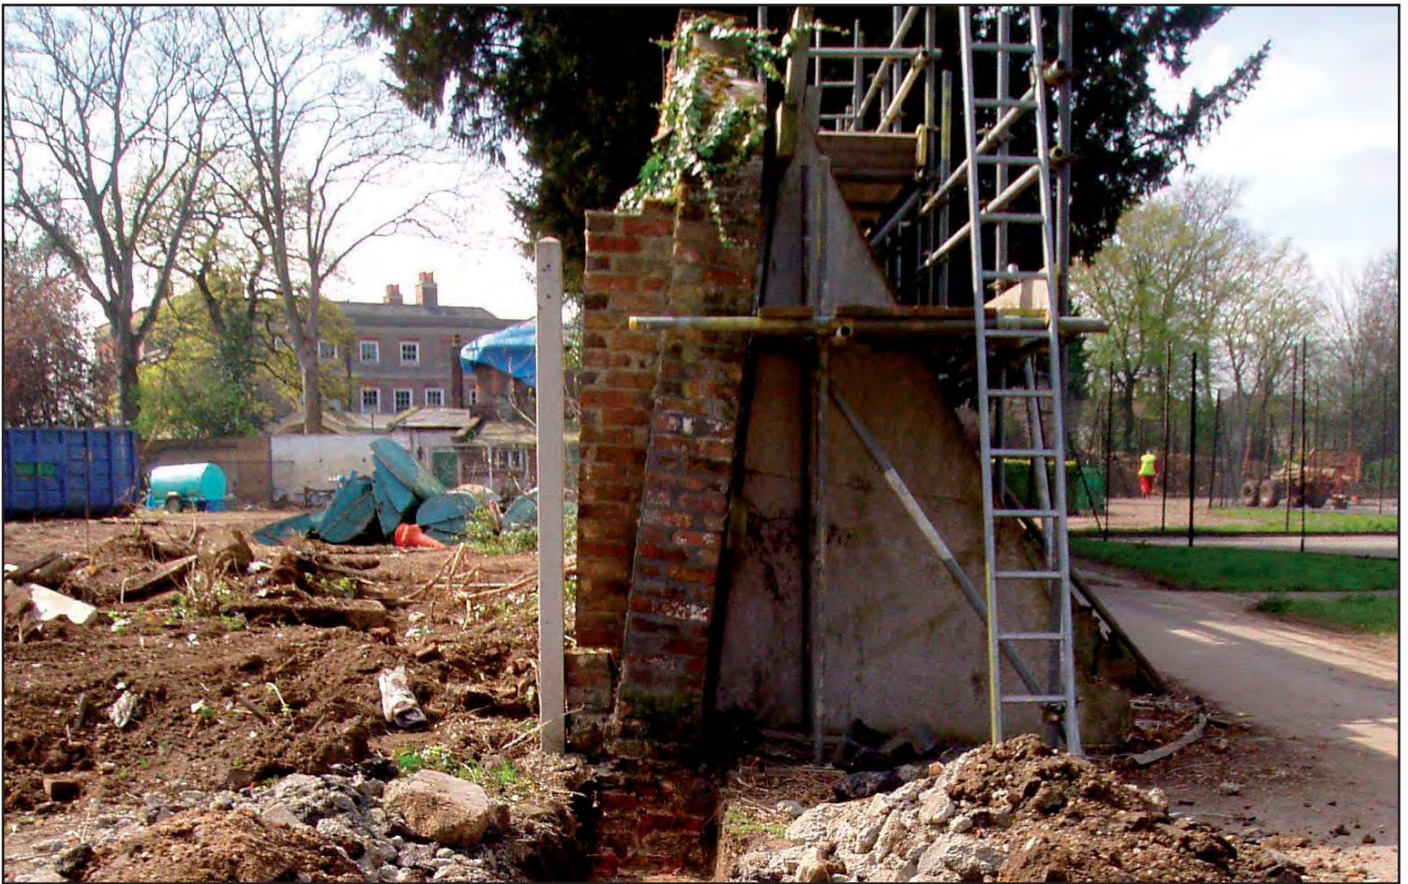
Plate 47: Footings from NE end wall of Wall 1 exposed during works

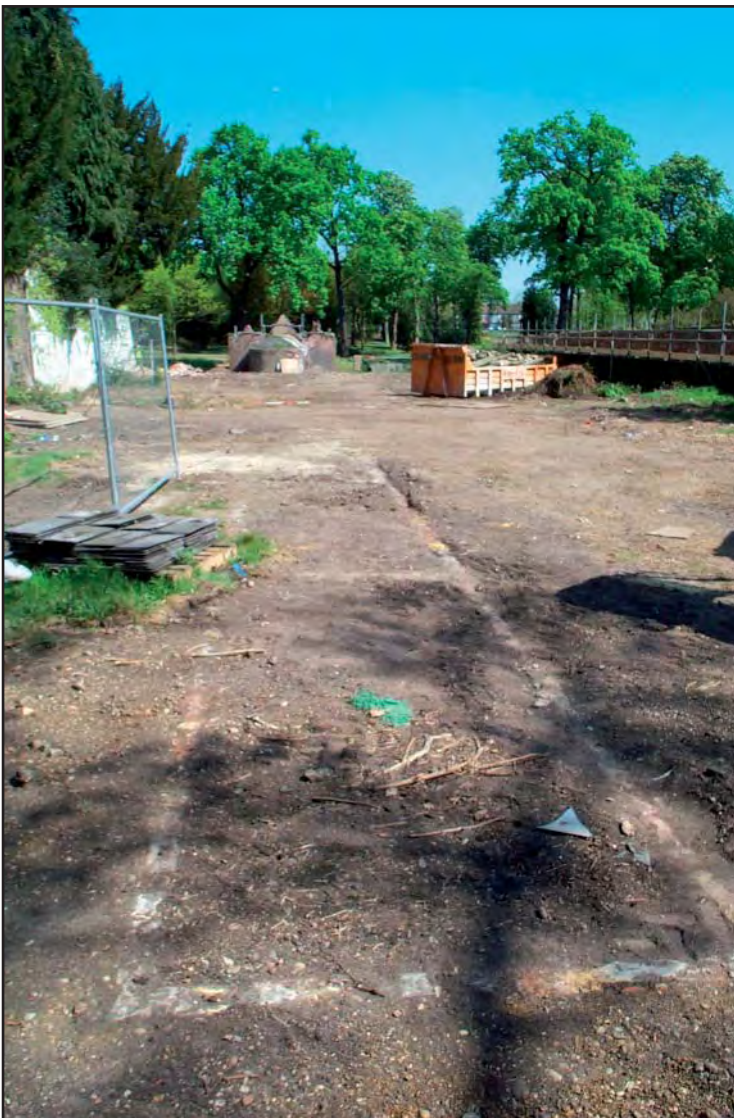
Plate 48: Trace of former structures in Kitchen Garden looking towards NE

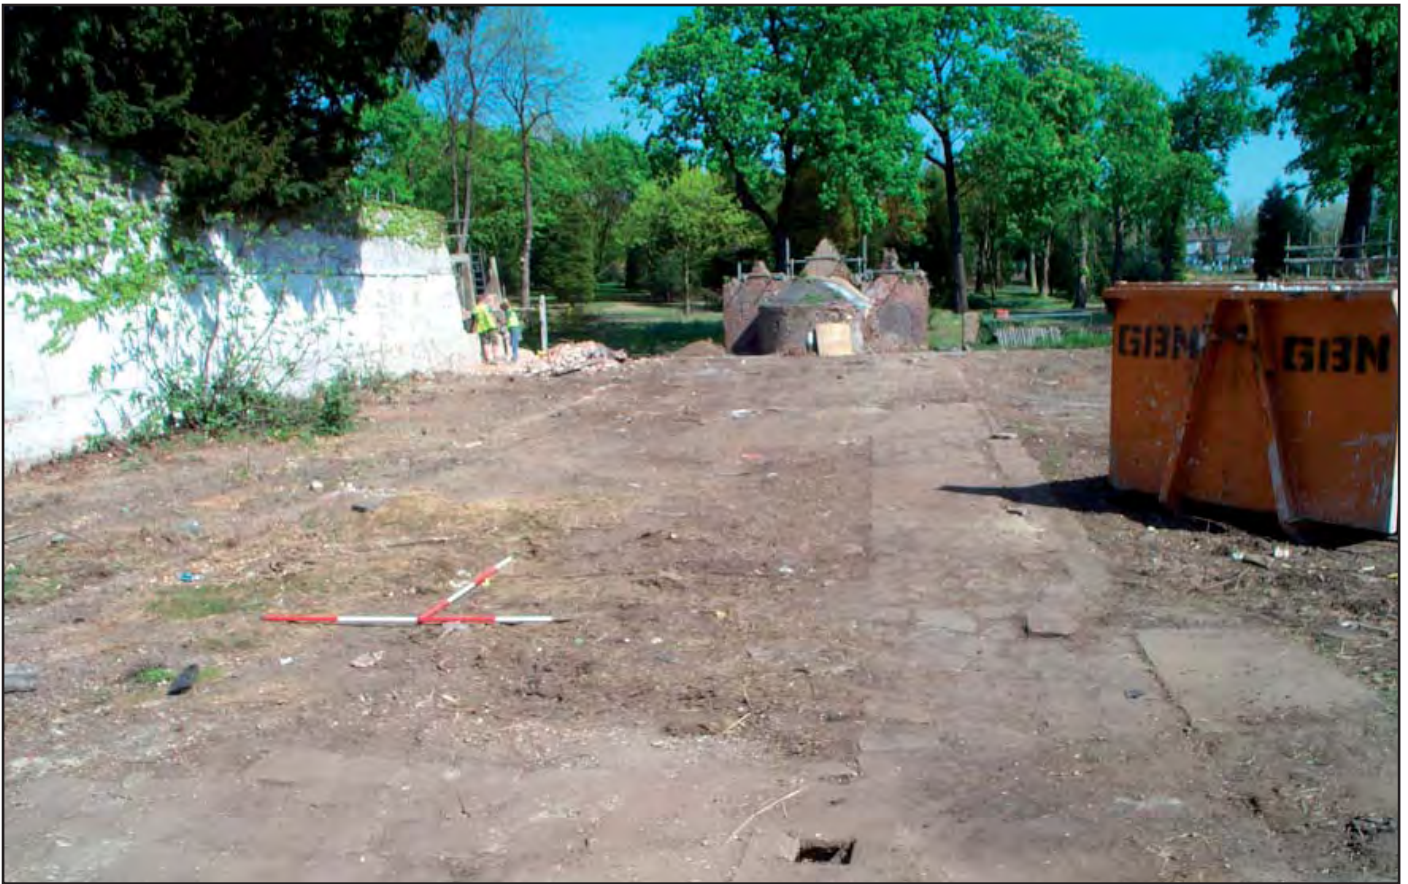
Plate 49: Trace of former structures in Kitchen Garden looking towards NE

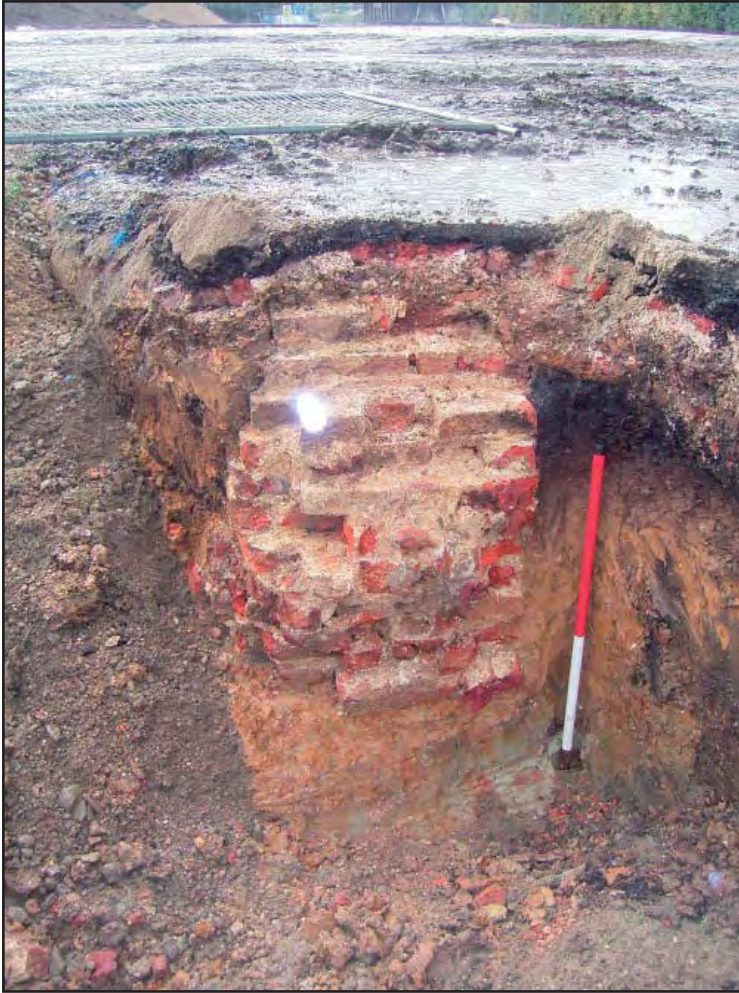
6.4.18 **Trench 31** was located in the southern half of the tennis court area (Figure 15, Plate 51). It measured approximately 4m x 2.5m on a roughly north-south alignment and two short sections of wall foundation were revealed (5021) and (5022) which it appears were once connected but are now truncated by the machining in the current works. Each wall is between 0.6 and 0.7m wide and approximately 0.95m tall. They are cut into the natural which is a greyish yellow silty clay. Directly overlying both walls is approximately 0.10m of demolition/levelling material on which the modern tarmac surface of the tennis courts lies.

Plate 51: Truncated stub of wall (5021) in Trench 31 in Tennis Court Area
