Valentines Park Ilford

London Borough
of Redbridge

**Historic Building Recording and
Archaeological Watching Brief**

April 2009

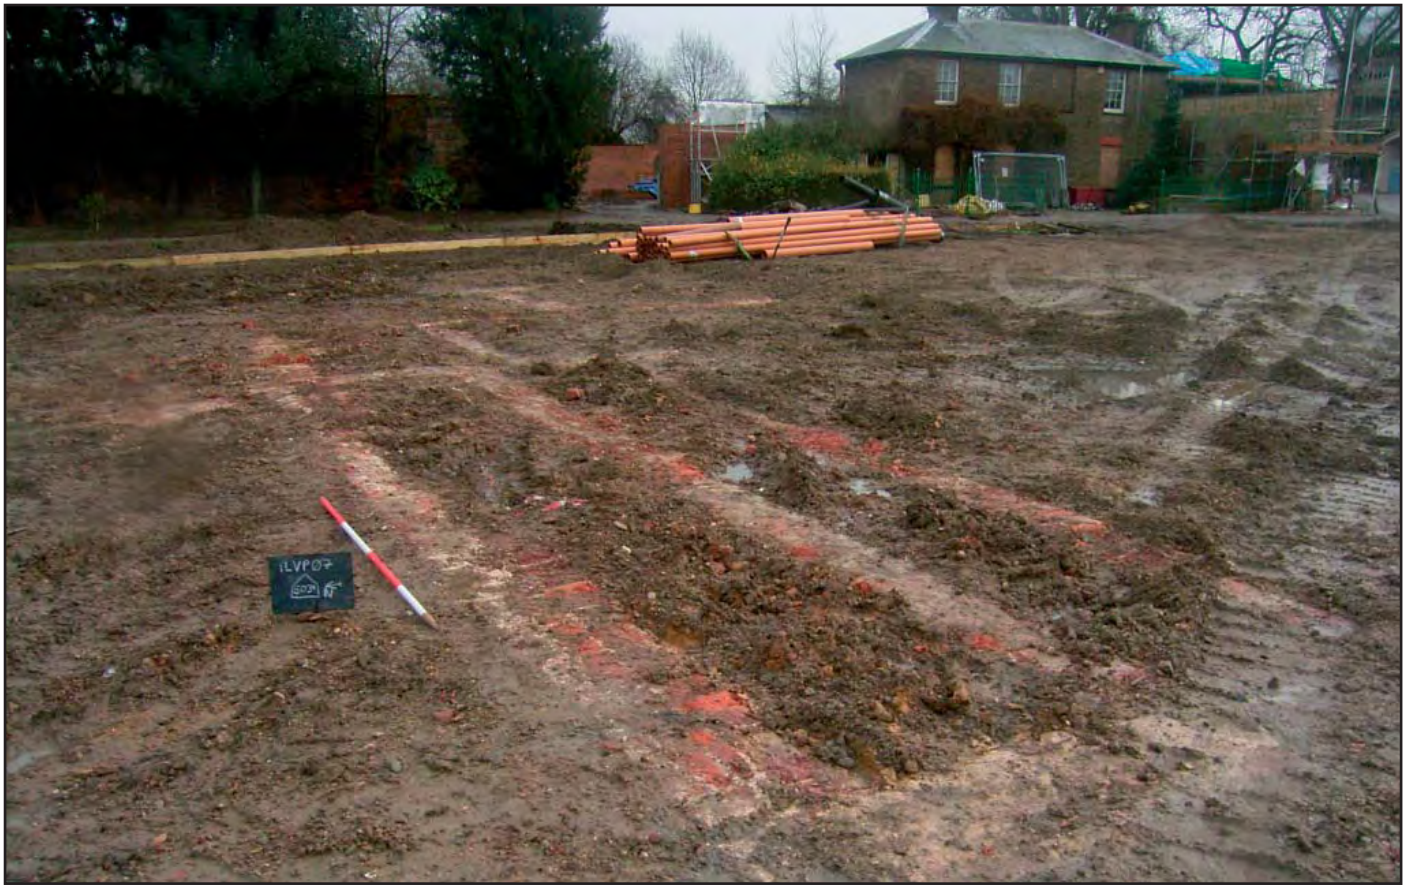
Plate 53: Footings (5034) exposed in Tennis Court Area viewed from north

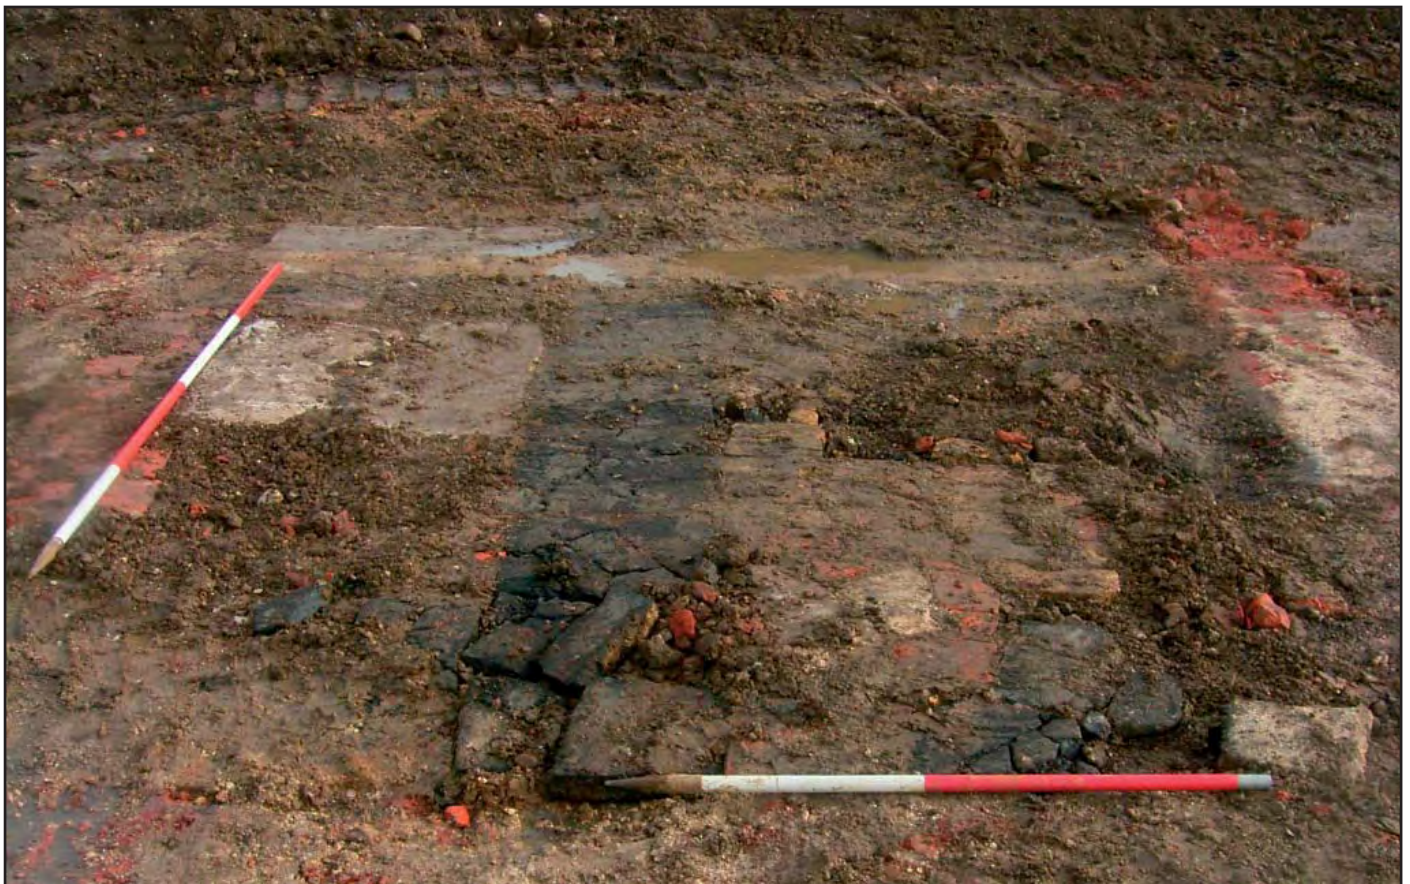
Plate 54: Footings (5035) of possible former blacksmiths in Tennis Court Area

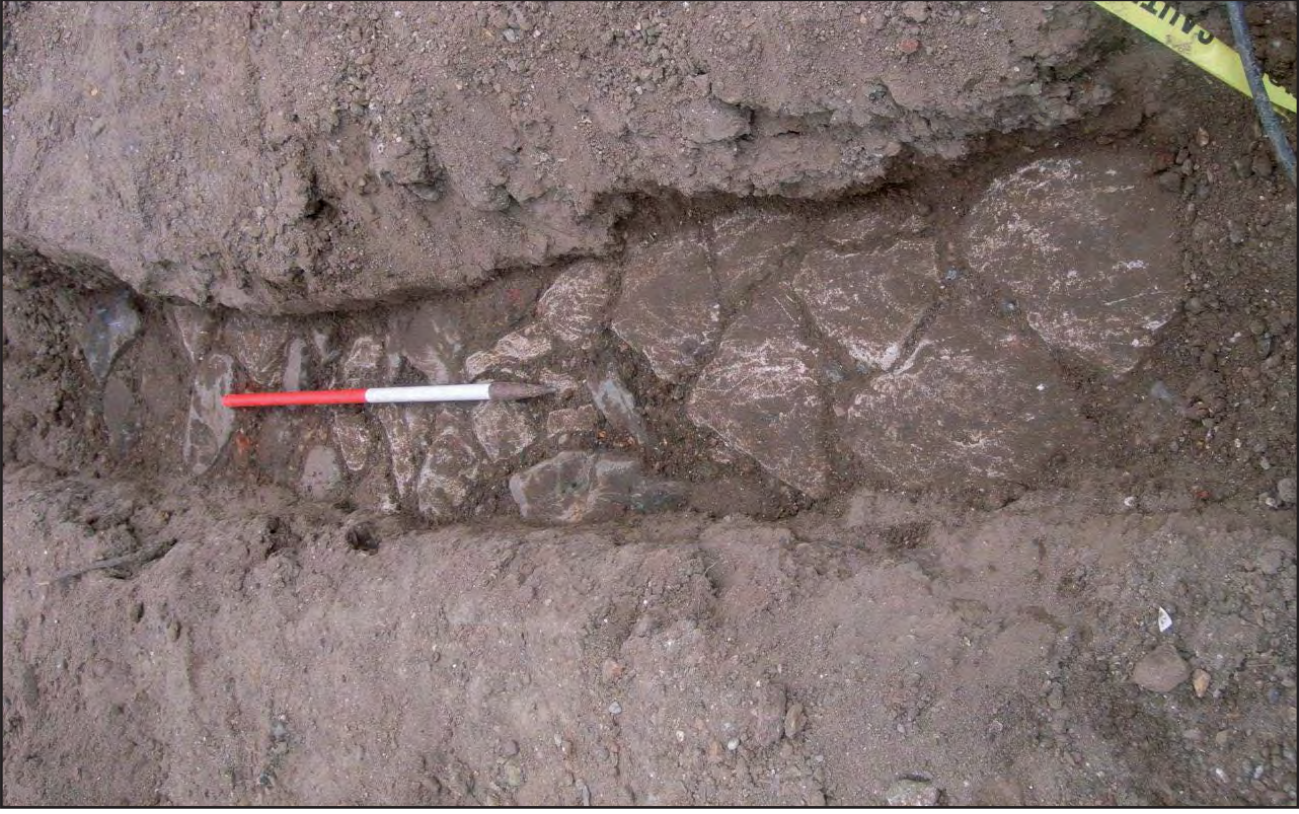
- 6.4.30 **North of the Dovecote** - A cable trench was excavated approximately 8.5 m north west of the Dovecote. Beneath a layer of sandy silt 0.35 m in depth, a surface comprising irregular slabs of limestone and sandstone was exposed (Fig 18, Plate 55). The stones are irregularly shaped (limestone average c.38 cm x 28 cm; sandstone average 30 x 20 cm) This appears to be a yard surface at least 3 m in width and is truncated to the north and south. It is probably of 18th or 19th century date.

Plate 55: Stone laid surface exposed to north of Cottage
