The Stables Coleshill Estate Oxfordshire

Historic Building Investigation and Recording

May 2017

Client: National Trust

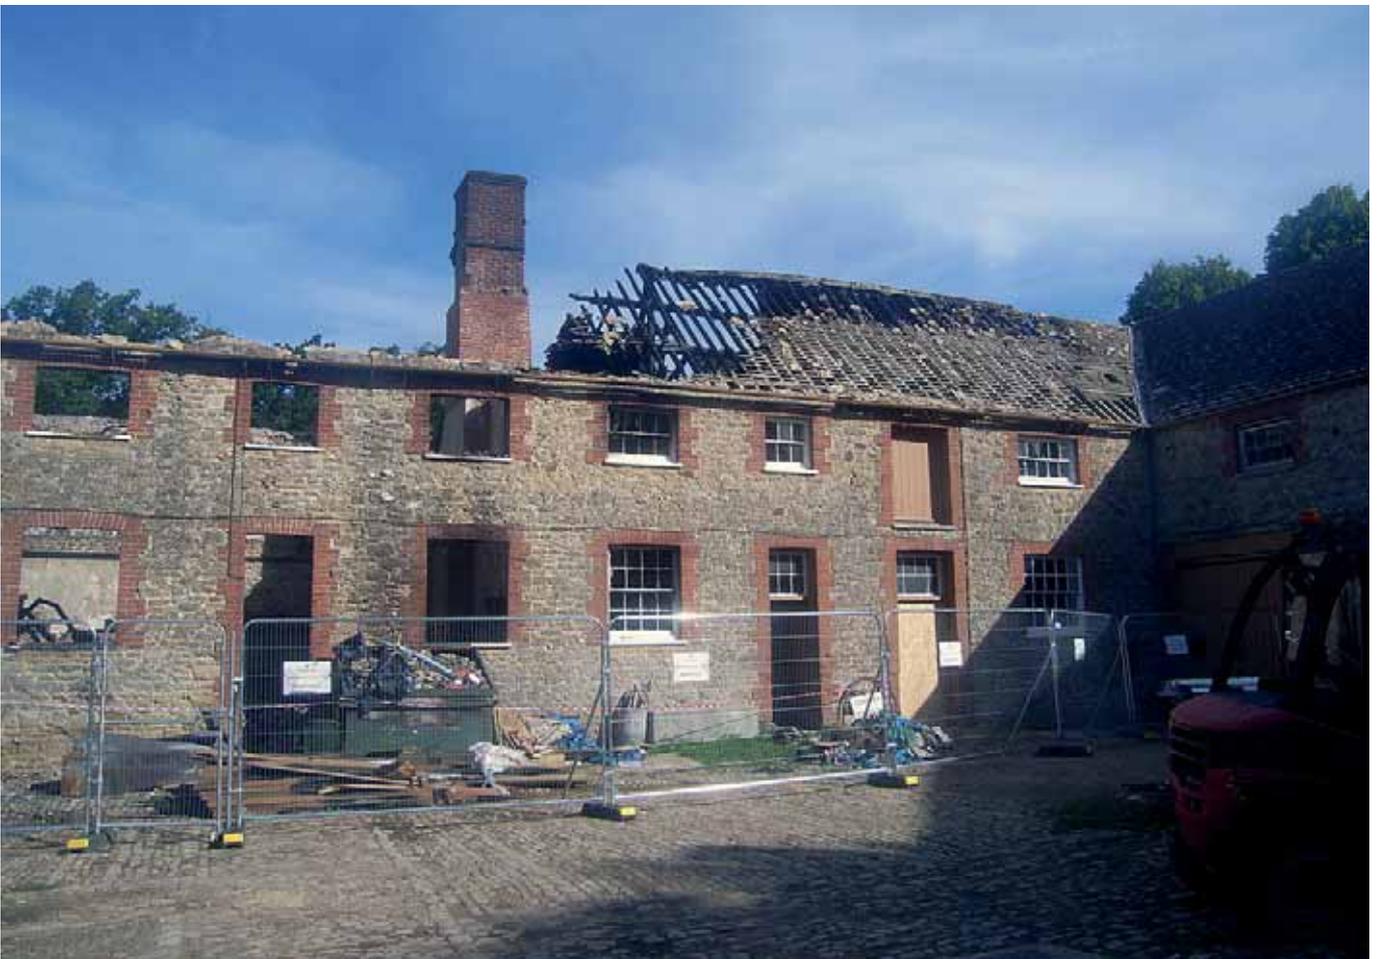
Plate 2: South side of North Range of stableyard, before erection of scaffolding

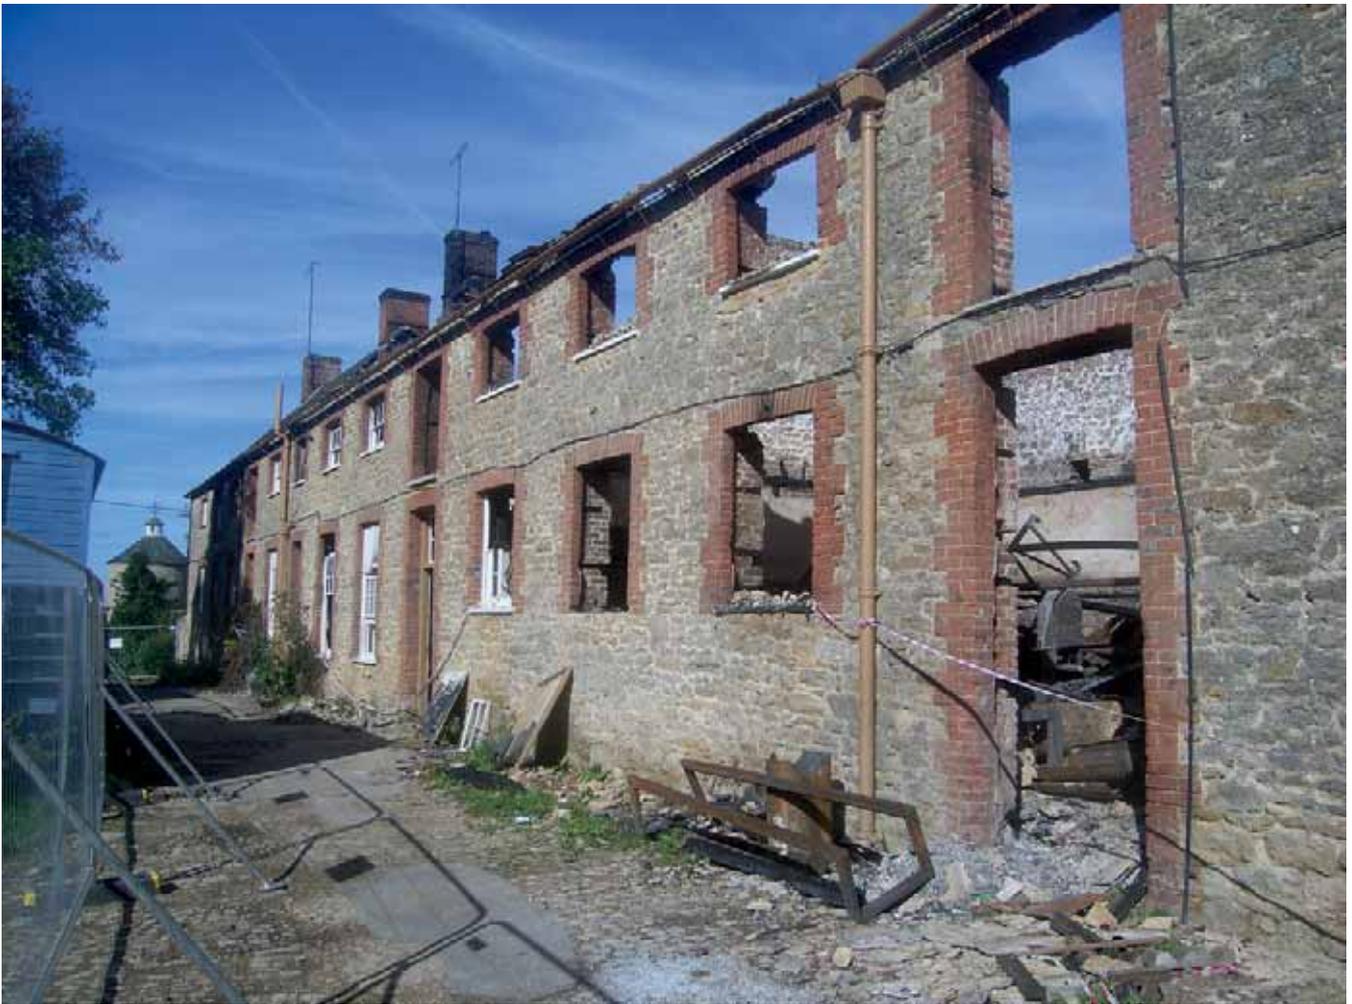
Plate 3: South wall of North Range of stableyard

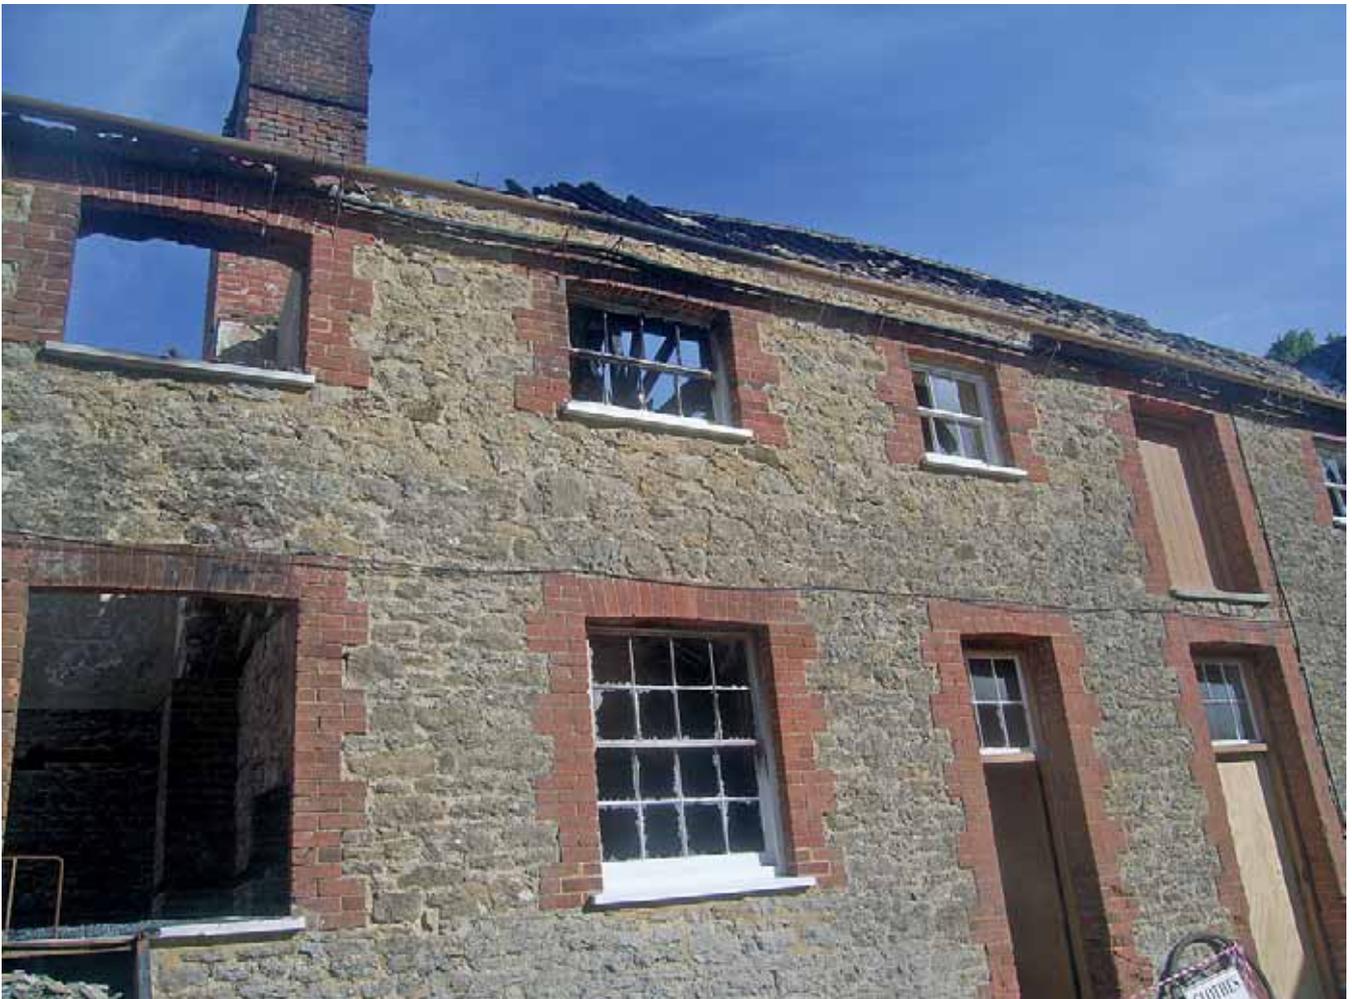
Plate 4: Part of south wall of North Range

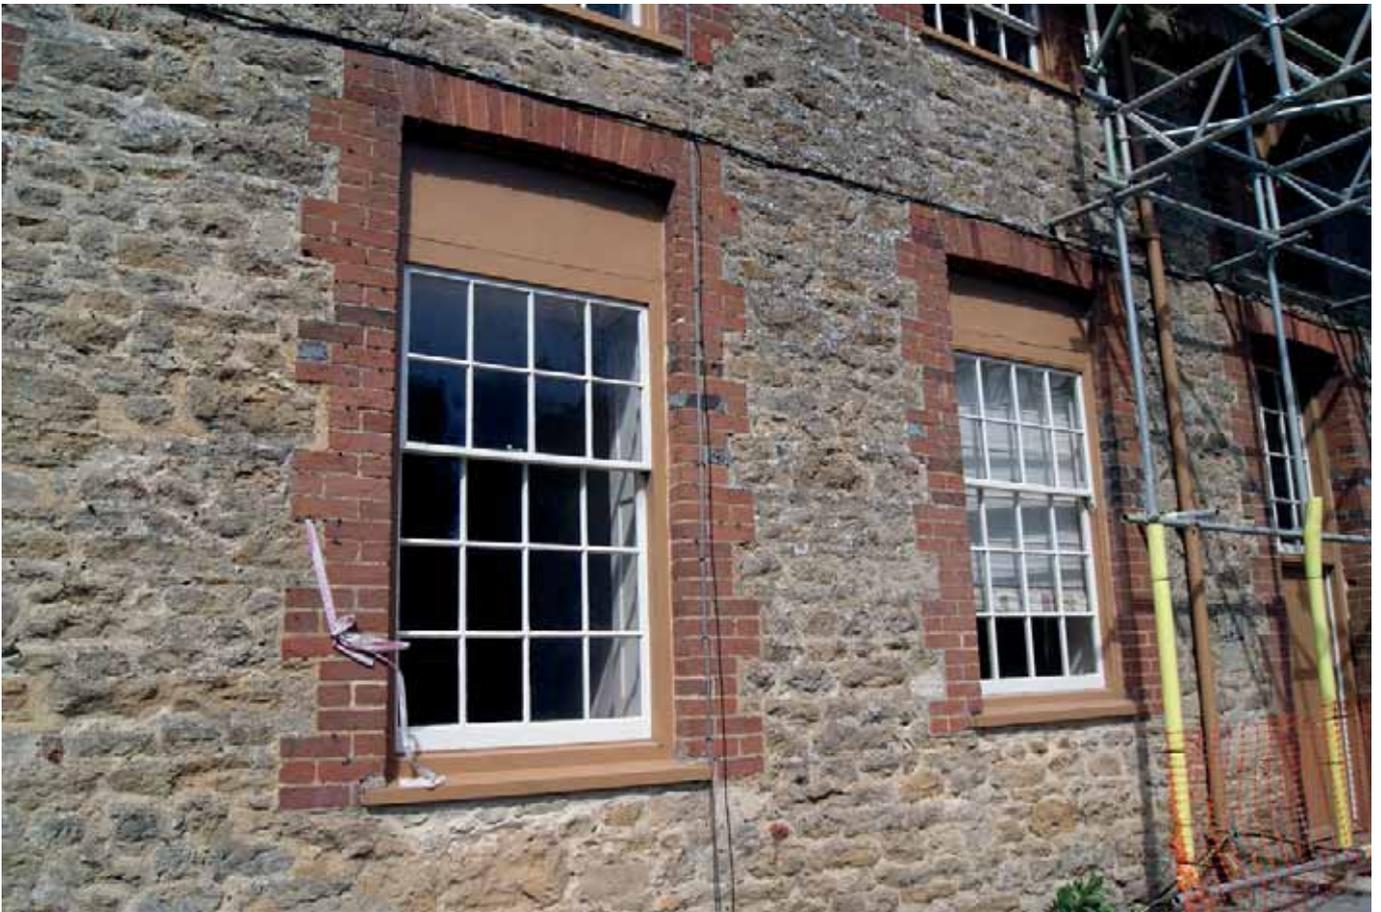
Plate 5: Windows in North Range of Stableyard in area not damaged by fire

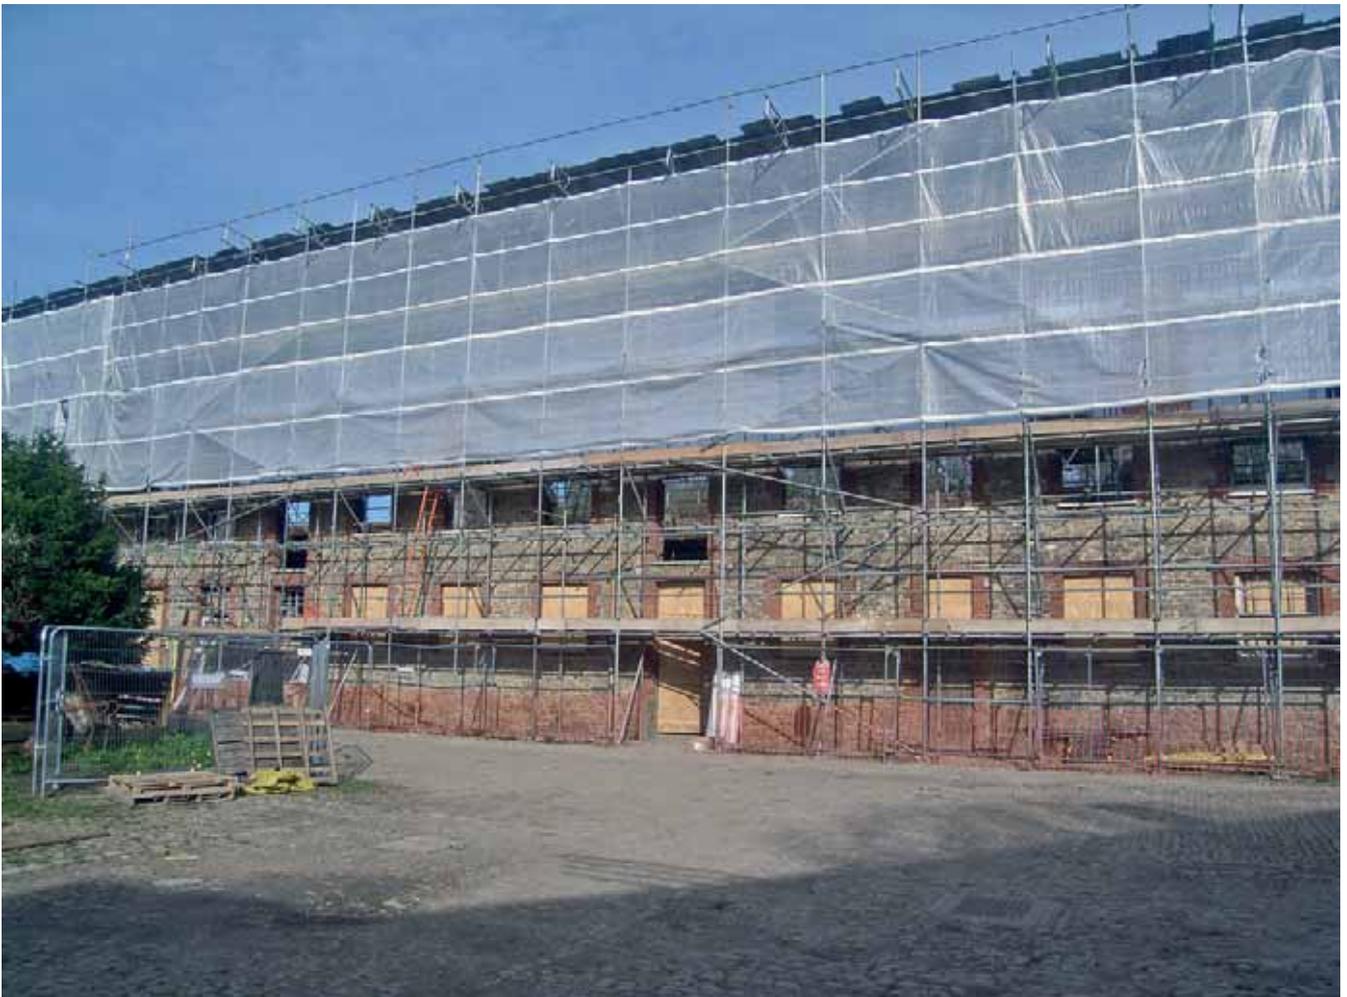
Plate 6: General view of south wall after erection of scaffolding

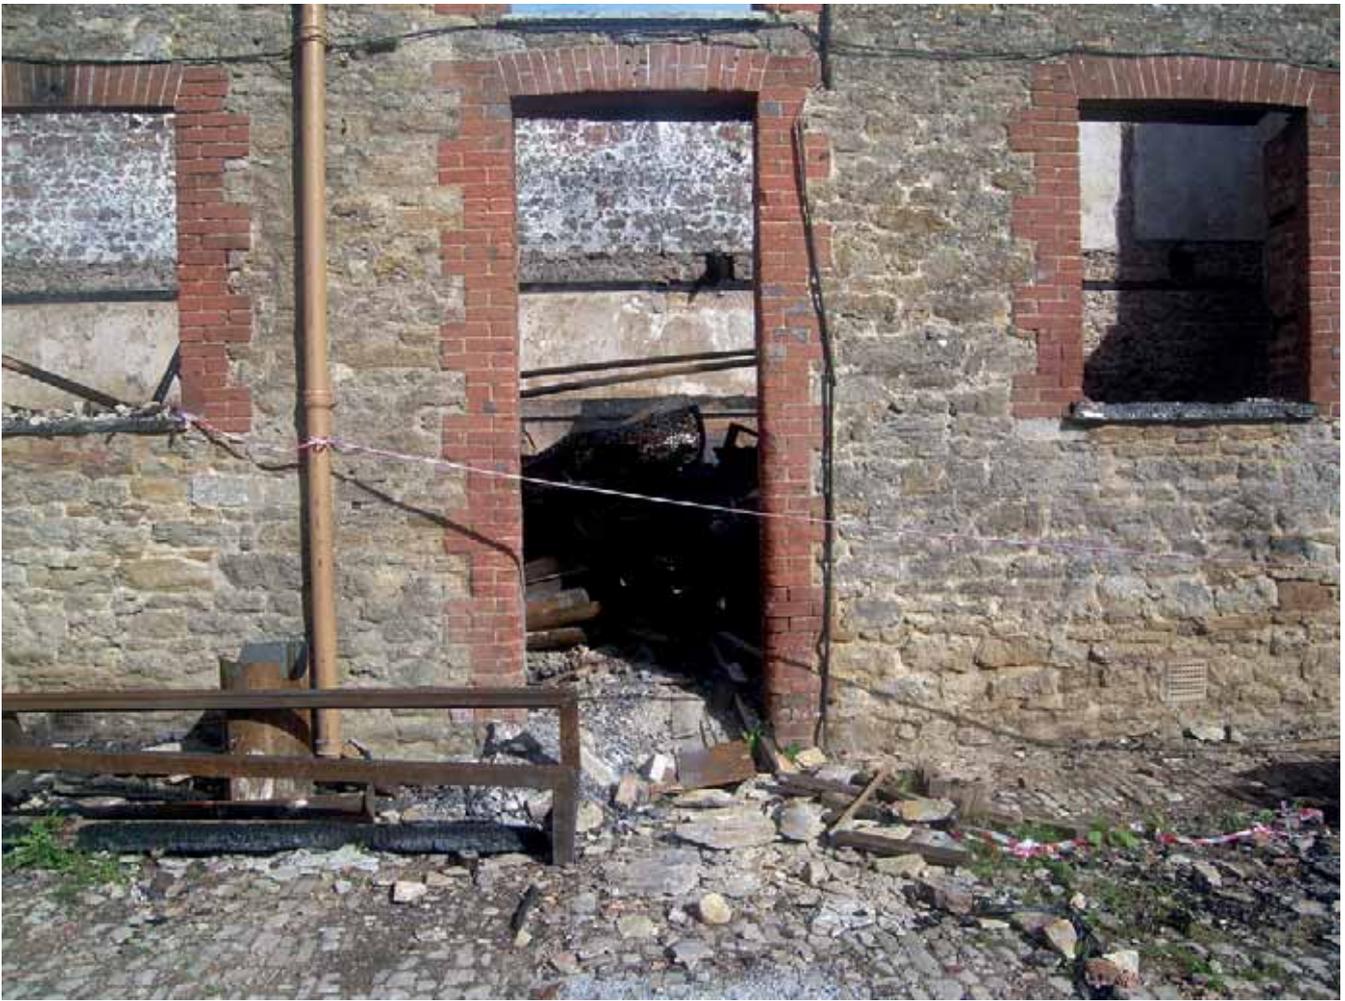
Plate 7: Typical doorway in south wall before erection of scaffolding

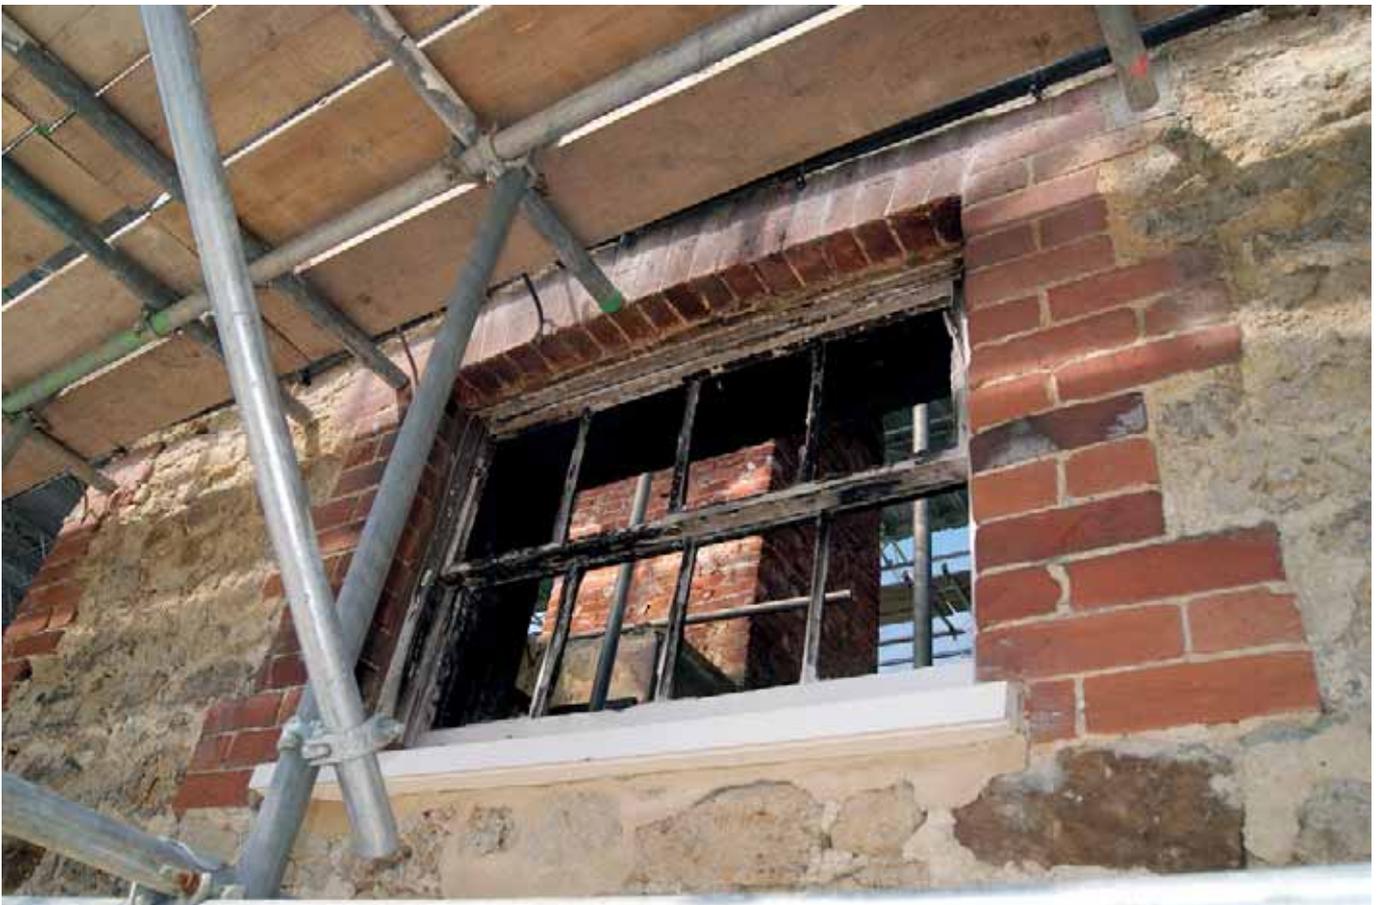
Plate 8: Typical window towards west end of south wall

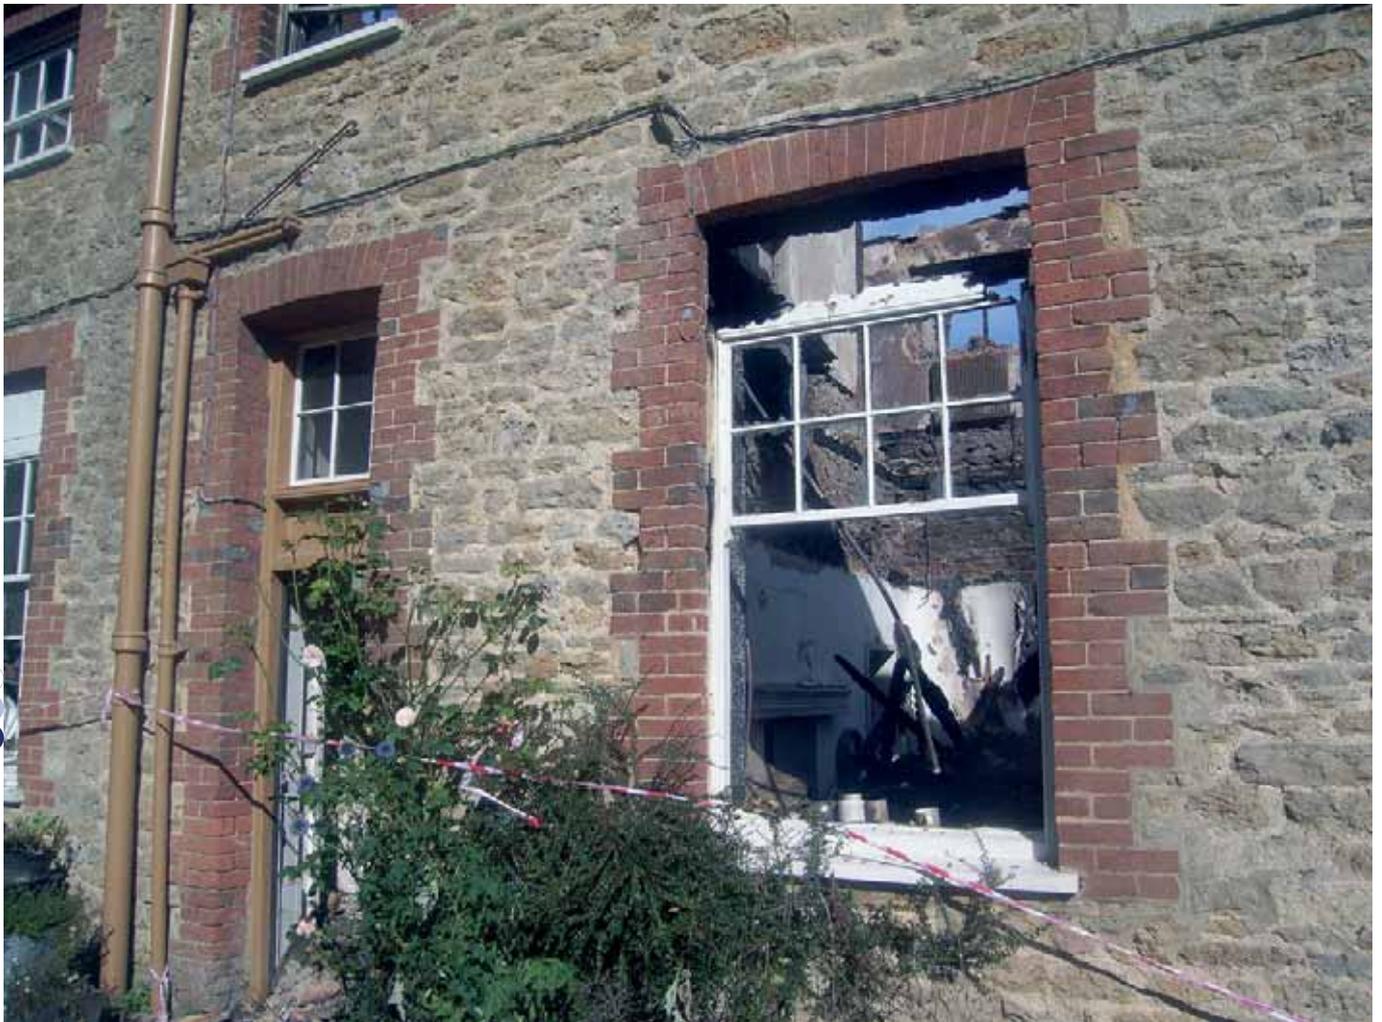
Plate 9: Window and door towards west end of range

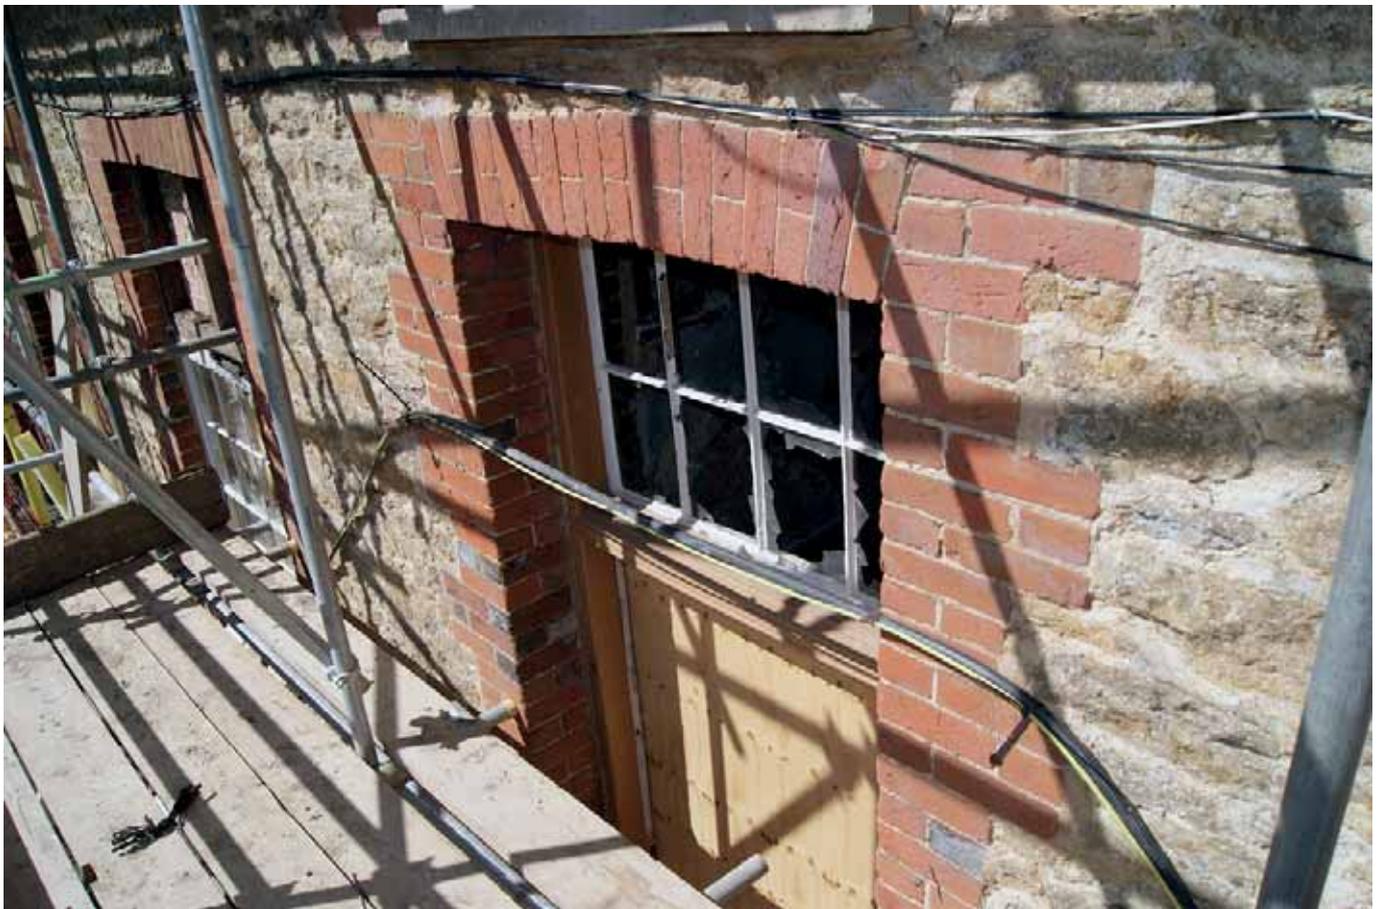
Plate 10: Typical lintel and doorway in North Range

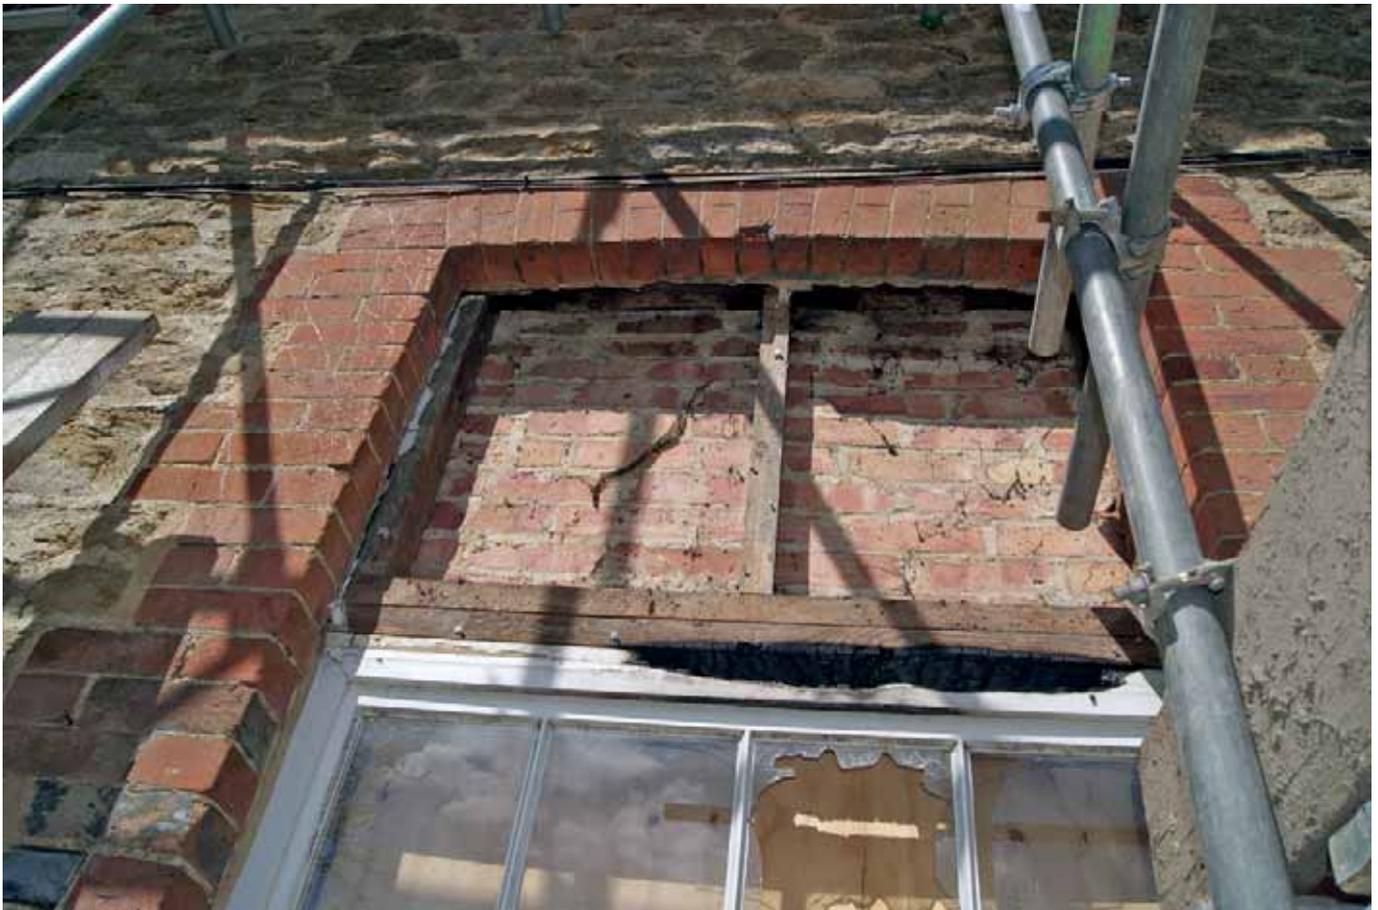
Plate 11: Window to G5 with infilled upper section due to lower inserted ceiling

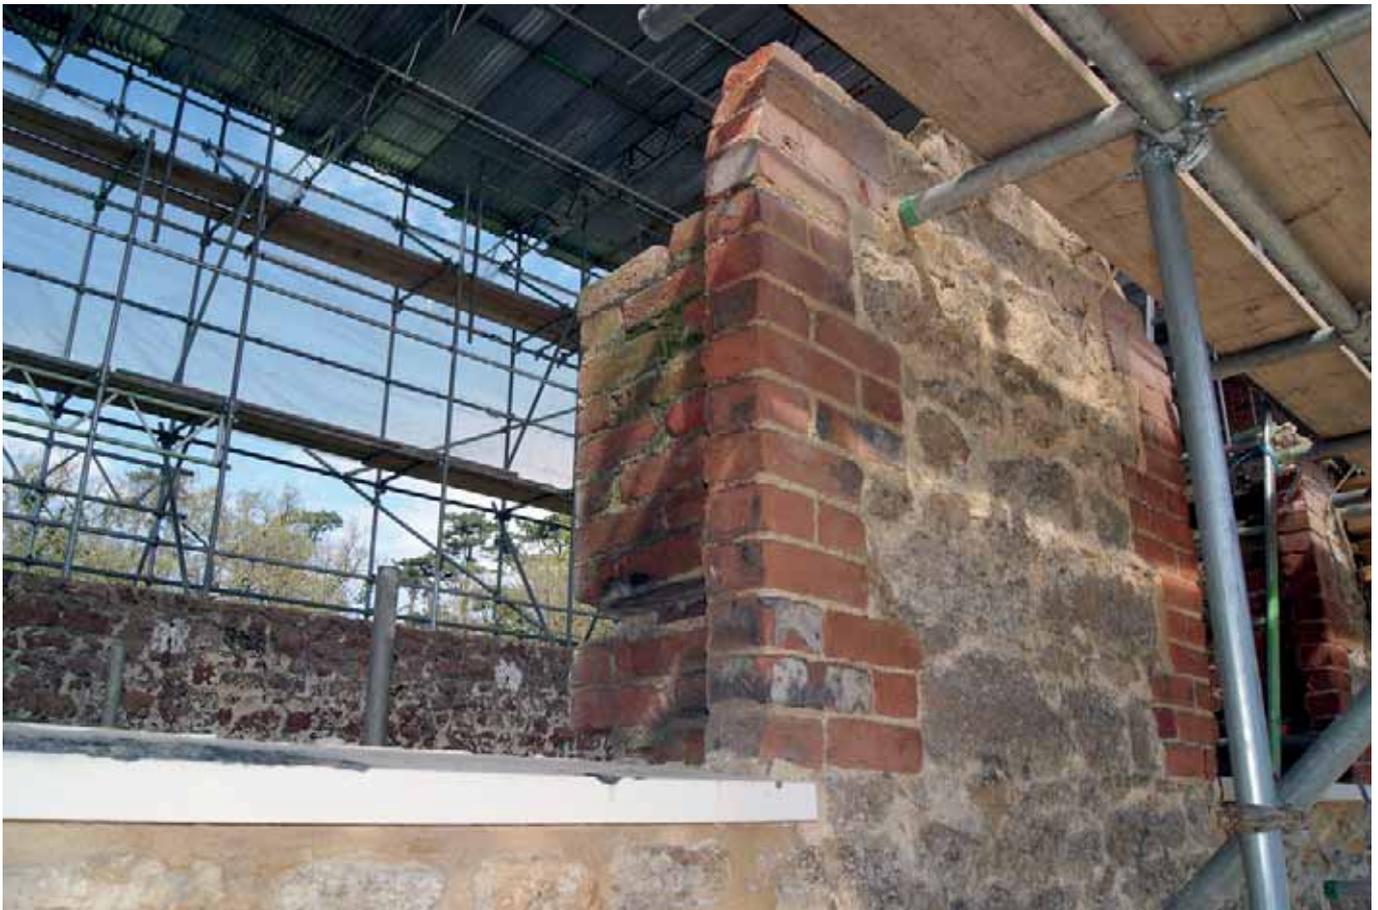
Plate 12: Typical first floor window jambs facing south

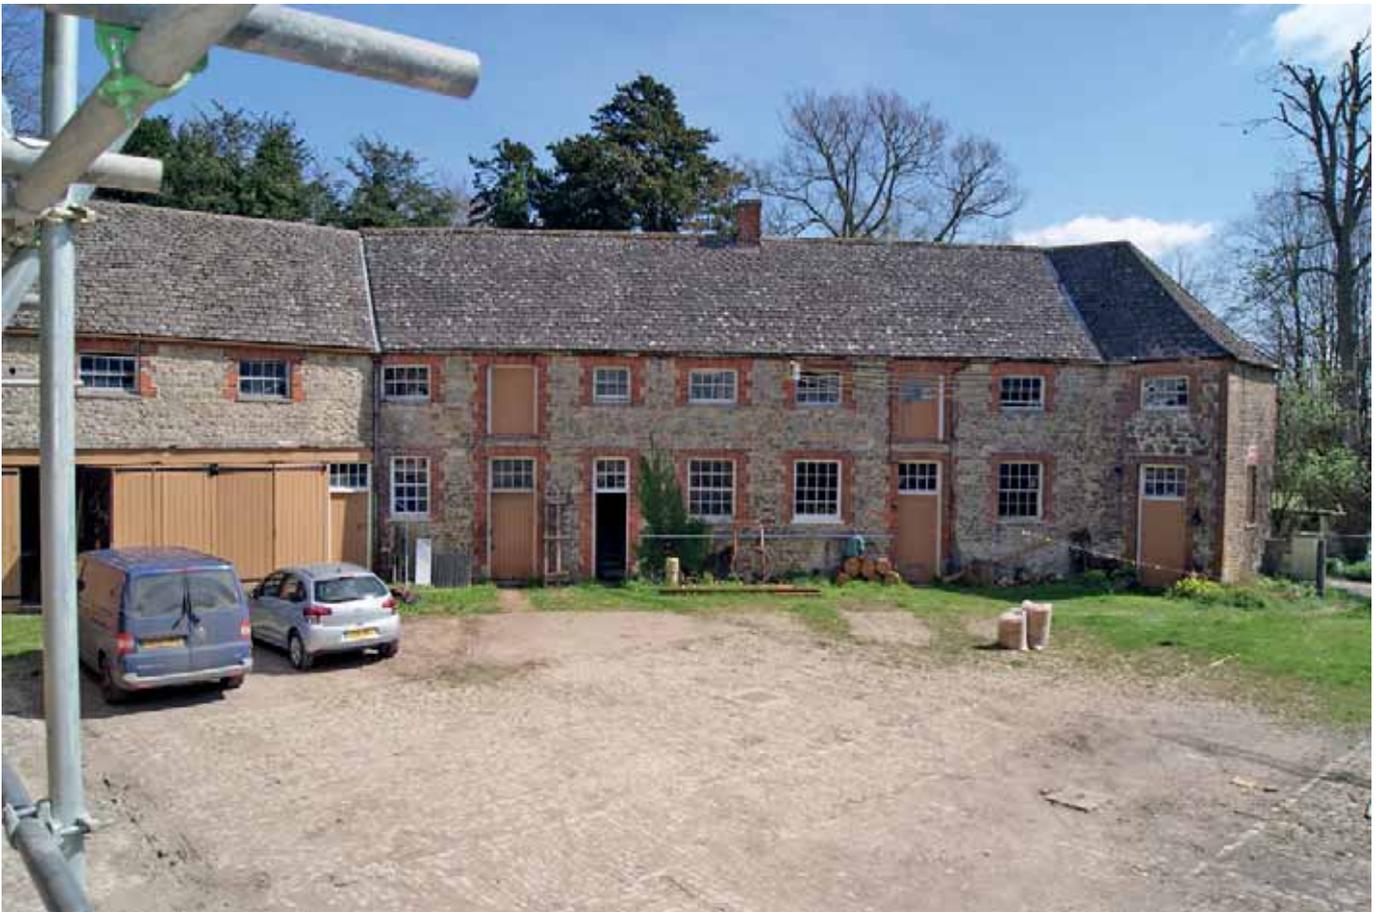
Plate 13: General view of eastern part of stableyard not damaged in fire

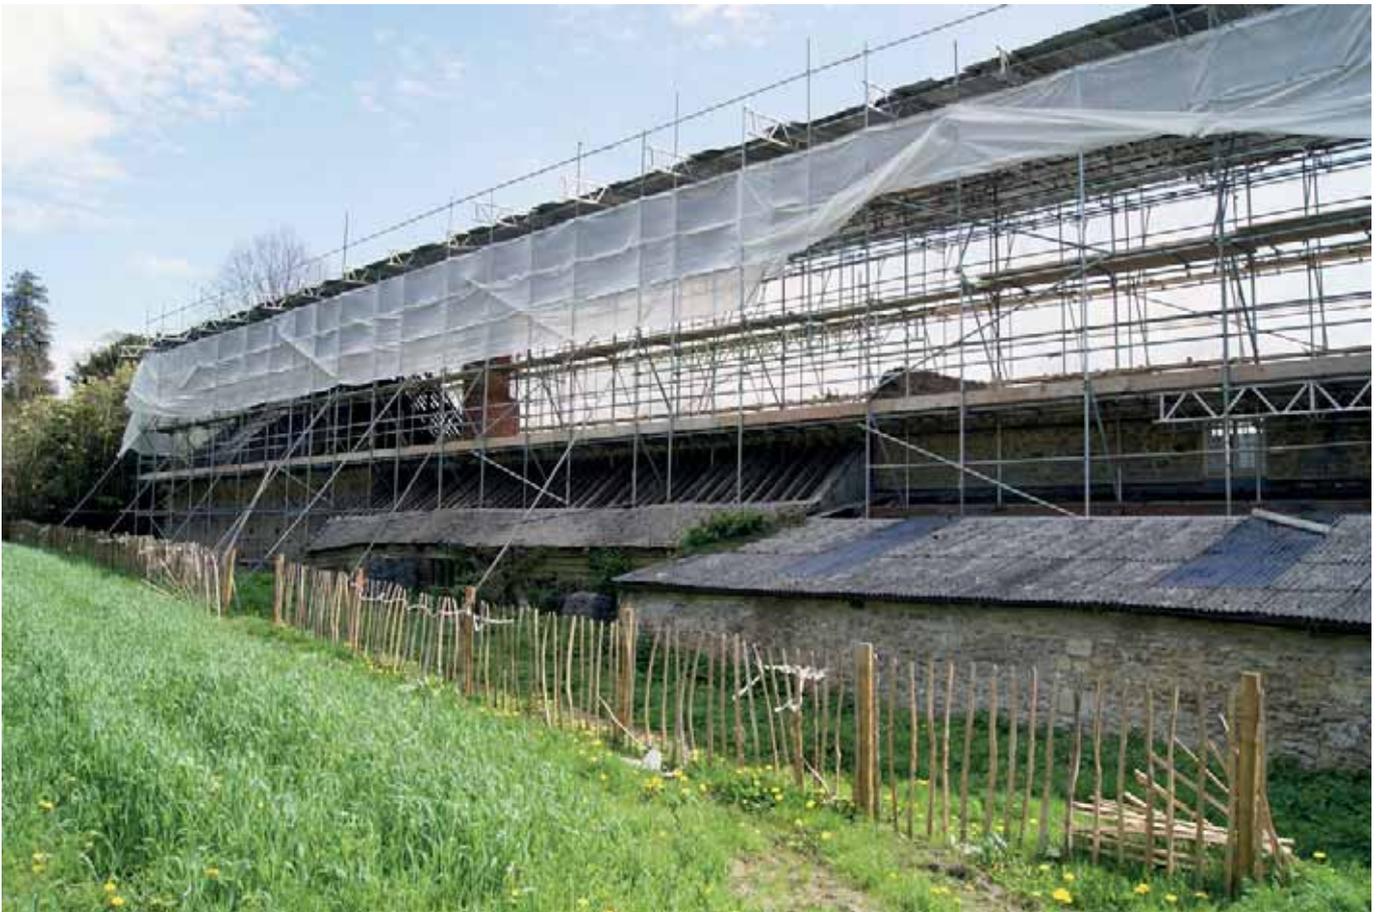
Plate 14: General view to rear (north)

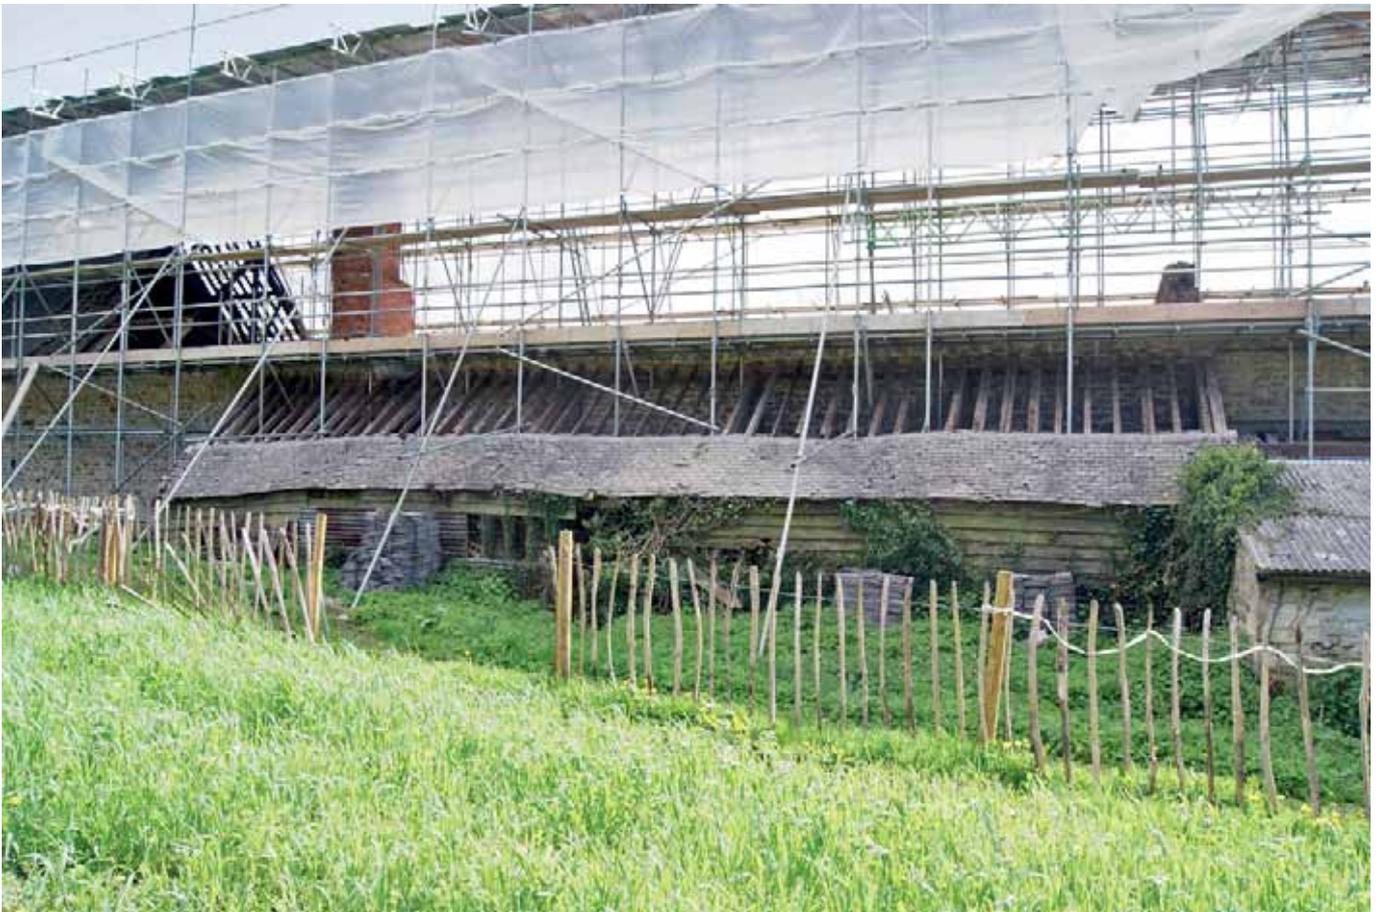
Plate 15: Narrower lean-to range to rear

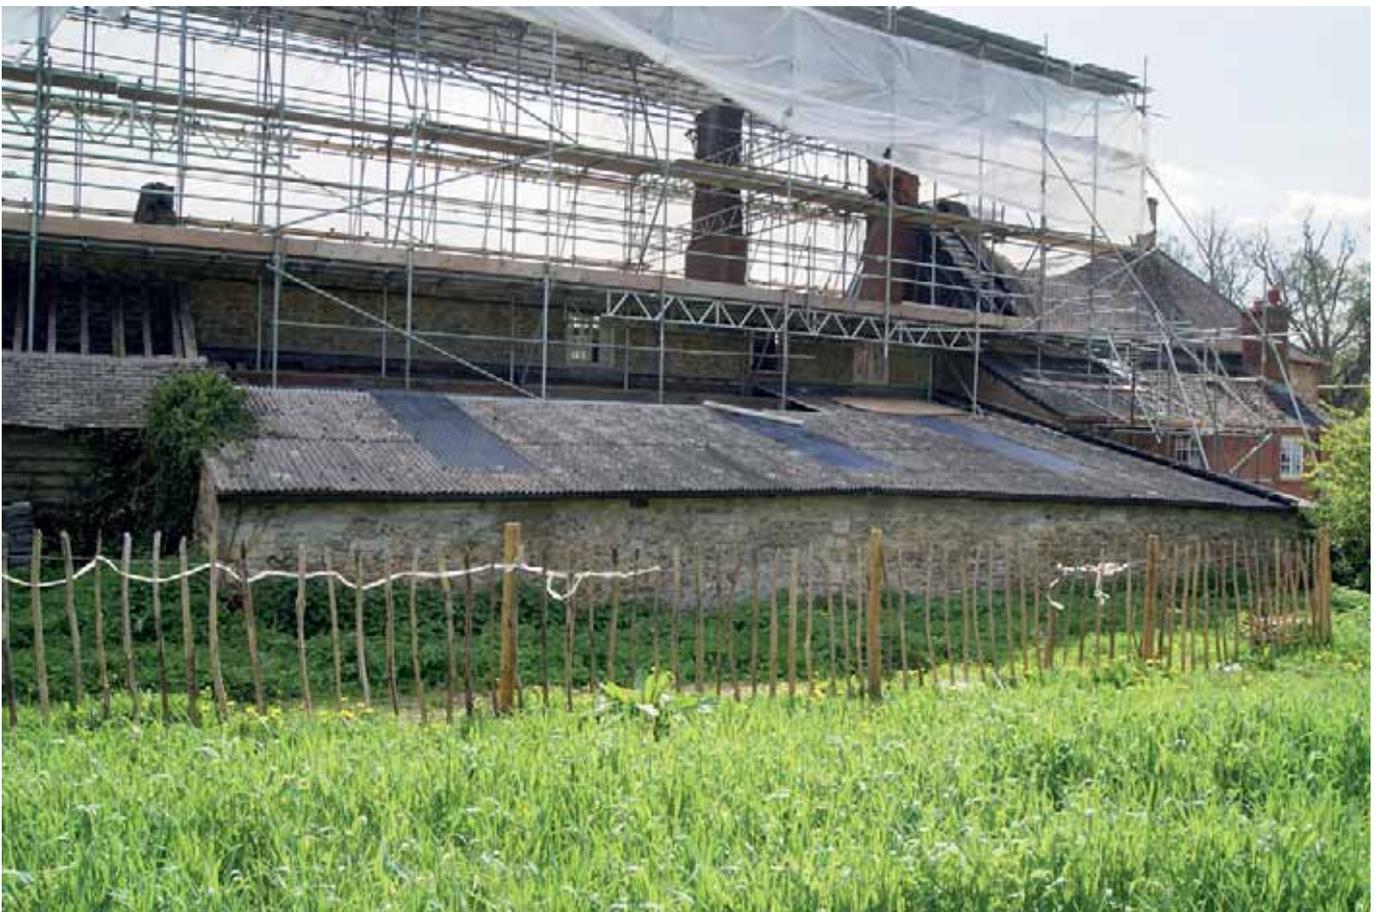
Plate 16: Wider lean-to range to rear

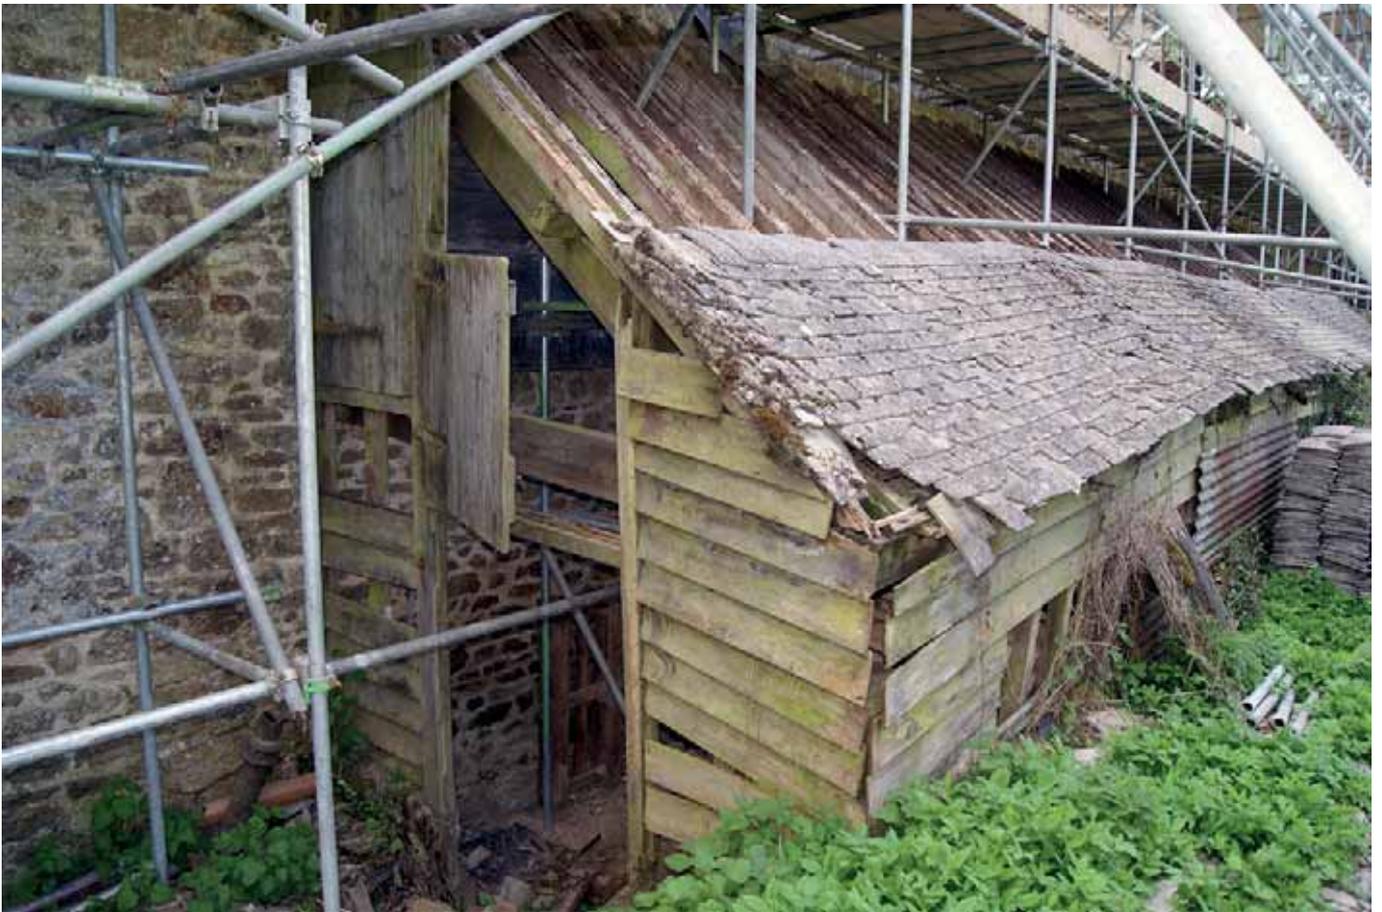
Plate 17: Doorway at east end of narrow lean-to range

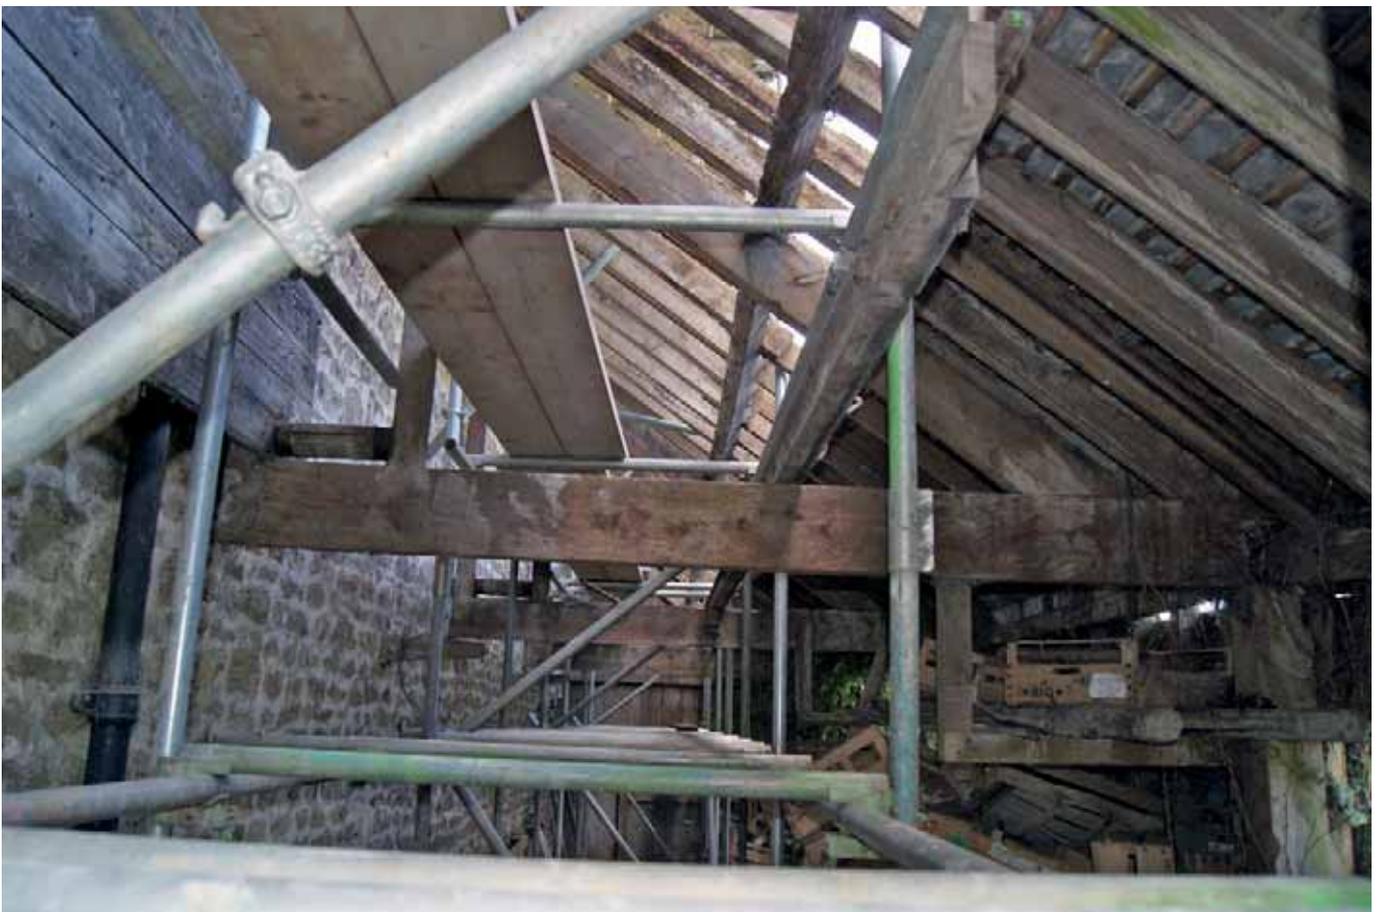
Plate 18: Interior of narrow lean-to range
