The Stables Coleshill Estate Oxfordshire

Historic Building Investigation and Recording

May 2017

Client: National Trust

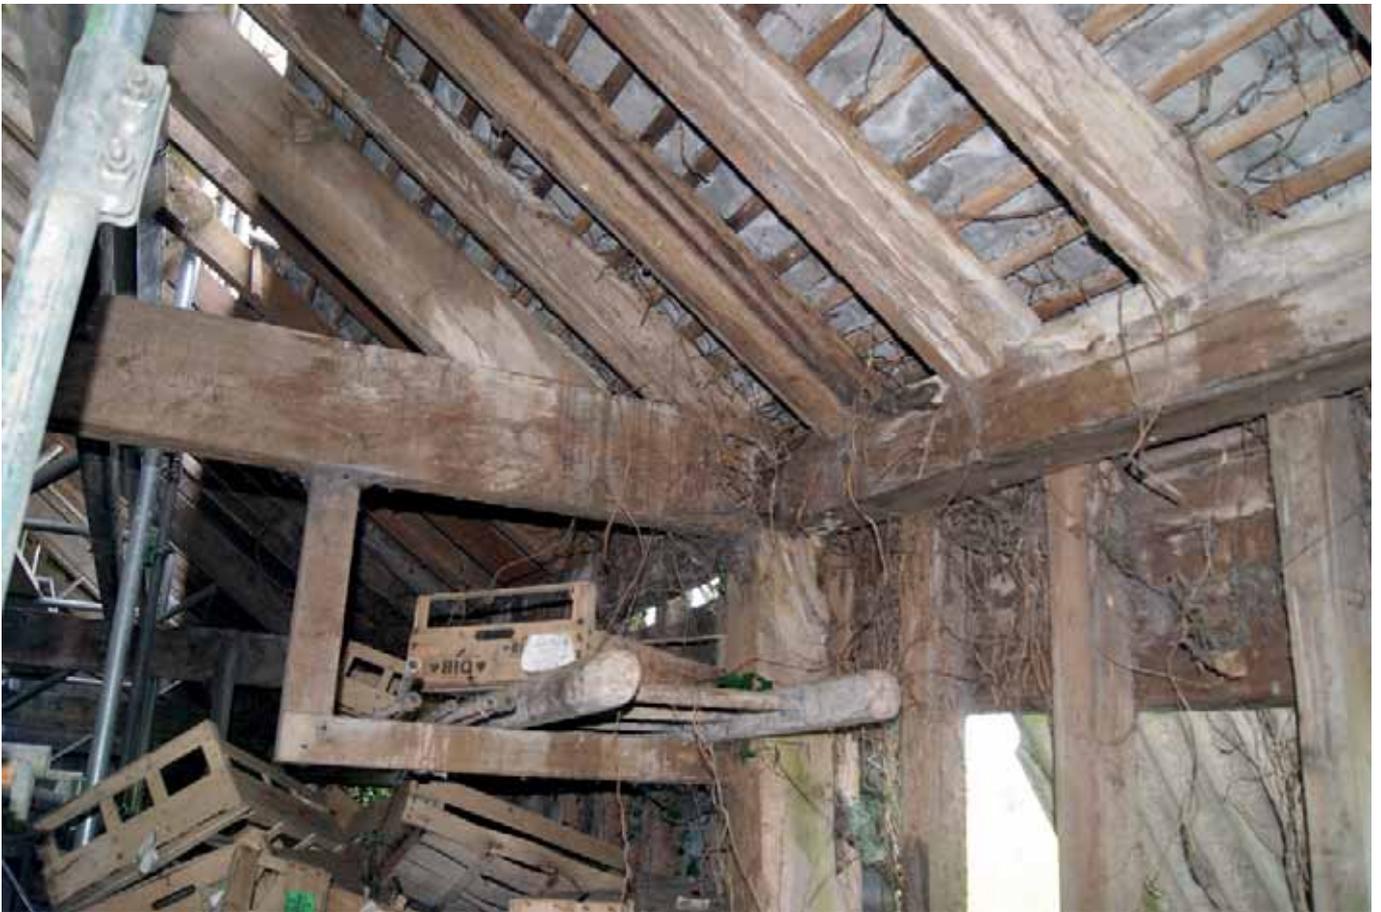
Plate 19: Internal detail of narrow lean-to range

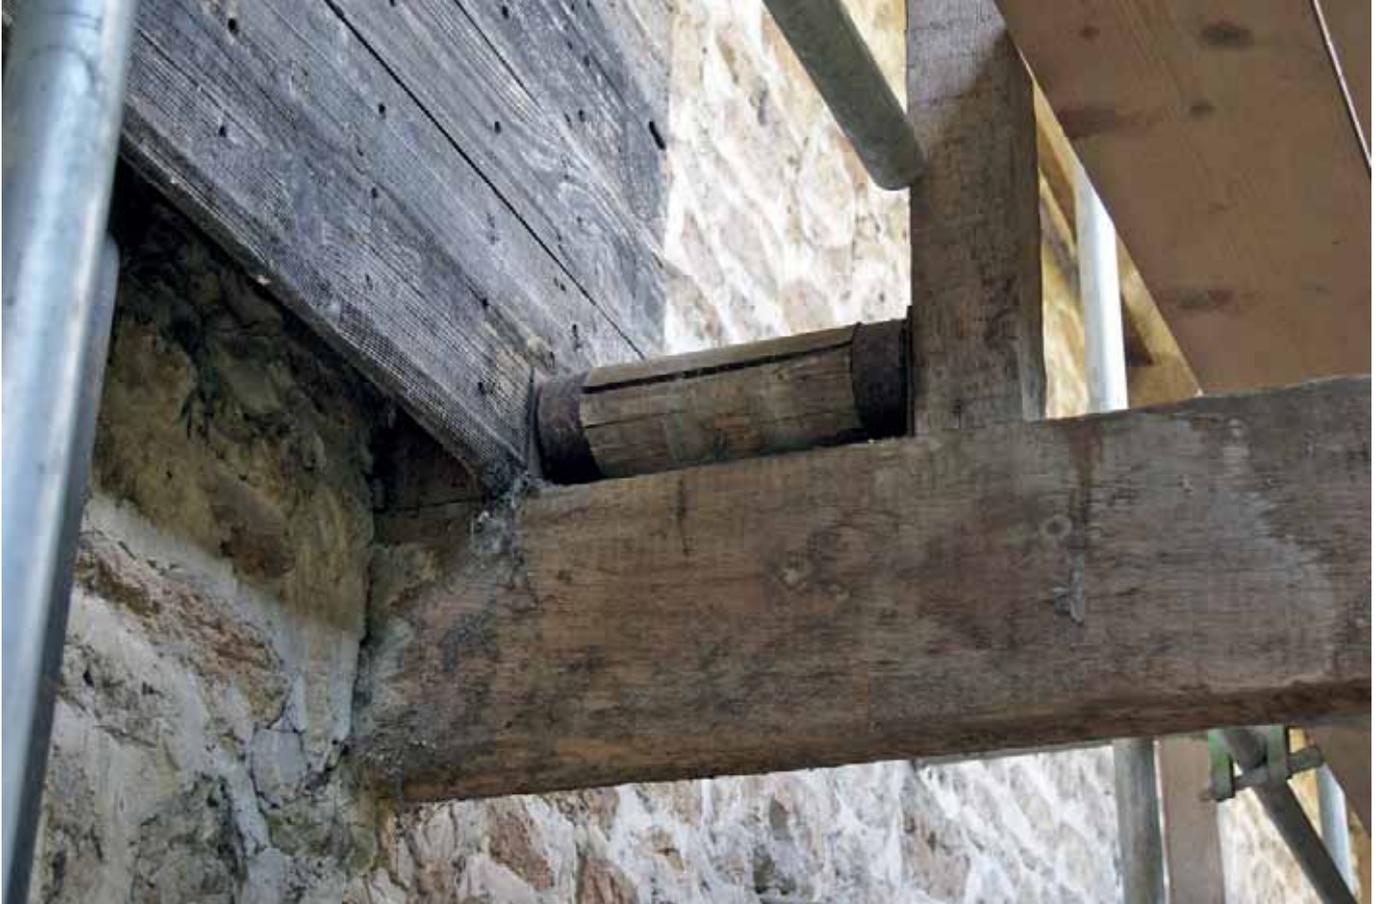
Plate 20: Roller in narrow lean-to from possible former conveyor belt

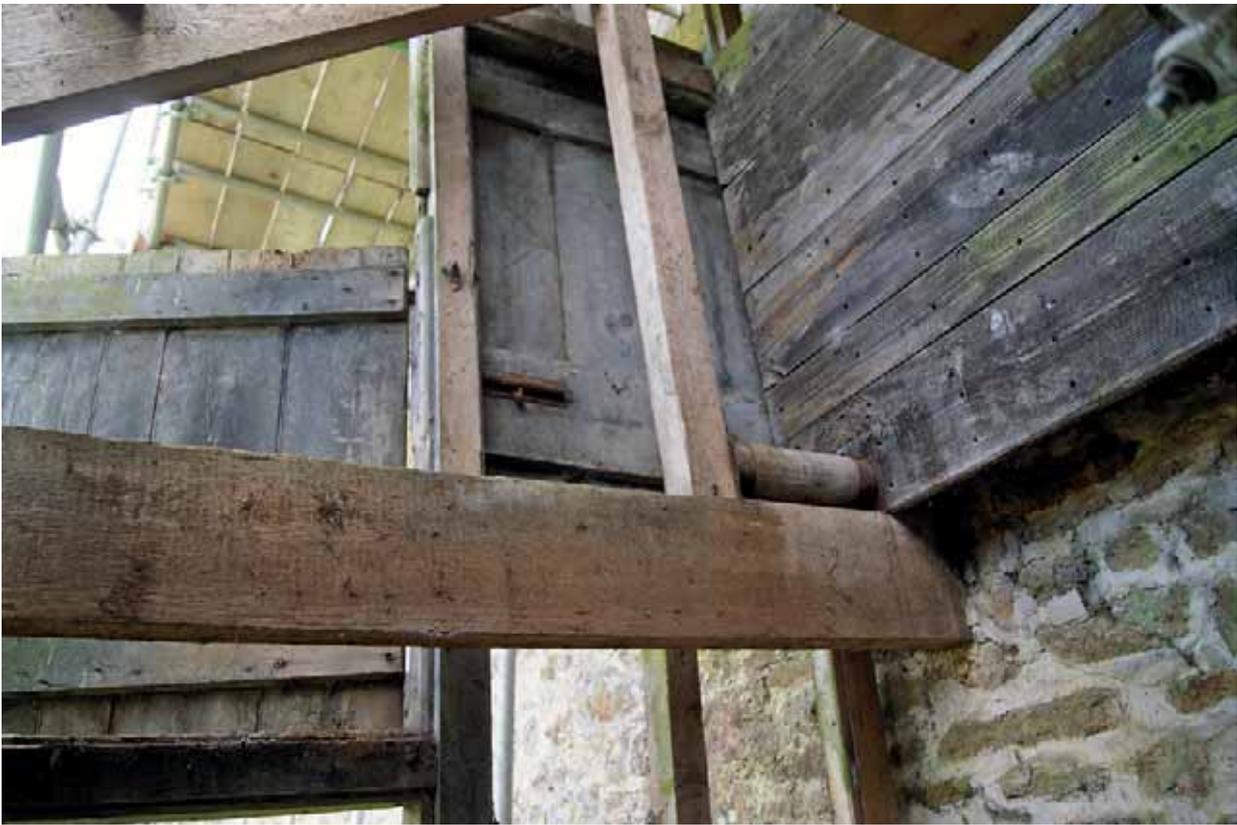
Plate 21: Roller and door in narrow lean-to

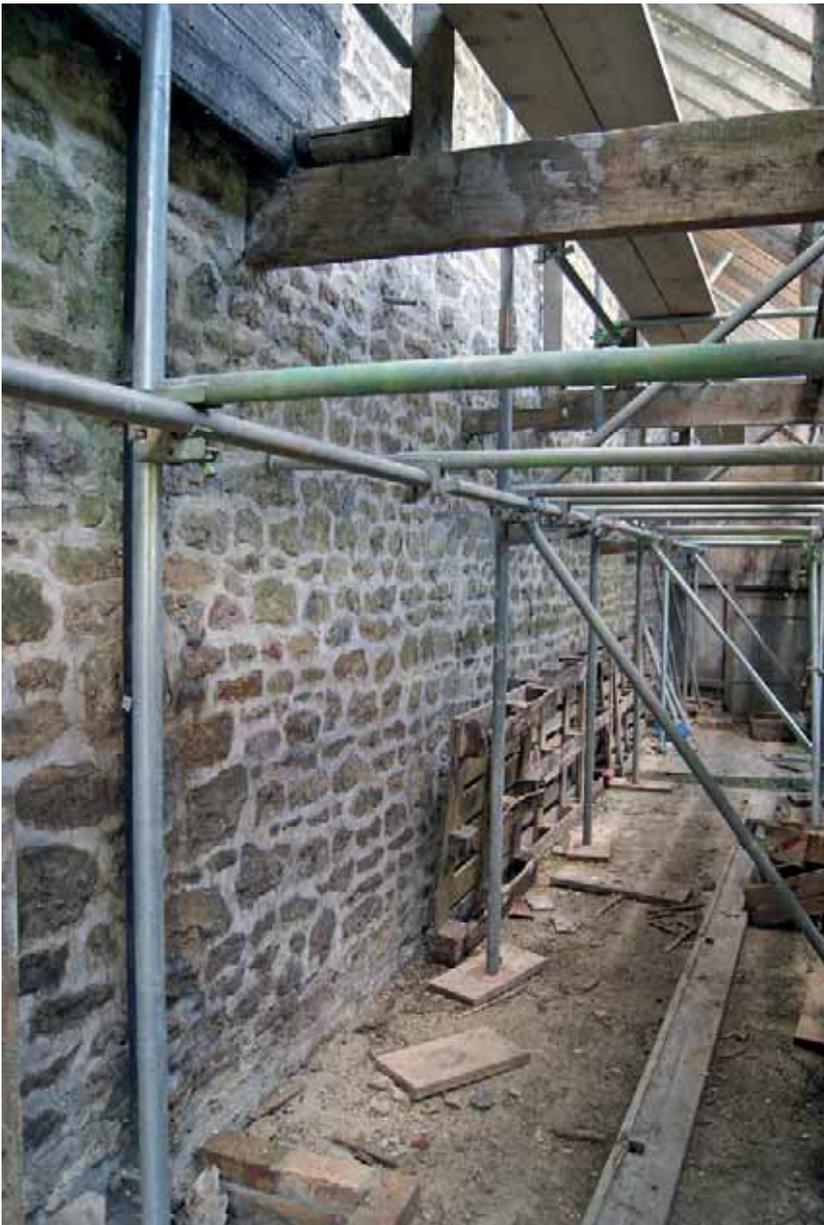
Plate 22: General view within narrow lean-to

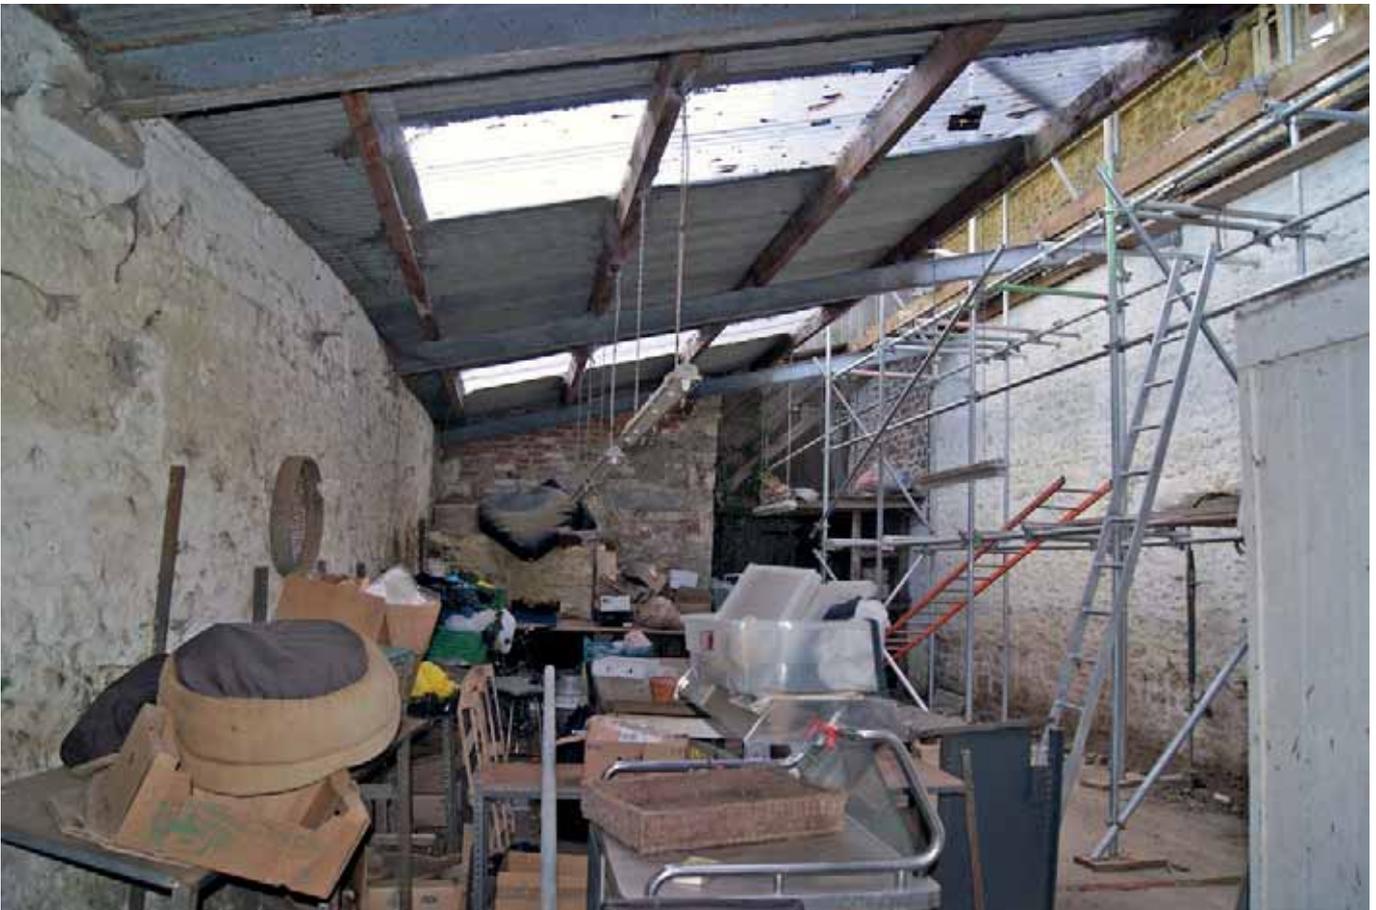
Plate 23: General view within wider lean-to

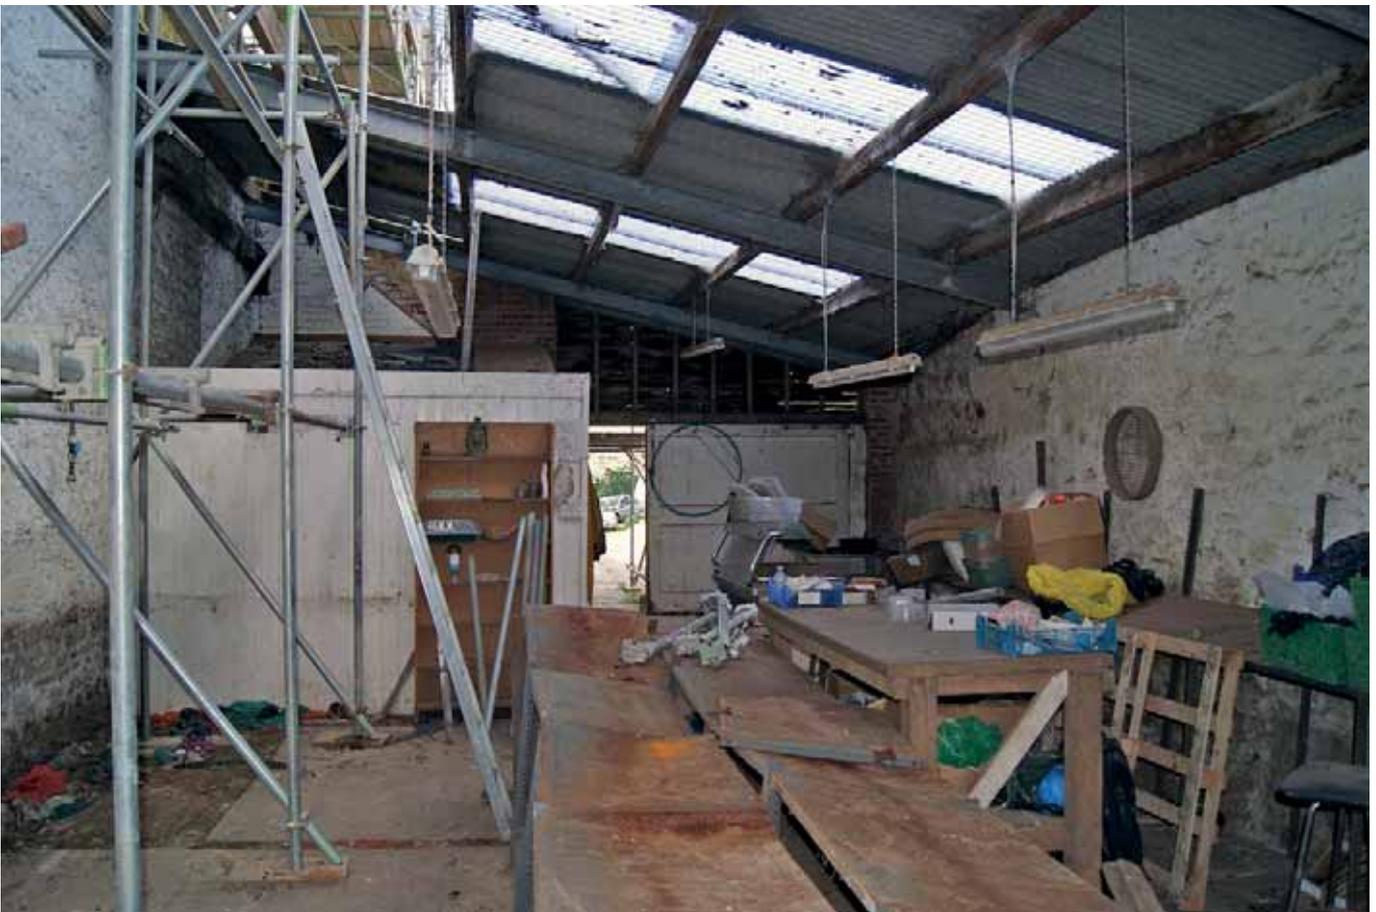
Plate 24: General view within wider lean-to

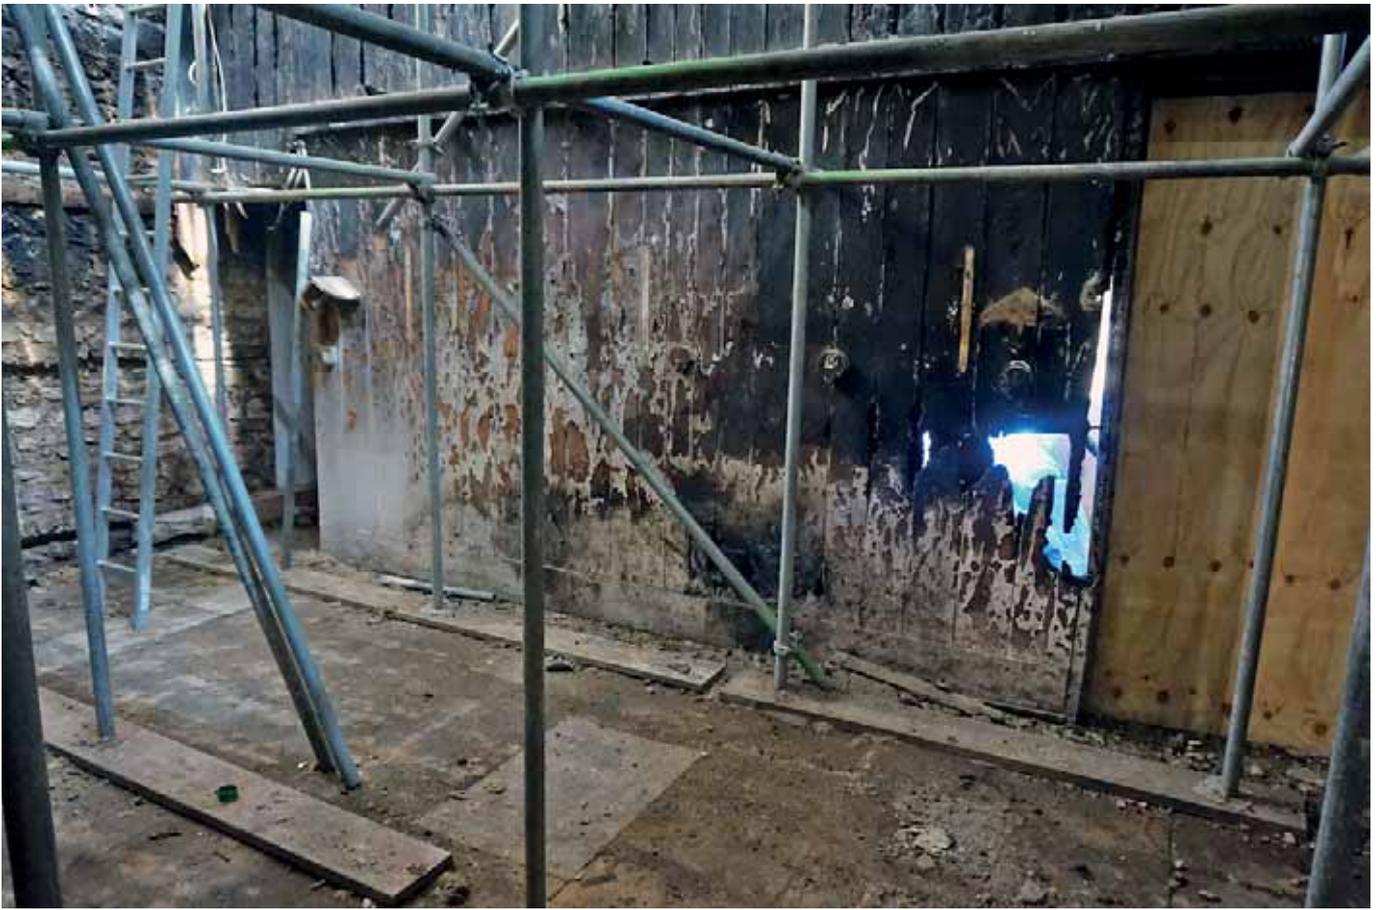
Plate 25: East side of former Harness Room (G1)

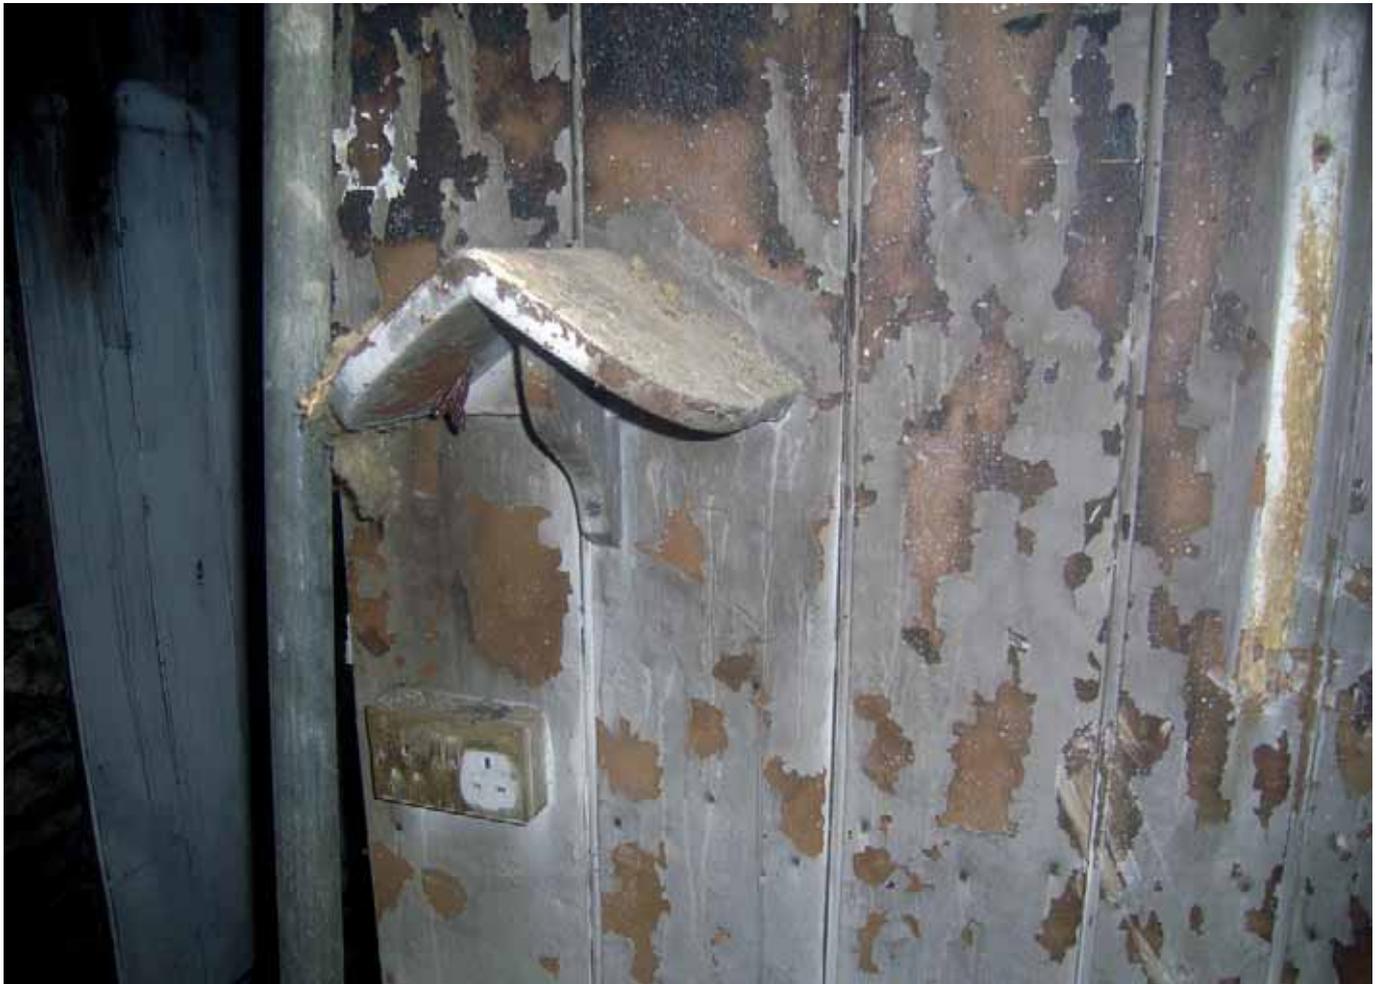
Plate 26: Saddle bracket in former Harness Room (G1)

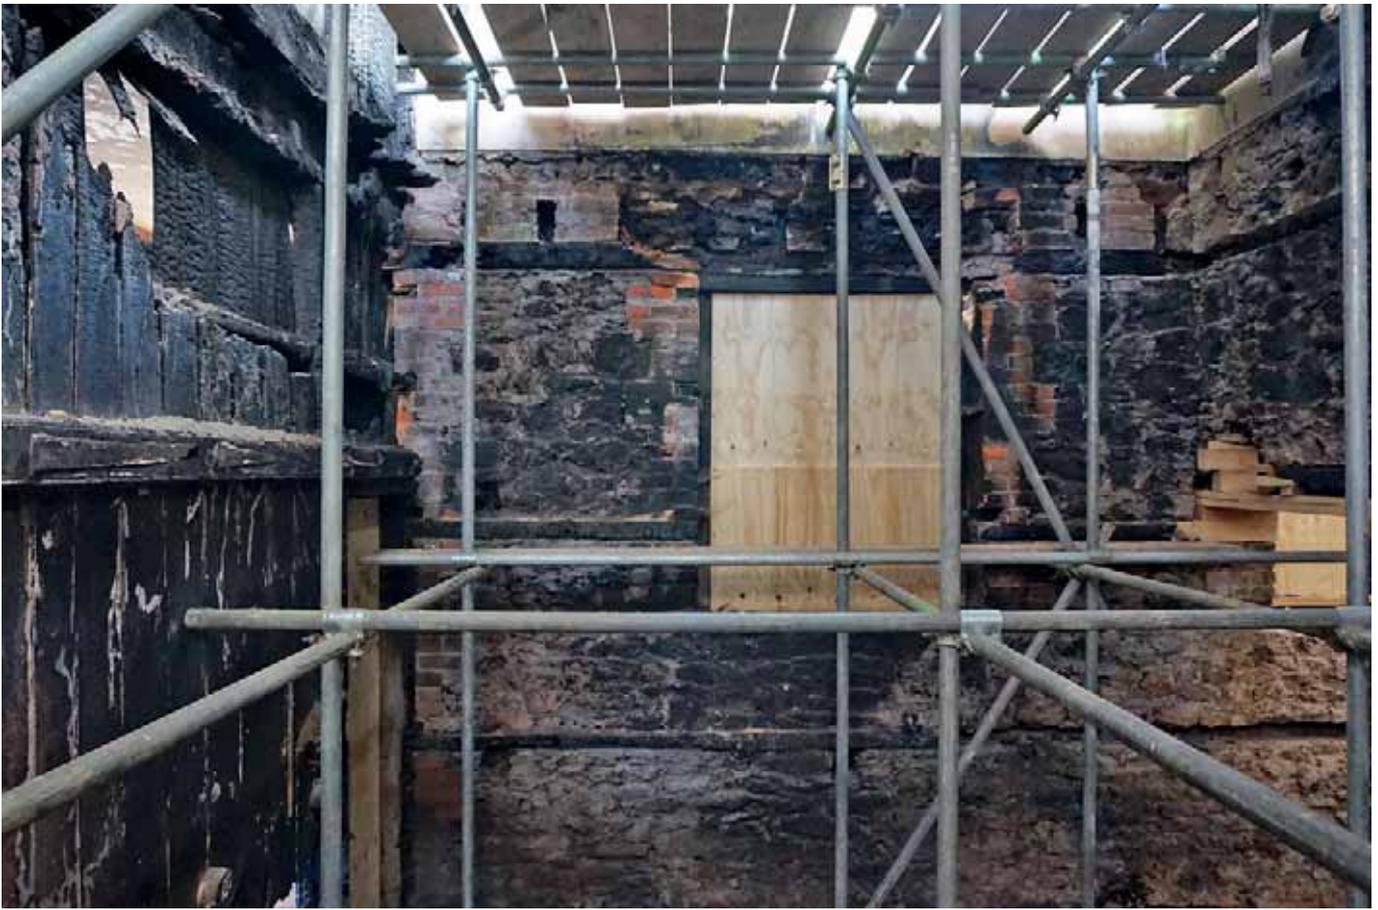
Plate 27: South side of former Harness Room (G1)

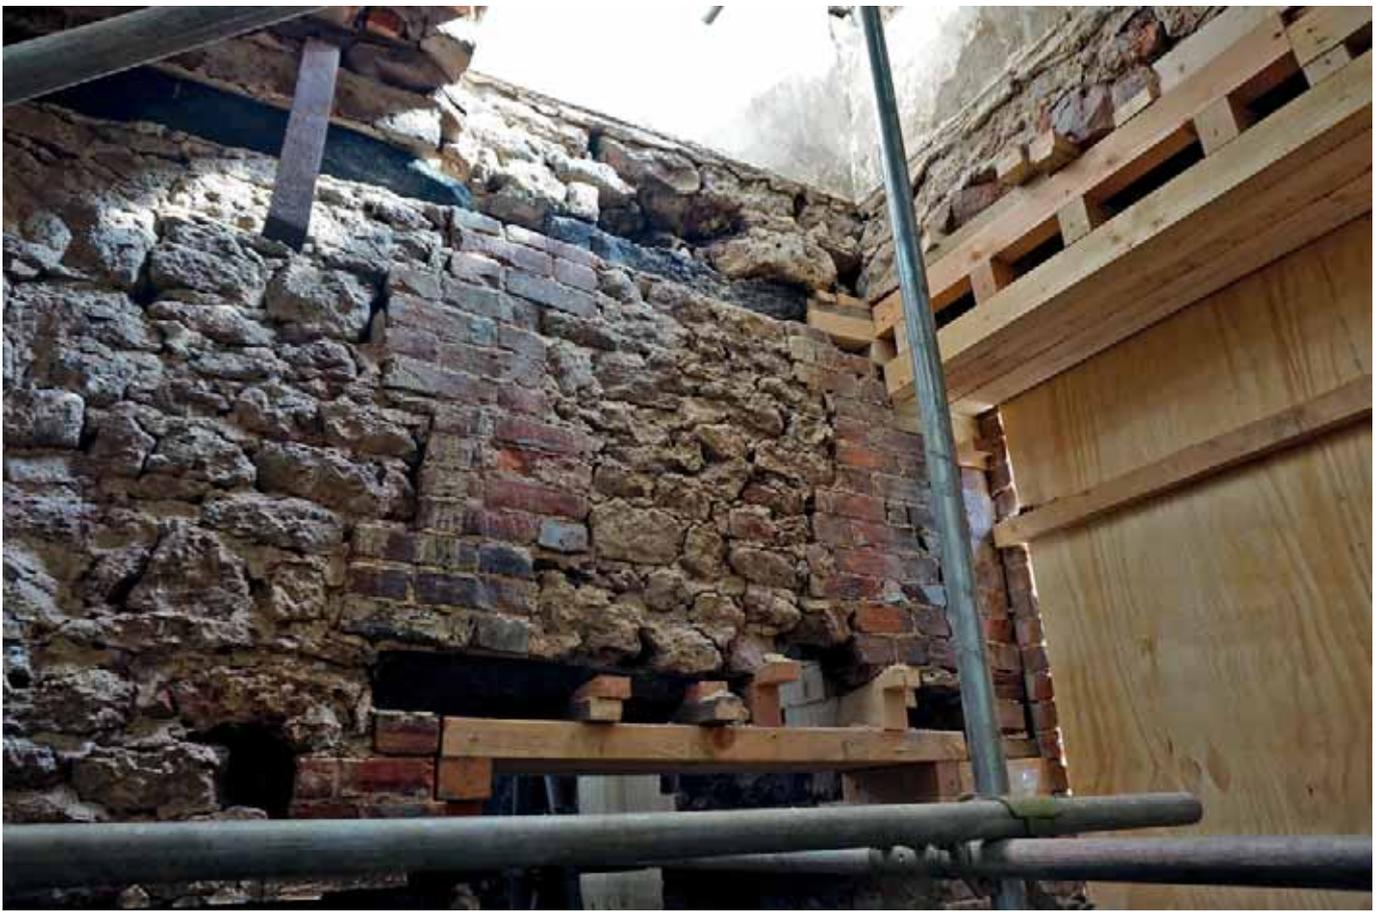
Plate 28: Harness brackets in G1)

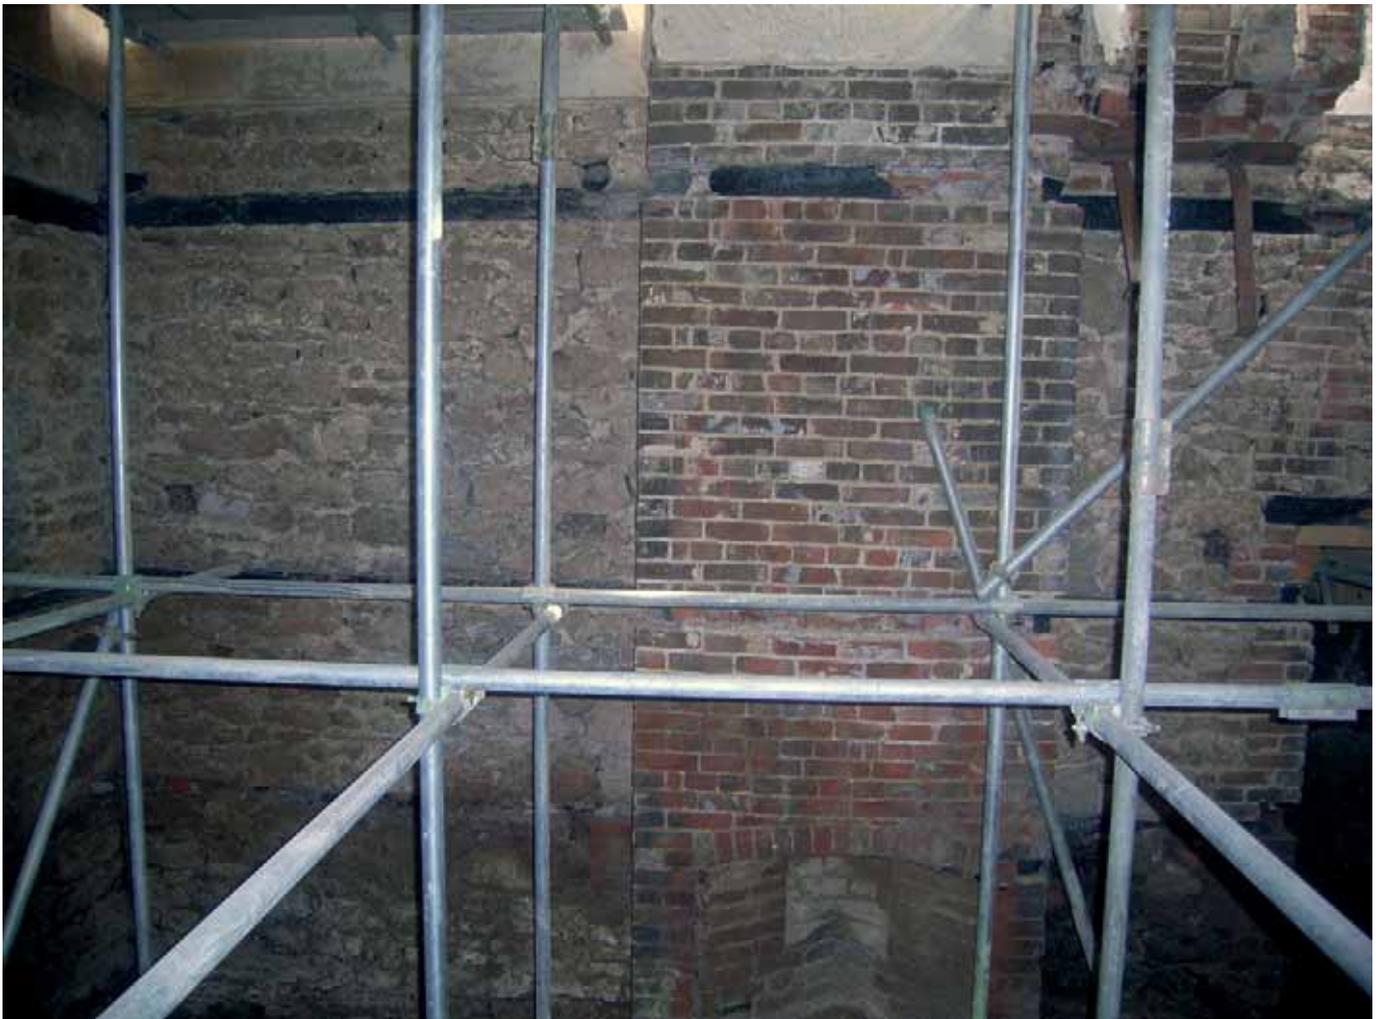
Plate 31: Stonework above doorway between G1 and G2

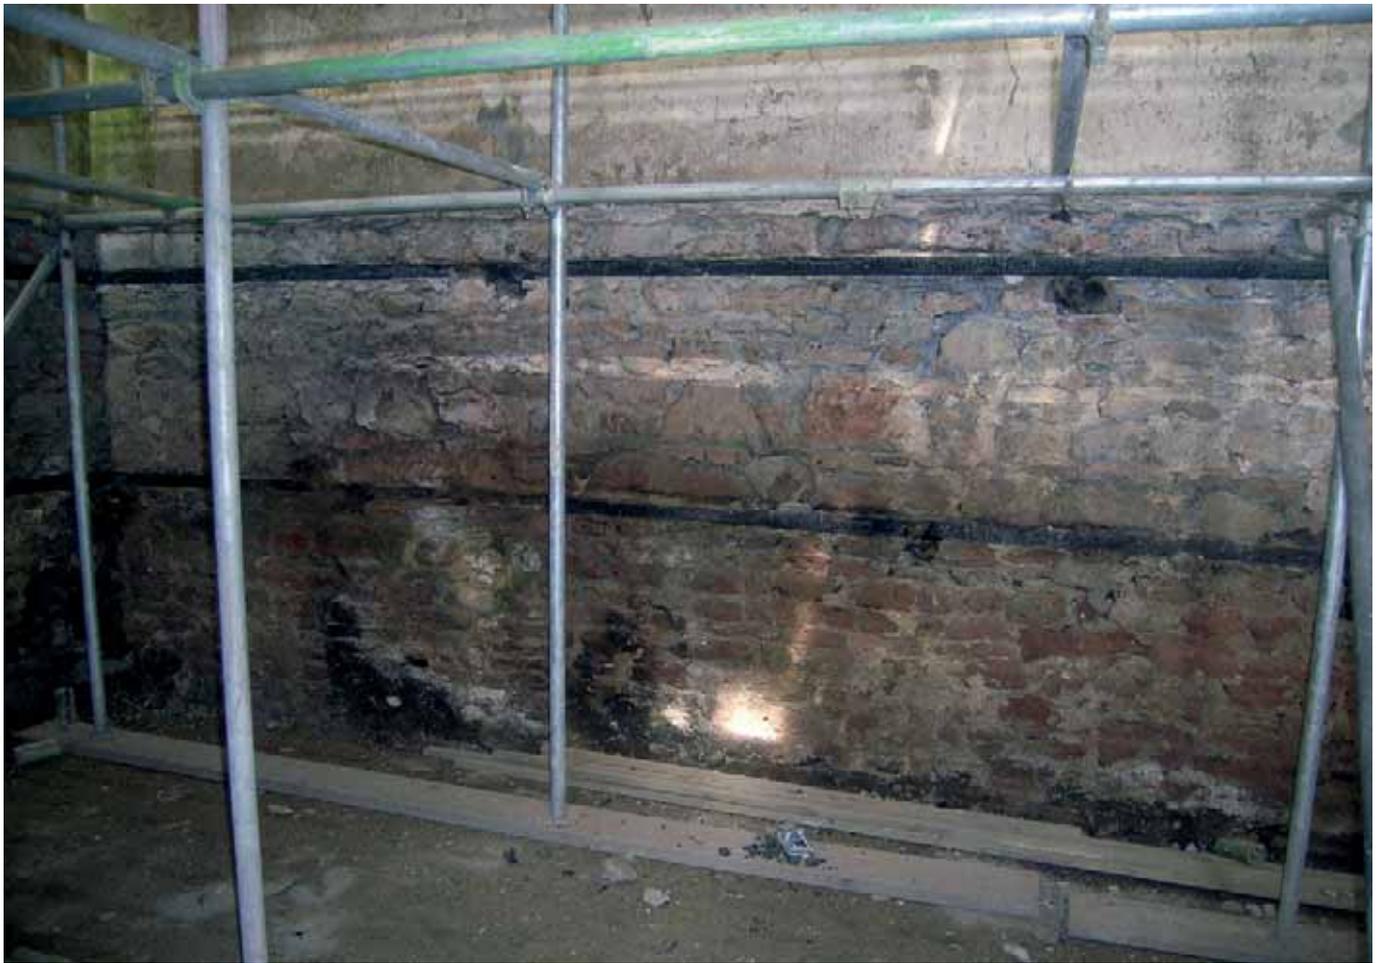
Plate 32: East wall of former Saddle Room (G2)

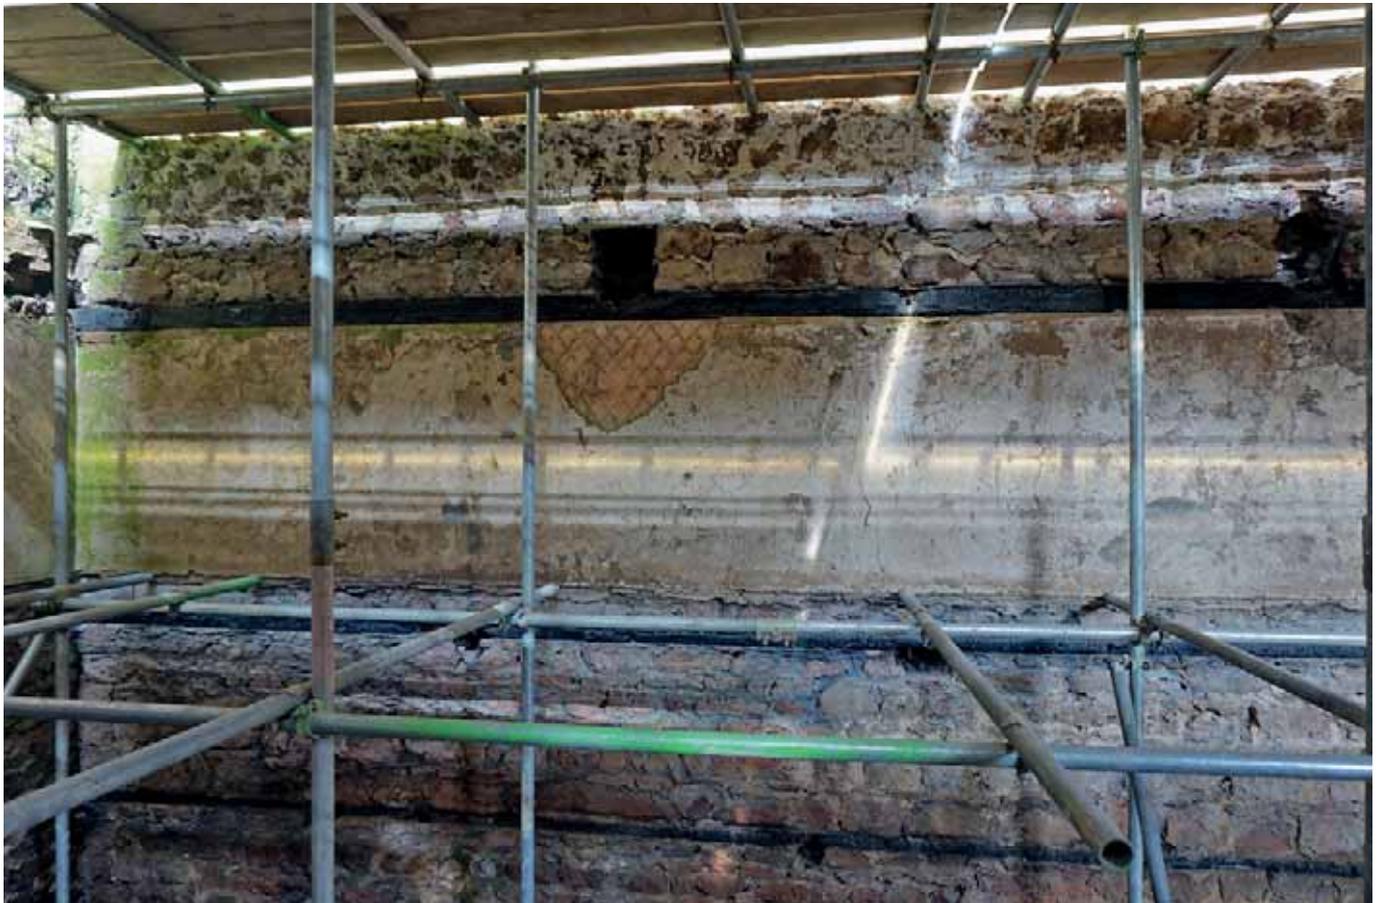
Plate 33: North wall of G3 (former Stable)

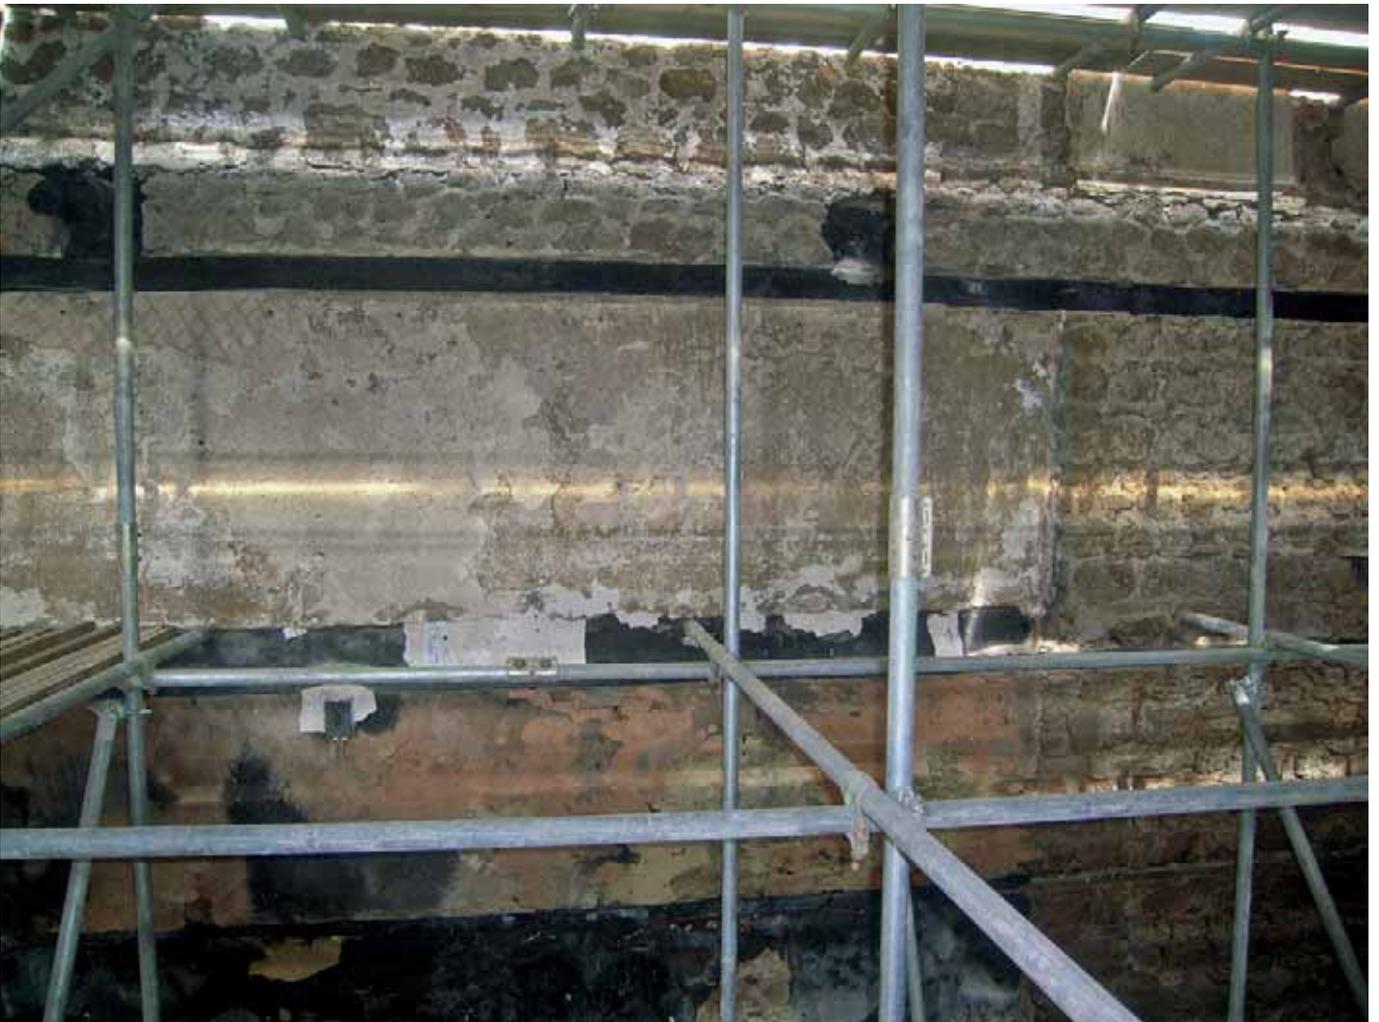
Plate 34: Upper part of north wall of G3 (former Stable)

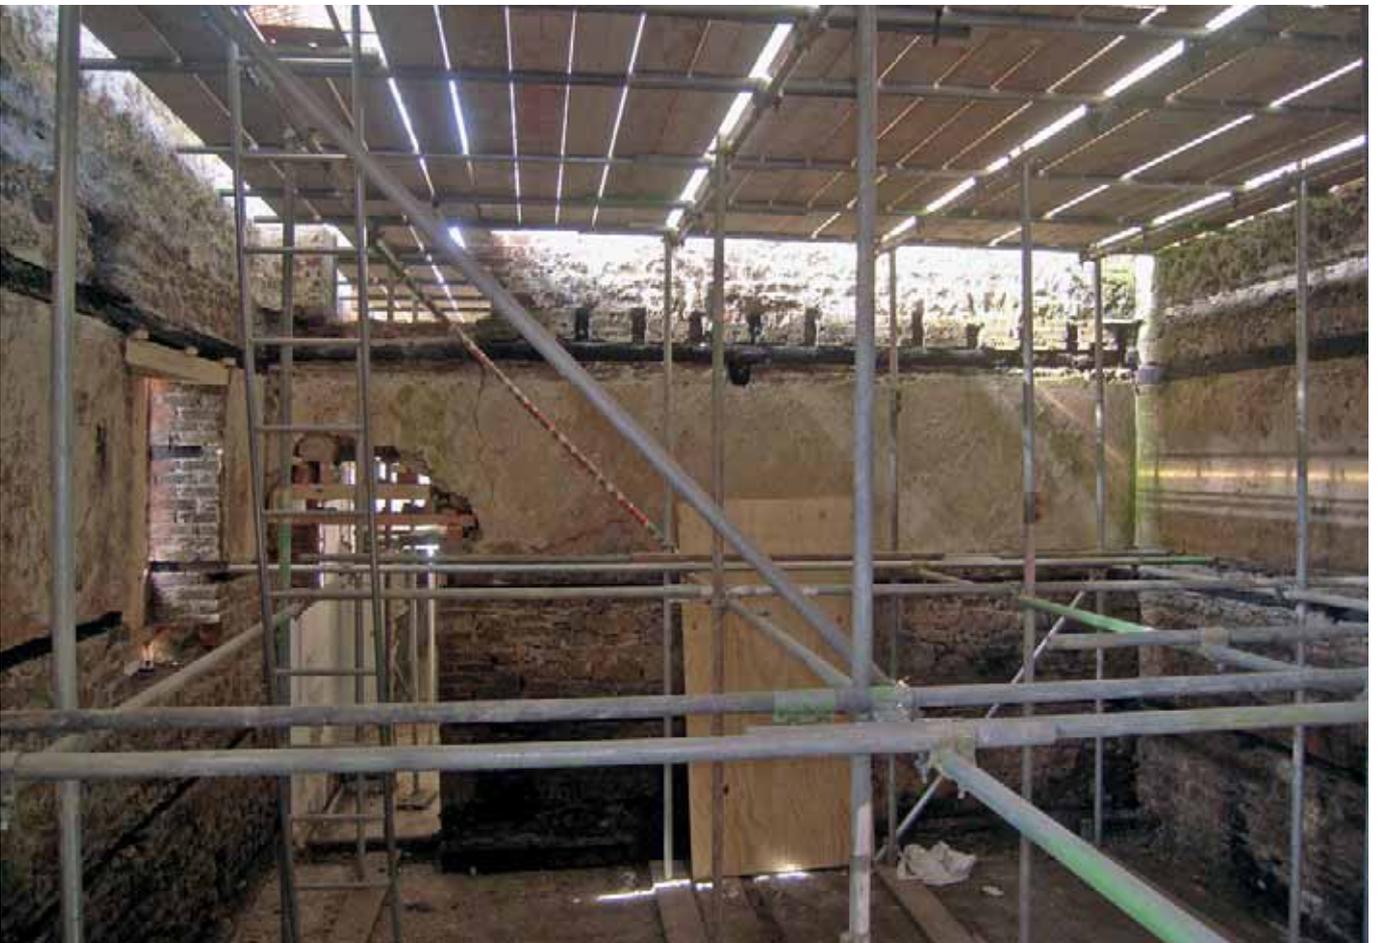
Plate 35: North wall of G3

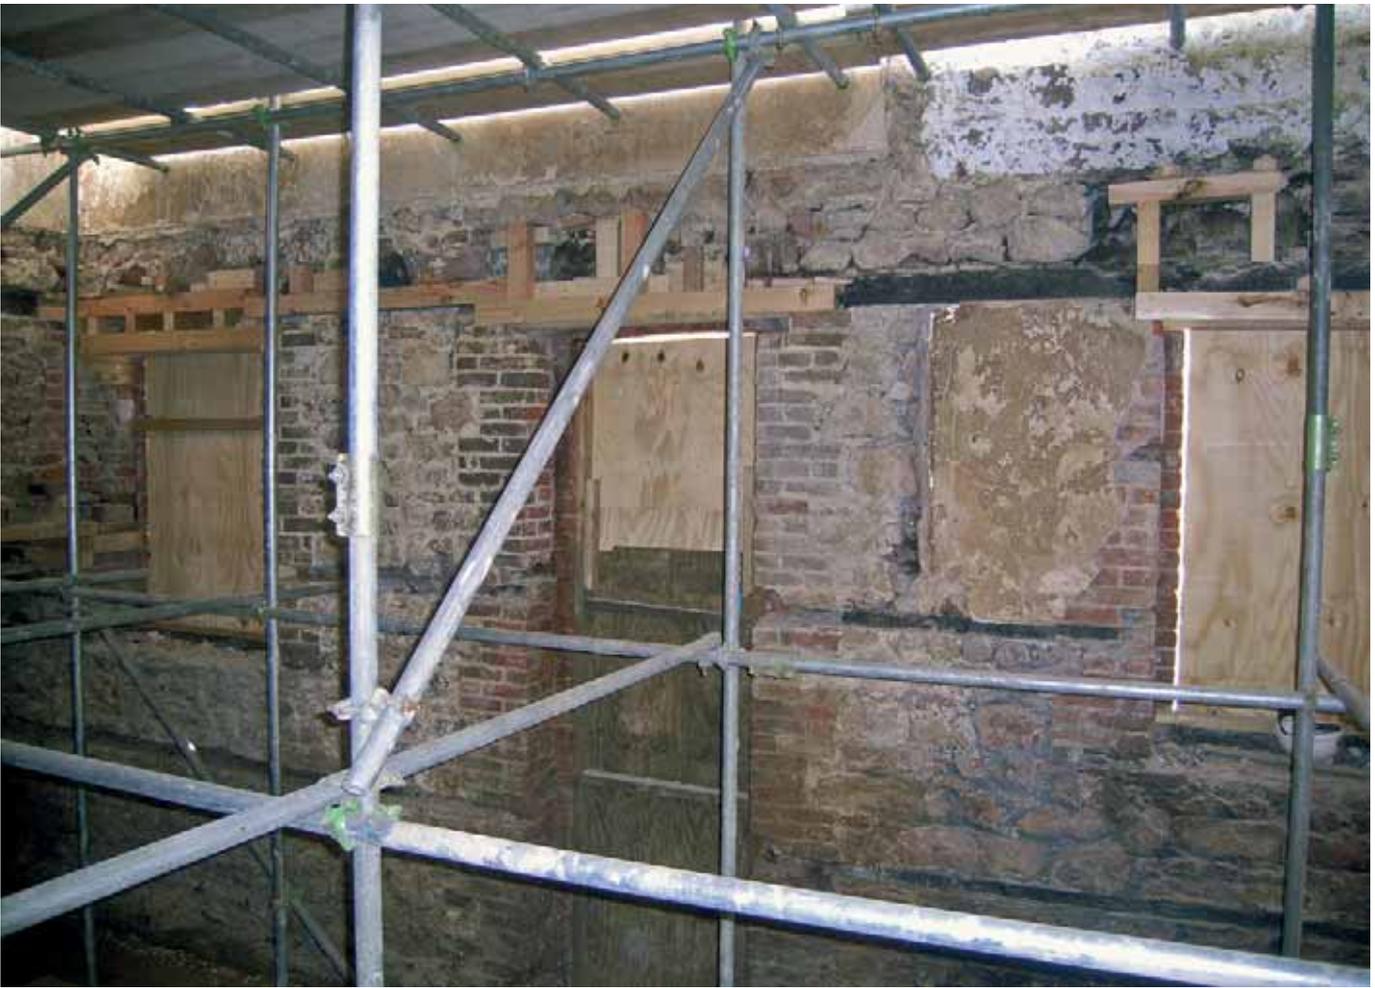
Plate 36: West wall of G3

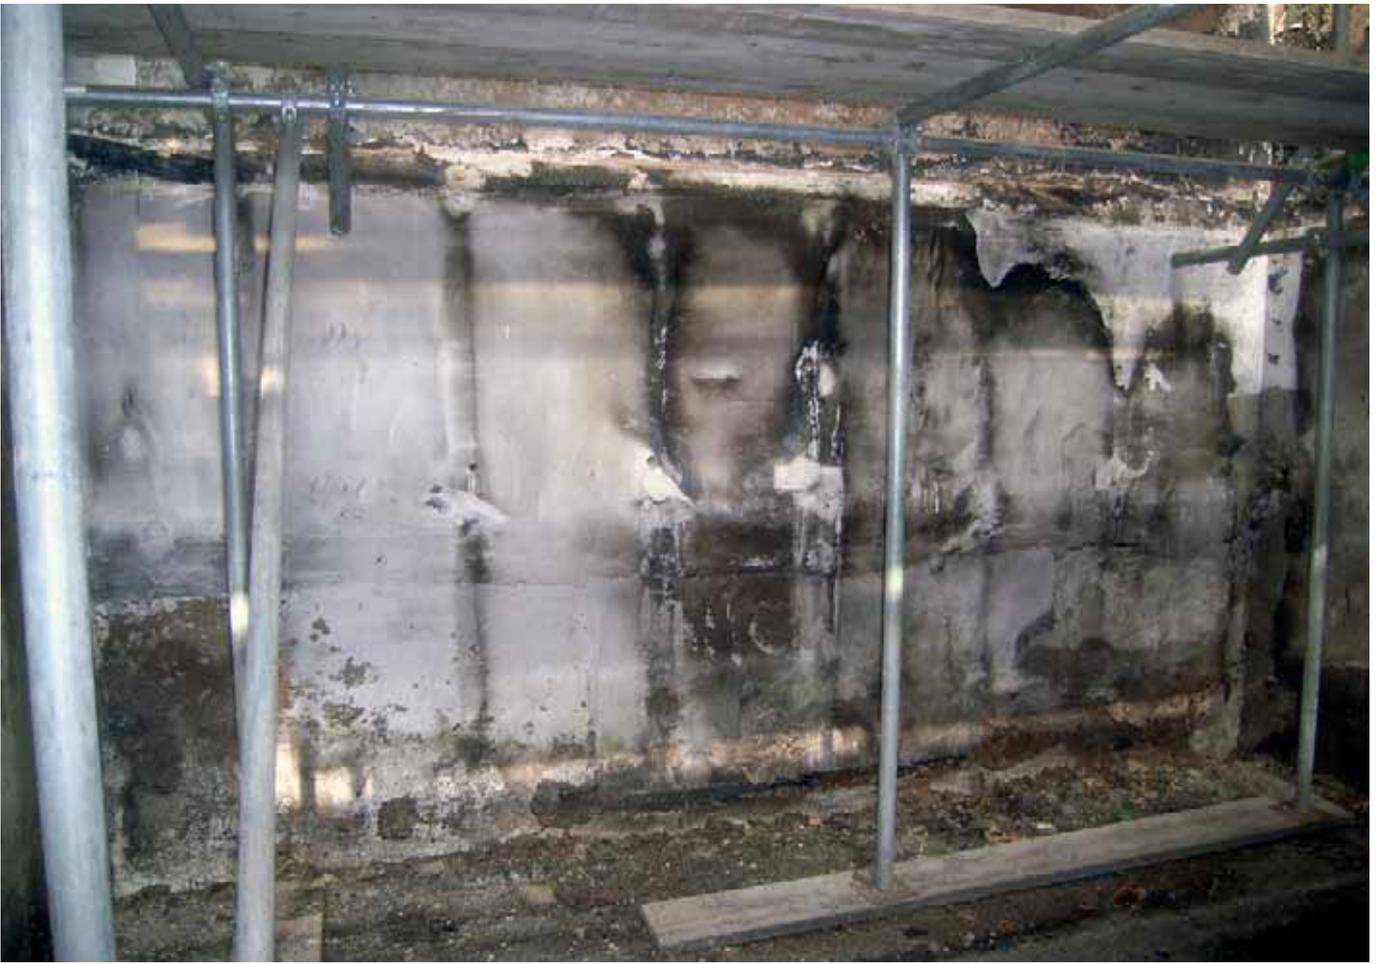
Plate 41: East wall of G4

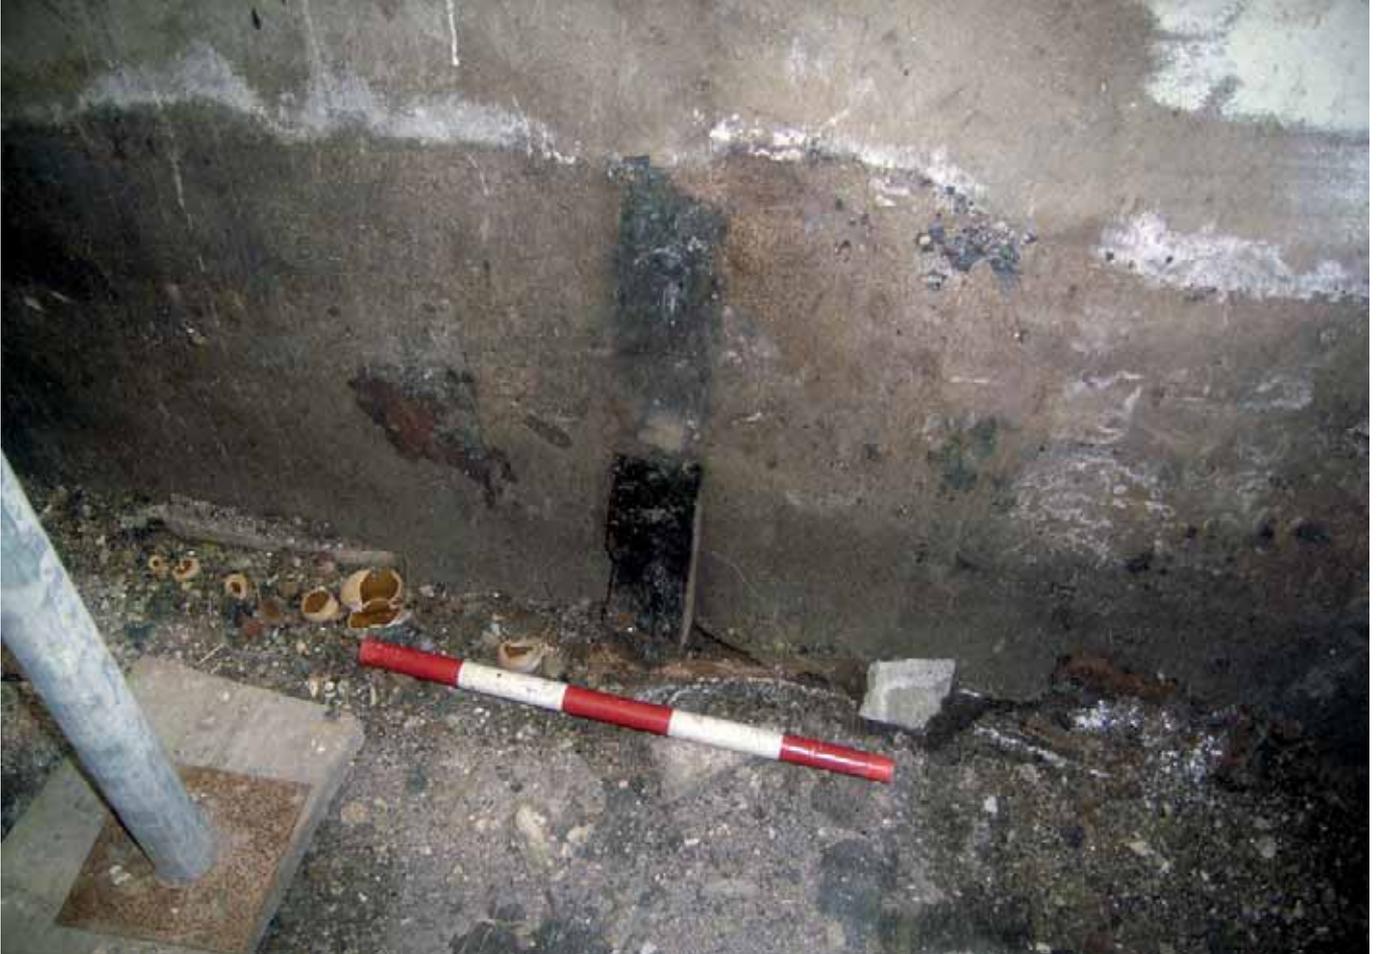
Plate 42: North wall of G4
