The Stables Coleshill Estate Oxfordshire

Historic Building Investigation and Recording

May 2017

Client: National Trust

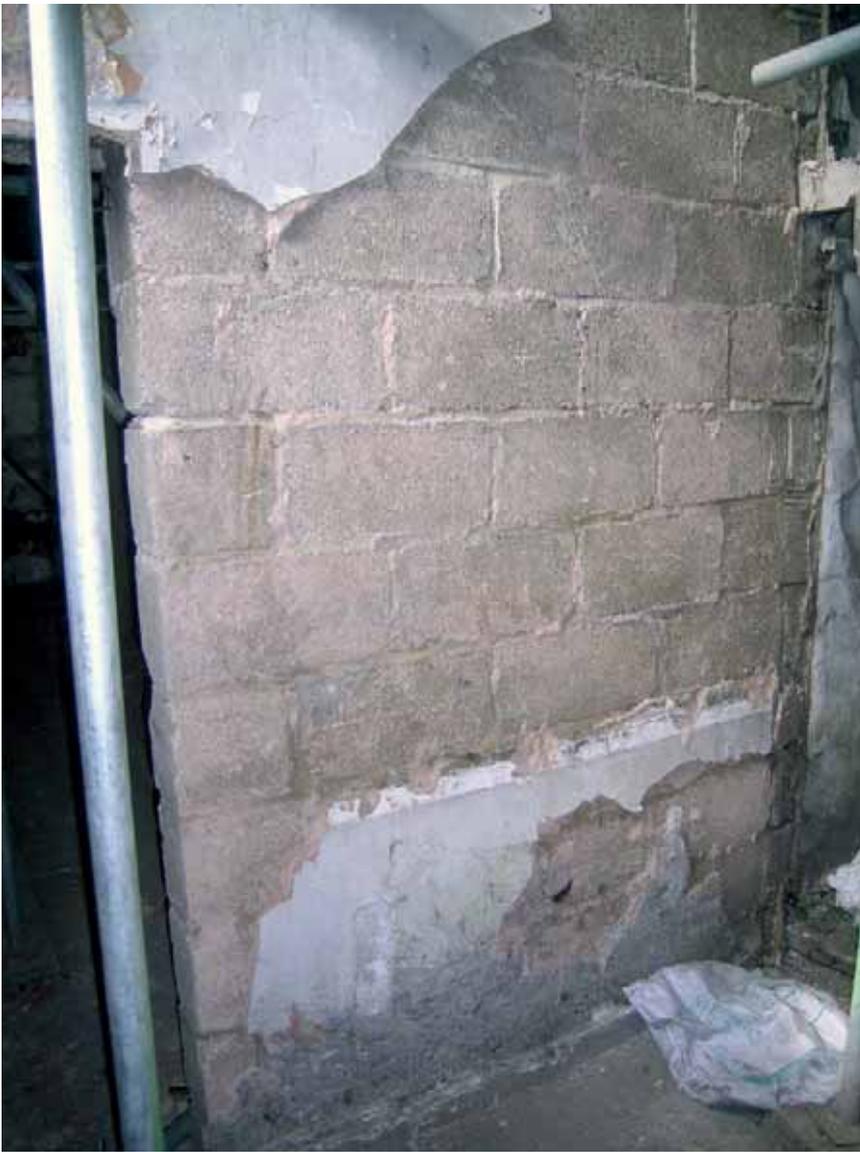
Plate 45: Concrete blockwork forming south wall of G4

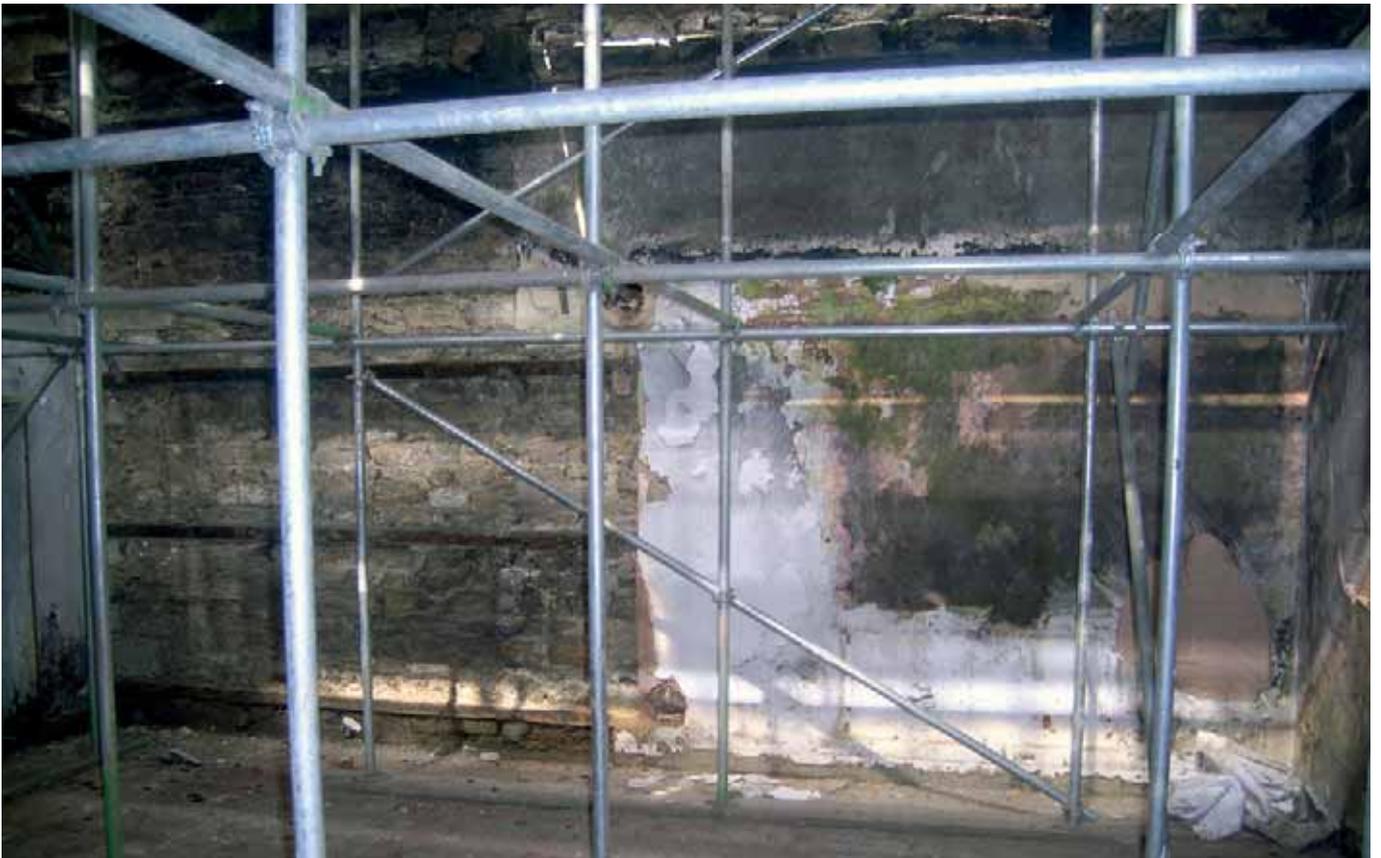
Plate 46: Concrete blockwork forming west wall of G4

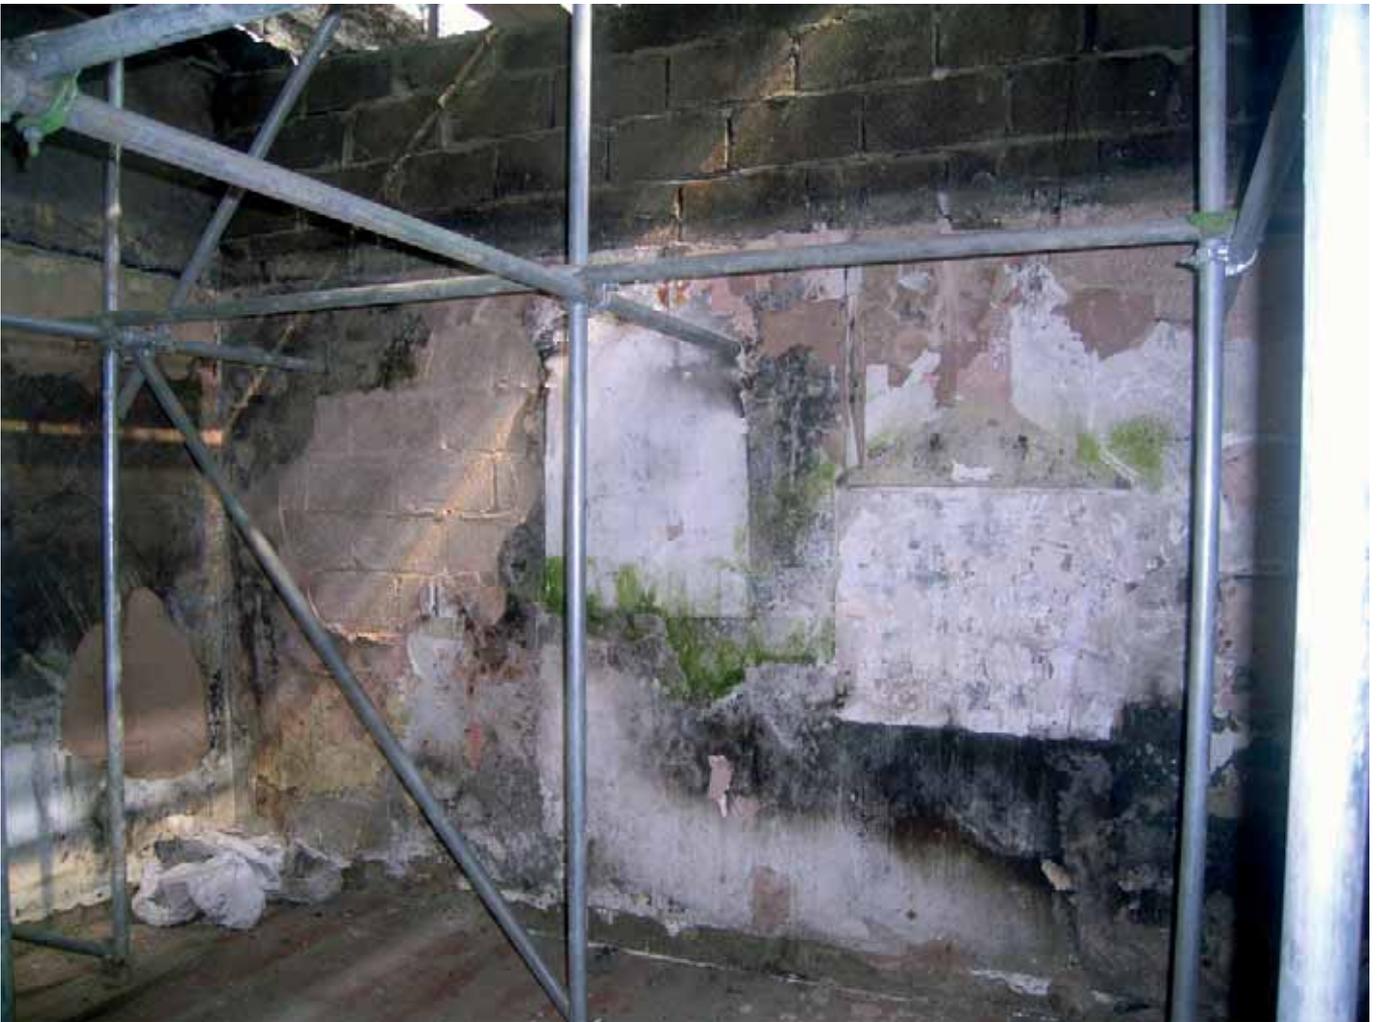
Plate 47: North wall of G4 and G5

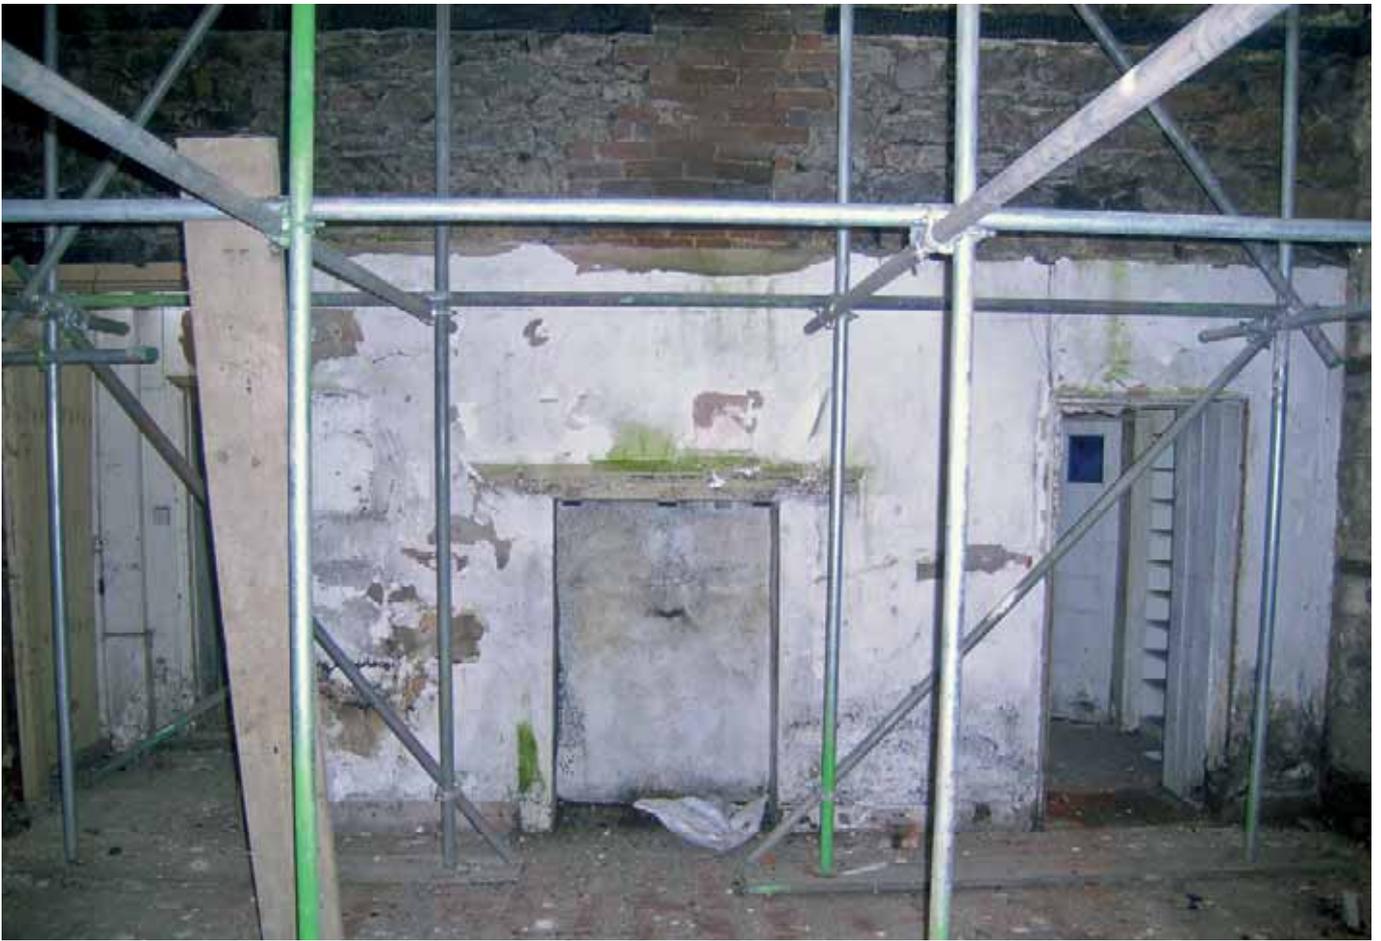
Plate 49: Blockwork above window in G5

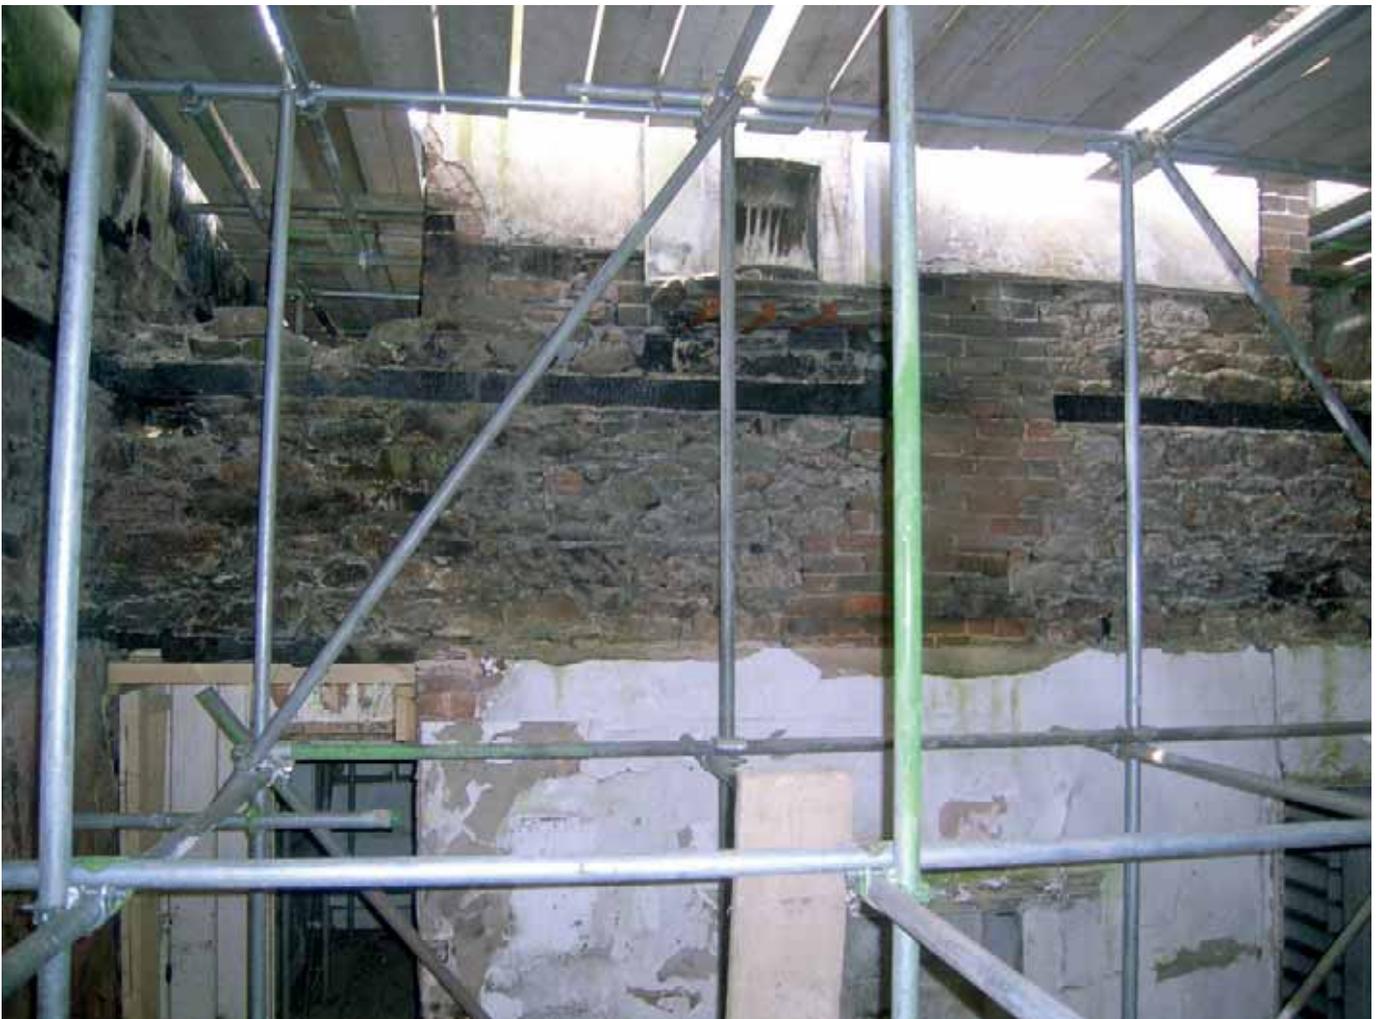
Plate 50: West wall of Washing Room (G6)

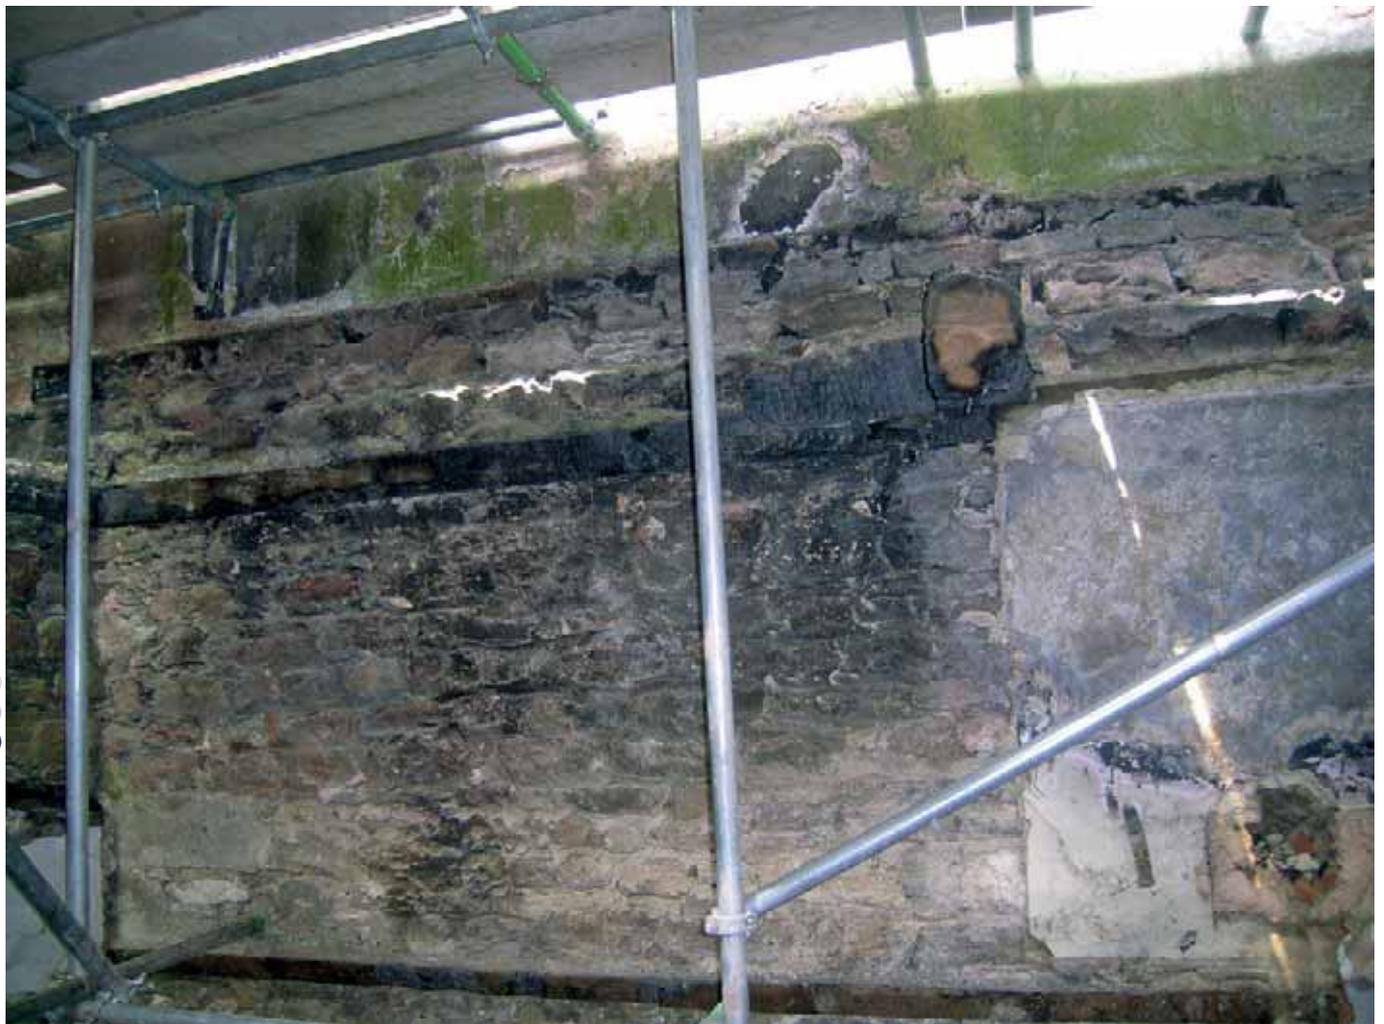
Plate 51: West wall of Washing Room (G6)

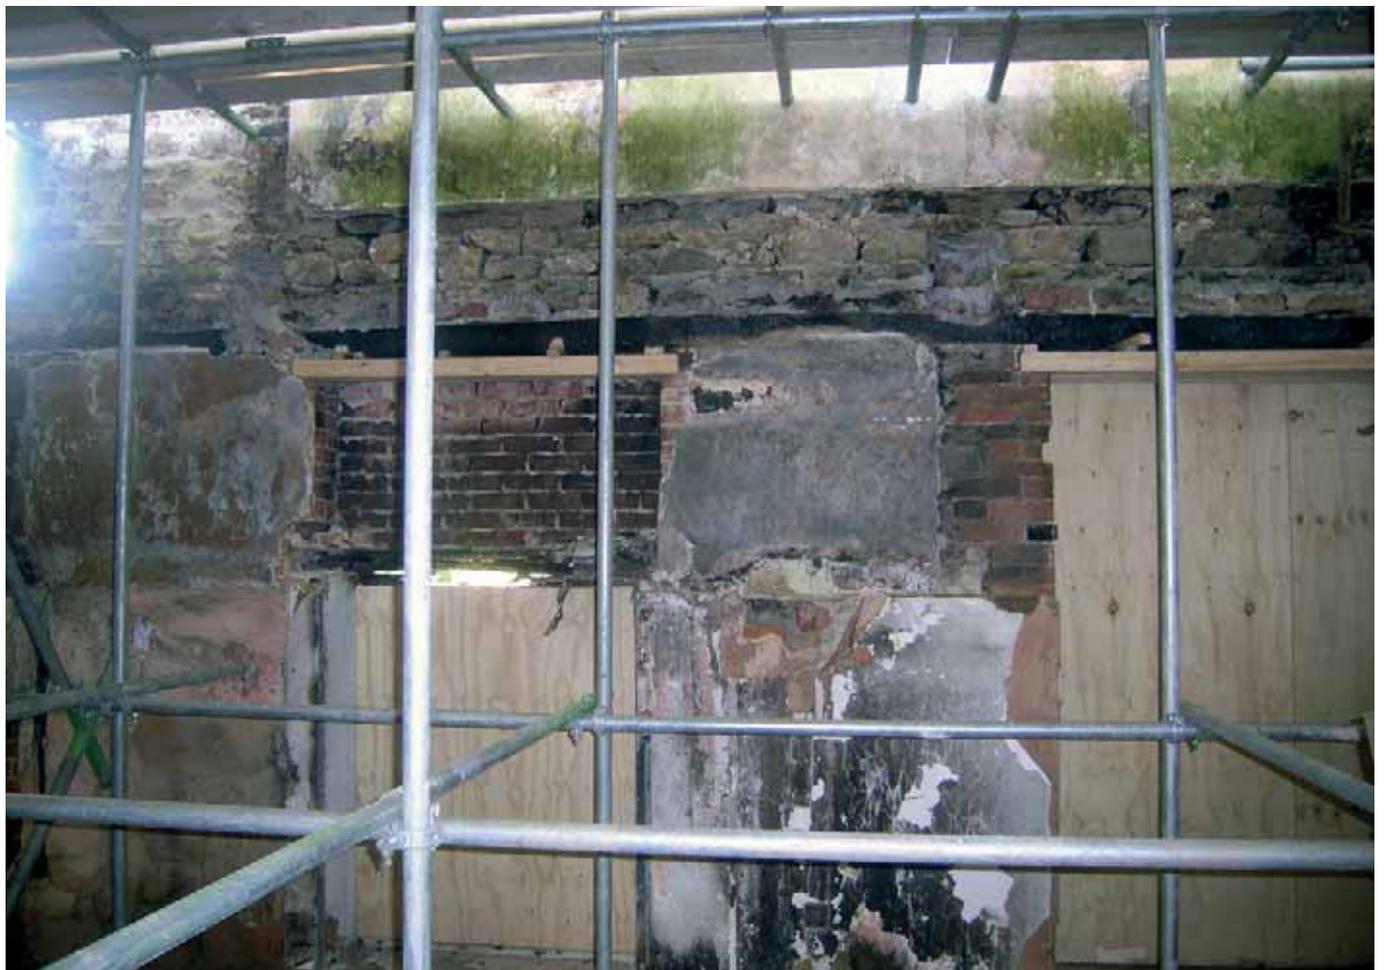
Plate 52: Upper part of north wall in G5/G6

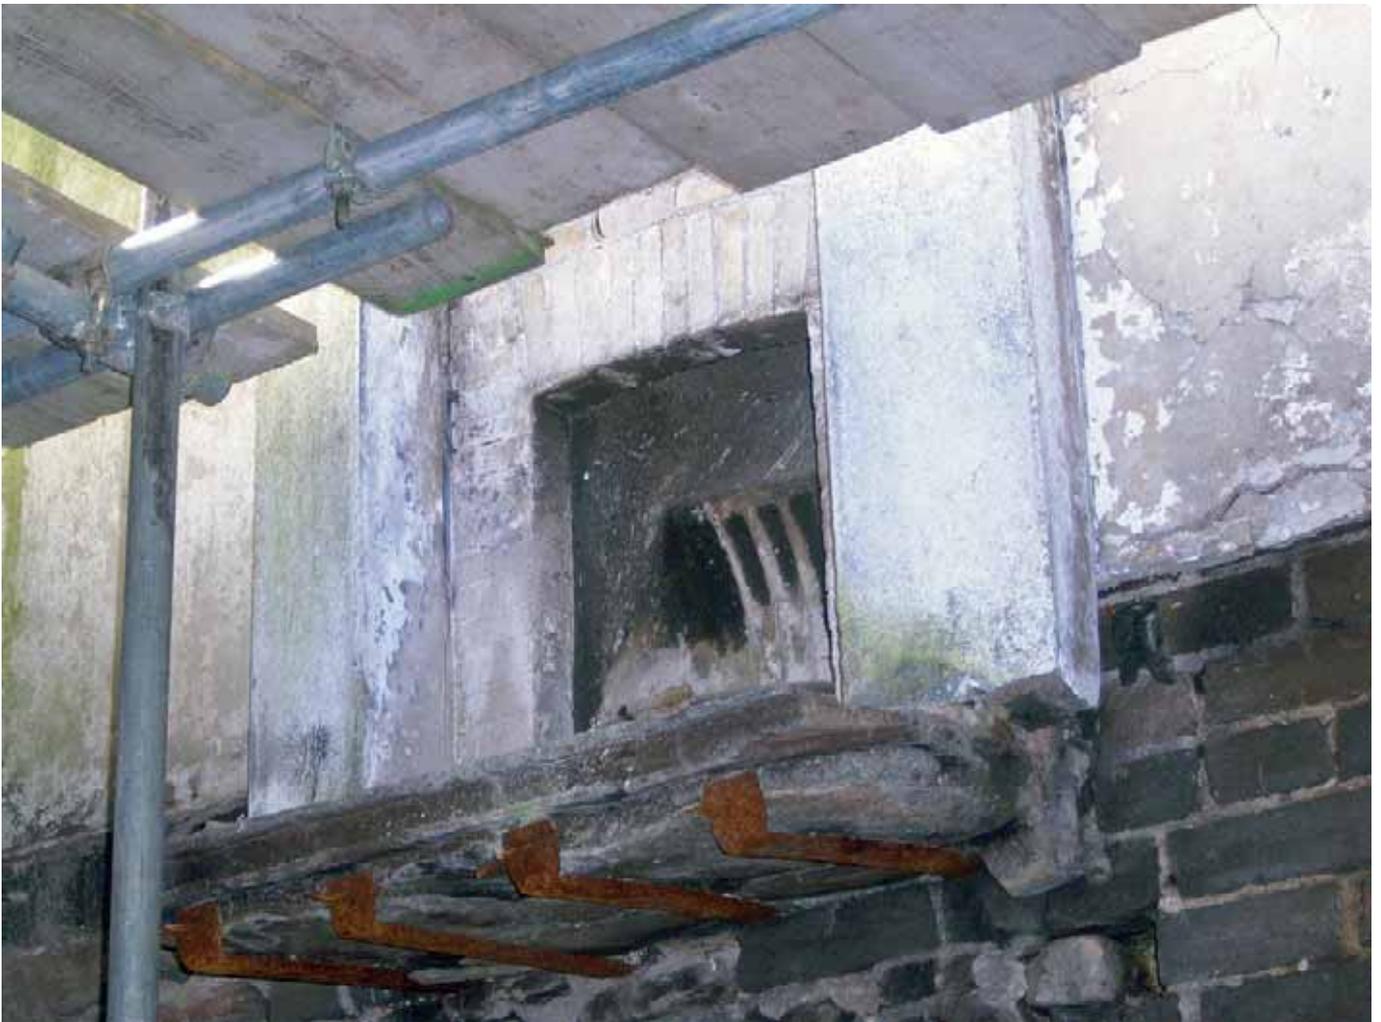
Plate 53: South wall of G5/G6

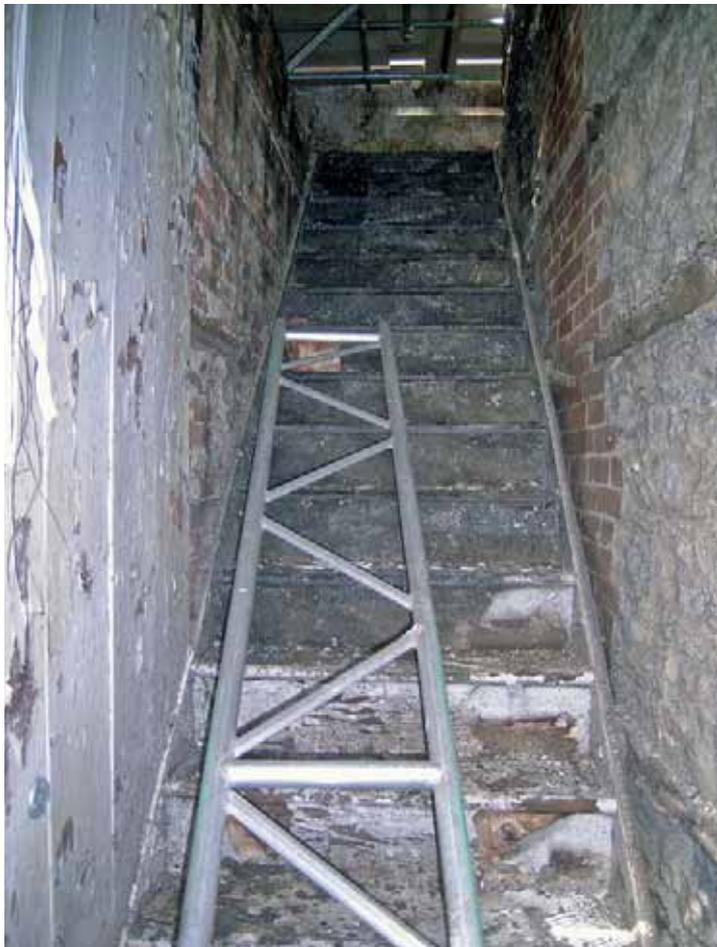
Plate 54: First floor fireplace in F5

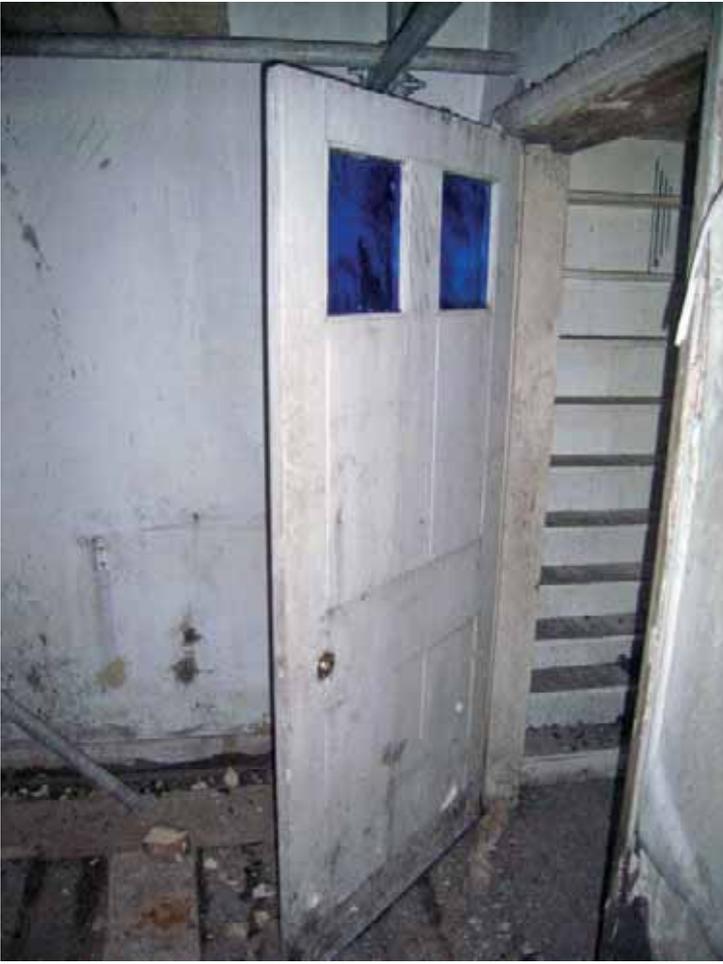
Plate 56: Partition adjacent to stairs by G6

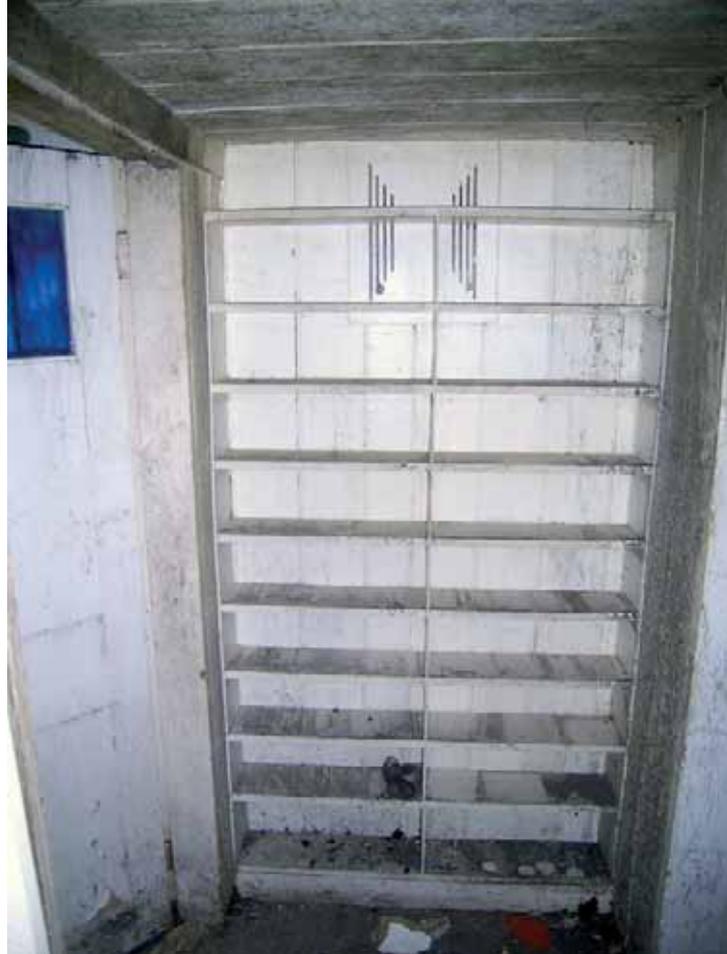
Plate 58: Shelves under stairs to east of G7

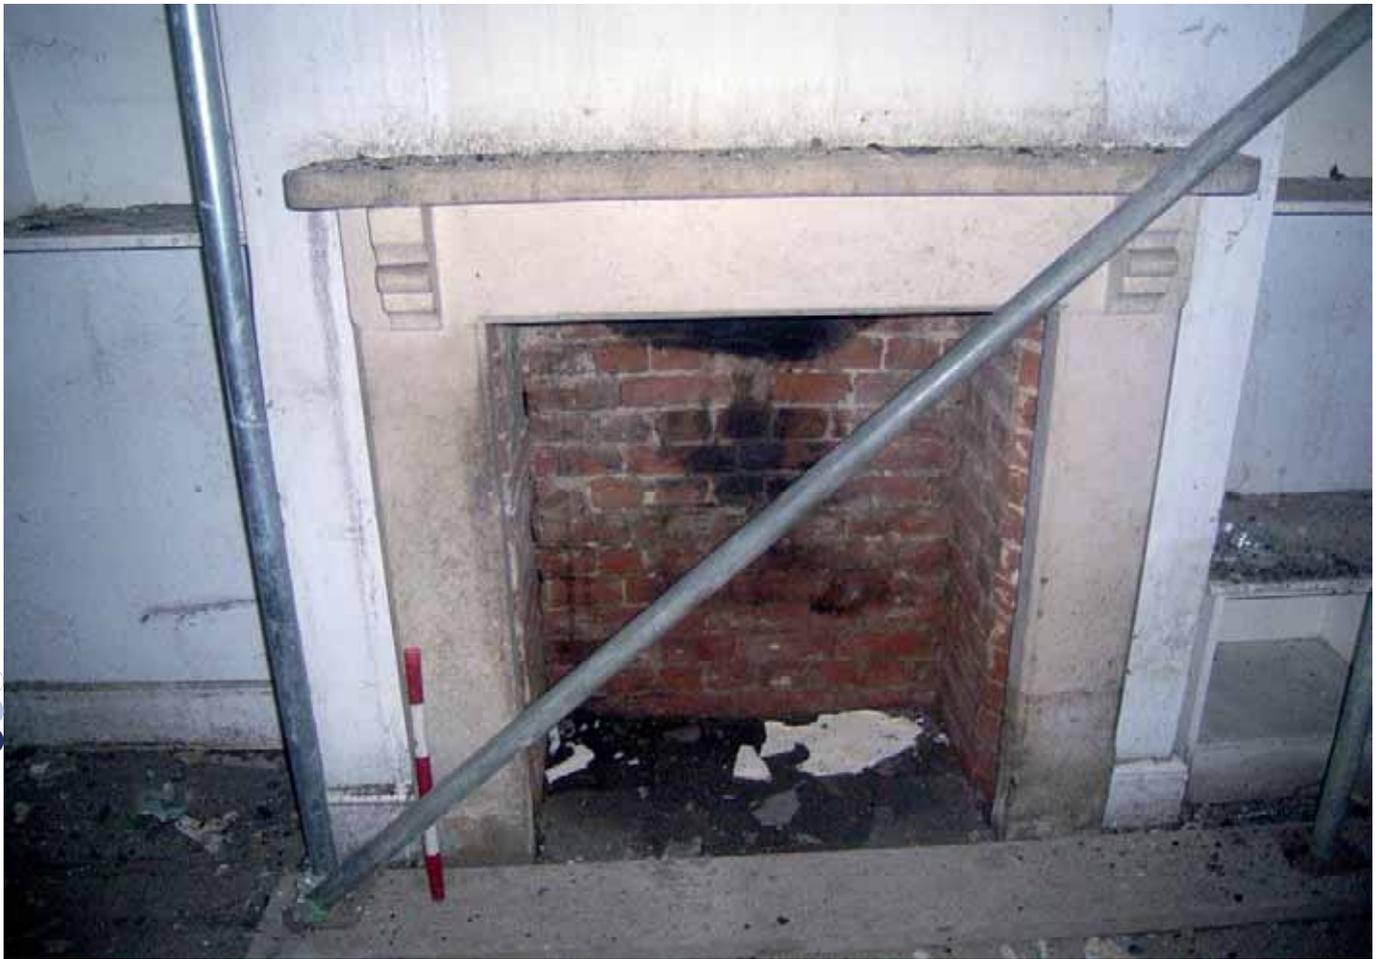
Plate 61: General view of Room G7

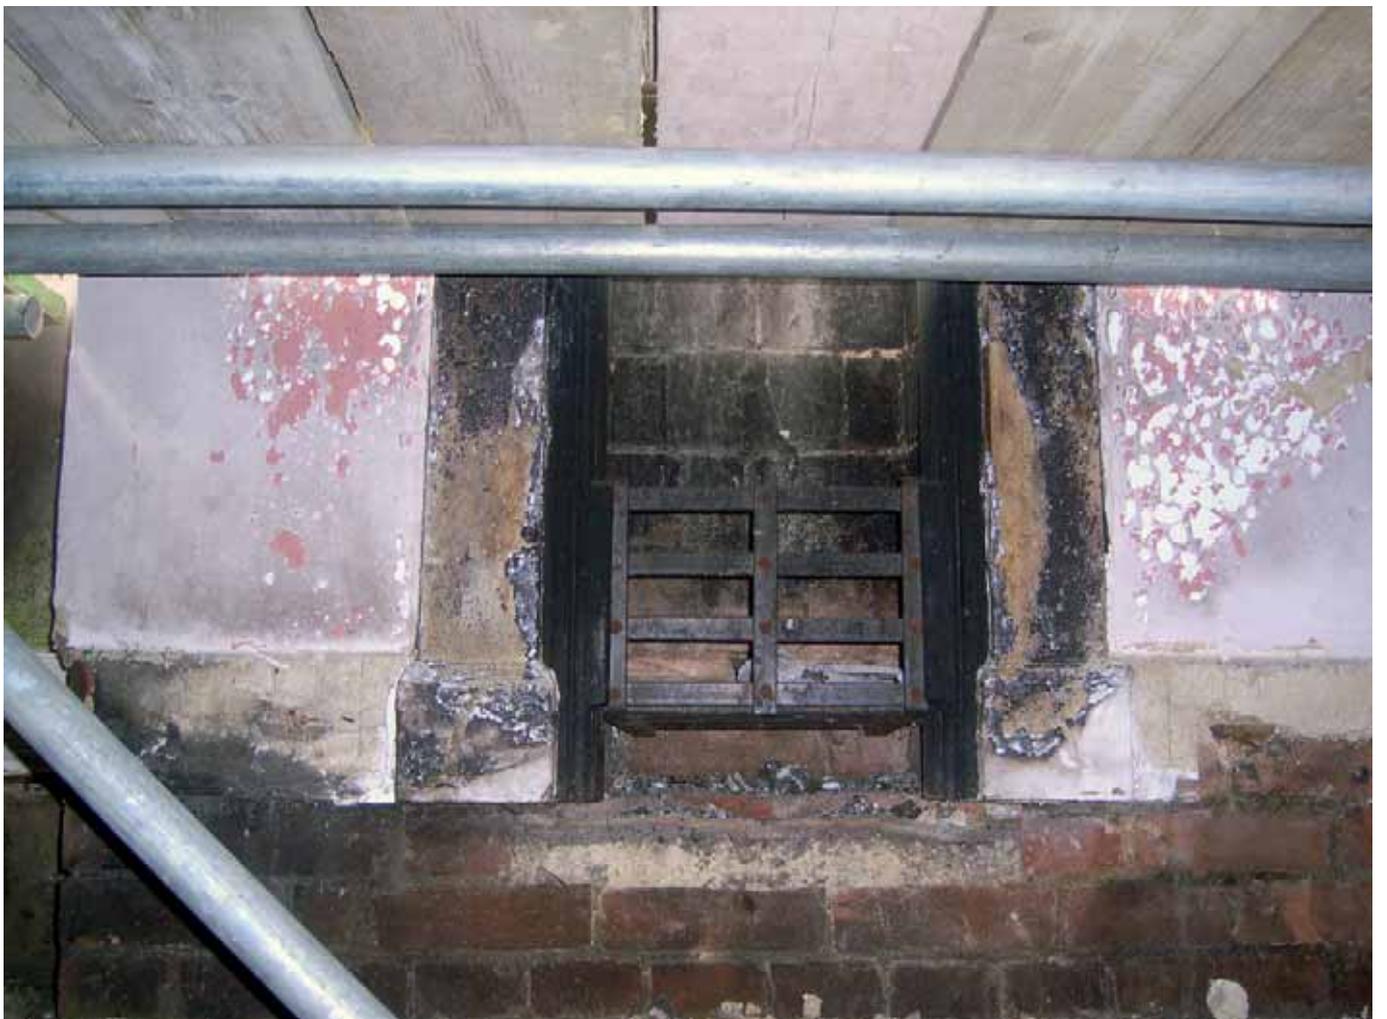
Plate 62: Fireplace in G7

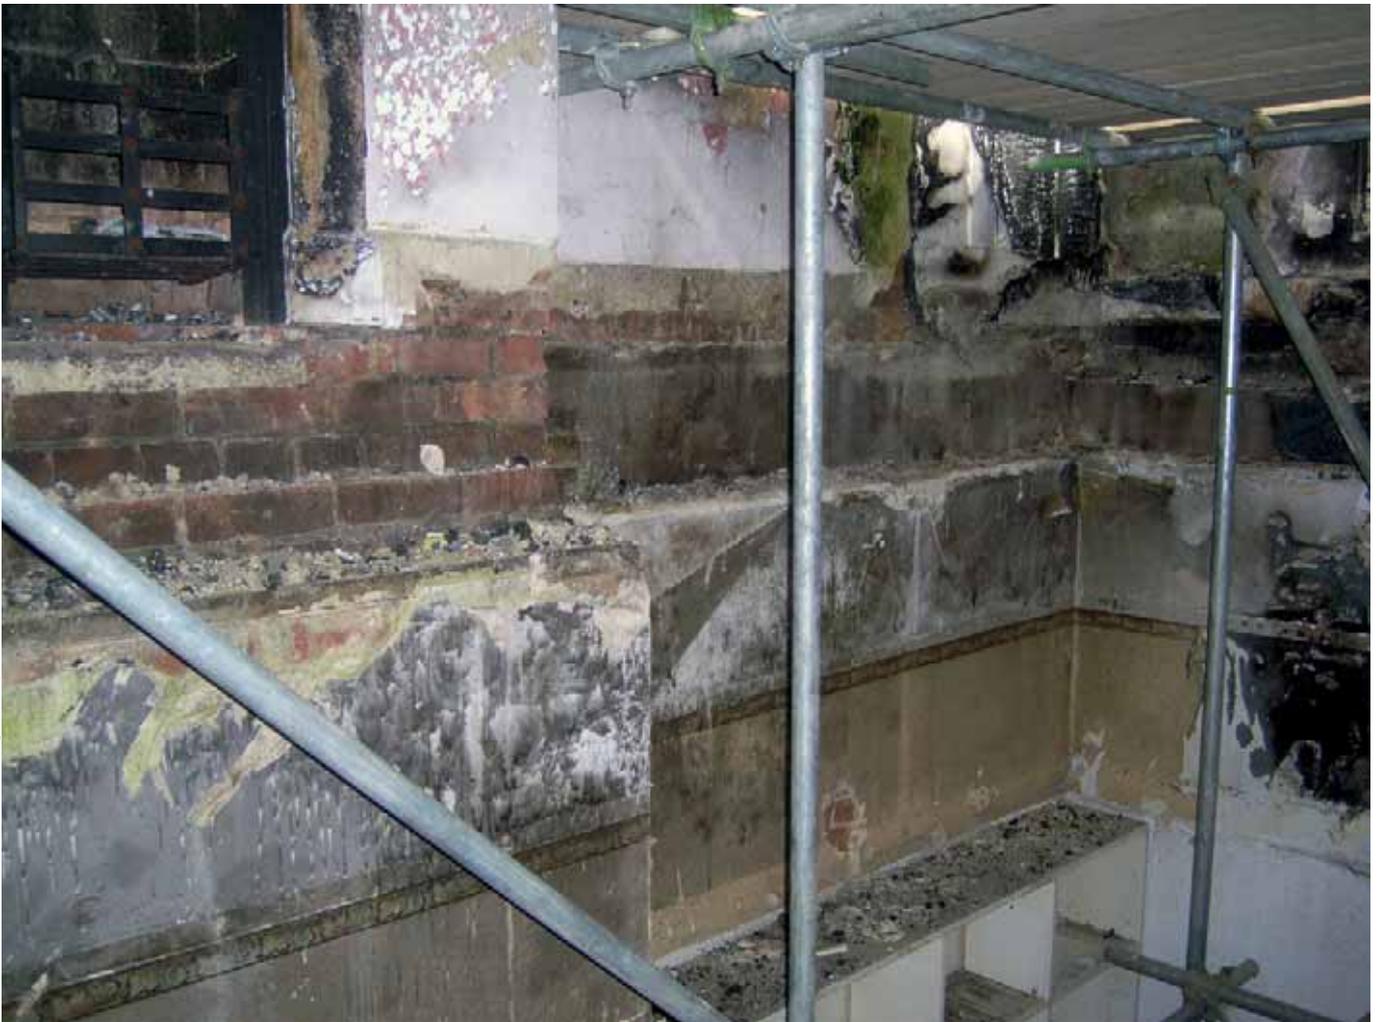
Plate 63: First floor fireplace in F6

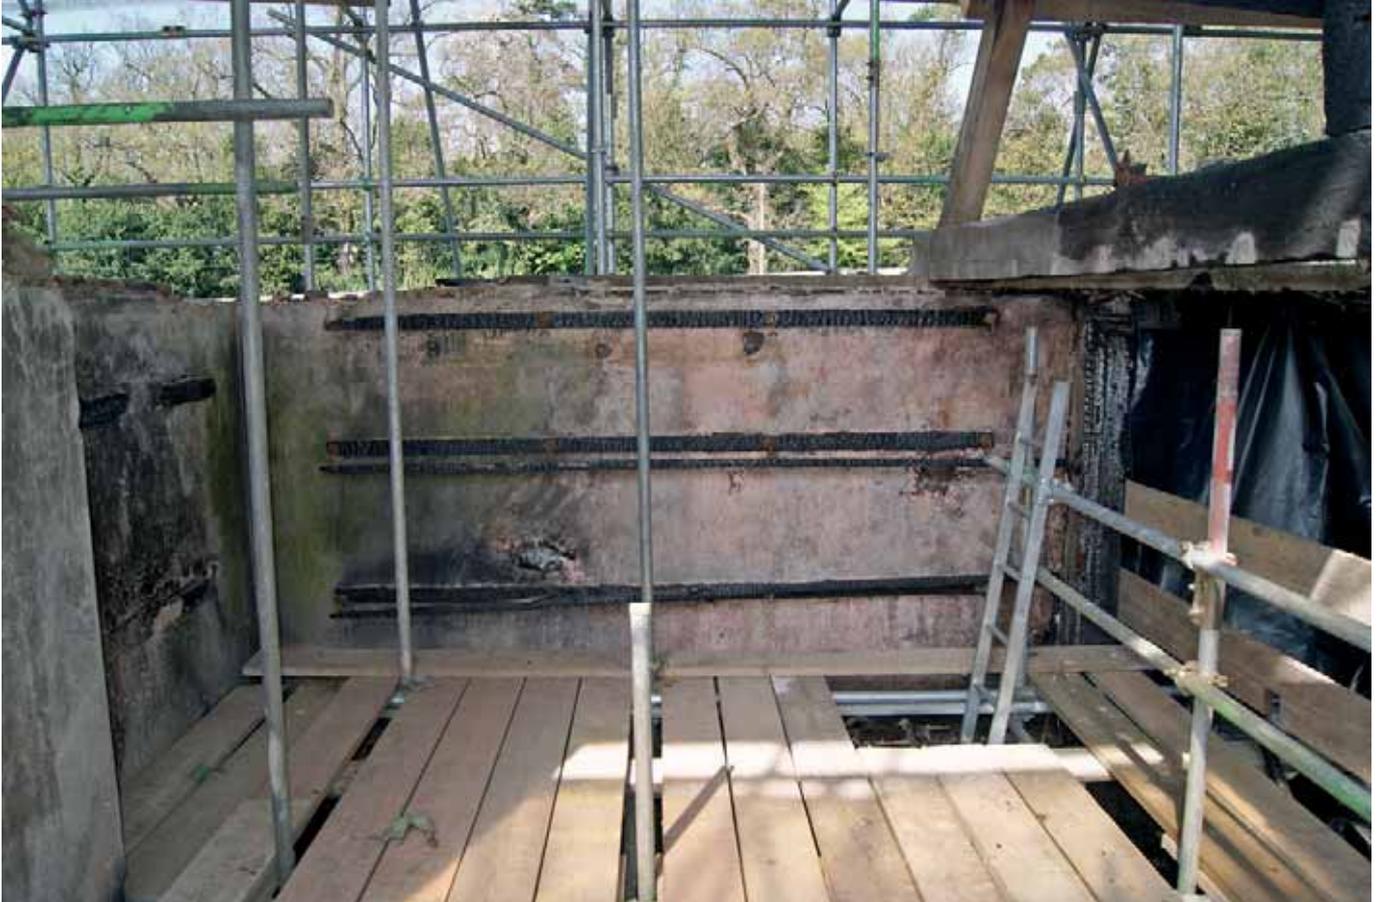
Plate 66: South wall of F1

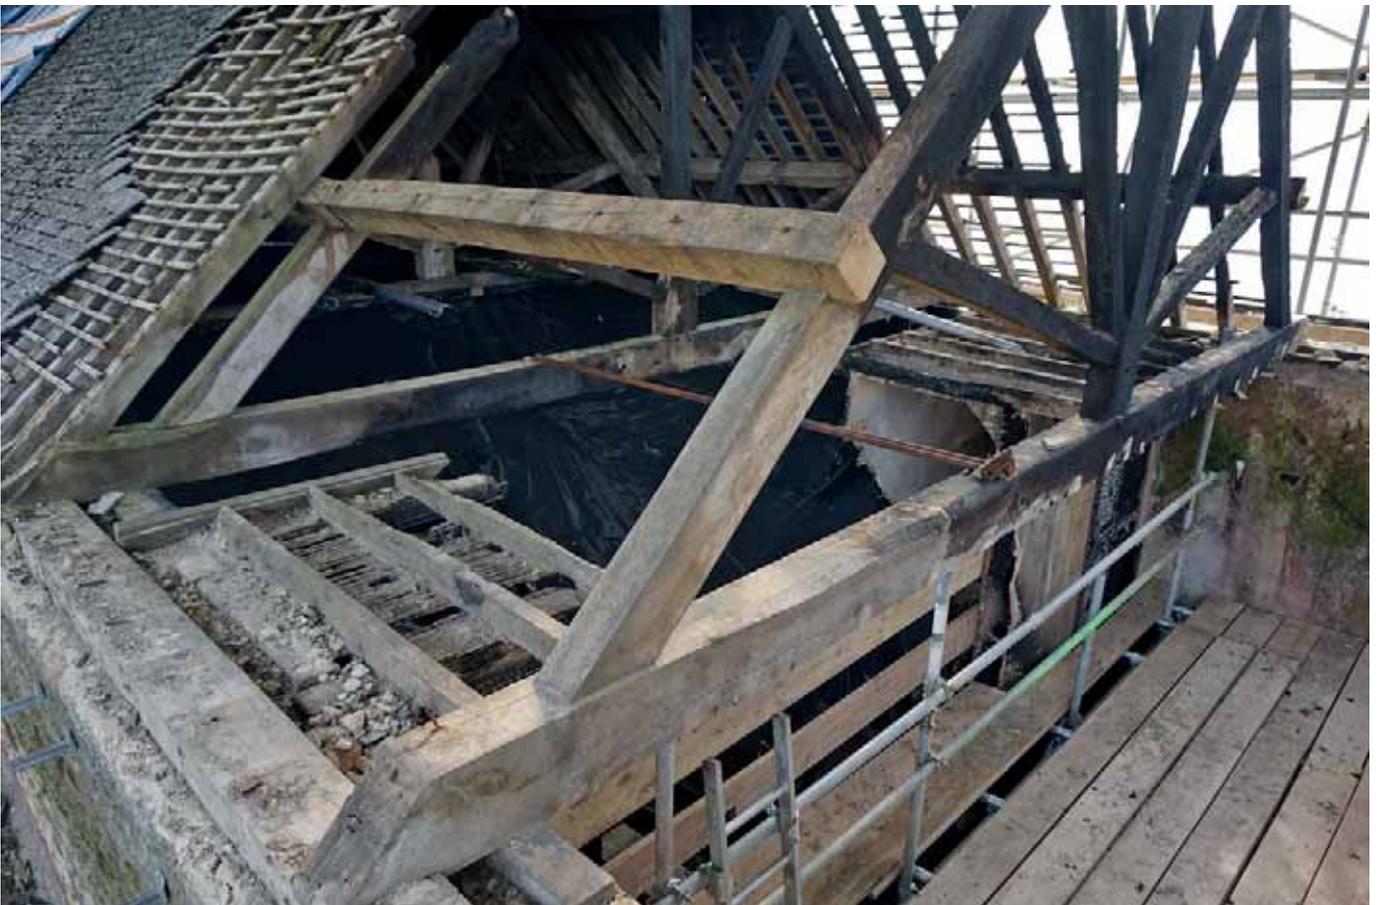
Plate 70: Surviving roof truss to east of F1

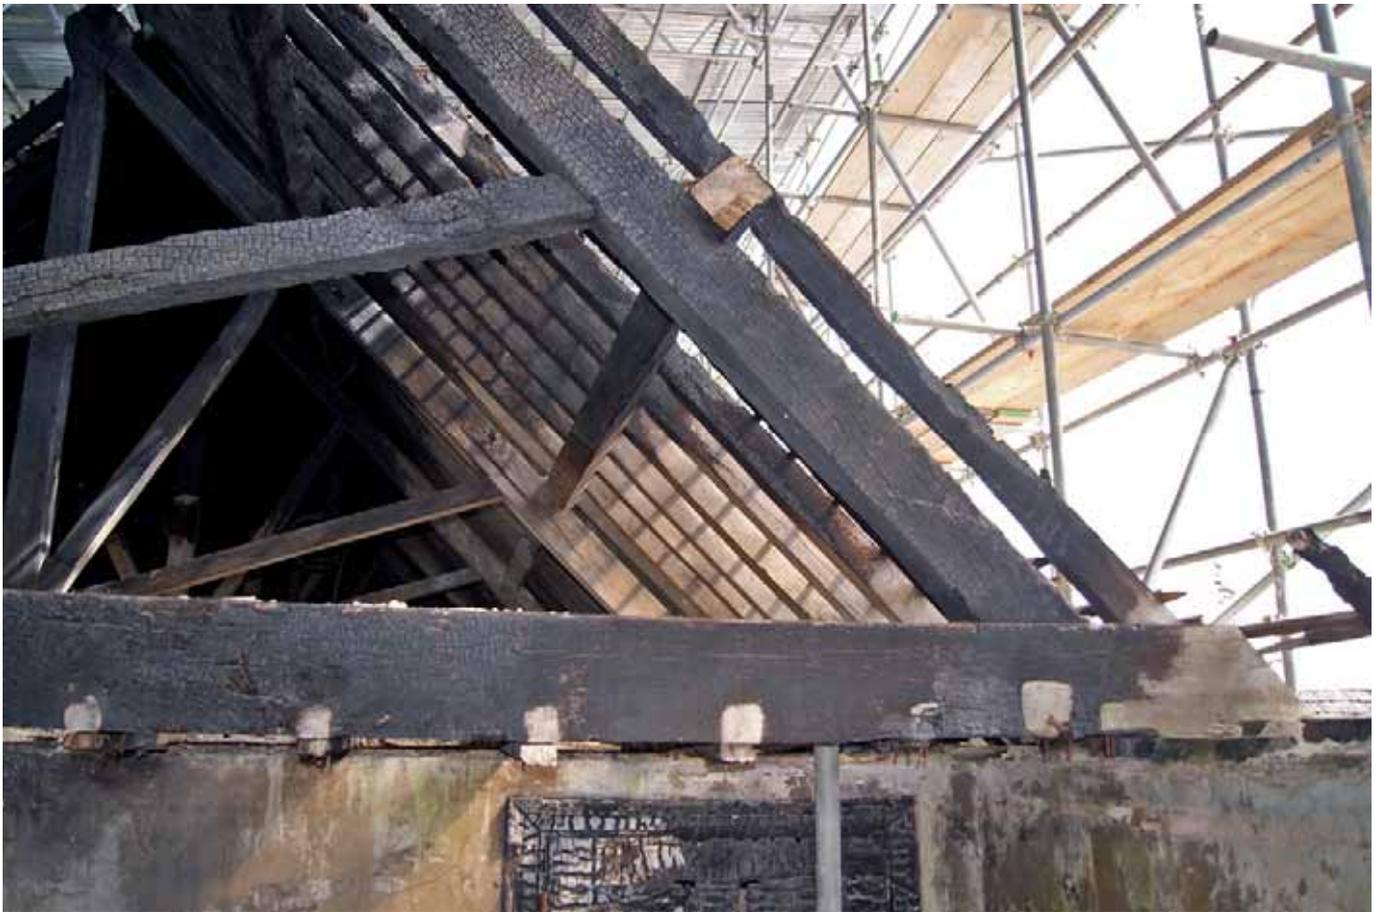
Plate 71: Roof details to east of F1

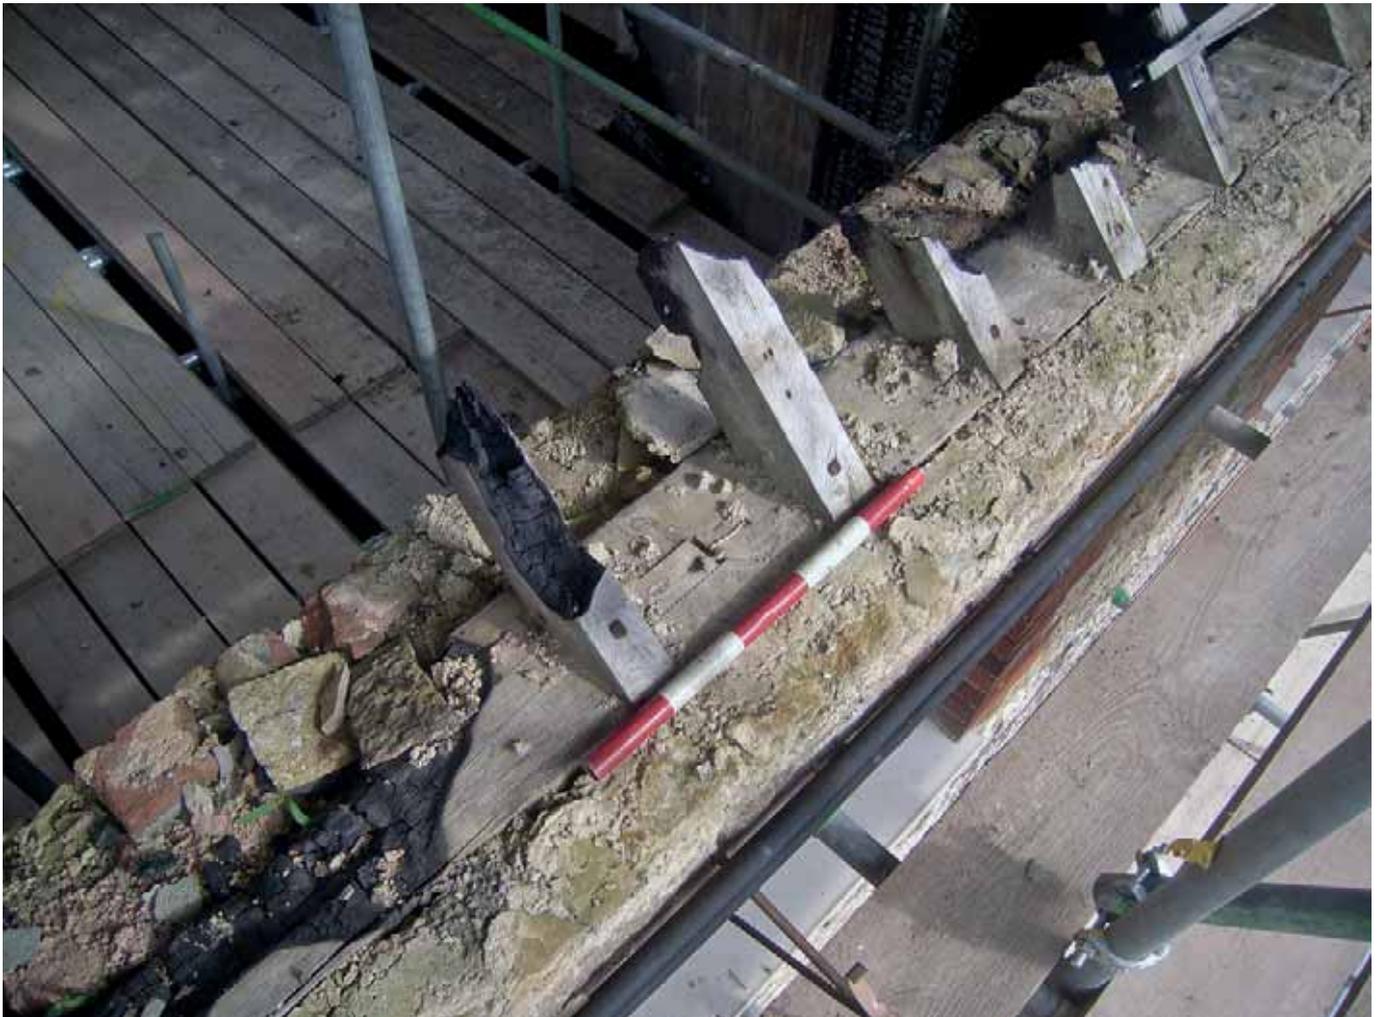
Plate 72: Truss details to east of F1
