The Stables Coleshill Estate Oxfordshire

Historic Building Investigation and Recording

May 2017

Client: National Trust

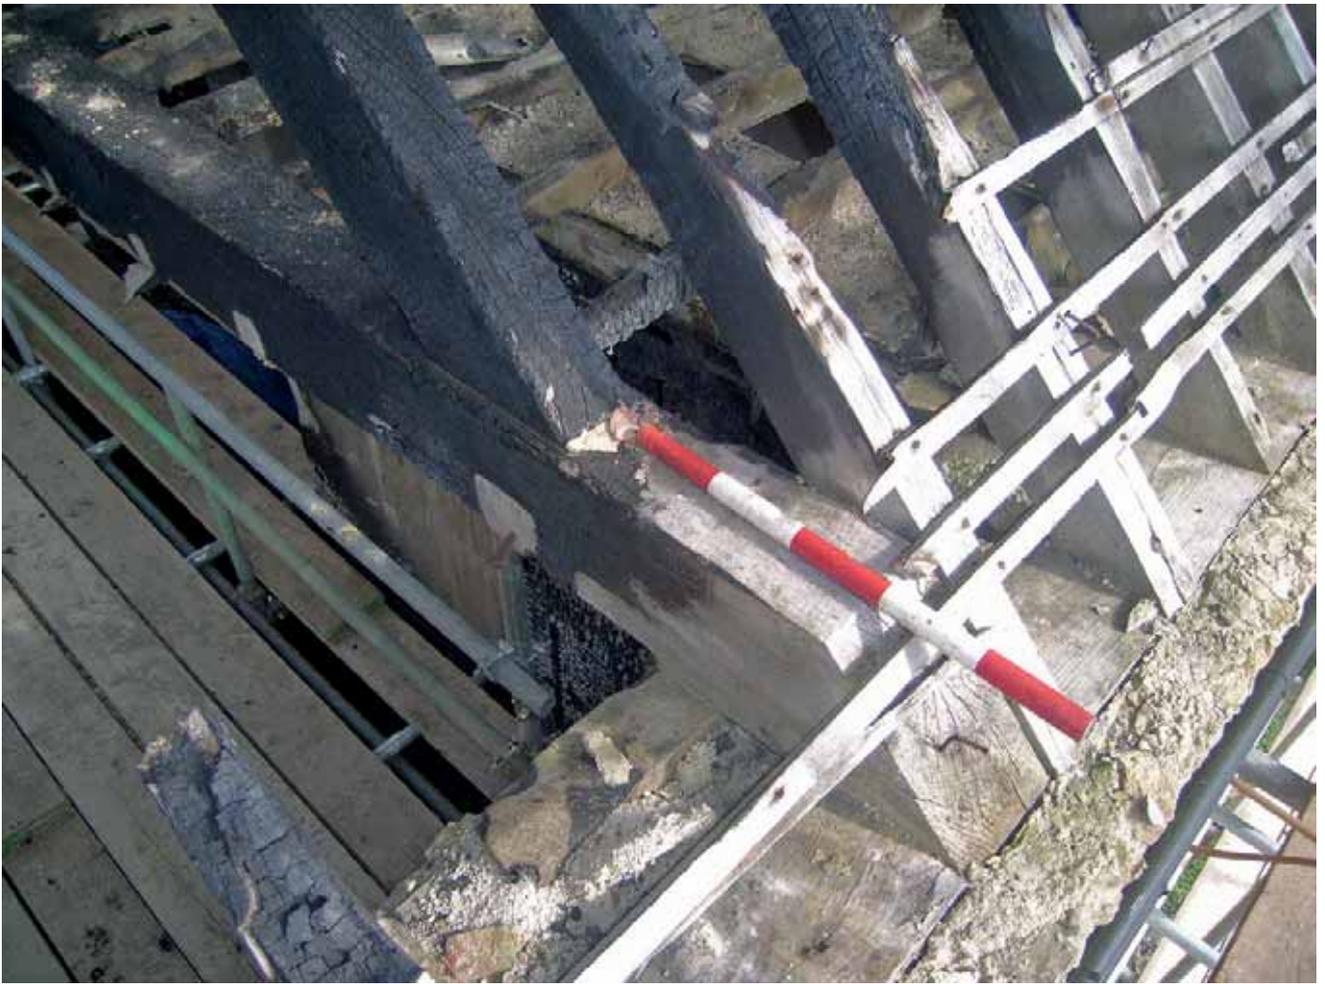
- 3.3.51 The ends of the tie-beams rest on two wall plates: an inner plate (10 x 10 cm) at the inner edge of the wall and an outer plate (20 x 10 cm) at the outer edge of the wall. The king-post is fixed to the tie-beam with a vertical iron bolt up through the underside of the tie but there are no other iron straps or fixings (eg towards eaves) as are sometimes found with this type of truss.
- 3.3.52 East-to-west ceiling joists (9 x 6 cm) are nailed to the underside of the tie-beams

Plate 73: Wall plate with rafter feet in F1

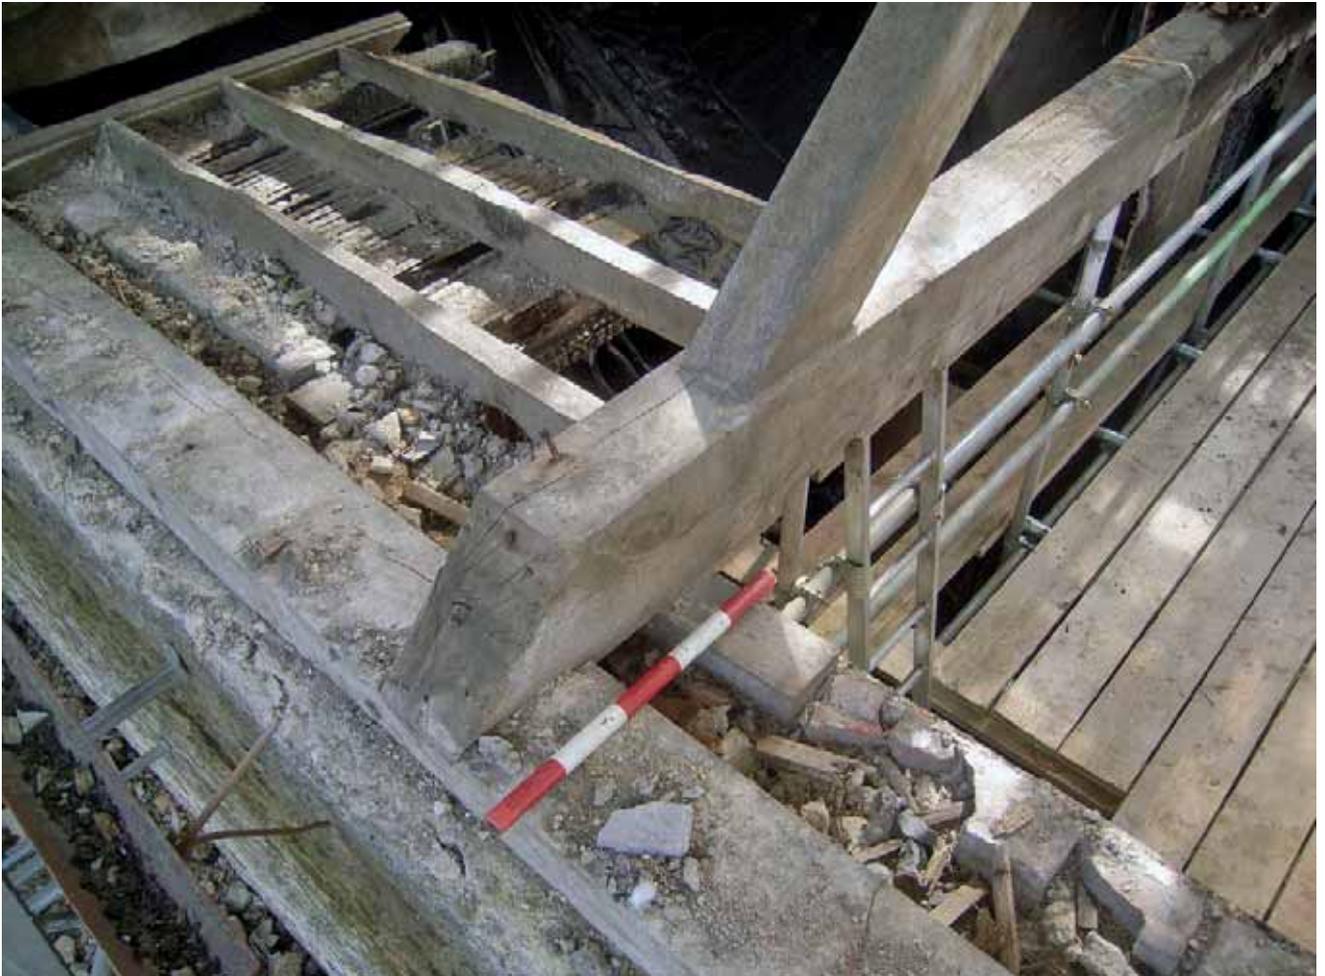
Plate 74: End of tie-beam in F1

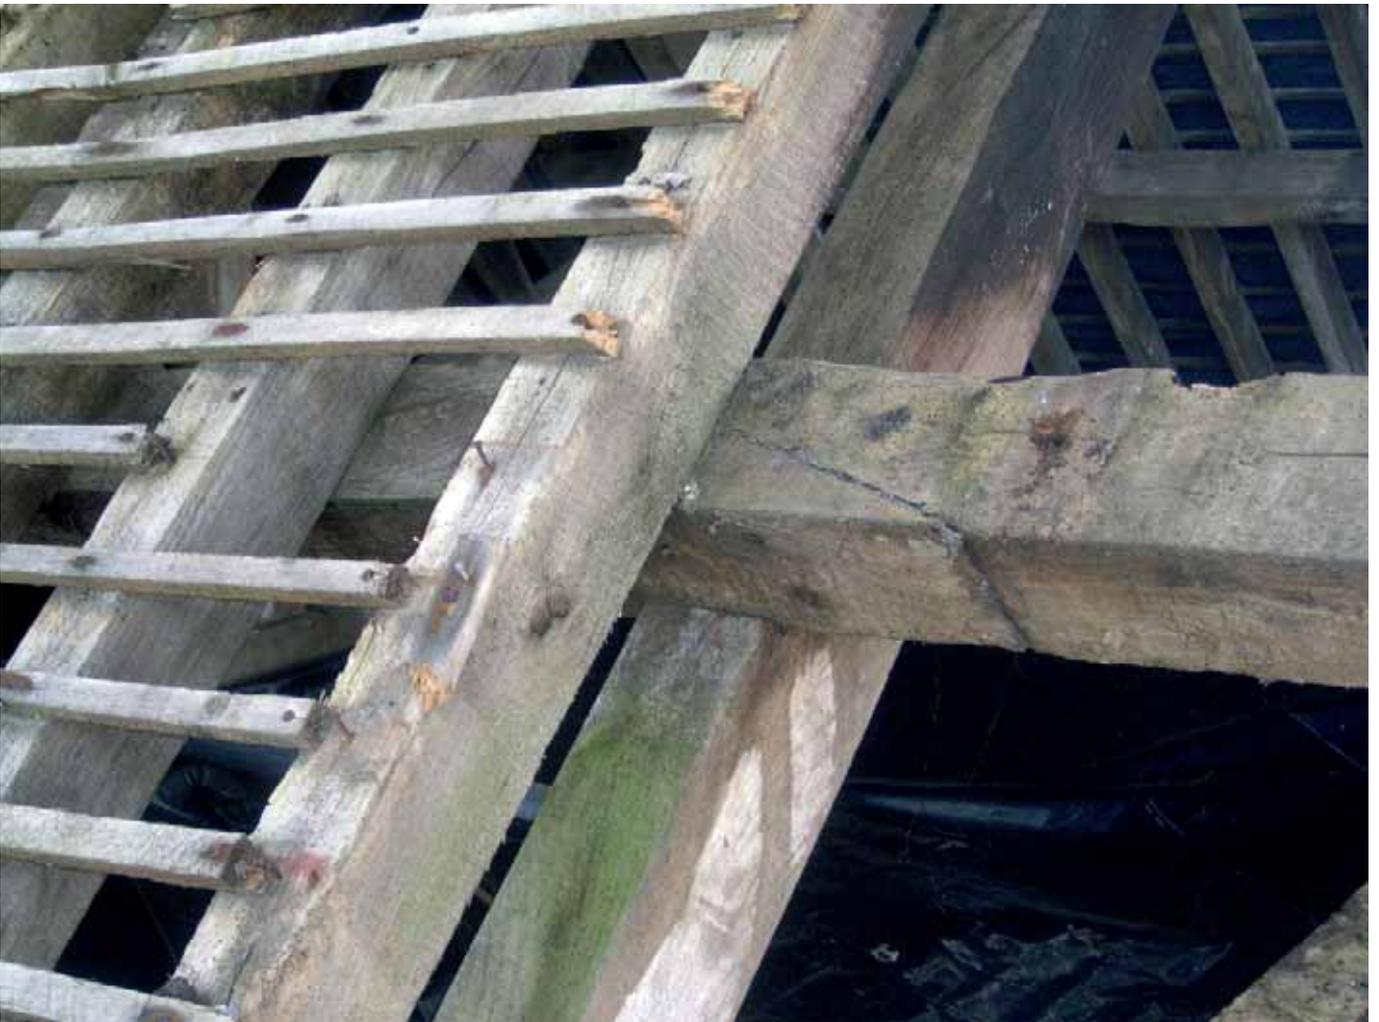
Plate 75: End of tie-beam in F1

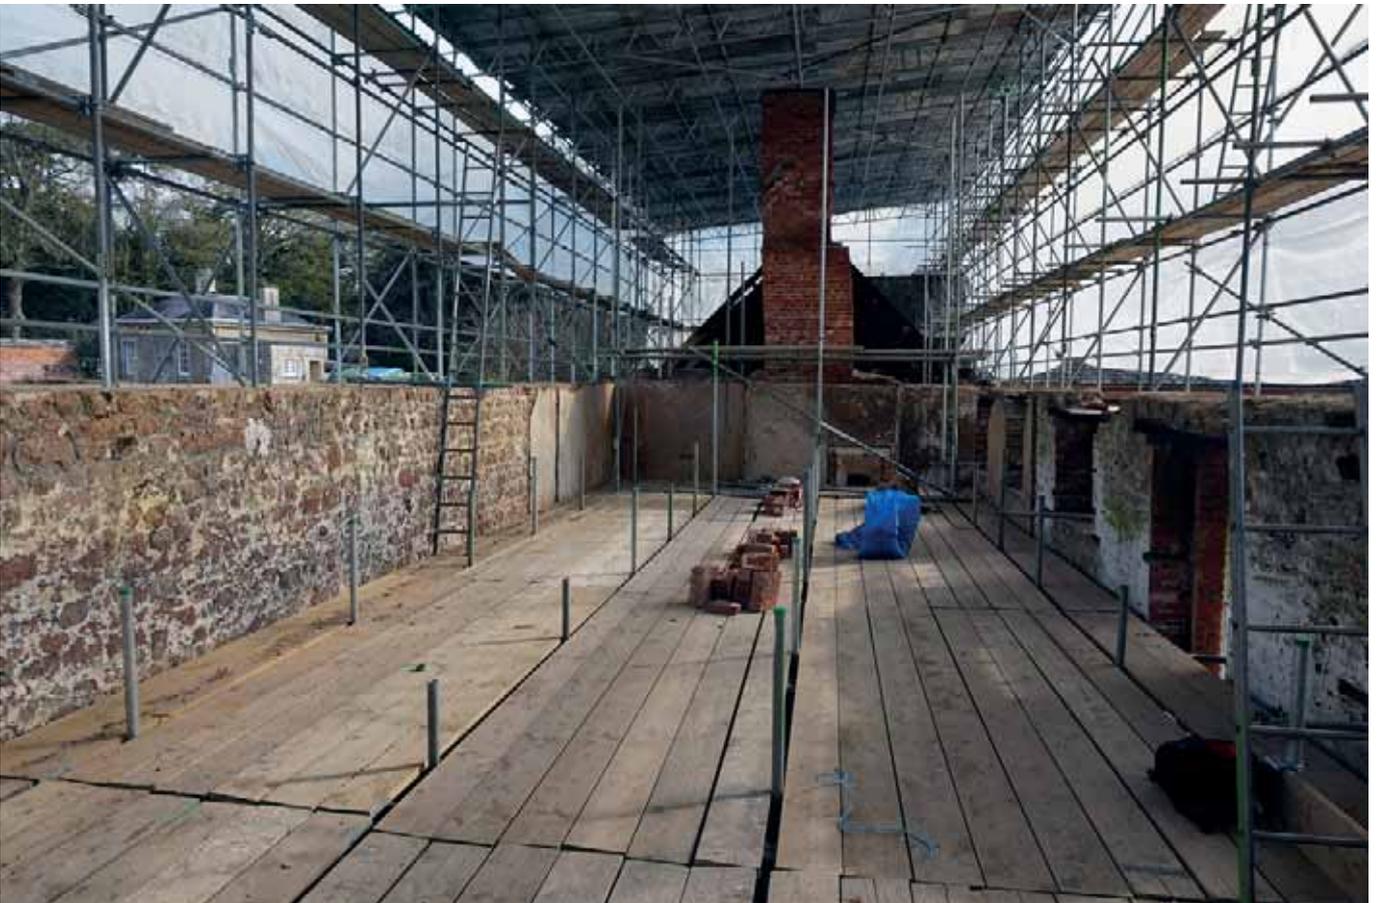
Plate 76: Roof detail to east side of F1

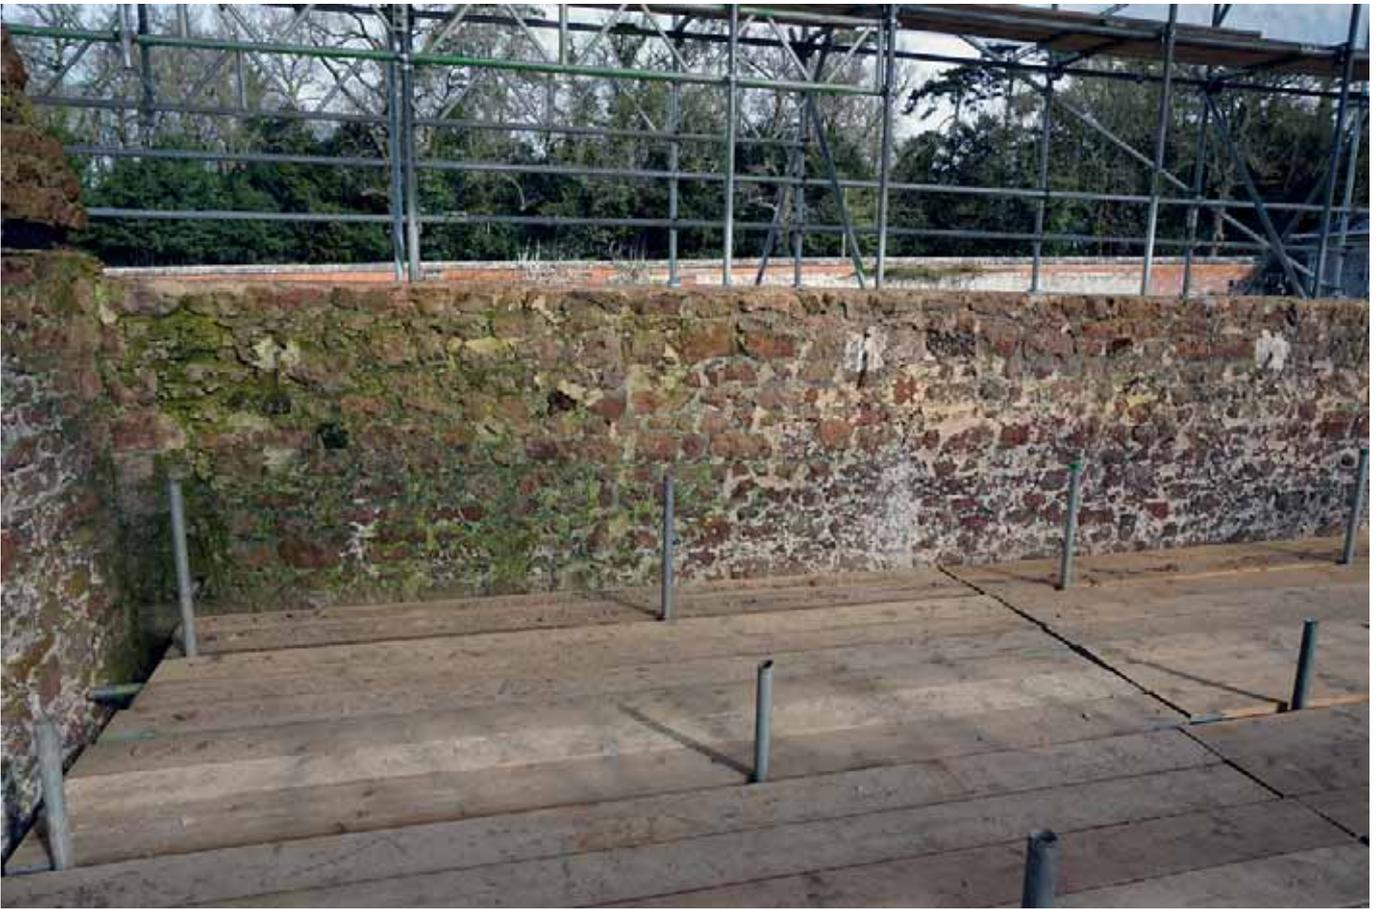
Plate 77: General view of F2-3 looking east

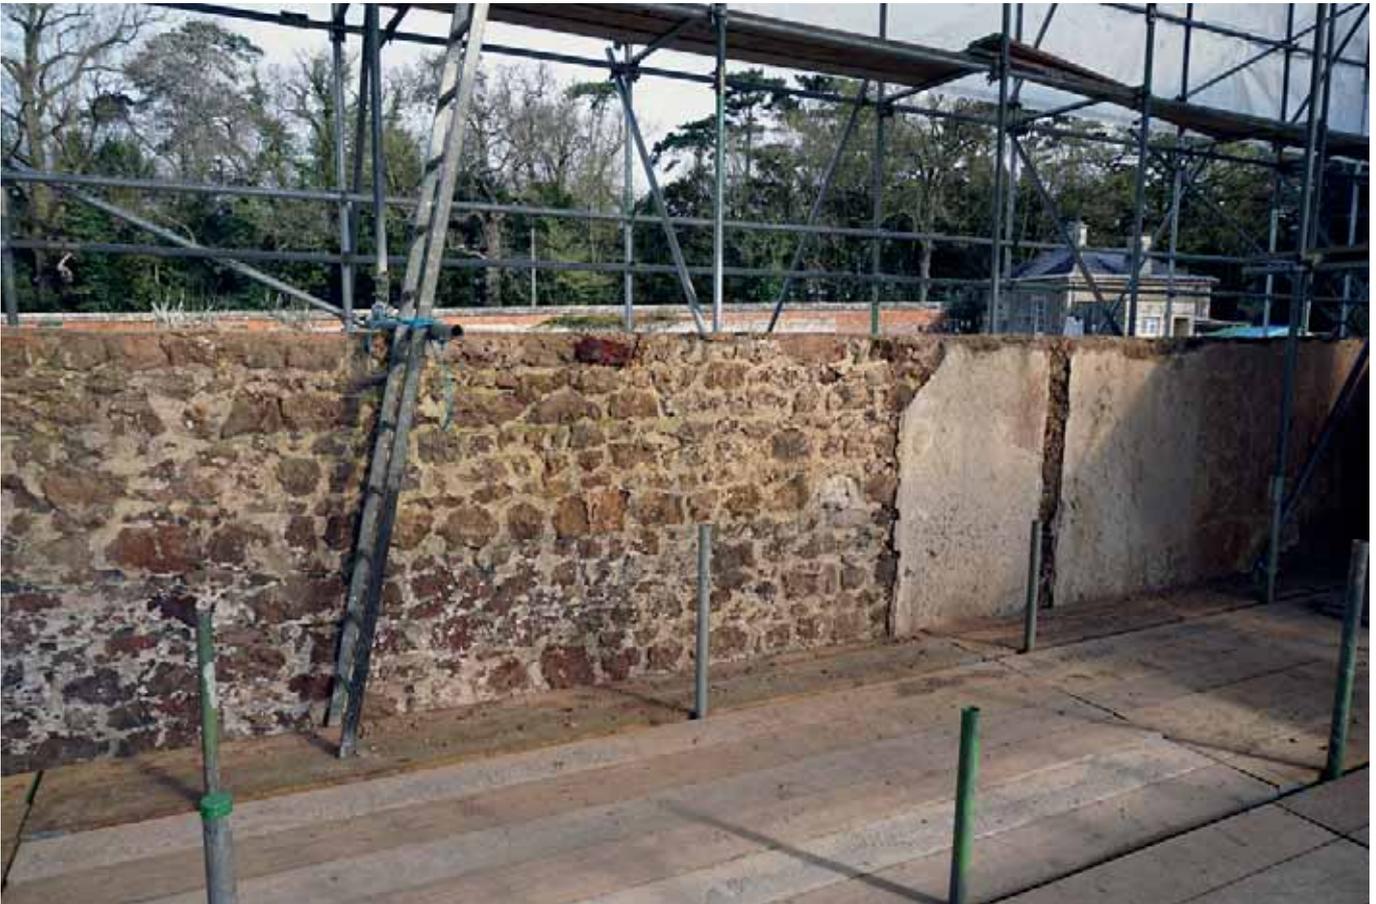
Plate 78: Western part of north wall in F3

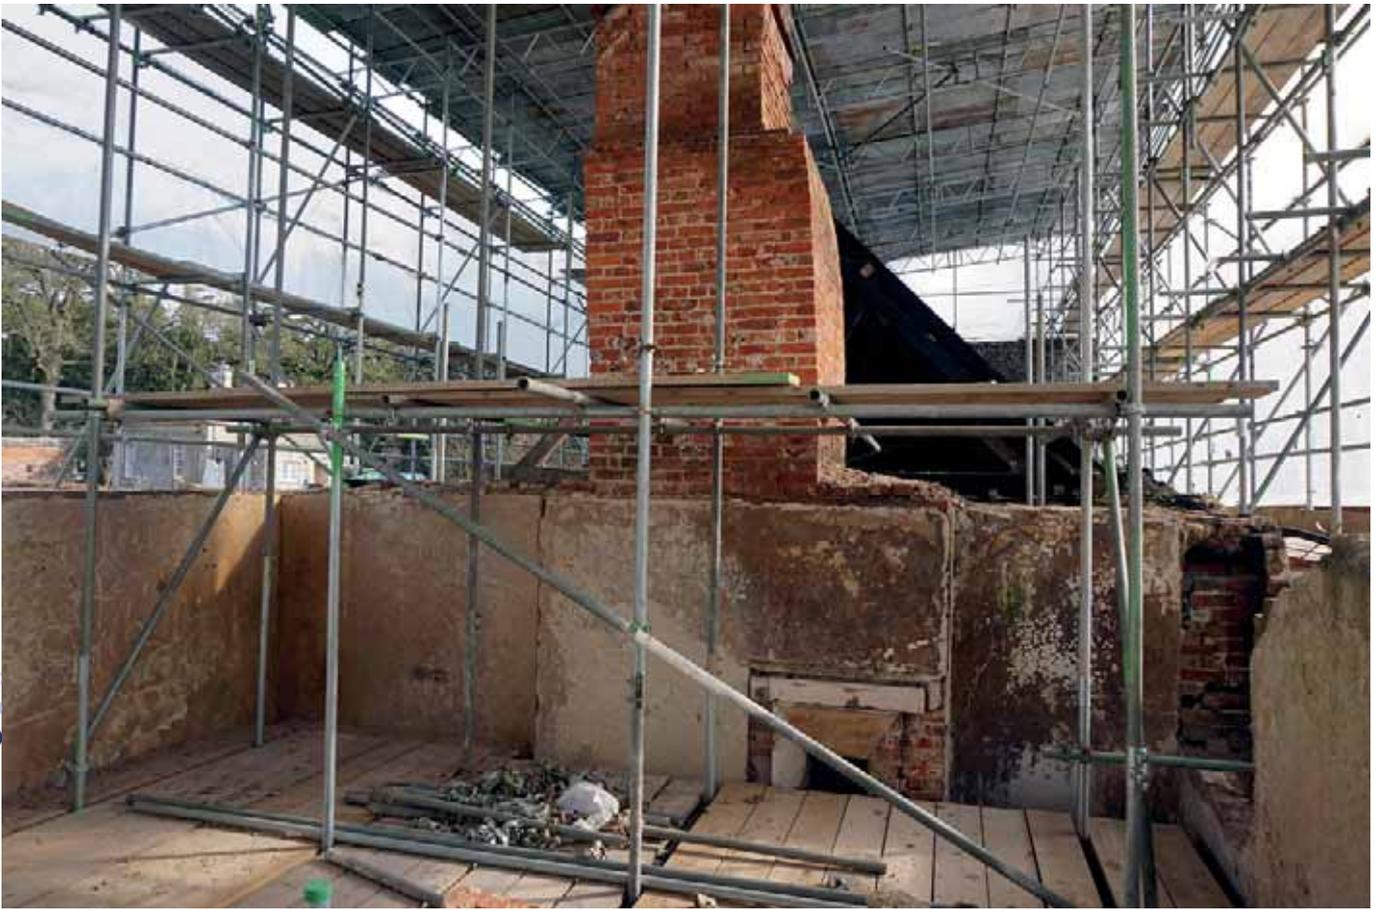
Plate 79: Eastern part of north wall in F2

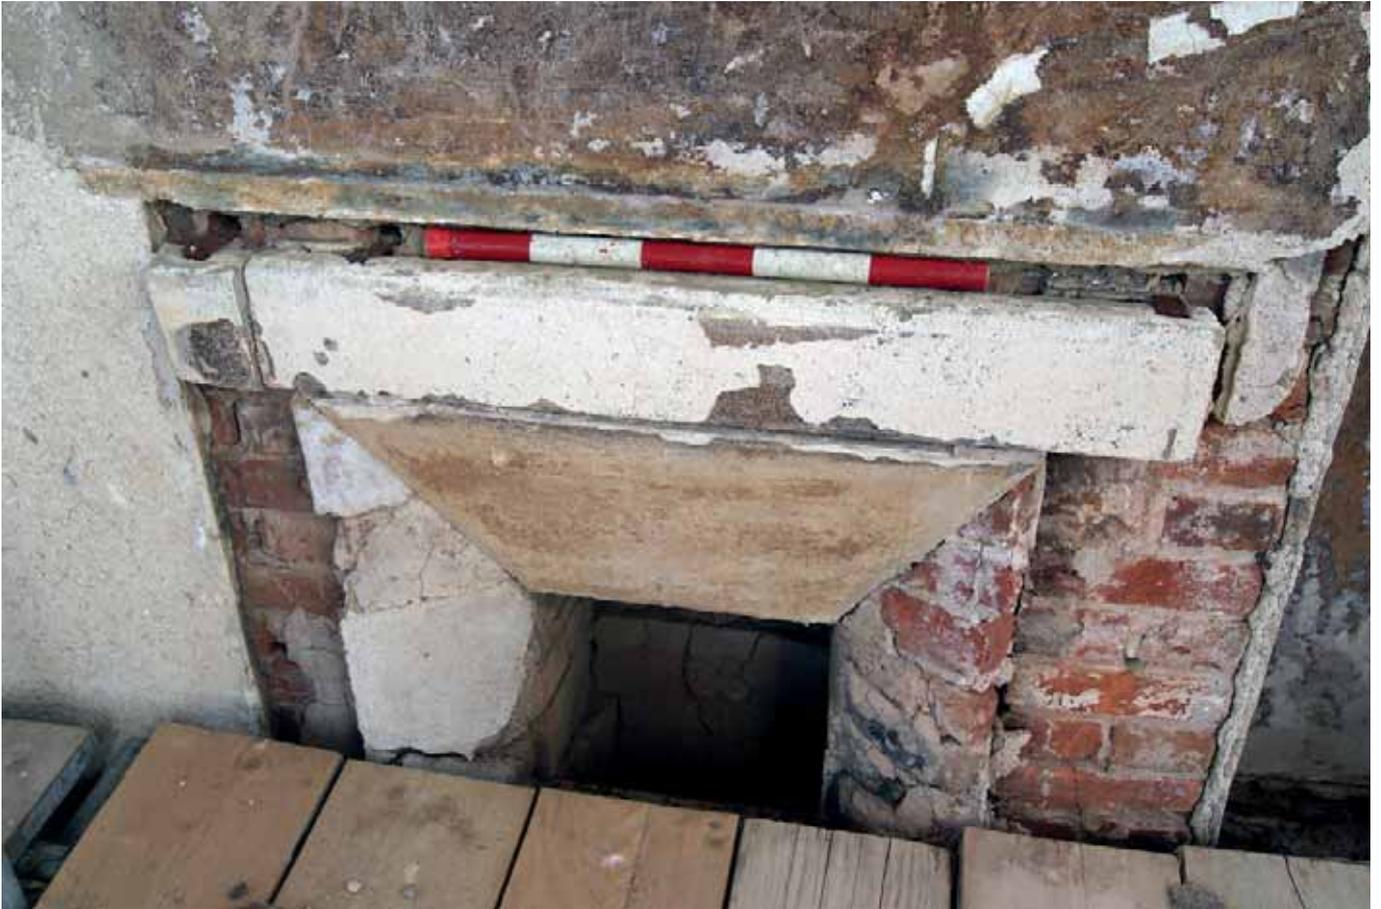
Plate 80: East end of F2

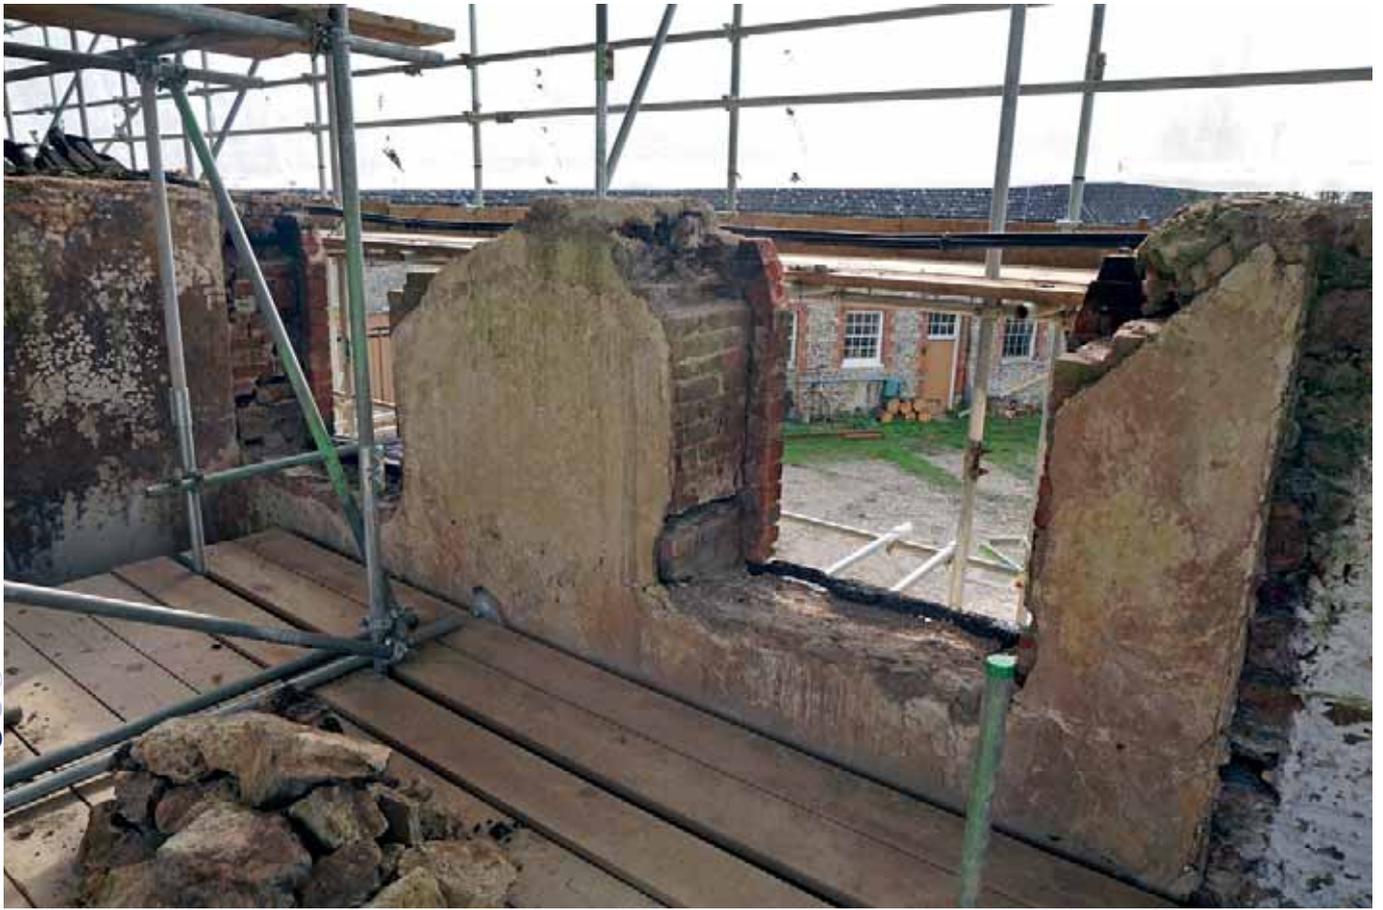
Plate 81: Fireplace at east end of F2

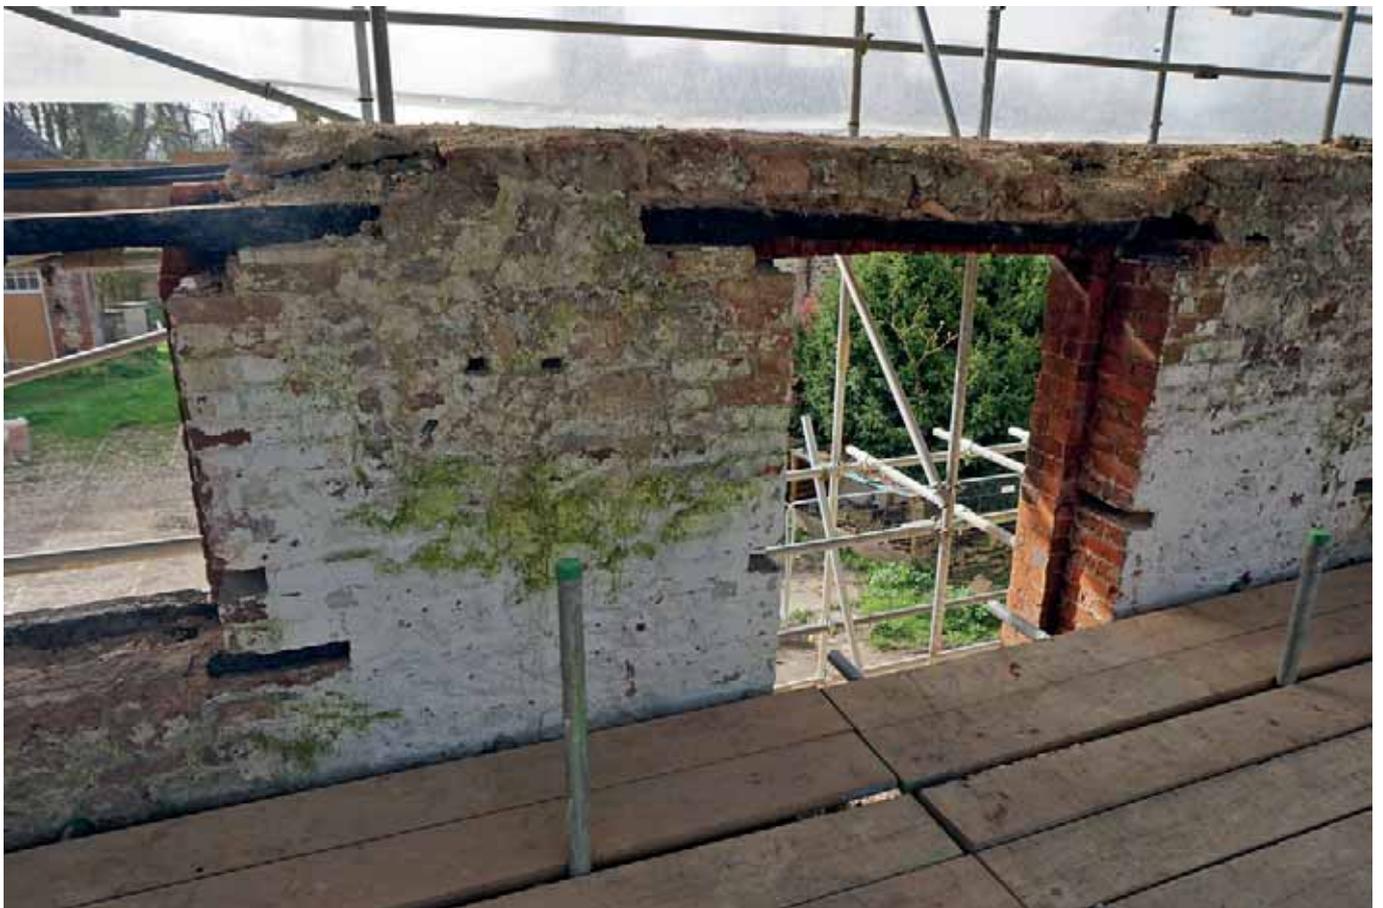
Plate 82: South wall in F2

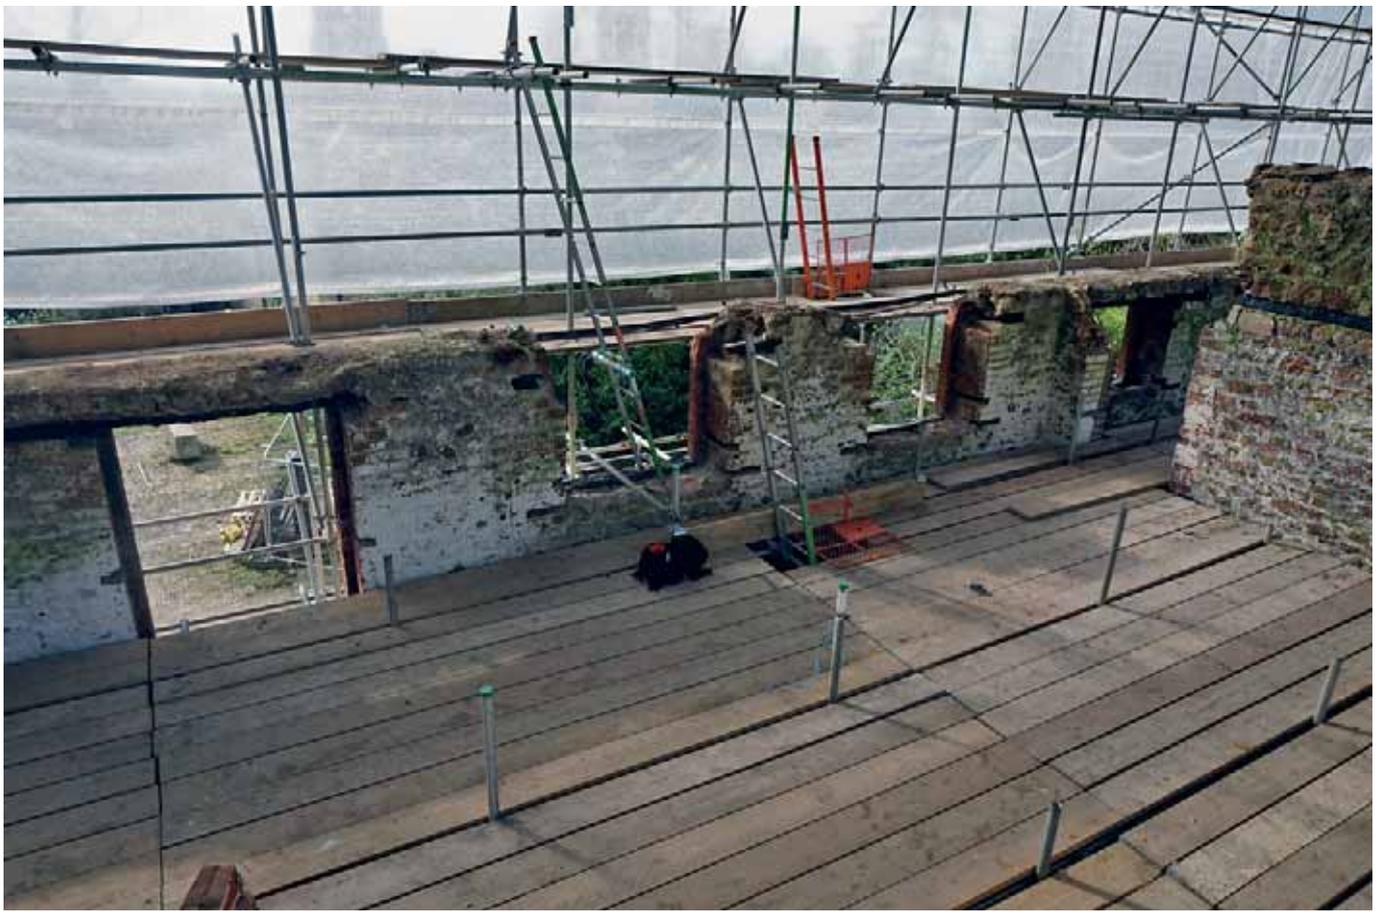
Plate 83: South wall in F3

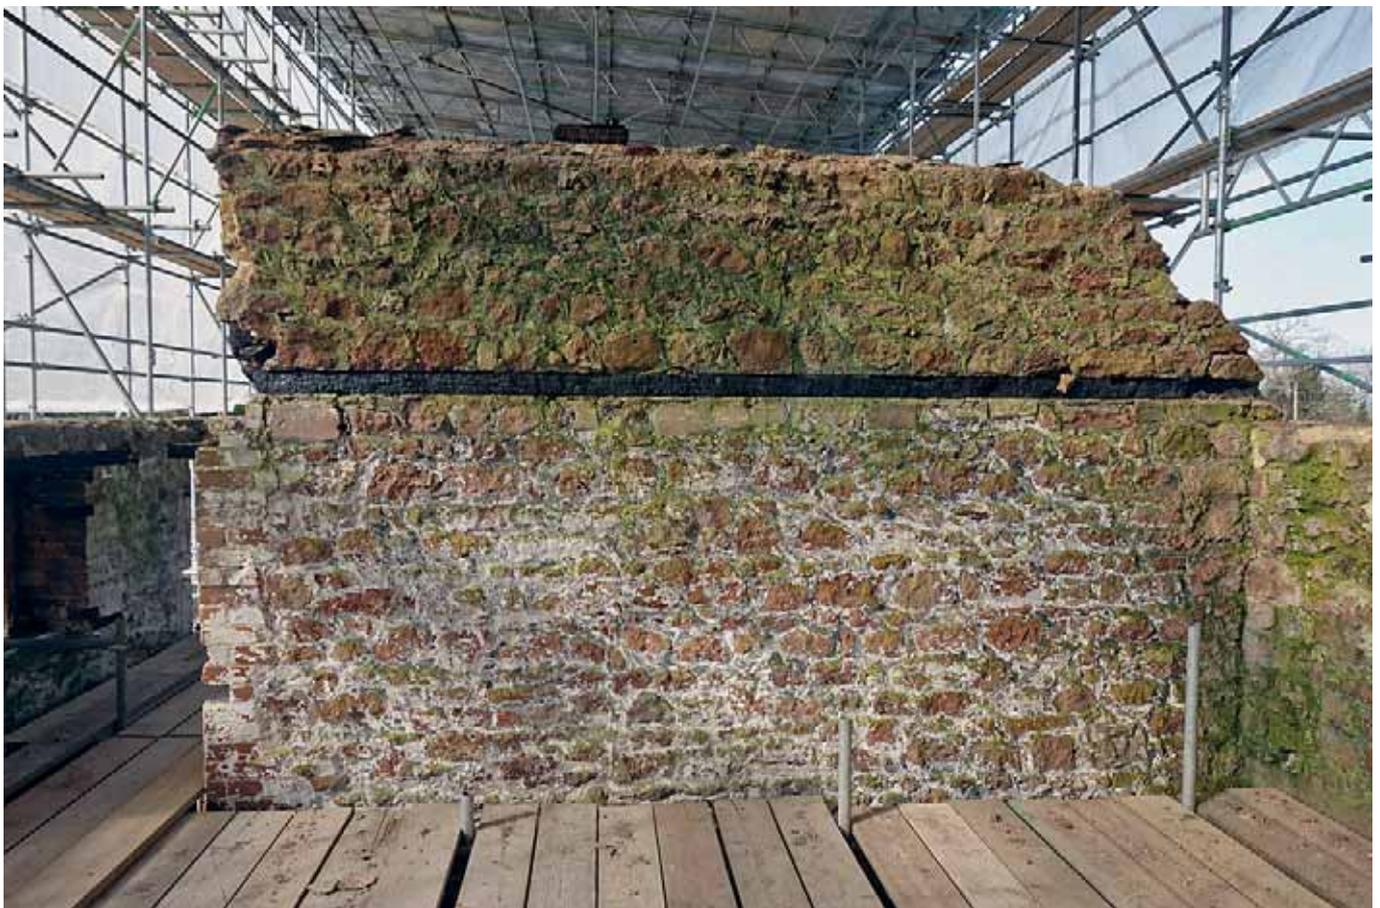
Plate 84: South wall in F3

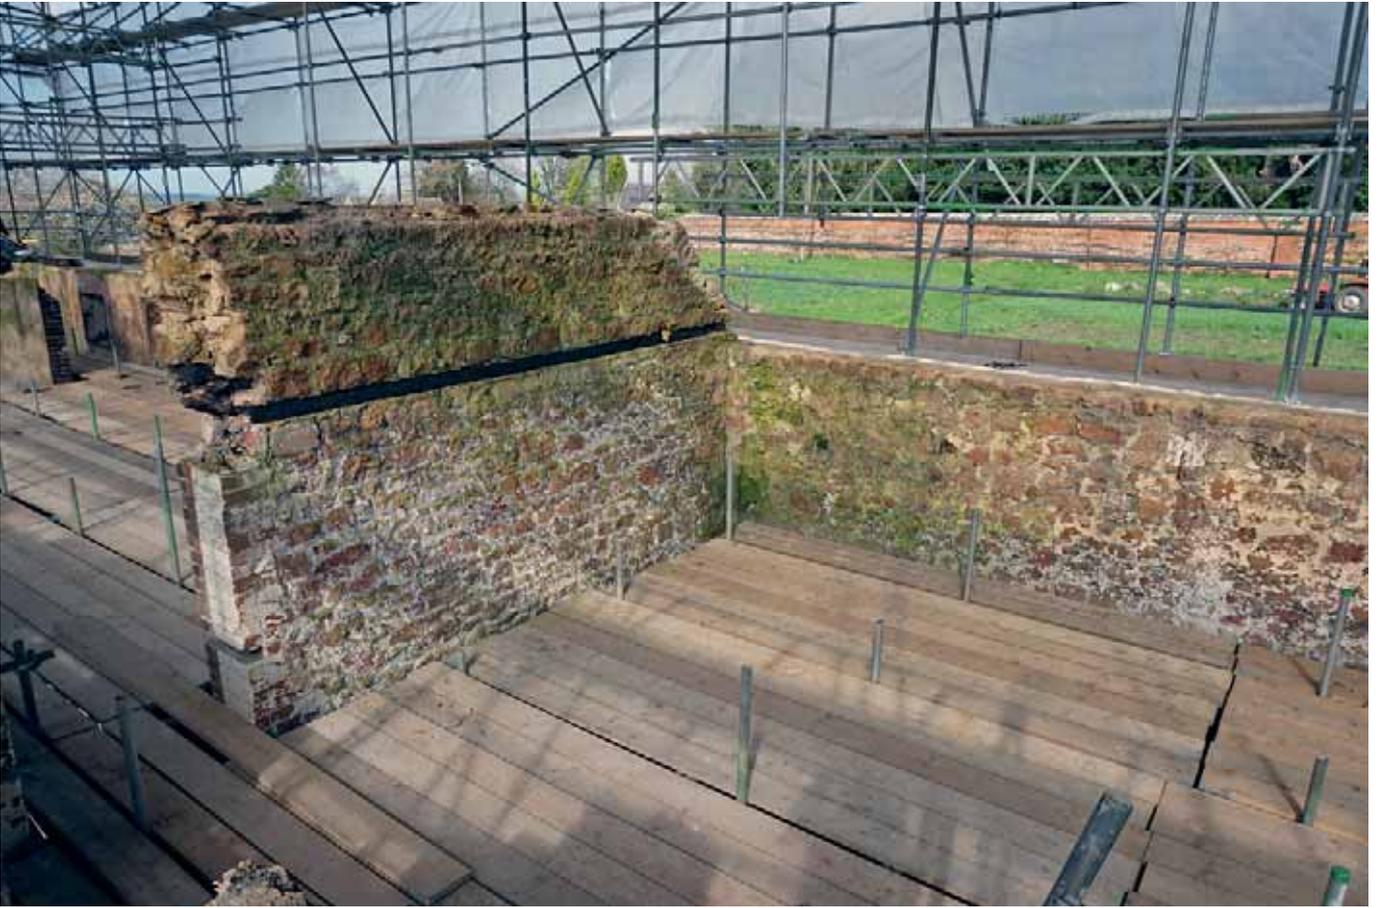
Plate 85: West wall of F3

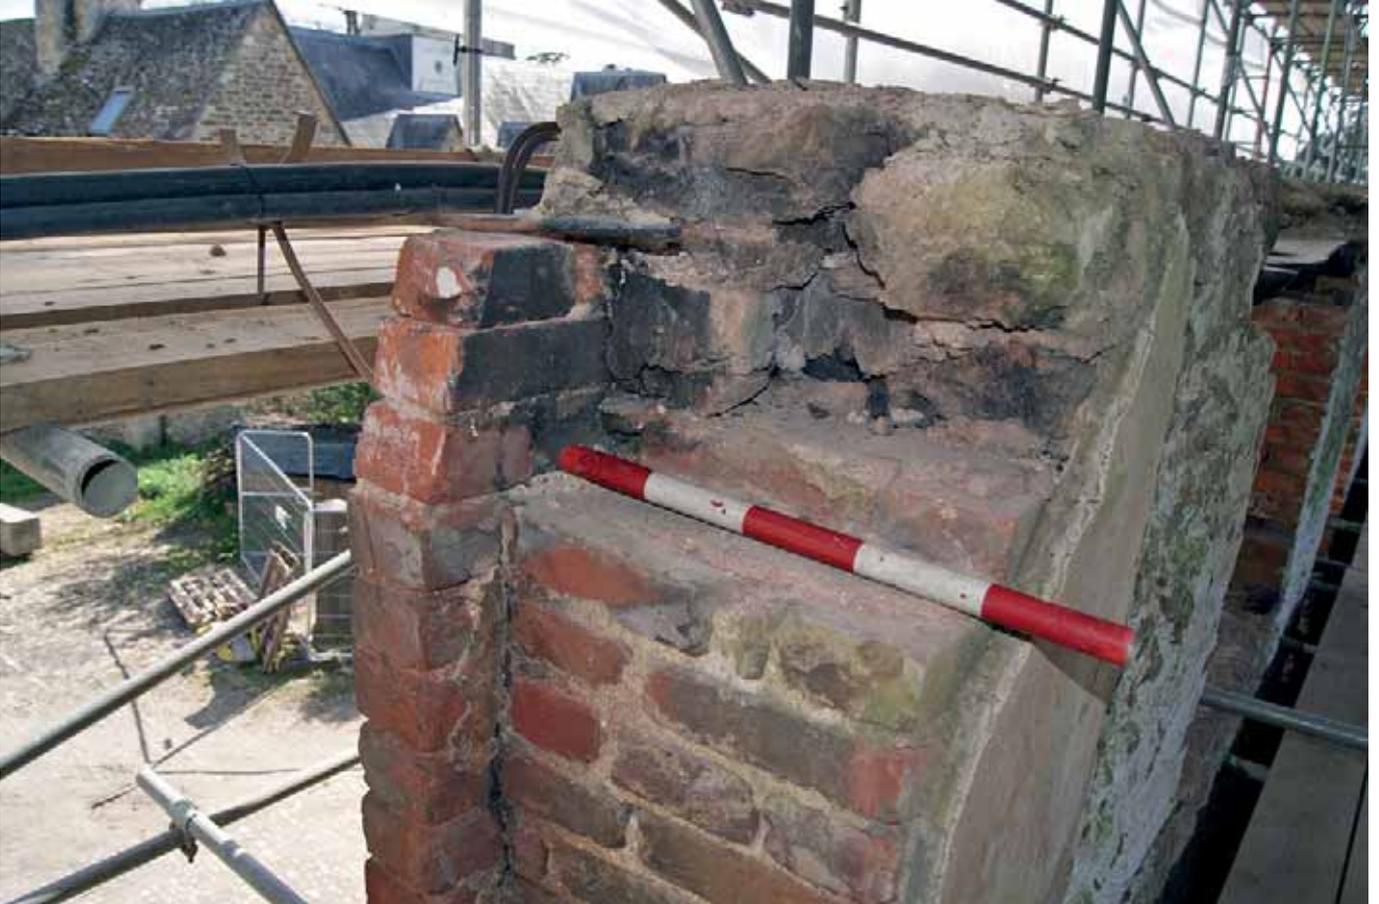
Plate 86: Room F3 looking north-west

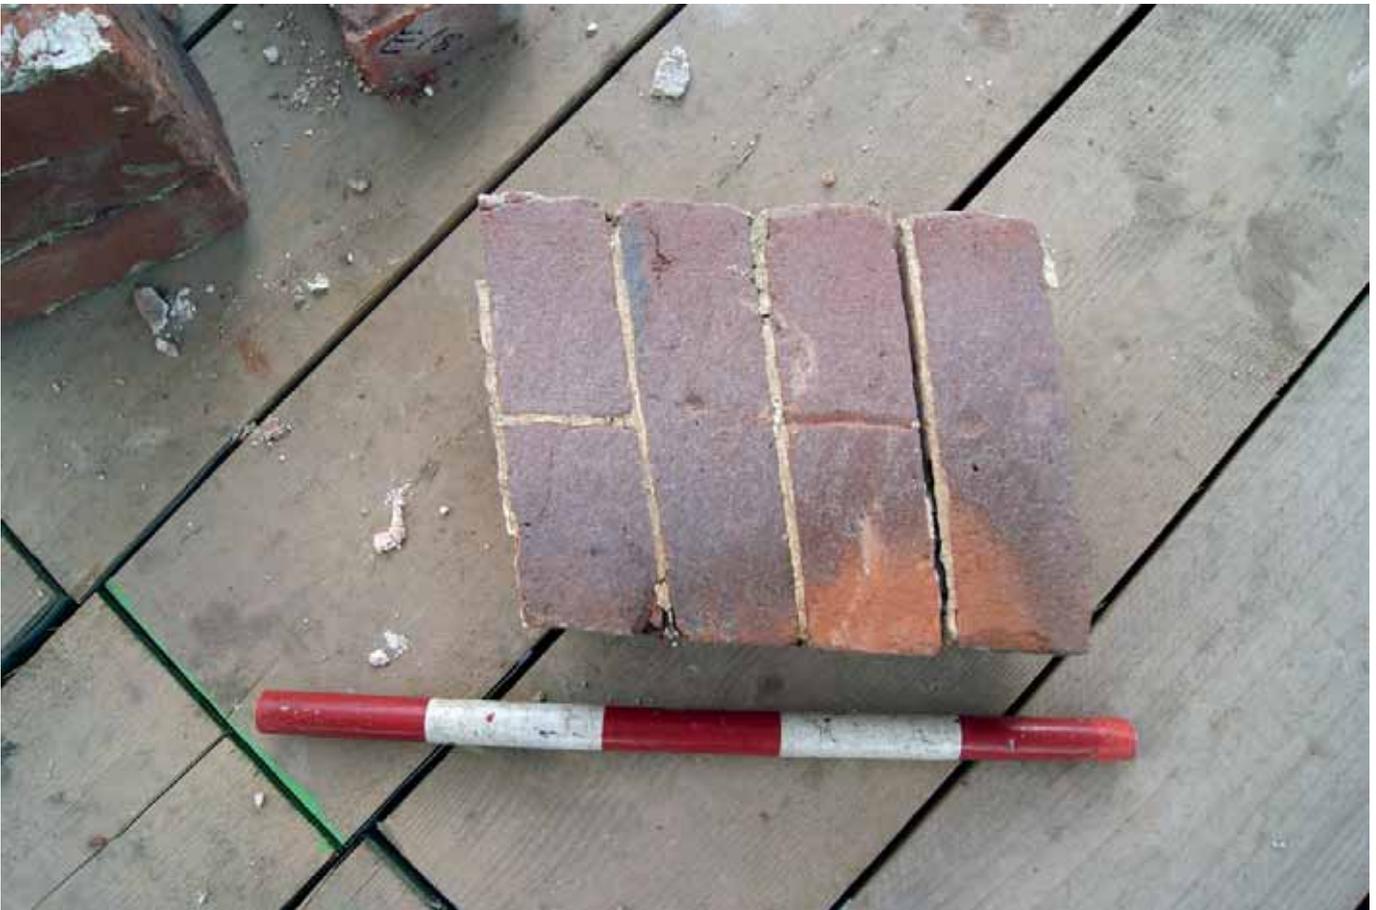
Plate 87: Jamb detail in F3

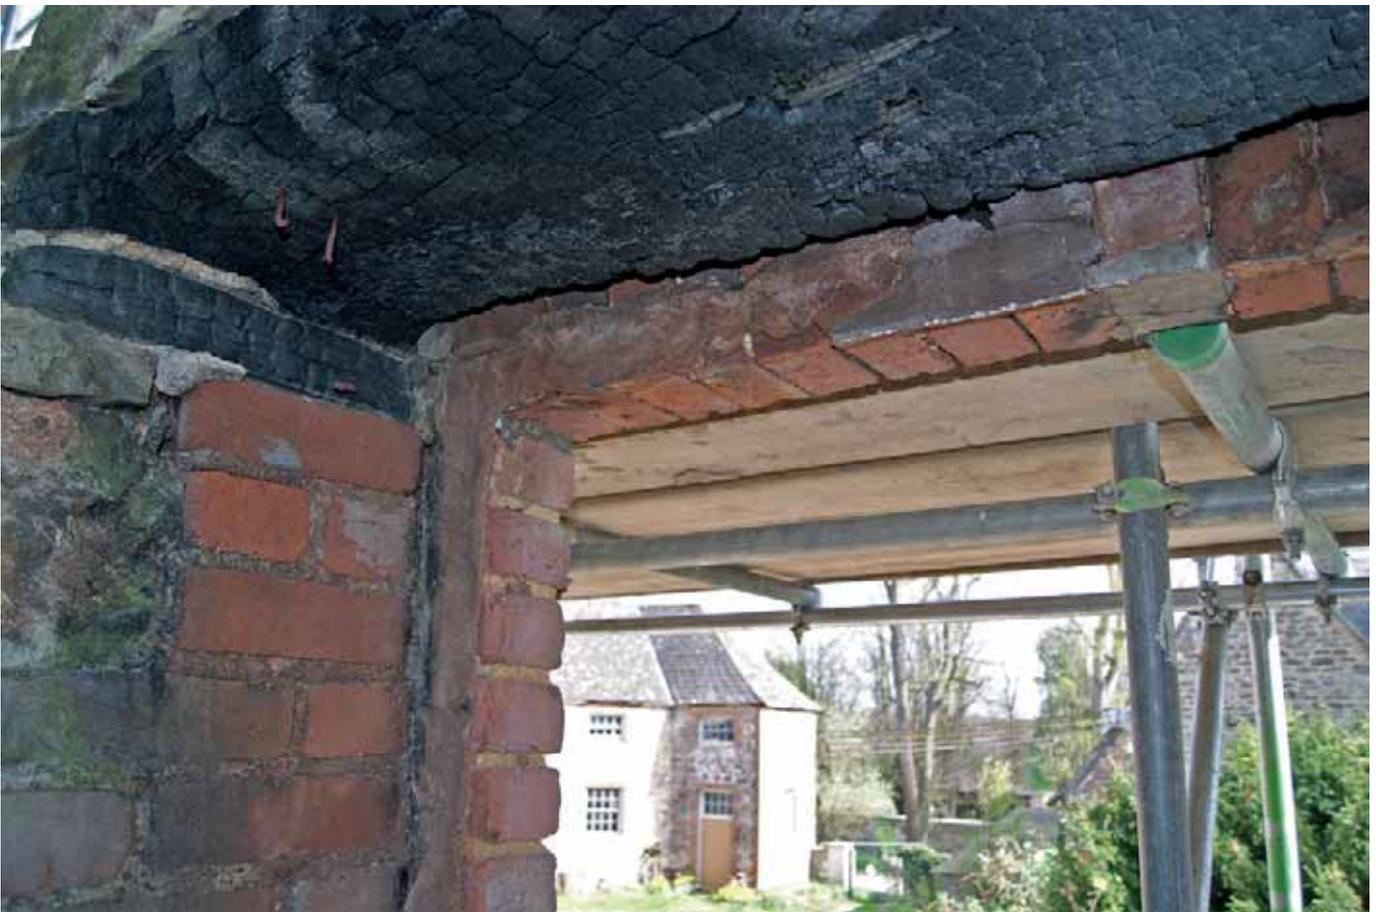
Plate 88: Rubbed bricks from dismantled first floor lintel

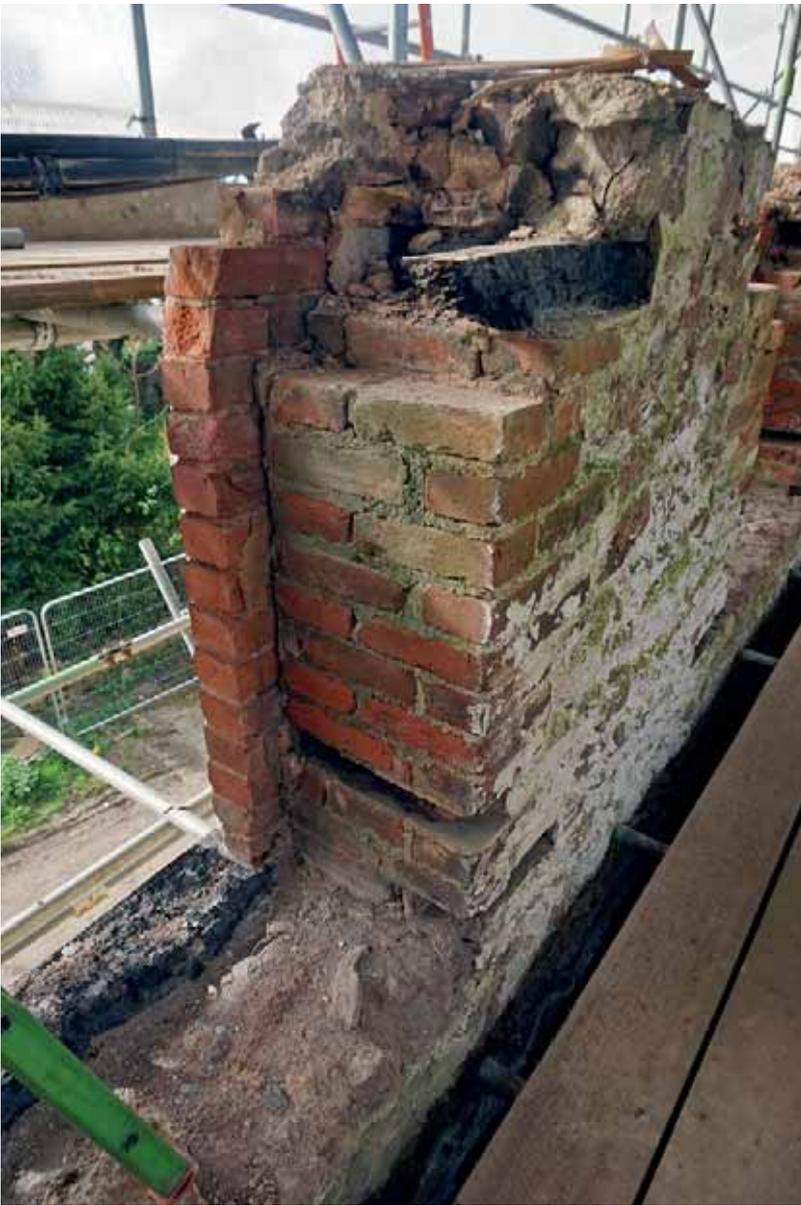
Plate 89: Detail of window opening in F4

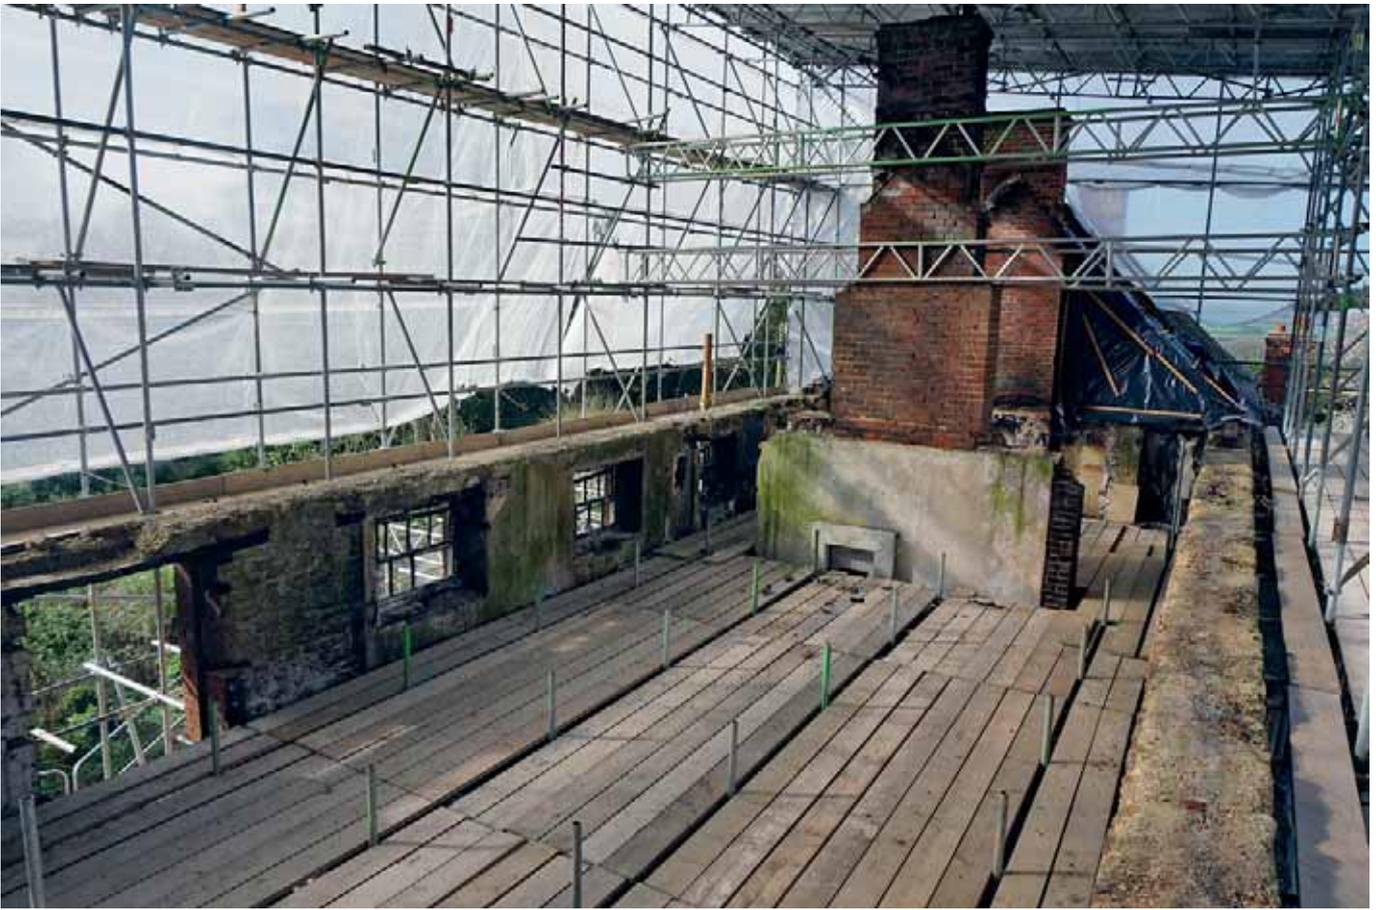
Plate 91: Fire damaged timber lintel in F4
