The Stables Coleshill Estate Oxfordshire

Historic Building Investigation and Recording

May 2017

Client: National Trust

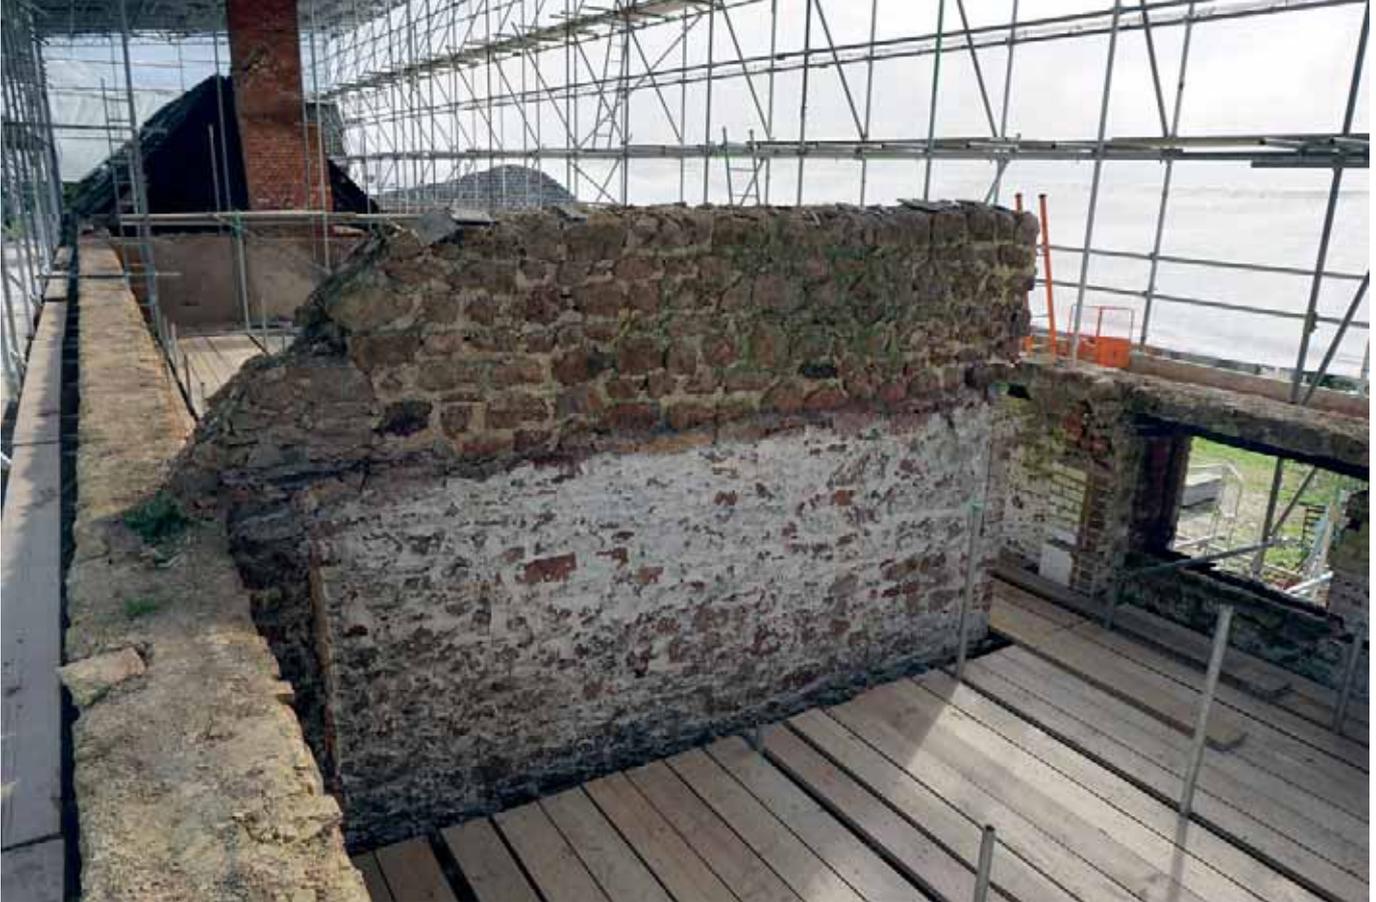
- 3.3.45 In the west half of this area (ie F5) there are two windows in both the north wall and the south wall which would each have illuminated the probable mews living quarters. Each of these windows survive, albeit with fire damage. The windows in the north wall are four-over-four sashes, with angled boarded reveals, and as referred to in the external description it is believed that they are secondary insertions. Between the windows there is the faint imprint of a vertical feature which may have been a cross wall dividing the space. In the west wall there is a small fireplace with a concrete surround which is probably of 20th century date and behind this there appears to be the faint imprint of a former mantelpiece, presumably from a former (primary) surround.

Plate 92: General view of F5

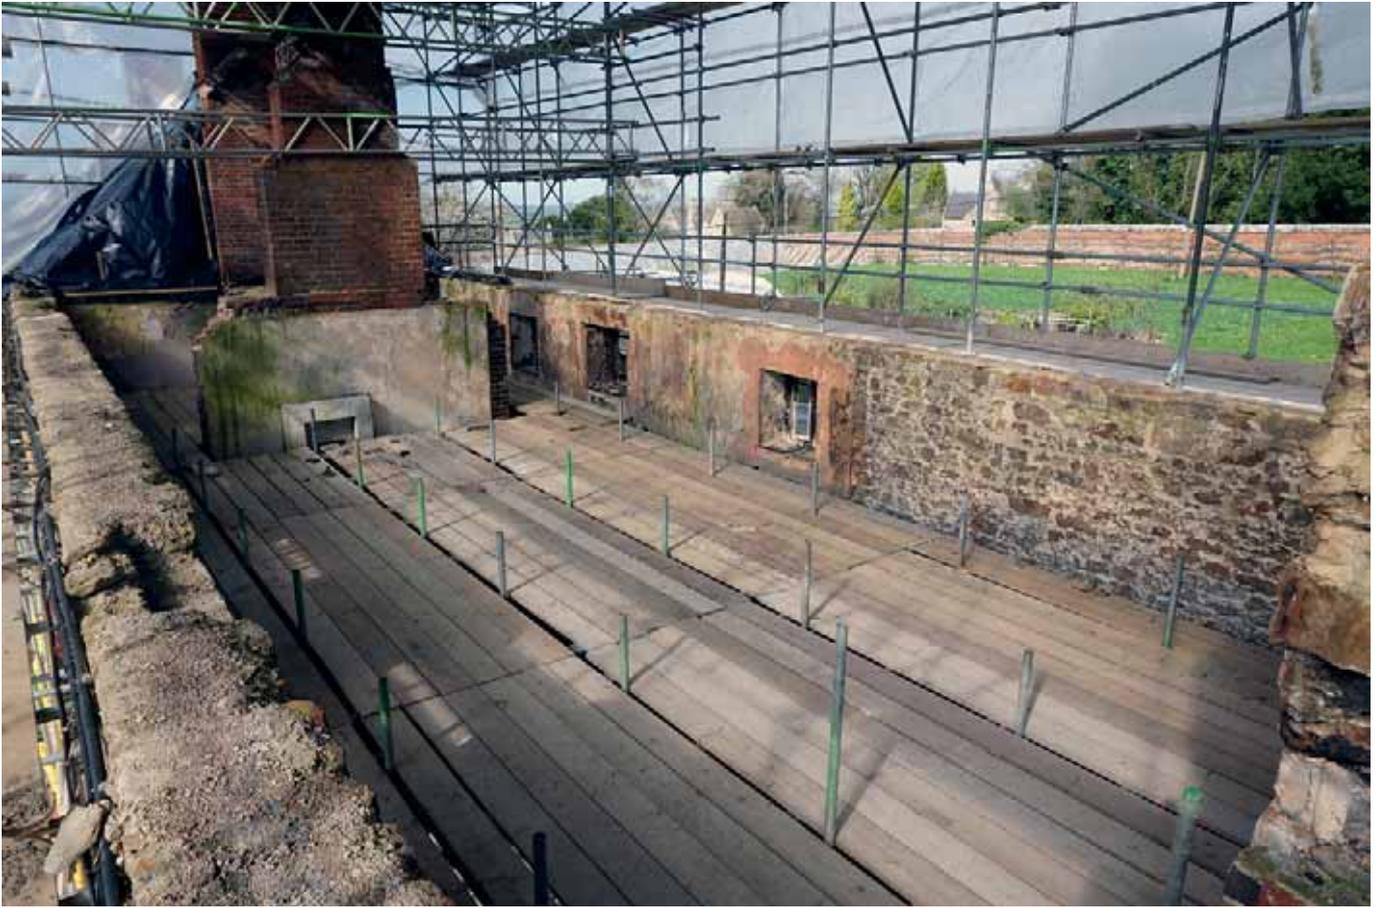
Plate 93: Wall at east side of F4

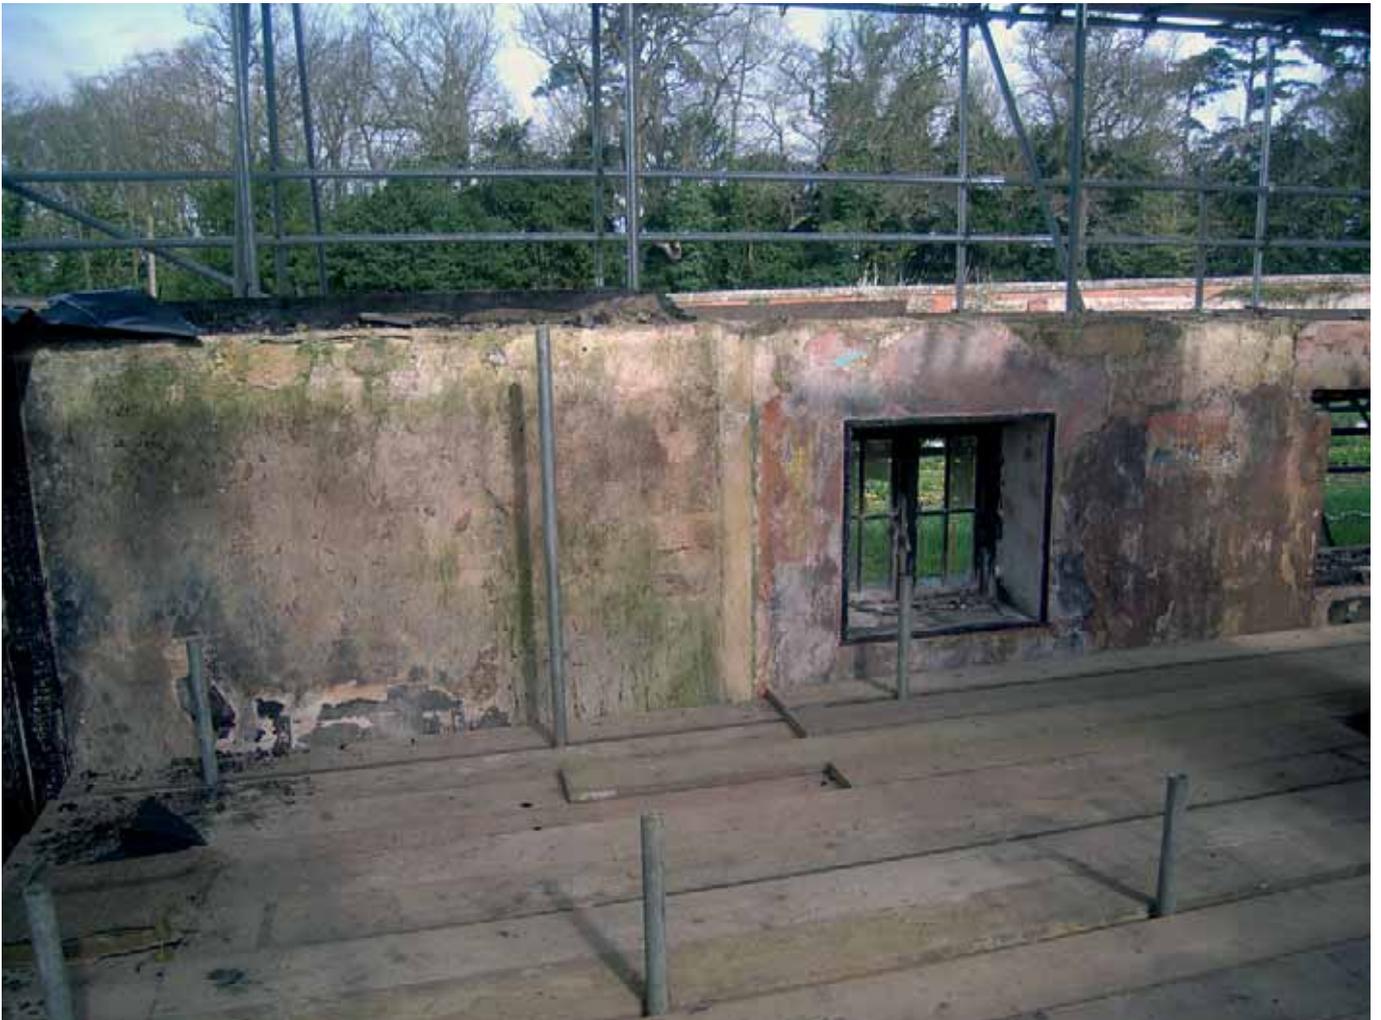
Plate 94: Rooms F4 and F5 looking north-west

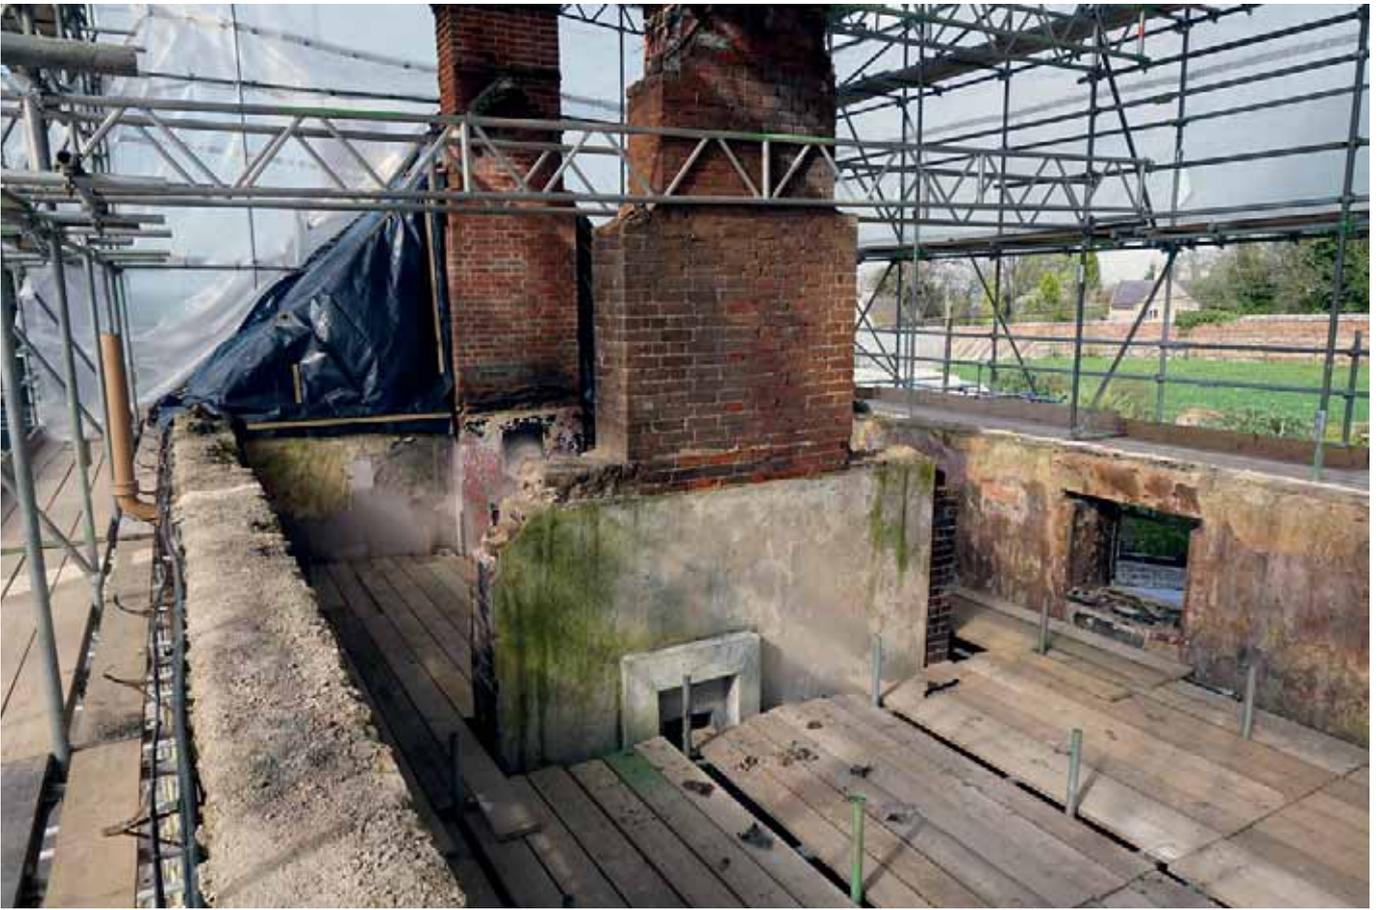
Plate 95: North wall of F5

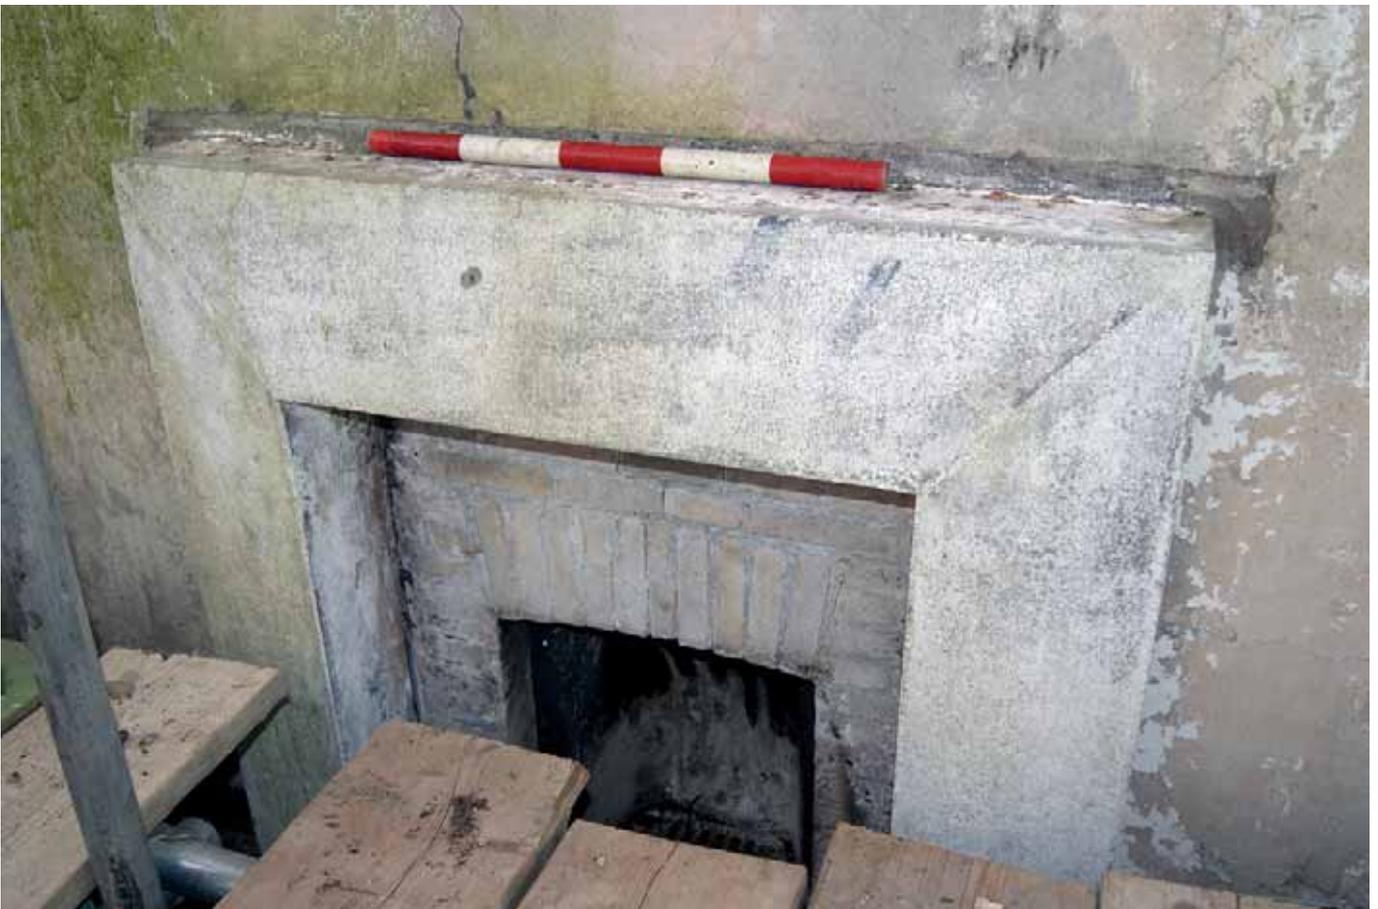
Plate 96: Stack at west side of F5

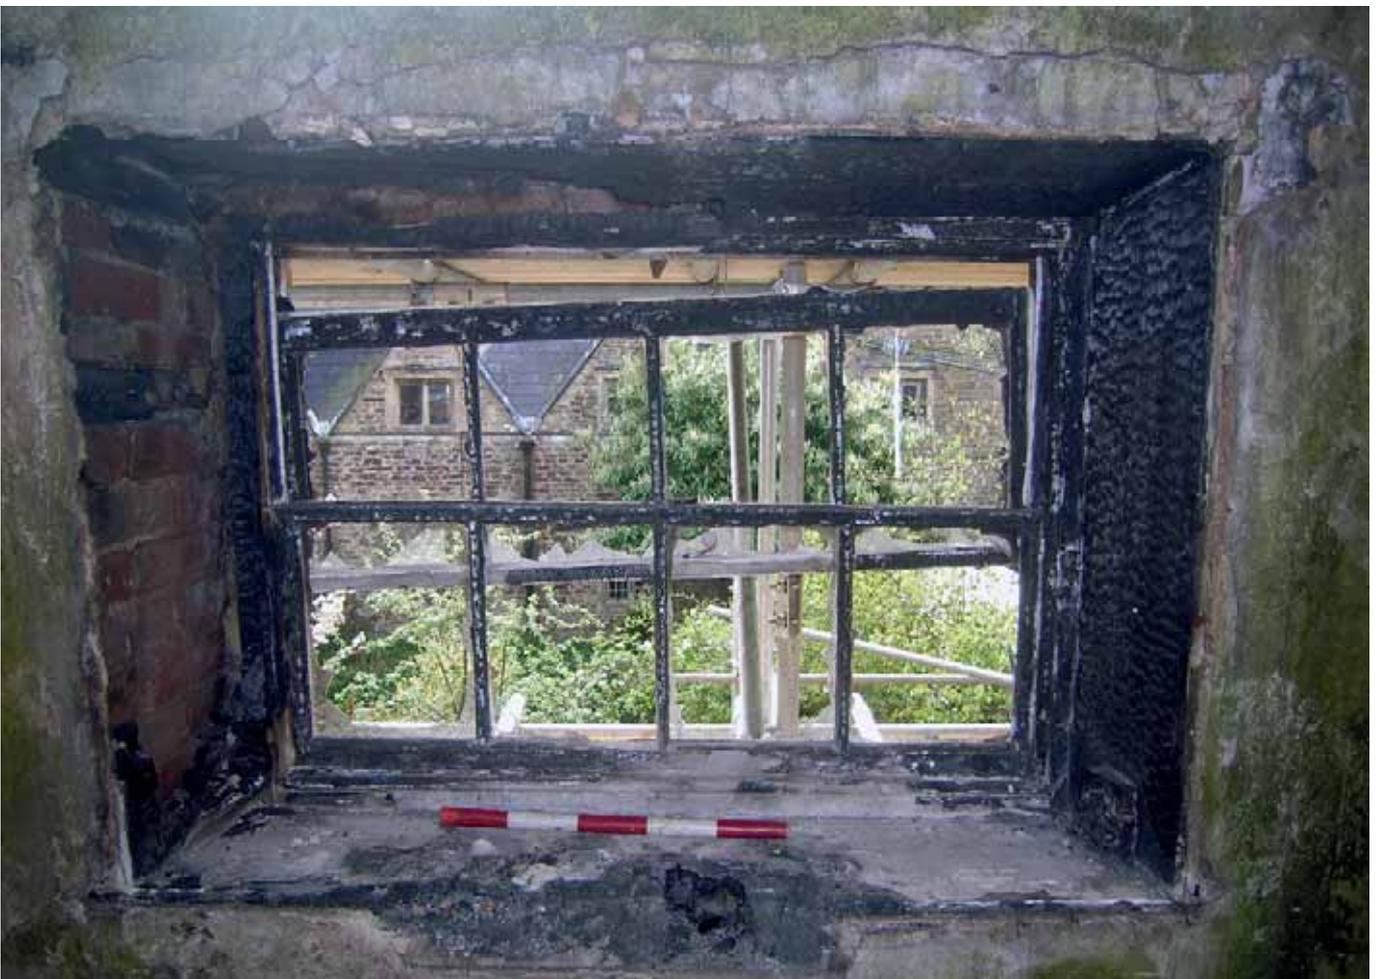
Plate 98: Window in south wall of F6

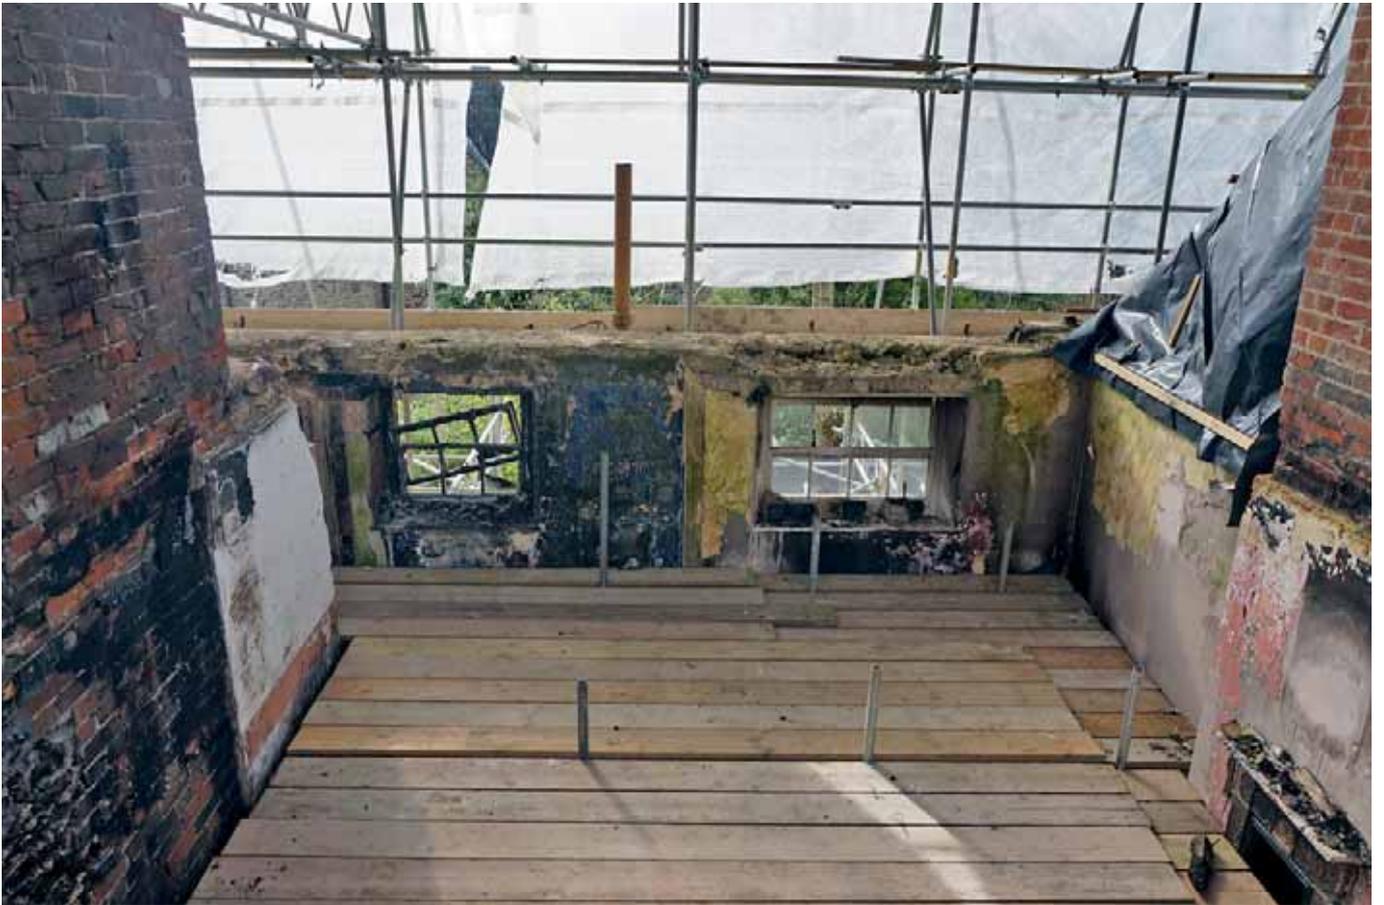
Plate 101: West end of fire damaged area at first floor level (F6)
