**SALTER'S BOATYARD, FOLLY BRIDGE
ABINGDON ROAD, OXFORD**

ARCHAEOLOGICAL INVESTIGATIONS DURING DEVELOPMENT

OXFORD ARCHAEOLOGICAL UNIT
DECEMBER 1999

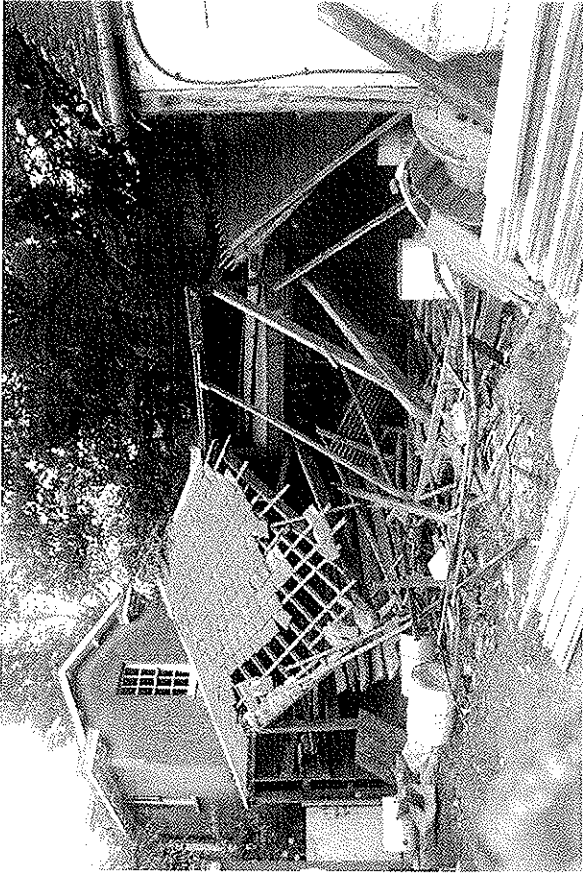
Plate D1: Building D from the north-west showing the collapsed state of this former mid 19th-century open-fronted timber storage shed at the time of survey

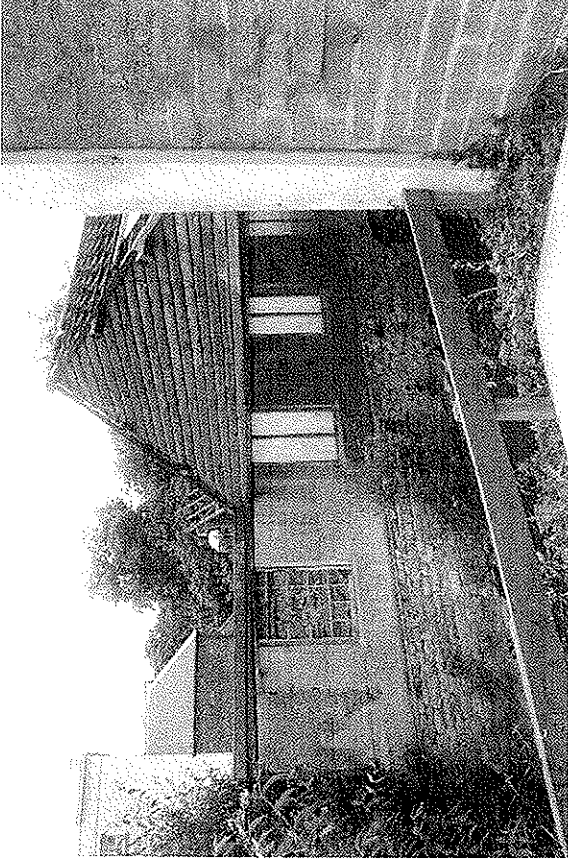
Plate F1: Building F from the south-west showing the truncated roof and cast in-situ concrete north wall.

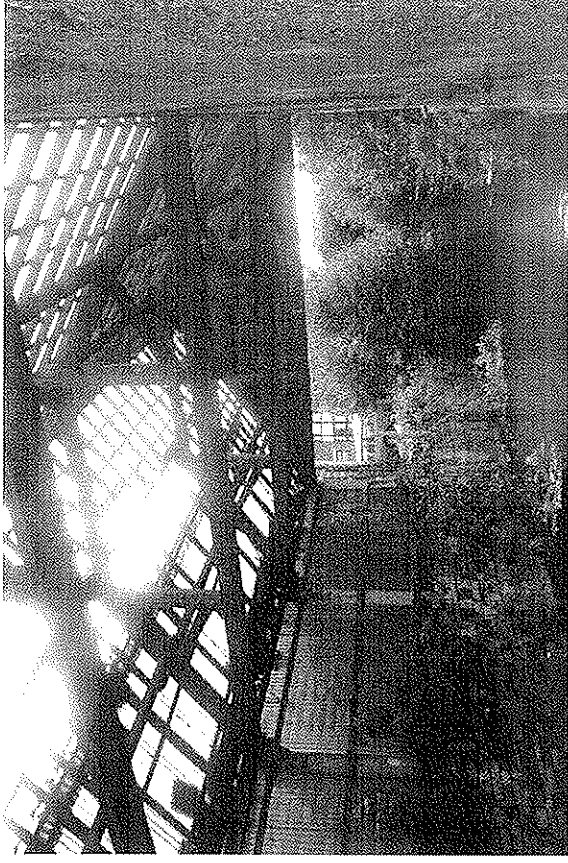
Plate F2: Building F. Interior view from north-east showing queen-post trusses with truncated principals and cast *in-situ* concrete posts on left.
