# Parterre Gardens Witley Court Great Witley Worcestershire

## Archaeological Investigation Report Volume I

Oxford Archaeology

May 2004

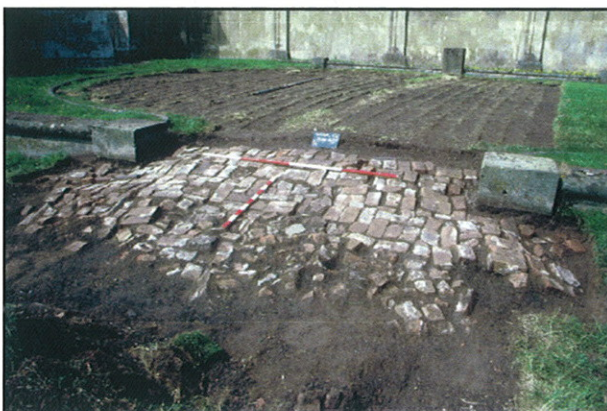
- 7.5.3 Two additional flights of steps (S30 and S31) were revealed approximately 10 m to the north of the West and East pavilions during turf removal for the reinstatement of the main north-south aligned paths within the South parterre garden. Steps S30, located to the north of the West pavilion had been heavily damaged (Plate 42), whilst Steps S31, situated to the north of the East pavilion, appear not to have been subject to such similar disturbance (see Fig. 6; Plates 37-38 and 40).

Plate 40 - Trench 22, excavated step foundations S31 with south eastern Temple in background. Looking south.

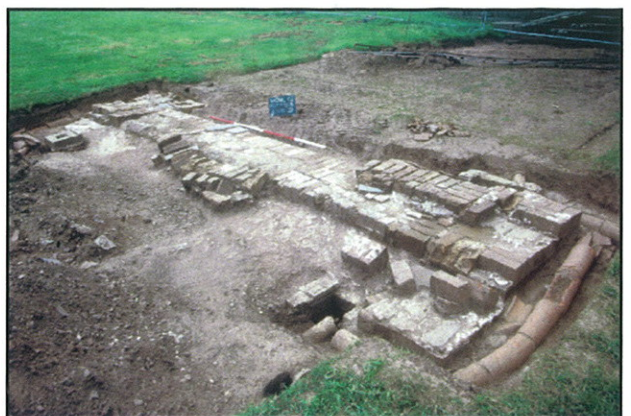
- 9.7.5 Later re-use of three flights of steps, located at the entrance to the winter garden (S1) and at the entrance between the North parterre to the East parterre (S17 and S18a), was evidenced by the dumping of a compacted brick rubble over the original step footings creating a ramp (see Plate 41). The purpose for the ramping of these areas is uncertain, but one suggestion may be that this was undertaken by the demolition contractors to aid the removal of stonework from the site.

Plate 41 - Trench 15, brick constructed ramp exposed overlying step foundations S1. Looking north.

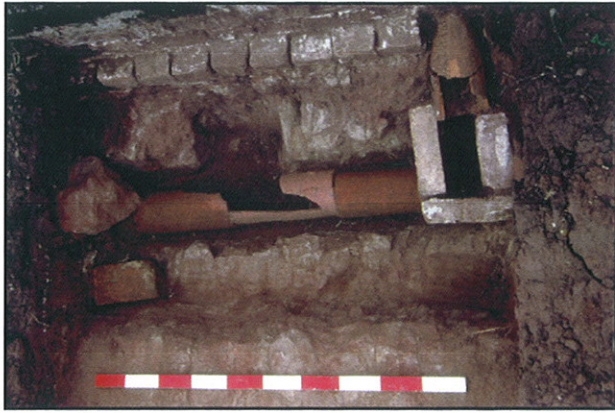
- 7.5.4 Steps S1, which form the access from the South parterre gardens to the Winter garden, were constructed entirely of limestone and were founded on an earlier sandstone structure (Plate 48). This earlier structure may represent the remains of a step base, or, structure related to the house prior to the construction of the Nesfield garden.

Plate 48 - Trench 15, excavation of step foundations S1 after brick ramp removed. Looking north.

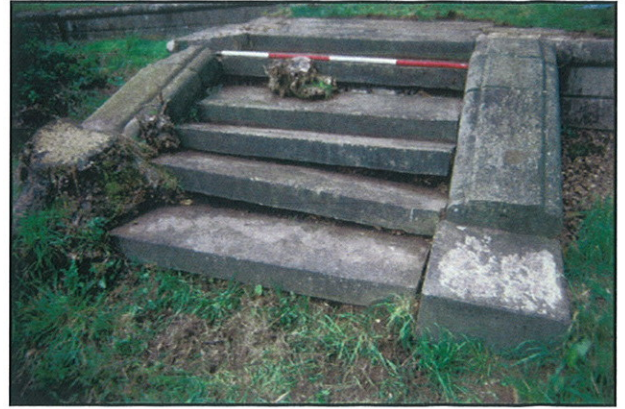
Plate 56 - Trench 103, shows current surviving state of steps S9. Looking west.

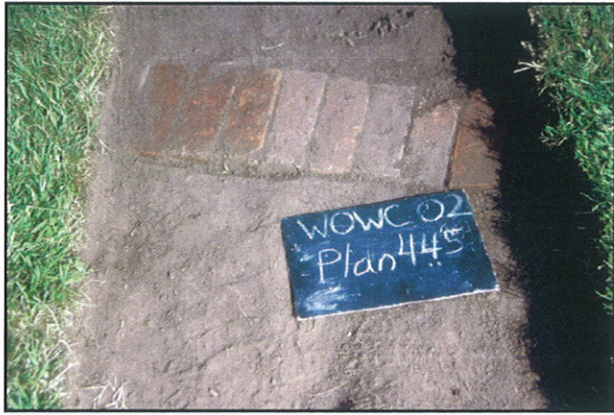
Plate 61 - Trench 18, detail of brick footing of north west quarter bed. Looking north west.

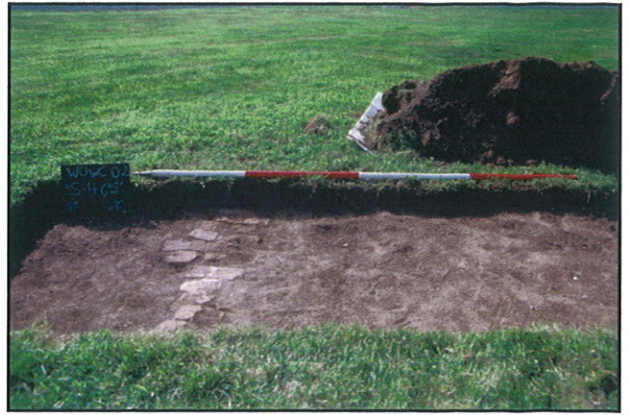
Plate 62 - Trench 19, excavation to reveal inner edge of north east quarter bed. Single course brick footing exposed, but fragmentary. Looking north west.

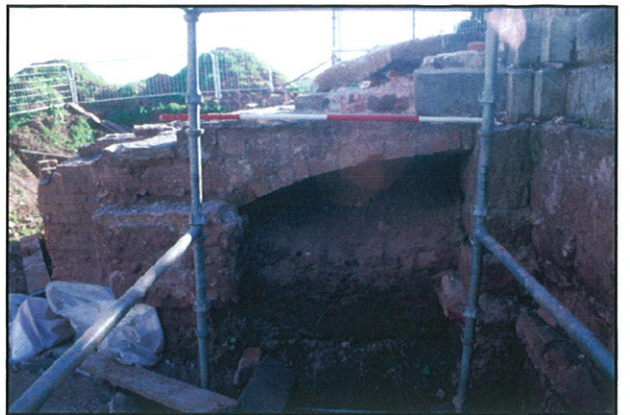
Plate 64 - Trench 20, arched foundation of steps S7 above fountain tunnel. Looking south.

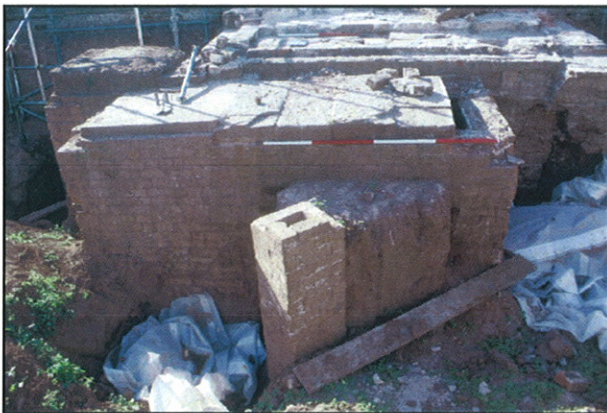
Plate 65 - Trench 20, detail of tunnel entrance structures. Looking west.

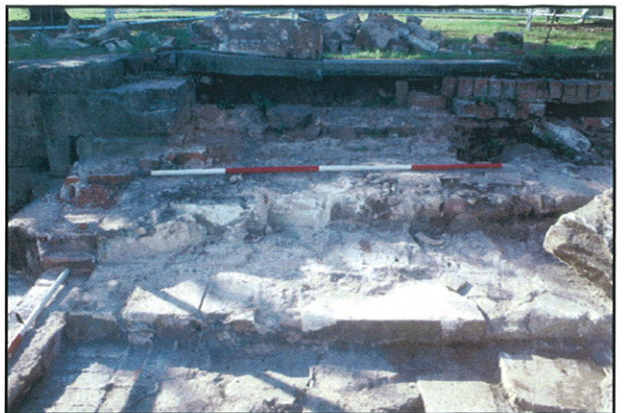
Plate 66 - Trench 20, continued excavation of steps S7. Looking west.
