The Temple Bar Hertfordshire

Report on the Archaeological Investigation of Temple Bar During its Dismantling

Oxford Archaeology

February 2005

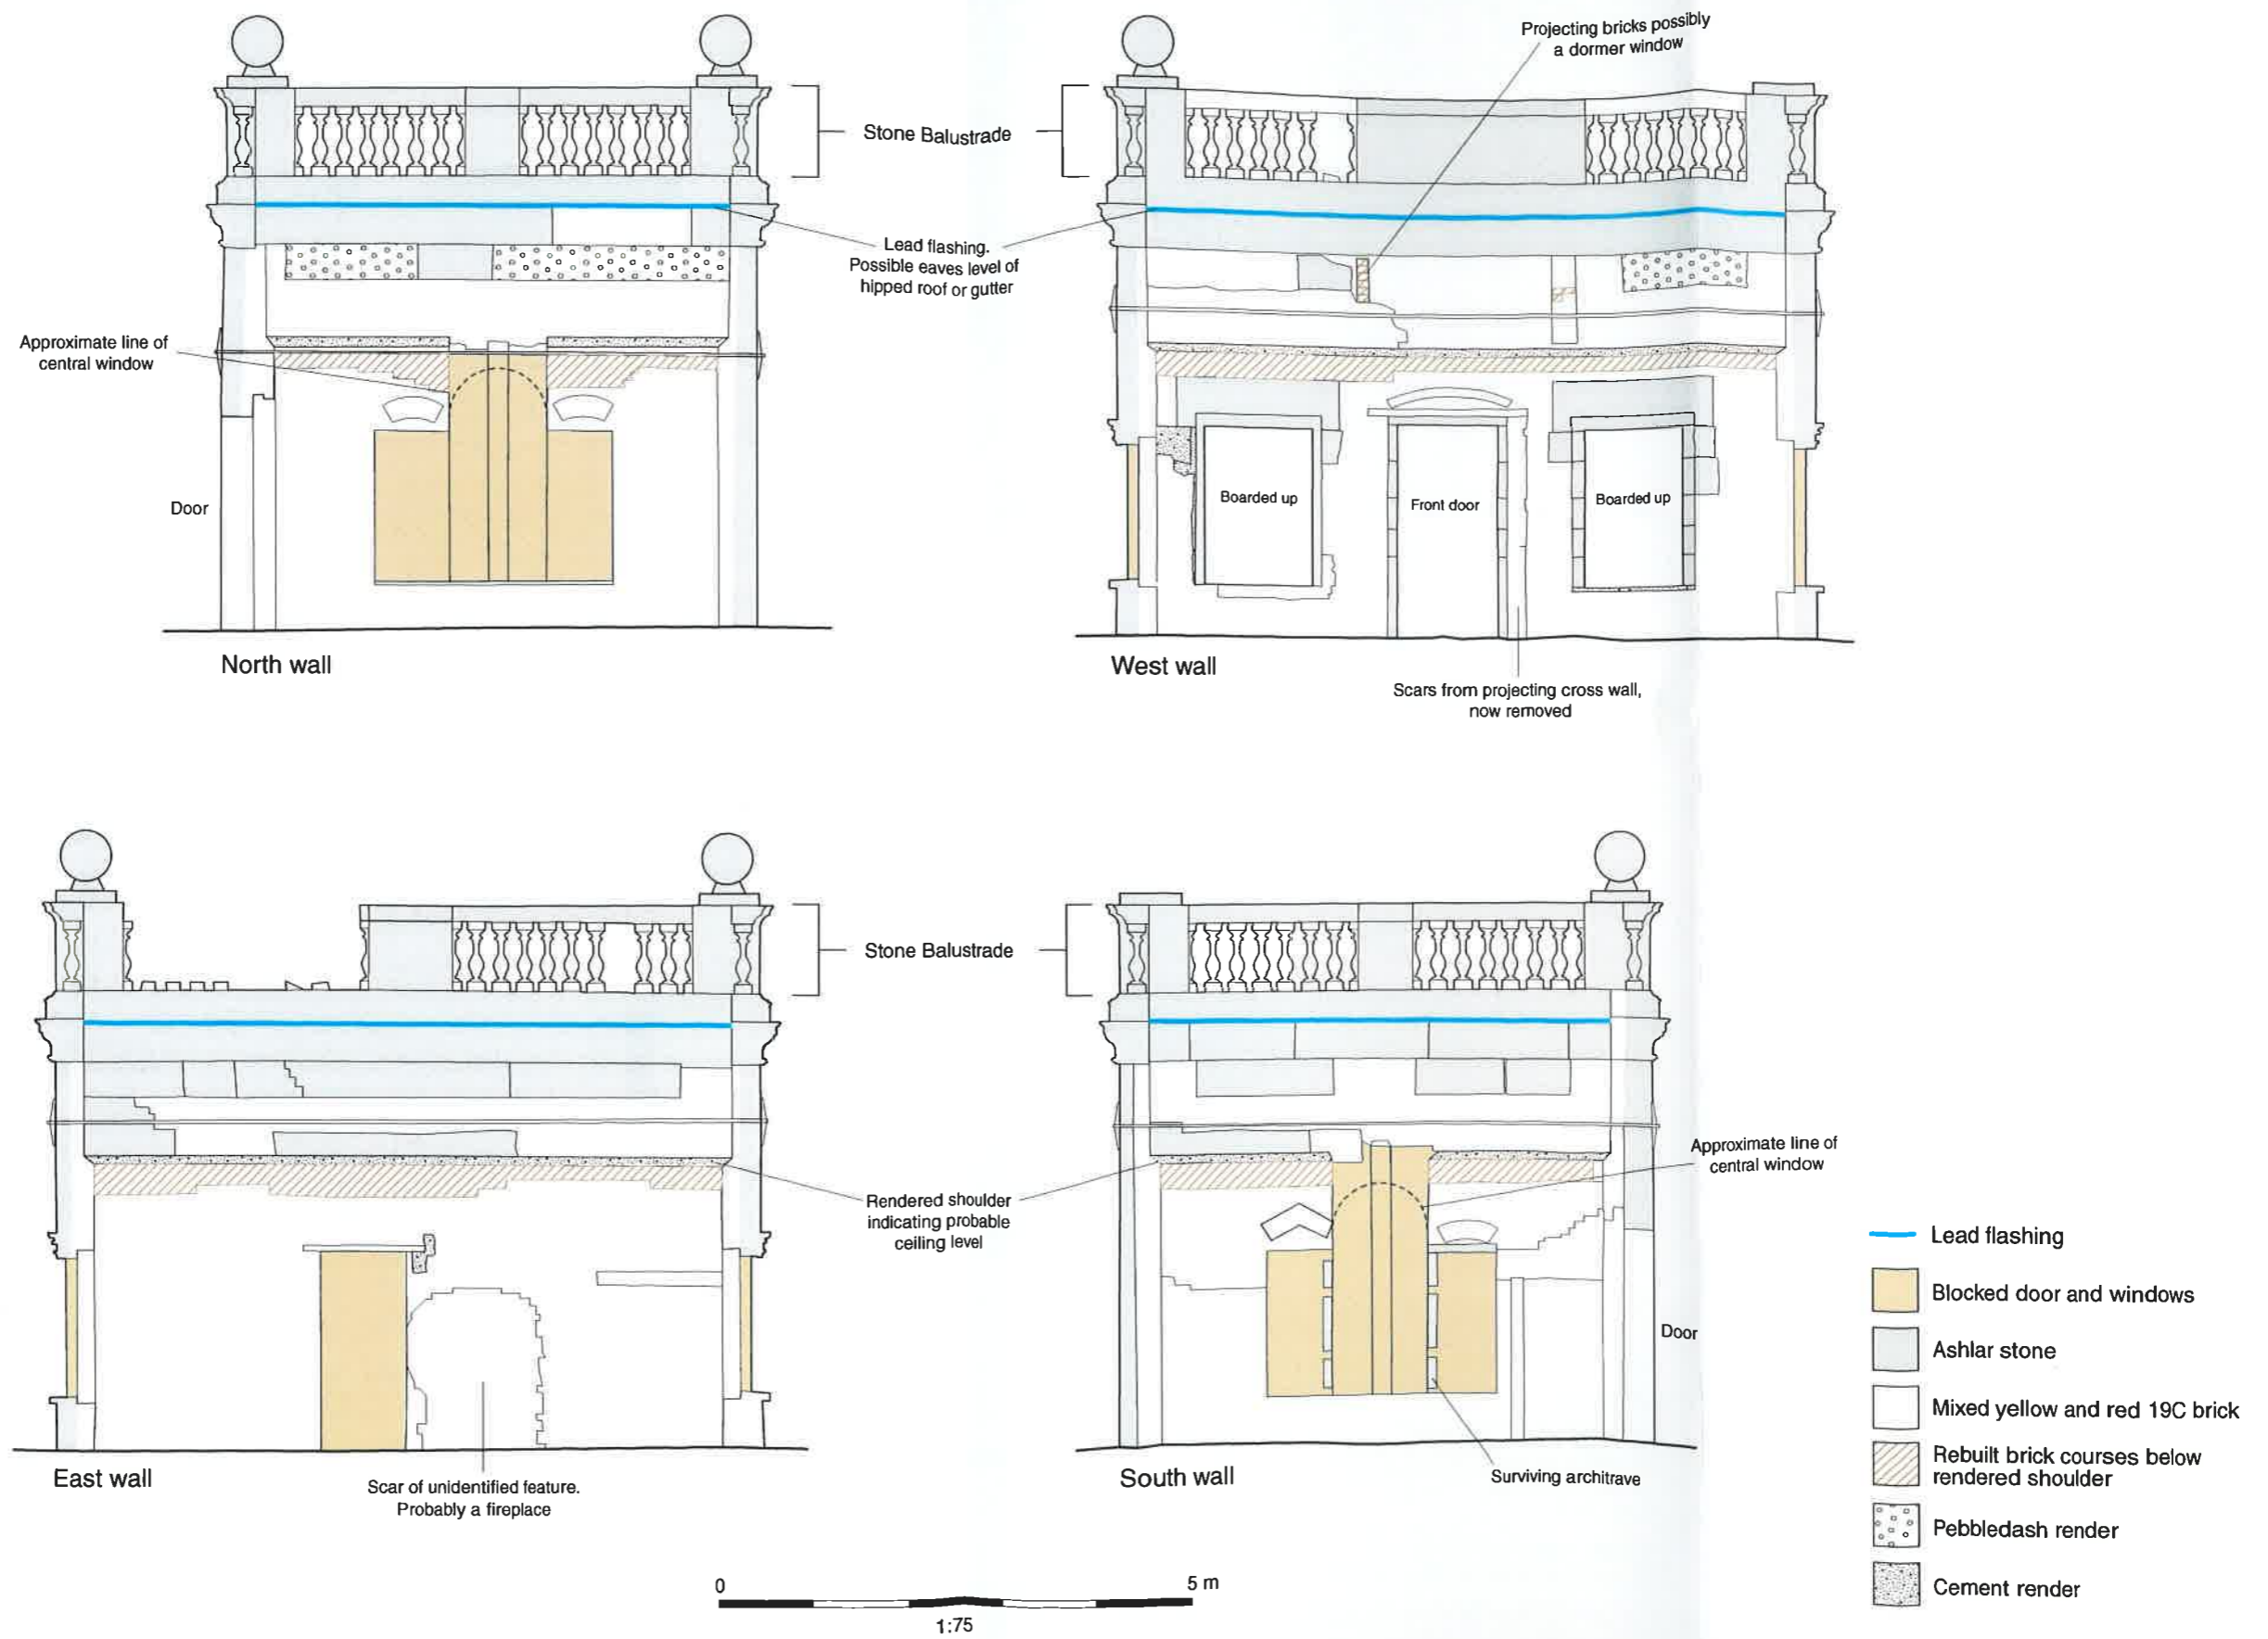
- 7.5 **INTERIOR**
- 7.5.1 The Lodge has been completely stripped out, the walls have been stripped of plaster revealing the brick and stonework behind (Figure 12), and any interior partition walls have been removed. The walls are of mixed build with somewhat inconsistent brickwork. The windows and doors have been bricked or boarded up. The floor was overgrown and fragmentary, areas of hard-core, cement surface and compacted sand survived along with traces of interior brick partition walls and a fireplace. No trace survives of the interior decoration of the Lodge or of the roof structure. Investigation showed the division of the Lodge into two main rooms with the dividing wall aligned east to west with a central chimney stack.

Figure 11: Temple Bar, interior Lodge elevations

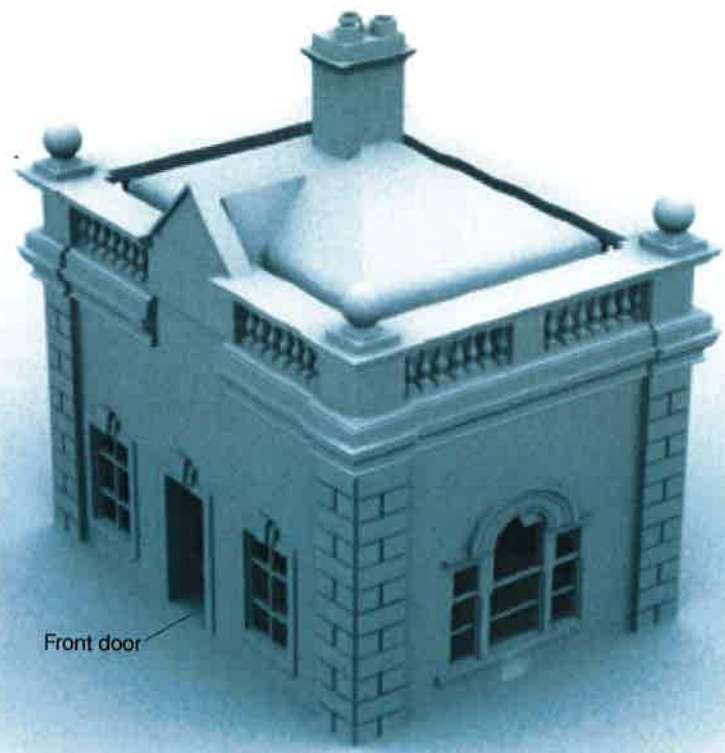
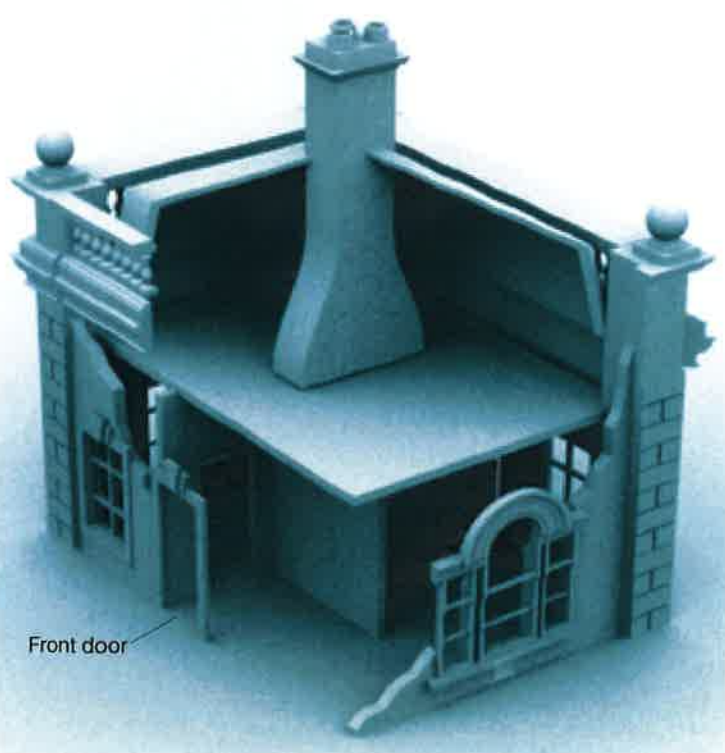
- 7.4.1 There is little evidence for the fabric or structure of the roof other than early photographs (see Plate 3), which show a hipped or mansard roof just above the level of the balustrade with shallow slopes leading up to a central chimney. The roof is leaded with rolls running along the corners and down the faces of the roof. The pitch of the roof seems to change and become steeper some way from the balustrade, and either led directly to the line of flashing visible on the interior stonework, or more probably led to a gutter at that height. The only evidence apparent within the structure at the time of examination was a line of lead, indicating this probable level of the guttering, approximately 4.5 m above floor level. If there was an attic space within the roof, there may have been small dormer roof lights, two vertical piers of brick just above the front door into the Lodge may be evidence of support for a dormer window, but the evidence is not conclusive.

Figure 13: Temple Bar, reconstruction of Lodge showing probable type of roof

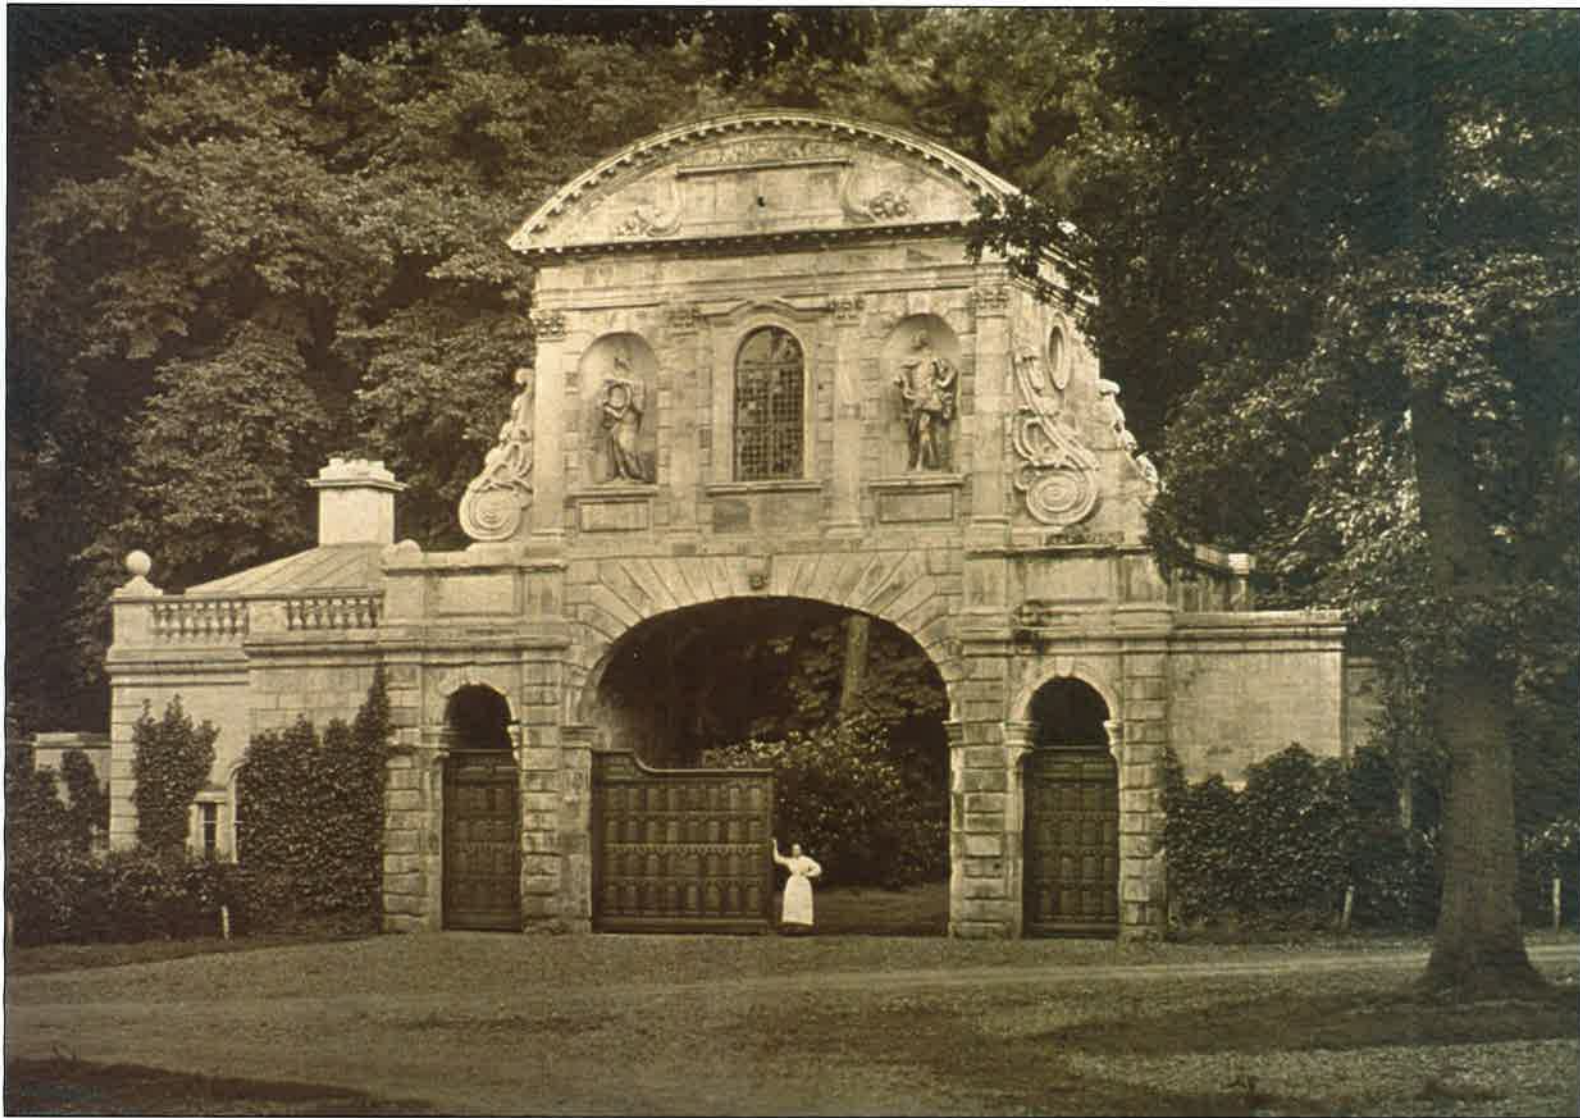
7.3.2 The picture taken in 1895 shows the side of a larger extension, covered with ashlar or rendered, with a small window (Plate 3) and apparently a flat roof; or at least a flat parapet. At the time of visiting, a rough concrete surface extended to the east, beyond the end of these extension walls. The ashlar of the Lodge's wall shows a scar for the lead flashing of a roof, it has the slightly unusual form of a central valley rather than being a more standard pitched roof. During examination of the foundations, the southern half of this extension had a 100 mm diameter drainage pipe within it (Plate 47). Although not seen by OA, a digital photograph included in FRR Architect's preliminary statement about the Bar and Lodge shows the annexe in a dilapidated state. The walls appear to be brick with ashlar facing, and the ashlar at the top of the eastern wall shows a corresponding 'V' shaped scar from lead flashing.

Plate 3: Temple Bar in 1895 showing the roof of the Lodge (Guildhall Library, Corporation of London)

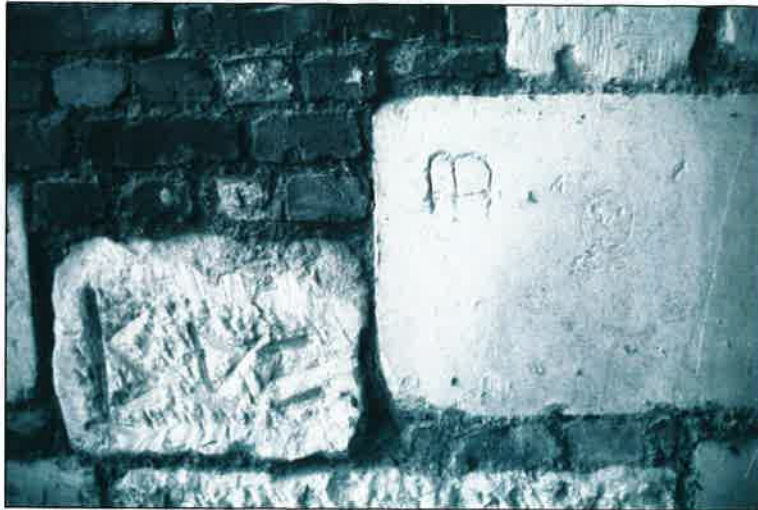
Plate 18: Graffiti on the southern upper walls (OA 2004, Film 6/4)

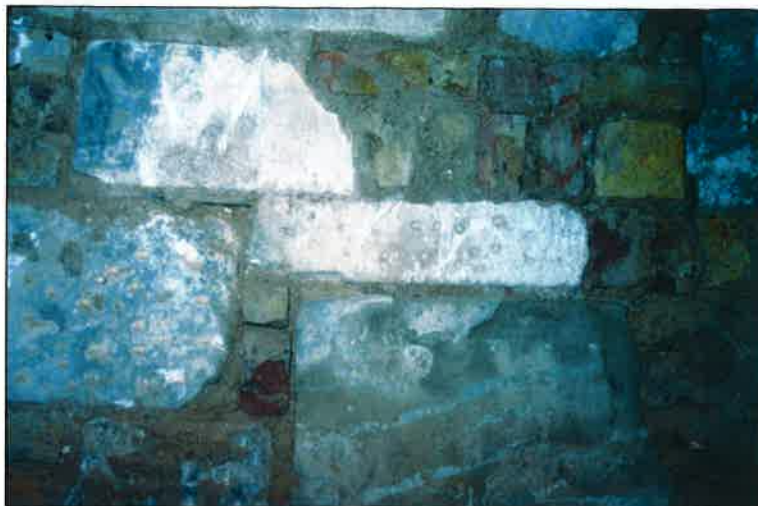
Plate 19: Pecking on stones within the upper room, providing a key for plaster (OA 2004, F3/17)

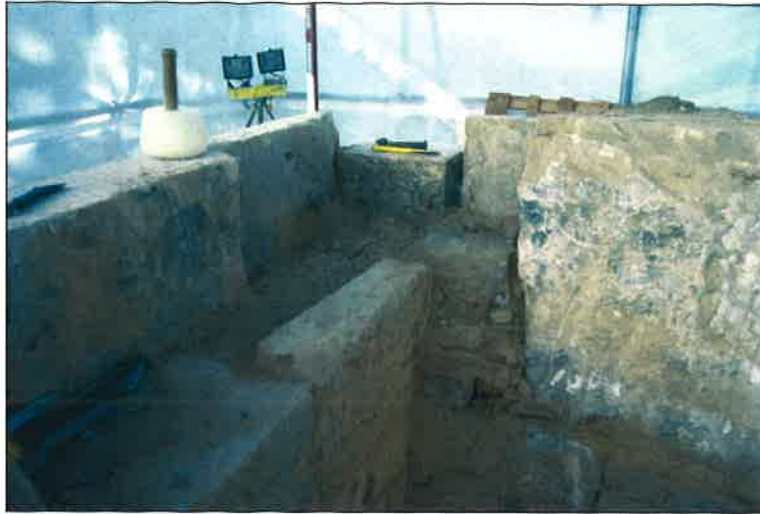
Plate 20: Rubble fill within the fill of the north western corner of the bar (OA 2004, F7/3)

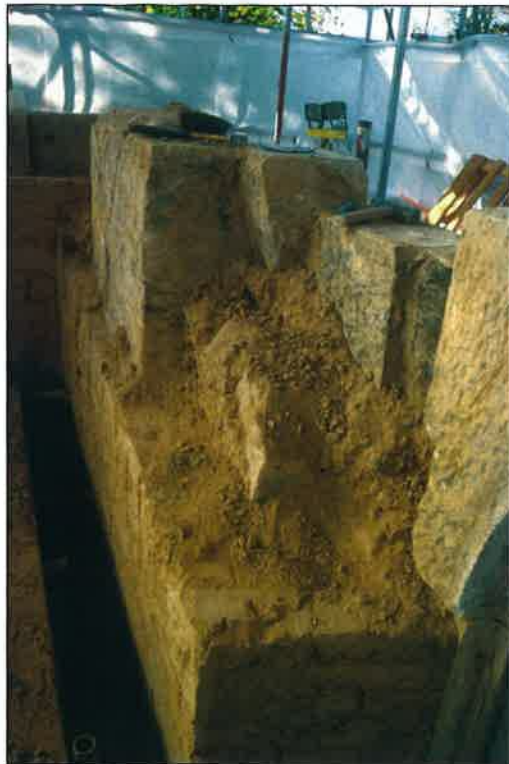
Plate 21: Rubble fill in south wall, also note the deep stones of the top stones of the southern eastern niche (OA 2004, F7/5)

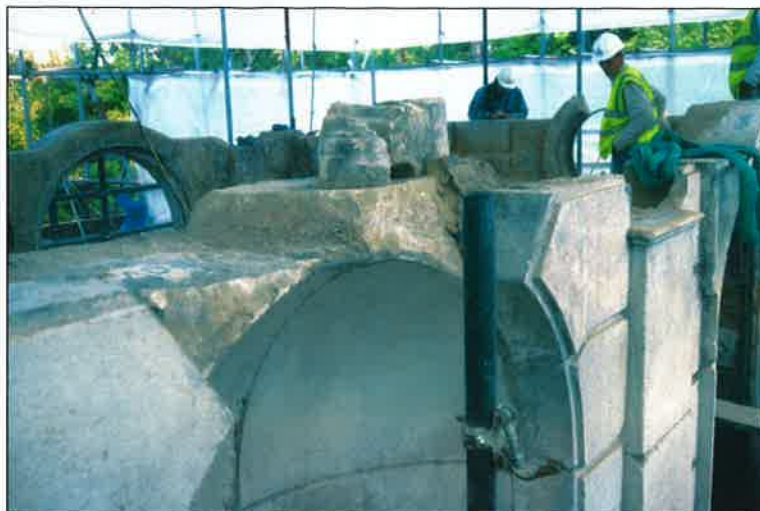
Plate 22: South western niche front with key stone and two voussoirs removed (OA 2004, F7/16)

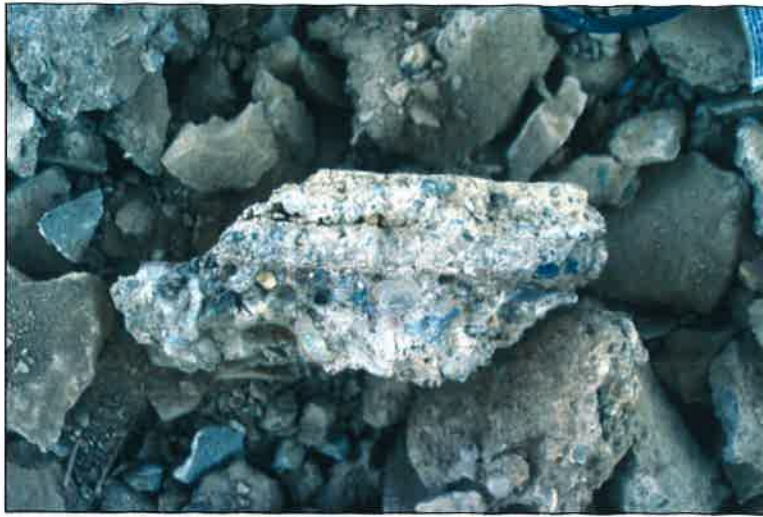
Plate 27: Section of concrete, showing the three layers making up the floor inside the upper room (OA 2004, F8/04)

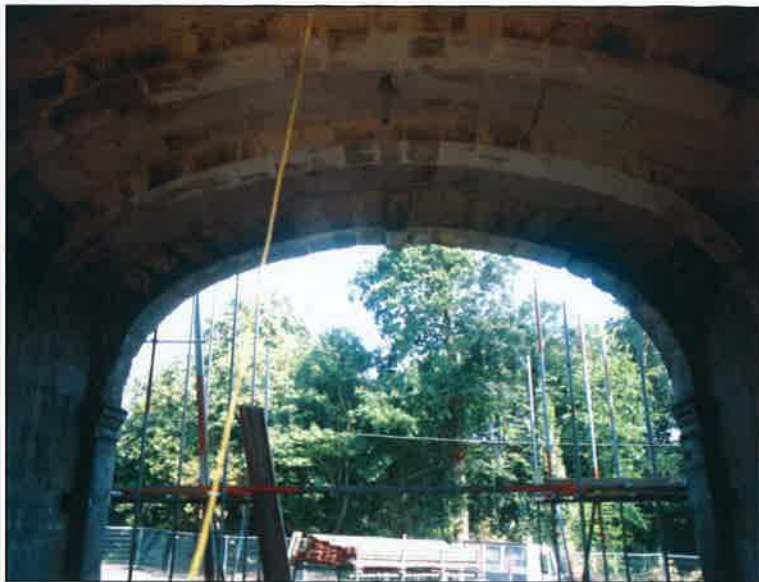
Plate 31: Underside of the northern half of the central arch (Ben Jeffs, 2004)

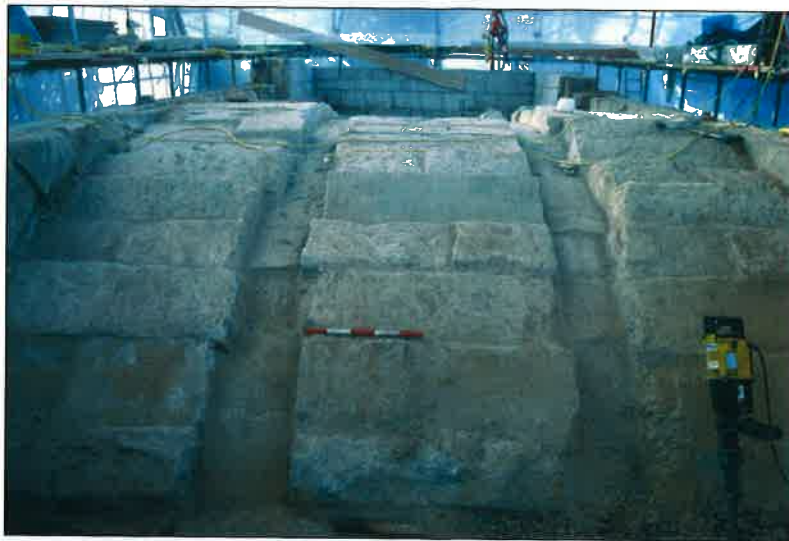
Plate 34: Eastern side of the main arch, note the use of two stones in some places (OA 2004, F9/16)

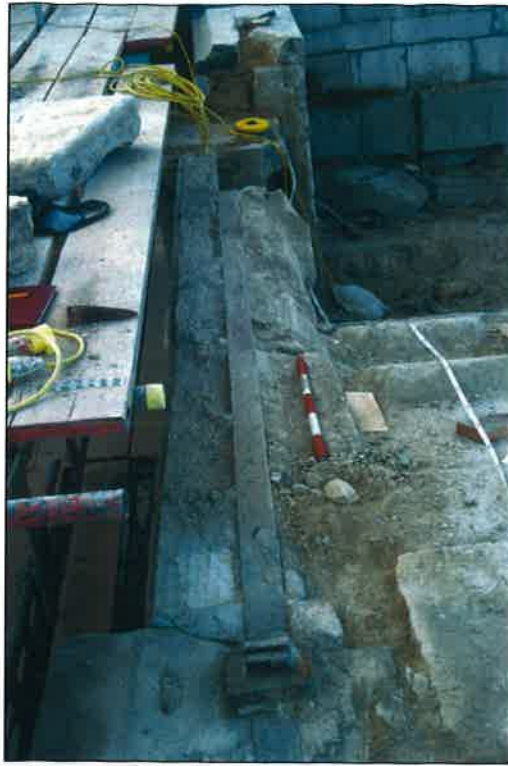
Plate 36: Socket for the bar chain over the south western voussoirs of the central arch (OA 2004, F9/34)

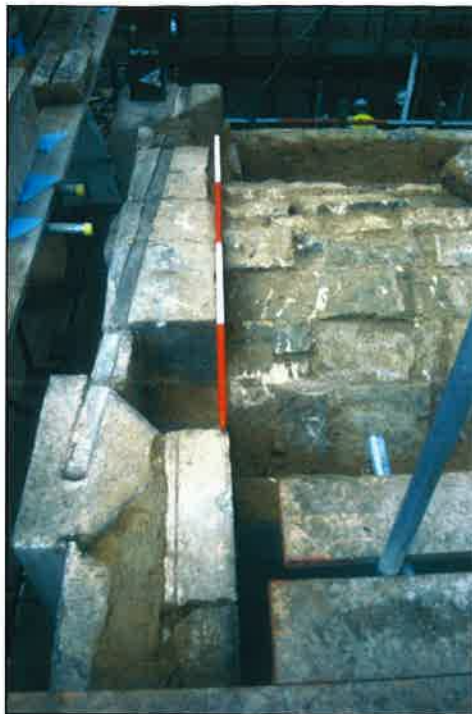
Plate 39: The angled bar-chain over the western postern arch (OA 2004, F10/12)

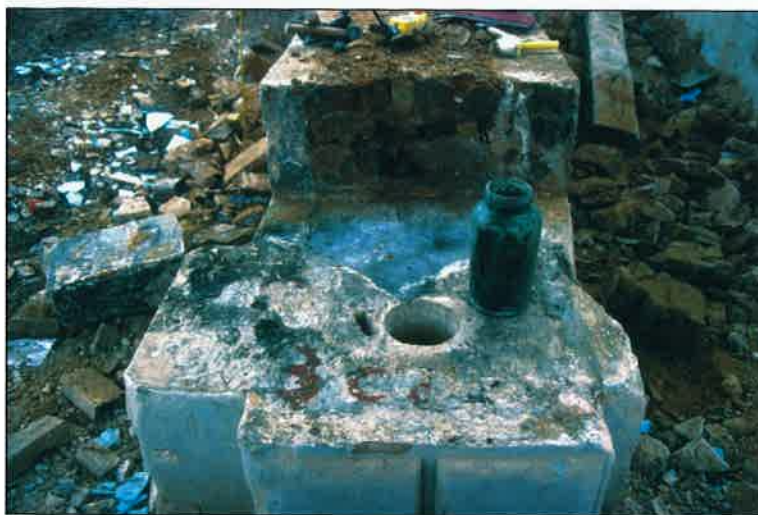
Plate 40: The time capsule jar within stone (OA 2004, F12/27)

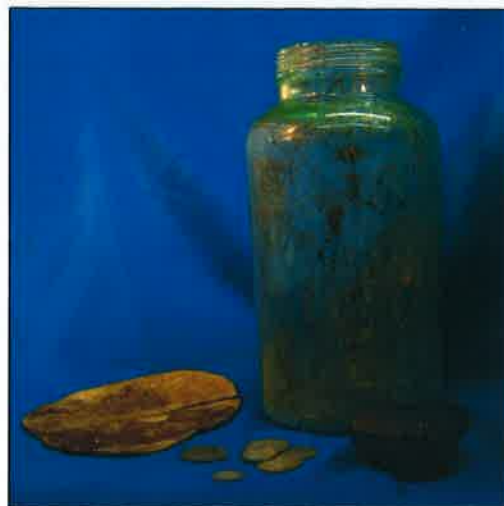
Plate 41: Time capsule jar and contents (newspaper too fragile and not included) (Lucy Martin, OA 2005)

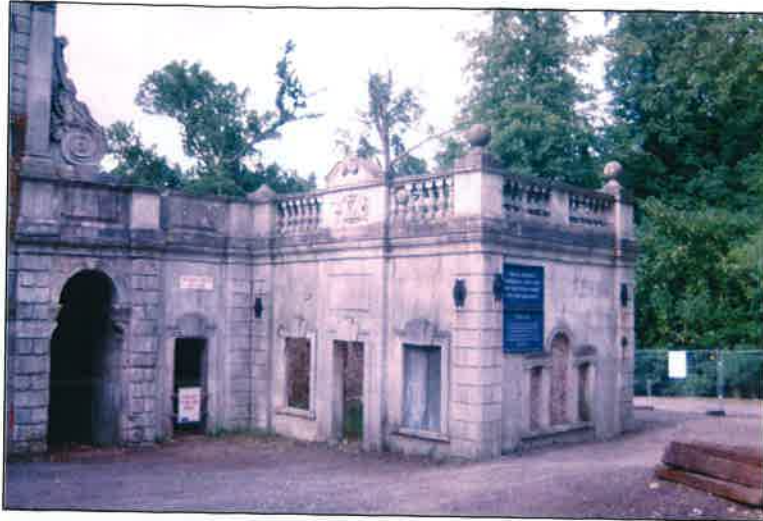
- 7.2.1 The Lodge has the same Portland stone exterior as the Bar and only has a single storey or possibly a storey and a half (Plate 42). The main walls are smooth ashlar, leading straight down to the ground with no plinth, and the corners are accentuated with large rusticated pilasters, the projection of which continues up through the cornice and into blind corner panels within the balustrade. The west face has the front and main entrance into the Lodge and is divided into three bays the middle one, containing the door and date plaque, breaks slightly forward of the bays on either side. The rear of the lodge, its eastern side is plain ashlar with brick at the centre where the annexe once was. This annexe had been previously removed, and now three brick buttresses abut this area (Plate 43).

Plate 42: The entrance side of the lodge, the west and south facades (OA 2004, F5/7)

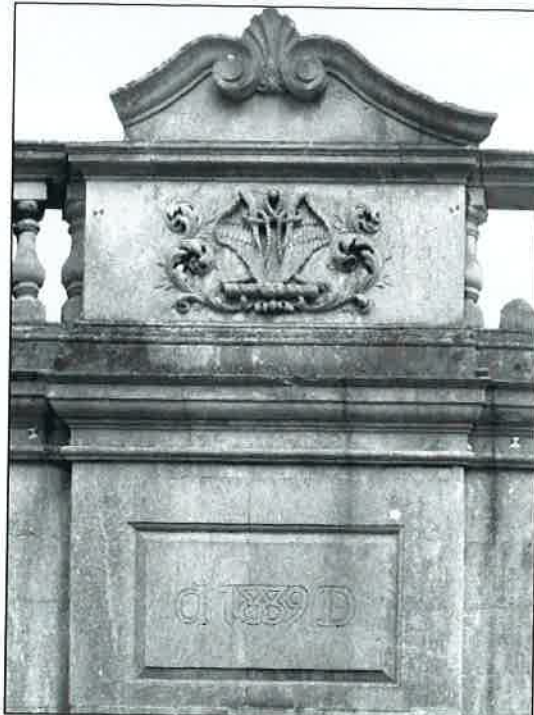
Plate 44: The crest and date panel above the front door of the lodge (Downland partnership, detail from Temp59-61, 10.07.03)

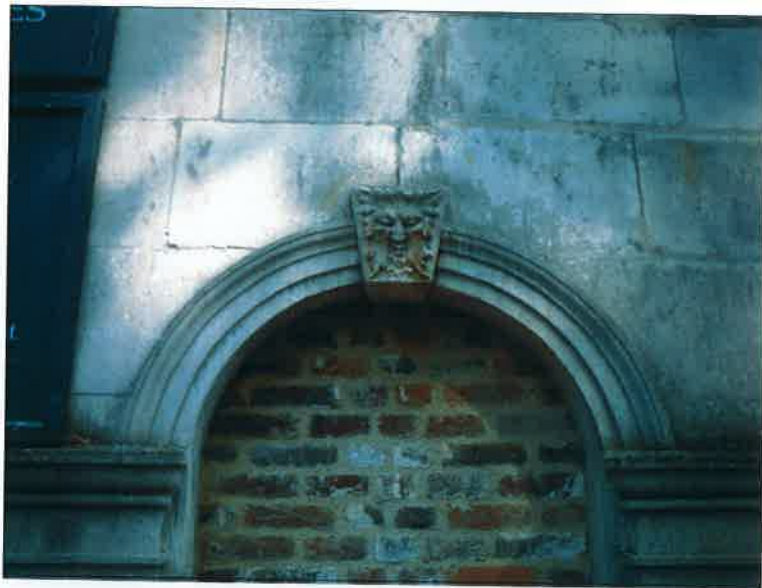
The mullions between the three windows take the form of flat plain pilasters below a plain architrave. At the top of the central rounded window are enlarged keystones carved with a satyr like face, which may be a green man (Plate 46).

Plate 46: A possible Green Man face featured on the keystone of the Venetian windows on the north and south facades

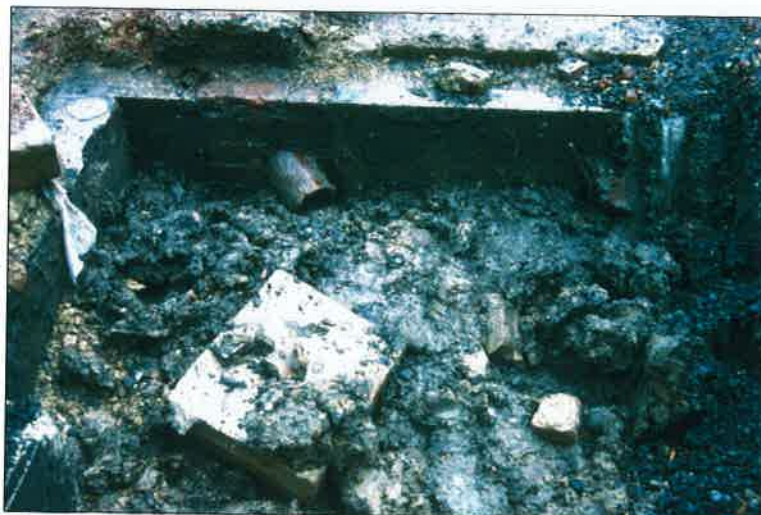
Plate 47: Drainage pipe found in the southern wall of the extension (OA 2004, F14/20)

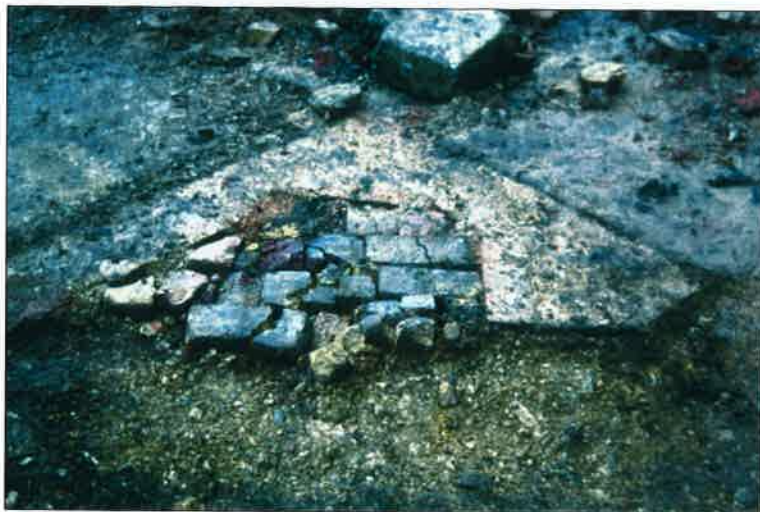
Plate 49: Brick pavers in the north east corner of the lodge's southern room, a secondary hearth (OA 2004, F14/15)

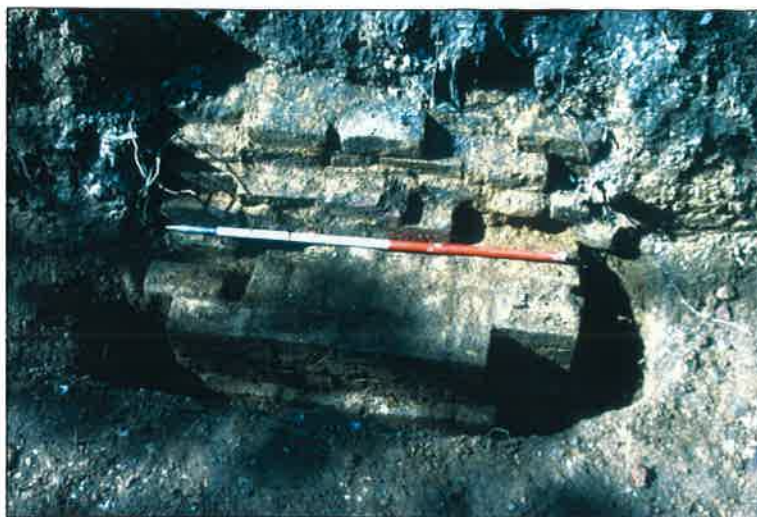
8.2.1 Test Pit 1 (Figure 14) (Plates 51 and 52) was not excavated to the full depth of the foundations due to time constraints and poor weather conditions. The upper 0.70 m of the foundation was truncated by the machine excavation, and had been loosened prior to examination by the removal of the stones of the Bar. The foundation here was for the western pier between the main central arch and the western pedestrian arch.

Plate 51: Test pit 1, general shot looking north (OA 2004, F13/19)
