No 40-41 Church Lane West Wycombe Village Buckinghamshire

Building Recording and Investigation

Client: The National Trust

Report on Historic Building Investigation

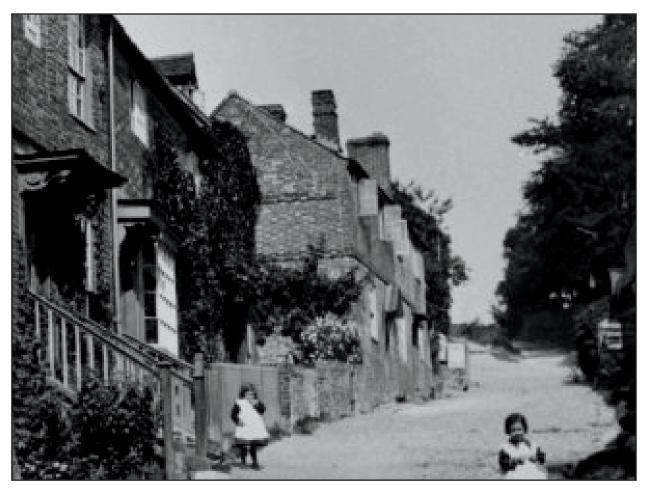
Figure 7a: Early 20th-century view looking up Church Lane showing No.40-41. From Bucks Record Office website (MHW01921)

- 1.4.12 The building is shown on at least two historic photographs from the early 20th century and although in each the building is in the background they are of some use, principally in confirming that the form of the front of the building has not changed greatly in the last century. One of the photographs dated 1907 is taken from the furniture factory, looking up Church Lane with No.40-41 on the left. This image (ref: MHW01921) can be found on the Buckinghamshire Record Office website (http://www.buckscc.gov.uk/leisure-and-culture/centre-for-buckinghamshire-studies/online-resources/swop/) together with a series of other images of West Wycombe village from the first half of the 20th century. An extract from the image is also included as Fig 7a in the current report. The photograph appears to show the same porches over the two doorways, the three southernmost windows with open casements and a clear scar against the south wall from the former lower roofline (discussed further below). It also shows a pattern in the brickwork towards the apex of the southern gable which is still visible now but apparently less distinct now than it was in 1907.

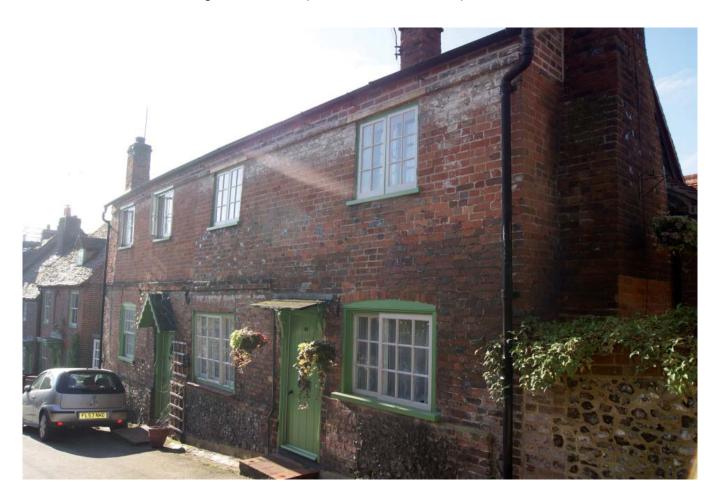
Plate 1: East elevation facing Church Lane (after conservation work)

- 2.2.4 The *east elevation* is the main front of the building facing Church Lane and from here the complex evolution of the house is apparent from the patchwork of different brick types and constructional phases (see Fig 5 & Pl. 1-2). The elevation is set on a flint plinth with brick dressings and sloped shoulder at the top and due to the sloping ground there are two steps in this plinth, adjacent to each front door. The main plinth is assumed to be part of the 18th-century refacing of the building rather than the possibly primary timber-framed 17th-century building and we know that the section in the northern bay must be secondary as this whole bay was an 18th-century extension. This type of plinth with moulded capping is an unusual feature to West Wycombe.

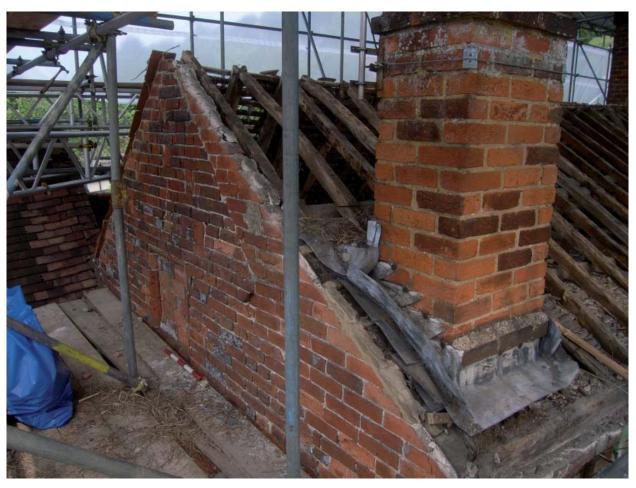
Plate 5: South elevation showing phasing in brickwork (after conservation work)

- 2.2.8 The gabled *south elevation* (Fig 6) is constructed from red brick (largely Flemish bond with glazed blue headers) and has slightly projecting string courses at first floor level and close to the original eaves height. This brickwork appears to be the same as the earliest phase of walling in the east elevation (discussed above). There is a possible infilled window in the gable (discussed further below) and a large patch of flint walling at ground floor.

- 2.2.14 The current project has involved inserting insulation into the roof and this has necessitated raising the roof by c.10-15 cm. Therefore a series of bricks have been added along the upper ridges of the gable and although the colour of the inserted bricks closely match the original wall it is possible to distinguish the reformed brickwork from the new pointing. This can be seen when comparing Plates 6-7 (taken during the works) and Plate 5 (taken after the work).

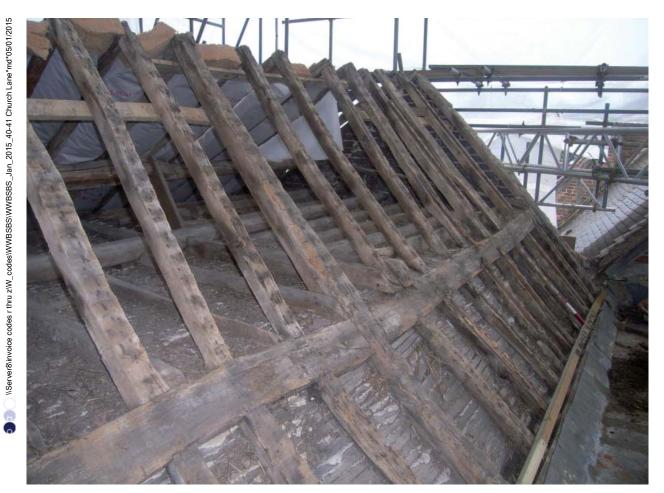
Plate 9: West slope of Bay 1 at south end of building

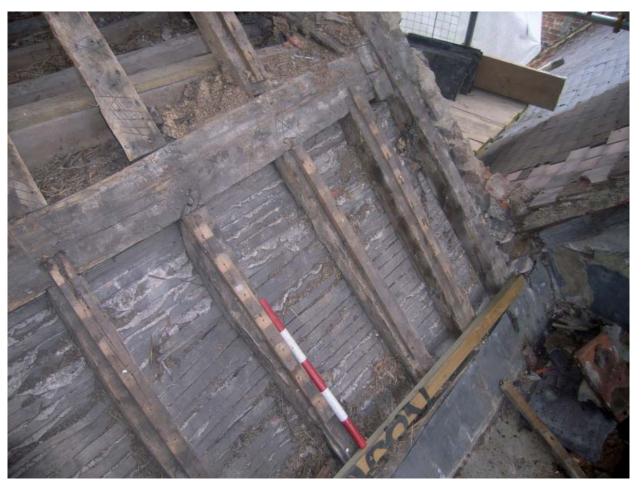
Plate 10: West slope of Bay 1 at south end of building

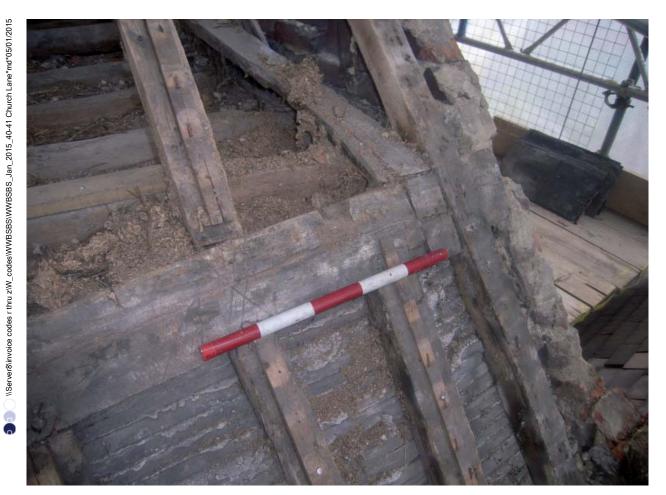
Plate 11: Purlin/butt rafter in west slope of Bay 1 at south end of building

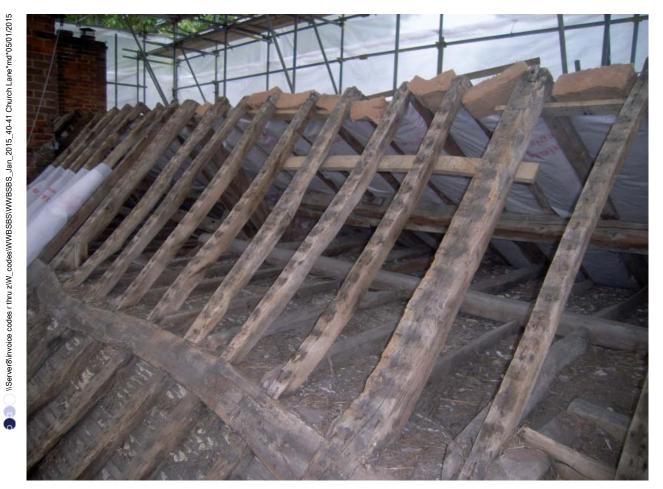
Plate 13: West slope of Bay 2 to south of centre of building

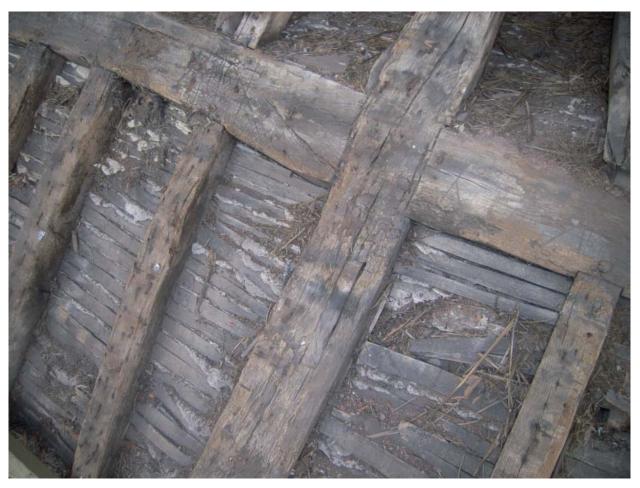
Plate 14: Detail in west slope

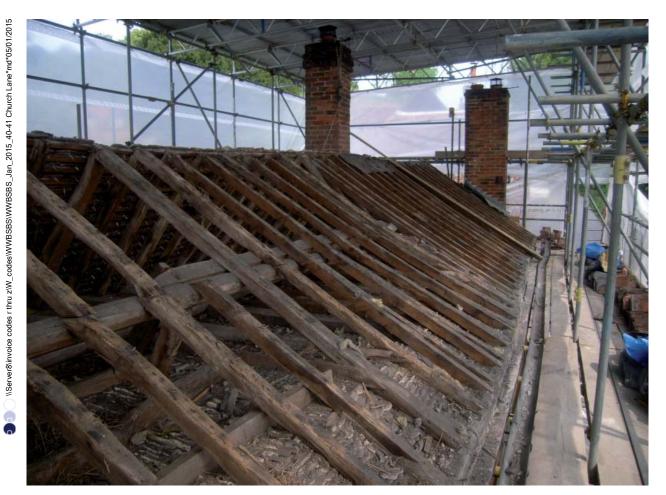
Plate 15: East slope looking north

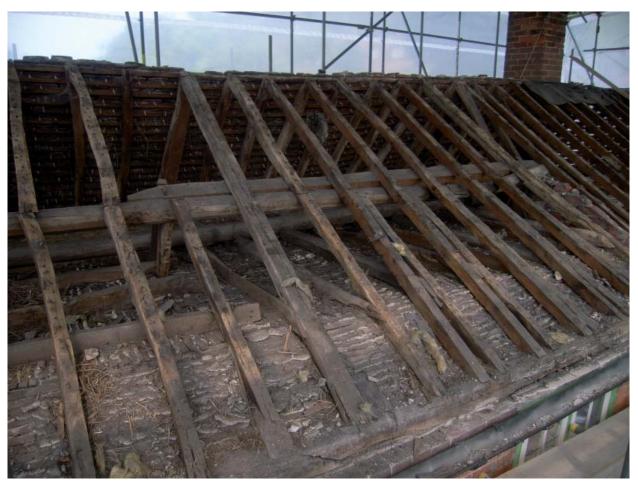
Plate 16: East slope of Bay 2

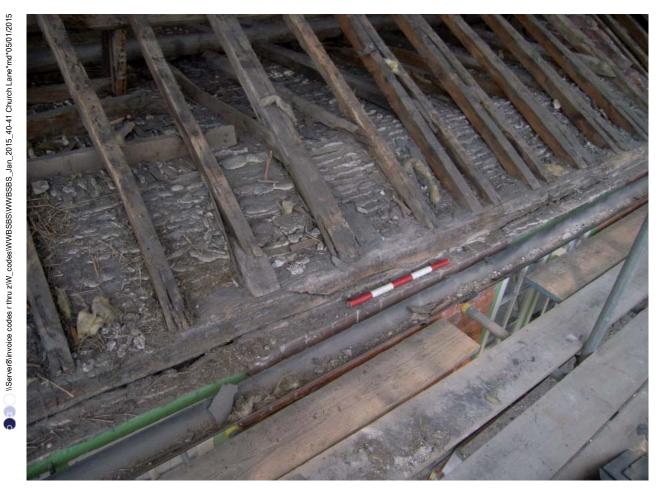
Plate 17: Wall plate detail in Bay 2

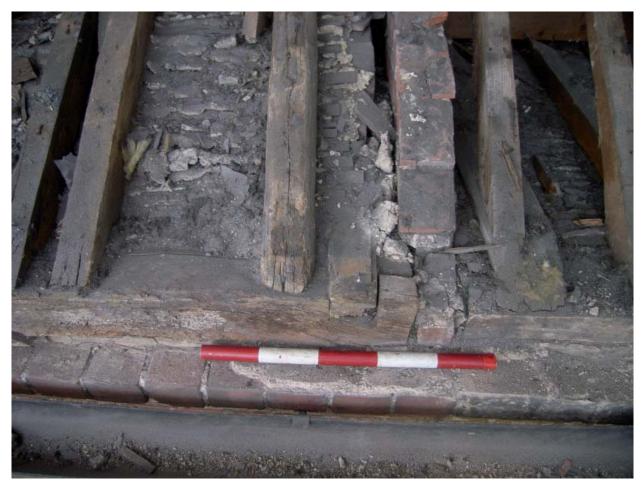
Plate 18: Detail of east slope at centre of building

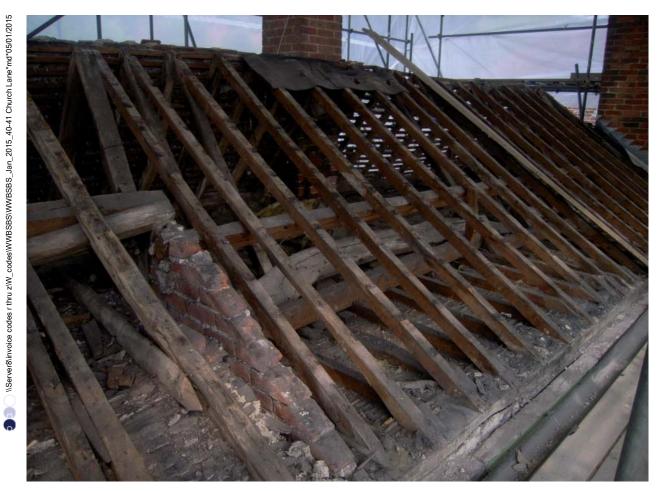
Plate 19: East slope of Bay 3 to north of central line of building

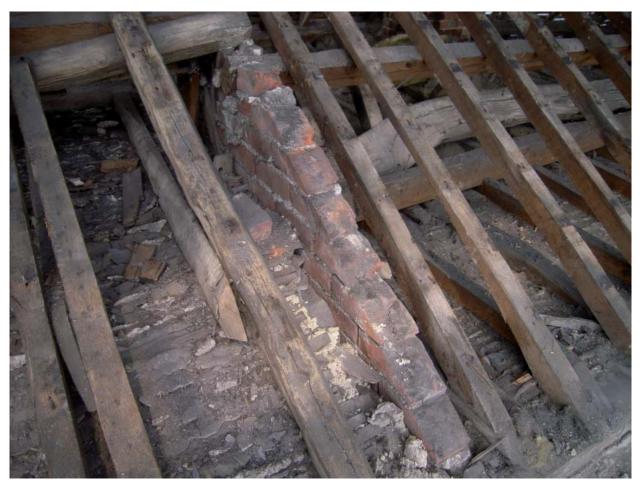
Plate 20: Brick wall in east slope at centre of building

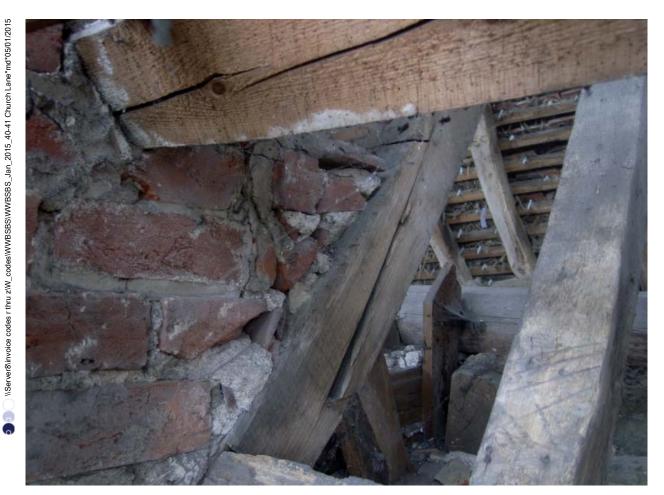
Plate 21: Cruck blade detail in east slope at centre of building

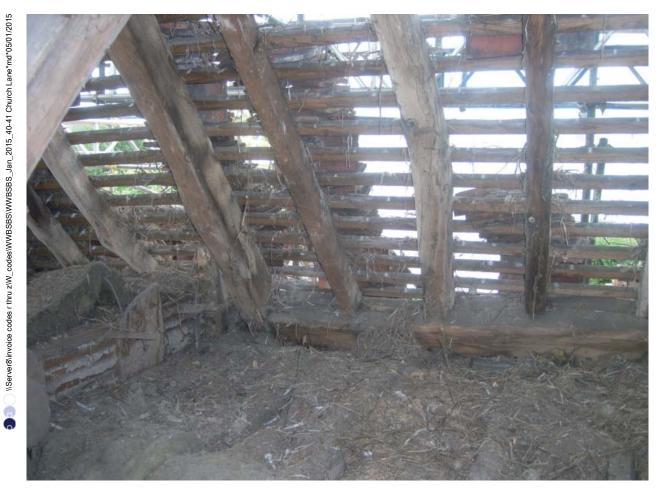
Plate 25: West slope of Bay 3 from inside roof space

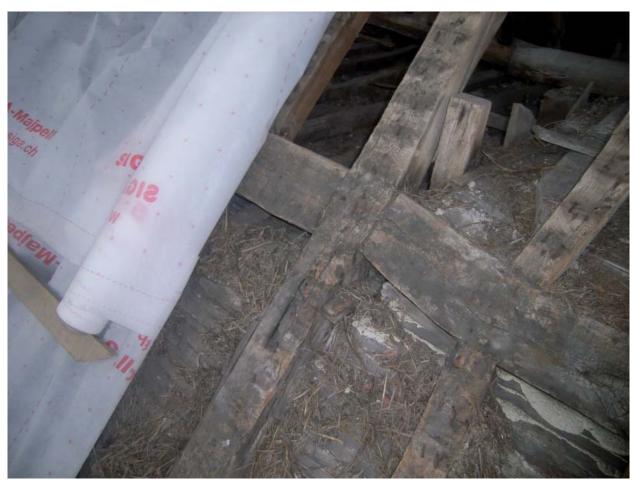
Plate 26: Butt purlin in west slope

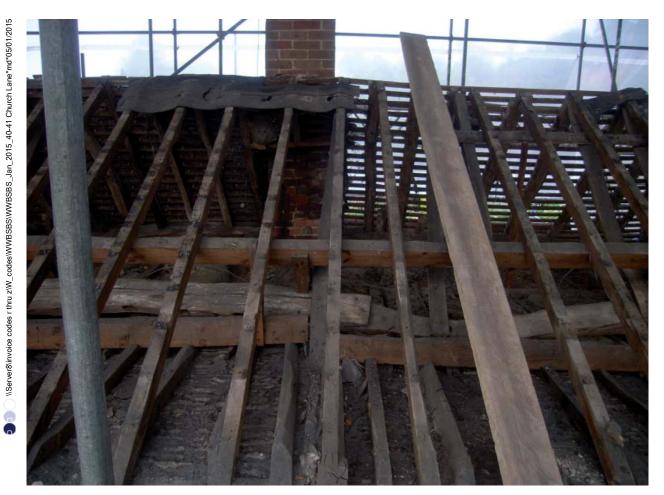
Plate 27: East slope between Bays 3 (primary to left) and Bay 4 (secondary to right)

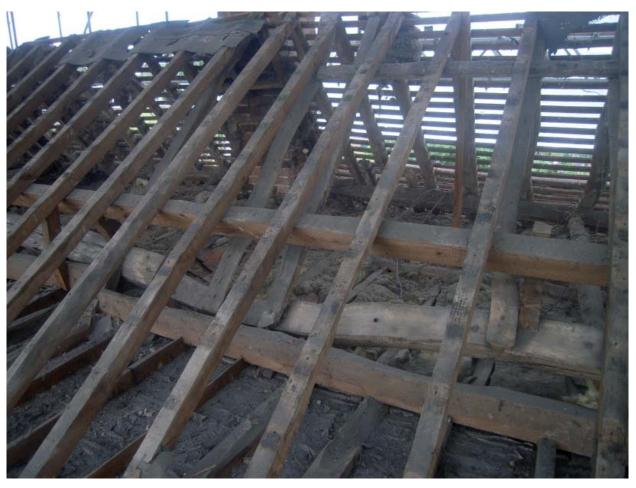
Plate 28: East slope of northernmost bay with earlier purlin below secondary rafters

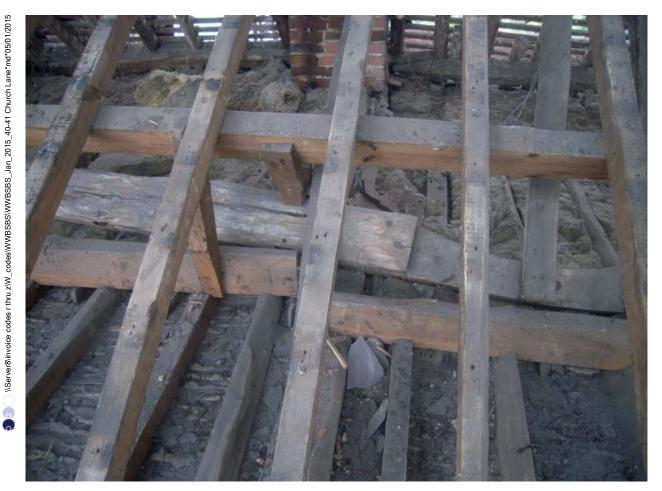
Plate 29: Junction between Bays 3 and 4 with older purlin extending into roofspace of later bay

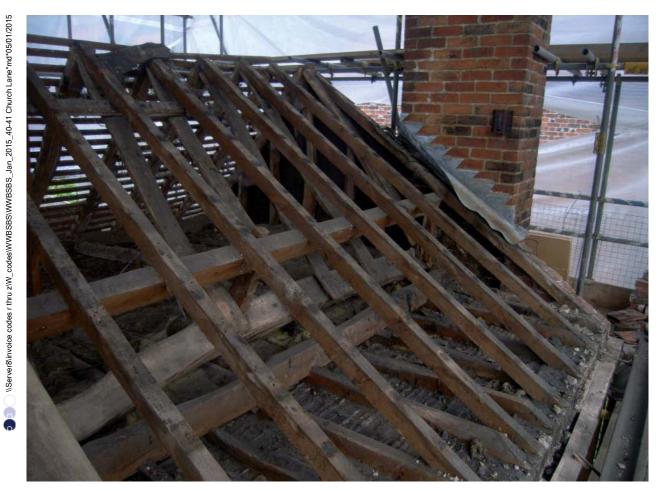
Plate 31: North end of east slope

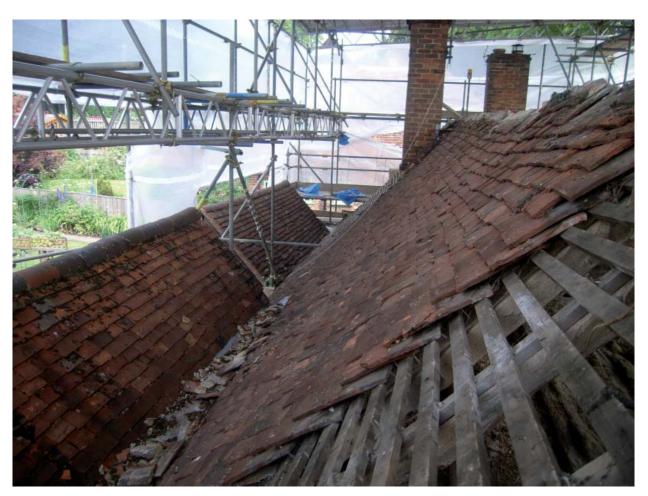
Plate 32: General view of west slope looking north

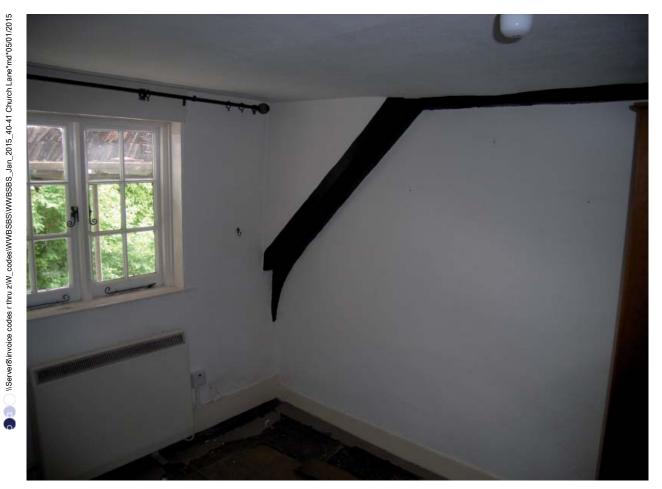
Plate 33: 1st floor room looking SE showing cruck

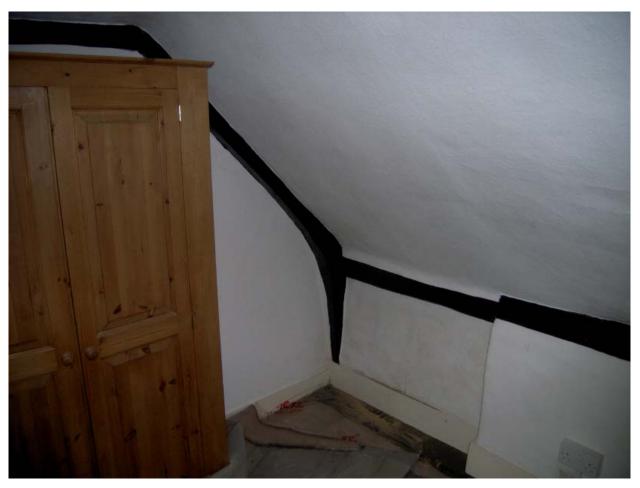
Plate 34: 1st floor room looking SW showing cruck

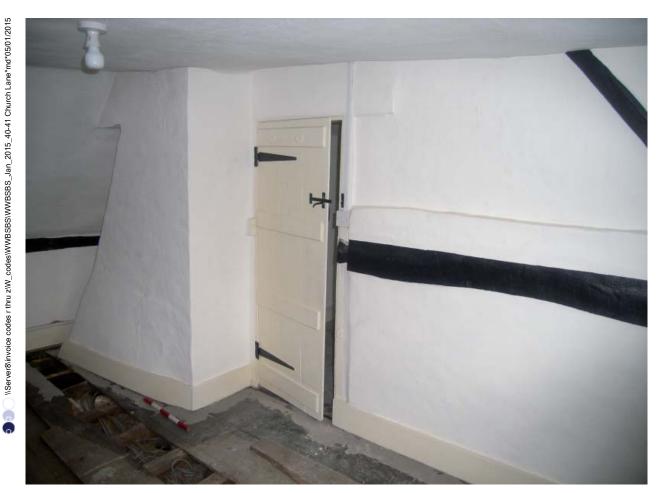
Plate 35: Truss at original north end of cottage (between Bays 3 and 4)

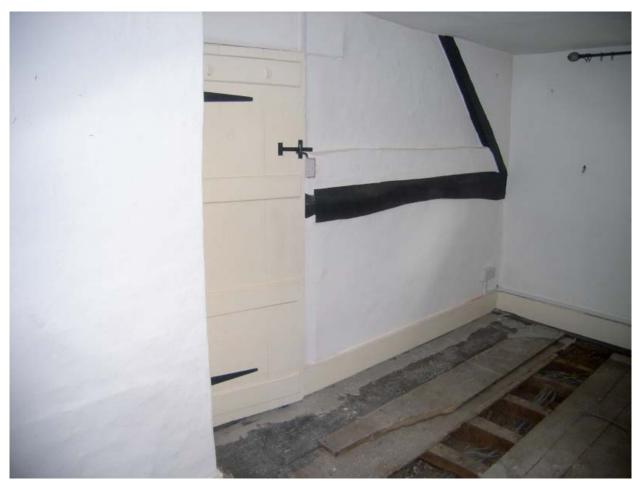
Plate 36: Truss at original north end of cottage (between Bays 3 and 4)
