Nos. 1-7 Longwall Street, Oxford

Historic Building Investigation and Recording

February 2022

Client: Magdalen College, Oxford

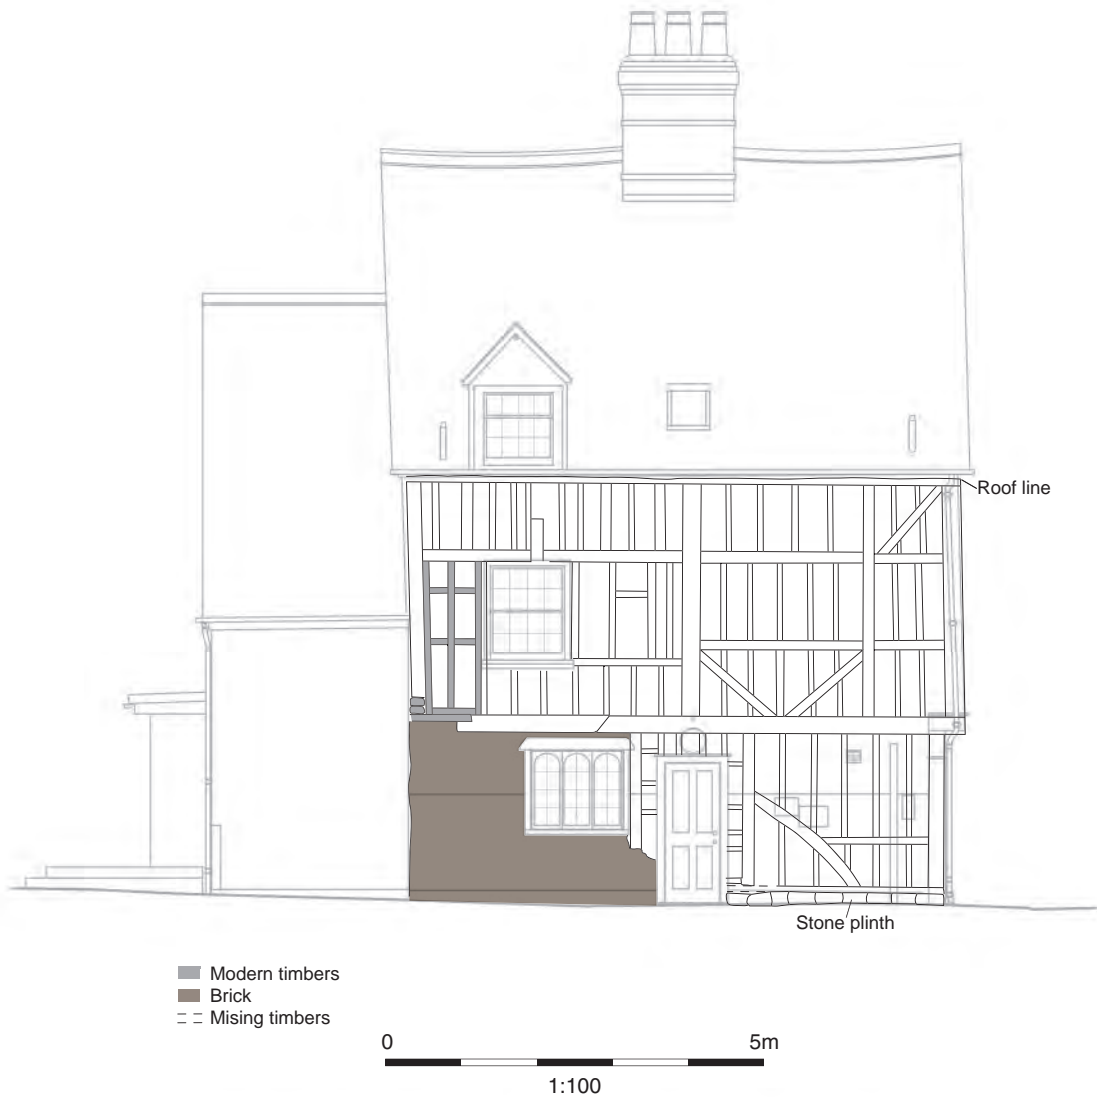
Figure 7: South elevation of Nos. 1-2 Longwall Street

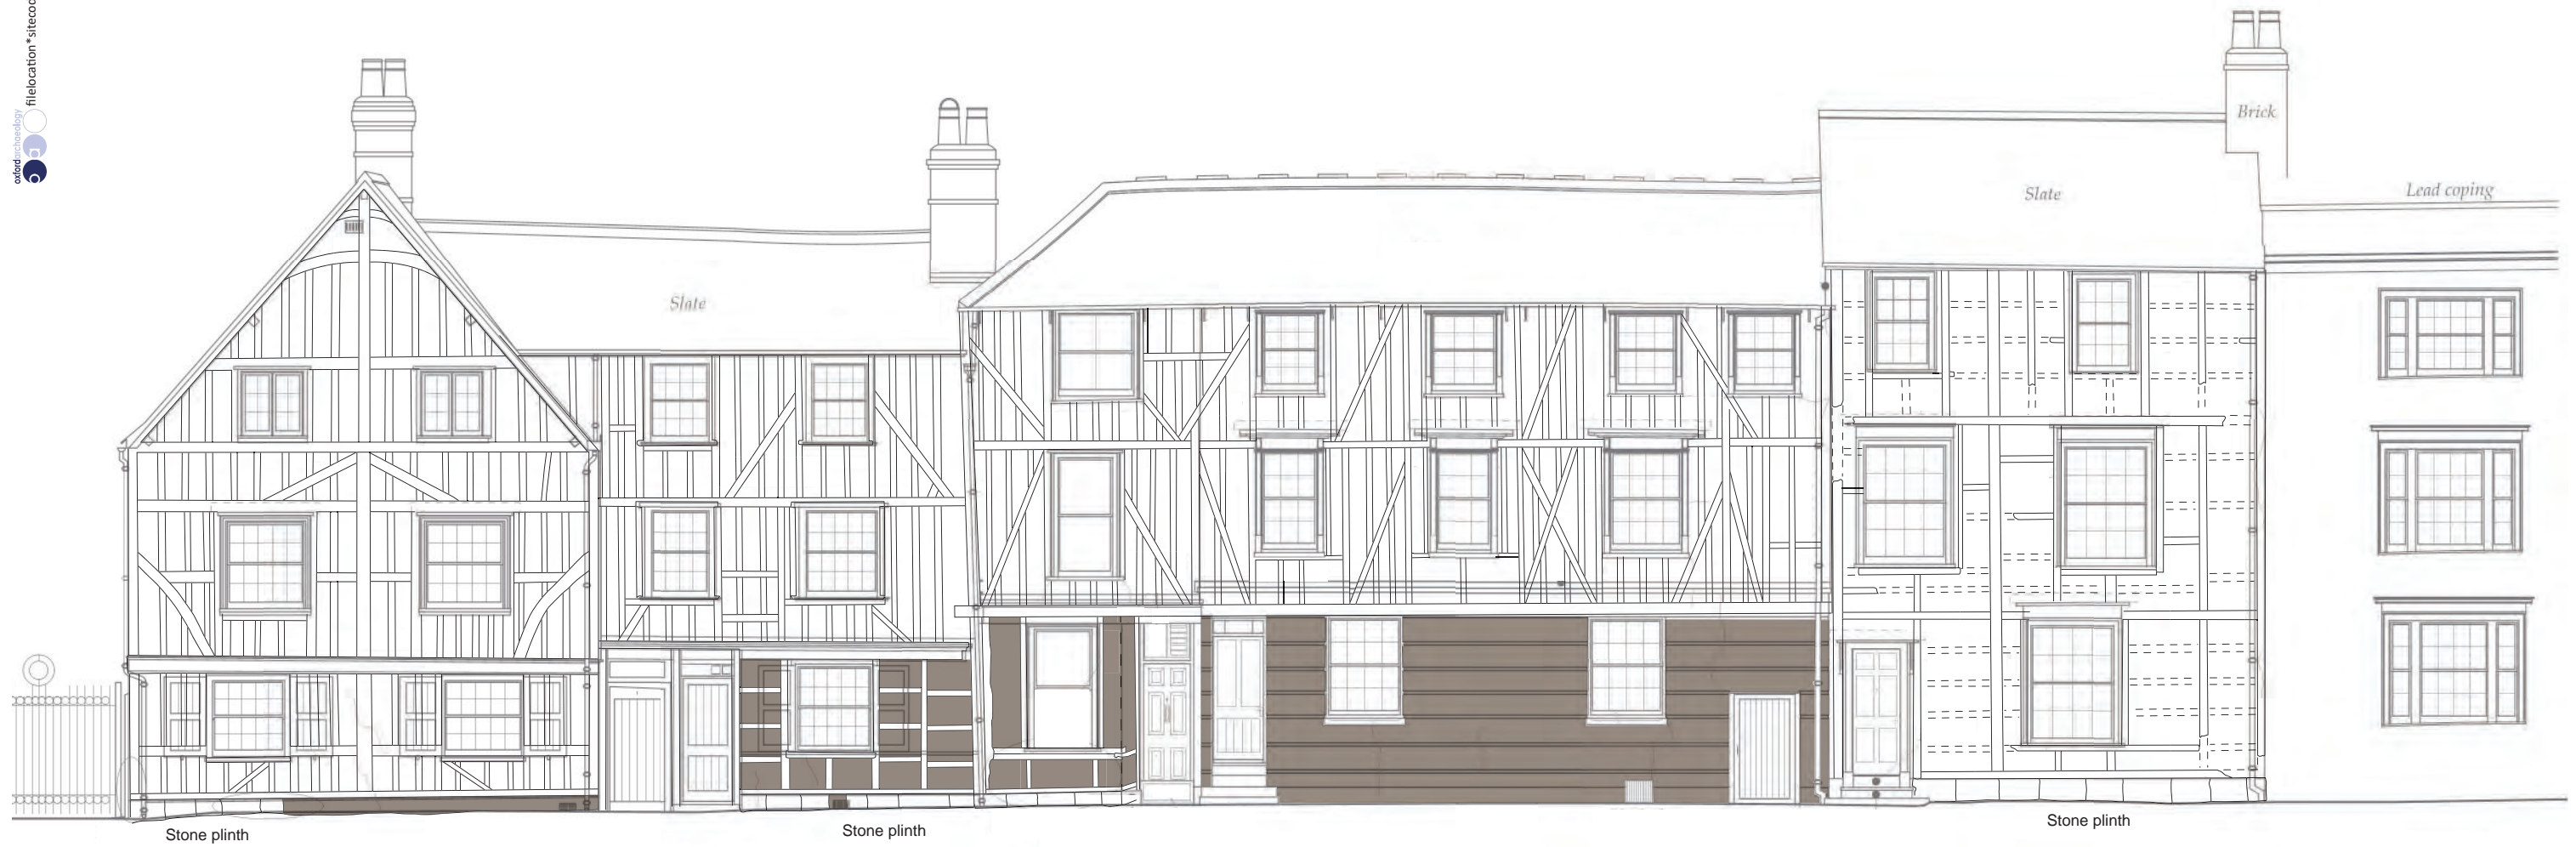
Figure 8: East elevations of Nos. 1-7 Longwall Street with later refacing timbers not shown

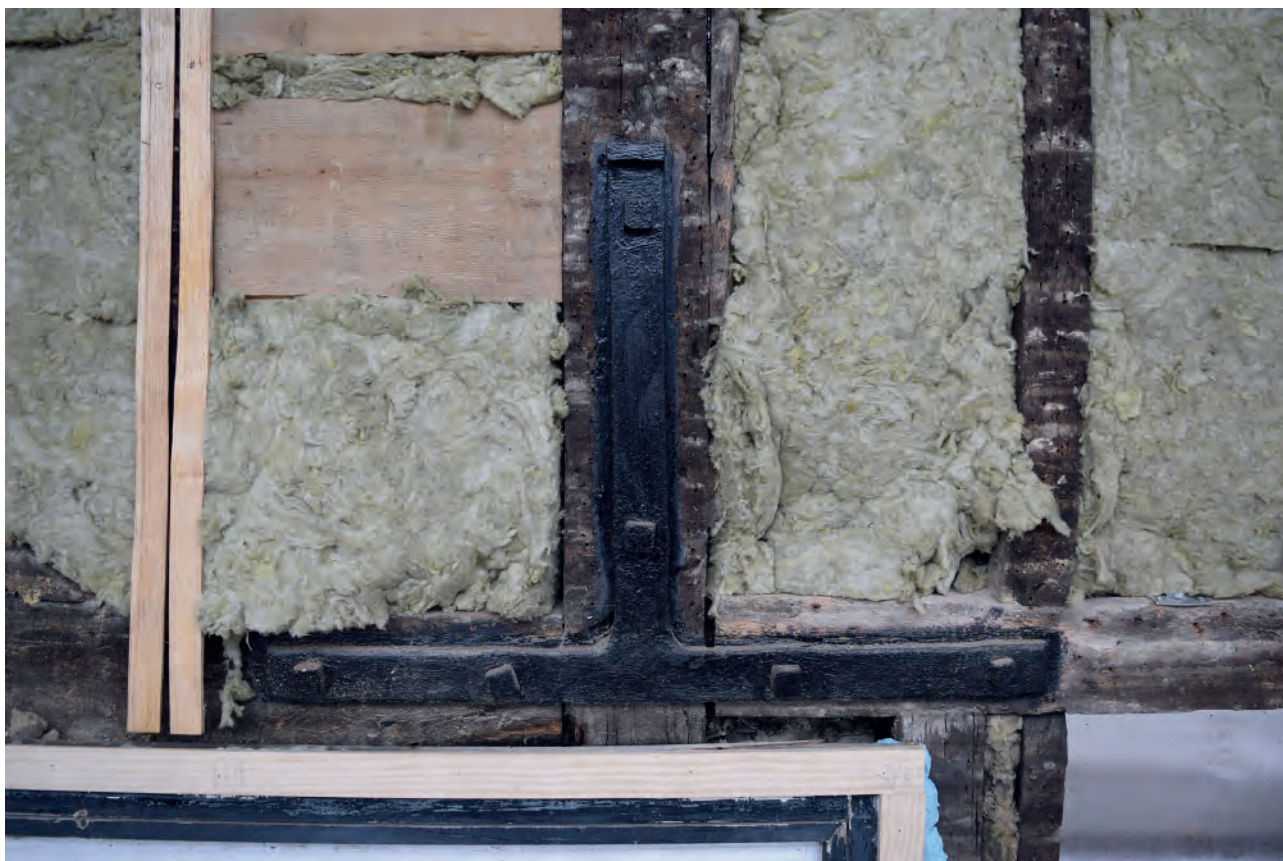
Plate 11: Strap above the northern first floor window of Nos. 1-2

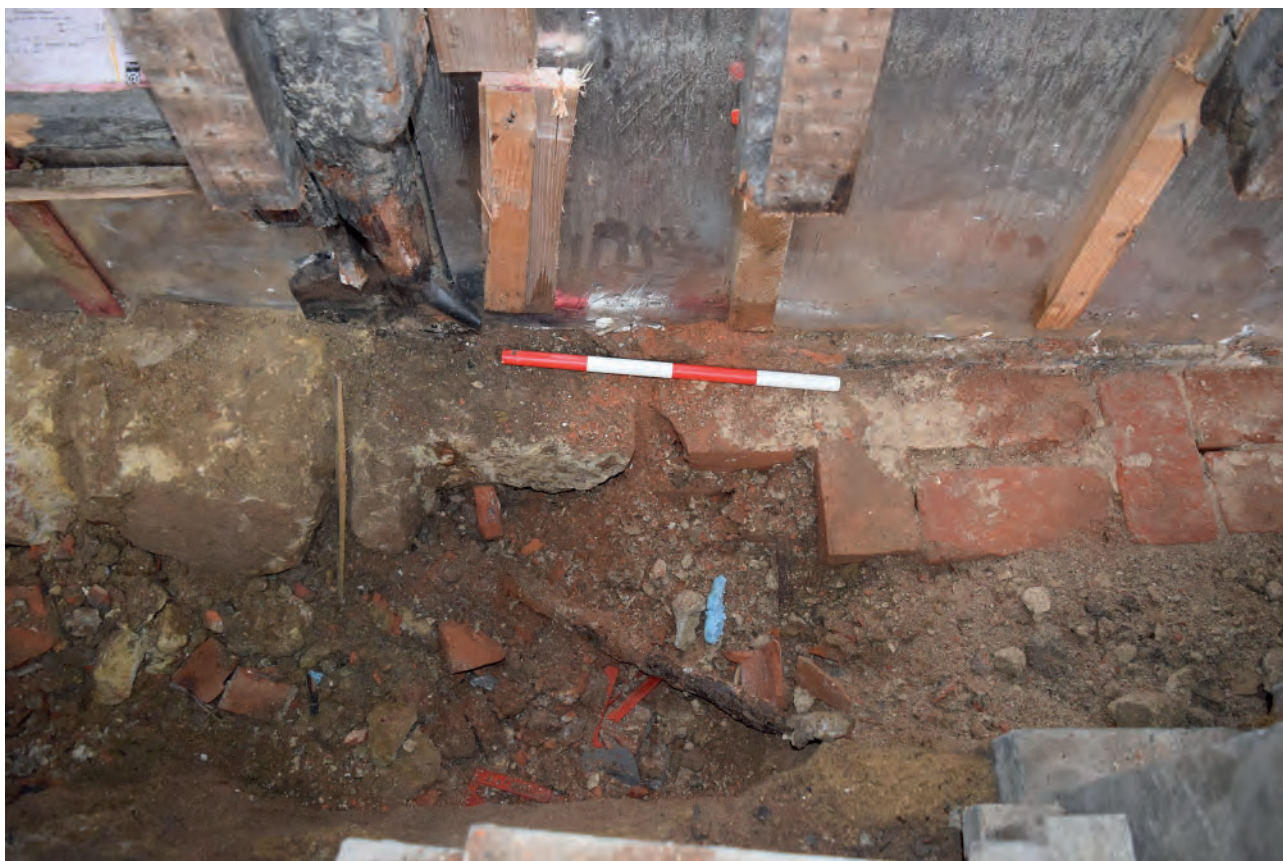
Plate 15: Secondary brick plinth on the northern side of Nos. 1-2

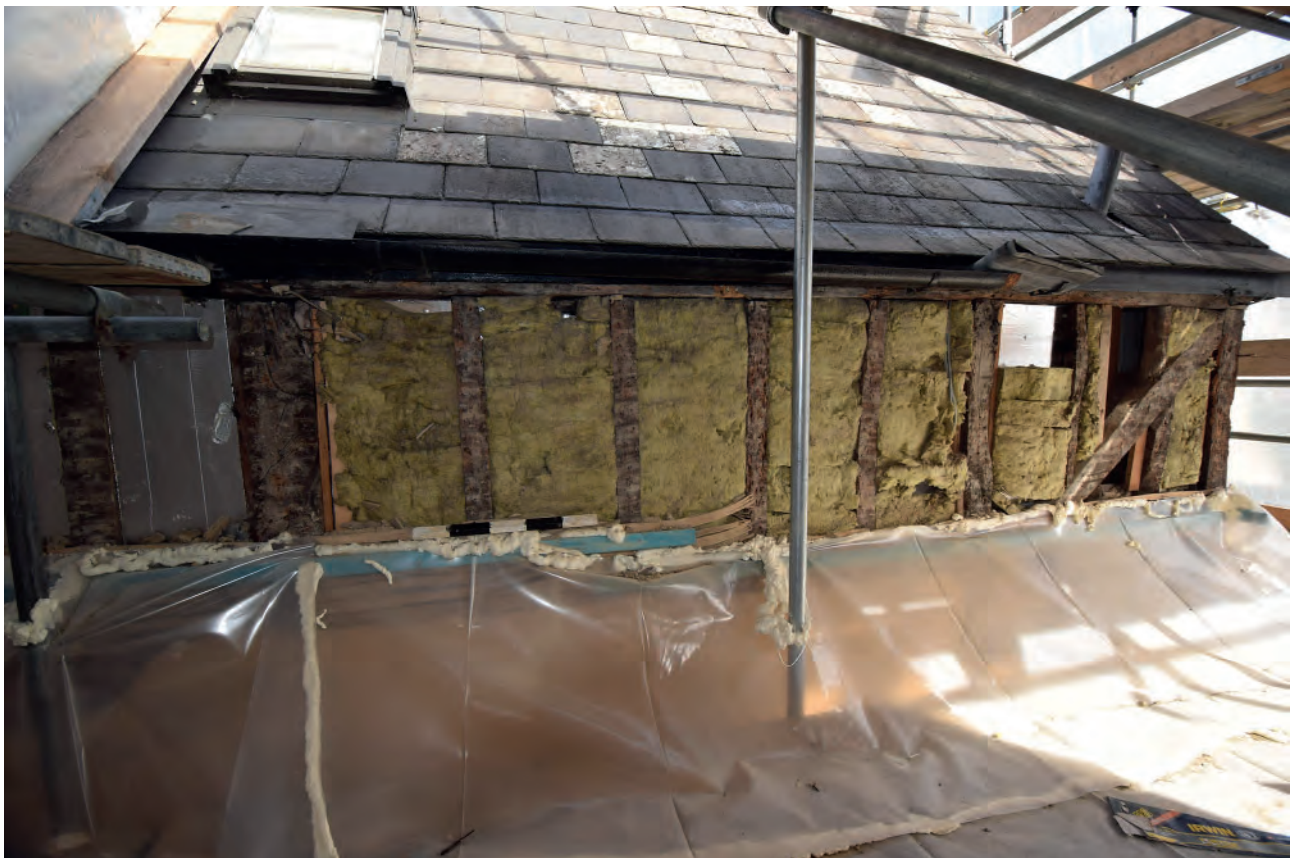
Plate 20: East elevation of Nos. 1-2 at second floor level

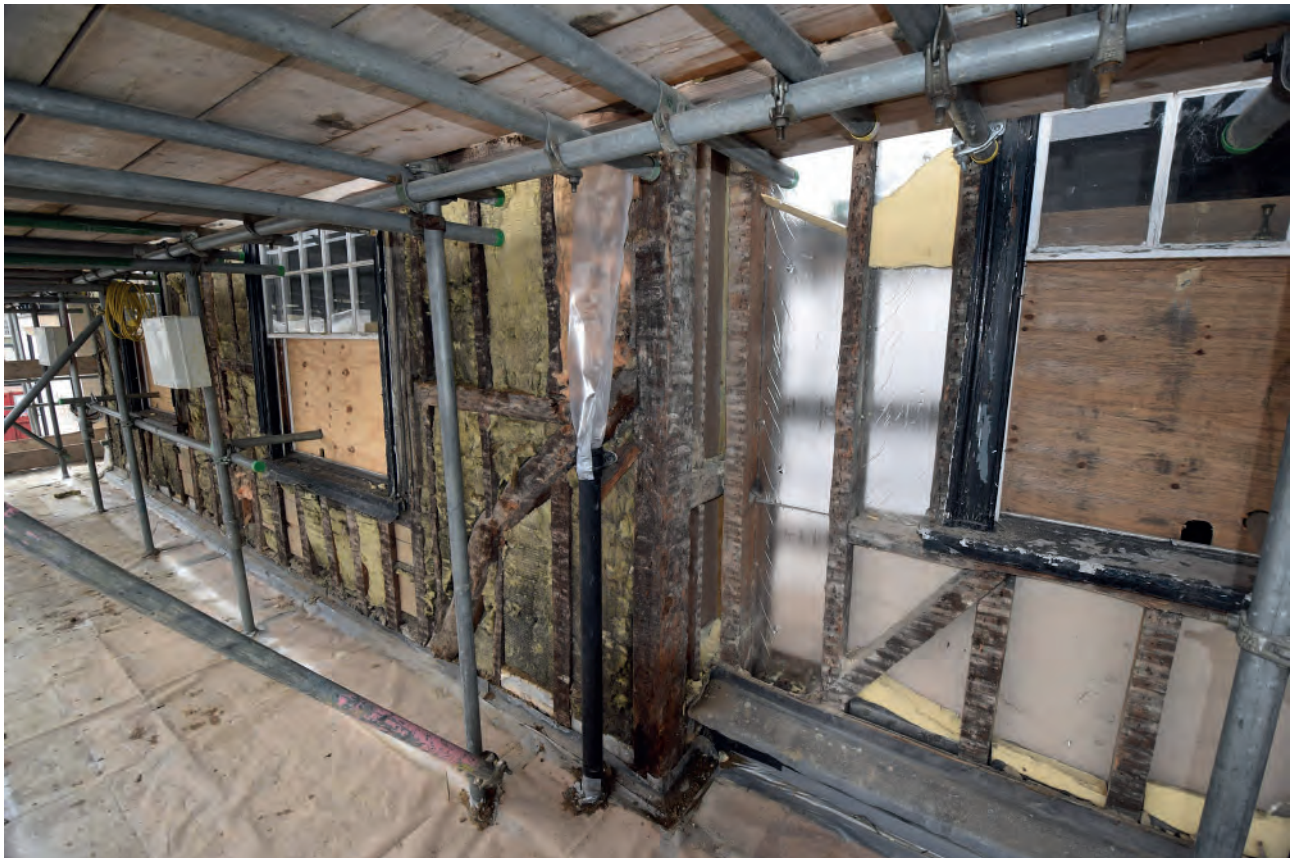
Plate 26: Change from Nos. 1-2 to No. 3

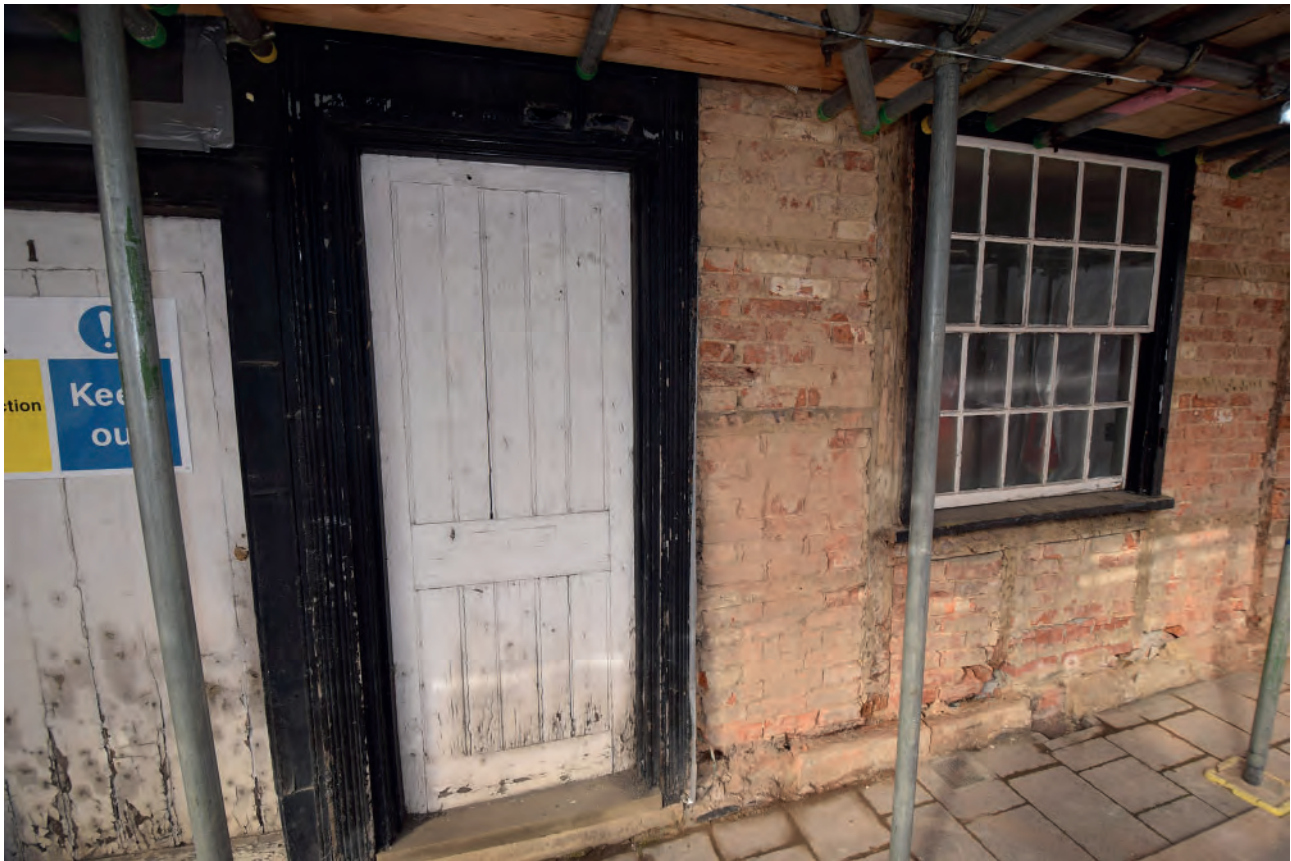
Plate 27: Ground floor of No. 3

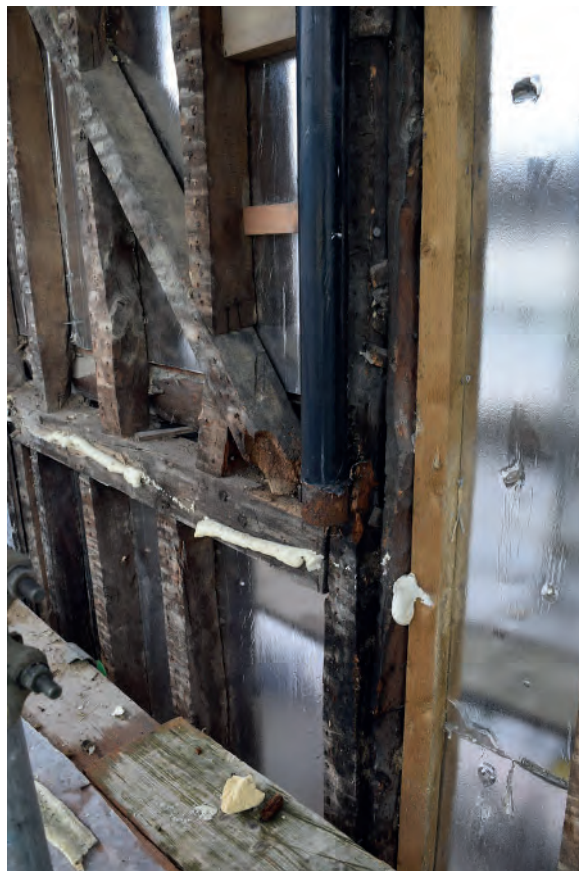
Plate 28: Change from No. 3 to Nos. 4-6 with laths in between

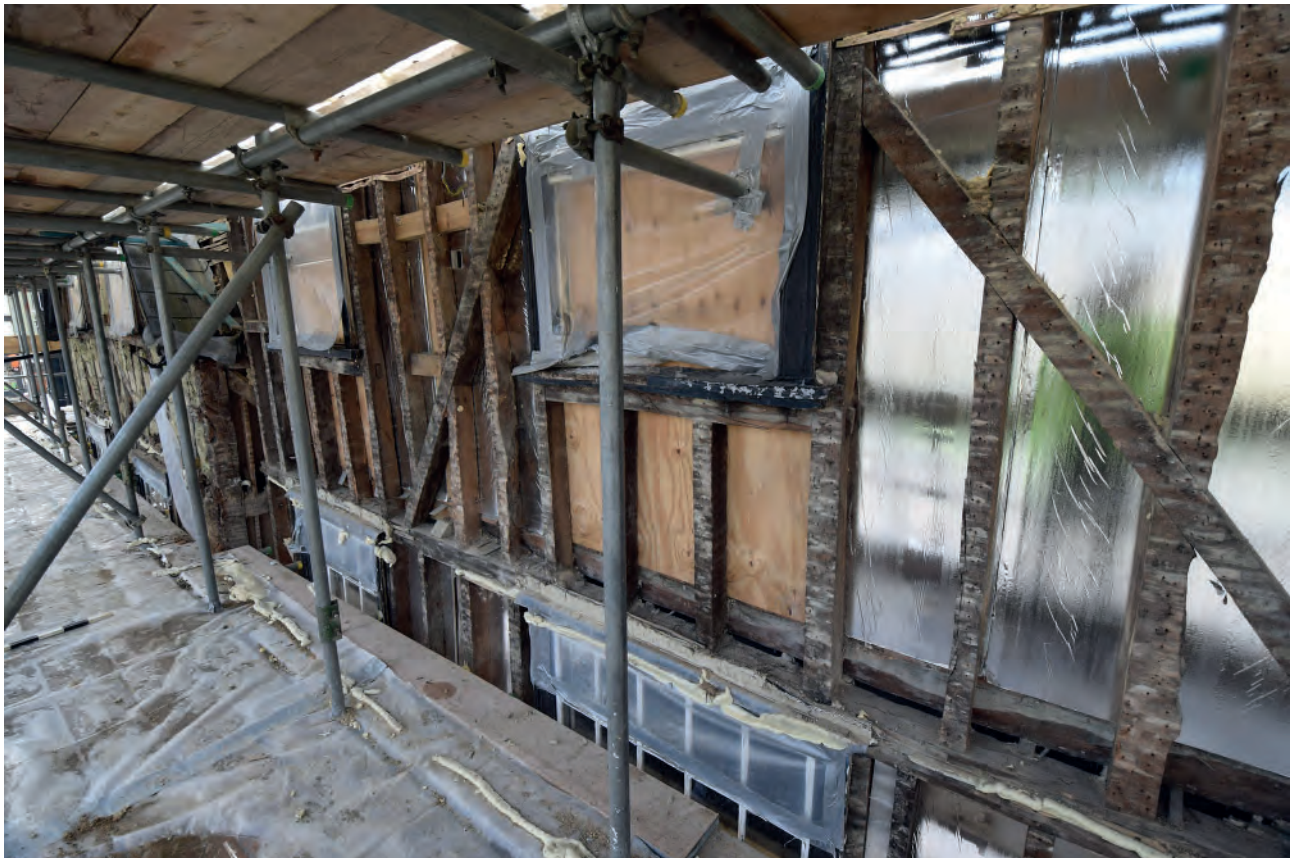
Plate 30: Second floor of No. 3

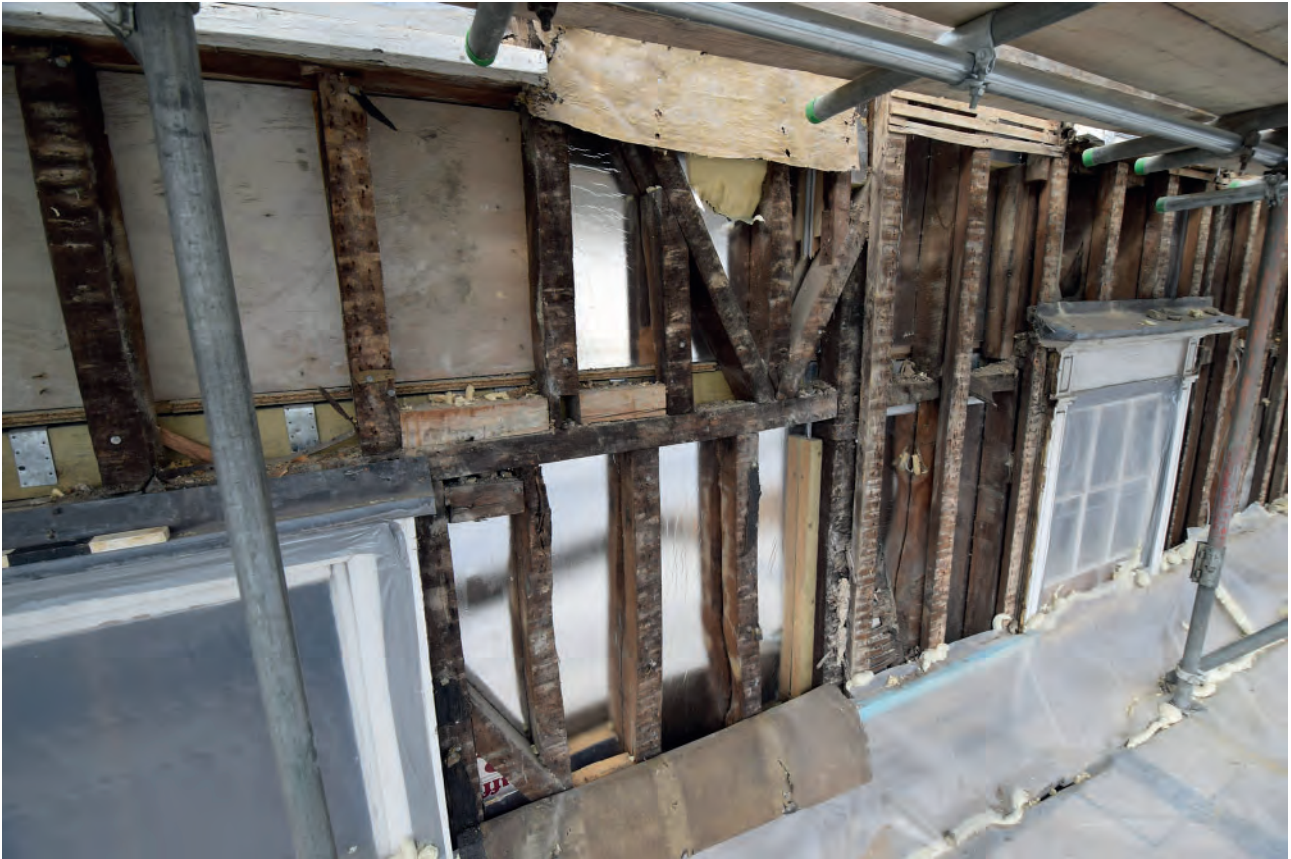
Plate 35: Primary framing of No. 4 and refacing of Nos. 5-6

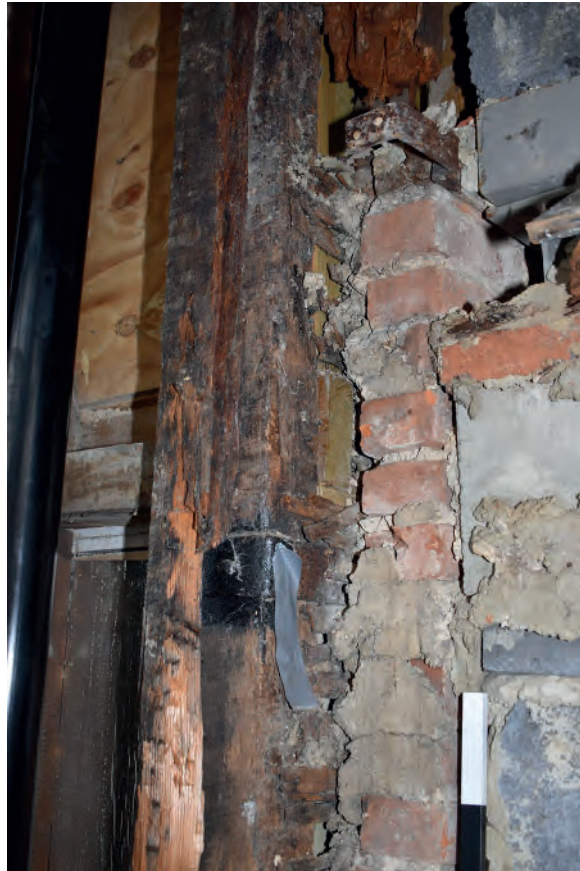
Plate 39: Iron brace and laths between Nos. 5-6 and No. 7

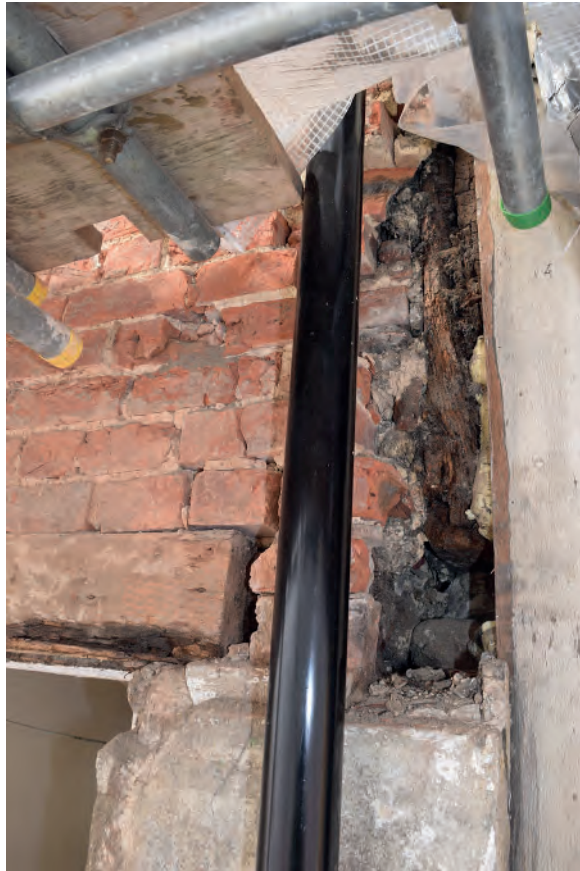
Plate 49: Remains of northern corner post of Nos. 5-6

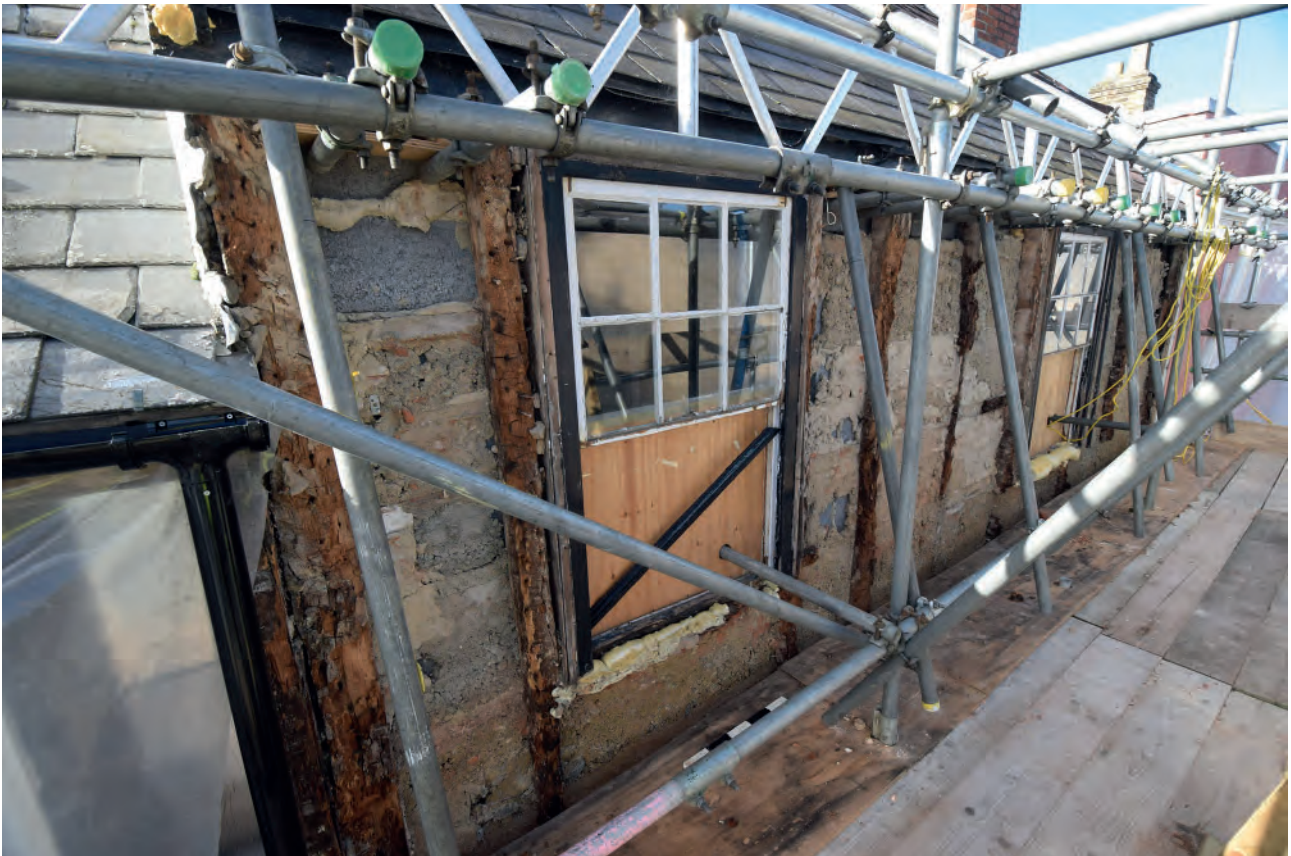
Plate 56: Second floor of No. 7

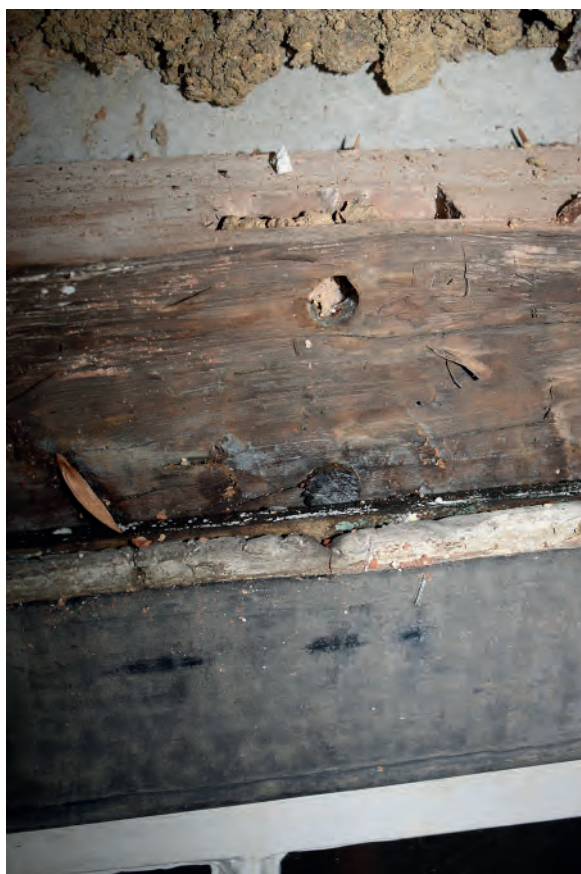
Plate 61: Peg hole and mortise above first floor south window of No. 7
