The South Terrace, Cliveden

Archaeological Investigations 2013-17

May 2018

Client Name: The National Trust
Client Ref No.: n/a
Document Title: The South Terrace, Cliveden
Document Type: Report on Archaeological Investigations 2013-17

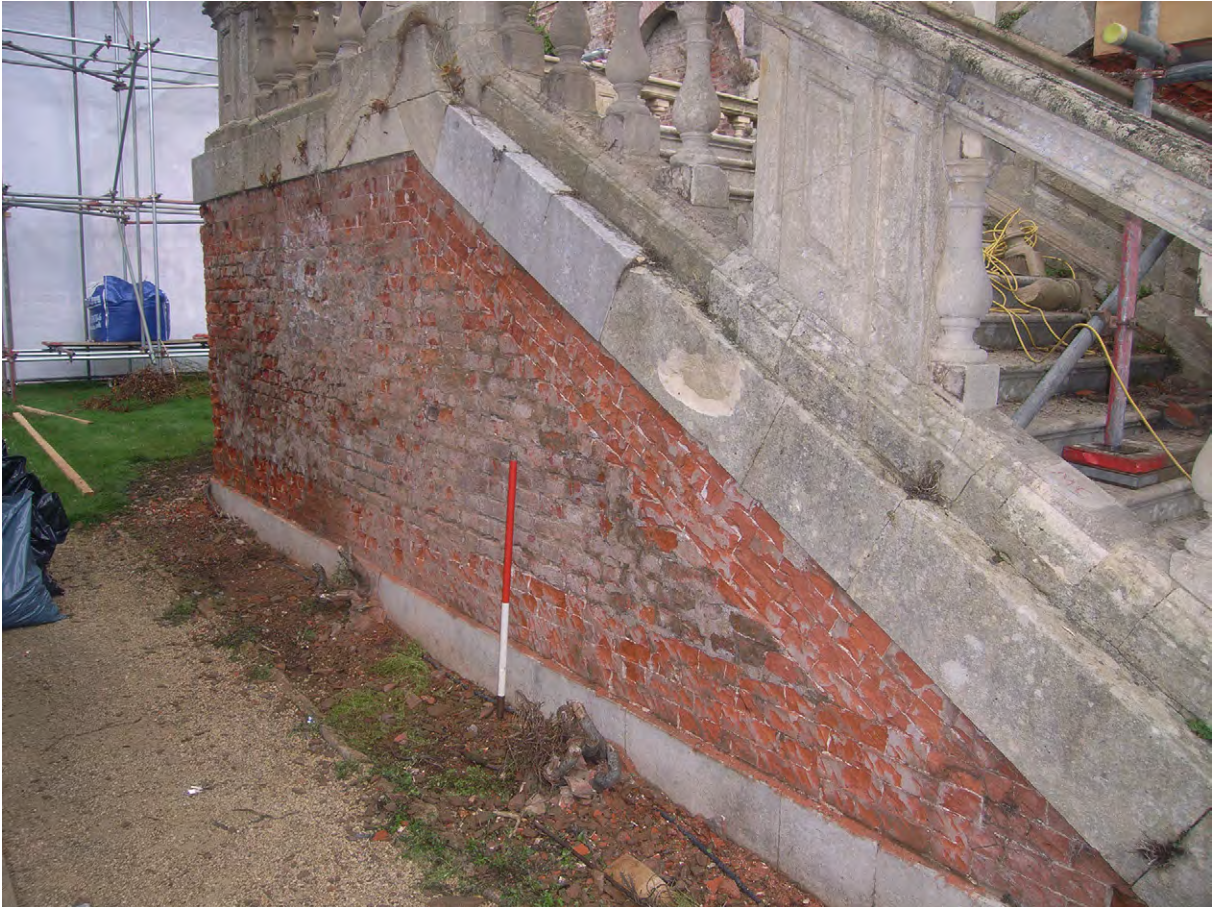
Plate A.19: Fine brickwork to western lower flight

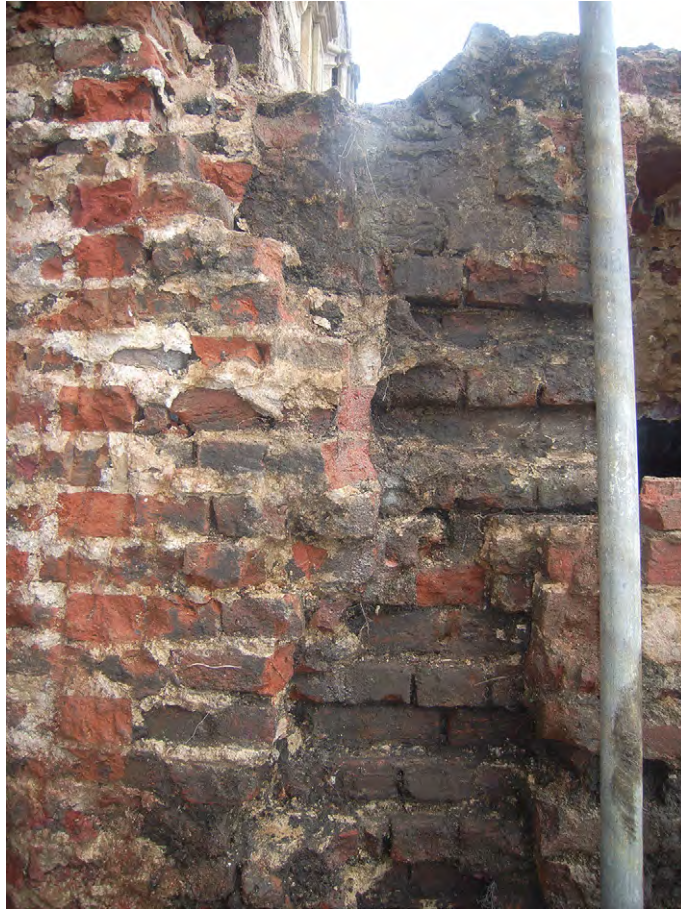
Plate A.27: Stepped brickwork [A.4.2] behind brick in front [A.4.1]

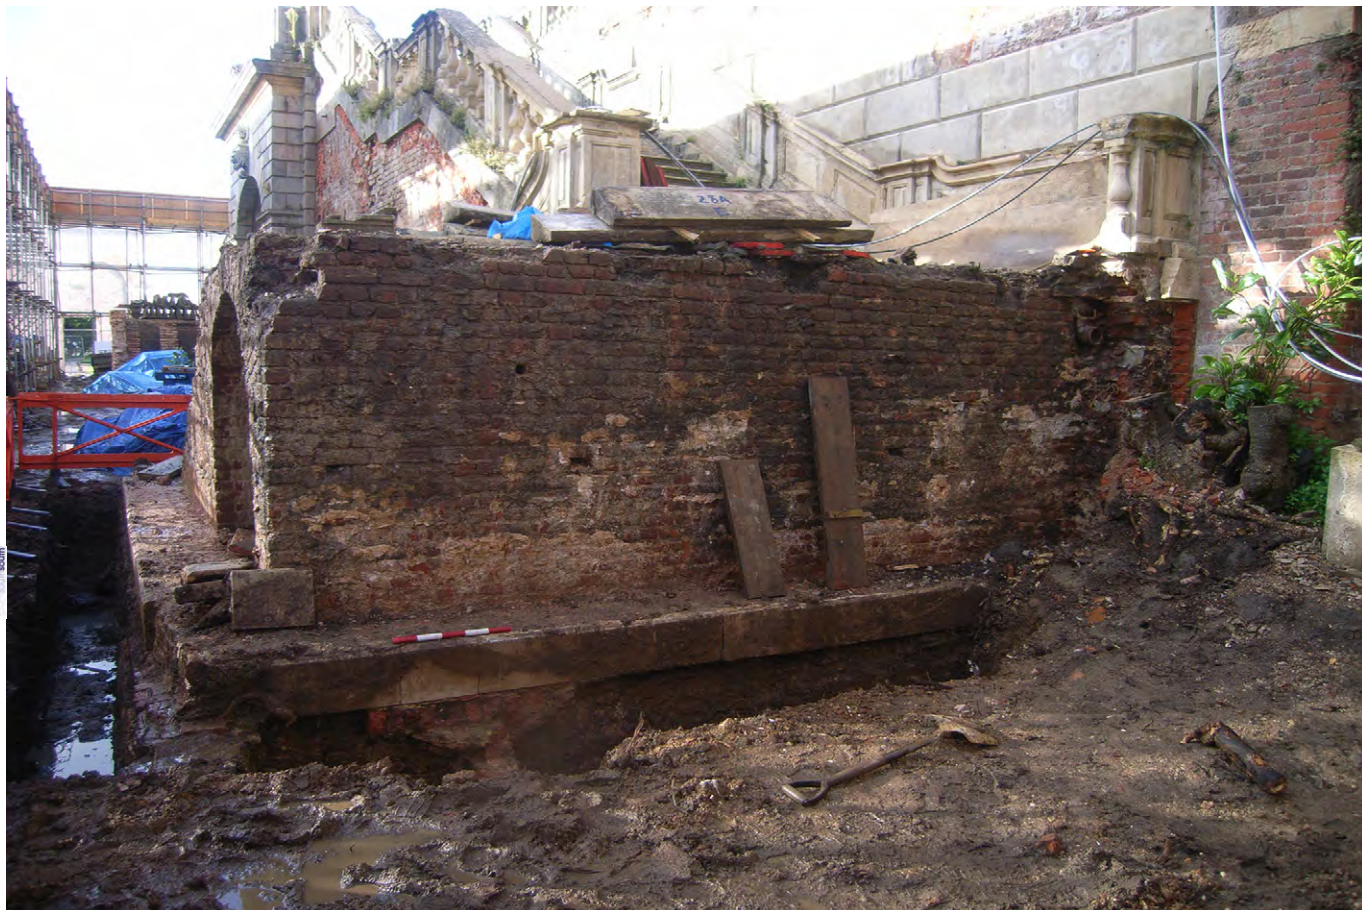
Plate A.52: North wall of east side of stairs with blackened core [A.3.1, A.3.2] and pristine face [A.2.1]

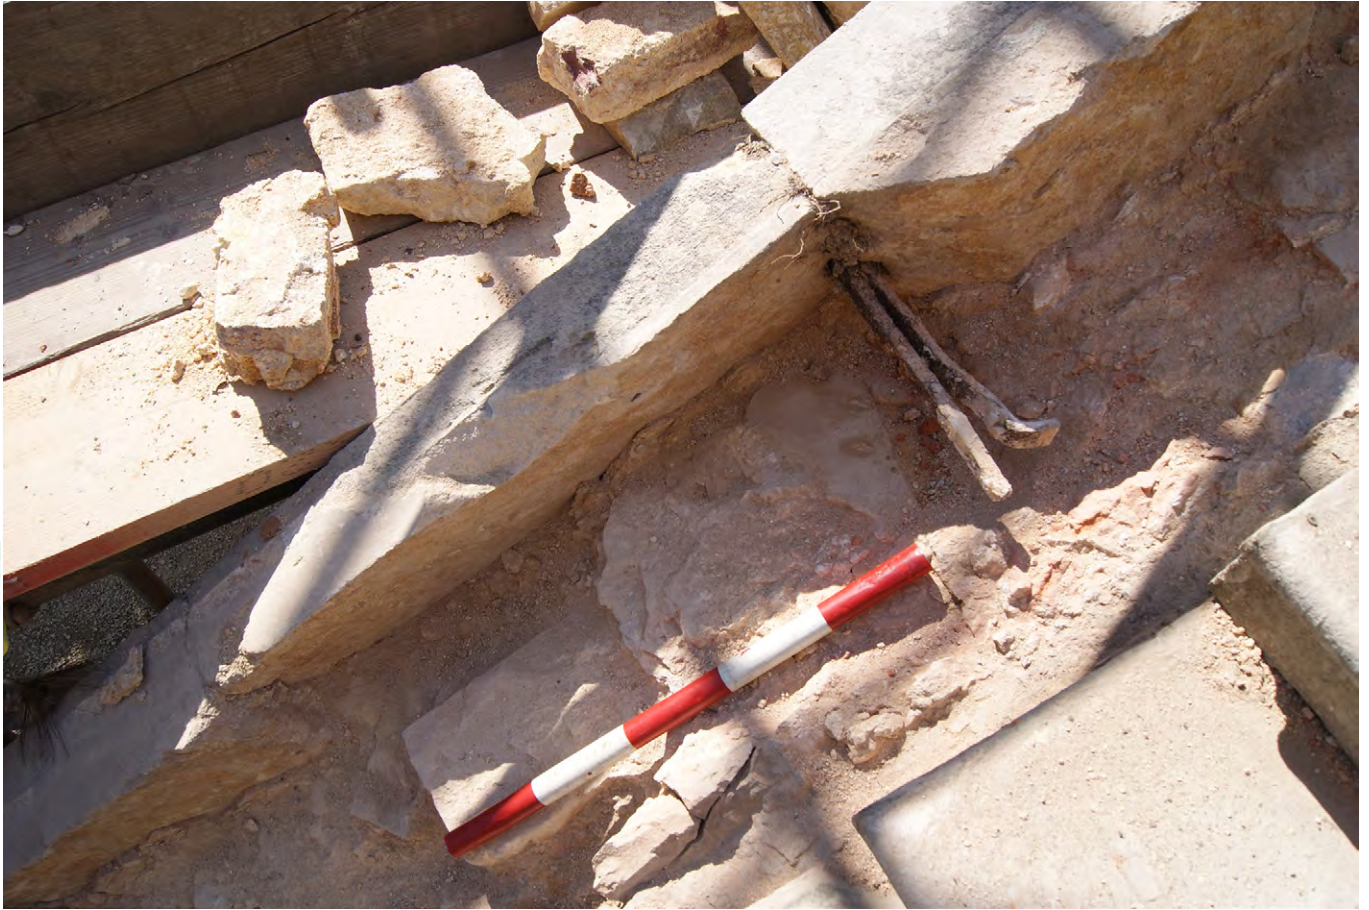
Plate A.58: Cast iron clamp on south side of west lower landing

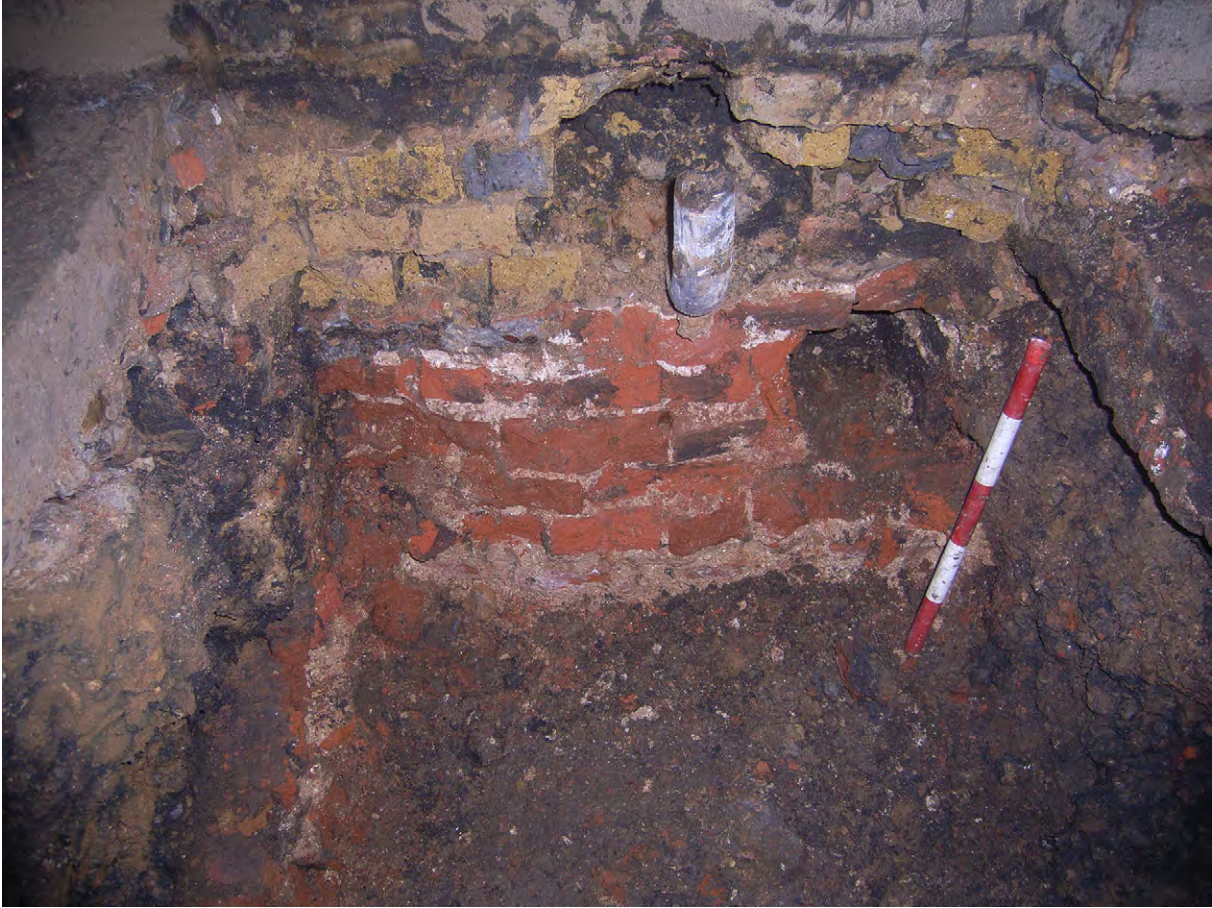
Plate C.44: Pit dug in floor in East Fernery Water Tank, looking east

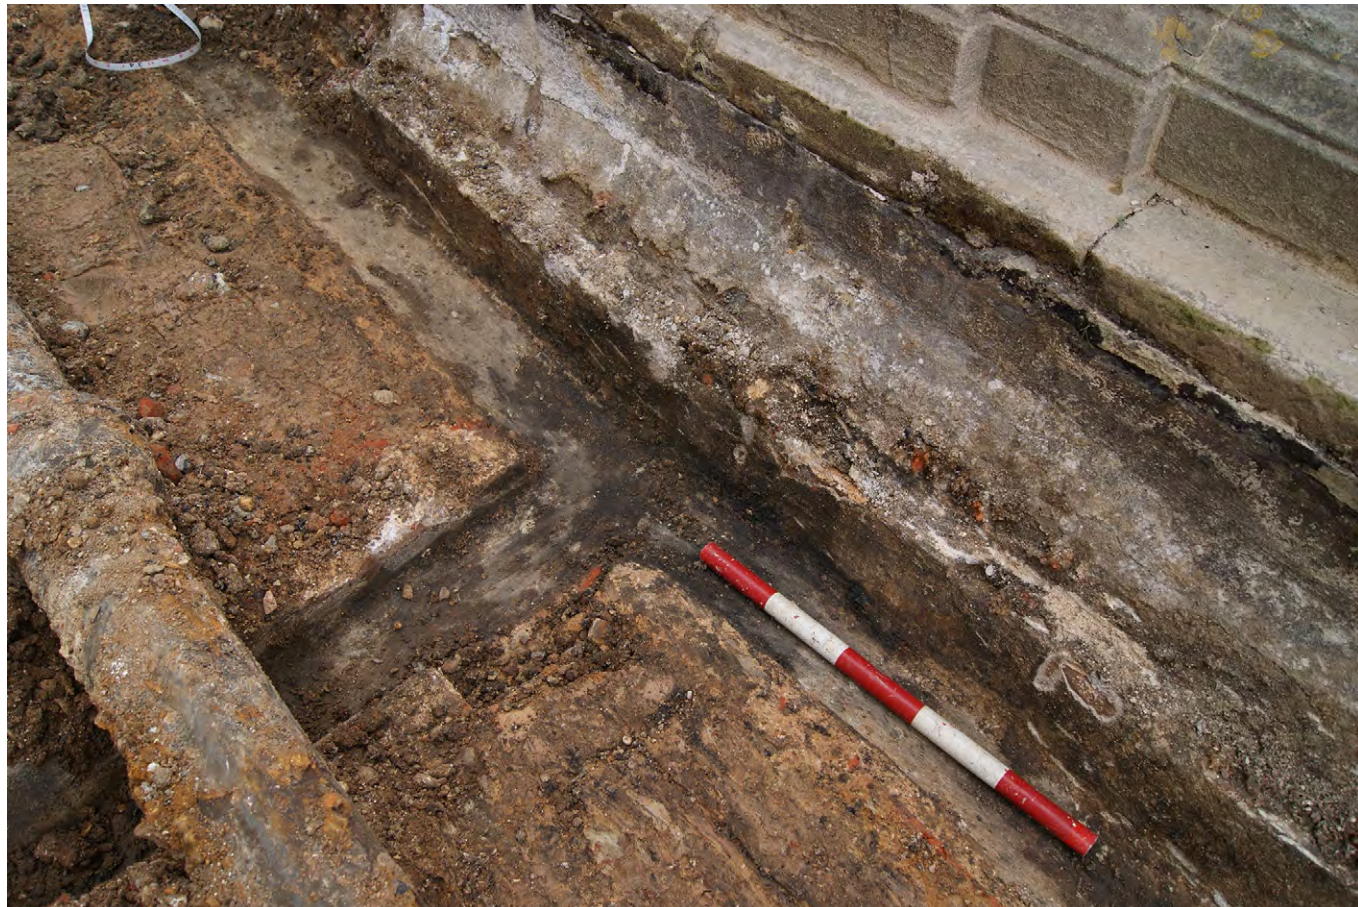
Plate F.25: Drain 2 [F.2.7] and 5 [F.2.10] by balustrade, looking south-east

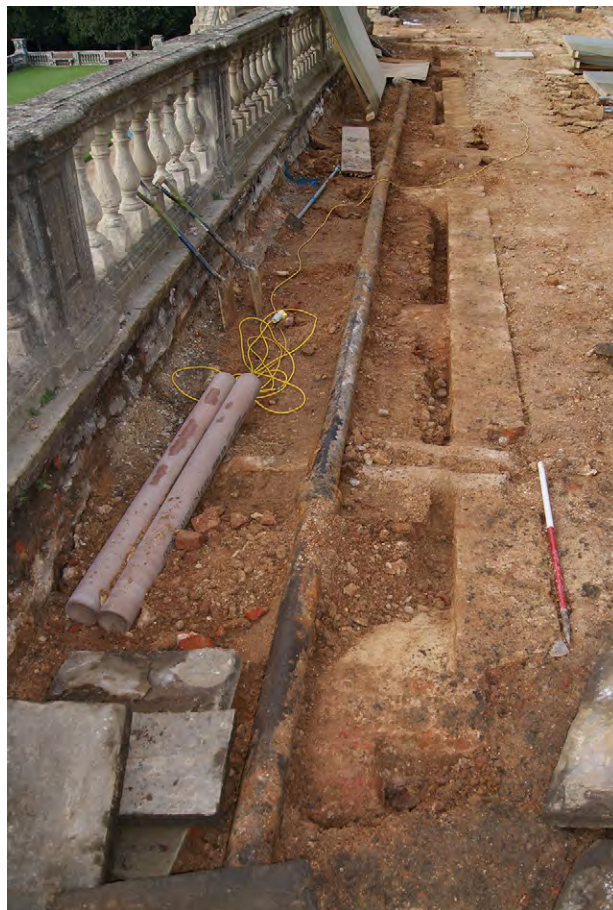
Plate F.41: East-to-west wall [F.2.1] towards front of terrace, looking west

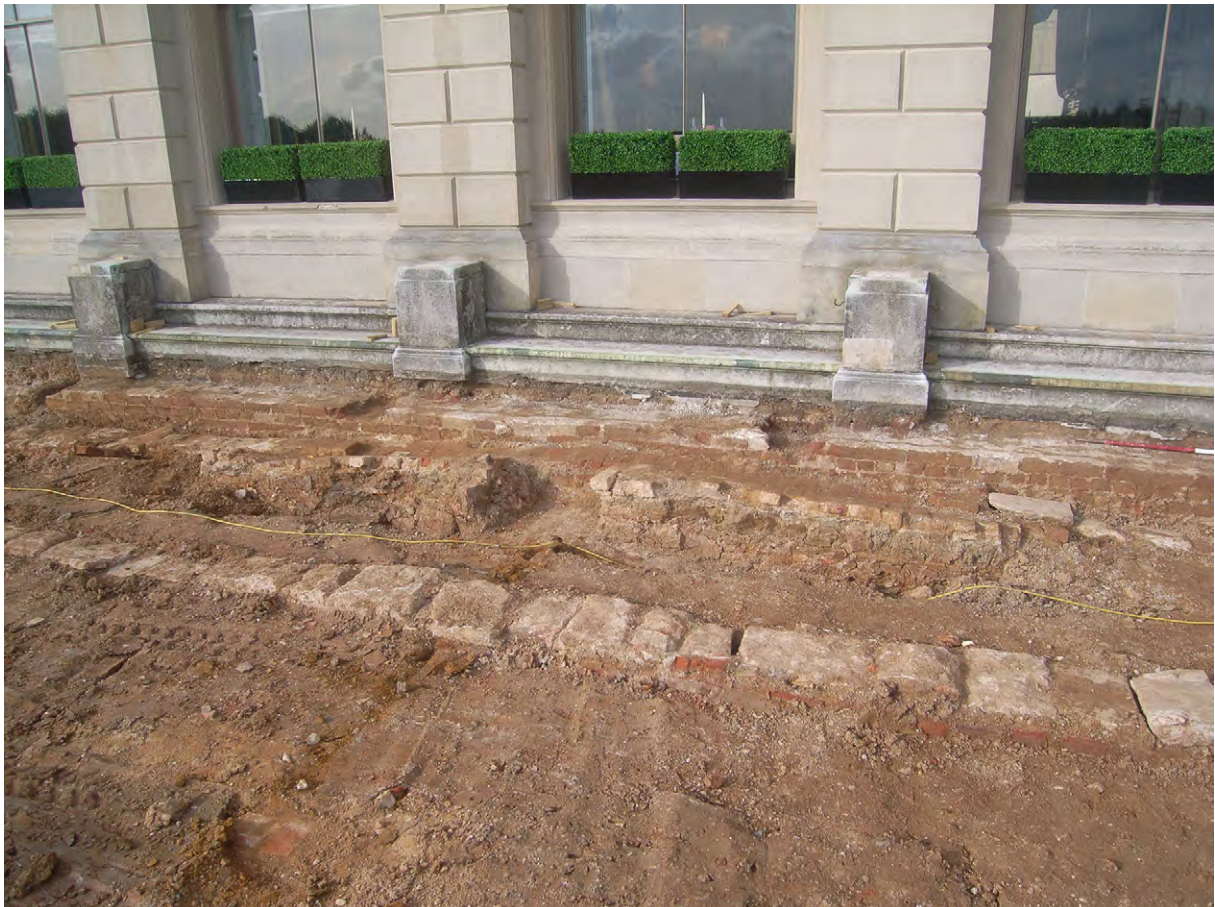
Plate F.49: Drains and features in front of mansion, looking north

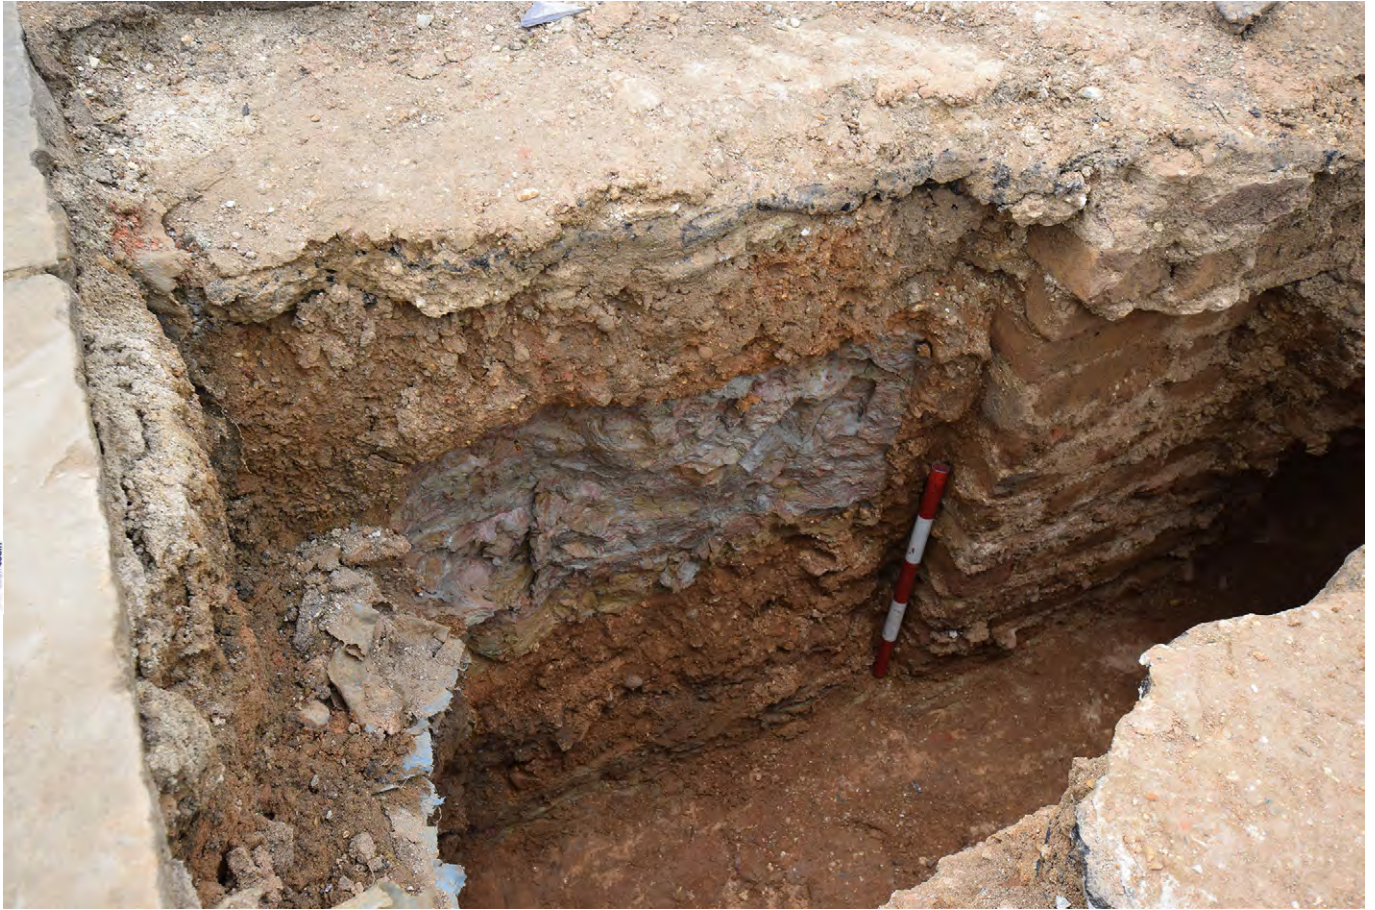
Plate F.60: Ground make up in Pit F.104 looking west

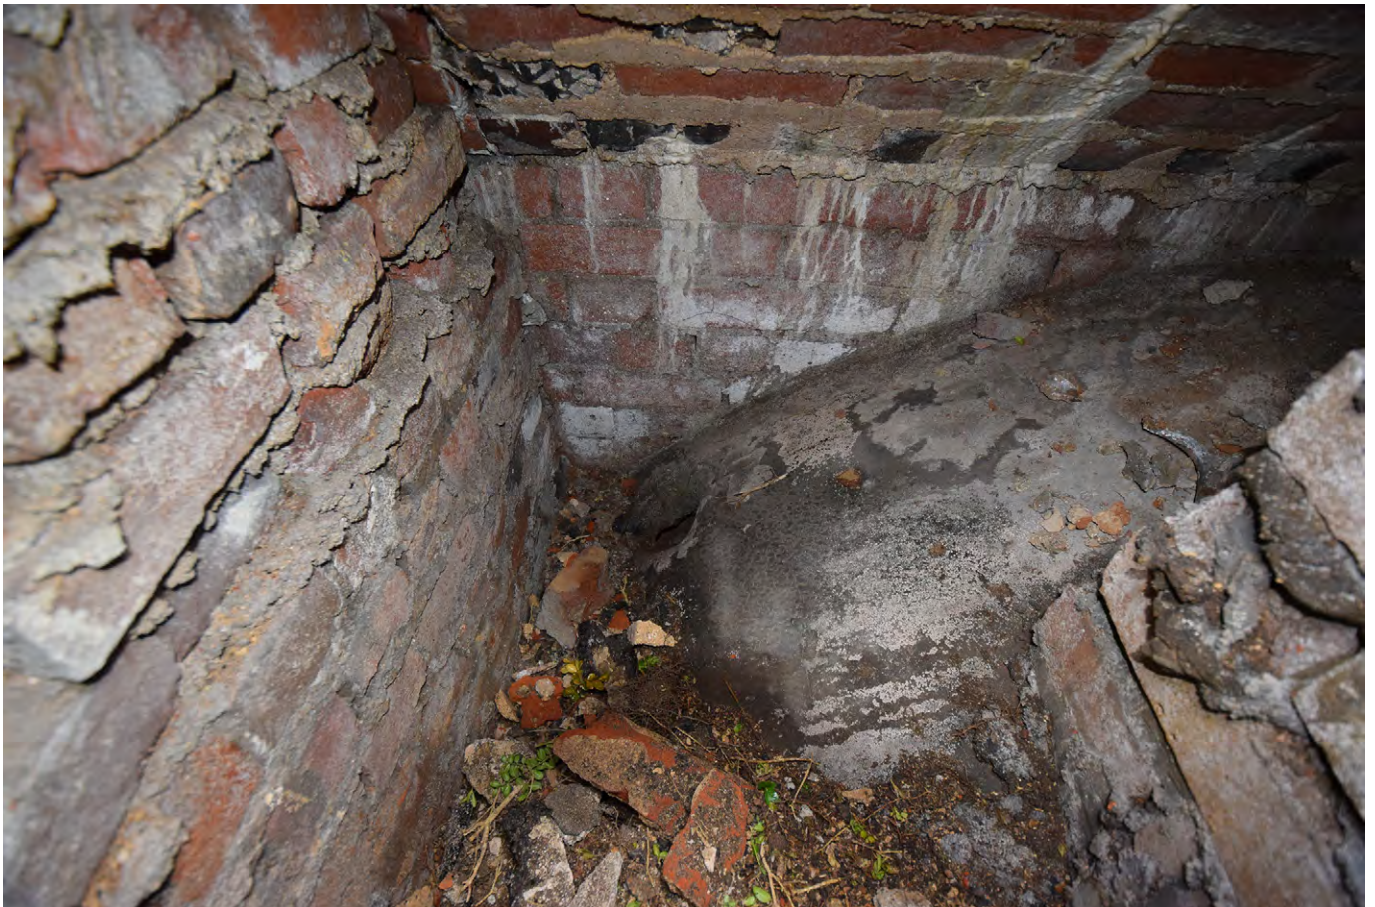
Plate F.61: Features exposed beneath terrace surface in Pit F.104

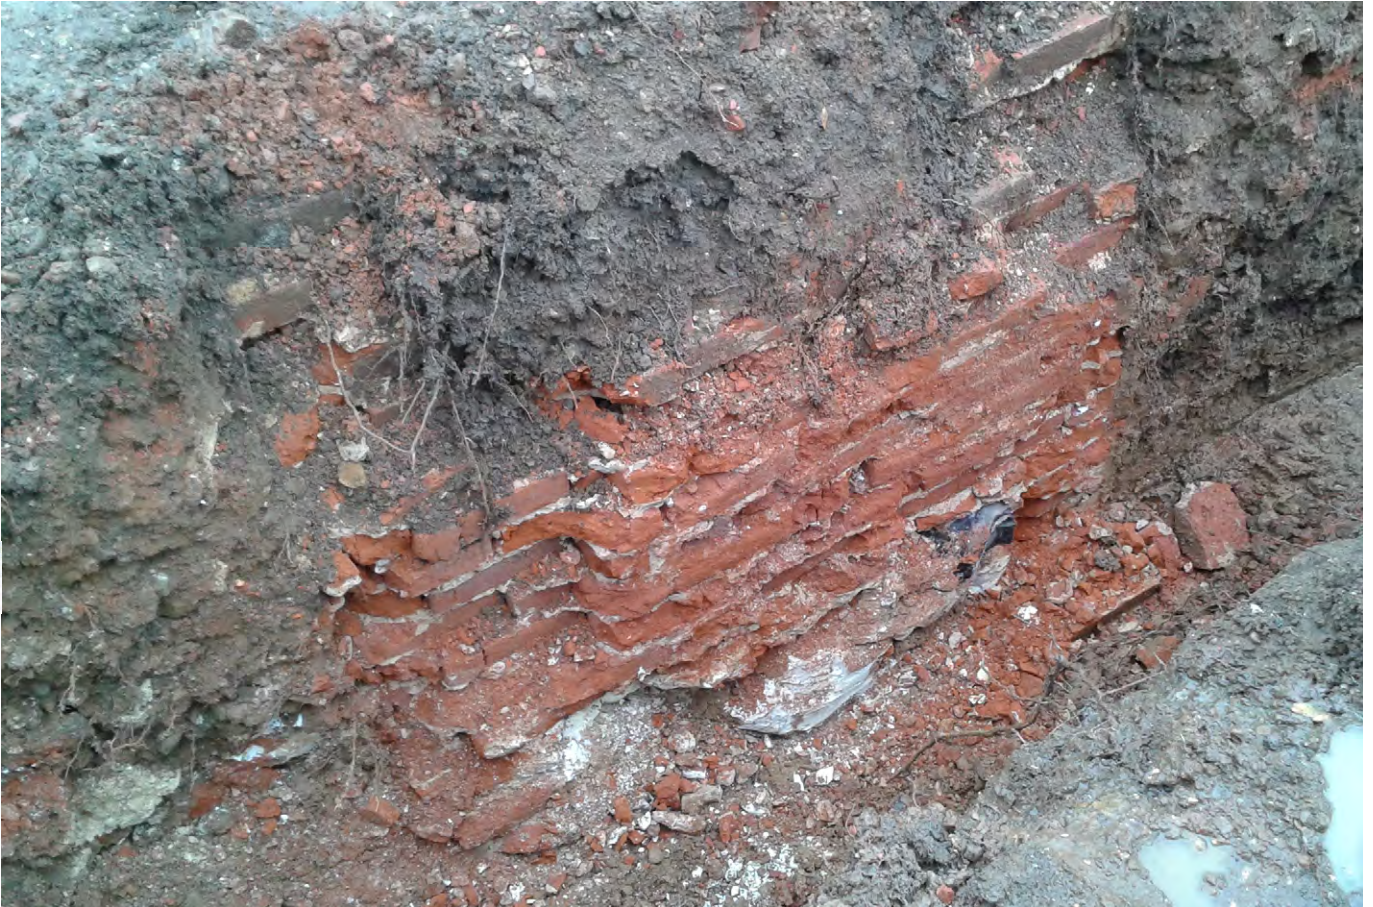
Plate G.3: Wall [G.100.5] after its truncation, looking south-west

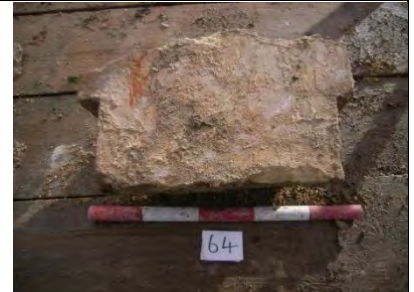
65: Large and well preserved string course. Mouldings survive well for 34 cm long although the actual block is longer. Curved moulding to upper part of face with ogee mouldings below. As part of the current project to repair the terrace staircase this piece has been sealed within the brick vault beneath the east landing.

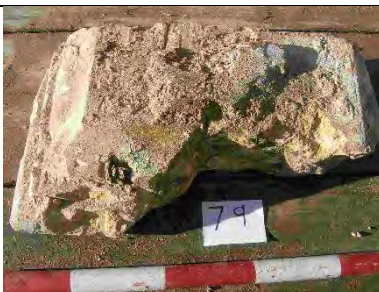
80: A corner section of a pilaster base with ogee moulding. It has been roughly used as fill in the wall and there are lumps of mortar left fixed to the stone. Fine white limestone. 43 cm long x 18 cm wide x 21 cm tall. The flat-faced lower section of the base is 11 cm tall. *(Possibly 17th century)*

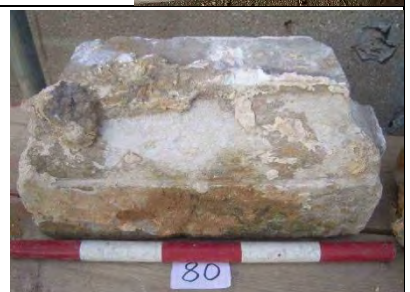
81: A stepped section of a moulded cornice which would have extended around a corner. 22 cm x 29 cm x 16 cm tall. Yellowy Cotswold stone (*17th century or later*)
