# Manor Farm Courtyard Gazeley

## Level 2 Historic Building Survey

December 2016

**Client: Dalham Estate**

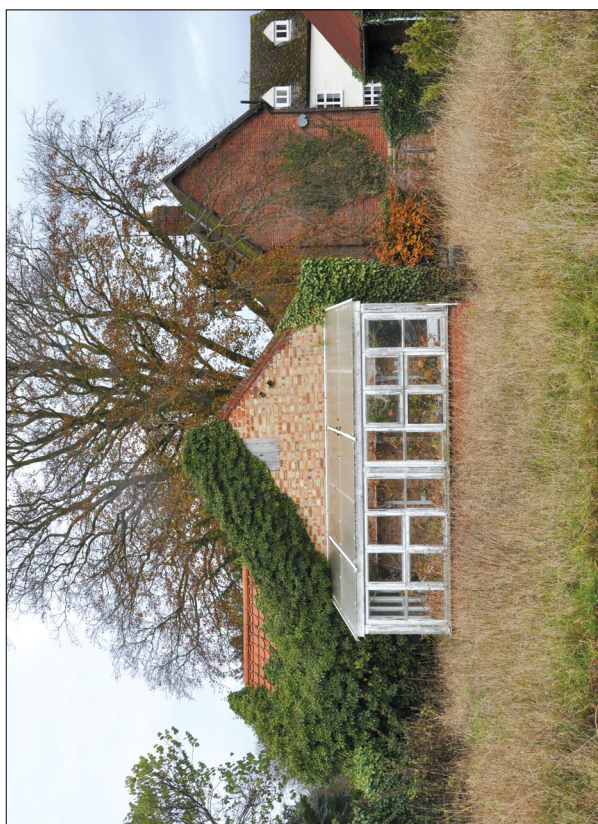
- 3.3.3 The single story building was previously at the northern end of a long range of buildings that were demolished between 1950 and 1979 (Fig 6). This truncated southern elevation is now faced in Fletton type bricks (Plate 3). A small boarded window is located on the upper gable end. This was not accessible internally at the time of the survey.
- 3.3.4 A lean-to greenhouse has been built onto the southern elevation (Plate 3). The greenhouse is modern (Plate 4) and measures 4.8m x 2.10m internally and has a height of 3.0m where it joins building **A**.

Plate 3: Lean-to greenhouse attached to Building **A**, viewed from the south

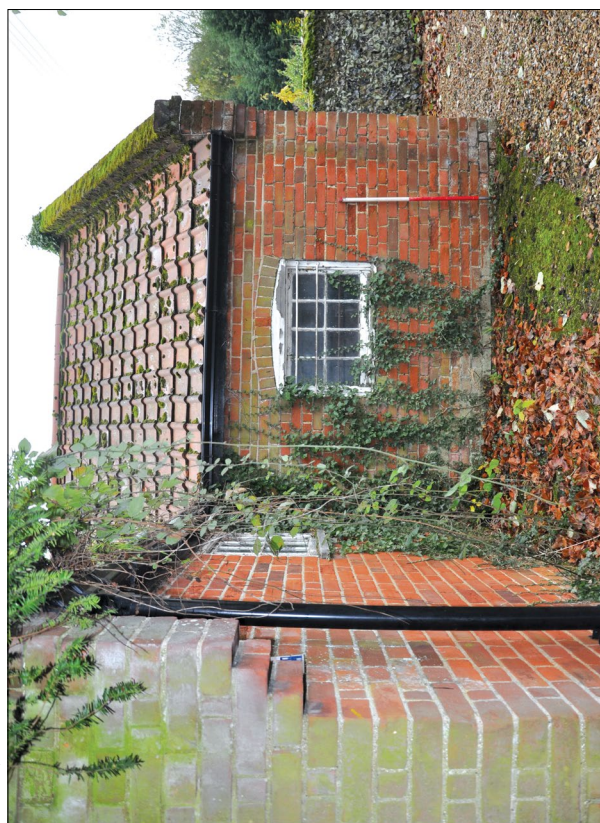
- 3.3.2 The construction of the building is generally of 225mm and 330mm soft red brick laid in a Flemish bond to a gable height of 4.5m with half brick course above window openings (Plate 12). Flint is used on the western elevations and corbelled brickwork on the eaves (Plates 14 & 16). The walls extend above roof level to form parapets to the gable ends, terminating with bricks on edge above a corbelled brickwork at the eaves. The roof is constructed of clay pantiles with matching ridge sections (Plate 9).

Plate 12: North-west facing elevation of tack room attached to Building A, viewed from the north

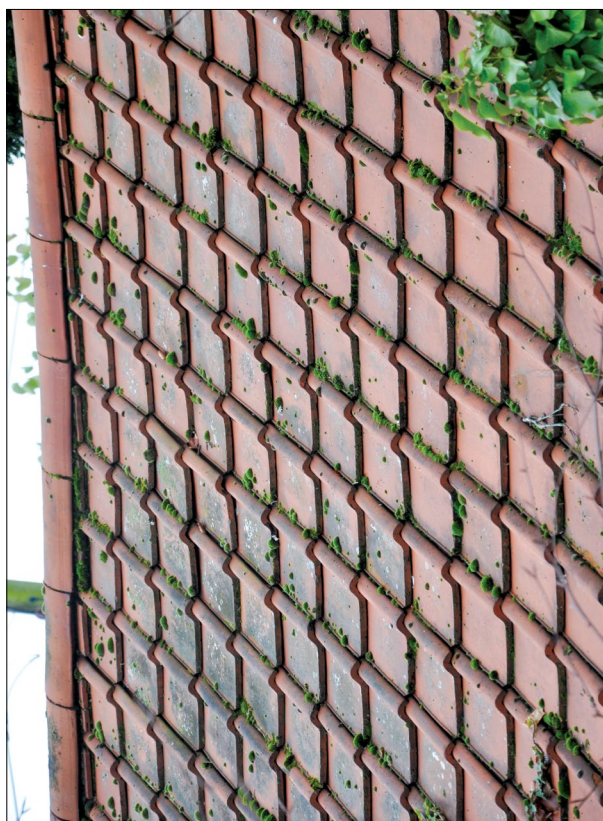
Plate 9: Detail of roof of Building A, viewed from the east

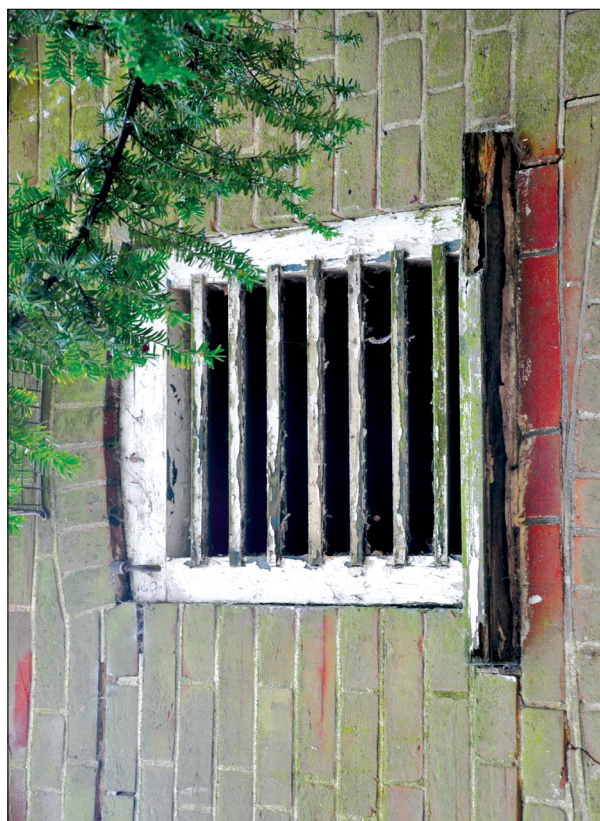
- 3.3.7 The northern elevation consists of red brick, to an apex height of 4.50m. Into this, a double wooden garage door had been inserted (Plate 10). This door replaced an earlier one that became unsuitable when the building was changed from stabling to an automobile garage. It measured 6.25m by 2.06m and, although locked at the time of survey, would open centrally. A small access door was set into the right side of the double door.
- 3.3.8 The only embellishment to the elevation was a small, seven slated louvre ventilation window which is set into the wall under underneath a segmented arch (Plate 11). The window is constructed from wood

Plate 11: Detail of louvre window, in north-west facing elevation of Building A

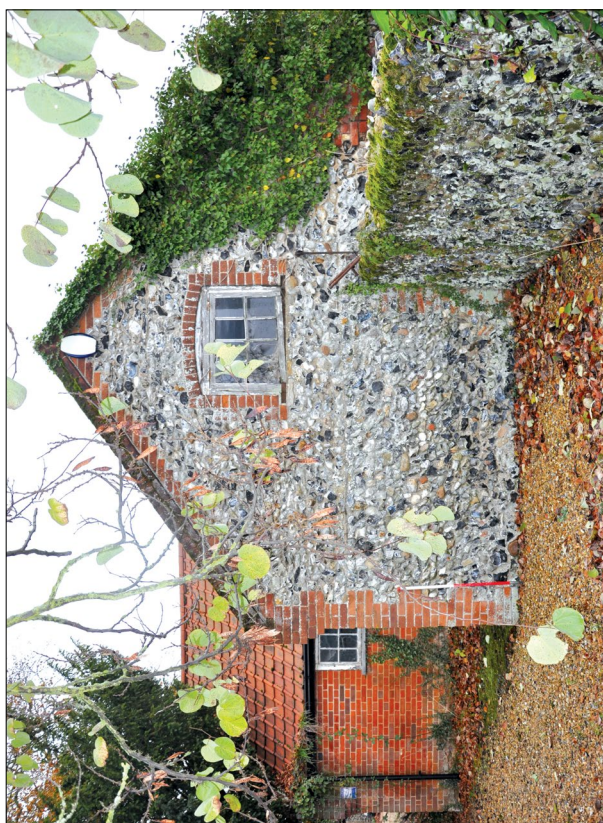
- 3.3.9 The western elevation consists of a small annex attached to the western side of building **A** (Plates 14 & 16). This was set flush with the southern wall of the building and measured 2.87m x 4.40m and was 3.10m high at the apex.

Plate 14: West facing elevation of tack room attached to Building A, viewed from the west

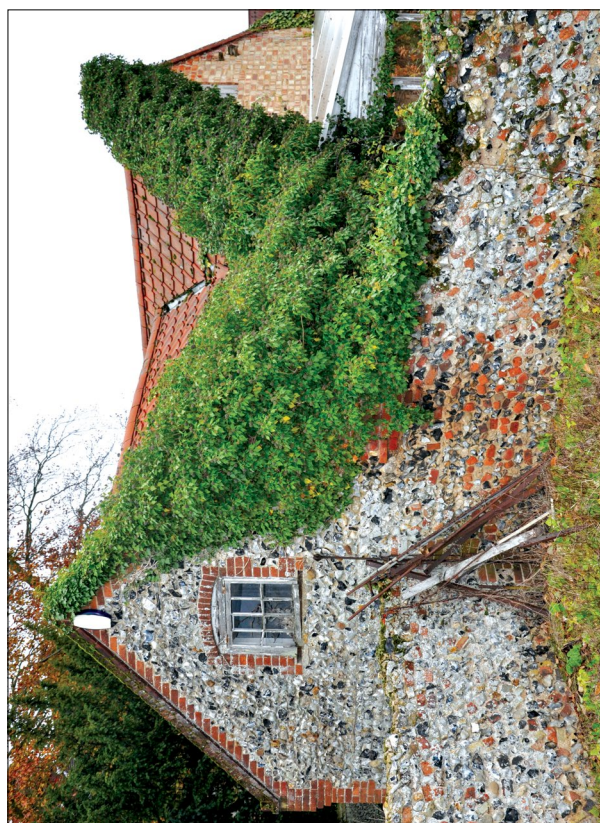
- 3.3.10 The walls are generally of soft red facing brickwork of either 225mm or 330mm. The road facing elevation is constructed from flint with brick dressing and half brick soldiers above the windows. The wall extends above roof level to form a parapet (Plate 16).
- 3.3.11 There are two small windows inserted into the western elevation (Plates 13 & 14). One is inserted into a plain brick wall and consists of an eight pane, glazed casement type measuring 0.96m x 0.70m. The other is set into the flint dressed gable end wall and has more ornamentation. It too consists of a wooden eight pane casement type, with a brick surround and half brick soldiers formed into a segmented upper arch (Plate 14 & 16). This measured 0.98m x 0.90m. The gabled roof is clad in clay pan tiles with matching ridge sections. (Plate 9).

Plate 16: Oblique view of Building A, viewed from the south-west

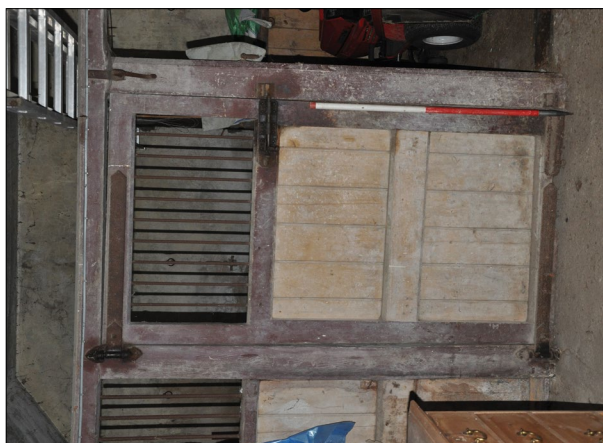
- 3.3.14 A single door measuring 1.06m wide and constructed in a similar style was located to the western end of the loose box (Plate 18). This was hinged on its left hand side with strap hinges to top and bottom and secured with a bolt (Plate 19). Both of these are original fittings dating to the late 19th century. No makers marks could be seen on the door furniture.

Plate 18: Detail of door to stable (loose box) within Room 1 of Building A

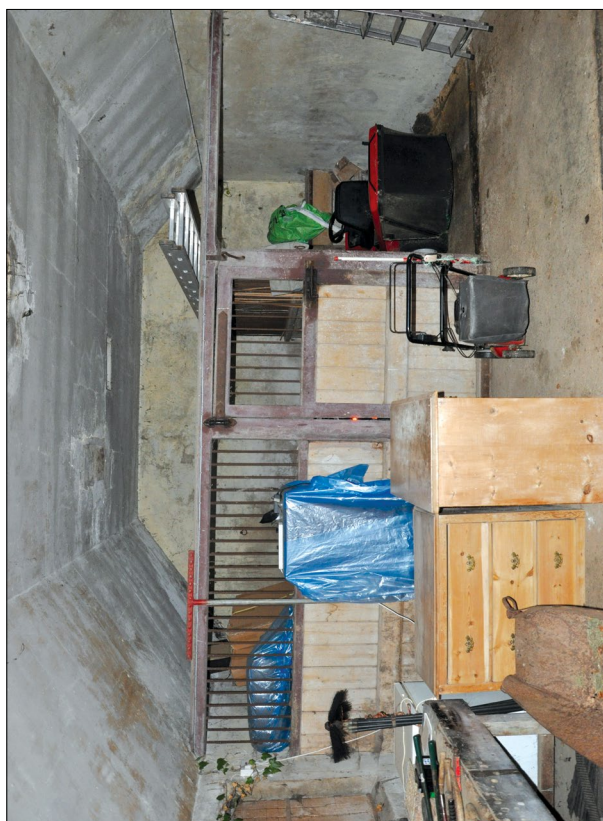
- 3.3.13 The room measured 8.63m x 5.54m and had a ceiling height of 3.06m. At the time of the survey the room was being used as a store for household items but its historical use was still apparent. A loose box measuring 6.64m x 3.54m is located to the west and rear of the room (Plate 17). This is of wooden construction with close board panelling and a horizontal batten to the lower two thirds and round iron bars to the upper (Plate 23).

Plate 17: Interior of Room 1 of Building A, viewed from the north

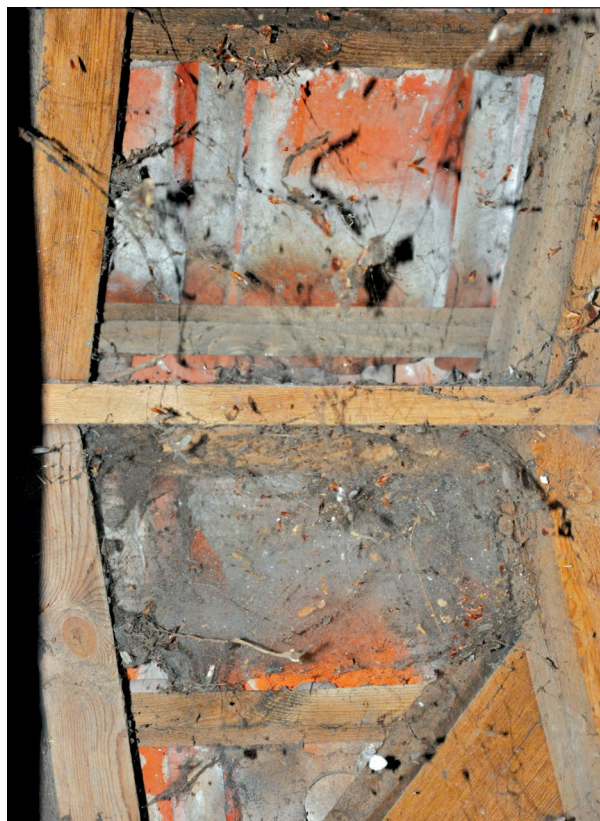
- 3.3.16 The roof structure had been replaced sometime in the 20th century. This replacement used machine cut timbers (Plate 24). Only small portions of the roof structure could be seen through a ventilation shaft. There was no access to the loft space at the time of the survey.

Plate 24: Detail of re-roofing in Building A

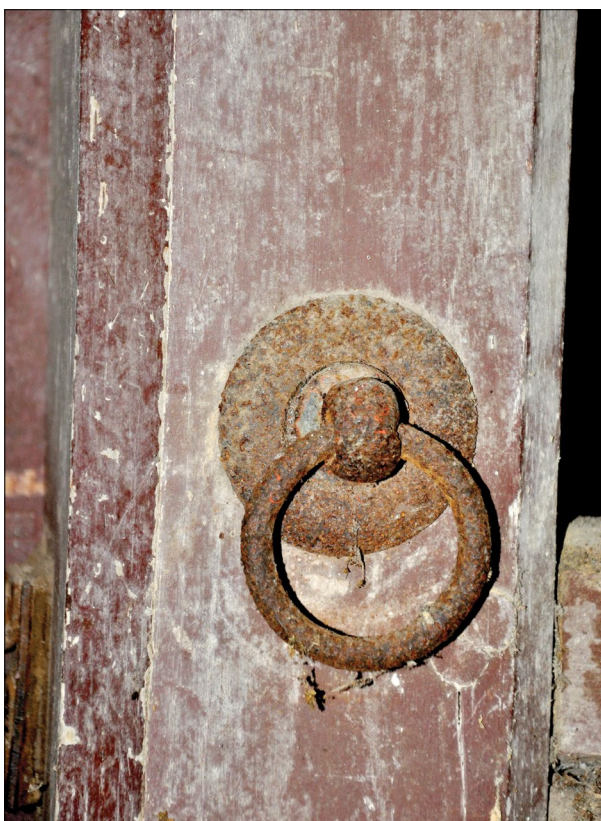
- 3.3.15 Two other items were seen that related to the former use as a stable. The first of these was a small iron tie ring that was located on the door post (Plate 21). This would have been used to secure the horse when saddling or grooming. The second of the fittings was a tack hook located to the right of the door opening (Plate 22). Close inspection did not reveal a makers or manufacturing mark. Given that Manor Farm in the late 19th Century was probably a busy working complex it is entirely possible that a blacksmith was resident and the ironworks seen in Room **1** were produced on site.

Plate 21: Tie ring to stable door post in Room 1 of Building A

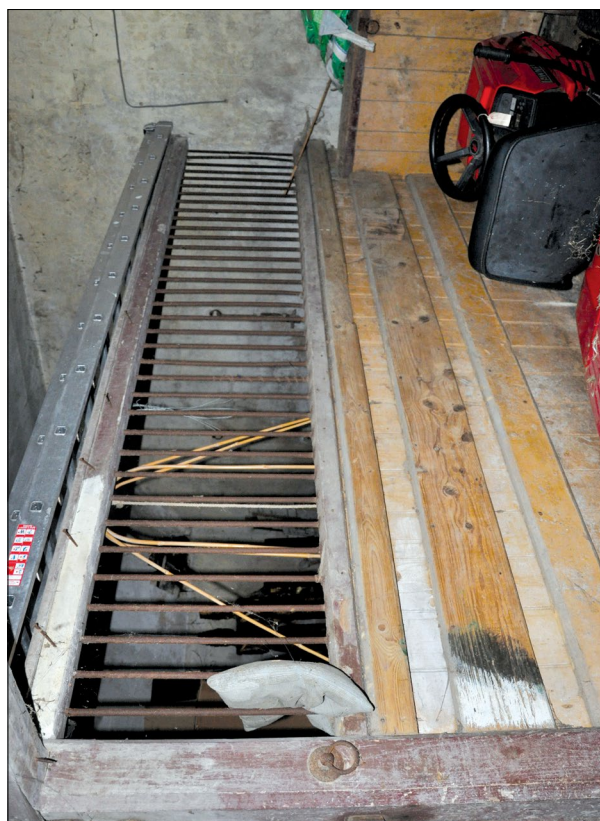
Plate 23: Bars to upper stable stall in Room 1 of Building A

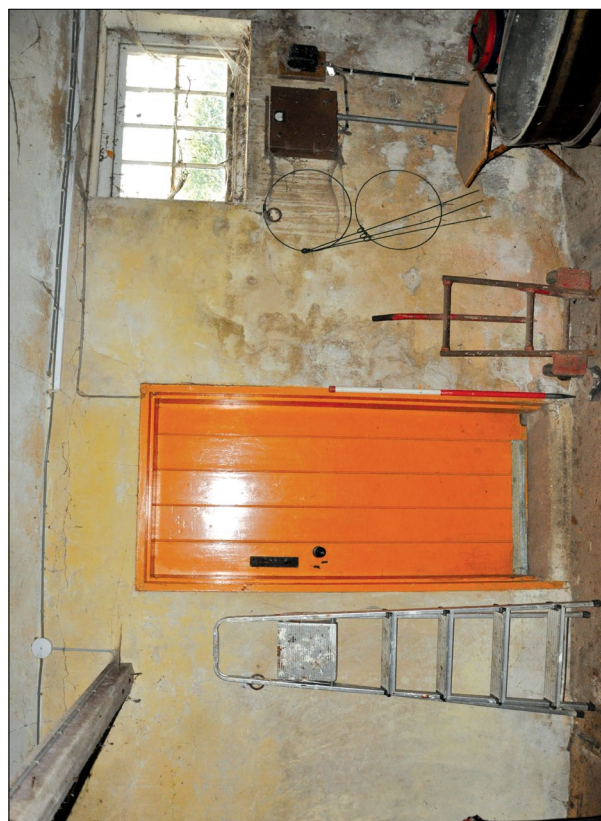
- 3.3.17 The hipped ceiling of room **1** is plastered, as are the walls. Three windows were located on the eastern side of the room. These have been previously described. A further window is located on the western wall. This casement window measured 0.96m x 0.70m. In common with the others in the room, it consists of eight glass panes and wooden window bars (plate 27). The floor is modern concrete.

Plate 27: Western wall of Room 1 and door into tack room (Room 2) of Building A

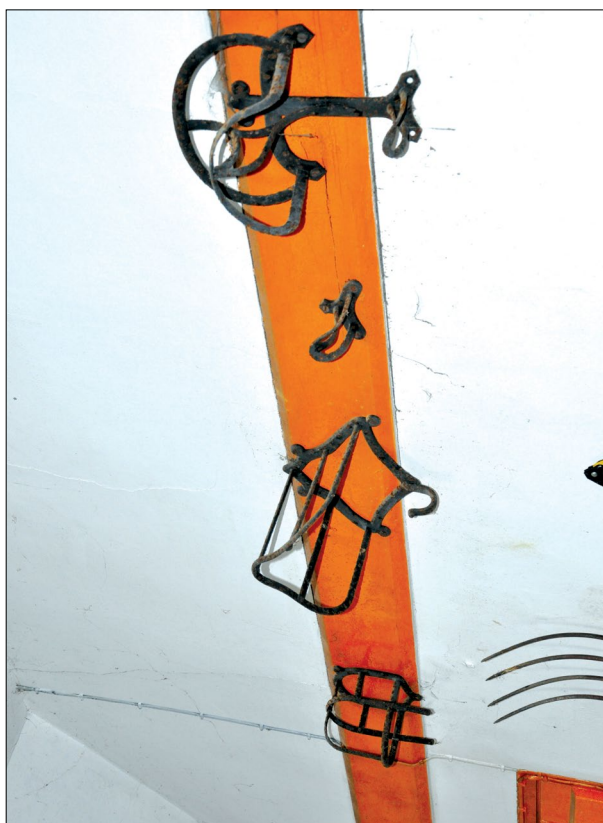
Plate 30: Detail of ornate fitting of upper tack rail in Room 2 of Building A

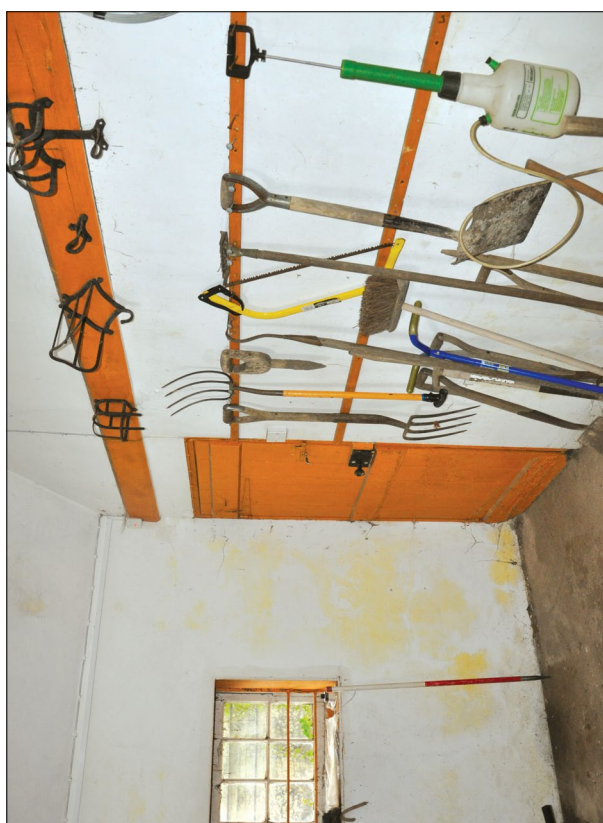
Plate 29: Oblique view of Room 2 in Building A, showing door and tack rails

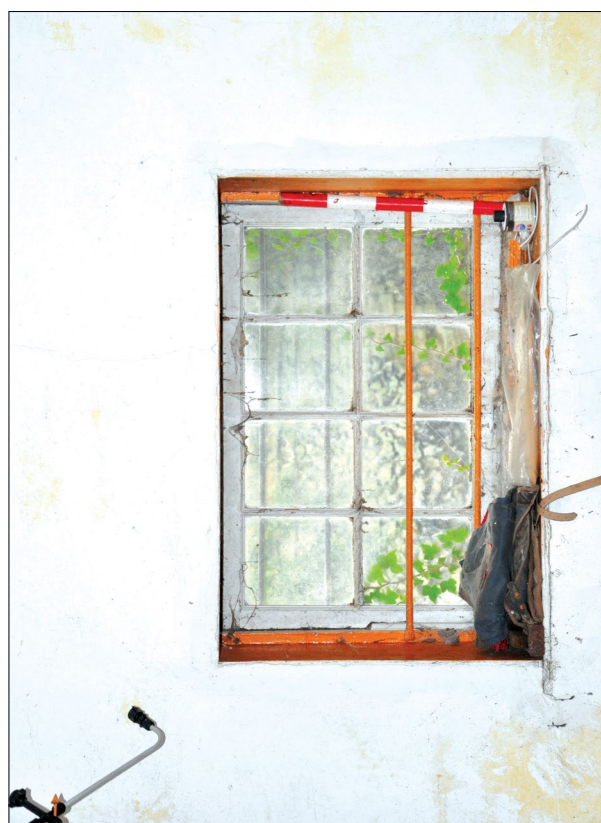
Plate 31: Detail of window in Room 2 of Building A, north-west elevation

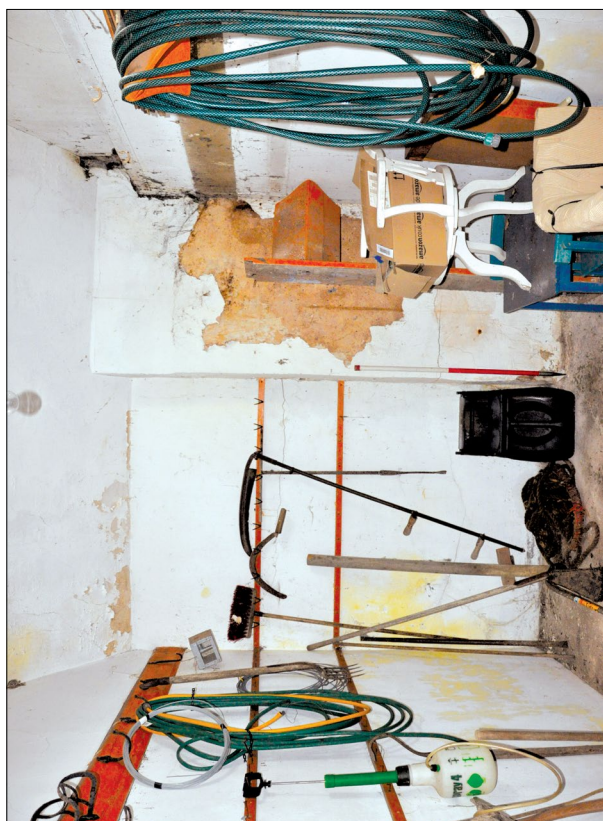
Plate 33: Southern end of Room 2 of Building A showing redundant chimney breast

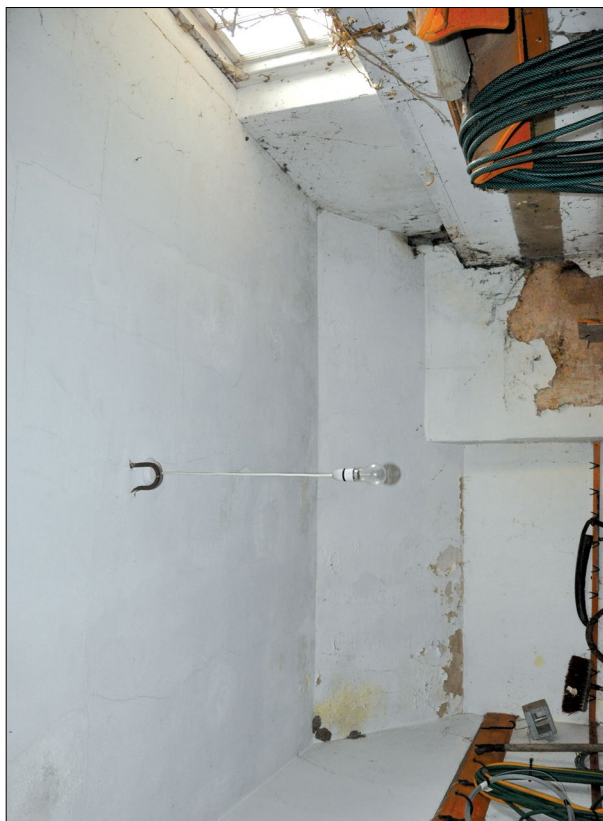
Plate 34: Detail of roof and ceiling at the southern end of Room 2 of Building A

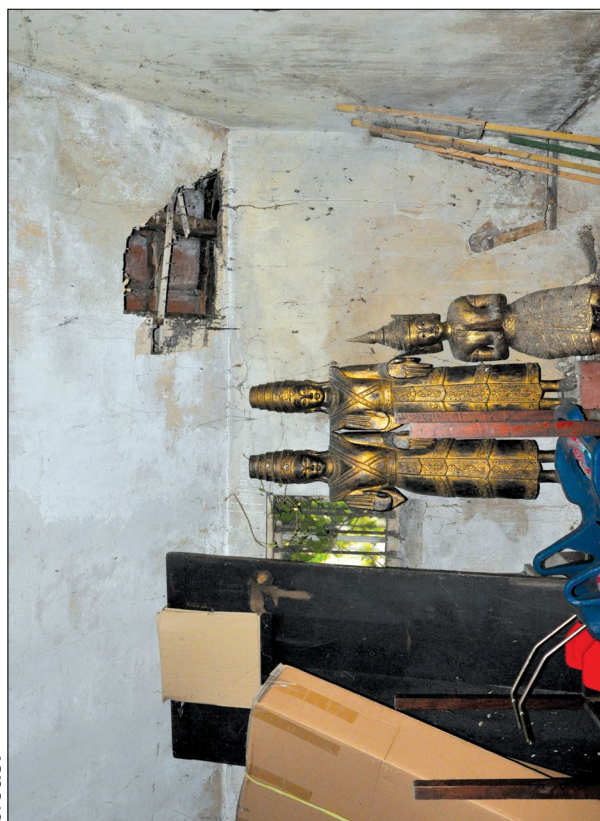
Plate 35: Detail of internal roof in Room 1 of Building A

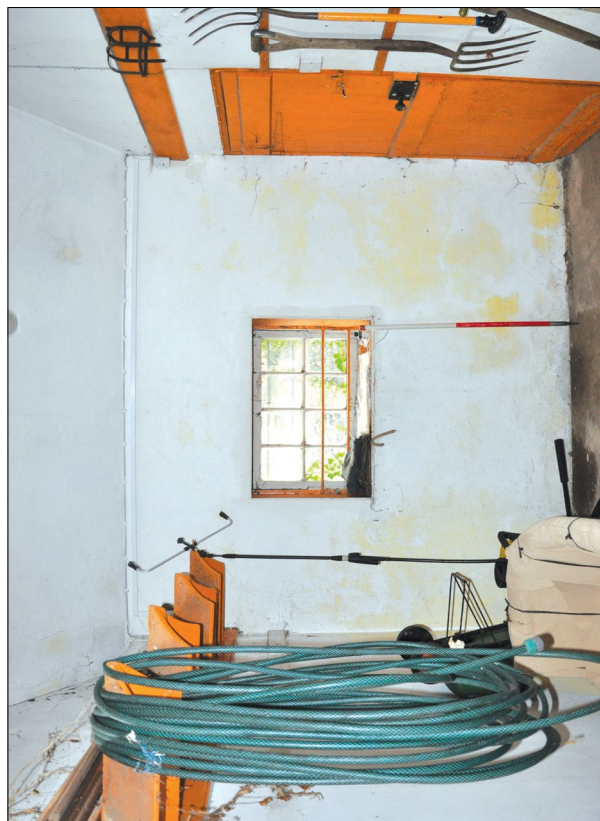
Plate 36: North-west end of Room 2 in Building A

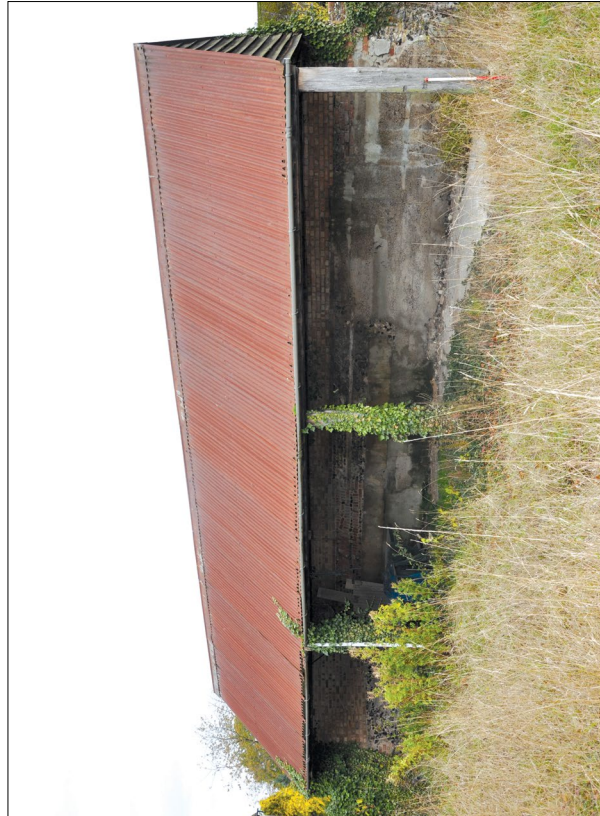
Plate 39: South-west facing elevation of Building **B**, viewed from the south-west

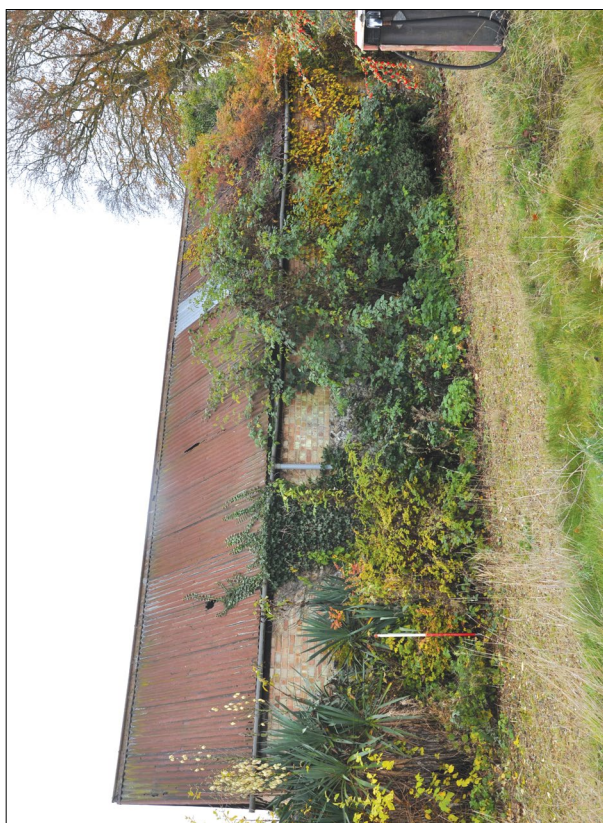
Plate 42: North-east facing elevation of Building C, viewed from the east

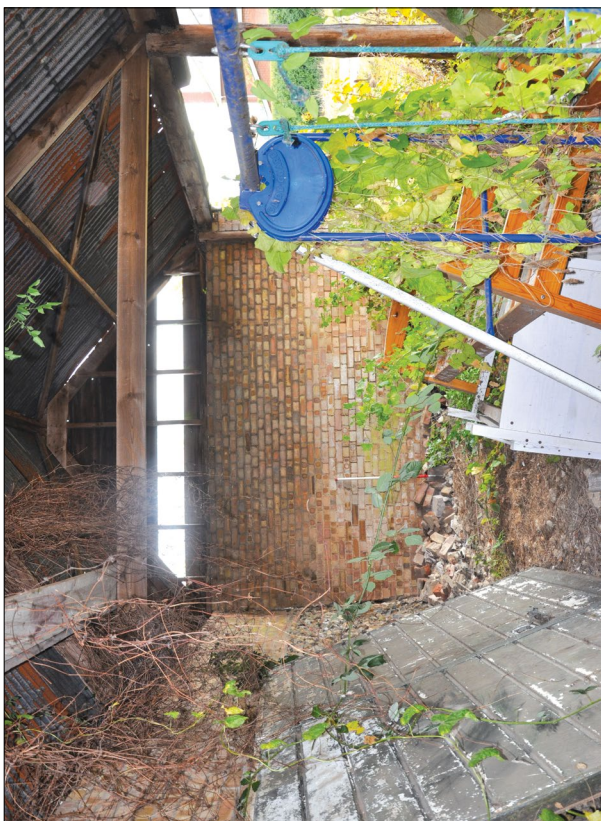
Plate 46: Internal view of southern eastern elevation of Building C

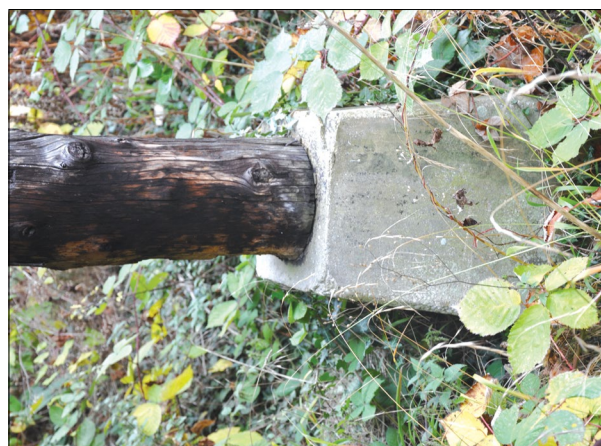
4.1.10 Building **C** is of a very similar design and construction as building **B**. It also started life as an open fronted barn with four bays (Plate 45) and once again it has seen drastic and unsympathetic alteration and repair. The roof structure has been replaced with modern timbers and re-roofed using corrugated iron. The bay divisions have been replaced with telegraph poles mounted onto concrete plinths (Plate 47).

Plate 47: Detail of concrete base and post to Building C

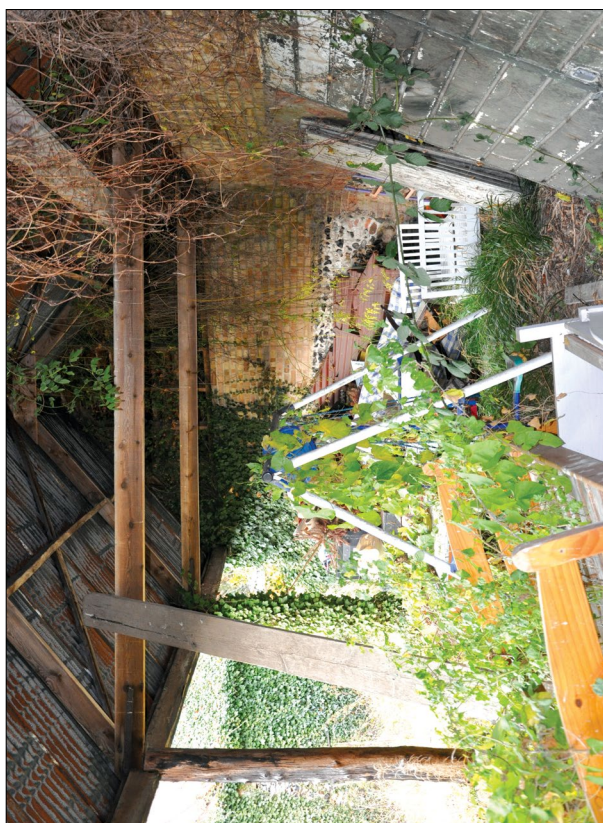
Plate 50: Internal view of the north-west elevation of Building C

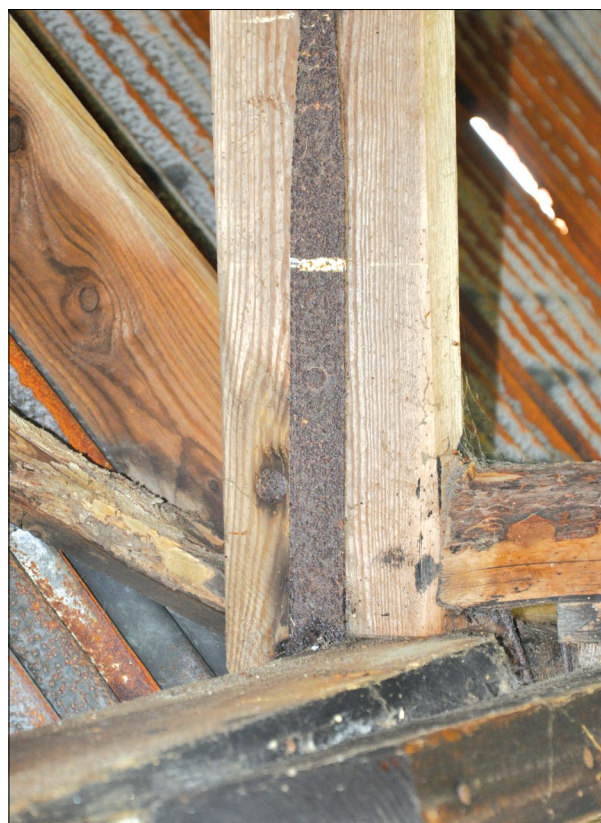
Plate 52: Detail of iron tie to the roof plate and cross beam, in Building C

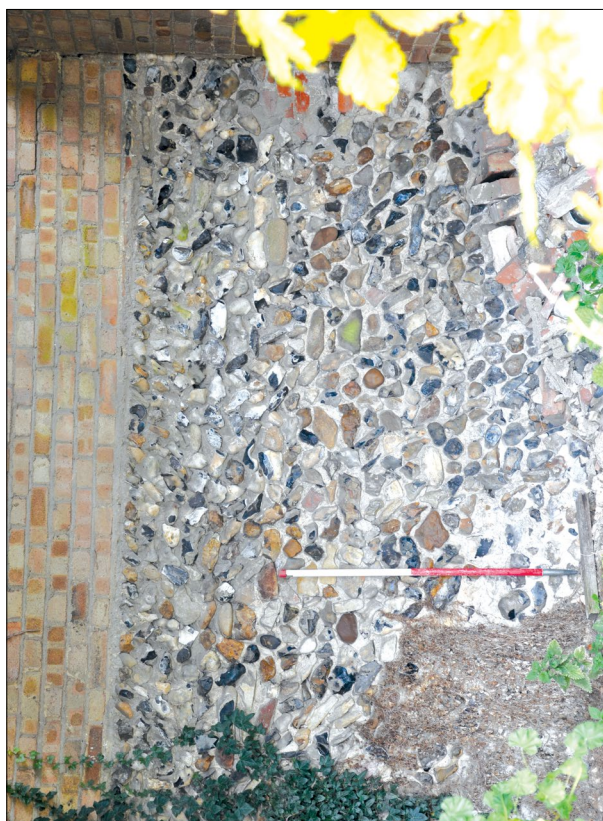
Plate 49: Detail of flint wall to the north-east elevation of Building C

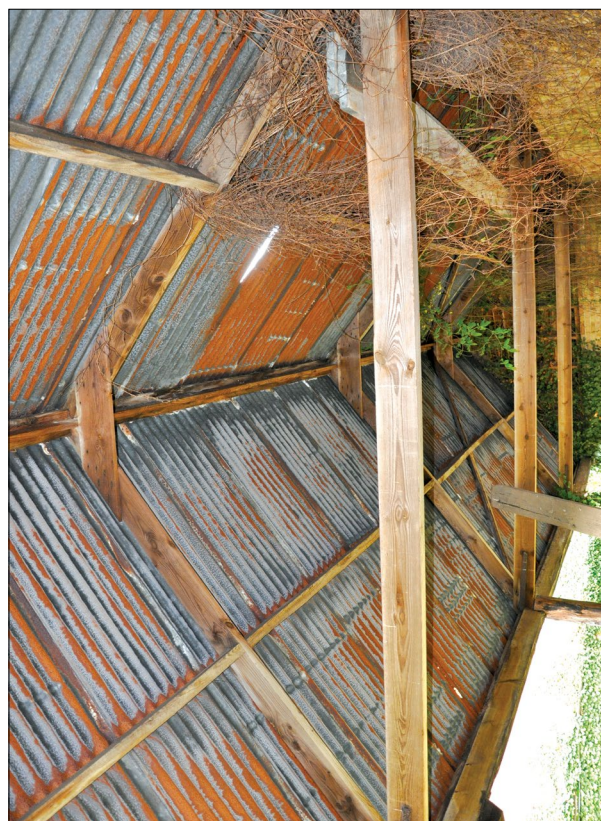
Plate 51: Roof structure of Building C

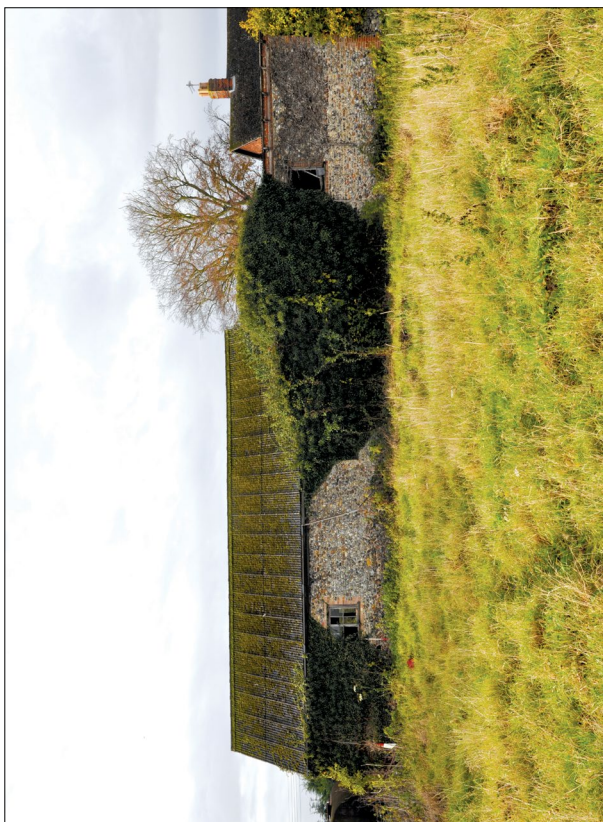
Plate 53: Eastern elevation of Building D, viewed from the east

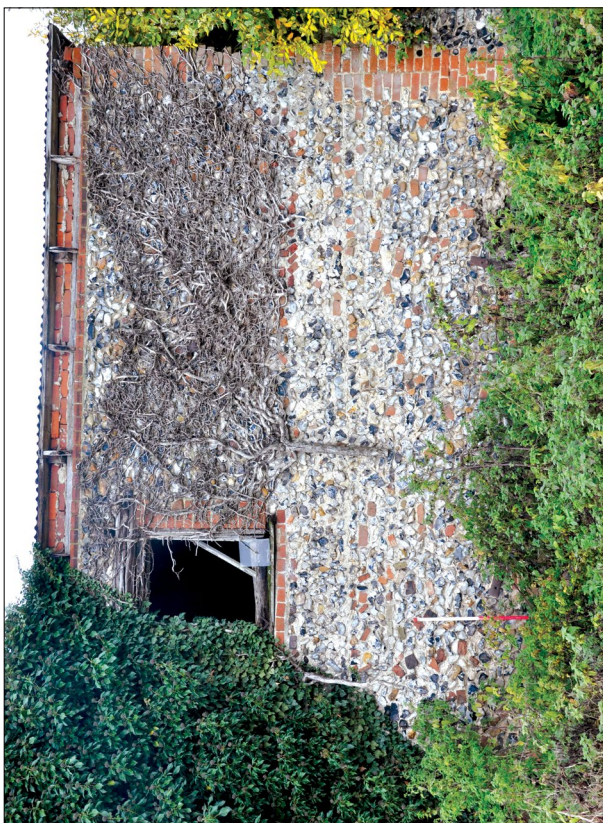
Plate 54: Detail of window to the western end of Building D

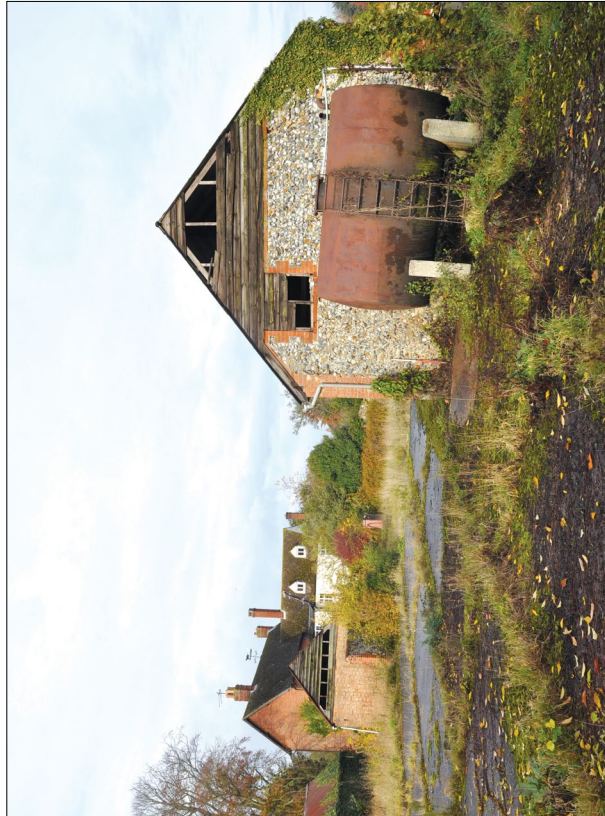
Plate 57: South facing elevation of Building **D** in courtyard setting, viewed from the south

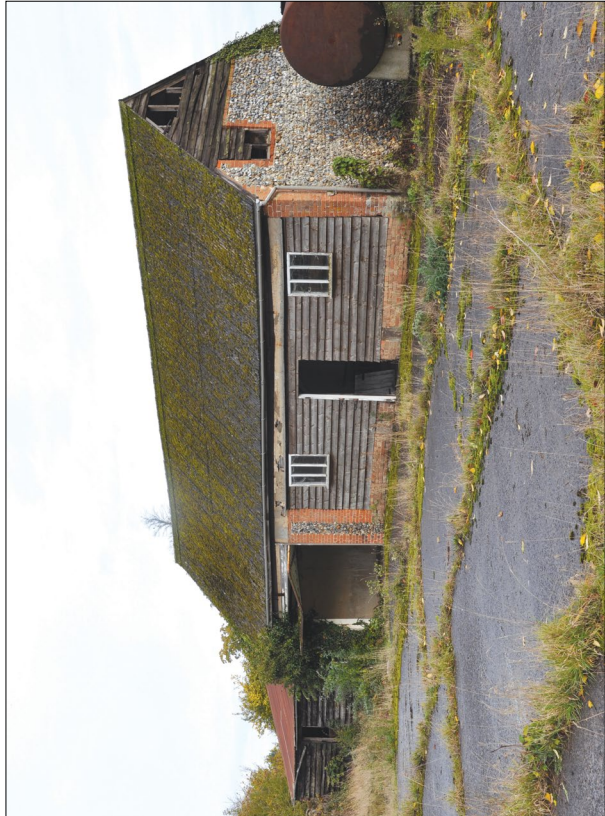
- 3.6.7 The south-west elevation consists of a flint and brick dressed wall, infilled with a later weather boarded frontage on a six course Fletton brick plinth. The weather boards each measure 0.18m in depth (Plates 59 & 60).
- 3.6.8 A door opening is located centrally and measures 2.02x1.02m. This door is missing but the wooden door surround is intact, this is not of any significant age and does not retain any metalwork.
- 3.6.9 Casement windows are located either side of the door (Plate 60) just below the level of the roof plate. These measure 0.85m x 1m and consist of three fixed panes (Plate 61). The windows are not contemporary with the 19th century structure.

Plate 59: Oblique view of Building **D**, viewed from the south-east

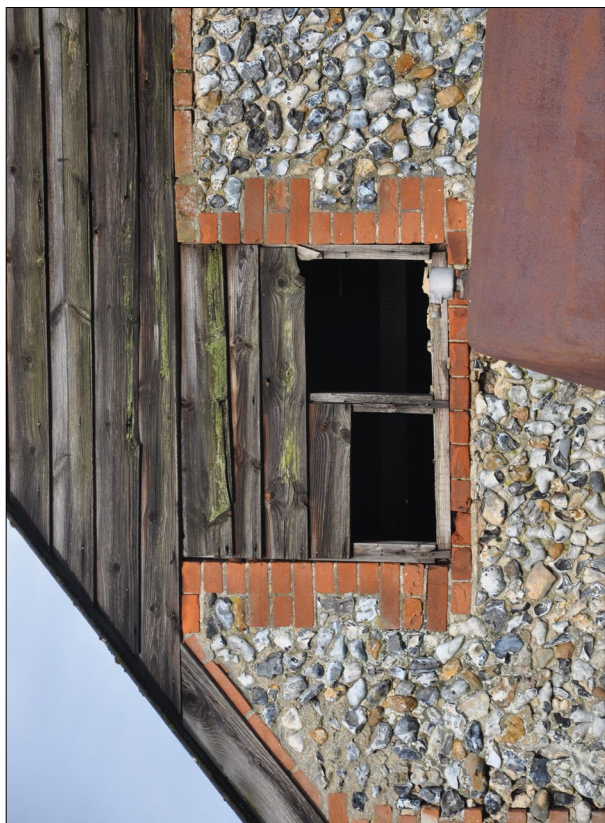
building has been as a cow house. Original windows exist on both upper gable ends (Plates 58 & 67). The roof has been replaced with asbestos sheeting.

Plate 58: Detail of window to upper floor of Building **D**, southern elevation

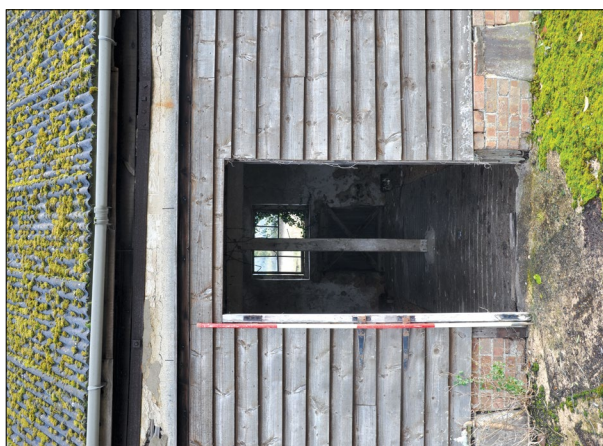
Plate 62: Detail of doorway to east facing elevation of Room 1 in Building D

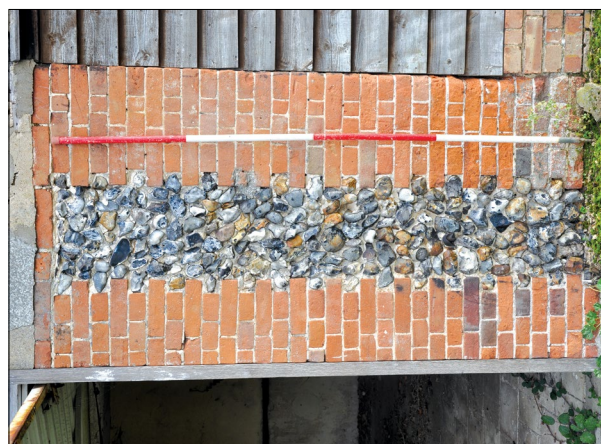
Plate 63: Detail of flint dressing to the eastern elevation of Building D

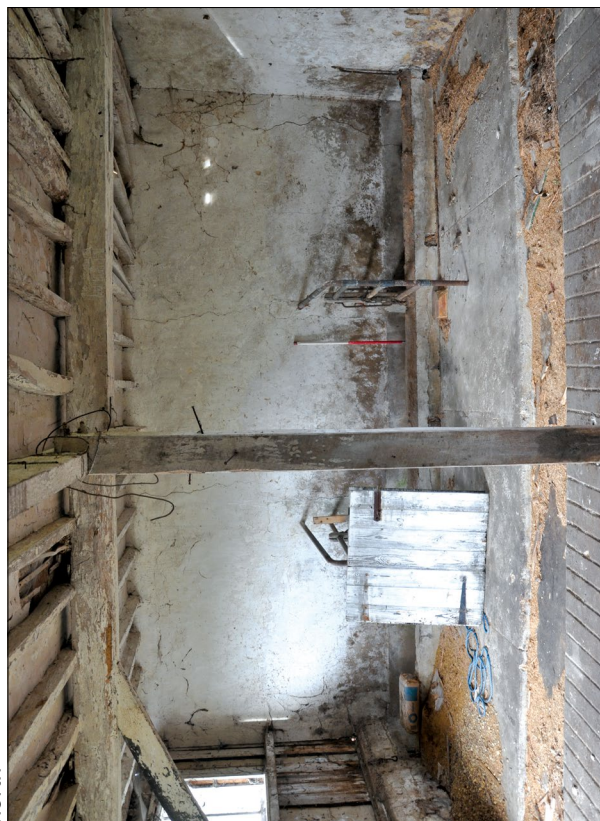
- 4.1.14 The southernmost single story addition (Plate 68) is present on the 1883 OS map (Fig 2). It has a clap-board western elevation and has seen use relatively recently as a stable. The rear wall of the building has been raised off of an original flint perimeter wall to add extra height. This suggests that this end of the building was originally open to the elements. The full extent of this wall can be seen from the field to the east of the courtyard (Plates 53 & 54). The roof structure of this southernmost building is constructed from modern timbers and corrugated iron.

Plate 68: Internal northern wall of Room **1** in Building **D**

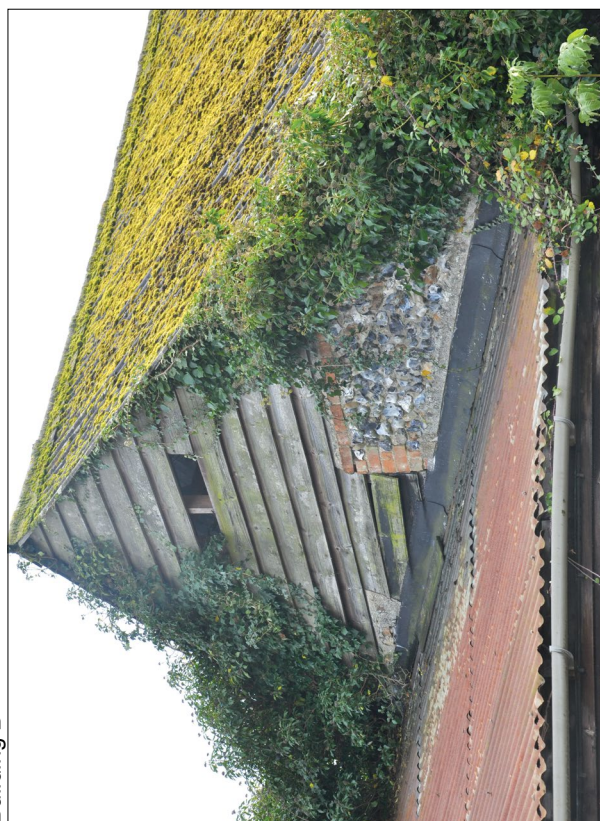
Plate 67: North facing elevation of Building **D**, viewed from the north-east

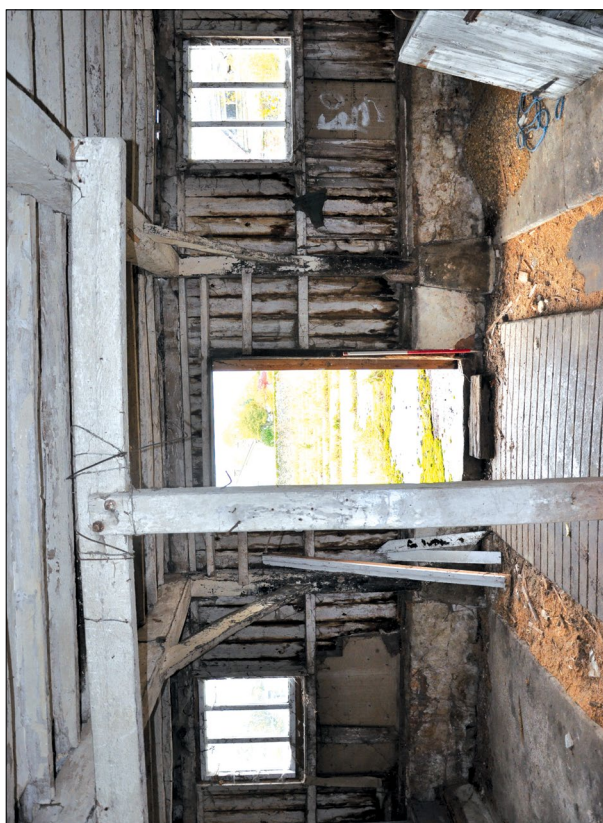
- 3.6.15 The structure has been strengthened by the later addition of central cross beams and a 150mm x 150mm supporting post (Plate 70). None of the timbers within the room bore carpenter's marks.

Plate 70: Internal view of east facing elevation of Room 1 in Building D

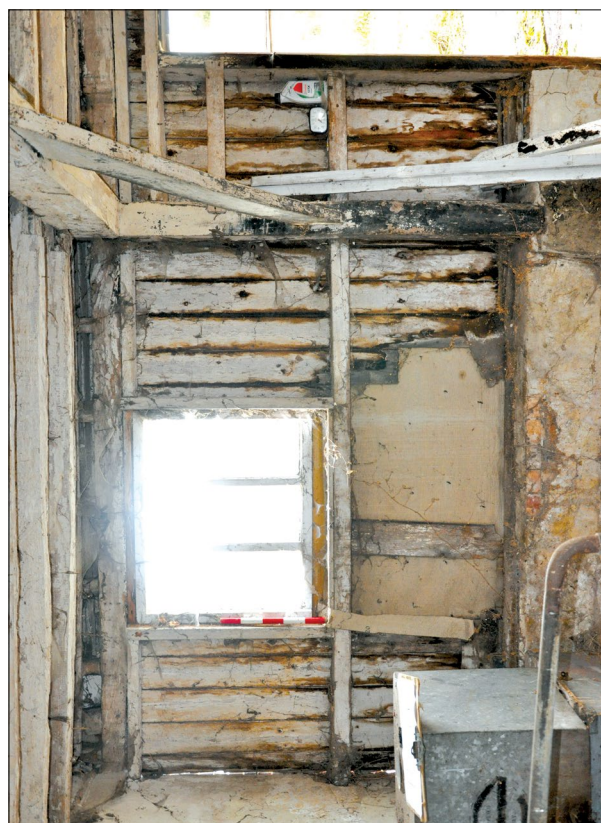
Plate 72: Detail of window and internal wooden structure of Room 1 in Building D

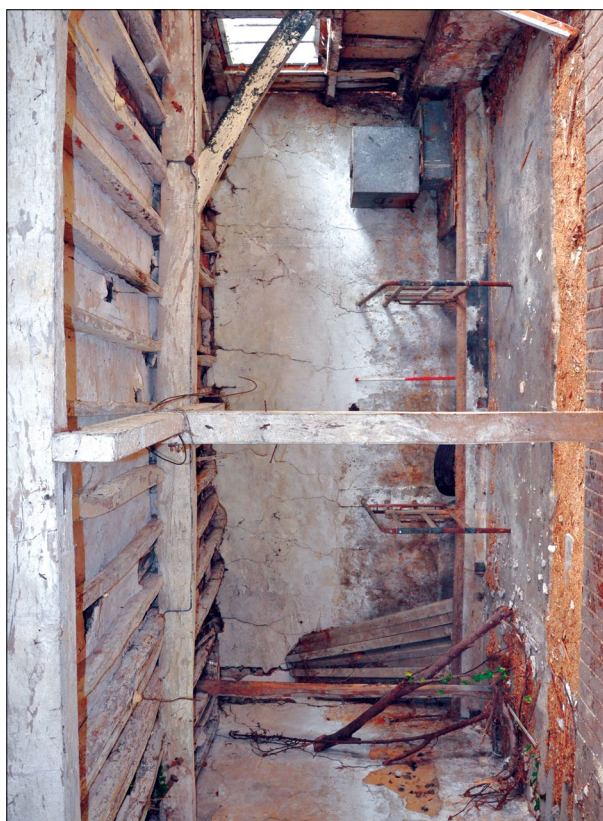
- 3.6.11 Three stalls have been incorporated along the southern and northern walls (Plates 69 & 71). These differ slightly in size but on average are 2.10m x 2.45m. Stalls are separated by tubular iron rails.

Plate 69: Internal view of the southern elevation of Room 1 in Building D

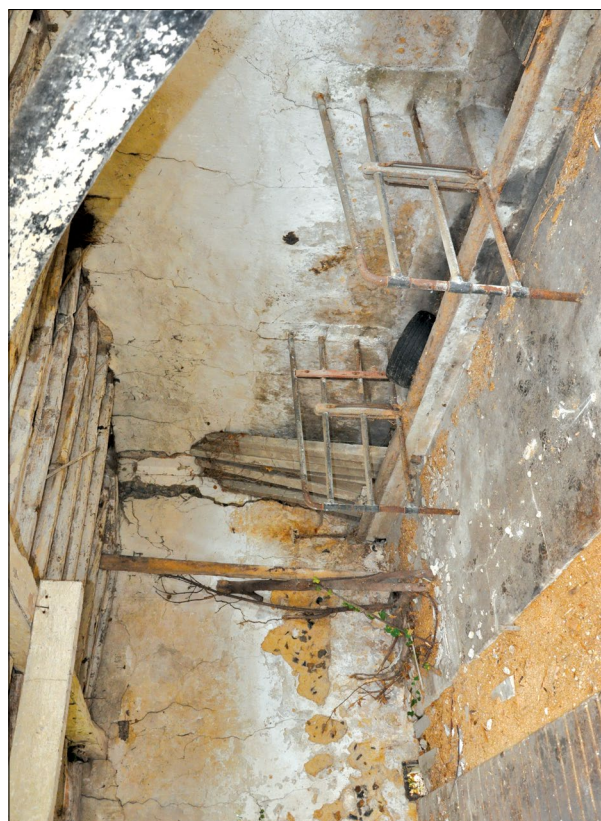
- 3.6.16 The walls are of plaster and have been white washed (Plate 71). The floor surface consists of a cast concrete (Plate 77).

Plate 71: Detail of cattle stalls in Room 1 of Building D

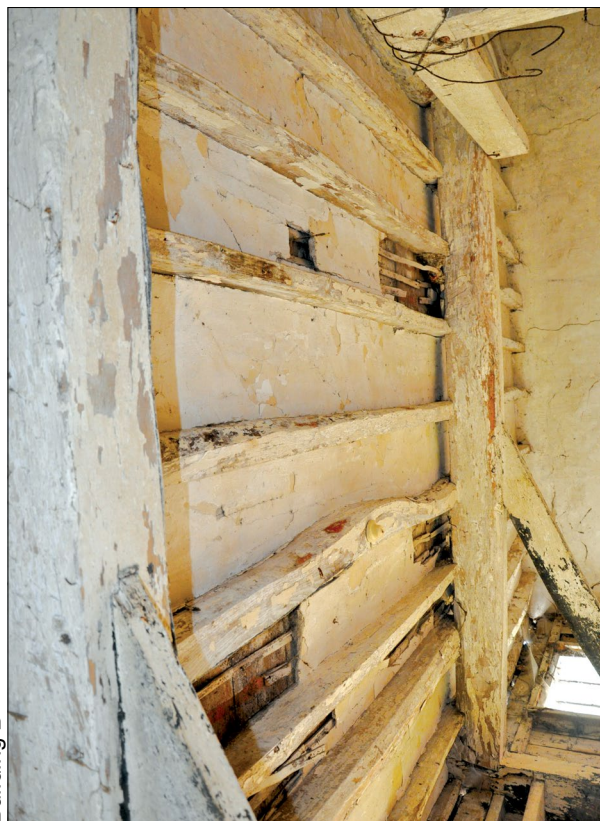
- 3.6.12 The roof space was not accessible at the time of survey but sheeting rails on 75mm x 50mm rafters could be seen from the ground level.
- 3.6.13 The room incorporates a first floor or loft at plate level, with boarding above squared and lime washed joists spanning the 225mm x 200mm tie/cross beams (Plate 76). Lath and plaster is present on the underside of the roof boarding (Plate 76).

Plate 76: Roof structure of Room 1 in Building D

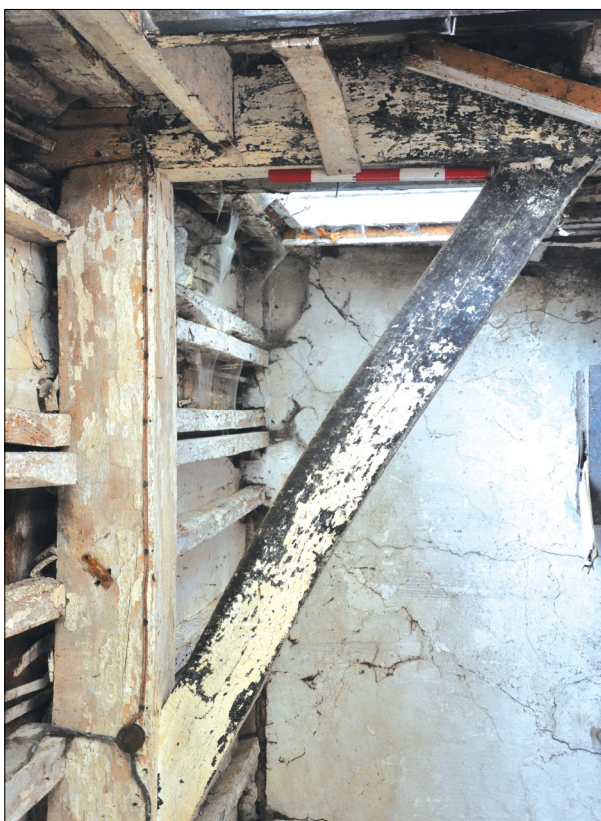
Plate 73: Detail of brace in roof structure of Room 1 in Building D
