# Manor Farm Courtyard Gazeley

## Level 2 Historic Building Survey

December 2016

**Client: Dalham Estate**

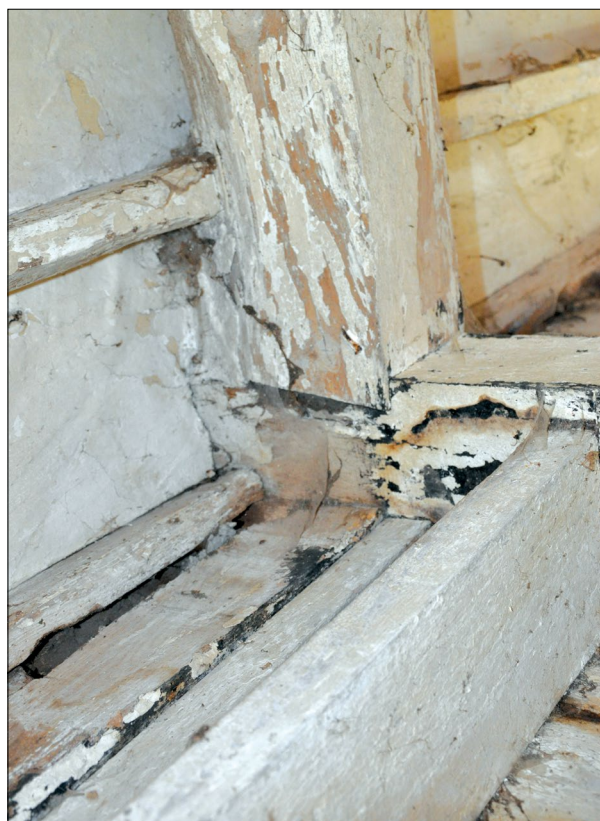
Plate 75: Detail of wall plate and cross beam of Room 1 in Building D

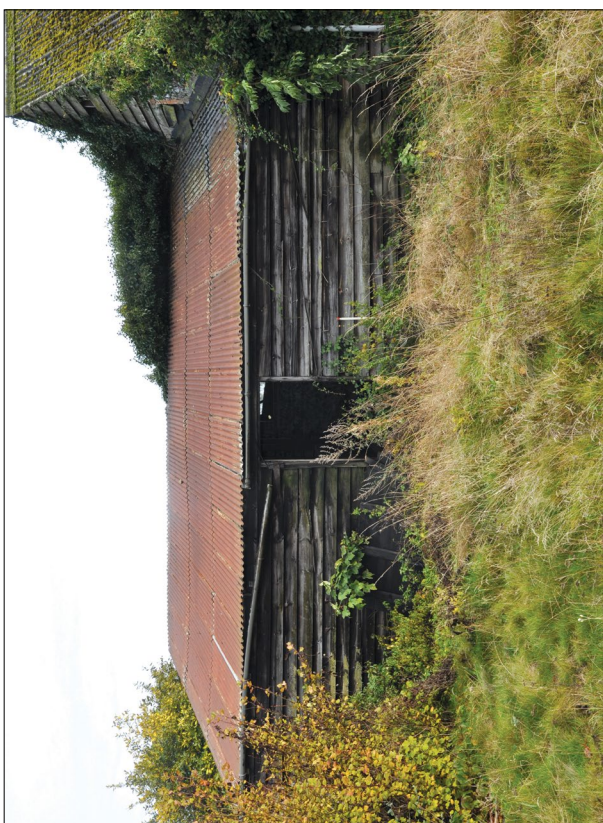
Plate 84: Modern garage door to the eastern elevation of Room 2 in Building D

- 4.1.13 The middle building of this range has been converted to a garage and a large modern metal door has been incorporated into the western elevation (Plate 60 & 84). The historical use of this part of the building is difficult to ascertain. It was most probably always annexed and as the floor is constructed of a quality stone (Plate 85) it maybe assumed that this once housed a cart or carriage of a higher specification than the utilitarian type used by the farm workers.

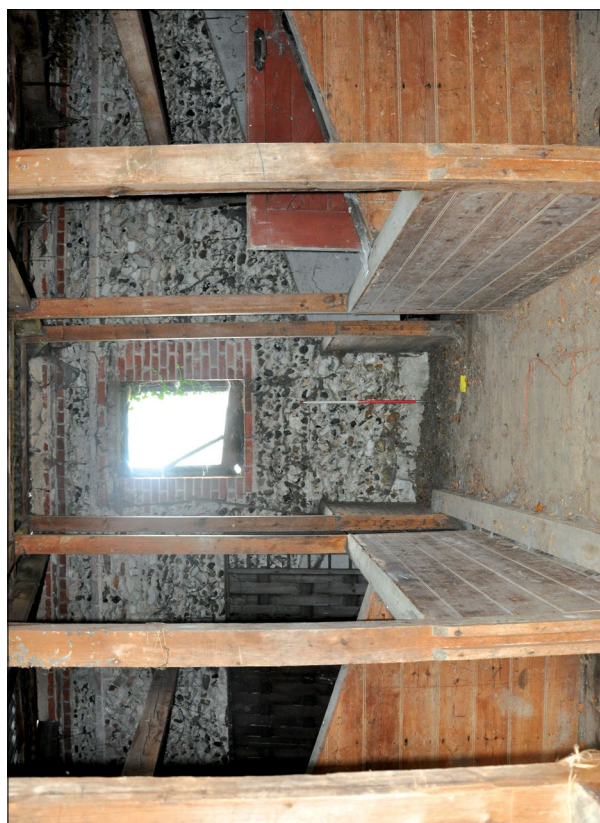
Plate 86: West facing elevation of Building E, viewed from the west

- 3.6.4 The eastern elevation comprises a flint and red brick wall (much obscured by foliage), with two windows located at 2.16m from ground level (Plates 53, 54 & 55). Both of these windows measure 1m x 1m and are of a wooden casement type. The surrounds of the windows are of a more recent brick and this suggest that the units have been replaced post 19th century.
- 3.6.5 A further window is located at the northern end of the elevation. Here the window is situated at a higher level in a much higher wall (Plate 54). It is thought that this end of the range may have at one time formed an open courtyard which was in-filled when the single storey addition was added in the 19th century (Fig 6, Plates 86 & 88)

- 3.7.1 This consists of a wooden, weather boarded single storey structure that has been added to the northern end of building **D** (Plate 86) sometime during the late 19th or early 20th centuries (Fig 6). This extension utilised existing courtyard walls. A structure seen on the OS map of 1883 (Fig 2) seems to be set back further and so is unlikely to be the same as the one that exists today.
- 3.7.2 The building measures 8.55m x 5.45m and has a roof height at the western elevation of 2.08m rising to 3.57m at the rear of the building. The single gable pitched roof structure comprises machine cut timbers and corrugated iron sheeting (Plate 97).

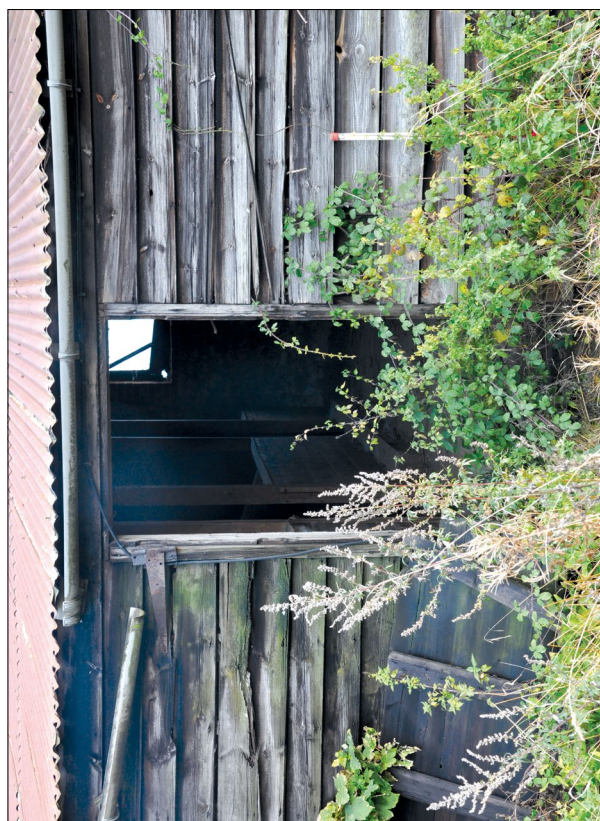
Plate 85: Detail of floor surface in Room 2 of Building D

- 3.6.17 The northernmost part of the barn has been converted to a garage (Plates 59 & 60) this measures 6.50m x 5.16m and has a ceiling height of 2.65m. A large garage door has been inserted into the frontage and a stone floor laid (Plates 75 & 85). this floor pre-dated the door and suggests that this part of the building may have housed a cart or carriage.
- 3.6.18 The garage door truncates the brick and flint wall (Plate 63). Bricks are of a soft red material and laid in an English bond. Internally, the garage has little remaining that could be considered contemporary with the earlier structure except a window on the eastern wall (Plate 79), a chamfered beam, measuring 150mm x 150mm (Plate 83) and a tack rail located on the northern wall (Plate 82).
- 3.6.19 The walls and the ceiling are plastered and painted (Plate 82). No access to the first floor was visible.

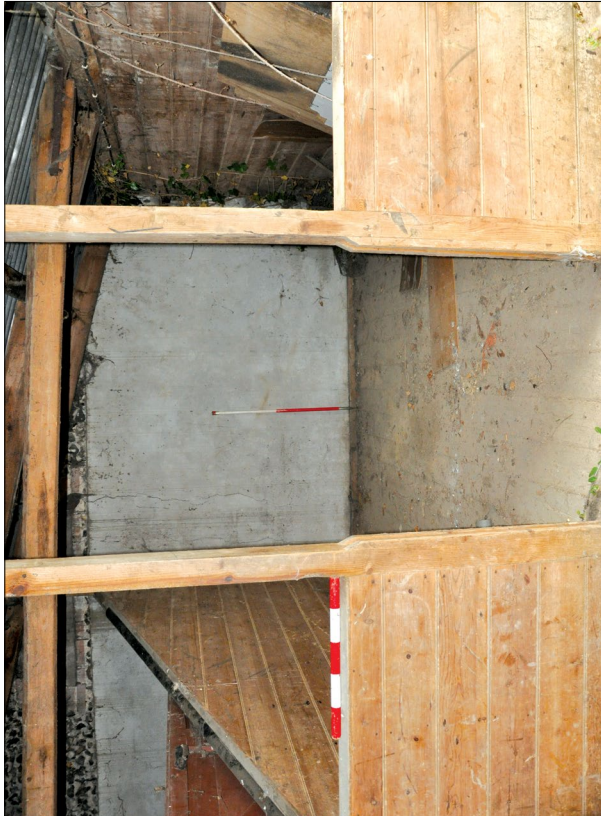
Plate 87: Detail of door to west facing elevation of Building E

- 3.7.3 A central door surround measuring 1.2m x 2m is located centrally to the western elevation (Plate 87). The door itself is missing but the strap hinges remain (Plate 87).

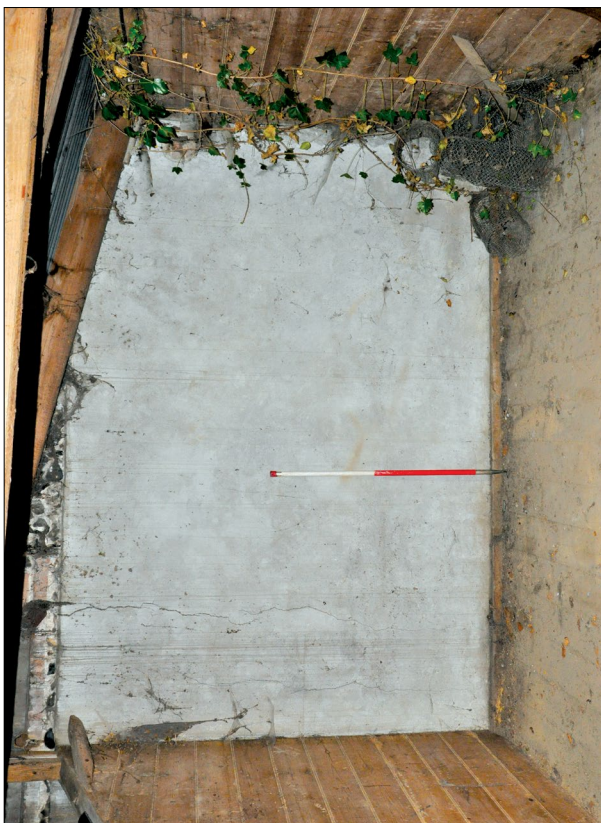
Plate 89: North facing external wall of Building D, viewed internally from Building E

- 3.7.5 The stalls (Plate 89) measure 3.48m x 2.99m and are separated by graduated close board divisions (Plate 92). Carpenter's marks were noted on the uprights of the stall closest to the entrance (Plates 93-95). None were visible on any other timbers. Stalls are accessed by open doorways measuring 0.92m. Timbers extend to ceiling height.

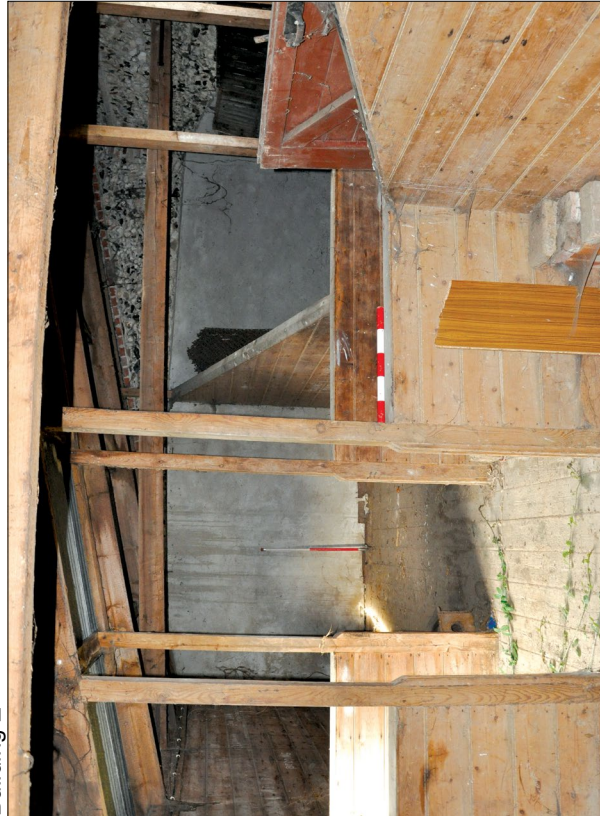
Plate 90: Detail of stall to the southern side of Building E

- 3.7.6 The northern and southern walls are partially rendered and painted (Plate 90). The rear wall is of flint and is part of the original perimeter courtyard wall (Fig 6).
