The Old Rectory Letcombe Bassett

**Historic Buildings Recording and
Watching Brief**

southsouthsouth
January 2017

Client: Mr Nicholas Ashe

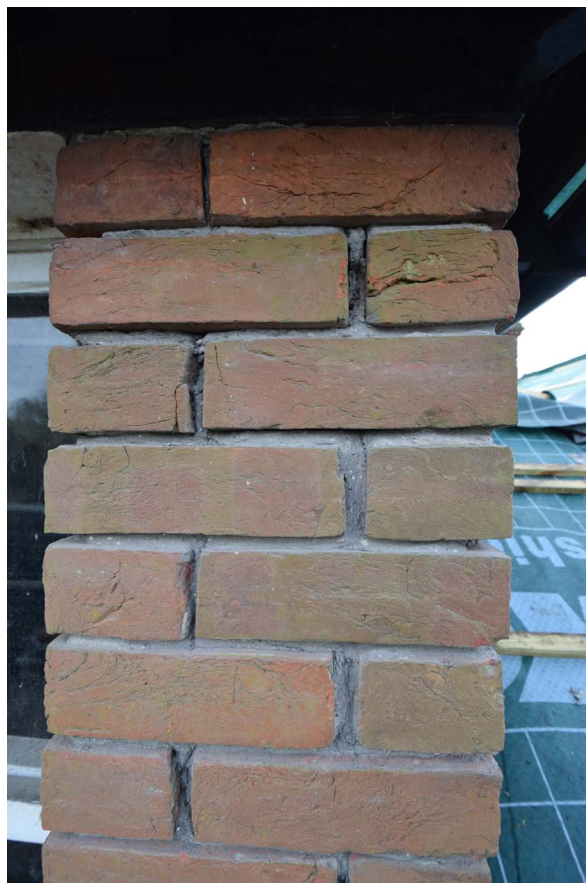
Plate 21: The exposed original mortar of the 18th-century extension before repointing

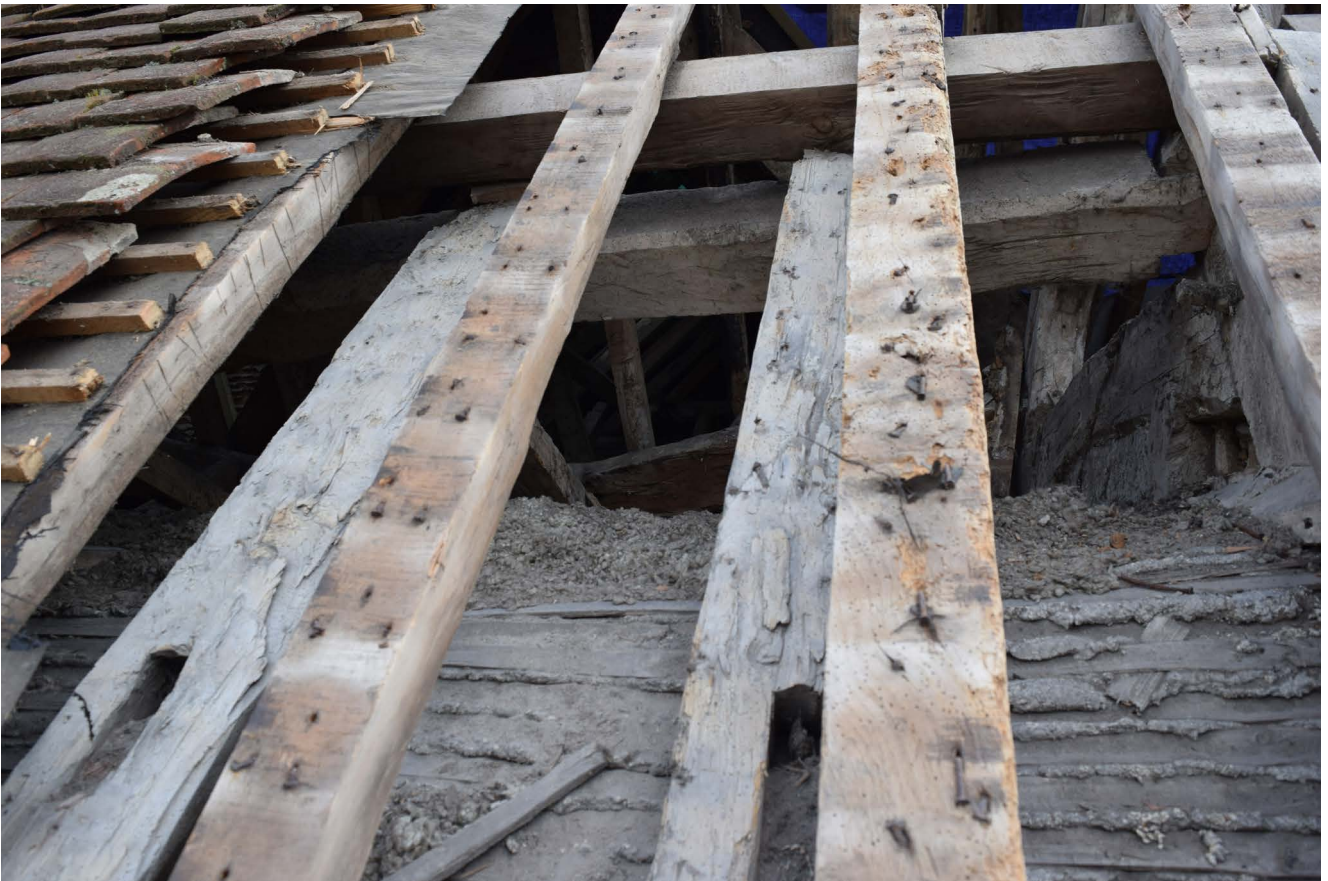
Plate 28: The redundant sockets in an earlier phase of roof timbers in the northernmost wing

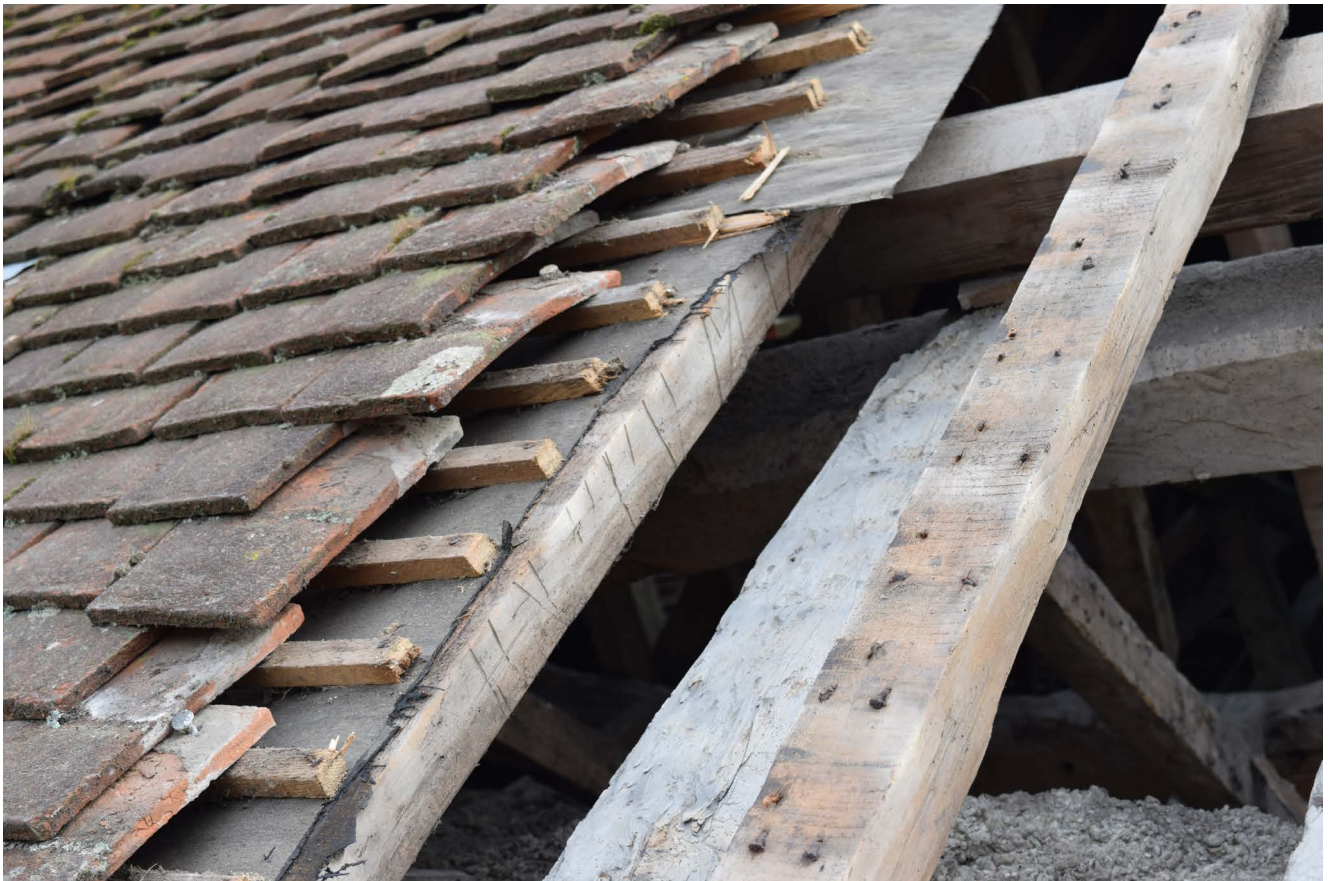
Plate 34: Baltic timber marks in one of the northernmost rafters of the northernmost wing

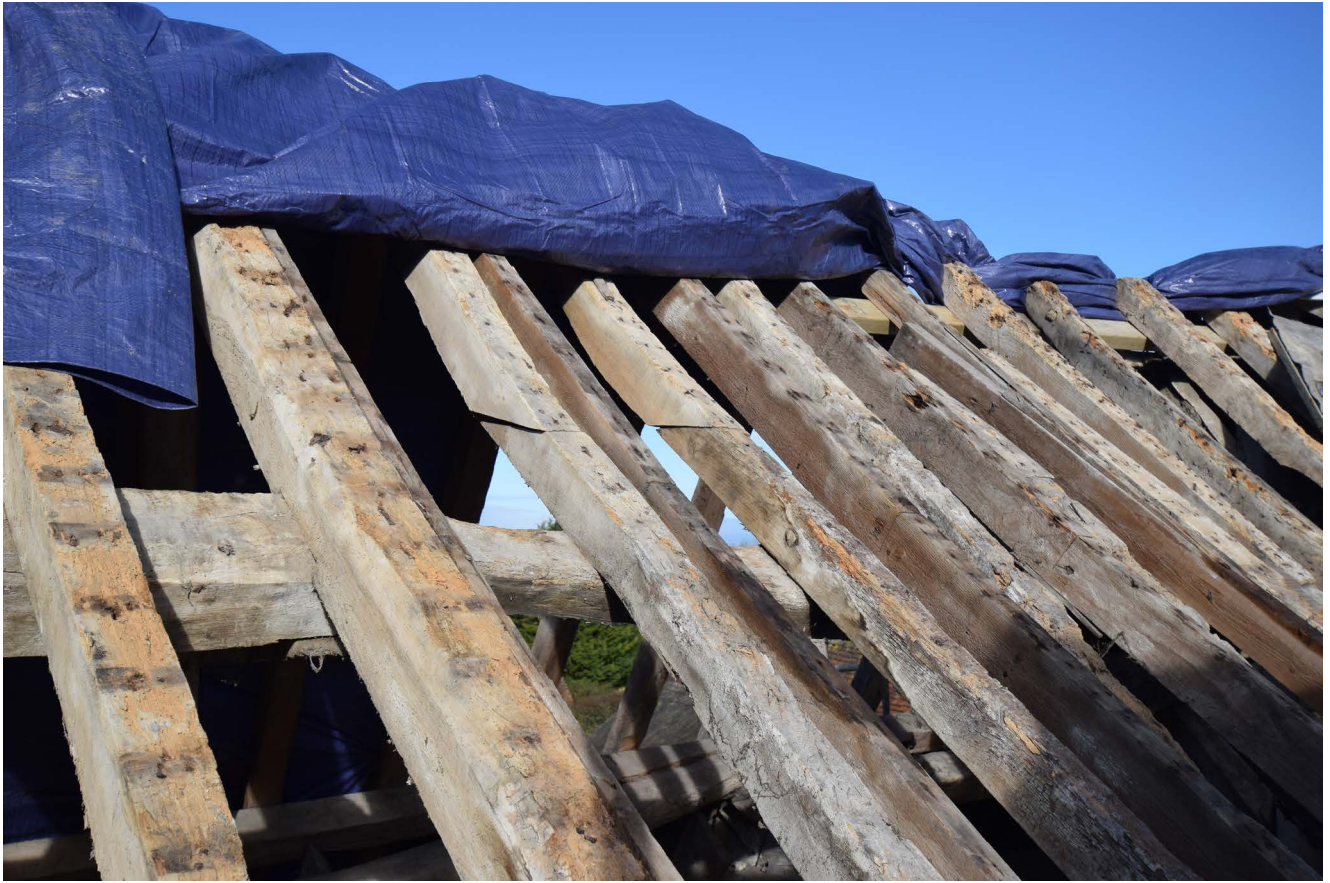
Plate 35: Joined timber to form rafters in the southernmost pitch of the northernmost wing

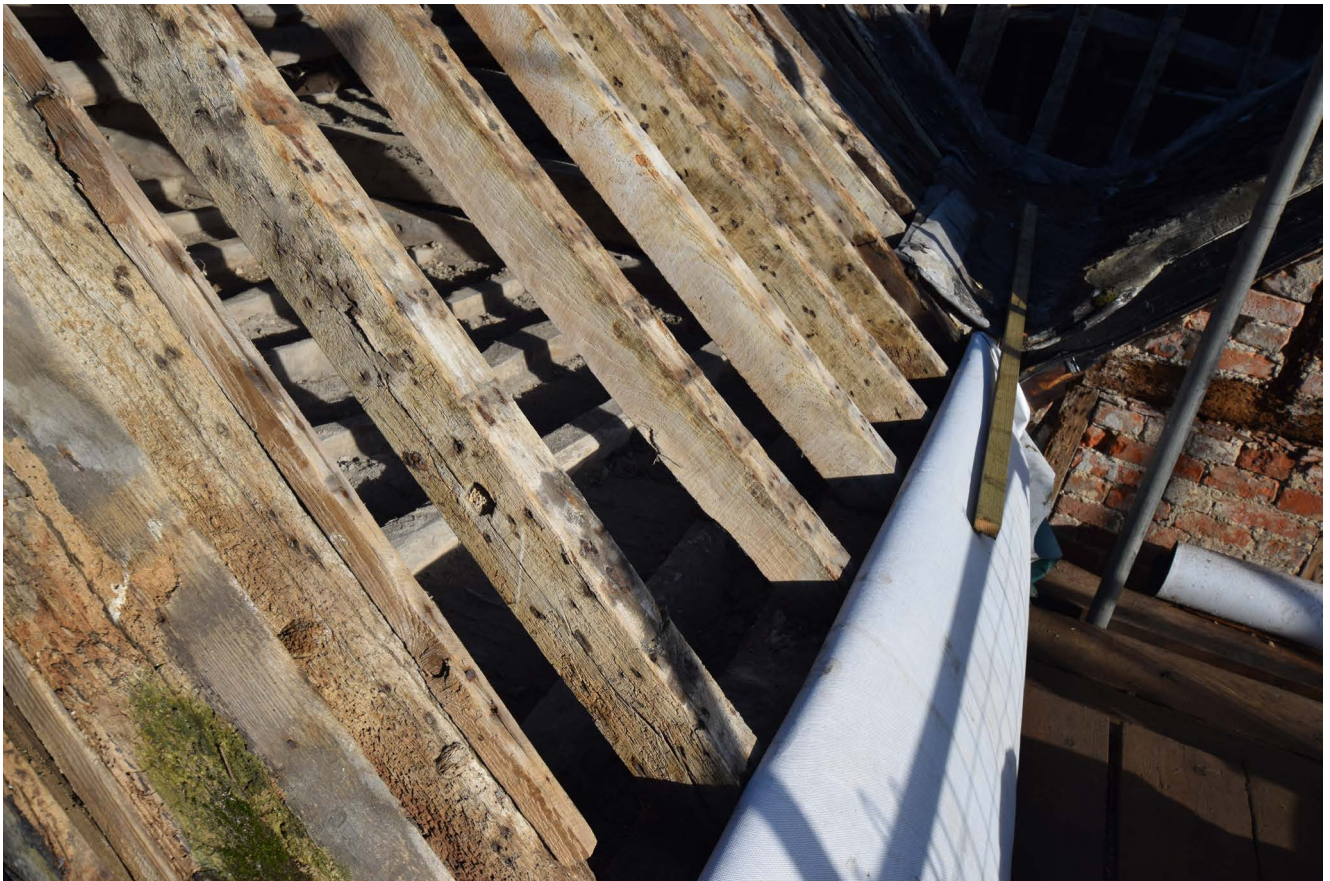
Plate 36: Reused rafters in the southernmost pitch of the northernmost wing

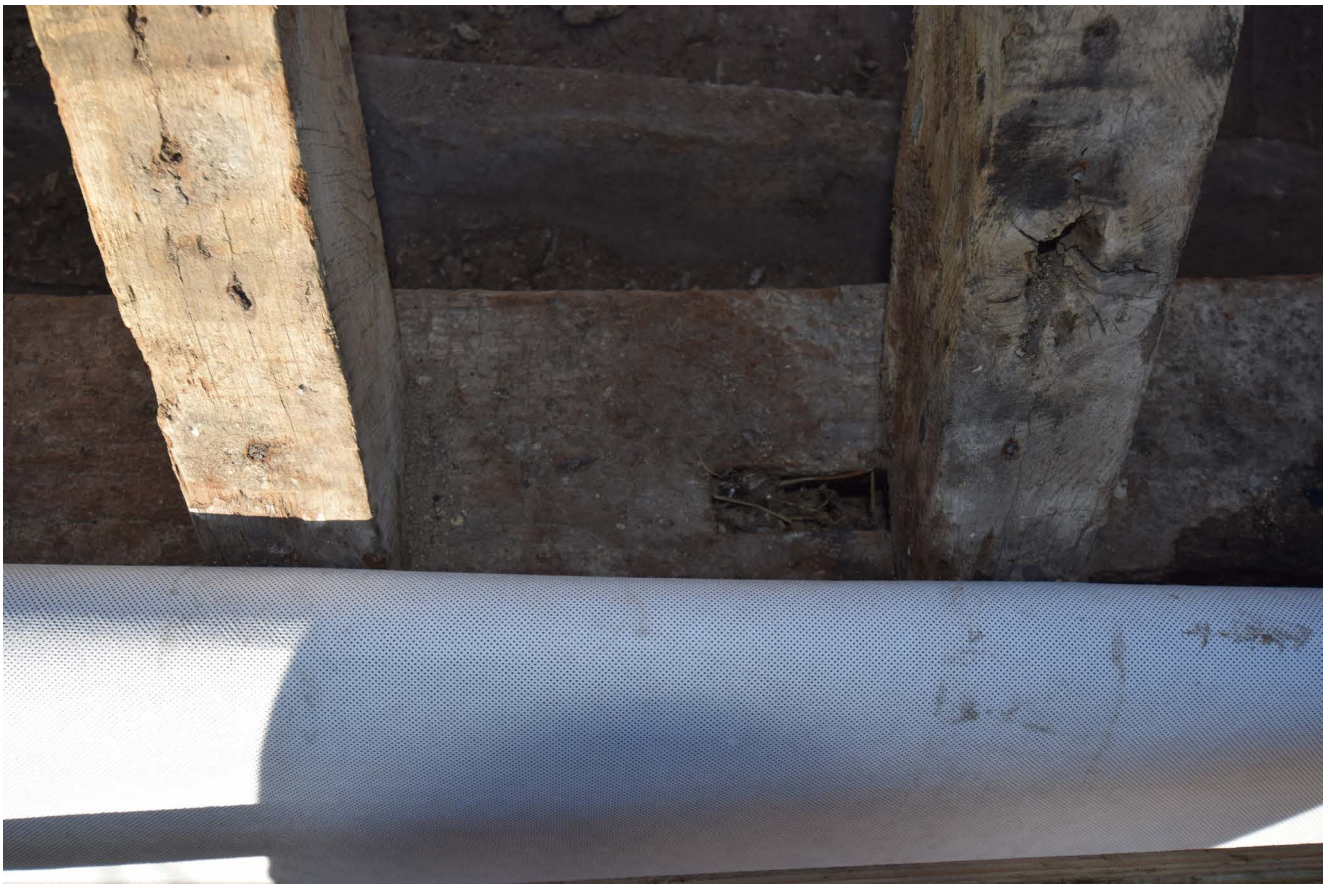
Plate 37: Reused timber used as a wallplate in the southern return of the northernmost wing

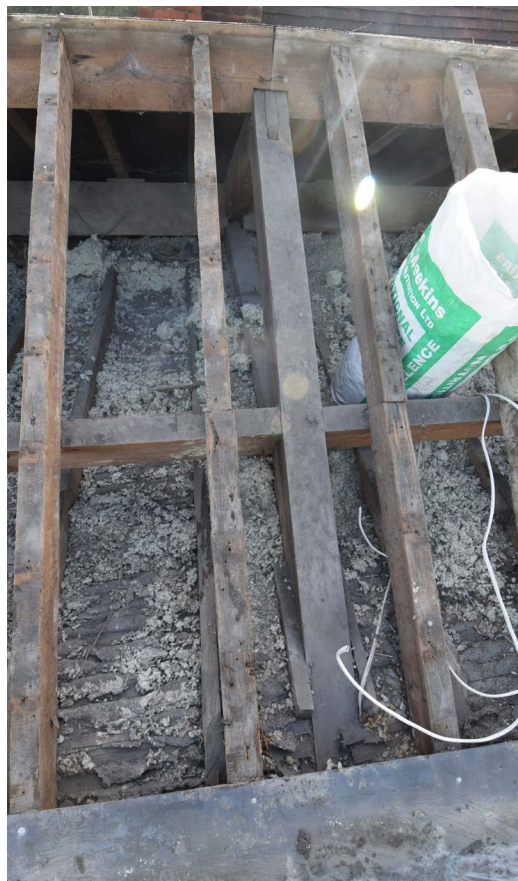
Plate 52: The principal rafter in the southernmost 19th-century roof

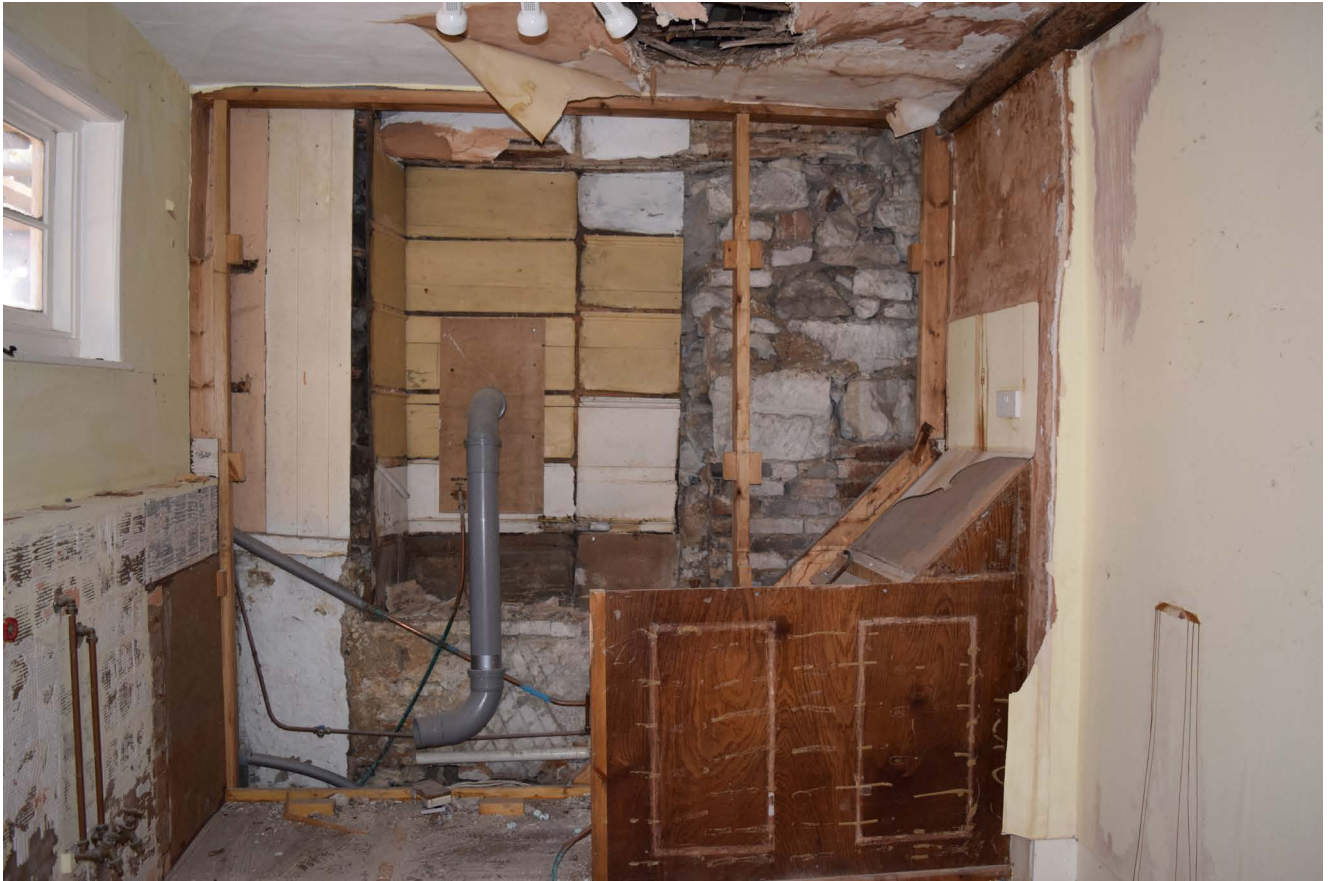
Plate 55: The south east wall of the Utility Room after removal of fittings

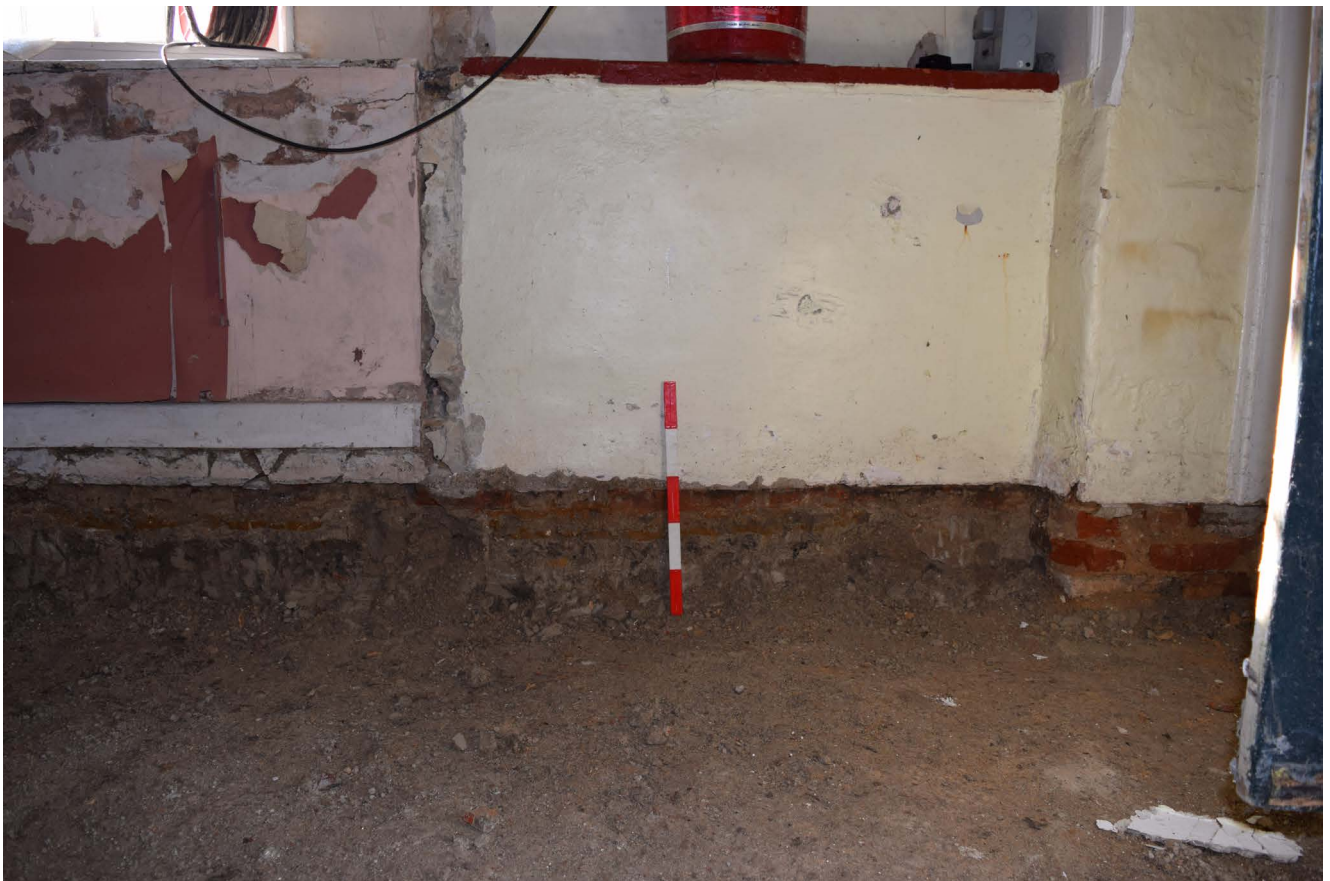
- 4.3.11 The mid 20th-century parquet flooring and earlier quarry tiles were removed and the floor excavated to allow damp-proofing. No features were visible in the excavated floor area, although a slight difference in the colour and compaction where the earlier façade had been extended forward was observed, although obscured by the use of the room since excavation as a through-route.
- 4.3.12 Very shallow footings were just visible in the external walls, and a brick base was in the location of the former Victorian column (Pl 58).
- 4.3.13 The ceiling was removed and exposed the beam and joists. The beams have received additional timber to the underside to correct a severe slump in the frame which

Plate 58: The base of the front wall of the Library after floor excavation

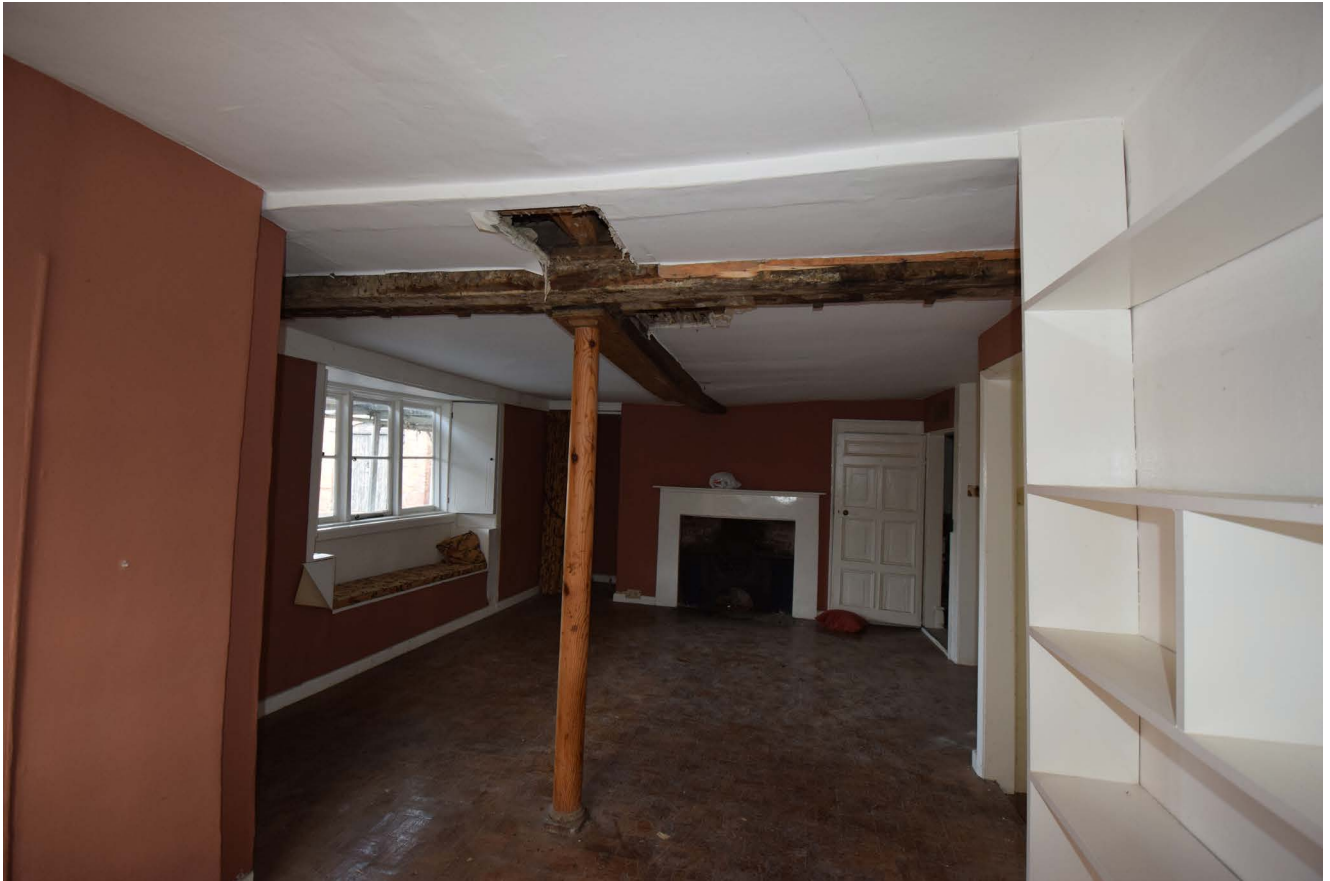
Plate 59: The investigation work to the beams in the Library

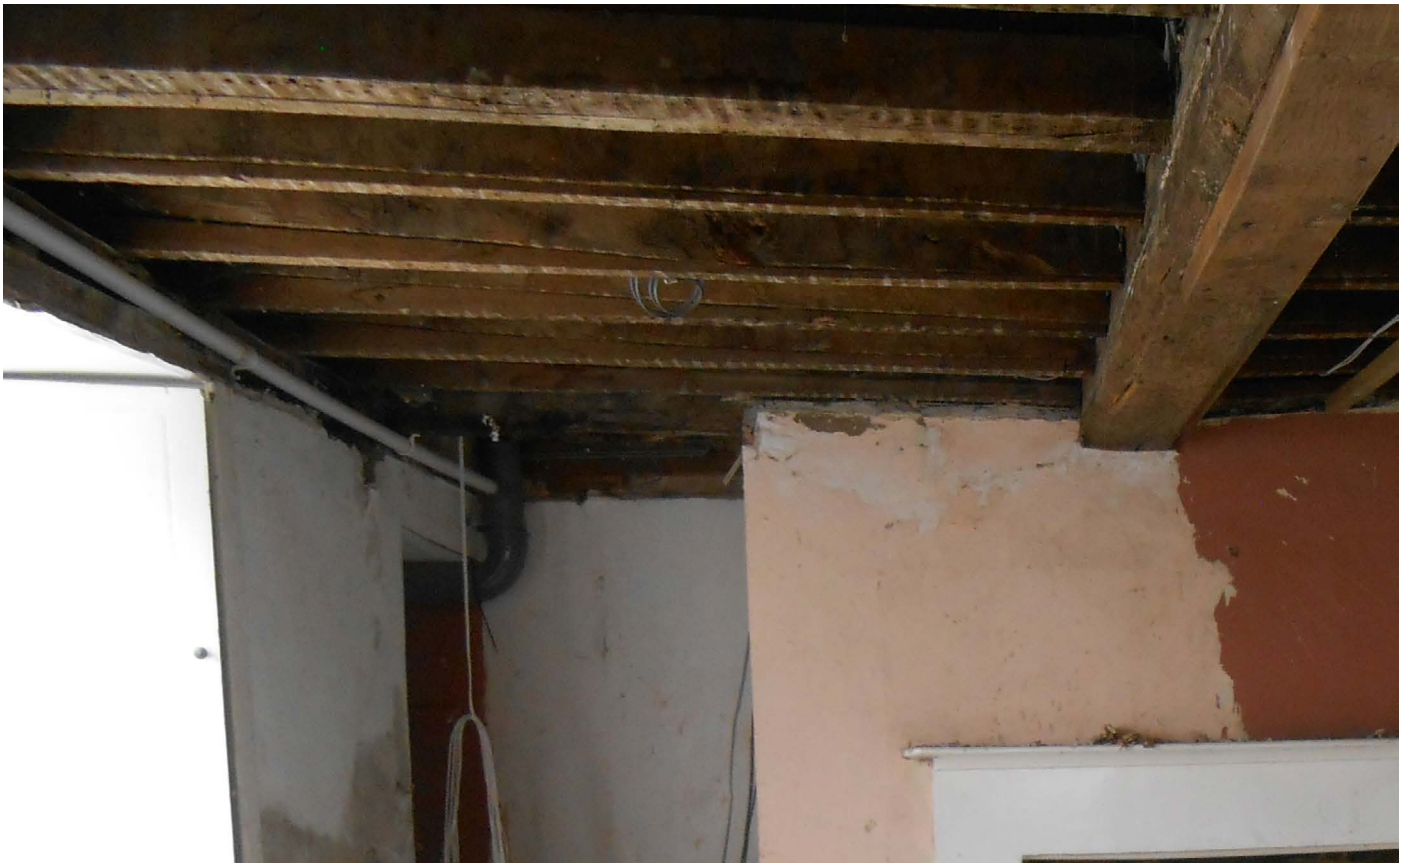
Plate 60: The old repairs to the Library ceiling joists, after plaster stripping. Photograph provided by Nigel Hutt, Clerk of Works

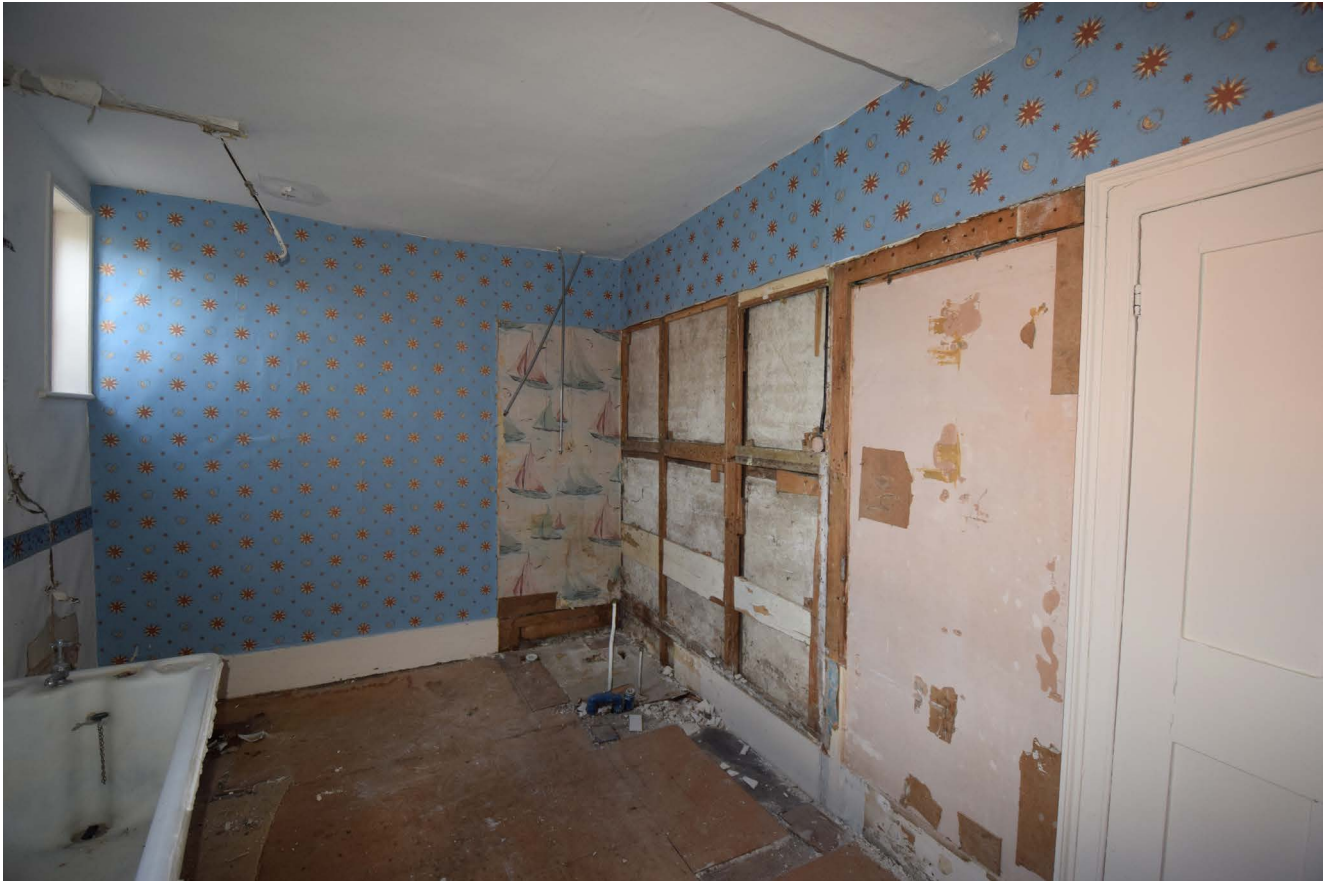
Plate 61: The south west wall of Bathroom 1 after removal of fittings

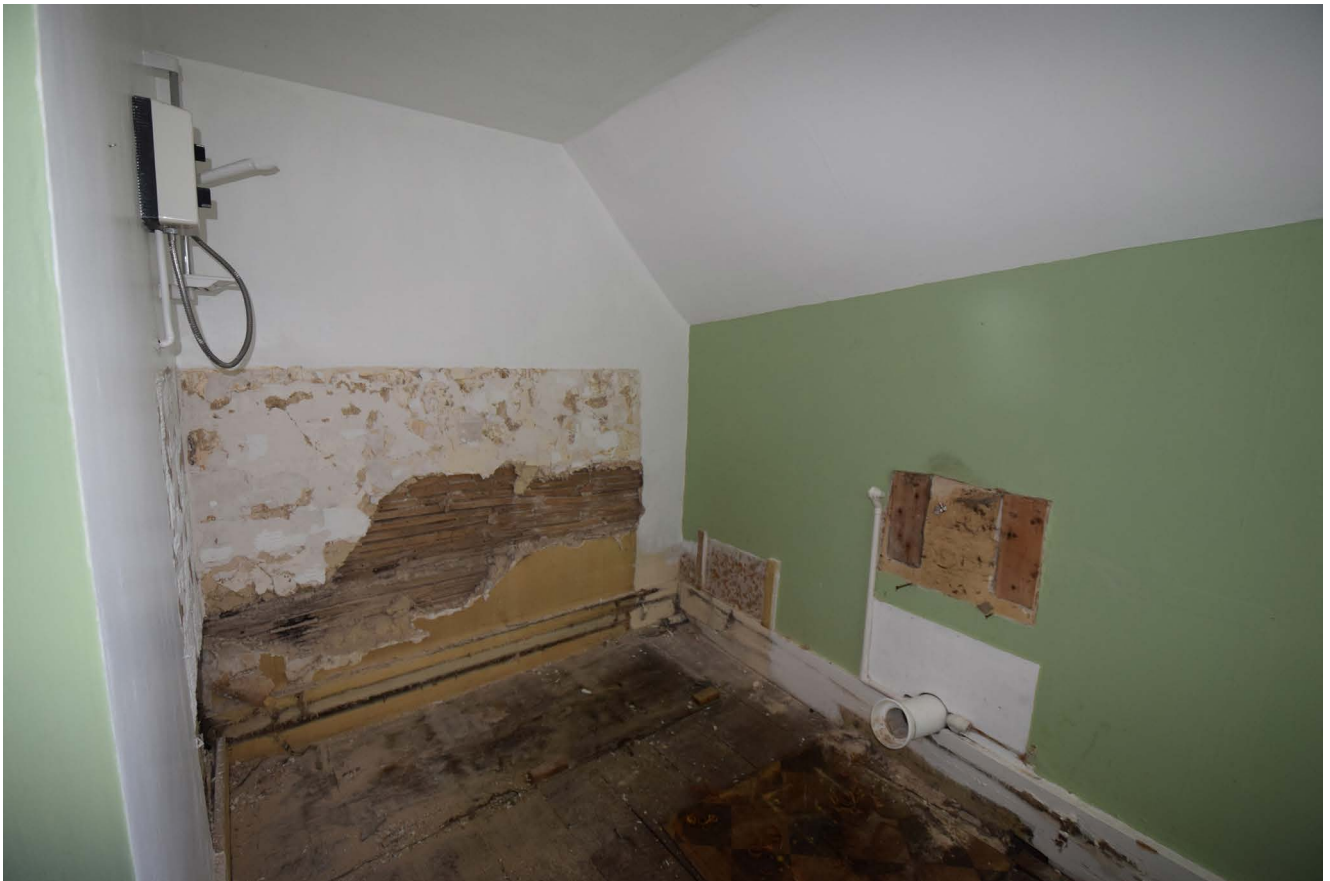
Plate 62: The south west wall of Bathroom 3 after removal of fittings

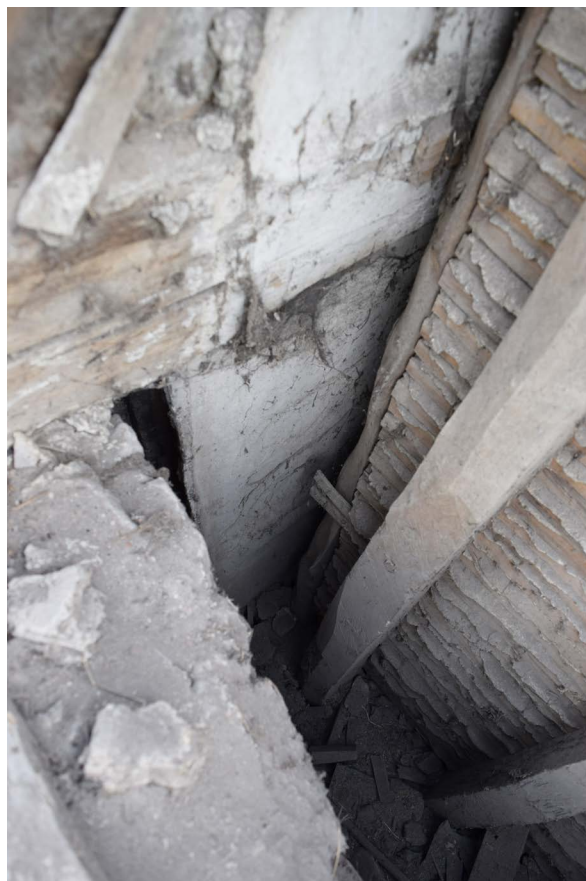
Plate 63: The surface of the south west wall of an earlier phase of the northernmost wing

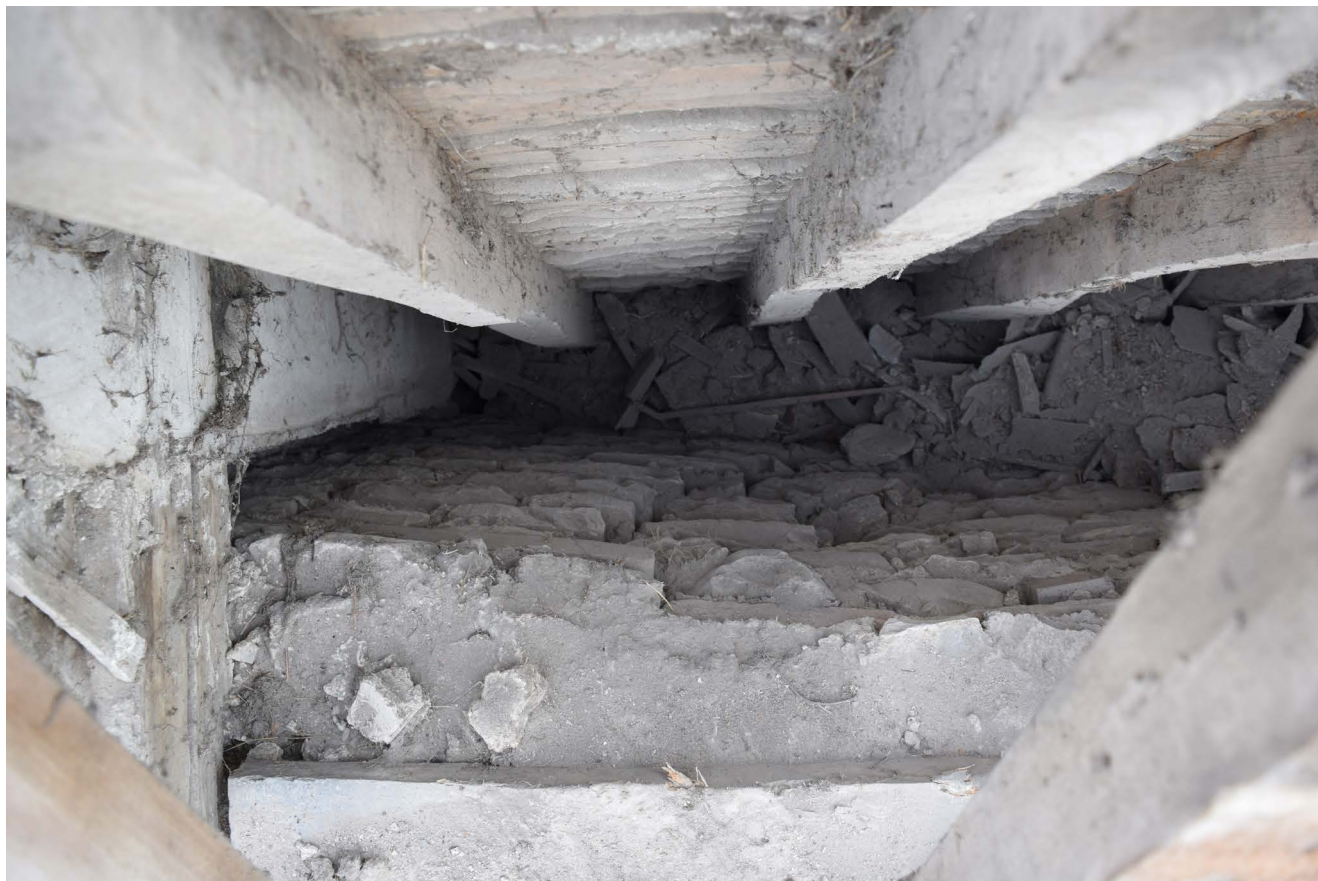
Plate 64: The space between the northernmost external and internal walls of Bedroom 3

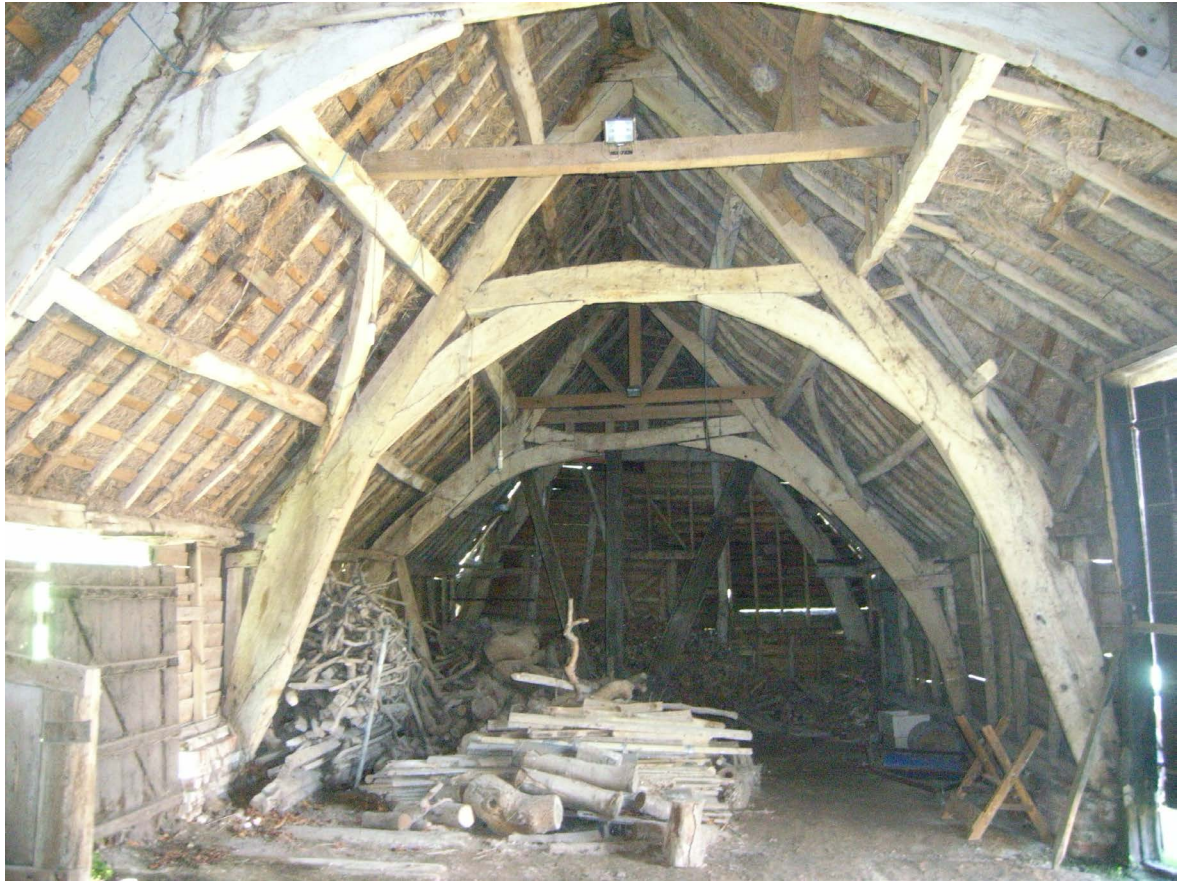
- 5.1.1 The accepted interpretation of the current form of the building is that the hall with cross-wings was constructed in the 17th century, extending an earlier building of similar construction to form the northernmost wing. Analysis of the layout of this wing during the production of the Heritage Statement and Impact Assessment prior to the major repair work supported this interpretation, however, during the repair work to this roof, remains of another earlier roof were discovered. The cusped timbers in that roof demonstrate the potential of a reasonably high-status early 14th-century building being the basis of this house. Although only one pair of principal rafters incorporating these cusped timbers survive, they are contemporary with the age of the three 14th-century cruck trusses in the adjacent tithe barn, although these are unadorned (Pl 67).

Plate 67: The 14th-century crucks in the adjacent tithe barn
