# Ullenwood Court, Gloucestershire Former Second World War camp

## Historic Building Investigation and Recording

January 2021

**Client: Churcham Homes**

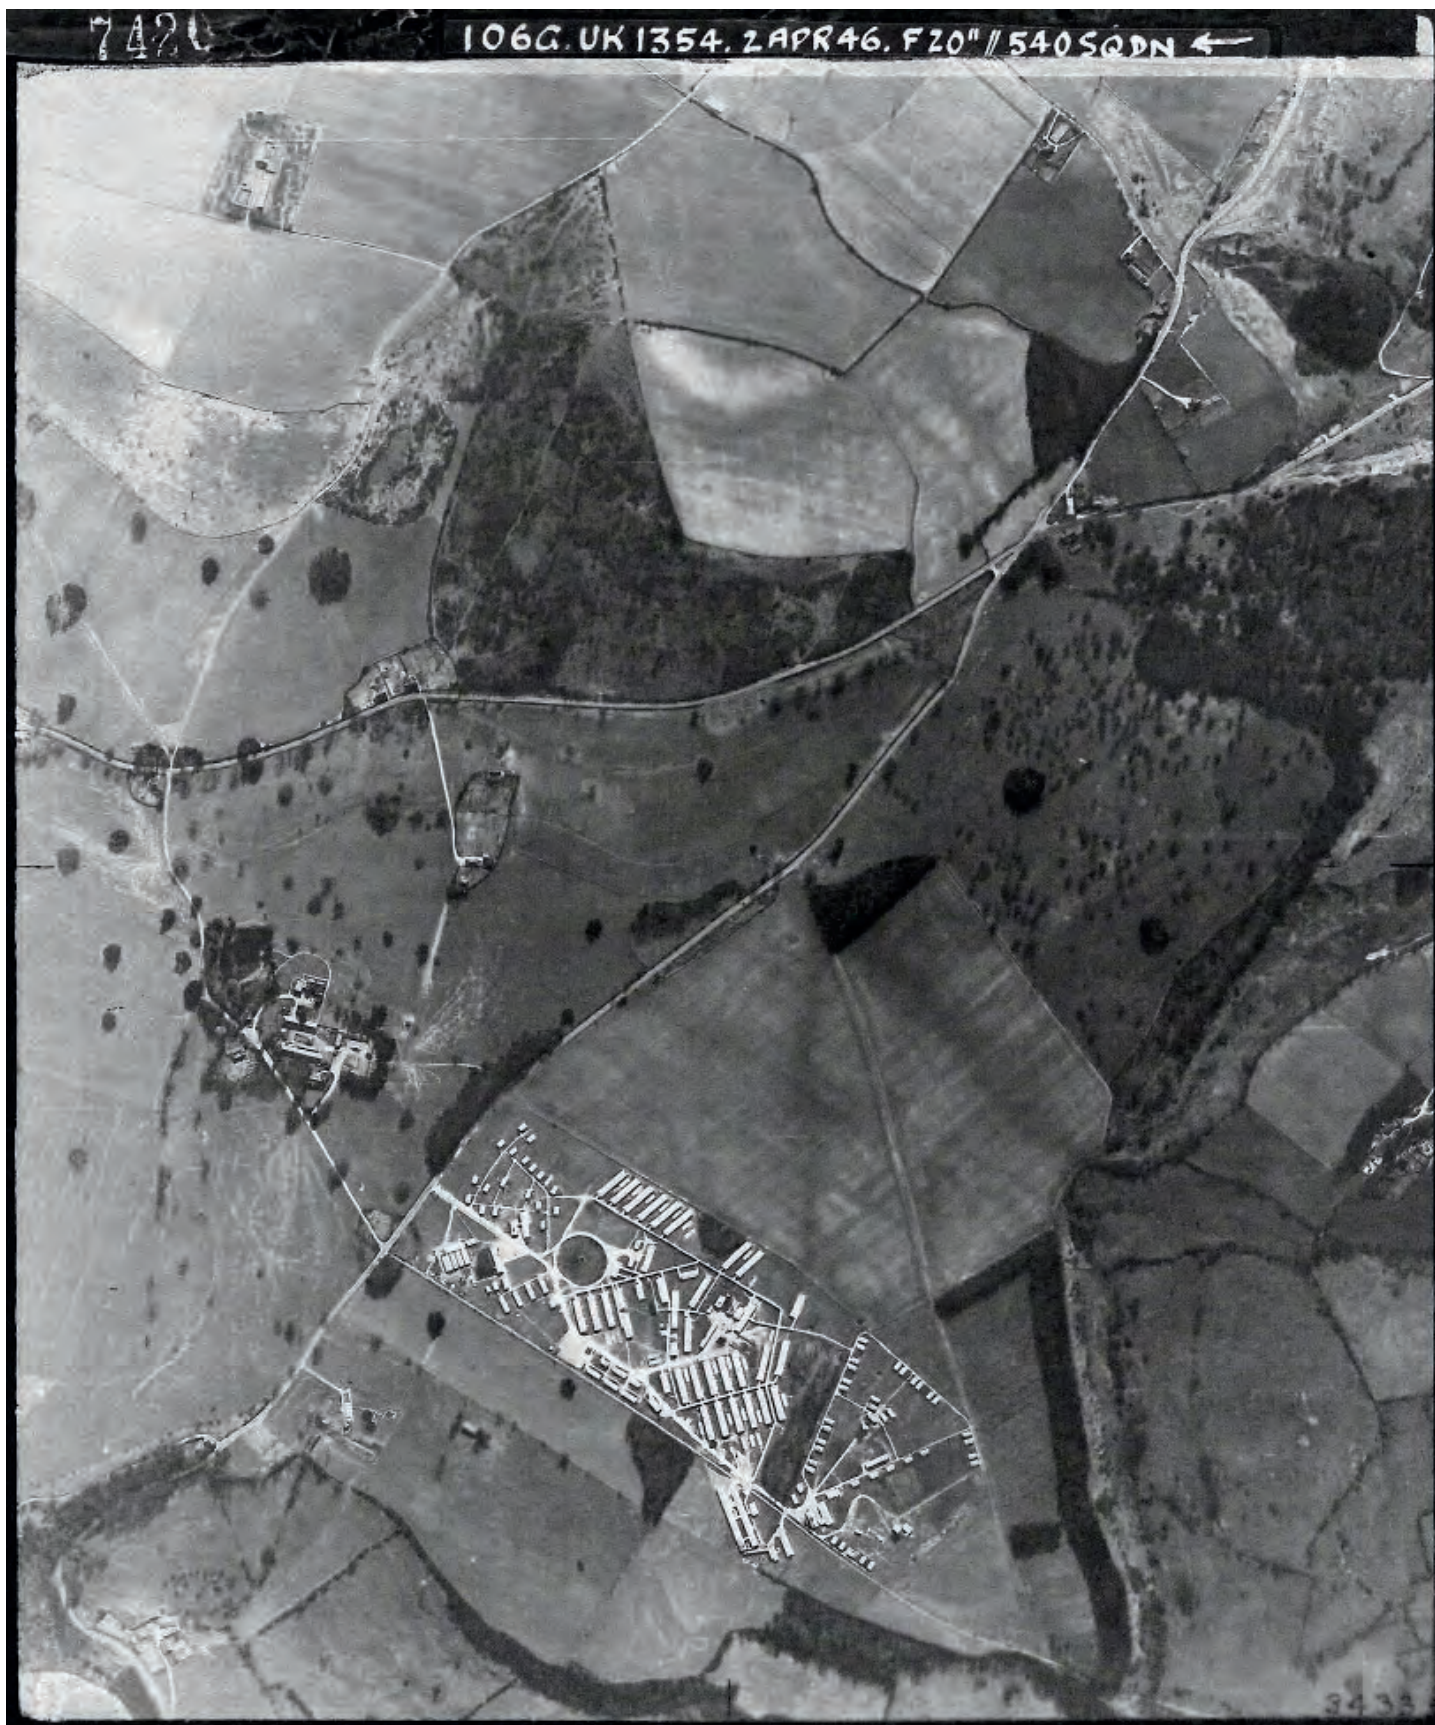
Figure 5: Aerial photograph (1946)

- 3.1.12 The layout of the camp is shown clearly on several aerial photographs from this period, those dating from 1946 and 1967 are included within this report (Figs. 5 and 6). The dominant feature of the complex is regular rows of similar buildings, which were presumably the main hospital wards, orientated broadly NW-SE and connected by tracks. In addition, the photograph also shows a number of other smaller and less regular ranges, mainly towards the centre of the site, which probably provided most of the service, administrative or ancillary facilities.

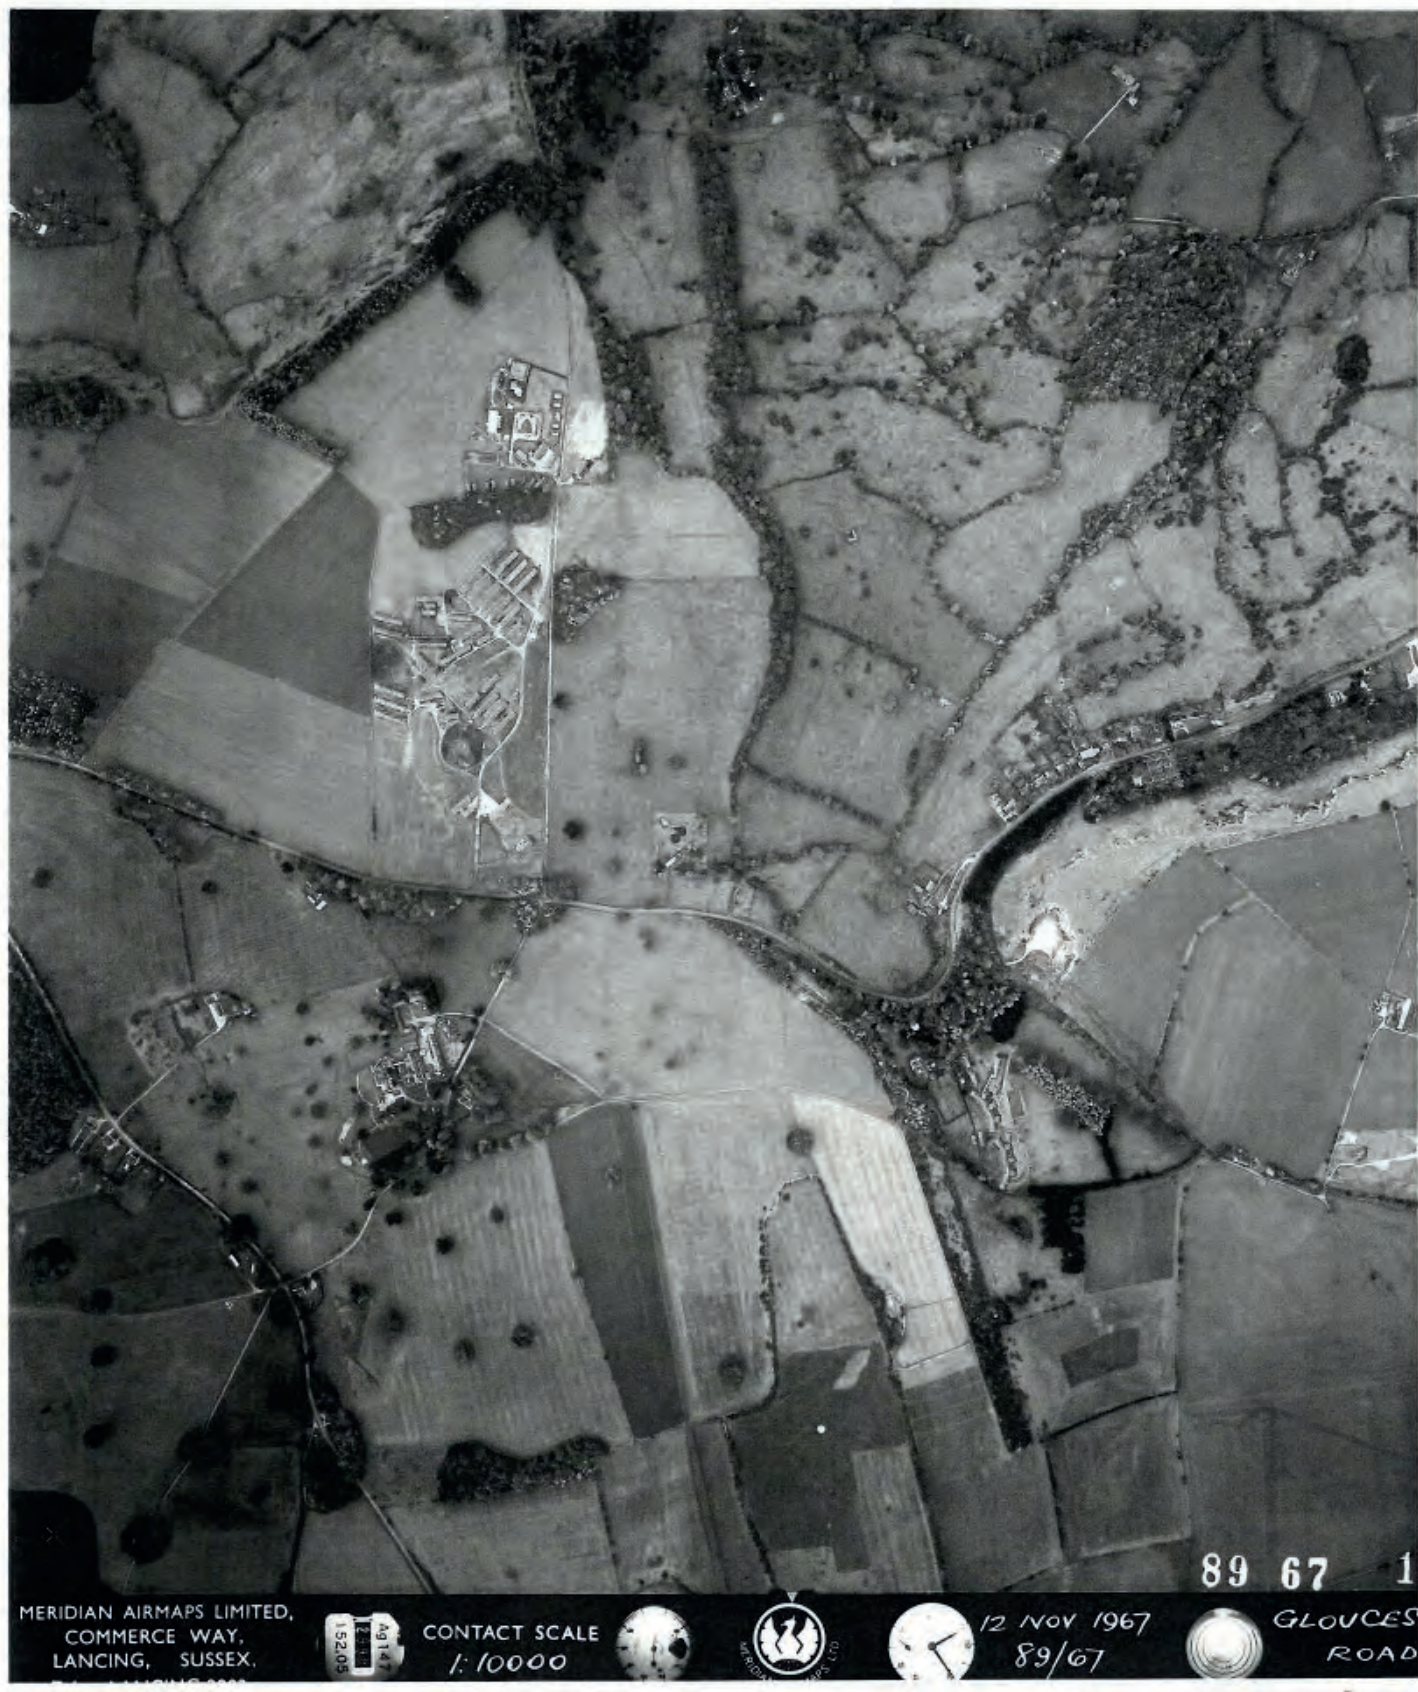
Figure 6: Aerial photograph (1967)

3.1.19 Aerial photographs suggest that the buildings from the war-time camp almost entirely survived in 1959 (RAF58/2958/0080) but that by 1967 a large number of these buildings had been removed. The 1967 photograph (MAL/67089) shows the site broadly as it is today (Fig.6).

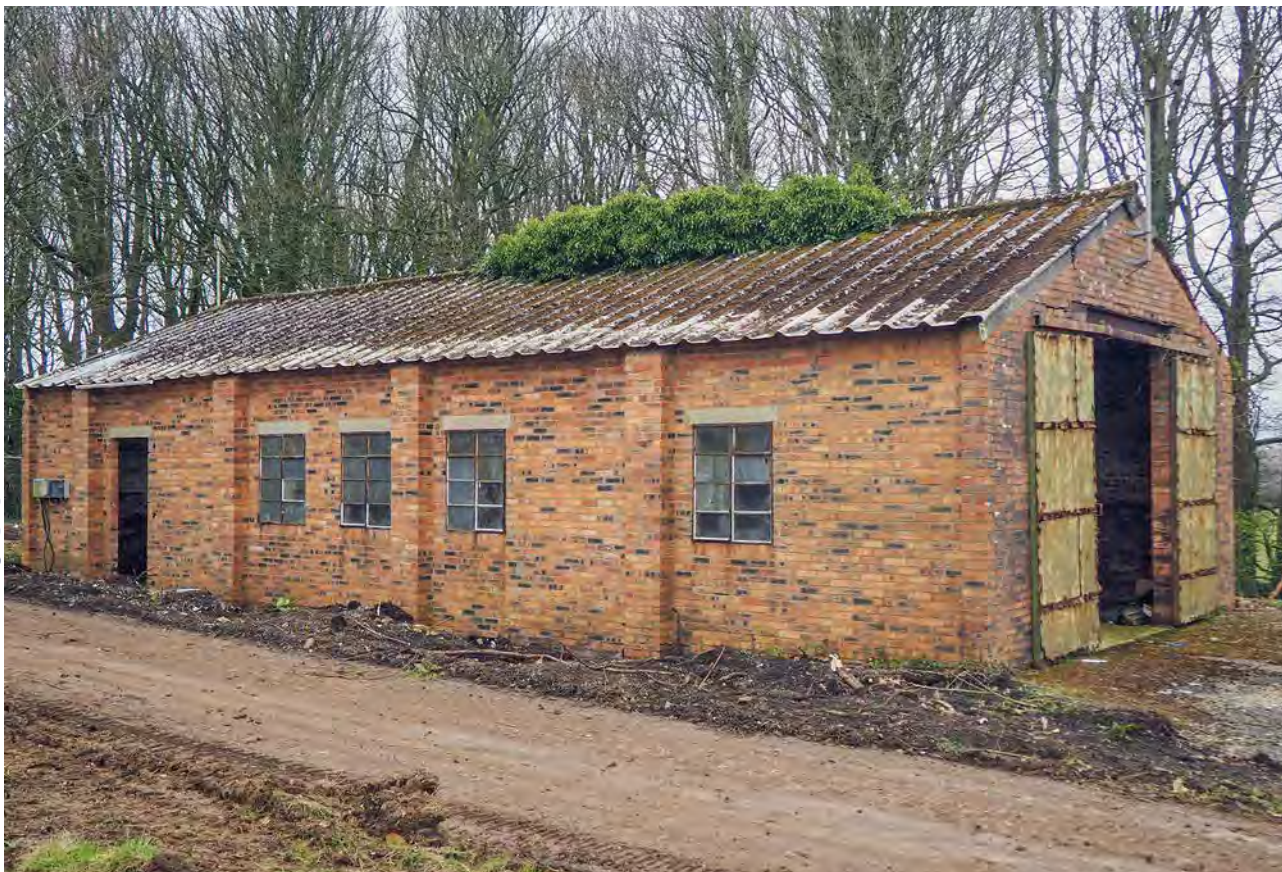
Plate 3: A brick plant structure, building 22

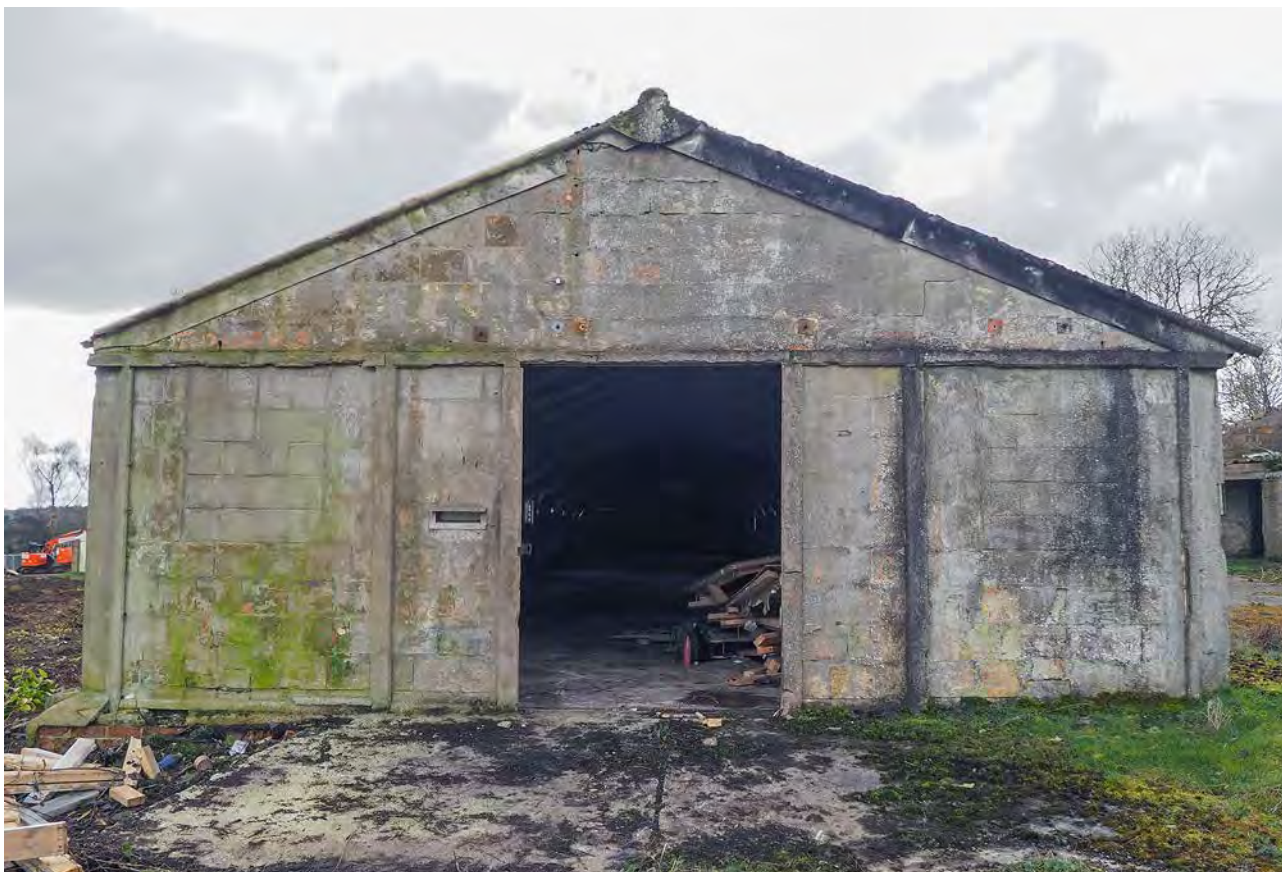
Plate 4: Building 20, front elevation

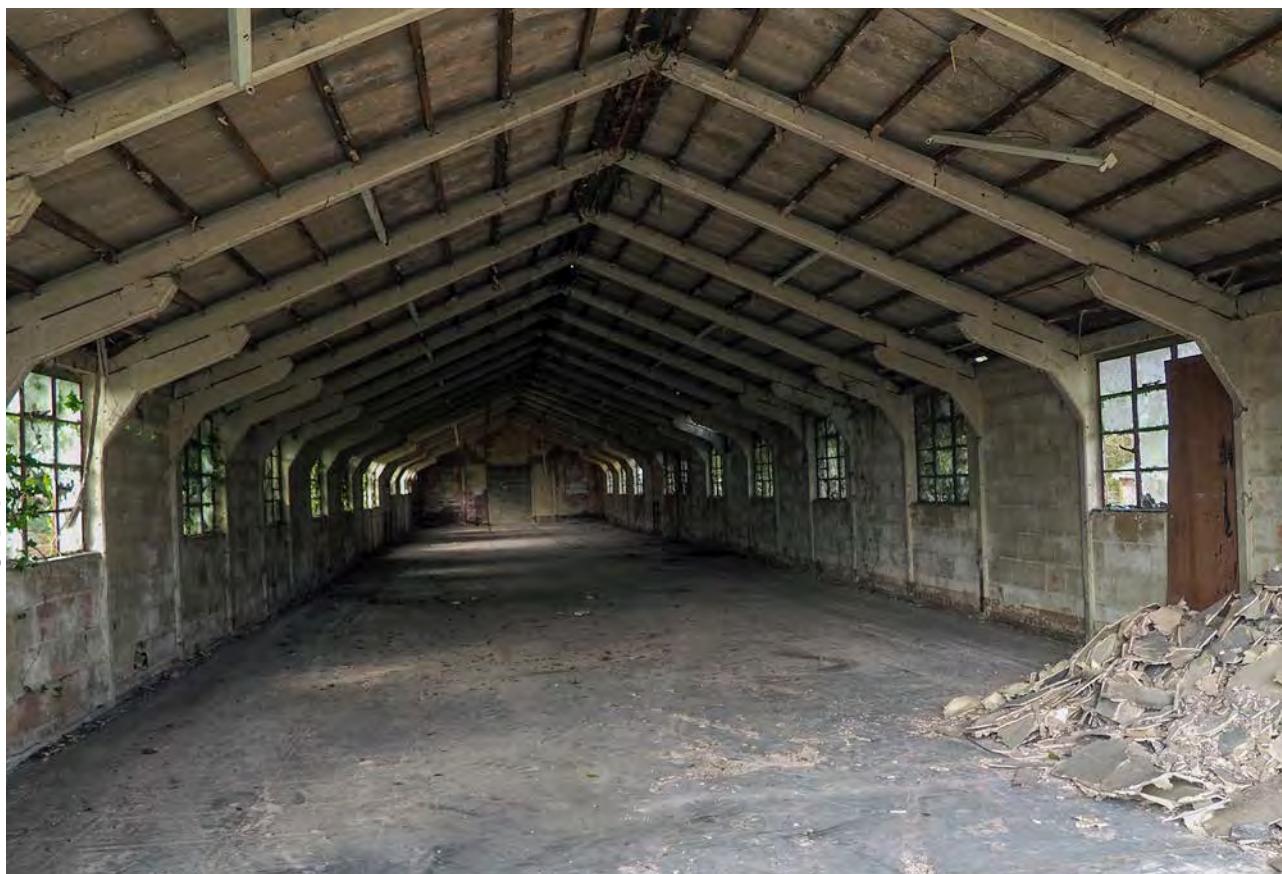
Plate 5: Building 24, internal view of portal frames

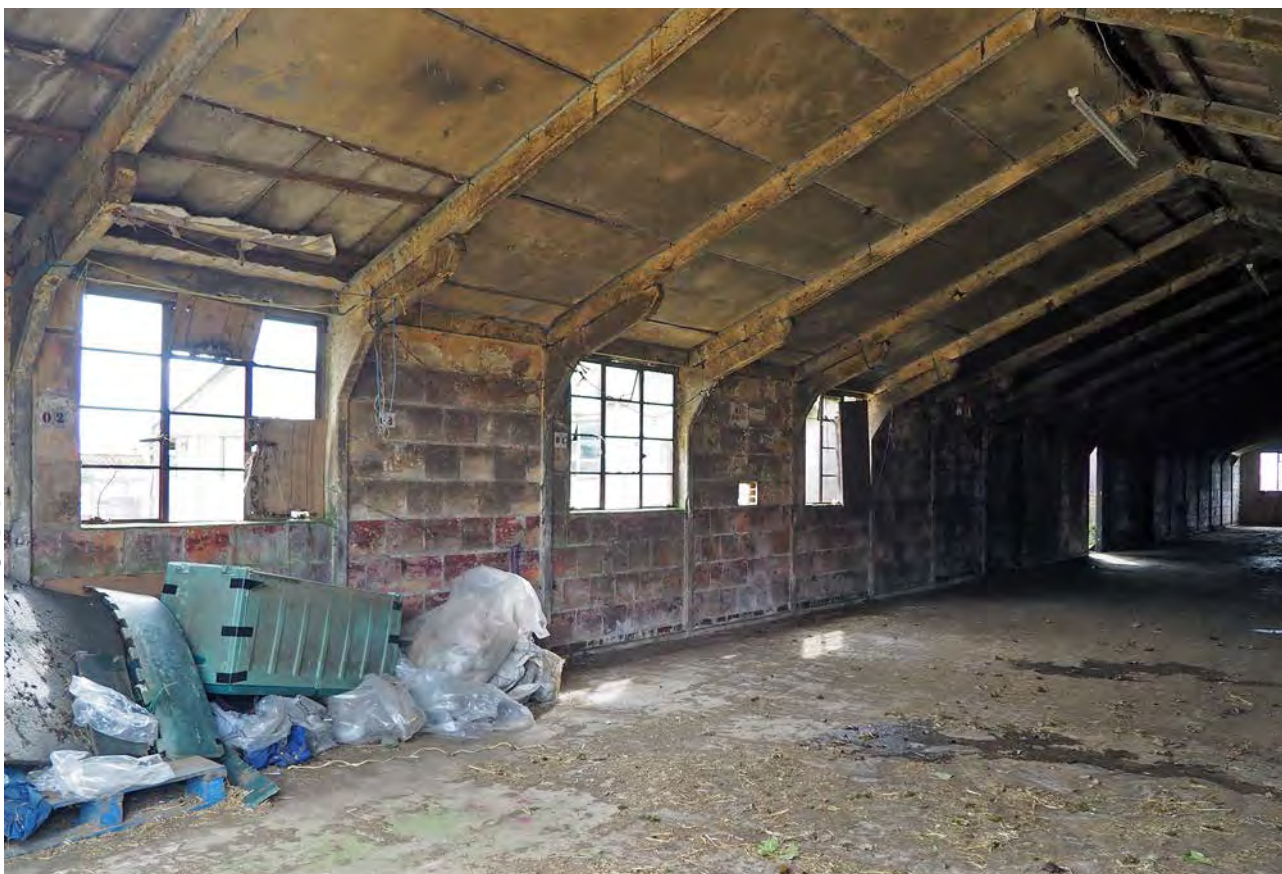
Plate 7: Building 17, hard board ceiling

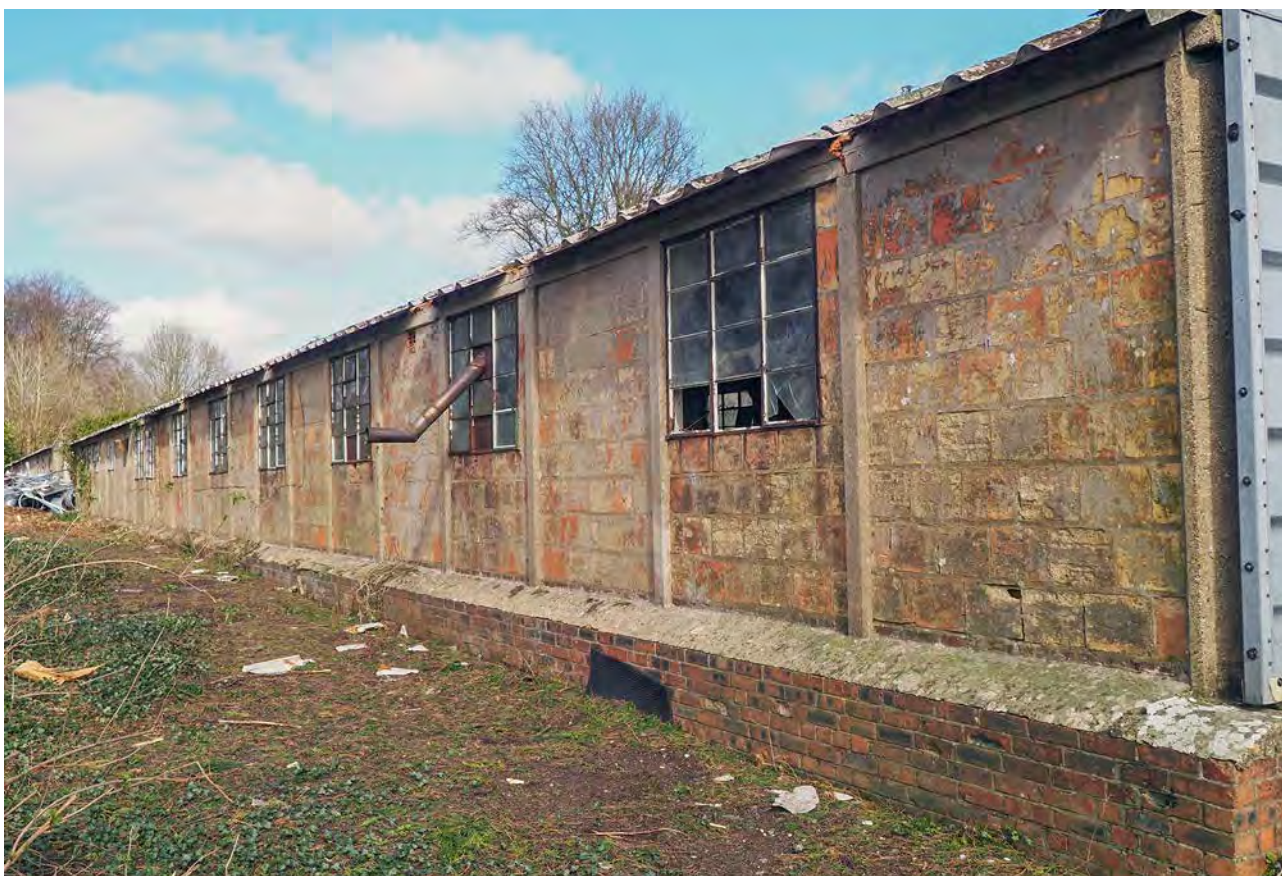
Plate 8: Building 28, external view showing wall construction

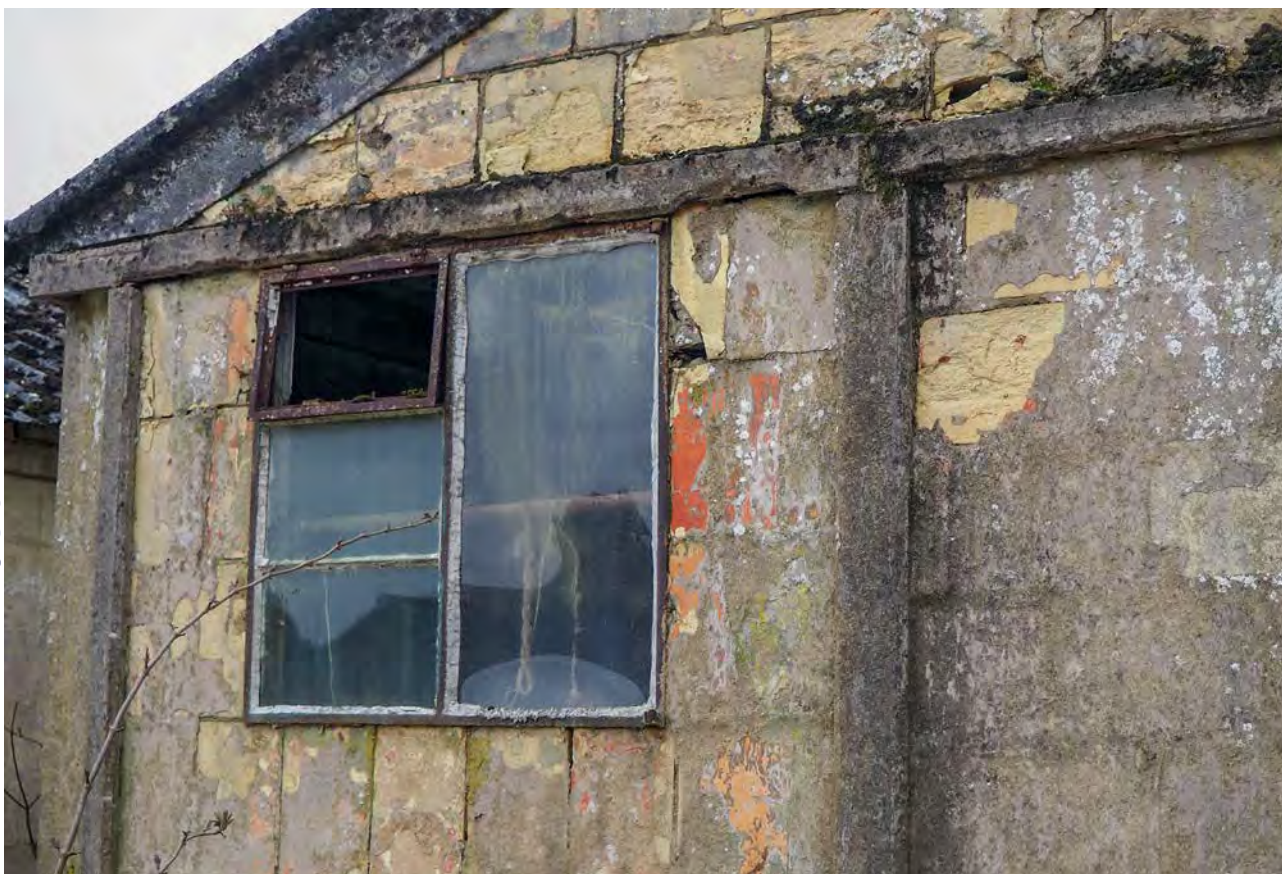
Plate 9: Building 17, small window

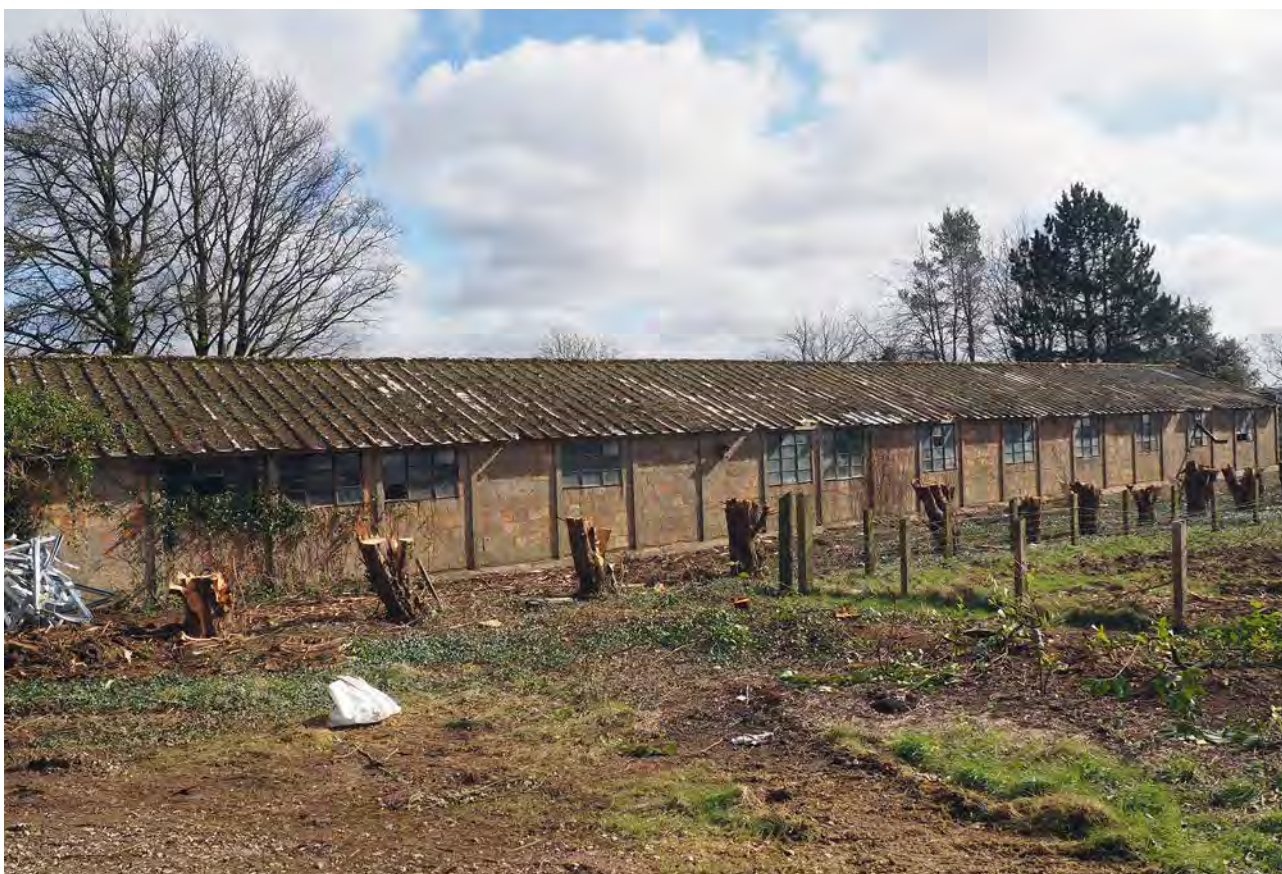
Plate 10: Building 28, side elevation

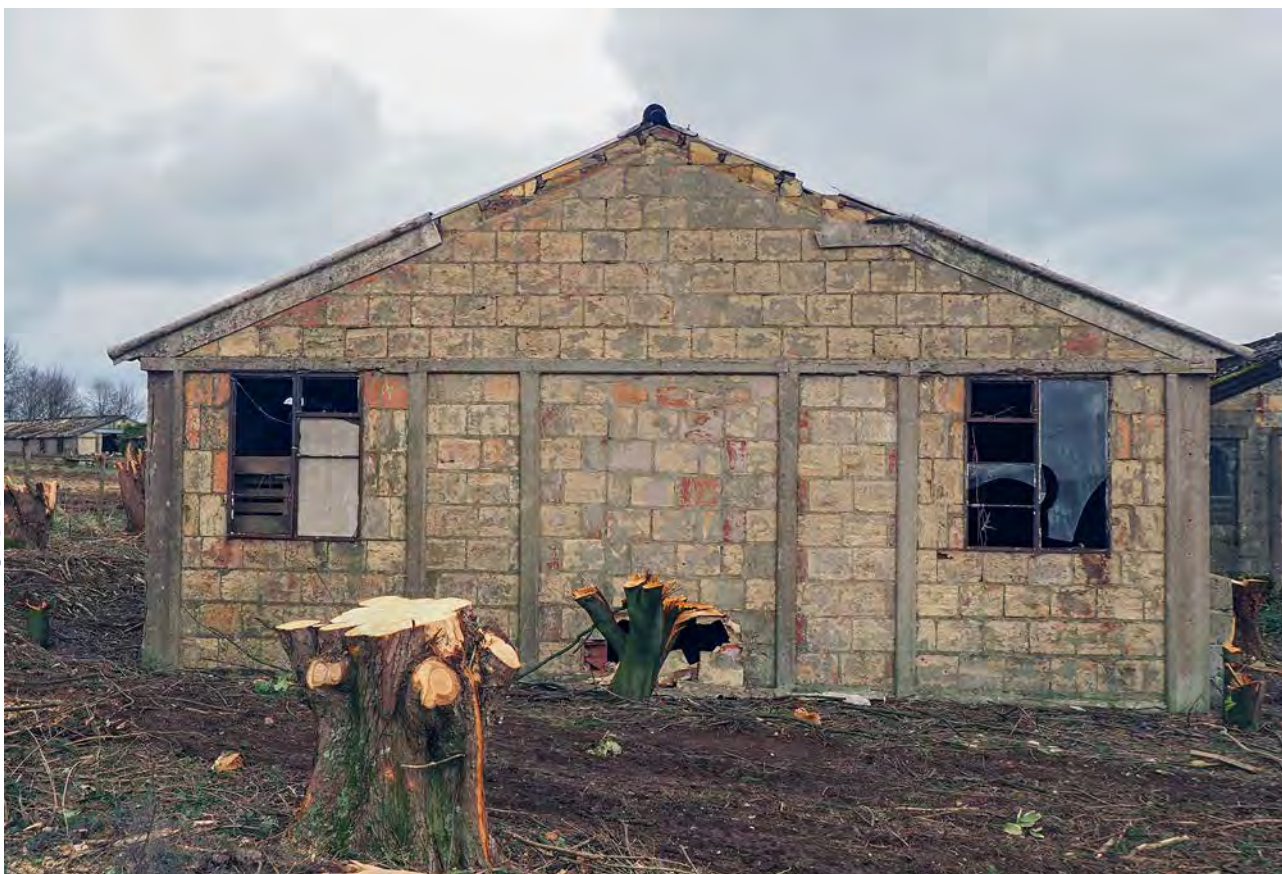
Plate 11: Building 17, rear elevation

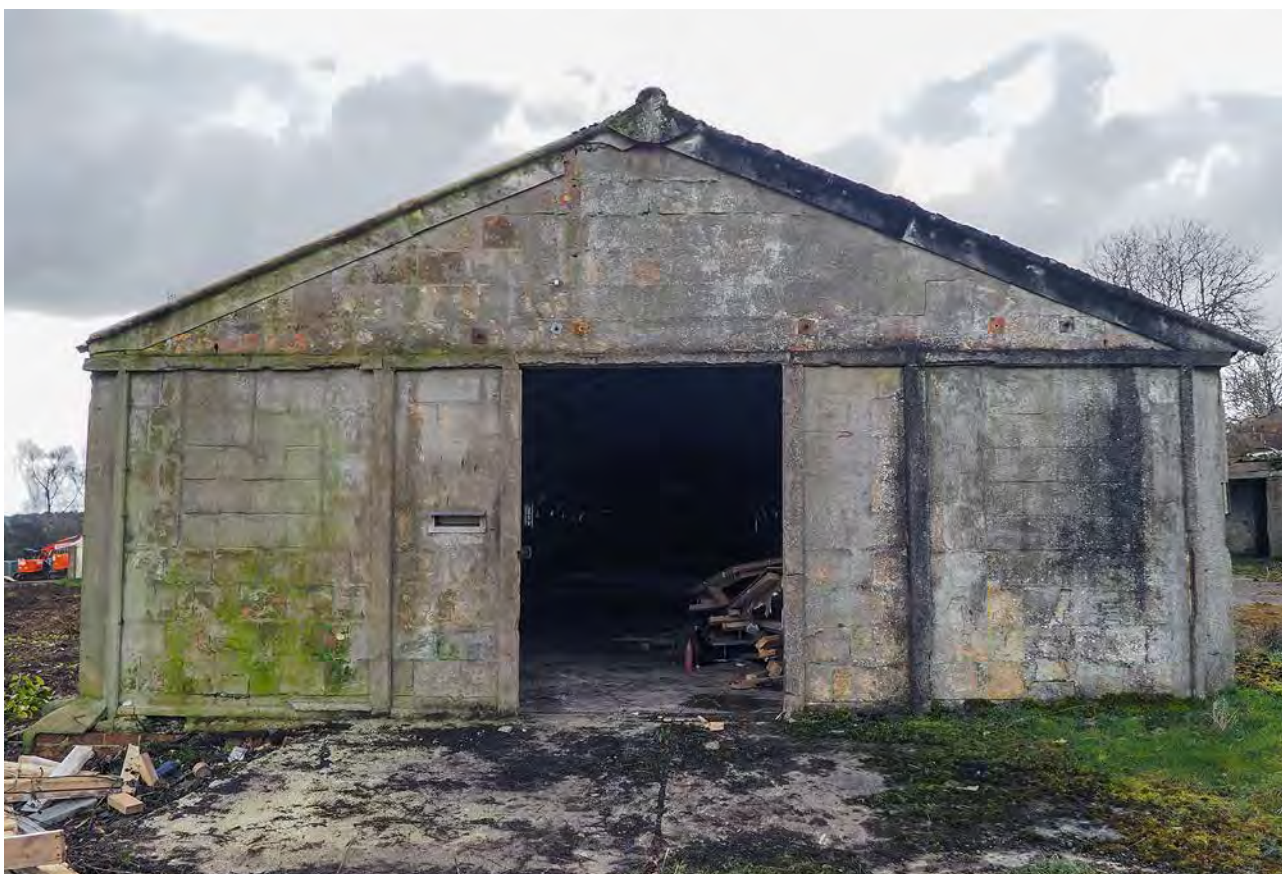
Plate 12: Building 20, front elevation

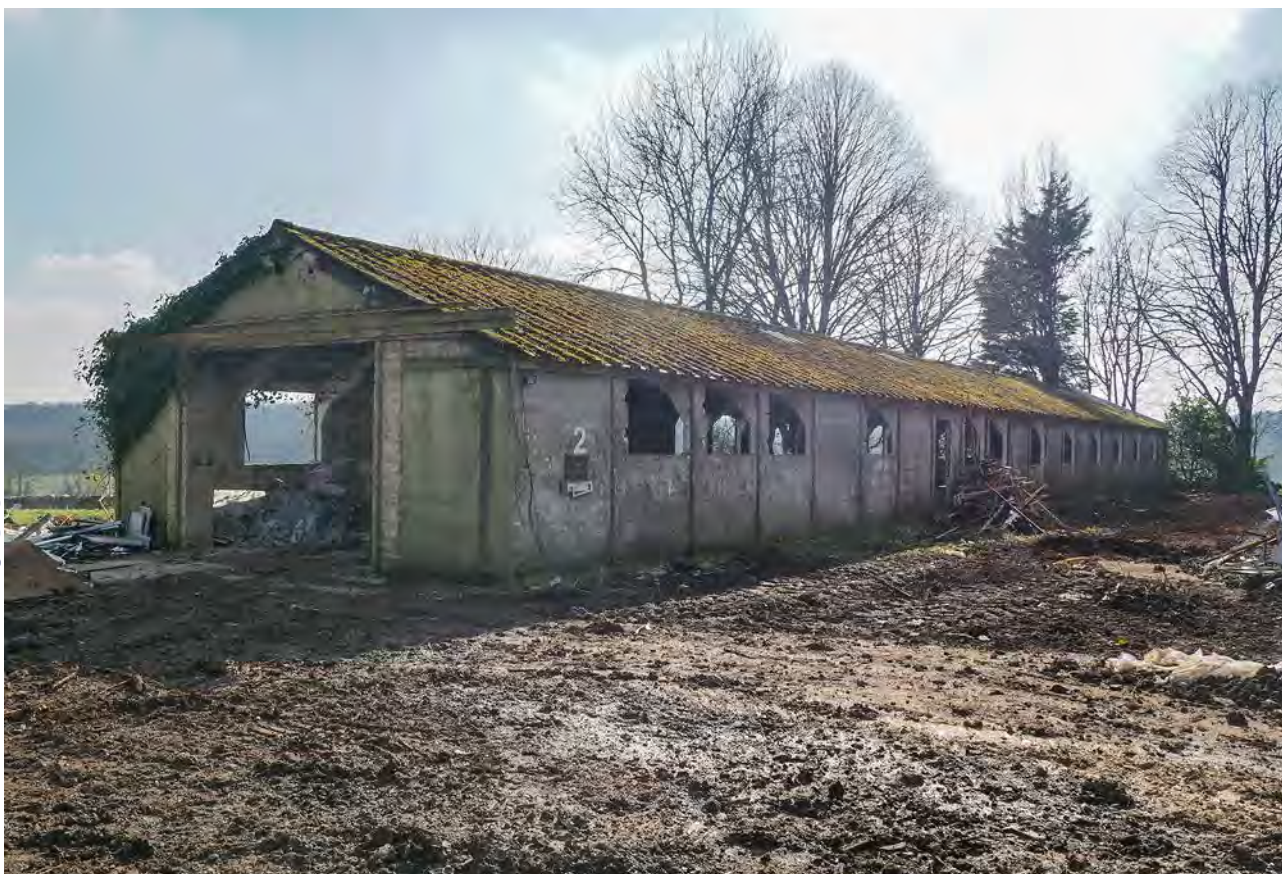
Plate 13: Building 5, front elevation

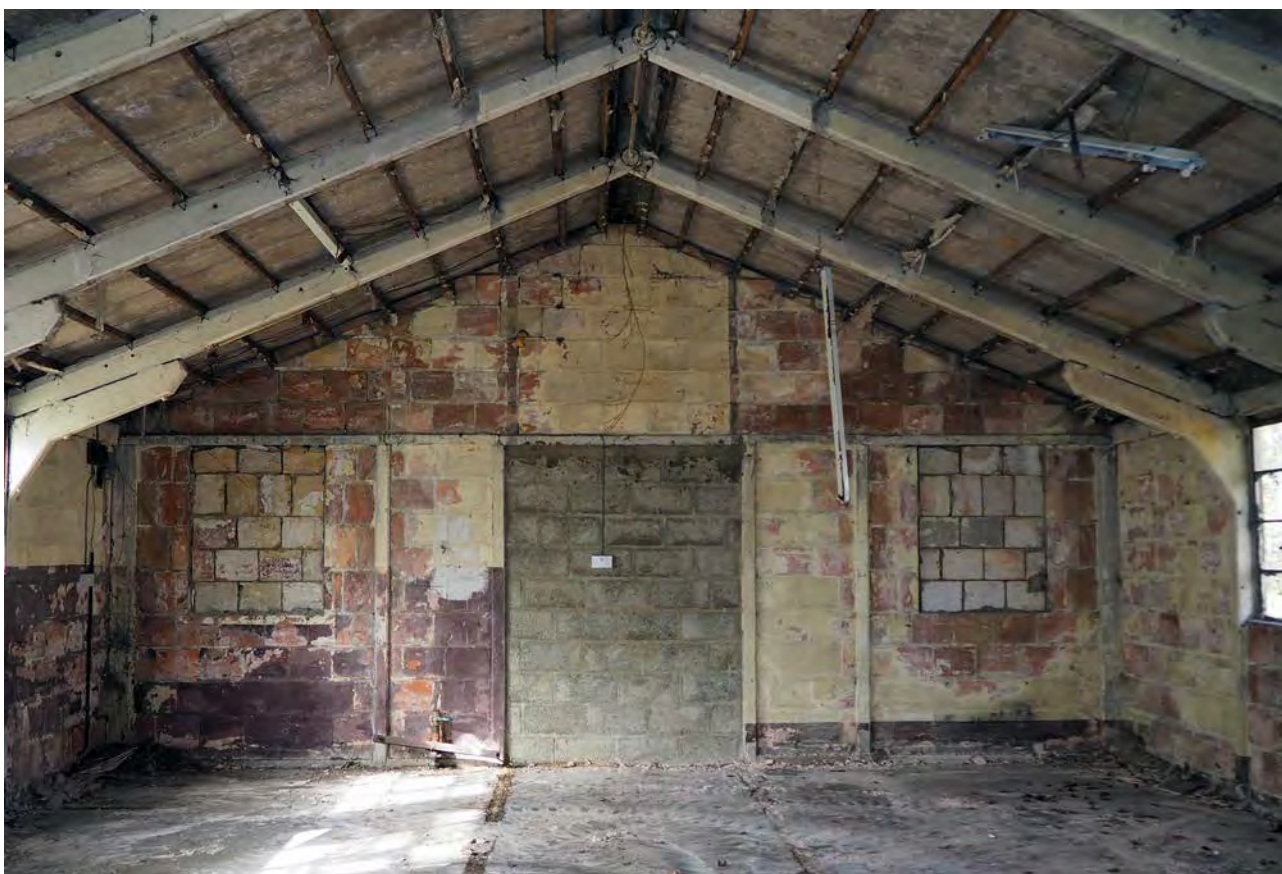
Plate 14: Building 24, internal view showing evidence of former room partitions

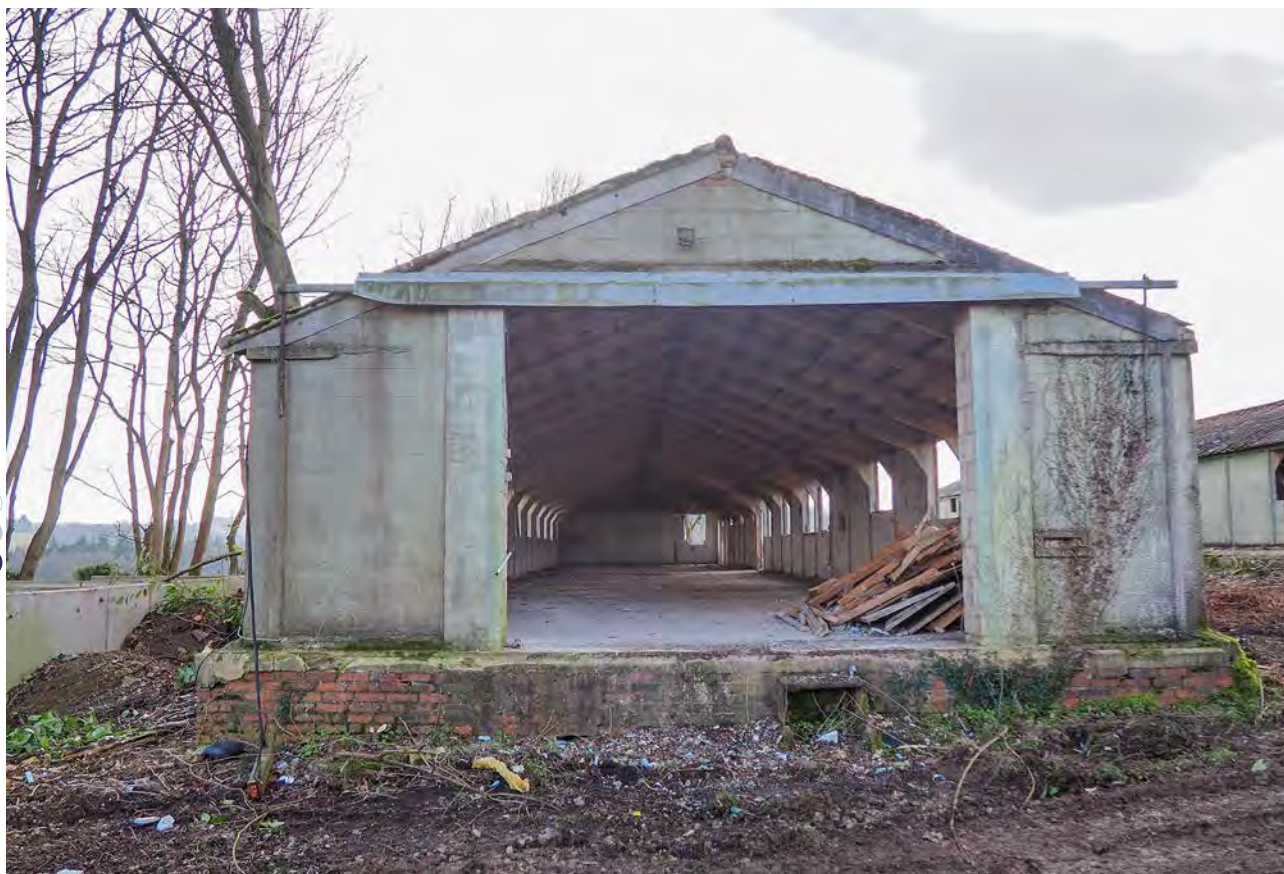
Plate 15: Building 2, front and west elevations

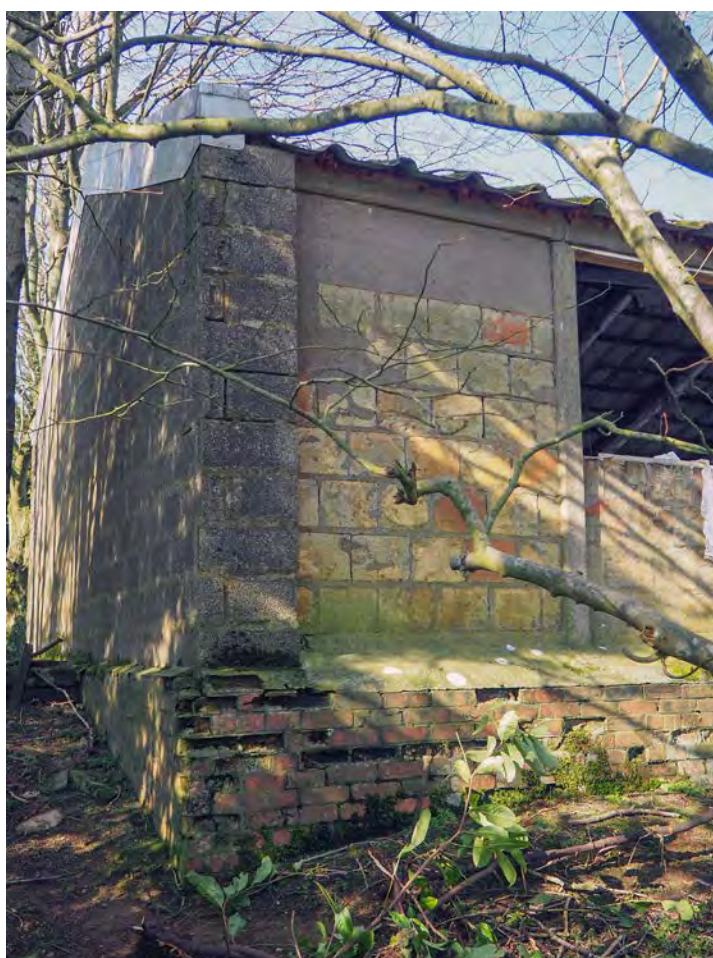
Plate 16: Building 2, rear elevation

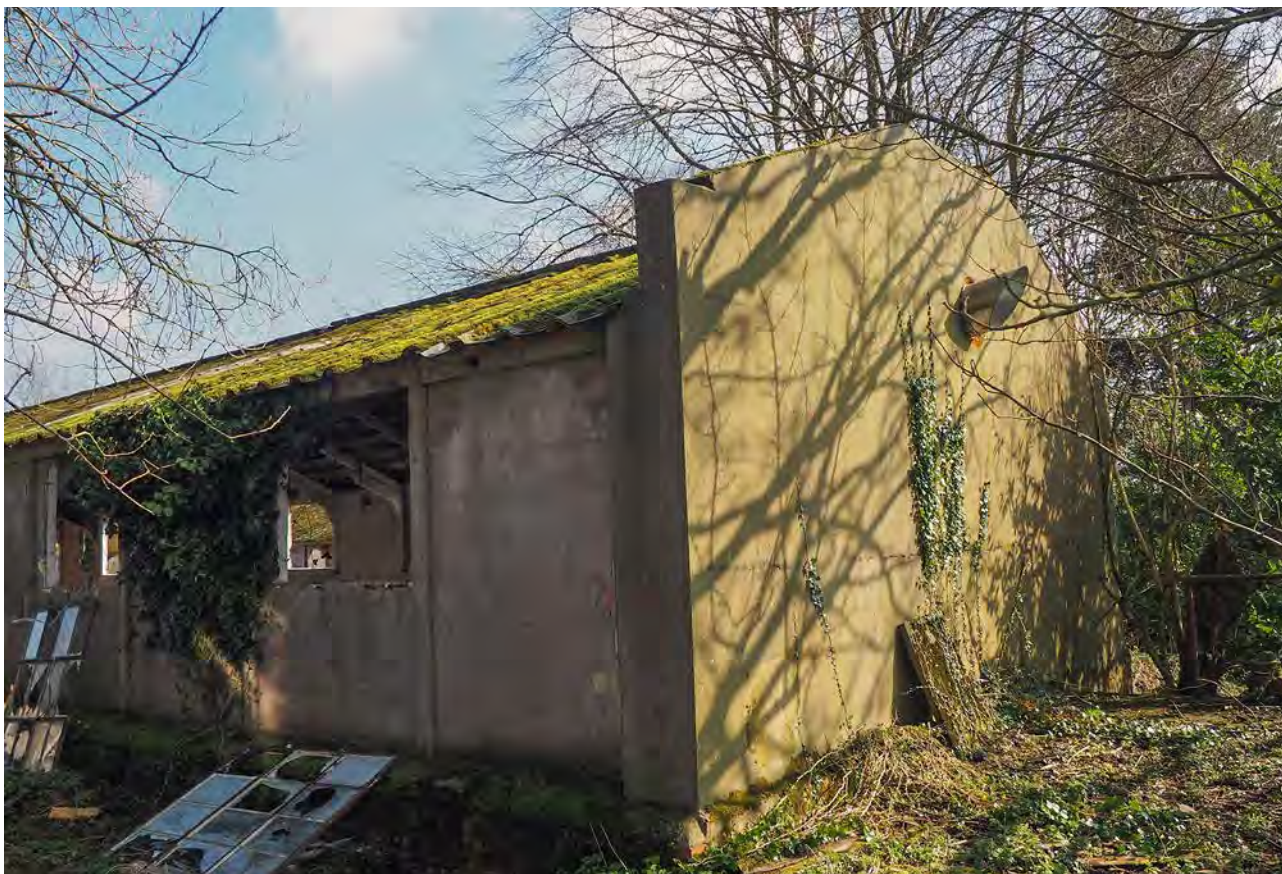
Plate 18: Building 3, rear elevation

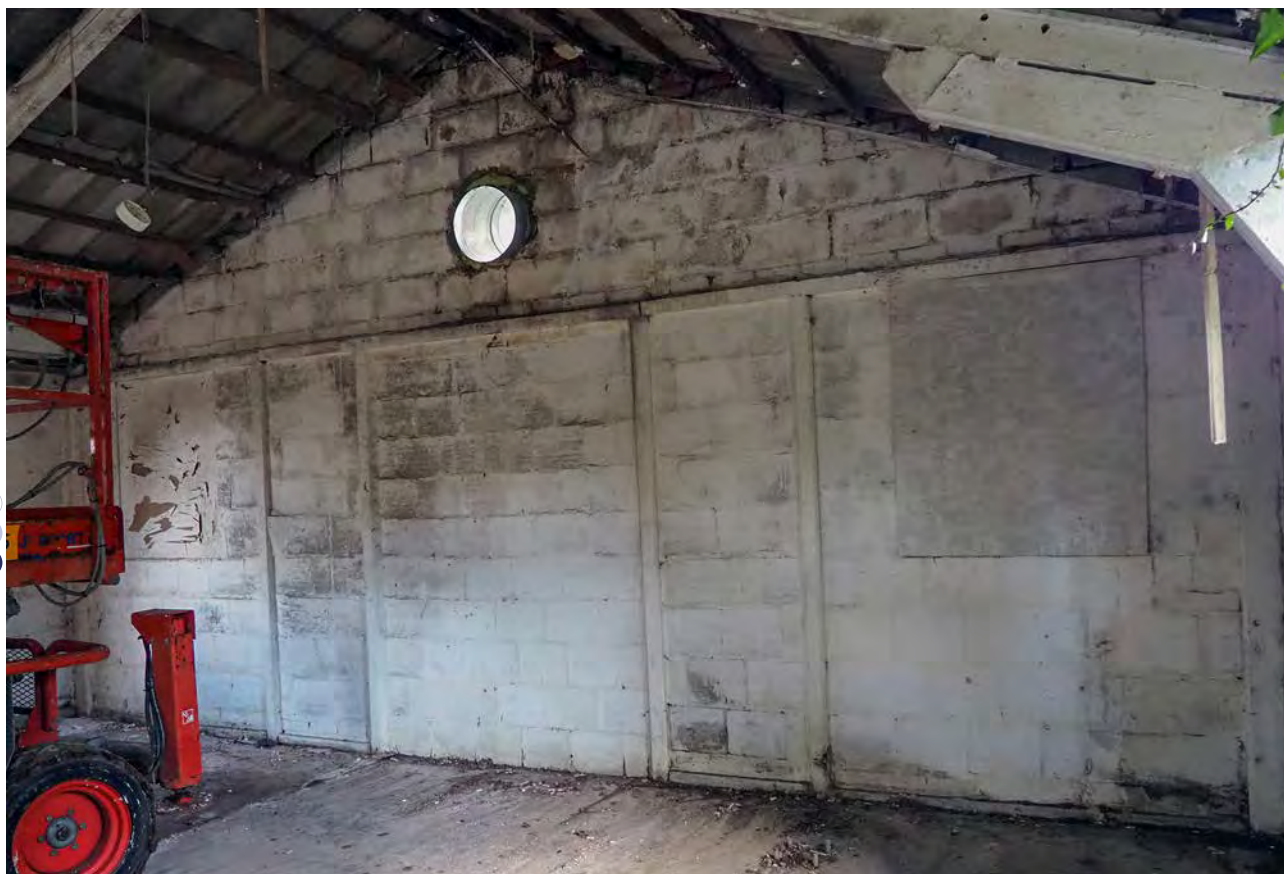
Plate 19: Building 3, internal view of rear elevation

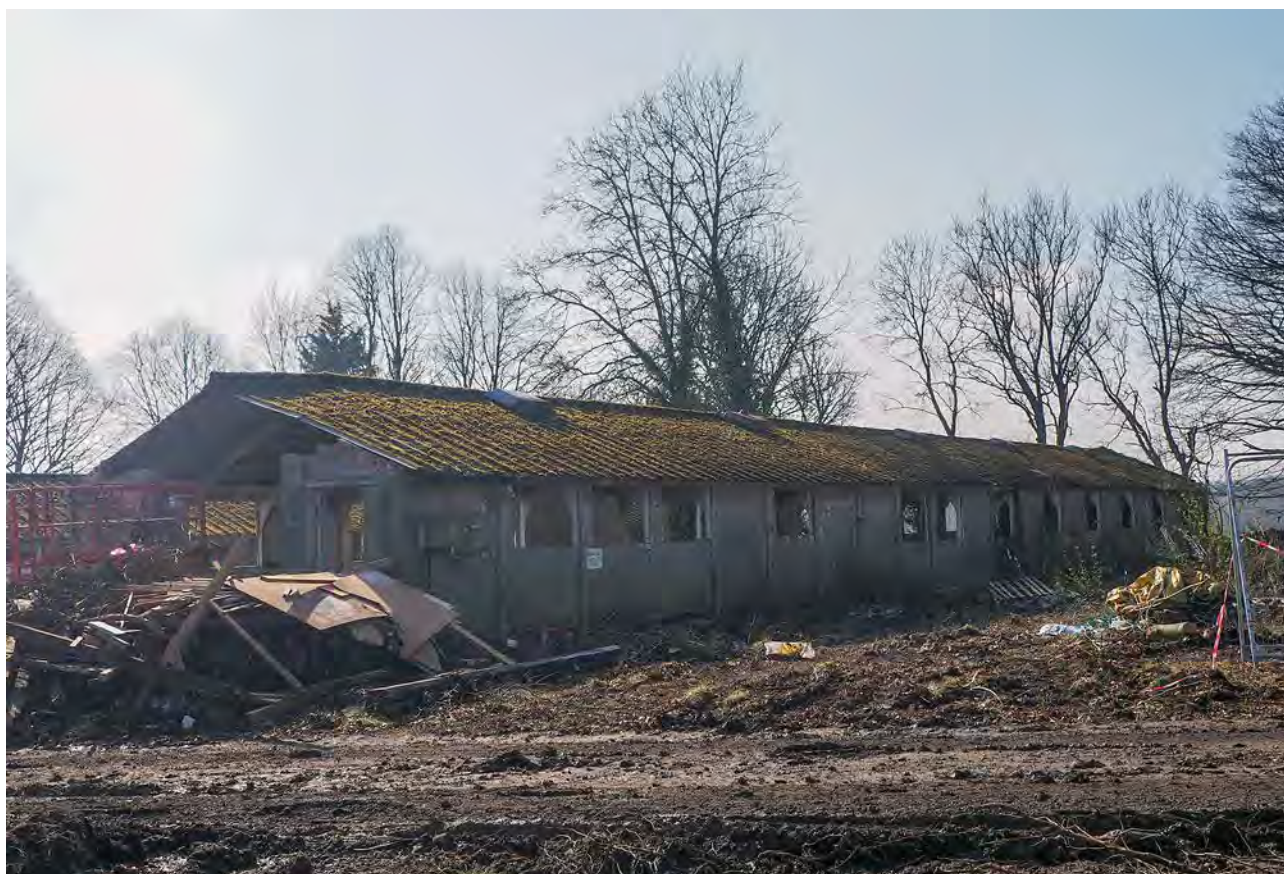
Plate 20: Building 4, front and west elevation
