# Ullenwood Court, Gloucestershire Former Second World War camp

## Historic Building Investigation and Recording

January 2021

**Client: Churcham Homes**

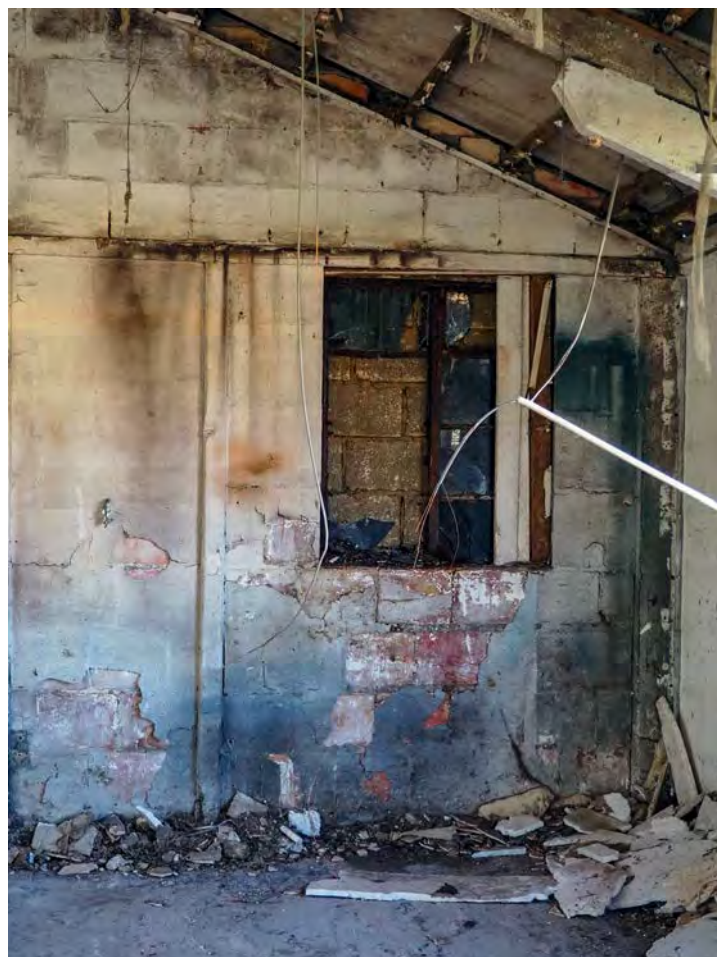
Plate 21: Building 4, internal view of rear elevation

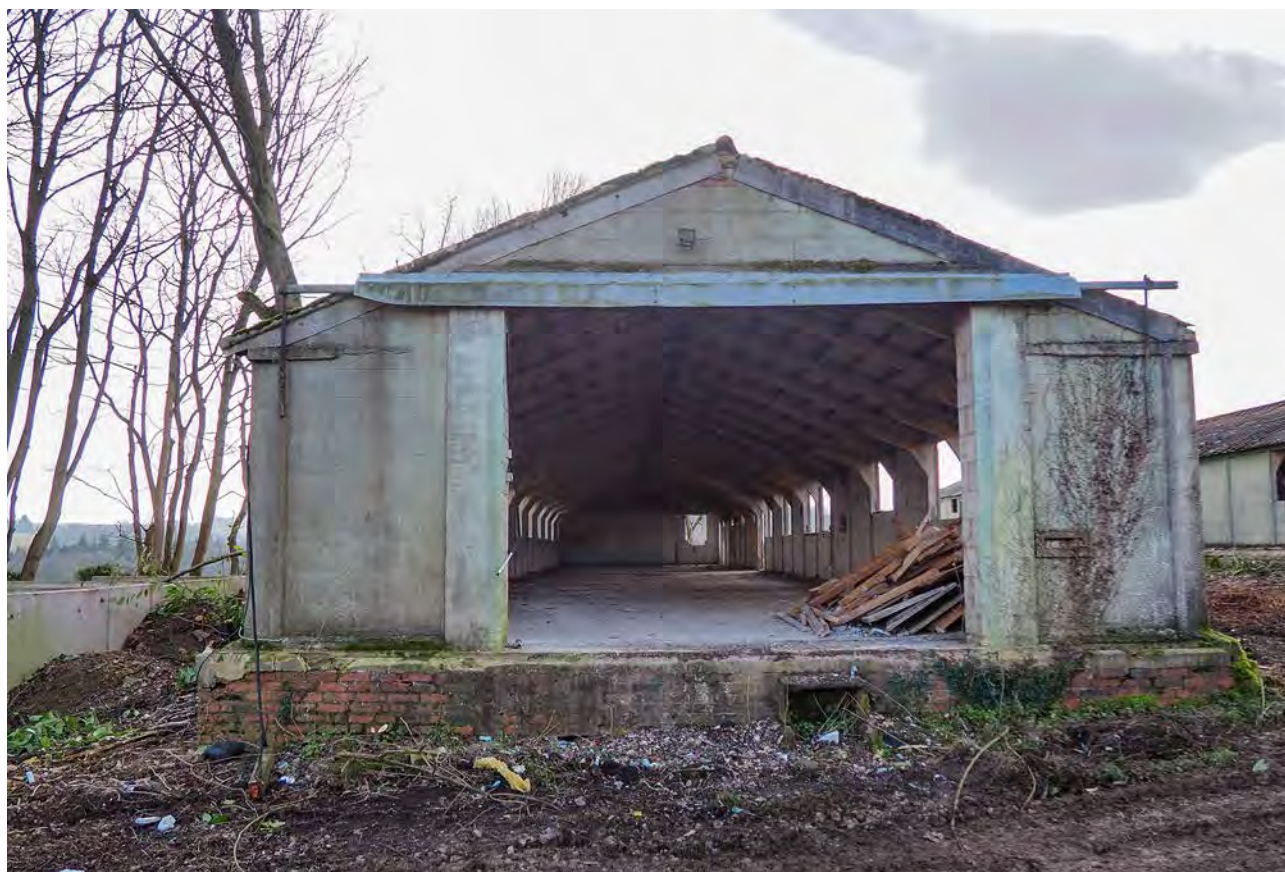
Plate 22: Building 5, front elevation

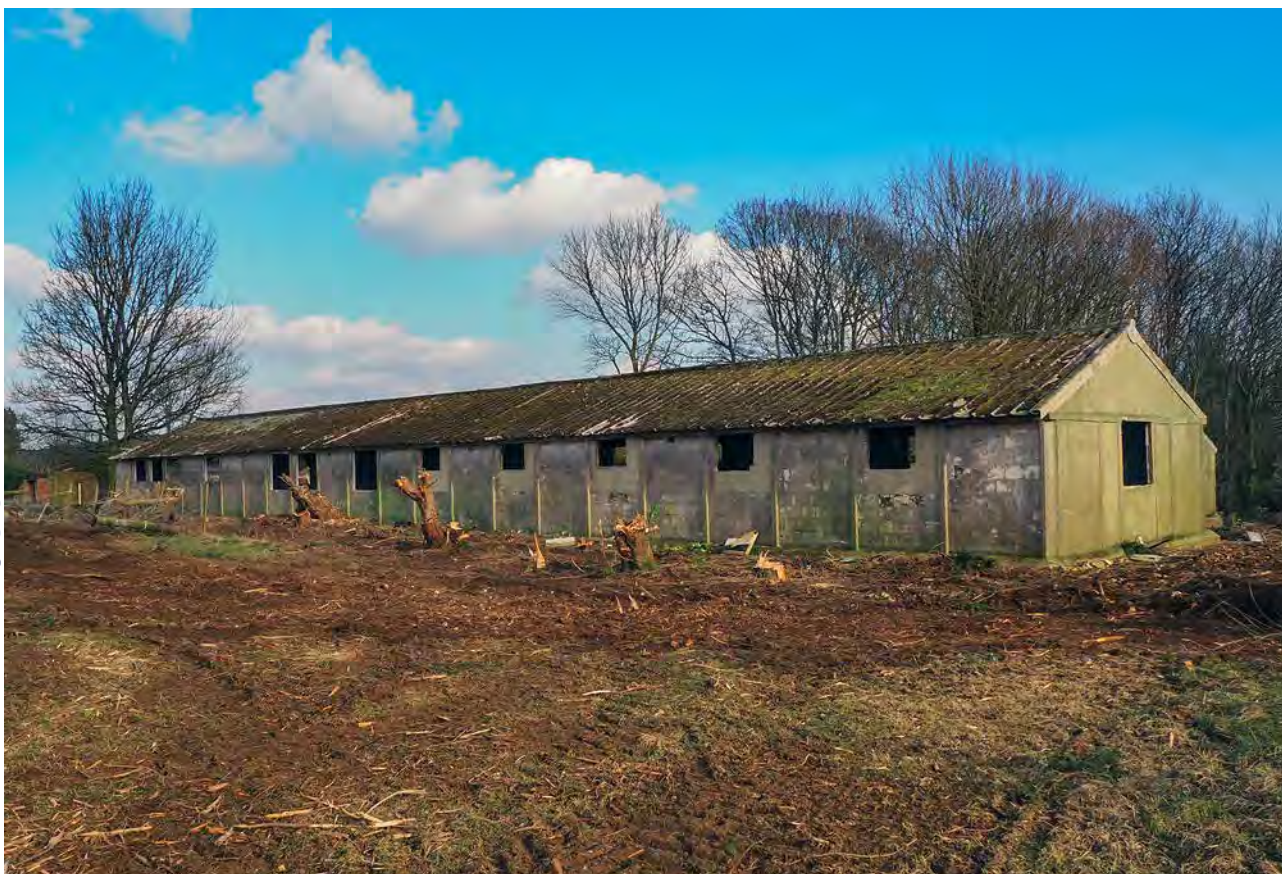
Plate 23: Building 6, front and west elevations

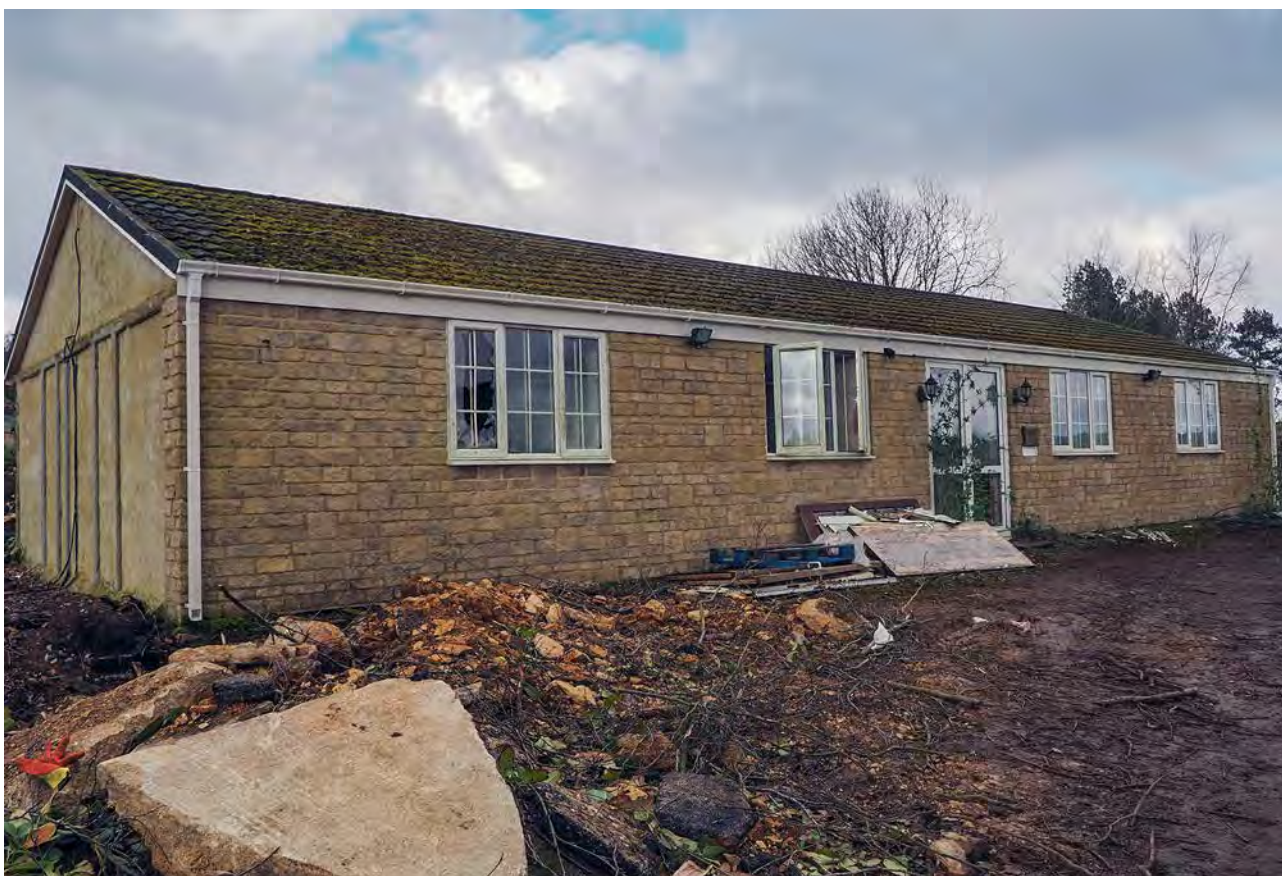
Plate 24: Building 7, east and south elevations

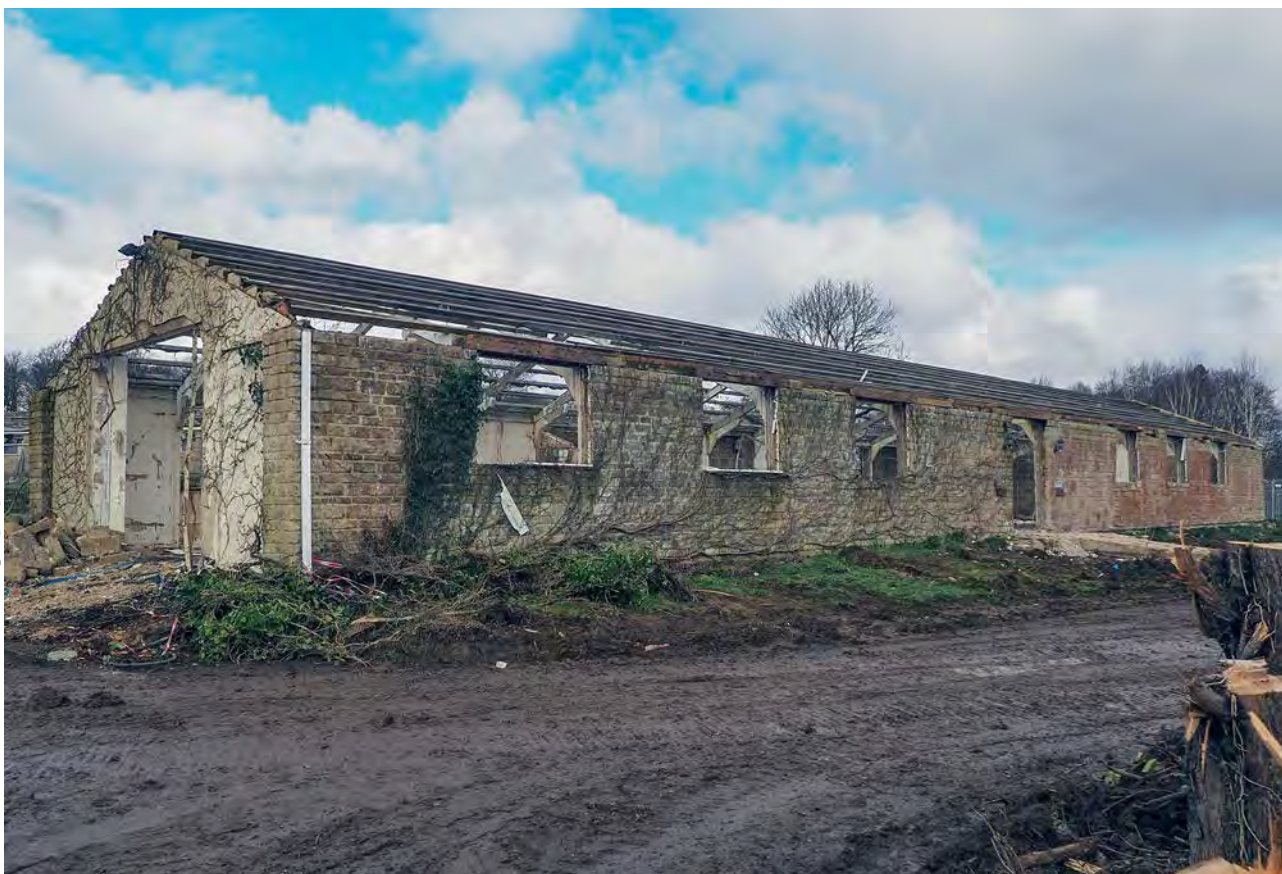
Plate 25: Building 8, east and south elevations

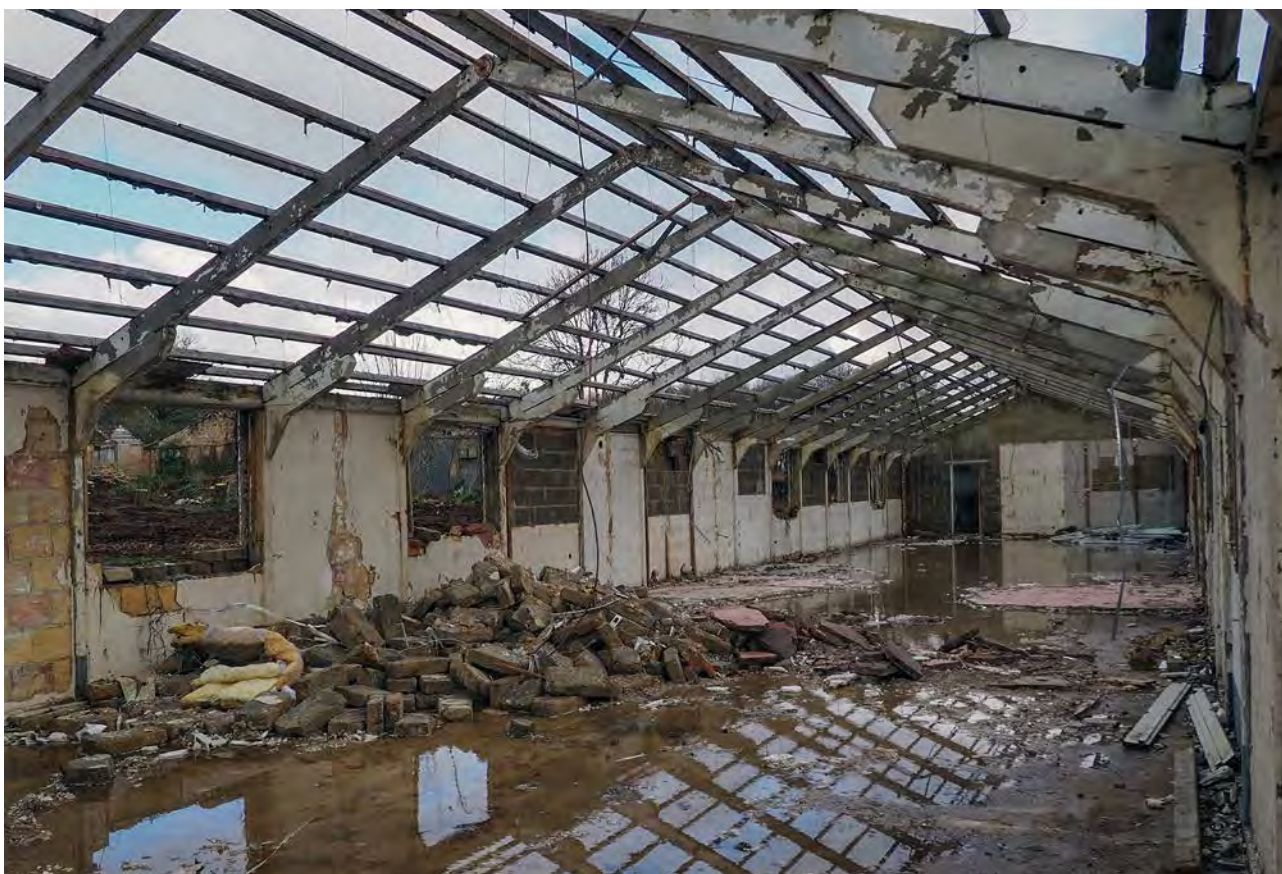
Plate 26: Building 8, internal (north) view

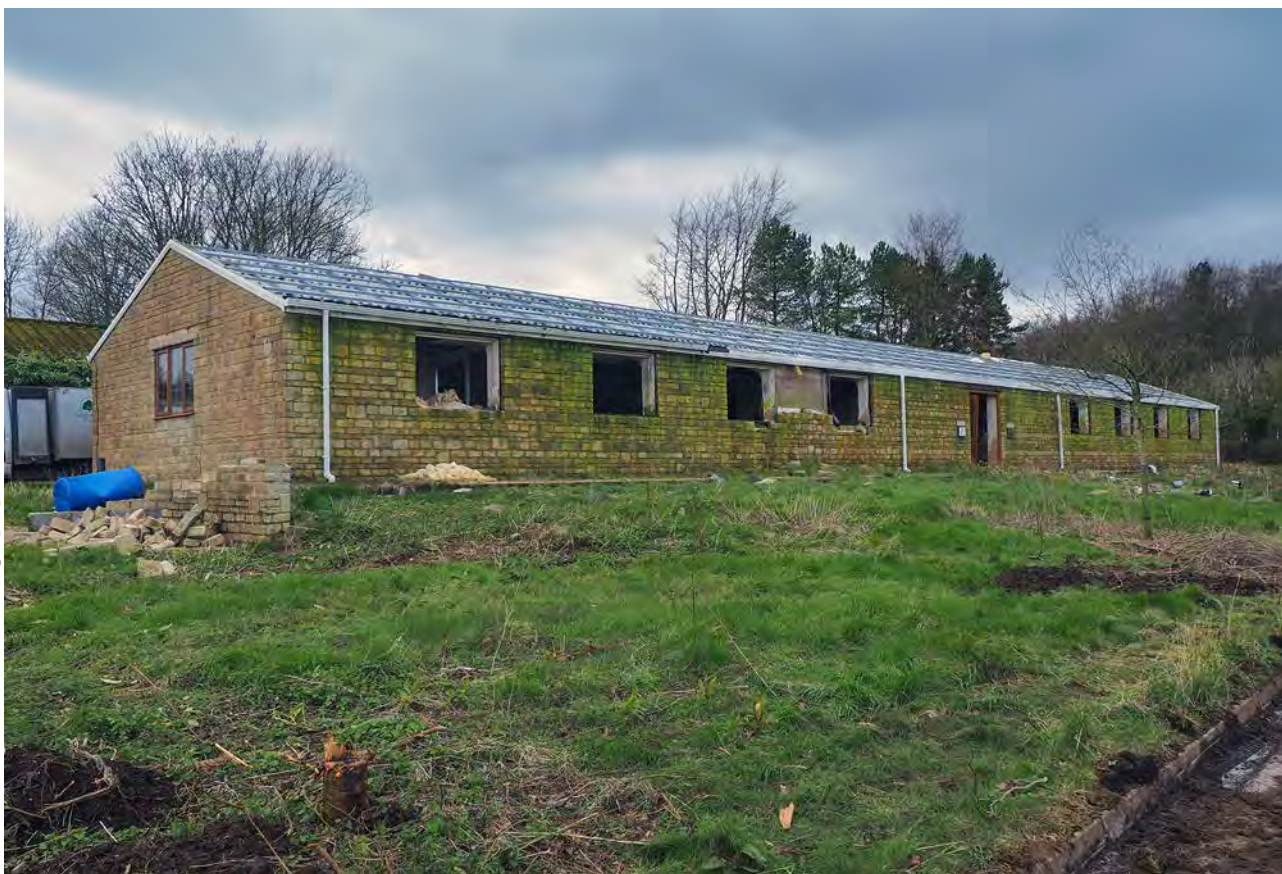
Plate 27: Building 9, east and south elevations

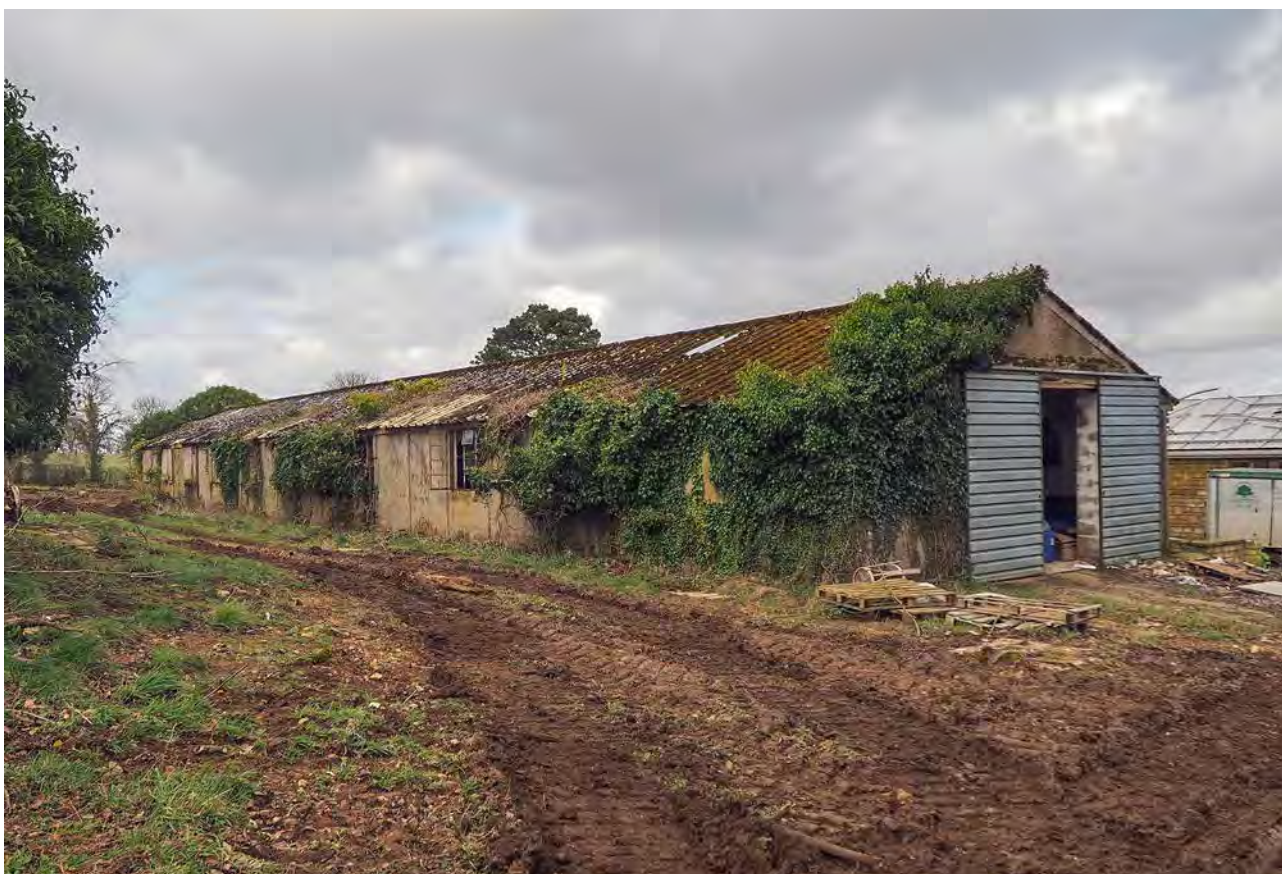
Plate 28: Building 10, front and west elevations

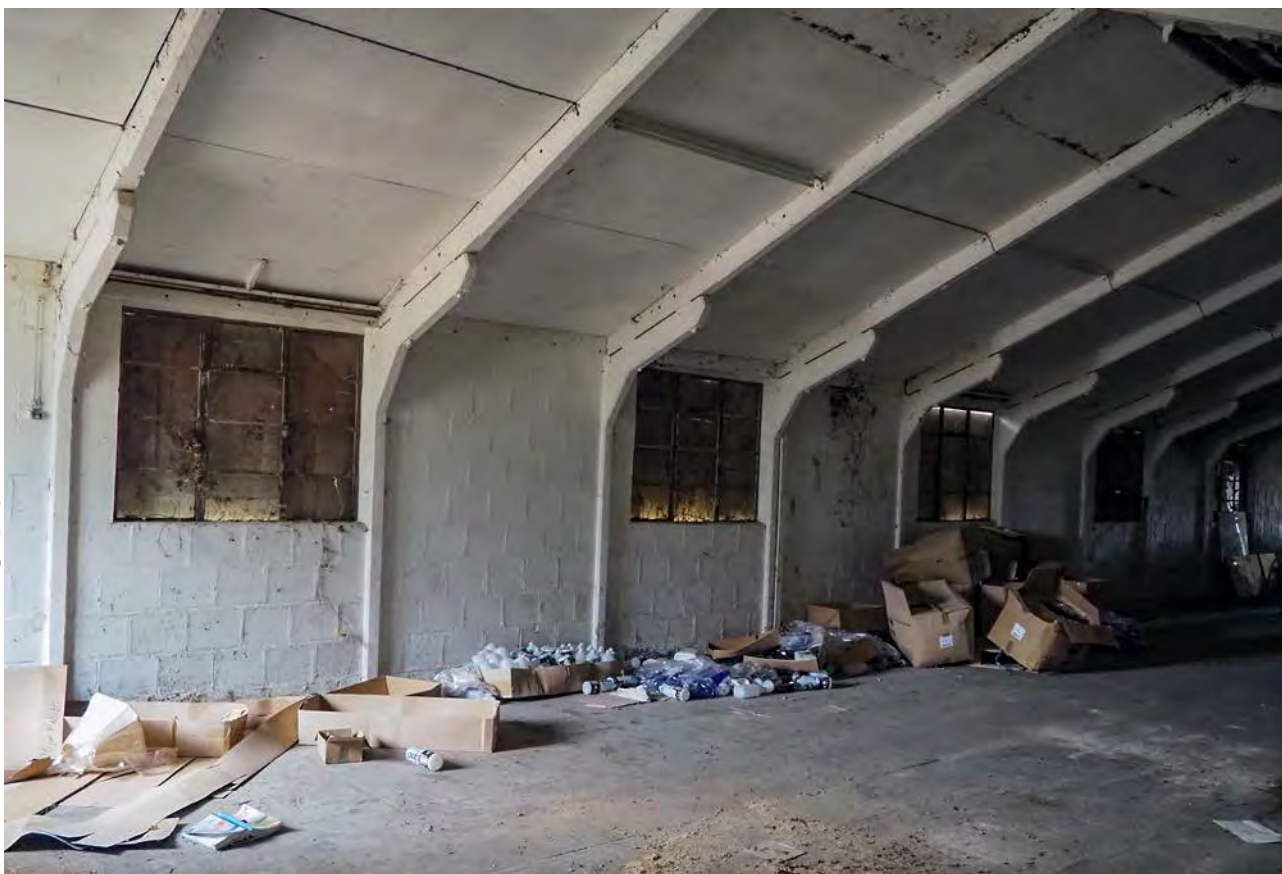
Plate 29: Building 10, internal view of portal frames and critted windows

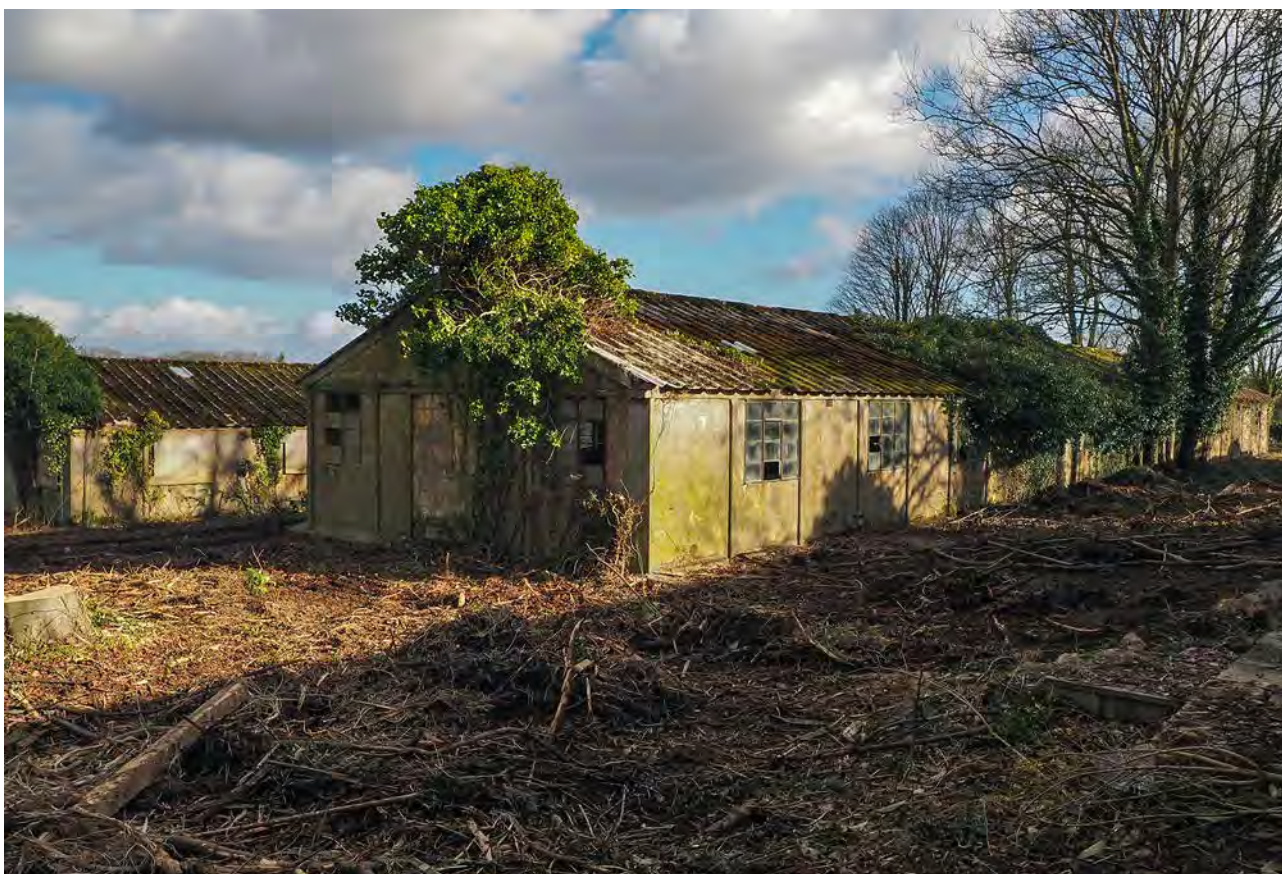
Plate 30: Building 11, rear and west elevations

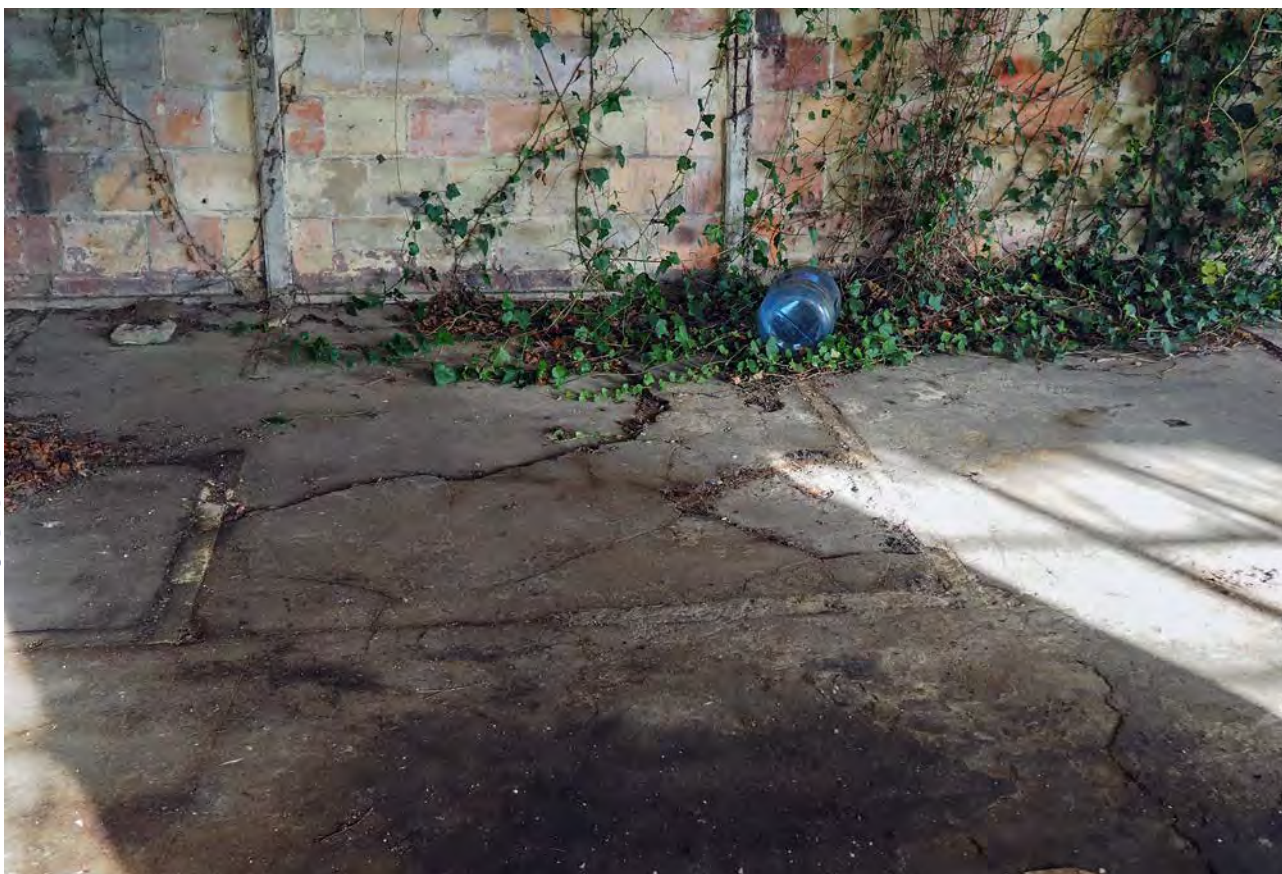
Plate 31: Building 11, internal floor markings to rear

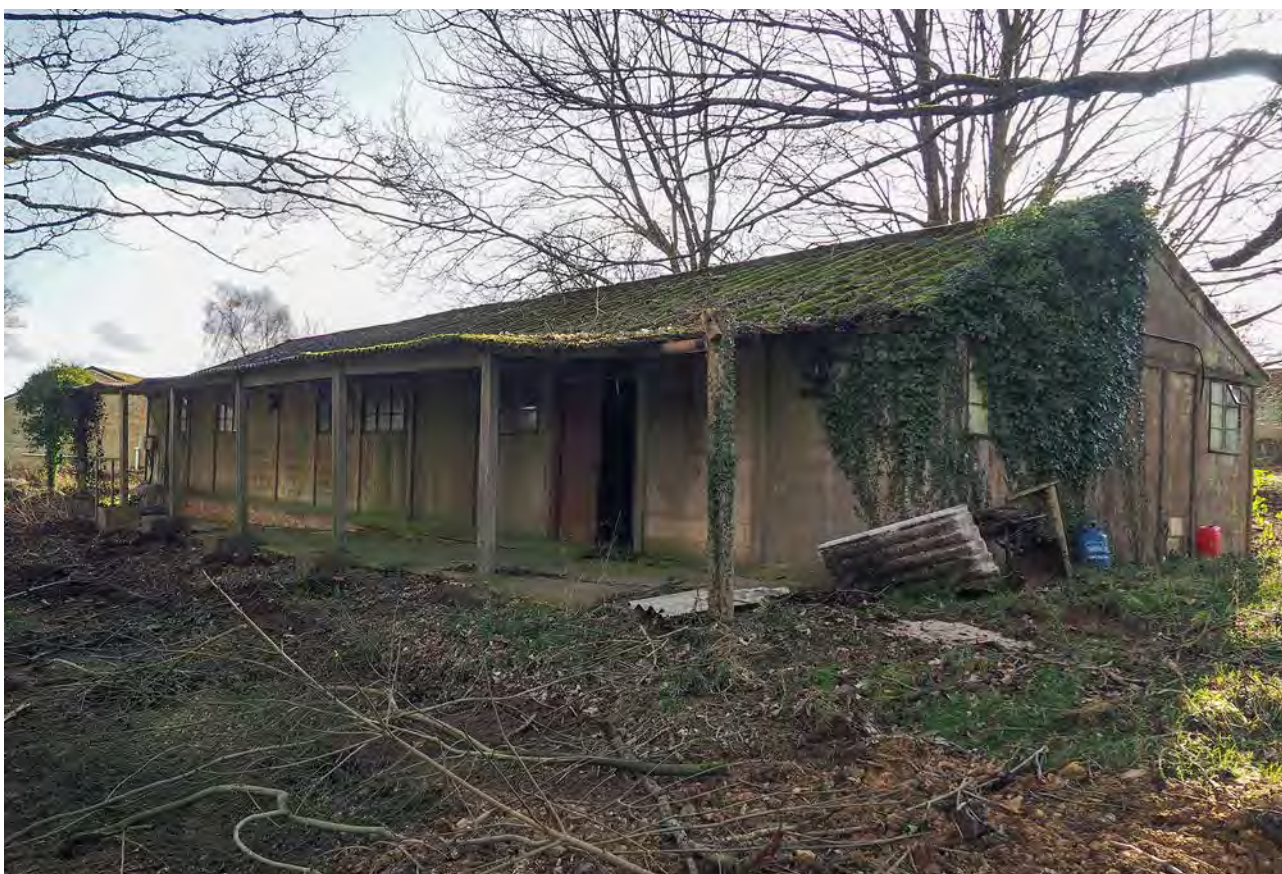
Plate 32: Building 12, north and east elevations

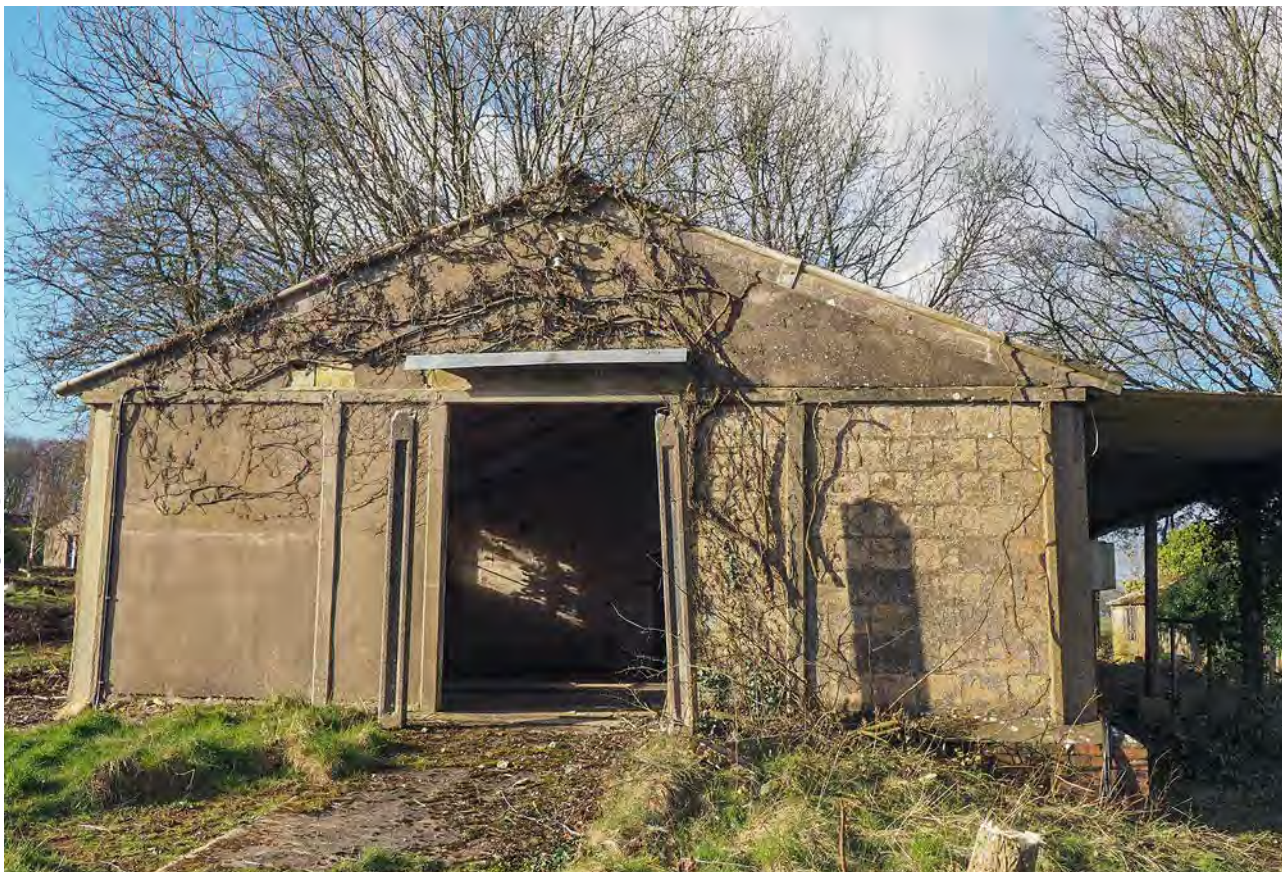
Plate 33: Building 12, front elevation

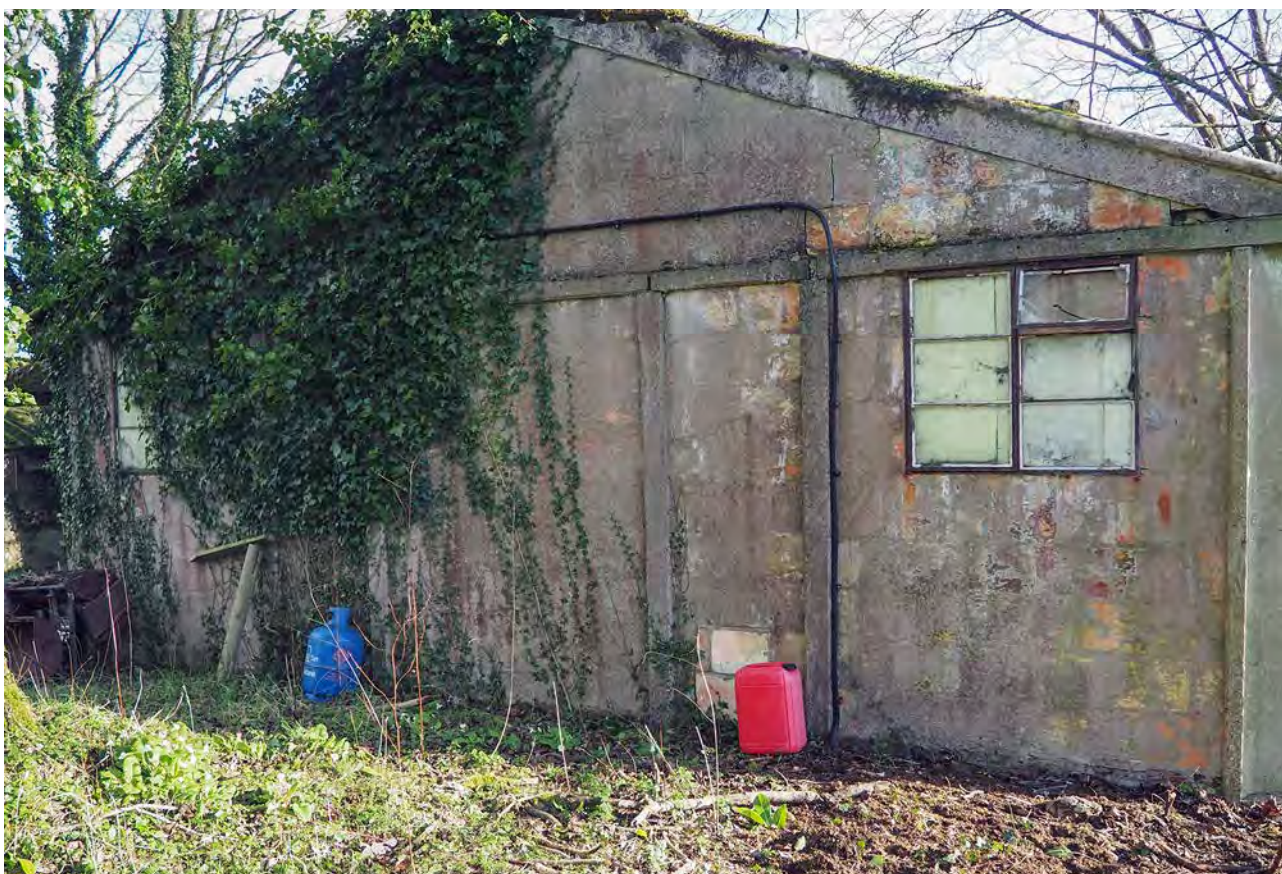
Plate 34: Building 12, rear elevation

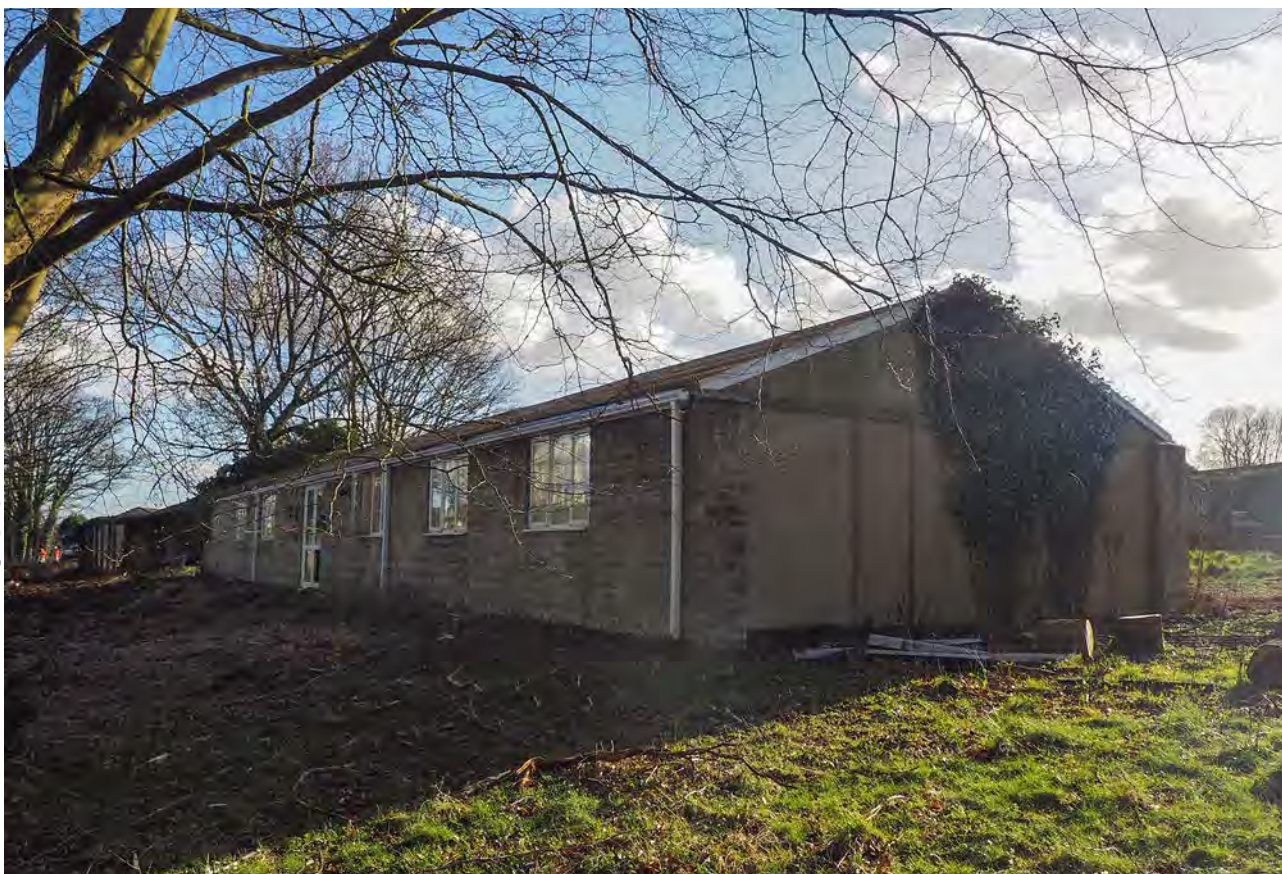
Plate 35: Building 13, south and west elevations

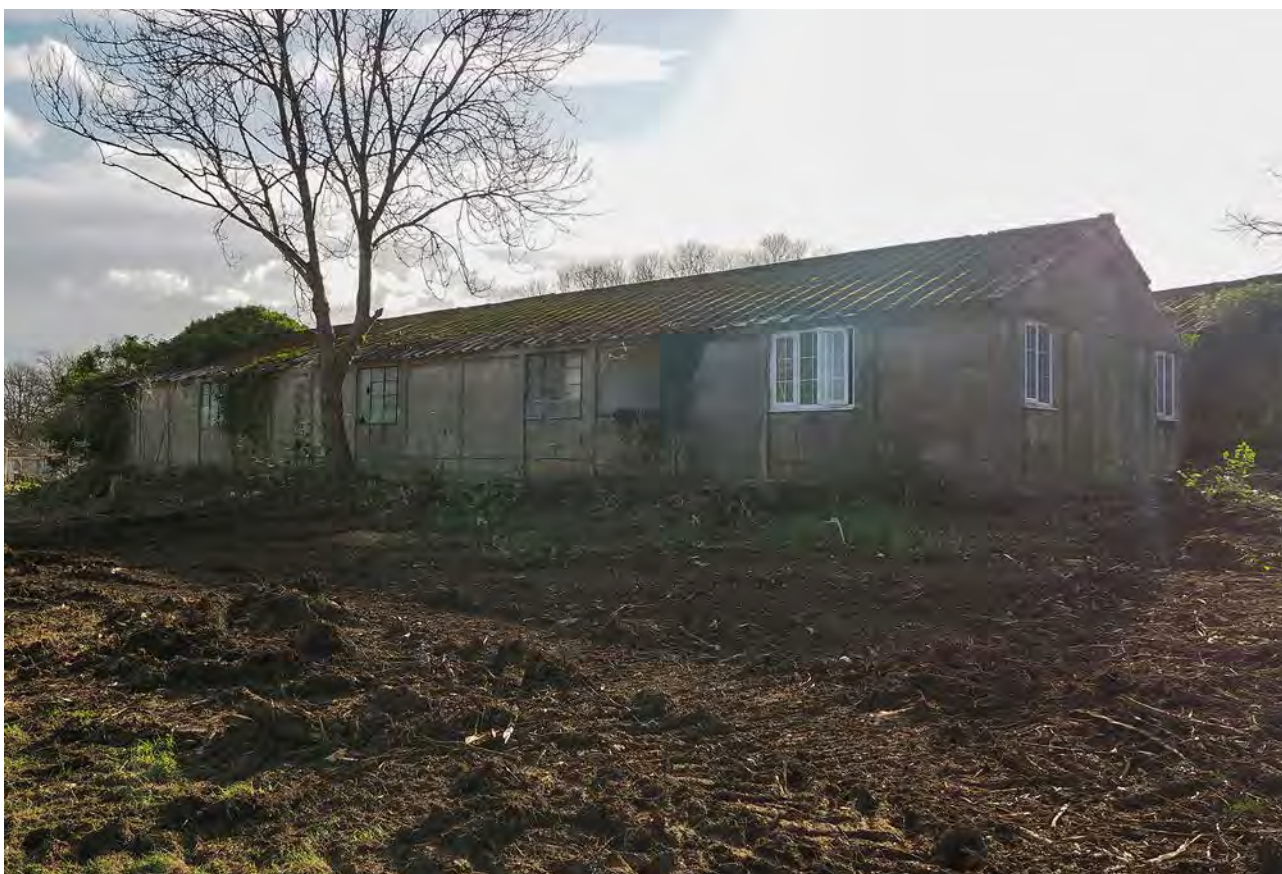
Plate 36: Building 14, north and east elevations

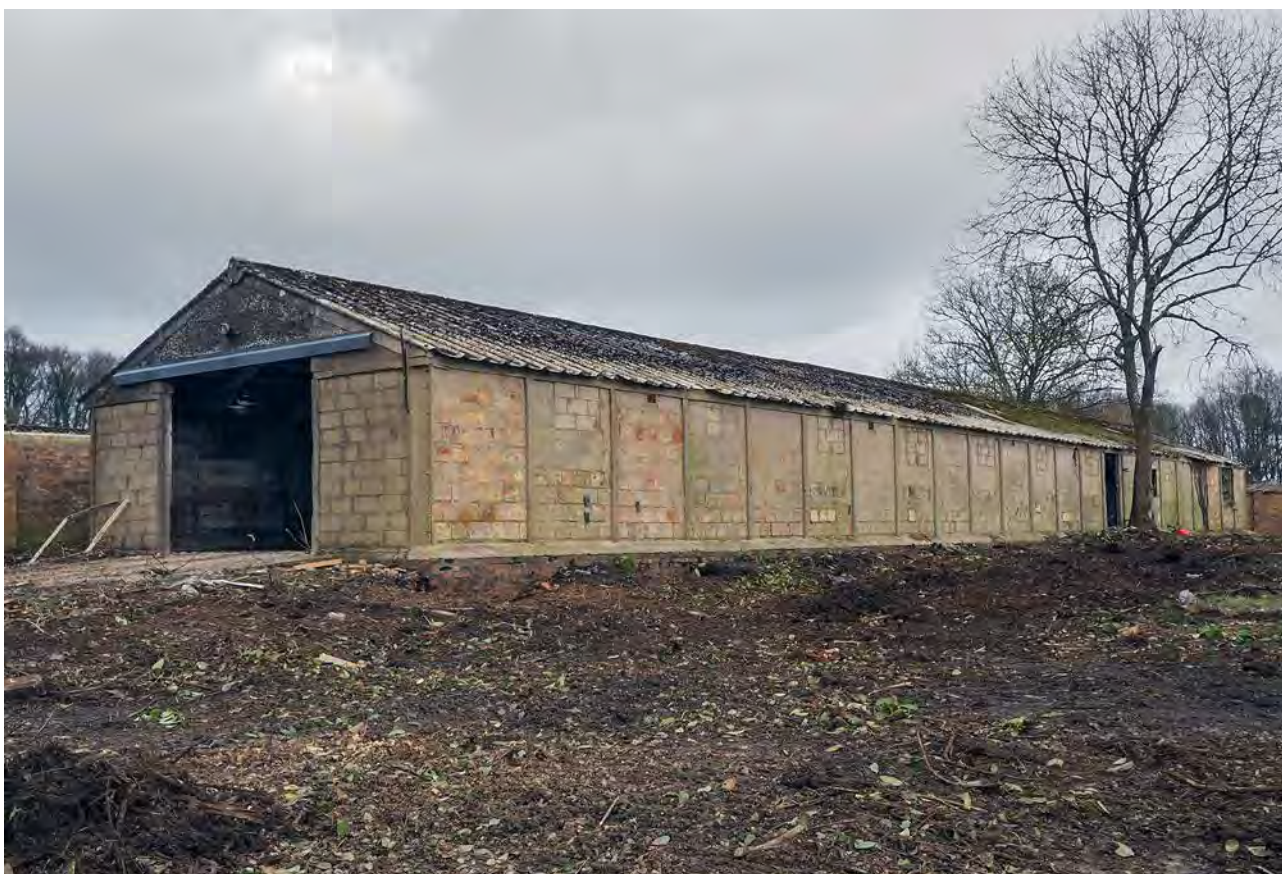
Plate 38: Building 16, south and east elevations

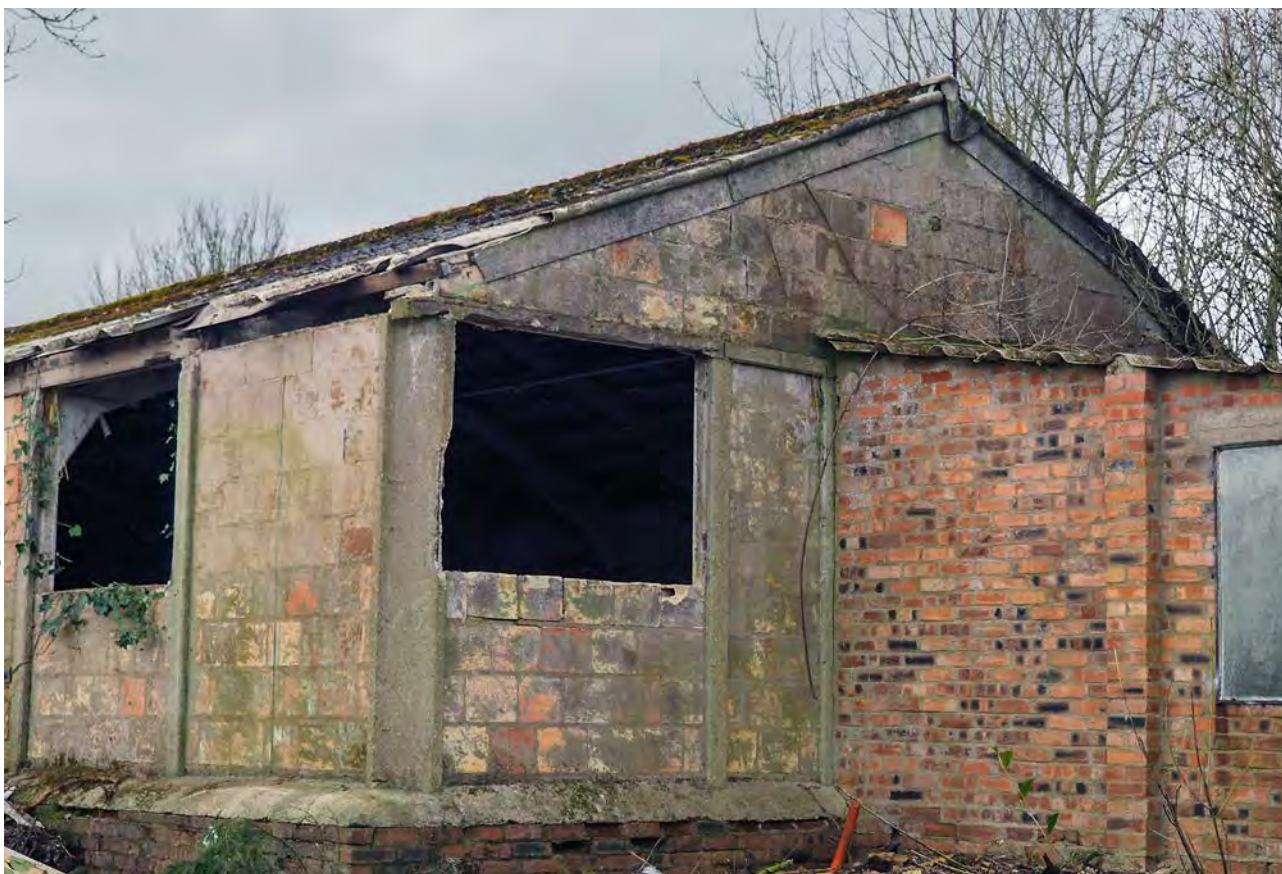
Plate 39: Building 16, rear elevation showing linking tunnel to building 19

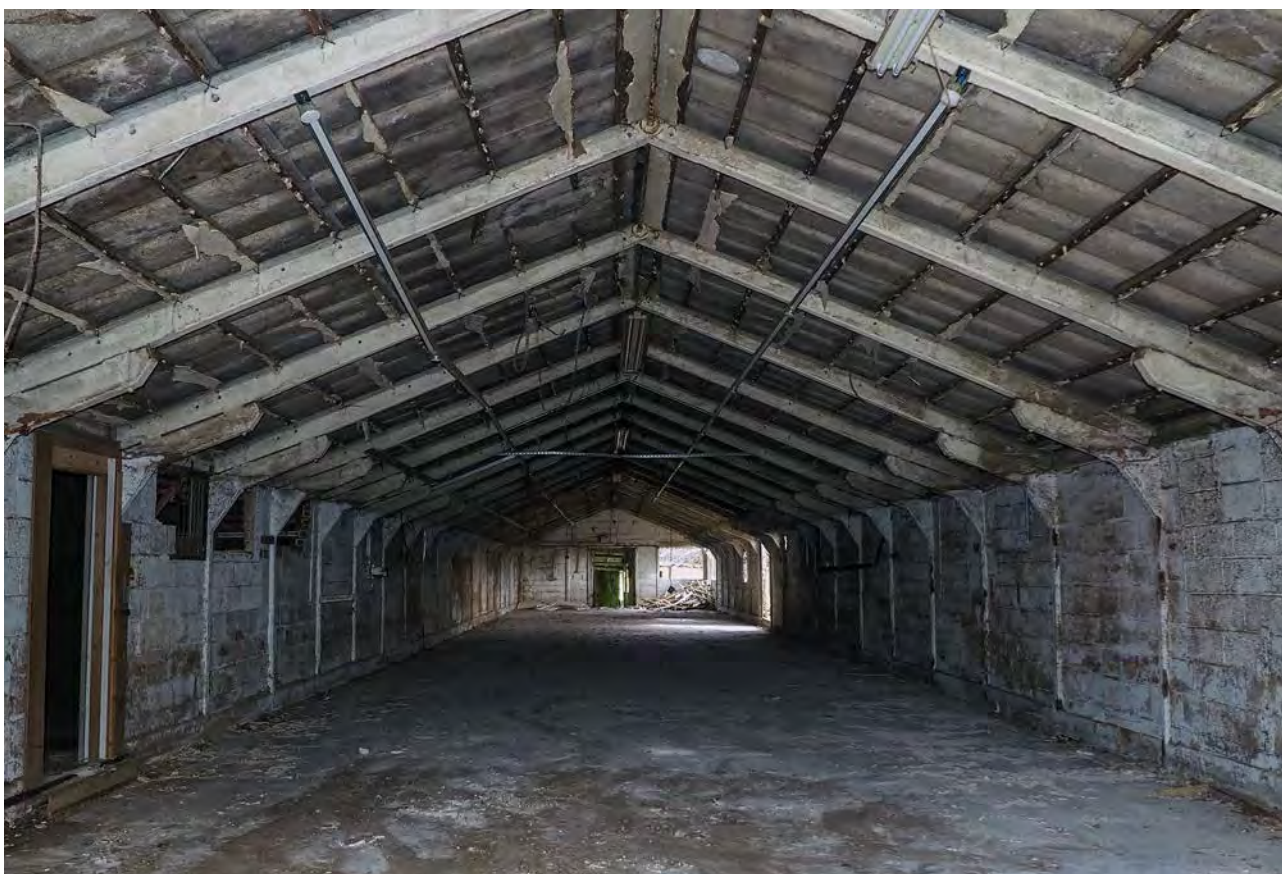
Plate 40: Building 16, internal view looking north

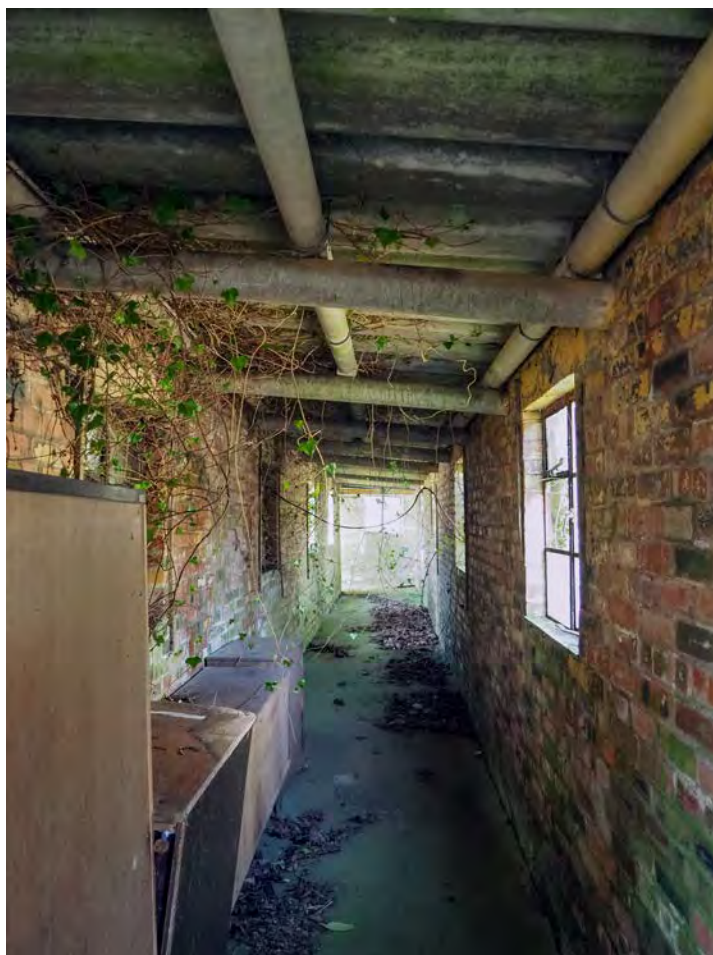
Plate 41: Tunnel to west of building 16, looking north

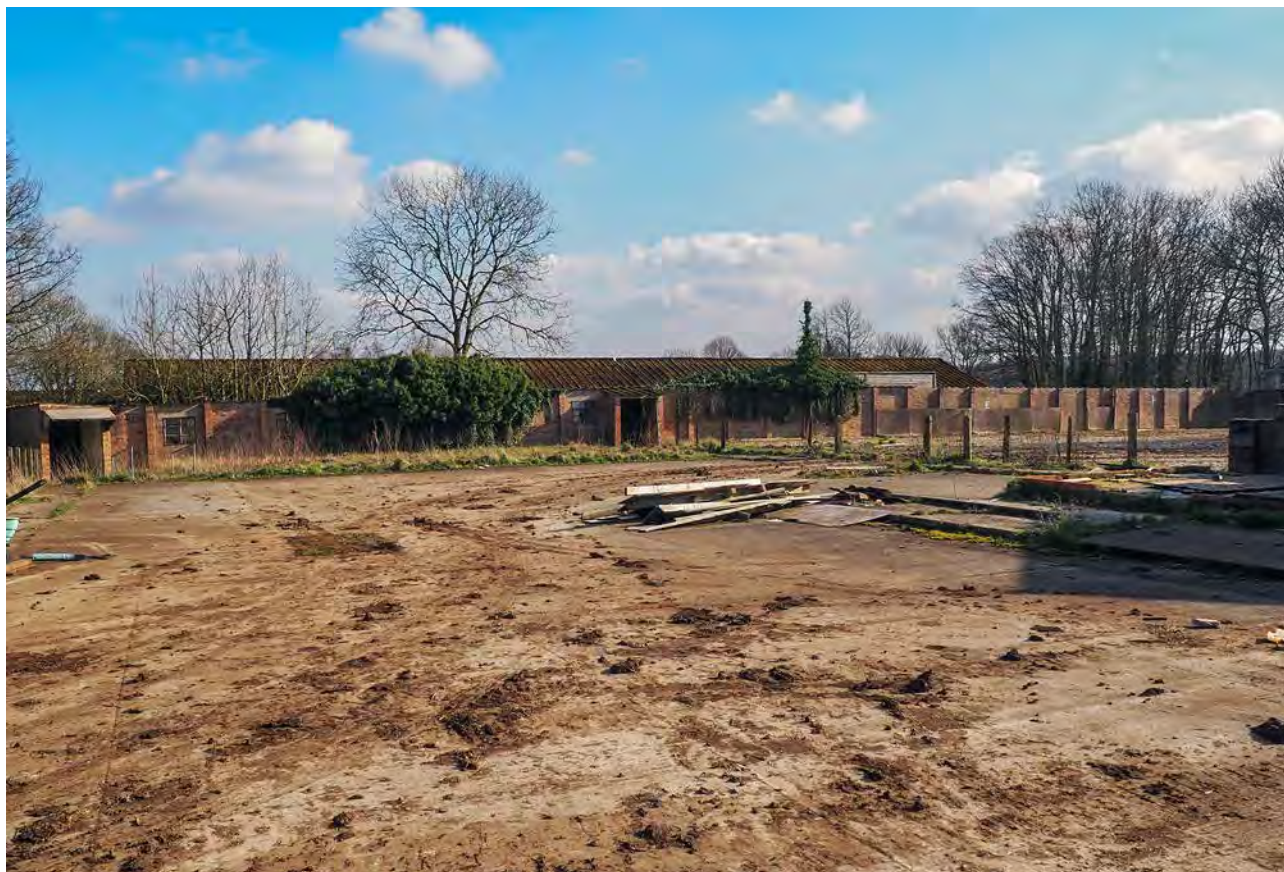
Plate 42: Riding school between buildings 16 and 17
