# Ullenwood Court, Gloucestershire Former Second World War camp

## Historic Building Investigation and Recording

January 2021

**Client: Churcham Homes**

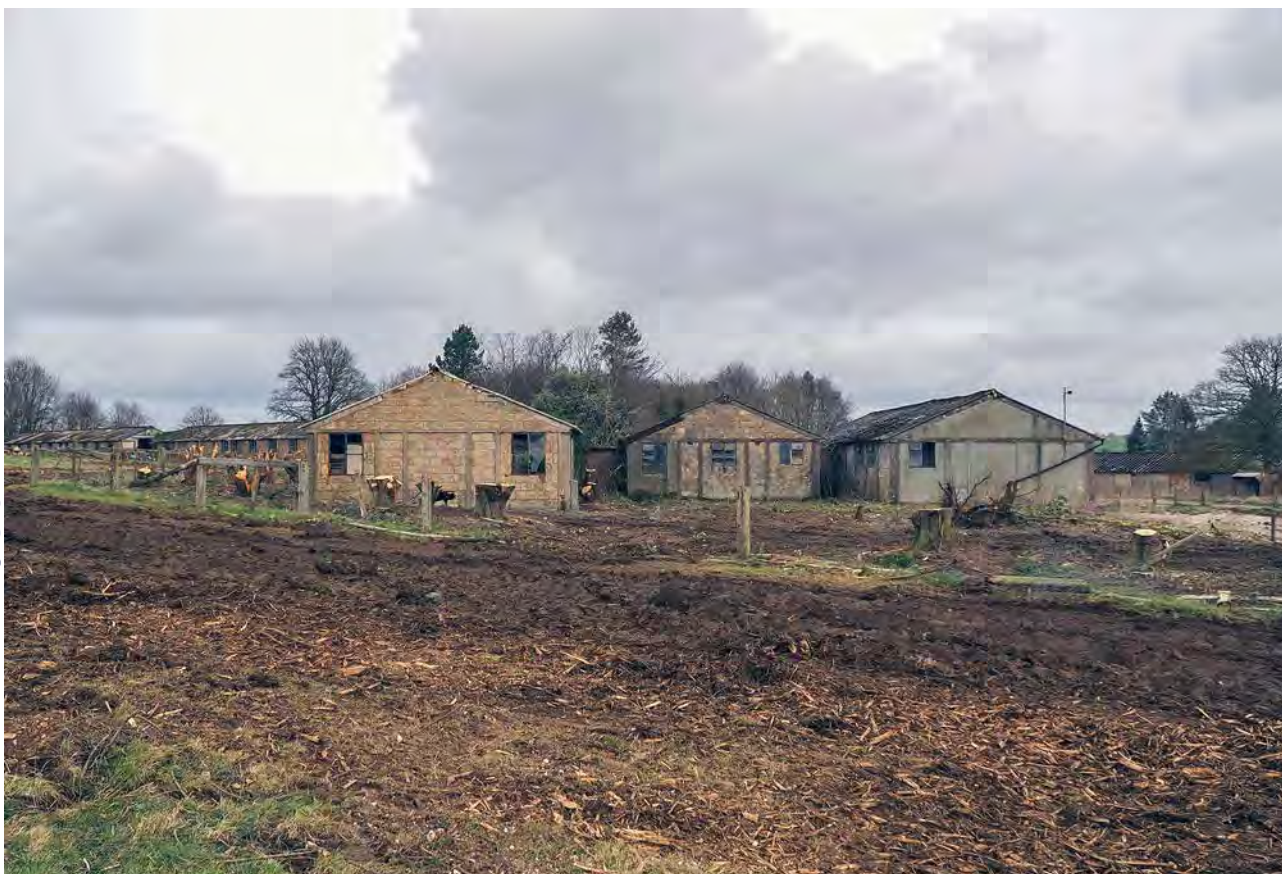
Plate 43: Building 17 (three elements), rear elevations

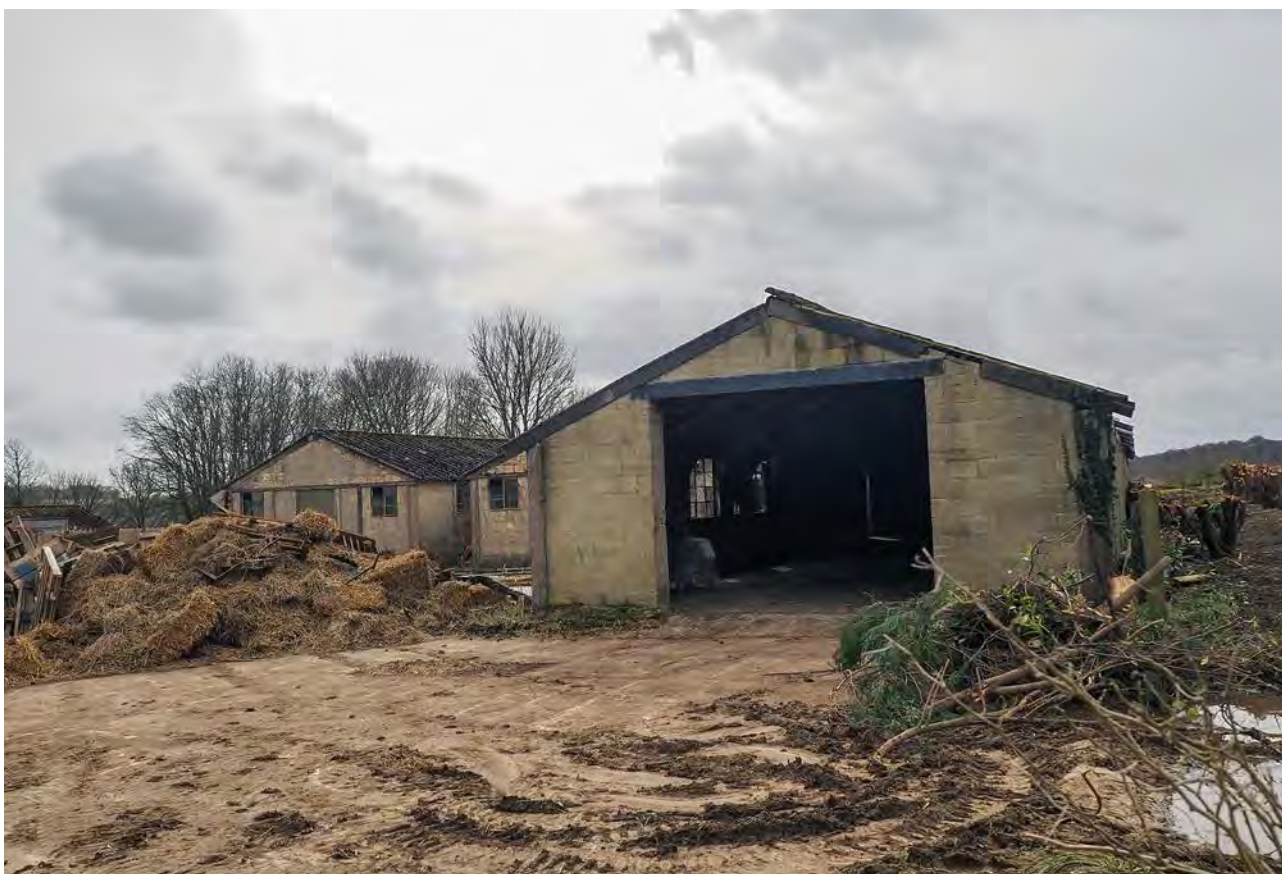
Plate 44: Building 17 (three elements), front elevations

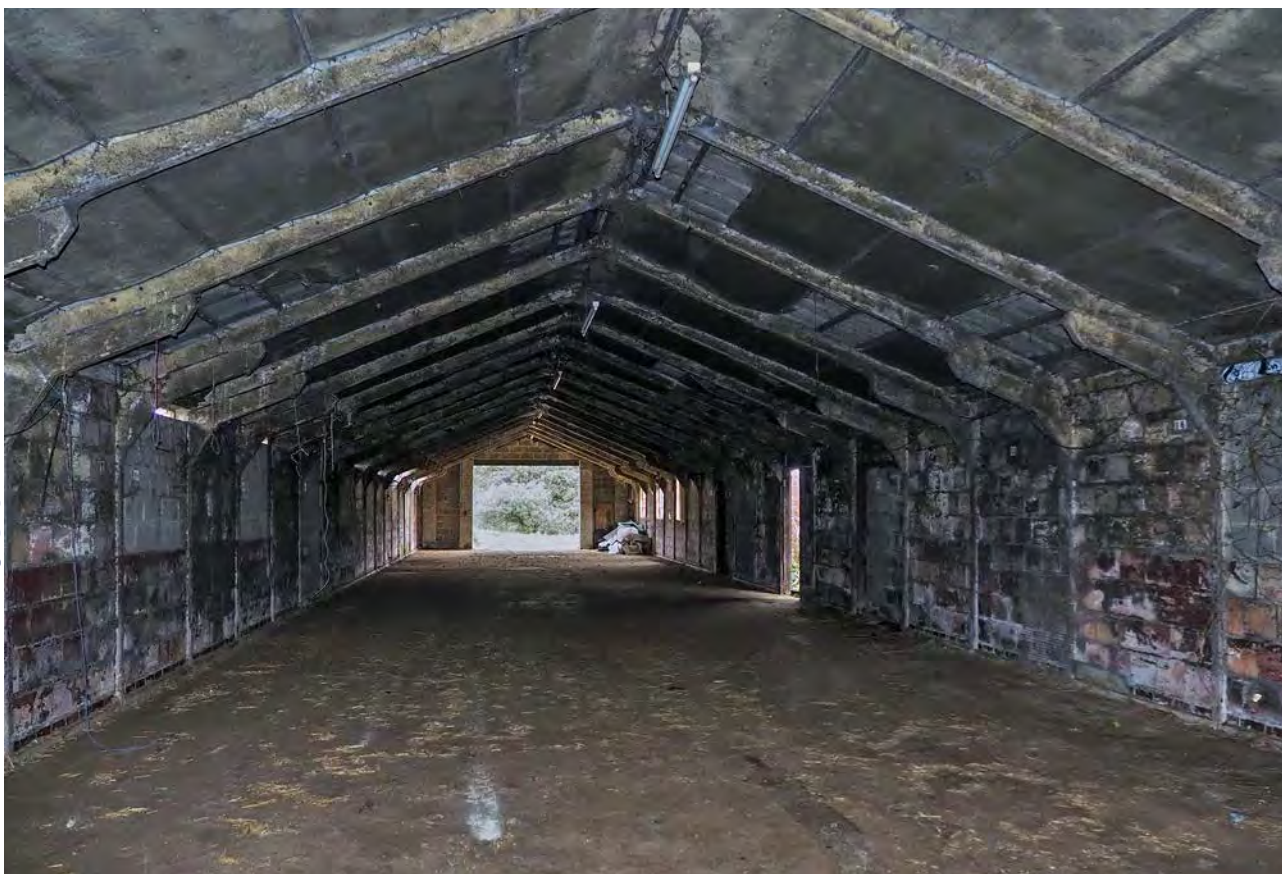
Plate 45: Building 17 (west element), looking north

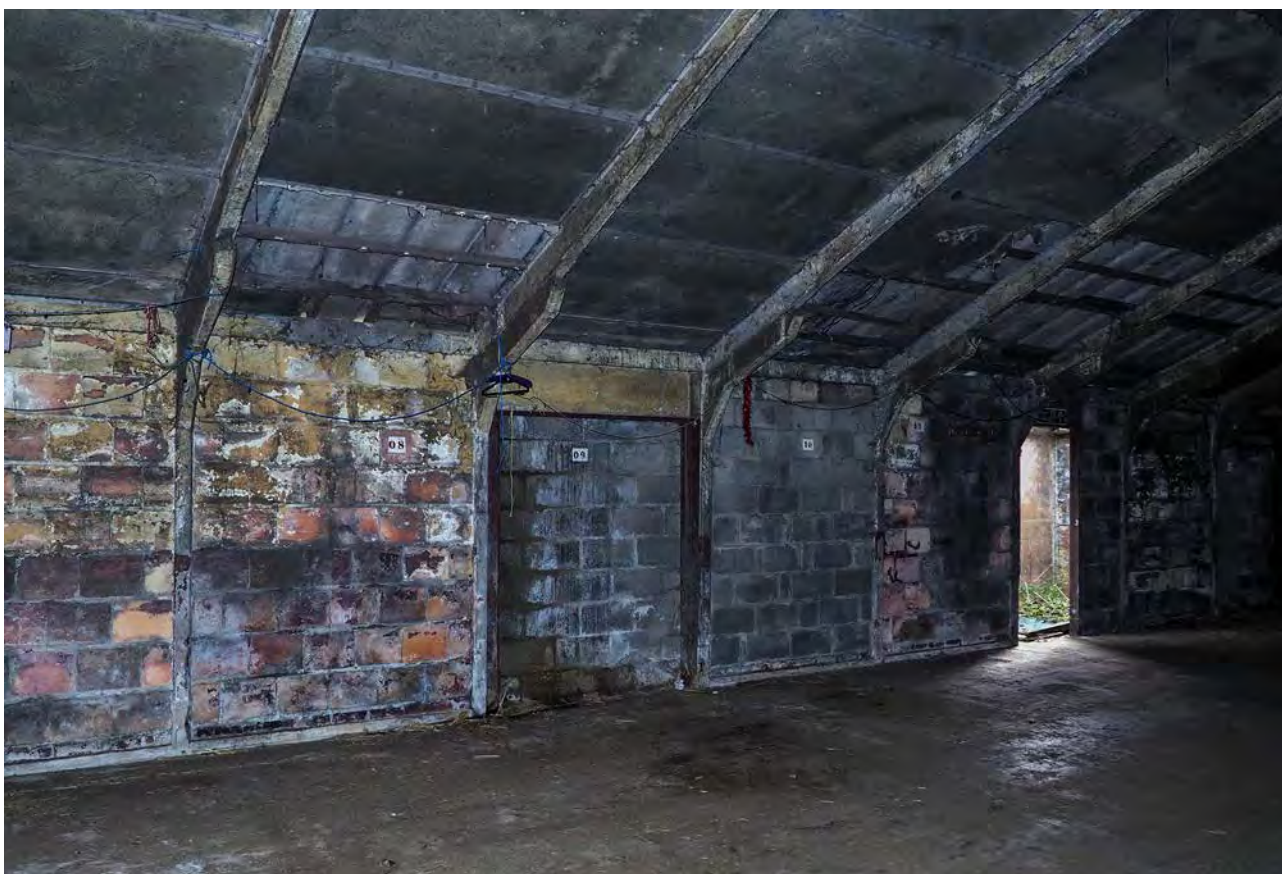
Plate 46: Building 17 (west element), internal view of east elevation

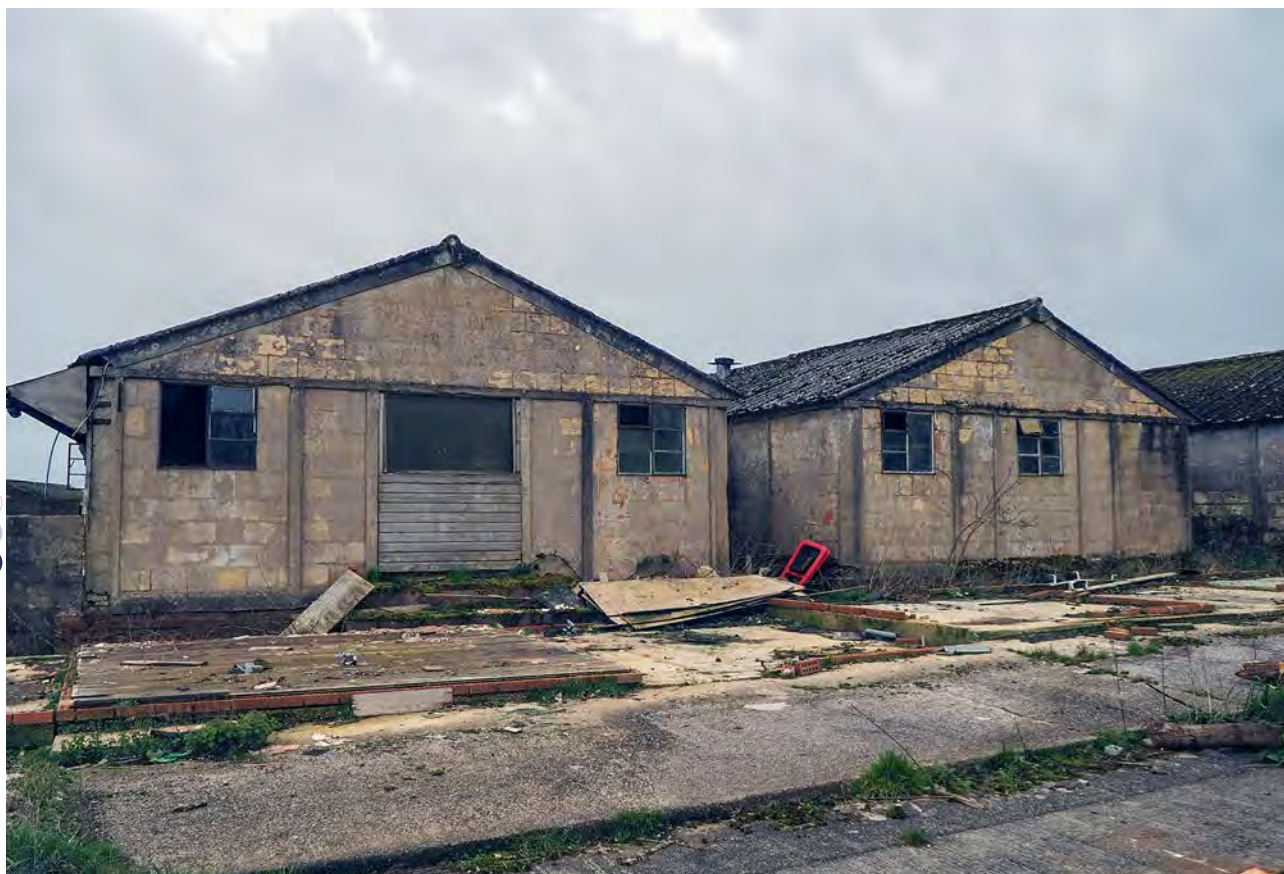
Plate 47: Building 17 (central and east elements), front elevations

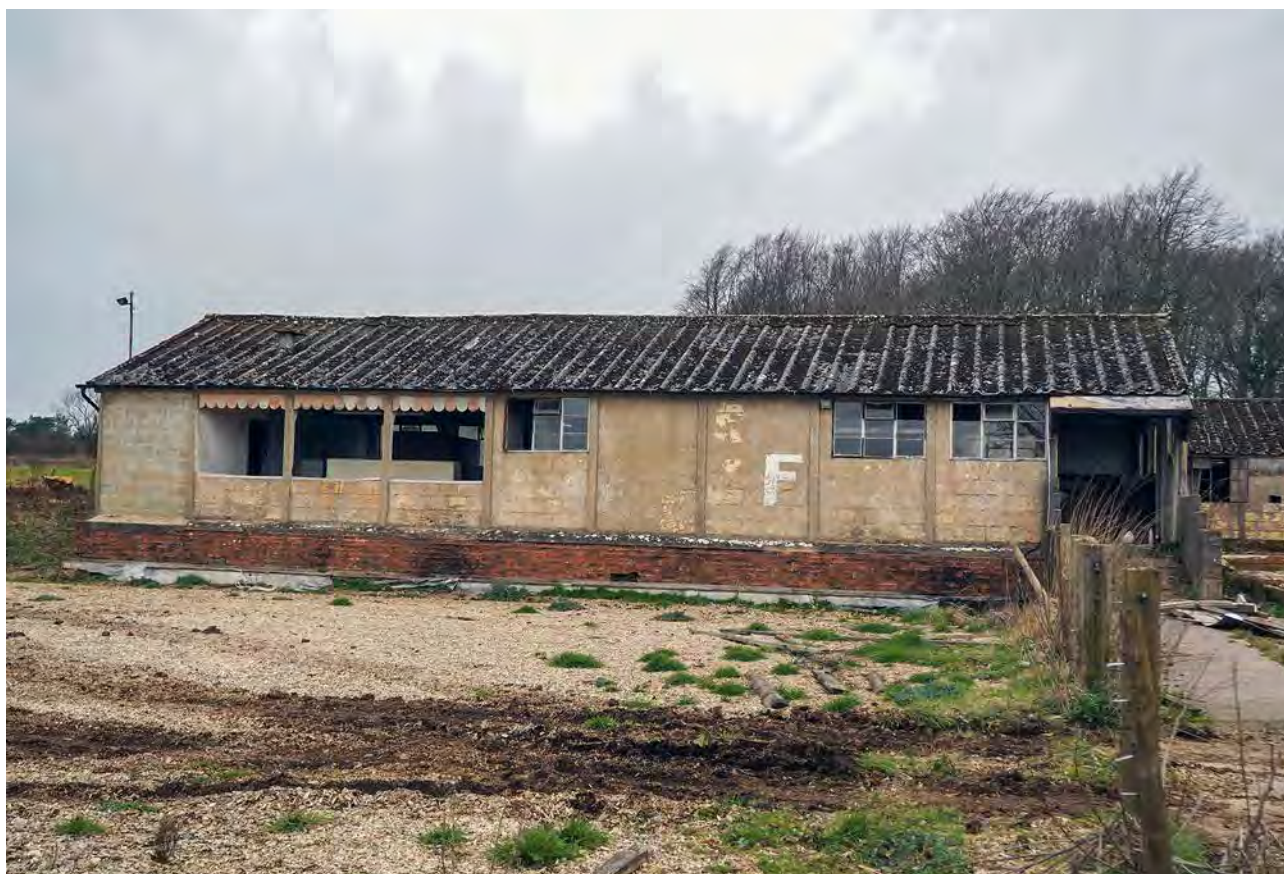
Plate 48: Building 17 (east element), east elevation

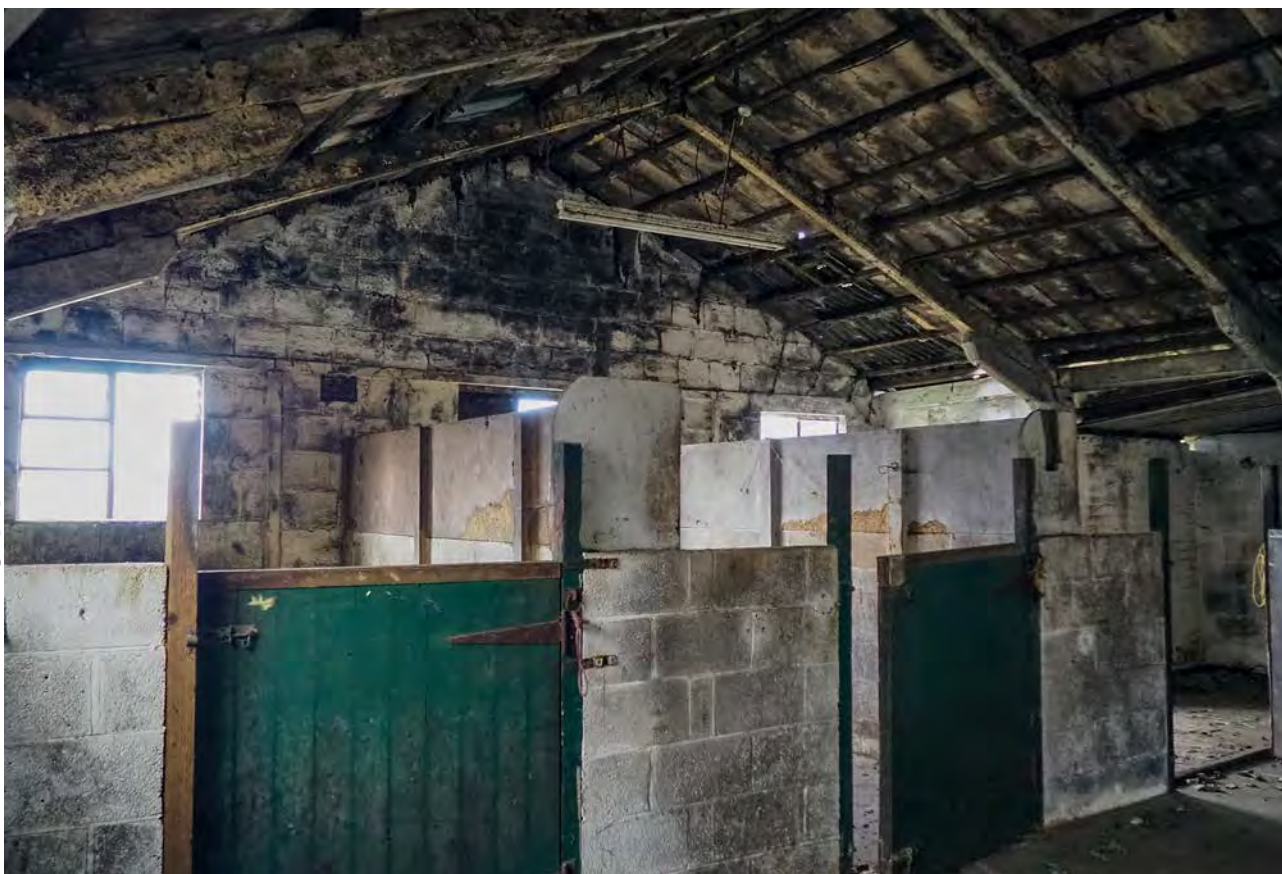
Plate 49: Building 17 (east element), internal view

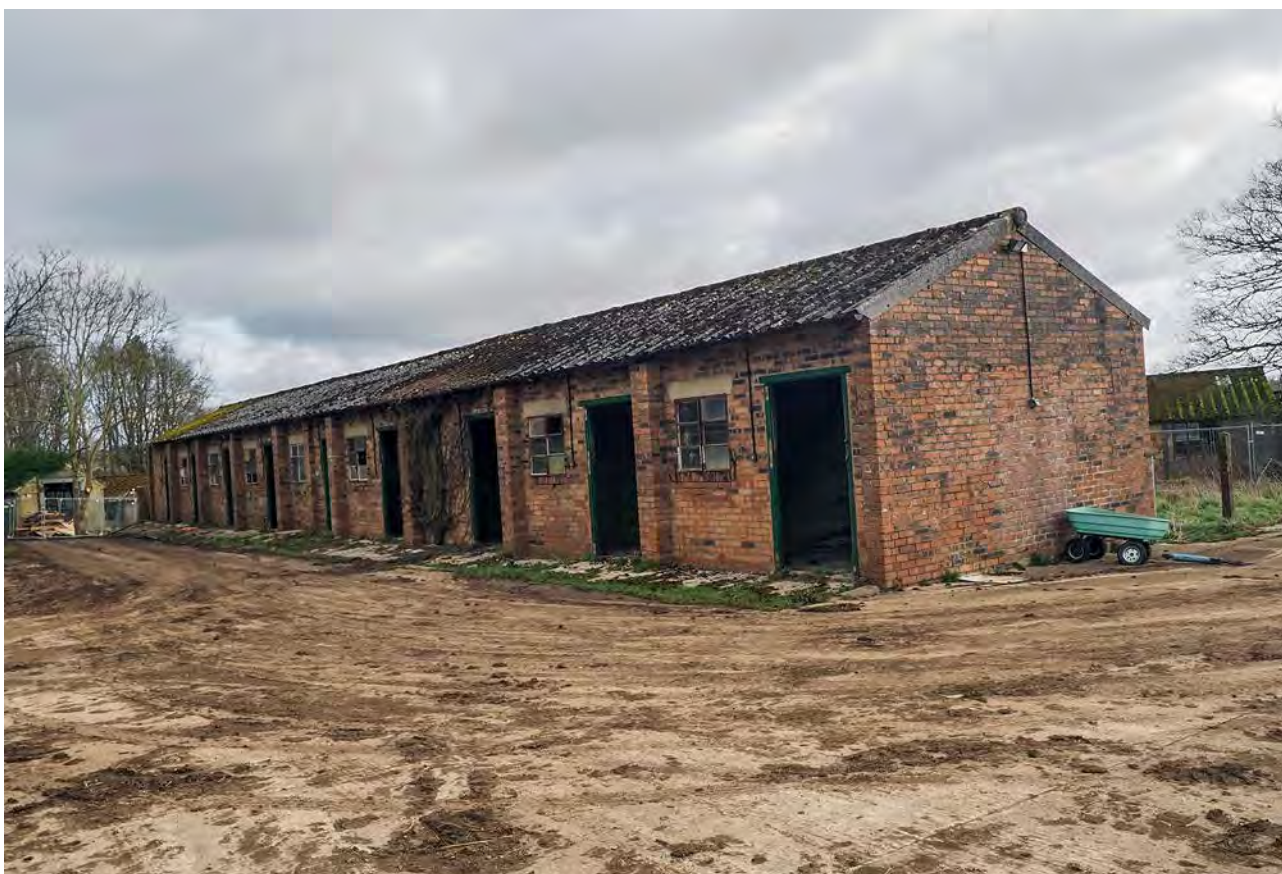
Plate 50: Building 18, front elevation

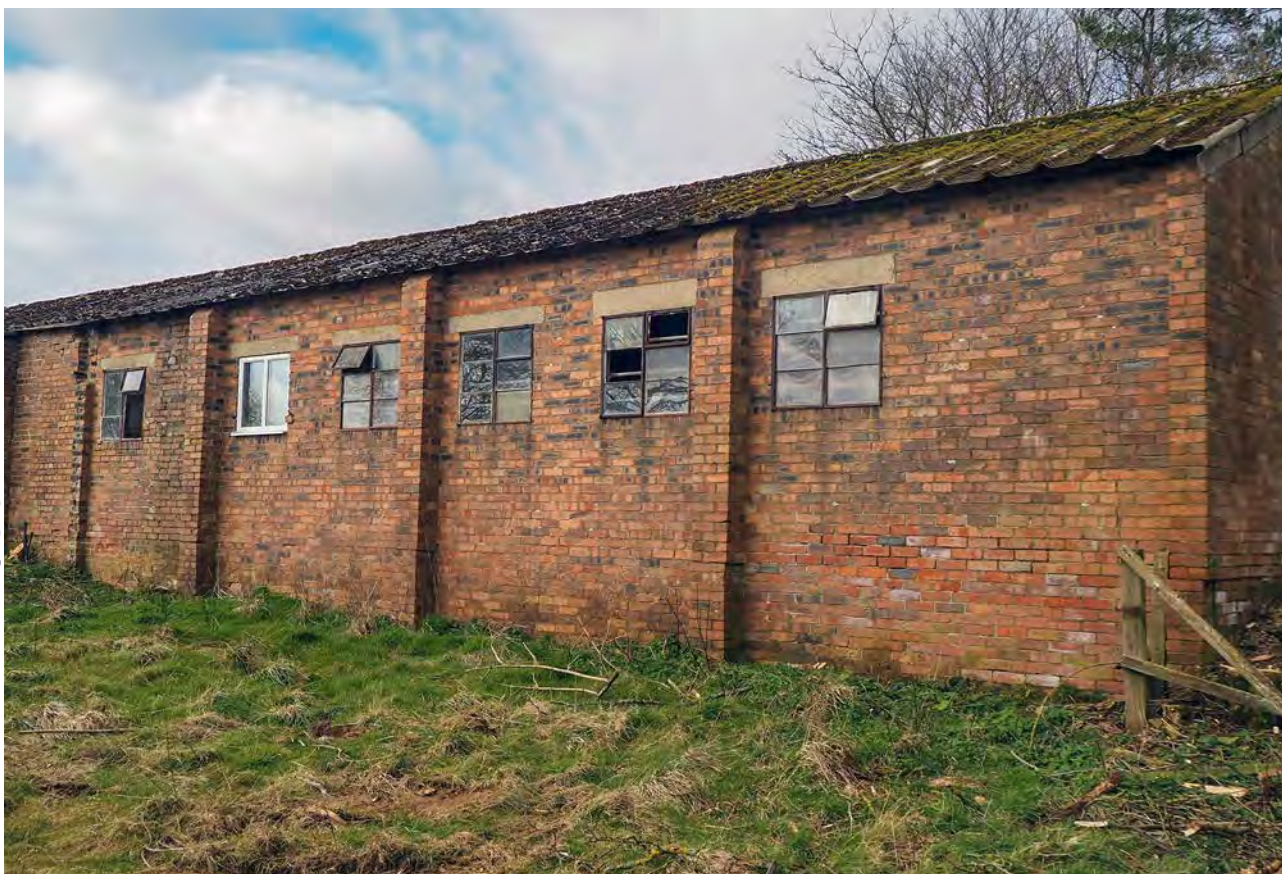
Plate 51: Building 18, rear elevation

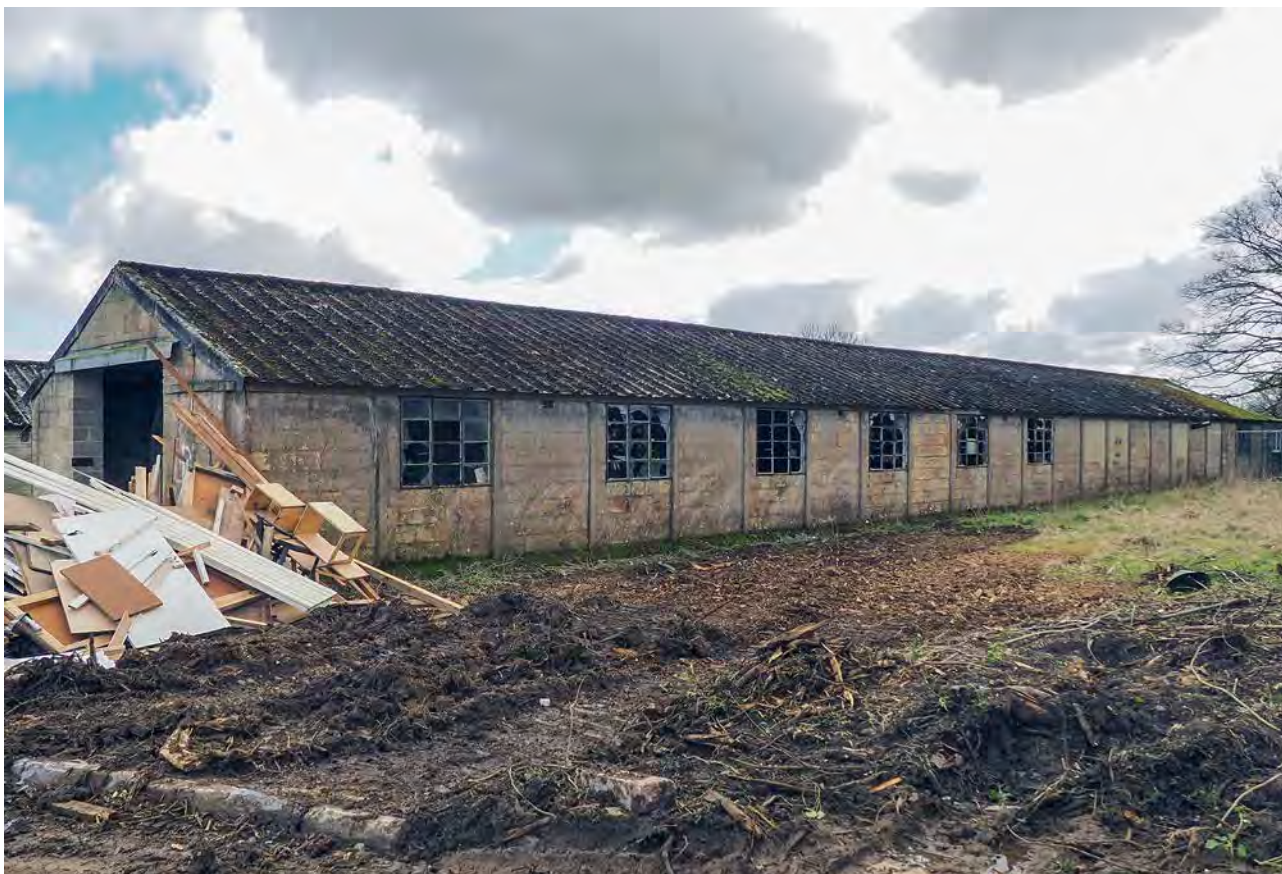
Plate 54: Building 19, front and west elevations

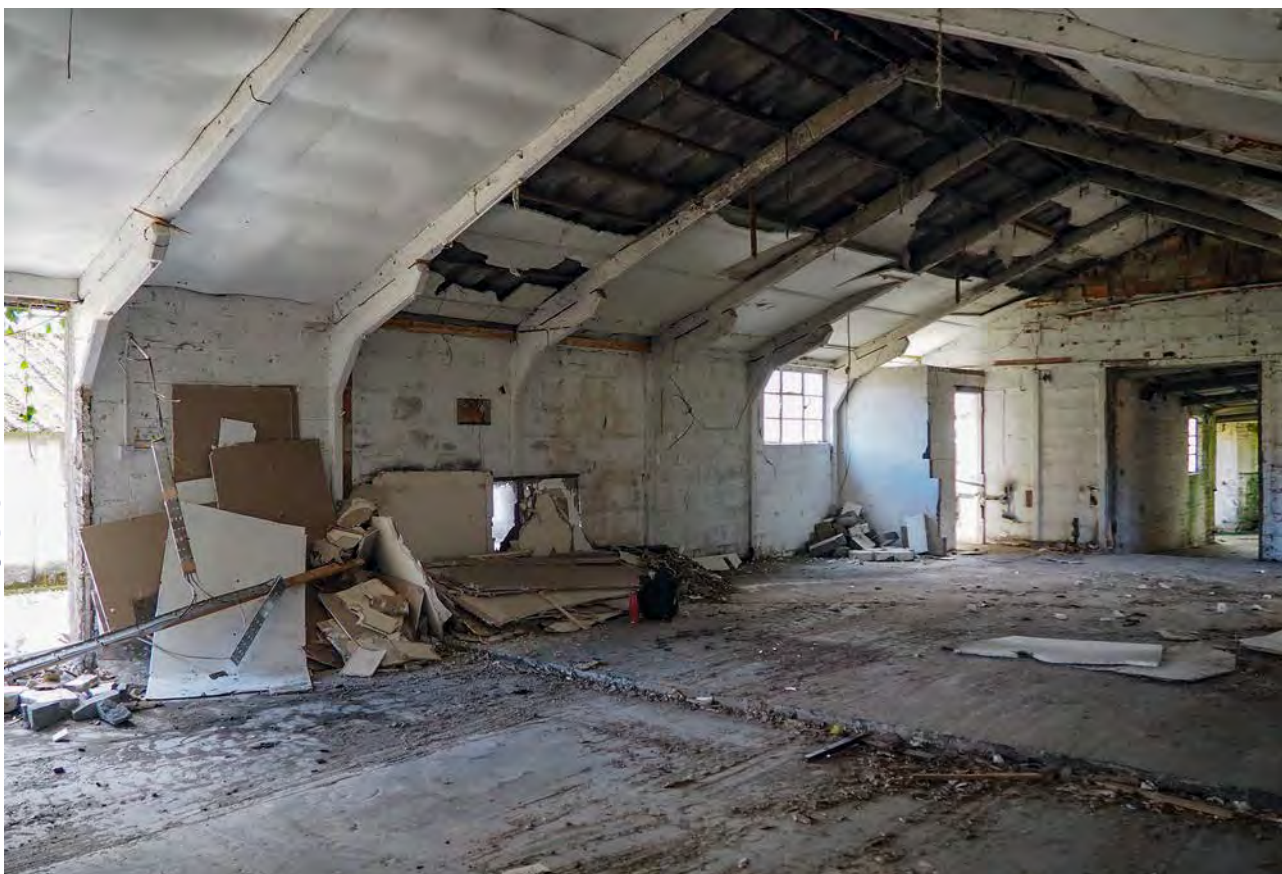
Plate 55: Building 19, looking south towards linking tunnel

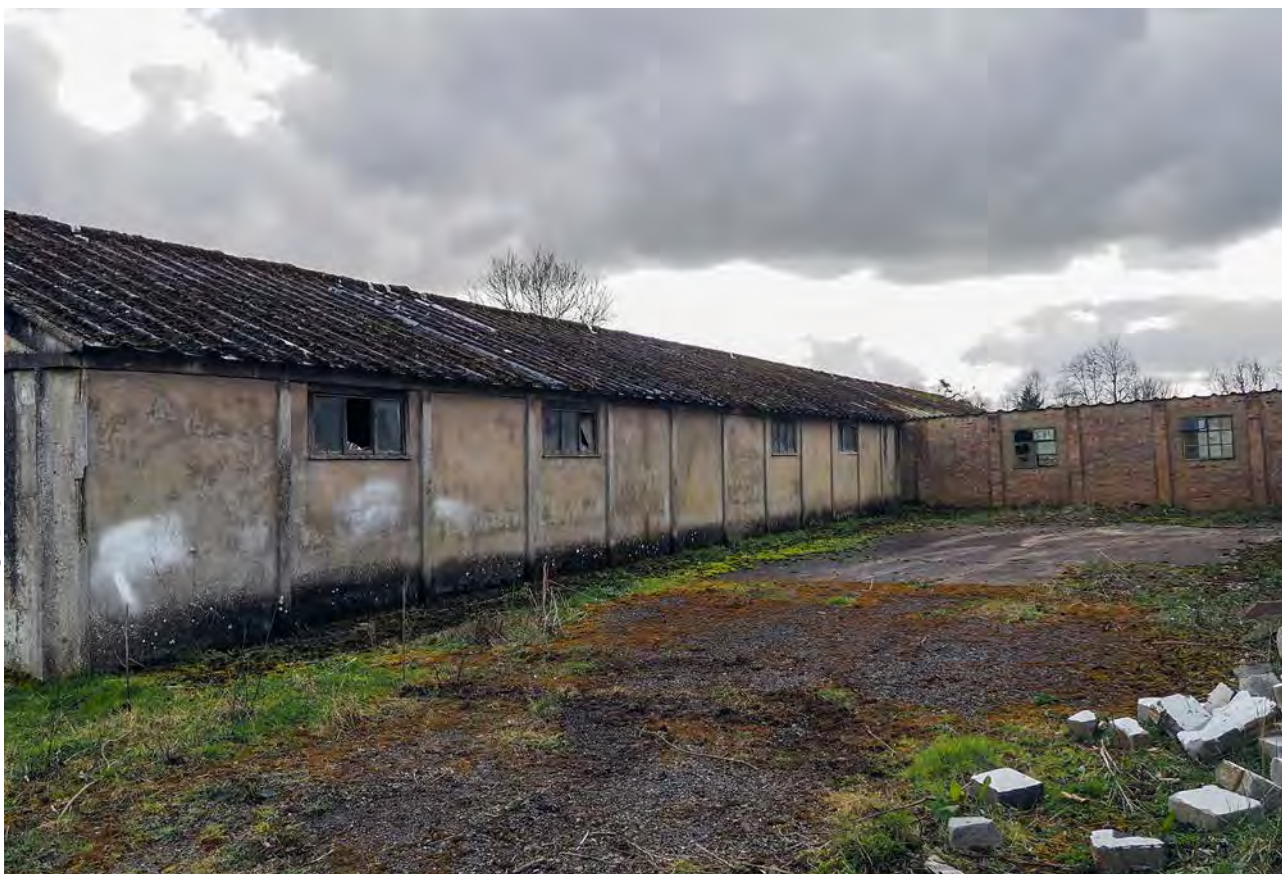
Plate 57: Building 20 and linking tunnel to building 19

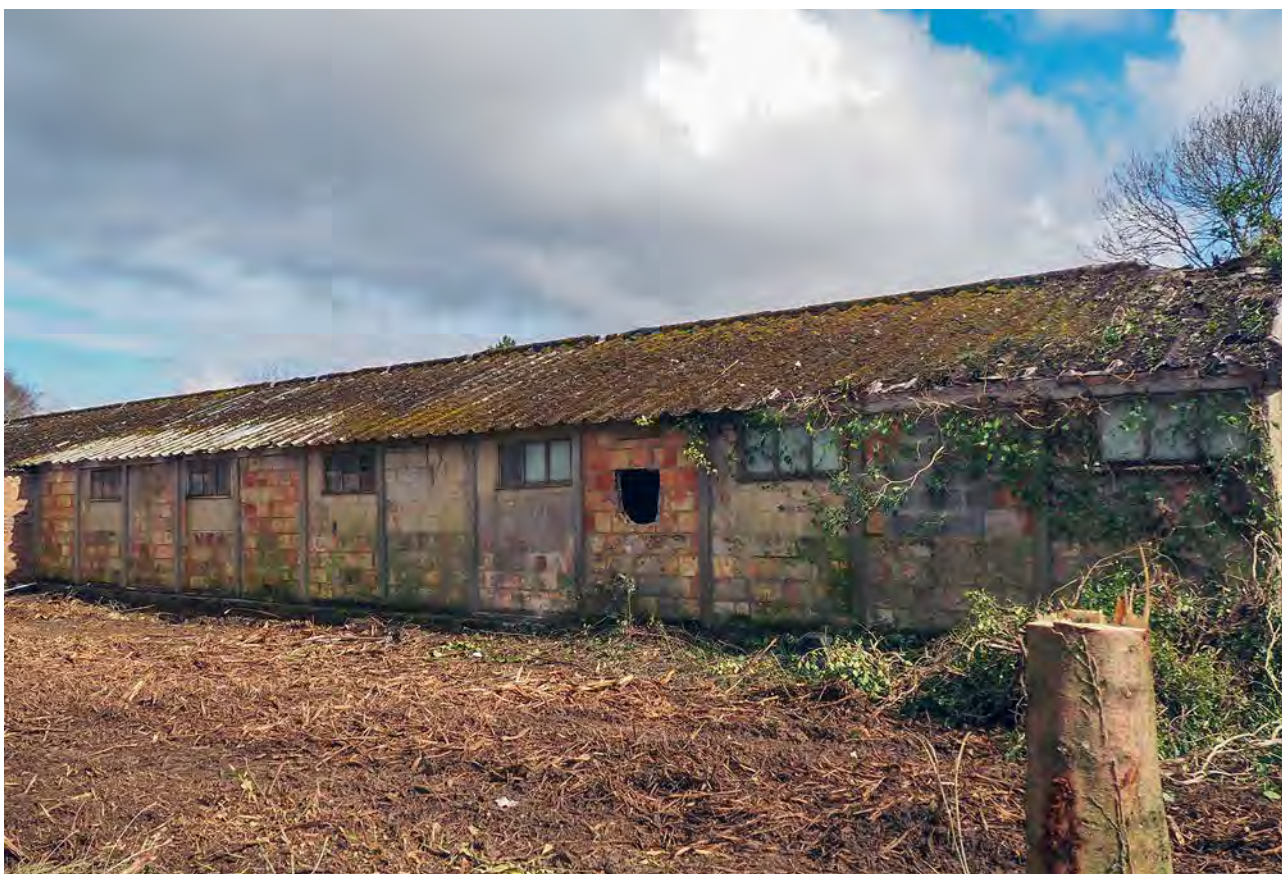
Plate 58: Building 20, east elevation

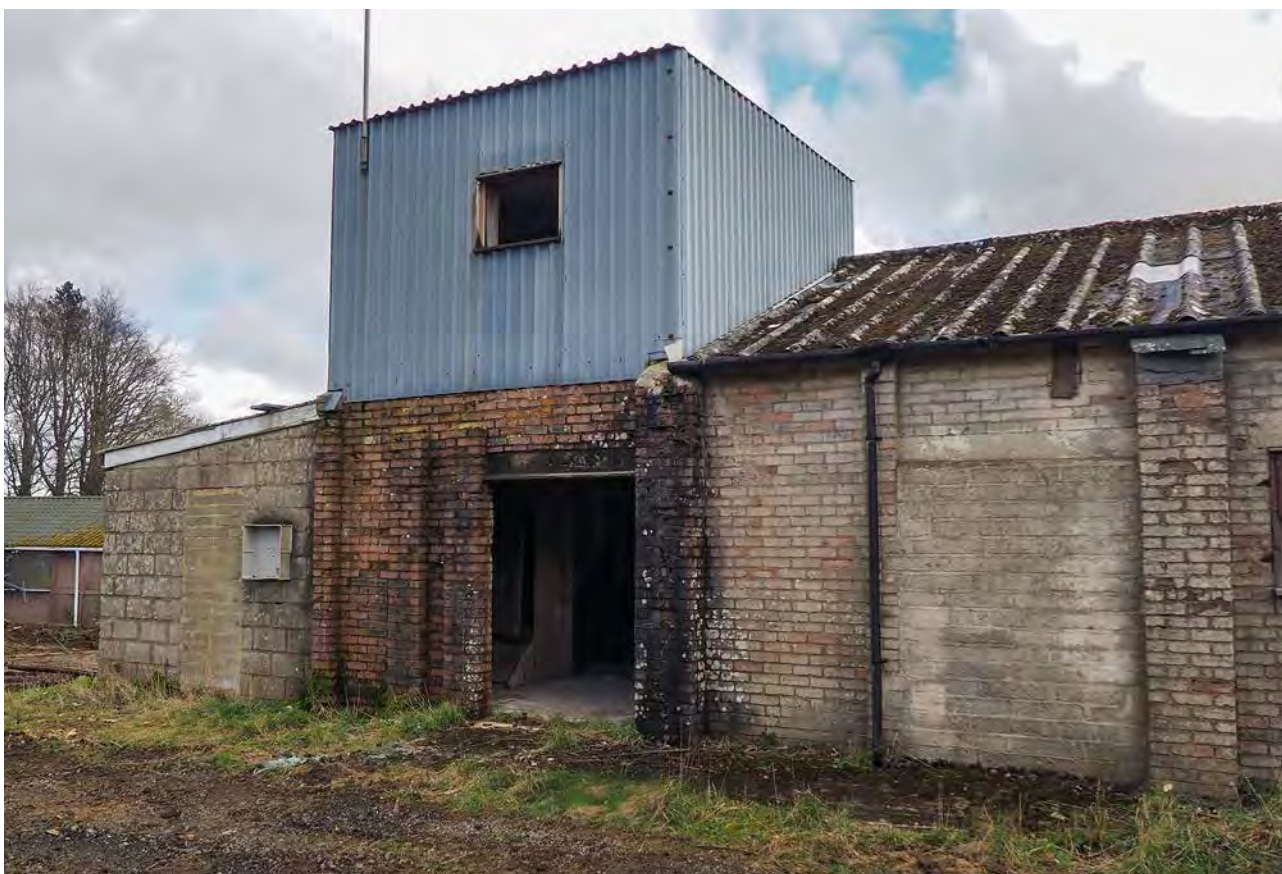
Plate 60: Building 21, west elevation

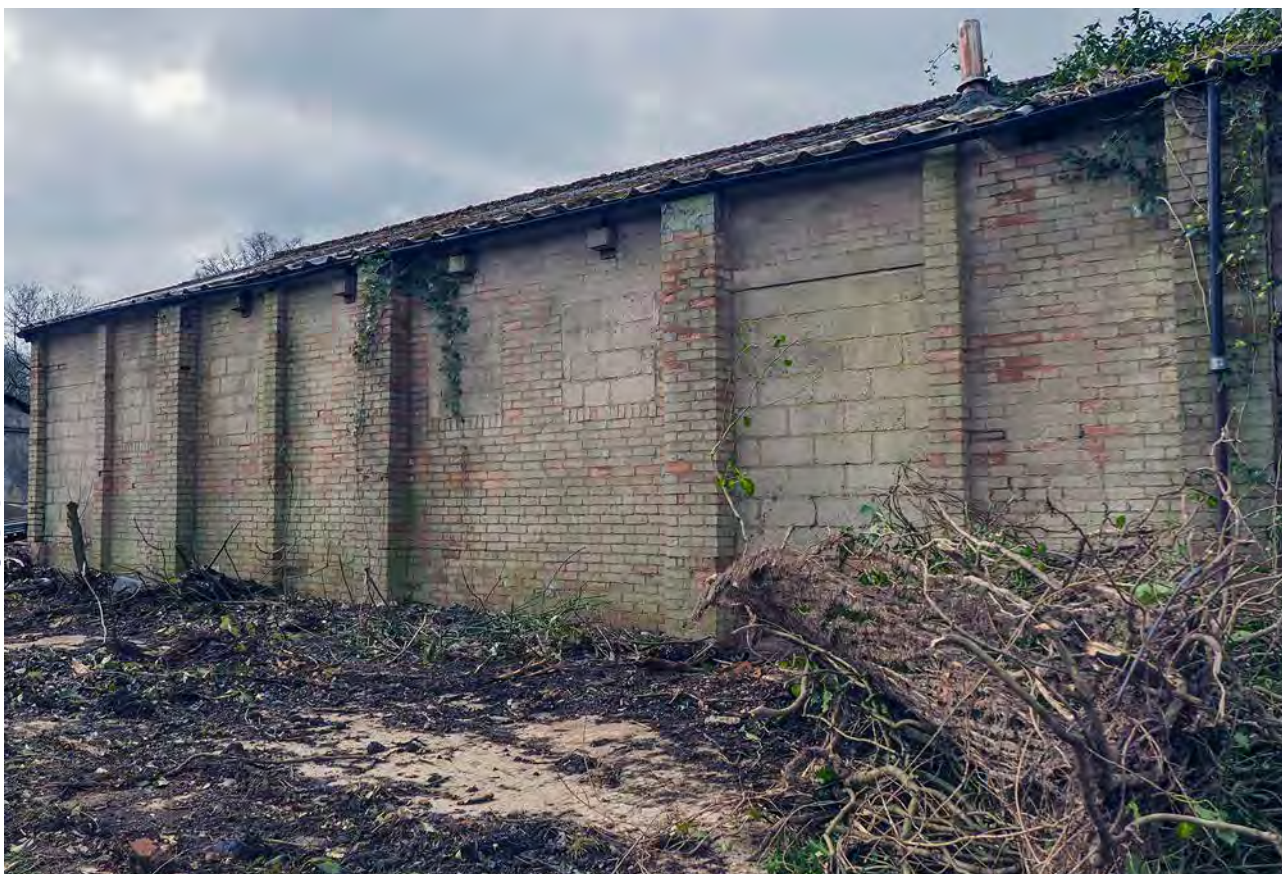
Plate 61: Building 21, east elevation

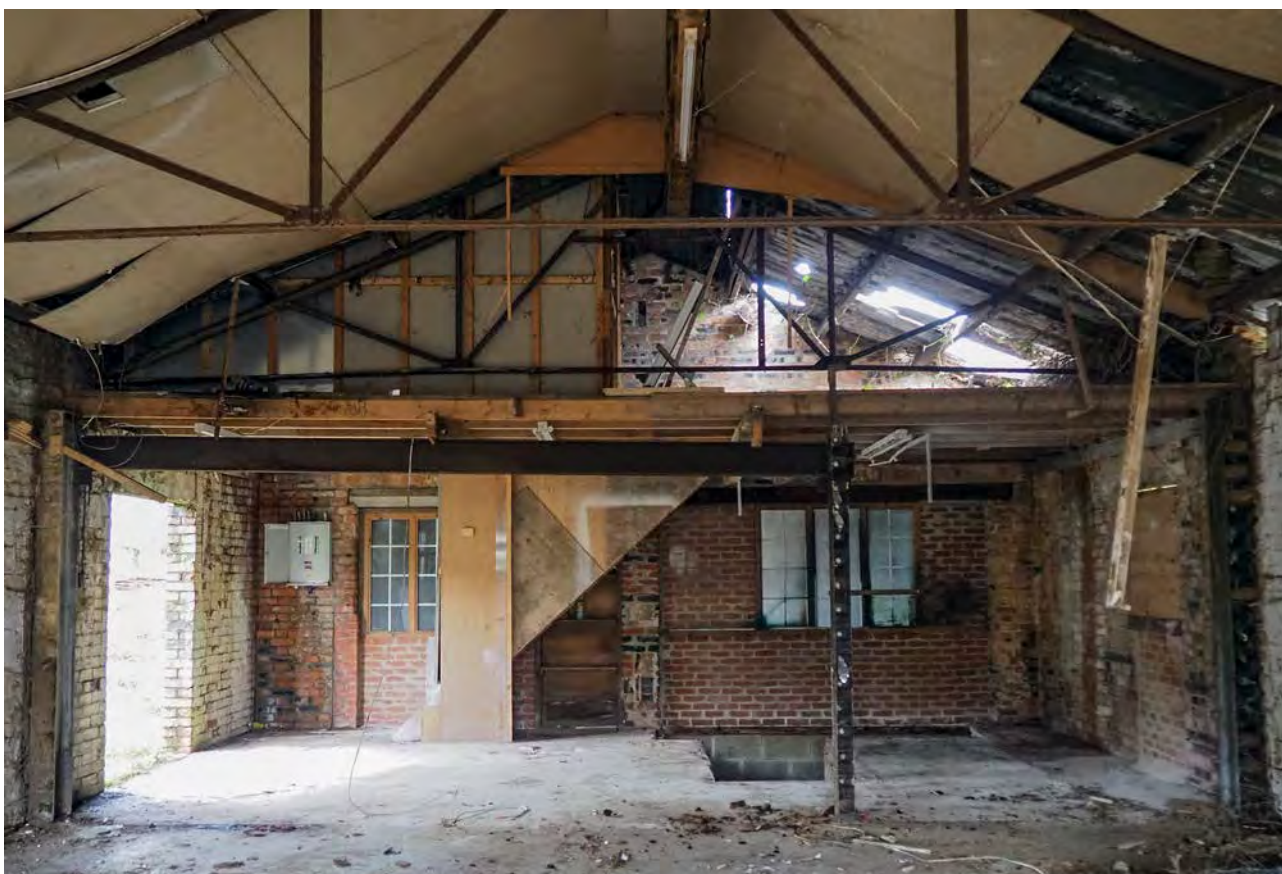
Plate 62: Building 21, internal view

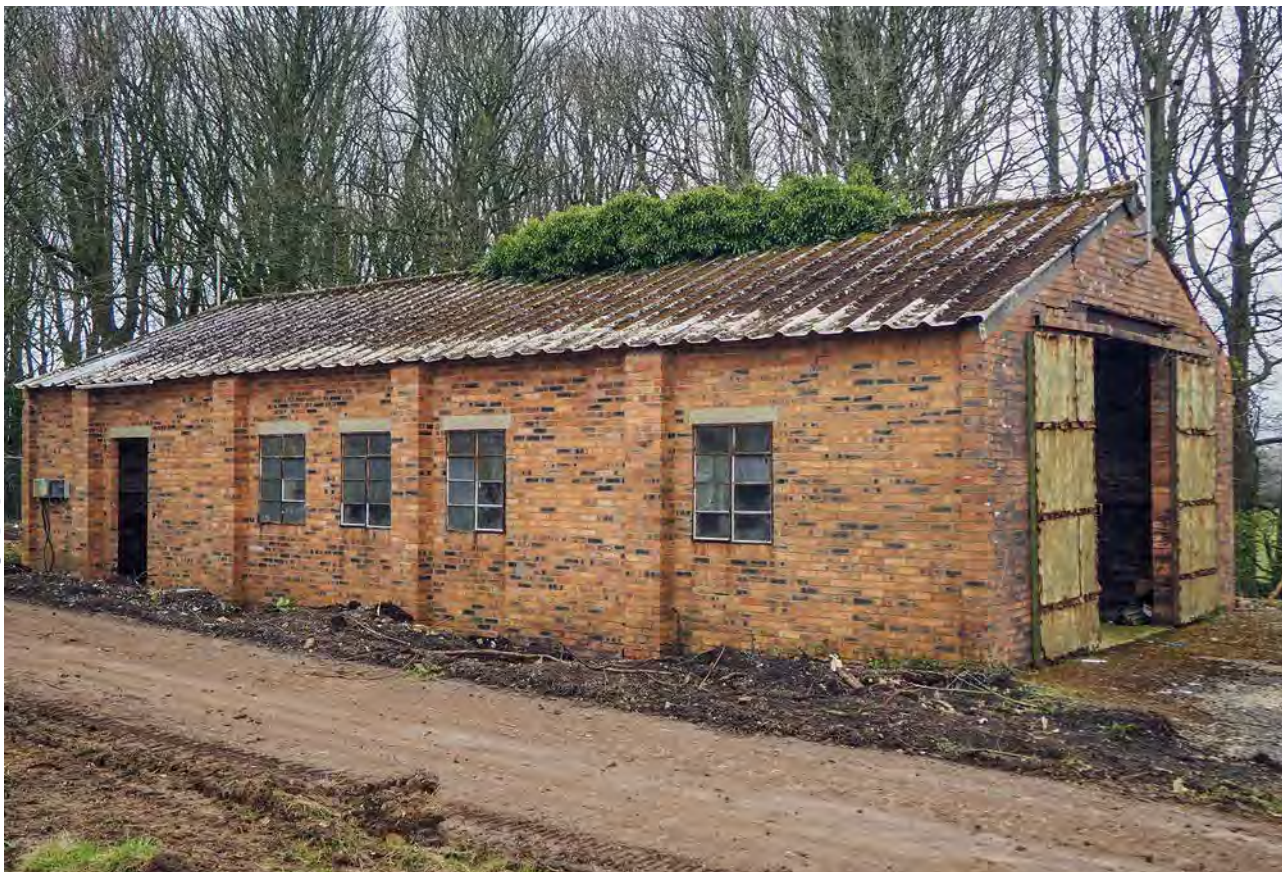
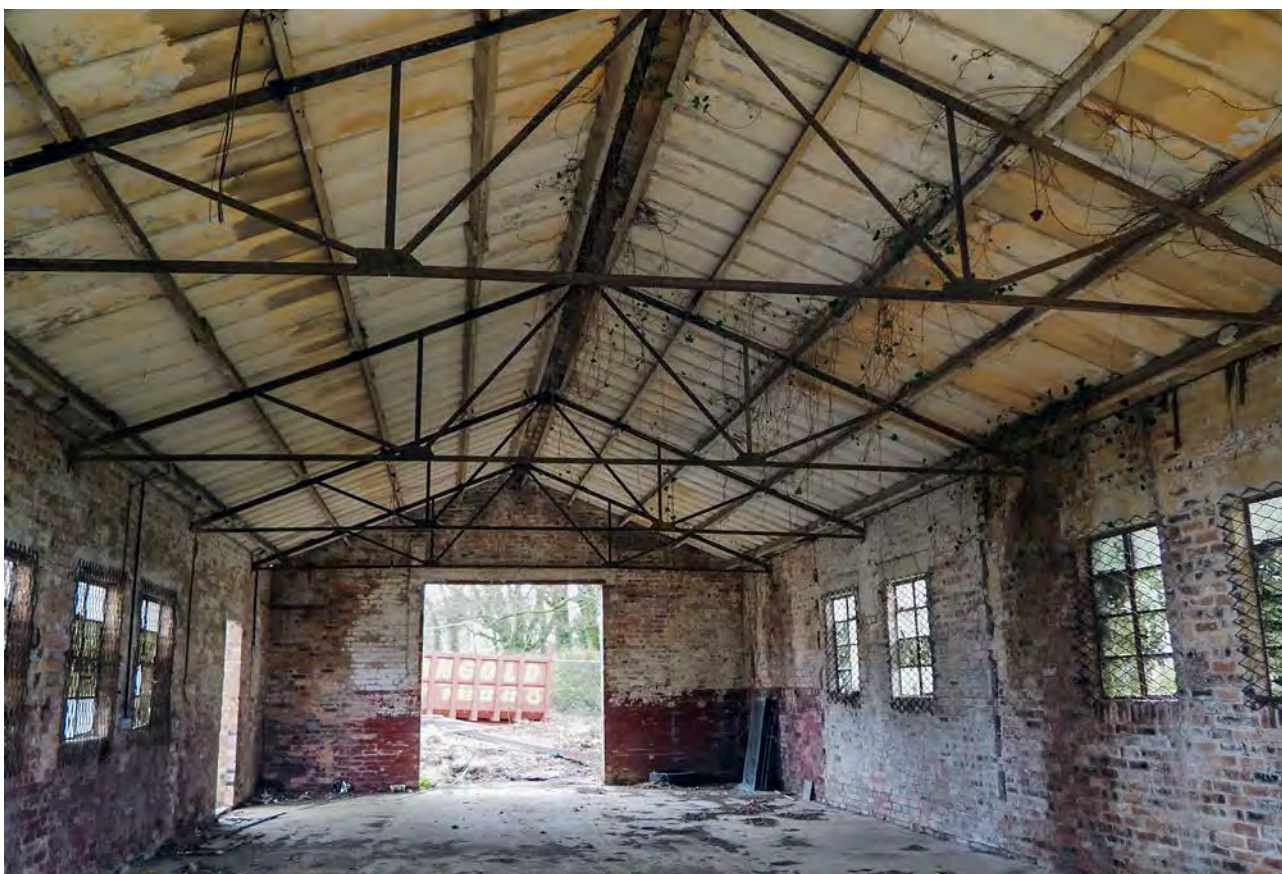
- 4.3.93 The building is a simple, single-storied brick structure with a rectangular plan (Photos 63 and 64). The door at the north-west end (2.75 by 3.76m), has modern roller shutters and a concrete lintel, but the opening at the south-eastern end (2.76 by 3.05) retains its primary doors. These are sheet metal cladding set on a horizontal steel rails over the steel lintel, which slide open on rollers. The building has a gabled roof, which is clad in corrugated asbestos sheeting.

Plate 63: Building 22, south and west elevations

Plate 64: Building 22, internal view looking north-west

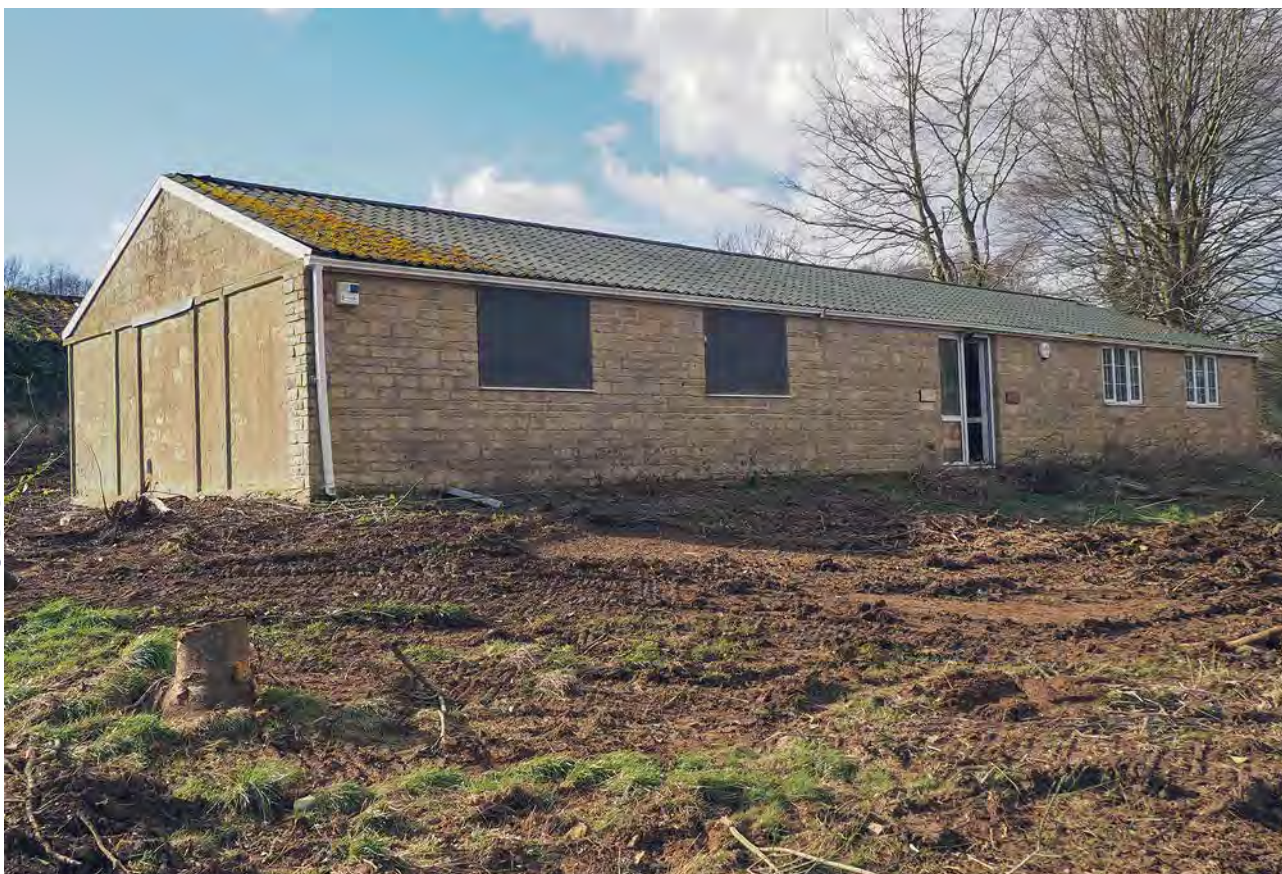
- 4.3.96 **Building 23** is part of a group of buildings at the north end of the site, numbered 23 to 32. These are all of the standard wartime structure, although building 23 is shorter and roughly half the length of the structures to the west (Photo 65). The building has been converted for use an office with carpets and a suspended ceiling. The front (east) face is visible from the road and has been clad in modern stone, with a central doorway and two UPVC windows to each side. The rear elevation is rendered and only two UPVC windows remain at the north end, with two boarded up windows at the south end. The roof has been reclad in secondary corrugated panels.

Plate 65: Building 23, east and south elevations

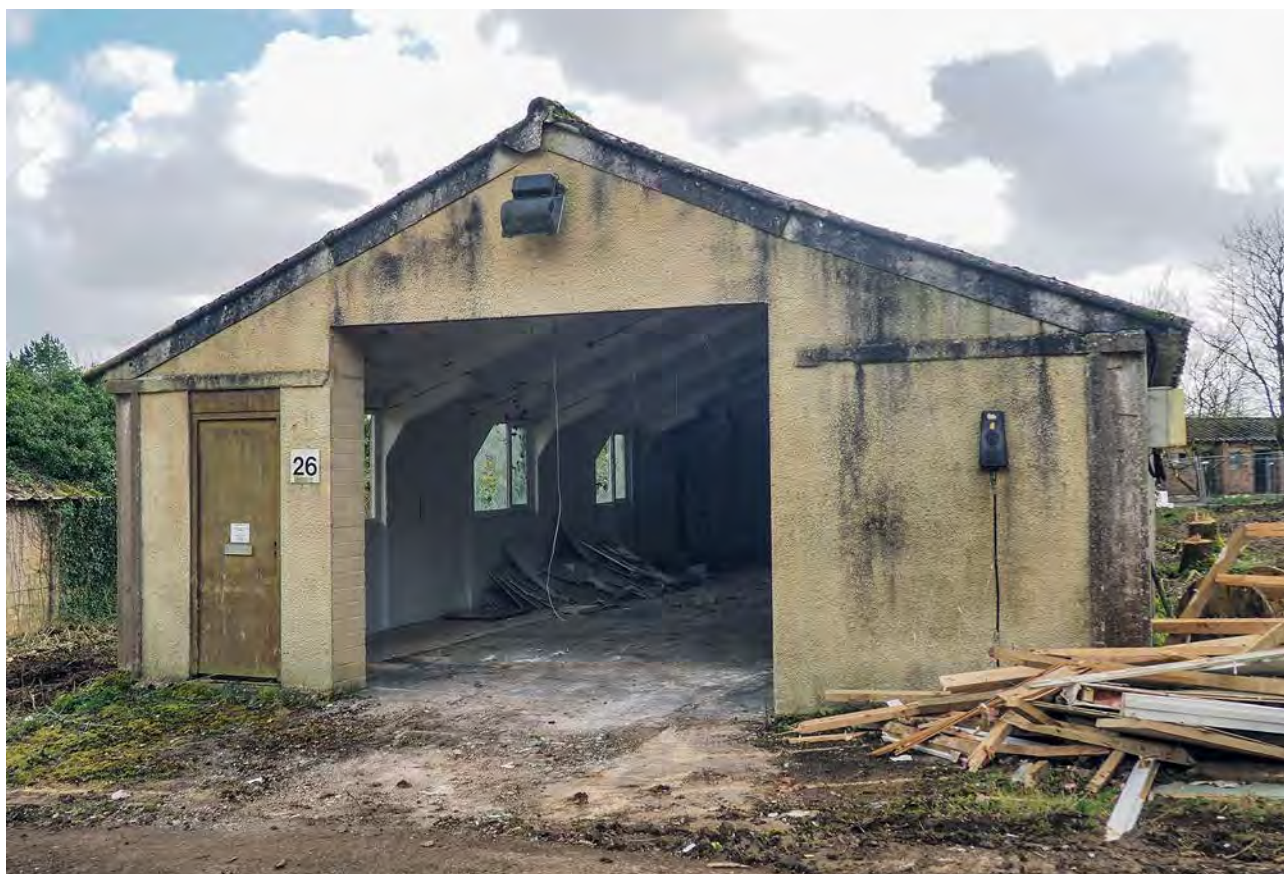
- 4.3.100 **Building 26** has adapted and rendered front and rear elevations to allow for the insertion of wider access doors (Photo 68). Concrete breeze block pillars form the sides to the openings, and there was evidently formerly roller doors here although these are not original features. A single timber door has been inserted to the side of the main opening of the rear elevation, otherwise the primary construction of the rear elevation remains.

Plate 68: Building 26, front elevation
