# Ullenwood Court, Gloucestershire Former Second World War camp

## Historic Building Investigation and Recording

January 2021

**Client: Churcham Homes**

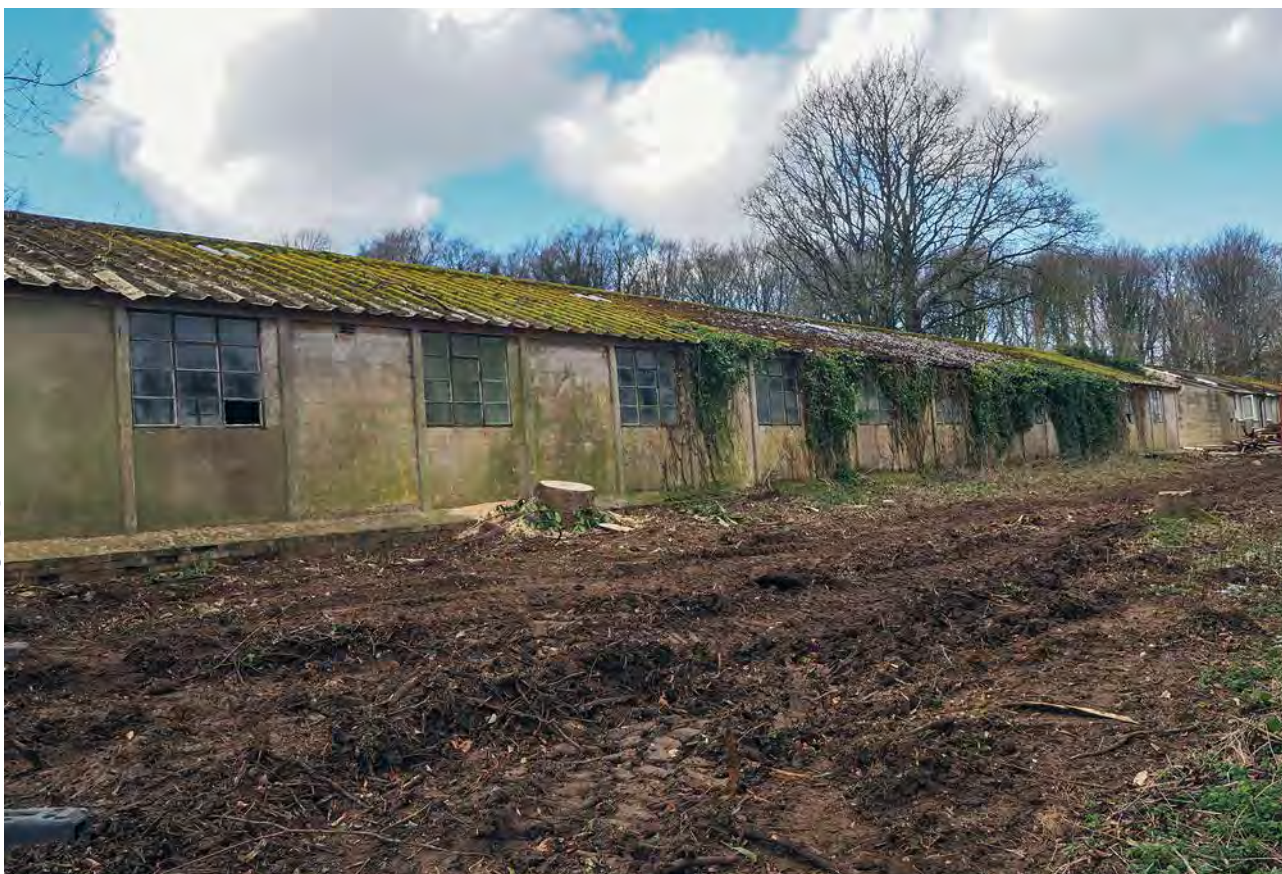
Plate 69: Building 27, east elevation

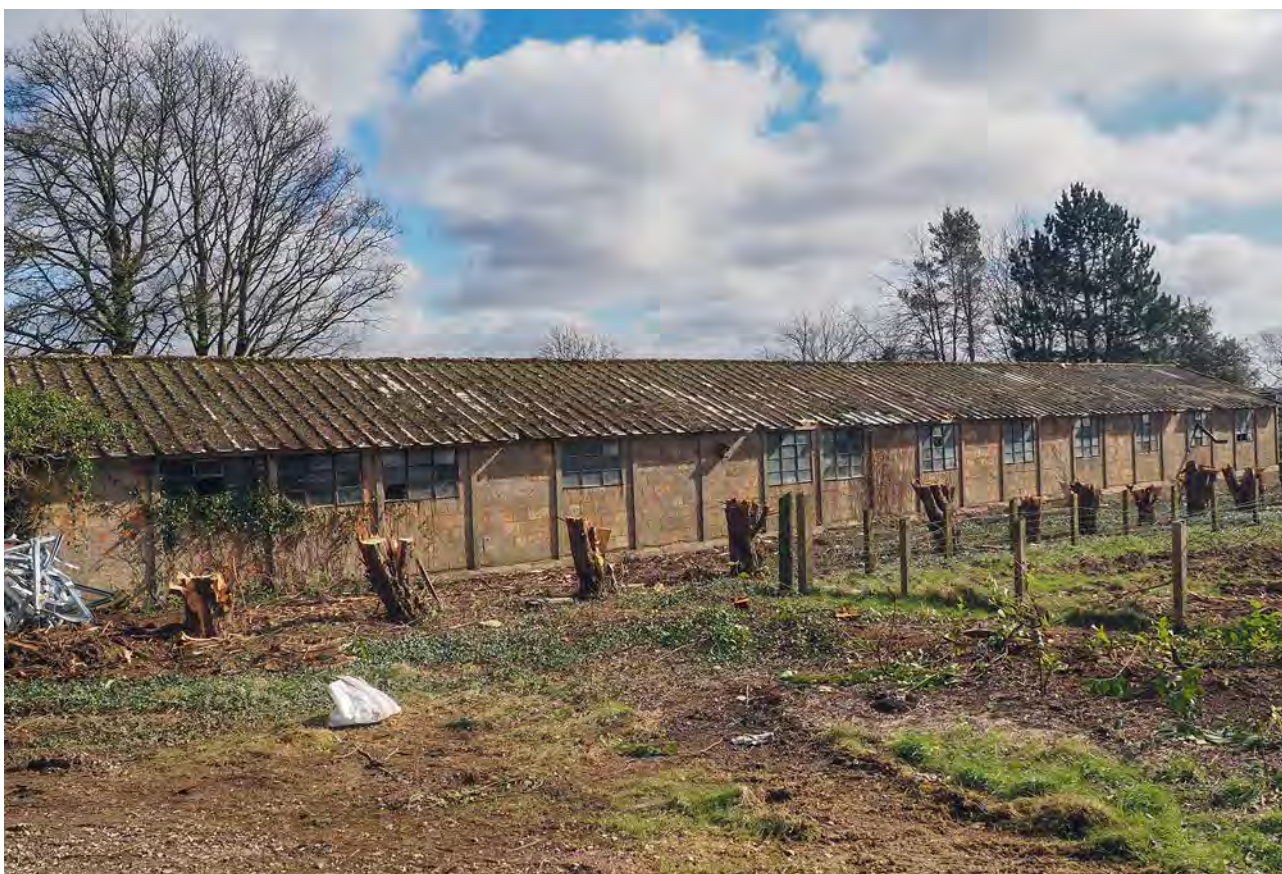
Plate 70: Building 28, west elevation

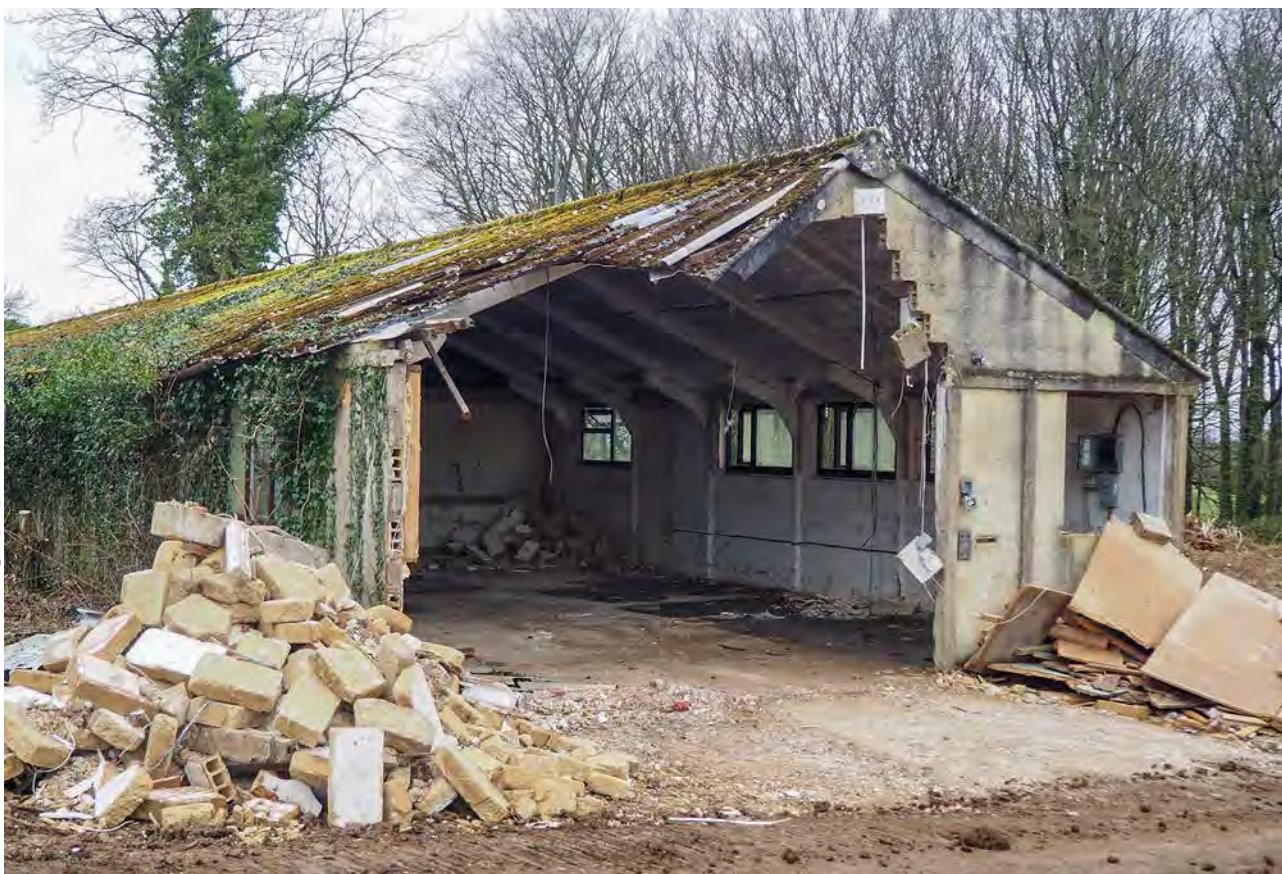
- 4.3.107 **Building 29** has been subject to recent clearance and demolition (Photo 71), resulting in the loss of much of the front elevation. It is also covered in considerable vegetation making

Plate 71: Building 29, front elevation

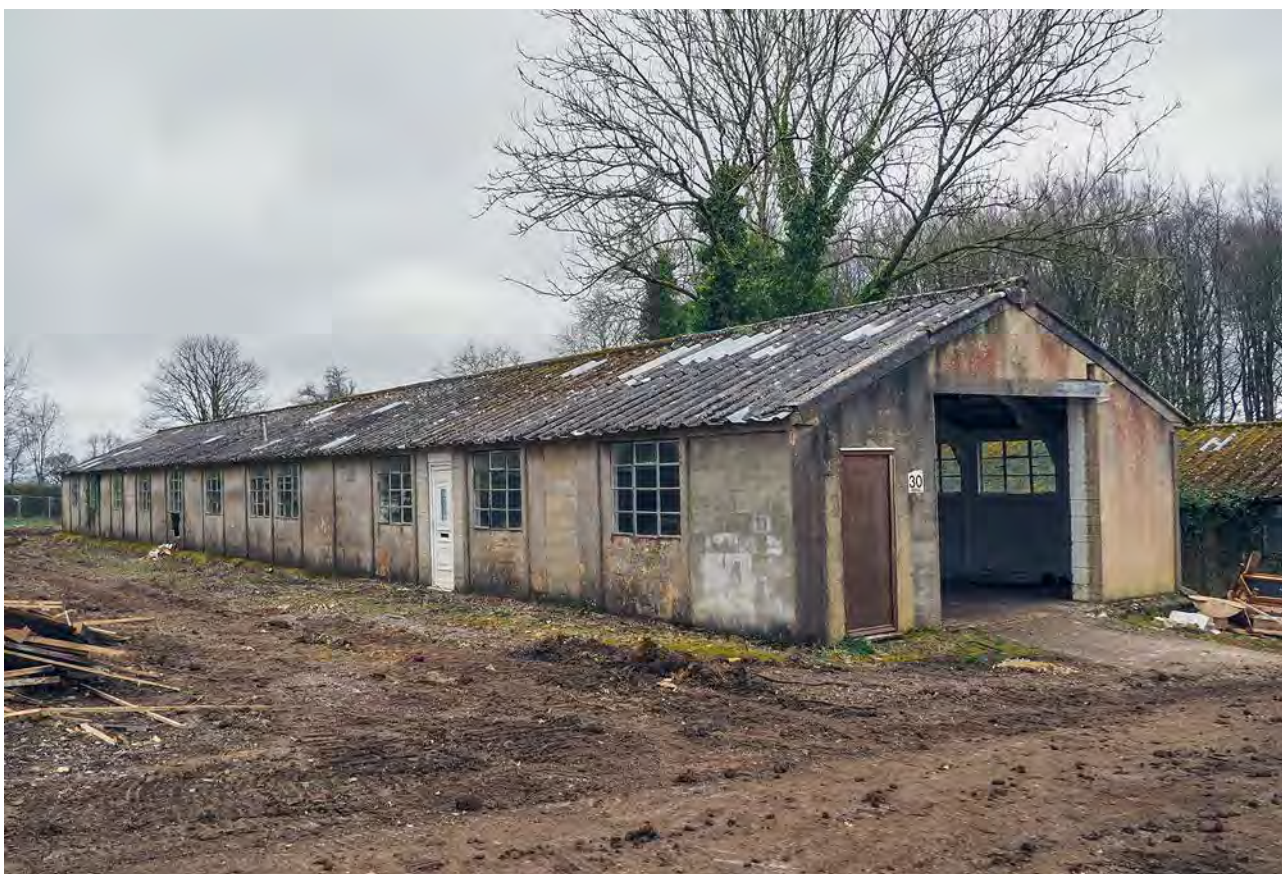
4.3.108 **Building 30** is of the standard wartime construction at Ullenwood (Photo 72). It is similar to building 32 with a rebuilt front elevation which has roller doors and a door to the west side. The west elevation has an infilled door in bay 3 from the front elevation, and there is a later door in bay 5. The central area of the rear elevation has been infilled, and a later door has been inserted to the east, with breeze blocking surrounding it. The windows to the east elevation are largely infilled, although there are four crittal windows *in situ* at the south end. Internally, the building is painted white and a small wc and basin has later been inserted. The central section is infilled with breeze block and there is a door to the east.

Plate 72: Building 30, south and west elevations

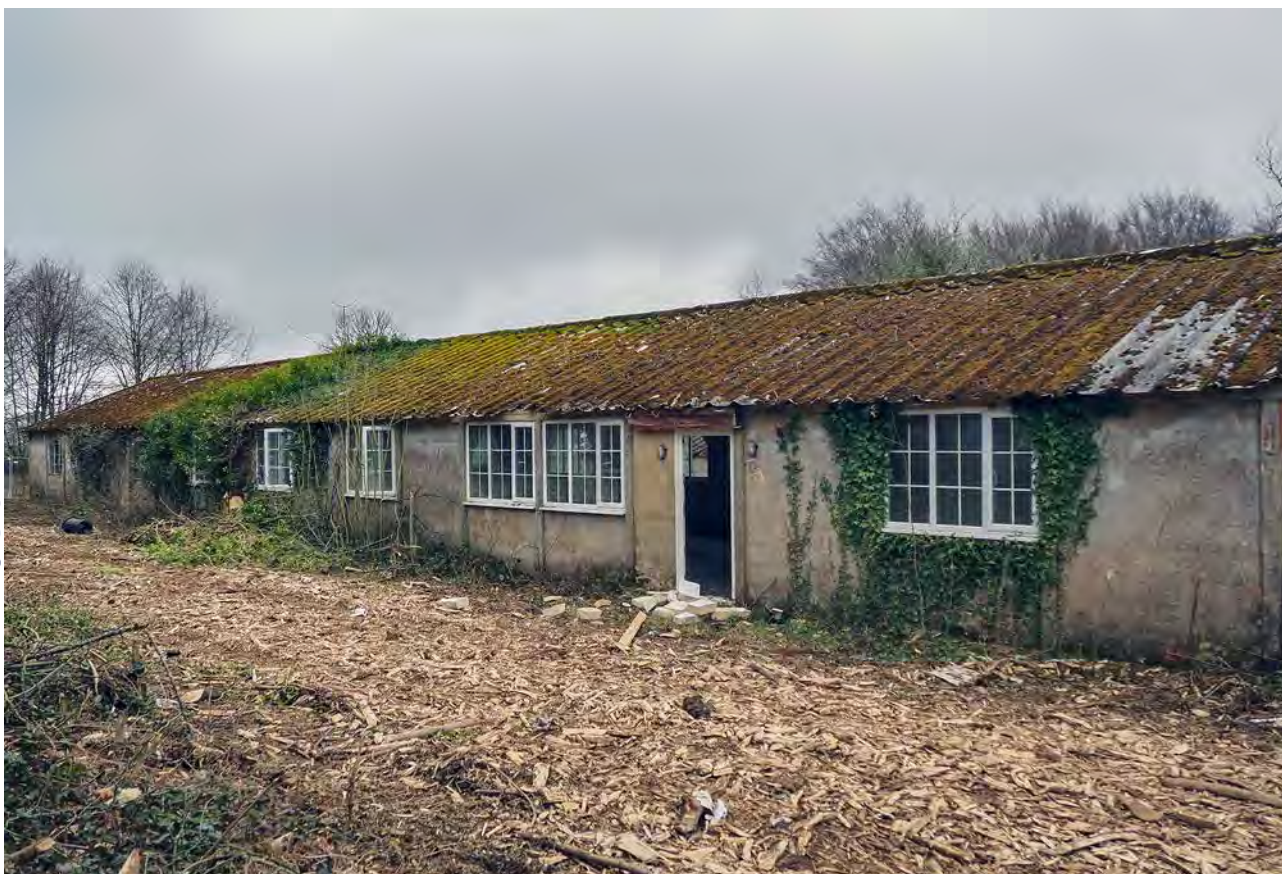
4.3.109 **Building 31** is of the standard wartime construction at Ullenwood but has been modified to allow for its later use (Photo 73). The front (south) elevation has been rebuilt in breeze blocks and is rendered in pebble dash. The door and windows to the end (north) elevation have been infilled with breeze blocks, but otherwise the primary construction of the building remains extant. The west elevation has an infilled door in the third bay from the front elevation, and a new door has been inserted in the eighth bay. Three crittal windows remain *in situ* to the rear of the east and west elevations.

Plate 73: Building 31, west elevations

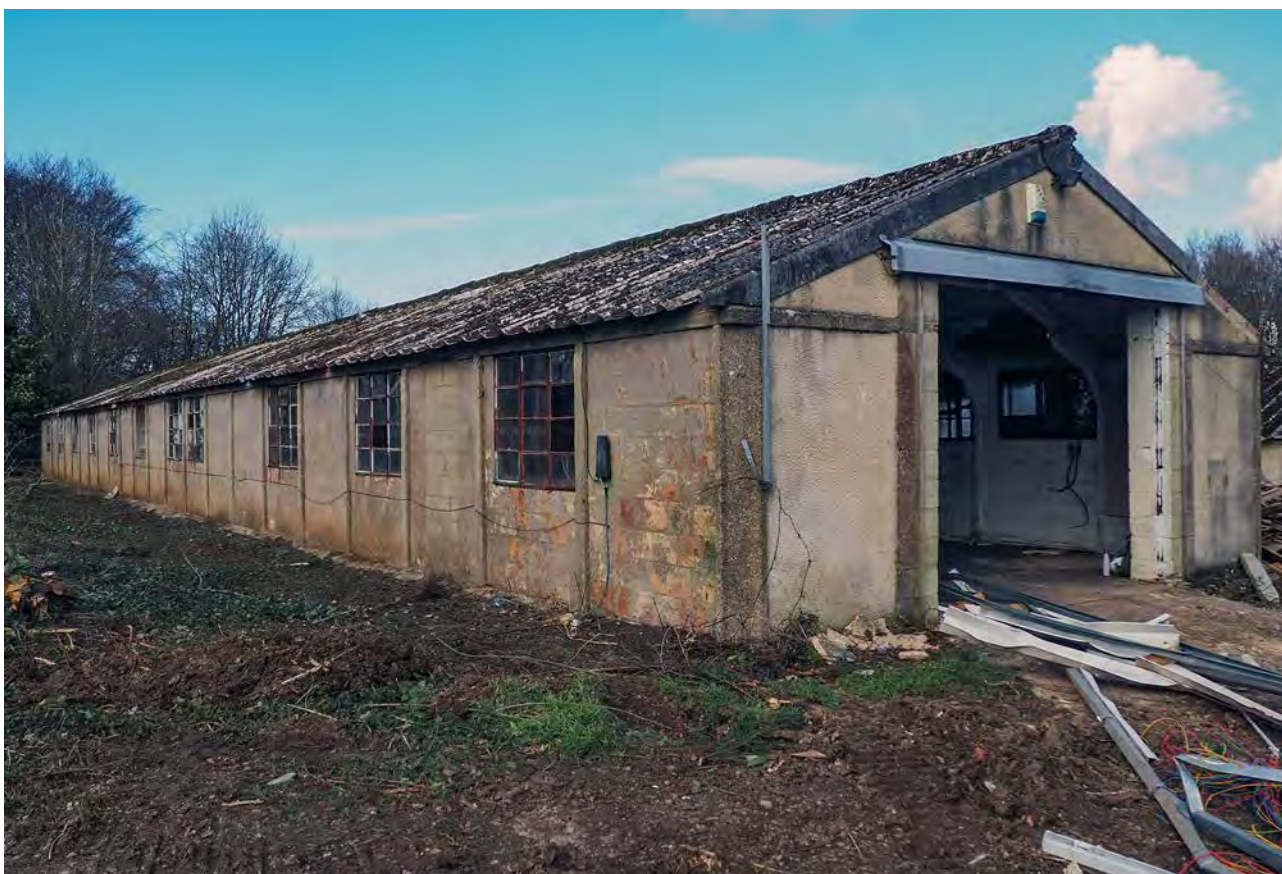
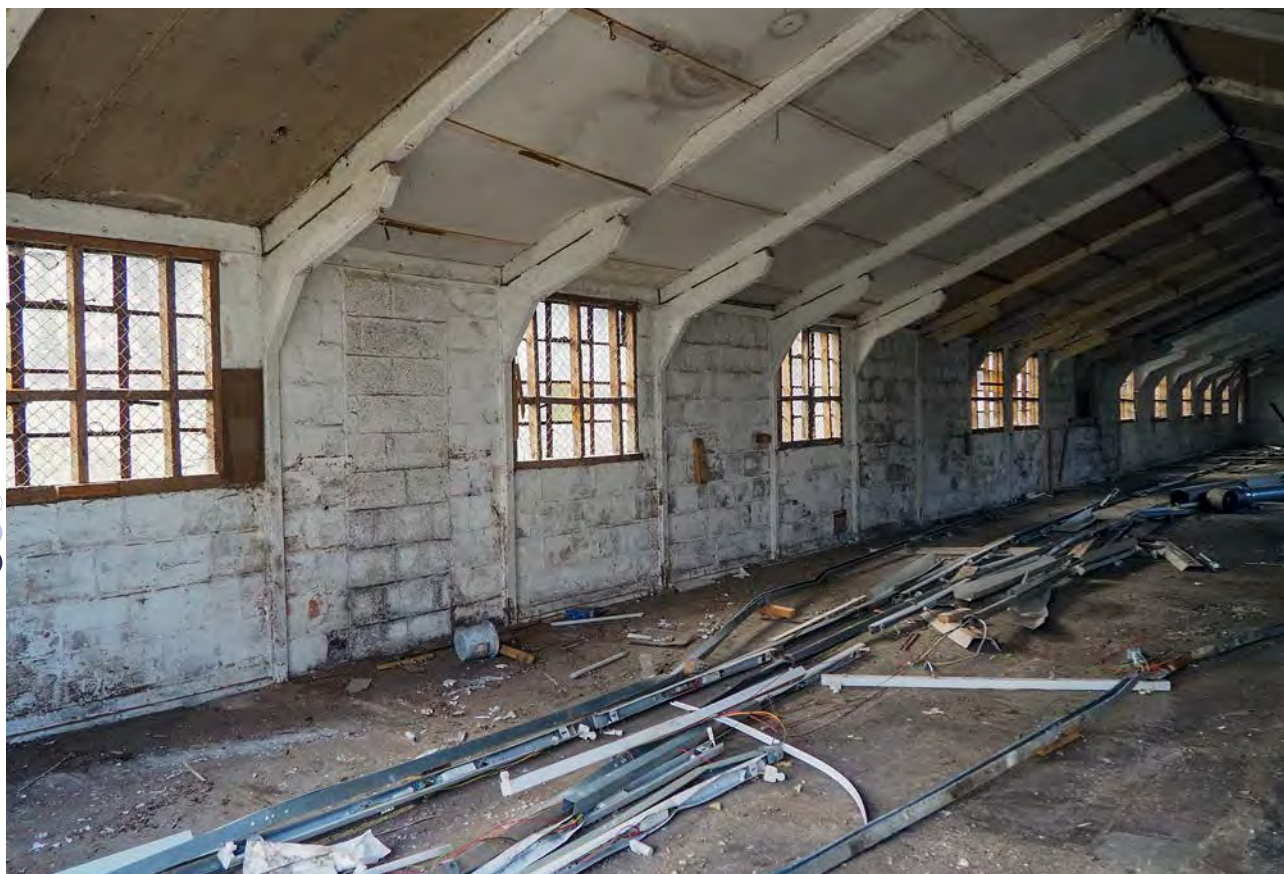
4.3.110 **Building 32** is the standard wartime construction at Ullenwood (Photos 74 and 75), with a modified and widen front entrance to allow for its secondary use. There are breeze blocks to each side of the entrance and there was evidently formerly a roller door here, but this has been removed. The primary construction of the elevation is visible internally, including evidence of the windows to the formerly narrower opening. Crittal windows survive in their primary openings to the east and west elevation. The rear elevation also retains its primary construction with infilling to the former doors and windows.

Plate 74: Building 32, south and west elevations

Plate 75: Building 32, internal west view
